## Building Inspection Report

Inspection Date: Fri, 6 Feb 2026

Property Address: 12 Absalom Street Riverstone NSW 2765

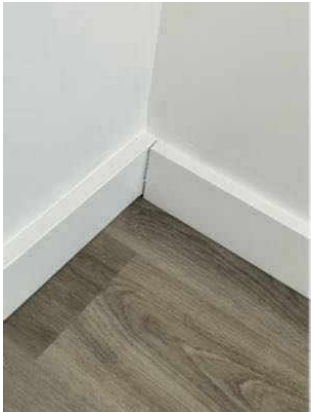
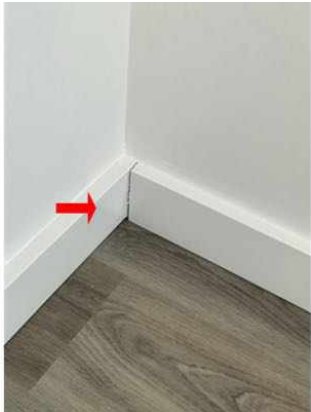
#### Defects 3.01

Building:	Main Building
Location:	All Areas
Finding:	Substandard Work- Various Areas of the Building
Information:	Substandard work has been identified in multiple areas throughout the building, failing

- **\*\*Paint Application:\*\*** Inconsistent and incomplete paint coverage on walls, ceilings, and downpipes, with visible brush marks, drips, and streaks.
- **\*\*Fixtures and Fittings:\*\*** Misaligned or improperly installed fixtures and fittings, not meeting the standard requirements for level and alignment.
- **\*\*Tiling:\*\*** Unevenly laid tiles with inconsistent grout lines and lippage exceeding allowable tolerances.

- Accelerated deterioration and reduced durability of the affected elements.
- Compromised aesthetic quality and overall value of the property.
- Potential safety hazards and increased maintenance costs.
- Negative impact on the building's functionality and usability.

A comprehensive inspection should be conducted post-repairs to ensure all rectifications comply with the required standards.

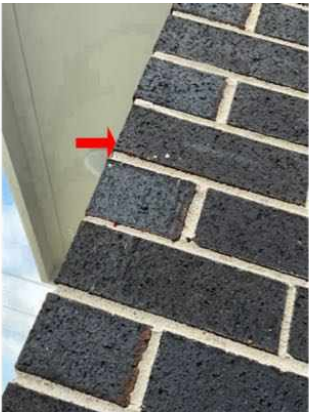
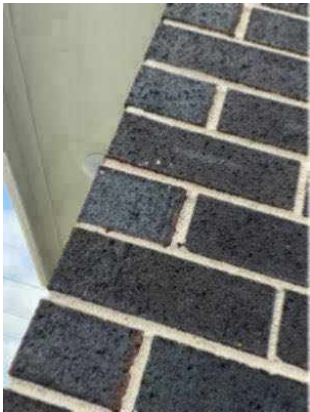
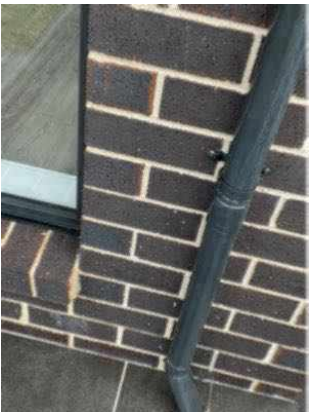
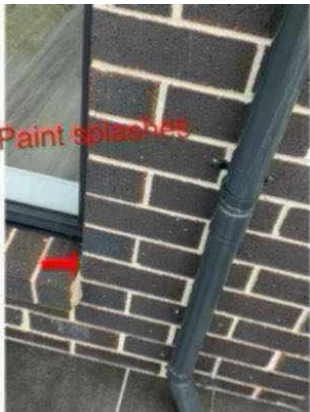
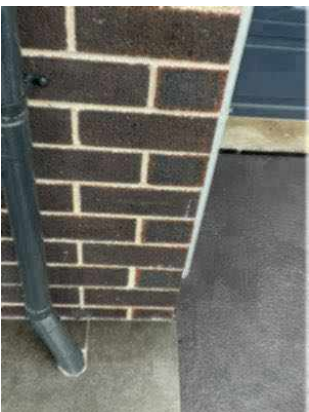
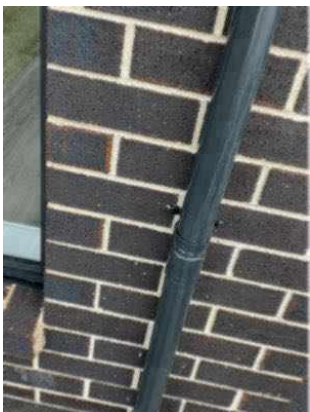
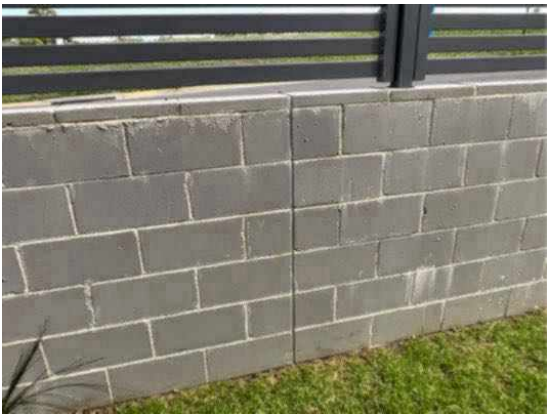
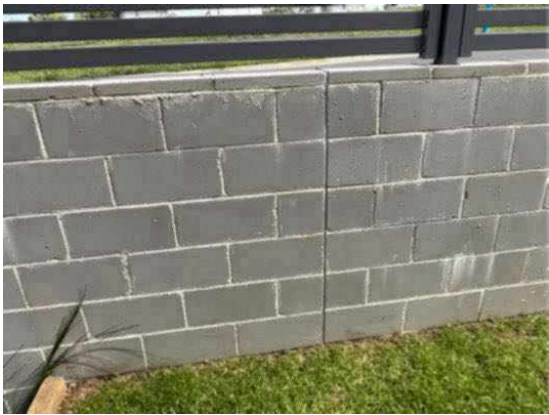
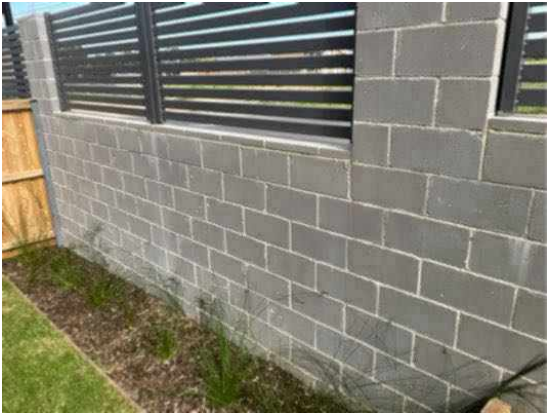
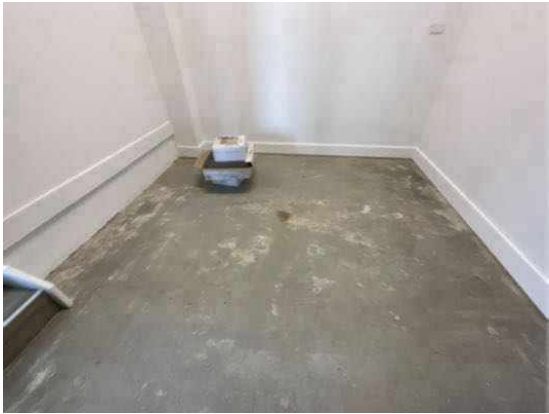
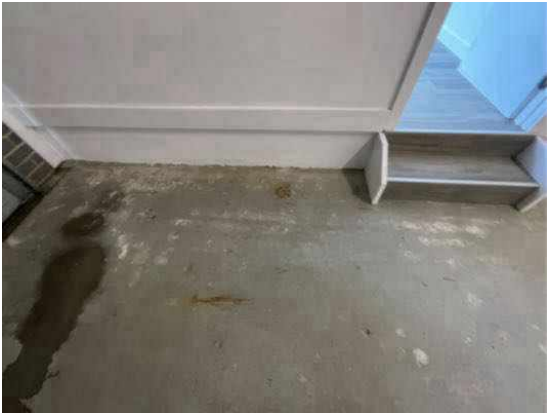
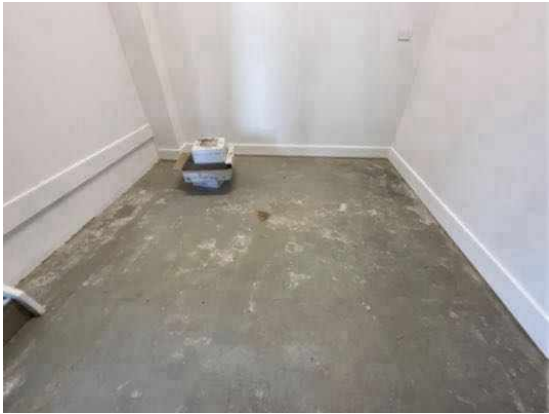
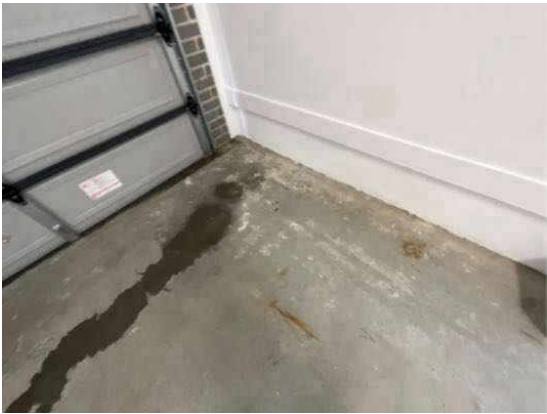
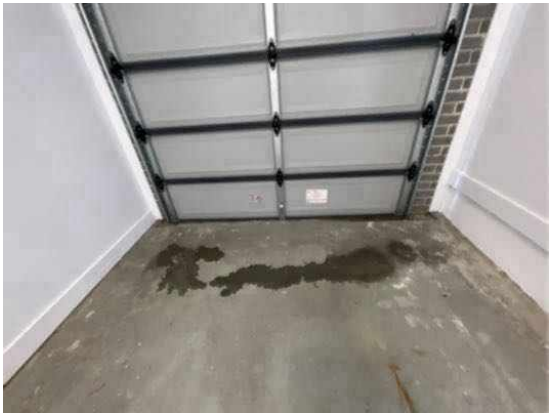
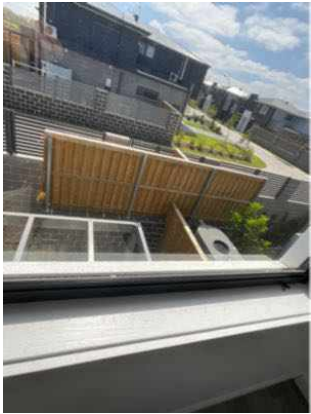
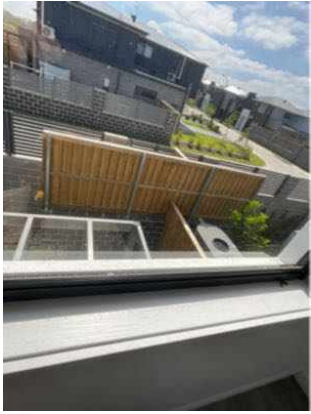
### Defects 3.02

Building:	Main Building
Location:	All Areas
Finding:	Cleaning required
Information:	It was observed that the house requires cleaning.

Works are defective where windows are not clean, floors are not swept, mopped or vacuumed as appropriate, tiles, sinks, basins, baths, windows or any other area throughout the property are not cleaned, and shelving, drawers and cupboards are not ready for use not cleaned and ready for use at handover.

Building sites are defective if they are not clear of building debris.

This is to be addressed prior to handover.

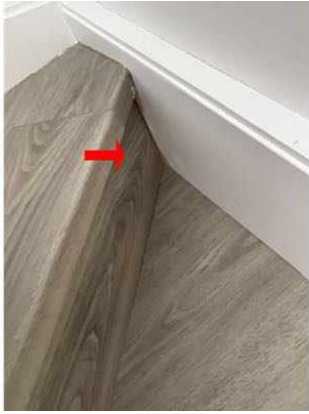
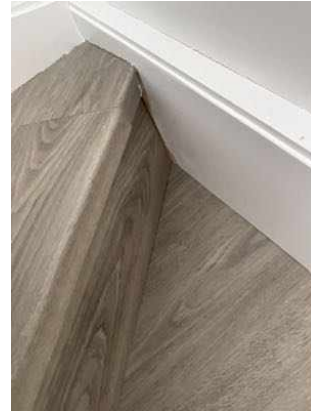
### Defects 3.03

Building:	Main Building
Location:	All Areas
Finding:	Paint - Substandard
Information:	Areas were identified where the surface finish of the painting is substandard and this is considered a defect.

Any irregularity in the surface which is visible from a normal viewing position is considered a defect. Marks may also be a result of fault by other tradespeople throughout the construction process.

Defective surface finish of paintwork is marked with an arrow to the below photos in the following locations.

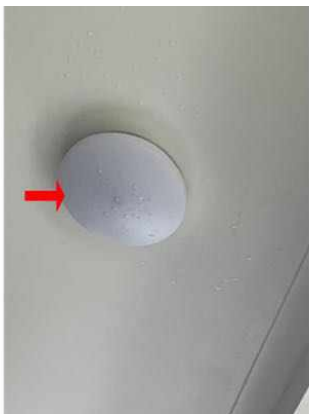
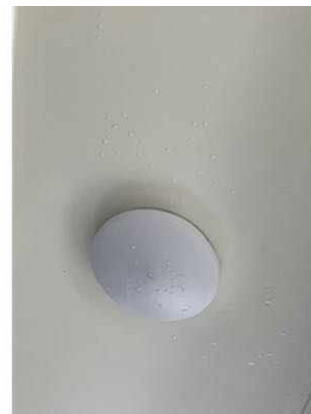
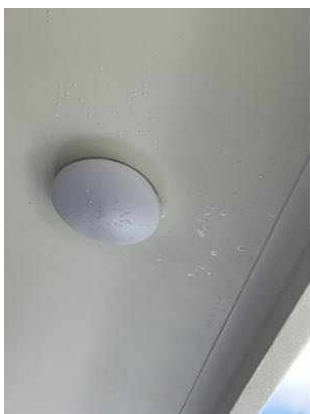
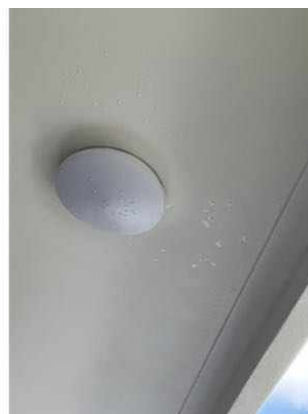
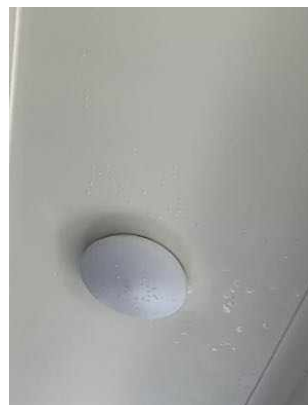
### Defects 3.04

Finding: Water staining

Information: Water staining was evident in this area at the time of inspection. Water staining indicates that surfaces have been exposed to excessive moisture over time. The minerals and other elements in the water lead to staining, which may graduate to corrosion and deterioration if left unmanaged.

While mostly an appearance defect, water staining can be indicative of more serious defects, which may be currently concealed by other building elements.

Where water staining is active, a licensed plumber must be consulted to identify the cause of the staining and to provide advice on any reparation works that may be required. Replacement of any broken or damaged structures is advised.

Conversely, where water staining is old and inactive, affected building materials may be repaired or replaced at client discretion. A qualified carpenter or registered builder may be appointed to perform these works.

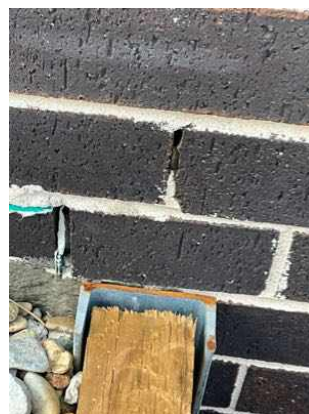
### Defects 3.05

Building:	Main Building
Location:	Exterior walls - left side
Finding:	Mortar joints - Filling required
Information:	Instances of voids and holes affecting the masonry mortar have been identified. Excepting weep holes and vents voids and holes are defects if they are visible from a normal viewing position.

Sub standard and incomplete work are determined by identifying a failure to achieve the minimum requirement set out in the mandated Australian Standard as outlined in the Building Code of Australia and referenced by the Manufacturers Guideline. Reference and clarification can also be made to the Guide to Standards and Tolerances for simplification.

Where a building element is installed in such a way that it fails to achieve the required minimum standard or level of finish at the time of the inspection, the builder needs to rectify the defect as soon as possible and complete works to the required standard prior to handover.

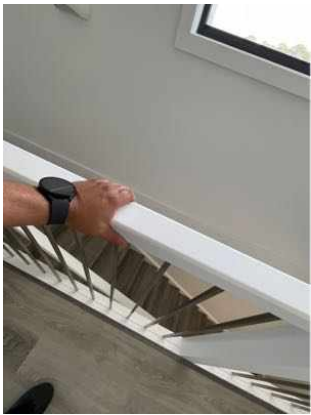
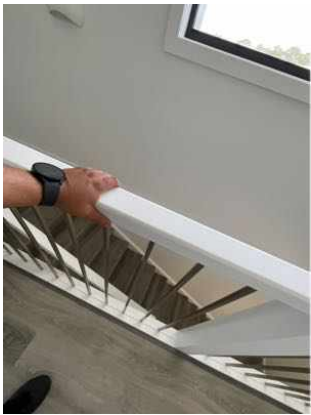
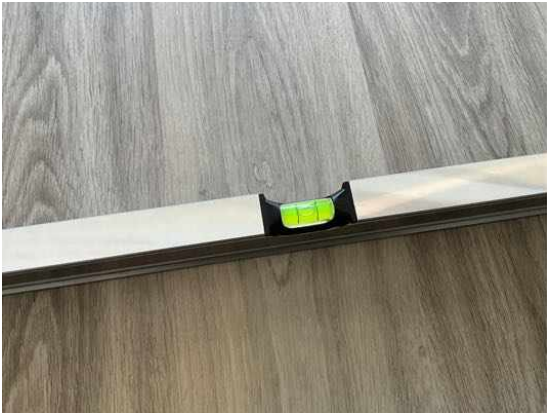
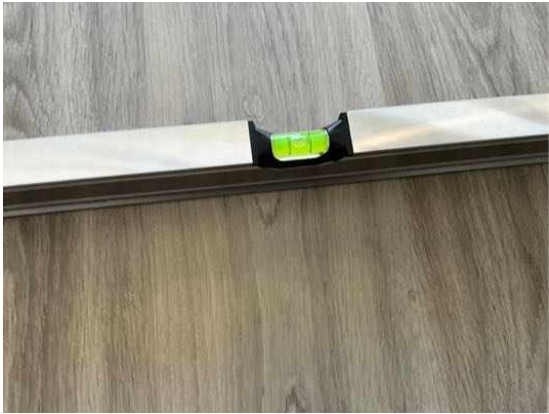
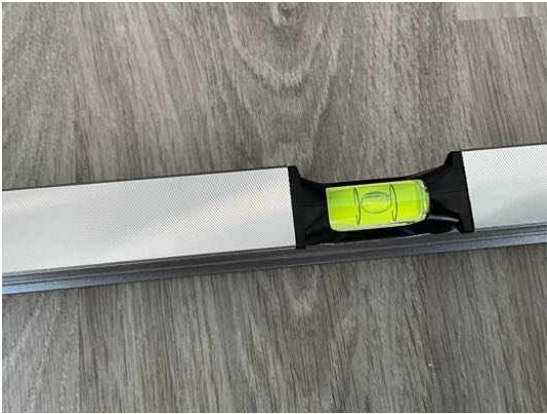
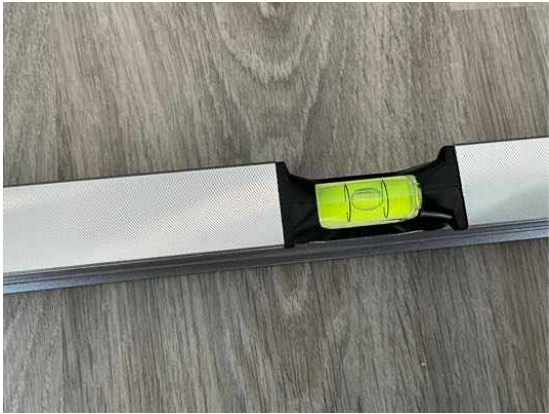
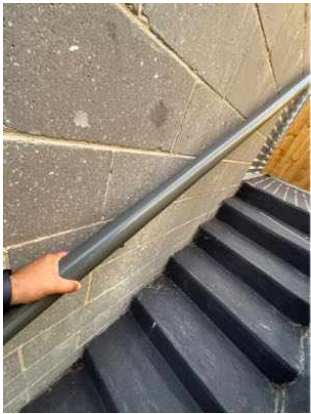
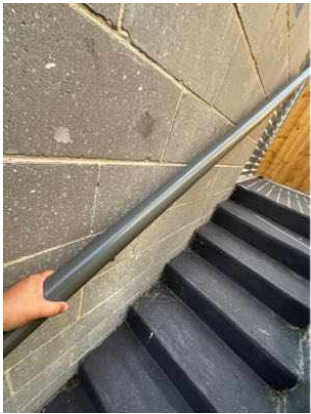
Building: Main Building  
Location: All Areas  
Finding: Additional Photos  
Information: Additional photos are provided for your general reference
