Building and Timber Pest Inspection Report

Inspection Date: Tue, 20 Jan 2026

Property Address: 1 Karol Ct, Hampton Park VIC 3976,
Australia

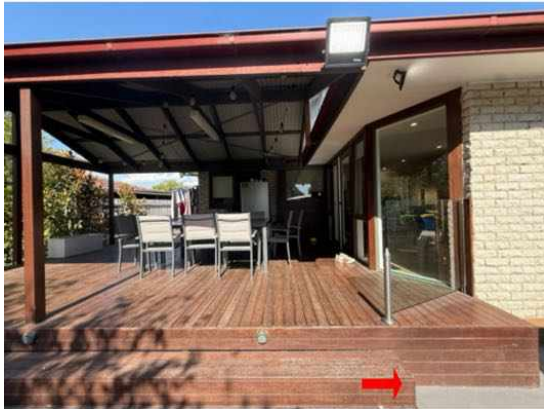
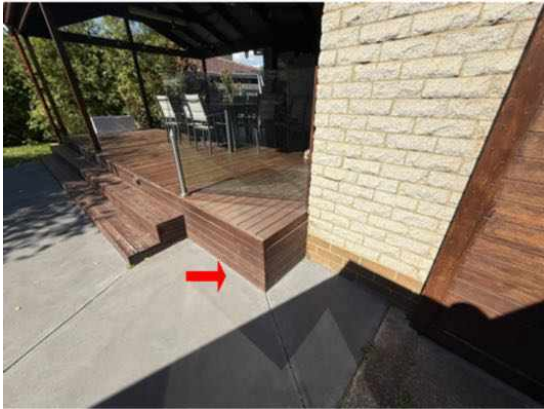
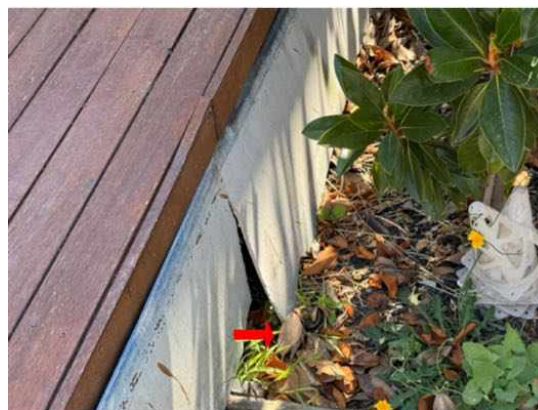
Generally this takes the form of finished ground levels external paving or concrete being retrospectively installed above the damp course level the adjacent internal floor level or weep and ventilation holes.

Where bridging has occurred full inspection is prevented and termites may enter a property in a concealed or undetectable manner.

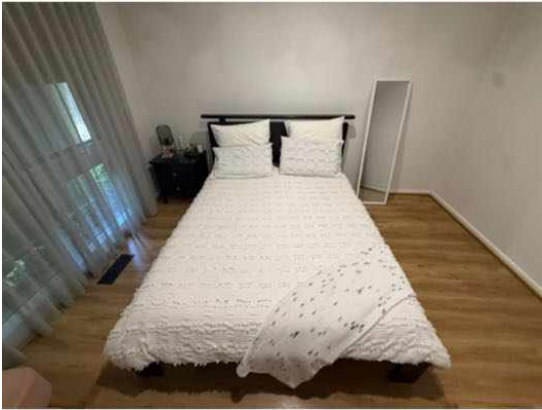
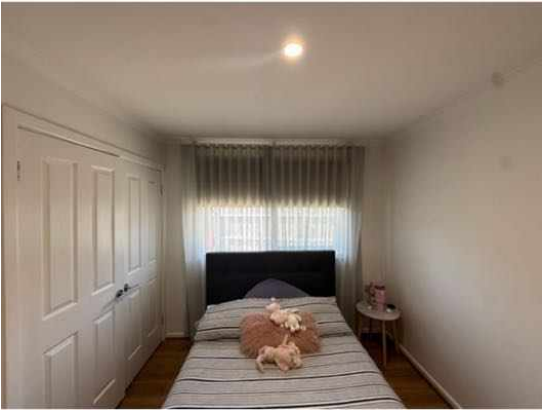
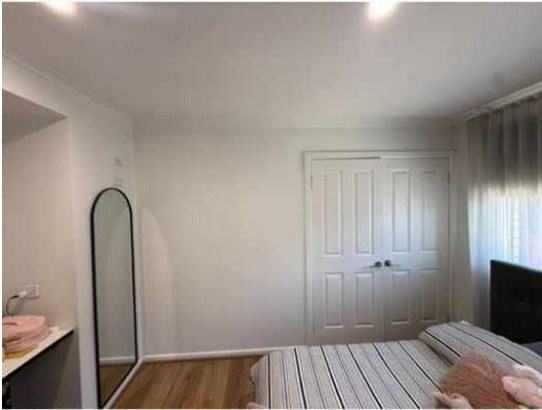
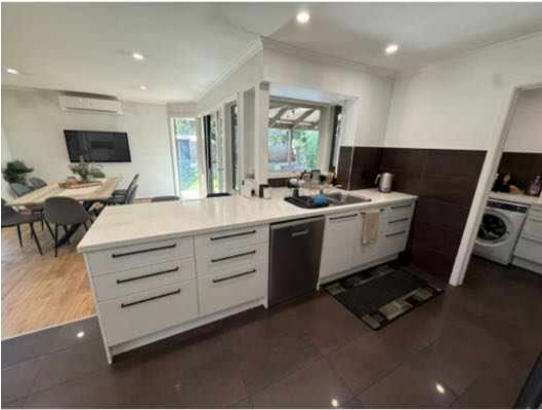
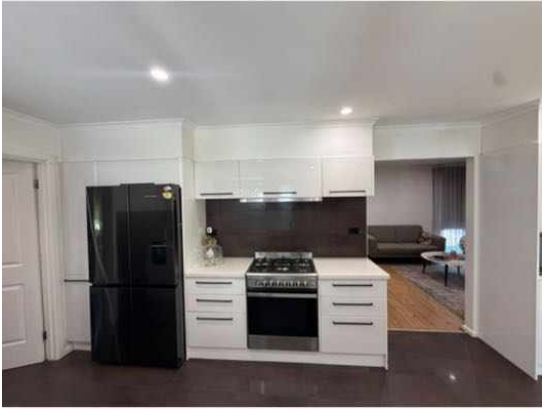
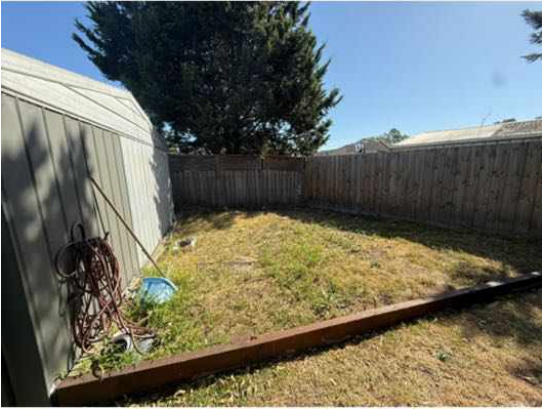
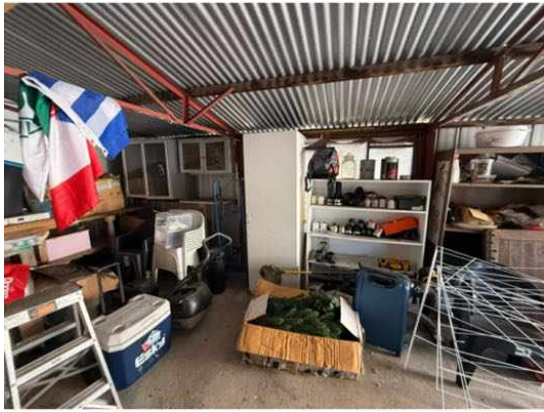
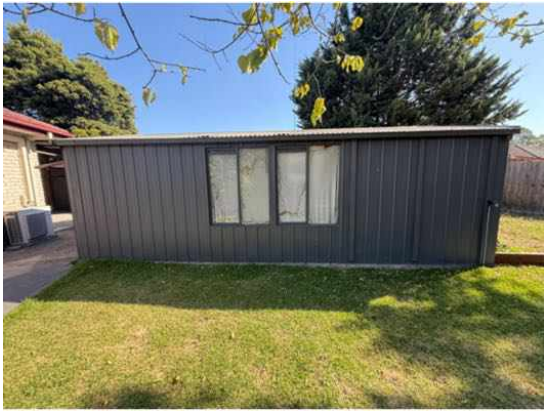
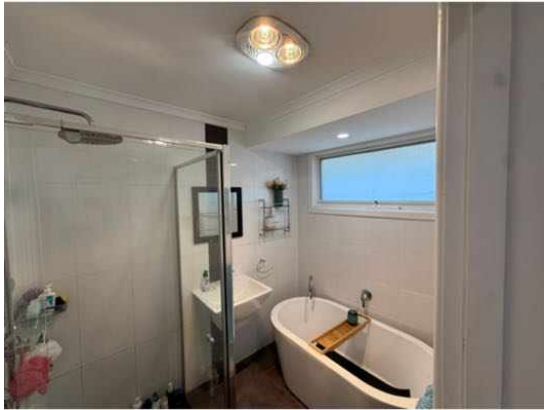
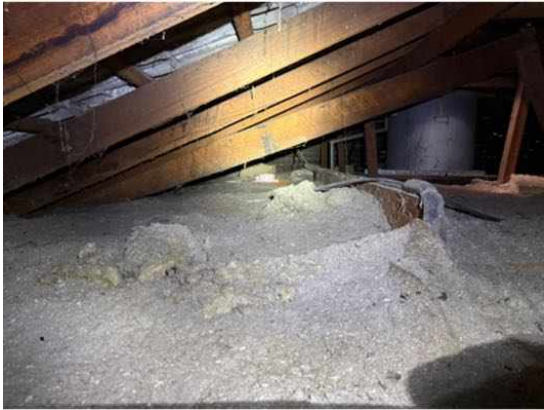
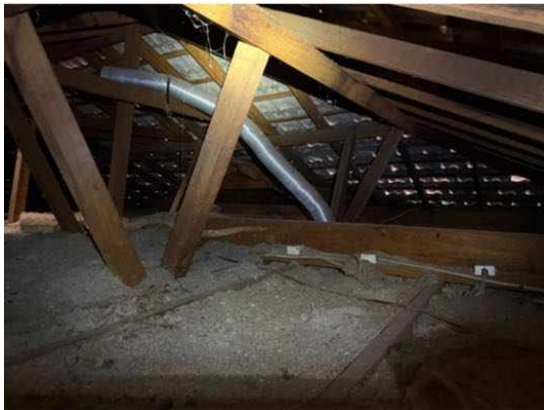
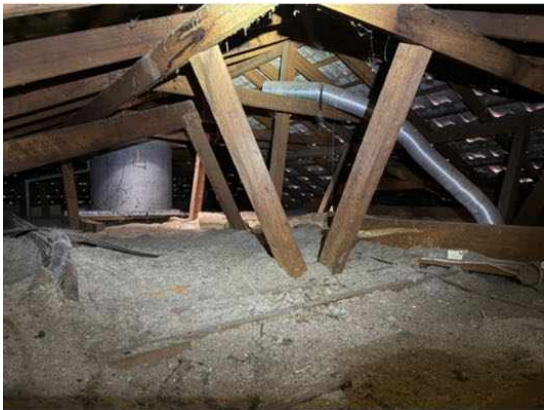
Building: Main Building
Location: All Areas
Finding: Additional Photos - Obstructions and Limitations
Information: These photographs are an indication of the obstructions and limitations which impeded full inspection of the property at the time of inspection. These obstructions can hide an array of defects and should be removed to allow full inspection to be carried out. A re-inspection is recommended once the areas are made accessible.
