Building and Timber Pest Inspection Report

Inspection Date: Fri, 6 Feb 2026

Property Address: 6/33 Burke Rd, Malvern East VIC 3145,
Australia

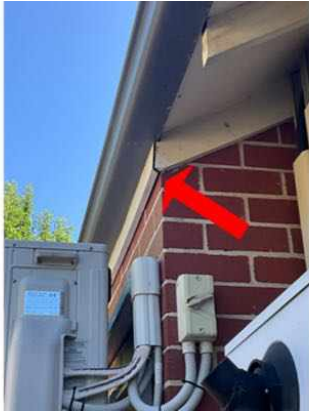
Finding 3.07

Should cracks increase in size or number, speak with your building inspector for further advice.

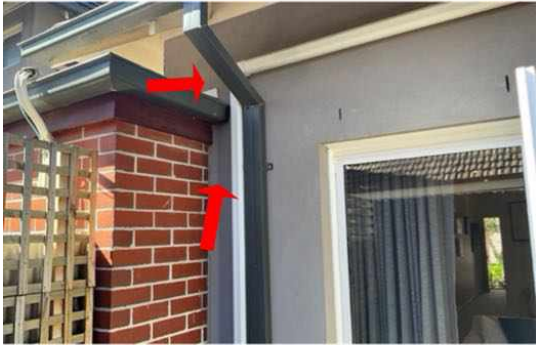
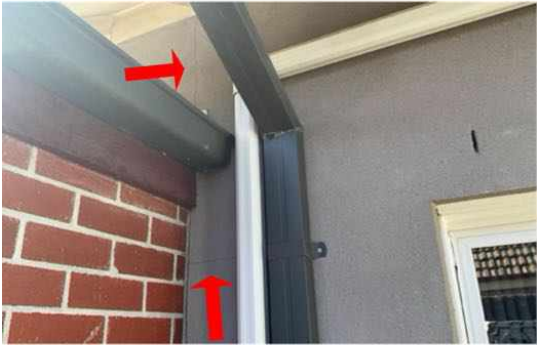
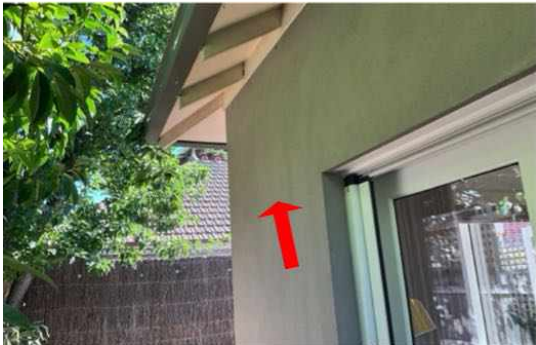
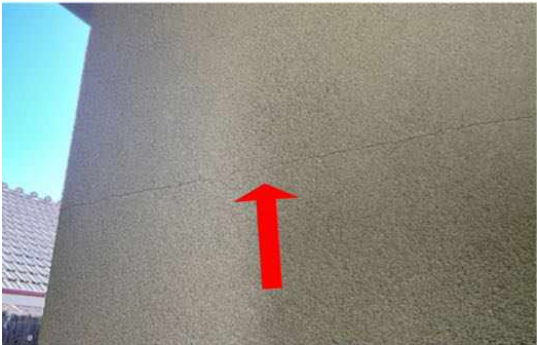
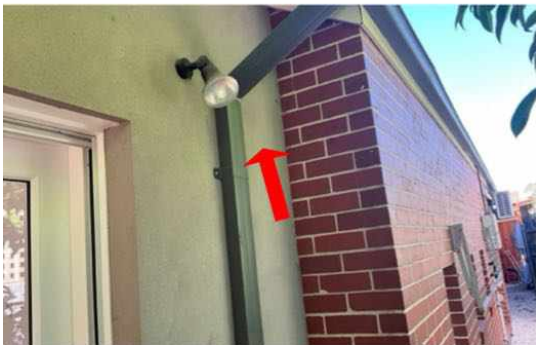
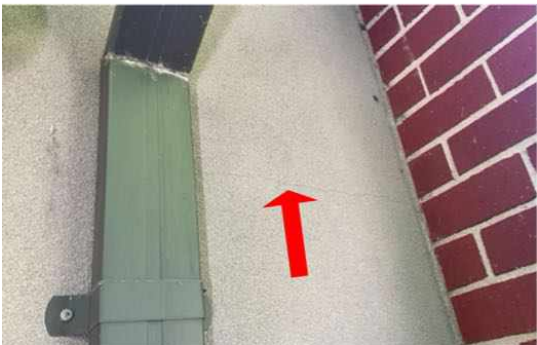
moisture will not only cause rust and decay of the associated building materials, but can also provide conditions that are conducive to termite and timber pest activity. Blockages in gutters should therefore be removed immediately to ensure dry conditions are maintained.

It is highly advised that blocked gutters be cleared by the homeowner or a general handyperson as a matter of urgency. Failure to do so may result in moisture entering the property causing more significant damage.

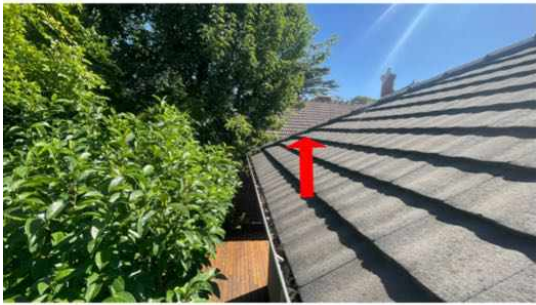
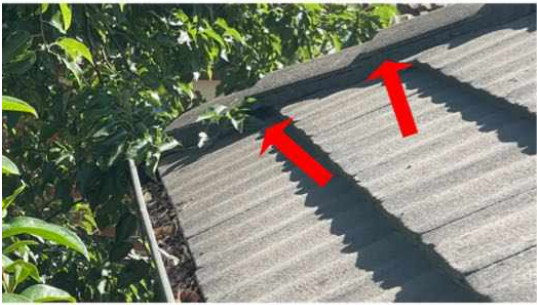
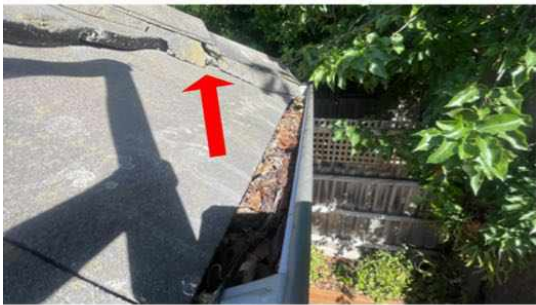
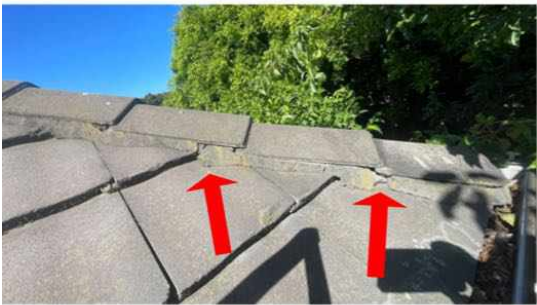
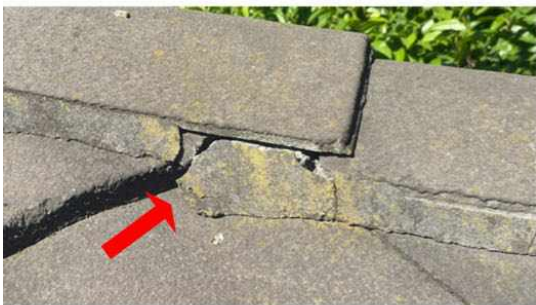
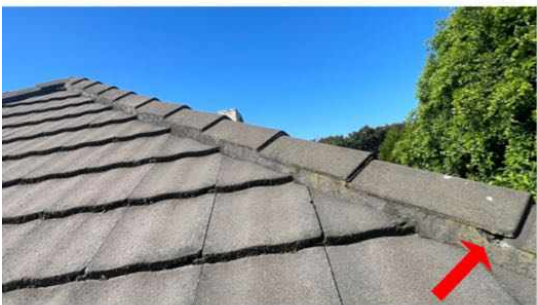
Consultation with a roofing contractor is advised to gain advice on remedial works that will be required . Where left unmanaged, damage can lead to a number of secondary defects, including water leaks and weather exposure to internal roofing structures.

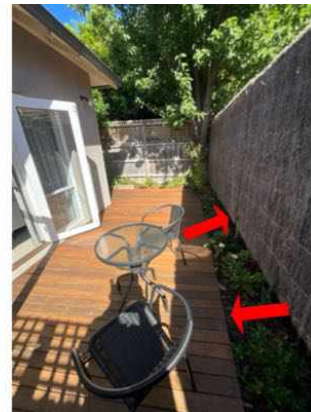
When met with excessive moisture, timber begins to decay and develop wood rot. Any timbers that are in direct contact with external grounds especially if left untreated or non-durable also provide ingress for subterranean termites into that particular element.

Where possible, the removal of any such materials that may be conducive to termite activity should be carried out as soon as possible to minimise the risk of termite attack. Where not possible or practical, regular monitoring of timber elements is recommended. Replacement of any damaged materials should be carried out where necessary.

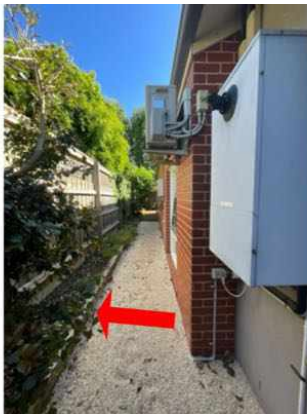
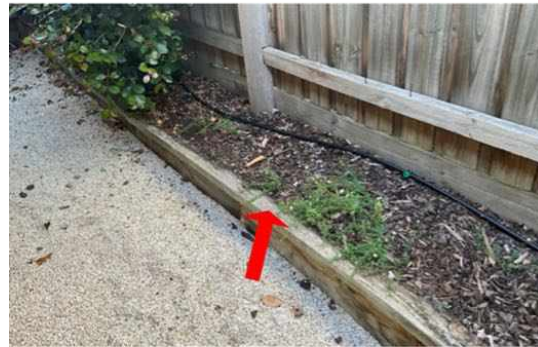
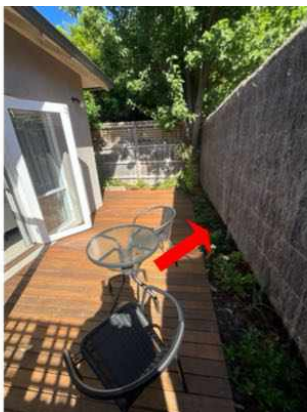
Finding 6.02

Building: All External Areas
 Location: All External Areas
 Finding: Garden Beds - Conditions Conducive to Termites
 Information: Garden beds were found to be evident around and against the property. These garden beds can include untreated timber, and with a combination of moisture from

The removal and replanting of species that do not provide "cover" or cutting back of existing vegetation will assist greatly in preventing this from occurring.

The removal of any such materials that may be conducive to termite activity should be carried out as soon as possible to minimize the risk of potential termite attack.

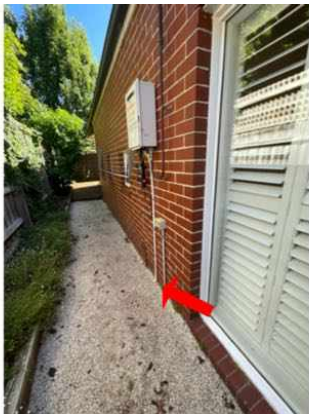
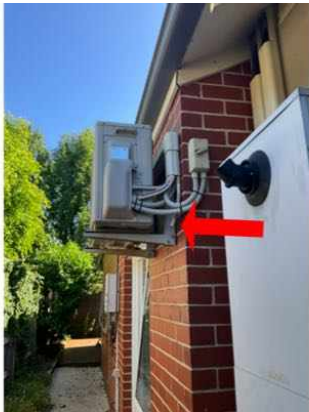
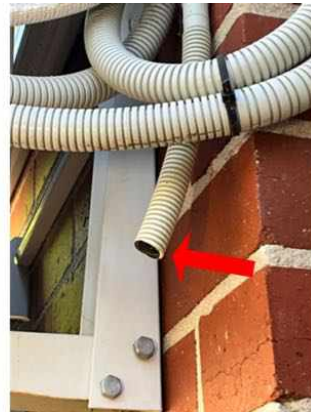
Finding 6.03

Building:	
Location:	Exterior walls - rear
Finding:	Overflows - Not plumbed for drainage
Information:	The overflows are not plumbed or connected to suitable drainage, which can result in the surrounding area becoming excessively damp.

These damp conditions can lead to secondary defects such as rot, rust or corrosion of associated building elements, the formation of fungal decay, or even the creation of potential slip hazards. When coupled with poor site drainage, pooling of water may also attract termite activity to this area.

It is highly recommended that a qualified plumber be appointed to install adequate drainage to the overflow or at least redirect it away from the edge of the house. These works will ensure that the area remains dry and free of any secondary defects.

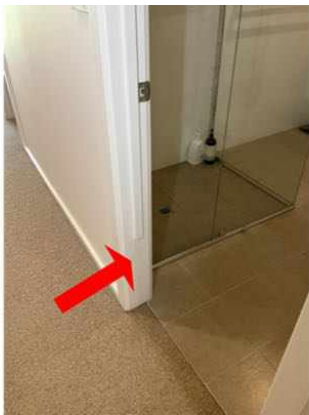
Information: At the time of inspection, it was noted that the bathroom door frame had a gap on the side at the base when the door was closed. It is unclear as to why this is present.

Whilst the door opened and closed as intended , the homeowner may wish to attend to the frame to ensure it seals correctly.

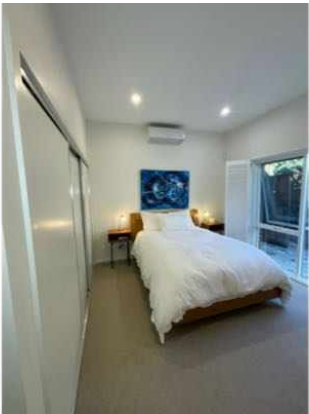
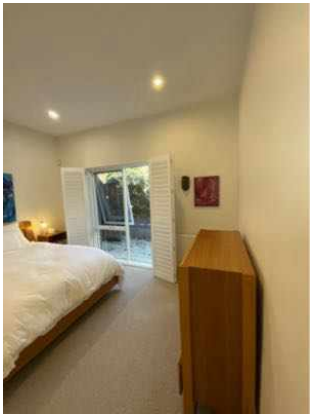
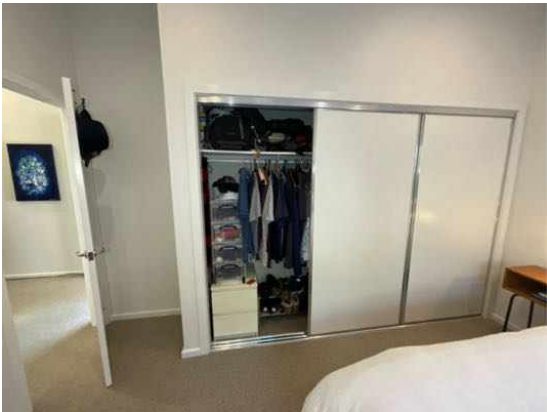
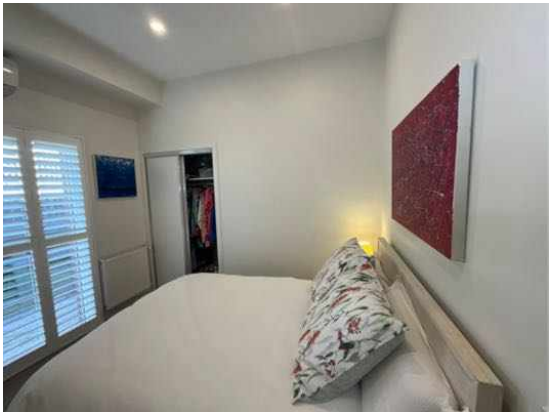
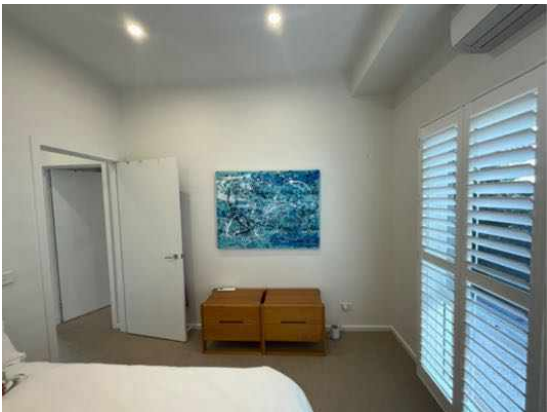
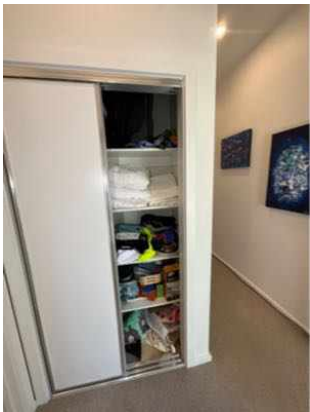
Finding: Additional Photos - Obstructions and Limitations

Information: These photographs are an indication of the obstructions and limitations which impeded full inspection of the property at the time of inspection. These obstructions can hide an array of defects and should be removed to allow full inspection to be carried out. A re-inspection is recommended once the areas are made accessible.
