Building and Timber Pest Inspection Report

Inspection Date: Thu, 12 Mar 2026

Property Address: 29 Warringa St, Salisbury Plain SA 5109, Australia

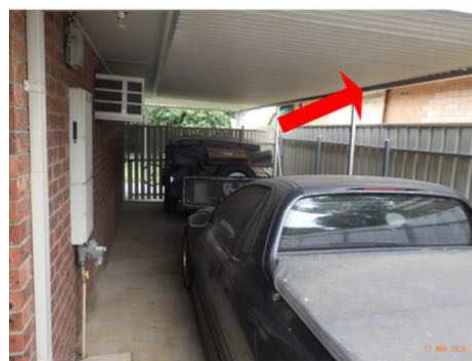
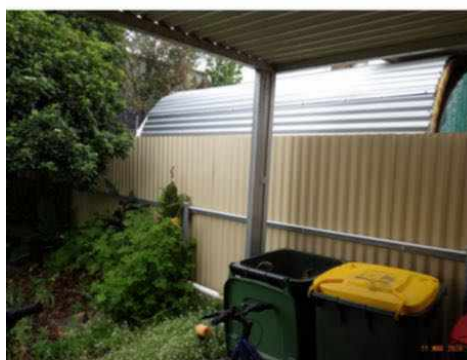
Building: Building 1
 Location: Yard - Back and side
 Finding: Stormwater run off- Inadequate
 Information: The stormwater run-off to the veranda, right side and rear was found to be inadequate at the time of inspection, creating potential for subsequent water damage to associated building elements.

It is important that water does not lie against the base of walls; surrounding paths and ground levels should be sloped to drain water away from walls. Downpipes should not discharge stormwater onto lower walls or plinths. Stormwater should be carried away by large, regularly cleaned drains. Ground levels may need to be lowered to expose a buried DPC.

Where drainage is inadequate, installation of additional drainage may be required. A qualified builder should be appointed to further inspect the property and perform any remedial works as necessary. Water damage and secondary defects are likely to occur if left unmanaged.

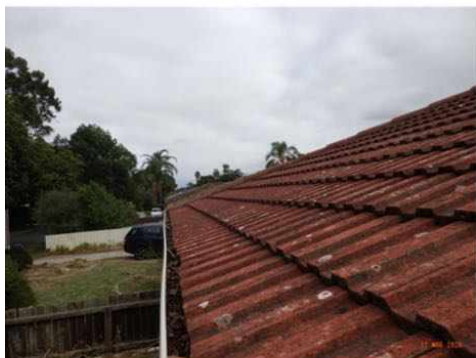
Finding 2.02

Building:	Building 1
Location:	Roof Exterior
Finding:	Gutters - Blocked
Information:	Roof plumbing structures, such as guttering and downpipes, should be free of all debris to prevent blockages. Blockages of the guttering and downpipes will lead to pooling and accumulated water overflows, which is likely to subsequently flood eaves and exterior walls.

Blocked gutters are likely to lead to high levels of moisture in the affected areas. Such moisture will not only cause rust and decay of the associated building materials, but can also provide conditions that are conducive to termite and timber pest activity. Blockages in gutters should therefore be removed immediately to ensure dry conditions are maintained.

Consult a Licensed Plumber for further specific advice on remedial works that may be required. In the interim, it is highly advised that blocked gutters be removed by the homeowner or a general handyperson as a matter of urgency.

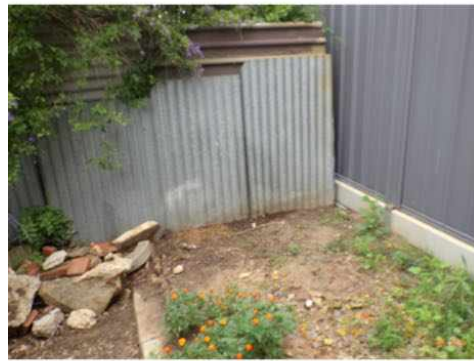
Finding 3.01

Building:	Building 1
Location:	Yard - Side
Finding:	Fencing - Deteriorated
Information:	It was noted at the time of inspection that sections of the fencing throughout the property have deteriorated. Typically fencing deteriorates due to age and or wear, rot and or rust which is generally expected for a structure of this age, due to prolonged exposure to weather conditions. Sometimes inadequate installation or maintenance can be to blame.

If left unattended, it is likely that further damage will occur. It is suspected that repair of several elements of the fencing may be required however replacement may be a consideration of the client also.

A licensed fencing contractor should be appointed to provide further advice and perform rectification works as necessary.

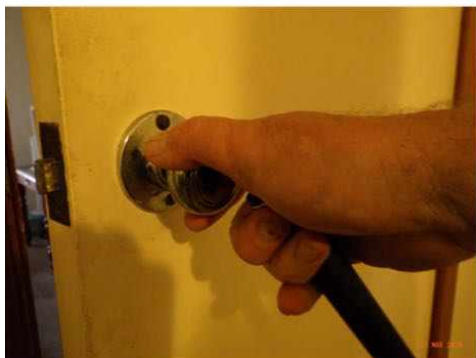
Finding 3.02

Building:	Building 1
Location:	All Internal Areas
Finding:	Several Doors - Striker plate misaligned
Information:	The striker plate to several doors appears to have become misaligned and has consequently resulted in the door's operation being compromised.

This is a common defect and is expected in a property of this age, whether being due to substandard installation or general deterioration of the door hardware and or seasonal changes. As movement has been noted to the property this is a likely contributing factor to the doors not striking and rubbing on floor coverings.

Readjustment of the striker plates is recommended at client discretion. Works such as these can be completed by a general handyman or qualified carpenter.

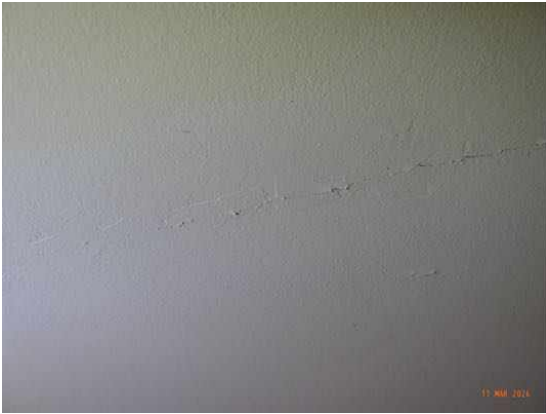
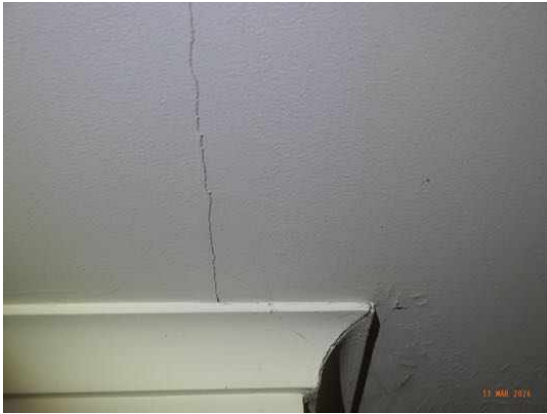
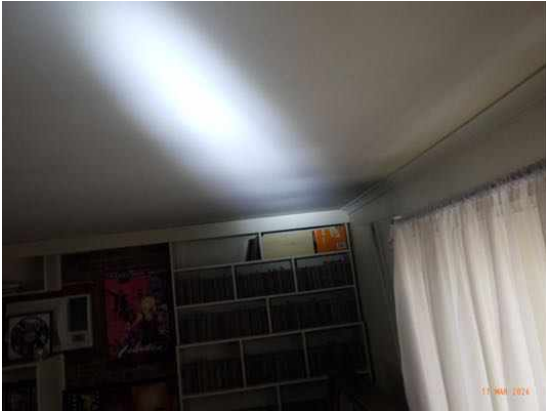
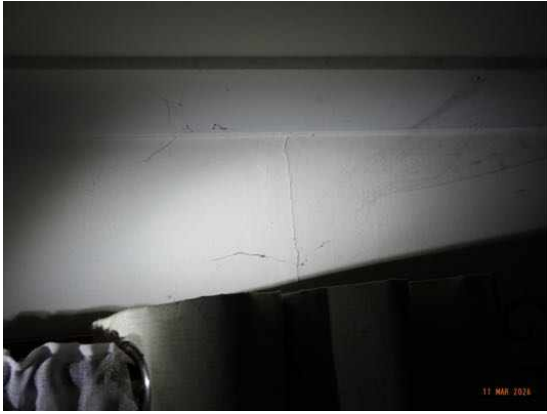
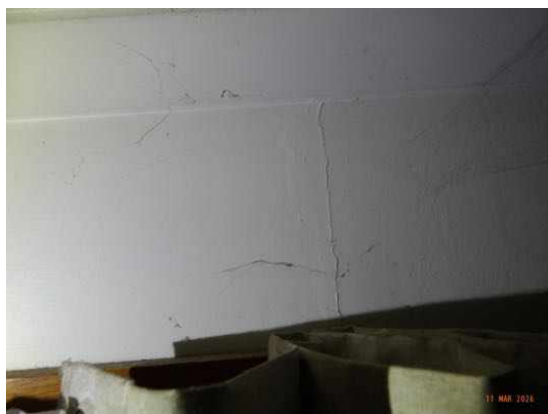
Finding 3.03

Building:	Building 1
Location:	All Internal Areas
Finding:	Cracking - Damage Category 1 - Fine (up to 1mm)
Information:	There were fine cracks and minor paint deterioration evident to the walls and ceilings throughout the dwelling at the time of inspection.

Although fine cracks are quite noticeable, they are often only considered to be an appearance defect, and usually do not indicate any structural damage. Generally, the cause of a fine crack is indicative of a separation between building materials and finishes (e.g. paint, plaster, etc.) along joints.

Cracking of this nature can generally be repaired with minor sanding, filling and/or repainting. Such works should be performed by a qualified painter or a general handyman.

Monitoring of all cracking should be conducted frequently. Always contact a building inspector should cracks widen, lengthen, or become more numerous.

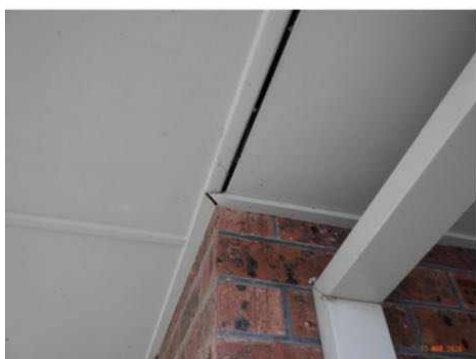
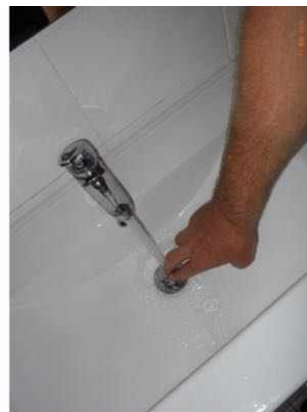
Finding 3.04

Building:	Building 1
Location:	All Areas
Finding:	Minor defects present
Information:	Minor defects were evident throughout the dwelling at the time of inspection, which are consistent with normal wear and tear and considered appropriate for a property of this age.

These defects are typical of ongoing material ageing, settlement, and general use over time, and include, but are not limited to:

- Minor gapping to eaves linings
- Drain plugs jammed to vanity unit

While these defects are not considered structurally significant at present, they should be addressed as part of routine and ongoing property maintenance to prevent further deterioration. Repairs and maintenance works should be carried out by appropriately licensed and qualified tradespeople to ensure the continued serviceability and longevity of the dwelling.

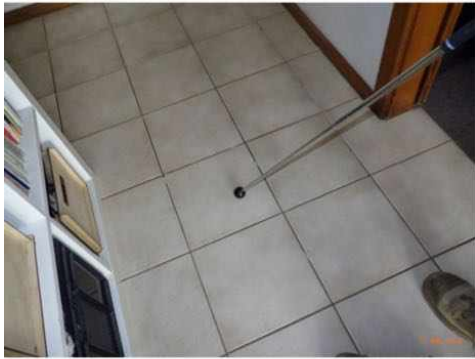
Finding 3.05

Building:	Building 1
Location:	Entry
Finding:	Tiles - Drummy
Information:	Drummy tiles were identified to the entry tiles at the time of inspection.

The term 'drummy' refers to tiles that have become detached from their fixing, despite otherwise being in relatively good condition, or sometimes they get laid onto dust during the building process and never really form a good bond. Such defects are generally caused by physical or moisture damage to the area or poor workmanship during the building process.

As no damage to tiles or grout was evident at the time of inspection further monitoring is recommended and should deterioration to the tiles become evident a licensed tiling contractor should be appointed to required repairs at the discretion of the client.

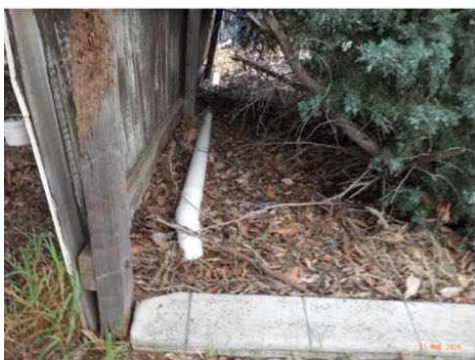
Building:	Building 1
Location:	Yard
Finding:	Evidence of termite damage - minor
Information:	Despite no live termite or timber pest activity being indicated, previous termite damage was found to have affected this area. This damage is considered to be inactive and is minor in nature.

It is advised that the area be visually inspected frequently to ensure that the condition of affected building materials does not worsen. At the time of inspection, damage is not structural and is only considered to be superficial.

A building contractor may be appointed to provide a further invasive inspection if further damage is evident.

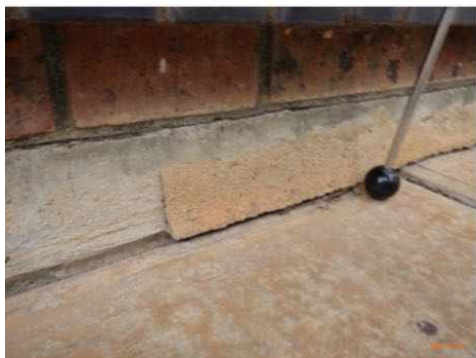
If the slab edge is not properly exposed there is a high risk of termite attack. The risk is lessened with steel frame construction however still present.

Where the slab edge cannot be properly inspected, it is highly recommended that termite or timber pest inspections be carried out every 12 months to aid protection of the property against infestation.

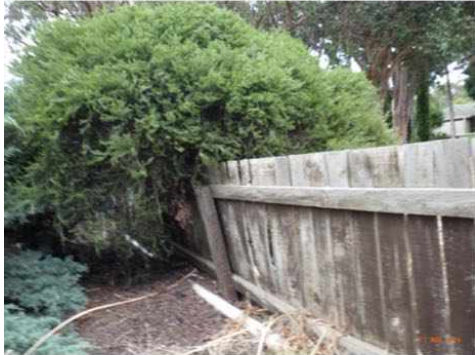
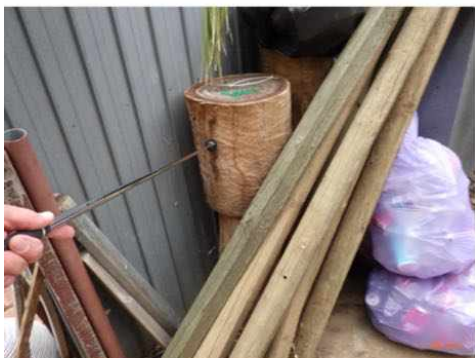
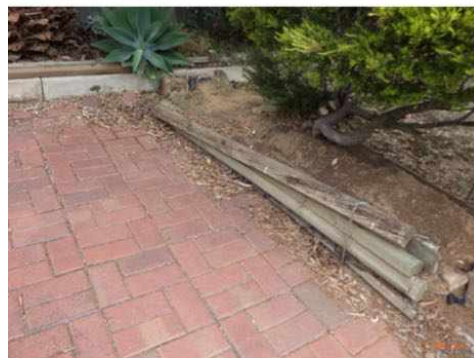
Finding 6.02

Building:	Building 1
Location:	All External Areas
Finding:	Untreated or non-durable timbers in a hazardous environment
Information:	To reduce the risk of timber pest attack it is essential that timber used in a hazardous environment (e.g. in direct contact with the ground or frequently exposed to damp conditions) is of sufficient durability and/or is adequately preservative treated. Additionally any timber lying around or timber stumps should be removed.

Untreated timbers in direct contact with the ground are likely to develop severe wood rot and/or fungal decay if left unattended creating attraction for subterranean termites to infest the timbers from surrounding areas.

If untreated or non-durable timbers are found to be in a hazardous environment it is highly advised that replacement of these building elements be performed as soon as possible to aid the protection of the property against termite / timber pest attack. Failing this close monitoring is recommended in an attempt to identify termite infestation at an early stage.

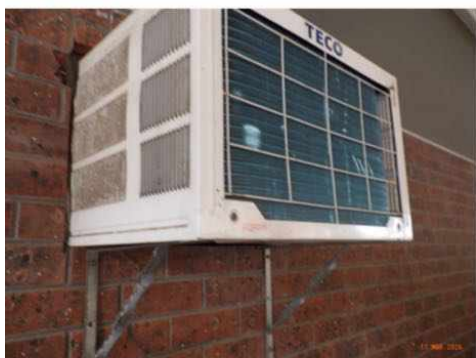
Building:	Building 1
Location:	Yard - Side
Finding:	Air conditioner and or external tap - No drainage
Information:	Moisture around the perimeter of the building should be minimised to ensure that the area is kept dry and stable which in turn reduces the risk of water damage and termite infestation.

There appears to be no drainage points set up to the air conditioning unit, and or the external tap. While this is not a legal requirement it is recommended to reduce the risk of moisture related issues and the creation of an environment conducive to termite activity.

It is recommended that a licensed plumber be appointed to set up drainage in order to prevent such an environment from being created.

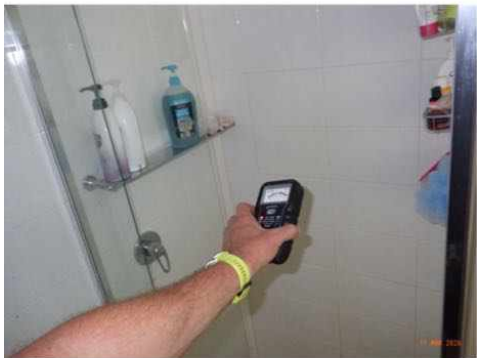
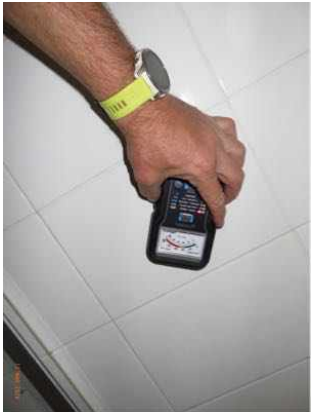
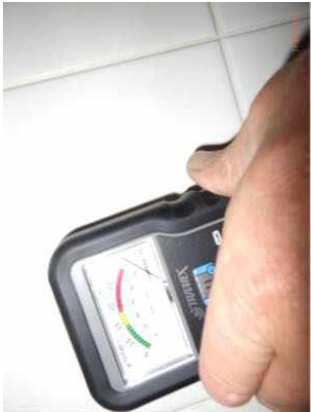
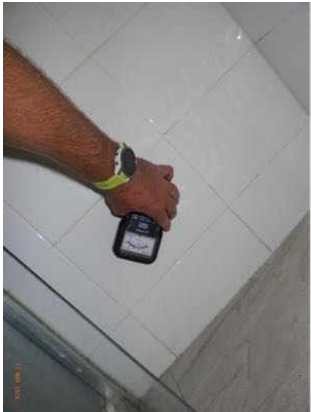
Finding 6.05

Building:	Building 1
Location:	Bathroom
Finding:	Shower damp - Sealant and grout
Information:	Damp is evident to sections of wall to the shower alcove of the bathroom.

This defect is quite common, and is suspected to have been caused by moisture permeating or leaching through the tiling, grouting and sealant in this area, which shows evidence of deterioration.

There were high moisture readings around the taps and on the adjacent wall however there were no high readings transferring to the other side of the wall.

Consultation with a bathroom sealant specialist is advised immediately to make repairs to the shower alcove.

Always ensure that sealant and grout is in good condition to prevent any moisture issues occurring in the future.

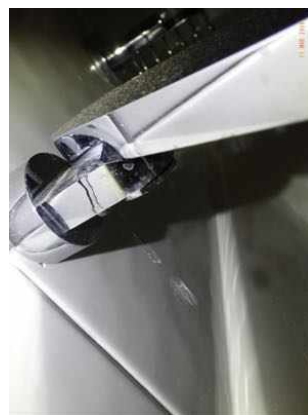
Finding 6.06

Building: Building 1
Location: Bathroom
Finding: Bath - Leaking
Information: At the time of inspection, the bath tap showed evidence of leaking during operation.

Although common, water leaks can be detrimental to surrounding building elements. Rust, corrosion, decay and water damage are all potential outcomes of a water leak that is left unattended, which are then likely to develop into more serious defects and may necessitate major repair works.

It is highly advised that water leak be addressed by a licensed plumber as soon as possible to prevent any damage.

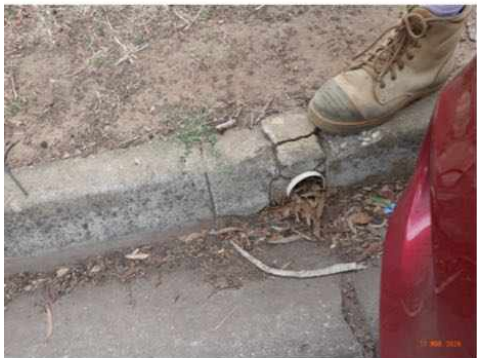
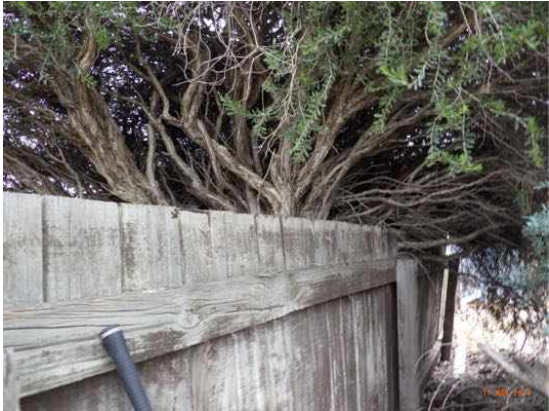
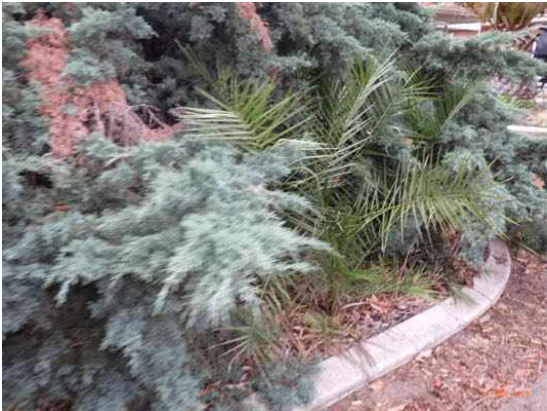
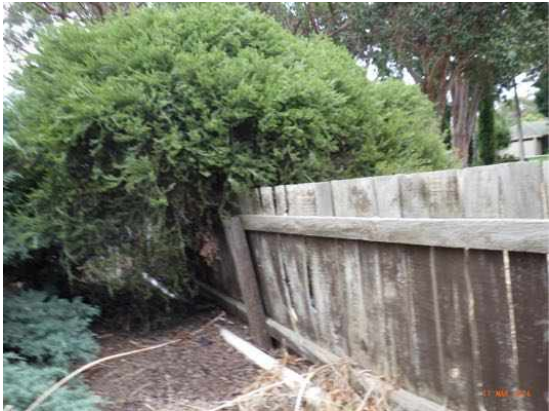
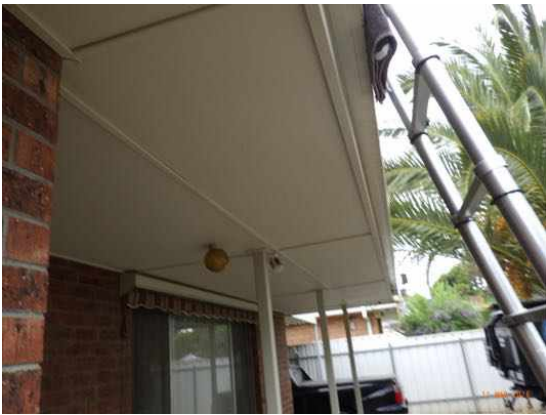
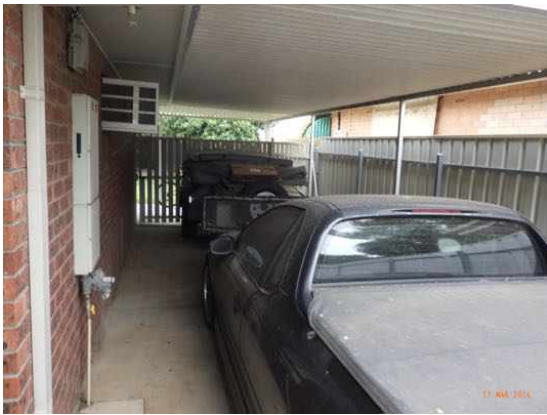
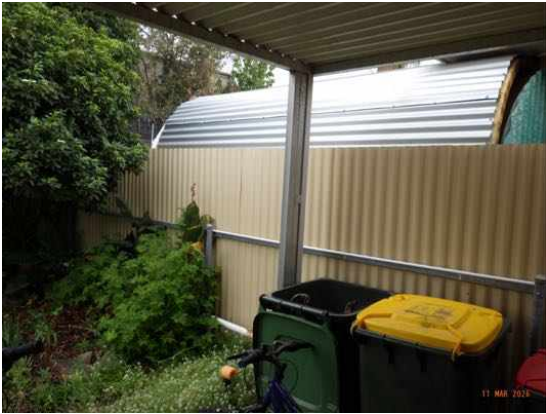
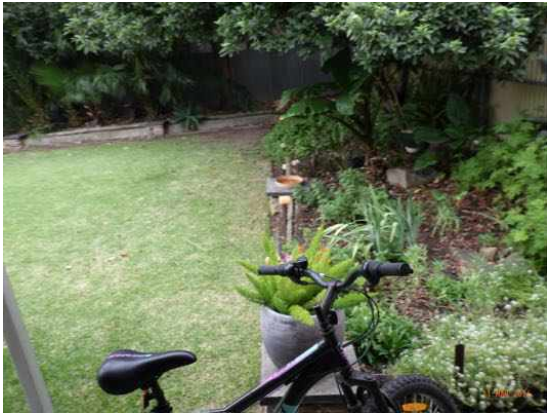
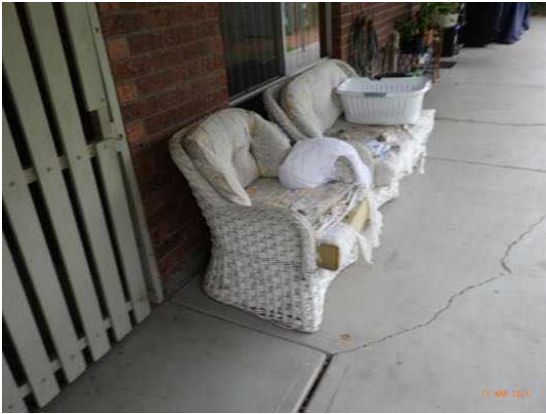
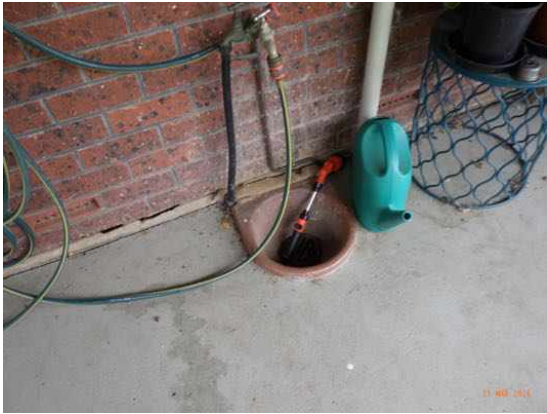
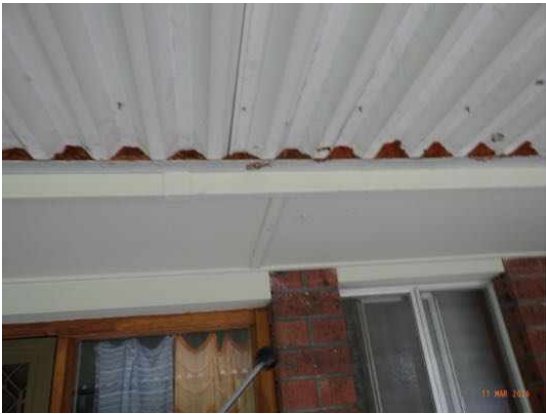
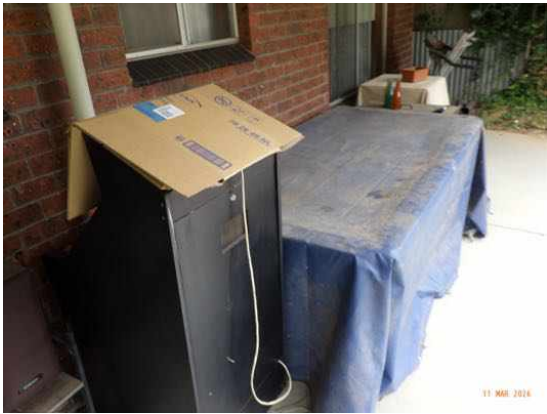
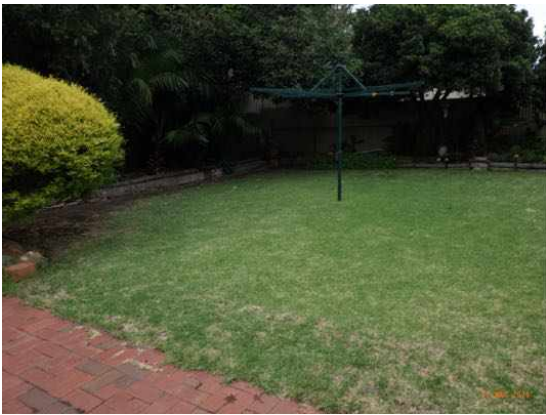
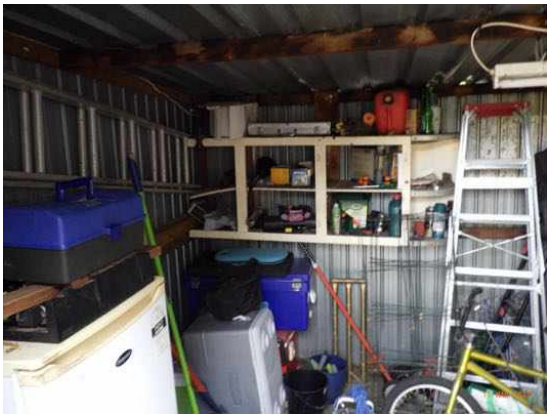
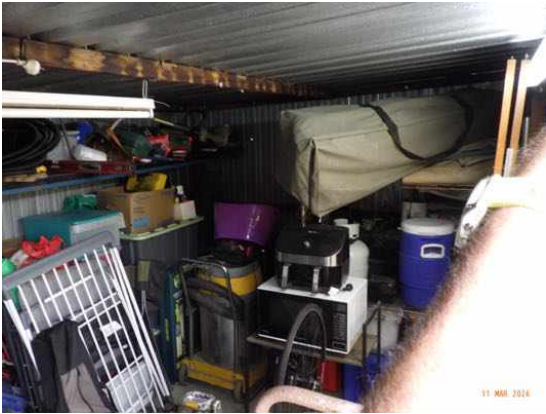
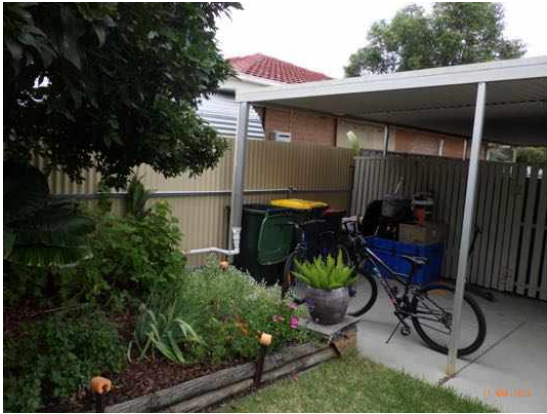
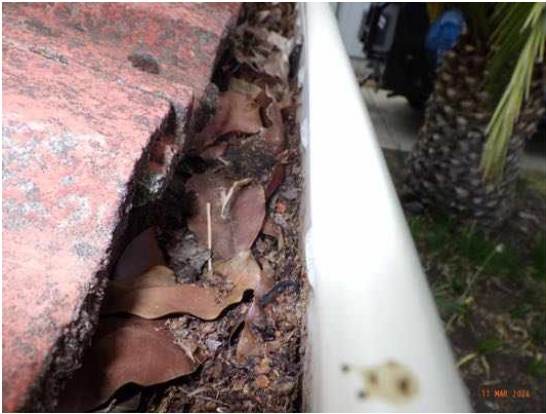
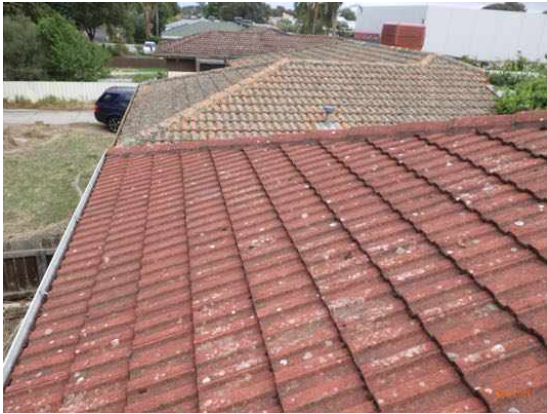
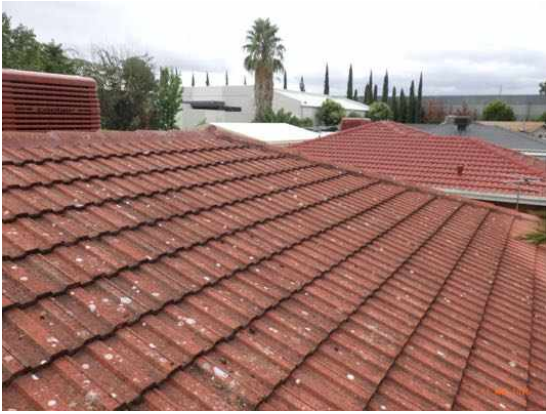
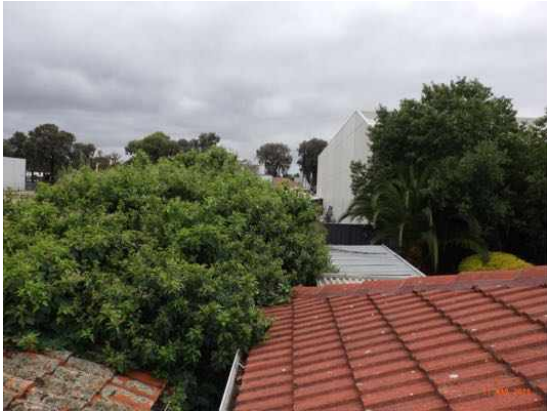
Building: Building 1
Location: All Areas
Finding: Additional Photos - Obstructions and Limitations
Information:

These photographs are an indication of the obstructions and limitations which impeded full inspection of the property at the time of inspection. These obstructions can hide an array of defects and should be removed to allow full inspection to be carried out.
