Building and Timber Pest Inspection Report

Inspection Date: Mon, 23 Mar 2026

Property Address: 12 Clarence Ave, Bli Bli QLD 4560, Australia

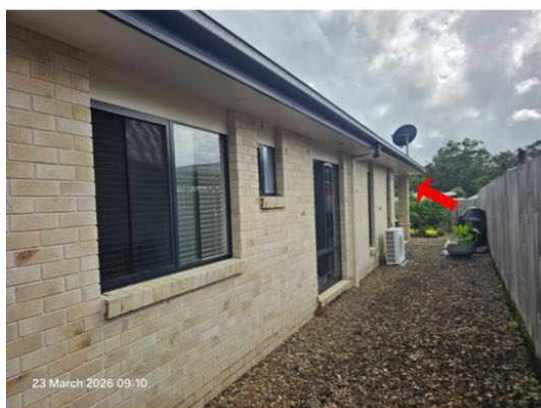
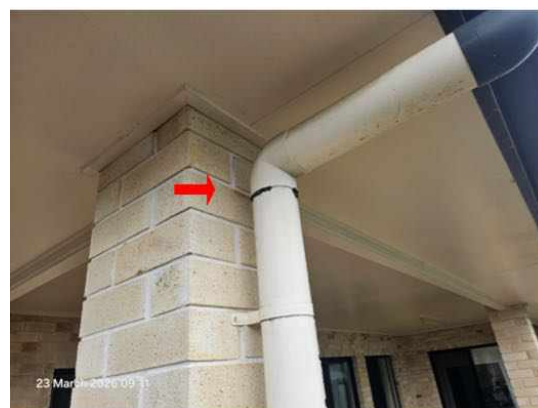
Building: Main Building
 Location: As shown
 Finding: Downpipe leaking
 Information: During the inspection of the perimeter of the building it was noted that there was a downpipe leaking. Leaking downpipes can create excess moisture at the building perimeter, leading to conditions conducive attractive to timber pests.

The client could engage a plumber to assess and resolve the leak.

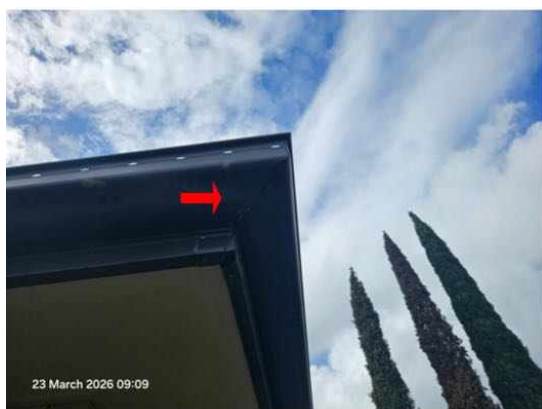
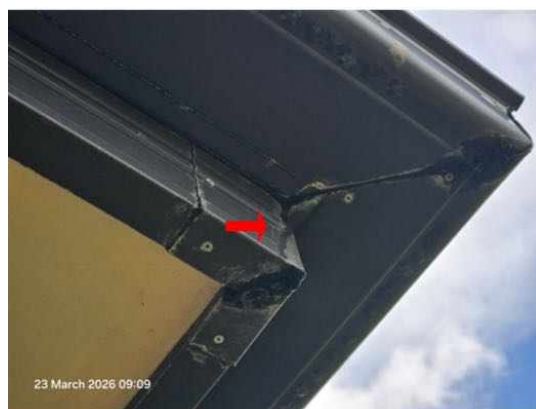
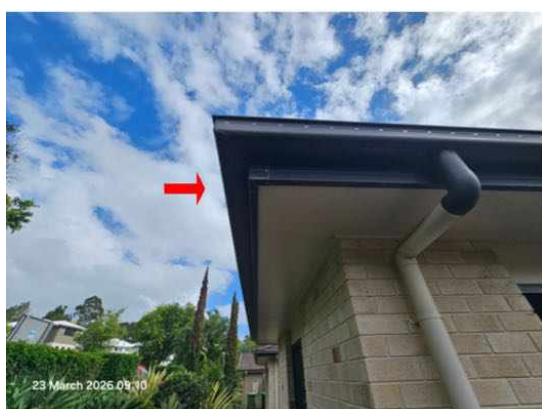
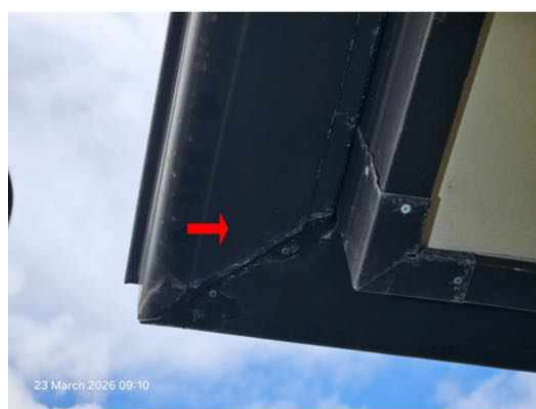
Finding 3.02

Building: Main Building
 Location: As shown
 Finding: Gutter leaks
 Information: On the day of inspection there was evidence of a water leaks in the selected areas of the roof gutter around the perimeter of the property. Water was observed dripping from some of the joins.

Leaking joins can lead to further defects in the form of rust and holes. Repairing leaks in a timely fashion will help mitigate the risk and add to the longevity of the roof

plumbing.

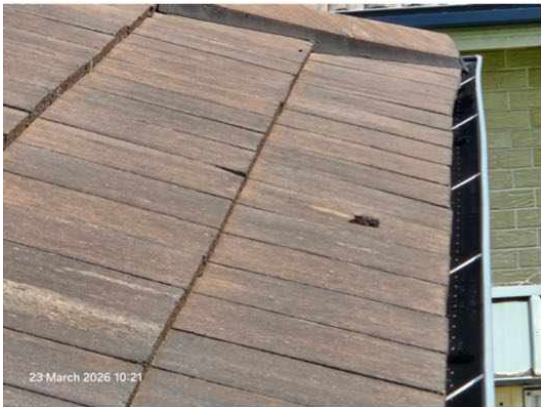
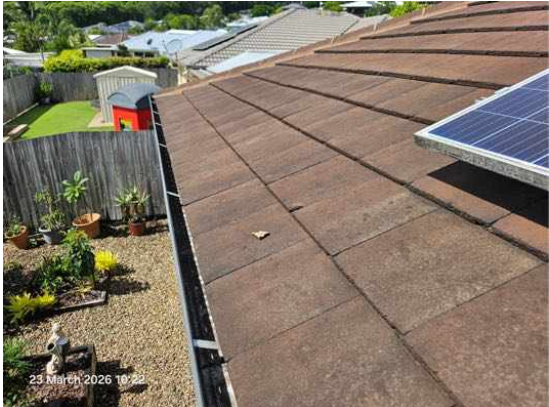
Finding 3.03

Building:	Main Building
Location:	Rear elevation
Finding:	Roof tiles - Broken
Information:	Upon inspection of the exterior roof covering, broken / chipped roofing tiles were identified. Broken and friable roof tiles are generally the result of ageing and weathering of what is essentially a porous material.

If left to further deteriorate, broken and brittle roof tiles are likely to lead to water penetration via the roof into the ceiling space, causing secondary damage to ceiling linings, insulation and roof structures. Broken roof tiles are also likely to detract from the effectiveness of the roof drainage system, creating potential for secondary damage to the exterior roof covering and roof plumbing.

The roof condition is noted as a minor defect ; however it should be repaired in the short term to maintain the surface condition and prevent possible leaks and further deterioration.

Replacement of broken tiles is required and could be performed by a roofing contractor.

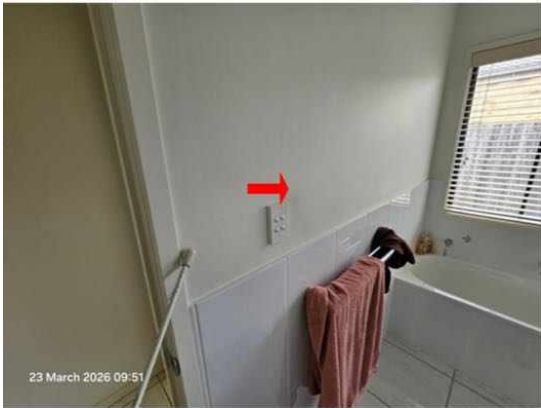
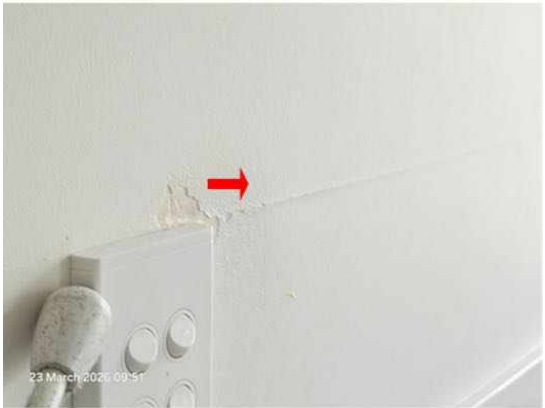
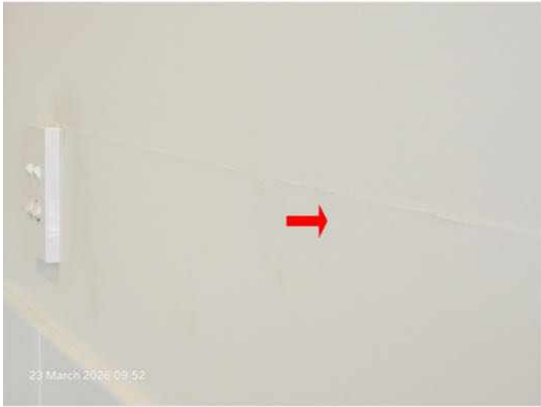
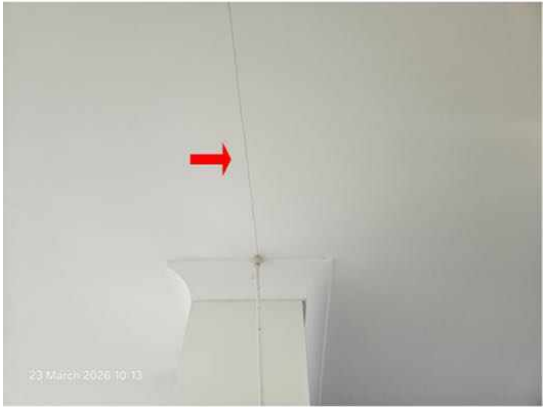
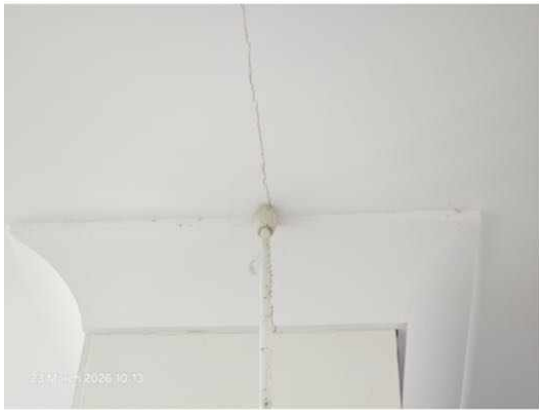
Finding 3.04

Building: Main Building
 Location: As shown
 Finding: Minor internal settlement / movement cracking
 Information: Minor settlement / movement cracking to internal wall and ceiling linings was observed at the time of the inspection. Cracking of this nature can be a result of frame settlement and drying after construction. An expansion joint may be advantageous in the kitchen ceiling to prevent future cracking after repair.

These fine but visible cracks can be patched and painted over by an experienced painter or handyman at the clients discretion.

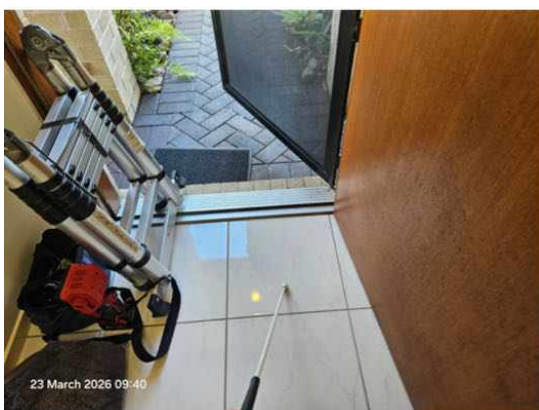
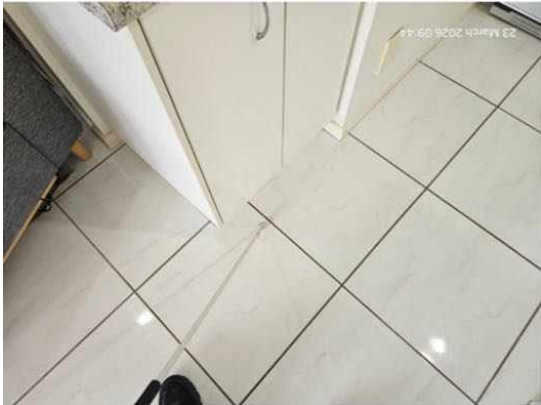
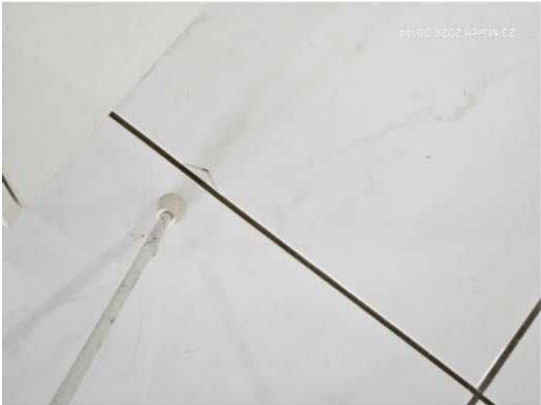
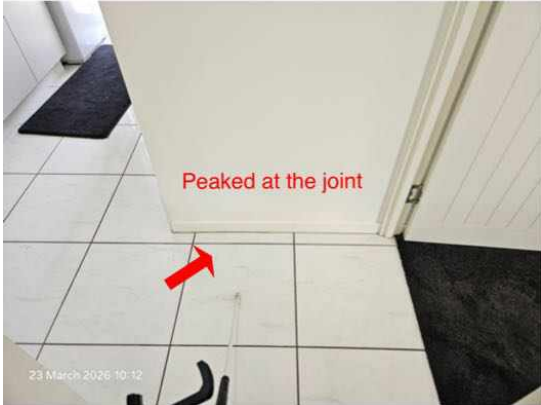
Finding 3.05

Building:	Main Building
Location:	Entry, laundry
Finding:	Tiles - Drummy
Information:	Drummy tiled areas were identified at the time of inspection. Please see the attached photos for locations.

The term 'drummy' refers to tiles that have become detached from their fixing, despite otherwise being in relatively good condition. Such defects are generally caused by physical or moisture damage to the area. Drummy tiled areas may also be a direct result of poor workmanship during the construction process.

Tiled areas may swell and shrink with changes in air humidity if the area has sustained moisture damage. Any exposure to moisture is capable of causing tiled areas to become drummy and/or cracked over a prolonged period of time. Drummy tiled areas generally require removal and replacement of affected tiles.

Specialist trades are available for these types of services. A licensed builder may be required to undertake works if damage is extensive or if secondary building defects have resulted. Otherwise, it is advised that a tiling contractor or a tile adhesive injection service may be appointed to perform works as necessary.

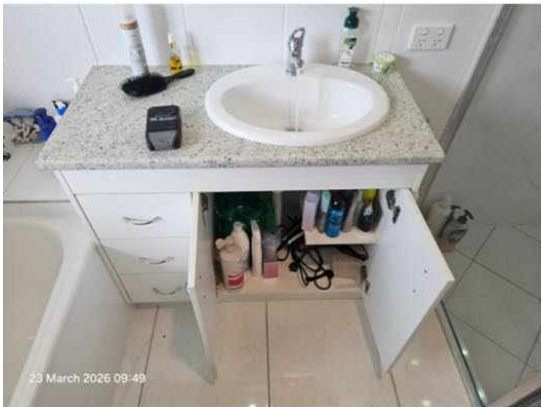
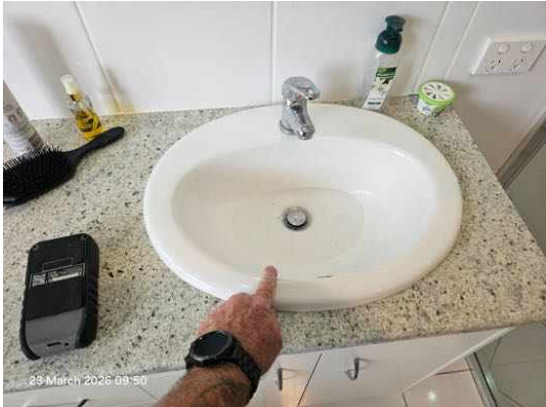
Finding 3.06

Building: Main Building
 Location: Bathroom
 Finding: Basin slow to drain
 Information: During inspection it was noted that the basin was slow to drain. This may be due to debris in the waste.

It should be inspected by a licensed plumber.

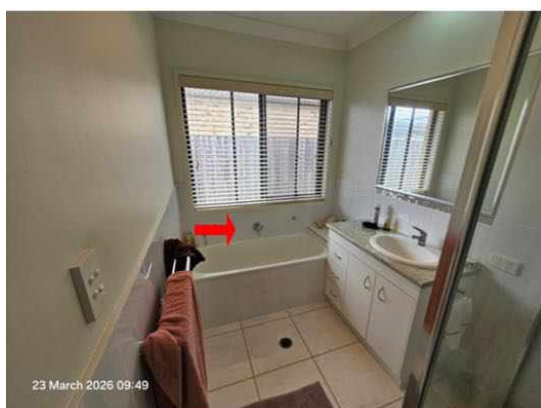
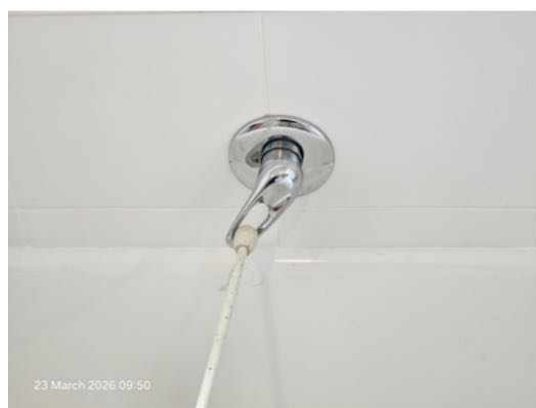
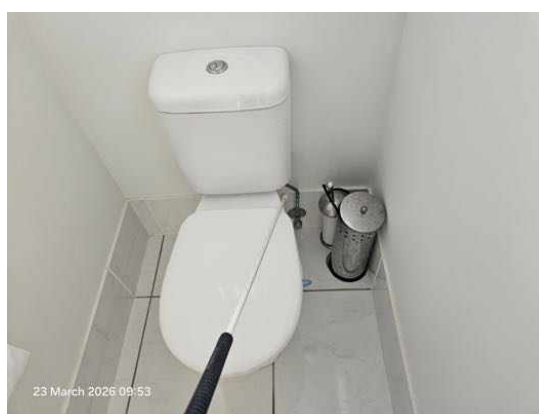
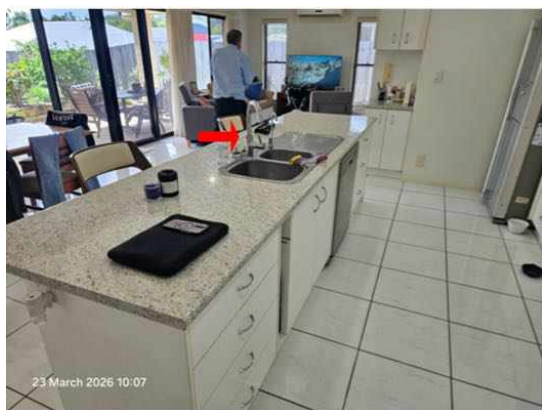
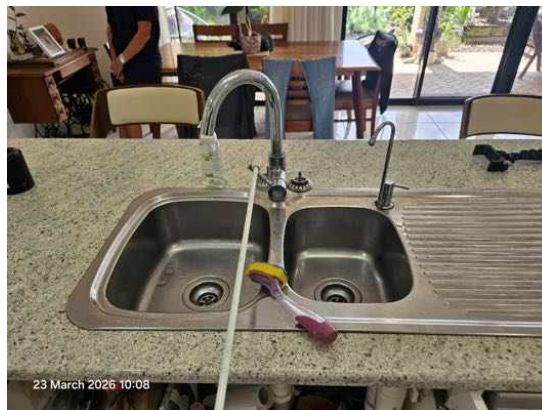
Finding 3.07

Building: Main Building
Location: Kitchen. Bath, WC
Finding: Water Hammer
Information: Evidence of water hammer has been noted to be present in the kitchen sink, the bath mixer, and in the toilet cistern cock. Water hammer is generally caused by factors that create high water pressure in the affected plumbing system usually evidenced by a banging or vibrating noise during operation of a tap or appliance. The toilet appears to react to pressure when the cistern fill ends.

Although water hammer is generally considered to be a minor defect, increased stress by hydraulic shock within the water pipes can cause weaknesses to develop and in worst cases for a pipe to burst. Water hammer can also accentuate the movement of poorly fixed water pipes which can lead to fatigue cracks or friction holes developing.

Securely fixing loose water pipes and installing shock absorbing devices designed to lessen the effect of water hammer, can be a solution for affected water reticulation systems.

A licensed plumber should be appointed to advise on any remedial works as necessary.

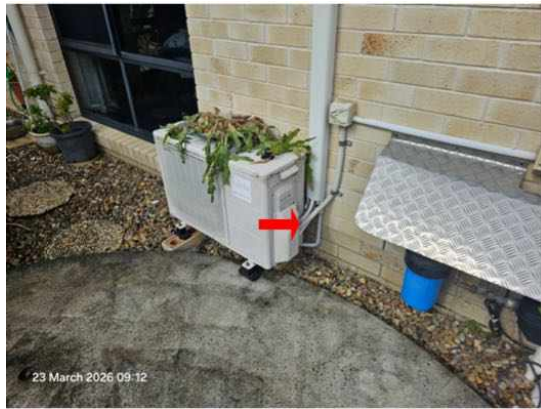
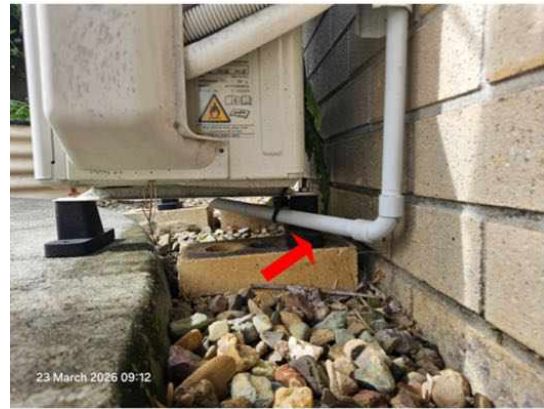
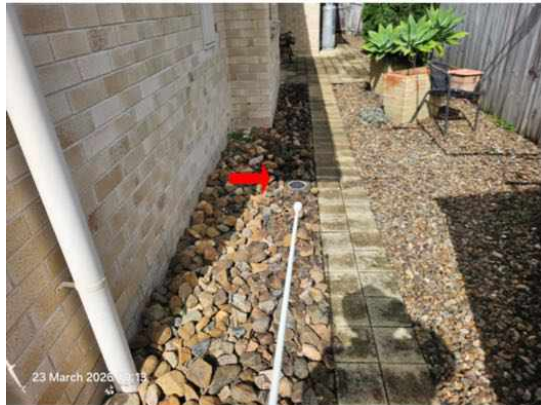
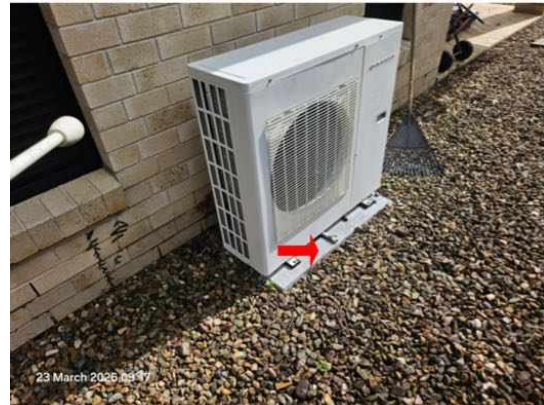
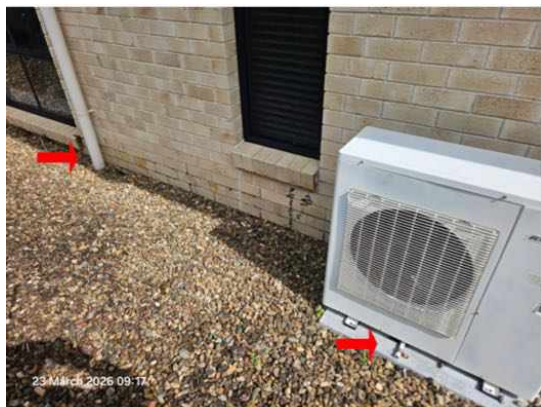
Building: Main Building
Location: As shown
Finding: Air conditioner - Disconnected drain
Information: The Air Conditioner (A/C) overflow was found to be disconnected from storm water drainage and could create excessive moisture in the surrounding area.

Such leaking creates an environment which is conducive to an array of defects, including water damage to associated building elements and the attraction of termite or timber pest infestation.

It is recommended that a licensed plumber be appointed to connect the A/C overflow to a drainage source in order to prevent such an environment from being created. An alternative is to extend the overflow further into the garden away from the building perimeter.

These minor works should be carried out in the short term.

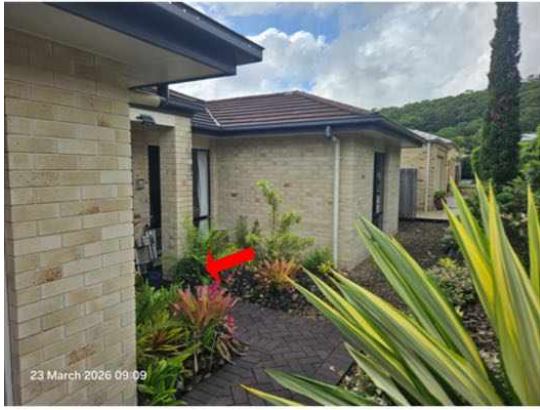
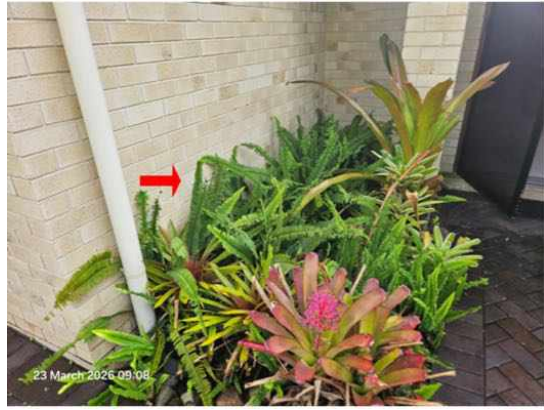
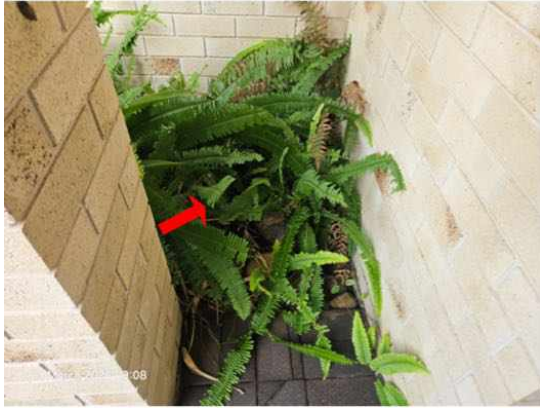
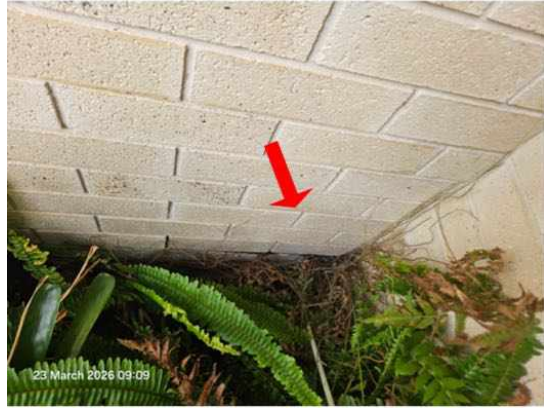
Finding 6.02

Building: Main Building
 Location: Front elevation
 Finding: Garden - growing against house.
 Information: It was noted on the day of inspection that the plants, in particular an invasive vine, were growing against the building. This can be at risk of creating an environment for timber pests and vermin to enter the building.

It is recommended that the foliage be cut back to give a clear inspection zone against the building.

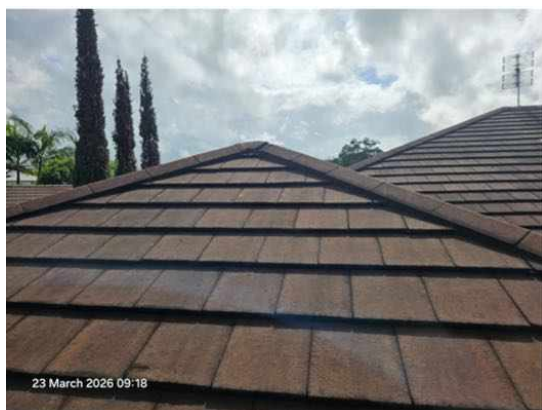
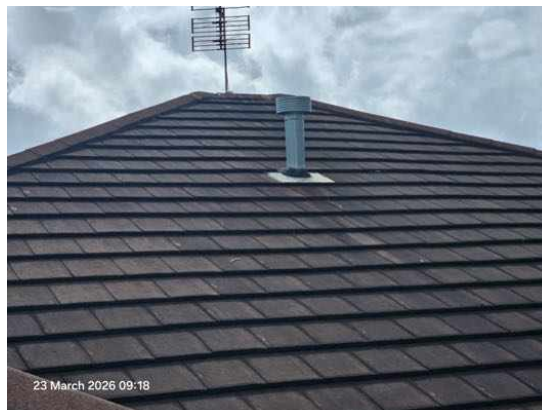
Noted Item

Building: Main Building
 Location: All Areas
 Finding: Roof tiles brittle
 Information: On the day of inspection the roof exterior inspection was not carried from the roof surface, rather it was done from the roof edge and the ground viewing angles.

This is due to the type roof tile in place. These flat profile tiles are predominately brittle to trawlers and at the risk of breaking tiles, it has been opted to keep off the roof top.

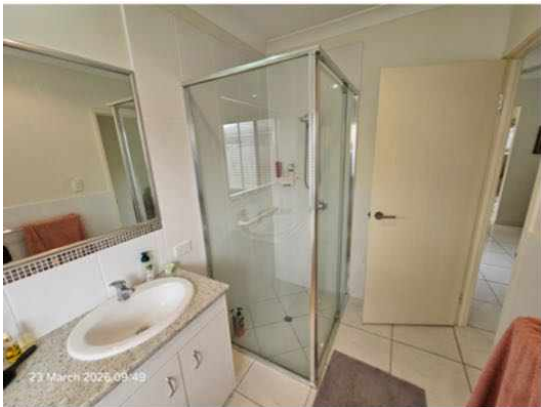
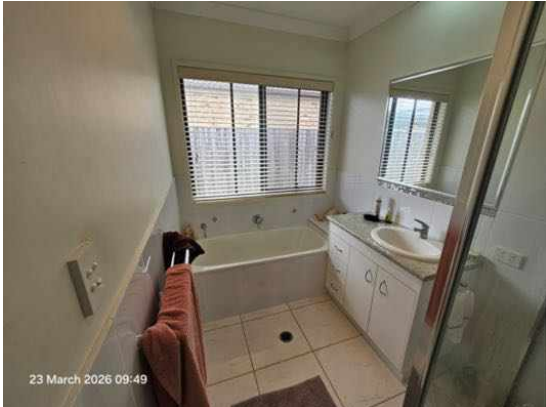
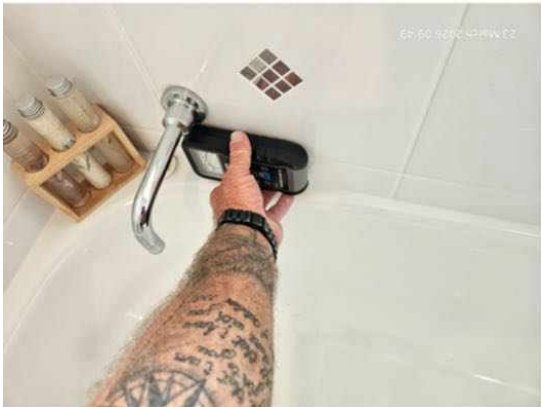
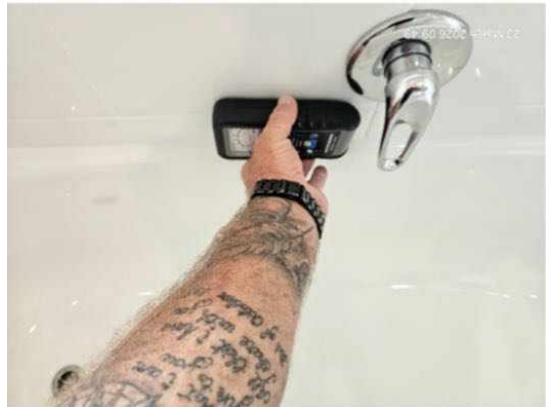
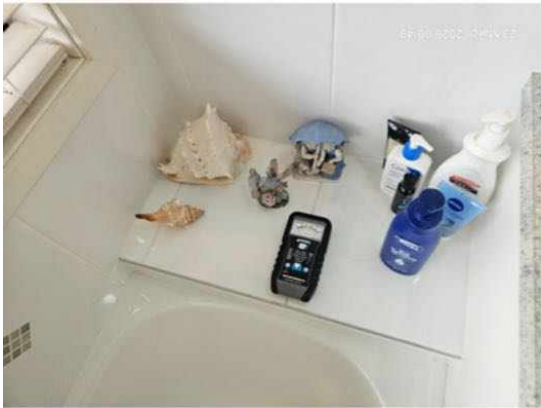
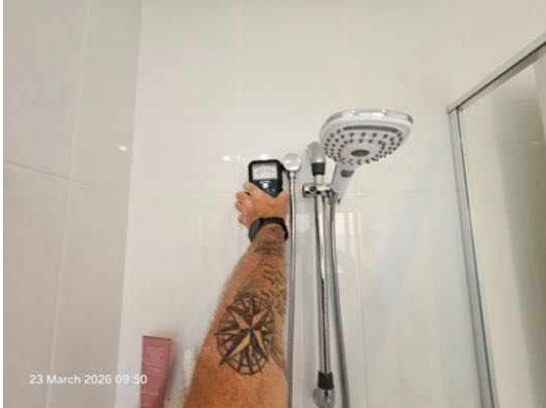
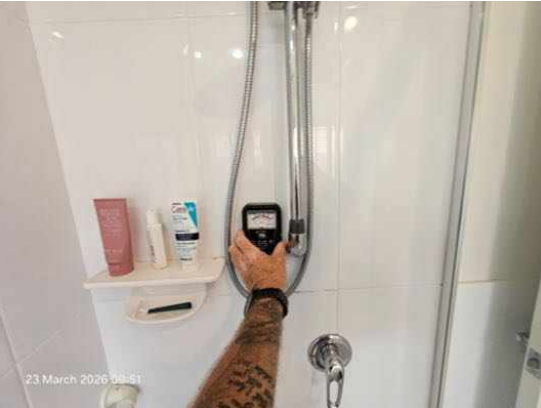
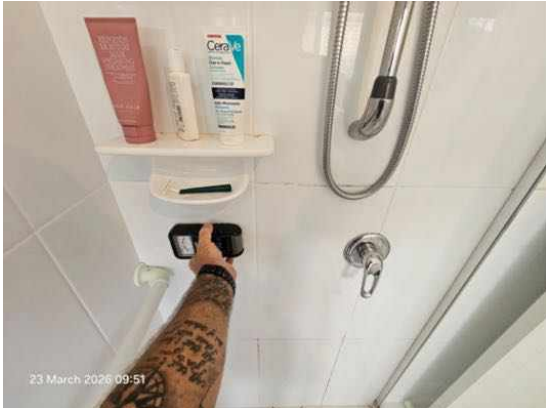
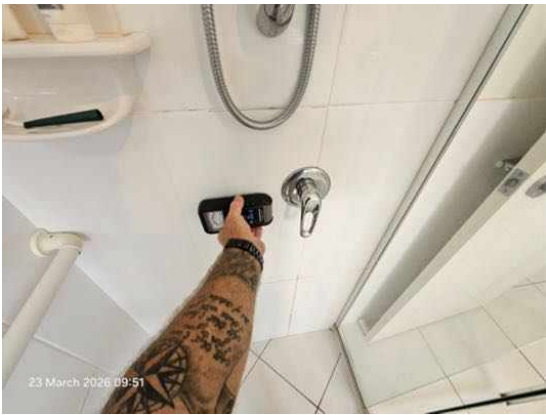
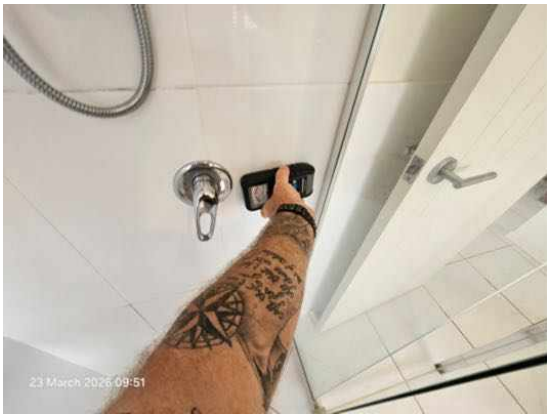
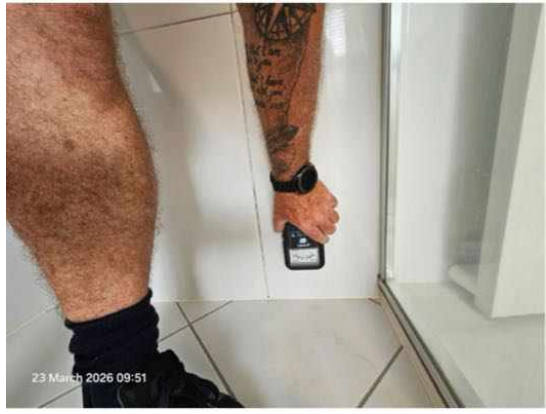
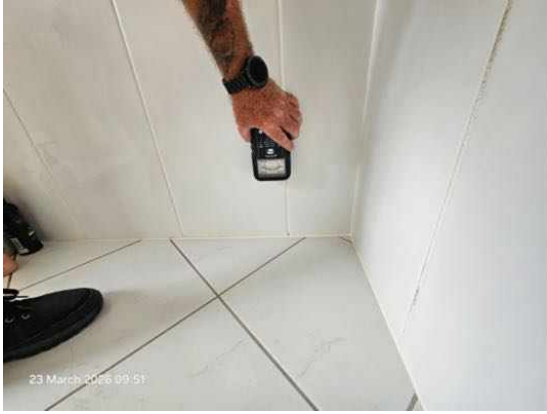
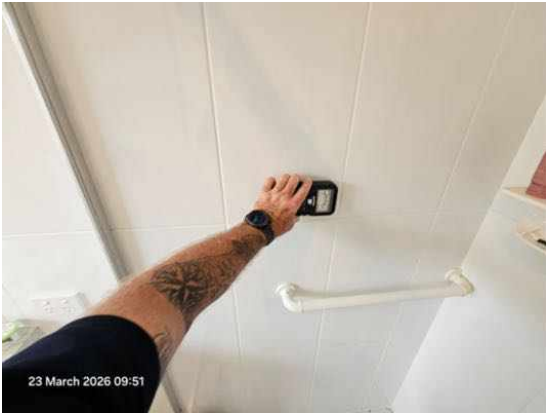
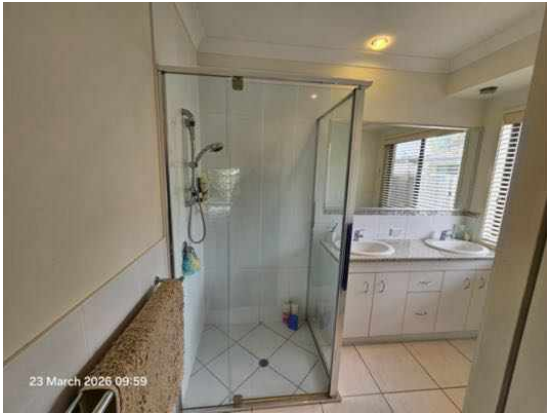
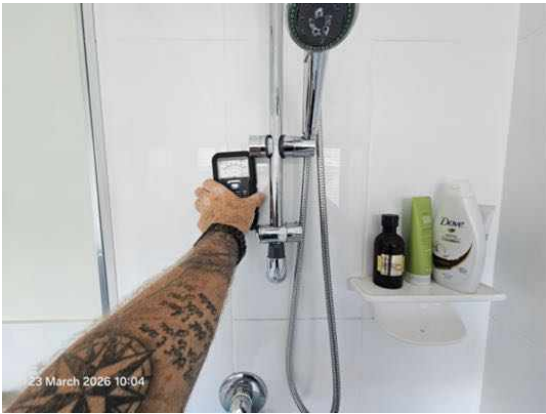
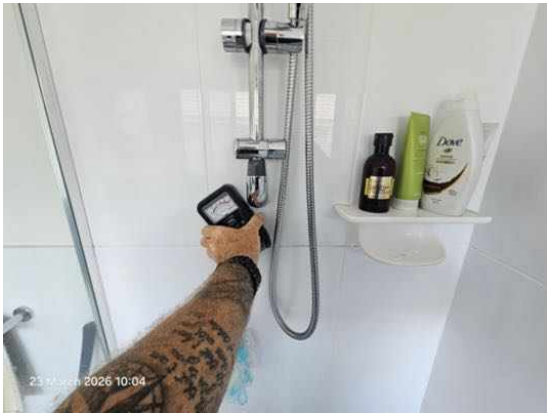
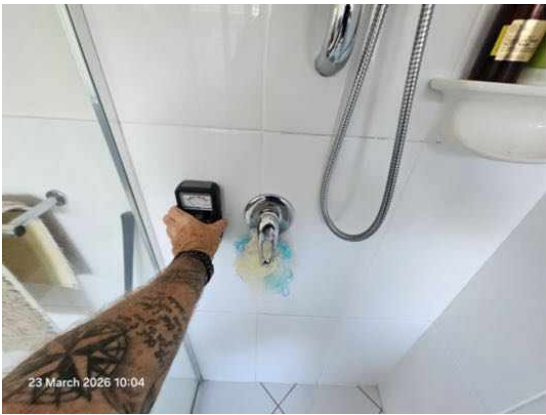
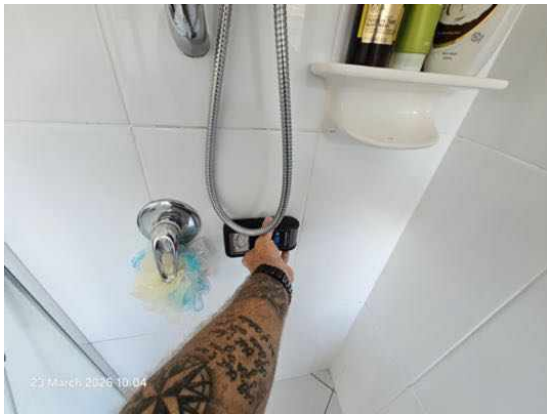
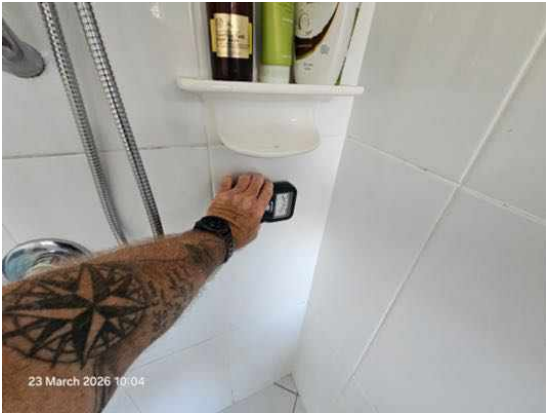
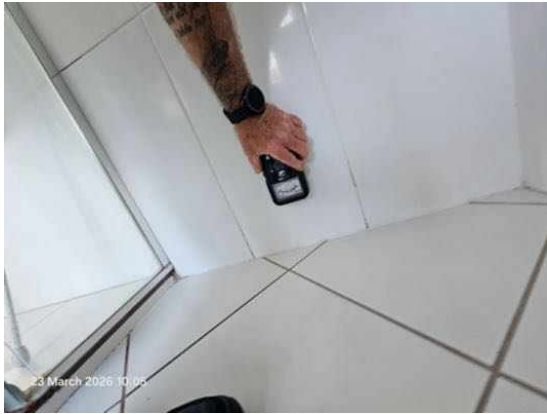
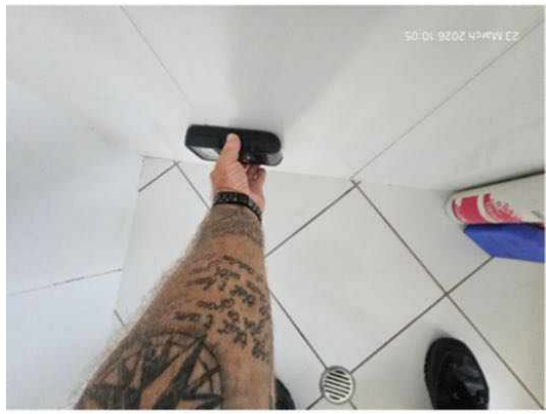
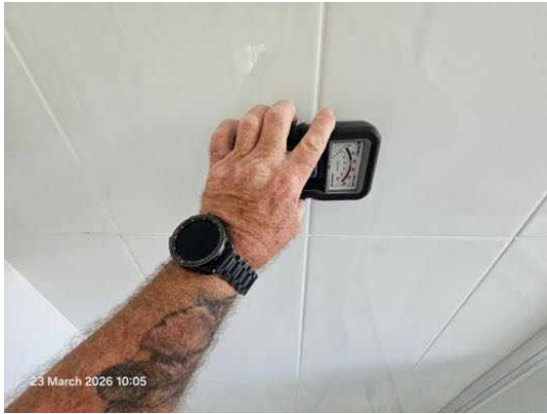
Building: Main Building
 Location: Bathroom, ensuite
 Finding: No moisture detected in bathroom / ensuite
 Information: On the day of inspection the showers in the bathroom/s and ensuite are measure for moisture using a "Tramex" moisture meter. During this inspection no moisture was detected in these areas and the tiled / sheeted surfaces appear to be in good order.

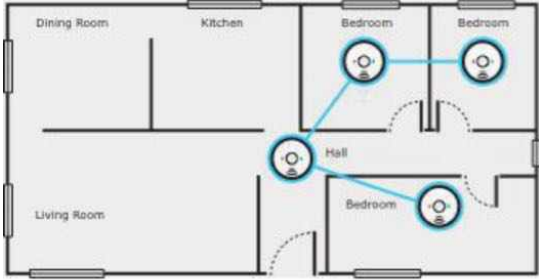
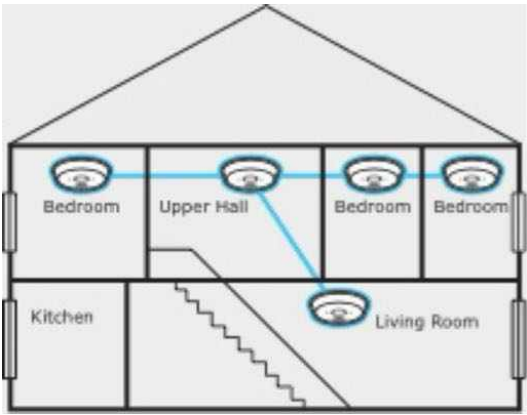
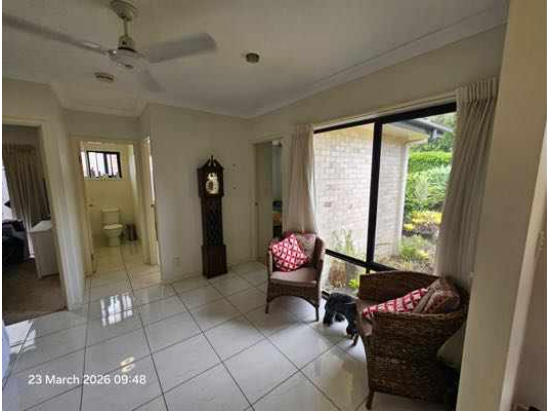
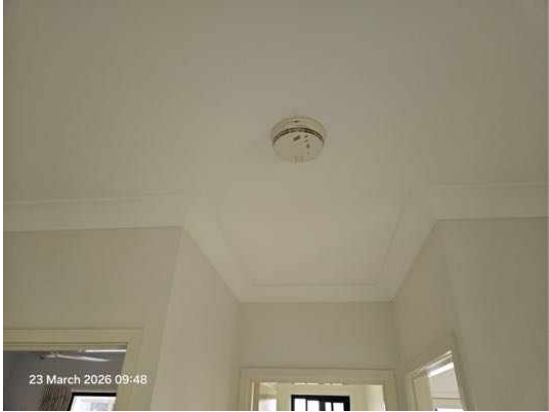
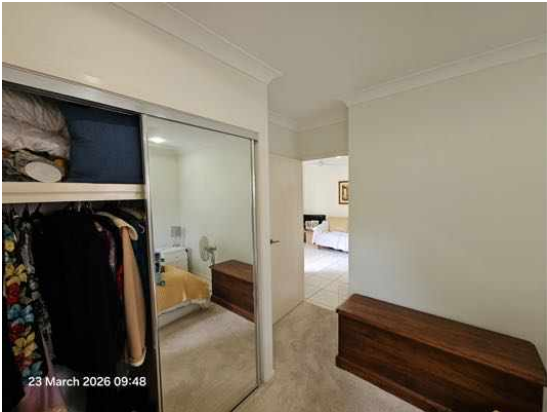
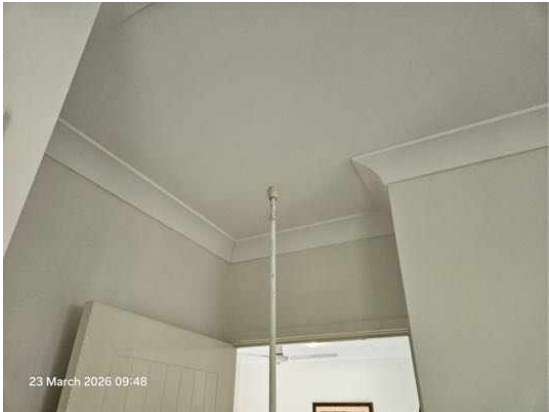
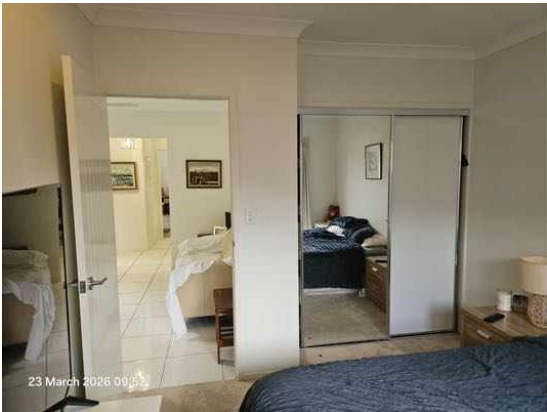
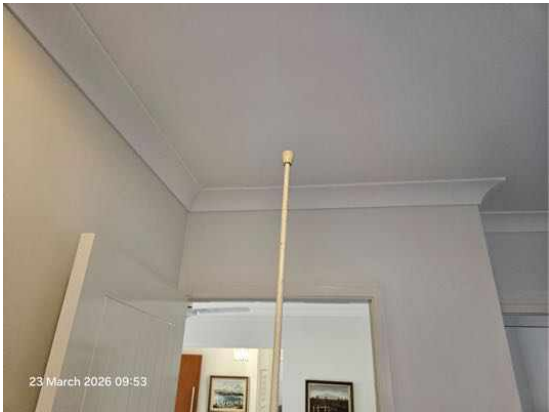
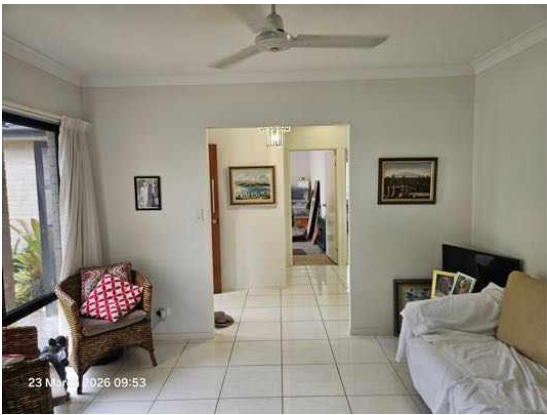
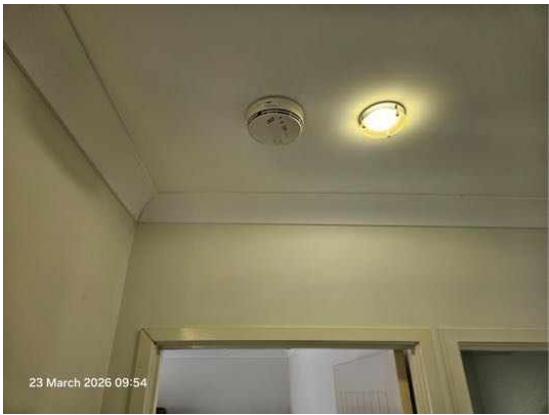
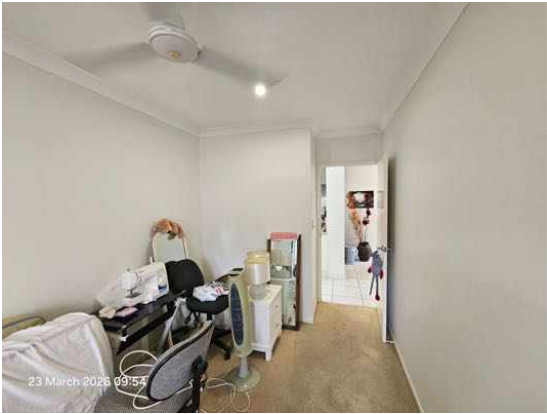
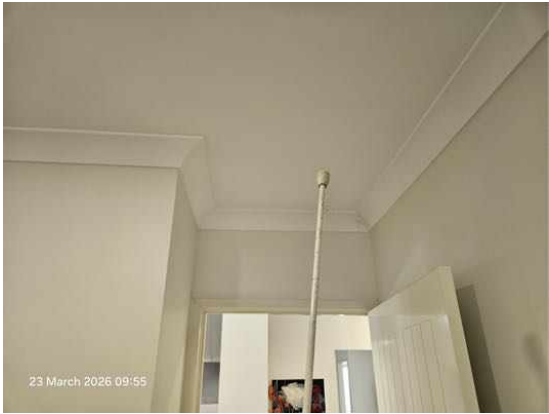
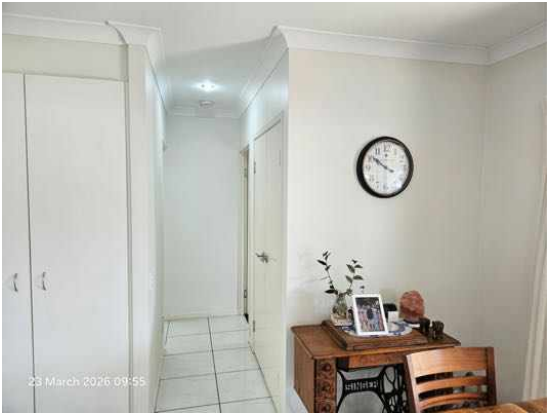
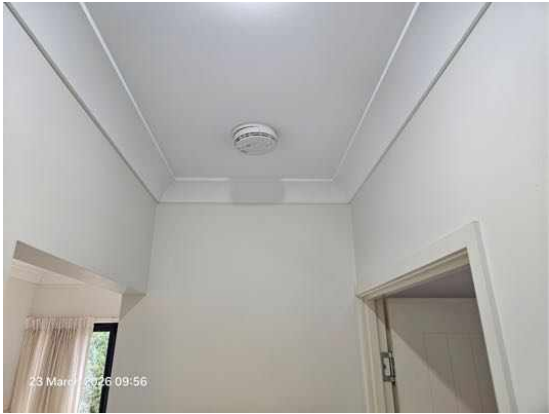
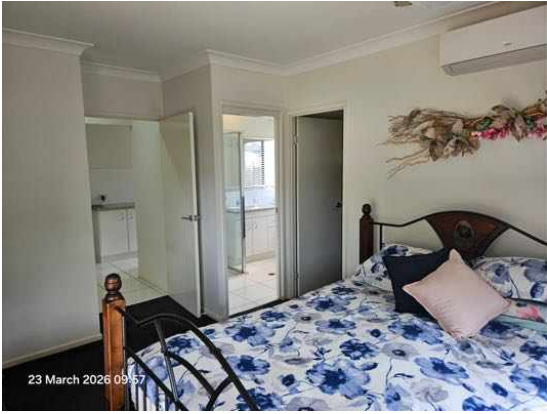
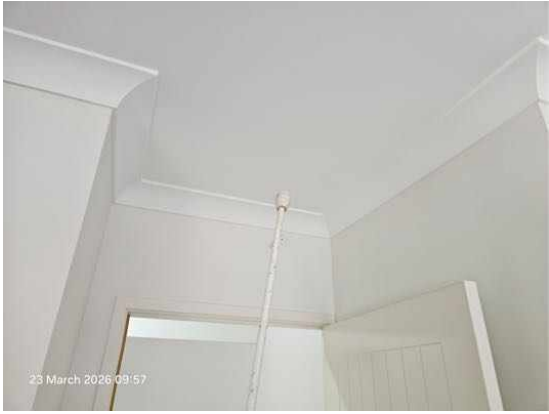
Building: Main Building
Location: All Internal Areas
Finding: Smoke Detectors and Alarms. AS 3786:2014
Information: Reporting on Smoke Detectors or Alarms, including hard wired smoke detection systems and their legislative requirements, is outside the Scope of this Report.

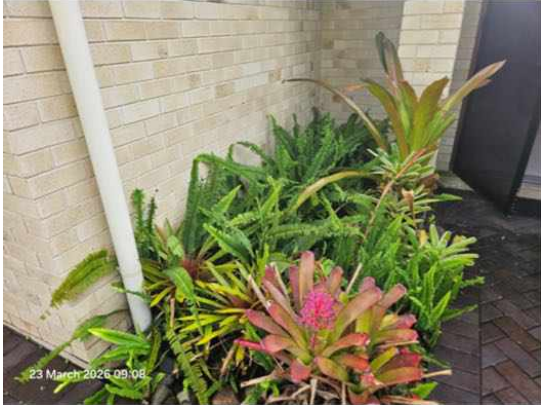
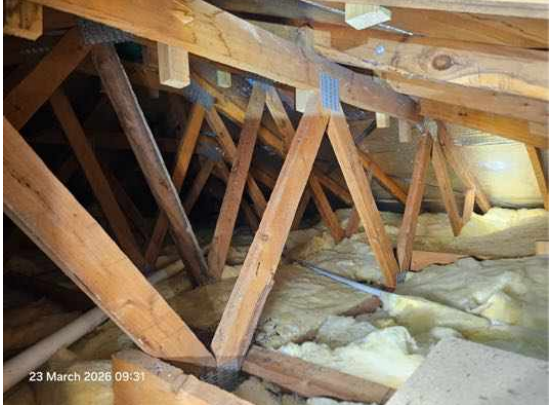
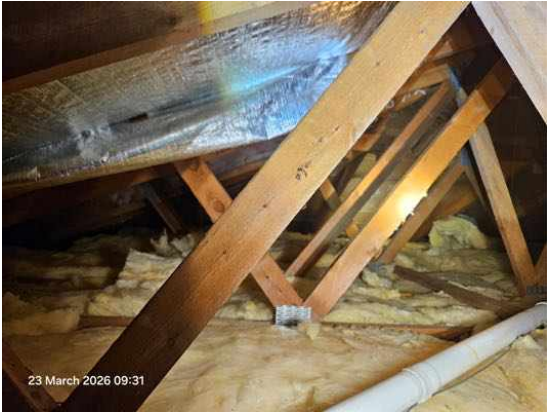
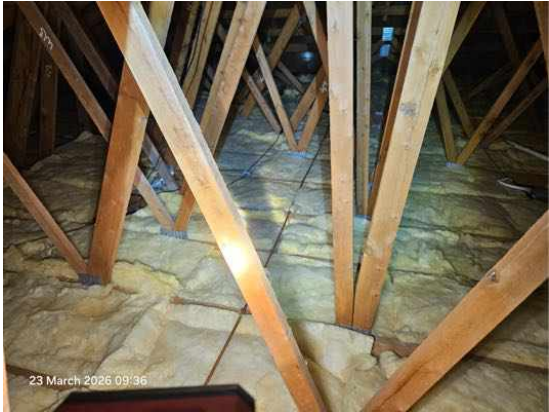
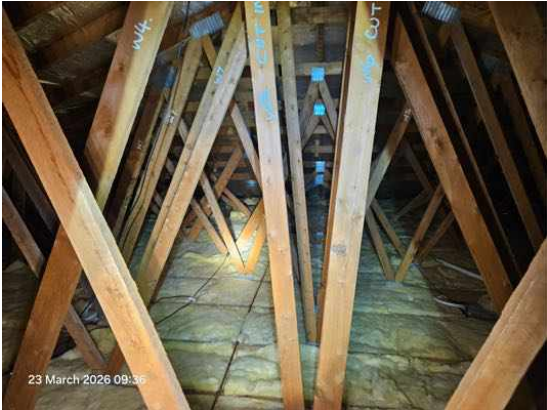
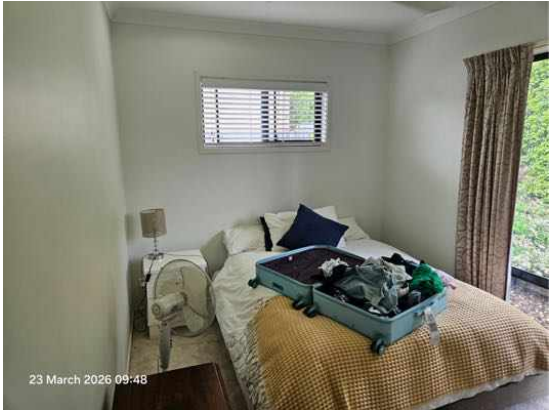
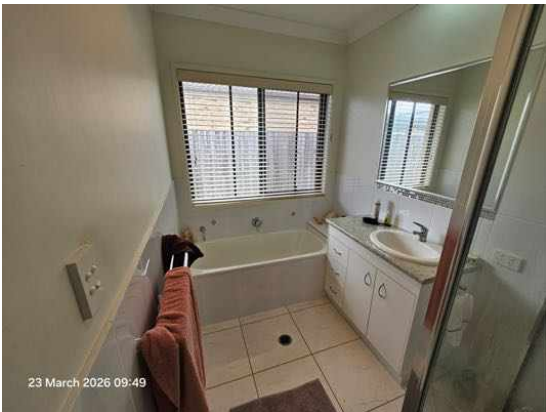
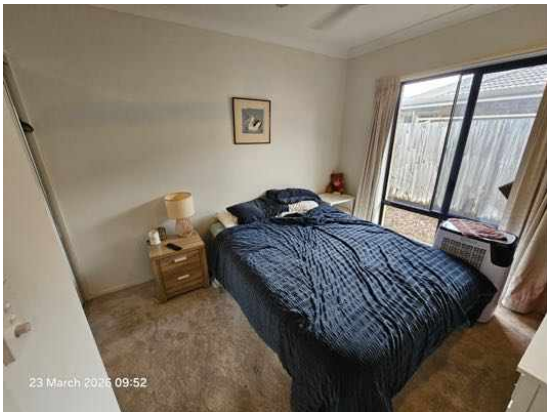
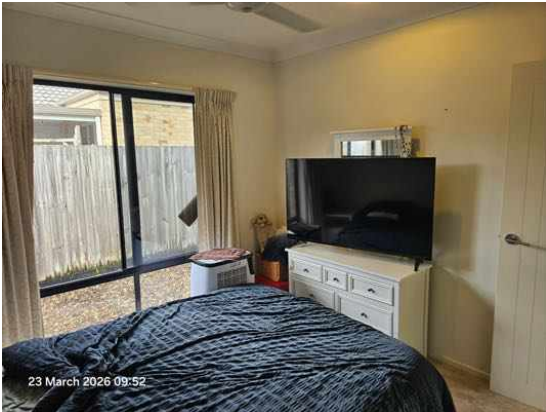
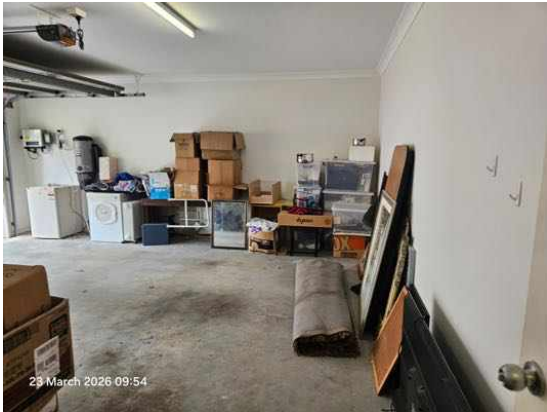
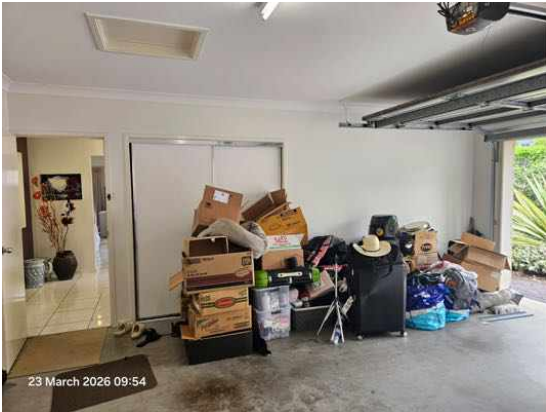
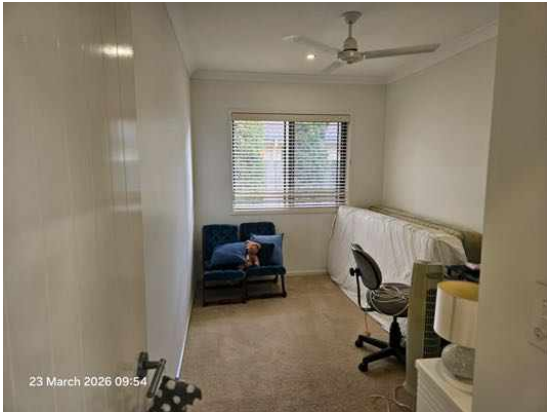
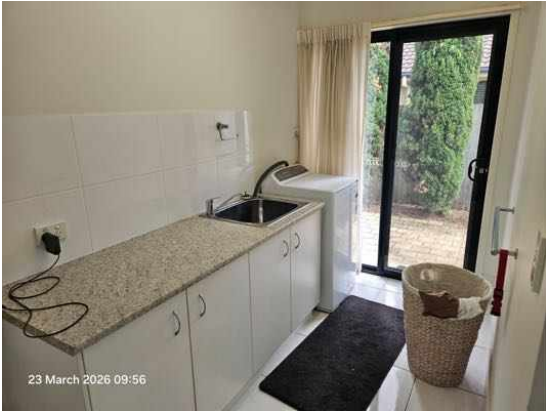
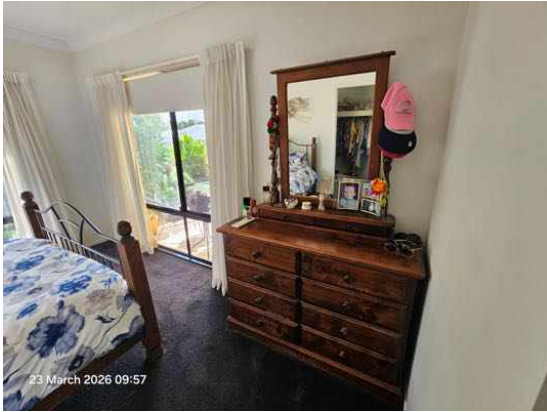
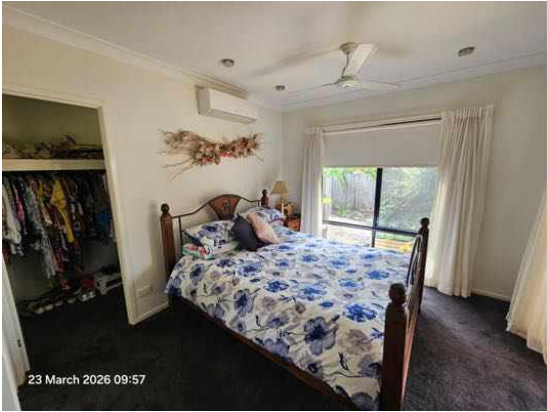
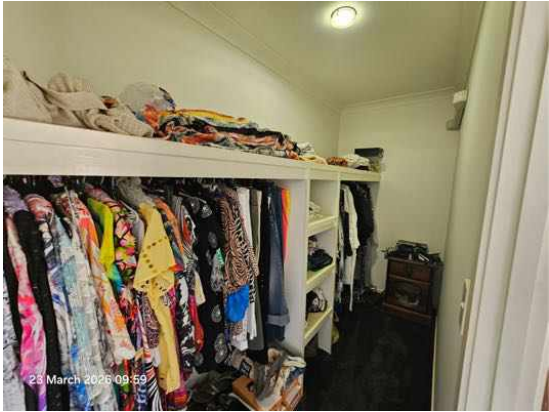
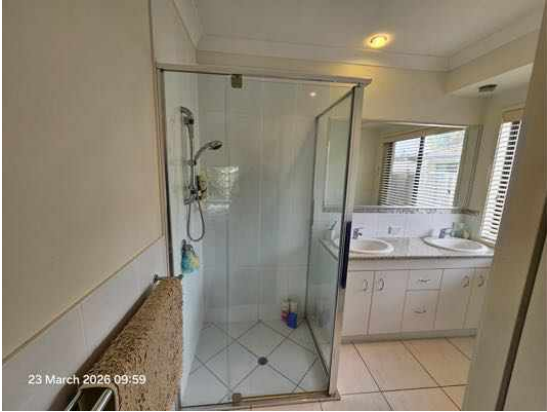
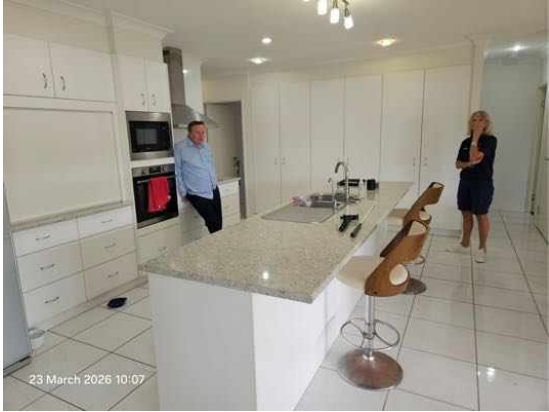
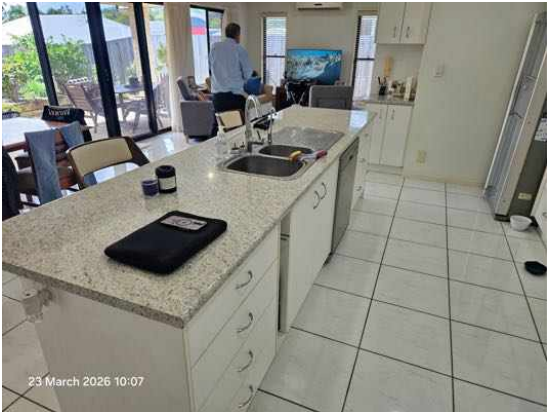
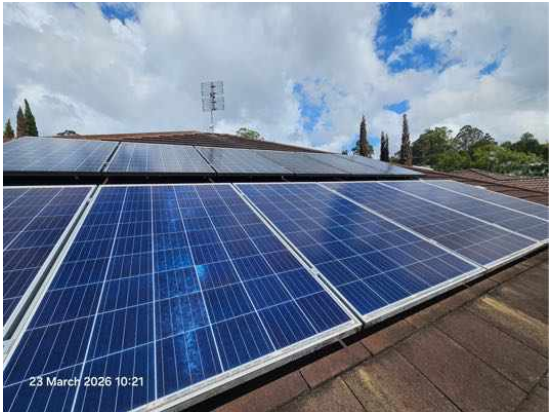
Building: Main Building
Location: All Areas
Finding: Additional Photos - Obstructions and Limitations
Information: These photographs are an indication of the obstructions and limitations which impeded full inspection of the property at the time of inspection. These obstructions can prevent full inspections of the areas shown.
