Building and Timber Pest Inspection Report

Inspection Date: Mon, 23 Mar 2026

Property Address: 12 Clarence Ave, Bli Bli QLD 4560, Australia

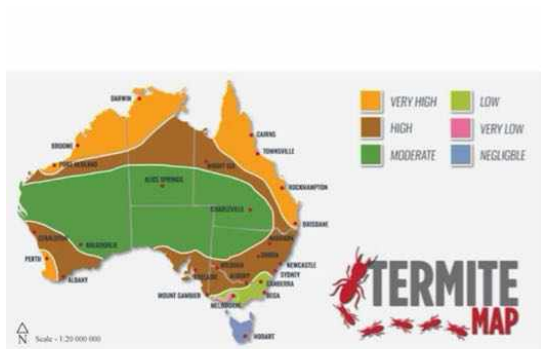
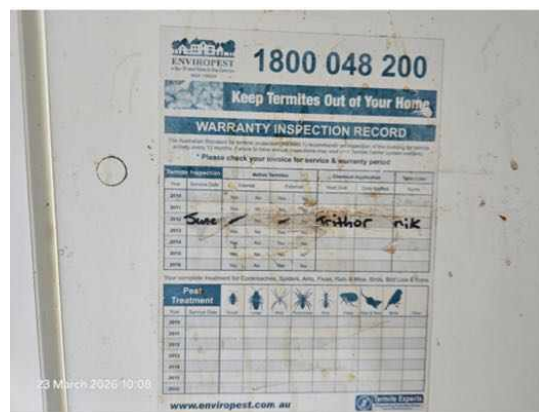
Noted Item

Building: Main Building
 Location: Meter box, kitchen cupboard
 Finding: Durable pest inspection notice - not assessable
 Information: On the day of inspection it was noted that the durable timber pest inspection / treatment notice was missing, not visible or out of date. These notices / stickers are to verify the timber pest inspection dates, the inspector, the currency and type of timber pest system / barrier in place or being used in and around the property.

Annual, or more regular, inspections are crucial in maintaining and managing the properties timber pest risk profile. By not having regular inspections of the property raises the properties risk of undetected defects and damage. Without regular inspection at intervals of not greater than annually the buildings risk profile will be categorised as high. Properties with trees within 50m and with gardens close to the building are at greater risk and will have a high risk profile.

It is recommended that a licensed timber pest controller be contacted to assess the properties needs and provide costings for an annual inspection programme.

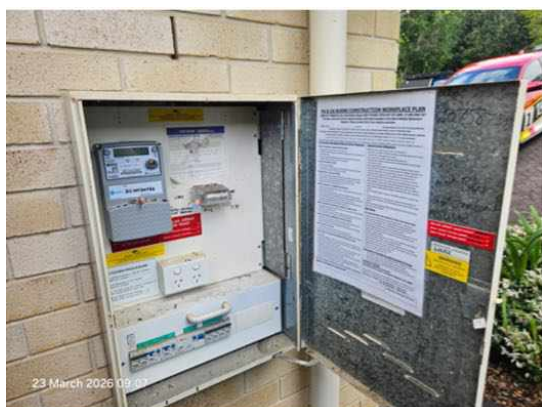
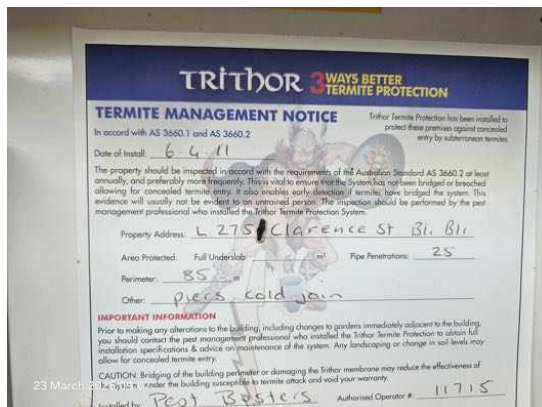
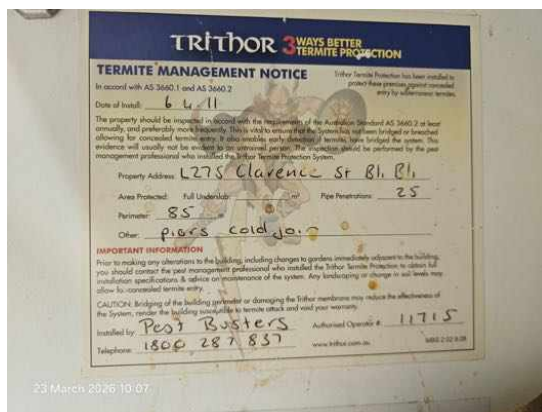
Noted Item

The building employs a “Trithor” physical barrier system to the perimeter and slab penetrations in combination with a Cypress Pine structural frame.

In order for a barrier system to be effective, the property must have regular inspections at intervals of not greater than 12 months. Depending on the risk profile attributed to the property, these inspections may be recommended at lesser time periods.
