# Building and Timber Pest Inspection Report

Inspection Date: Fri, 30 Jan 2026

Property Address: 13 St James Ct, Narre Warren VIC 3805,  
Australia

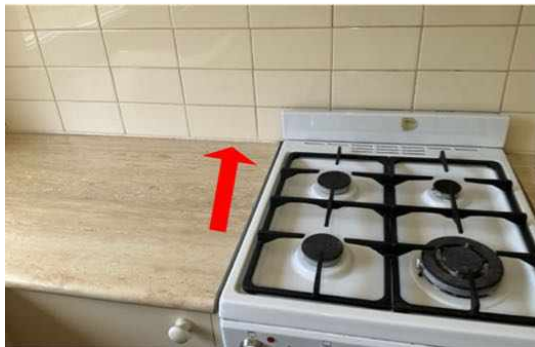
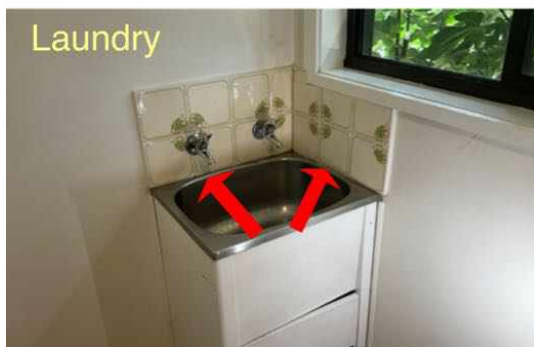
Finding: Sealant/ grout - Damaged or Missing

Information: Sealant or grout is damaged in this area. Sealant and grout is used to protect gaps and crevices in building materials to ensure that they are water-tight and prevent water penetration to the associated structures.

Failure to do so may lead to further deterioration of the sealant which in turn can lead to water damage to the surrounding area.

Where sealant or grout is missing or damaged , a competent handyman may be appointed to scrape out and re-apply any silicone where necessary.

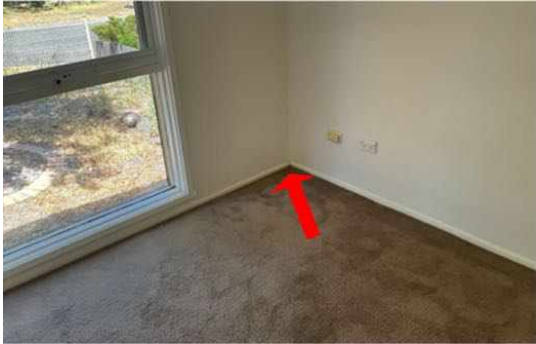
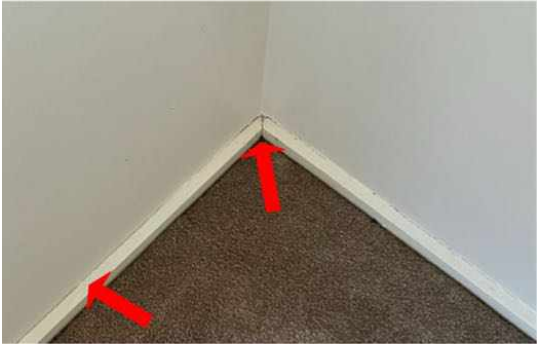
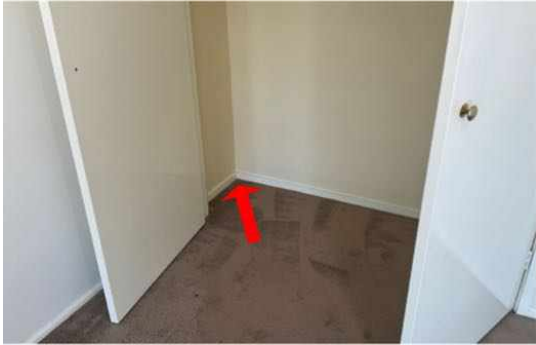
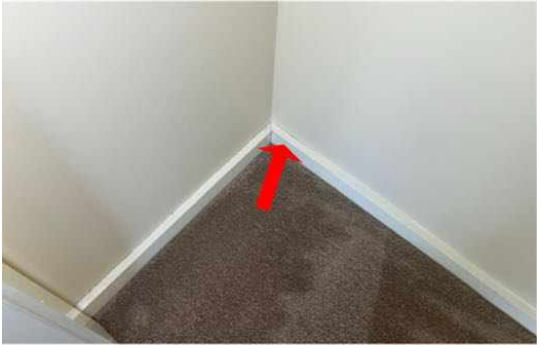
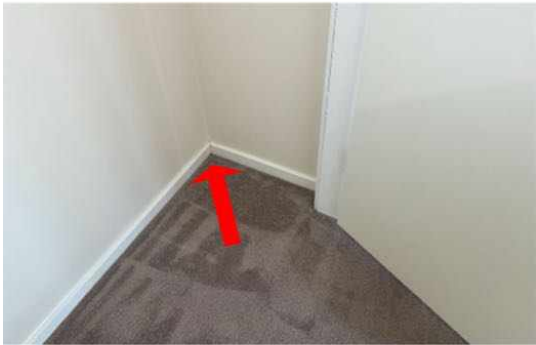
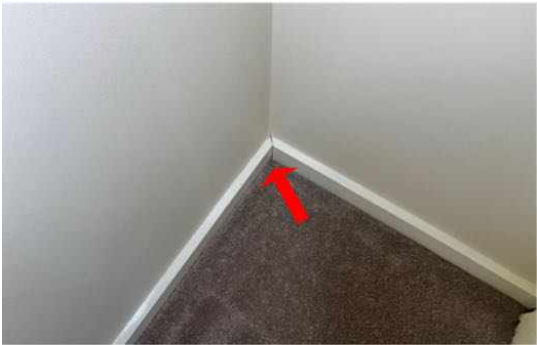
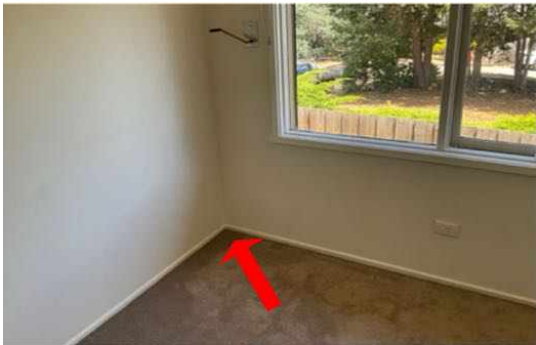
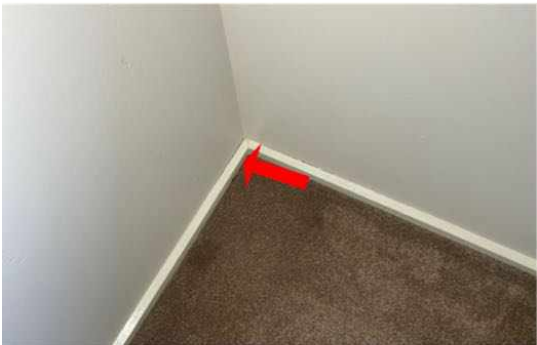
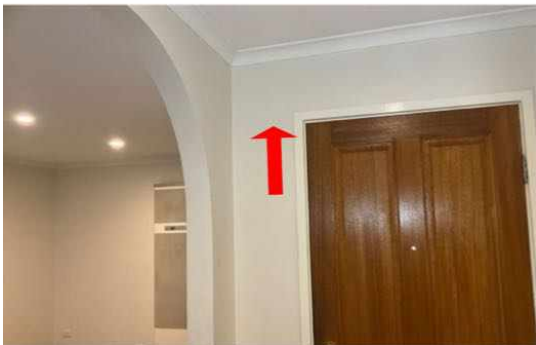
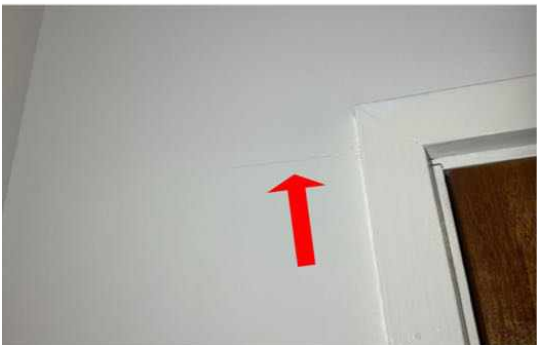
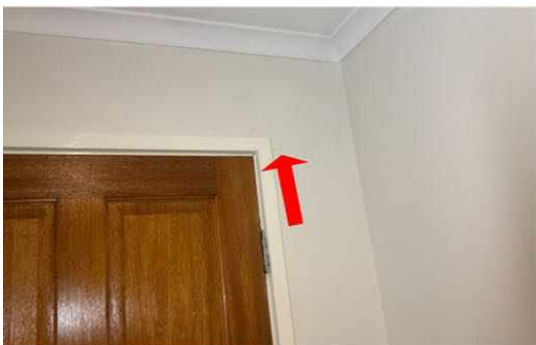
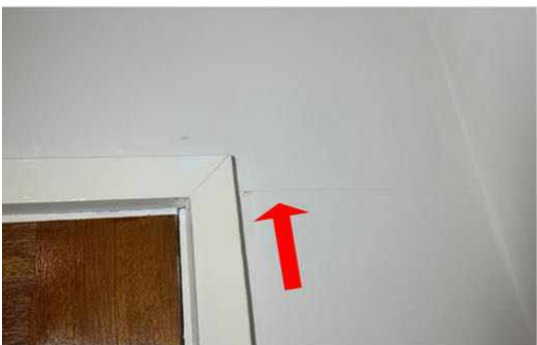
### Finding 3.02

Building:	
Location:	All Areas
Finding:	Cracking - fine
Information:	Some fine cracking was noted throughout the property.

Although fine cracks are quite noticeable, they are often only considered to be an appearance defect, and usually do not indicate any structural damage. Generally, the cause of a fine crack is indicative of a separation between building materials and finishes (e.g. paint, plaster, etc.) along joints.

Note: photos included are indicative of fine cracking noted at the the time of inspection. Other fine cracks may be present but not recorded here.

Cracking of this nature can generally be repaired with minor sanding, filling and/or

Monitoring of all cracking should be conducted frequently. Always contact a building inspector should cracks widen, lengthen, or become more numerous.

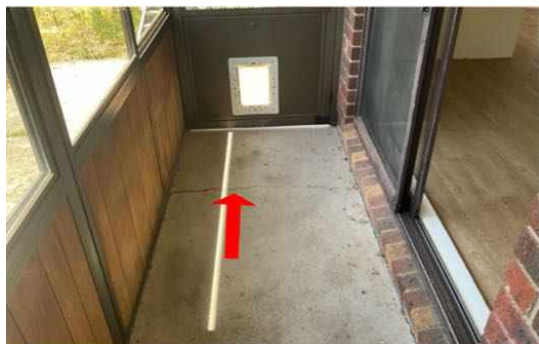
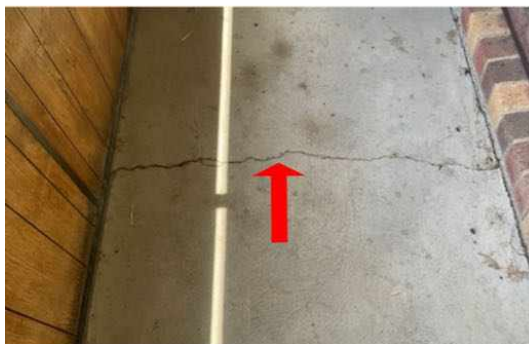
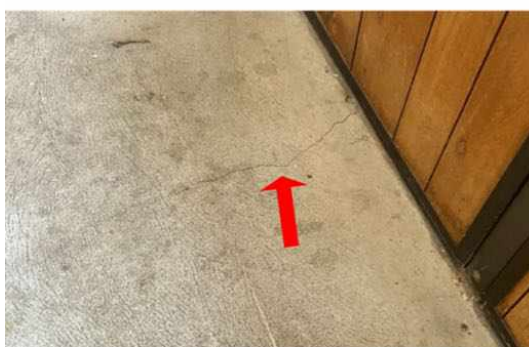
**Finding 3.03**

Building:  
Location: Sunroom  
Finding: Cracking - Concrete flooring in the sunroom  
Information: Fine but noticeable cracks were identified in the concrete flooring of the sunroom . Although fine cracks are quite noticeable, they are often only considered to be an appearance defect, and usually do not indicate any structural damage.

Generally the cause of a fine crack in existing concrete flooring is indicative of the expansion and contraction of the concrete. Such causes are generally due to environmental factors, such as moisture levels, weather conditions, or to poor original installation of the concrete. Factors such as inadequate reinforcing of the slab may

create cracking and other secondary defects.

Monitoring of all cracking should be conducted frequently. Always contact a building inspector should cracks widen, lengthen, or become more numerous.

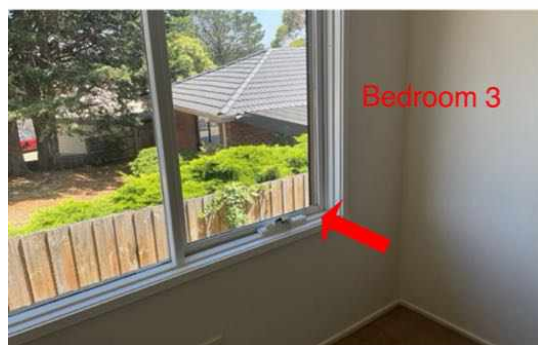
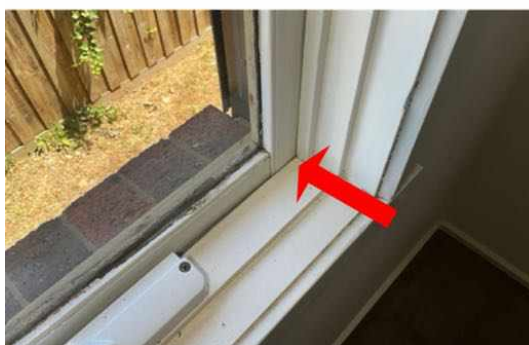
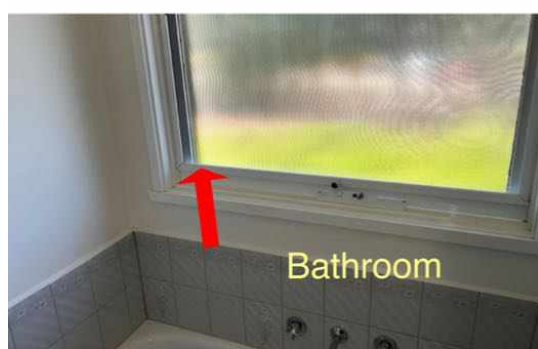
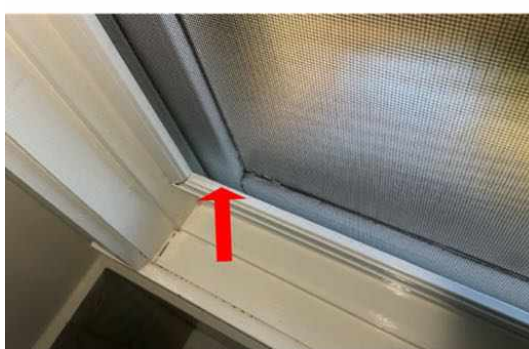
### Finding 3.04

Information: The window in this area was sticking and difficult to operate at the time of the inspection. Windows provide ventilation to the adjoining area and should be at a fully operational level to ensure user comfort. Restricted function of the window may also create potential for secondary defects to the associated building elements, such as damage to the window frames as well as a potential safety hazard if required for emergency egress from the building.

The most usual causes are swelling of timbers due to moisture, bulging or bowing of frames, or general material degeneration.

Easement will be required, which may involve some sanding and repainting. It will almost always include ensuring the areas are cleaned and free of any debris that may be detrimental to their operational state.

A competent handyman or window specialist may be engaged to perform this task.

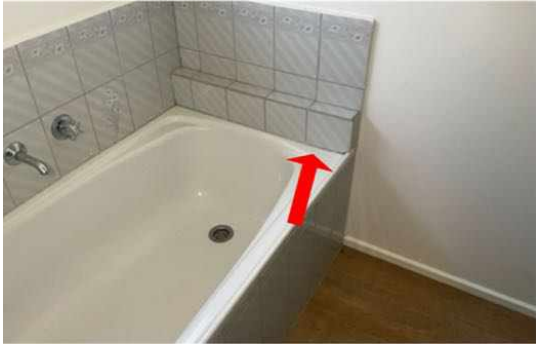
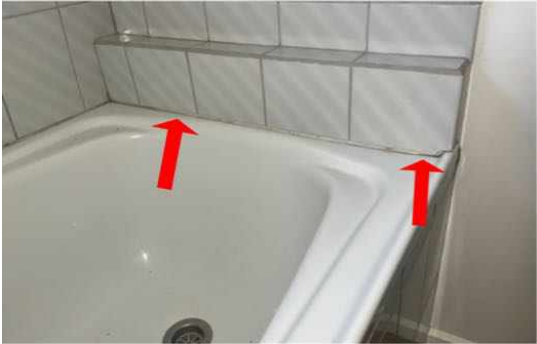
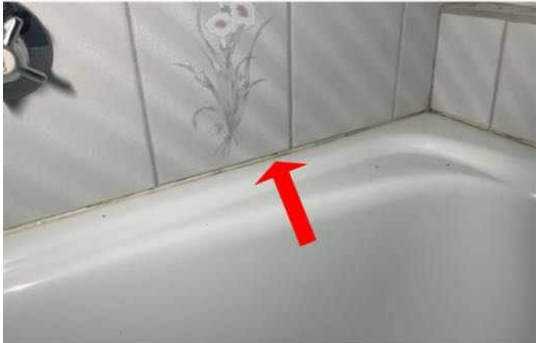
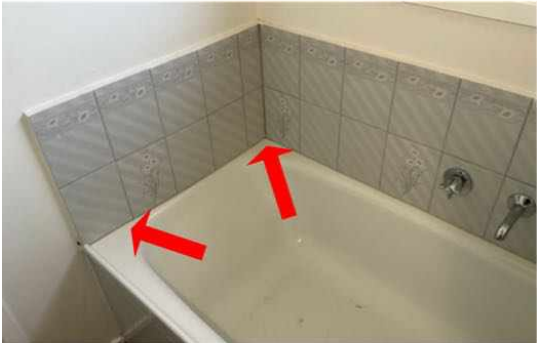
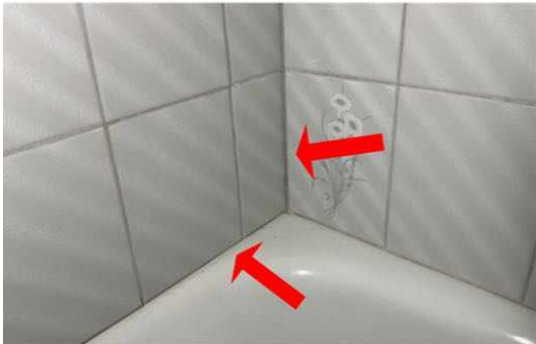
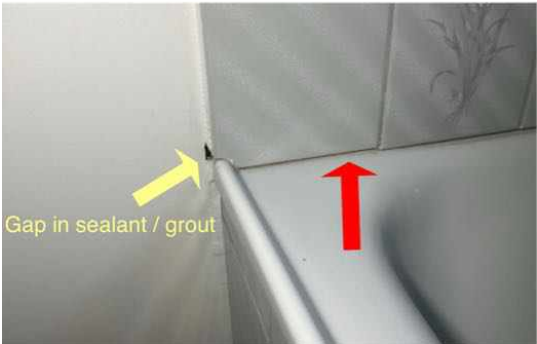
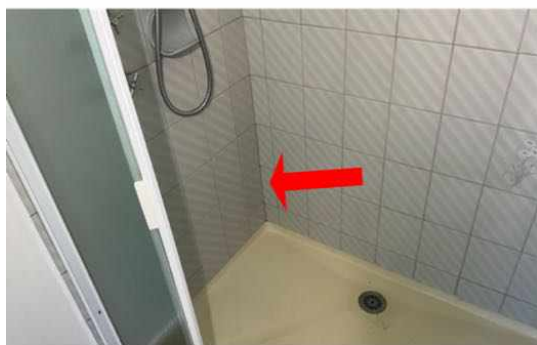
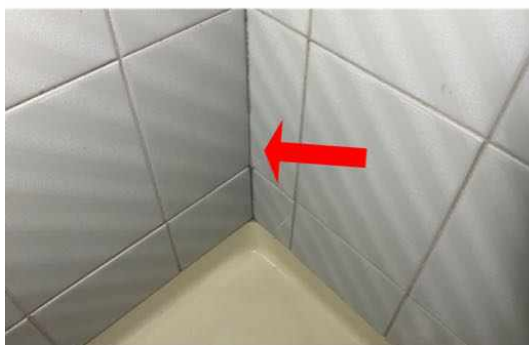
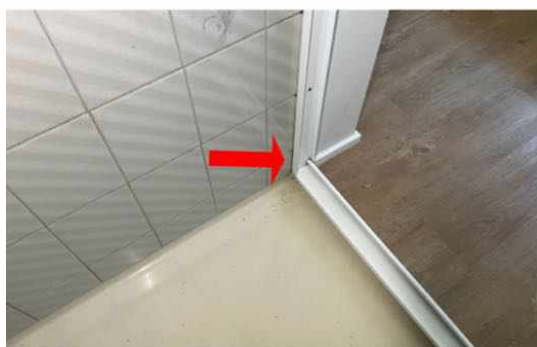
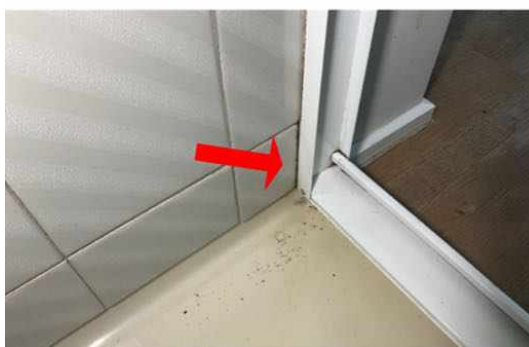
### Finding 3.05

Finding: Grout and sealant - Missing or degraded within the bathroom area

Information: It was noted on inspection that grout or sealant is degraded to areas within the bathroom.

Different materials move at different rates, generally causing cracking to grout at this point. Build up of moisture in the bathroom can also cause grout and sealants to degrade and become mouldy.

Any damaged or degraded materials should be scraped out and flexible and mould resistant materials should be applied to affected areas to prevent any subsequent water damage that may occur. Regular maintenance and replacement of damaged or missing grout/ sealant is highly recommended to the wet areas, as this is a regular wear and tear defect. Both grout and sealant in areas that come into regular contact with water should be maintained for the long term care of your property.

A bathroom specialist or tiling contractor should be appointed to complete these works as soon as possible.

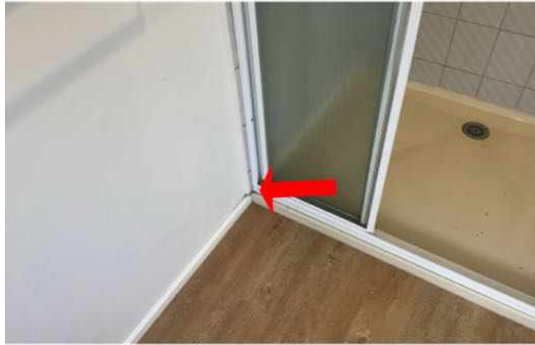
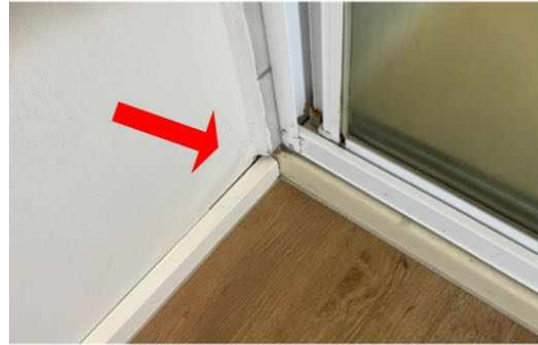
### Finding 3.06

Finding: Suspected Moisture damage to lower wall next to shower

Information: Evidence of suspected moisture damage was identified to the lower wall next to the shower.

It is suspected that this has occurred as a result of excess moisture from spills from the shower. No current moisture was noted to the area when tested with a moisture meter. As such it is suspected no further damage will occur in the area.

A competent handyman may be engaged to inspect the moisture damaged areas and repair or replace any items at the discretion of the homeowner.

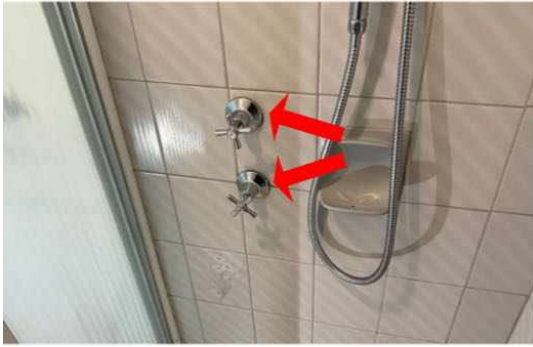
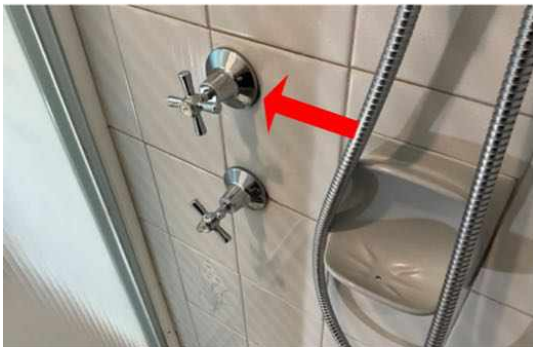
### Finding 3.07

Information: At the time of inspection, gaps were noted around the taps in the shower. These gaps can lead to water ingress behind the tiles which in turn can lead to secondary damage to other building materials.

All tap hardware and connections should be tightly fixed and sealed to prevent moisture ingress.

A competent handyman can be engaged to seal up the gaps.

This should be carried out as a priority. Failure to do so may result in further damage.

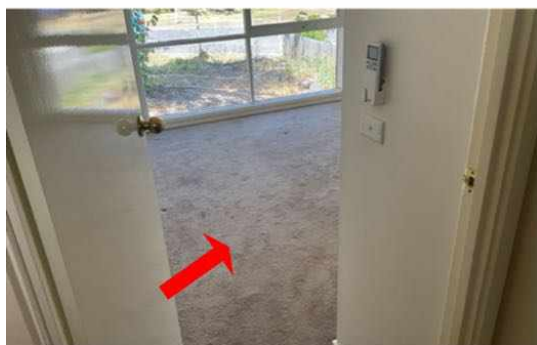
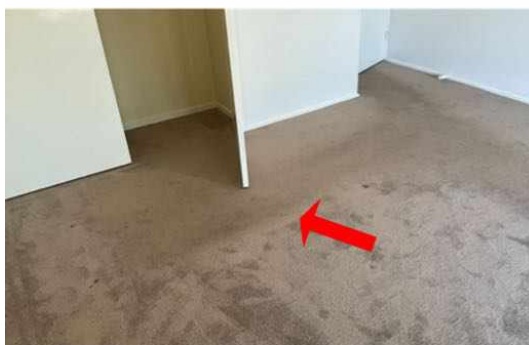
### Finding 3.08

Creaking floors generally indicate that the fixings for the flooring may be coming loose slightly.

The area should be monitored for any changes or unevenness. Should this occur, consultation with a registered builder should be undertaken to determine the cause. The potential resolution may involve regluing and screwing the floor down through to replacement of subfloor support structures.

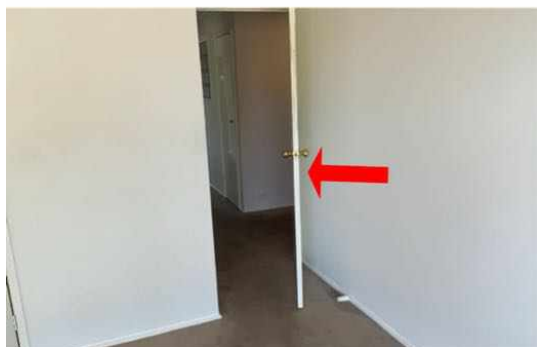
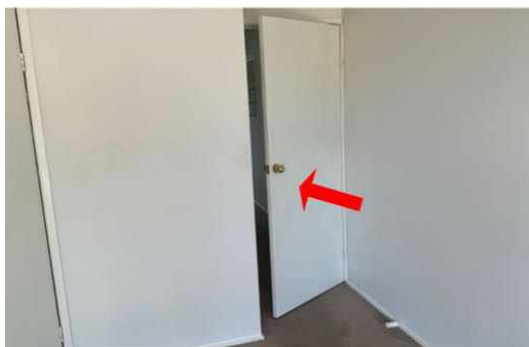
Information: It was noted at the time of inspection that the door to this area would not stay half open and "self closed".

This may be the result of incorrect installation or can be due the framing not being plumb.

A licensed carpenter or registered builder can be engaged to rectify these issues at the discretion of the homeowner.

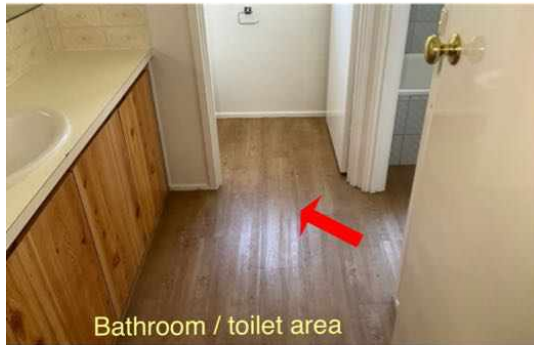
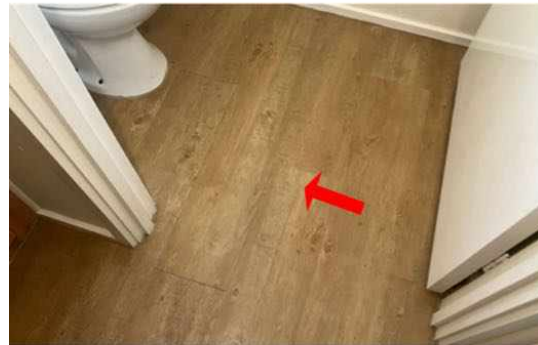
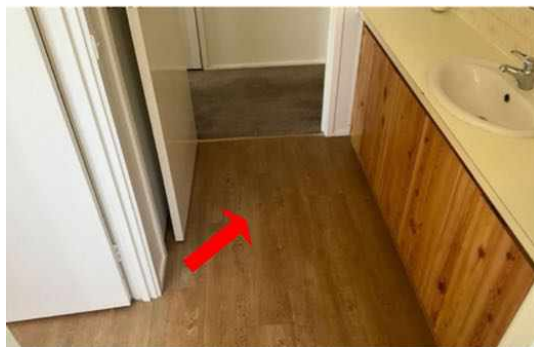
### Finding 3.10

flooring.

The area should be monitored for any changes or movement. Should this occur, consultation with a flooring specialist should be undertaken to determine the cause . The potential resolution may involve lifting and relaying the flooring through to full replacement .

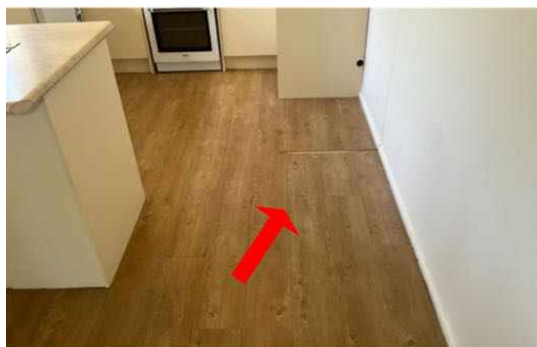
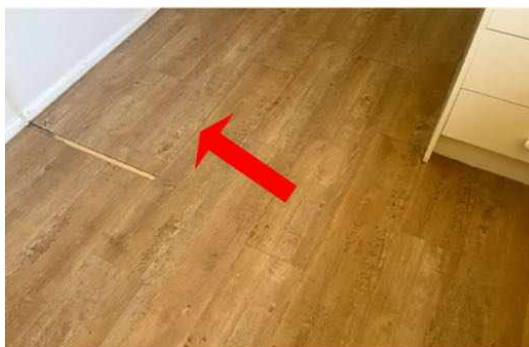
This sponginess may be the result of poor installation of the boards but may also indicate a fault in the subfloor structure underneath the flooring. Lower quality flooring can also be the cause. Without actually lifting the flooring in this area, it is difficult to determine the exact cause.

The flooring should be monitored for any further movement or changes and should that occur, consultation with a flooring specialist should be sought.

This may require the flooring to be lifted and the area underneath inspected.

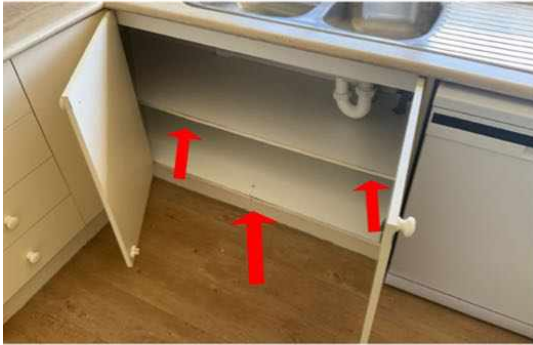
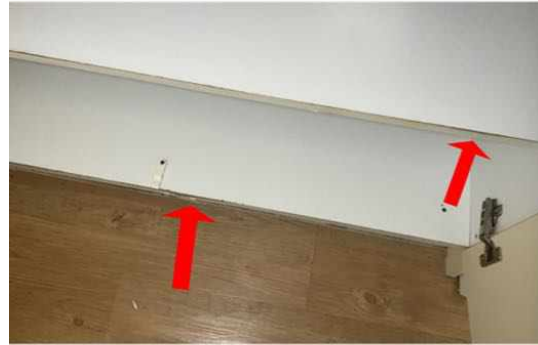
### Finding 3.13

Finding: Damage to the kitchen cupboards - edging peeling off

Information: Evidence of damage was identified to the kitchen cupboards at the time of inspection. It appears that the edging on the cupboards were peeling off.

The shelves may be re edged. Failing that , replacement of the shelves may need to be undertaken.

A kitchen specialist or competent handyman may be engaged to inspect the damaged areas and repair or replace any items where necessary.

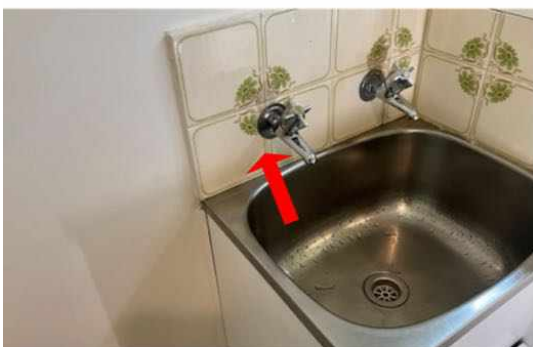
### Finding 3.14

Finding: Wall tiles - Cracked

Information: Cracking in the wall tiles around the tap was evident in the laundry at the time of inspection. It is suspected that this cracking has occurred as a result of the slight movement within the building, impact damage or poor initial installation.

Cracked tiles throughout the household detract from the overall appearance of the affected areas, as well as creating potential for water penetration to adjoining building elements. If left unmanaged, water damage can occur as a result of constant water penetration over a prolonged period of time.

While not considered a matter of urgency, replacement of cracked tiles is advised as a solution. A tiling contractor may be appointed to perform these works at client discretion.

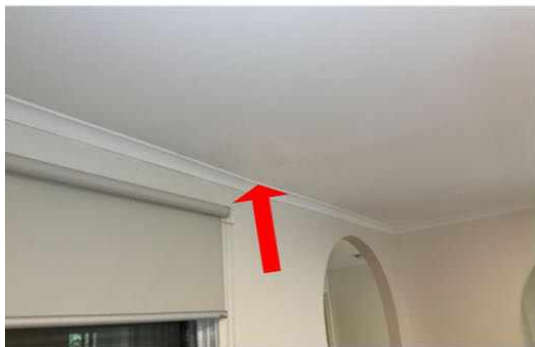
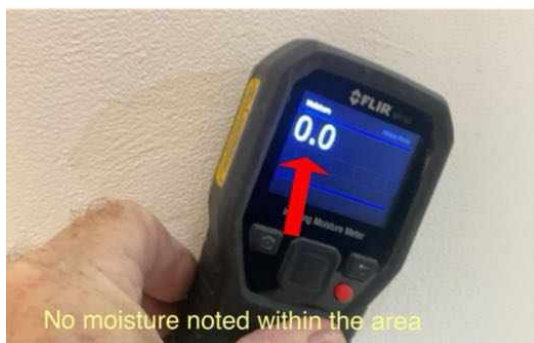
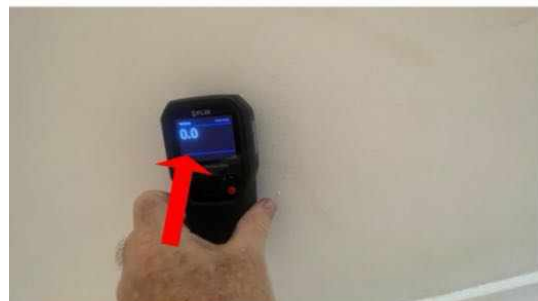
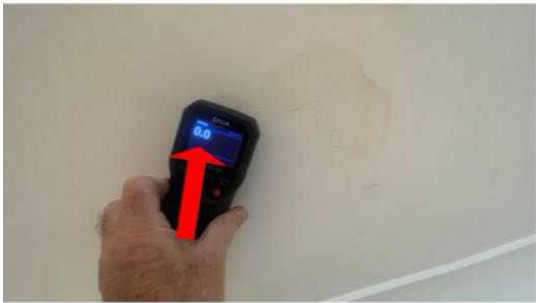
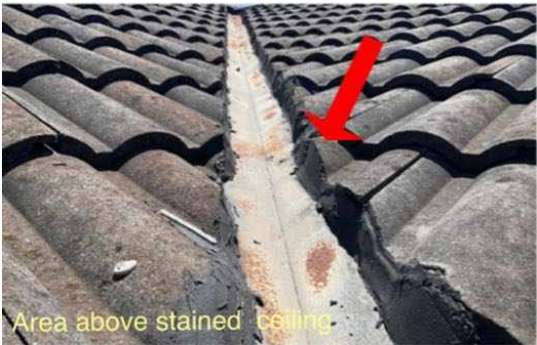
### Finding 3.15

Finding: Ceiling - Water stained

Information: Water staining to ceiling linings in this area was evident at the time of inspection. No current moisture was noted in the ceiling when checked with a moisture meter.

Water staining indicates that surfaces have been exposed to excessive moisture over time. The minerals and other elements in the water lead to staining, which may graduate to corrosion and deterioration if left unmanaged.

While mostly an appearance defect, water staining can be indicative of more serious defects, which may be currently concealed by interior ceilings.

Please note: it is suspected the staining may have been from a leak which has subsequently been fixed. Ongoing monitoring of the ceiling should be carried out to ensure no leaking occurs in the area in the future.

Where water staining is active ( not suspected in this instance), a licensed plumber must be consulted to identify the cause of the staining and to provide advice on any reparation works that may be required. Replacement of any damaged structures is advised.

Conversely, where water staining is old and inactive, the ceiling may be repainted at the client's discretion.

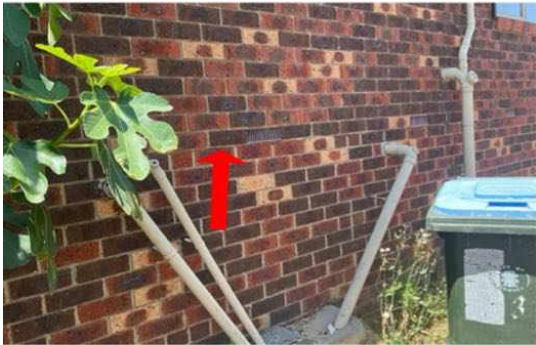
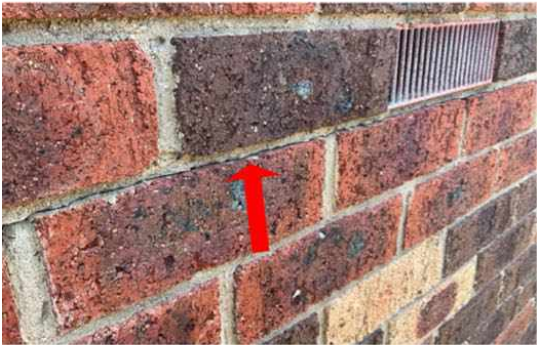
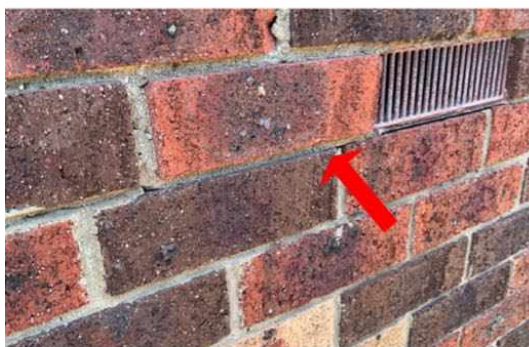
**Finding 3.16**

Building:  
 Location: All External Areas  
 Finding: Brickwork - Cracking [Fine]  
 Information: Find cracking was noted within the mortar between brickwork on this exterior wall .

Although fine cracks are quite noticeable, they are often only considered to be an appearance defect and usually do not indicate any structural damage. Generally, the cause of a fine crack is indicative of a separation between brickwork and mortar throughout the structure, but single bricks may also show cracks of this nature.

Cracking of this nature can generally be repaired with minor filling and should be conducted by a qualified bricklayer.

Always contact a building inspector should cracks widen lengthen or become more numerous.

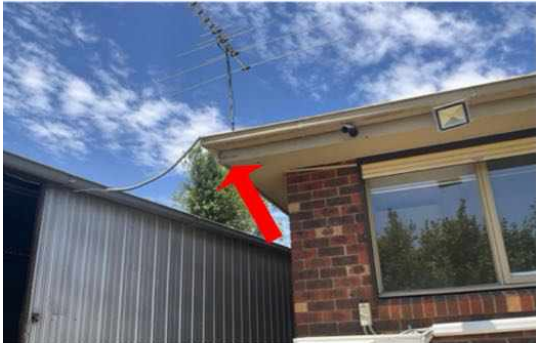
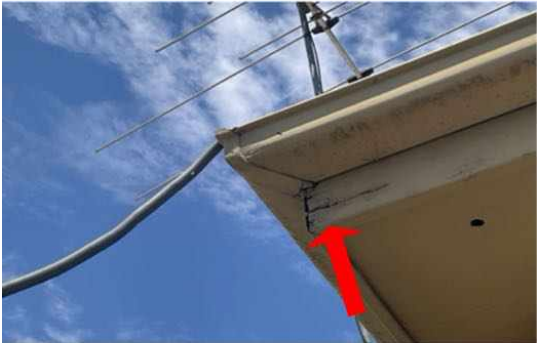
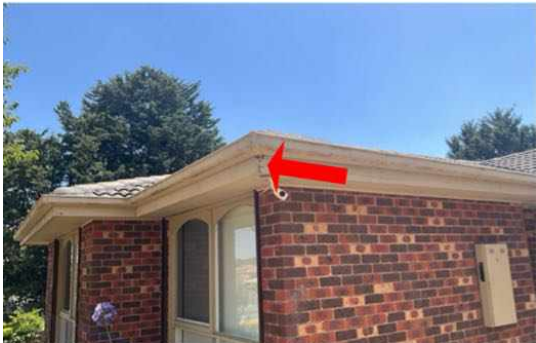
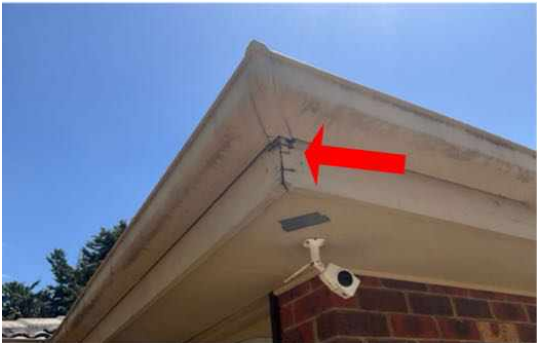
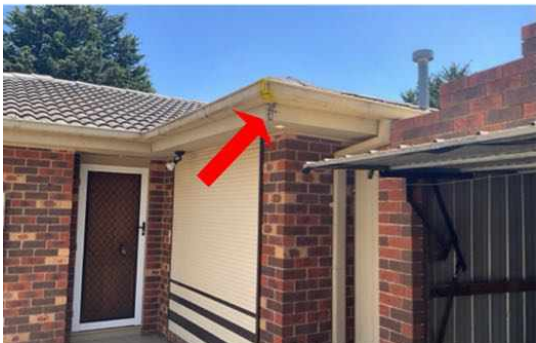
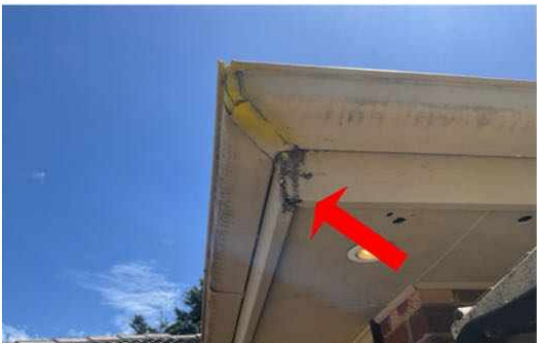
### Finding 3.17

Finding: Fascias - Slight Wood rot

Information: Slight wood rot was found to be affecting the fascias in this area. Wood rot also known as Fungal Decay, occurs when timbers and other cellulose building materials are exposed to damp conditions on an ongoing basis.

It is likely that this wood rot has developed as a result of faults in the roof plumbing, creating excessive moisture in this areas. Frequent exposure to rain and other weather conditions also make fascias and barges susceptible to accelerated deterioration.

Early intervention and regular maintenance will prolong the useful life of these building elements. Prior to any works being performed, the cause of the moisture that has created the visible wood rot should be identified and addressed in a suitable manner.

It is advised that a roof plumber be appointed to inspect all roof plumbing and subsequently identify the cause of the wood rot. Replacement of affected fascias and barges may then be a necessary step in protecting surrounding building elements from such deterioration.

A qualified roofing plumber may be appointed to assess the cause of excessive moisture and to provide advice on any remedial works as required. A qualified carpenter or registered builder may also be required to replace affected building materials.

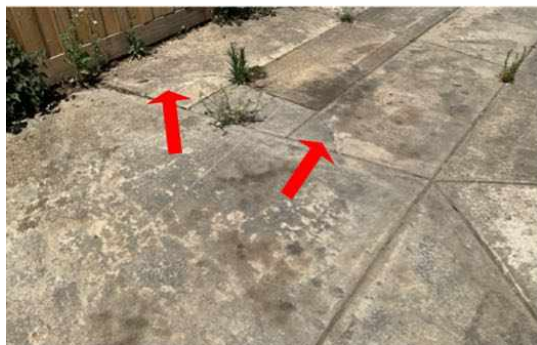
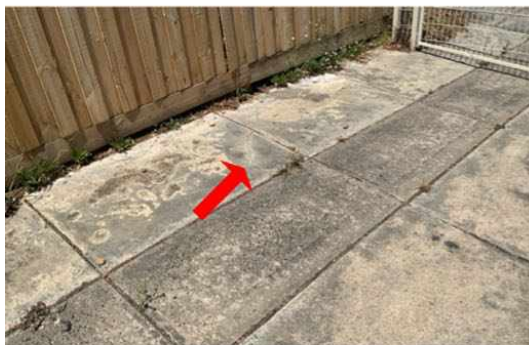
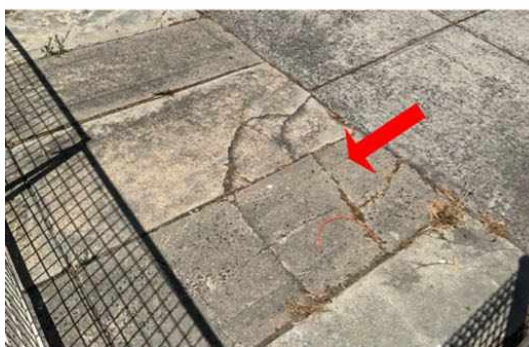
**Finding 3.18**

Building:  
Location: Driveway  
Finding: Noticeable Cracking - Concrete driveway  
Information: Noticeable cracks were identified in the concrete driveway.

General age and expected deterioration of the concreted areas is a common cause of this type of cracking. However, expansion and contraction of the driveway may also have occurred due to environmental factors. Such factors include variable moisture and weather conditions, the presence of trees and their roots having a settling or lifting affect on the soil, or the effect of load bearing, e.g. heavy vehicles over a sustained period of time.

Cracking to this degree may also be due to poor original installation of the driveway. Factors such as poor compaction of the sub surface and/or inadequate reinforcing of the slab may create cracking and other secondary defects. Noticeable cracks may also be due to subsidence of soils.

The area should be monitored for any changes that may occur and potentially cause tripping hazards. Should this occur, repair and likely replacement of the concrete section may be necessary.

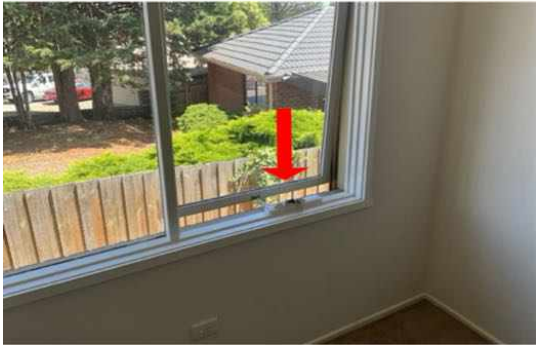
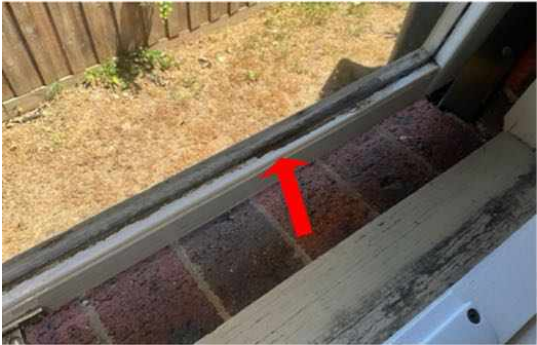
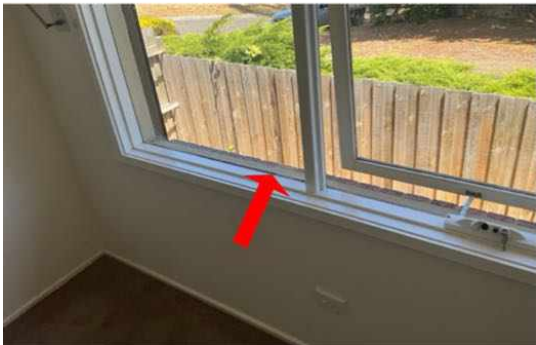
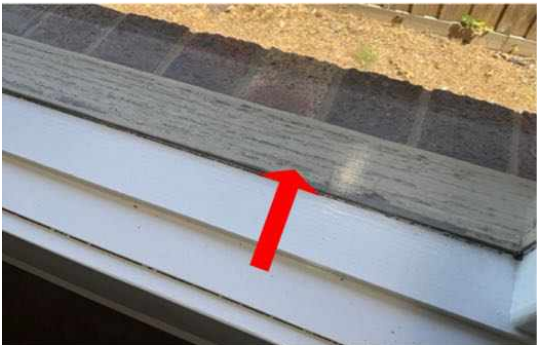
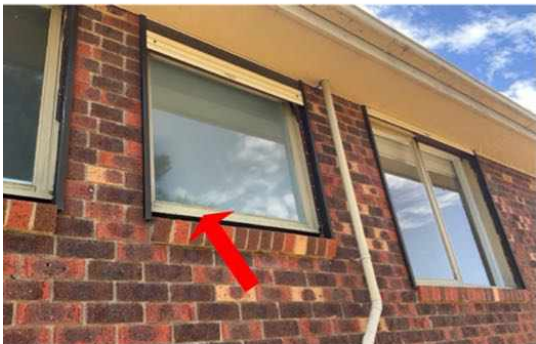
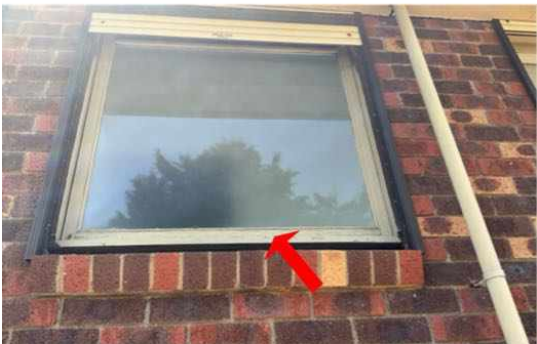
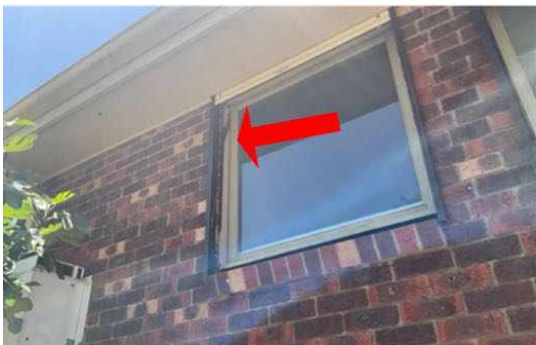
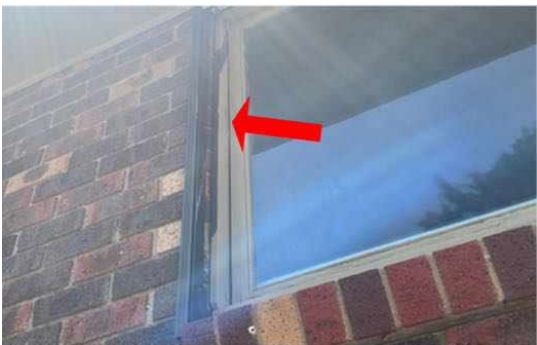
### Finding 3.19

Building:  
 Location: Exterior walls - front  
 Finding: Timber - exposed to weather  
 Information: It was noted at the time of inspection that some exterior timbers were weathered .

Timbers that are frequently exposed to harsh weather conditions require adequate protection in order to maintain their condition. Where timbers have not been painted or treated adequately, general deterioration is likely to occur at an accelerated rate.

If left unattended, replacement of these timbers is likely to be necessary in the short-term future. Adequate treatment of these timbers is required as soon as possible by a painting contractor or general handyman.

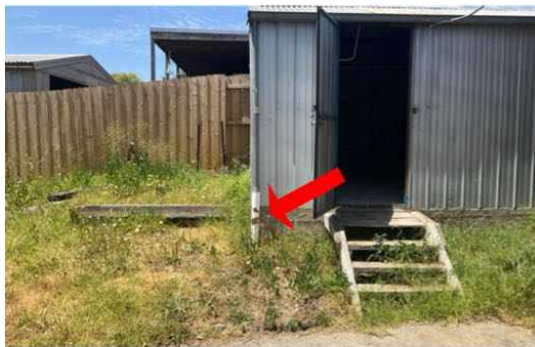
### Finding 3.20

Building: Garage  
 Location: Garage  
 Finding: Downpipe damaged at the base  
 Information: At the time of inspection, the downpipe in this area has been damaged at the base near ground level . This has the potential to allow water to escape the downpipe and pool around the edge of the house.

Pooling water can undermine the foundations of the property over time and can also create conditions conducive to timber pest activity.

It is recommended that a licensed plumber be engaged to correctly seal the downpipe to prevent any leaking.

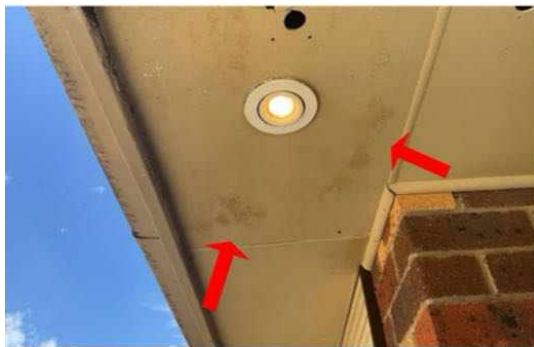
### Finding 3.21

Building: Eaves  
 Location: Eaves  
 Finding: Eave linings - Water stained  
 Information: At the time of inspection, there appeared to be some water staining to various areas of the eaves linings around the property .

Water staining indicates that surfaces have been exposed to excessive moisture over time. The minerals and other elements in the water lead to staining, which may graduate to corrosion and deterioration if left unmanaged.

While mostly an appearance defect, water staining can be indicative of more serious defects, which may be currently concealed. It is suspected that the staining in this instance may be from overflowing gutters due to being blocked with leaves and other vegetation.

Where water staining is active, a licensed plumber must be consulted to identify the cause of the staining and to provide advice on any reparation works that may be

required. Replacement of any damaged structures is advised.

Conversely, where water staining is old and inactive, affected building materials may be repaired or replaced at client discretion. All gutters should be cleared to allow for correct operation.

Please note: Eave sheeting was traditionally made of asbestos containing material (ACM) . Caution should be taken in the area. It is highly recommended that an asbestos inspection and sampling be carried out to determine the presents of any ACM. Consultation with your Jim's consultant should be carried out to seek further information.

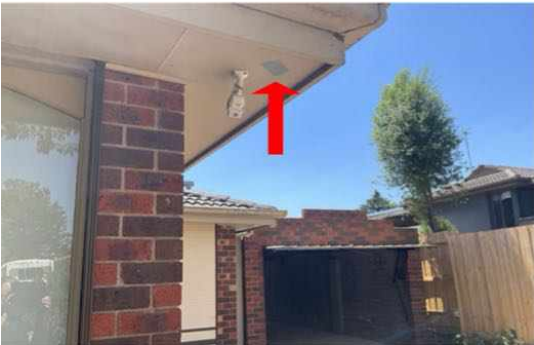
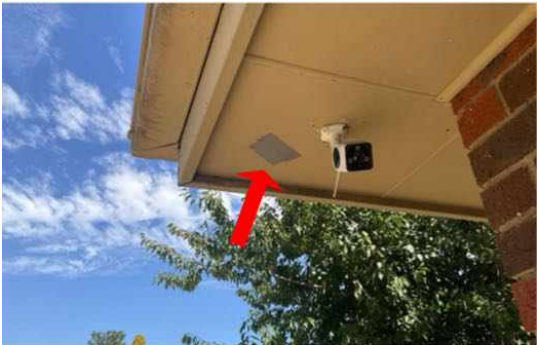
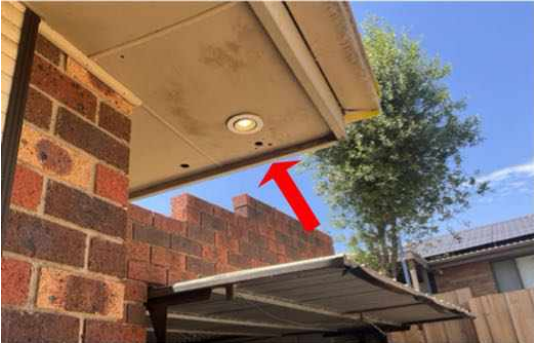
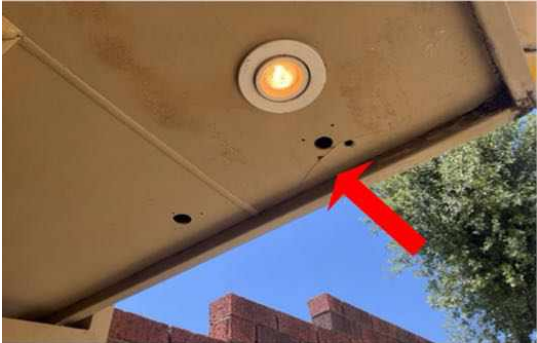
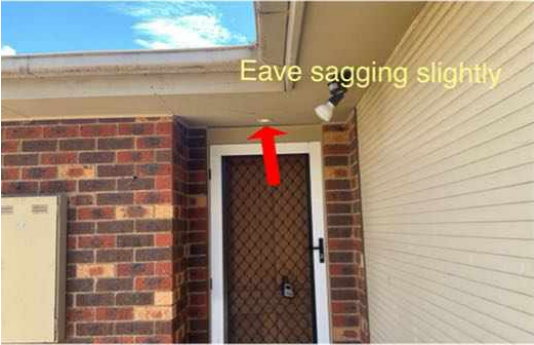
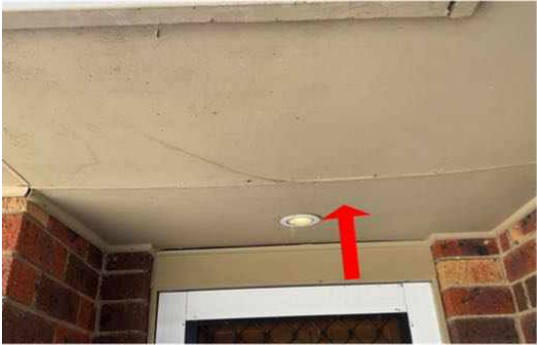
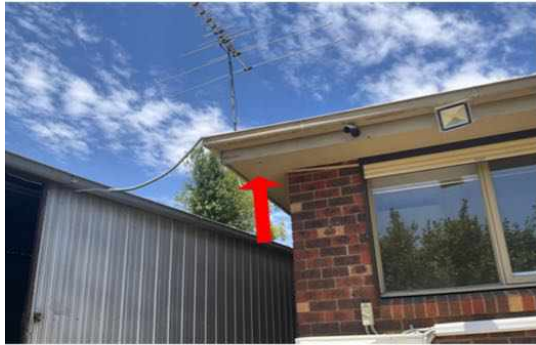
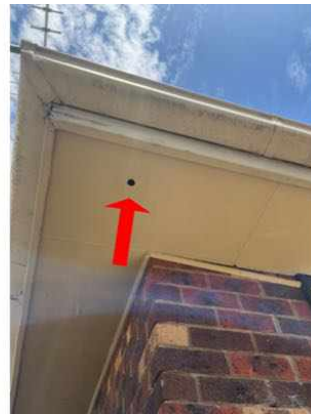
Building:	
Location:	Eaves
Finding:	Eaves - Damaged
Information:	The eaves in some areas of the property were found to be in a visibly poor condition. The damage may have been sustained as a result of a number of possible causes, including poor roof drainage, leaking roof plumbing or minor impact damage.

The damage to the eave sheeting in this area detracts from the appearance of the structure, as well as potentially compromising the structural integrity of the roofing area.

Where eaves show moderate to severe damage, remedial works may be required. Where water damage is suspected as being the underlying cause, appointment of a licensed plumber is advised as a matter of urgency to identify the source of the water leak.

Please note: Eave sheeting was traditionally made of asbestos containing material (ACM) . Caution should be taken in the area. It is highly recommended that an asbestos inspection and sampling be carried out to determine the presents of any ACM. Consultation with your Jim’s consultant should be carried out to seek further information.

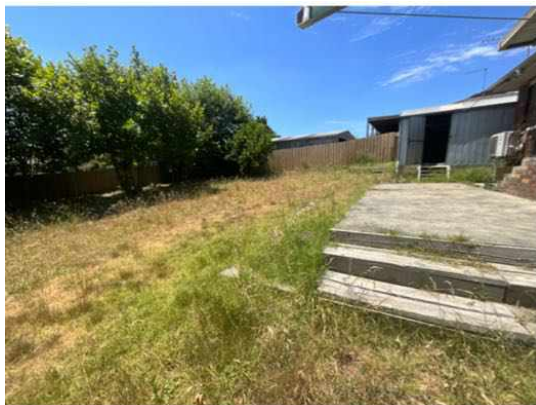
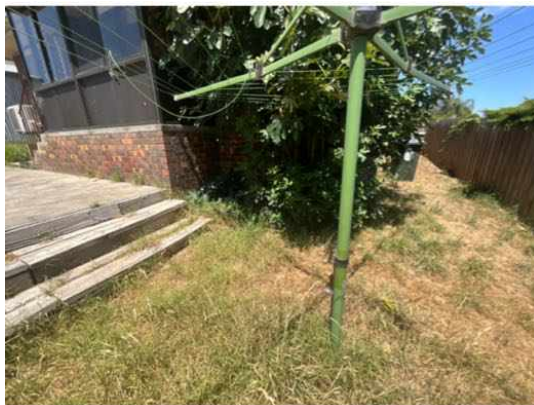
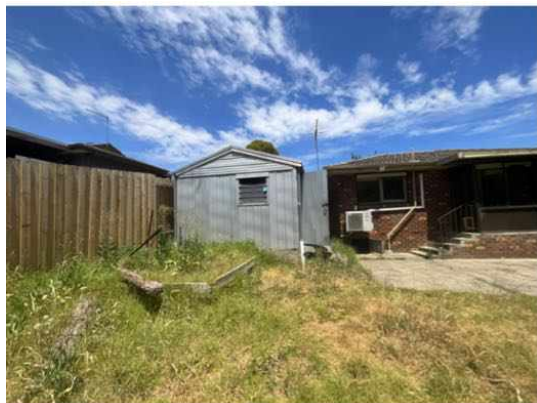
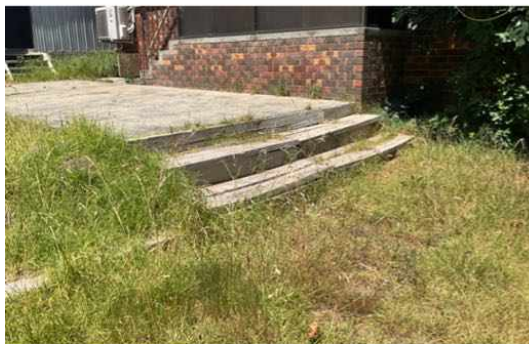
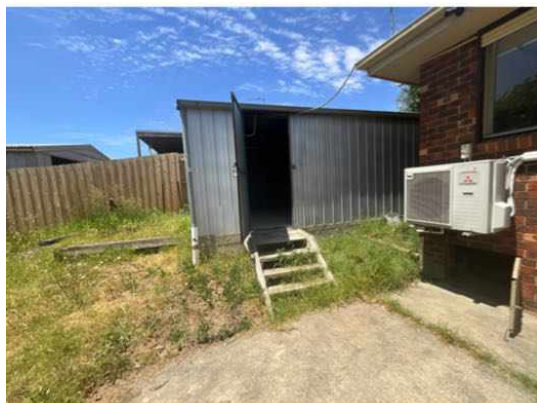
This lack of maintenance can provide opportunities for vermin to be present undetected.

The homeowner, or gardener should be engaged to perform this task prior to settlement.

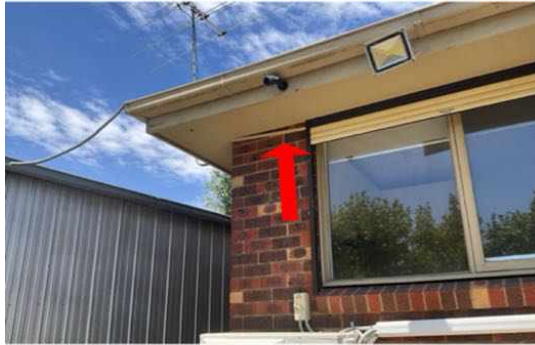
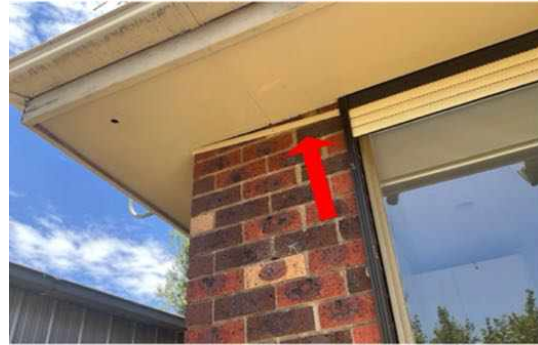
### Finding 3.24

Finding: Beads - Damaged

Information: Beading acts (like cornice or skirtings) to cover the intersection or joins of building materials. It was noted at the time of inspection that beading in this area has come loose. This deterioration is suspected to have been caused by general ageing and frequent exposure to weather, which is expected in a building of this age and condition.

Beading is important in weatherproofing the surrounding building elements and preventing termite or pest ingress. Furthermore, beading works to protect the joins of building materials, which are more susceptible to deterioration and decay.

Repair or replacement of the beading is advised to ensure the protection and longevity of any associated building elements. Such works may be performed by a general handyperson or qualified carpenter.

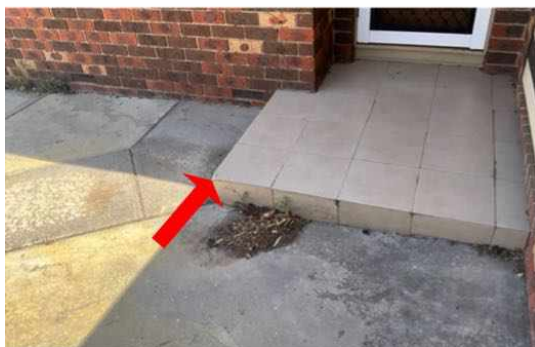
### Finding 3.25

Finding: Entry tiles - Cracked

Information: Minor Cracking in the entry tiles was evident at the time of inspection. It is suspected that this cracking may have occurred as a result of lacking a solid or suitable foundation for the tiles to be laid on. Settlement in the foundations may also have caused movement and resulted in the cracking and subsidence to tiles in this area.

Cracked tiles detract from the overall appearance of the affected areas, as well as creating potential for secondary damage to surrounding areas.

While not considered a matter of urgency, replacement of cracked tiles is advised. A tiling contractor or landscaper may be appointed to perform these works at client discretion.

Where cracks become more numerous, consultation with a registered builder specialising in foundations may be required.
