# Building and Timber Pest Inspection Report

Inspection Date: Fri, 30 Jan 2026

Property Address: 13 St James Ct, Narre Warren VIC 3805,  
Australia

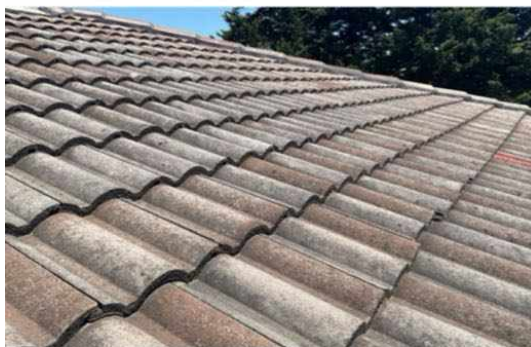
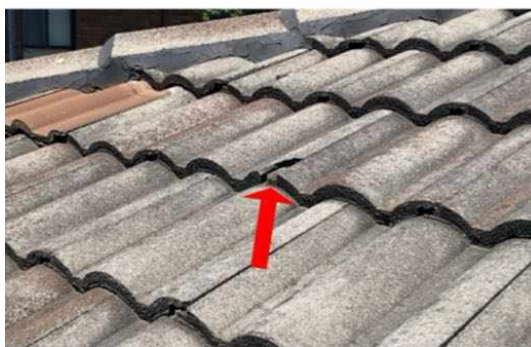
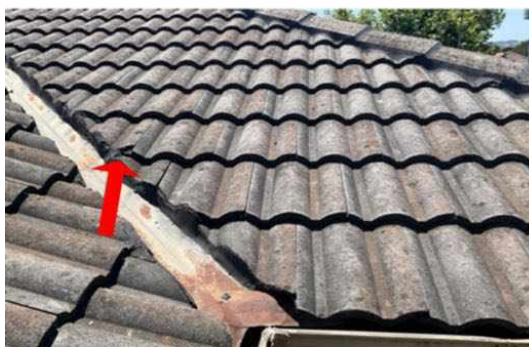
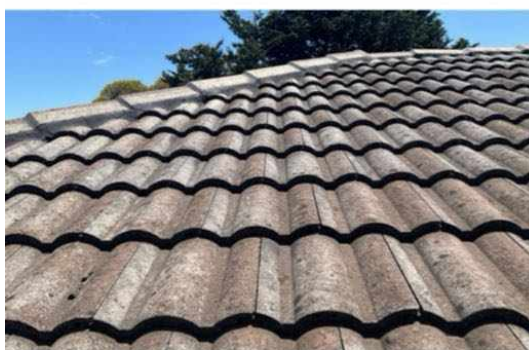
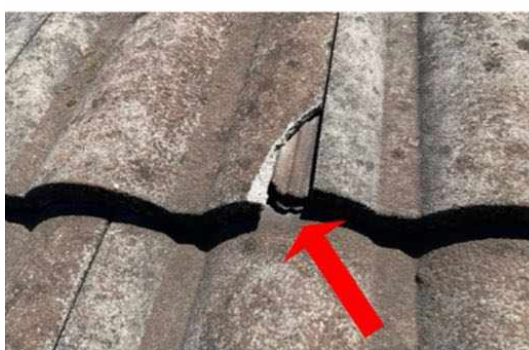
### Finding 3.26

Finding: Roof tiles - fair condition but with some maintenance required  
Information: Upon inspection of the exterior roofing, the roof tiles appeared weathered but were considered to be in a fair condition. While weathering of the tiles is consistent with the age of the property, some maintenance works are required.

Areas of minor chipping of tiles was noted. Evidence of some previous repairs were also observed. Rusting to the channels was also noted.

Repairs to chipped or cracked tiles is required.

Consultation with a roofing contractor is highly advised to gain advice on remedial works that will be required . Where left unmanaged, damage is likely to lead to a number of secondary defects, including potential water leaks and moisture exposure to internal roofing structures.

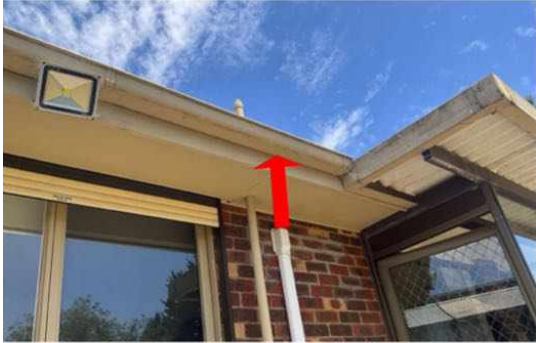
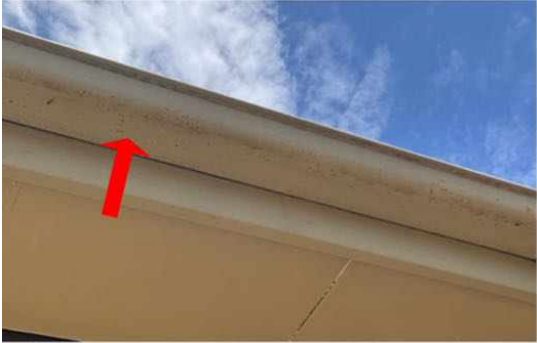
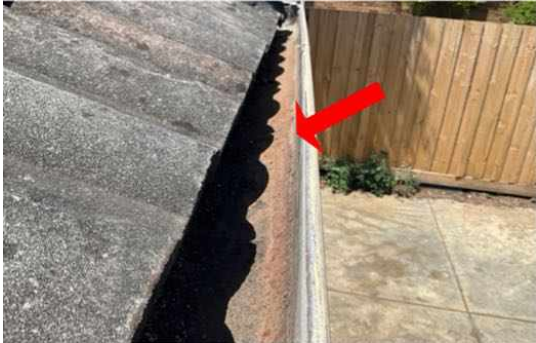
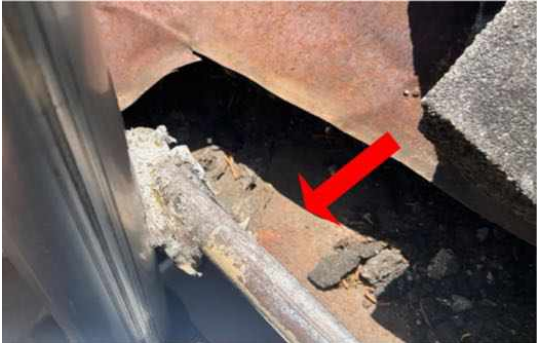
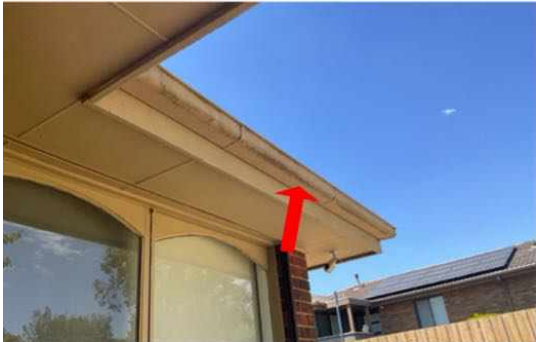
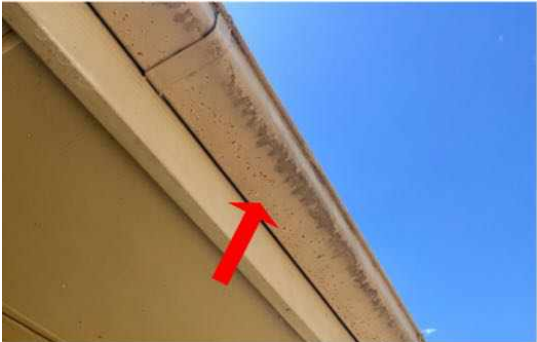
### Finding 3.27

Finding: Roof plumbing - slight rusting or corrosion

Information: The guttering in this area has evidence of slight rusting and corrosion. It is suspected that this has been caused by blockages, resulting in pooling or standing water, that have prematurely rusted elements of the roof plumbing.

Rusted roof plumbing will generally develop holes and leaks that can affect other building elements with poor drainage of storm water. Poorly drained roof areas will also lead to damp conditions surrounding the base perimeter of the building which, if left unmanaged, can lead to a range of secondary building defects.

Where rusting has caused leaking, repair and/or replacement of rusted roof plumbing is highly required in order to reinstate the roof drainage system to a fully operational level. To further maintain these areas, gutters should be cleaned frequently, allowing the avoidance of any partial blockages.

A licensed plumber or specialist roof restoration company should be appointed to undertake these works. It is advised that such works be completed where relevant to prevent any further damage and deterioration.

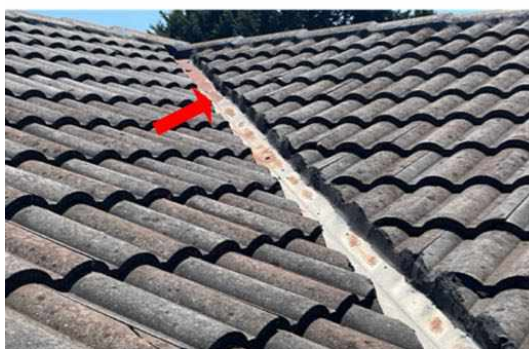
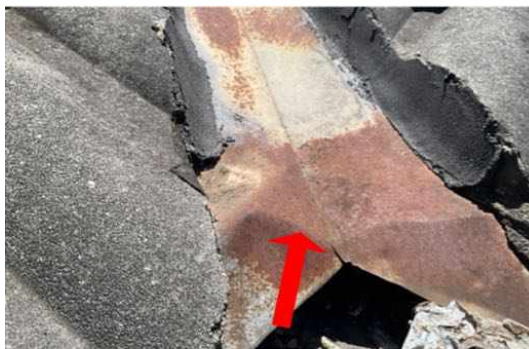
Finding 3.28

Building:  
 Location: Roof Exterior  
 Finding: Roof valley - Rusted  
 Information: At the time of inspection it was noted that the valleys between the tiled roof structures have a coverage of surface rust.

If left unmanaged, this can lead to holes developing and potential water ingress to the internal roofing structures - leading to secondary damage of building elements. Accelerated deterioration of the valley channels and any associated building elements is also likely to occur.

A roofing contractor should be appointed to assess the damage and to perform remedial works as necessary. Works may include replacement of severely affected areas or minor works such as the application of rust-retardant surface protectors.

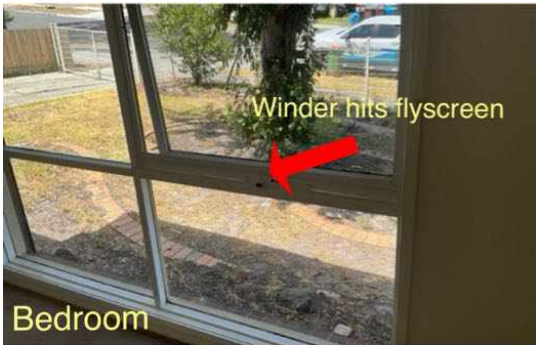
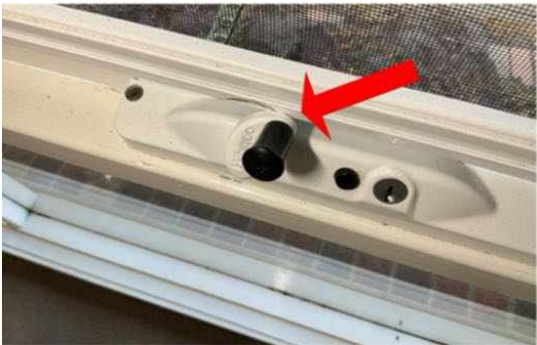
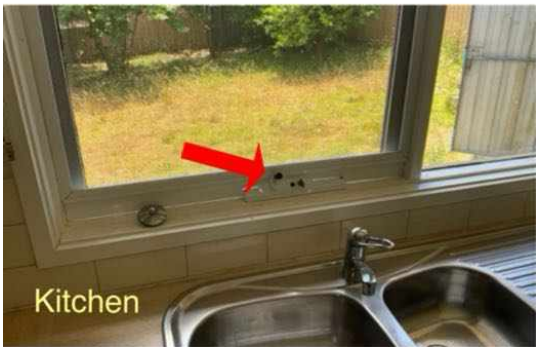
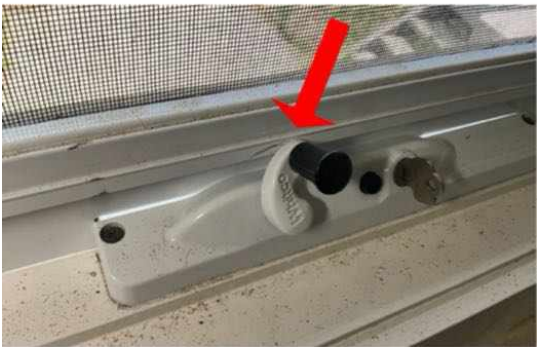
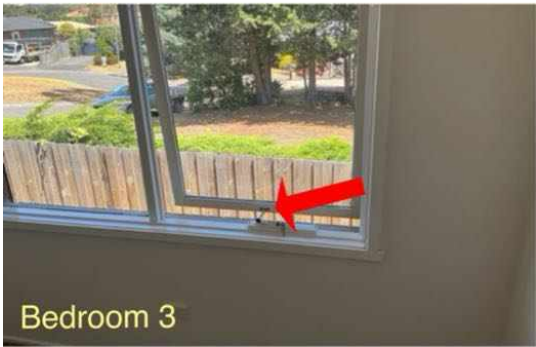
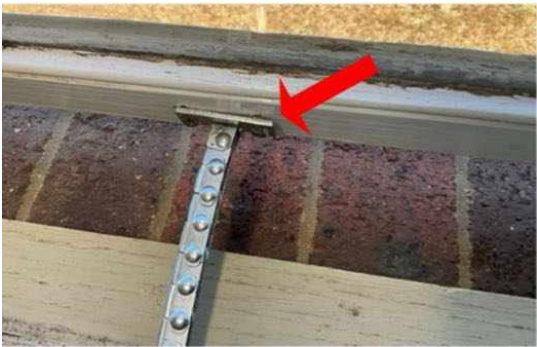
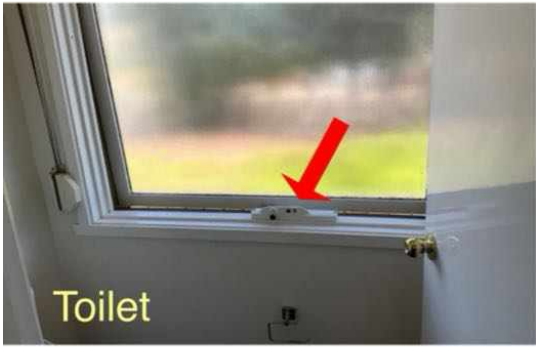
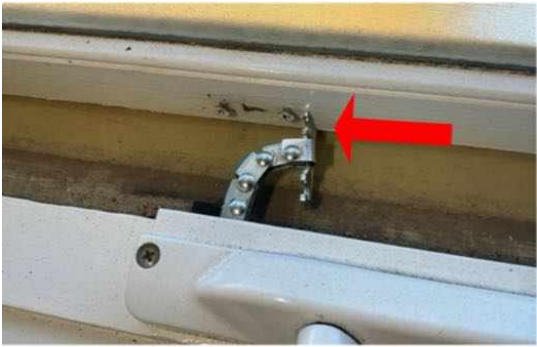
### Finding 3.29

Building:  
 Location: All Areas  
 Finding: Additional Photos - minor defects  
 Information: Additional photos are provided for your general reference. Arrows have been included where necessary to highlight areas of importance.

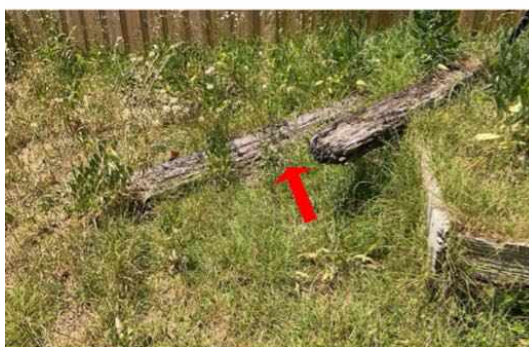
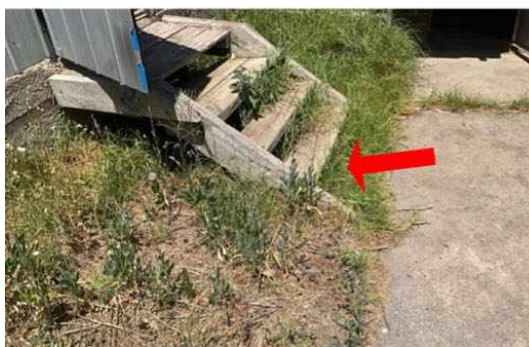
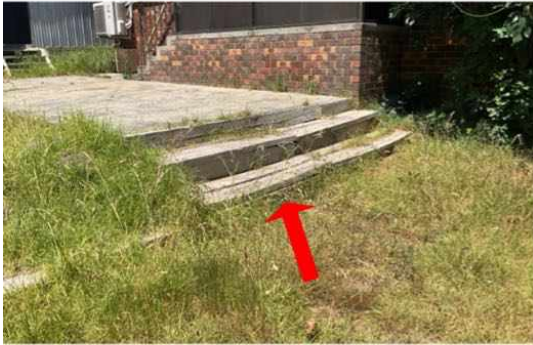
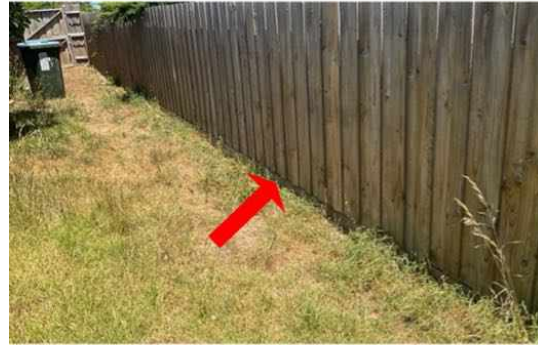
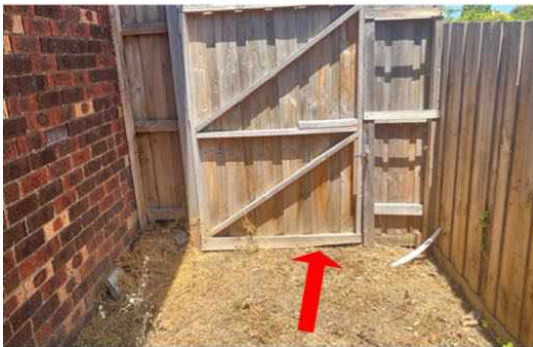
Building:	
Location:	All External Areas
Finding:	Building materials in direct ground contact - conducive to termites
Information:	Where timber elements are in direct contact with the ground and consequently moisture or dampness, they become conducive to termite activity. Whether timber is used as a building element, part of a fencing structure or stored as an unused item, they can provide an environment that is attractive to termite infestation.

When met with excessive moisture, timber begins to decay and develop wood rot. Any timbers that are in direct contact with external grounds especially if left untreated or non-durable also provide ingress for subterranean termites into that particular element.

Where possible, the removal of any such materials that may be conducive to termite activity should be carried out as soon as possible to minimise the risk of termite attack. Where not possible or practical, regular monitoring of timber elements is recommended. Replacement of any damaged materials should be carried out where necessary.

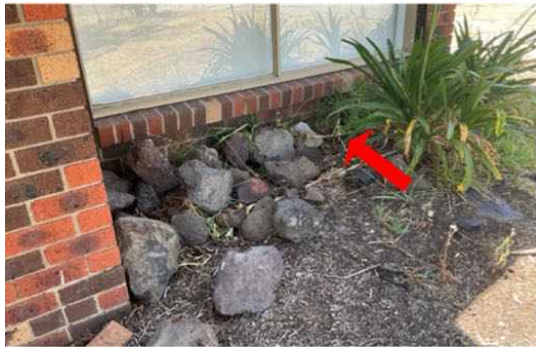
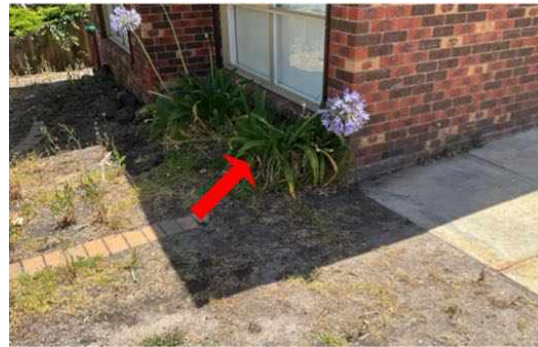
## Finding 6.02

Finding: Garden Beds - Conditions Conducive to Termites

Information: Garden beds were found to be evident around and against the property. These garden beds can make conditions conducive to termite activity and termite ingress.

The removal and replanting of species that do not provide "cover" or cutting back of existing vegetation will assist greatly in preventing this from occurring.

The removal of any such materials that may be conducive to termite activity should be carried out as soon as possible to minimize the risk of potential termite attack.

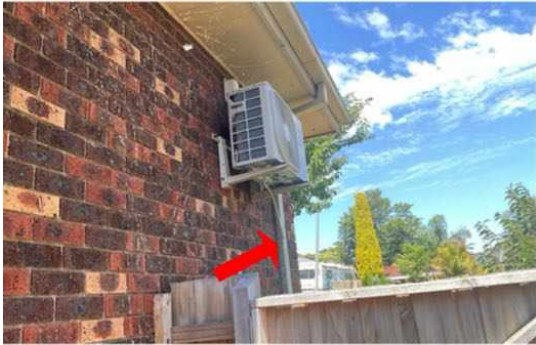
### Finding 6.03

Finding: Hot Water System and Air Conditioning Overflow - Not plumbed for drainage

These damp conditions can lead to secondary defects such as rot, rust or corrosion of associated building elements or the formation of fungal decay. When coupled with poor site drainage, pooling of water may also attract termite activity to this area.

It is recommended that a qualified plumber be appointed to install adequate drainage to the overflows or that they be diverted away from the edge of the building. These works will ensure that the area remains dry and free of any secondary defects.

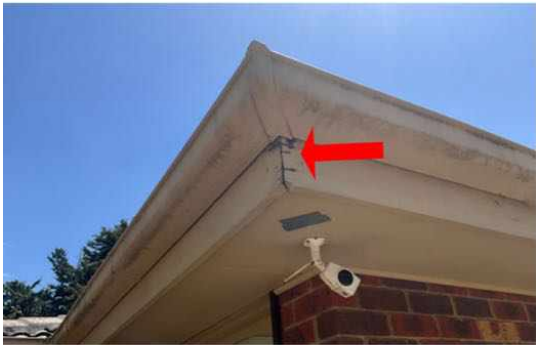
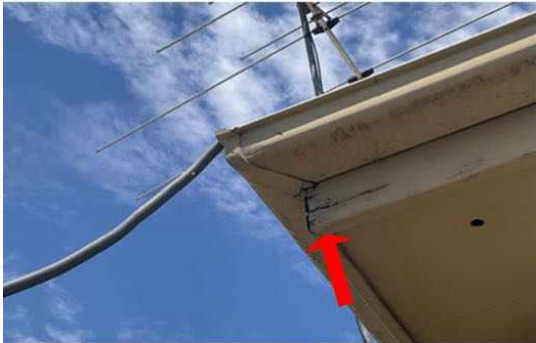
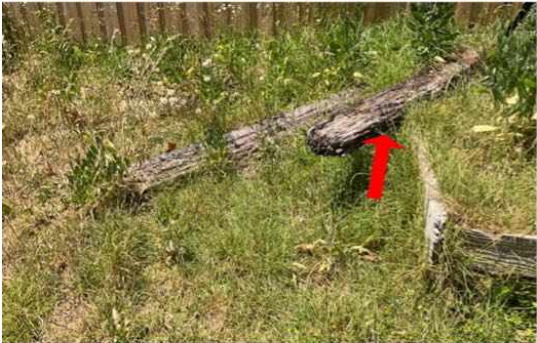
**Finding 7.01**

Building:  
Location: All External Areas  
Finding: Fungal decay - conditions conducive to timber pest attack  
Information: Fungal decay also known as wood decay or wood rot generally refers to the deterioration of timber elements when in contact with excessive levels of moisture for a prolonged period of time.

Generally fungal decay develops on timber elements that are in use in an external environment which are exposed to rain penetration.

Decaying timbers can create an environment conducive to timber pest attack. It is recommended that the decaying timbers be repaired / replaced to lessen the risk of timber pests.

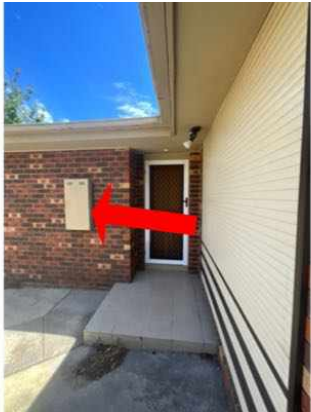
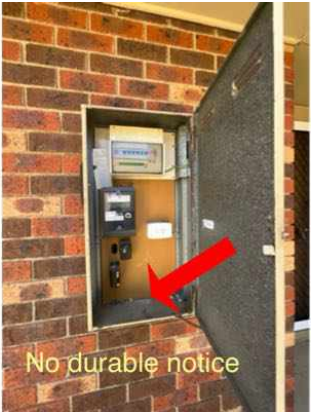
Building:  
 Location: Meter Box  
 Finding: Termite Management System - no evidence of a chemical installation  
 Information: The application of a post-construction chemical termite barrier is highly recommended for all properties, particularly if live termite activity has been found on the site previously. Such barriers are highly effective in preventing termite attack on any timber building elements throughout the property.

A durable notice should be placed in the switchboard unit to indicate current termite barriers. At the time of inspection, it appeared as though no termite management system has been installed, with no evidence to suggest preventative works taking place.

The client may consider gaining further advice from a pest controller as to the costs and procedures involved with this application. It is recommended that obtaining such advice be a short-term priority.

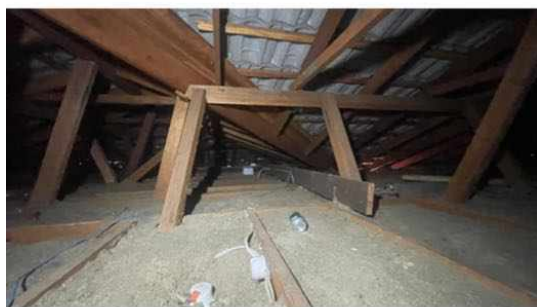
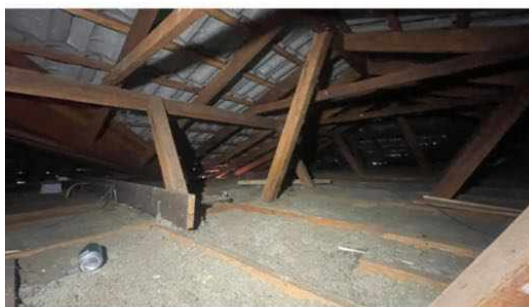
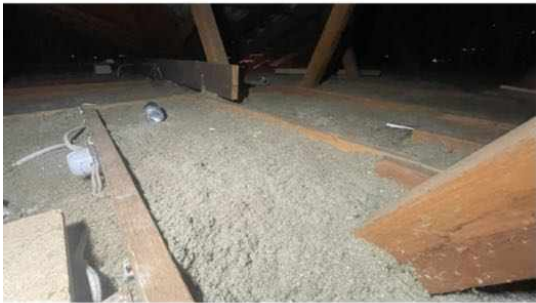
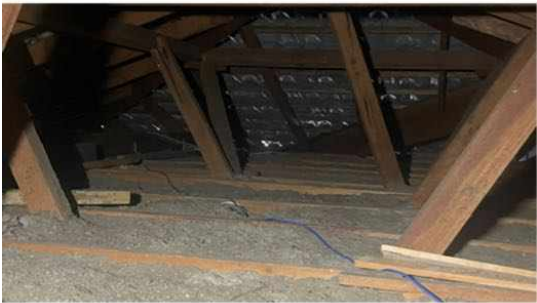
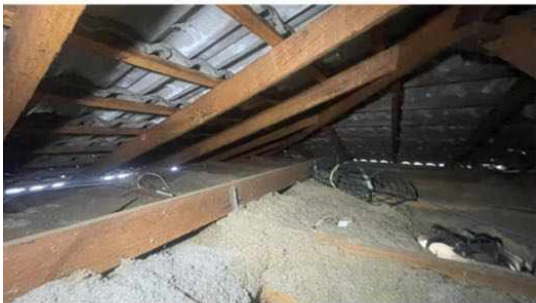
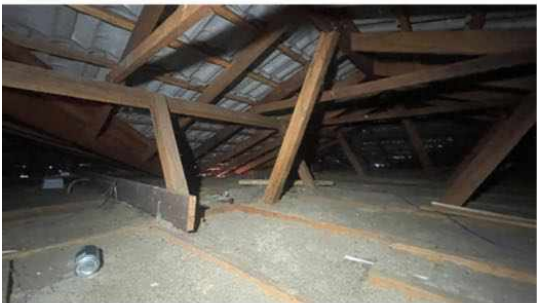
Information: At the time of inspection, it was noted that the insulation within the roof void was the older "blow in " style insulation. Whilst there appeared to be a decent coverage, this insulation has a tendency to settle and reduce in volume over time. This settling can reduce the effectiveness of the insulation.

Should the insulation settle too much and become less effective, it is recommended that new insulation be installed to improve the thermal efficiency.

An insulation contractor should be engaged to perform this task where necessary at the discretion of the homeowner.

Please note: insulation should always be kept away from above any downlight, as depending on the type of downlight, they can generate heat. Where the insulation is covering any downlights, it is recommended to move this away .

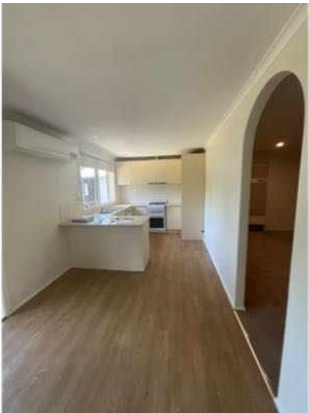
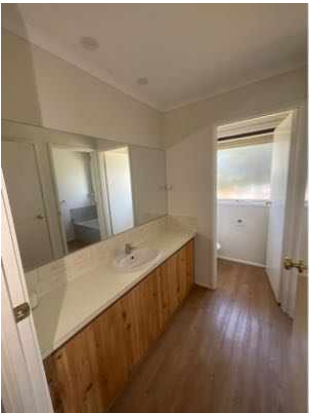
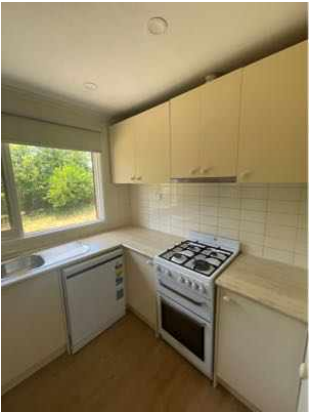
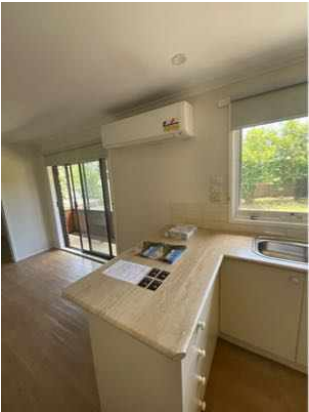
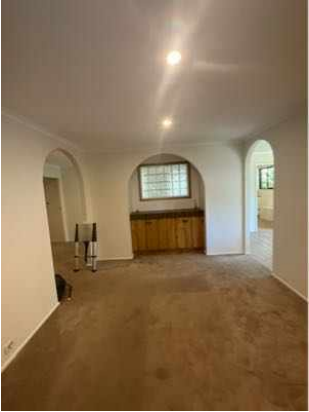
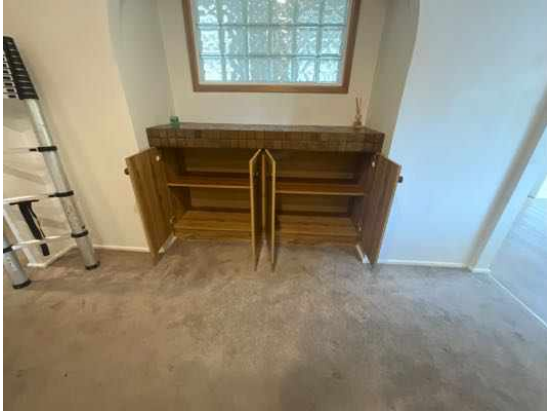
Building:  
Location: All Areas  
Finding: Additional Photos - Obstructions and Limitations

These photographs are an indication of the obstructions and limitations which impeded full inspection of the property at the time of inspection. These obstructions can hide an array of defects and should be removed to allow full inspection to be carried out. A re-inspection is recommended once the areas are made accessible.
