## Building Inspection Report

Inspection Date: Wed, 18 Mar 2026

Property Address: 26 Exhibition Dr, Modbury North SA 5092,  
Australia

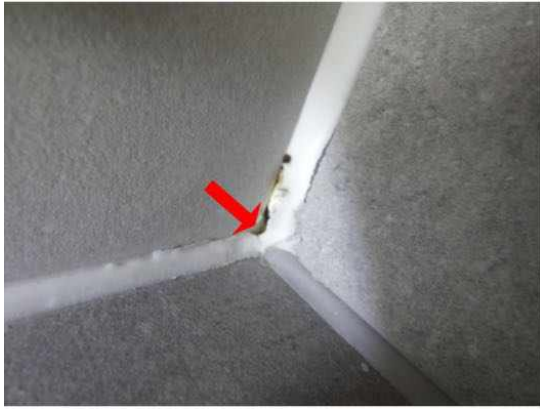
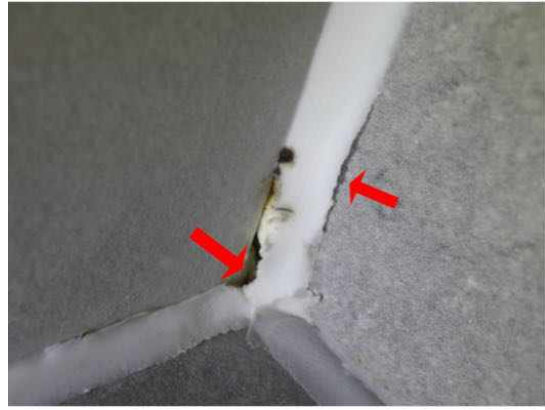
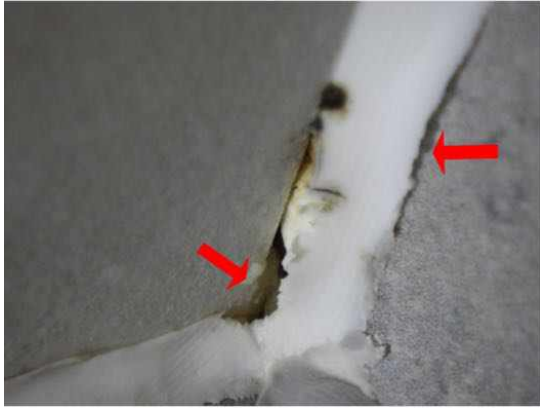
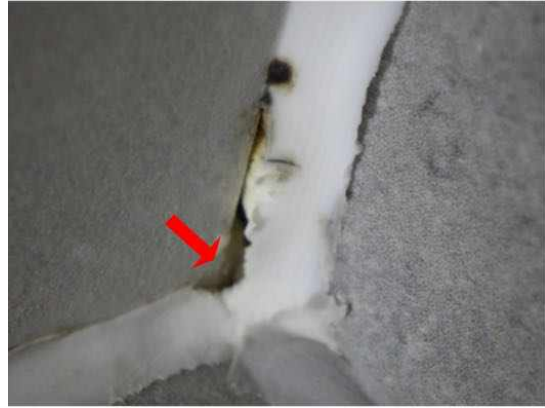
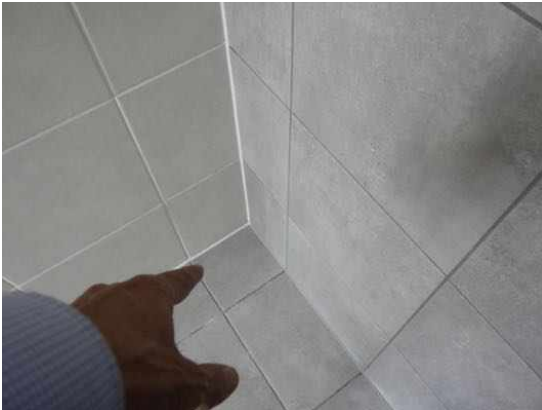
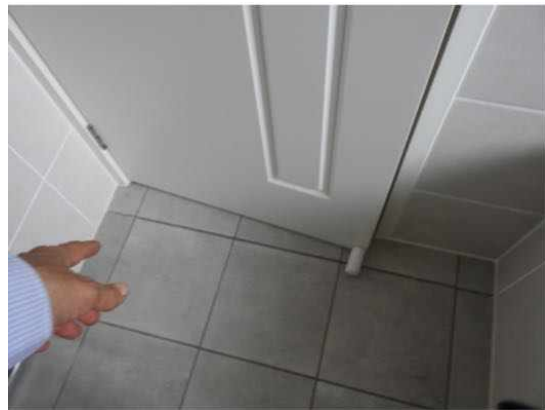
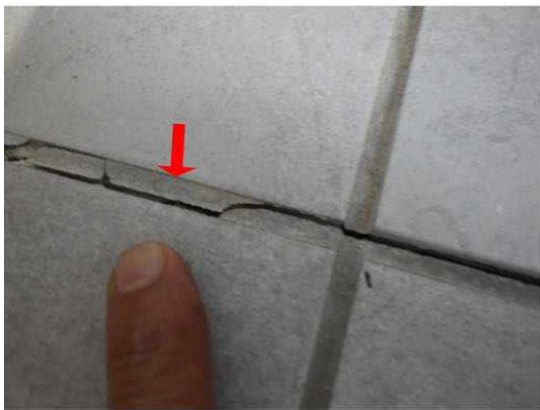
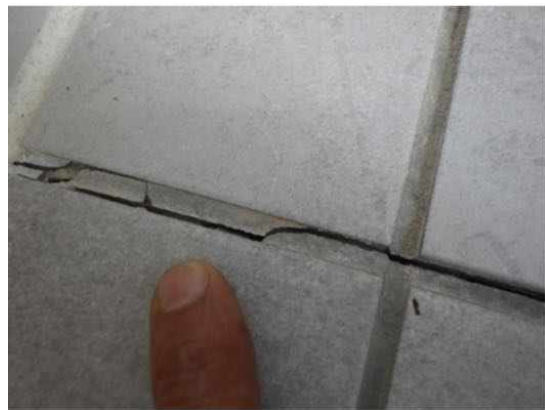
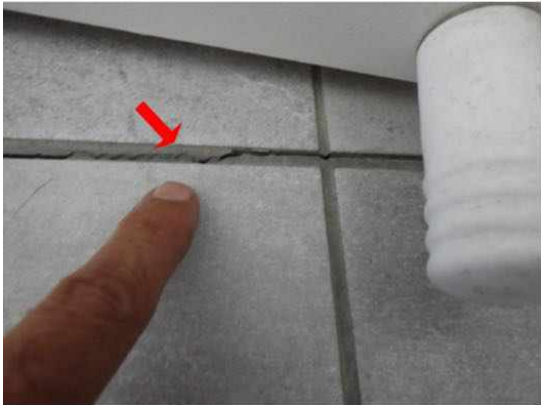
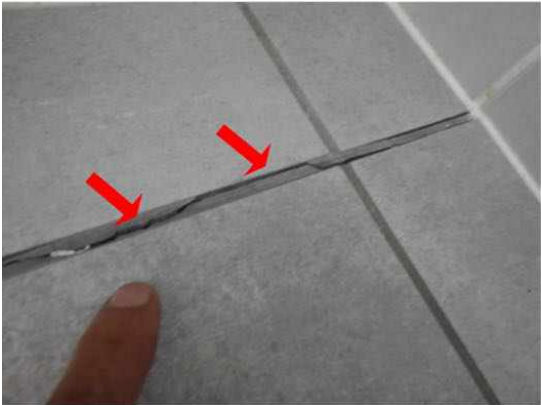
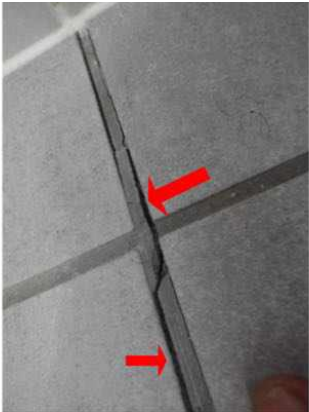
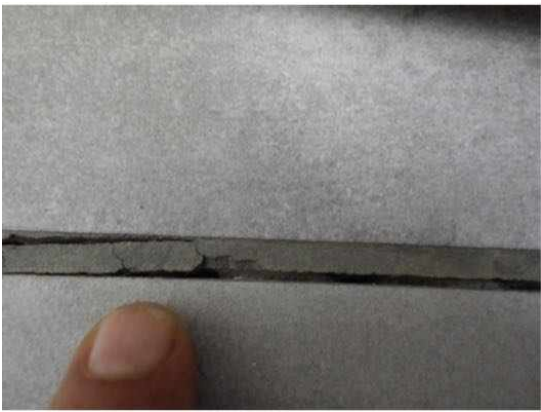
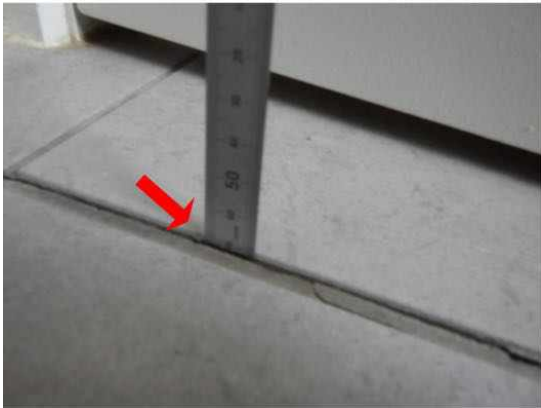
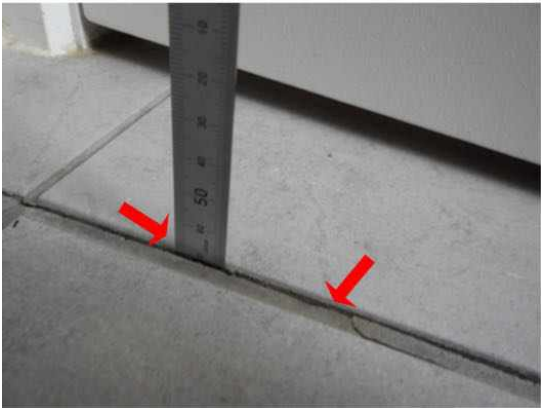
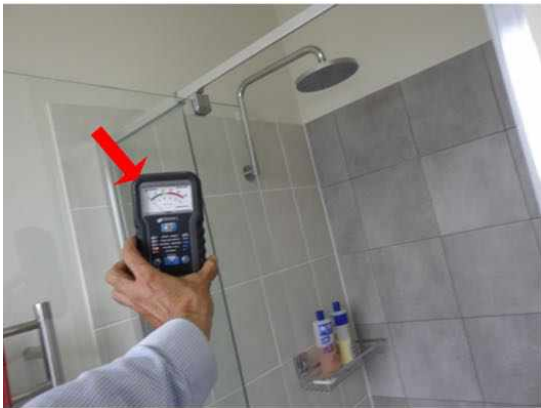
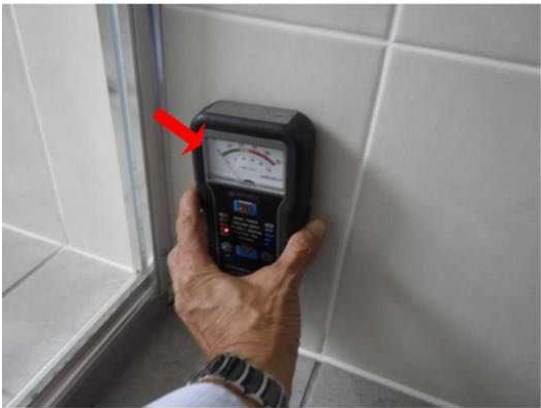
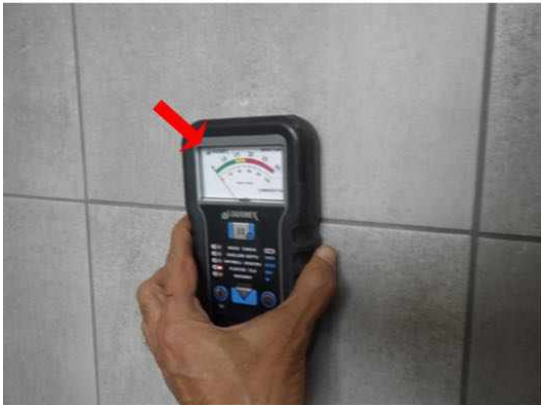
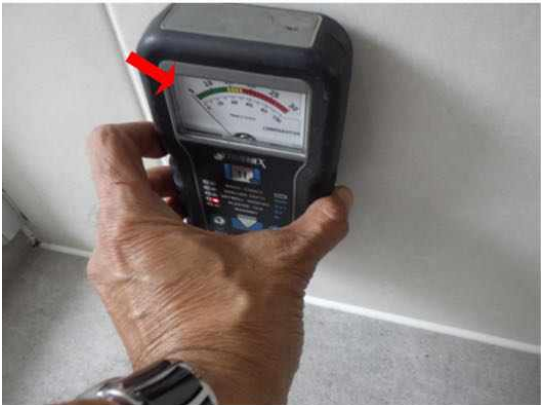
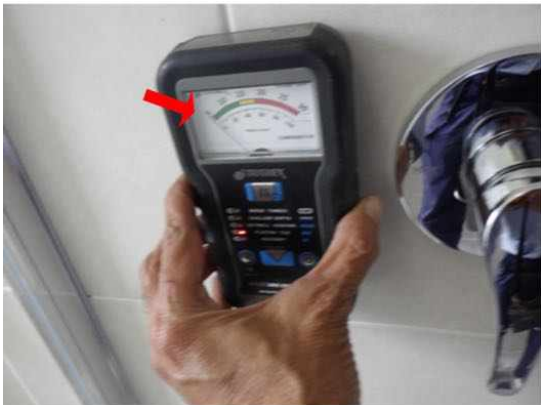
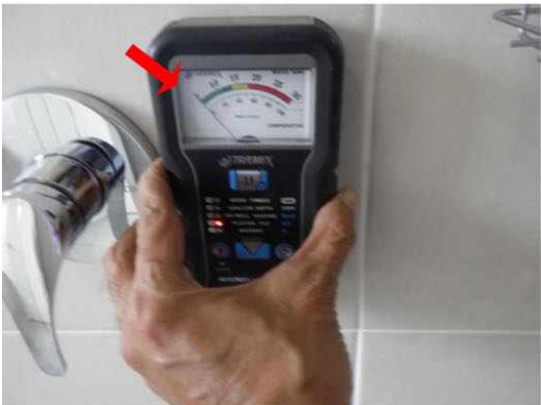
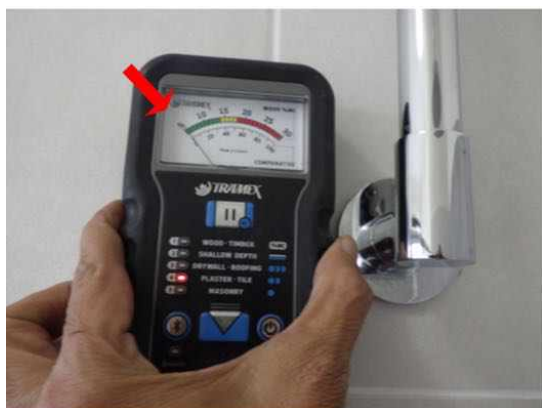
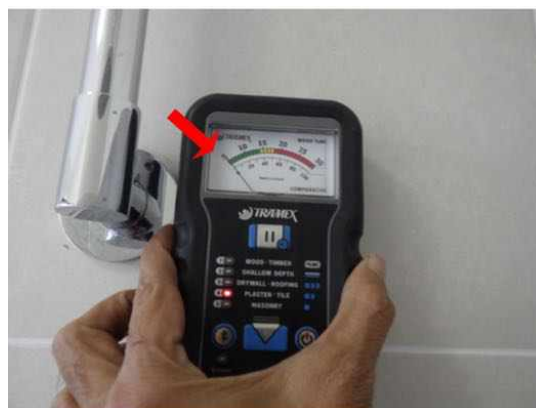
#### Defects 2.01

Building: Building 1  
Location: Bathroom 2  
Finding: Sealant and grouting - Missing or damaged  
Information: It was noted on inspection that sealant or grout is degraded to the tiled shower alcove and or other areas of the bathroom- ensuite.

Apart from that at the time of inspection no high moisture readings were noted in this shower alcove area.

Different materials and floor areas move at different rates, generally causing cracking to grout or sealant at this point. A flexible sealant is required to allow for expected expansion and contraction, while keeping the joint water tight and protective of all associated building materials.

Flexible and mould resistant materials should be applied to affected areas to prevent any subsequent water damage that is likely to occur. Regular maintenance and replacement of damage or missing or damaged sealant and grout is highly recommended to the wet areas, as this is a regular wear and tear defect. Sealant and grouting in areas that come into regular contact with water should be maintained for the long term care of your property.

A sealant specialist or tiling contractor should be appointed to complete these works as soon as possible

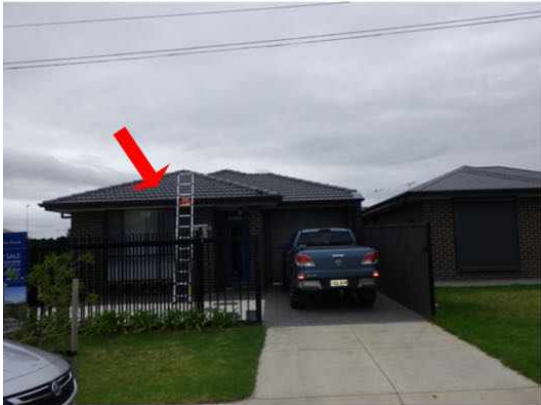
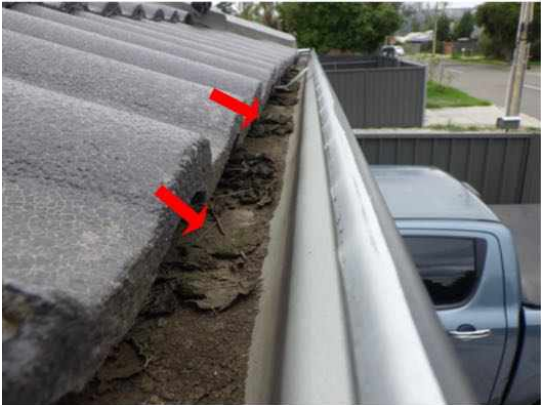
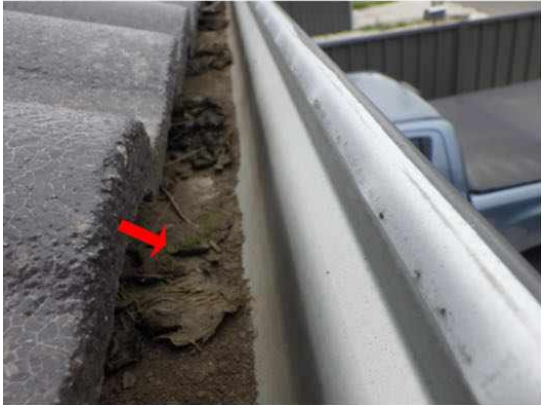
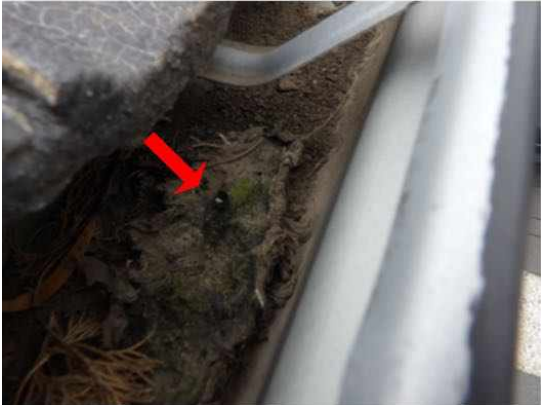
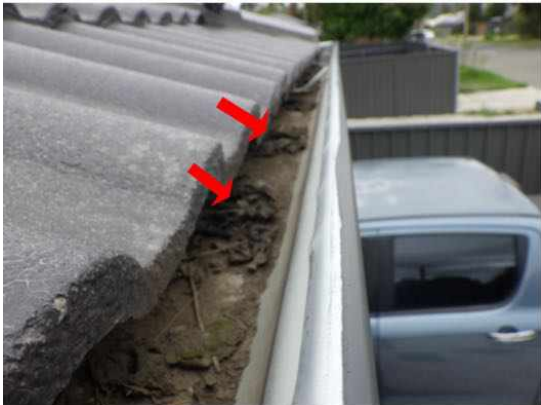
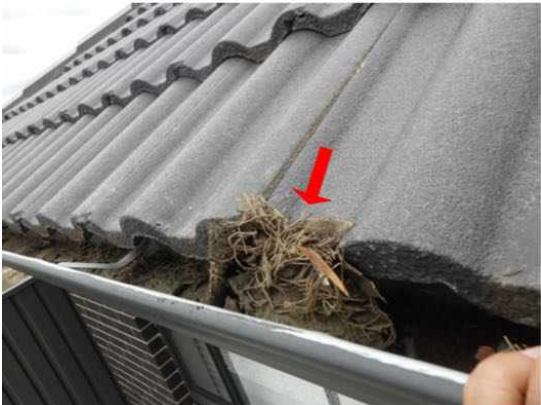
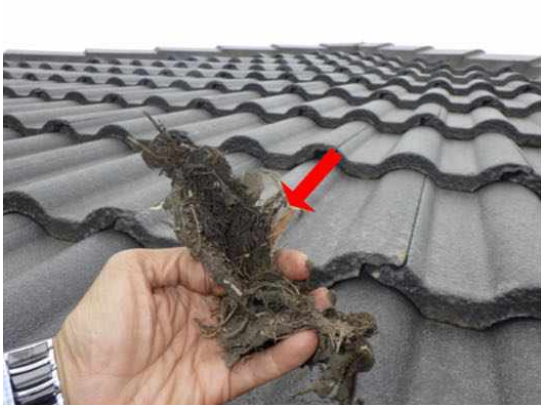
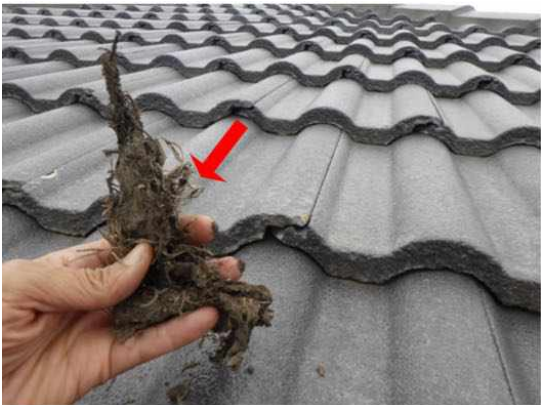
### Defects 3.01

Blocked gutters are likely to lead to high levels of moisture in the affected areas. Such moisture will not only cause rust and decay of the associated building materials, but can also provide conditions that are conducive to termite and timber pest activity. Blockages in gutters should therefore be removed immediately to ensure dry conditions are maintained.

Consult a Licensed Plumber for further specific advice on remedial works that may be required. In the interim, it is highly advised that blocked gutters be removed by the homeowner or a general handyperson as a matter of urgency.

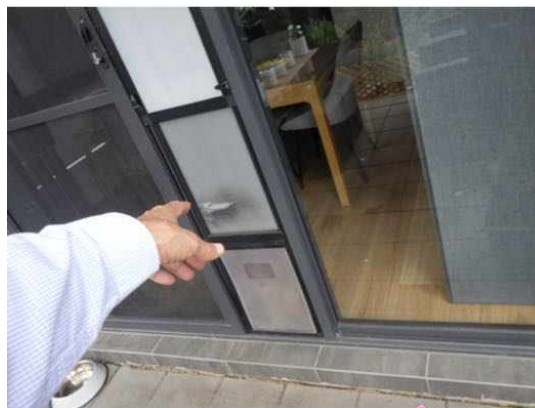
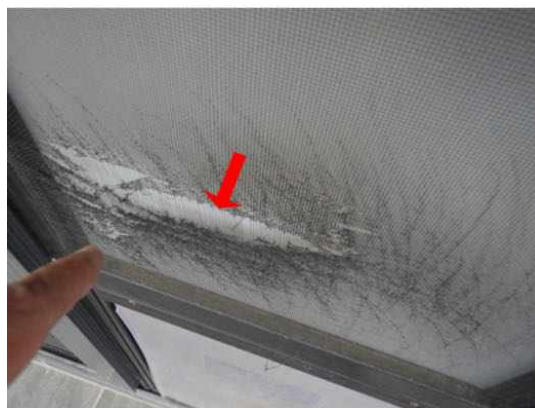
Defects 3.02

Building: Building 1  
 Location: All External Areas >  
 Finding: Building element - Damaged/ Loose from its original fixing  
 Information: At the time of inspection it was noticed that few sections of building elements were damaged / loose from its original fixing around the property - eg- External wall front - Timber member loose from its original fixing , rear brick - chipped & Sliding door frame assembly - flyseen damaged.

Breakage occurs generally when the building materials have either aged and decayed, or as a result of damage (accidental or deliberate).

Repair and/or replacement of broken elements is advised to ensure that additional secondary defects do not arise as a consequence. Such works are necessary, as all building elements play a key role in the operation and function of the overall structure and its performance.

A relevant tradesperson should be appointed to repair or replace the affected building element prior to any subsequent damage being caused.

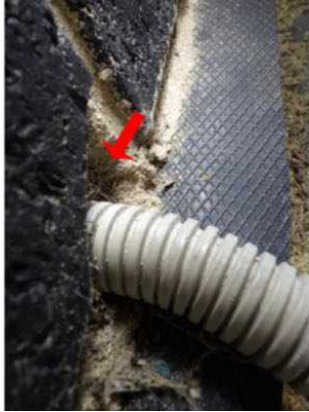
### Defects 3.03

Building:	Building 1
Location:	All External Areas
Finding:	External walls - Holes
Information:	Significant holes were identified around pipe penetrations in this wall section. It is suspected that the installation of this pipework was completed to a substandard level of workmanship or is incomplete.

Gaps and holes around pipework makes the area susceptible to insect and vermin ingress, as well as allowing water penetration to the cavity wall. As such, associated building elements are likely to deteriorate at an accelerated rate, and major implications are expected if holes around the pipework are left unmanaged.

All excessive holes, gaps or cracks should be adequately filled by a suitable sealant or trimmings as soon as possible to prevent any further damage. Such works may be conducted by a general handyperson or licensed plumber.

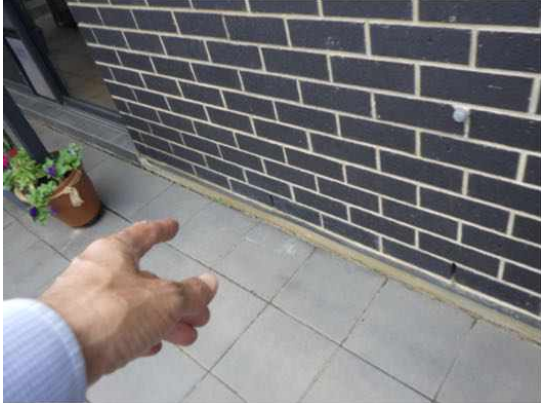
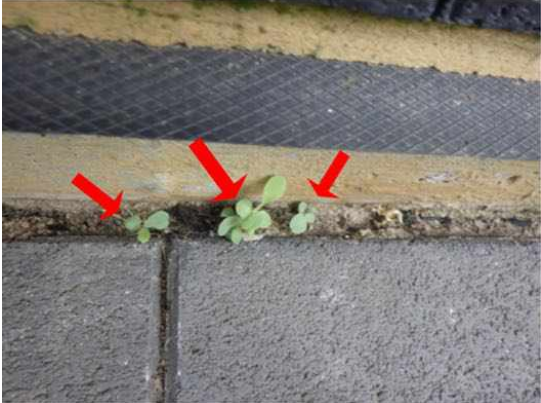
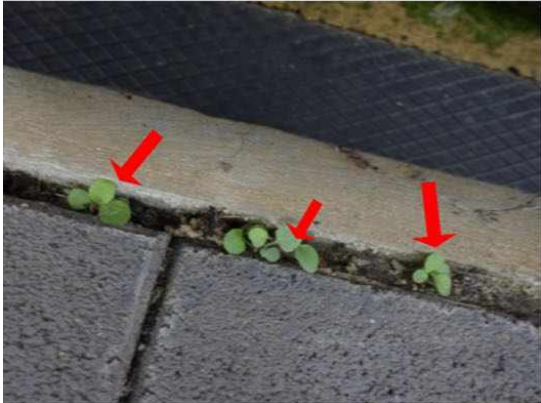
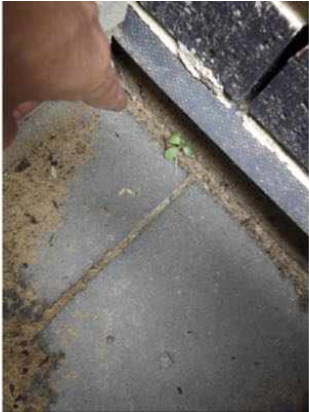
### Defects 3.04

Building:	Building 1
Location:	All External Areas
Finding:	Bridging - Vegetation
Information:	Where vegetation obstructs inspection of building elements, also known as bridging as it provides a bridging point for the access of termites, full inspection can not be achieved. Consequently moisture or dampness may be present and the areas becomes conducive to termite activity. Plants against or very close to buildings provide cover, shade and can provide an environment that is attractive to termite infestation.

The removal of any such materials that may be conducive to termite activity should be carried out as soon as possible and arrange re inspection to minimize the risk of termite attack.

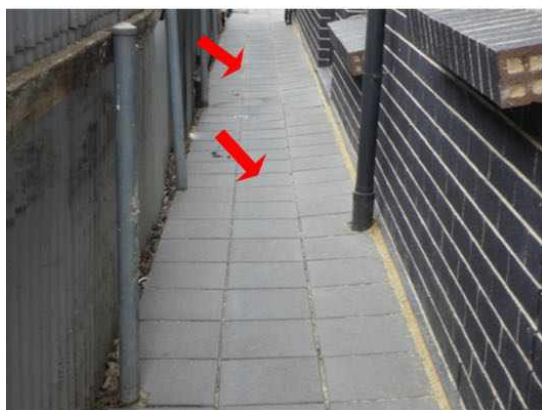
**Defects 3.05**

Building:	Building 1
Location:	All External Areas
Finding:	Paving - Uneven
Information:	Sections of the external paved area are uneven, creating a potential trip hazard. It

appears as though the area has been subject to rough installation, or that paving sections have lifted due to movements in the foundation of the property.

Where paving creates a trip hazard, personal injury may ensue if due caution is not taken by all persons within this area.

Re-paving of the area is required as soon as possible to remedy this situation. Further consultation with a specialist concreter is advised.

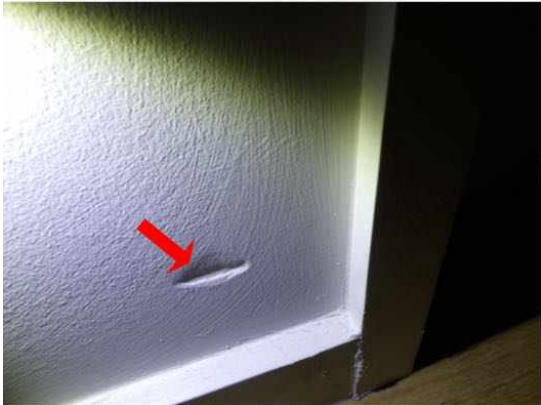
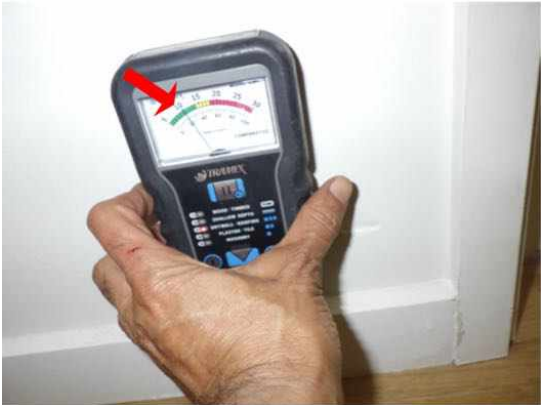
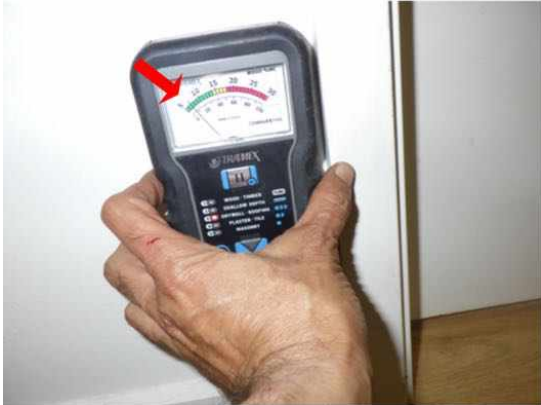
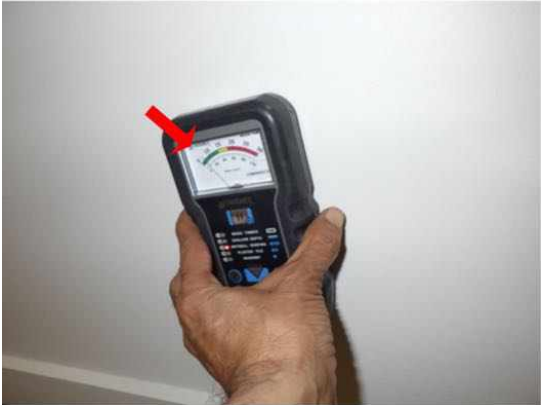
### Defects 3.07

Scuffed surfaces, while detracting from the overall appearance of the affected building element, do not indicate any operational or structural damage. This degree of surface damage is consistent with general wear and tear and minor impact damage, normally accumulated over a number of years.

Marked surfaces may be left as is at the discretion of the client; no repairs or replacement are necessarily required, as this is an appearance defect. However, the client may wish to seek quotations for the cost to refurbish or replace the identified building element.

A general handyman or plasterer may be appointed to rectify marked surfaces if considered necessary by the client.

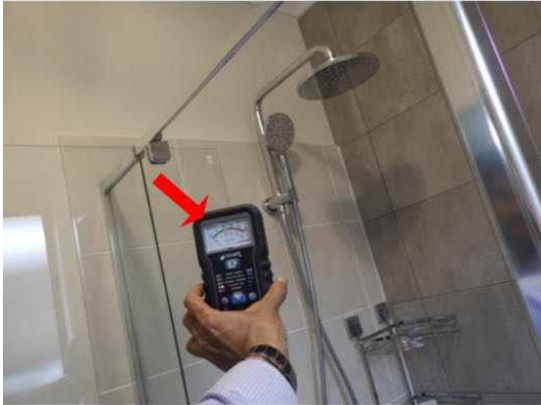
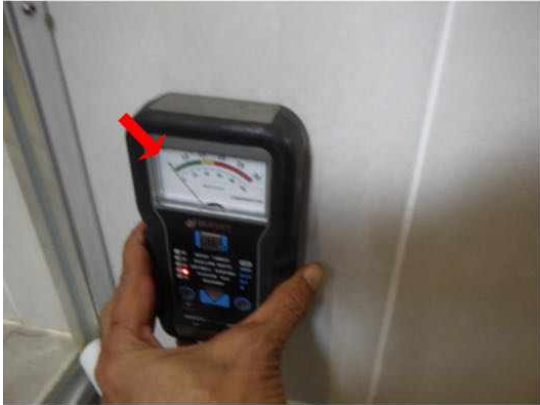
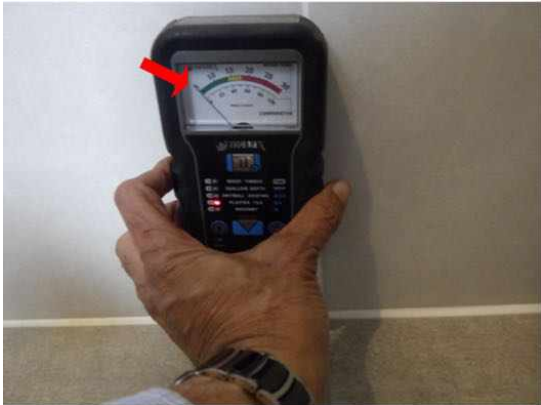
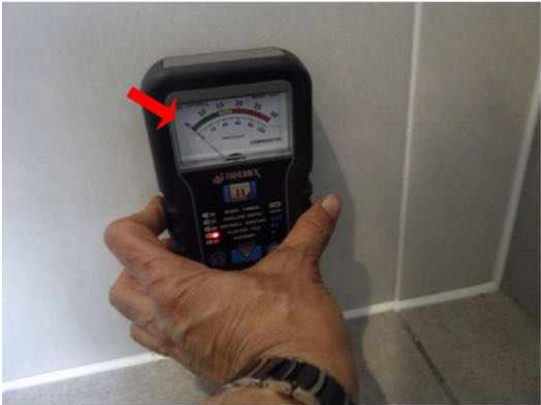
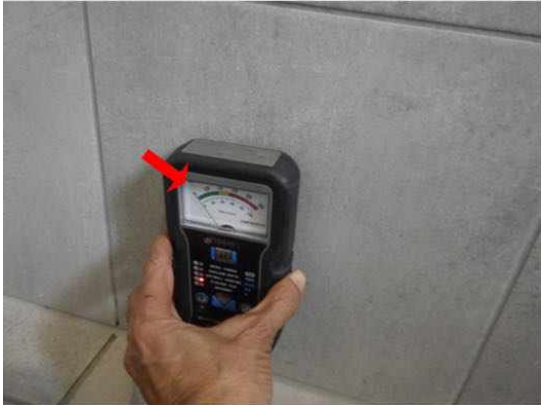
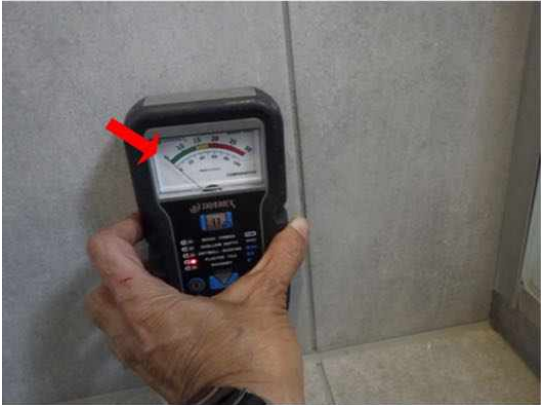
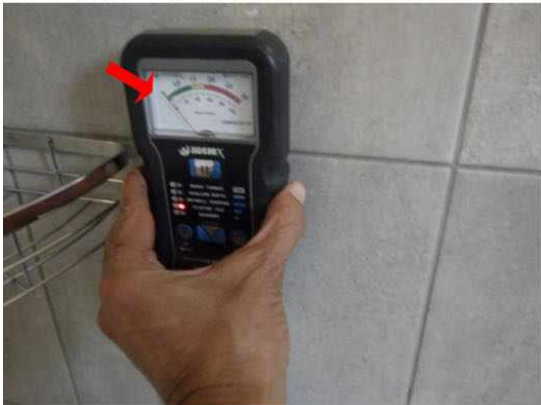
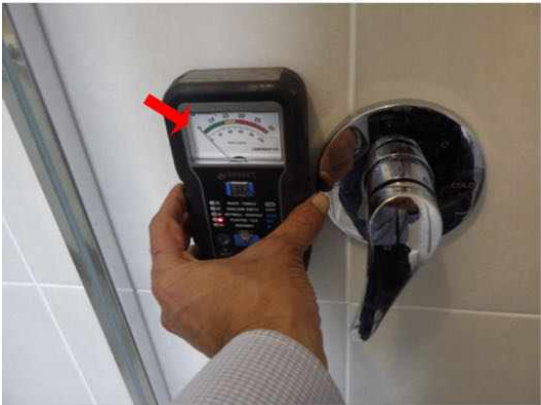
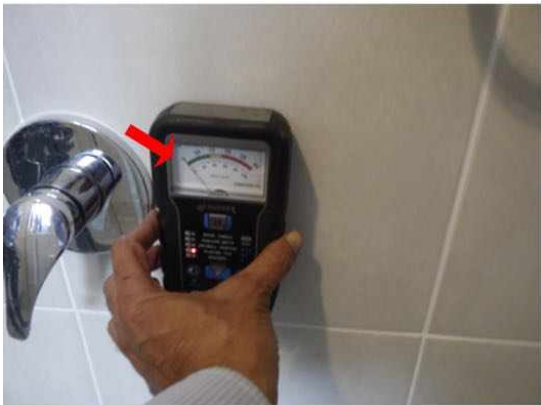
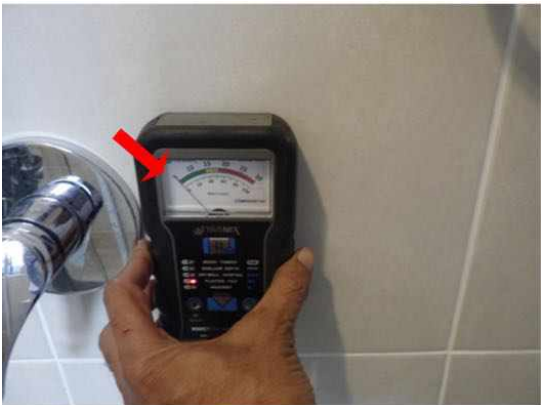
**Noted Item**

Damp (or structural damp) refers to the presence of unwanted moisture in the structure of a building, either as the result of intrusion from outside, or condensation from within the structure. In the shower area, internal water leaks or other sources of excessive moisture are generally the cause of damp.

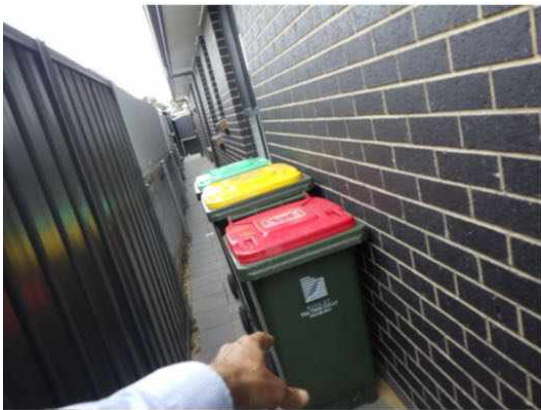
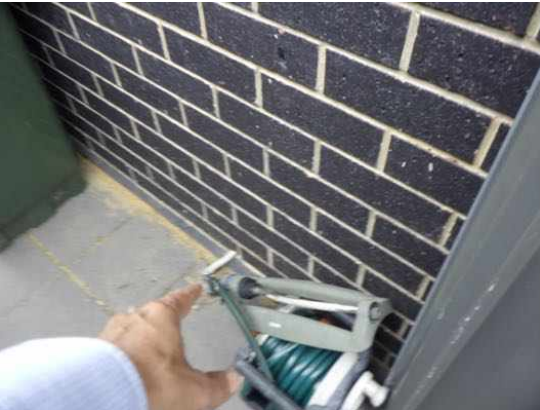
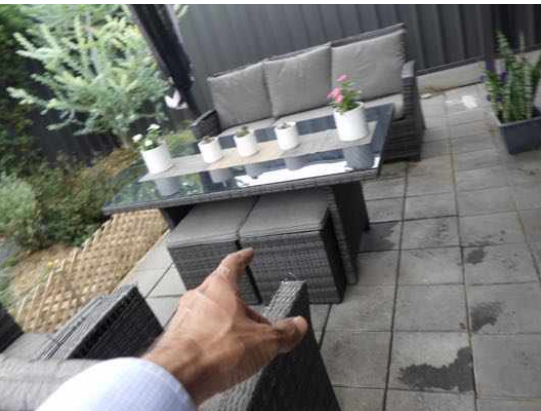
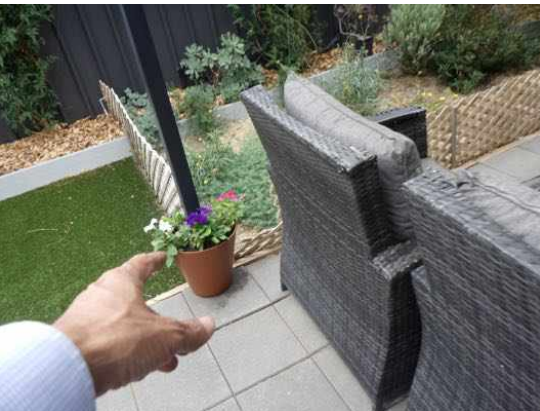
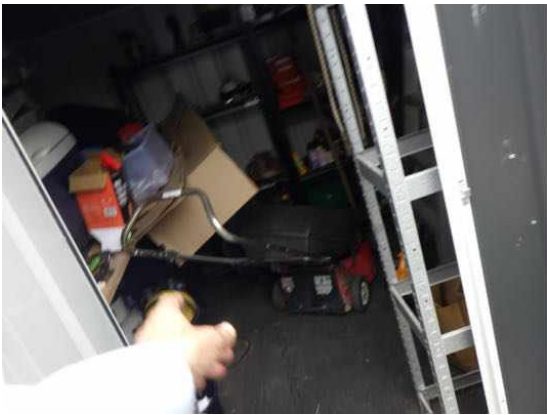
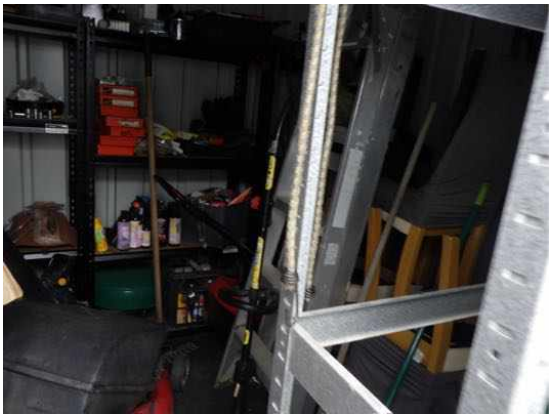
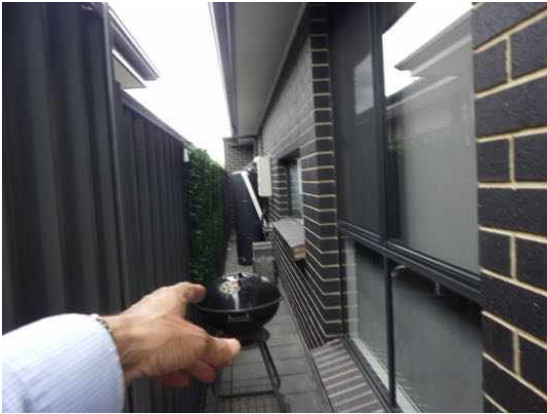
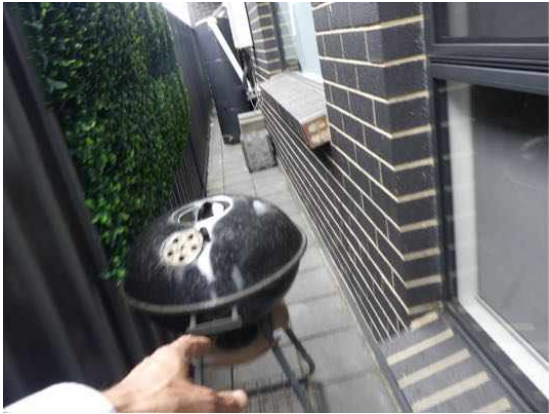
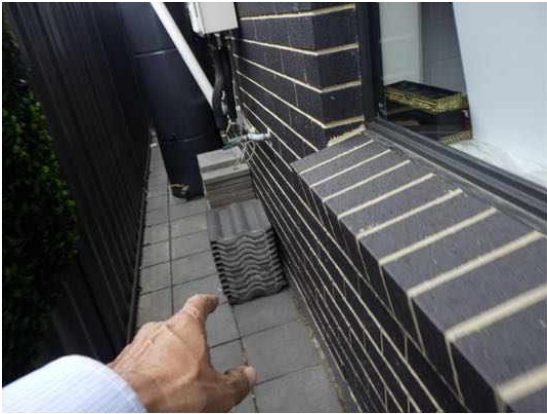
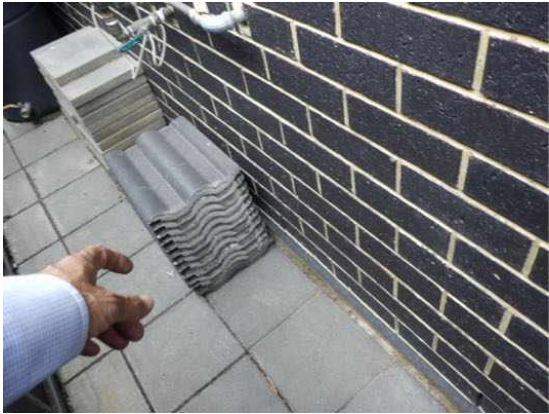
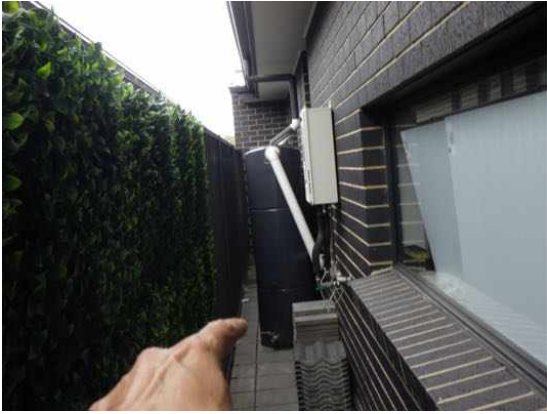
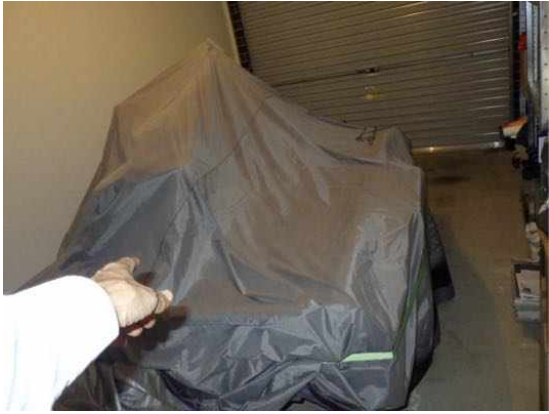
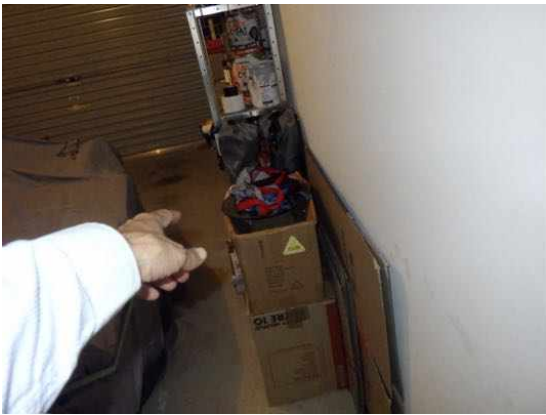
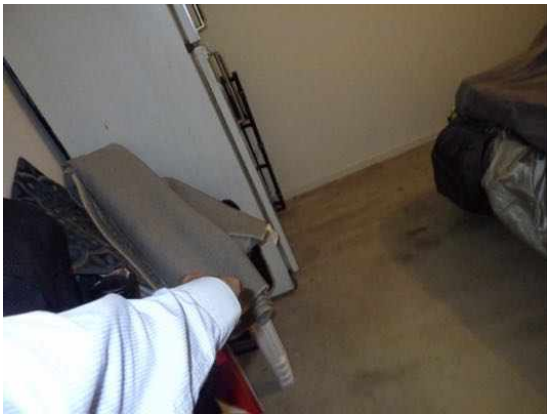
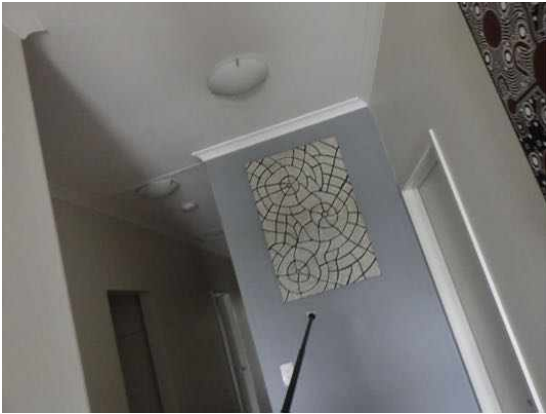
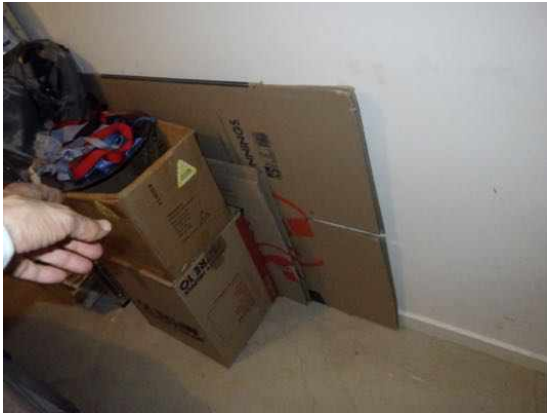
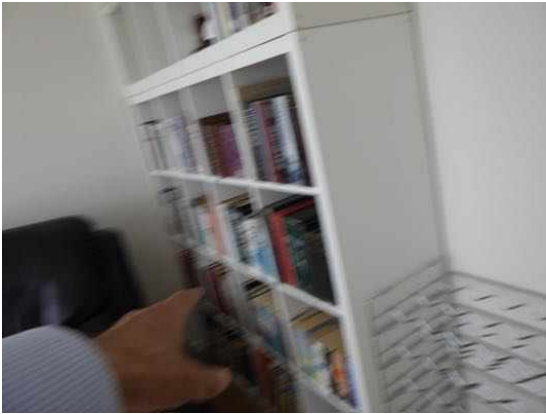
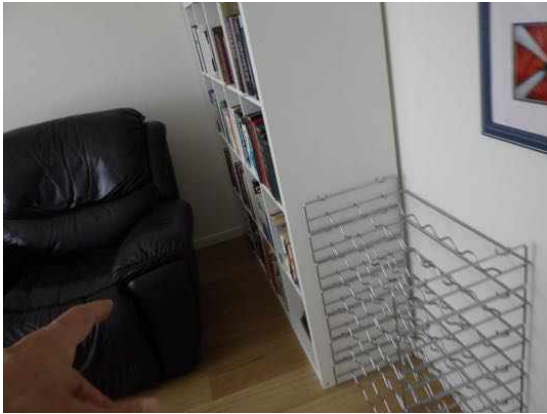
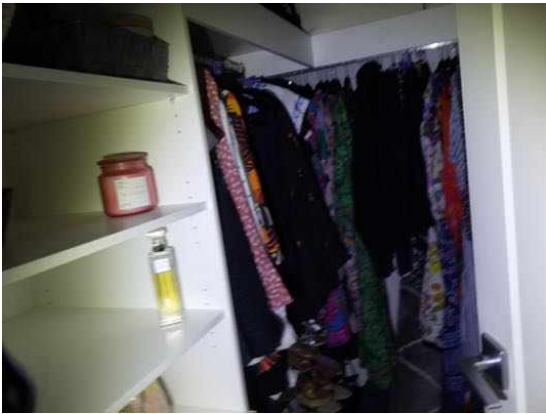
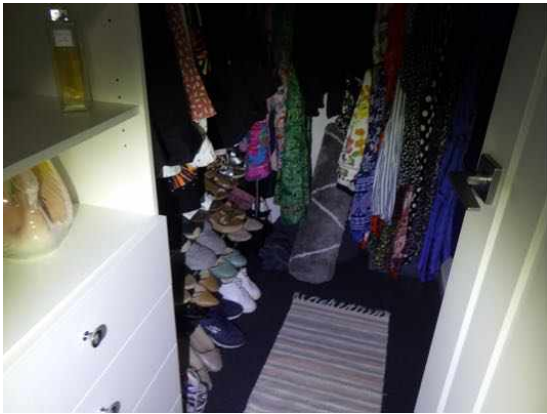
**Noted Item**

Finding: Additional Photos - Obstructions and Limitations

Information: These photographs are an indication of the obstructions and limitations which impeded full inspection of the property at the time of inspection. These obstructions can hide an array of defects and should be removed to allow full inspection to be carried out. A re-inspection is recommended once the areas are made accessible.

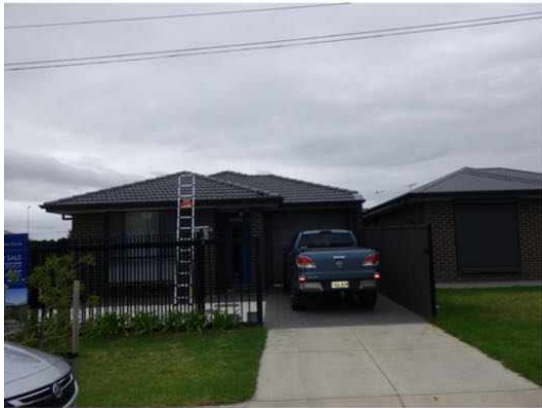
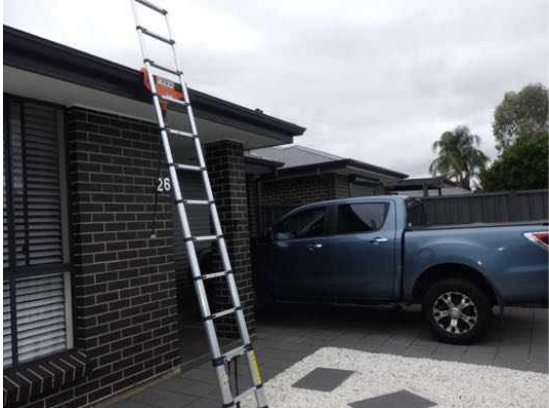
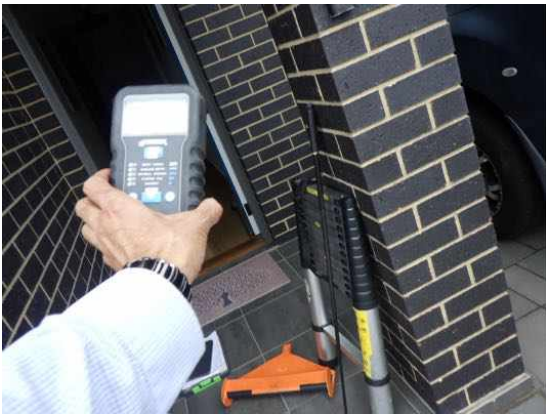
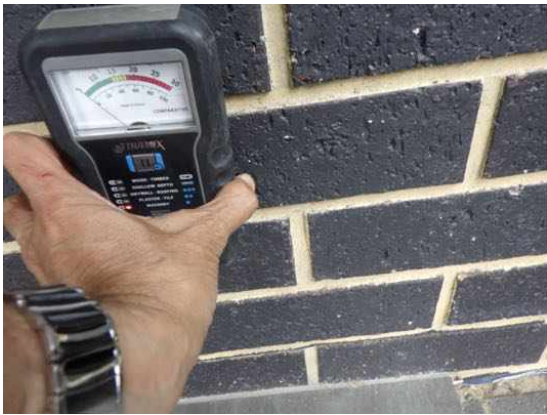
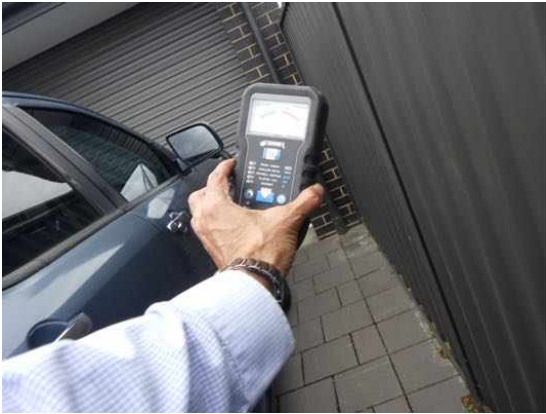
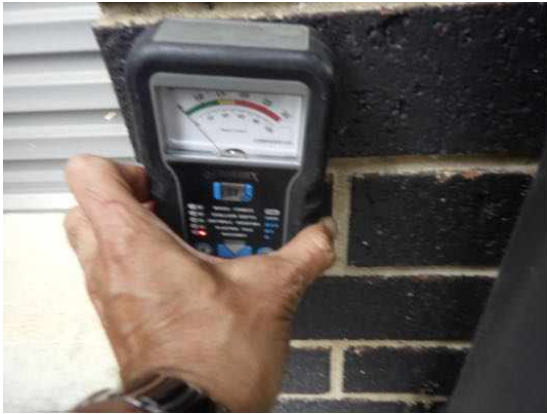
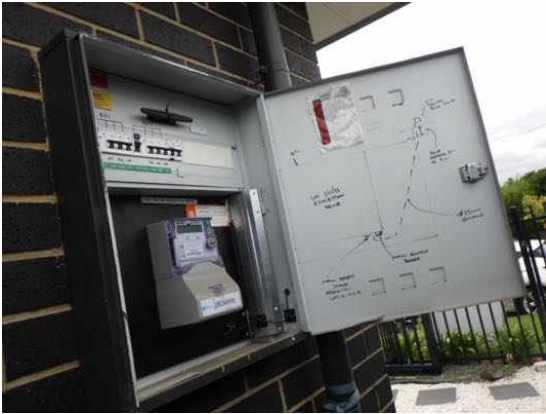
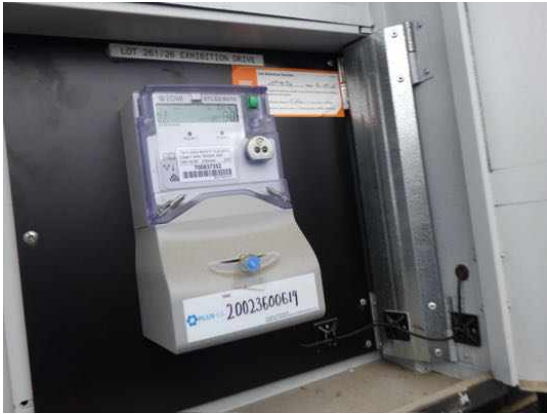
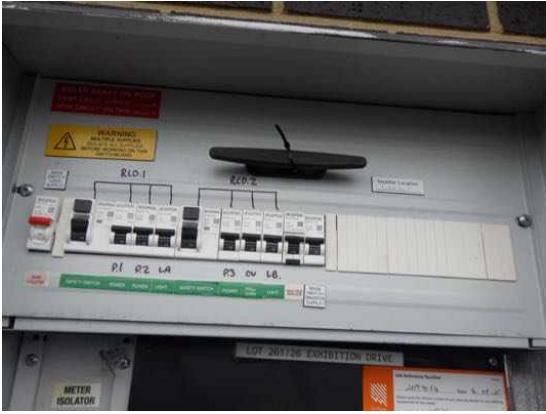
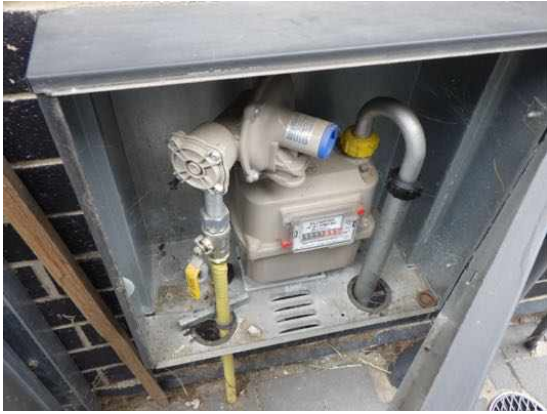
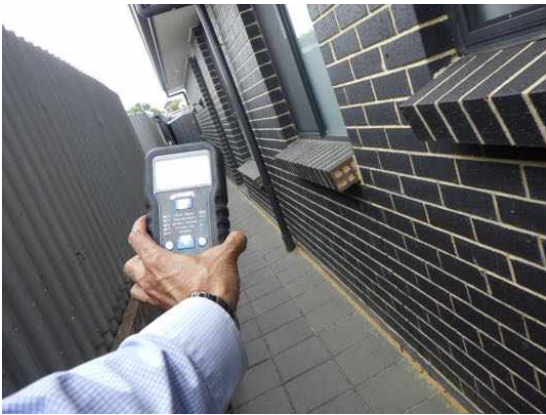
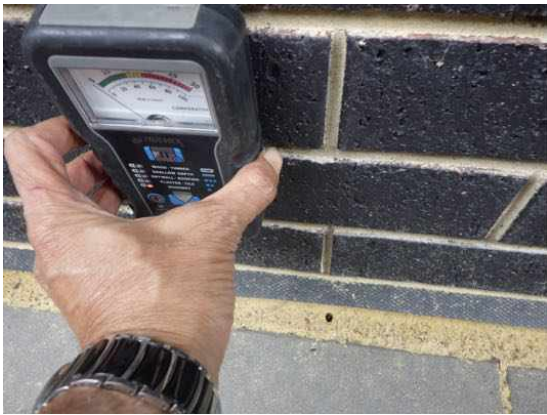
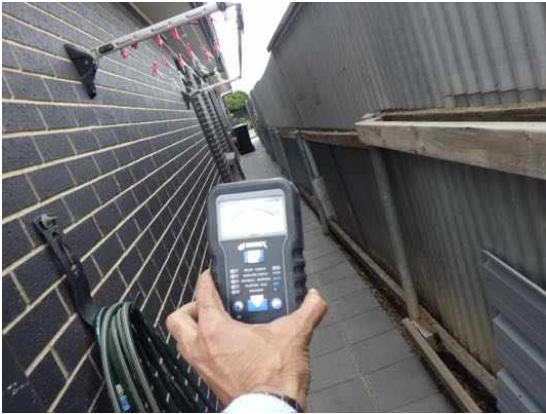
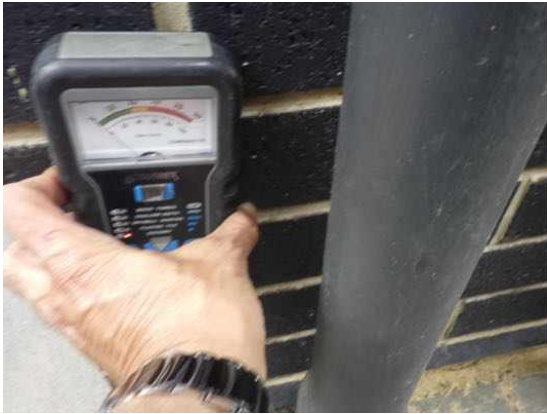
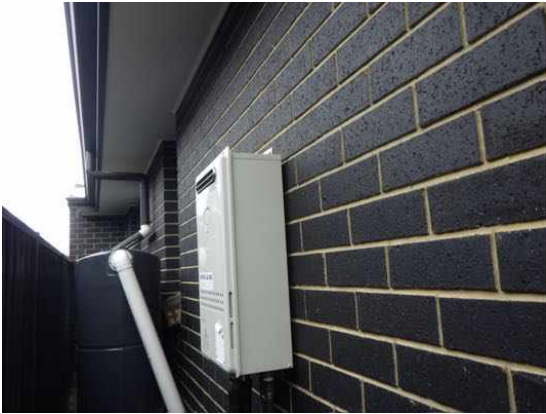
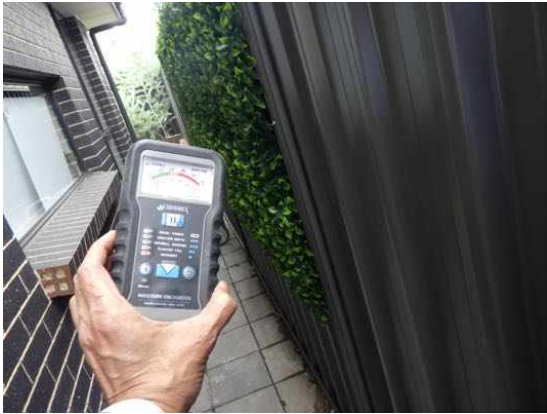
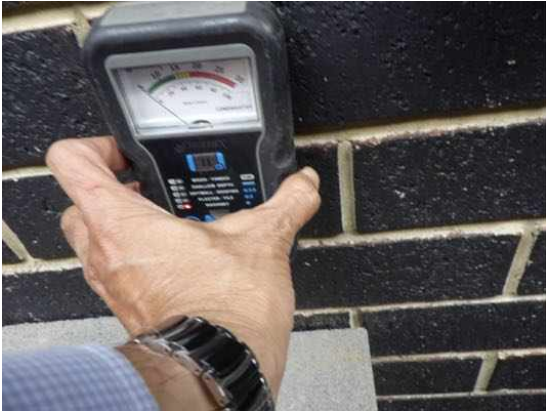
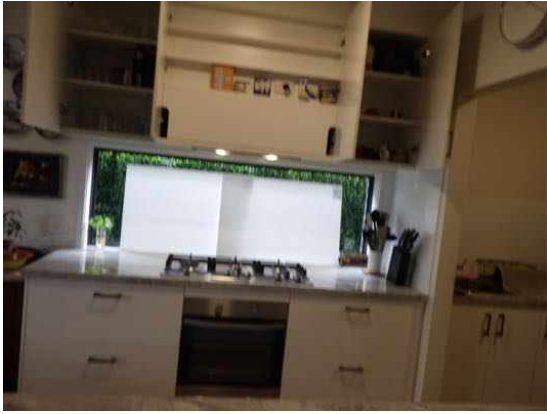
Building: Building 1  
Location: All Areas  
Finding: Additional Photos  
Information: Additional photos are provided for your general reference
