## Building Inspection Report

Inspection Date: Wed, 18 Mar 2026

Property Address: 26 Exhibition Dr, Modbury North SA 5092,  
Australia

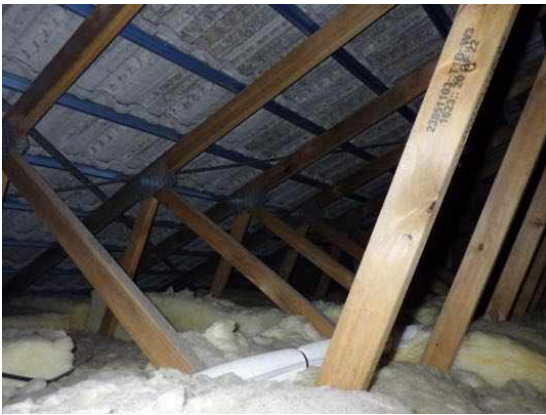
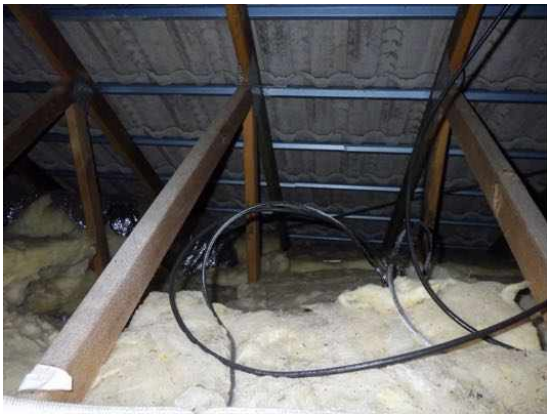
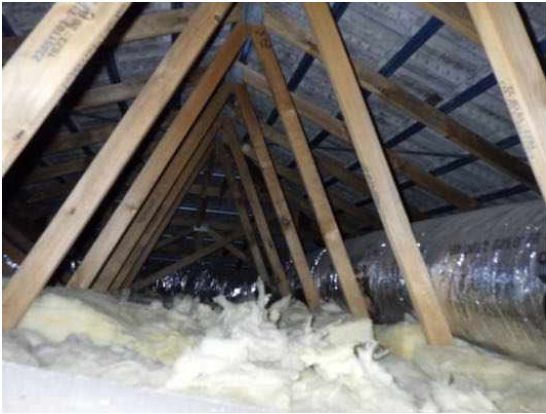
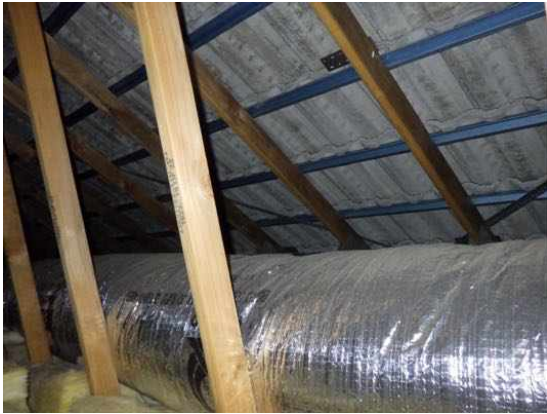
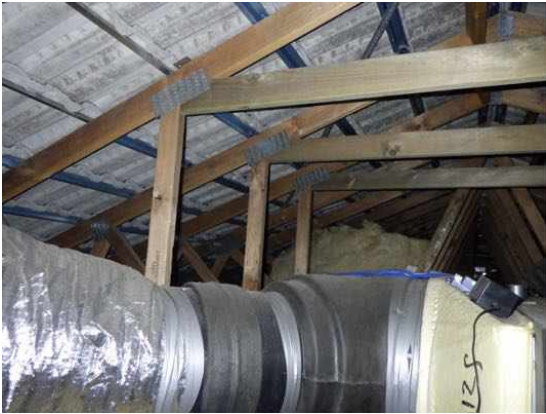
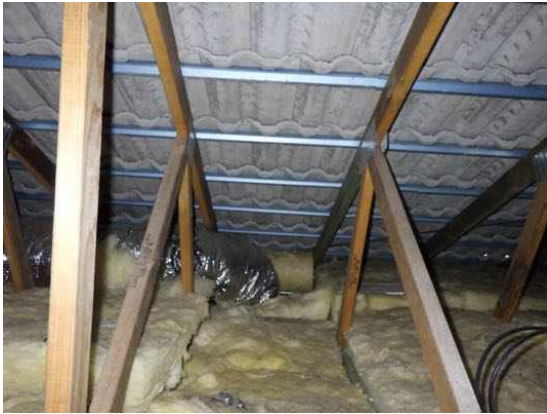
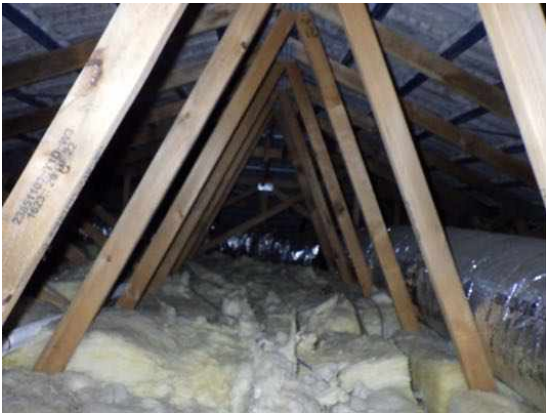
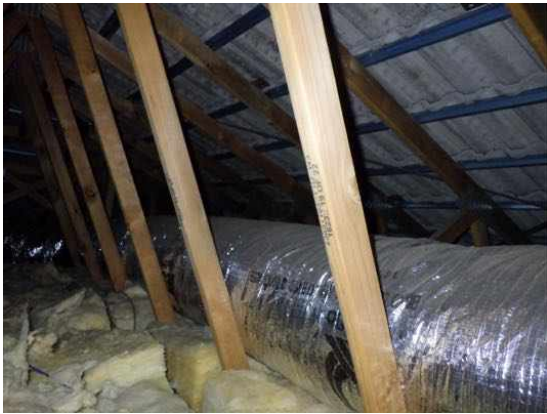
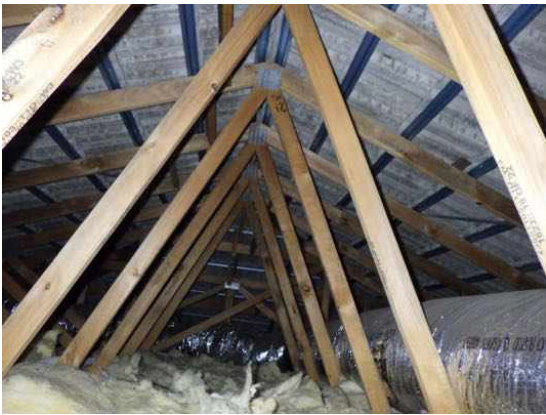
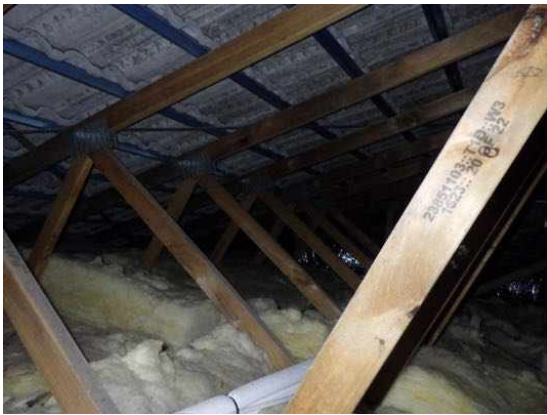
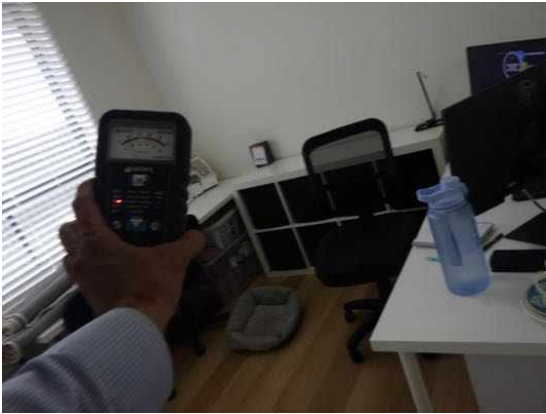
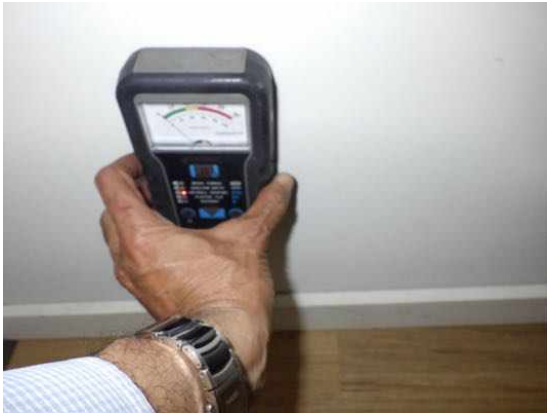
Information: These photographs are an indication of the obstructions and limitations which impeded full inspection of the property at the time of inspection. These obstructions can hide an array of defects and should be removed to allow full inspection to be carried out. A re-inspection is recommended once the areas are made accessible.
