Building and Timber Pest Inspection Report

Inspection Date: Tue, 3 Mar 2026

Property Address: 14A Eastern Arterial Rd, St Ives NSW 2075,
Australia

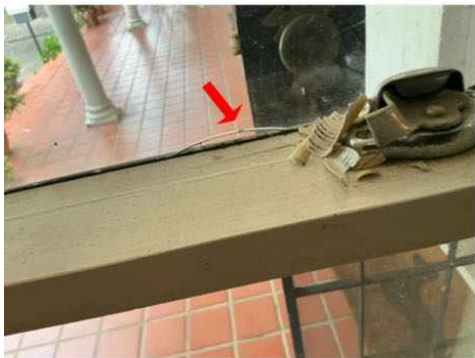
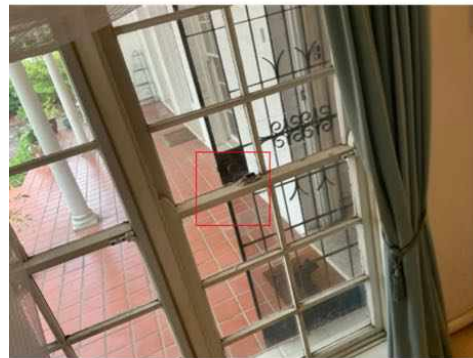
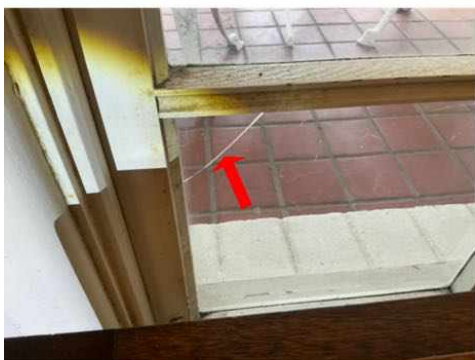
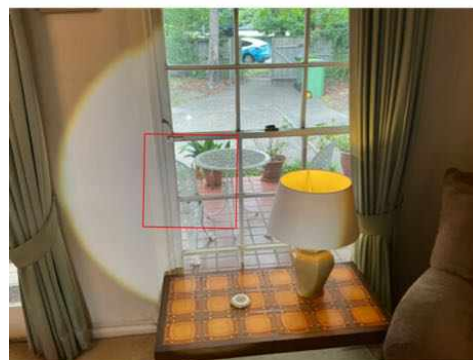
Building: Main Building
 Location: Bedroom - Master, Living Room
 Finding: Window - Cracked
 Information: Cracks were identified in the window in this area. Cracking in windows is generally the result of impact damage, and is likely to develop further when left unmanaged.

The likelihood of this windowpane further cracking and shattering is increased exponentially, providing a safety hazard in the area. The cracked window also impairs the weather tightness of the building, creating potential for minor water leaks.

A qualified glazier is required to repair the window as soon as possible. Depending on the extent of the cracking, replacement of the window may be required. Please be advised that any persons coming into contact with the cracked window should do so with due caution to avoid any personal injury that may ensue.

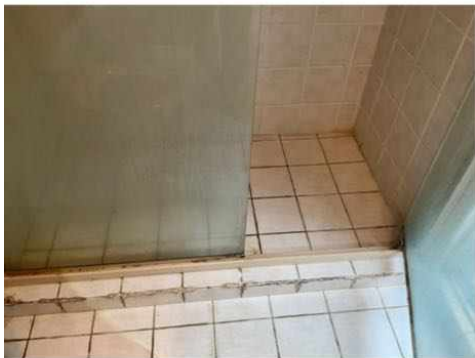
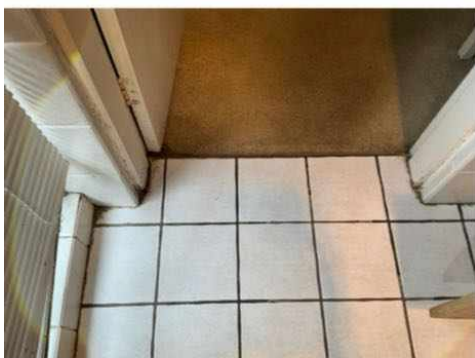
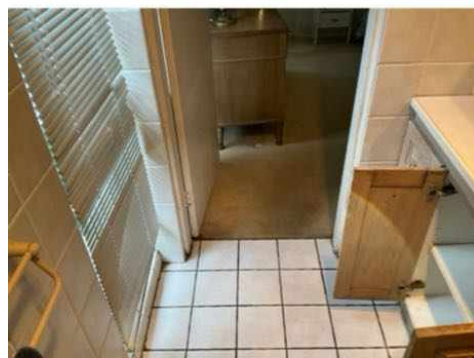
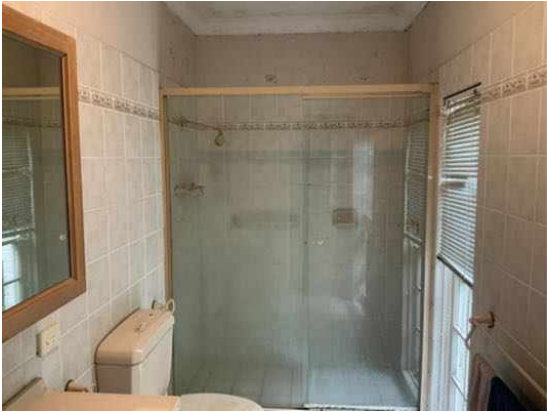
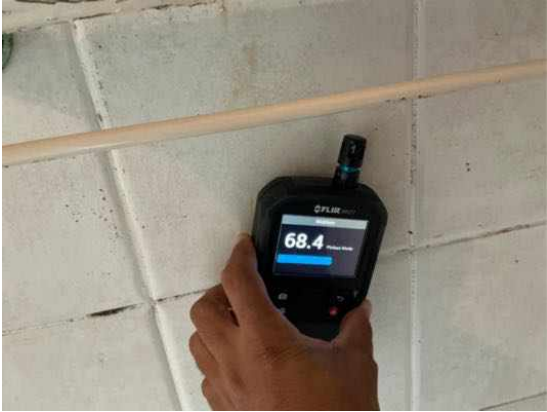
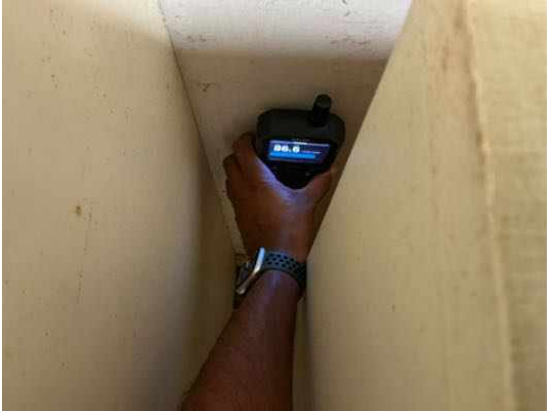
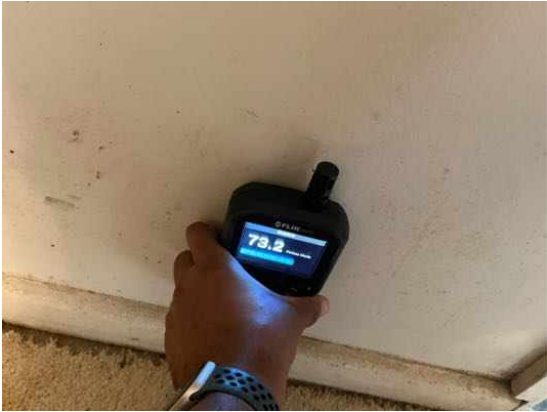
Finding 2.01

Finding: Excessive Moisture - Waterproofing Failed

Information: At the time of inspection, high moisture meter readings were recorded at the base of the bathroom wall, indicating that the waterproofing system has failed and is no longer performing as intended. The presence of excess moisture suggests ongoing water penetration behind wall finishes, which poses a risk of structural damage, timber decay, tile debonding, and potential mould development if left unresolved.

This issue is categorised as a major defect, as the failure of waterproofing compromises the integrity of the bathroom structure and requires specialist attention. It is strongly recommended that the client engage a licensed plumber to assess and rectify any plumbing-related causes contributing to moisture ingress, followed by a qualified waterproofing specialist to remove affected finishes, repair damaged substrates, and reinstate a compliant waterproofing system to current standards.

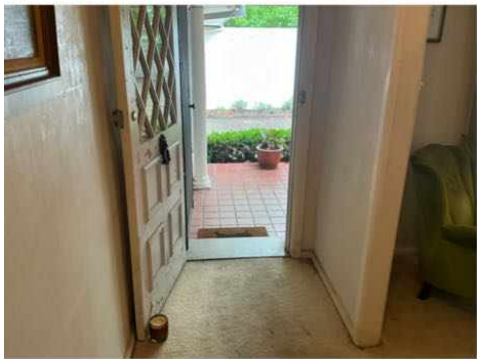
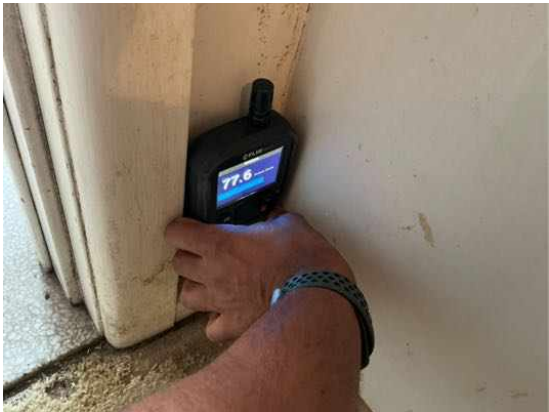
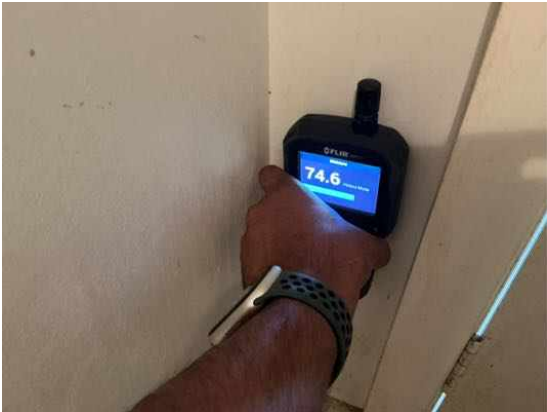
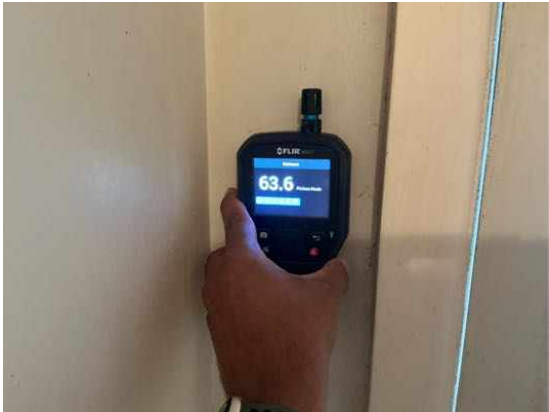
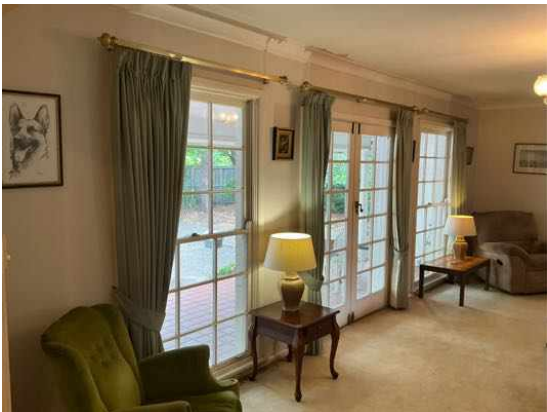
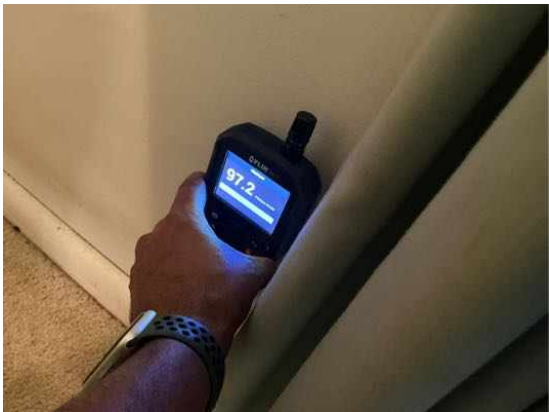
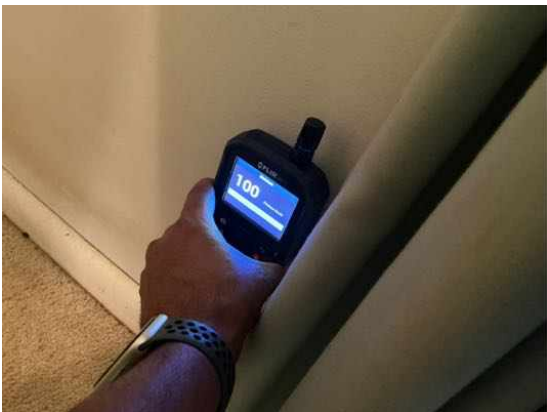
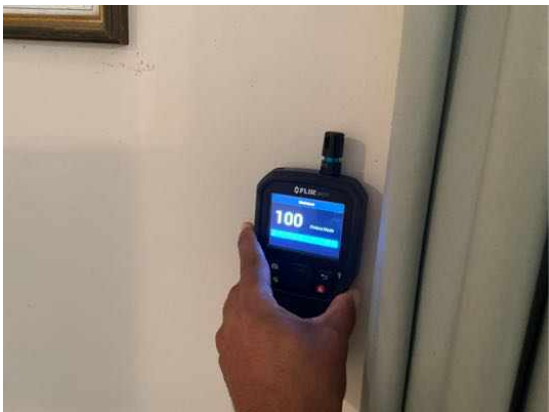
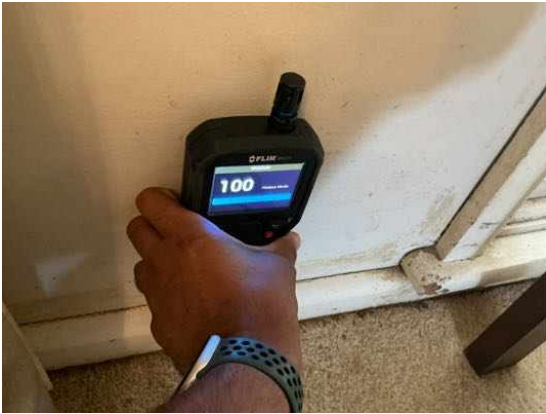
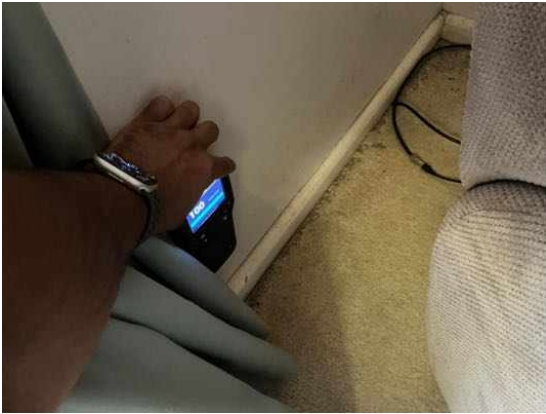
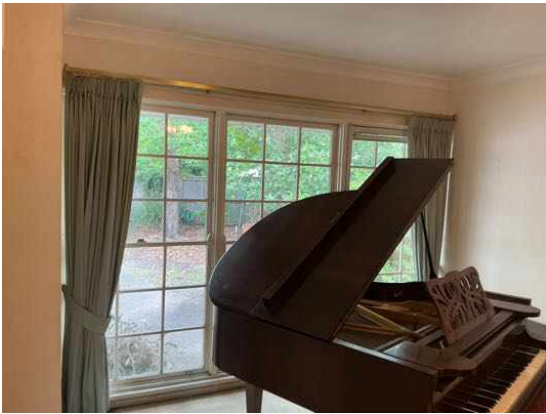
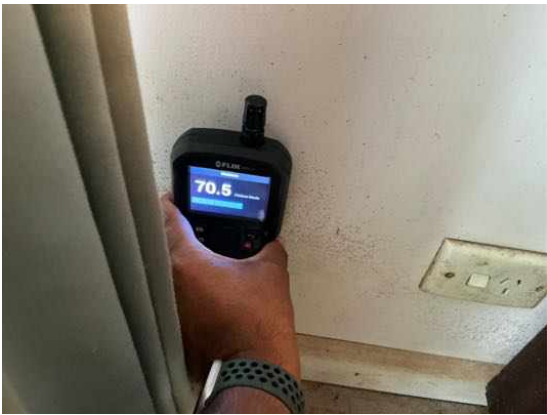
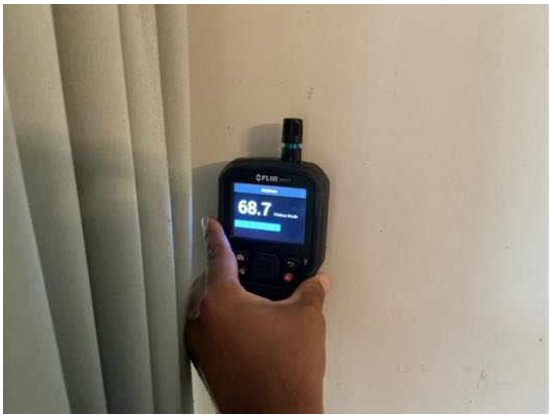
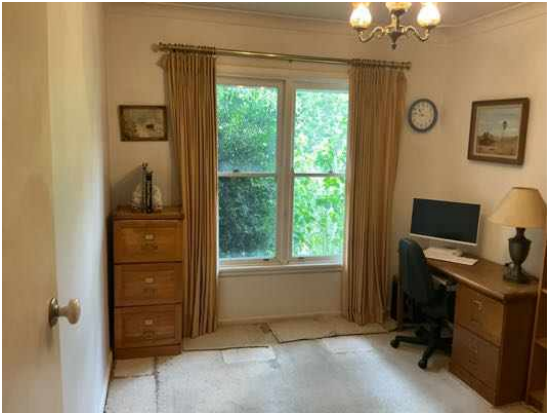
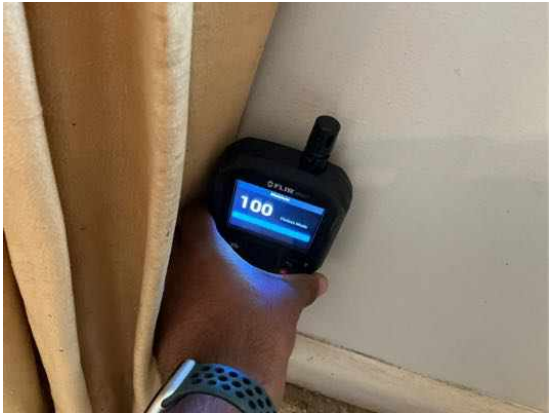
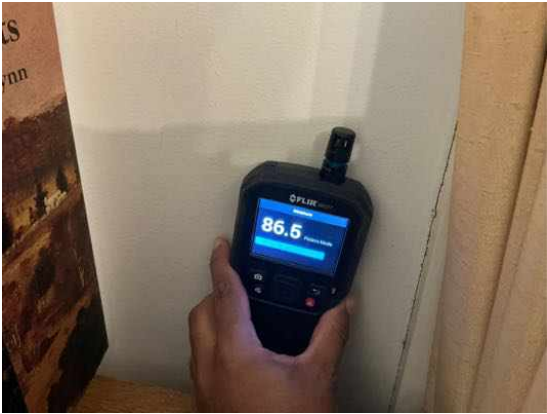
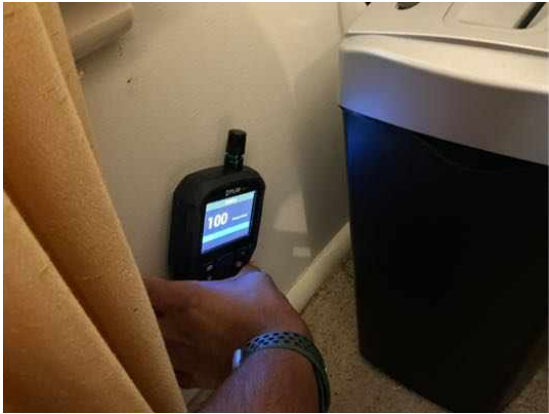
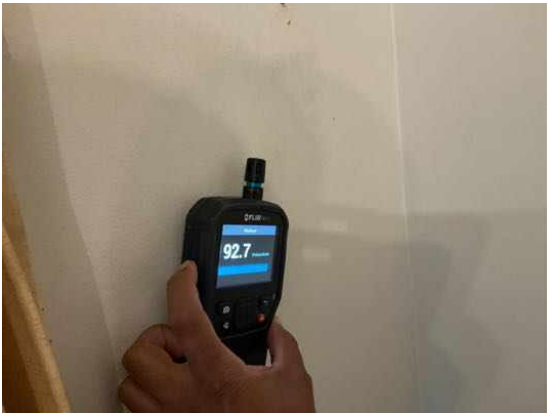
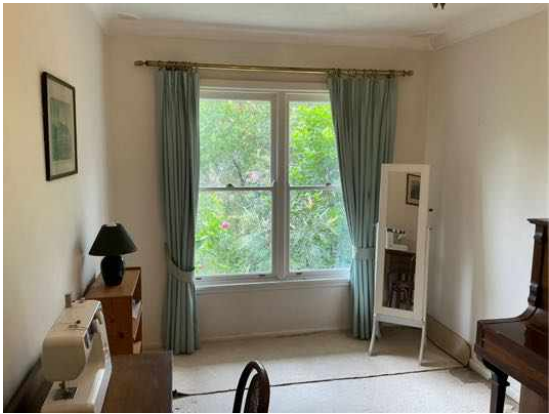
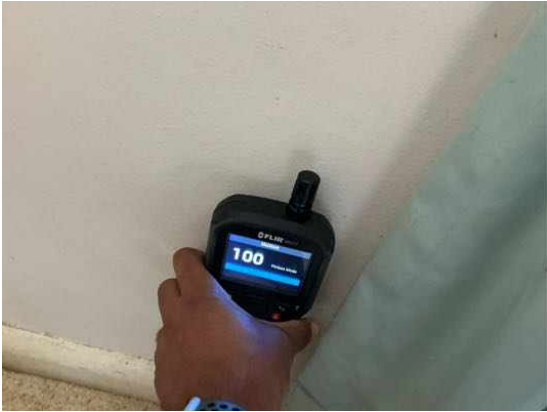
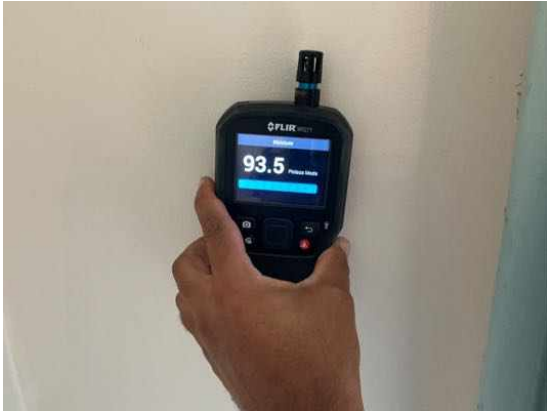
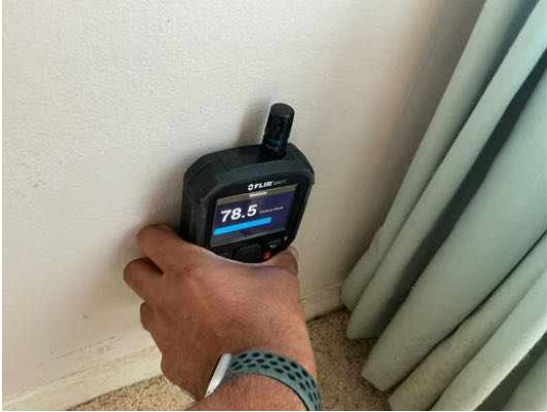
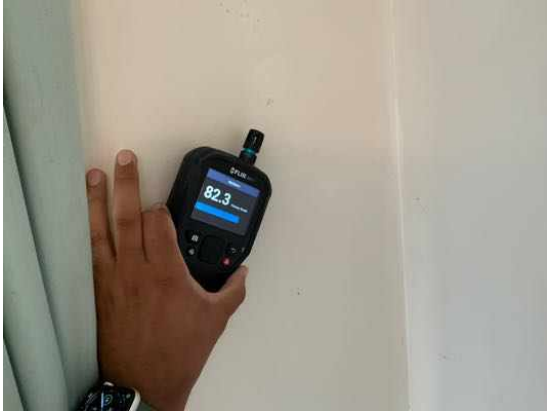
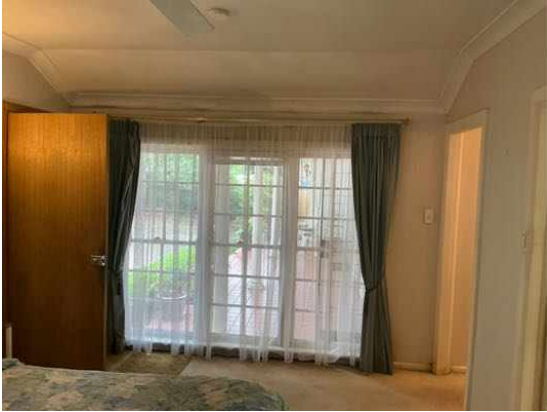
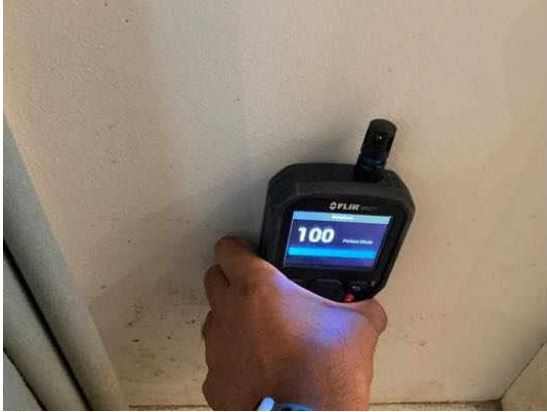
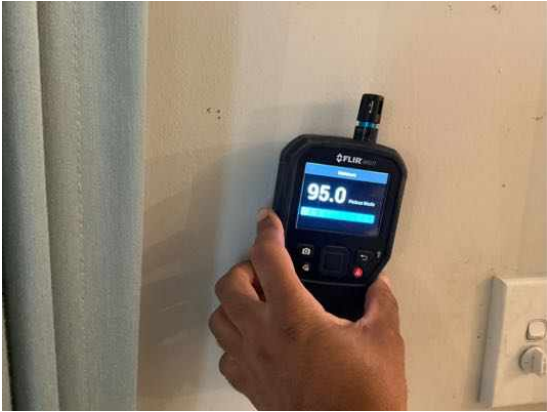
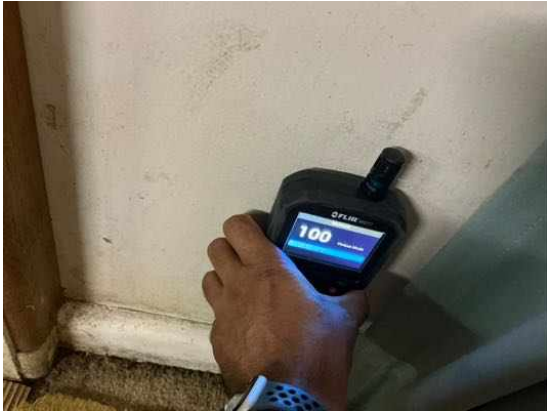
Finding 2.02

Building:	Main Building
Location:	All Areas
Finding:	Excessive Moisture Throughout Internal Walls
Information:	At the time of inspection, elevated moisture readings were recorded to multiple internal wall areas throughout the dwelling using a moisture meter. Readings were noted to be significantly high in several locations, particularly along lower wall sections and adjacent to external walls and window areas.

The property was reported by the real estate agent to have been vacant and closed for an extended period. Lack of ventilation in unoccupied homes can contribute to moisture build-up and condensation internally. However, additional contributing factors were observed externally and within the subfloor area. These include deteriorated roof mortar, gutters filled with debris, evidence of water ponding to eaves areas, inadequate surface drainage around the perimeter of the dwelling, and inadequate subfloor drainage. Poor drainage within the subfloor can allow moisture to accumulate beneath the dwelling, contributing to rising damp conditions and elevated moisture readings internally.

Prolonged elevated moisture levels can result in paint deterioration, mould growth, material breakdown and potential timber decay if not addressed.

- Engage a licensed roofer to inspect the roof covering and ridge capping mortar and carry out necessary repairs and/or resurfacing works.
- Arrange for thorough cleaning of all gutters and ensure ongoing regular maintenance.
- Improve surface drainage around the dwelling and rectify subfloor drainage issues to prevent water accumulation beneath the structure.
- Consider installation of mechanical subfloor ventilation to improve airflow and reduce moisture build-up beneath the dwelling.
- Repaint affected internal areas once above sources have been rectified.
- Increase ventilation internally by opening windows periodically to allow airflow through the home.
- Engage a qualified damp-proofing or moisture specialist to further assess and provide recommendations for rectification if moisture levels remain elevated after external issues are addressed.

Addressing both the building envelope defects, subfloor conditions and ventilation improvements will be necessary to reduce moisture levels within the property.

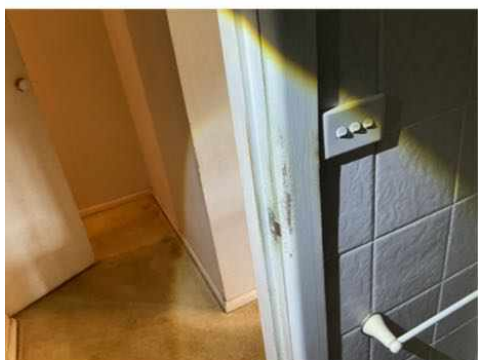
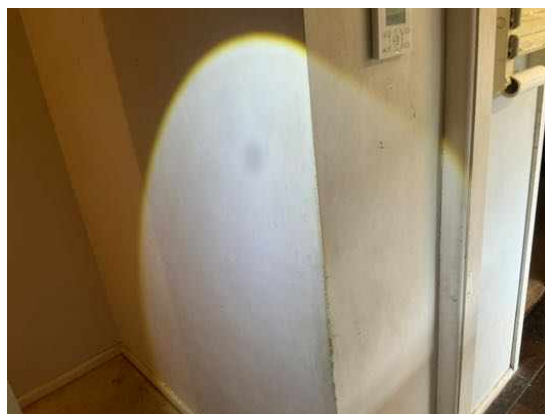
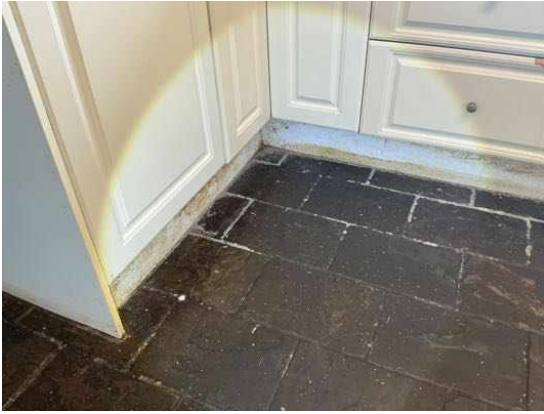
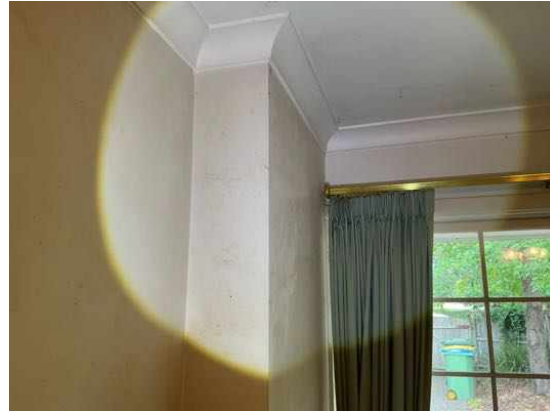
Finding: Maintenance and/or Wear and tear on building elements

Information: It was observed at the time of inspection that some building elements and areas around the property require general maintenance and/or exhibit signs of wear and tear. These typically include minor imperfections such as paint scuff marks, scratches on surfaces, small chips, nails or hooks left in walls from previous picture hanging, and other superficial blemishes.

These are generally considered minor items that are common in established homes. While they may be noticeable on visual inspection, they do not affect the structural integrity or functionality of the property. In most cases, these issues can be easily addressed by a qualified handyman as part of routine maintenance.

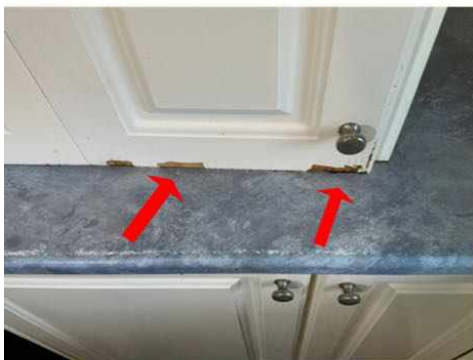
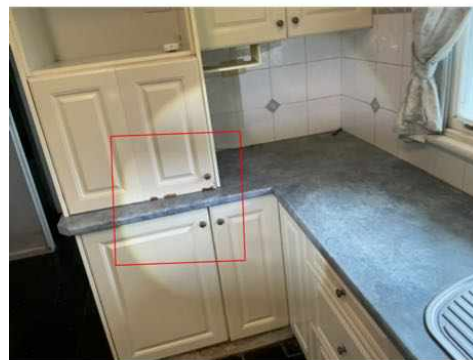
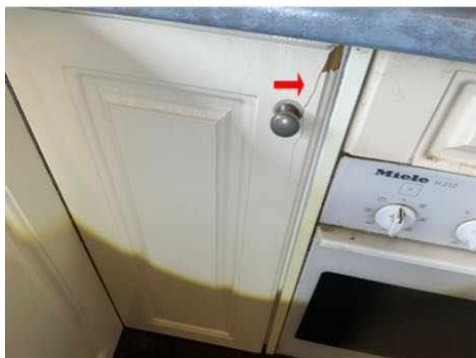
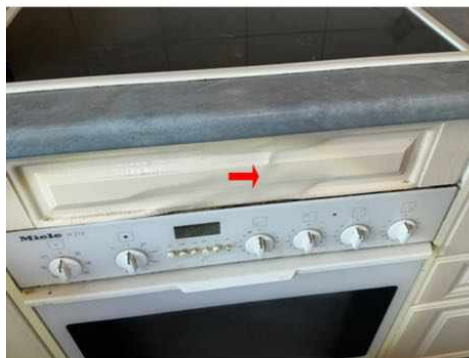
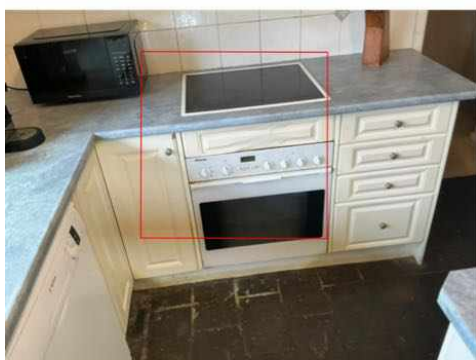
Finding 3.12

Finding: Kitchen Cabinetry – General Wear and Tear

Information: At the time of inspection, general wear and tear was noted to the kitchen cabinetry, including surface scuffing, edge deterioration and aged finishes. These conditions are consistent with normal use over time; however, deterioration to protective surfaces can allow moisture penetration and further damage if left unaddressed.

While the defects are not considered structurally significant at this stage, rectification or refurbishment may be required to restore functionality and improve overall appearance.

It is recommended that a kitchen renovation specialist or a qualified carpenter be engaged to assess the cabinetry and advise on suitable repair, resurfacing, or replacement options as required.

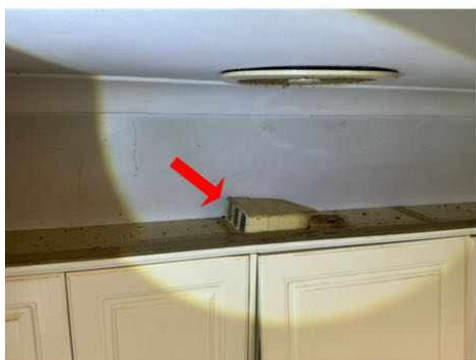
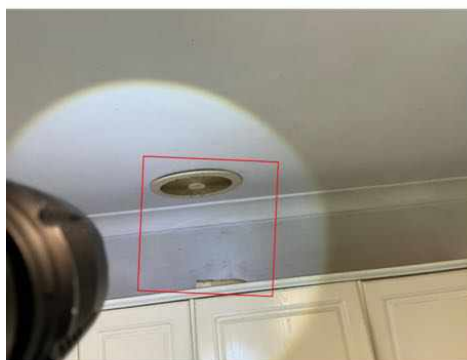
Finding 3.13

Building:	Main Building
Location:	Kitchen
Finding:	Kitchen Exhaust - Not Extracted Outside
Information:	It was noted at the time of inspection, the kitchen exhaust has not been vented outside.

If the kitchen exhaust fan is not vented to the outside, several issues can arise. The primary concern is that it will recirculate air back into the kitchen rather than removing it, leading to a buildup of moisture, heat, and cooking odors. This can create an unpleasant living environment and may contribute to the growth of mold and mildew due to increased humidity. Additionally, grease particles and other contaminants will not be effectively removed, potentially causing residue buildup on kitchen surfaces and appliances, which can be difficult to clean and may pose a fire hazard over time. Proper ventilation is crucial to maintain air quality, ensure safety, and preserve the condition of the kitchen and home.

Client is advised to hire a qualified electrician to get a quote of installation and install it as soon as possible.

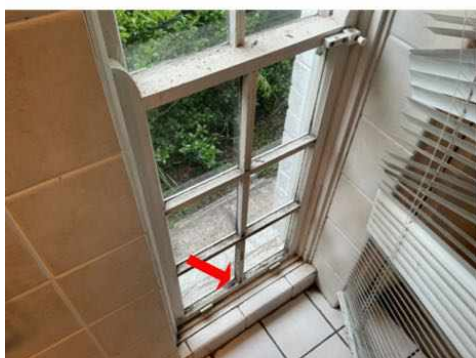
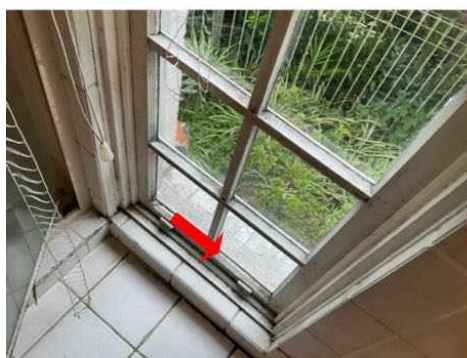
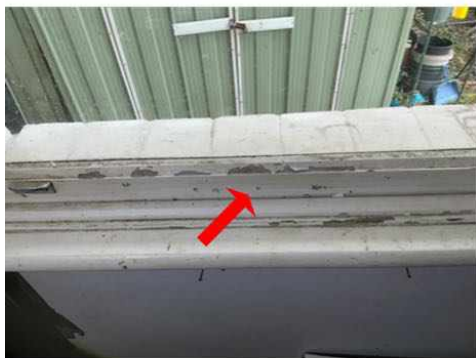
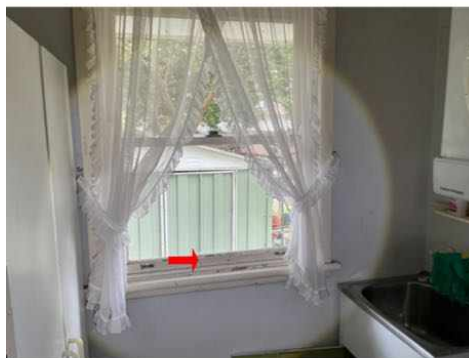
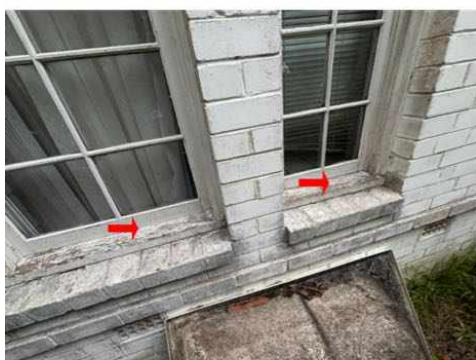
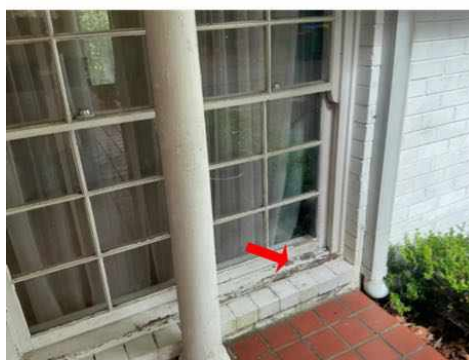
Finding 3.14

Building:	Main Building
Location:	All Areas
Finding:	Windows - Deteriorated
Information:	Some windows have been noted as deteriorated at the time of inspection.

The deterioration of wooden windows over time can be due to several factors. Prolonged exposure to the elements, such as rain, sunlight, and fluctuating temperatures, can cause the wood to warp, crack, and rot. Moisture is particularly damaging, as it can penetrate the wood and lead to fungal growth, which accelerates decay. Without proper maintenance, including regular painting or sealing, the protective coatings on wooden windows can wear away, leaving the wood vulnerable to environmental damage. Insect infestations, such as termites or wood-boring beetles, can also contribute to the deterioration. Additionally, poor initial construction or the use of low-quality wood can result in faster degradation. Regular upkeep, such as repainting, sealing, and checking for signs of damage or insect activity, is essential to prolong the lifespan of wooden windows and maintain their structural integrity and appearance.

Consider hiring a window specialist or carpenter to fix or replace the window or getting a quotation from a Painter if the windows can be repainted.

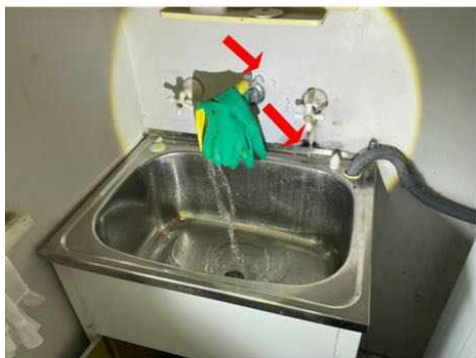
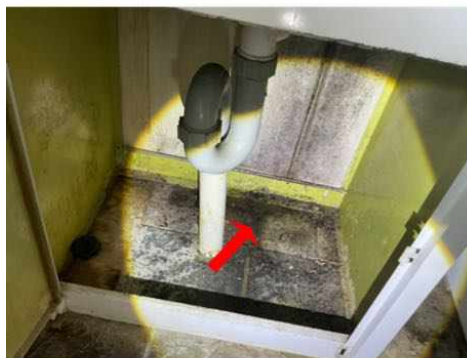
Finding 3.15

Finding: Laundry Tap Leak & Inadequate Sealing to Vanity

Information: At the time of inspection, the laundry tap was observed to be leaking from the top when in operation. Ongoing leakage from the tap can result in water running down the wall and cabinetry, contributing to moisture damage and deterioration of surrounding finishes.

It was also noted that there is no adequate seal between the vanity unit and the adjoining wall. Due to the absence of proper sealing, water is able to track down behind and beneath the sink cabinet, as evidenced by moisture staining and deterioration within the cupboard area below. Prolonged exposure to moisture may lead to swelling of cabinetry, mould growth and potential damage to adjoining materials.

The client is advised to engage a licensed plumber to repair the leaking tap. If the tap cannot be effectively repaired, replacement is recommended. In addition, the junction between the vanity and the wall should be properly sealed with a suitable waterproof sealant to prevent further water ingress.

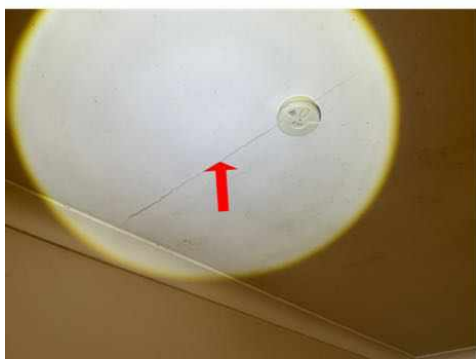
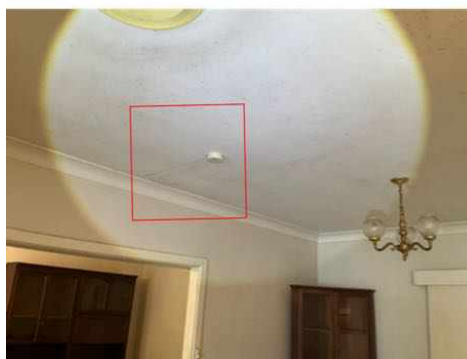
Finding 3.16

Finding: Cracking - Damage Category 2 - Noticeable (up to 5mm)

Information: Noticeable cracks are a common occurrence as a result of many primary defects. Such causes may include age, general wear and tear, expected building movement, general expansion/contraction of building materials in different weather conditions, and/or minor failings in the installation or application of building materials.

Noticeable cracks may result in minor sticking or jamming of associated doors and windows, which require easement. However, noticeable cracks are easily filled and repaired.

Monitoring of all cracking should be conducted frequently. Always contact a building inspector should cracks widen, lengthen, or become more numerous. Additionally, your building inspector should also be contacted if associated building elements such as doors and windows become more difficult to operate over time.

Relevant tradespeople, such as carpenters, painters and plasterers, should be appointed to perform remedial works, as deemed necessary.

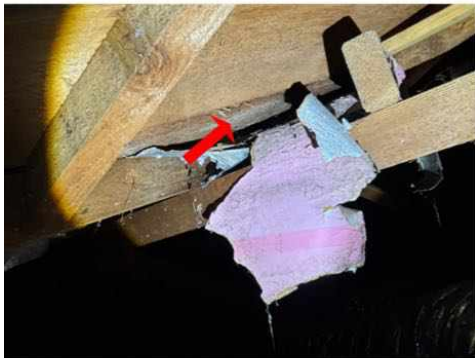
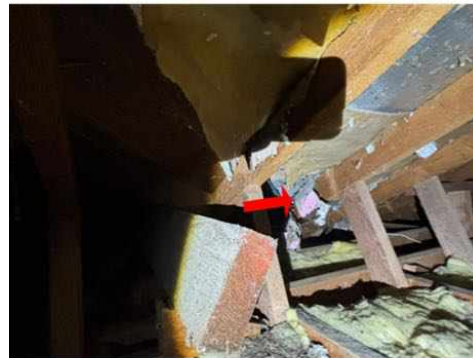
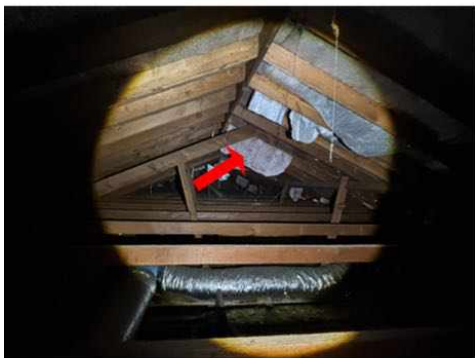
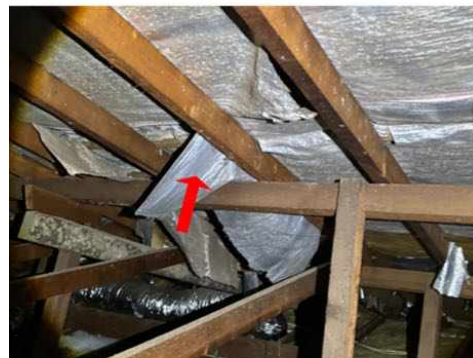
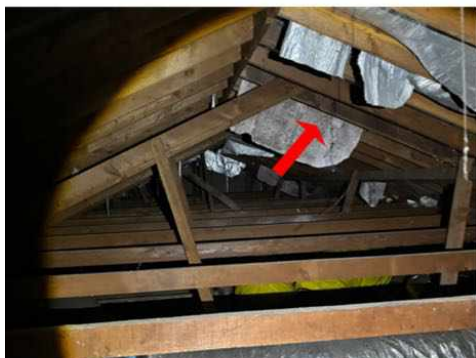
Finding 3.17

Building: Main Building
Location: Roof Void
Finding: Sarking - Damaged
Information: Sarking, a laminated aluminium foil applied to the interior of the roof covering, assists in insulating the property and acting as a vapour-barrier to the roof void and, subsequently, to the household.

Where sarking is damaged, both insulation and moisture protection of the property are inhibited. This creates a loss of energy and thus negatively impacts the energy efficiency of the property, allowing potential for moisture ingress from condensation or leaking roof tiles.

It is important to repair any holes or damaged sections of sarking to ensure that the building material is fully functional. A registered roofer should be consulted to provide further advice on this defect and to perform rectification works at client discretion.

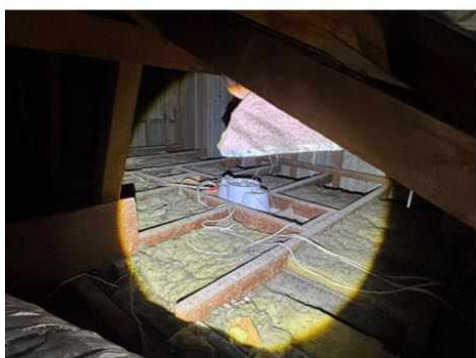
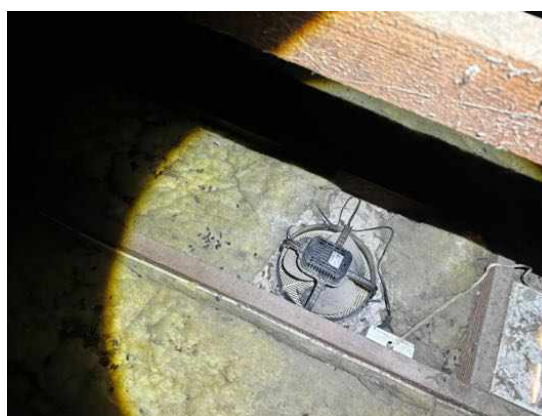
Finding 3.18

Building:	Main Building
Location:	Roof Void
Finding:	Vent - Extracted into Roof Space
Information:	During the inspection, it was noted that the exhaust vent has been improperly terminated into the roof space instead of being ducted to the exterior of the property.

This configuration is a defect as it allows moist air to accumulate within the roof cavity, increasing the risk of condensation, mould growth, and deterioration of insulation or timber framing. Proper ventilation is essential to maintain a healthy indoor environment and protect the structural integrity of the building. It is recommended that the vent be appropriately re-routed to discharge externally in compliance with relevant building standards.

A licensed mechanical ventilation contractor/electrician should be appointed as soon as possible to provide further consultation on the scope of these works and to provide quotations for any necessary works.

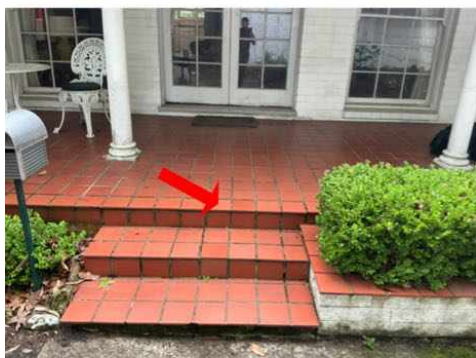
Finding 3.19

Building:	Main Building
Location:	Porch

Finding:	Tiles Coming off & Deteriorating Sealant/Grout
Information:	At the time of inspection, sections of tile were noted to be coming loose, with missing or deteriorated grout and sealant in the affected area. This condition may allow water to penetrate beneath the tiles, leading to potential moisture damage, mould growth, or further tile displacement. Rectification by a qualified tiler is recommended to resecure the loose tiles and reapply grout to restore the integrity of the surface.

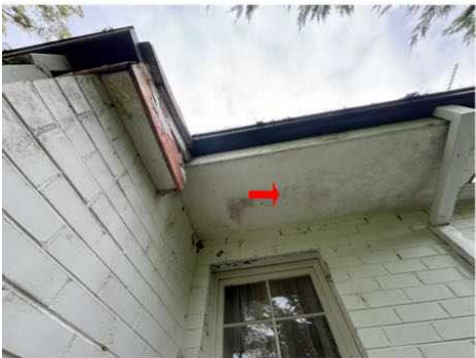
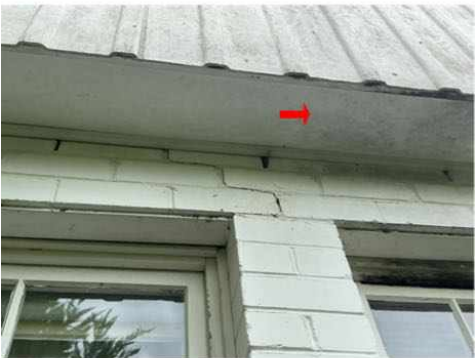
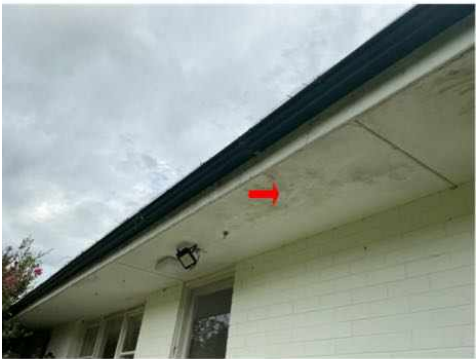
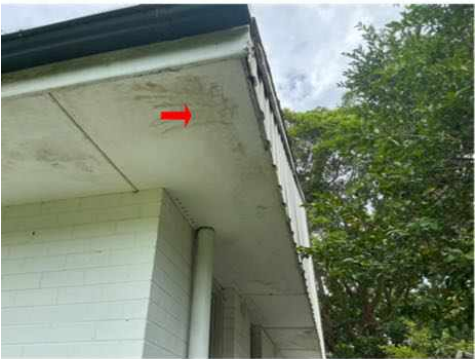
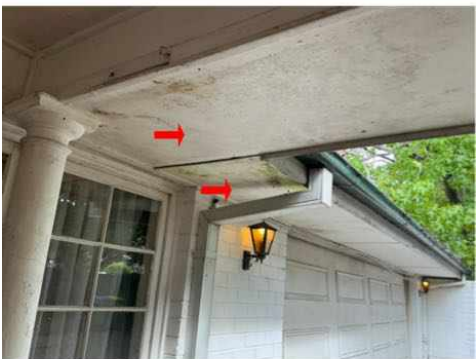
Finding 3.20

Building:	Main Building
Location:	Eaves
Finding:	Eaves - Water Ingress (Debris Above)
Information:	<p>At the time of inspection, bubbling was noted on the eaves lining, which appears to have been caused by previous water ingress from the roof area above. The gutters in this section were observed to be blocked with debris, restricting proper water flow and likely contributing to the moisture damage seen. If not addressed, trapped moisture can lead to deterioration of the eaves material, staining, or mould growth over time.</p> <p>It is recommended that the gutters be thoroughly cleaned to prevent further water overflow and that the affected eaves area be repaired and repainted once dry. A lawn maintenance company should be engaged for ongoing gutter cleaning, and a qualified roofer or painter should inspect and rectify any moisture damage to restore the integrity of the eaves.</p>

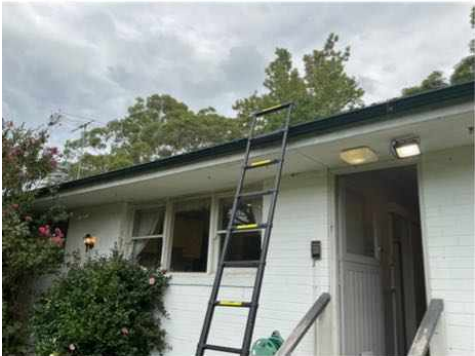
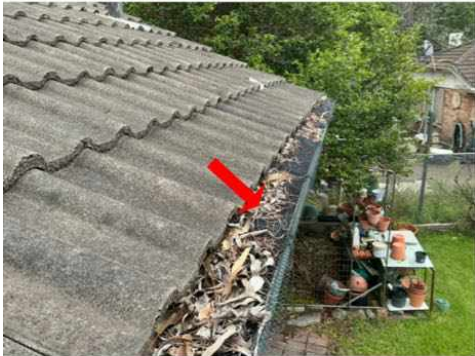
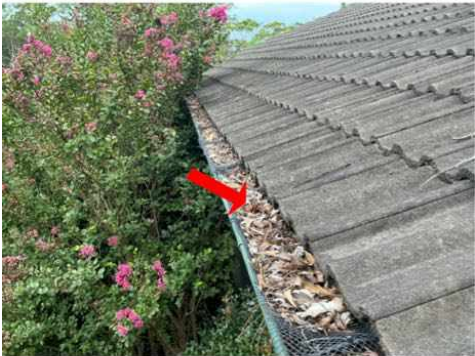
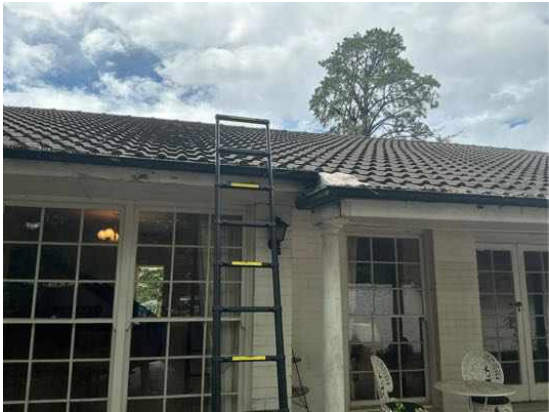
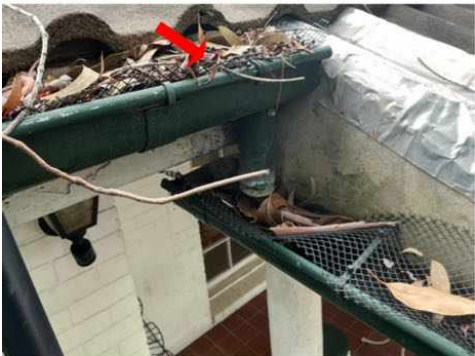
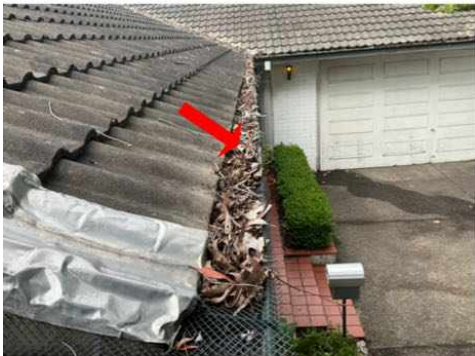
Finding 3.21

Building: Main Building
Location: All Areas
Finding: Damaged Gutter Guards & Debris in Gutters
Information: At the time of inspection, gutters were found to be full of leaves, debris, and dirt accumulation, and sections of the gutter guard were damaged or displaced. Blocked gutters can obstruct water flow, leading to overflow, fascia damage, and potential water ingress into the structure during rainfall. The damaged gutter guards are also ineffective in preventing future debris buildup, which may accelerate corrosion and reduce the overall lifespan of the guttering system.

It is recommended that a lawn maintenance company be engaged to regularly clean

and clear the gutters, ensuring proper drainage. In addition, a gutter guard specialist should be engaged to repair or replace the damaged gutter guards to restore adequate protection and prevent recurring blockages.

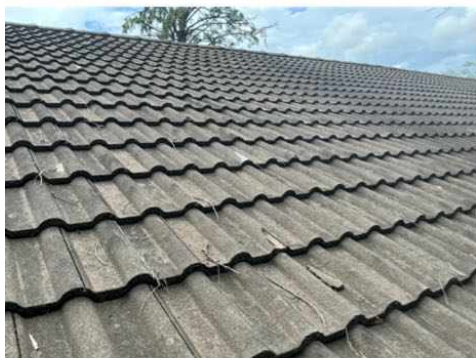
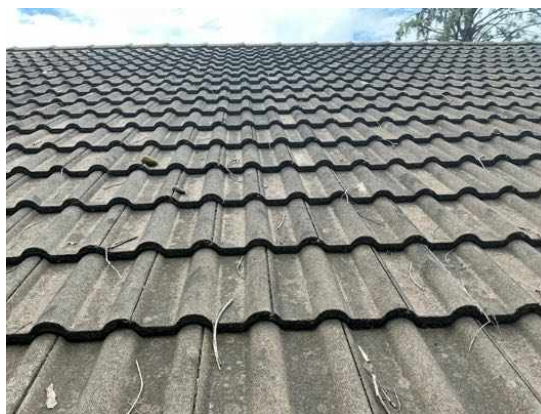
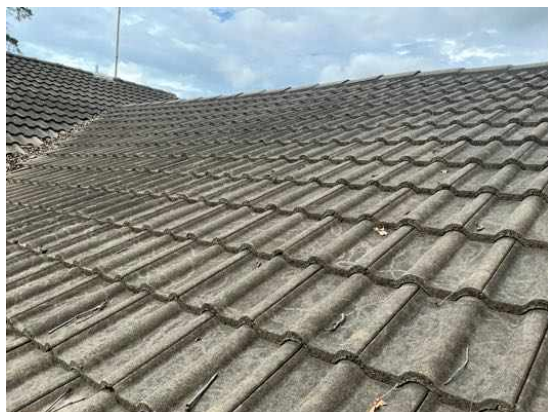
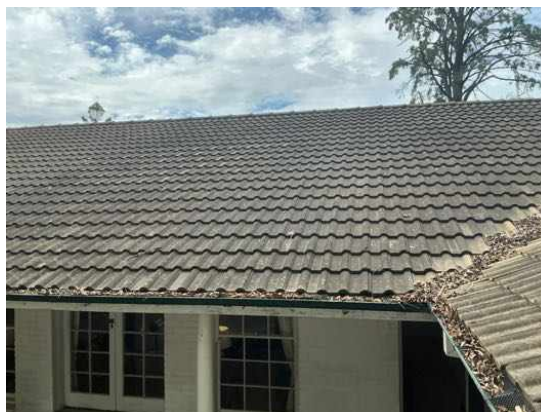
Finding 3.22

Building:	Main Building
Location:	All Areas
Finding:	Roof Tiles - Weathered, Mortar, Cracked & Slippage Identified
Information:	Upon inspection of the exterior roofing, the majority of roof tiles were considered to be in a fair condition. While weathering of the tiles is consistent with the age of the property, maintenance works are required.

Isolated areas of tiles have come loose in the valleys and cracking of mortar is also present. Re-pointing and re-sealing the tiles may be considered as an interim solution by the client to help preserve and extend the life span of the tiles. Where left unmanaged, deteriorating roof tiles are likely to lead to a number of secondary defects, including minor water leaks and weather exposure to internal roofing structures.

The client is advised to engage services of a professional roofer for further consultation.

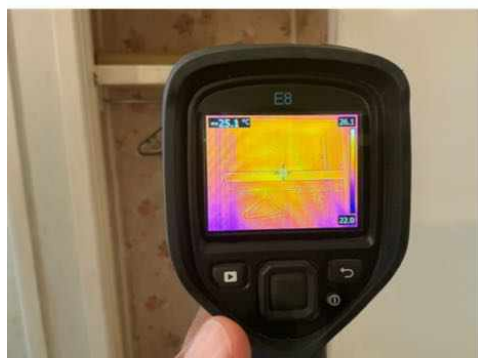
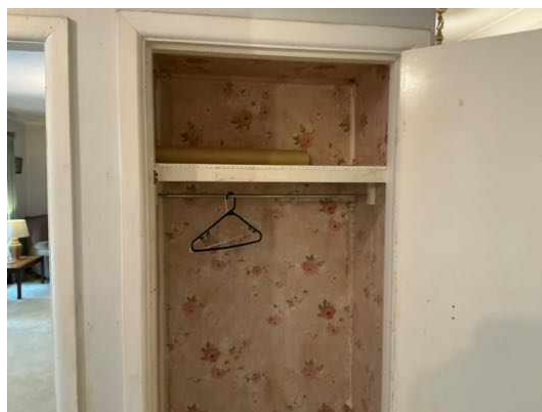
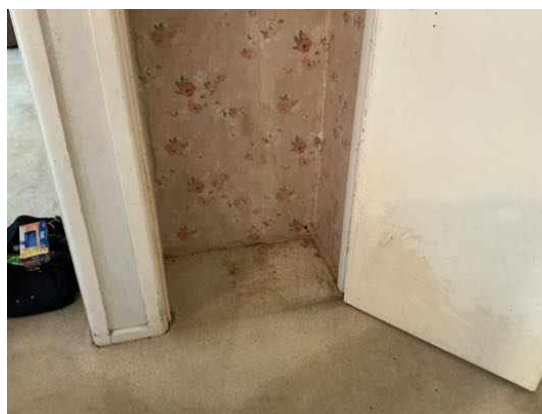
Finding 3.23

Finding: Stains (Dry) - Wall

Information: At the time of inspection, stains were noted on the internal wall surfaces; however, the areas were dry and no active moisture ingress was detected. These stains are likely the result of a previous moisture event, such as an historic roof leak or past water penetration during heavy rain, which may have since been repaired. The affected areas appear cosmetic at this stage, but the client is advised to monitor the walls over time, particularly after periods of heavy rainfall, and if staining worsens or moisture reappears, a roofing or waterproofing specialist should be consulted to further investigate. Repainting may be considered once it is confirmed that the issue is no longer active.

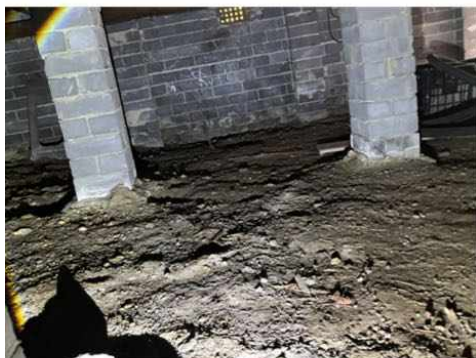
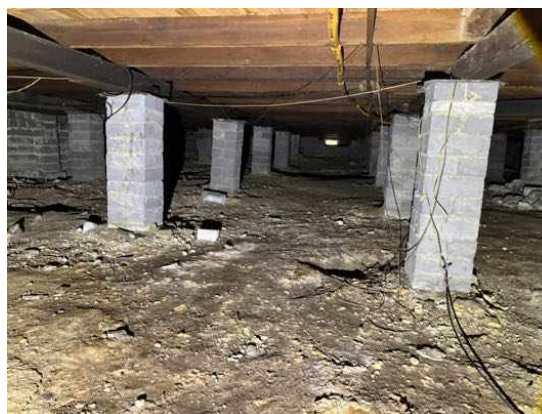
Finding 3.24

Building:	Main Building
Location:	Subfloor
Finding:	Subfloor Site Drainage - Inadequate
Information:	At the time of inspection, inadequate site drainage was observed under the subfloor, allowing water to accumulate and fail to drain effectively, creating a hazardous condition. This is a common defect in houses constructed on brick stumps, where poor site grading and limited subfloor ventilation can contribute to ongoing moisture retention. The resulting water pooling may lead to structural deterioration from prolonged dampness, mould and mildew growth, and create conditions conducive to termite activity. These issues can also impact indoor air quality and pose safety risks to occupants.

The client is advised to engage a licensed plumber or builder experienced in drainage and foundation work to assess and implement suitable solutions, such as improving site grading, installing appropriate drainage systems, and enhancing moisture barriers. In addition, the installation of mechanical subfloor ventilation is recommended to improve air circulation, assist with moisture control, and reduce the risk of ongoing damp-related issues.

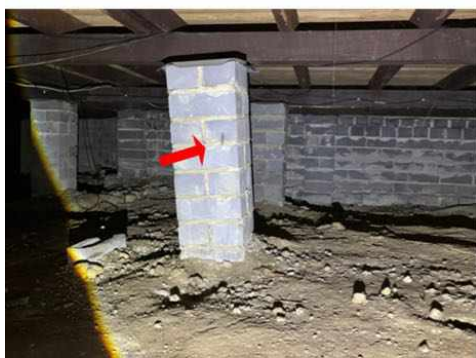
Finding 3.25

Building:	Main Building
Location:	Subfloor
Finding:	Subsidence - Brick Stump/Pier
Information:	At the time of inspection, one of the brick stumps supporting the subfloor structure was observed to be uneven and out of plumb, likely due to localised subsidence. While the issue appears to be isolated and has not yet resulted in significant structural distortion, it may compromise the long-term stability of the floor framing in the affected area.

It is recommended that a licensed builder with experience in re-stumping or subfloor rectification be engaged to assess the extent of movement and carry out any necessary re-levelling or replacement works to restore proper support.

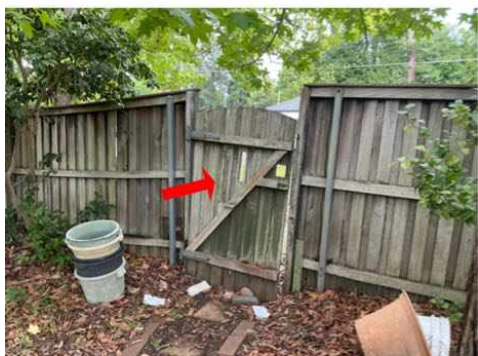
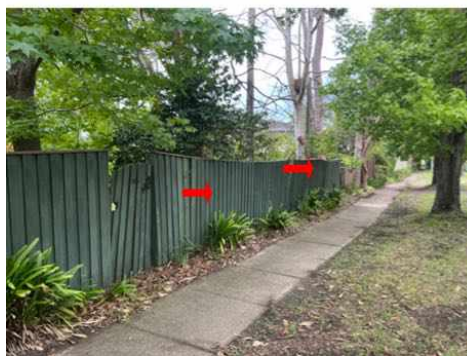
Finding 3.26

Building:	Main Building
Location:	Yard - Front
Finding:	Fencing & Gate - Leaning/Damaged
Information:	At the time of inspection, sections of the boundary fencing were noted to be leaning and damaged. The gate was also damaged. This condition may compromise the structural integrity and intended function of the fence, including privacy and security.

Progressive movement or failure is likely if not addressed. Rectification or replacement by a licensed fencing contractor is recommended to restore proper alignment and stability.
