Building and Timber Pest Inspection Report

Inspection Date: Tue, 3 Mar 2026

Property Address: 14A Eastern Arterial Rd, St Ives NSW 2075,
Australia

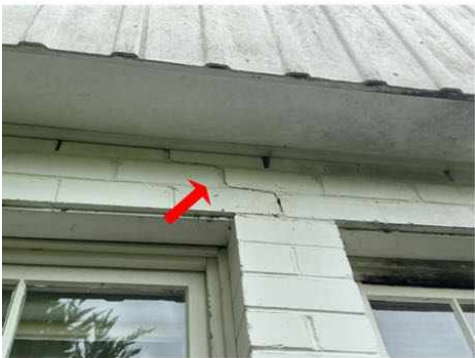
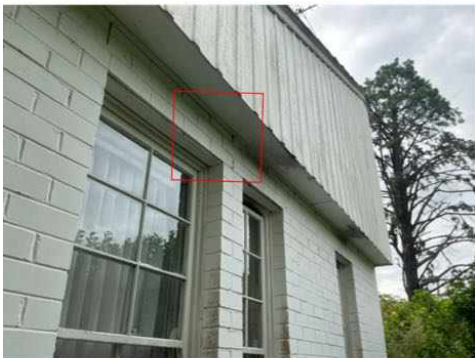
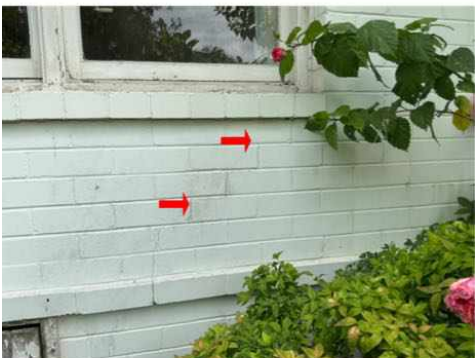
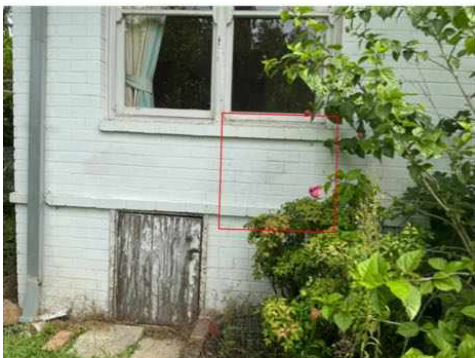
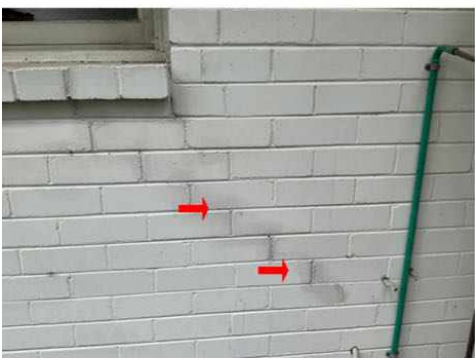
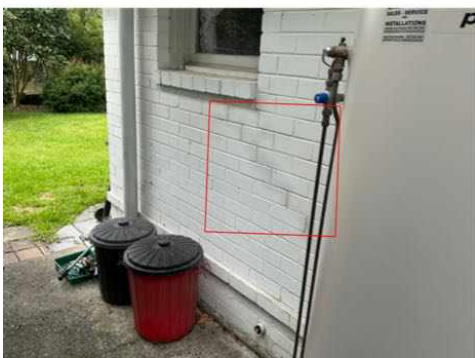
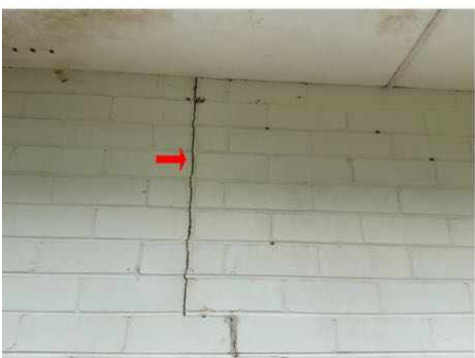
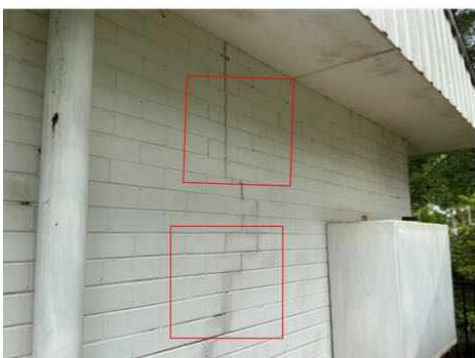
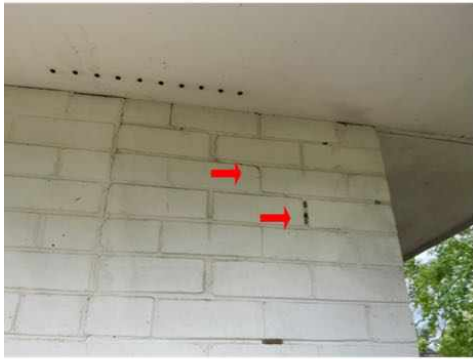
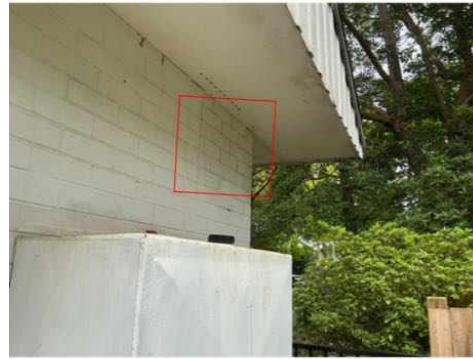
Finding 3.27

Building:	Main Building
Location:	All Areas
Finding:	Brickwork Cracking – External Walls
Information:	At the time of inspection, cracking to the external brickwork was noted to multiple elevations of the dwelling. Step cracking following the mortar joints was observed, consistent with movement within the structure. The cracks appear to fall within Category 2 classification, with widths assessed to be up to approximately 5mm in some areas.

Category 2 cracking is generally considered minor to moderate and is commonly associated with normal building movement, settlement, or seasonal ground moisture changes. At this stage, the cracking does not appear to indicate imminent structural failure; however, movement should be monitored over time.

The client is advised to monitor the cracks periodically. If the cracks increase in width beyond 5mm, continue to extend, or if additional movement becomes evident, a qualified builder and/or bricklayer should be consulted for further assessment and recommendations.

In the interim, the existing cracks may be filled or repointed with appropriate mortar to reduce moisture penetration and maintain the integrity of the brickwork.

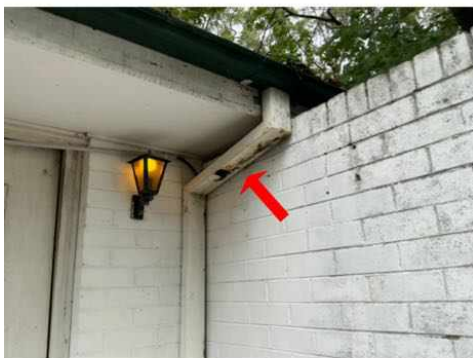
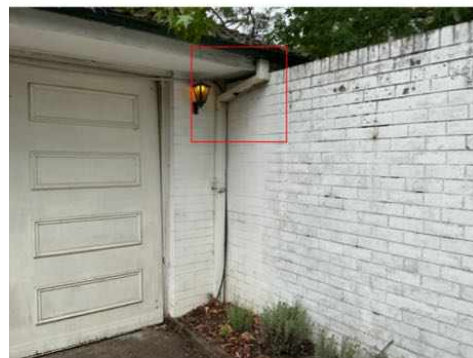
Finding 3.28

Finding: Gutters - Damaged

Information: The gutters were noted as damaged in this area at the time of inspection. Gutter damage can occur due to a range of factors, including prolonged exposure to weather conditions such as heavy rainfall, strong winds, or intense sunlight, which can cause warping, corrosion, or joint separation over time. Debris accumulation from leaves, twigs, and dirt can add extra weight, restrict water flow, and lead to sagging or overflow. Thermal expansion and contraction may also cause gutter joints or fasteners to loosen gradually. In some cases, improper installation, insufficient fall, or inadequate brackets can result in poor water drainage and early deterioration.

Regular cleaning, correct installation, and timely maintenance can help prevent these issues and extend the gutter's lifespan. It is recommended that a licensed roof plumber be engaged to inspect, repair, or replace the damaged sections to ensure proper drainage and avoid potential water ingress or structural damage.

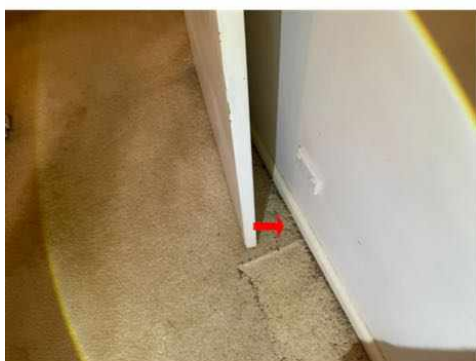
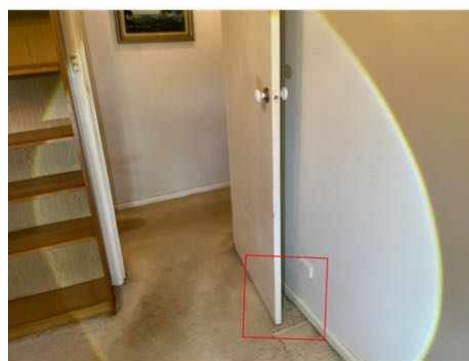
Finding 3.29

Finding: Door Stopper(s) - Missing
 Information: At the time of inspection, it was noted that a door stopper was missing in this area.

The absence of a door stopper can lead to potential damage to the door, wall, or surrounding finishes, as the door may swing open too far and impact the wall or adjacent objects. Over time, this can cause dents, scuffs, or even structural damage to the wall or door. It is recommended that a door stopper be installed to prevent further damage and ensure the protection of both the door and the surrounding area.

The client is advised to engage services of a handyman to install the door stopper.

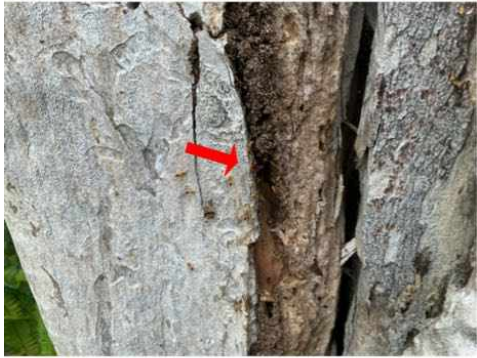
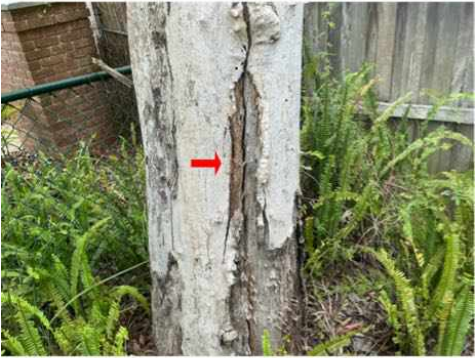
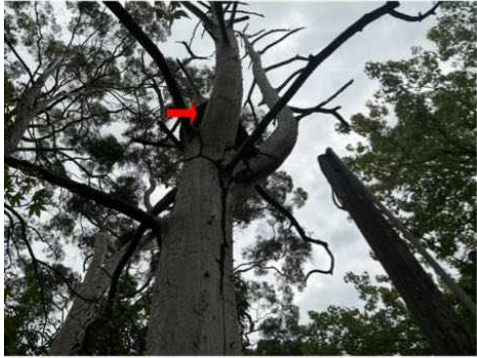
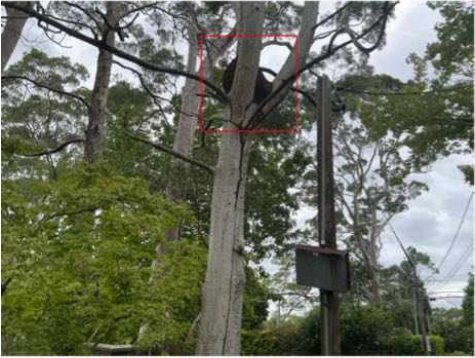
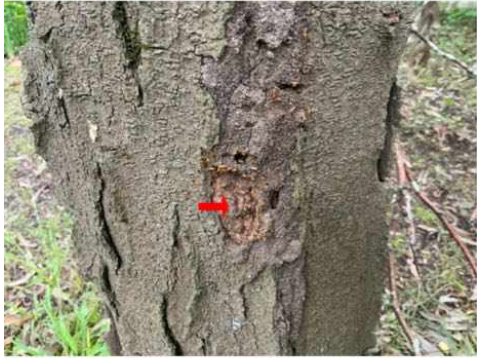
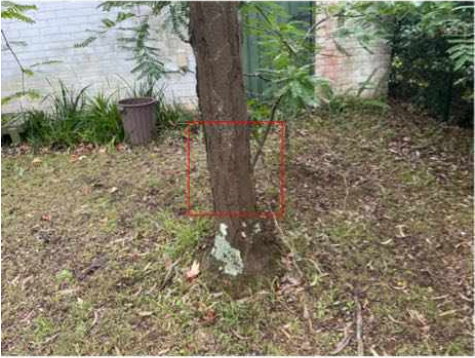
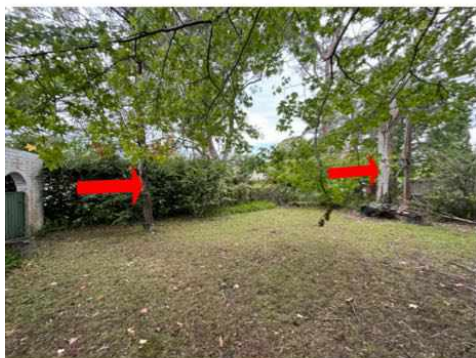
Finding 4.01

Building: Main Building
 Location: Yard - Front
 Finding: Live Termite Activity – Garden Trees
 Information: At the time of inspection, live termite activity was observed within trees located in the garden area of the property. Active termite movement was noted, and a termite nest was identified at the upper section of one of the trees.

No live termite activity or termite damage was noted within the dwelling at the time of inspection. However, the presence of an active colony within close proximity to the structure significantly increases the risk of termites migrating to the building.

program. Installation of a professional termite baiting system is recommended to eliminate the colony and reduce the risk of spread toward the dwelling.

Ongoing monitoring and routine termite inspections are also recommended to ensure early detection should activity occur within the structure in the future.

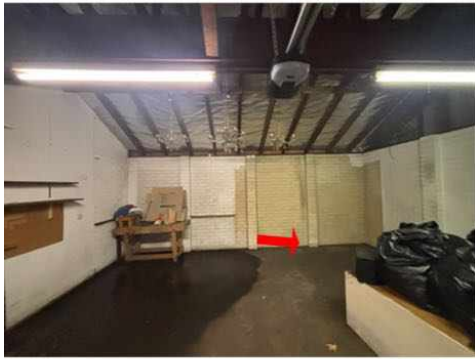
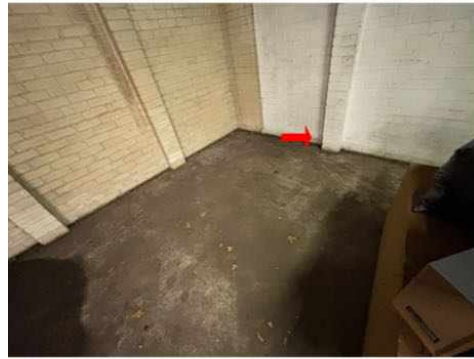
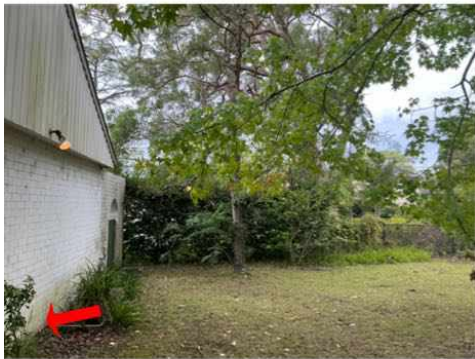
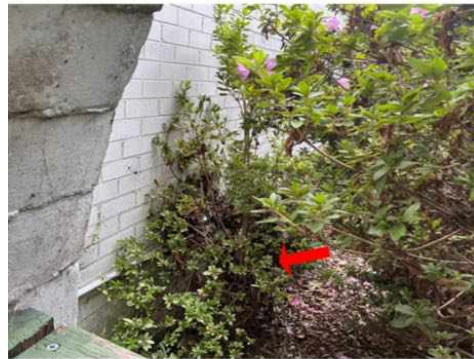
It is important for internal flooring to be raised above adjacent external ground levels. Where external ground levels are above or same level as internal flooring, water pooling and subsequent internal flooding is likely to occur which may attract termite activity to the internal area.

It is highly advised that a landscaper or relevant tradesperson be appointed to lower external grounds that are raised above or same as adjacent internal flooring. Alternatively if external grounds and internal flooring is level installation of a raised door sill may be appropriate in preventing any water pooling in the area. If the client wishes not to make any changes, then a qualified pest controller is recommended for termite treatment around the perimeter of the house and subfloor (if any) as soon as possible.

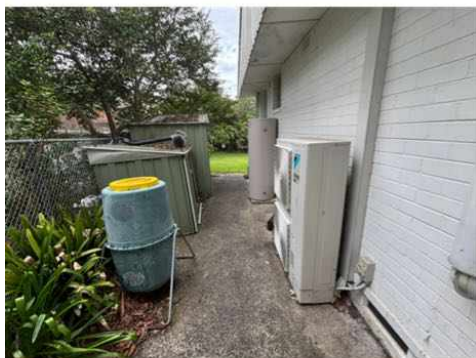
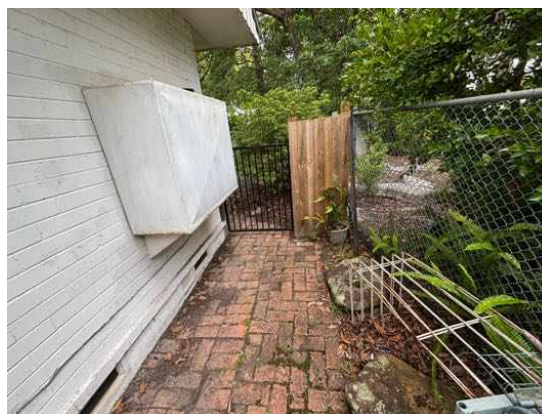
Where any part of an attachment to a building is not isolated and is not provided with a clear gap of not less than 25mm from the building, bridging occurs. Attachments to buildings such as hot water services, downpipes, verandahs, decks, steps, fences, service conduits and the like provide the opportunity for concealed entry.

Building attachments of this nature need to be frequently inspected for termite activity by a qualified inspector.

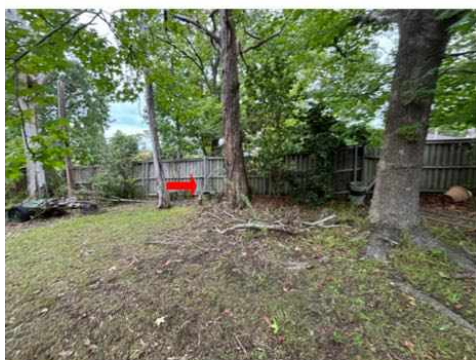
Finding 6.03

Building:	Yard
Location:	Fencing
Finding:	Building Materials in Direct Ground Contact - Conducive to Termites
Information:	Timber elements that are in direct contact with the ground and exposed to moisture or damp conditions are highly conducive to termite activity. This susceptibility arises because timber, when in contact with soil and dampness, creates an environment that is particularly attractive to termites, encouraging infestation and potential structural compromise. Whether the timber is used as a part of the building's construction or incorporated into fencing, its presence near or on the ground can become a pathway for termites to access and damage the property.

When exposed to excessive moisture, timber begins to deteriorate, developing conditions such as wood decay and rot. These compromised areas of timber are even more appealing to termites, as they are easier to infest and consume. This is especially true for untreated or non-durable timber, which lacks the protective treatments that can deter or withstand termite attacks. Termites can use these weakened, moisture-laden elements as a bridge into other parts of the structure, creating an entry point for potential infestations that can spread and cause extensive damage if left unchecked.

For any timber in direct contact with the external ground, special attention is required. The combination of moisture, untreated wood, and direct ground contact not only accelerates the decay process but also provides subterranean termites with a straightforward means of ingress into the structure. This entry can lead to termites moving undetected into other vulnerable areas, resulting in potentially significant structural issues and costly repairs.

To mitigate the risk of termite activity, it is imperative that any such materials or timber elements be appropriately treated or removed as soon as possible. Timbers that are necessary for use should be made durable through appropriate treatments and maintained to ensure they do not create conditions conducive to termites. Additionally, the client is advised to schedule regular termite treatments to maintain an effective barrier against infestations and ensure ongoing protection.

The client is strongly advised to assess the property for any timber elements that may be in direct contact with the ground and ensure prompt action is taken to remove or treat them effectively. Regular inspections, proactive maintenance, and consistent termite treatment are essential steps in minimising the risk of termite attack and protecting the structural integrity of the property. Taking these preventive measures is crucial for maintaining a termite-free environment and avoiding potentially costly damage and future repairs.

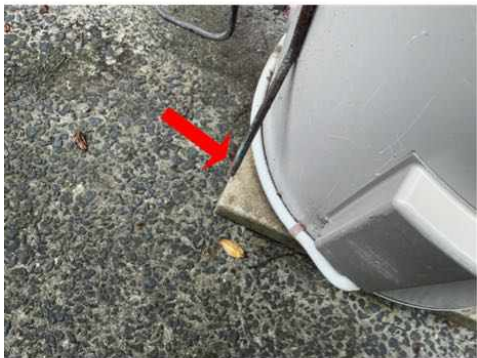
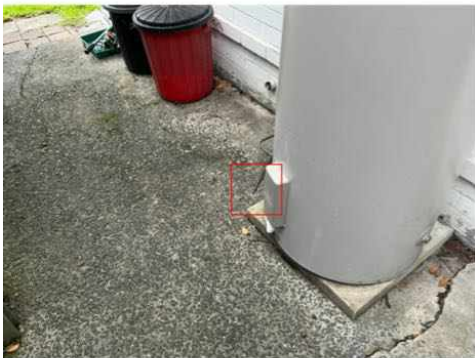
Finding 6.04

Building:	Main Building
Location:	Exterior walls - left side
Finding:	Overflow Disconnected - HWS/AC/Gas - Conducive Conditions to Termites
Information:	The overflow to this service was found to be disconnected from stormwater drainage and is creating excessive moisture in the surrounding area.

Such leaking creates an environment that is conducive to an array of defects, including water damage to associated building elements and the attraction of termite or timber pest infestation. These damp conditions can lead to secondary defects such as rot, rust, or corrosion of associated building elements, the formation of fungal decay, or even the creation of potential slip hazards. When coupled with poor site drainage, pooling of water may also attract termite activity to this area.

It is highly recommended that a licensed plumber be appointed to connect the overflow in order to prevent such an environment from being created. These minor works should be carried out as soon as possible.

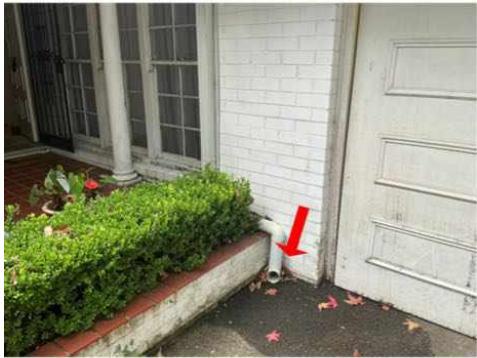
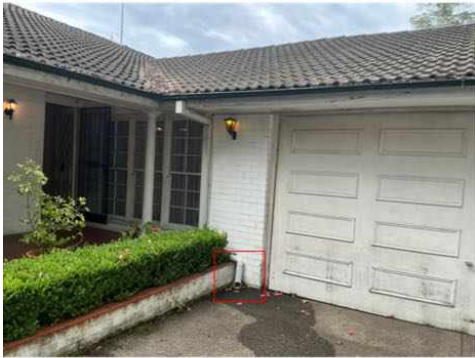
Finding 6.05

Building: Main Building
Location: Yard - Front
Finding: Stormwater Drain - Not Connected (Roof Plumbing)
Information: The inspection revealed that the roof plumbing system is not adequately connected to the site’s stormwater drainage, reducing its functional efficiency. This disconnection can lead to water pooling around the base of the property, increasing the risk of rust and corrosion to building elements, structural damage, and attracting termites due to the persistent dampness.

Improper drainage can also contribute to mould and mildew growth, affecting indoor air quality and health, and may lead to ground movement, causing cracks in walls and other structural issues.

It is strongly recommended that a licensed roof plumber be engaged to assess the system and ensure appropriate connections to stormwater outlets are installed to effectively redirect water away from the structure.

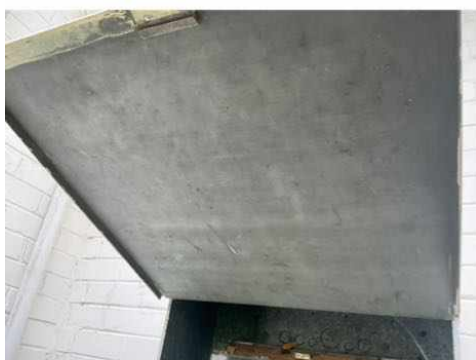
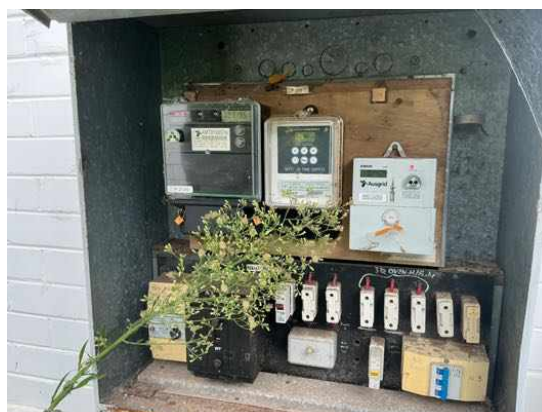
Finding 6.06

Building: Main Building
Location: Meter Box

Finding: Termite Management System - No Evidence of Installation
Information: The application of a post-construction chemical termite barrier is strongly recommended for all properties, especially if there has been any history of live termite activity on-site. These barriers are highly effective in protecting timber building elements throughout the property by preventing termite attacks. It is also advisable to install a durable notice within the switchboard unit, indicating the presence of any termite barriers for future reference.

During the inspection, there was no indication that a termite management system had been installed, nor was there any evidence to suggest that preventative measures had previously been undertaken. The client is encouraged to seek further advice from a licensed pest controller regarding the costs and procedures involved in the application of a termite barrier. Prioritizing this step in the short term is strongly advised to ensure long-term protection.

Additionally, the client may want to consult with the vendor to determine whether regular Timber Pest inspections, as per AS4349.3 or AS 3660.2, have been conducted in the past. This will provide further insights into any past termite management practices and help inform the appropriate course of action.

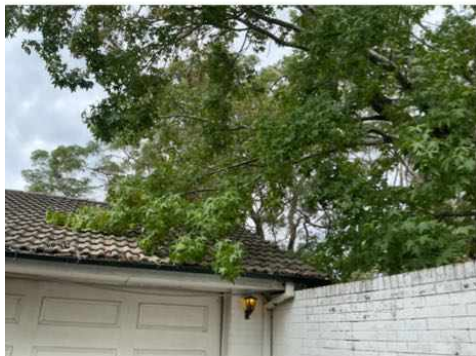
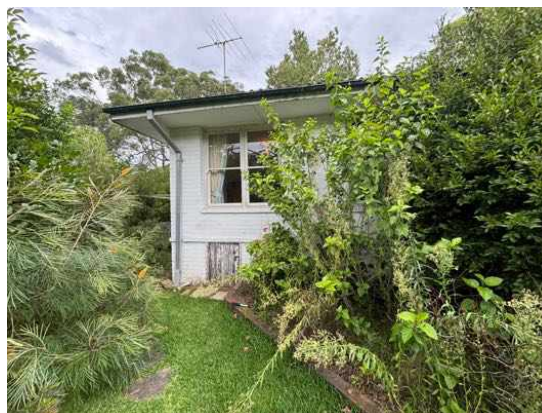
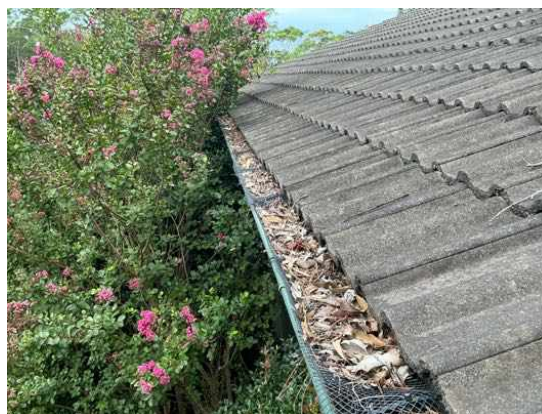
Finding 6.07

Building: Main Building
Location: All Areas
Finding: Overhanging Trees/Branches/Roots
Information: Overhanging trees and exposed roots were noted near the property, which pose potential risks to the structure and surrounding areas.

The overhanging branches can cause damage to the roof, gutters, or walls, particularly during storms or high winds. Additionally, the roots may pose a threat to the foundation by causing ground movement, leading to cracks or uneven settling over time. The accumulation of leaves and debris in gutters and drainage systems can also lead to blockages, contributing to water overflow and potential water damage.

It is recommended that a qualified arborist be engaged to prune back the overhanging

branches and assess any potential risks posed by the tree roots to prevent further damage to the property. It is advised to get this fixed as soon as possible. Regular maintenance should be carried out to ensure the trees are managed effectively and the property remains safe.

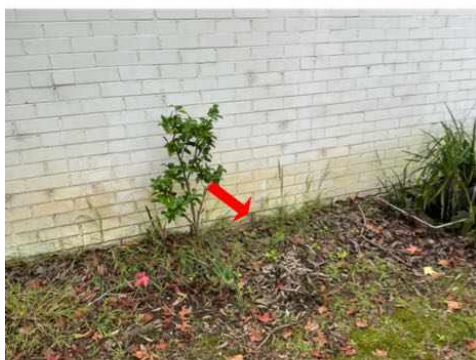
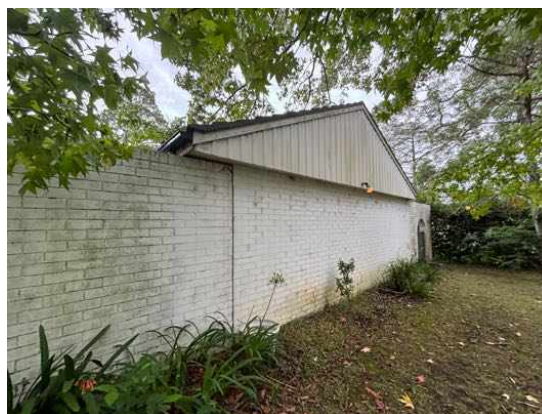
Finding 6.08

Building:	Main Building
Location:	Exterior walls - front
Finding:	Weep Holes - Blocked & At Ground Level
Information:	At the time of inspection, weep holes were observed to be blocked, and on ground level. This condition can trap moisture within the wall cavity and allow concealed termite entry by bridging the inspection zone. Clearing the weep holes and reducing ground levels below the weep holes is required to reduce moisture issues and termite risk. Consider engaging a licensed pest controller to carry out a termite treatment around the perimeter of the building.

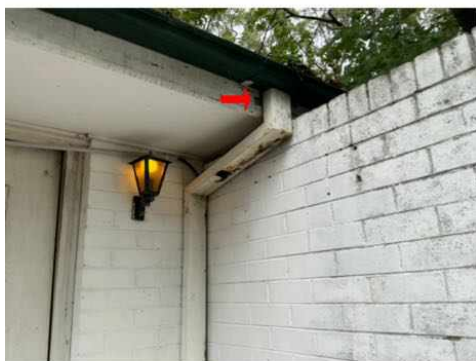
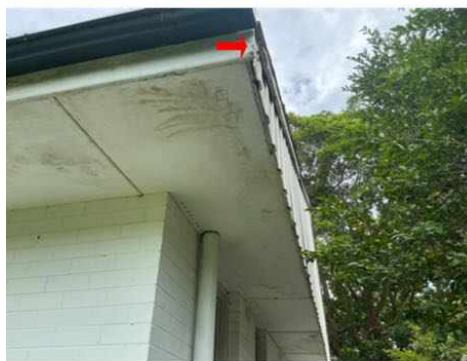
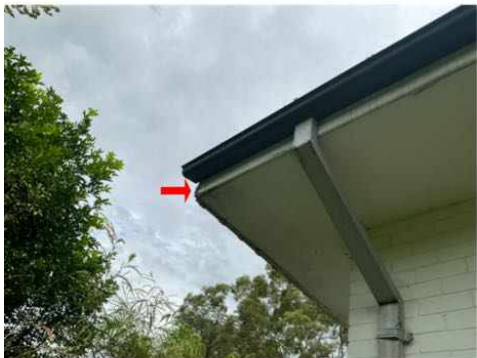
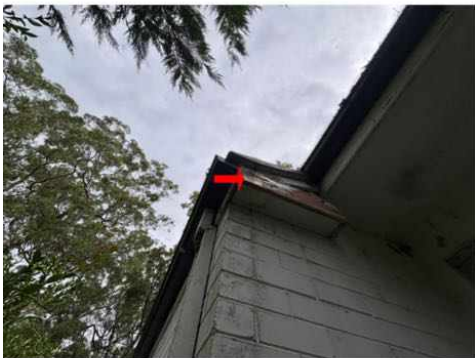
Finding 7.01

Building:	Yard
Location:	Fascia
Finding:	Fungal Decay - Present (Localised)
Information:	Fungal decay, also referred to as wood decay or wood rot, typically occurs when timber elements are exposed to excessive moisture for extended periods. This deterioration process is accelerated by temperatures ranging between 5°C and 40°C, as well as the presence of oxygen. Fungal decay is commonly found in timber components used in external environments, particularly when they are exposed to rain or moisture penetration.

In this instance, although the timber element shows signs of decay, the visible damage appears to be localized to a specific area and has not yet spread to adjoining structures or other parts of the building element. As a result, the fungal decay is likely to be relatively superficial, with minimal impact on the structural integrity or tensile strength of the timber. However, it is advisable to monitor the affected area to prevent further deterioration and address the underlying moisture issue to mitigate future risk.

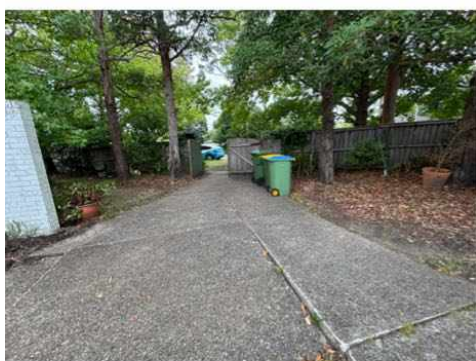
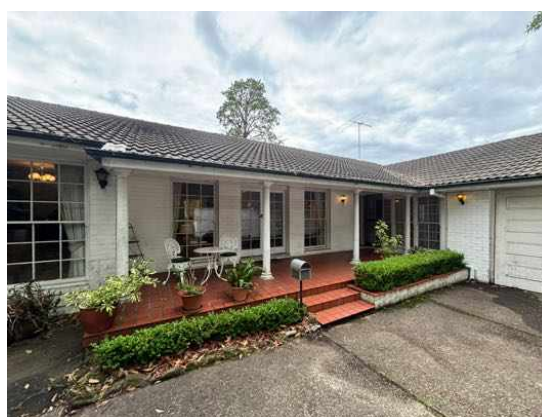
Building: Main Building
Location: All External Areas
Finding: Obstructions and Limitations - External Areas
Information: The attached photographs provide a visual representation of the obstructions and limitations that impeded a full inspection of the external areas of the property at the time of assessment. These obstructions, which may include vegetation, stored items, debris, or other physical barriers, can obscure potential defects and prevent a thorough evaluation of the property's condition. Obstructions of this nature can conceal a wide range of issues, such as structural damage, water ingress, pest infestations, or deteriorating building materials, which may not be visible during the initial inspection.

It is essential that these obstructions be cleared to allow for a comprehensive inspection of the external areas. Removing these barriers will enable a more accurate assessment of the property's condition and allow any hidden defects to be identified and addressed promptly. Failure to do so could result in undetected issues worsening over time, potentially leading to more costly repairs in the future.

Therefore, it is strongly recommended that the obstructions be removed and a re-inspection be scheduled once the affected areas are made fully accessible. This will ensure a complete evaluation of the property's exterior and provide the client with a clear understanding of any potential issues that may have been concealed during the initial inspection.

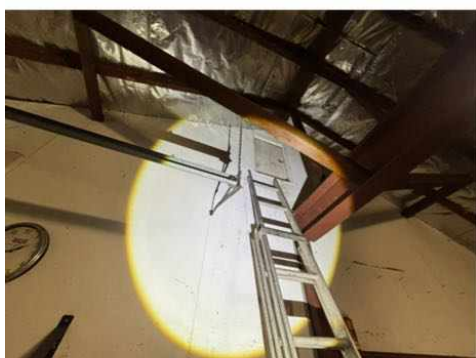
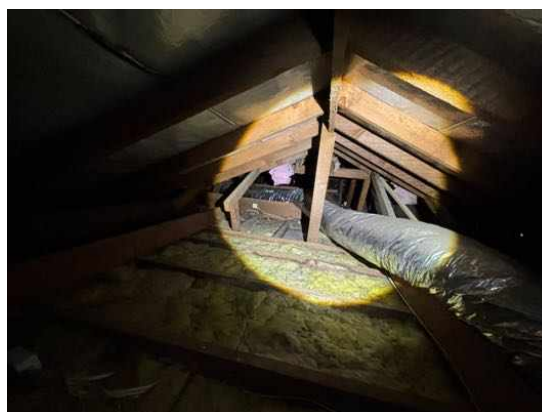
Building: Main Building
 Location: Roof Void
 Finding: Obstructions, Limitations, and General Roof Space Condition
 Information: The photographs provided document both the general condition and the obstructions and limitations that were present in the roof cavity of the main building at the time of inspection. These obstructions—such as insulation materials, stored items, structural elements, or electrical wiring—restricted safe and adequate access to key areas within the roof space. As a result, a comprehensive inspection of all components could not be completed.

Obstructions of this nature may conceal a variety of potential defects, including damaged framing, compromised insulation, evidence of moisture ingress, pest activity, or electrical hazards. While no major issues were observed in the visible areas, the presence of these limitations means that some defects may remain undetected.

It is recommended that these barriers be removed or repositioned to facilitate full and safe access to the roof space. Once clear, a follow-up inspection should be conducted to allow for a thorough assessment of all concealed areas. This will help ensure that the condition of the roof cavity is accurately evaluated and any hidden issues are appropriately identified and addressed.

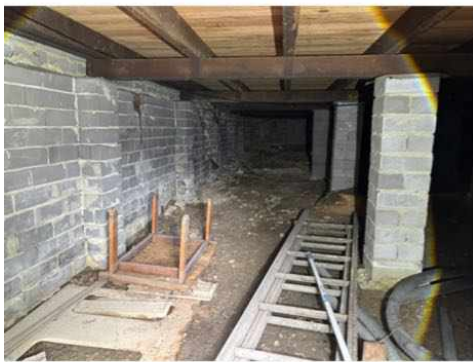
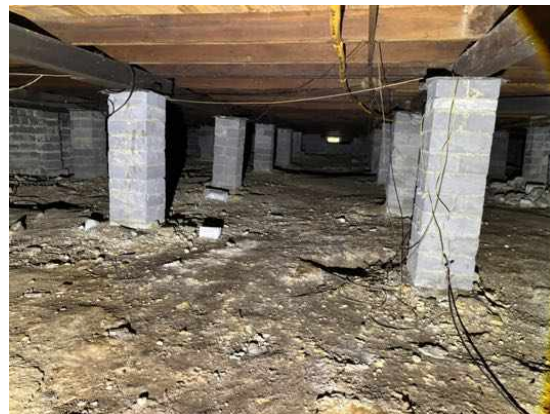
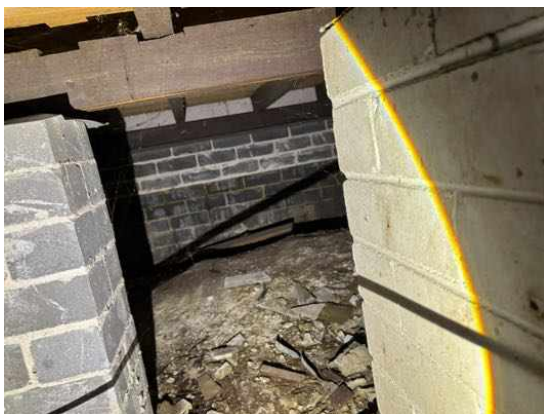
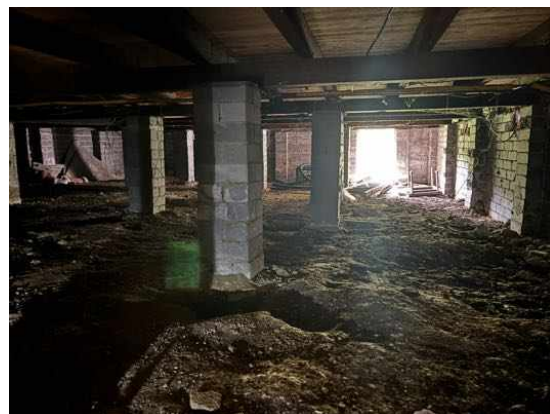
Building: Main Building
Location: Subfloor
Finding: Obstructions, Limitations, and General Subfloor Condition
Information: The attached photographs illustrate the obstructions and access limitations that restricted a full inspection of the subfloor area of the main property at the time of assessment. Items such as stored materials, construction debris, low-hanging services, and insulation impeded movement and visibility within key sections of the subfloor. In addition, the limited crawl height further restricted safe access to inspect critical structural components.

Restricted access and confined spaces can significantly hinder the ability to evaluate important elements such as floor joists, bearers, stumps, drainage, subfloor ventilation, and signs of moisture or pest activity. These obstructions may also conceal defects such as timber decay, water ingress, termite damage, inadequate support, or ventilation issues that are not immediately visible during a limited inspection.

While no major concerns were identified in the accessible areas, a full and unobstructed inspection is necessary to properly assess the overall condition of the subfloor. It is recommended that obstructions be removed and access improved where possible. Once adequate clearance is provided, a re-inspection should be arranged to ensure that any concealed defects can be identified and addressed accordingly. This will assist in providing a more comprehensive understanding of the subfloor's condition and reduce the risk of unforeseen issues.

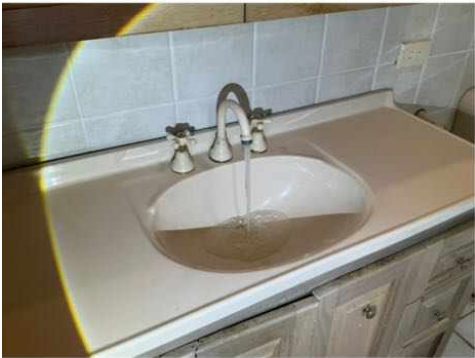
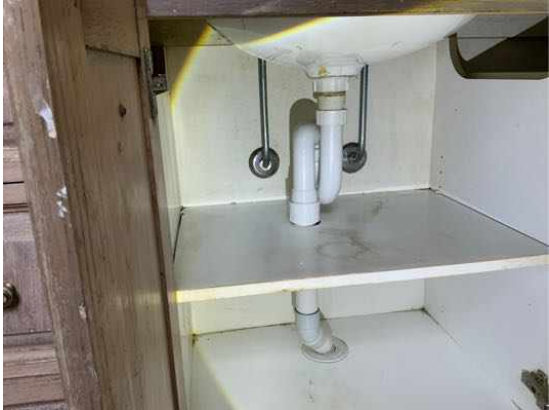
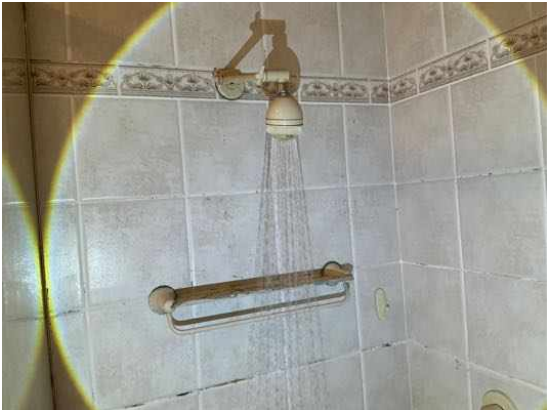
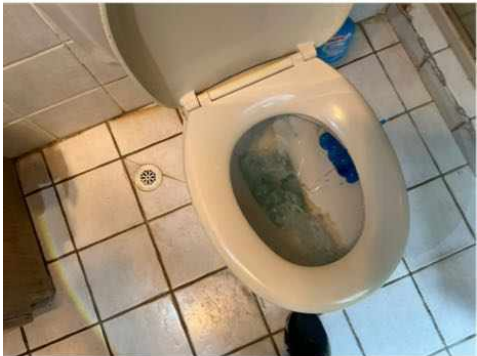
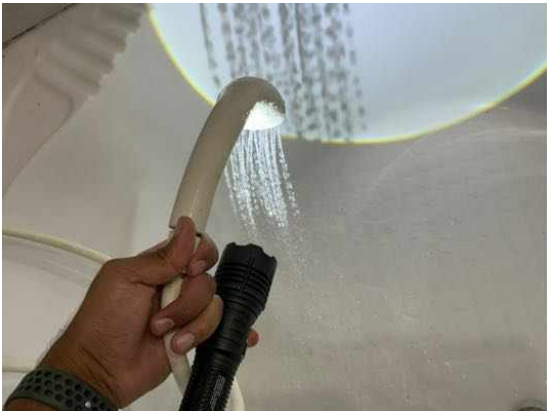
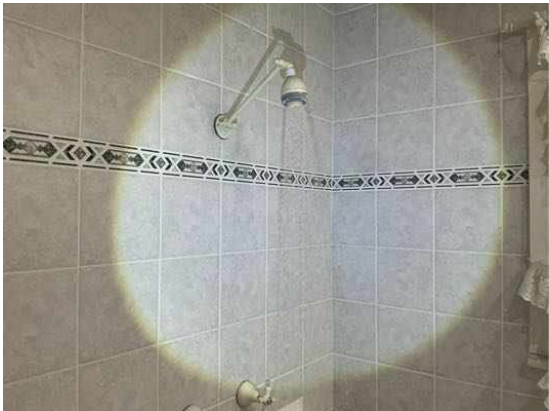
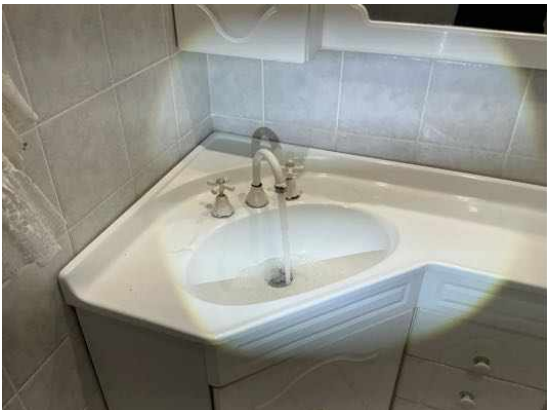
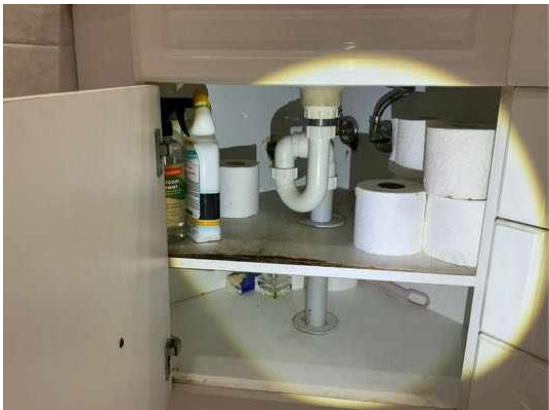
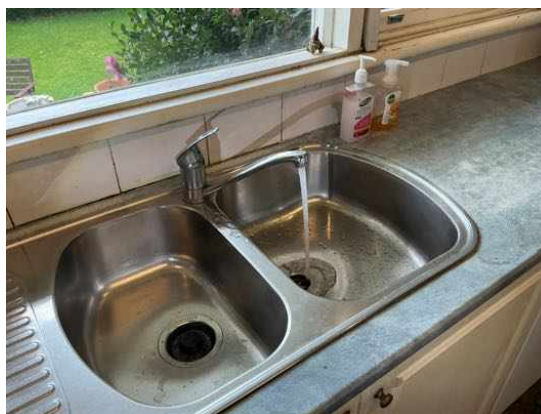
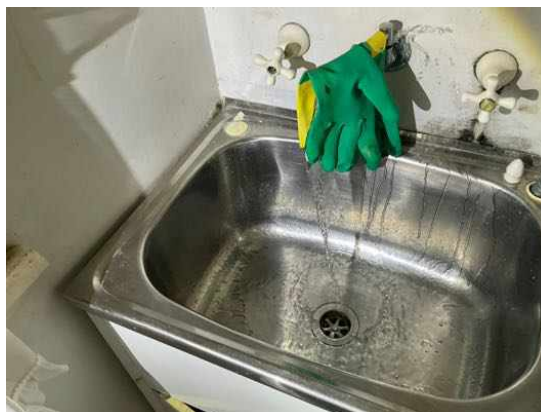
Building: Main Building
 Location: All Areas
 Finding: FYI - Taps, Drainage & Toilets Tested and Cabinetry Obstructions
 Information: During the inspection, all accessible taps, drainage systems, and toilets were tested for water flow and drainage efficiency, and checked for any visible signs of leakage. At the time of the inspection, no issues were noted in these areas. Unless highlighted in a separate defect statement, no immediate remedial work appears necessary. Supporting images may be found in the additional photos section for reference.

It is important to note that while a visual inspection of cupboards and cabinetry beneath sinks and vanities was undertaken, stored personal items and fixtures presented obstructions that limited full visibility of the internal areas. As per standard inspection practices, inspectors are not permitted to move or disturb personal belongings during the inspection process. Therefore, only visible and accessible sections were inspected, and concealed water damage or plumbing defects may not have been detected.

Given this, a re-inspection is recommended after all obstructions have been cleared to allow for a comprehensive assessment of these areas. Regular maintenance and monitoring of plumbing and drainage systems is also advised to ensure ongoing functionality and early detection of potential issues.

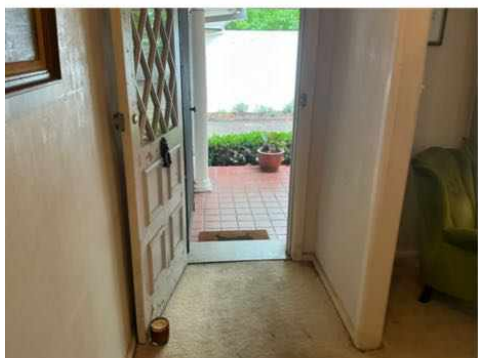
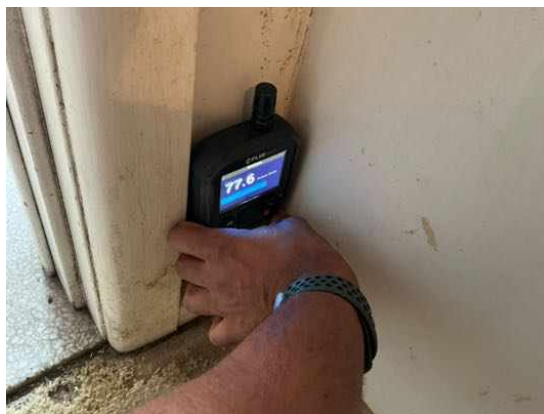
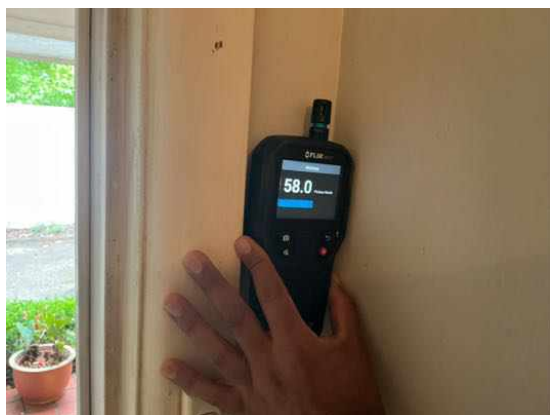
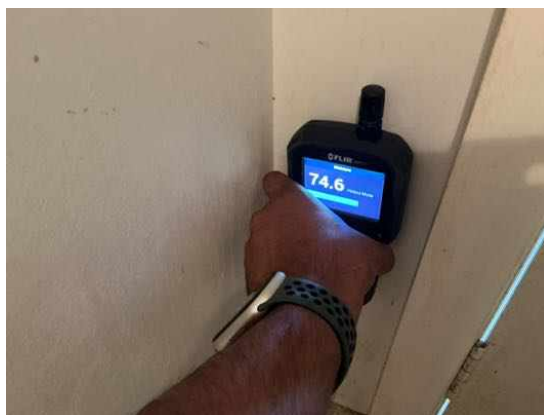
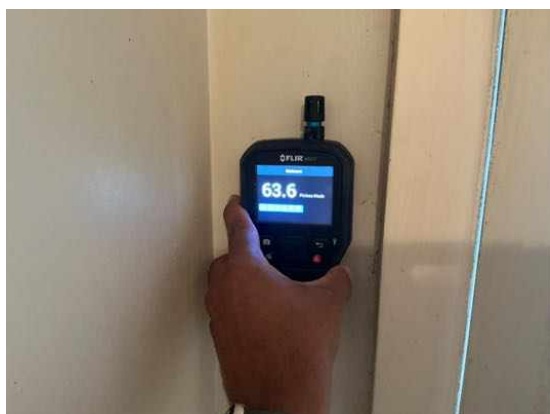
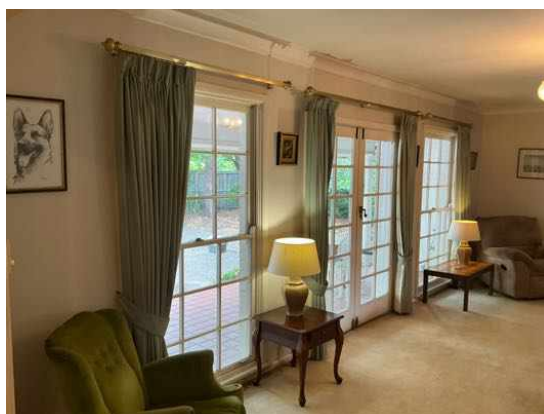
Building:	Main Building
Location:	All Areas
Finding:	Additional Photos - Moisture Meter Readings
Information:	Additional moisture meter reading photos have been provided for the property to offer further clarity on areas tested during the inspection. These photos are intended to give a visual reference for the specific locations where moisture levels were measured. These readings were taken at the time of the inspection to assess any potential moisture-related issues within the property. Any defects related to moisture that were identified during the inspection have been separately mentioned in the defect statements within the report.

It is important for the client to understand that moisture levels can fluctuate over time due to various factors, including changes in weather, humidity, and environmental conditions. While the readings reflect the property's moisture levels during the inspection, they may not represent future conditions, and increased moisture could lead to issues such as dampness, mould growth, or deterioration of building materials if left unmonitored.

For further clarification or additional information regarding the moisture readings, the client is encouraged to contact the building inspector directly. Regular monitoring of moisture-prone areas is recommended to ensure any emerging concerns are addressed promptly, particularly during wetter seasons or in high-humidity conditions.

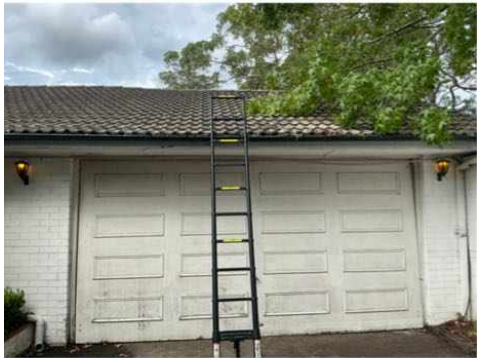
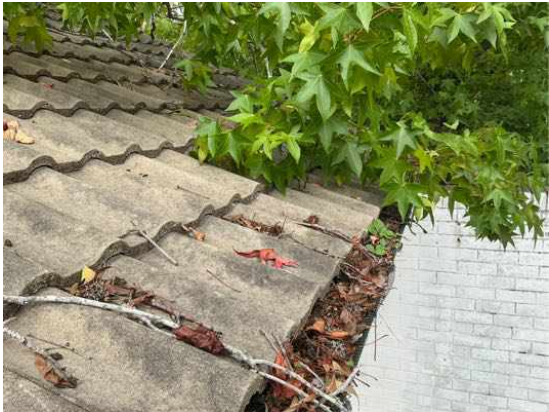
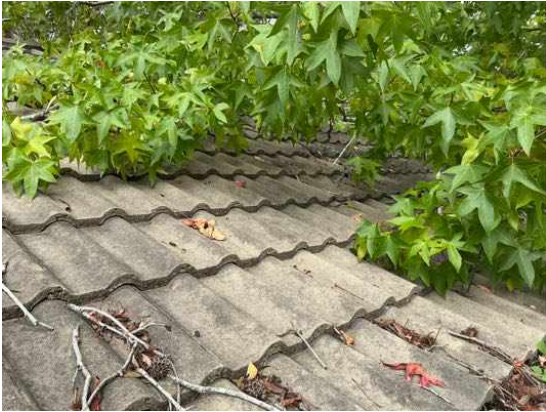
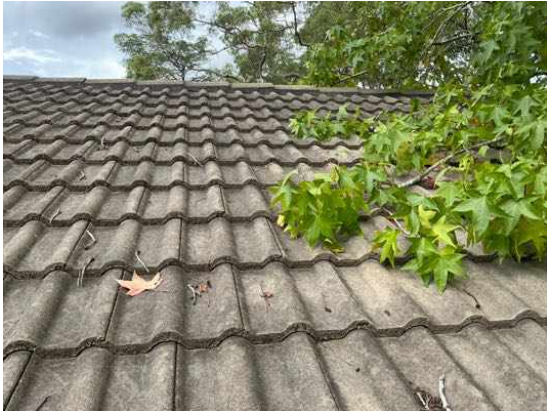
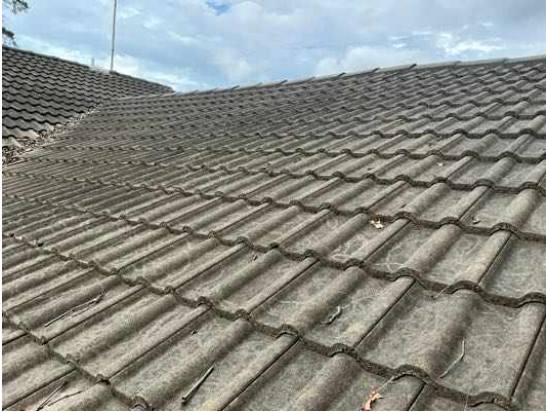
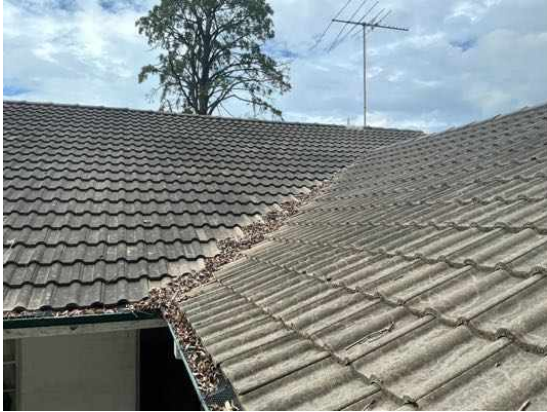
Building: Main Building
 Location: Roof Exterior
 Finding: Additional Roof Photos
 Information:

As part of the information provided, please note that the attached roof photos represent the condition of the roof at the time of inspection. These photos are for visual reference only and do not constitute a detailed roofing assessment. Any defects or issues identified with the roof are mentioned separately in the defect statements. It is strongly recommended that the client engage a qualified roofer to conduct a thorough inspection of the roof, ensuring that any potential issues, such as leaks, structural integrity, or wear and tear, are properly identified and addressed.

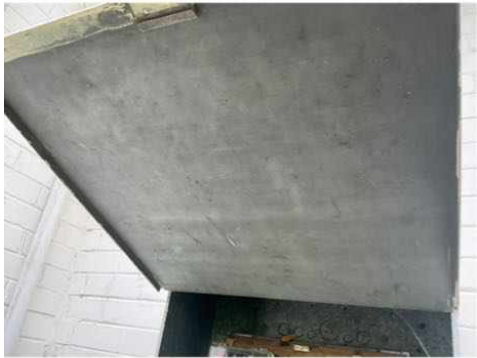
Building: Main Building
 Location: Meter Box
 Finding: Termite Management Recommendation – No Evidence of Chemical Installation
 Information: At the time of inspection, there was no visible evidence of a chemical termite management system installed around the property. Chemical barriers are a key component of termite protection and are particularly important in preventing concealed termite entry into timber elements of the structure.

In accordance with standard requirements, a durable notice should be located within the electrical switchboard to detail any termite protection systems applied, including chemical treatments. No such notice was observed during the inspection.

It is recommended that the client engage a licensed pest controller to assess the suitability of installing a chemical barrier, and to provide advice on associated costs and procedures. This should be considered a short-term priority, particularly if the property has any history of termite activity or is located in a high-risk area.

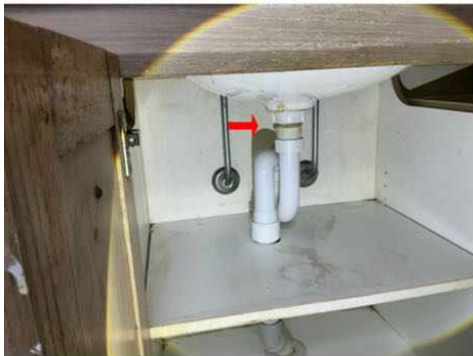
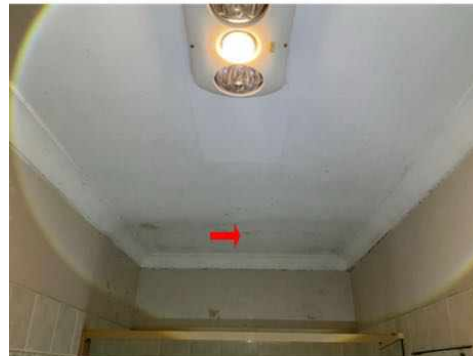
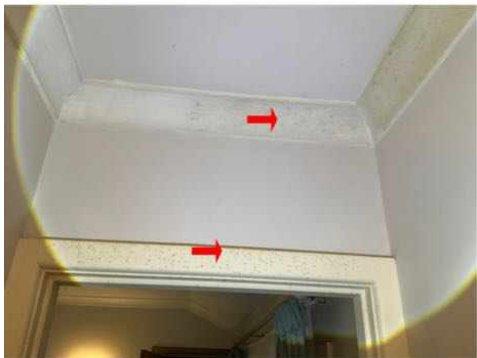
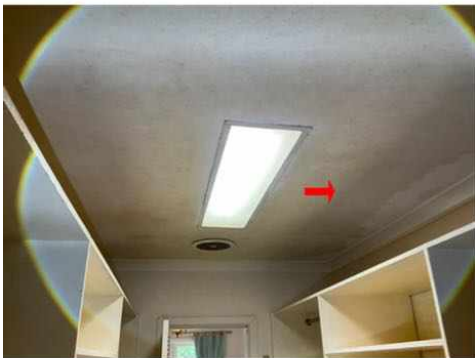
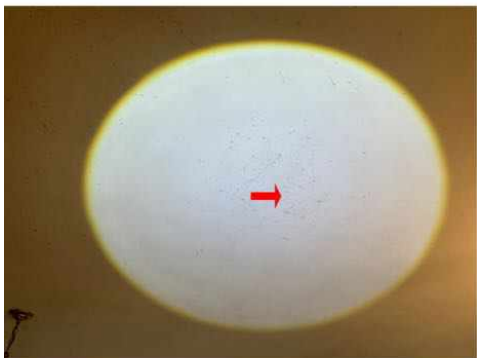
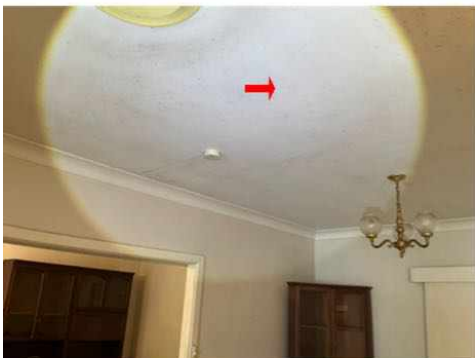
Information: Where evidence of suspected mould growth was identified during the inspection, there may be associated environmental, biological, or health concerns. In cases where the suspected mould is extensive or where questions regarding air quality, spores, or other related issues arise, it is recommended to engage a suitably qualified mould inspector. The inspector can take samples of the suspected mould, send them to a laboratory for analysis, and confirm whether it is mould and its type, allowing for a more accurate assessment and appropriate remediation.

To prevent further mould growth, the client is advised to maintain a dry and well-ventilated environment by addressing moisture and humidity levels within the property. Any suspected mould observed during the inspection should be cleaned promptly by the homeowner or a professional cleaning contractor, depending on the extent of the growth.

For building elements severely affected by suspected mould and beyond repair, replacement by a registered builder or qualified carpenter may be required to ensure the structural integrity of the property. Timely action is essential to mitigate potential health risks and prevent further deterioration.

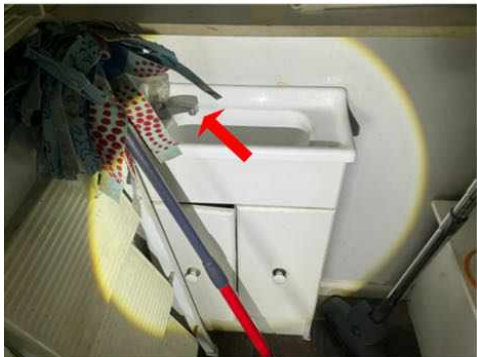
Building: Main Building
Location: Laundry Storage
Finding: Tap - Not Working
Information: At the time of inspection, one of the taps was found to be non-functional, with no water flow when tested. This may be due to a faulty valve, internal blockage, or disconnection within the plumbing system. The client is advised to engage a licensed plumber to assess and repair the issue to restore proper function.
