Building and Timber Pest Inspection Report

Inspection Date: Tue, 3 Mar 2026

Property Address: 14A Eastern Arterial Rd, St Ives NSW 2075,
Australia

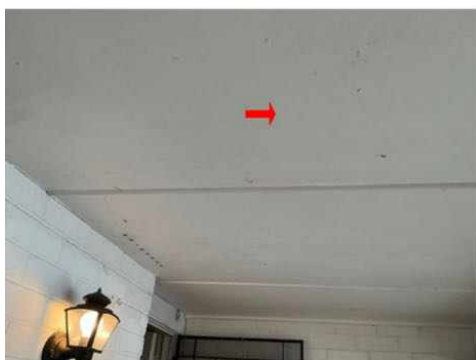
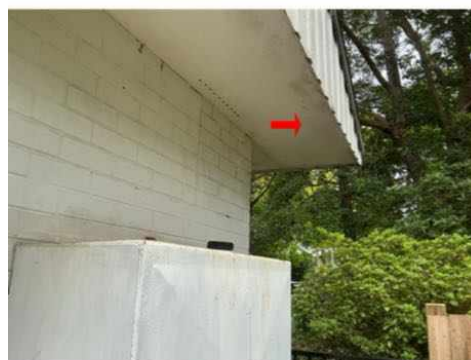
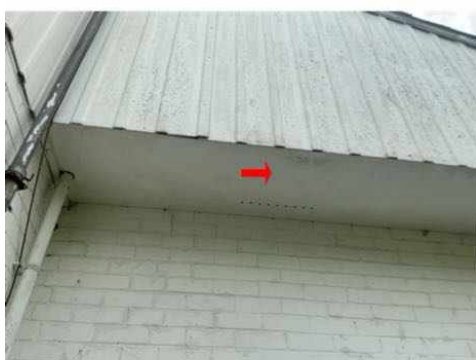
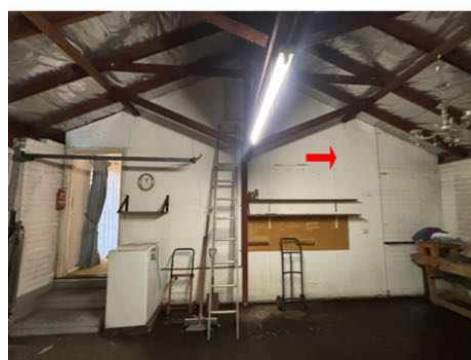
Building: Main Building
 Location: Eaves, Garage
 Finding: Asbestos - Suspected ACM Identified on Site
 Information: Reporting on Asbestos is outside the Scope of this Report. This suspected defect is highlighted as a caution only. We suspect, based on our experience in the building industry, that there is a higher risk of the identified building element containing asbestos.

As Asbestos Reporting is outside the scope of this report, we advise that you consider a separate Asbestos Inspection and Condition Audit, which can include the taking of samples for definitive confirmation of the presence of Asbestos.

In the interim, the client is advised to act with caution, especially when considering any damage to building materials general wear and tear renovations extensions demolition and general maintenance activities due to the suspected presence of Asbestos.

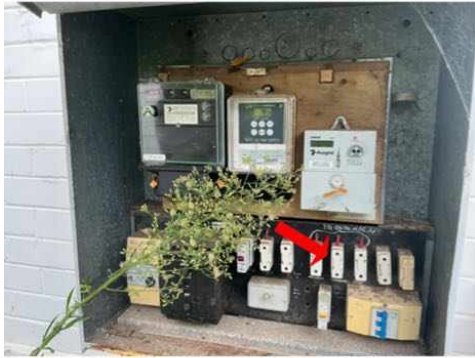
Building: Main Building
 Location: Meter Box
 Finding: Electrical Switchboard - Old Ceramic Fuses
 Information: At the time of inspection, the electrical switchboard appeared to be fitted with safety switches; however, older-style ceramic fuses were also observed.

While the presence of ceramic fuses is not considered a defect in itself, it is noted for the client's consideration that the switchboard may require upgrading in the short to medium term to improve the overall safety, reliability, and functionality of the electrical system.

It is recommended that a suitably licensed electrician be engaged to assess the installation and provide a quotation for any necessary upgrade works. Such an assessment may also identify additional rectification works required to bring the electrical system into compliance with current standards.
