Building and Timber Pest Inspection Report

Inspection Date: Wed, 1 Apr 2026

Property Address: 7 Manor Grn, Macleod VIC 3085, Australia

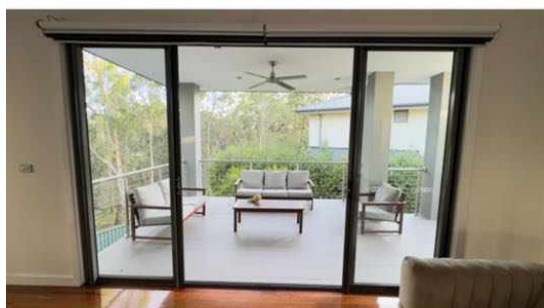
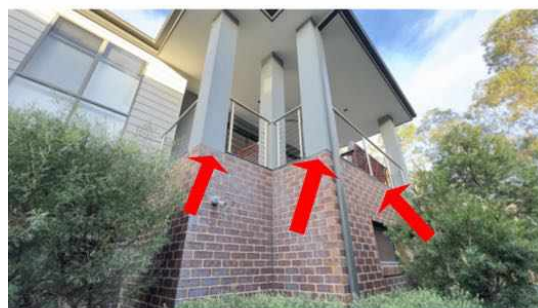
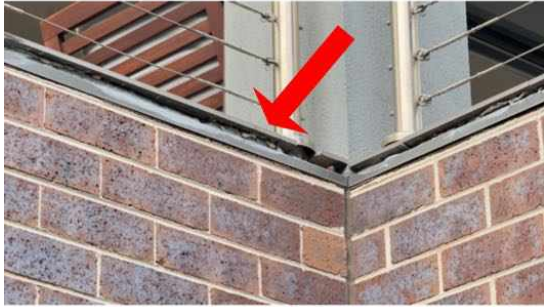
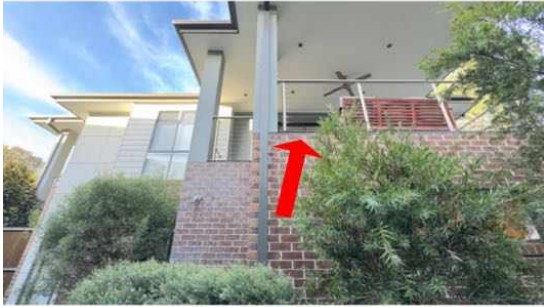
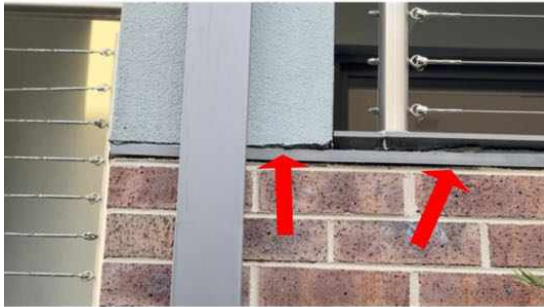
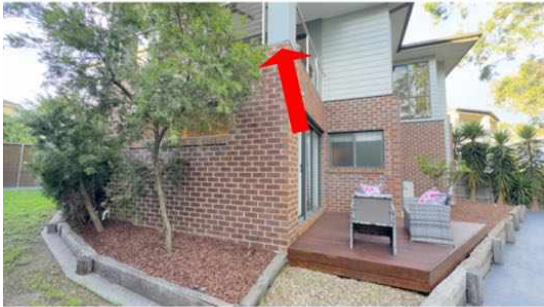
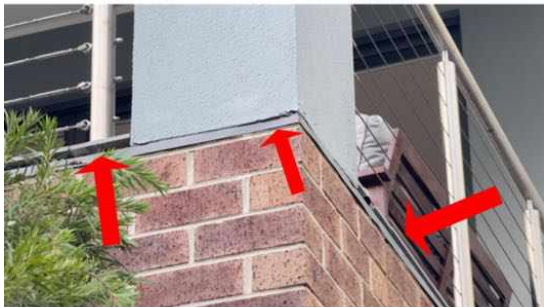
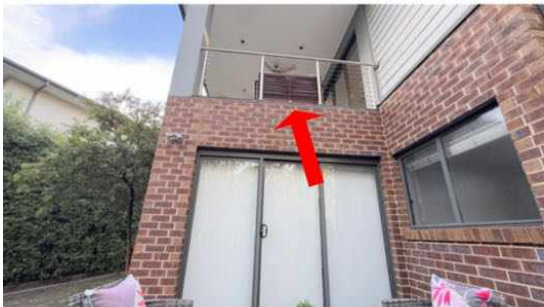
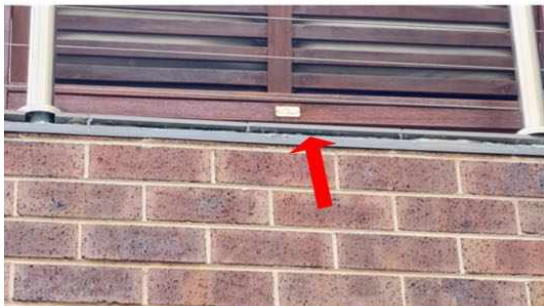
Building:	Main Building
Location:	Balcony
Finding:	Balcony - Inadequate Screed, Waterproofing & Exposed Substrate
Information:	At the time of inspection, the balcony was observed to have inadequate screed installation, compromised or insufficient waterproofing, and areas of exposed substrate. These conditions indicate that the balcony surface has not been constructed or maintained to an acceptable standard.

Inadequate screed can result in poor falls and ineffective drainage, while defective or absent waterproofing allows water to penetrate into the underlying structure. The presence of exposed substrate further increases the risk of water ingress and accelerated deterioration of building elements.

If left unaddressed, these issues may lead to ongoing water penetration, deterioration of finishes, structural damage, and increased repair costs.

It is recommended that a registered builder and qualified waterproofing specialist be engaged as a matter of urgency to assess the balcony, undertake removal of affected materials, install a compliant screed with appropriate falls, apply a suitable waterproofing system, and reinstate the balcony surface in accordance with current standards.

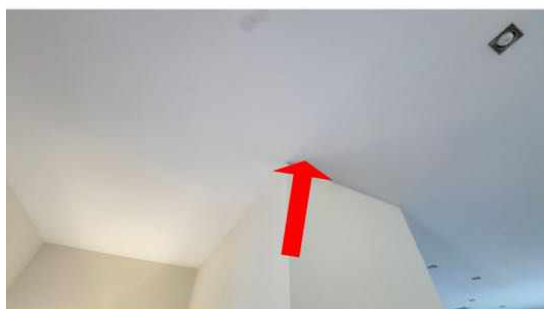
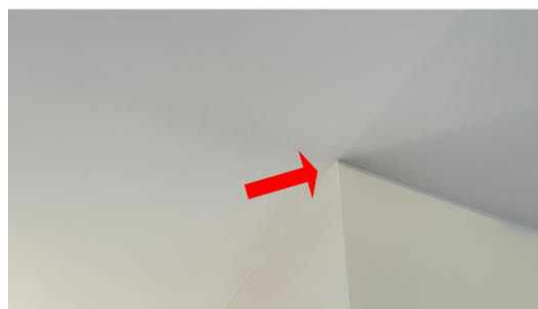
Finding 3.01

Building:	Main Building
Location:	Hallway
Finding:	Ceilings - Minor Plaster Cracking
Information:	The ceilings were inspected and cracking in the plaster was observed in this area. Cracks can affect the appearance of the ceilings and may worsen over time if left unaddressed.

When practical, a qualified plastering contractor should be engaged to assess and repair the cracked plaster. Prompt action will improve the appearance of the ceilings and help prevent further deterioration.

Cracking should be monitored over time to determine whether movement is ongoing. Where cracks are purely cosmetic, patching and repainting by a qualified plasterer may be undertaken as part of routine maintenance. If cracks widen, reappear after repairs, or are accompanied by other structural signs, further investigation by a registered builder or structural engineer is recommended immediately.

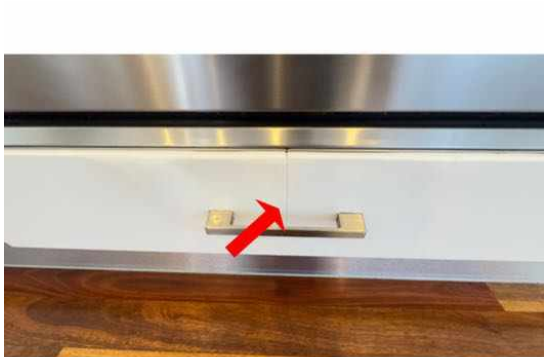
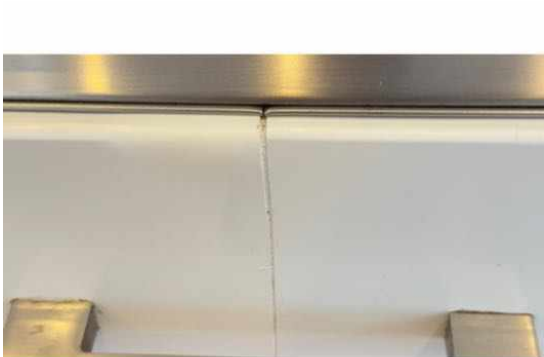
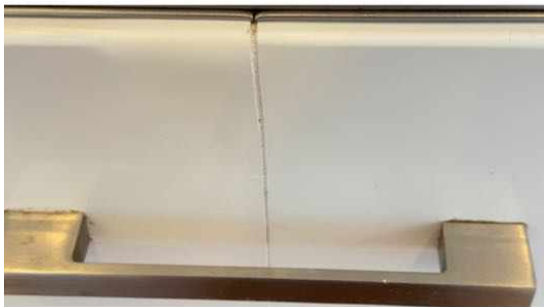
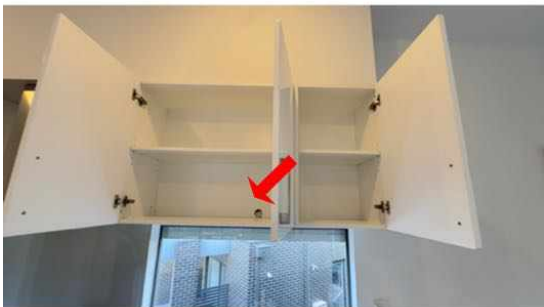
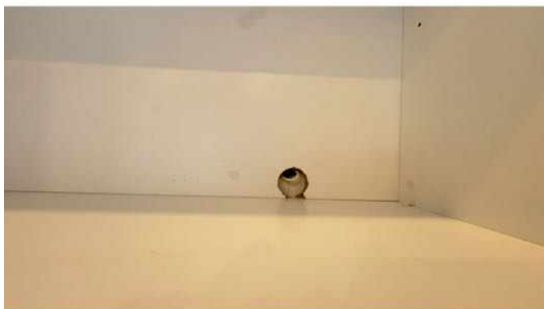
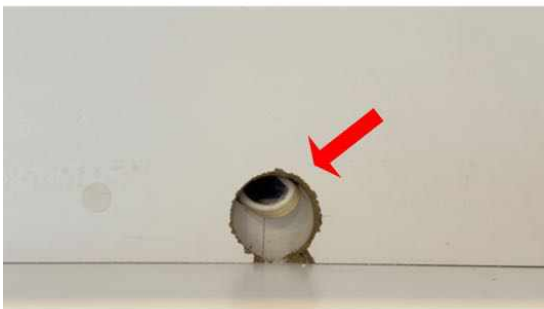
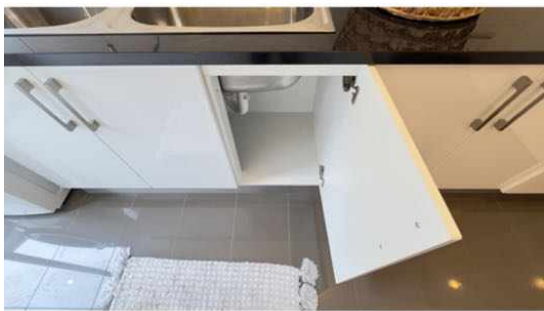
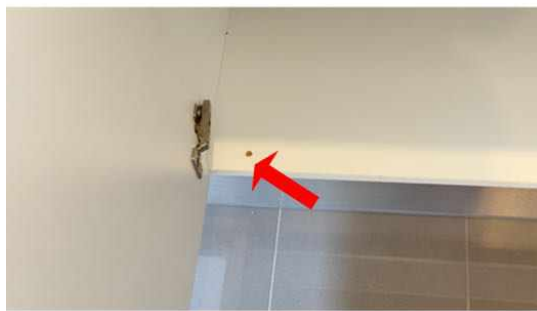
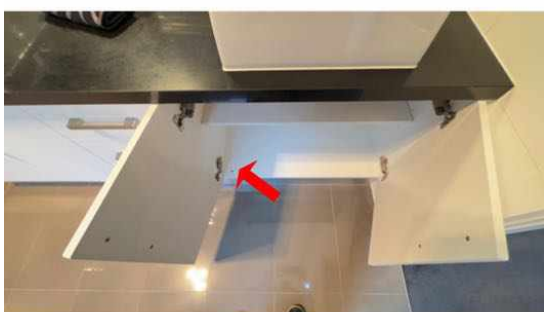
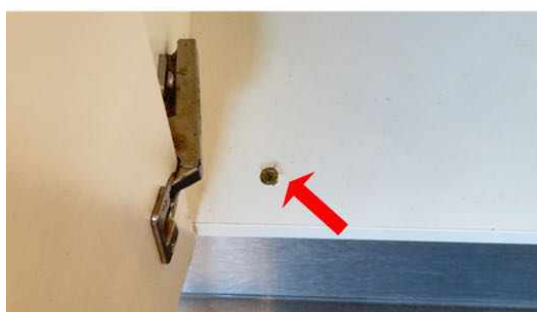
Finding 3.02

Building:	Main Building
Location:	All Areas >
Finding:	Cabinets - Poor Installation & Detailing
Information:	Cabinets were observed to have poor installation and detailing. These issues affect both the visual appearance and functional performance of the cabinetry.

This may be due to inadequate installation techniques, misalignment during installation, use of incorrect fixings or poor craftsmanship.

When practical, a qualified cabinetmaker or qualified carpenter should be engaged to address these detailing issues. Prompt action will help ensure proper fit, finish, and durability of the cabinetry.

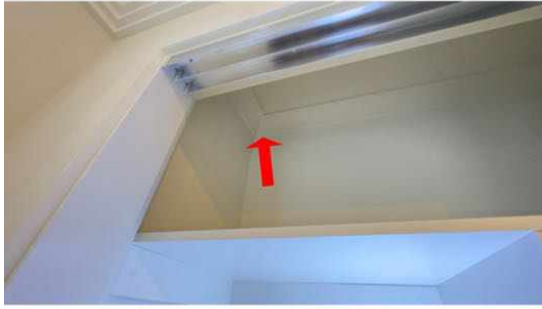
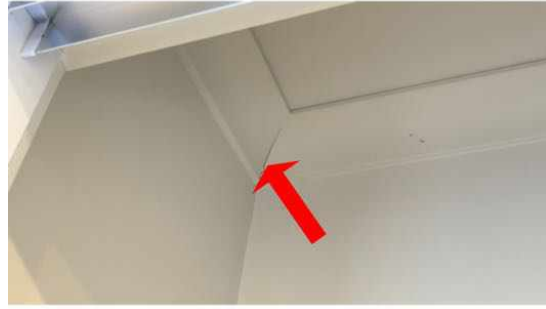
Finding 3.03

Building:	Main Building
Location:	Bedroom >
Finding:	Ceilings - Plaster Cracking
Information:	The ceilings were inspected and cracking in the plaster was observed in this area. Cracks can affect the appearance of the ceilings and may worsen over time if left unaddressed.

When practical, a qualified plastering contractor should be engaged to assess and repair the cracked plaster. Prompt action will improve the appearance of the ceilings and help prevent further deterioration.

Cracking should be monitored over time to determine whether movement is ongoing. Where cracks are purely cosmetic, patching and repainting by a qualified plasterer may be undertaken as part of routine maintenance. If cracks widen, reappear after repairs, or are accompanied by other structural signs, further investigation by a registered builder or structural engineer is recommended immediately.

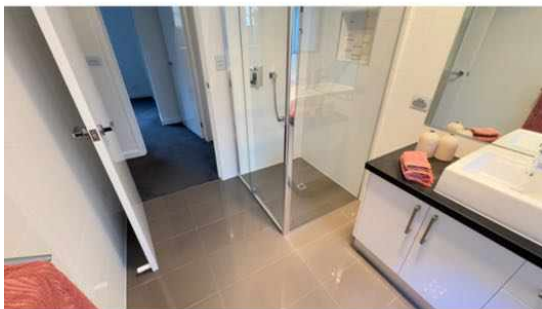
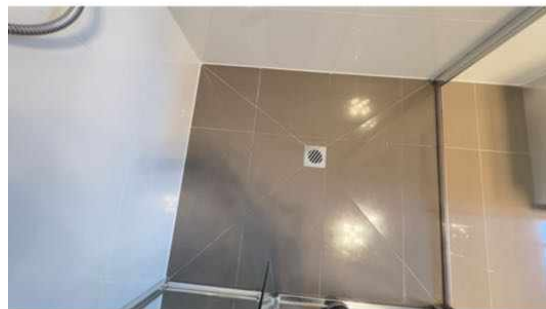
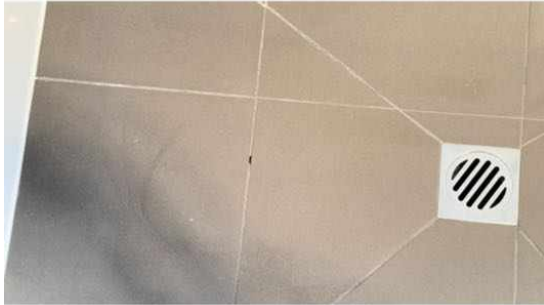
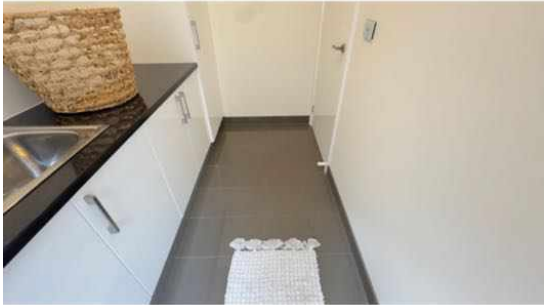
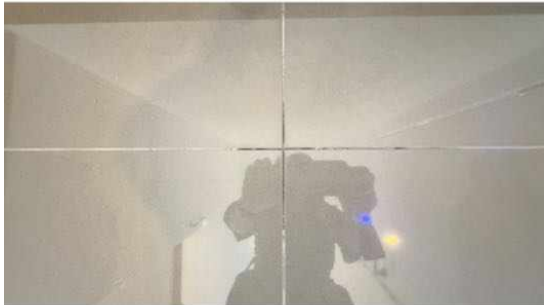
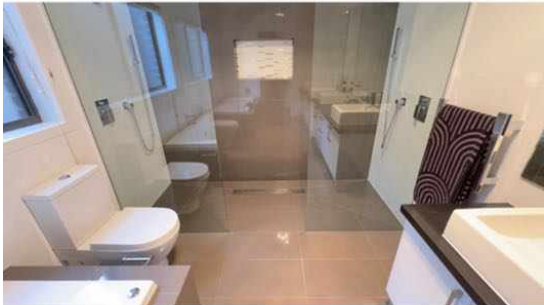
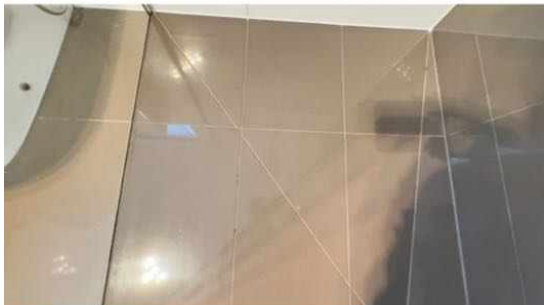
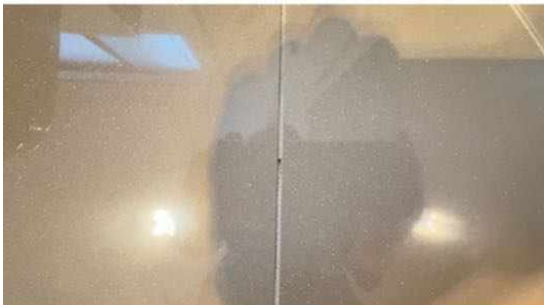
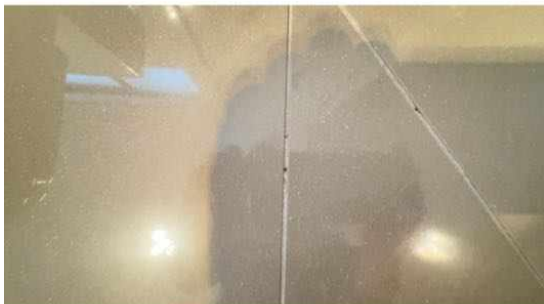
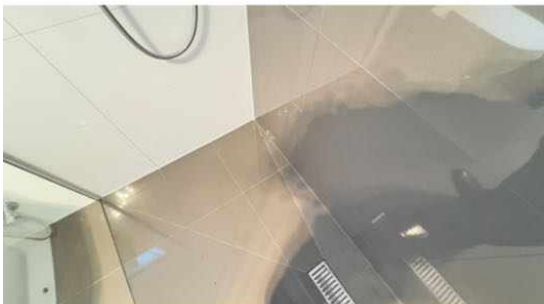
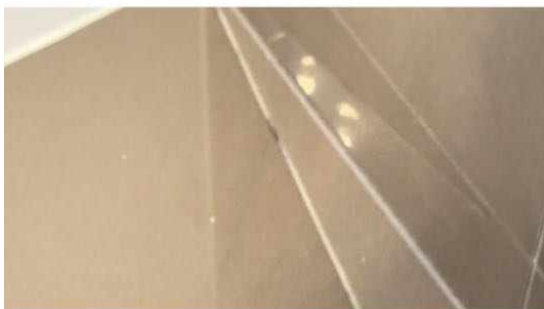
Finding 3.04

Building: Main Building
 Location: Laundry, Shower 1 & 2 >
 Finding: Floor Tiles - Inadequate Grout
 Information: Floor tiles were observed to have inadequate and deteriorated grout between joints in this area. Insufficient grout can allow water penetration, lead to tile movement, and contribute to substrate deterioration or mould growth.

Possible causes include poor original installation, age-related wear, or moisture exposure.

A qualified tiler should be engaged immediately to re-grout the affected areas. Prompt remediation will restore water resistance, maintain tile stability, and prolong the life of the flooring.

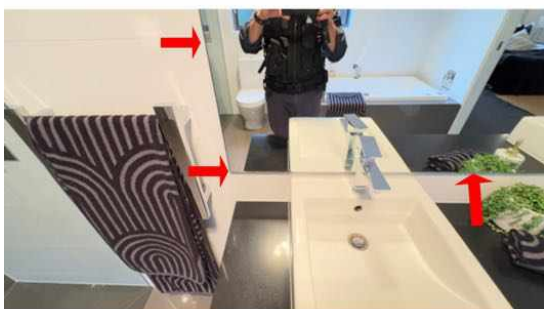
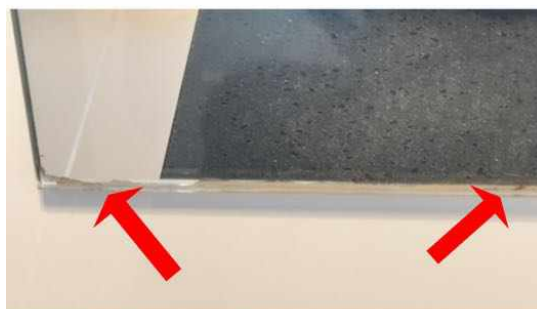
Finding 3.05

Building: Main Building
 Location: Bathroom >
 Finding: Bathroom Mirrors - Edge Deterioration
 Information: Mirrors were observed to have edge deterioration in this area. Damaged mirrors can be a safety hazard due to sharp edges, reduce visual appeal, and affect functional use.

This may be due to age-related wear, poor installation, or exposure to moisture causing edge damage.

A qualified glazier or bathroom specialist should be engaged without delay to inspect and repair or replace the damaged mirrors. This may include replacing affected mirrors, securing the mounting, and ensuring edges are properly sealed. Prompt action will help prevent injury, restore functionality, and maintain appearance.

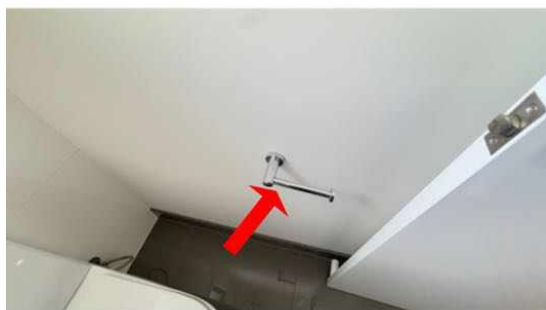
Finding 3.06

Building: Main Building
 Location: Toilet (WC)
 Finding: Fittings - Loose
 Information: Fittings were observed to be loose and inadequately secured to walls in this area,

moving when light pressure was applied. This reduces usability and may cause further damage if not addressed.

Common causes include incorrect or inadequate fixings, use of anchors unsuitable for the wall type, movement of the wall or timber substrate, wear from repeated use, or improper installation.

If left unresolved, loose fittings may detach, damage wall finishes, or cause progressive deterioration of both fittings and surrounding surfaces.

When practical, a qualified carpenter or experienced handyman should be engaged to securely refix or replace all loose fittings using appropriate fixings and methods for the wall type. The fittings should be monitored over time to ensure they remain secure.

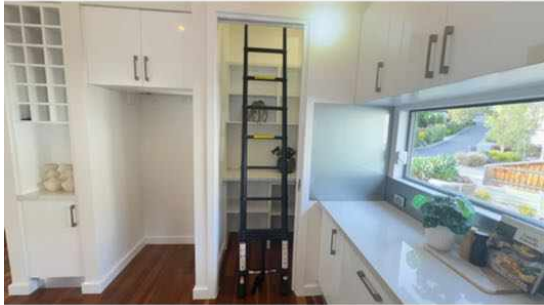
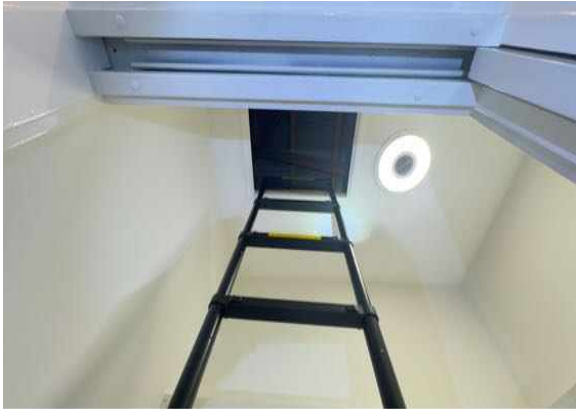
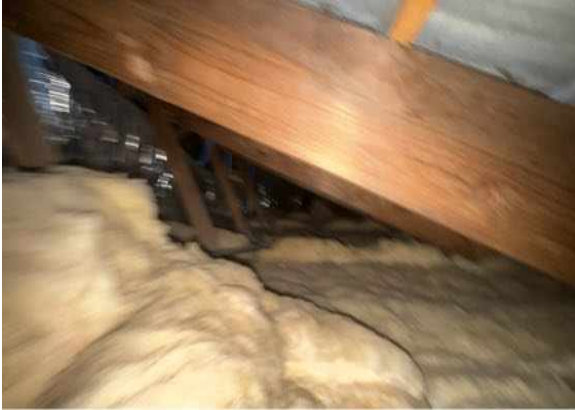
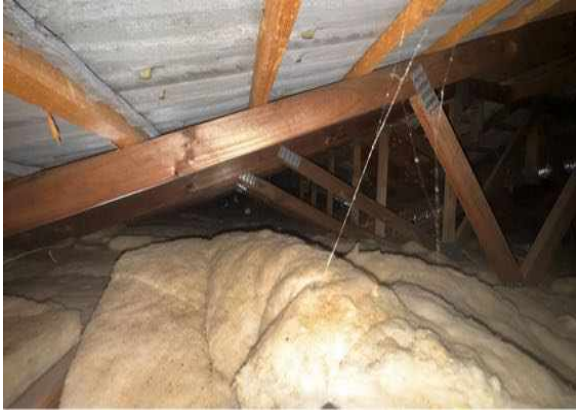
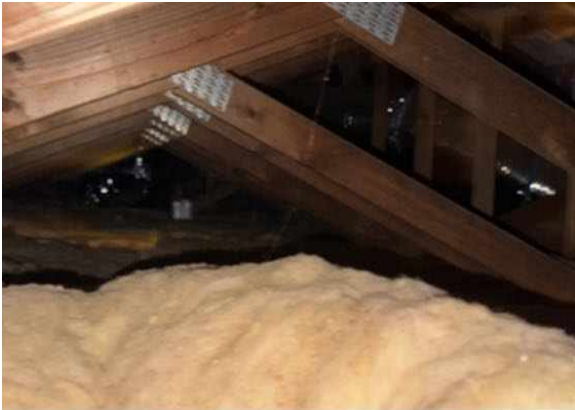
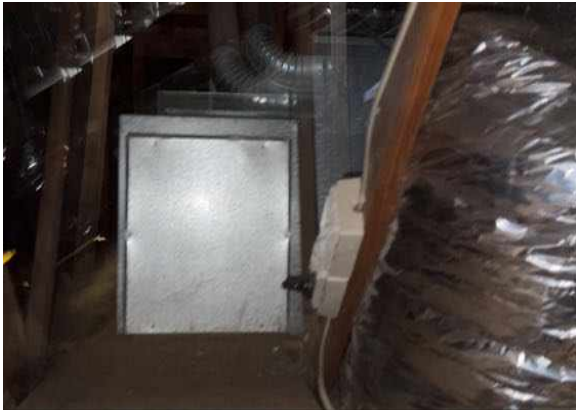
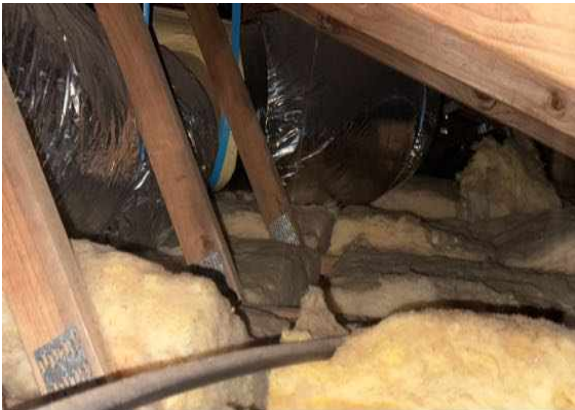
Building:	Main Building
Location:	Roof Void
Finding:	Roof Void - Limited Access
Information:	Limited access to the roof void was present due to facts including but not limited to, limited access, insulation, Air condition Unit & ducting, obstructions or placement of insulation and or sarking, for this reason complete access to the roof void was not possible.

NOTE: Unless all insulation is removed from the roof space a full inspection is never possible, timber pest or termite activity and/or damage may not be visible.

A visual inspection was carried out from accessible areas only, recommend installing another access hatch in a more accessible area for a re-inspection.

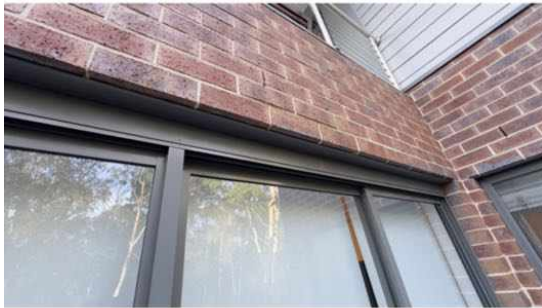
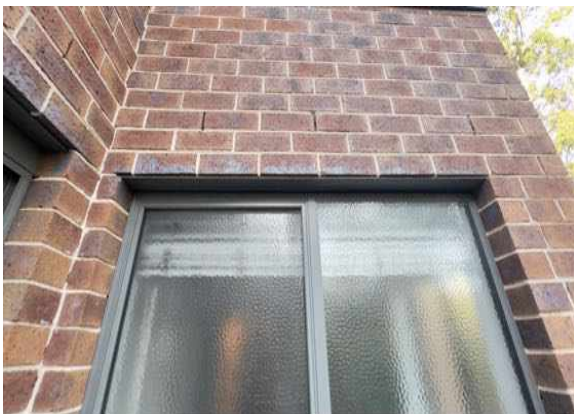
Finding 3.08

Building: Main Building
Location: All External Window Lintel Areas
Finding: Building Element Hardware - Rust & Corrosion
Information: This building element shows evidence of rusting and corrosion, which is likely to have developed as a result of excessive exposure to moisture and or inadequate coatings. As surface rust provides no protection to the underlying iron, the deteriorating condition is likely to worsen if not addressed in the short-term future.

These items can sometimes be treated but more than likely will require replacement. Where possible, the use of galvanized (treated) metals or aluminium coated metals aid in rust prevention, as does regular general maintenance. Rust formation can be controlled with coatings, such as paint, that isolate the iron from the environment.

Rusting and corrosion should be managed by ideally removing or limiting the affected surface from exposure to moisture. A qualified handyman or carpenter may be appointed to replace any building elements that have been affected by rust or water damage.

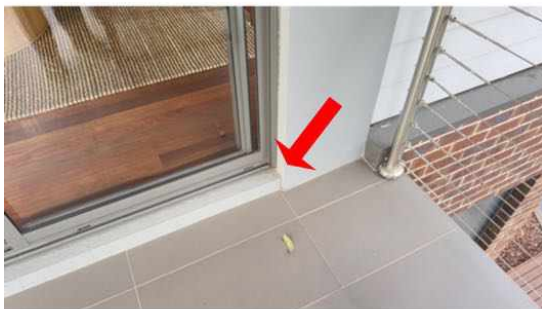
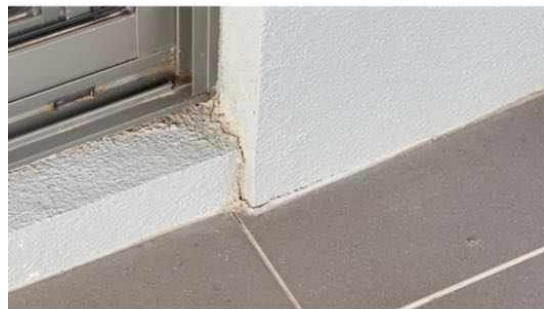
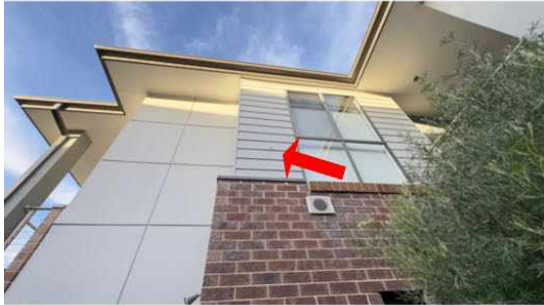
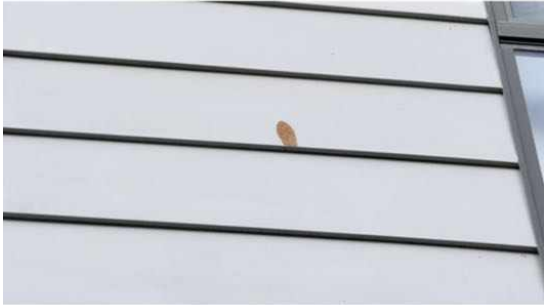
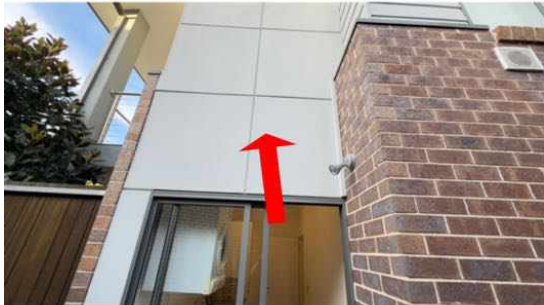
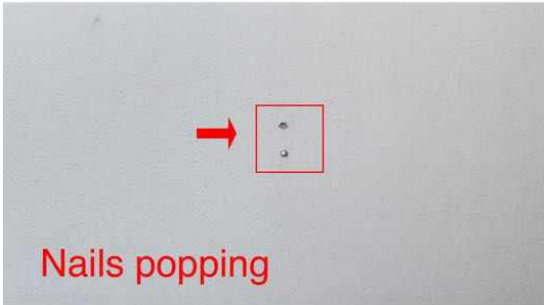
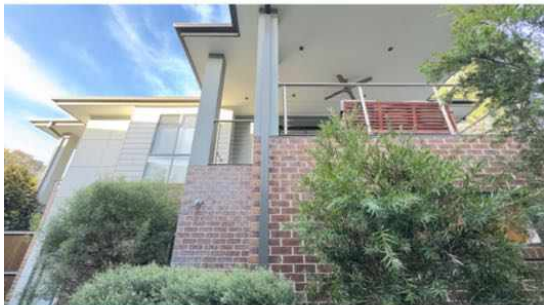
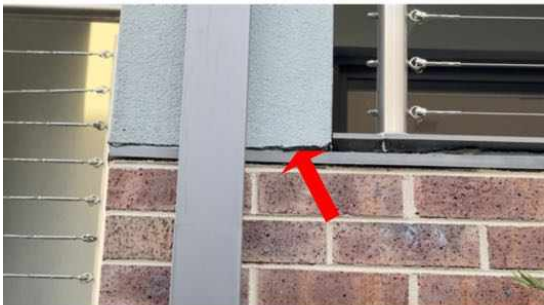
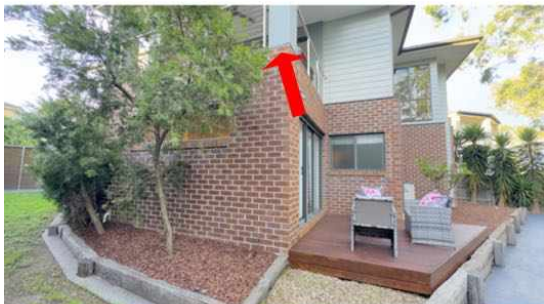
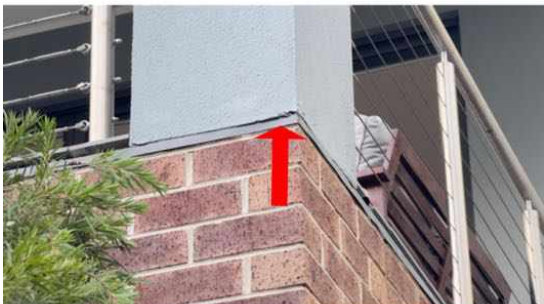
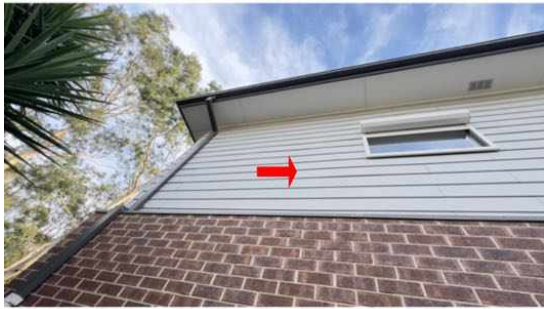
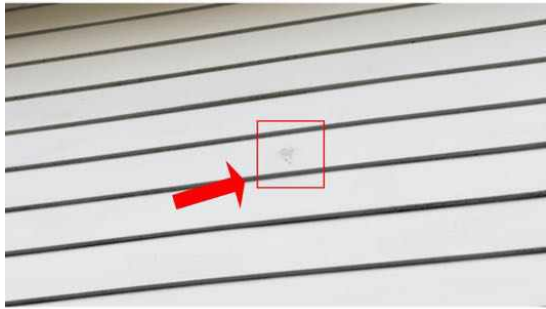
Finding 3.09

Building: Main Building
 Location: All External Areas >
 Finding: External Walls - Substandard Finish
 Information: The external walls were inspected for paint and or surface condition, and substandard finishes was observed in this area.

While primarily a cosmetic issue, the affected areas may indicate age-related wear, poor surface preparation, or previous repairs.

When practical, a qualified painter should be engaged to prepare and repaint the affected areas. Addressing paint deterioration will improve the appearance of the ceilings and help protect the surfaces from further wear.

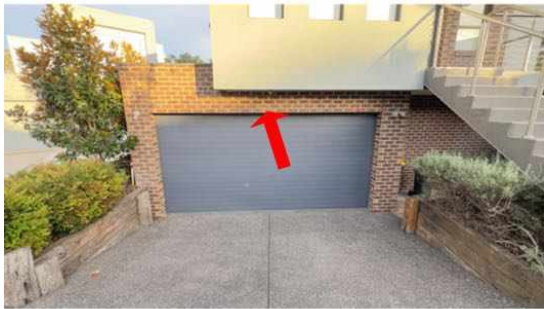
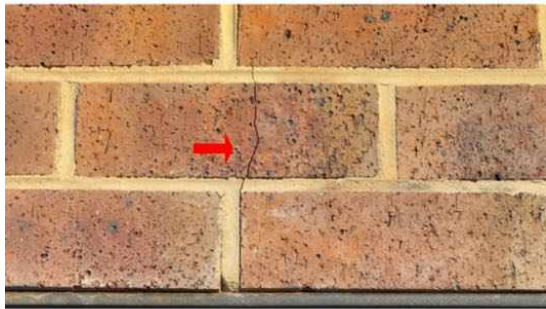
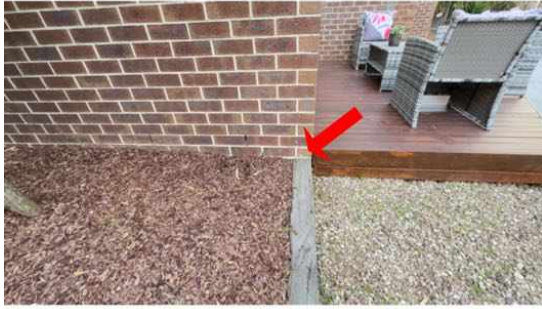
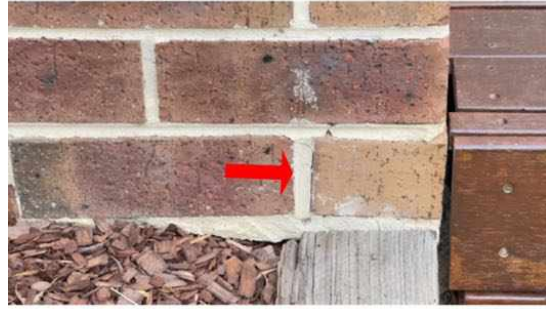
Finding 3.10

Building: Main Building
Location: All External Areas >
Finding: External Walls - Minor Cracking To Wall Claddings
Information: Minor cracking was observed to the external walls in this area. The cracking appeared superficial and did not indicate significant structural movement; however, such cracking can allow moisture ingress if left unaddressed.

The cracking is likely due to building movement or minor settlement.

When practical, a registered builder should assess and repair the cracking, which may include sealing and repainting. The area should be monitored, and any increase in cracking or signs of movement should be further investigated immediately by a Structural Engineer.

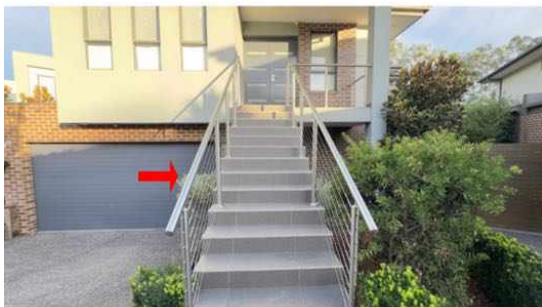
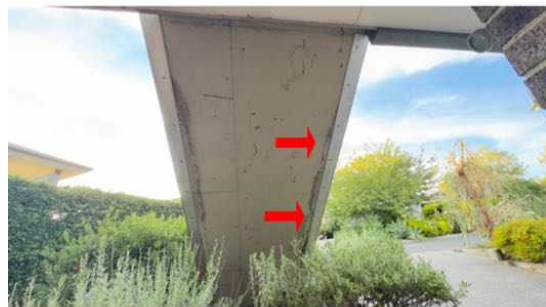
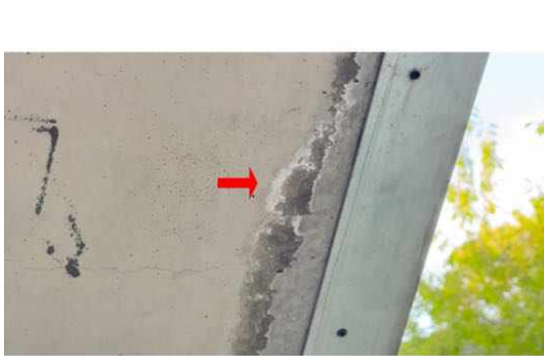
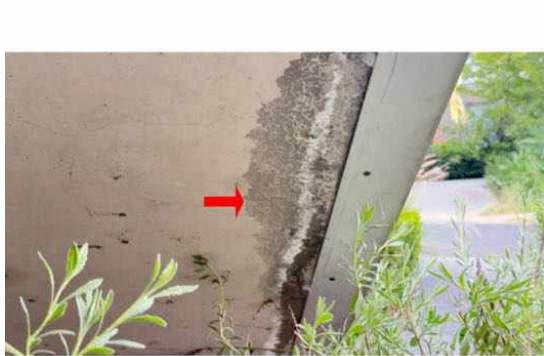
Finding 3.11

Building:	Main Building
Location:	Stair Landing
Finding:	Damp Problems - Penetrating Damp
Information:	The inspection identified signs of moisture penetration in this area, with damp patches, staining and deterioration of finishes observed. Penetrating damp can cause paint and plaster damage, timber decay, mould growth, and may compromise structural integrity and indoor air quality.

This condition may be caused by defective or aged external wall cladding, render, or brickwork, poorly installed or deteriorated flashings, gutters, or downpipes, cracks or openings in walls, inadequate perimeter drainage, or failure of damp-proof membranes.

A registered builder or waterproofing specialist should be engaged immediately to investigate the source, assess the extent of penetration, and carry out remedial works. This may include repairing or replacing defective cladding, flashings, gutters, or membranes, improving drainage, and treating affected surfaces. Prompt action will prevent further structural damage, mould growth, and health risks.

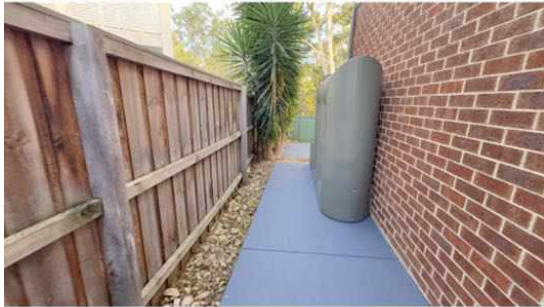
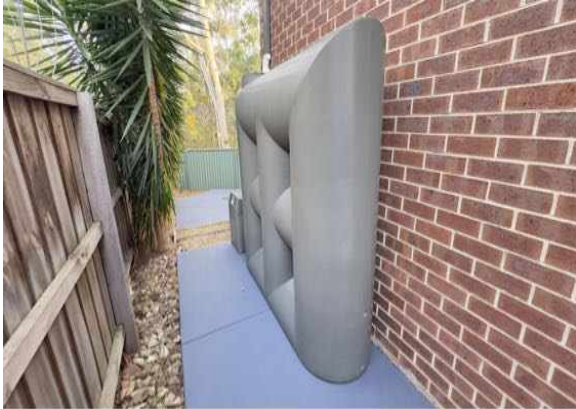
Finding 3.12

Building: Main Building
Location: All External Areas
Finding: Rainwater Tank - Leaf Strainer Blocked
Information: The leaf strainer on the rainwater tank is blocked with leaves and debris, restricting the flow of water into the tank. This is located at the inlet on top of the rainwater tank.

This has likely occurred due to a build-up of leaves and debris from the roof and gutters. A blocked leaf strainer may cause water to overflow, back up into gutters, or discharge uncontrolled around the tank and building.

A licensed plumber or competent hand man is required to clean and clear the leaf strainer. This should be attended to immediately to allow proper water flow and prevent overflow or damage.

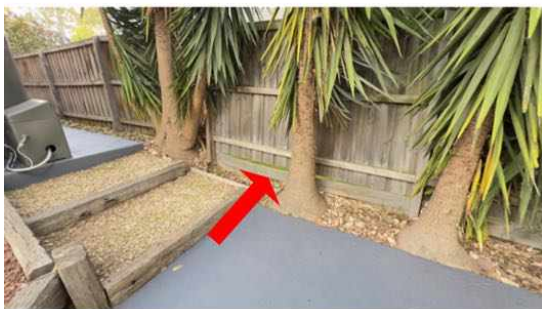
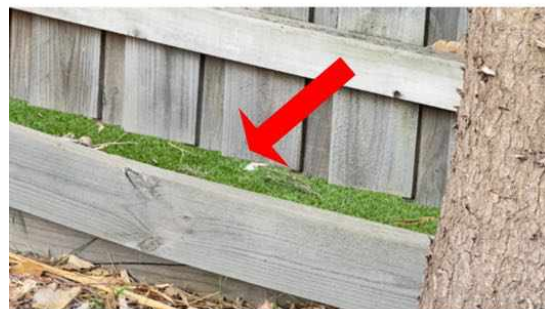
Finding 3.13

Building: Main Building
 Location: Fencing All Areas
 Finding: Fencing - Deteriated
 Information: Timber fencing was inspected and deterioration was observed in this area. Deteriorated fencing can compromise structural stability, reduce privacy, and may allow pest ingress or accelerated decay if left unaddressed.

Possible causes include age-related timber decay, prolonged exposure to moisture or sunlight, poor maintenance, or impact damage.

When practical, a qualified carpenter or fencing specialist should be engaged to repair or replace affected sections, and a qualified painter should be engaged to restore protective finishes. Prompt rectification will maintain structural performance, improve appearance, and extend the lifespan of the fencing.

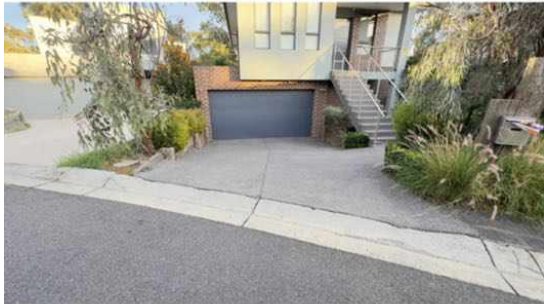
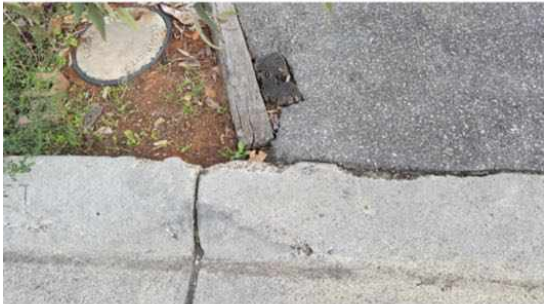
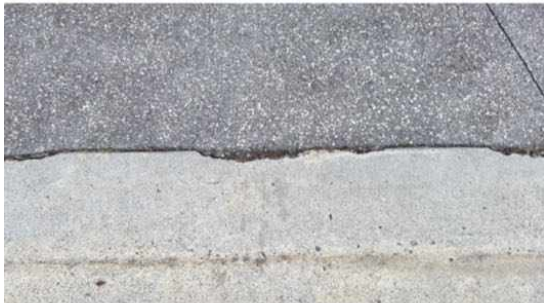
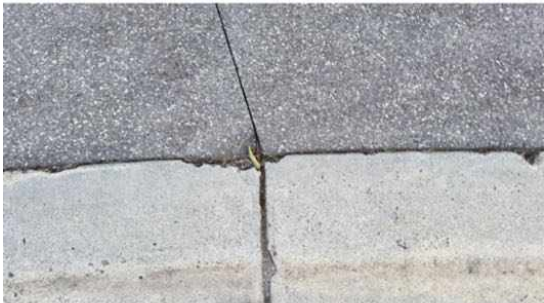
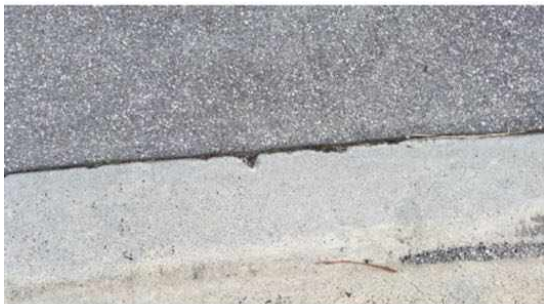
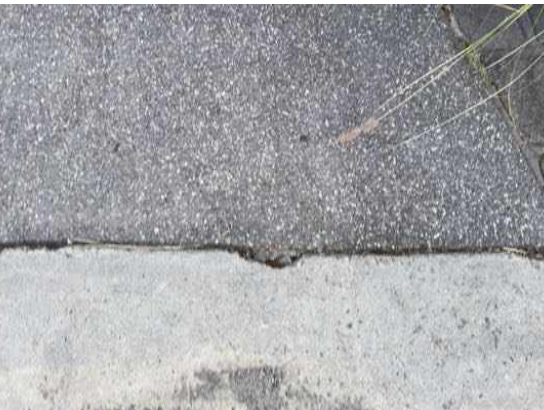
Finding 3.14

Building: Main Building
 Location: Driveway >
 Finding: Driveway - Minor Cracking & Surface Imperfections
 Information: The external driveway was visually inspected. Minor cracking, surface settlement, and

minor unevenness was observed in this area. While these defects do not currently compromise structural safety, they may affect long-term durability, appearance, and vehicle access.

These issues may be caused by age-related wear, soil movement or settlement beneath the driveway, possible tree root intrusion, or inadequate original construction or reinforcement.

A qualified concreter should be engaged when practical to repair or resurface affected areas. Prompt rectification will restore a smooth surface, improve appearance, and prevent further deterioration.

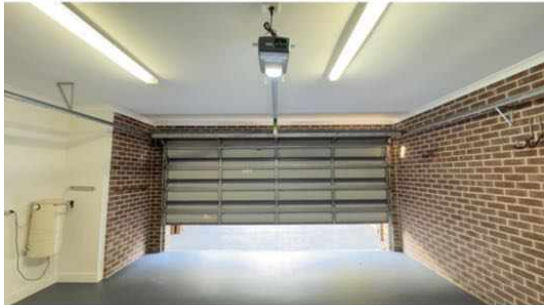
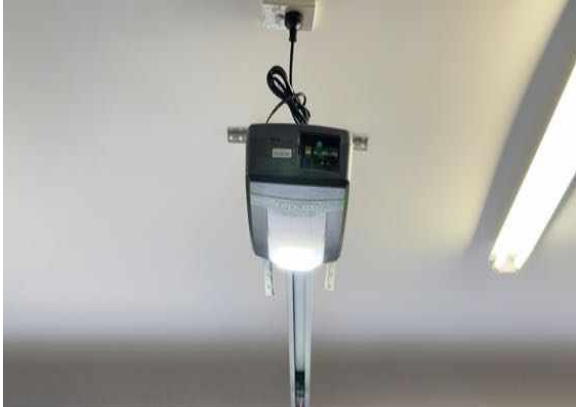
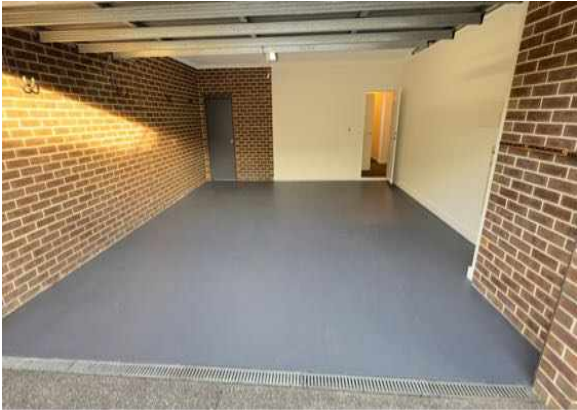
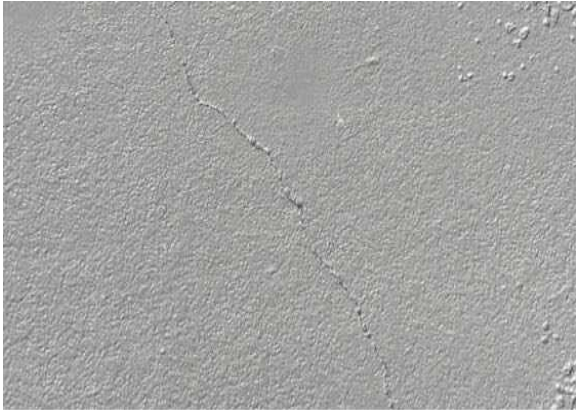
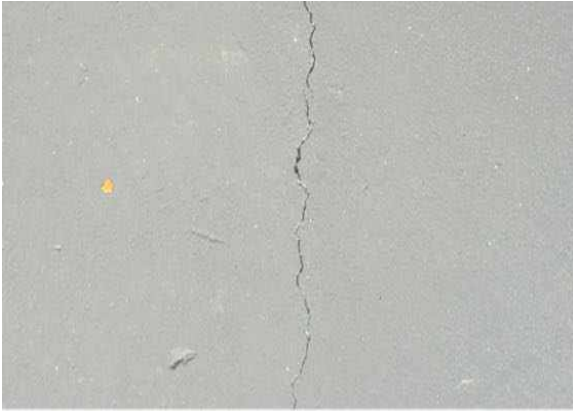
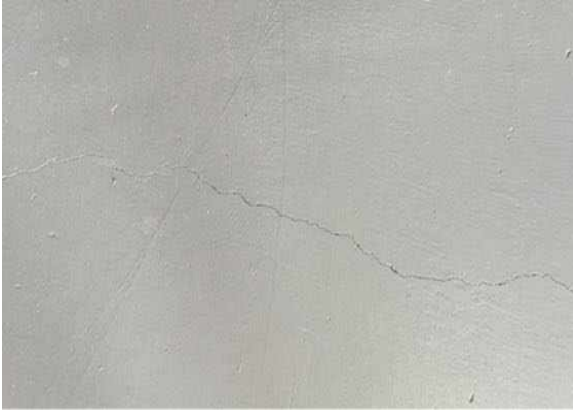
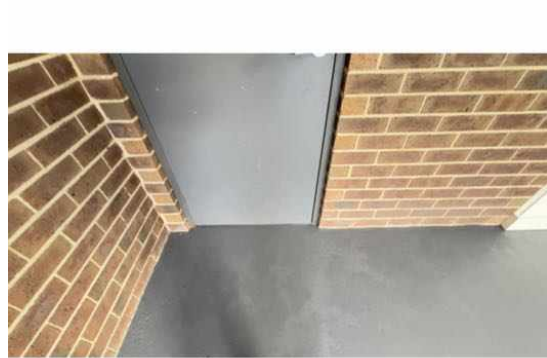
Finding 3.15

Building: Main Building
Location: Garage
Finding: Garage - Minor Cracking To Concrete Slab
Information: The concrete slab in the garage was inspected and minor cracking was observed in this area. While minor cracks are generally cosmetic, they may indicate normal shrinkage, settlement, or minor movement and should be monitored over time to ensure they do not worsen.

The cracks may be caused by shrinkage of concrete as it cures, minor settlement of footings or subfloor, thermal expansion or contraction, or age-related wear.

The affected area should be monitored, and if cracks widen, additional movement occurs, or other signs of structural concern are observed, a registered builder or structural engineer should be engaged immediately to assess and provide advice on remedial works. Prompt attention will help maintain the integrity and safety of the garage floor.

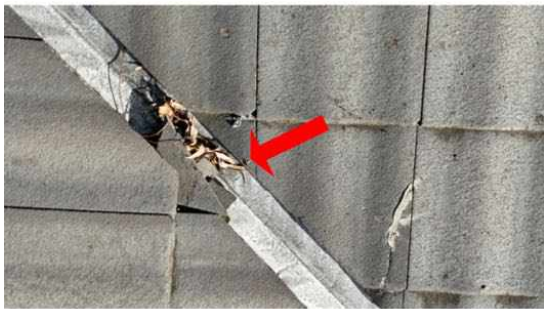
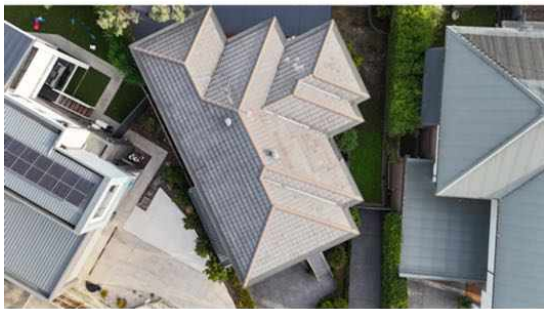
Finding 3.17

Building: Main Building
Location: Roof Exterior
Finding: Roof Plumbing - Gutters Blocked
Information: Gutters in this area are blocked and not allowing water to flow freely. The issue is observed along the gutter runs where leaves, debris, or other obstructions have accumulated.

This has likely occurred due to lack of maintenance or build-up of debris over time. Blocked gutters may cause water to overflow, damage the roof, walls, or foundations, and increase the risk of erosion or water ingress.

A licensed roof plumber or competent handy man is required to inspect and clear the blocked gutters in this area. This should be rectified immediately to ensure water drains correctly and to prevent potential damage to the building.

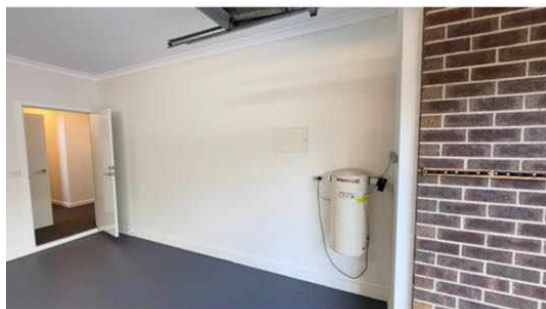
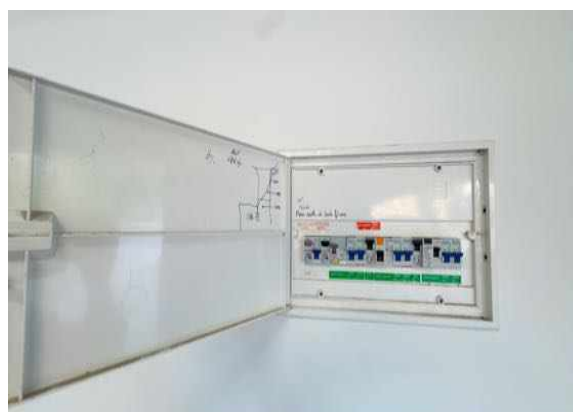
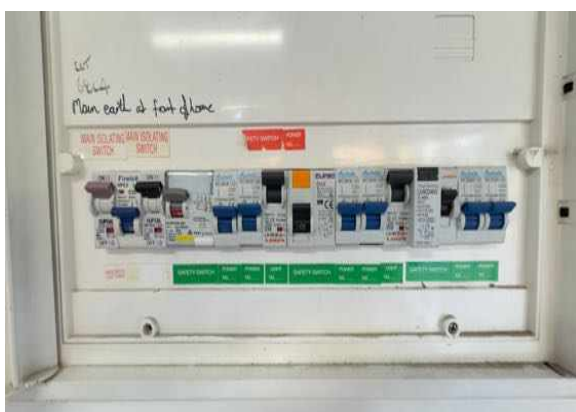
Building: Main Building
 Location: All External Areas
 Finding: Timber Pests - Durable Notice Not Identified
 Information: During the inspection, no durable notice relating to a termite management system was observed on the property. A durable notice is required to identify the type of termite management system installed, the date of installation, and any ongoing maintenance or inspection requirements. The absence of this notice makes it difficult to confirm the presence, effectiveness, or maintenance status of any termite protection measures.

Without a durable notice, there is an increased risk that termite management systems may not be adequately maintained or may have expired, particularly in the case of chemical barriers that require periodic replenishment. This uncertainty increases the likelihood of undetected termite activity and potential damage to timber elements within the building.

The lack of a durable notice may be due to removal during renovations, age of the property, or the absence of a compliant termite management system at the time of construction. Regardless of the cause, this represents a gap in termite risk management and ongoing building protection.

It is recommended that a licensed pest management technician be engaged immediately to assess whether a termite management system is present and

functioning. Where a system exists, the technician should confirm its type, condition, and maintenance requirements and install a compliant durable notice in accordance with current standards.

If no termite management system is identified, it is strongly recommended that an appropriate termite protection system be installed and documented. Regular inspections and maintenance should then be undertaken to reduce the risk of future termite infestation and associated structural damage.

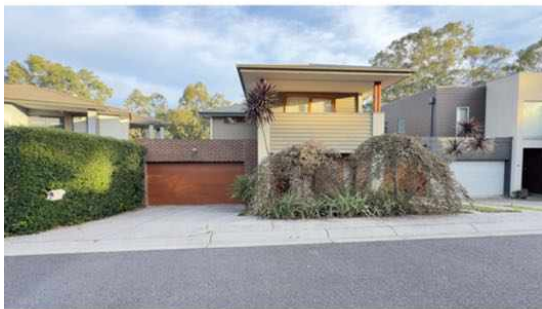
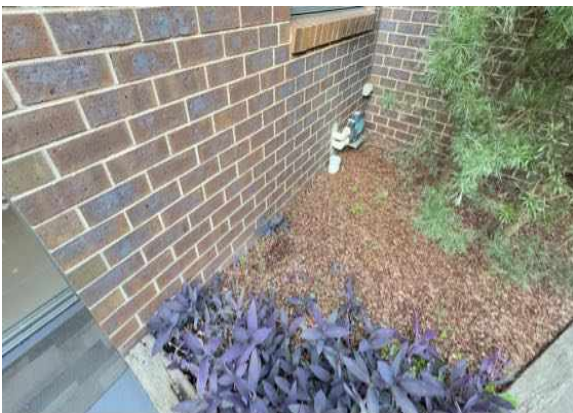
Finding 6.02

Building:	Main Building
Location:	All External Areas
Finding:	Timber Pests - Bridging Of Termite Barrier Found
Information:	During the inspection, bridging of the termite barrier was observed in certain areas. Bridging occurs when external elements, such as soil, vegetation, garden beds, or timber, make direct contact with the termite management system, effectively bypassing the barrier's protective function. This compromises the barrier's ability to prevent termites from accessing the building and can increase the risk of infestation.

The possible causes of bridging include poor landscaping practices, where soil or mulch is piled too high around the perimeter of the building, or growth of plants with roots extending into the barrier area. In some cases, structural movement or settling of

the soil may also cause previously effective barriers to become bridged. The presence of bridging provides a direct path for termites to bypass the chemical or physical barrier, potentially leading to hidden infestation.

*Bridging is a significant issue as it negates the effectiveness of termite barriers, leaving the building vulnerable to termite attacks. If left unaddressed, termites can find entry points through the bridged areas, leading to structural damage and potential long-term problems for the property. Since termites can go undetected for extended periods, the damage caused by such infestations can be costly to repair.

It is strongly recommended that a licensed pest management specialist or termite professional be engaged immediately to assess the termite barrier and address the bridging issue. This may involve removal of bridging materials, adjustment or repair of the barrier, and ensuring that the area around the barrier is clear of any materials that could facilitate termite entry.

In addition to addressing the bridging issue, it is also crucial to inspect the property for signs of termite activity immediately and consider replacing or reapplying the termite barrier to ensure it is still effective. Regular maintenance and monitoring of the barrier are recommended to prevent future issues and ensure long-term protection against termites.
