Building and Timber Pest Inspection Report

Inspection Date: Wed, 1 Apr 2026

Property Address: 7 Manor Grn, Macleod VIC 3085, Australia

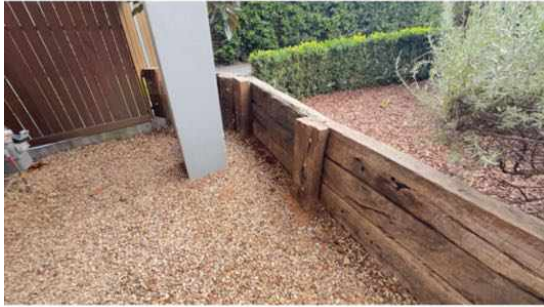
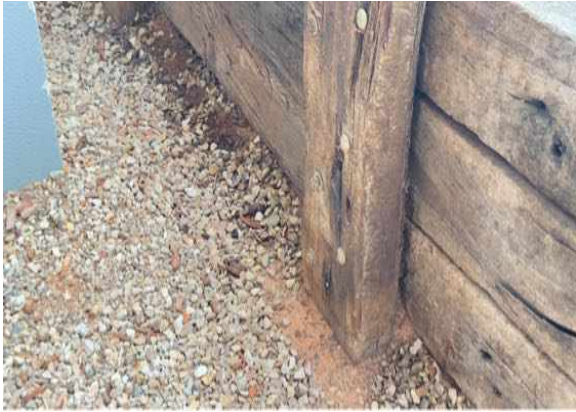
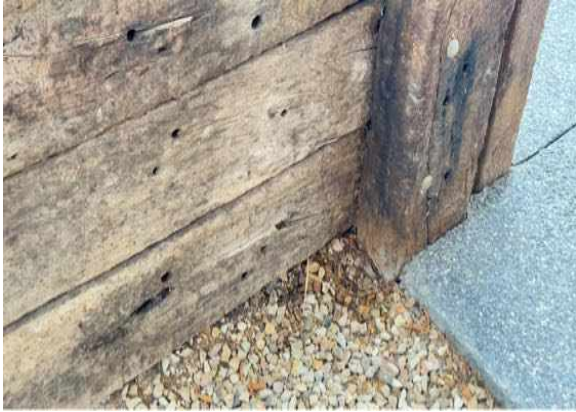
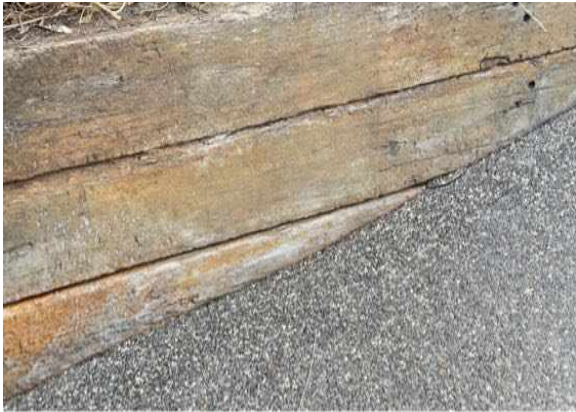
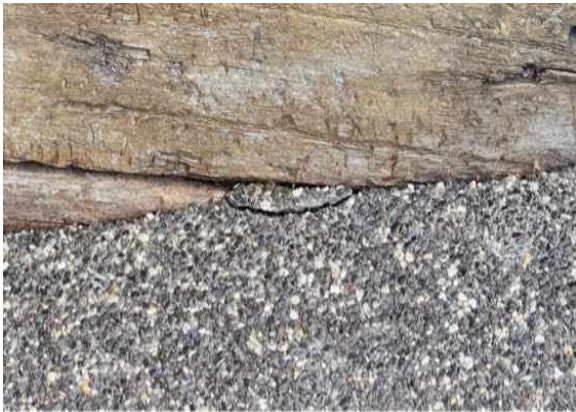
Building:	Main Building
Location:	All External Areas
Finding:	Timber Pests - Conducive Conditions - External Exposed Timbers
Information:	During the inspection, external exposed timbers were observed in this area. Timber that is in direct contact with soil, landscaping, or exposed to weather conditions such as rain and humidity is highly susceptible to termite attack and other timber pests. Moisture and environmental exposure can soften timber and make it more attractive and accessible to pests.

The presence of exposed timber may be due to building design, wear and tear, lack of protective coatings, or deterioration of paint, sealants, or other protective finishes. Timber left untreated or inadequately maintained is more likely to absorb moisture, decay, and act as a bridge for pests to access internal structural timbers.

If left unaddressed, exposed timber significantly increases the risk of termite infestation, fungal decay, and accelerated timber deterioration. Over time, this may compromise structural integrity, reduce the longevity of timber components, and increase maintenance or repair costs.

It is recommended that a registered builder or qualified carpenter assess all external timbers and undertake necessary remedial works. This may include repairing or replacing deteriorated timbers, applying protective coatings, ensuring adequate clearance from soil or vegetation, and preventing timber from coming into direct contact with moisture-prone areas.

A licensed pest management technician should also inspect the property to assess the potential risk of timber pests and determine whether additional preventative measures, such as termite barriers or monitoring systems, are required. Regular maintenance, moisture control, and pest inspections are essential to protect exposed timbers and maintain the safety and durability of the building.

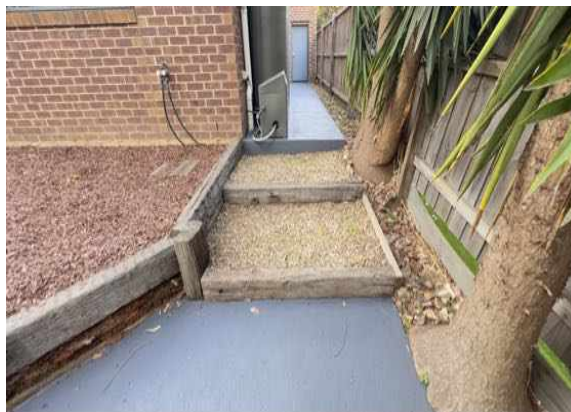
Finding 6.04

Building:	Main Building
Location:	All External Areas
Finding:	Timber Pests - Conducive Conditions - No Slab Edge Exposure
Information:	During the inspection, it was noted that there is no exposed slab edge in this area. While this may initially seem positive, the absence of visible slab edges can create conditions where termite activity goes undetected. Without slab edge exposure, concealed entry points for termites may exist beneath flooring or along hidden wall junctions, reducing the ability to monitor and inspect for potential infestations.

This condition may result from building design, ground cover or landscaping placed directly against walls, or finished floor coverings that obscure slab edges. Such conditions can inadvertently provide termites with unobserved access to structural timber and other vulnerable building elements.

If left unaddressed, the lack of slab edge exposure can increase the risk of concealed termite activity, making early detection difficult and allowing infestations to progress unnoticed. This may lead to significant structural damage, increased repair costs, and potential safety risks over time.

It is recommended that a licensed pest management technician be engaged immediately to assess the property, particularly in areas where slab edges are concealed, to determine potential termite risk and implement monitoring or treatment

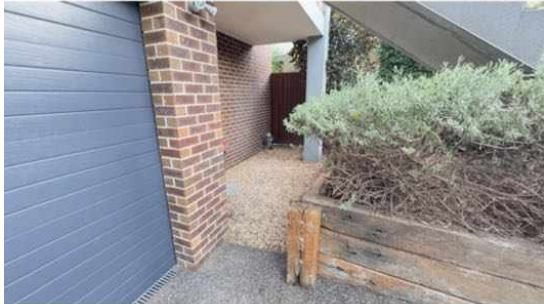
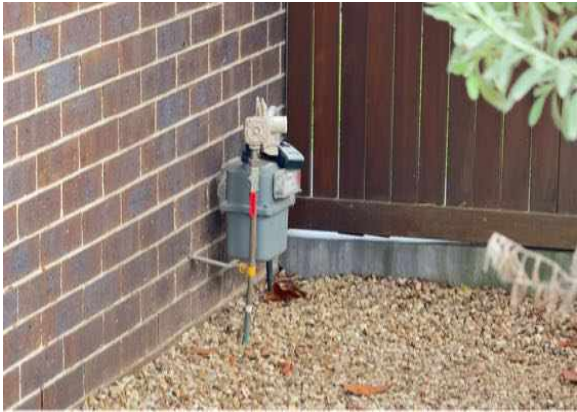
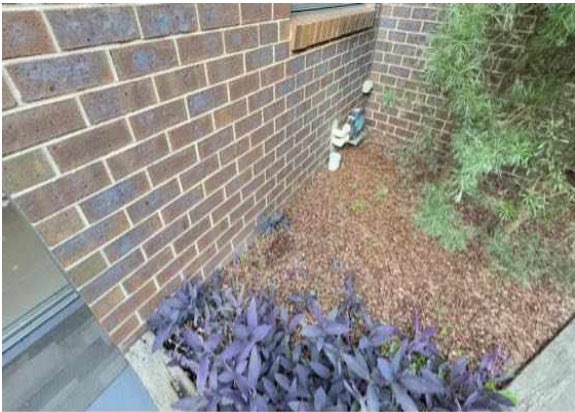
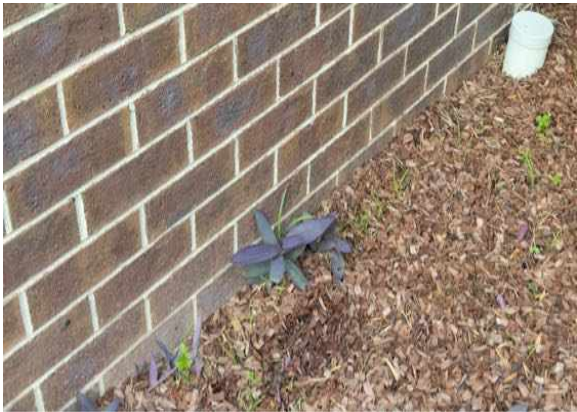
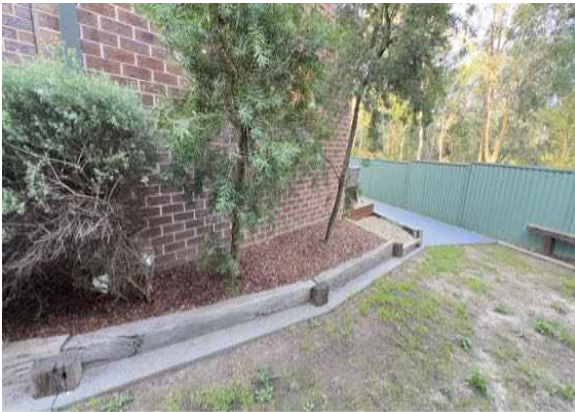
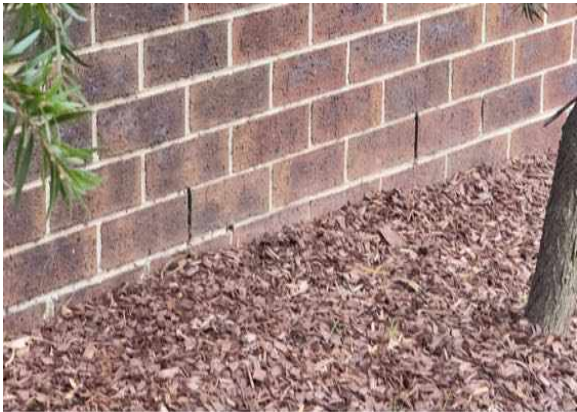
Additionally, a registered builder should be engaged to advise on methods to improve visibility and access to slab edges where practical. Regular inspections, maintenance of clear zones around walls, and ongoing termite management are essential to mitigate concealed timber pest risks and ensure the structural safety of the building.

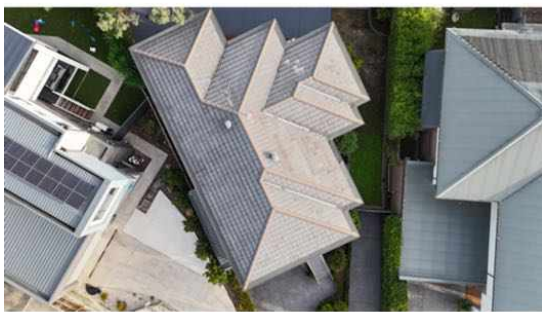
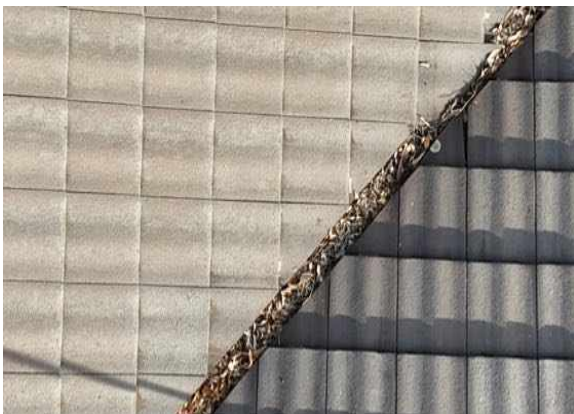
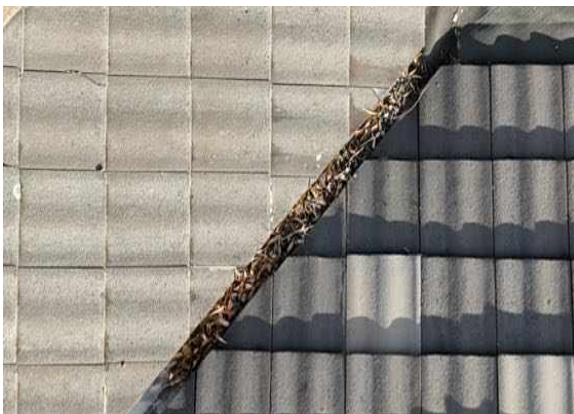
Finding 6.05

Building: Main Building
Location: All External Areas
Finding: Timber Pests - Conductive Conditions - Gutters Blocked
Information: During the inspection, gutters were observed to be blocked, resulting in water overflow and poor roof drainage. Blocked gutters are a significant concern as they can cause moisture to accumulate around roof edges, fascia boards, wall cavities, and subfloor areas. Persistent moisture in these locations creates conditions highly conducive to timber pest activity, including termites, borers, and fungal decay.

lead to concealed moisture penetration into building elements, reducing timber durability and increasing vulnerability to pest attack.

Moisture-related conditions of this nature substantially increase the risk of timber pest infestation and can accelerate deterioration of structural timbers if left unaddressed, potentially leading to progressive damage and higher repair costs.

It is recommended that a qualified roofing contractor or competent handyman be engaged promptly to clear and service all gutters and downpipes and ensure effective drainage away from the building. Ongoing gutter maintenance, in conjunction with regular timber pest inspections, is essential to reduce moisture-related risks and protect the long-term integrity of the structure.

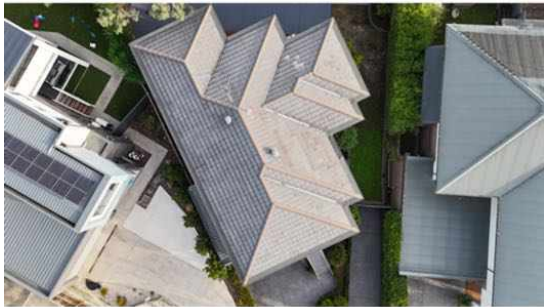
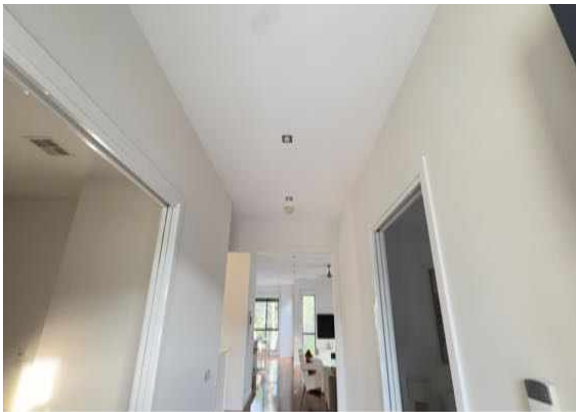
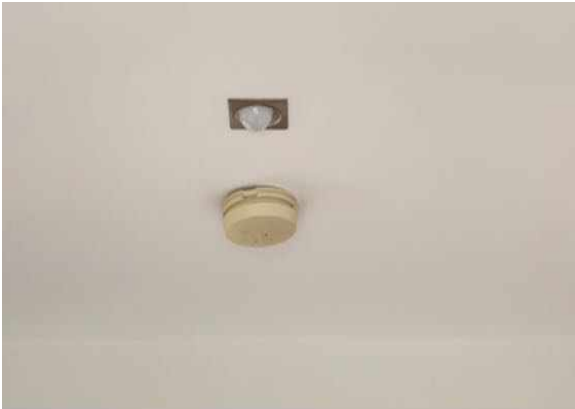
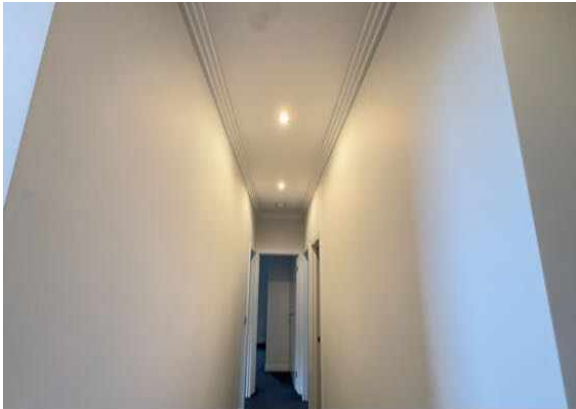
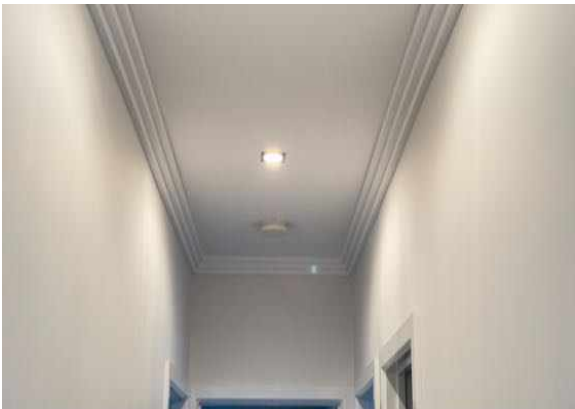
Building: Main Building
Location: All Internal Areas
Finding: Smoke Detectors - Advisory

Information: During the inspection, smoke detectors were noted for advisory purposes only. The operation, age, type, and compliance of smoke detectors could not be fully verified as part of this inspection.

Smoke detectors are critical life-safety devices, and non-compliant, outdated, or non-operational units may not provide adequate warning in the event of a fire.

It is recommended that a licensed electrician be engaged immediately to test, service, and upgrade smoke detectors as required to ensure correct operation and compliance with current safety requirements.

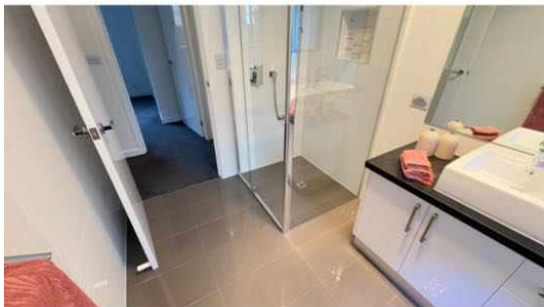
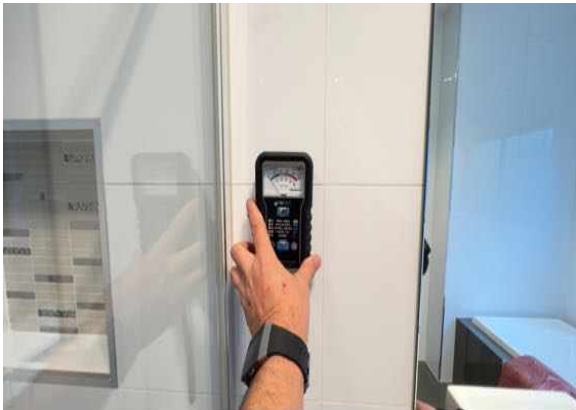
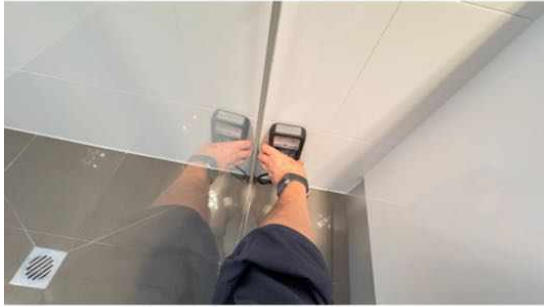
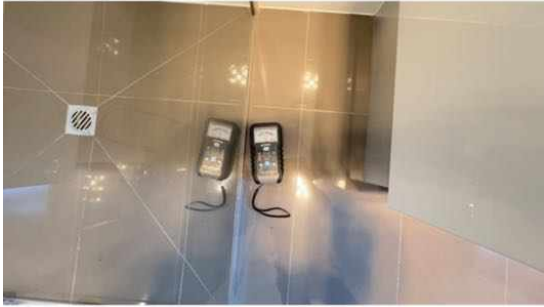
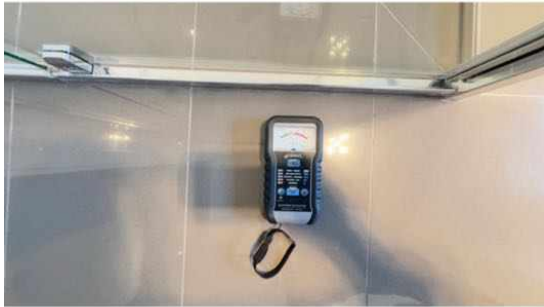
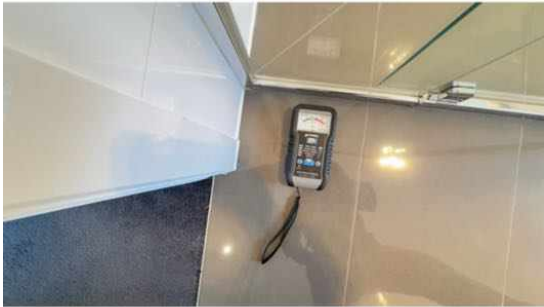
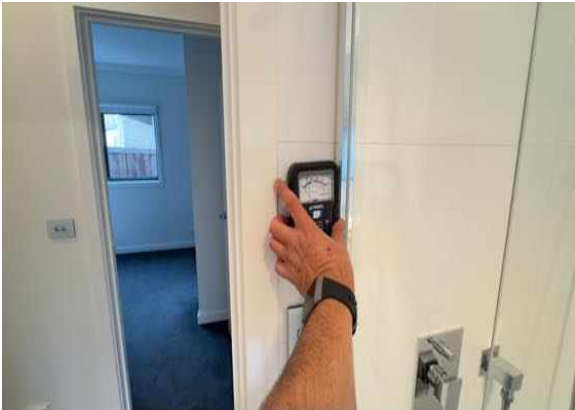
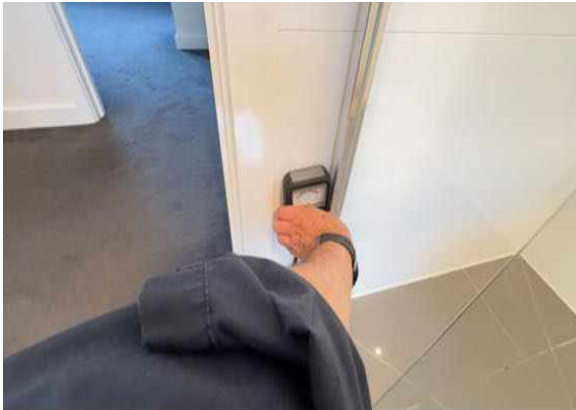
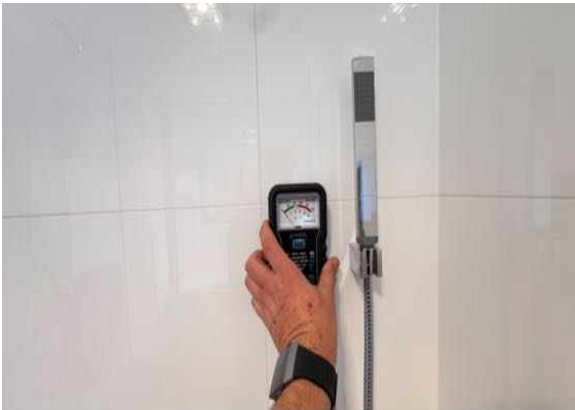
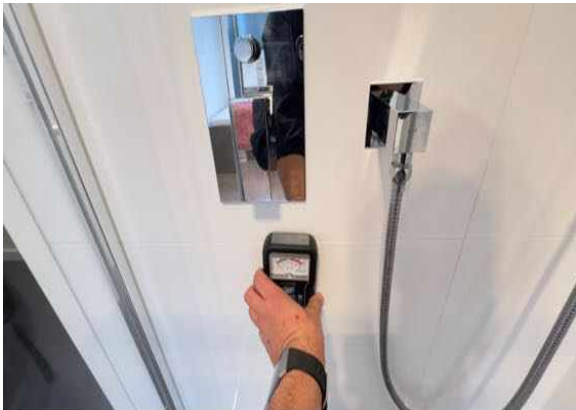
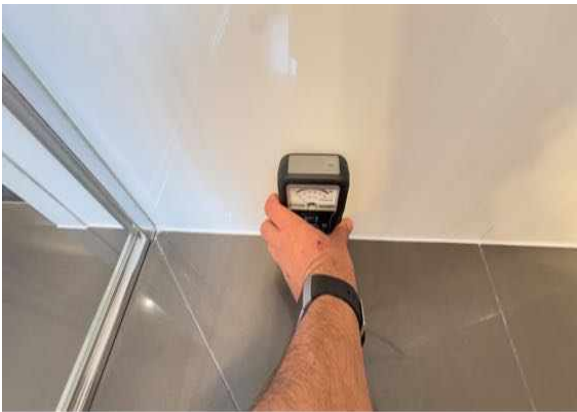
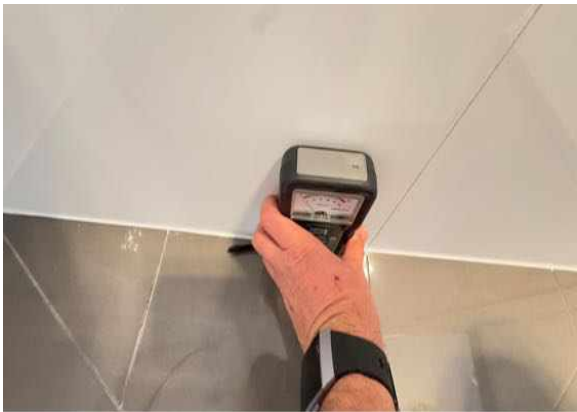
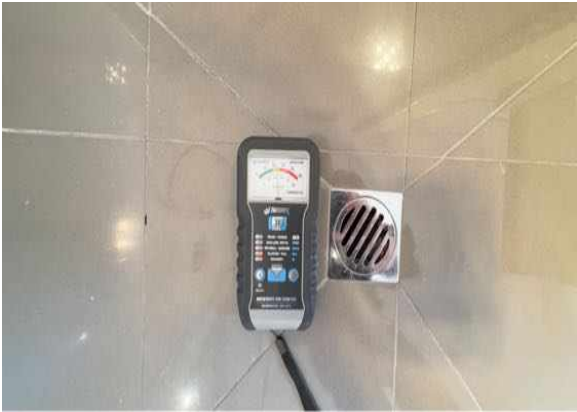
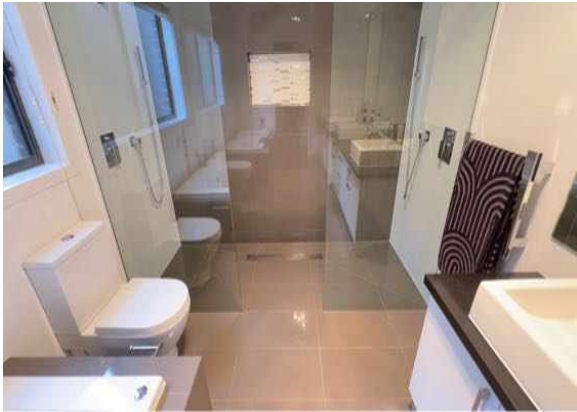
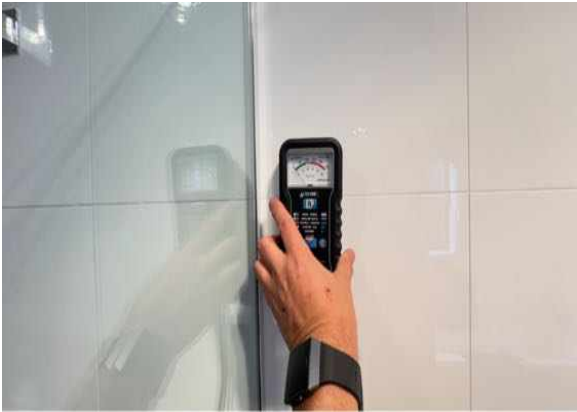
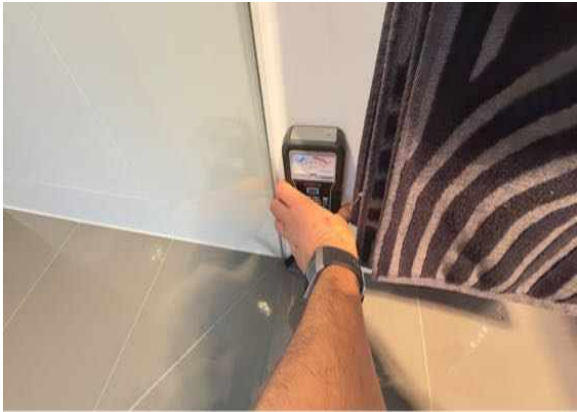
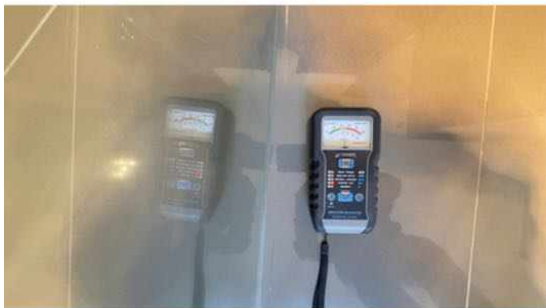
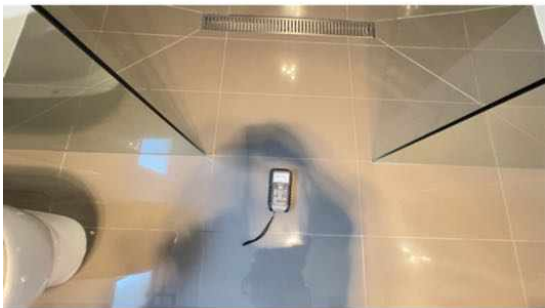
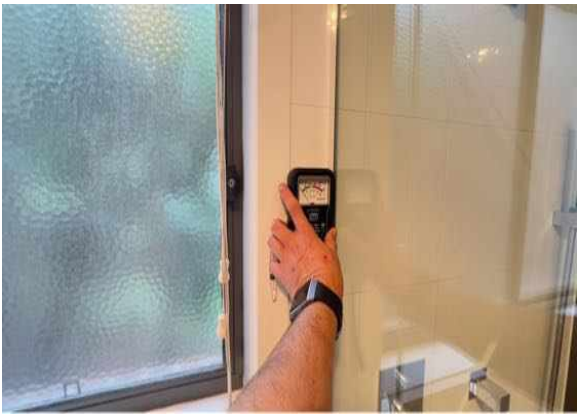
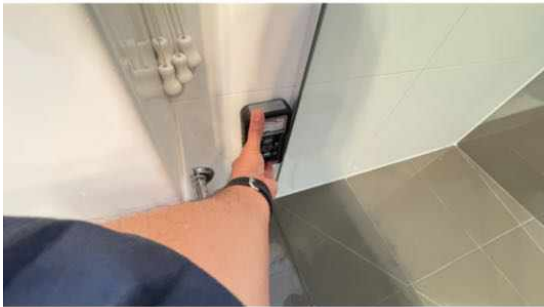
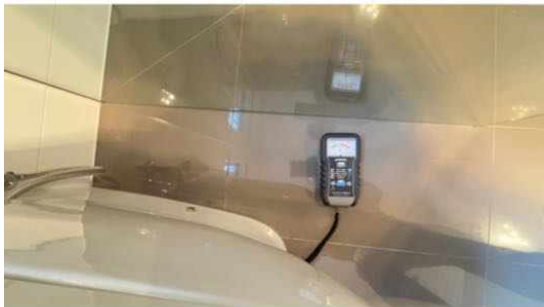
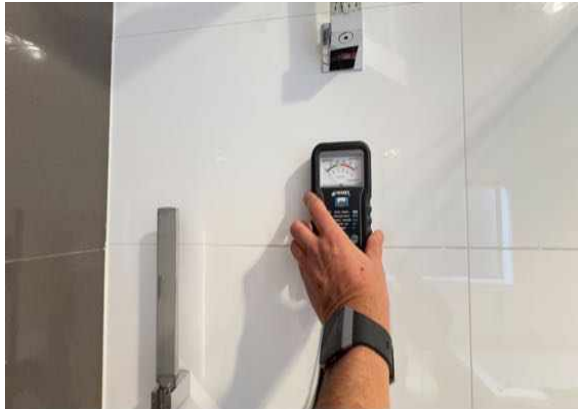
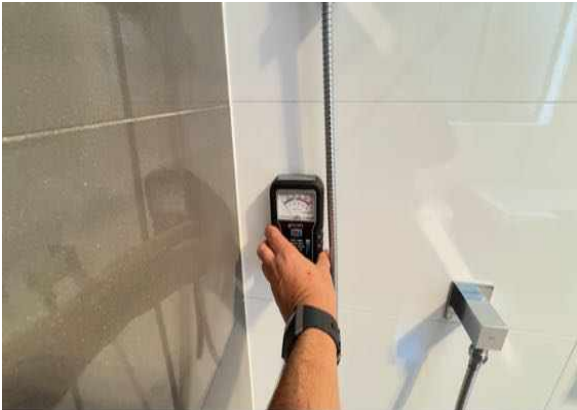
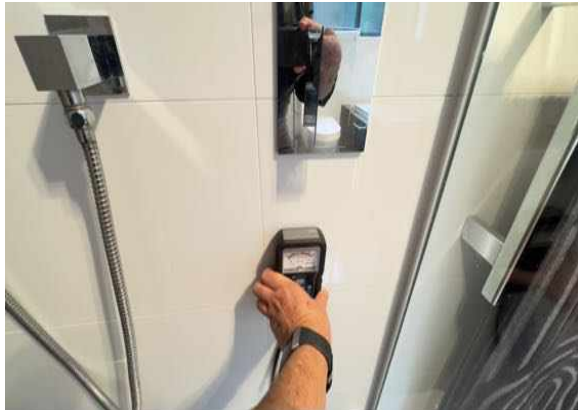
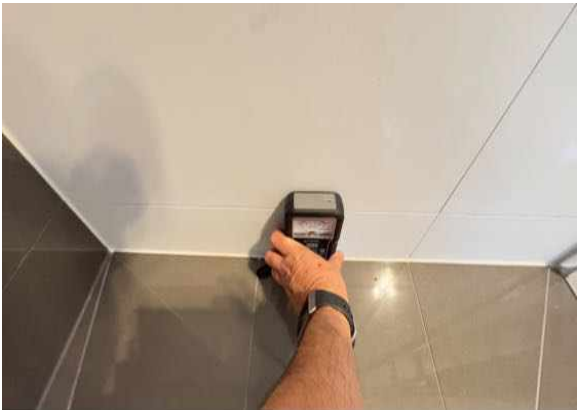
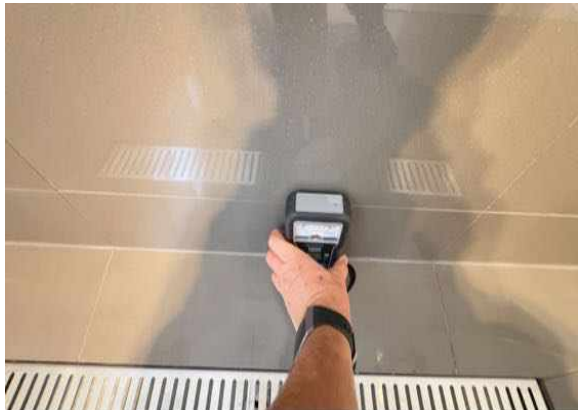
Building: Main Building
Location: All Areas Interior & Exterior
Finding: Moisture Levels - Advisory - No Elevated Moisture Levels Present
Information: At the time of inspection, no elevated moisture levels were detected in these areas. Moisture readings were taken (using a Tramex Moisture Meter) and non-invasive testing methods and reflect conditions present at the time of inspection only. This item is noted for advisory purposes and should not be relied upon as a guarantee that moisture issues are not present elsewhere or may not occur in the future.

It is important to note that moisture levels can fluctuate due to weather conditions, plumbing usage, seasonal changes, or intermittent leaks. Concealed moisture within wall cavities, subfloor areas, or other inaccessible locations may not be detected during a visual or limited moisture assessment.

Ongoing monitoring of the property is recommended, and further investigation by a qualified tradesperson should be considered if signs of water ingress, dampness, staining, mould growth, or material deterioration become apparent.

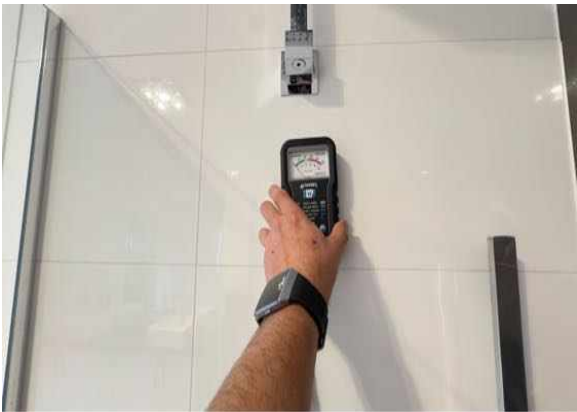
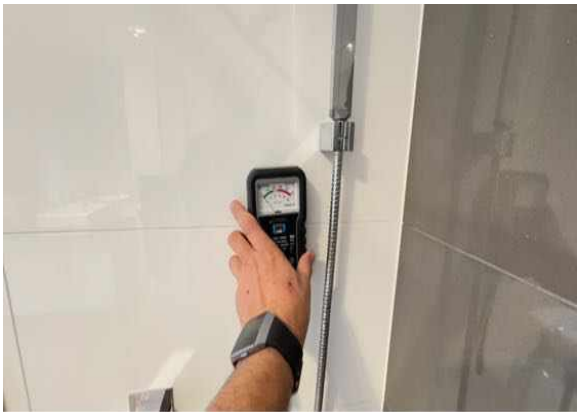
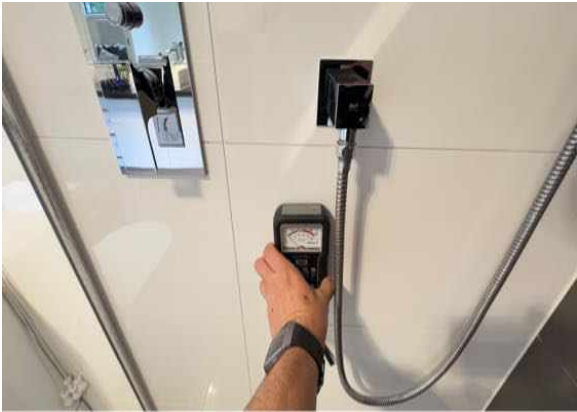
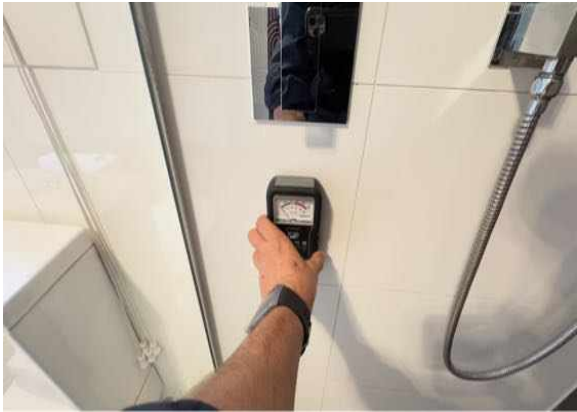
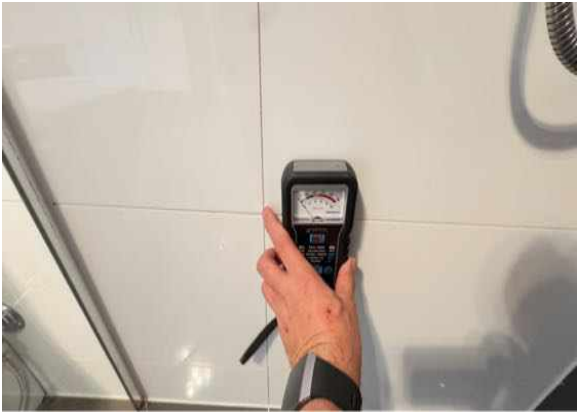
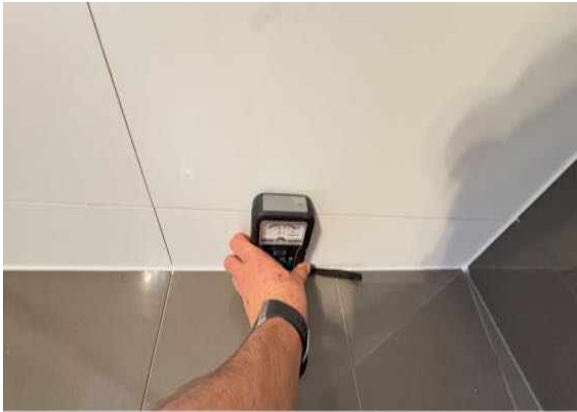
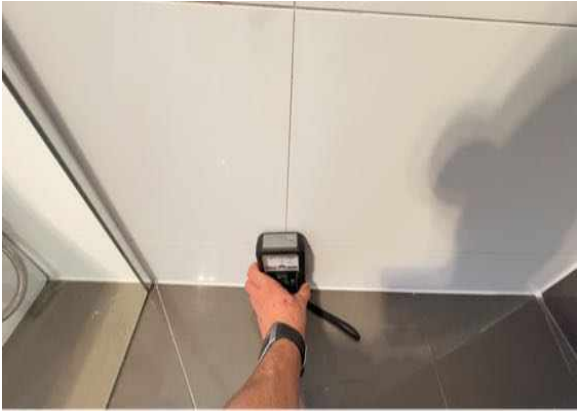
Building: Main Building
 Location: All Areas Interior & Exterior
 Finding: Thermal Scanning & Diagnostic - Advisory - No Elevated Moisture Levels Present
 Information: During the inspection, a thermal imaging camera was utilised as a non-invasive diagnostic tool to assist in identifying potential irregularities associated with moisture ingress, heat loss, insulation deficiencies, or concealed building defects. Thermal imaging detects surface temperature variations that may indicate abnormal conditions within building elements.

Any thermal anomalies identified during the inspection were further assessed where accessible using visual inspection methods and moisture testing. It is noted that thermal imaging is an indicative tool only and does not confirm the presence of defects or moisture without supporting evidence.

Due to the concealed nature of building construction and the limitations inherent in non-invasive inspection methods, the absence of significant thermal anomalies at the time of inspection does not guarantee that concealed defects or moisture issues are not present. Ongoing monitoring and further investigation are recommended should concerns arise.

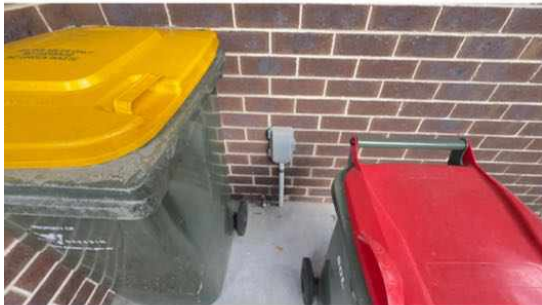
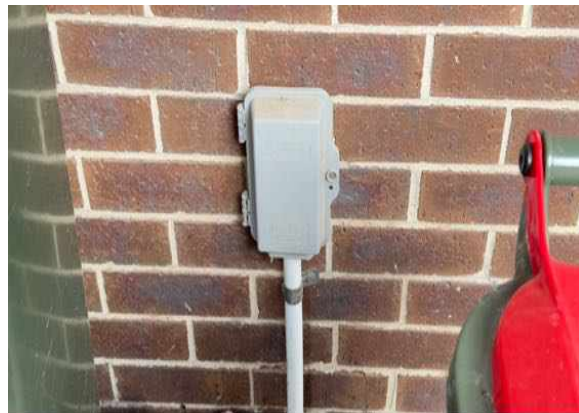
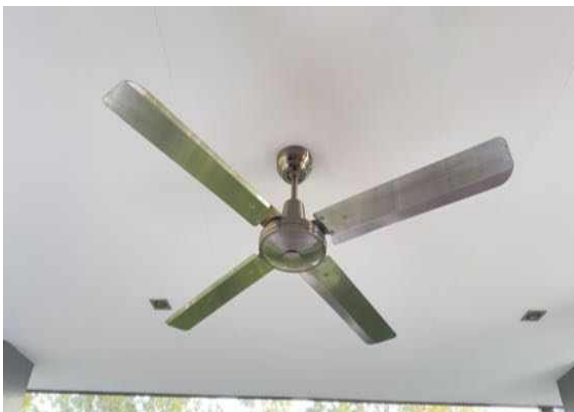
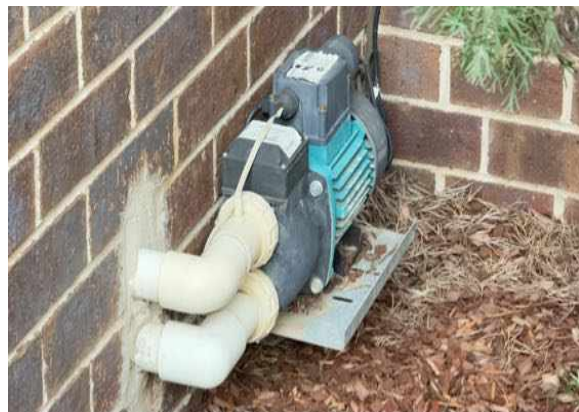
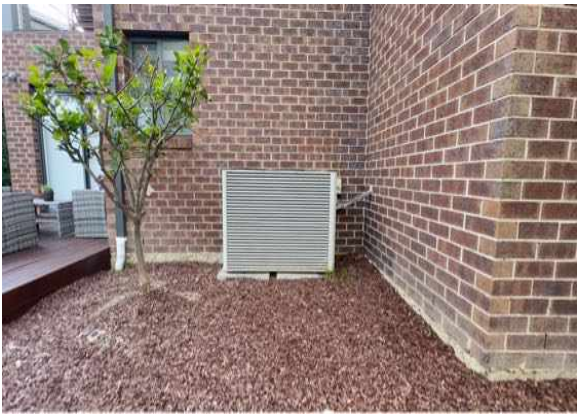
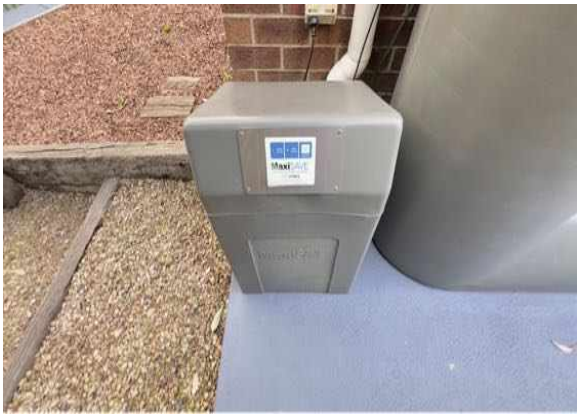
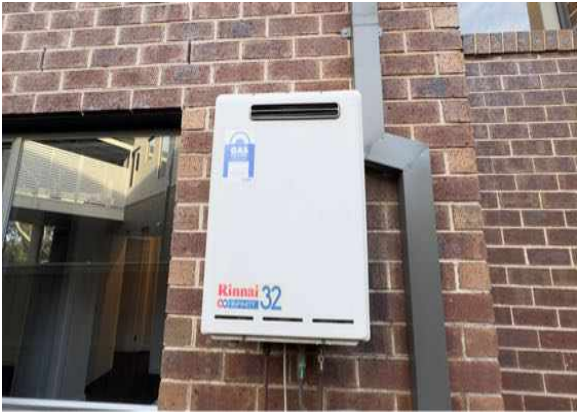
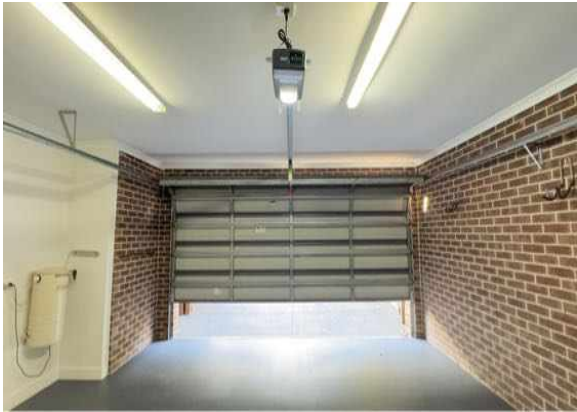
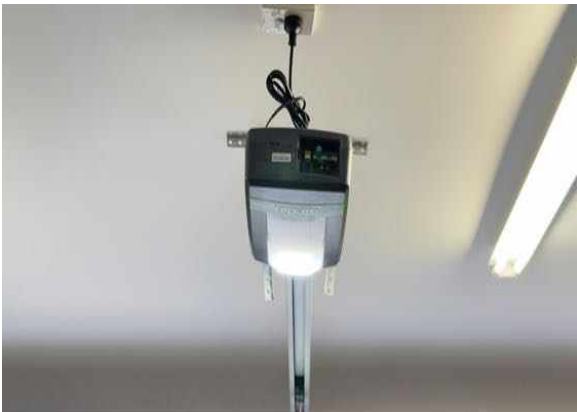
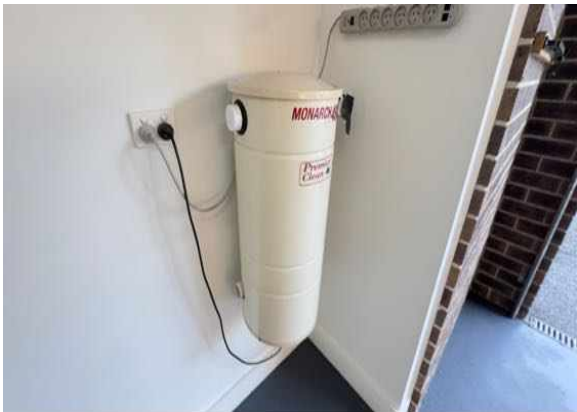
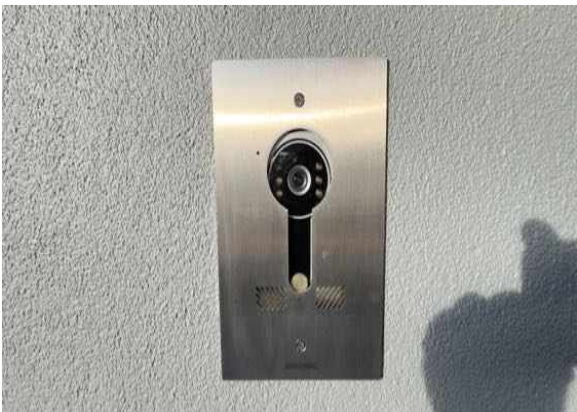
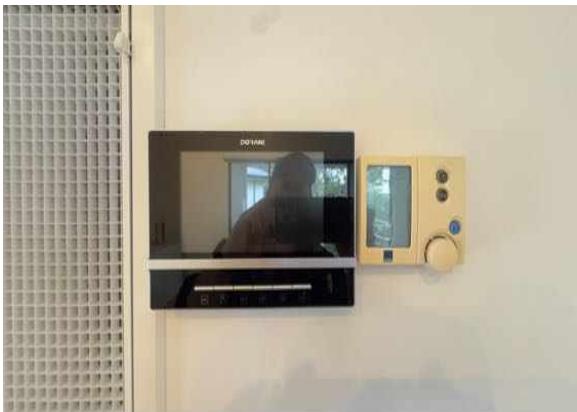
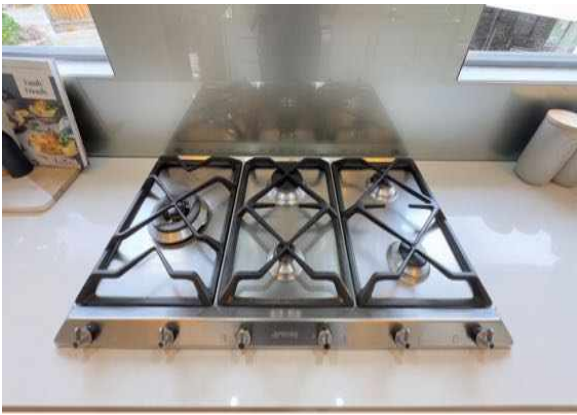
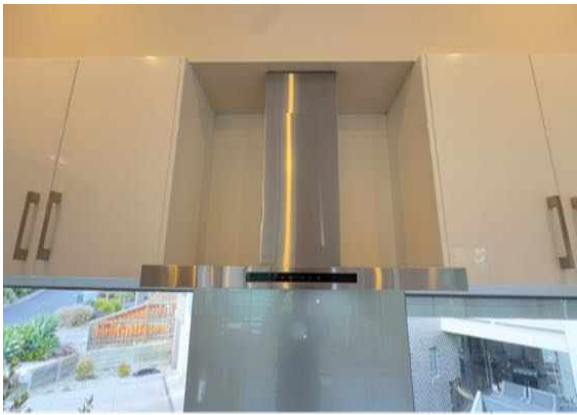
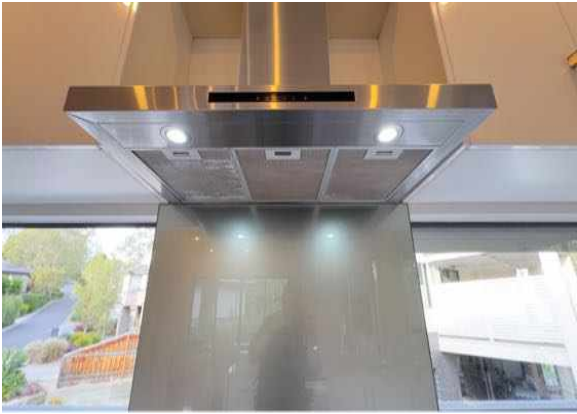
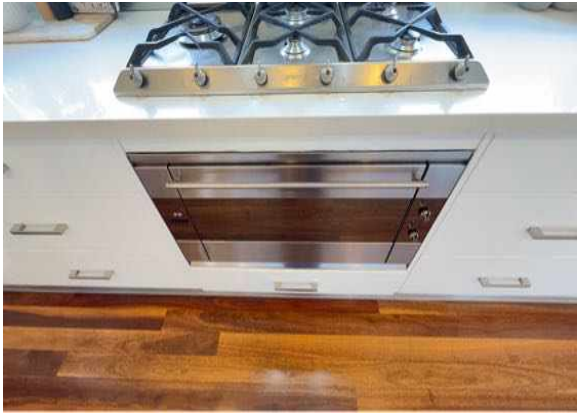
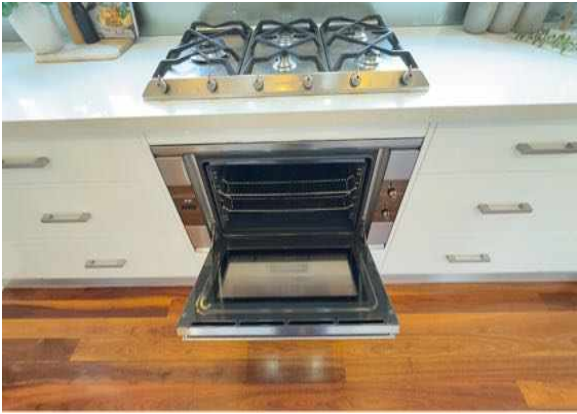
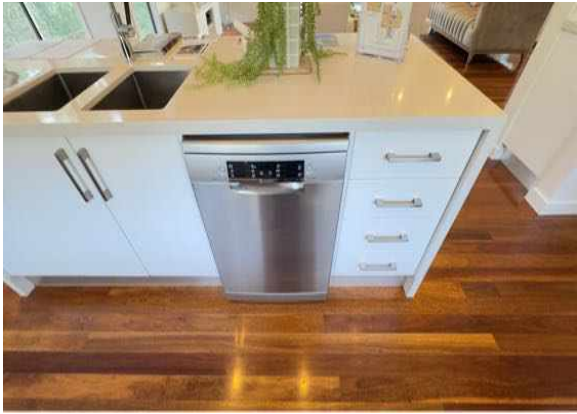
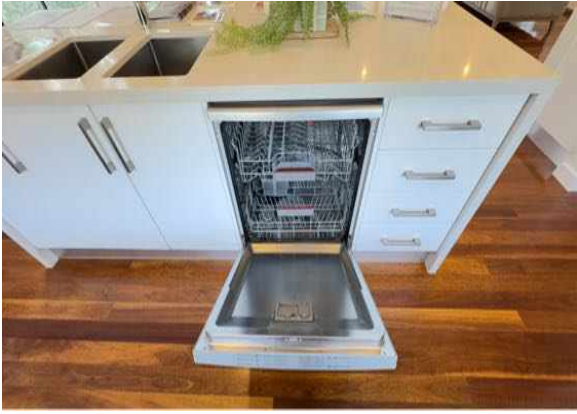
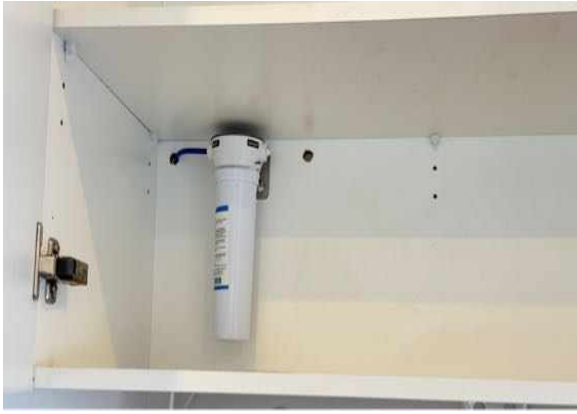
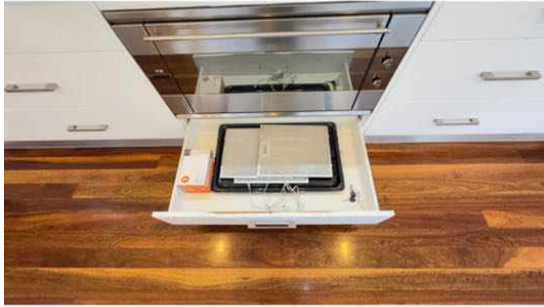
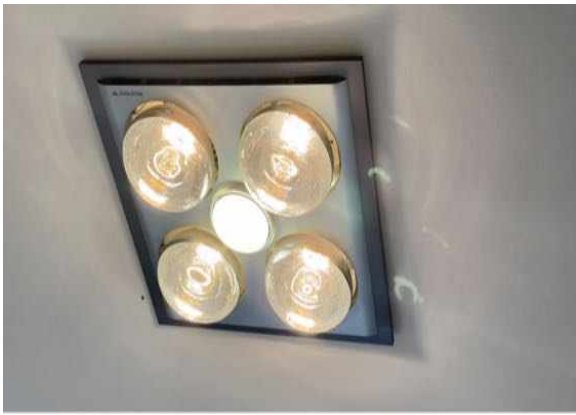
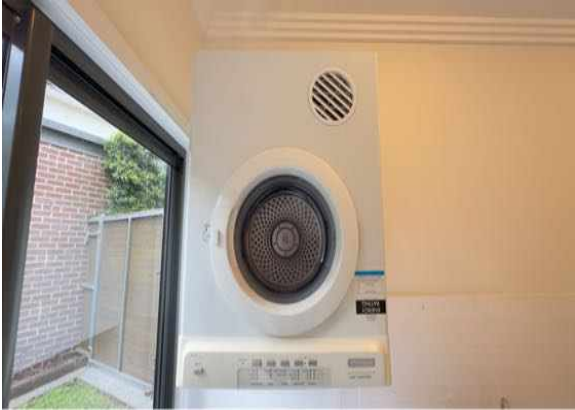
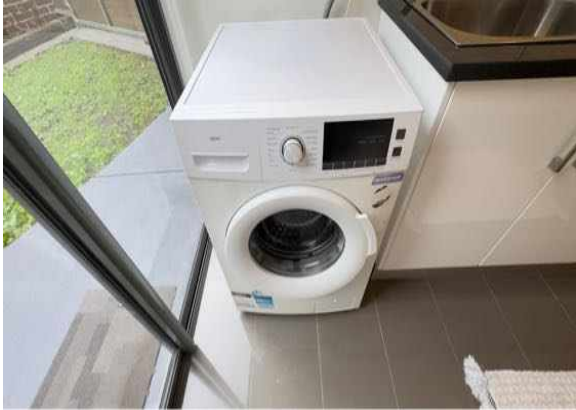
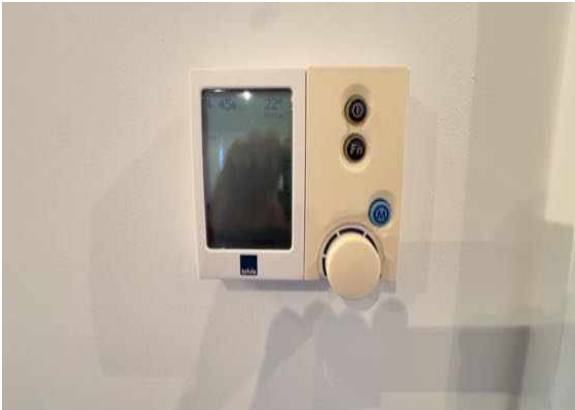
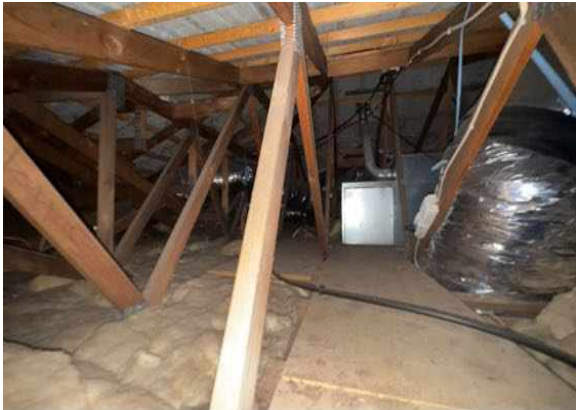
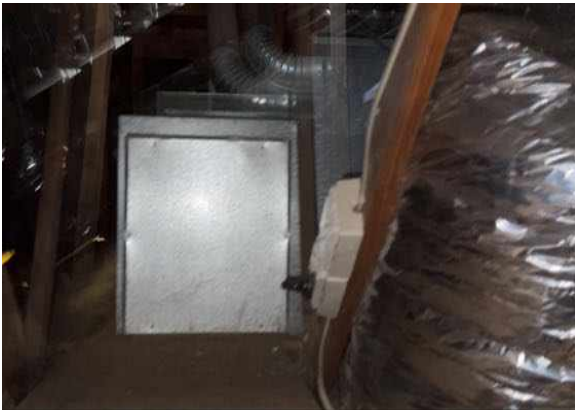
Building: Main Building
 Location: All Areas, Interior & Exterior
 Finding: Appliances, Heating & Cooling Systems, Mechanical Systems, Plumbing, Electrical, Fireplaces - Advisory
 Information: The inspection did not include testing, operation, safety, or assessment of any installed or portable appliances or mechanical systems. This includes, but is not limited to, ovens, cooktops, microwaves, rangehoods, dishwashers, ducted vacuum systems, air-conditioning units, heating systems, hot water services, ceiling fans, exhaust fans, intercoms, security systems, fireplaces, and solid fuel heaters.

Appliances may be worn, damaged, or malfunctioning. Electrical or gas appliances can pose serious safety hazards if incorrectly installed or maintained.

Service, repair, or replace equipment as necessary, particularly where service history or warranty coverage is unknown.

Inspect any water, gas, or electrical connections associated with appliances to ensure safety and compliance.

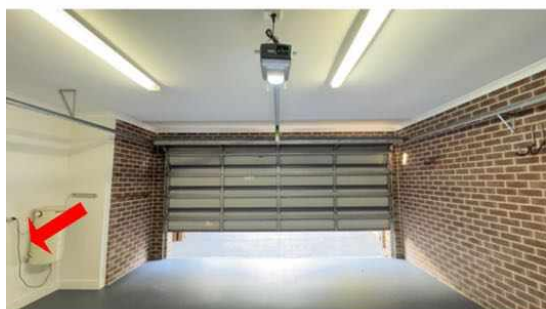
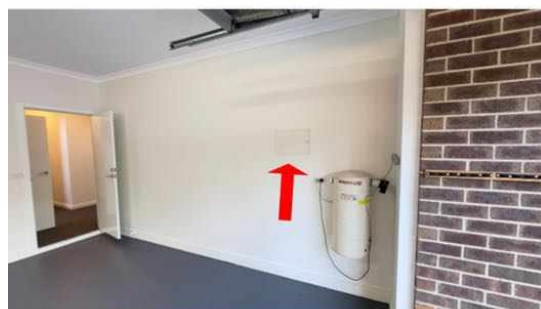
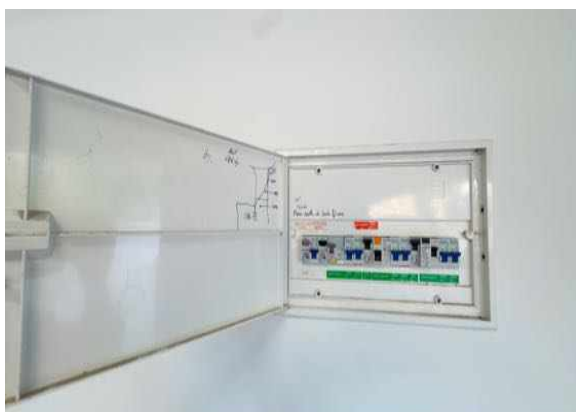
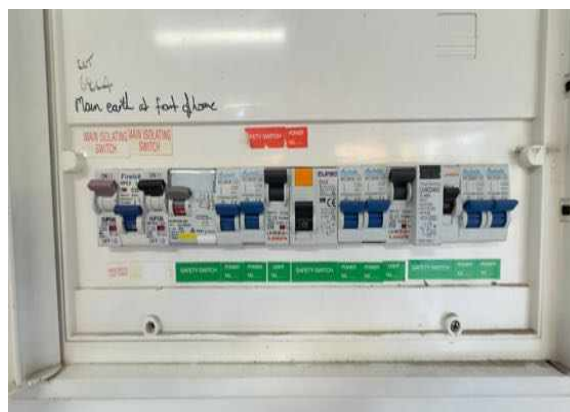
Building: Main Building
 Location: All External Areas
 Finding: Electrical Switch Board - Location
 Information: For your information, the main electrical switchboard was visually inspected. No intrusive testing or detailed electrical assessment was performed as part of this inspection.

For full compliance and safety verification, a licensed electrician should be engaged to inspect the switchboard, test all circuits, and ensure all components are functioning correctly. This will help maintain electrical safety and prevent potential hazards.

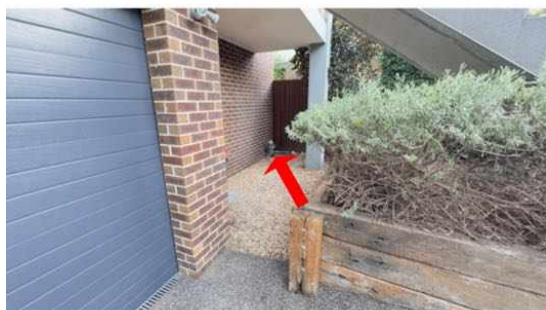
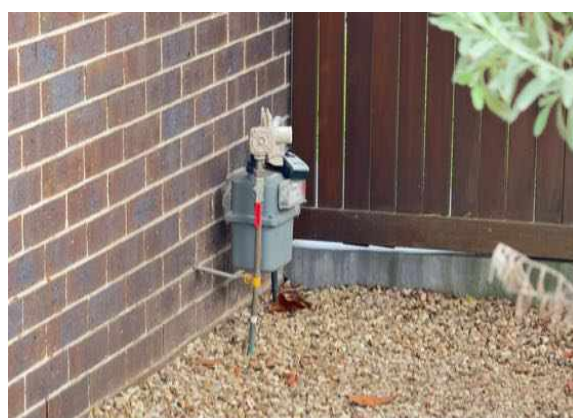
Building: Main Building
 Location: All External Areas
 Finding: Gas Meter - Location For Your Information
 Information: The gas meter was inspected and photographed for reference and location purposes only.

Gas meters can be affected over time by age, environmental exposure, or accidental impact, which may lead to corrosion, physical damage, leakage, or non-compliance with current regulations. Regular checks are recommended to ensure ongoing safe operation.

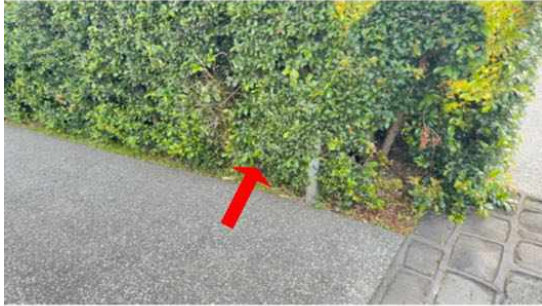
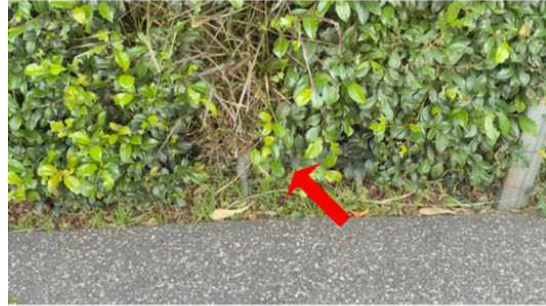
Water meters can be affected over time by age, environmental exposure, accidental impact, or poor maintenance. Potential issues could include leaks, corrosion, or malfunction that may impact water supply or cause water damage.

It is recommended that a licensed plumber carry out routine inspections and maintenance to ensure continued safe and compliant operation. Observations are for informational purposes only and do not form part of a full safety or compliance inspection.
