Building and Timber Pest Inspection Report

Inspection Date: Wed, 1 Apr 2026

Property Address: 7 Manor Grn, Macleod VIC 3085, Australia

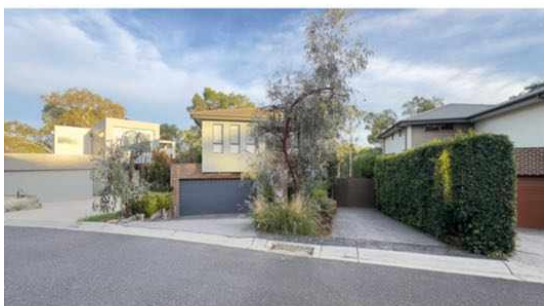
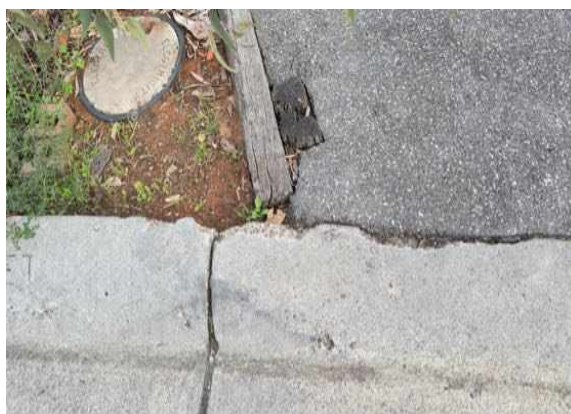
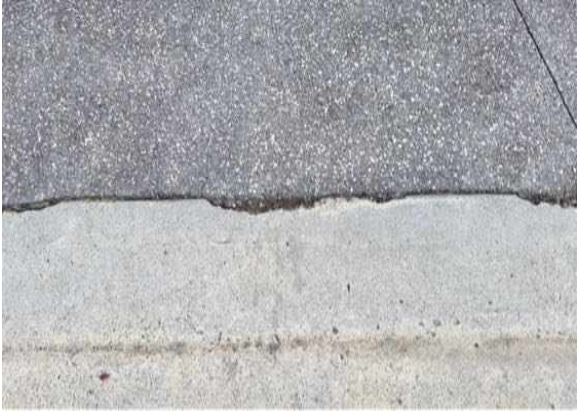
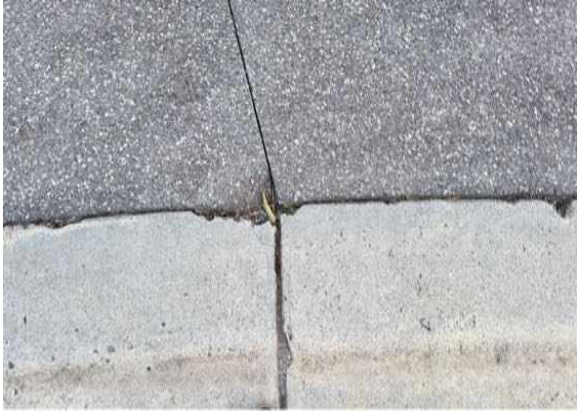
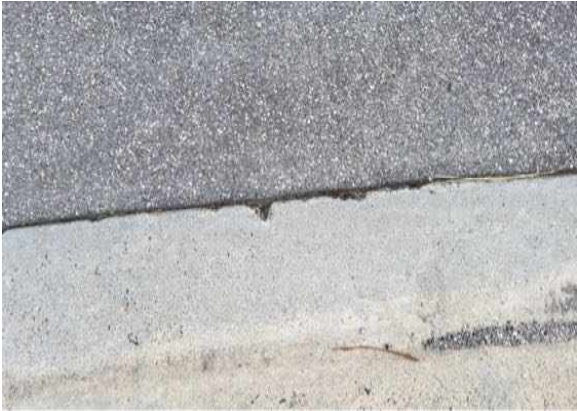
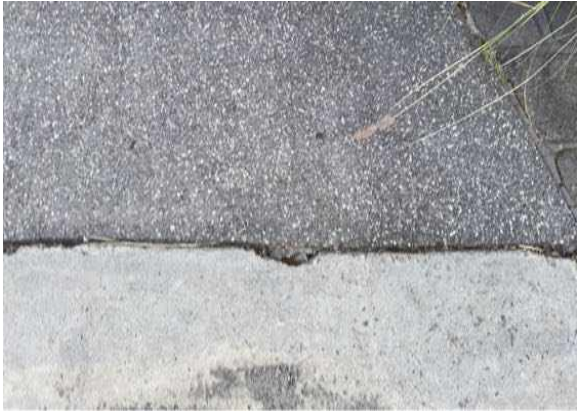
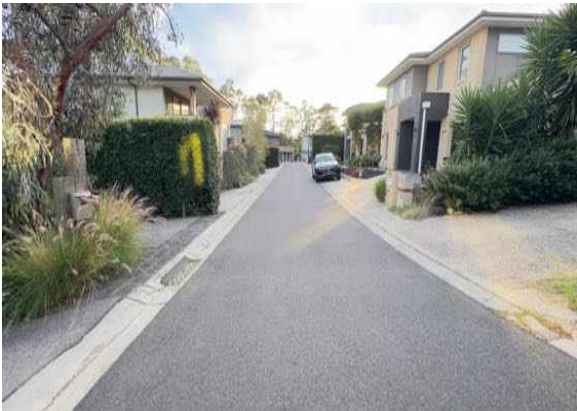
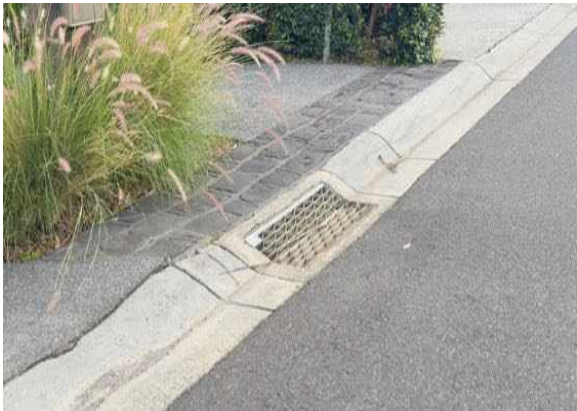
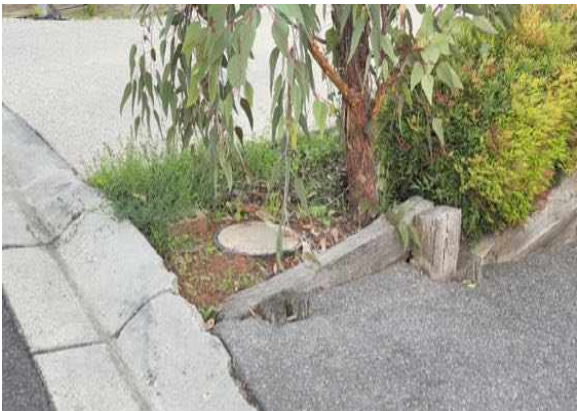
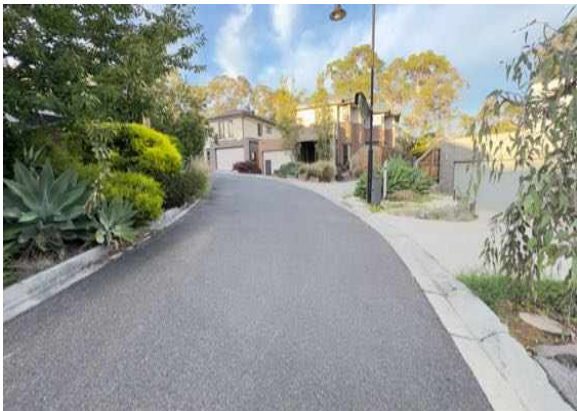
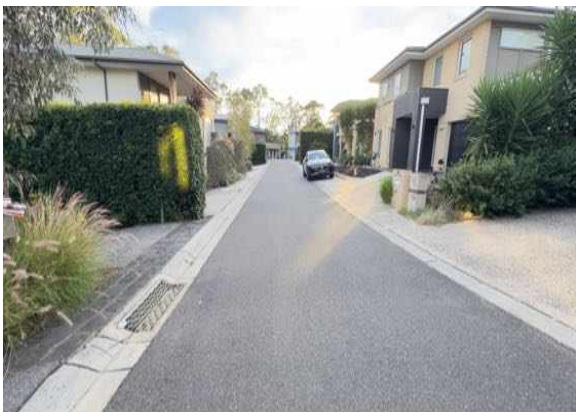
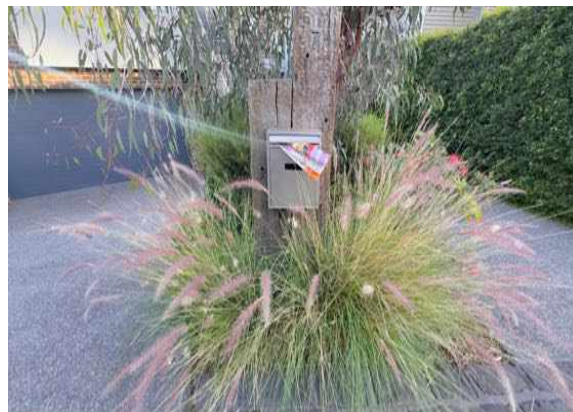
During the inspection, minor cracking, surface wear, or uneven sections were observed on footpaths or crossovers. Some accessible metal components, such as street signage or grates, showed signs of rust or deterioration. Debris accumulation and vegetation encroachment were also noted around council infrastructure. Access or visibility was limited to certain council-owned assets.

These areas should be monitored, and for detailed assessment, maintenance, or compliance verification, the relevant local council authority should be contacted immediately. Regular monitoring of adjacent council assets is recommended to ensure ongoing safety and proper maintenance.

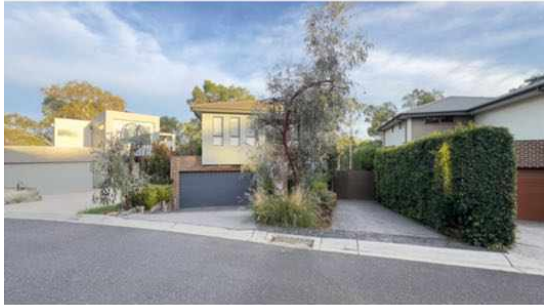
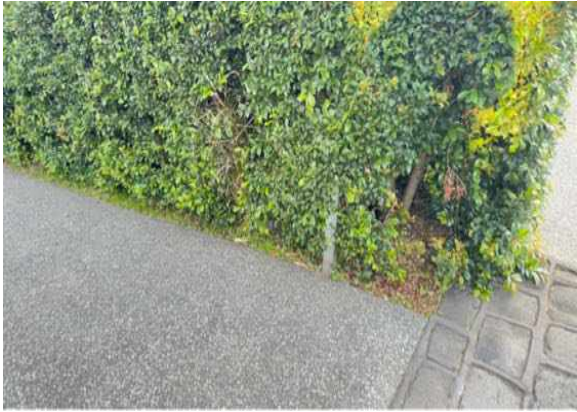
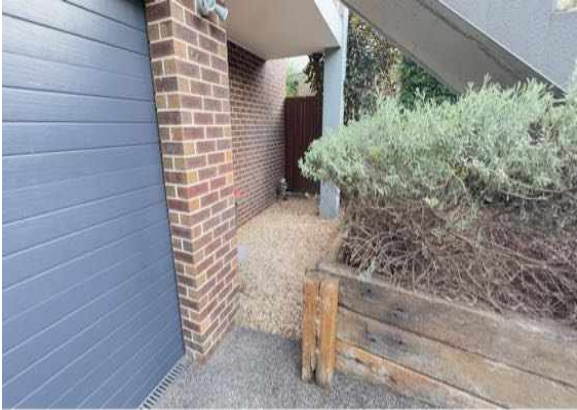
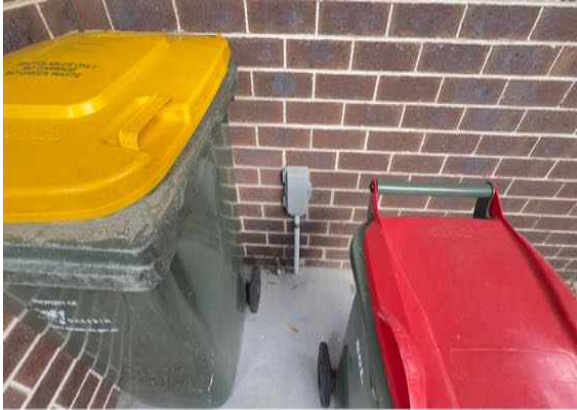
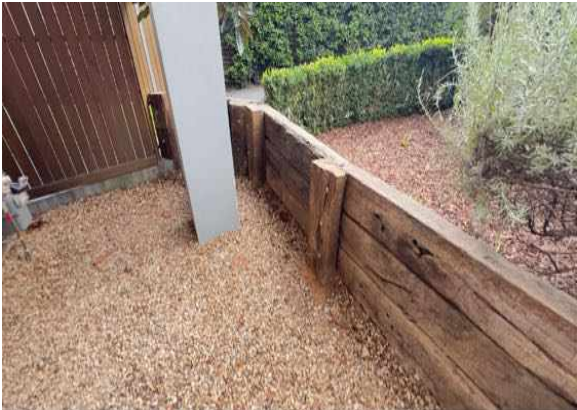
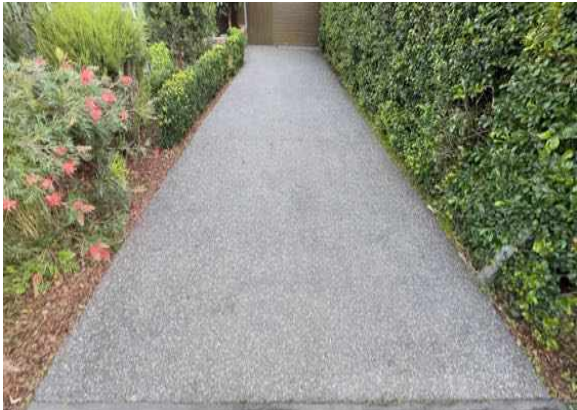
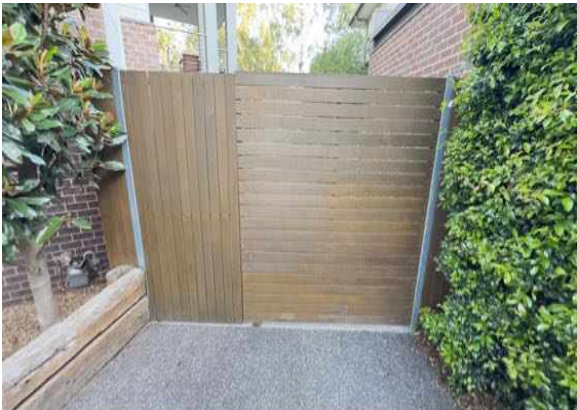
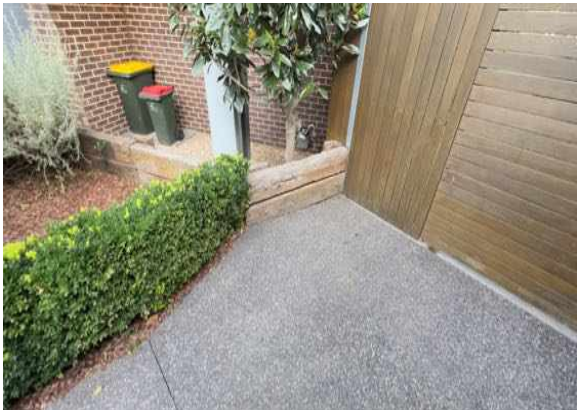
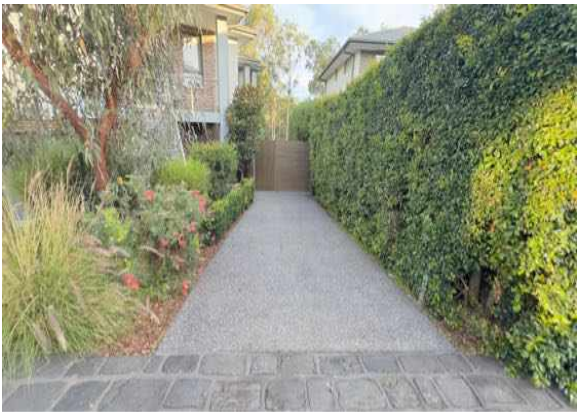
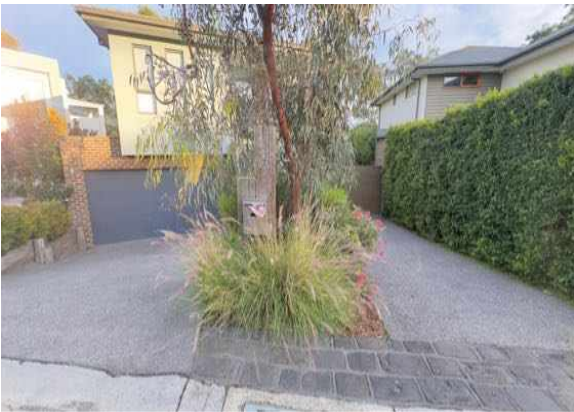
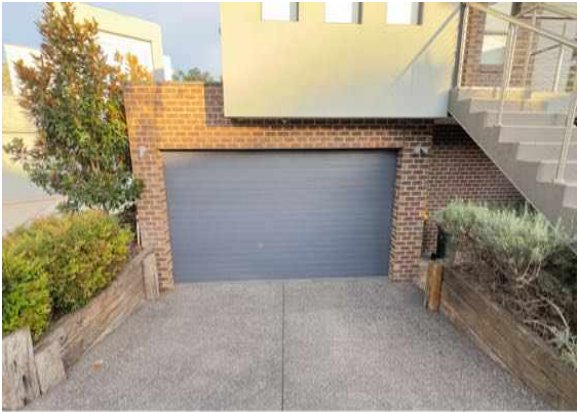
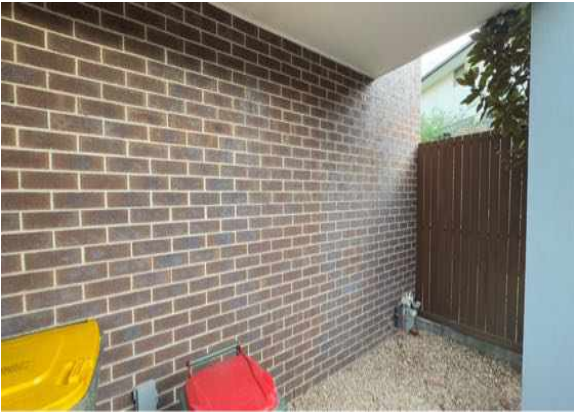
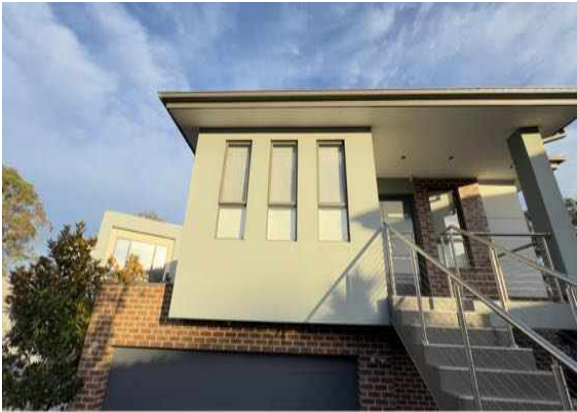
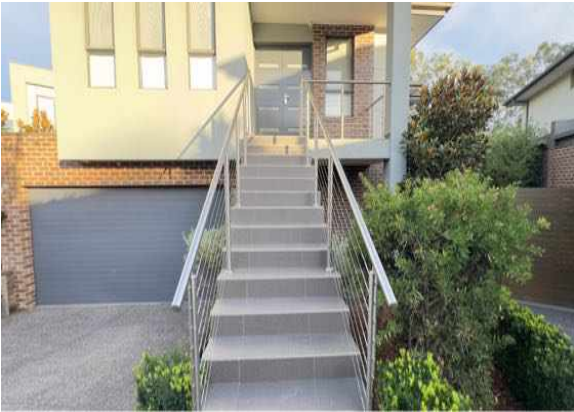
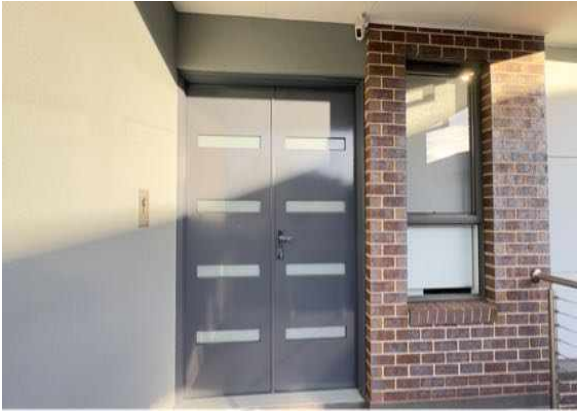
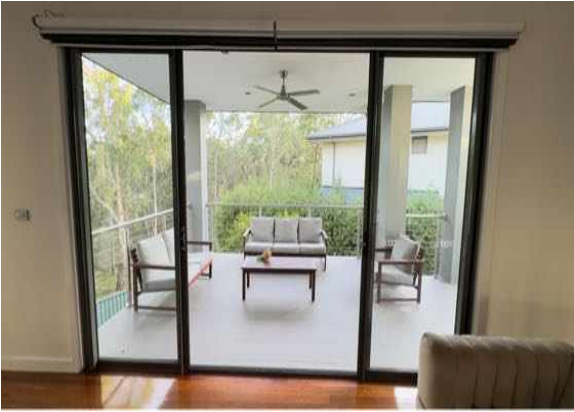
It is important to note that these restrictions can conceal a wide range of building defects, including but not limited to:

Because these areas could not be visually assessed, no comment can be made on their condition within this report.

It is strongly recommended that obstructions be removed and concealed areas made fully accessible immediately. A re-inspection should then be carried out to allow a complete assessment of the property's condition. This is particularly important prior to purchase, as defects in concealed areas can carry significant rectification costs.
