Building and Timber Pest Inspection Report

Inspection Date: Thu, 19 Mar 2026

Property Address: 19 Peter Cl, Hornsby Heights NSW 2077, Australia

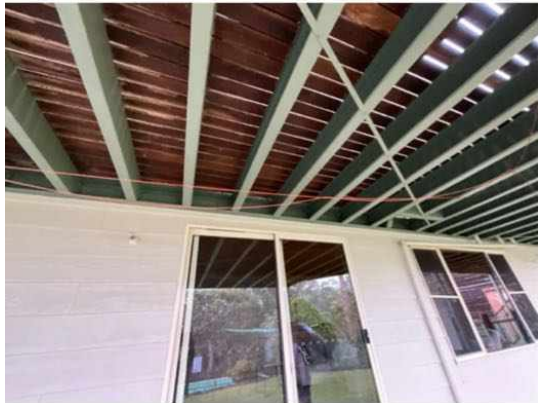
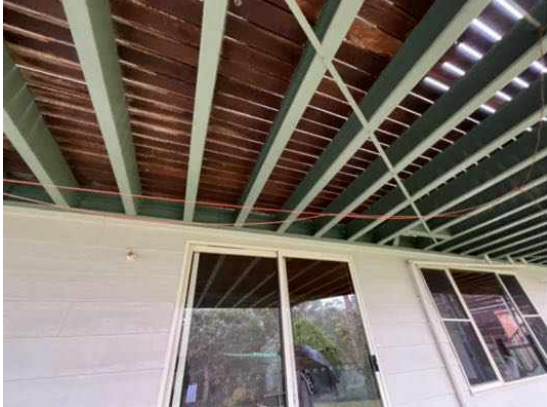
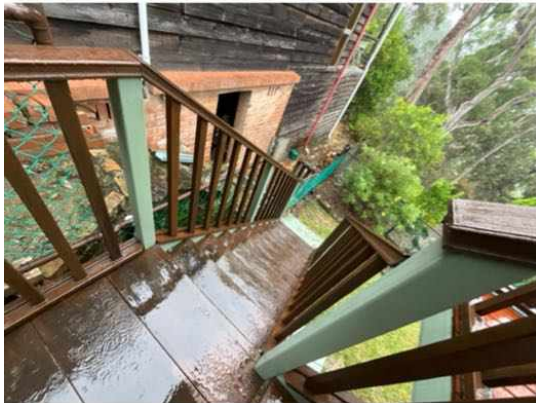
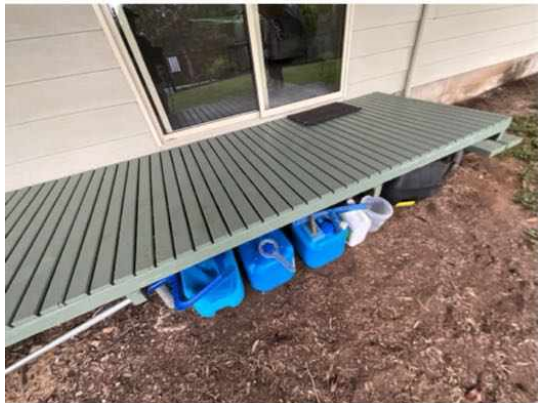
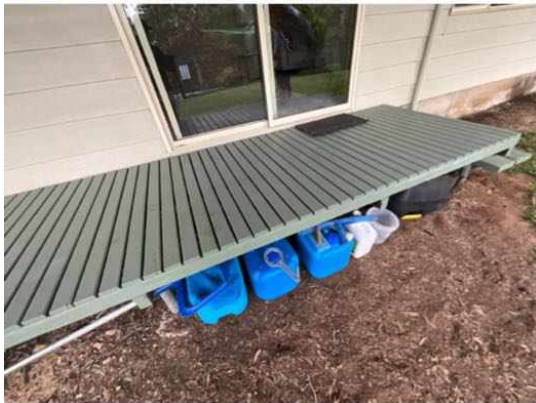
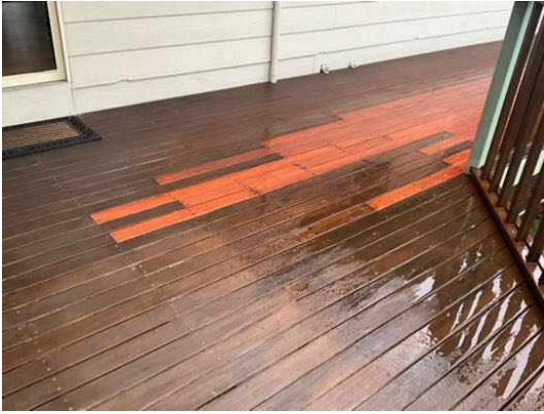
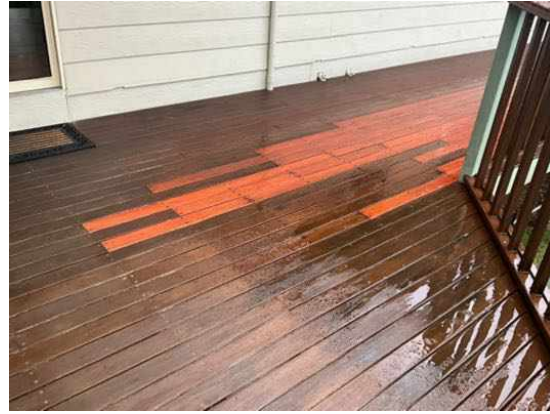
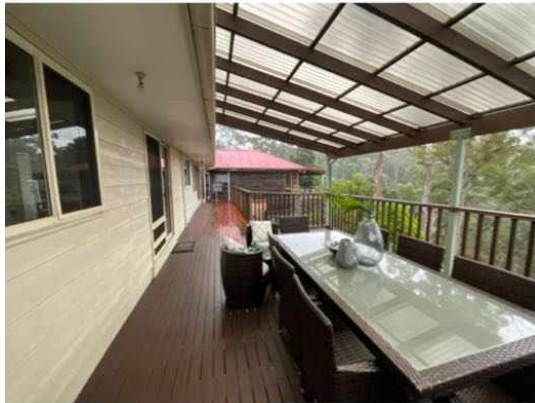
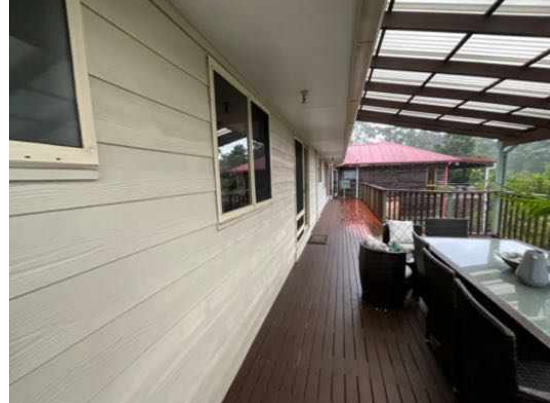
External timber structures are also constantly exposed to weather deteriorates in an exhilarate manner, ongoing assessments are required.

It is highly recommended that a structural engineer further, assess the external timber balcony or a deck to inform the client of its load capacity.

Regular maintenance inspections by competent practitioners is needed.

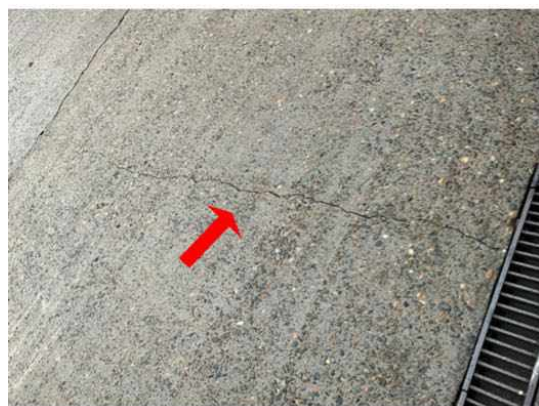
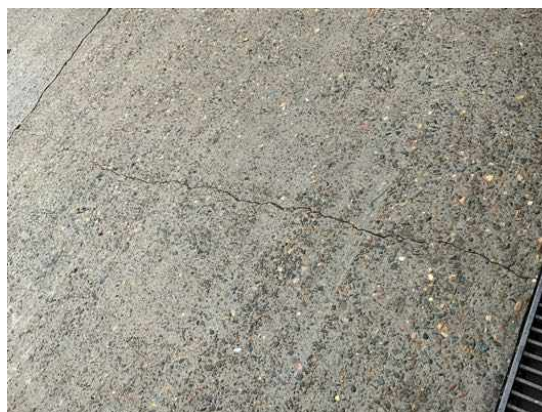
Finding 3.02

Building: Main Building
 Location: All Areas
 Finding: Crack in concrete slab - Category 0
 Information: A crack coded as Category 0 was identified in the slab. A Category 0 crack is described as a hairline crack, representing insignificant movement of slab from level.

The approximate width of the crack to be considered Category 0 is 0.3mm, or change in offset of less than 8mm when a 3m straight edge is placed over the defect.

No rectification is required at this time. However, all cracking should be monitored over a 12 month period to identify any further damage in the area.

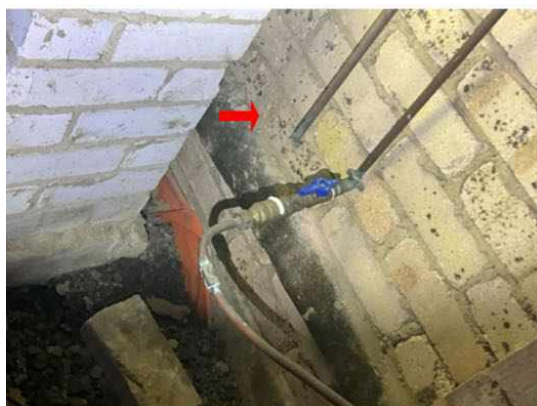
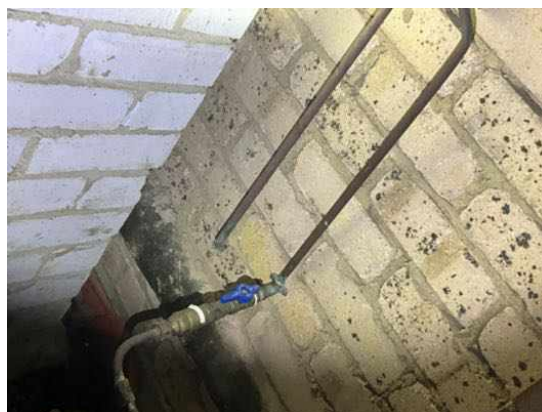
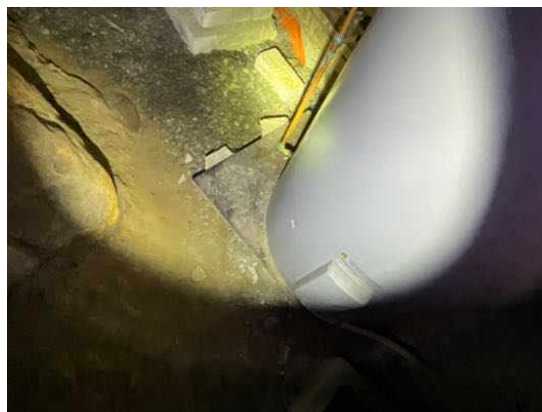
Finding 3.03

Building:	Main Building
Location:	Subfloor
Finding:	HWS Overflow - Not Connected
Information:	The Hot Water System (HWS) overflow was found to be disconnected from storm water drainage and is creating excessive moisture in the surrounding area.

These damp conditions can lead to secondary defects such as rot, rust or corrosion of associated building elements, the formation of fungal decay, or even the creation of potential slip hazards. When coupled with poor site drainage, pooling of water may also attract termite activity to this area.

It is highly recommended that a licensed plumber be appointed to connect the HWS overflow in order to prevent such an environment from being created. These minor works should be carried out as soon as possible.

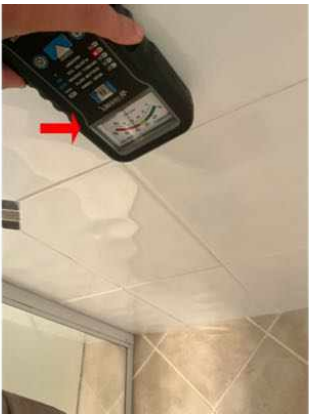
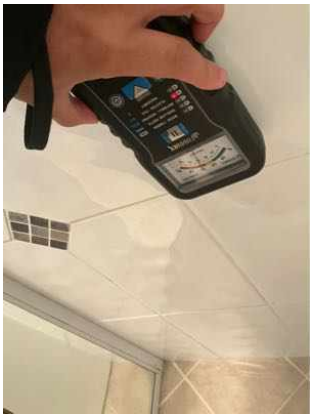
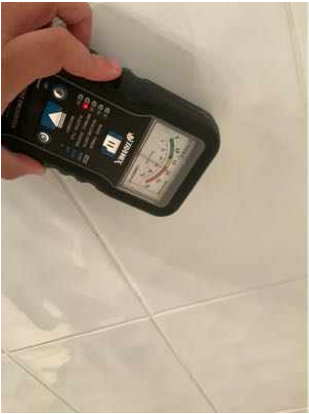
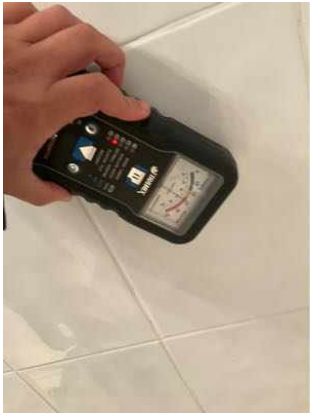
Finding 3.04

Building:	Main Building
Location:	Bathroom
Finding:	Evidence of excessive moisture was present at the time of inspection
Information:	Excessive moisture is present behind the bathroom tiles, indicating a potential water leakage issue within the wall.

The prolonged presence of moisture can lead to mold growth, deteriorate the structure, and create an environment conducive to health hazards. Additionally, it may compromise the adhesive holding the tiles, leading to their detachment.

A licensed plumber or a qualified contractor specializing in water damage remediation should investigate the source of the moisture, fix any leaks, and address the damage. Additionally, replacing affected tiles and ensuring proper waterproofing are crucial to preventing future issues.

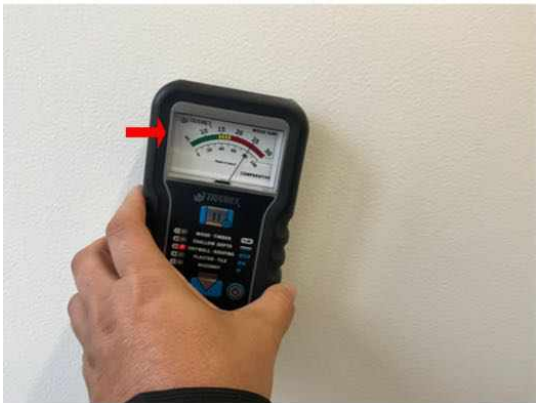
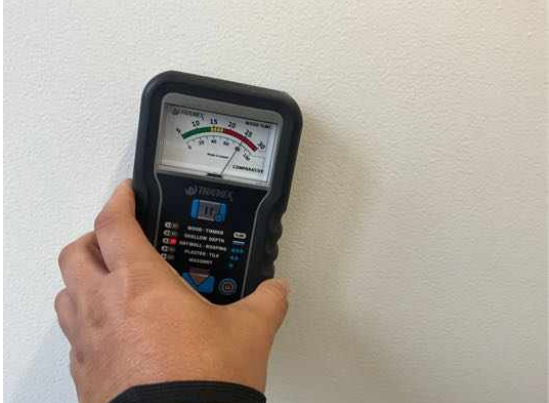
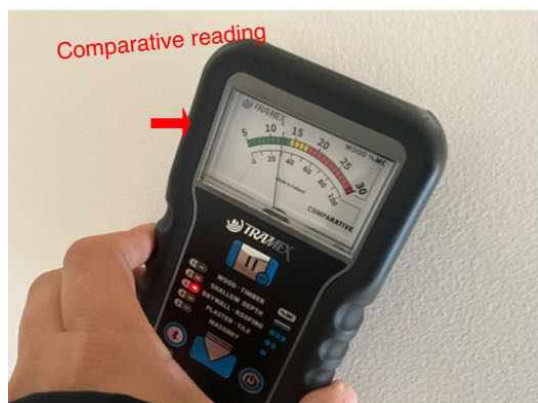
Finding 3.05

Building: Main Building
Location: Toilet (WC)
Finding: Evidence of excessive moisture - Drywall
Information: Excessive moisture is present at the time of , indicating a potential water leakage issue within the wall.

The prolonged presence of moisture can lead to mold growth, deteriorate the structure, and create an environment conducive to health hazards. Additionally, it may compromise the adhesive holding the tiles, leading to their detachment.

A licensed plumber or a qualified contractor specializing in water damage remediation should investigate the source of the moisture, fix any leaks, and address the damage. Additionally, replacing affected tiles and ensuring proper waterproofing are crucial to preventing future issues.

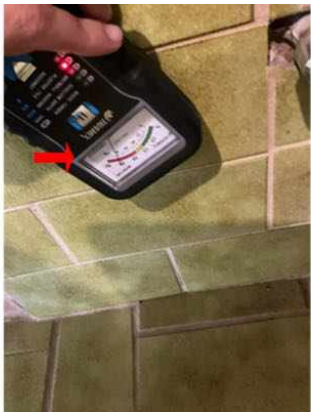
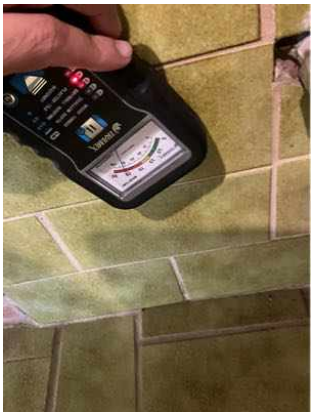
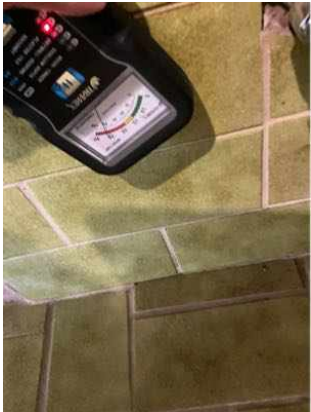
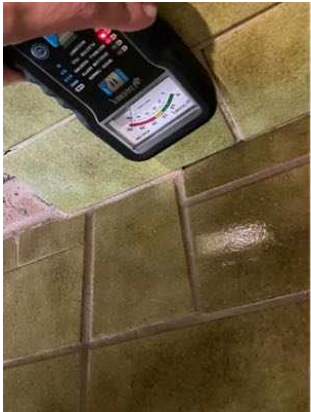
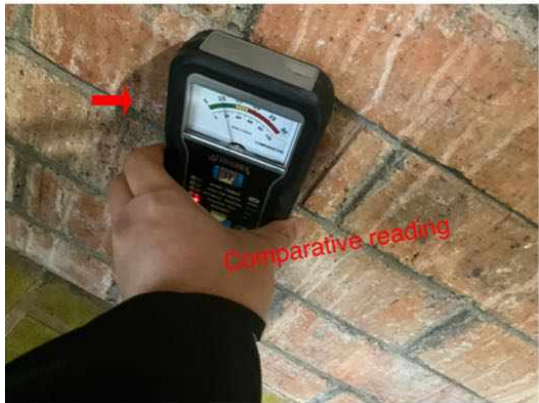
Finding 3.06

Building:	Main Building
Location:	Laundry / Toilet downstairs
Finding:	Evidence of excessive moisture was present at the time of inspection
Information:	Excessive moisture is present behind the bathroom tiles, indicating a potential water leakage issue within the wall.

The prolonged presence of moisture can lead to mold growth, deteriorate the structure, and create an environment conducive to health hazards. Additionally, it may compromise the adhesive holding the tiles, leading to their detachment.

A licensed plumber or a qualified contractor specializing in water damage remediation should investigate the source of the moisture, fix any leaks, and address the damage. Additionally, replacing affected tiles and ensuring proper waterproofing are crucial to preventing future issues.

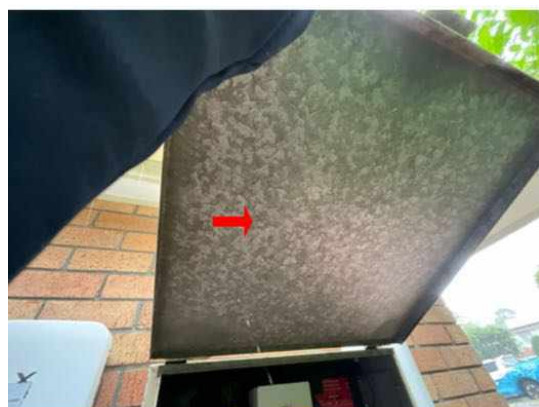
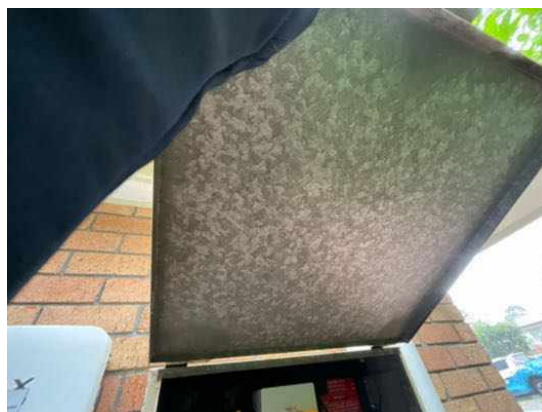
Building: Main Building
Location: Exterior walls - right side
Finding: No Evidence of Termite Management System - Durable notice / Legible Sticker
Information: The application of a pre & post-construction chemical termite barrier is highly recommended for all properties. Such barriers are highly effective in preventing termite attack on any timber building elements throughout the property.

A durable notice was not placed in the switchboard unit to indicate current termite barriers is legible at the time of inspection.

Client must seek further information from the vendor or real estate agent if the conditions of termite management systems were maintained.

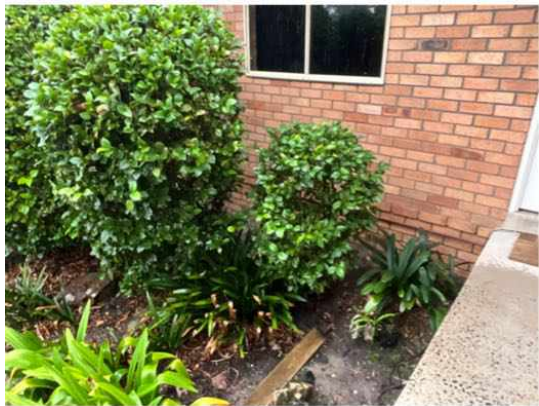
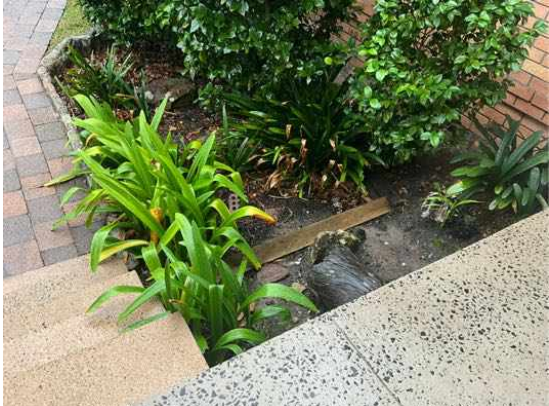
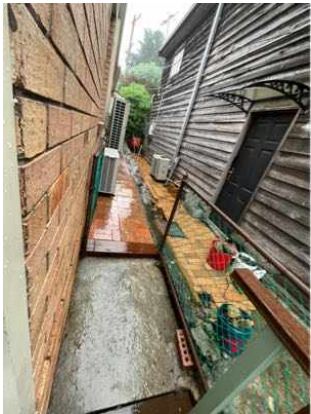
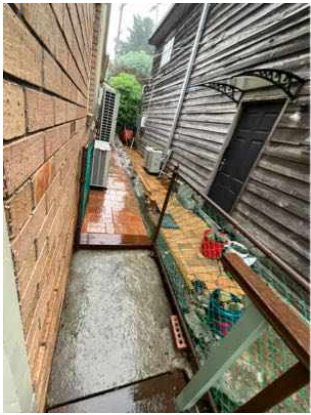
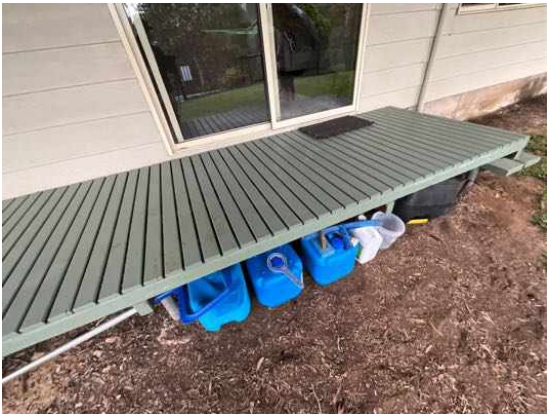
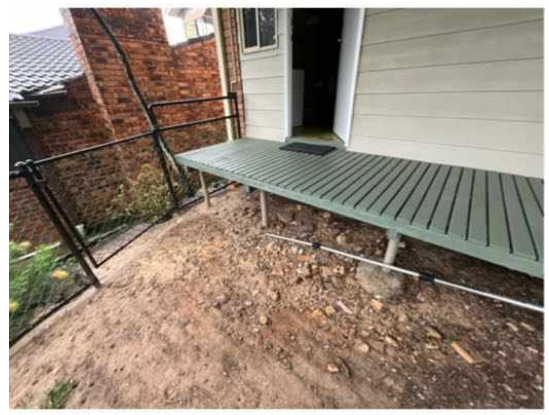
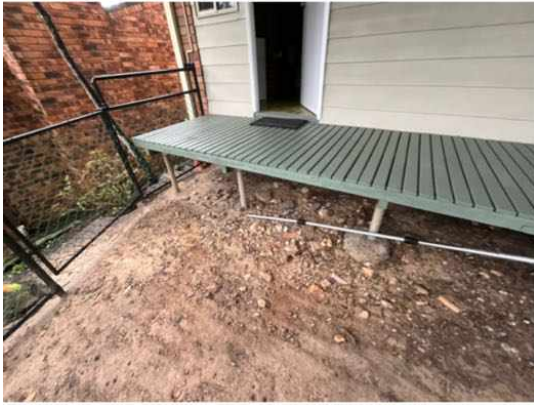
Finding 6.03

Building: Main Building
Location: All Areas
Finding: Timber on ground / conducive conditions to termite damage
Information: Timber on the ground is indeed conducive to termite damage. Termites are known to thrive in moist environments, and wood in contact with soil or moisture is more susceptible to infestation.

To prevent this, it's important to keep timber elevated and away from direct ground contact. Regular inspections and proper termite control measures are also essential to protect your wooden structures from termite damage.

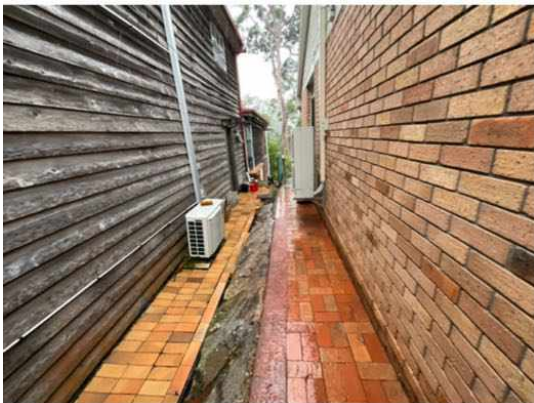
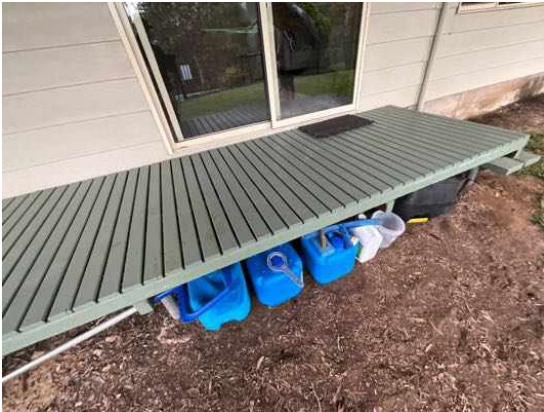
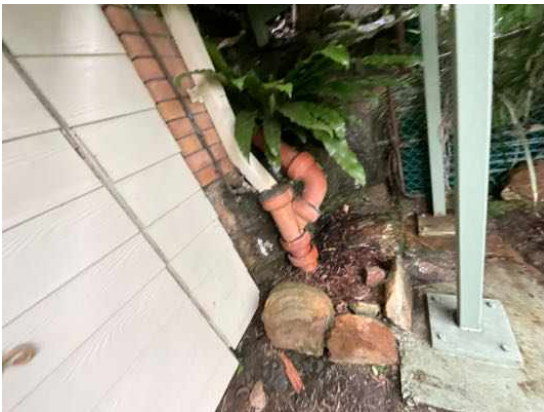
Finding 6.04

Building:	Main Building
Location:	All Areas
Finding:	Bridging or Obstruction Conducive environment for Termites
Information:	Bridging of termite barriers occurs when termites bridge (usually by building a mud tunnel) a termite barrier or inspection inspection zone or where termites have a passage, allowing them to bridge the barrier.

Where bridging has occurred full inspection is prevented and termites may enter a property in a concealed or undetected manner.

Recommended moving obstructions away from the external walls for further and future inspections.

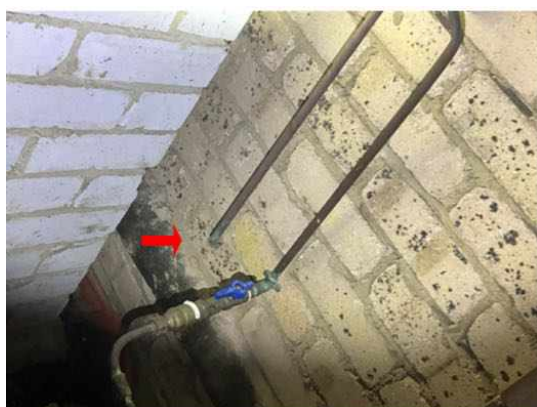
Finding 6.05

Building:	Main Building
Location:	Subfloor
Finding:	HWS not connected - conducive conditions for timber pest attacks
Information:	The hot water system (HWS) is not connected, leaving exposed pipes and creating conducive conditions for timber pest attacks.

Risk of Timber Pest Attack: The risk of timber pest attack is heightened when the hot water system is not connected. Exposed pipes provide easy access points for timber pests like termites and ants to infiltrate the building structure. These pests are attracted to moisture, and the absence of flowing water through the system can lead to moisture buildup, creating an ideal environment for pests to thrive and cause

damage to timber components within the building.

A licensed plumber or qualified plumbing technician should be engaged to reconnect the hot water system. They will assess the existing plumbing infrastructure, determine the appropriate connection points, and ensure proper installation and functionality of the HWS. Additionally, they may inspect for any signs of timber pest activity and recommend preventive measures, such as installing physical barriers or implementing moisture control measures, to deter pest infestations and protect the building from damage. Regular maintenance and inspections by homeowners or property managers are also essential to detect and address potential issues before they escalate.

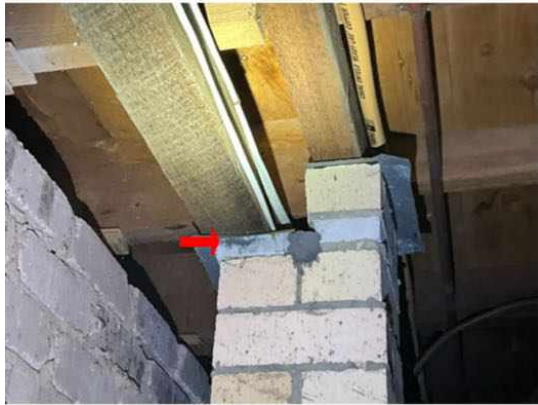
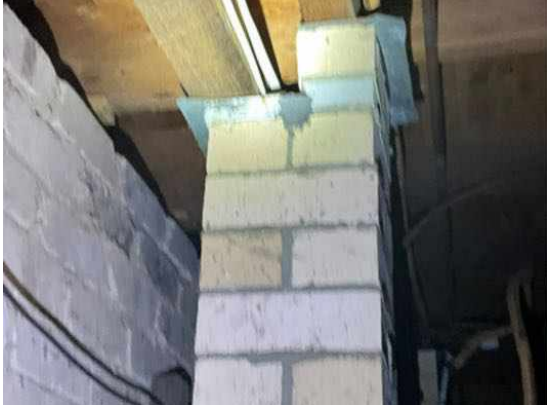
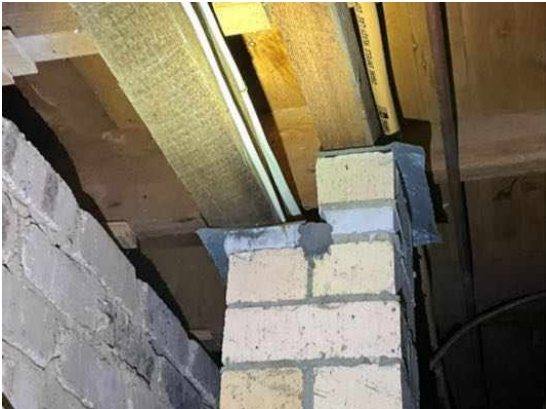
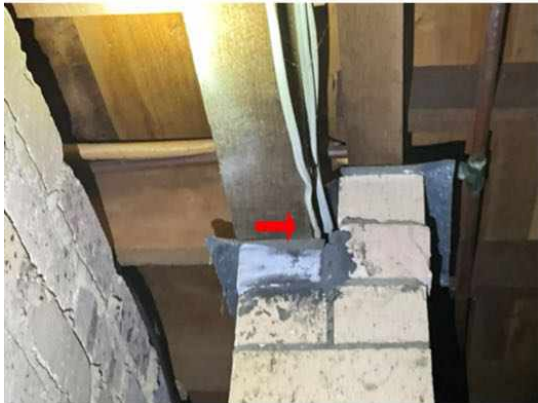
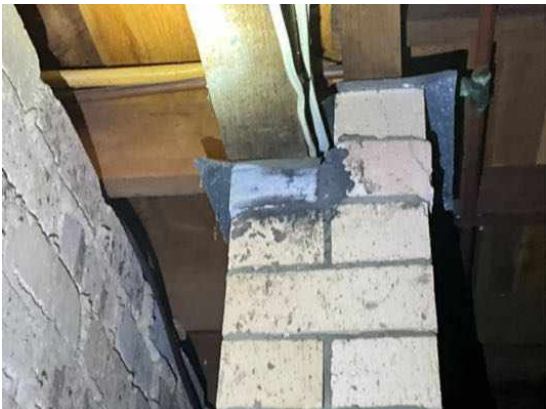
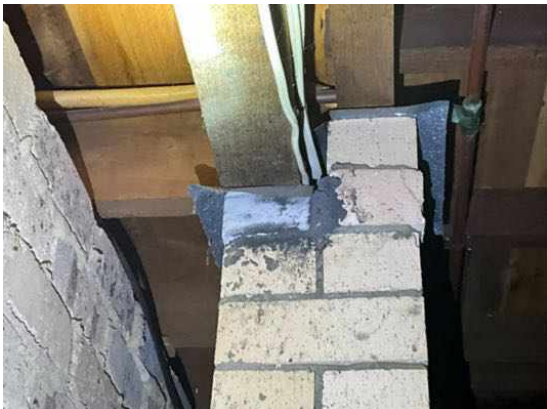
Finding 6.06

Building:	Main Building
Location:	Subfloor
Finding:	Ant caps not correctly installed
Information:	Ant caps were noted as not correctly installed to the subfloor piers/stumps. Gaps and poor placement reduce their effectiveness as a visual termite detection barrier.
Risk:	This condition is considered a potential termite management deficiency. Incorrectly installed ant caps may allow concealed termite entry, preventing early detection and

increasing the risk of undetected structural damage.

It is recommended that a licensed pest controller or builder experienced in termite management systems rectify the installation. Ant caps should be properly fitted, sealed, and continuous in accordance with AS 3660 to ensure effectiveness.

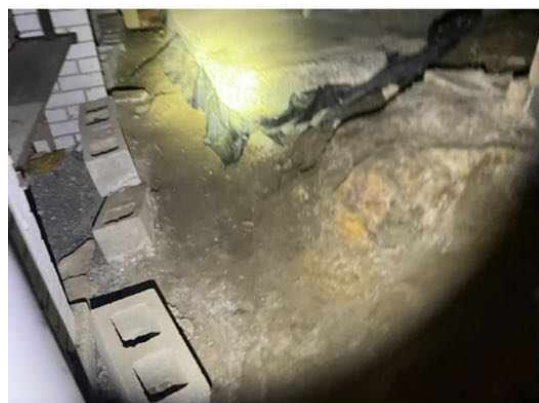
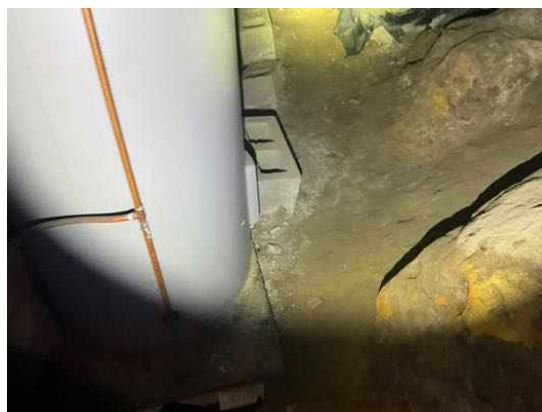
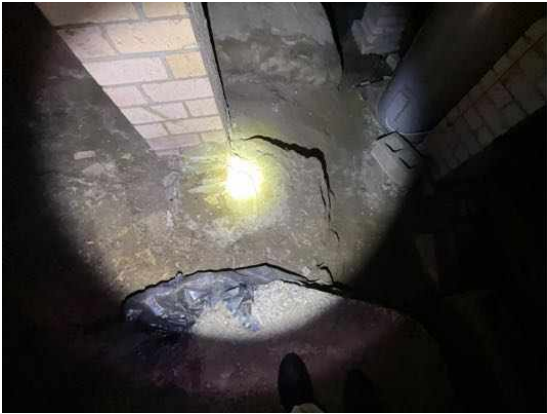
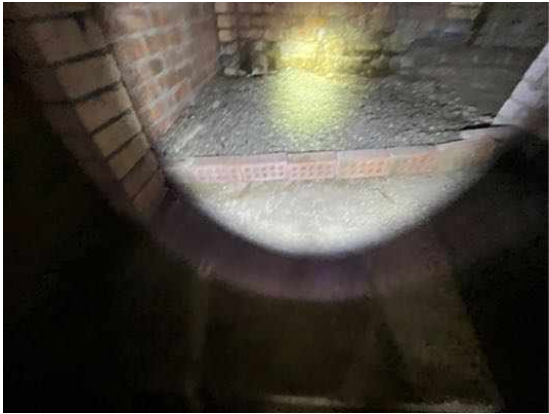
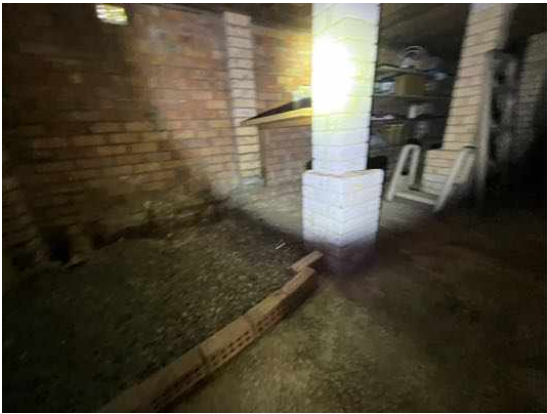
Finding 6.07

Building: Main Building
Location: Subfloor

Finding: Subfloor - poor ventilation, inadequate site drainage, water stains
Information: The subfloor lacks adequate ventilation, suffers from inadequate site drainage, exhibits water stains, creating conducive conditions for timber pests such as termites.

Risk: The combination of poor ventilation, inadequate drainage, water stains significantly increases the risk of timber pest infestations. Termites are attracted to moist environments and can thrive in subfloors with high humidity levels and water damage. The lack of proper ventilation and drainage exacerbates moisture retention, providing an ideal habitat for timber pests to establish colonies and cause extensive damage to the subfloor structure. Additionally, water stains indicate previous or ongoing moisture issues, which further attract timber pests and contribute to the deterioration of timber materials.

A licensed pest control professional specializing in timber pest management should be consulted to assess the extent of the infestation and develop a comprehensive treatment plan. They can implement strategies to eliminate existing timber pests, such as termites and prevent future infestations by addressing underlying moisture issues. Additionally, a qualified plumber or builder may be needed to improve subfloor ventilation, enhance site drainage, repair water-damaged areas. Regular inspections and maintenance are essential to ensure ongoing protection against timber pests and maintain the structural integrity of the subfloor.

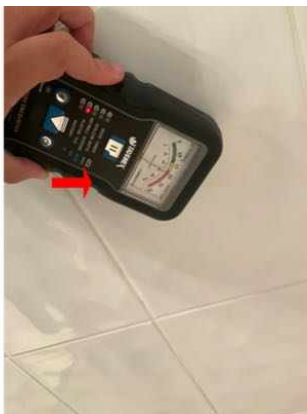
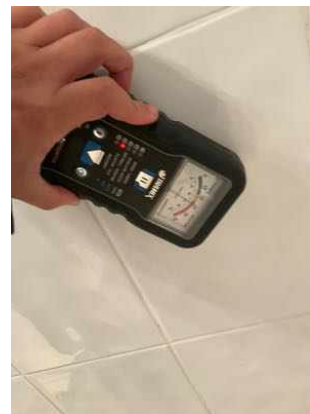
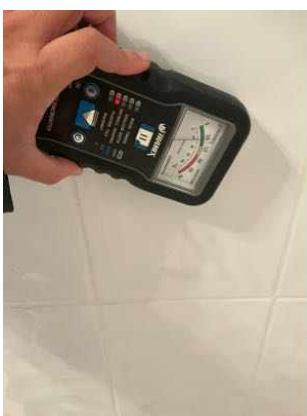
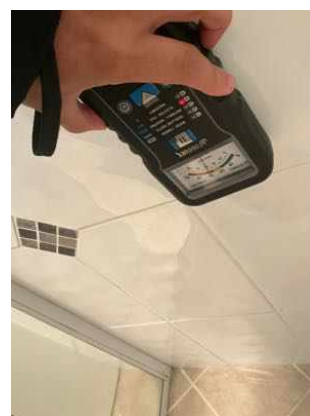
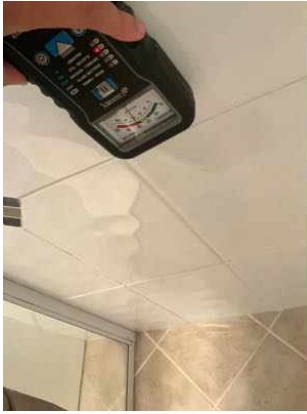
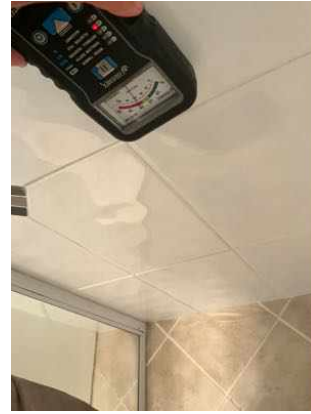
Finding 6.08

Building: Main Building
Location: Bathroom
Finding: Excessive moisture - Conducive to Timber pest
Information: Excessive moisture can attract termites and produce conditions that promote fungal growth and wood decay.

Excessive moisture is generally caused by deteriorated inadequate or missing roof drainage leaking plumbing pipes or fixtures poorly plumbed HWS overflows or condenser units and poor site drainage.

Prior to any remedial works being performed a qualified plumber should be appointed to further inspect the property and to identify the cause of the excessive moisture. Works to remove affected building elements may then be necessary and should be performed by an appropriate tradesperson.

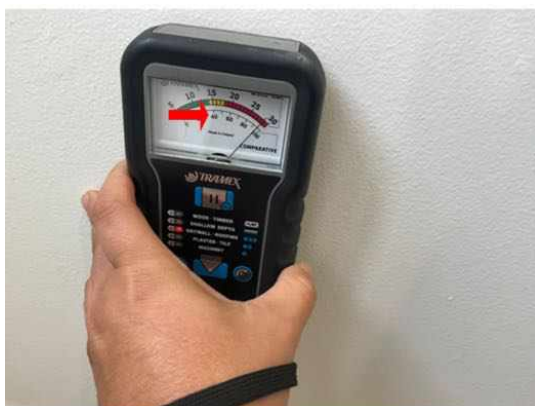
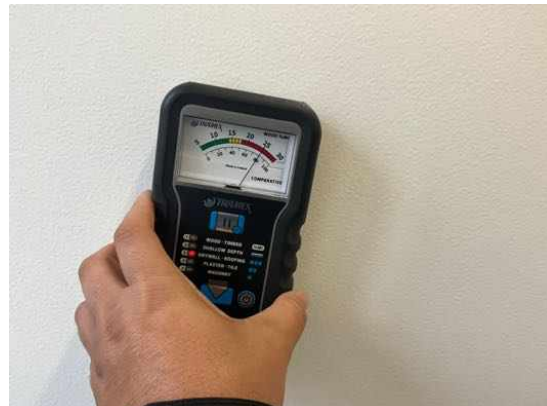
Building:	Main Building
Location:	Toilet (WC)
Finding:	Excessive moisture - Conducive to Timber pest
Information:	Excessive moisture can attract termites and produce conditions that promote fungal growth and wood decay.

Excessive moisture is generally caused by deteriorated inadequate or missing roof drainage leaking plumbing pipes or fixtures poorly plumbed HWS overflows or condenser units and poor site drainage.

If mould growth has been found there may be environmental biological or health issues involved. In these cases an appropriately qualified inspector should also be contacted.

Prior to any remedial works being performed a qualified plumber should be appointed to further inspect the property and to identify the cause of the excessive moisture. Works to remove affected building elements may then be necessary and should be performed by an appropriate tradesperson.

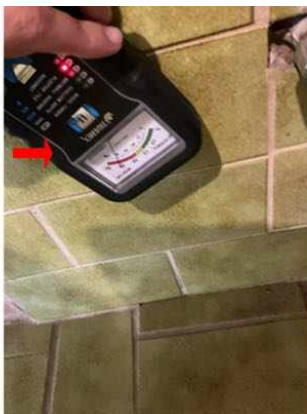
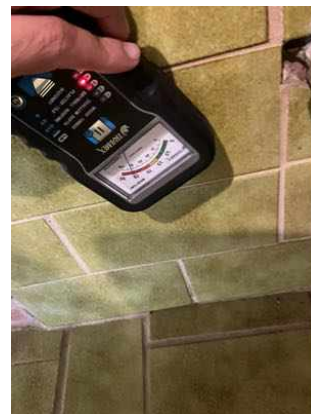
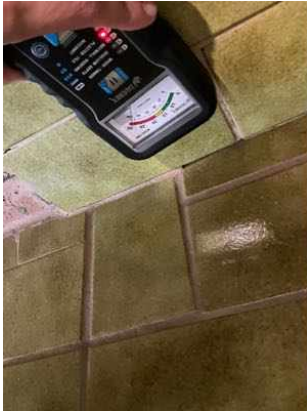
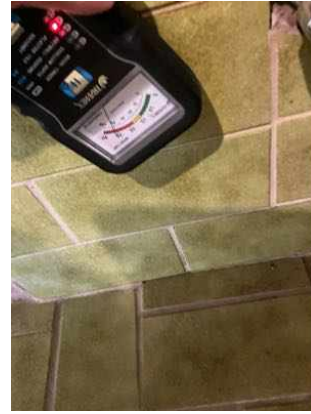
Finding 6.10

Building:	Main Building
Location:	Laundry / Toilet downstairs
Finding:	Excessive moisture - Conducive to Timber pest
Information:	Excessive moisture can attract termites and produce conditions that promote fungal growth and wood decay.

Excessive moisture is generally caused by deteriorated inadequate or missing roof drainage leaking plumbing pipes or fixtures poorly plumbed HWS overflows or condenser units and poor site drainage.

If mould growth has been found there may be environmental biological or health issues involved. In these cases an appropriately qualified inspector should also be contacted.

Prior to any remedial works being performed a qualified plumber should be appointed to further inspect the property and to identify the cause of the excessive moisture. Works to remove affected building elements may then be necessary and should be performed by an appropriate tradesperson.
