Building and Timber Pest Inspection Report

Inspection Date: Thu, 19 Mar 2026

Property Address: 19 Peter Cl, Hornsby Heights NSW 2077, Australia

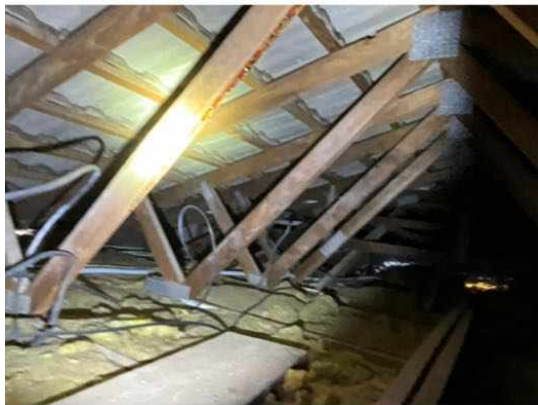
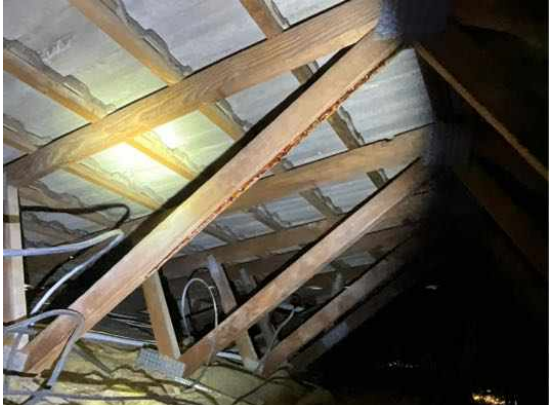
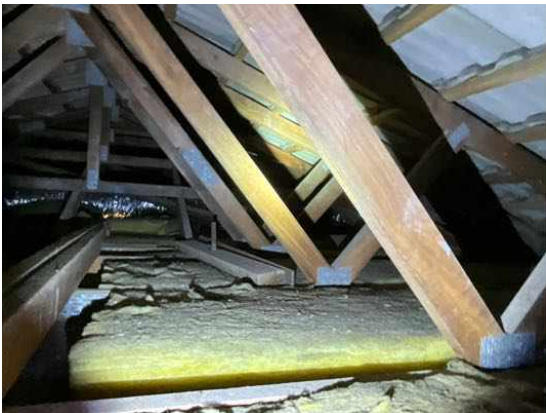
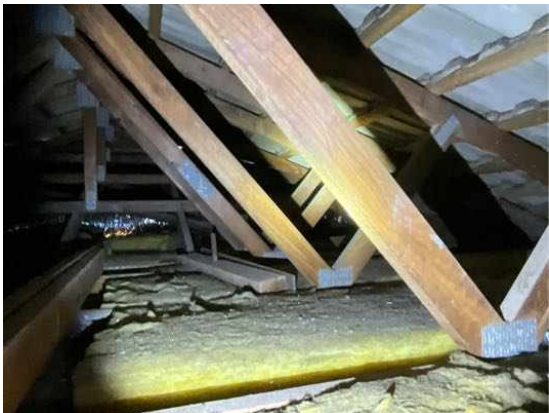
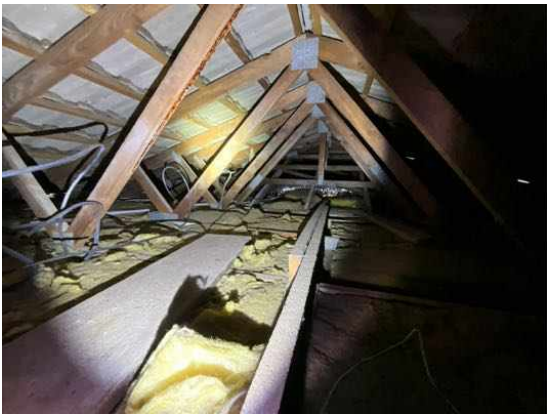
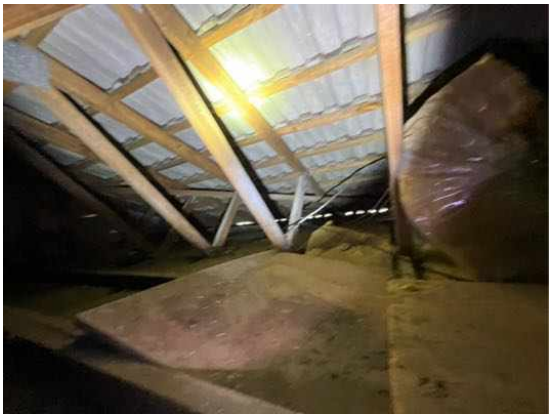
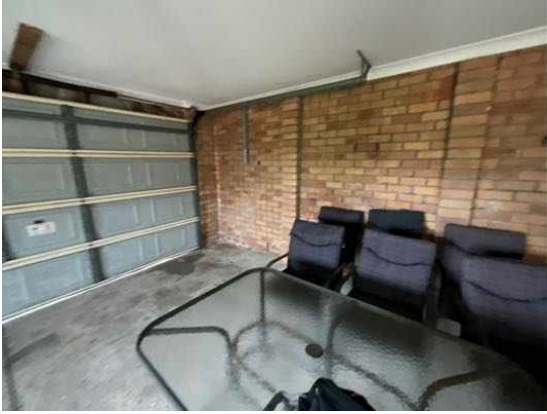
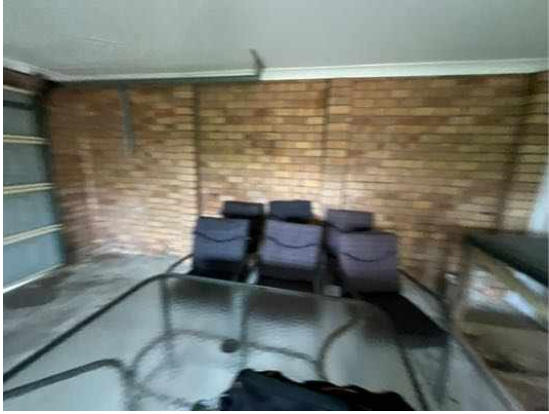
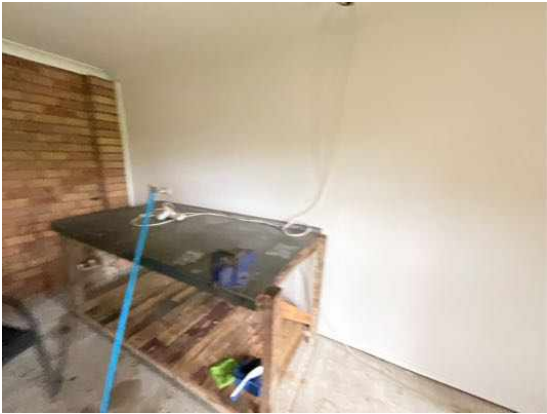
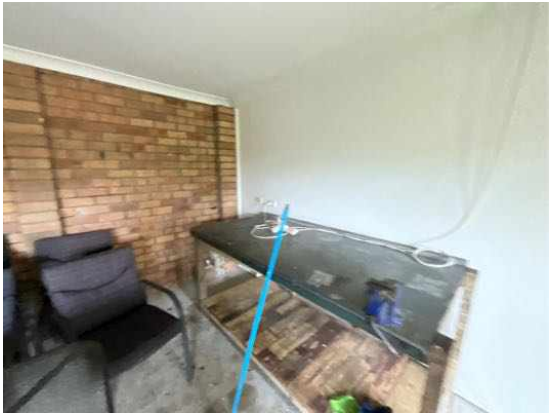
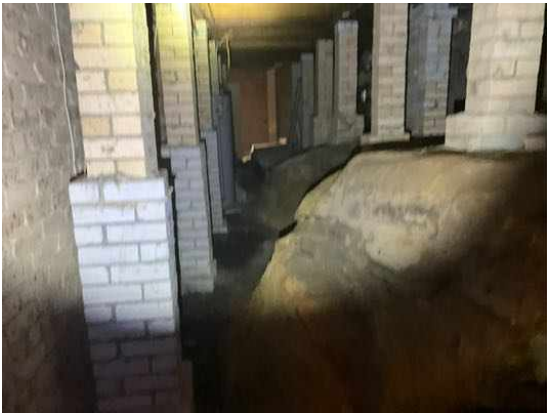
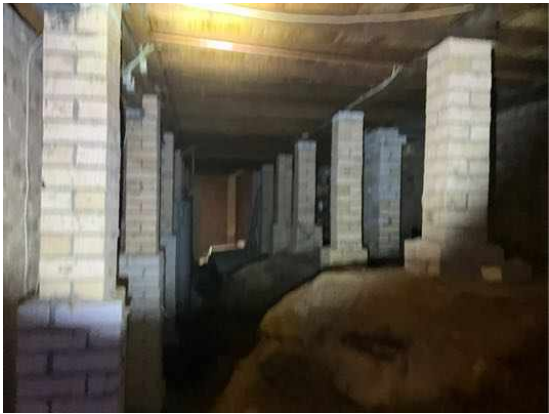
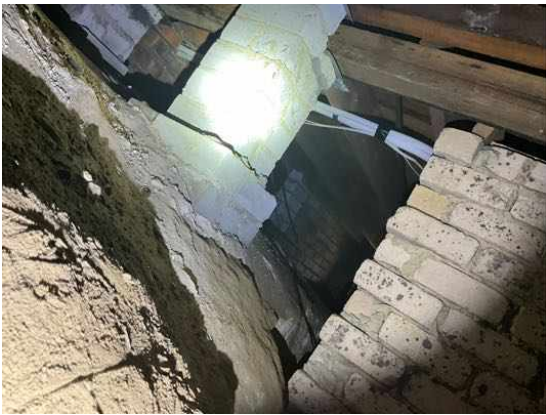
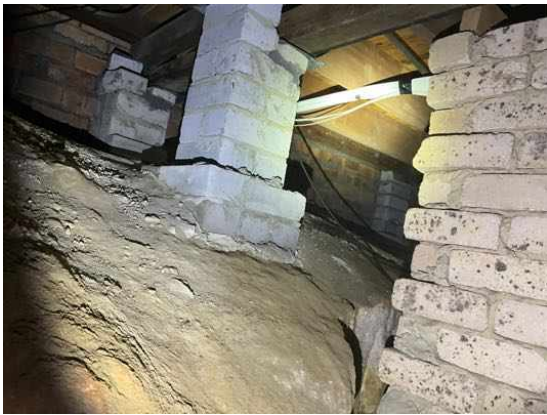
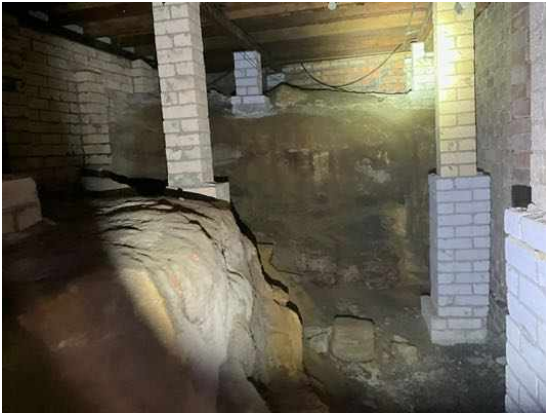
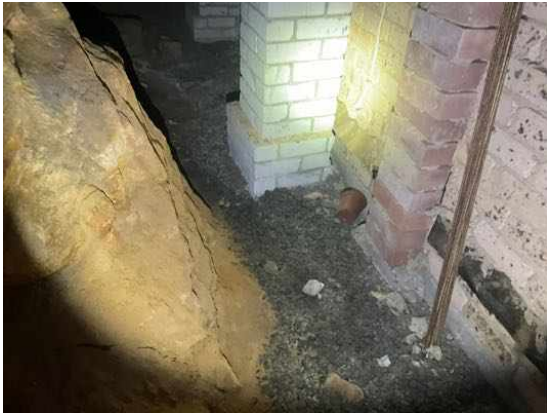
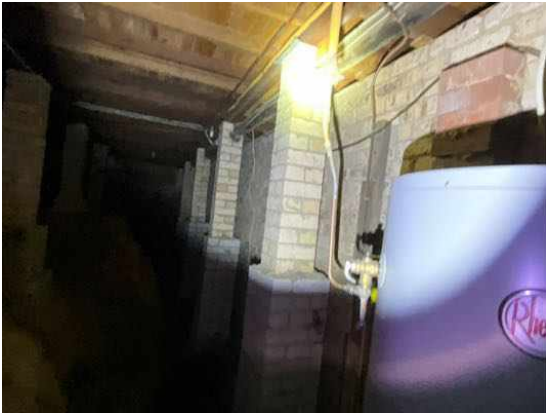
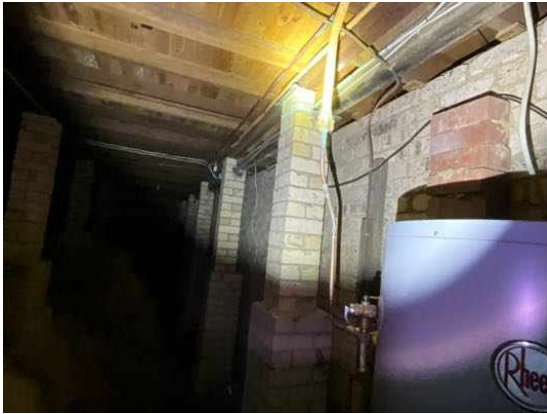
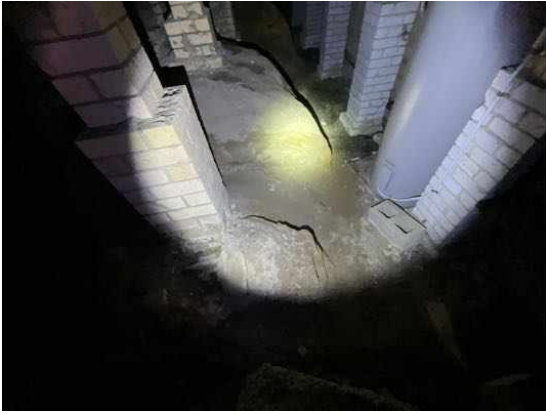
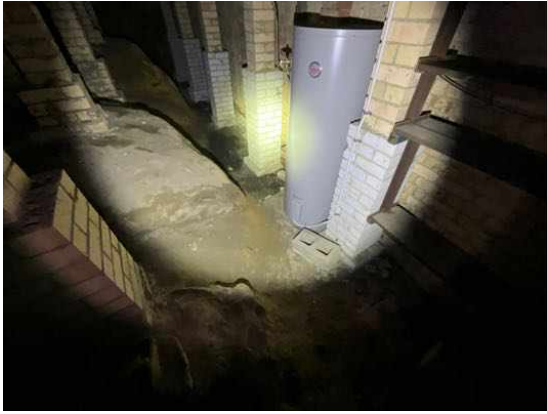
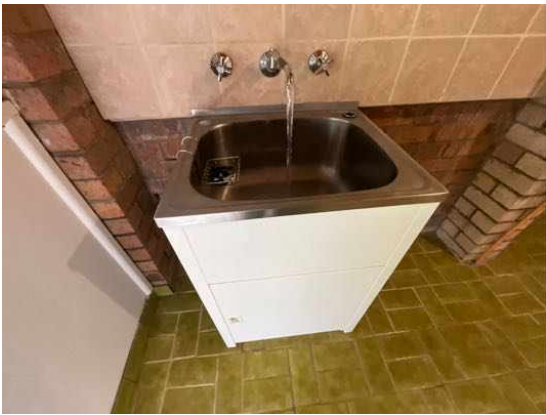
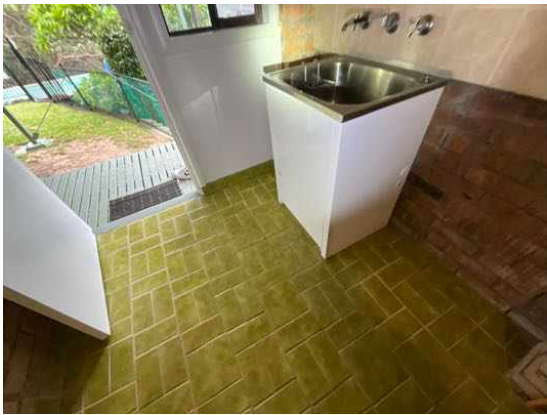
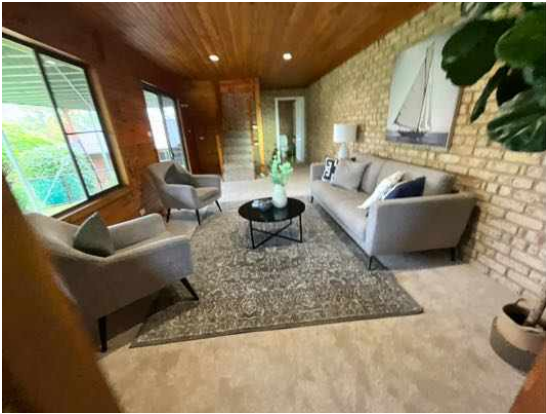
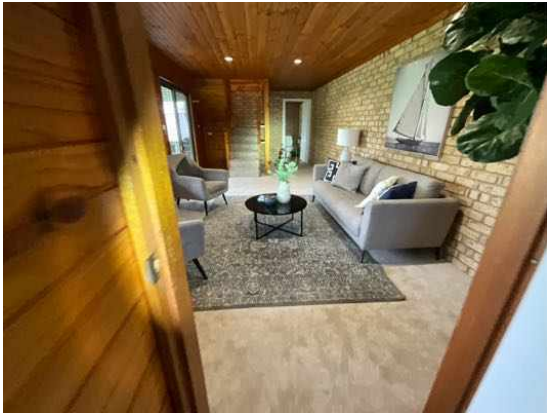
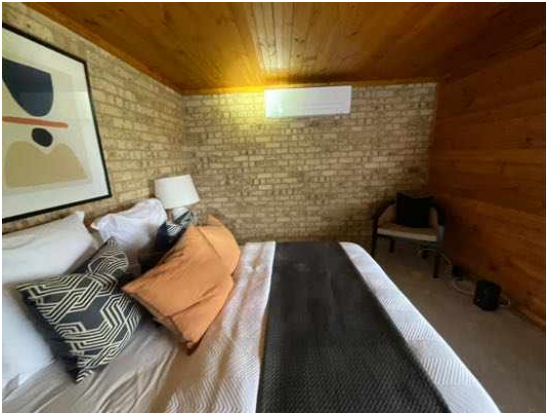
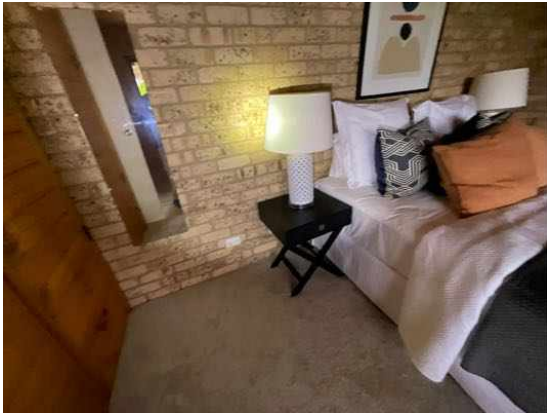
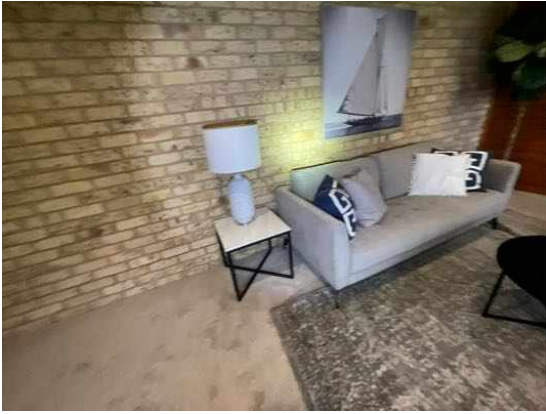
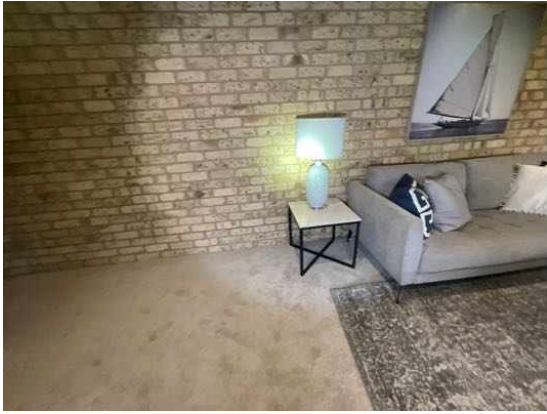
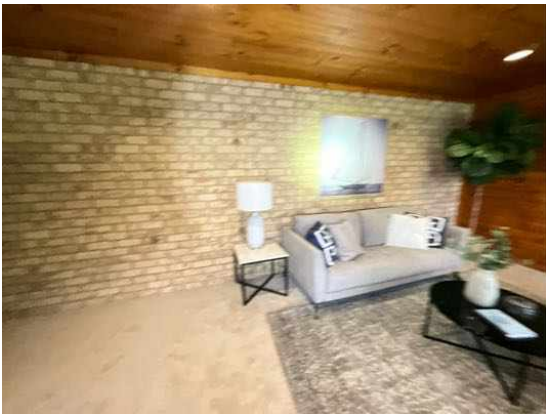
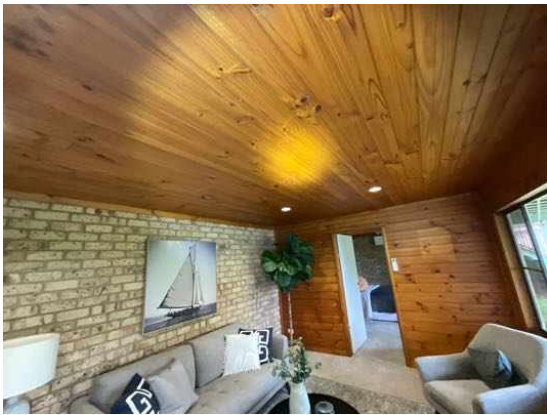
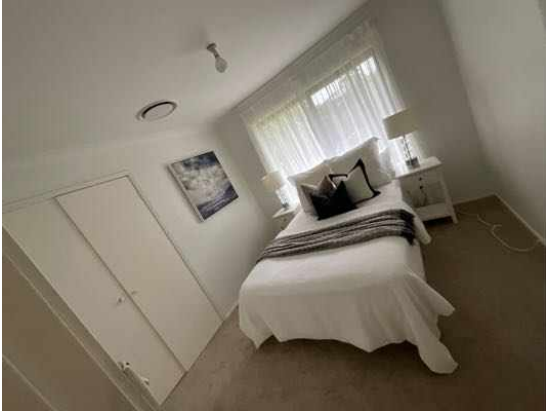
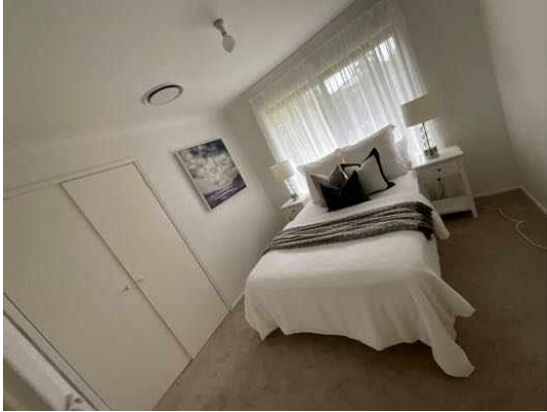
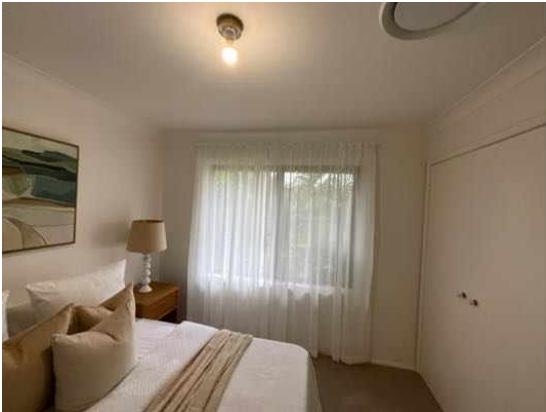
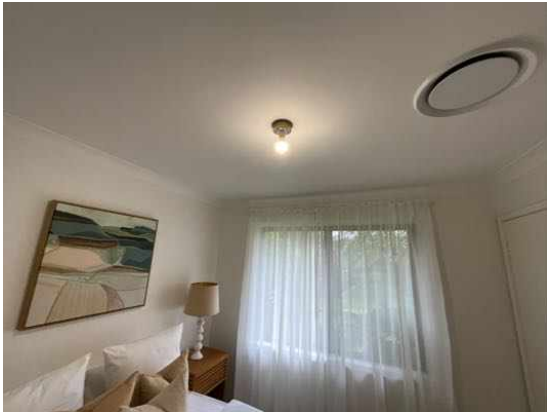
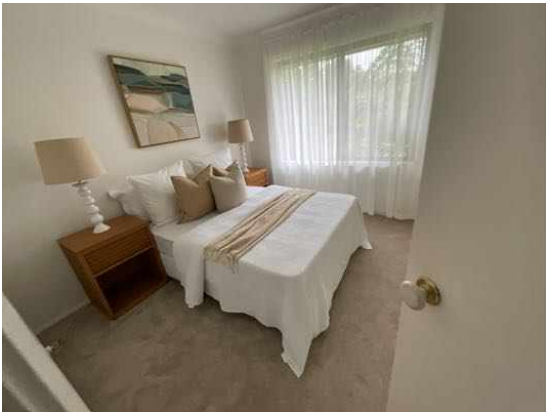
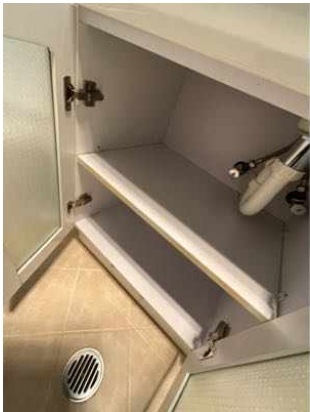
Building: Main Building
Location: All Areas
Finding: Additional Photos - Obstructions and Limitations
Information: These photographs are an indication of the obstructions and limitations which impeded full inspection of the property at the time of inspection. These obstructions can hide an array of defects and should be removed to allow full inspection to be carried out. A re-inspection is recommended once the areas are made accessible.
