# Building and Timber Pest Inspection Report

Inspection Date: Sat, 21 Feb 2026

Property Address: 16 Caritta Ct, Parklea NSW 2768, Australia

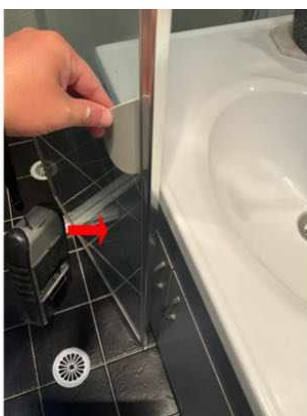
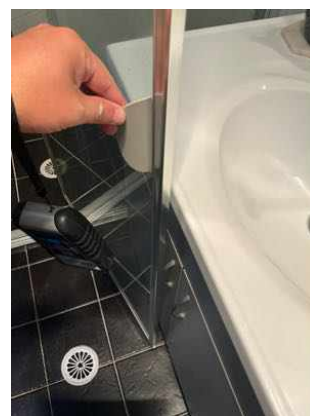
Building: Main Building  
 Location: Ensuite  
 Finding: shower screen door hitting vanity unit  
 Information: The shower screen door makes contact with the edge of the vanity unit when opened. This indicates inadequate clearance between the shower screen and the fixed bathroom fixture. The door's operation is impeded and presents a safety concern.

- Potential for impact damage to the vanity and shower screen.
- Increased risk of glass breakage, posing a personal injury hazard.
- Ongoing stress may lead to hardware failure or misalignment of the door.

This condition does not comply with the intent of AS 4349.1-2007, Appendix C – Significant Items, under “Defects in the condition of secondary and finishing elements,” specifically where normal use may cause failure or injury.

Engage a licensed glazier or shower screen installer to adjust or replace the screen to ensure proper clearance and safe operation. A cabinetmaker may be consulted if modification to the vanity is more feasible.

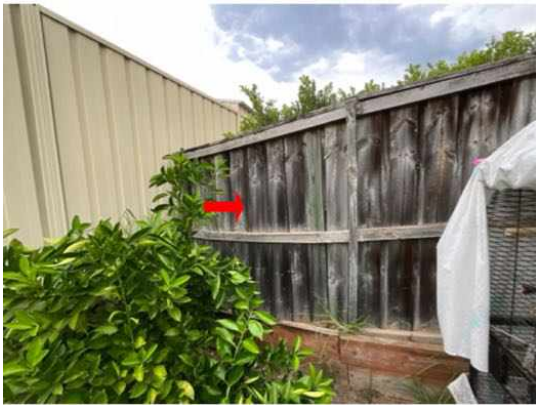
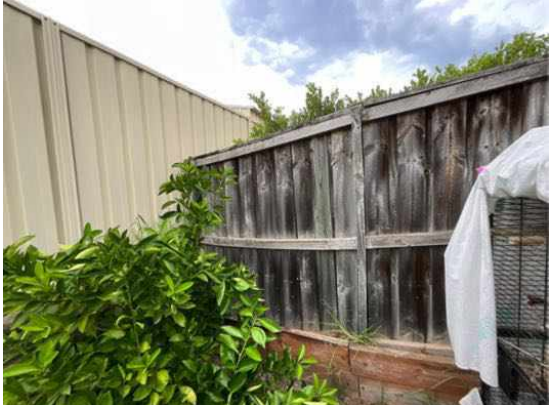
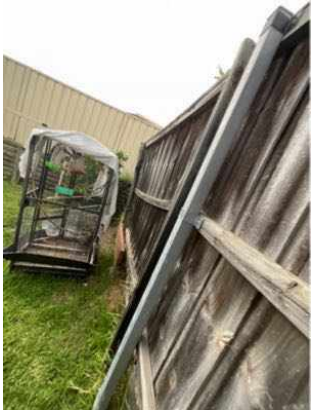
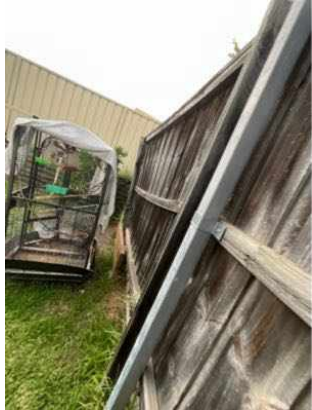
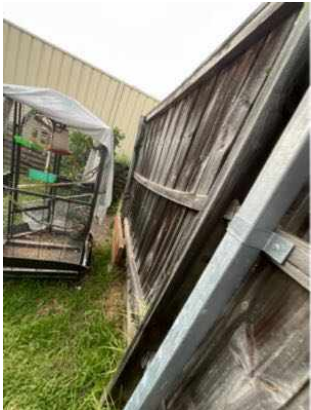
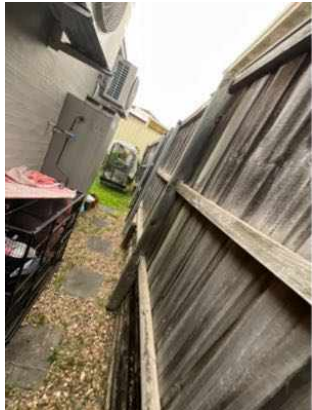
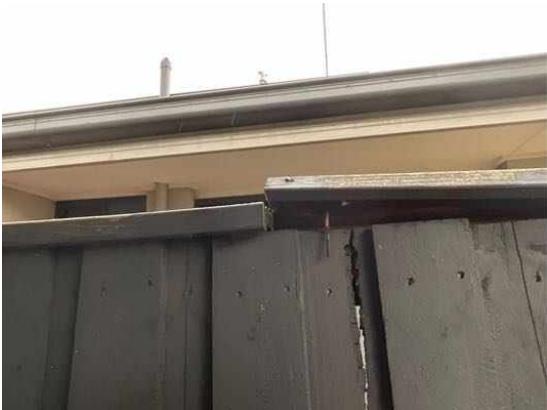
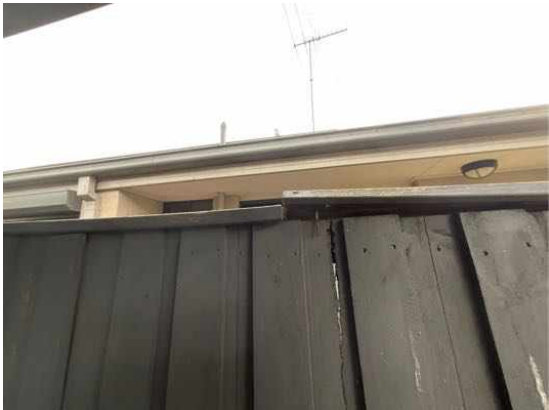
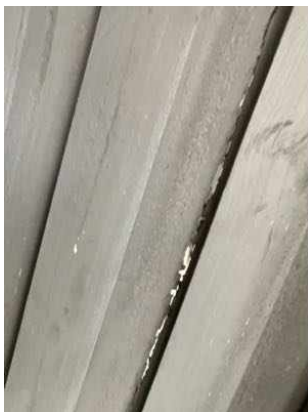
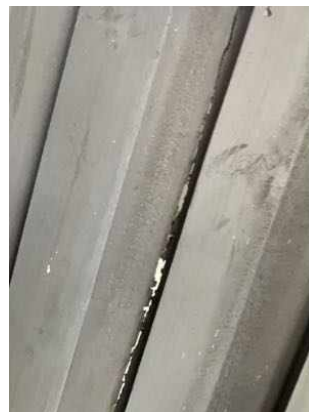
## Finding 2.01

Building:	Main Building
Location:	All Areas
Finding:	Deteriorated fence
Information:	The fence along the property boundary has deteriorated significantly, showing signs of rot, rust, and structural weakness. Several sections are leaning or have become detached, compromising the integrity of the fence and its ability to perform its intended function.

The deteriorated fence poses multiple risks:

1. **Safety Hazard:** The unstable fence may collapse, posing a risk of injury to residents, visitors, and passersby.
2. **Security Concern:** The compromised fence may allow unauthorized access to the property, increasing the risk of theft, vandalism, or trespassing.
3. **Property Damage:** Falling sections of the fence could damage nearby structures, plants, or other property features.

- **Licensed Fencing Contractor:** A professional fencing contractor should be hired to assess the extent of the damage and either repair or replace the deteriorated sections.
- **Handyman Services:** For minor repairs, a qualified handyman could be engaged to reinforce or repair specific sections of the fence.
- **Landscaper (if the fence is part of a larger garden feature):** If the fence is integrated into the landscape design, a landscaper with experience in fencing could be involved in the repair or replacement process.

It's important to ensure that whoever is hired is experienced and qualified to ensure the fence is restored to a safe and functional condition, compliant with local regulations.

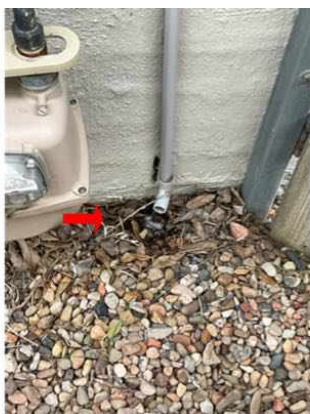
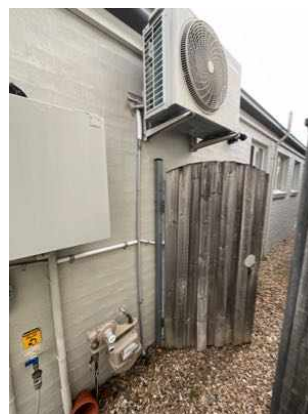
### Finding 3.01

Building:	Main Building
Location:	Exterior walls - right side
Finding:	Air conditioner - Disconnected overflow
Information:	The Air Conditioner (A/C) overflow was found to be disconnected from storm water drainage and is creating excessive moisture in the surrounding area.

Such leaking creates an environment which is conducive to an array of defects, including water damage to associated building elements and the attraction of termite or timber pest infestation.

It is highly recommended that a licensed plumber be appointed to connect the A/C overflow in order to prevent such an environment from being created. These minor works should be carried out as soon as possible.

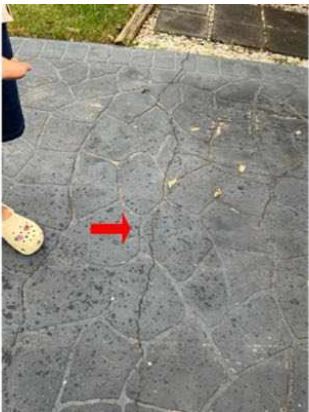
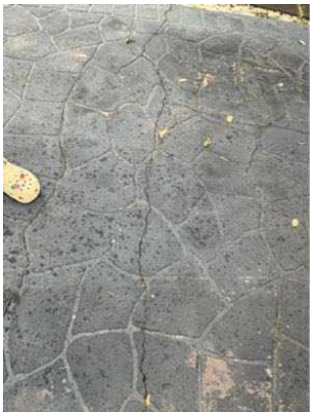
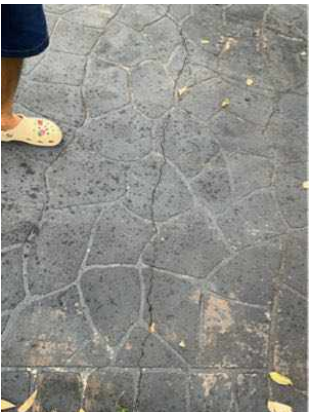
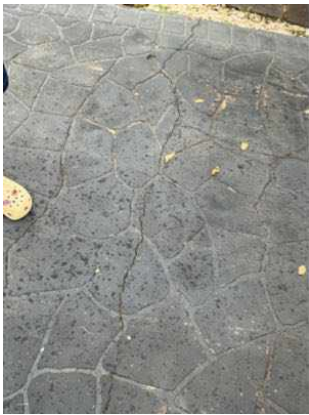
### Finding 3.02

Building:	Main Building
Location:	Driveway
Finding:	Noticeable Cracking in Concrete Slab
Information:	Noticeable cracking has been observed in the concrete slab, failing to meet the required construction and quality standards.

- Cracks are visible on the surface and may extend through the depth of the slab.
- Evidence of improper curing or inadequate reinforcement leading to cracking.

The presence of noticeable cracks in the concrete slab can result in:

- Compromised structural integrity of the slab, potentially leading to failure under load.
- Water ingress through cracks, causing corrosion of reinforcement and further weakening the structure.
- Potential trip hazards and aesthetic issues, reducing the overall value and safety of the property.
- Increased maintenance and repair costs due to ongoing deterioration.

- A structural engineer should be engaged to assess the extent of the cracking and recommend appropriate repair methods.
- A licensed contractor or concrete repair specialist should carry out the recommended repairs under the guidance of the structural engineer.

A detailed inspection should be conducted post-repair to confirm compliance with the required standards and to ensure that the structural integrity of the concrete slab has been restored.

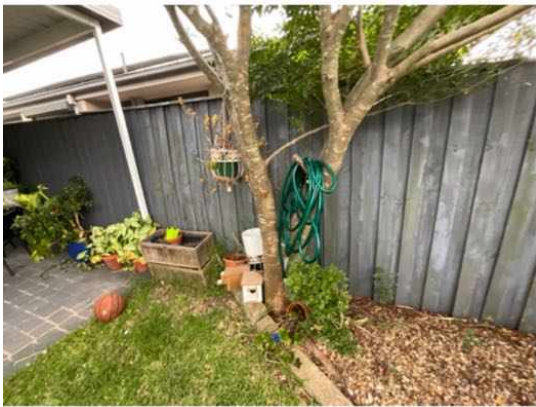
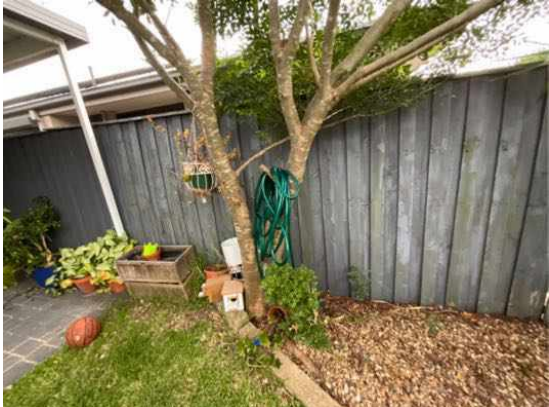
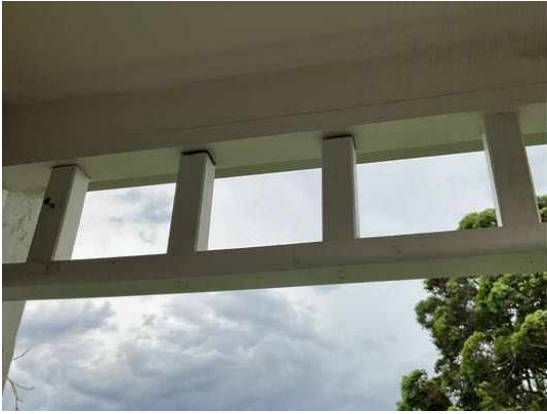
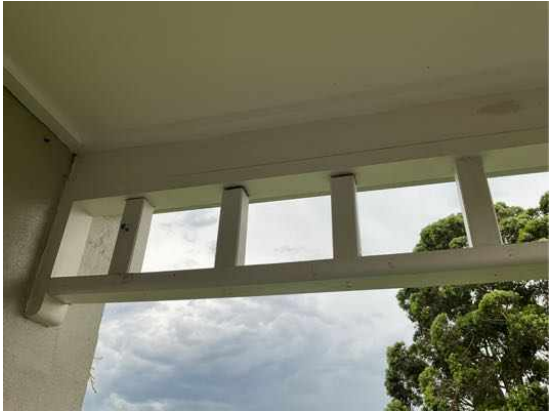
**Finding 3.03**

Building: Main Building  
Location: All Areas  
Finding: Timber - exposed to weather  
Information: External timbers that are frequently exposed to harsh weather conditions require adequate protection in order to maintain their condition. Where timbers have not been painted or treated adequately, general deterioration is likely to occur at an accelerated rate.

If left unattended, replacement of these timbers is likely to be necessary in the short-term future. Adequate treatment of these timbers is required as soon as possible by a painting contractor or general handyman.

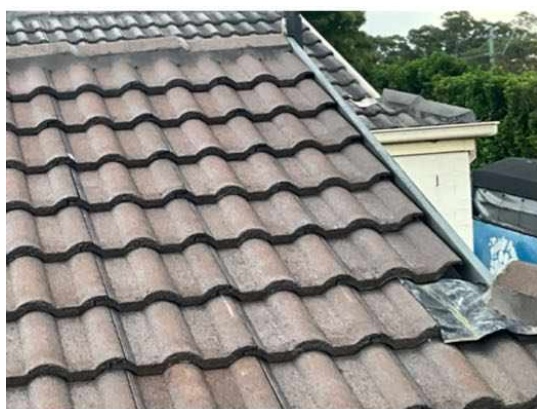
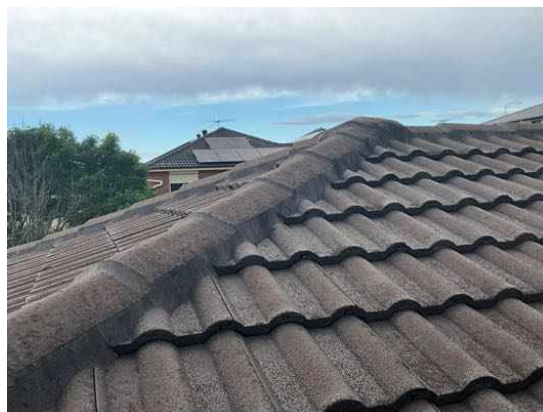
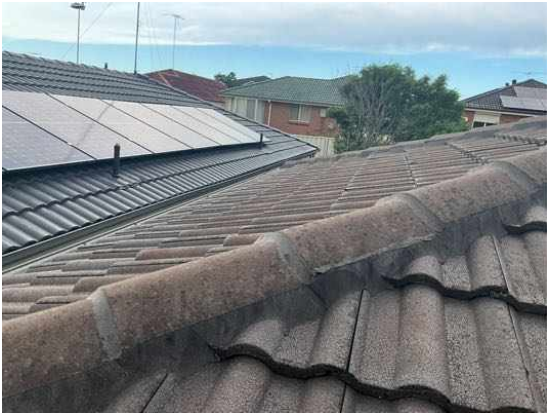
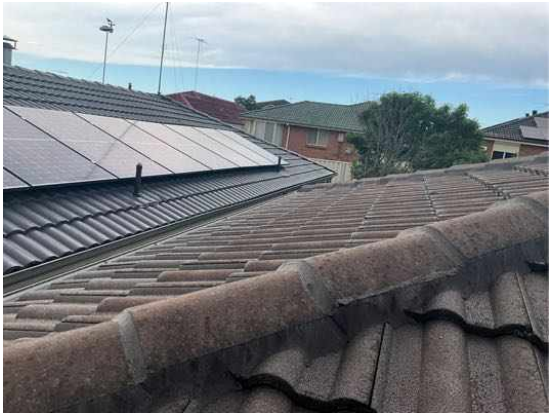
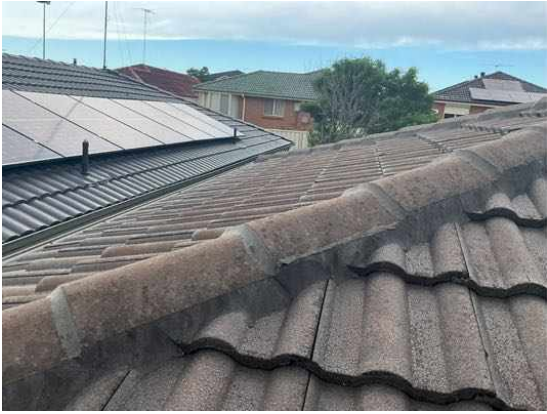
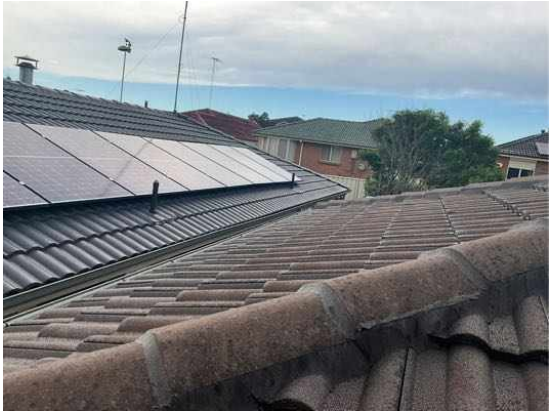
Finding 3.04

Building: Main Building  
Location: All Areas  
Finding: Roof Weathered  
Information:

Inspection of the roof revealed widespread weathering to the tiled roof surface. The tiles show loss of surface finish, colour fading, and age-related deterioration typical of older roof coverings. Although no significant cracking was noted, weathering can lead to increased porosity, reduced water-shedding capability, and a higher risk of future cracking or displacement during adverse weather conditions.

A licensed roofer should be engaged to undertake a closer inspection, carry out routine maintenance, and replace any tiles that may be compromised. Ongoing monitoring is recommended due to the age and condition of the roof covering.

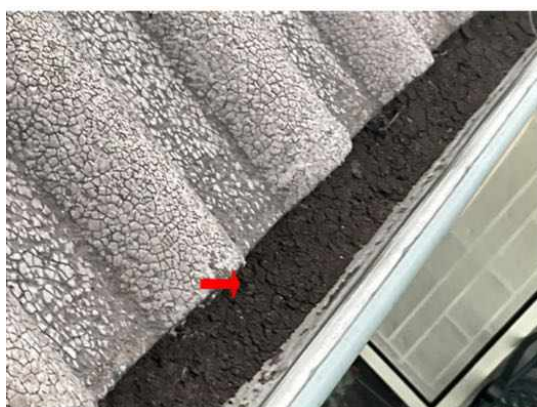
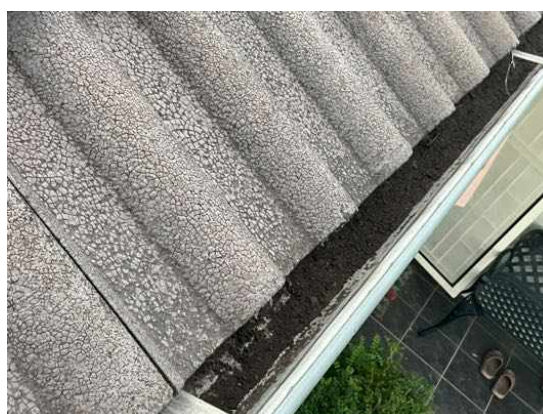
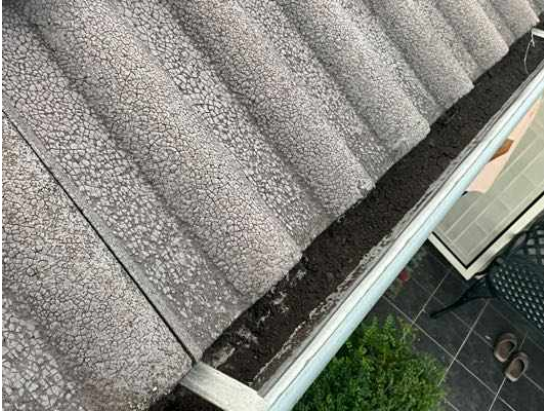
Finding 3.05

Building: Main Building  
Location: All Areas  
Finding: Blocked gutters - organic debris  
Information: The roof gutter system was observed to be blocked with organic debris and moss growth, as evident in the provided images.

- Water ingress into the eaves or walls,
- Timber rot or deterioration of fascia and soffits,
- Accelerated moss and algae growth, promoting further blockages,
- Potential foundation issues if water pools near the base of the structure.

A licensed roofing contractor or qualified gutter cleaning service should be engaged to remove the debris and inspect the system for any further issues.

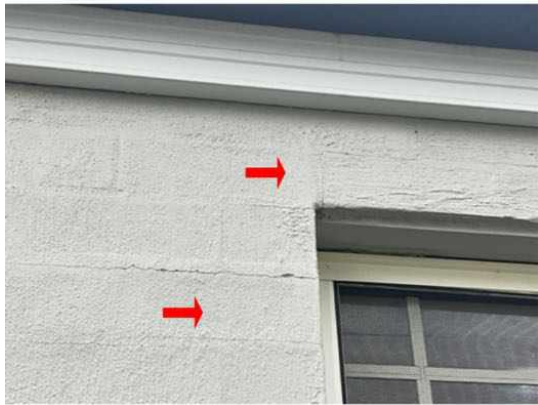
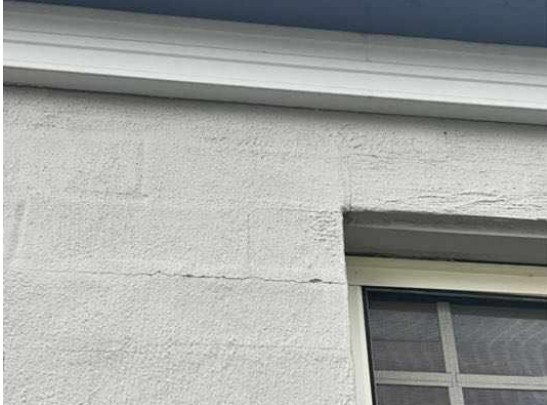
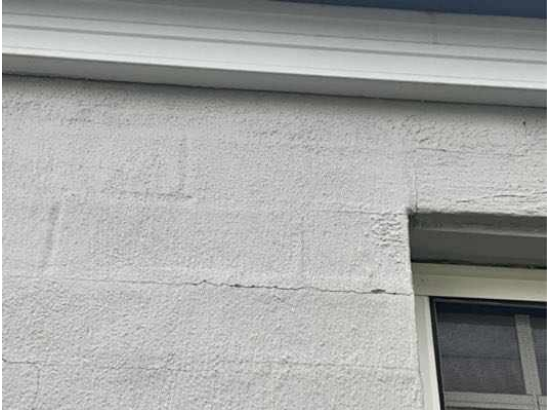
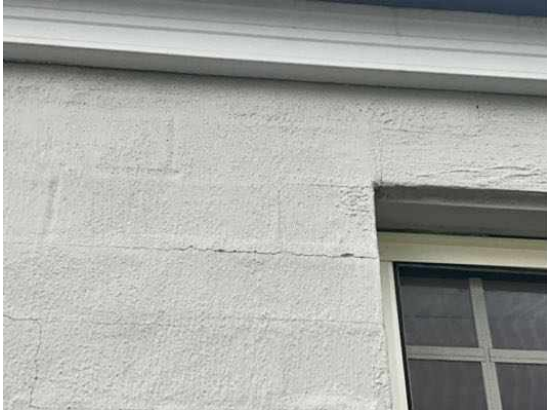
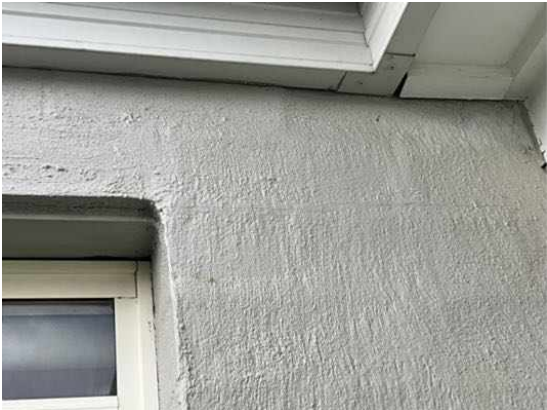
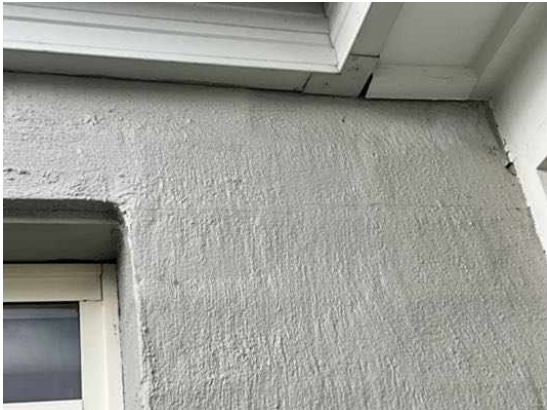
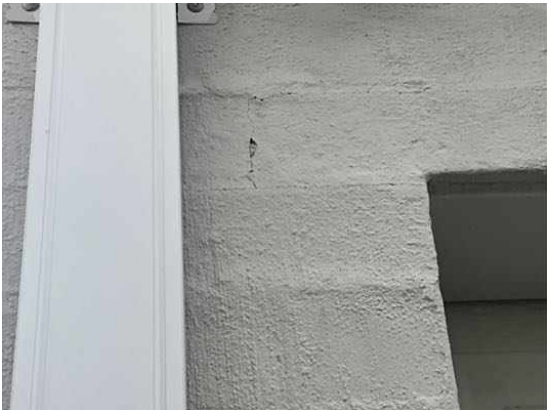
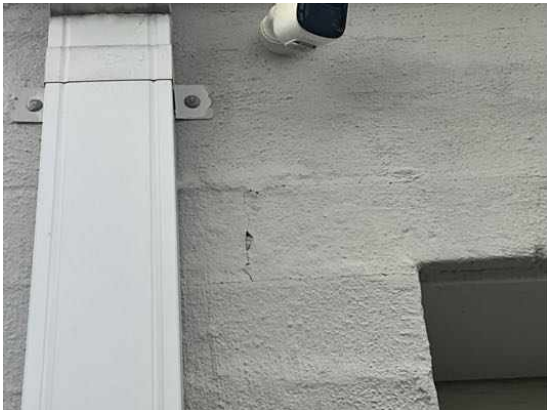
Building:	Main Building
Location:	Front Elevation
Finding:	Brickwork - Cracking [Fine]
Information:	Although fine cracks are quite noticeable, they are often only considered to be an appearance defect and usually do not indicate any structural damage. Generally, the cause of a fine crack is indicative of a separation between brickwork and mortar throughout the structure, but single bricks may also show cracks of this nature.

Always contact a building inspector should cracks widen lengthen or become more numerous.

Cracking of this nature can generally be repaired with minor filling and should be conducted by a qualified bricklayer.

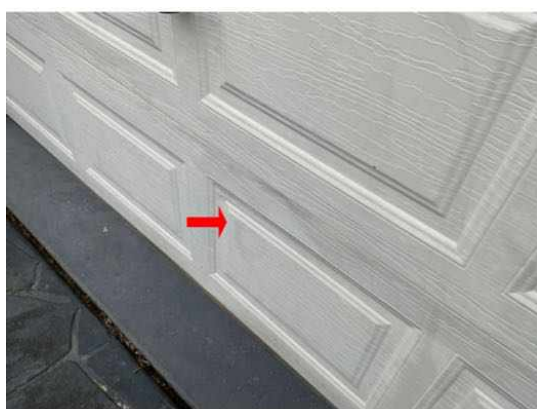
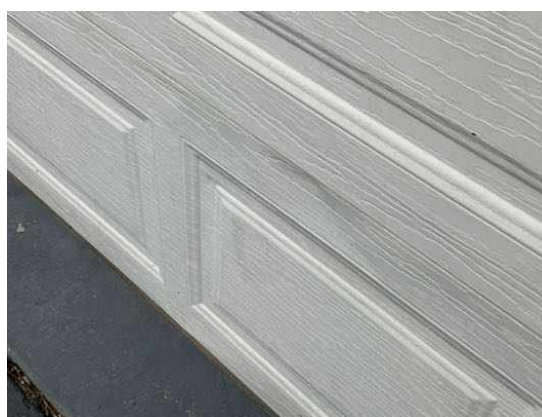
Finding 3.07

Building: Main Building  
 Location: Garage  
 Finding: Minor Dent on Garage Door  
 Information: A minor dent is visible on the lower section of the garage door. It does not affect how the door works but does impact its appearance.

A garage door technician or handyman can repair or replace the panel if needed.

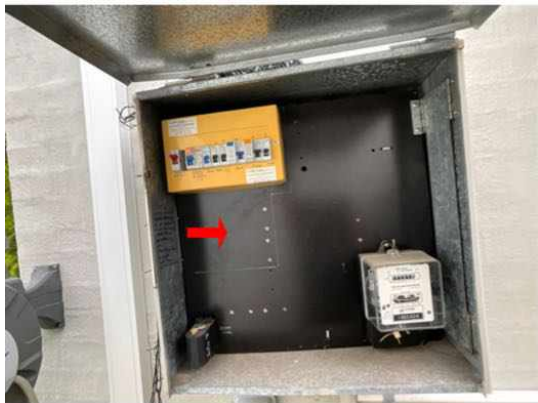
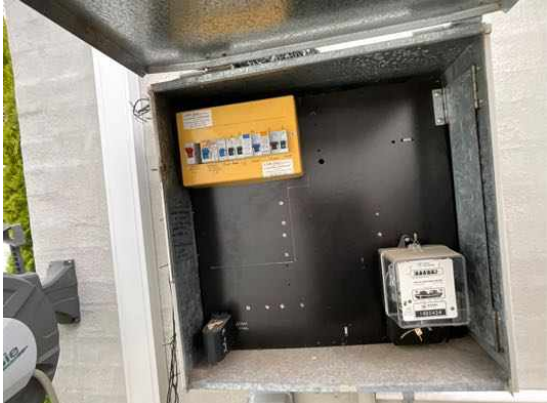
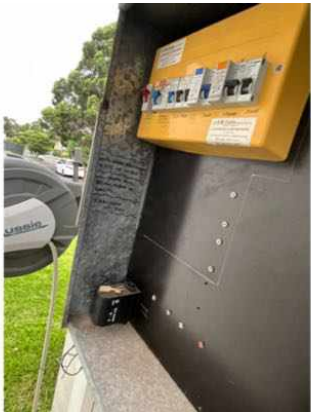
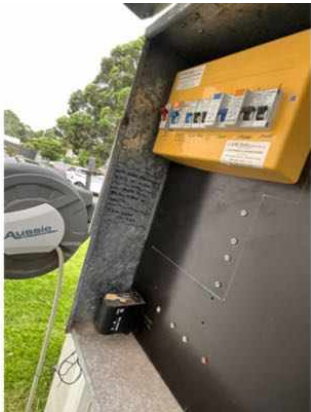
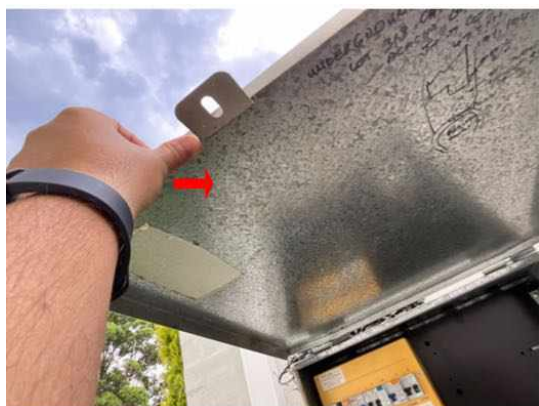
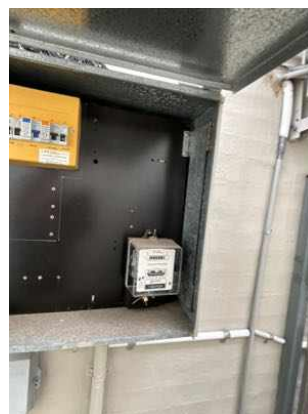
Building: Main Building  
Location: Exterior walls - right side  
Finding: No Evidence of Termite Management System - Durable notice / Legible Sticker  
Information: The application of a pre & post-construction chemical termite barrier is highly recommended for all properties. Such barriers are highly effective in preventing termite attack on any timber building elements throughout the property.

A durable notice was not placed in the switchboard unit to indicate current termite barriers is legible at the time of inspection.

Client must seek further information from the vendor or real estate agent if the conditions of termite management systems were maintained.

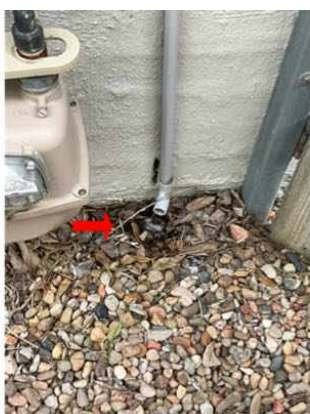
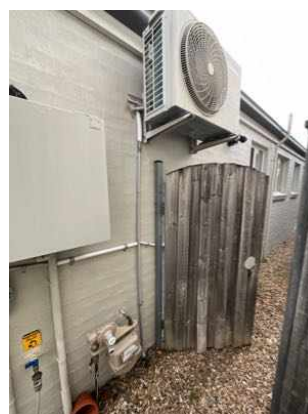
### Finding 6.02

Building:	Main Building
Location:	Exterior walls - right side
Finding:	Aircon - Excessive moisture conducive condition near Air-conditioner
Information:	Excessive moisture near an air conditioner can indeed create conducive conditions for termites. Termites are attracted to damp and decaying wood, which can be found in areas with high moisture levels. To fix this issue:

1. Fix Leaks: Check for any leaks or condensation around your air conditioning unit. Repair any damaged pipes, drains, or insulation

2. Proper Drainage: Ensure that your air conditioner has proper drainage. Make sure the condensate drain line is clear and directed

5. Please consult a HVAC Technician: HVAC (Heating, Ventilation, and Air Conditioning) technicians are trained to diagnose and

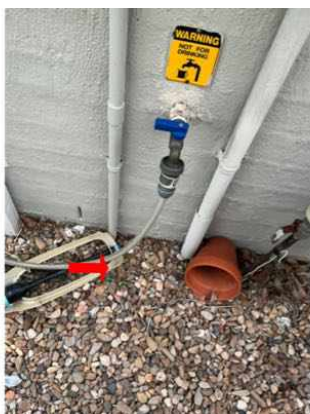
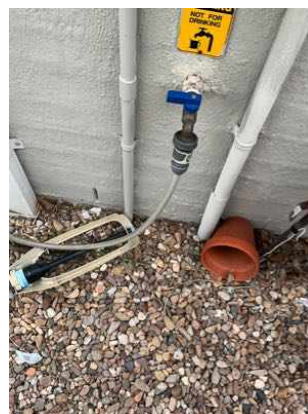
Building:	Main Building
Location:	Exterior walls - right side
Finding:	No Drain under tap
Information:	There is no drain installed under the tap, leading to water accumulation and creating conducive conditions for timber pests. This defect needs immediate attention to prevent potential damage and pest infestation.

1. Water Accumulation: Without proper drainage, water can accumulate around the base of the tap, leading to persistent dampness in the surrounding area.
2. Timber Pest Infestation: The damp environment created by standing water is highly conducive to timber pests, such as termites and wood borers, which thrive in moist conditions and can cause significant damage to wooden structures.
3. Structural Damage: Prolonged exposure to moisture can lead to wood rot and deterioration of structural timber, compromising the integrity of the building.

A licensed plumber or a qualified building contractor can address this defect by:

1. Assessment: Evaluating the area to determine the best approach for installing a proper drainage system under the tap.
2. Installation: Installing a drain that effectively channels water away from the base of the tap, preventing water accumulation and dampness.
3. Repair and Prevention: Inspecting and repairing any existing water damage and implementing measures to prevent future water accumulation and pest infestations.

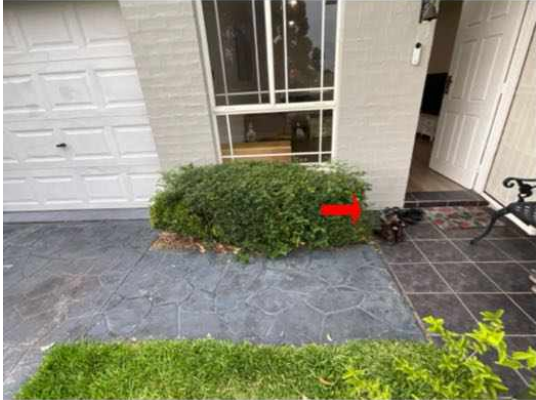
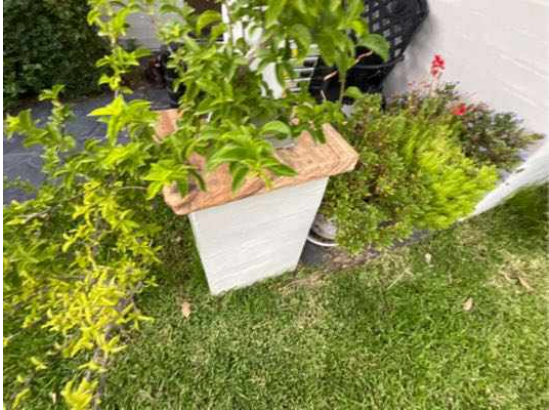
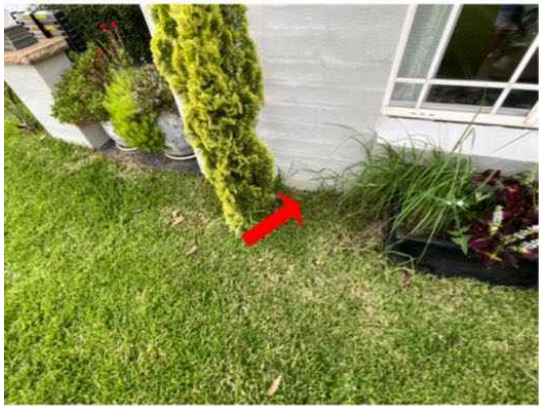
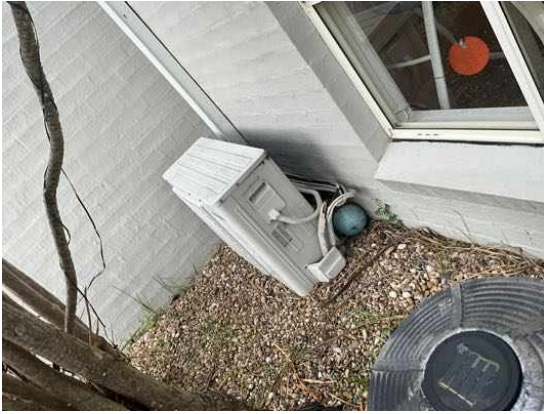
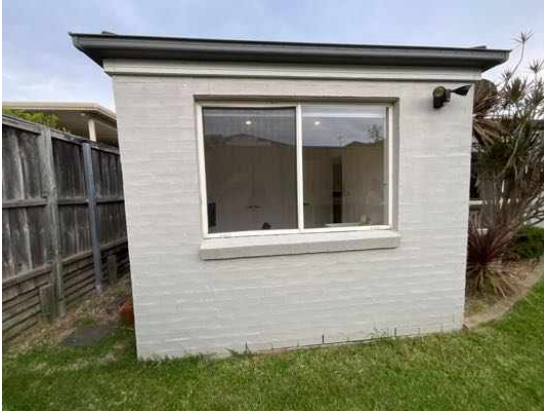
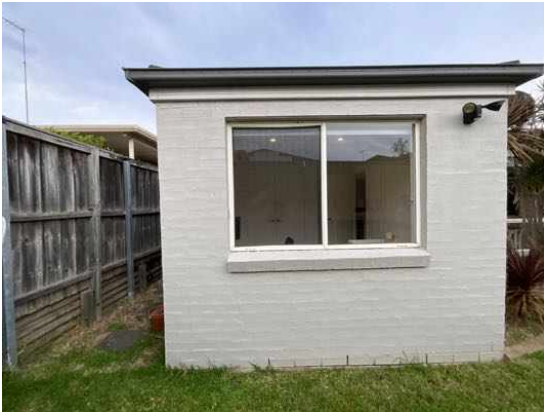
## Finding 6.04

Building:	Main Building
Location:	All Areas
Finding:	Slab Edge - Exposure
Information:	An inspection zone of at least 75mm in relation to the exposed slab edge, between the bottom brick and the perimeter pavement, is required. This inspection zone should be maintained in order to force termites into the open where they can be detected more readily during regular inspections. The slab edge should not be concealed by anything that may prevent inspection of the area, including render, landscaping, soil, turf, paving, concrete cladding or other structures.

If the slab edge is not properly exposed there is a high risk of termite attack. Sometimes, in order to determine the type of slab, a suitably qualified person such as an architect or builder may be required to consult the construction plans.

Where the slab edge cannot be properly inspected, it is highly recommended that termite or timber pest inspections be carried out every 6-12 months to aid protection of the property against infestation.

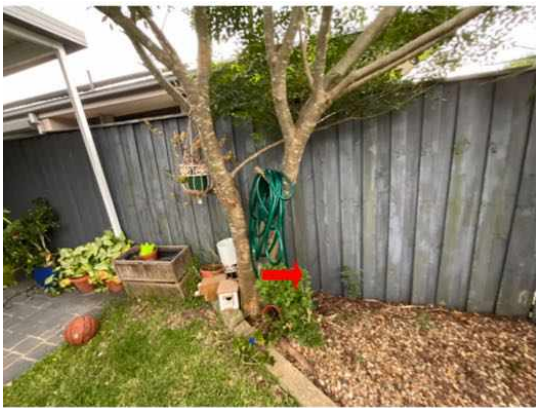
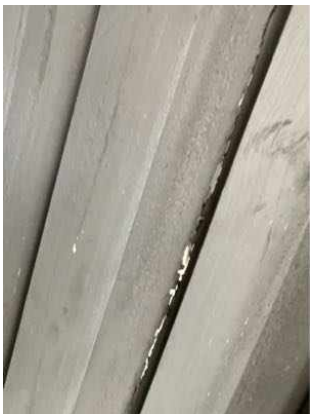
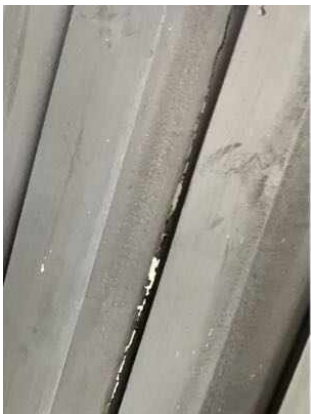
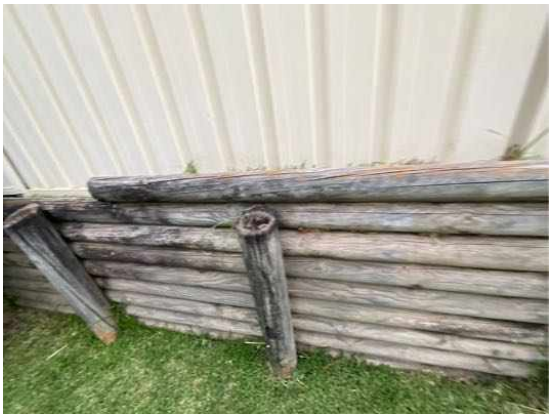
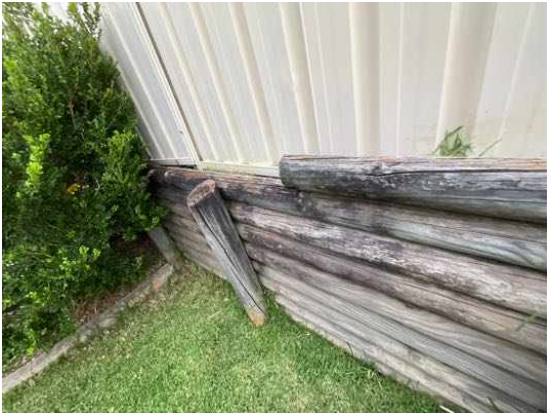
### Finding 6.05

Building:	Main Building
Location:	All Areas
Finding:	Timber on ground / conducive conditions to termite damage
Information:	Timber on the ground is indeed conducive to termite damage. Termites are known to thrive in moist environments, and wood in contact with soil or moisture is more susceptible to infestation.

To prevent this, it's important to keep timber elevated and away from direct ground contact. Regular inspections and proper termite control measures are also essential to protect your wooden structures from termite damage.

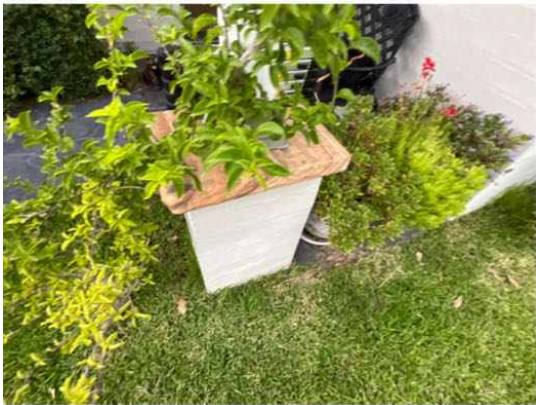
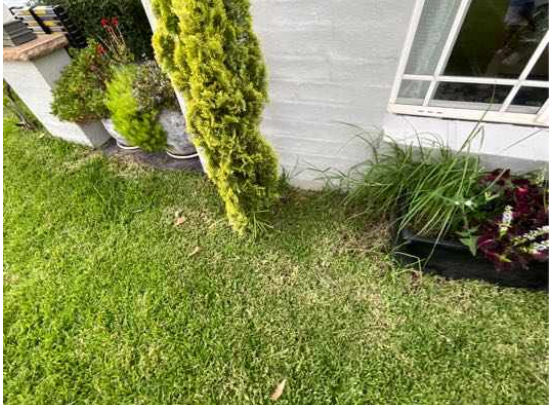
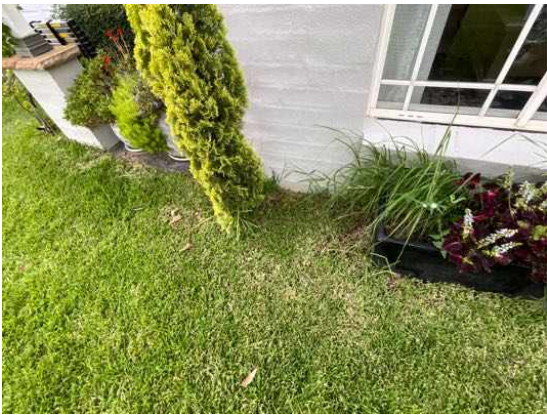
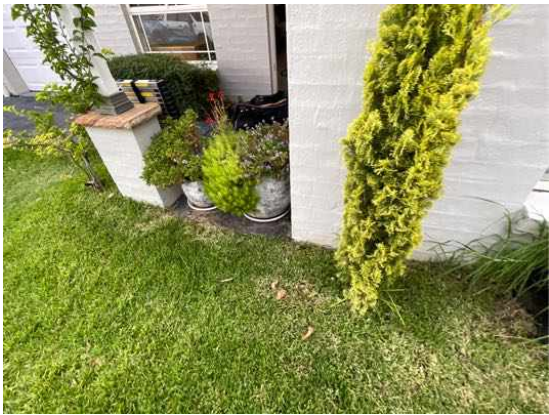
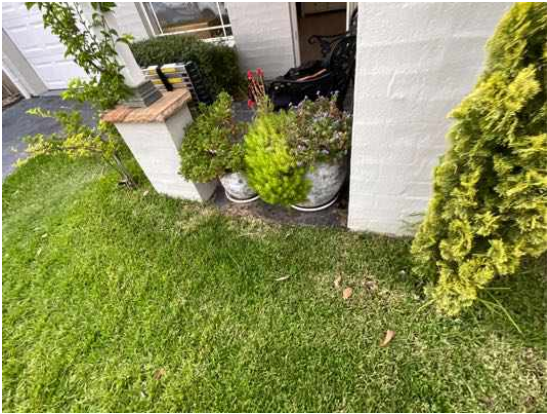
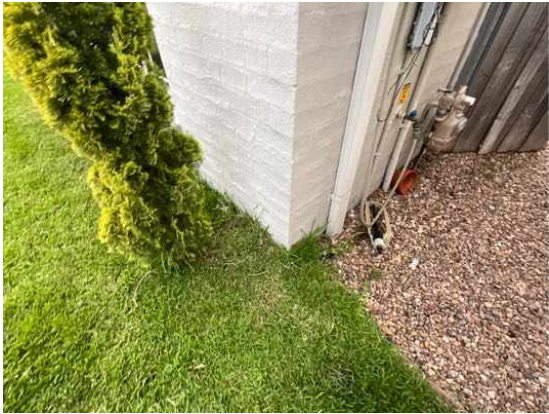
**Finding 6.06**

Building: Main Building  
Location: All Areas  
Finding: Dense vegetation around a property can increase the risk of termite infestation  
Information: The presence of dense vegetation around a property can increase the risk of termite infestation, as it provides a conducive environment for them. To address this, consider maintaining a clear space between the vegetation and your home. If you suspect a termite issue, it's advisable to consult with a licensed pest control professional for inspection and treatment.

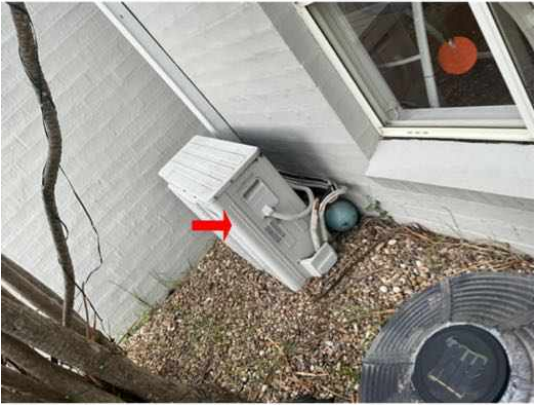
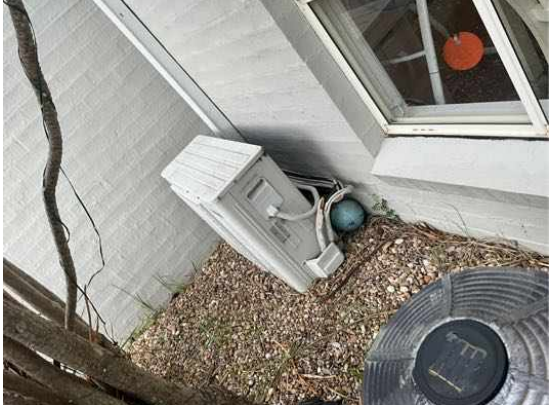
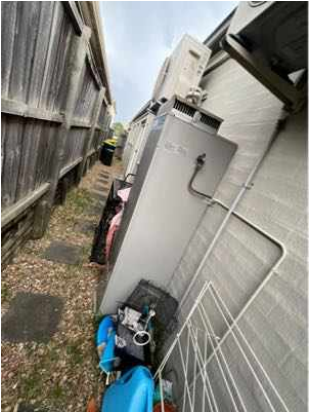
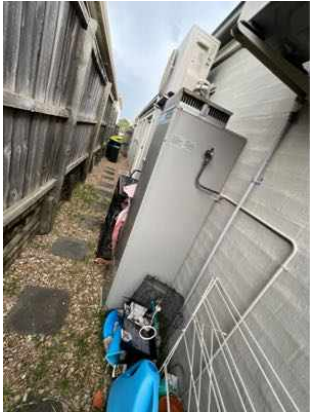
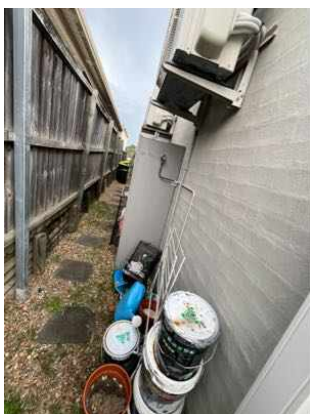
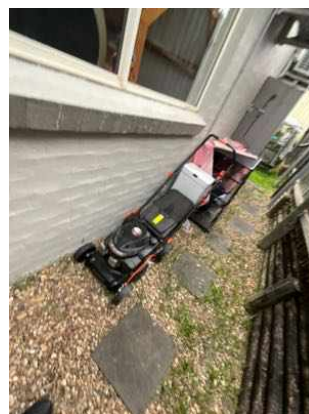
Finding 6.07

Building: Main Building  
Location: All Areas  
Finding: Bridging or Obstruction Conducive environment for Termites  
Information: Bridging of termite barriers occurs when termites bridge (usually by building a mud tunnel) a termite barrier or inspection inspection zone or where termites have a passage, allowing them to bridge the barrier.

Where bridging has occurred full inspection is prevented and termites may enter a property in a concealed or undetected manner.

Recommended moving obstructions away from the external walls for further and future inspections.

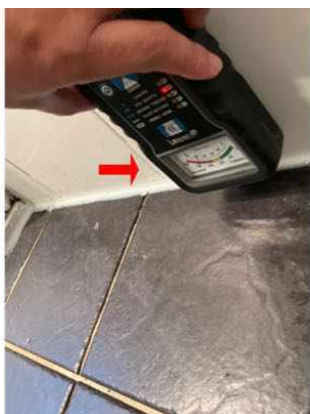
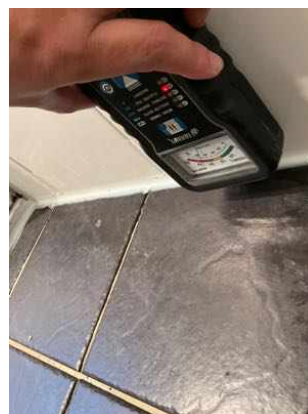
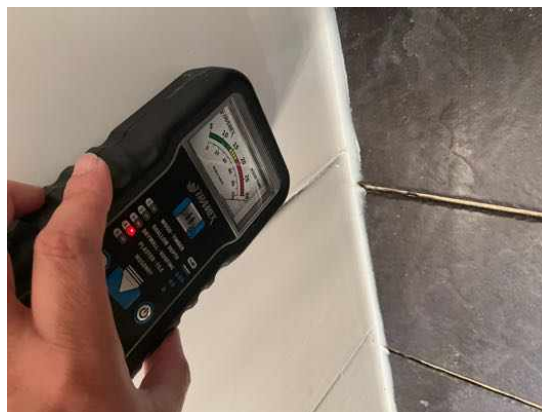
### Finding 6.08

Building:	Main Building
Location:	Ensuite
Finding:	Excessive moisture - Conducive to Timber pest
Information:	Excessive moisture can attract termites and produce conditions that promote fungal growth and wood decay.

Excessive moisture is generally caused by deteriorated inadequate or missing roof drainage leaking plumbing pipes or fixtures poorly plumbed HWS overflows or condenser units and poor site drainage.

Prior to any remedial works being performed a qualified plumber should be appointed to further inspect the property and to identify the cause of the excessive moisture. Works to remove affected building elements may then be necessary and should be performed by an appropriate tradesperson.

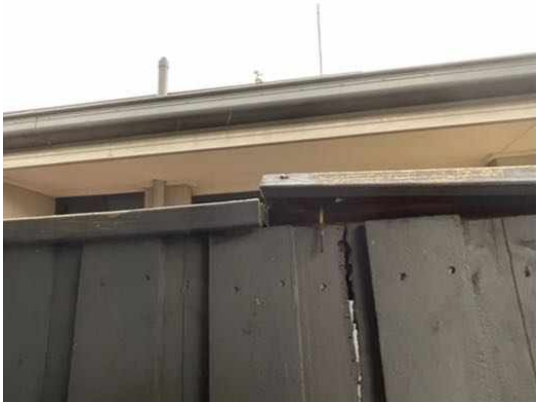
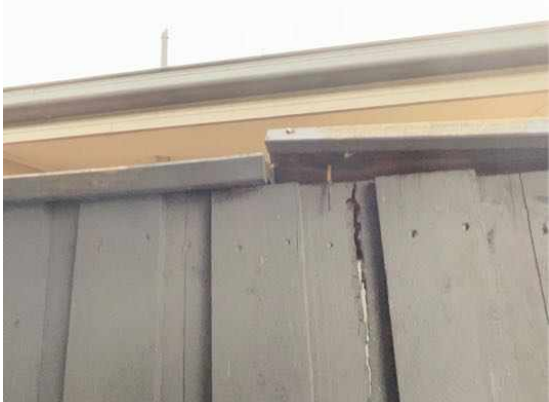
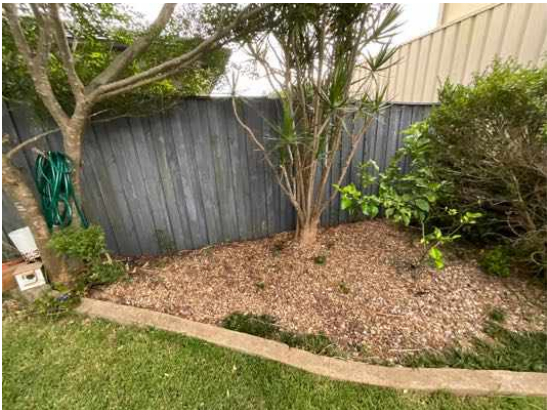
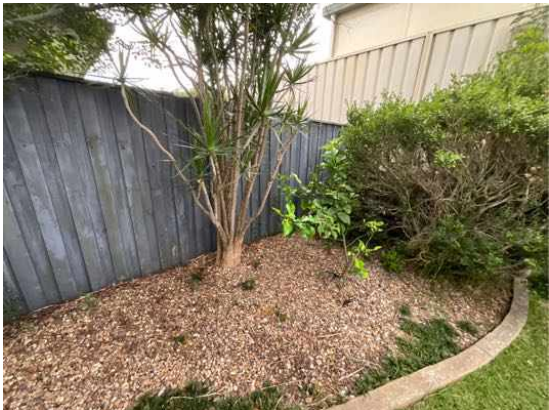
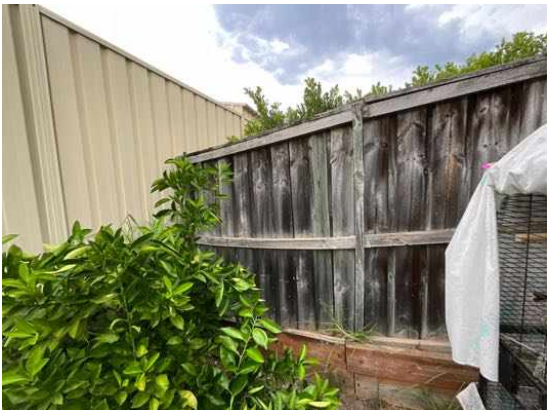
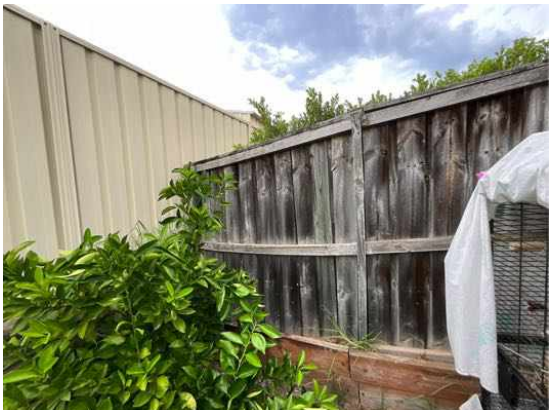
### Finding 7.01

Building:	Main Building
Location:	All Areas
Finding:	Wood rot
Information:	This building element shows evidence of wood rot. Wood rot, also known as Fungal Decay, occurs when timbers and other cellulose building materials are exposed to damp conditions on an ongoing basis. This could be the result of exposure to weathering over a prolonged period of time, or the attraction of excessive moisture from other abutting building materials. Contributing factors also include poor air ventilation in the area.

Wood rot is often associated with general damp problems and is evidenced by a 'musty' smell or mould and mildew occurring on surfaces. If left unmanaged, damp conditions can lead to further health problems and the decay of timbers will continue.

Early intervention and regular maintenance, particularly of exterior timbers, will prolong the useful life of these building elements. Prior to any works being performed, the cause of the moisture that has created the visible wood rot should be identified and addressed in a suitable manner. Replacement of affected timbers may then be a necessary step in protecting surrounding building elements from such deterioration.

A qualified plumber may be appointed to assess the cause of excessive moisture and to provide advice on any remedial works as required. A qualified carpenter or registered builder may also be required to replace affected building materials.
