# Building and Timber Pest Inspection Report

Inspection Date: Sat, 21 Feb 2026

Property Address: 16 Caritta Ct, Parklea NSW 2768, Australia

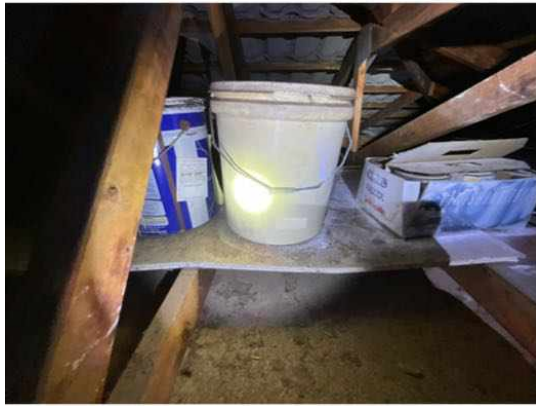
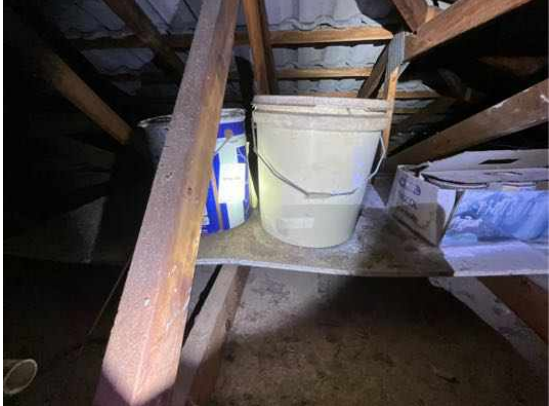
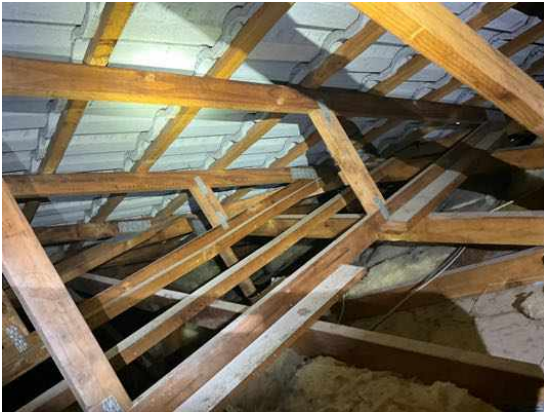
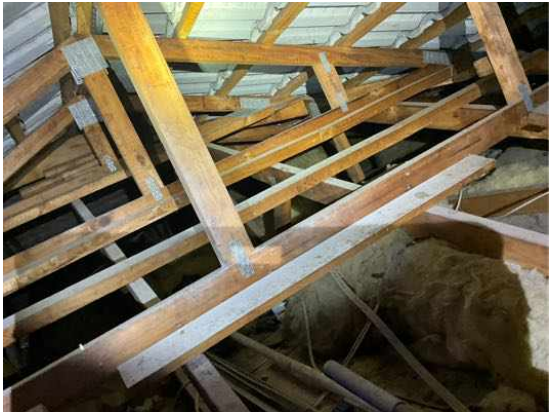
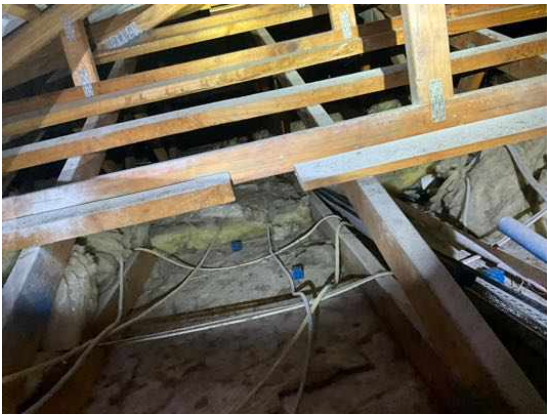
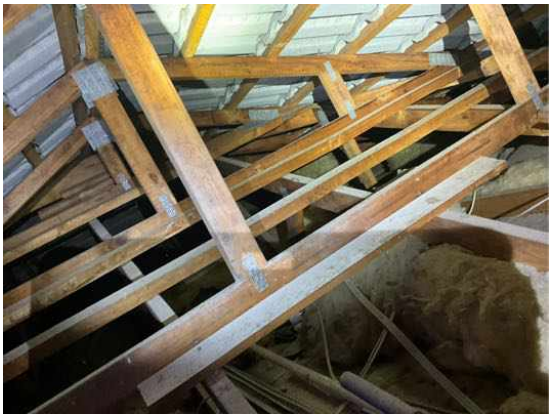
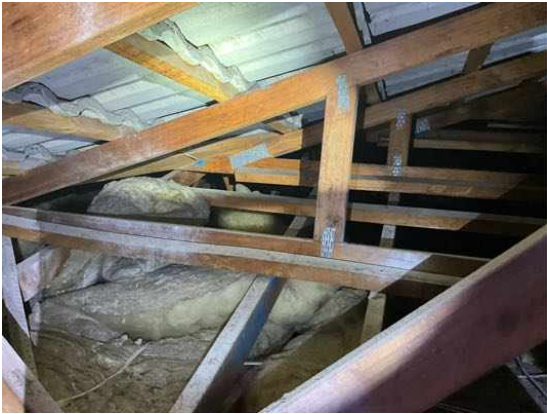
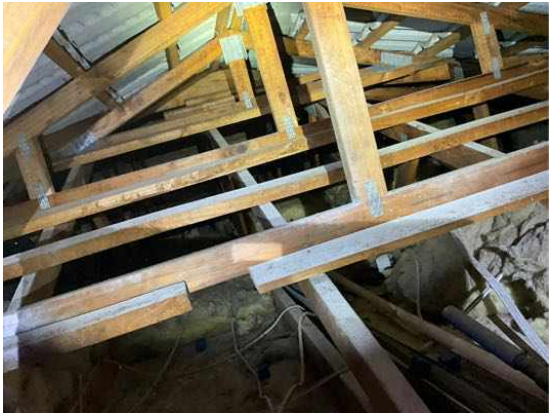
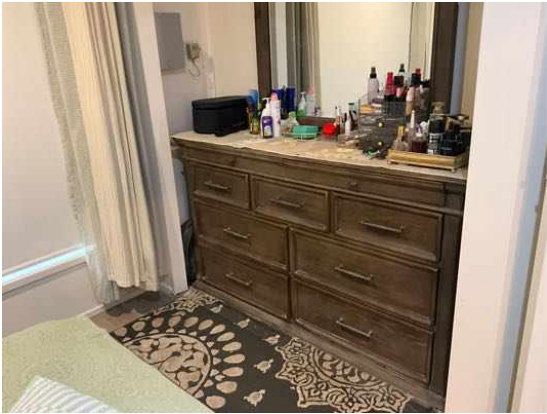
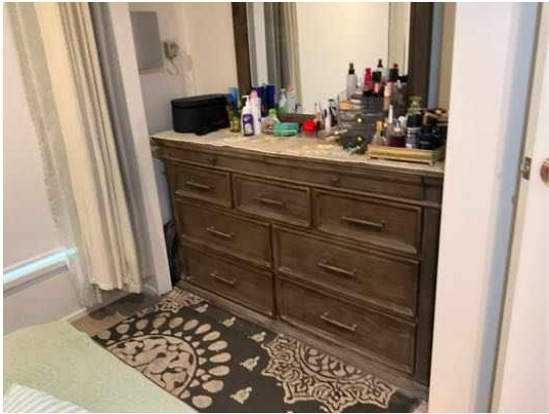
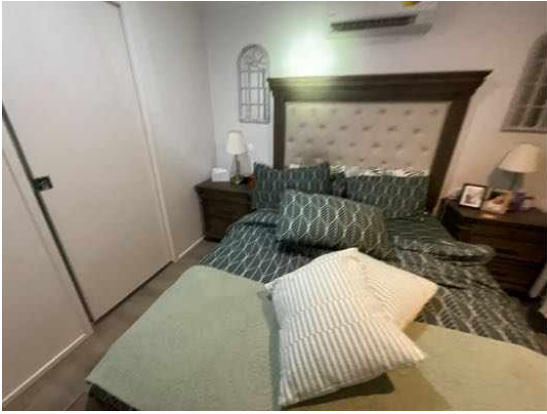
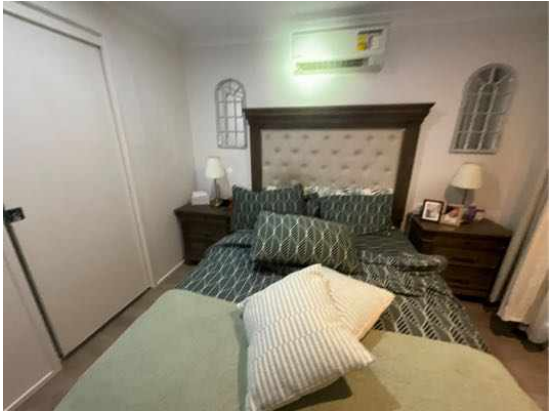
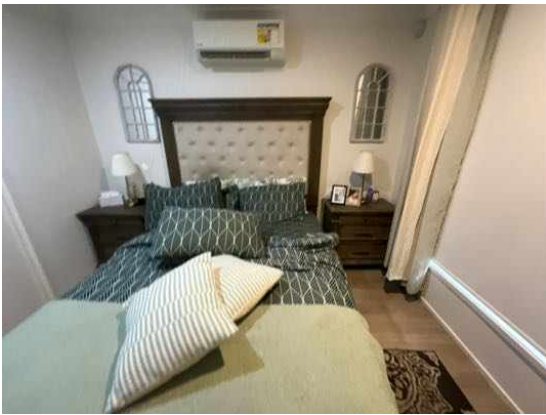
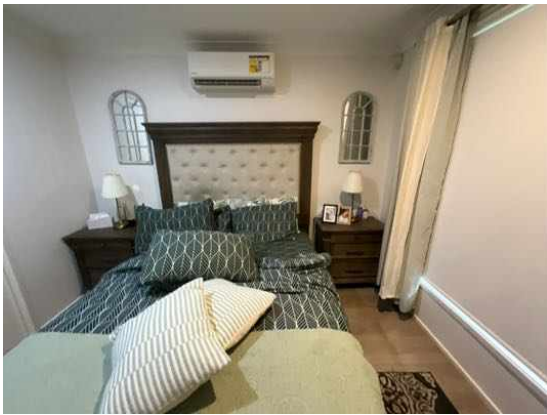
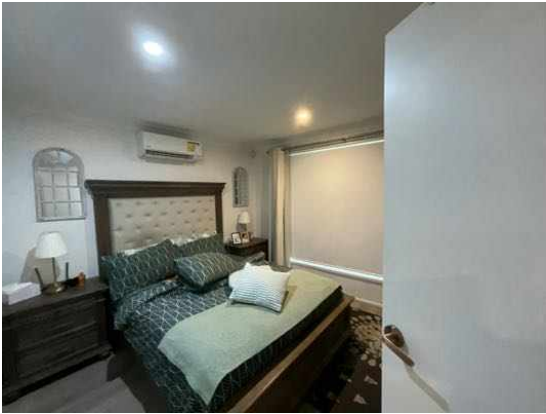
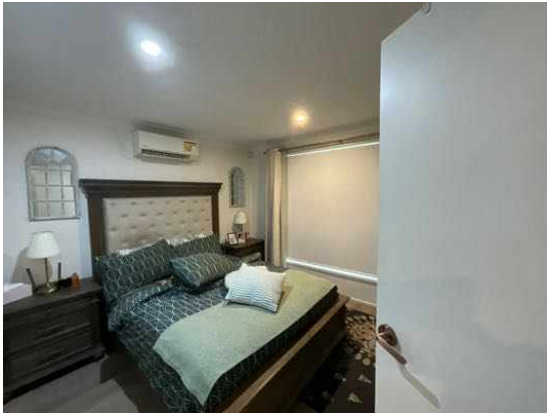
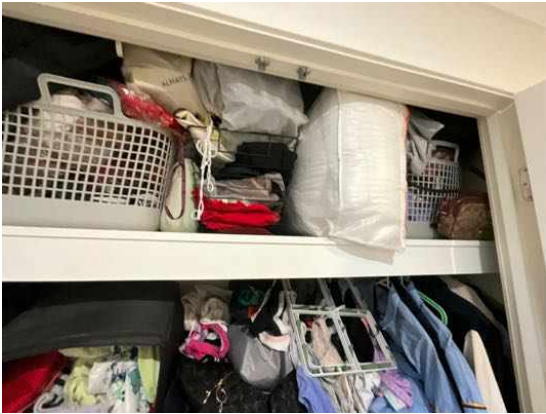
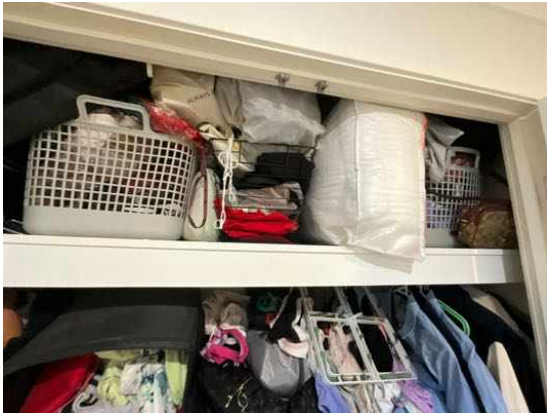
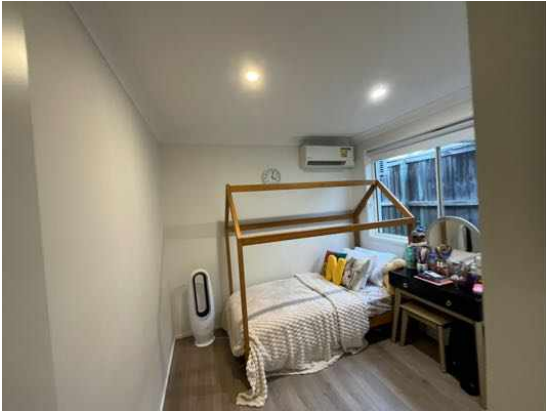
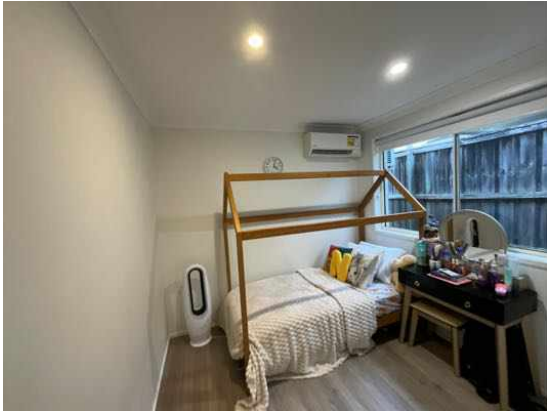
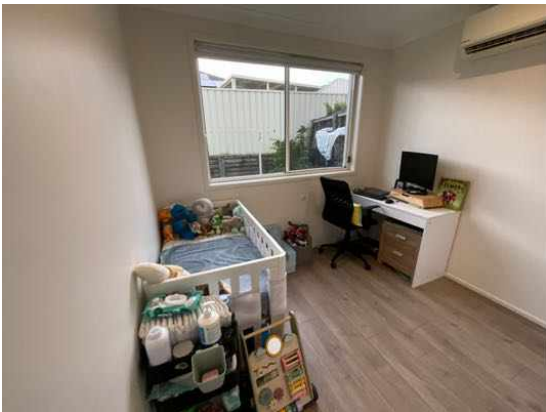
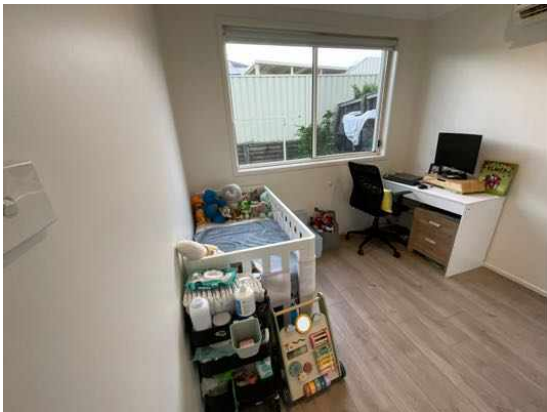
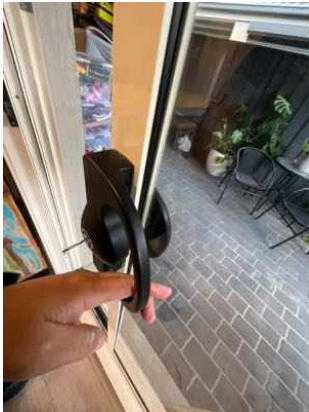
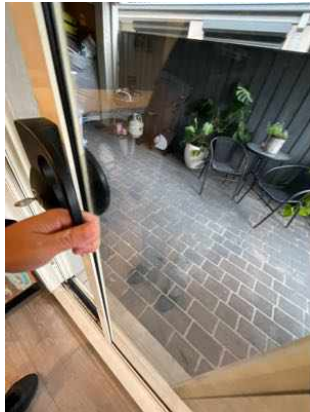
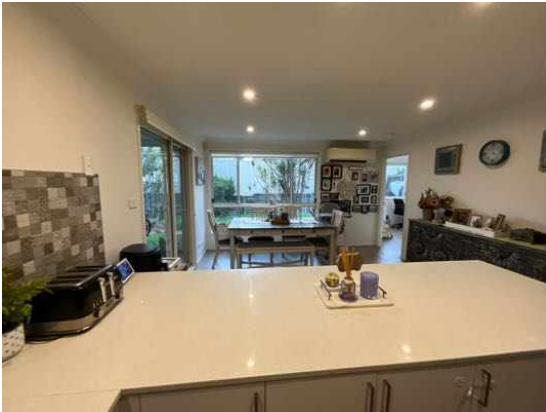
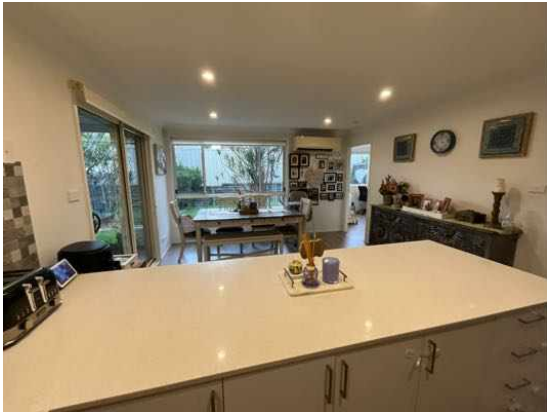
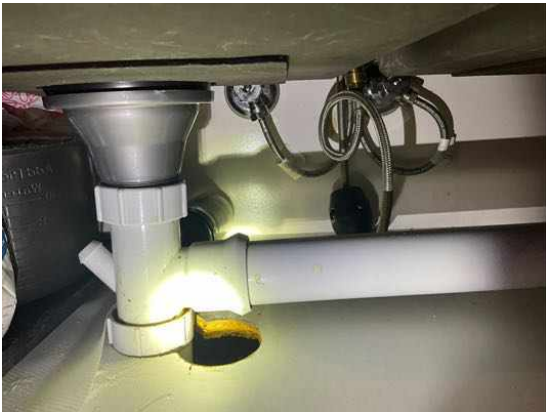
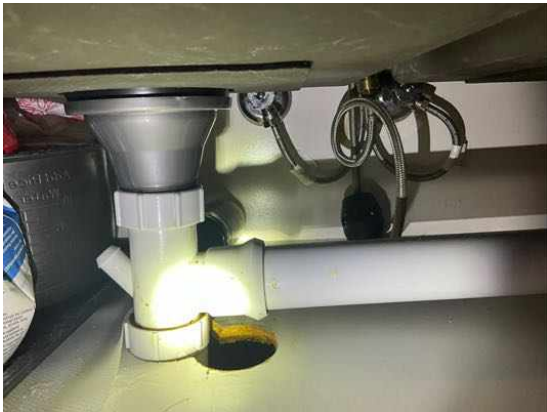
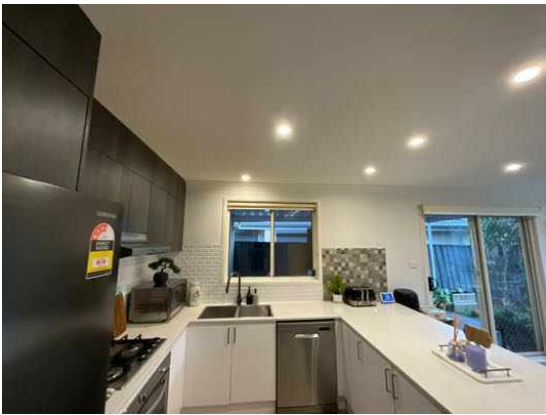
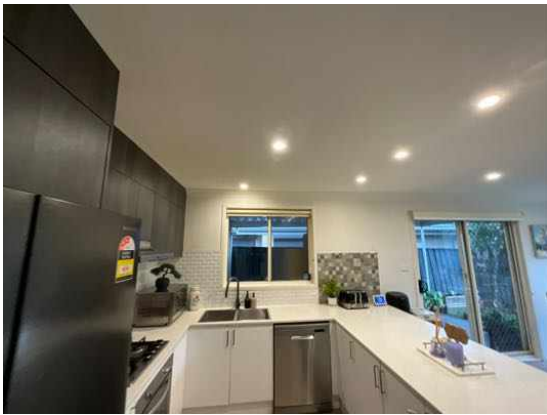
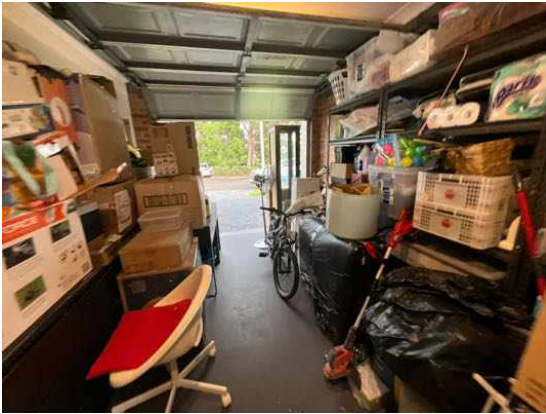
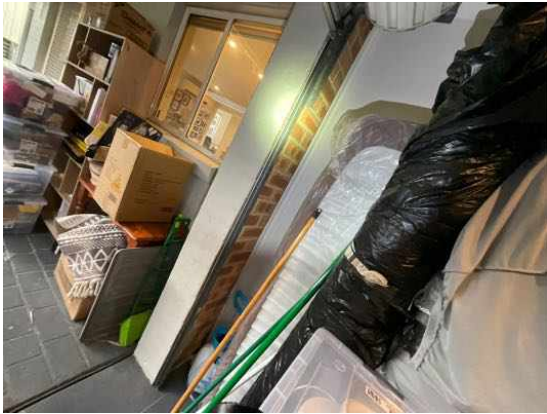
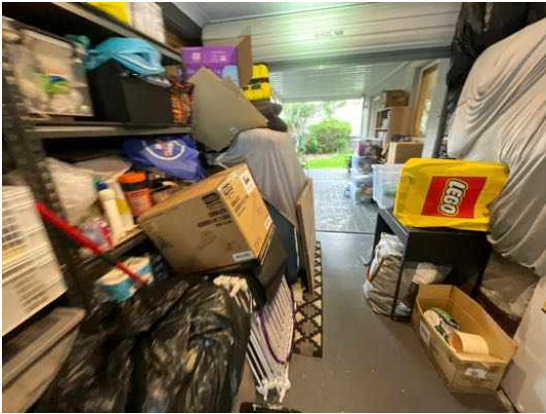
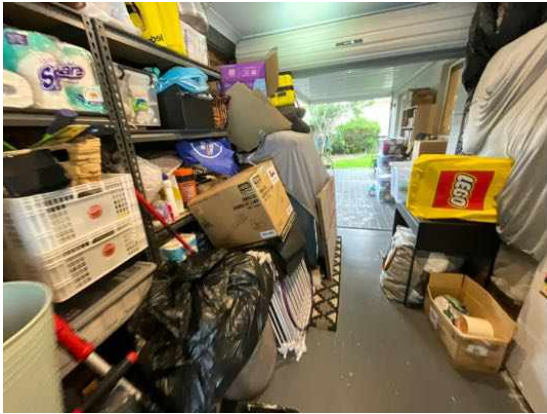
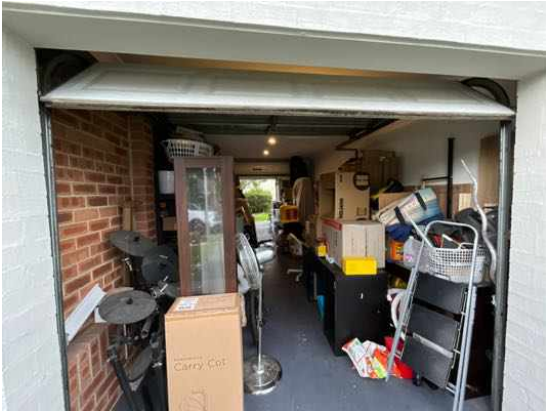
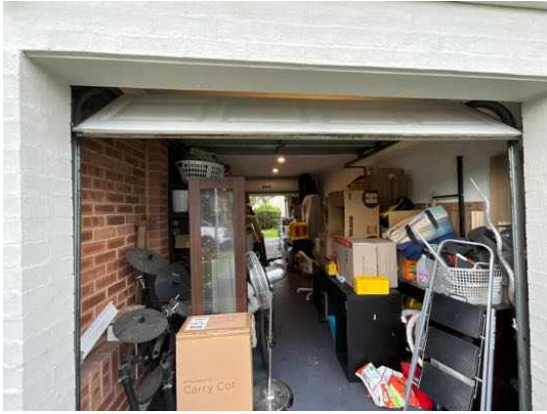
Building: Main Building  
Location: All Areas  
Finding: Additional Photos - Obstructions and Limitations  
Information: These photographs are an indication of the obstructions and limitations which impeded full inspection of the property at the time of inspection. These obstructions can hide an array of defects and should be removed to allow full inspection to be carried out. A re-inspection is recommended once the areas are made accessible.
