## Building Inspection Report

Inspection Date: Tue, 3 Feb 2026

Property Address: 14 Riberry St, Melonba NSW 2765,  
Australia

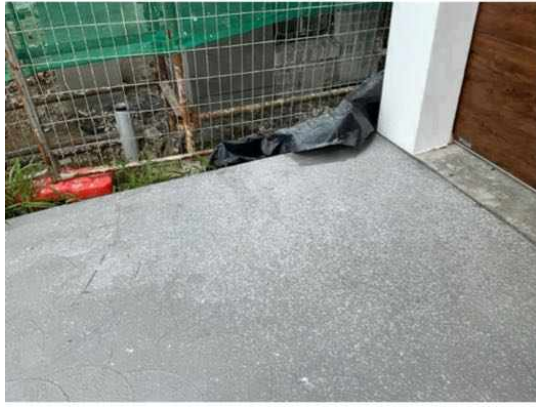
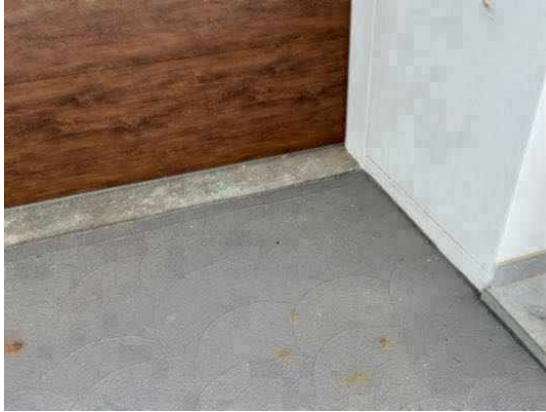
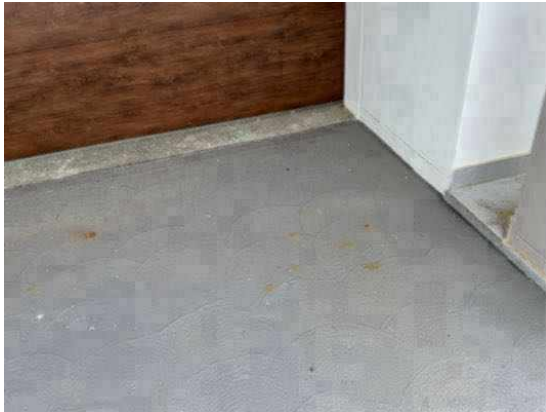
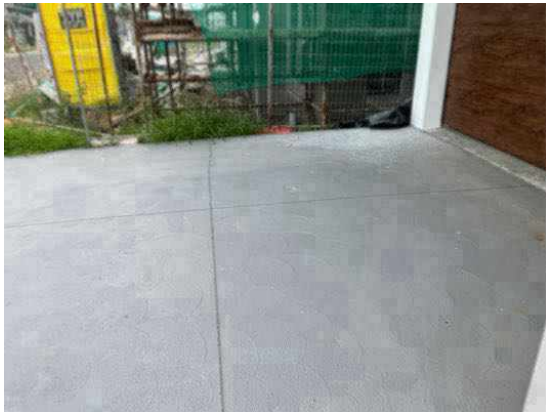
#### Defects 3.01

Building:	Main Building
Location:	All Areas
Finding:	Cleaning required
Information:	It was observed that the house requires cleaning.

Works are defective where windows are not clean, floors are not swept, mopped or vacuumed as appropriate, tiles, sinks, basins, baths, windows or any other area throughout the property are not cleaned, and shelving, drawers and cupboards are not ready for use not cleaned and ready for use at handover.

Building sites are defective if they are not clear of building debris.

Please note: Not all cleaning defects were documented with photographs. However, it is the responsibility of the builder to attend to all cleaning issues, regardless of whether they were captured in the provided images. It is important for the builder to thoroughly inspect the property and address any and all cleaning deficiencies to ensure the property is in optimal condition for the new occupants at handover. Failure to do so may result in further inspections and delays.

This is to be addressed prior to handover.

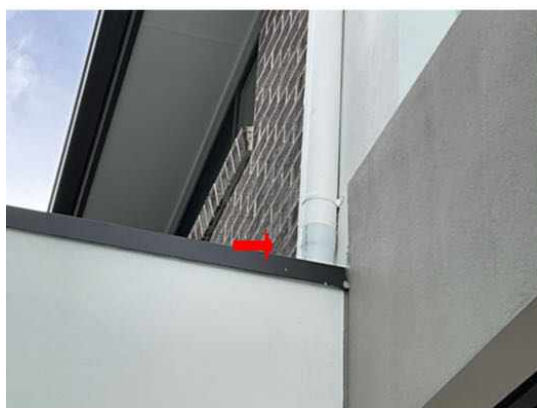
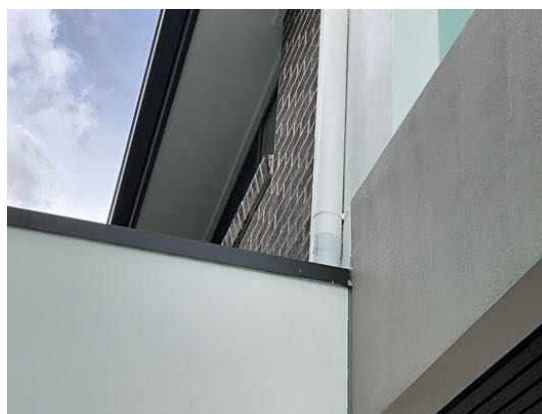
### Defects 3.03

Building:	Main Building
Location:	Exterior walls - left side
Finding:	Incomplete Painting of Downpipes
Information:	The downpipes have not been painted in full, as required by Australian tolerances and guidelines.

Failure to paint the downpipes in full can result in:

- Compromised protection against environmental factors, leading to potential rust and corrosion.
- Reduced lifespan and durability of the downpipes.
- Negative impact on the building's aesthetic appeal and overall quality.

The downpipes should be repainted to ensure complete coverage in accordance with AS 2311. This includes proper surface preparation, application of the specified number of coats, and adherence to the correct painting techniques to achieve a uniform and durable finish. Regular inspections should be carried out to ensure compliance throughout the painting process.

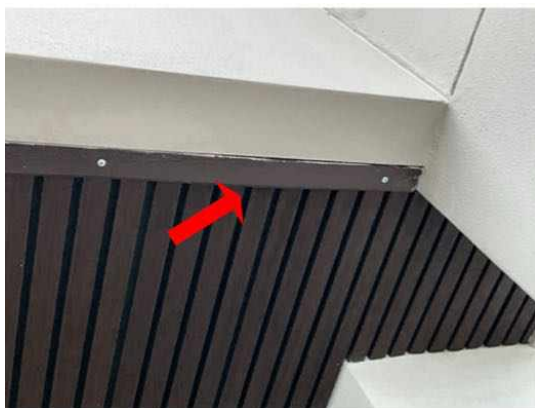
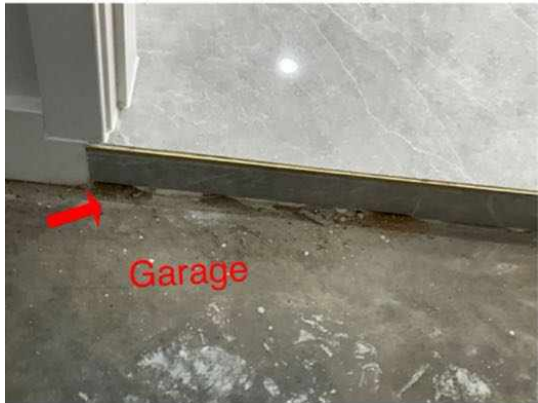
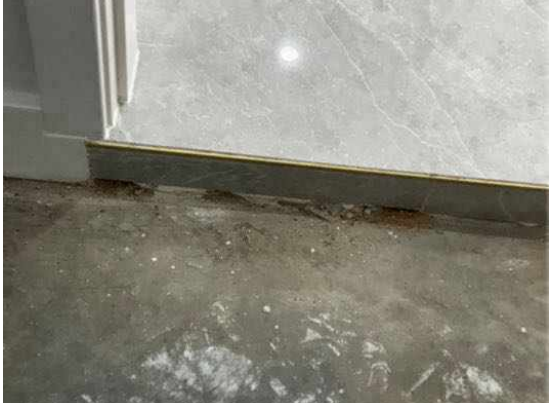
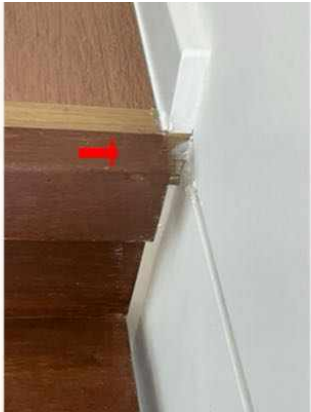
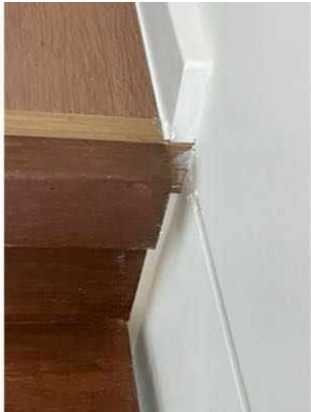
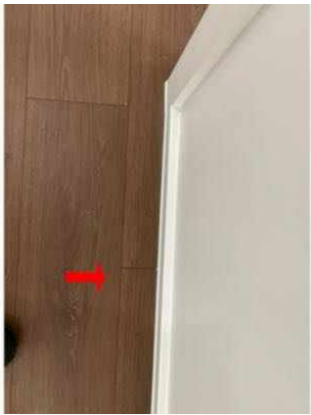
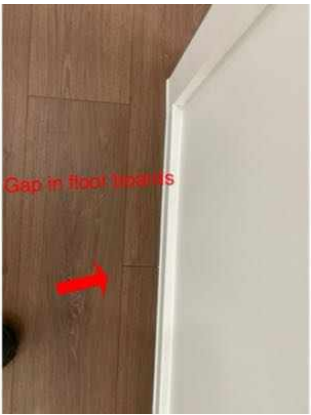
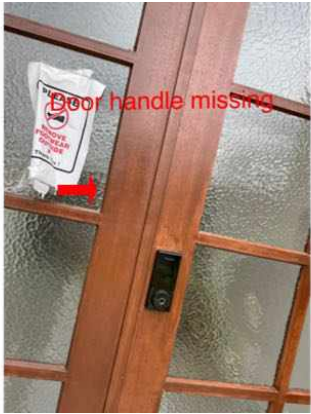
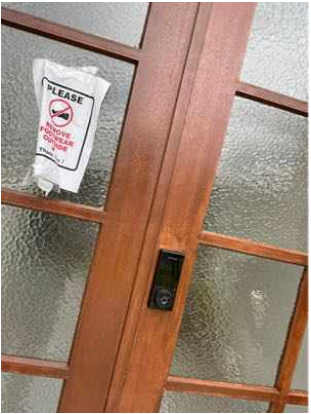
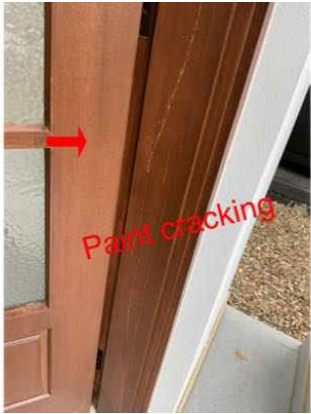
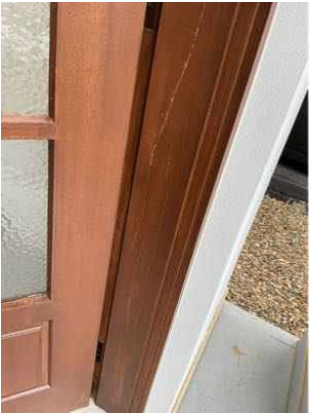
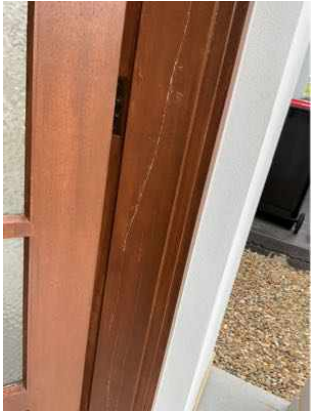
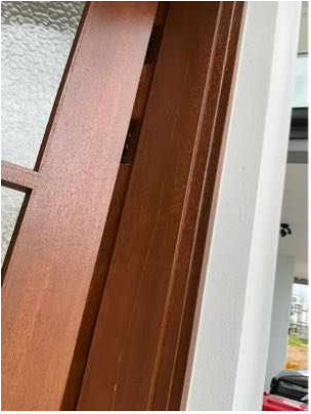
**Defects 3.04**

Building:	Main Building
Location:	All Areas
Finding:	Substandard Work- Various Areas of the Building...
Information:	Substandard work has been identified in multiple areas throughout the building, failing to meet the requirements specified by Australian Guides and Tolerances.

- **\*\*Surface Preparation:\*\*** Poor surface preparation resulting in inadequate paint adhesion and flaking.

- **\*\*Fixtures and Fittings:\*\*** Misaligned or improperly installed fixtures and fittings, not meeting the standard requirements for level and alignment.

- Accelerated deterioration and reduced durability of the affected elements.
- Compromised aesthetic quality and overall value of the property.
- Potential safety hazards and increased maintenance costs.
- Negative impact on the building's functionality and usability.

- Repainting surfaces with proper surface preparation and uniform application.
- Realigning and properly installing fixtures and fittings.

A comprehensive inspection should be conducted post-repairs to ensure all rectifications comply with the required standards.

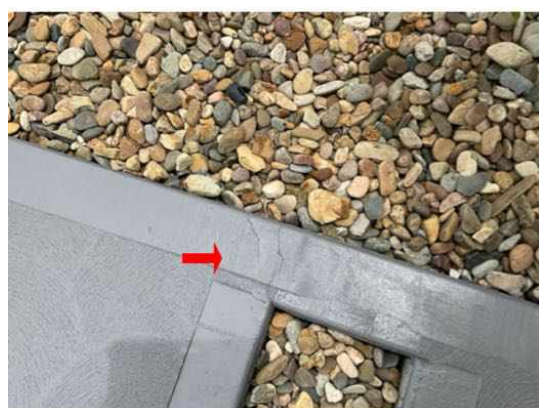
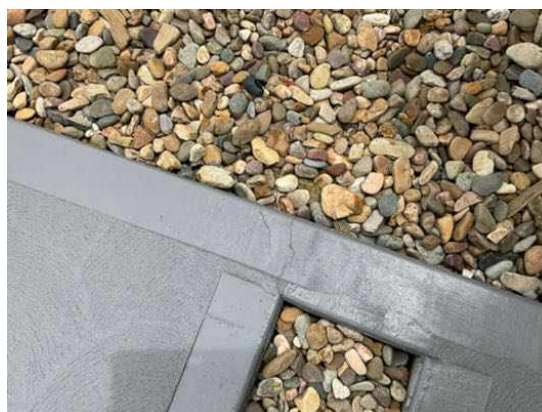
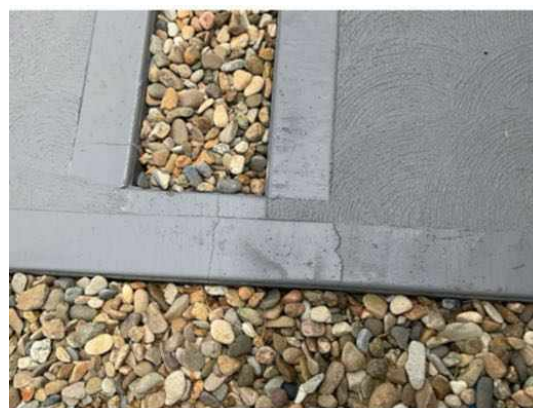
Defects 3.05

Building: Main Building  
 Location: Yard - Front  
 Finding: Crack in concrete slab - Category 0  
 Information: A crack coded as Category 0 was identified in the slab. A Category 0 crack is described as a hairline crack, representing insignificant movement of slab from level.

The approximate width of the crack to be considered Category 0 is 0.3mm, or change in offset of less than 8mm when a 3m straight edge is placed over the defect.

No rectification is required at this time. However, all cracking should be monitored over a 12 month period to identify any further damage in the area.

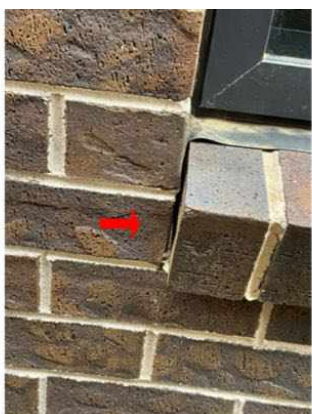
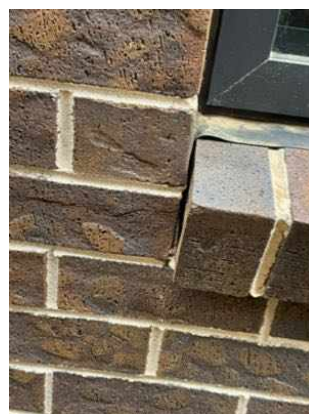
### Defects 3.06

Building: Main Building  
 Location: Exterior walls - right side  
 Finding: Mortar joints - Filling required  
 Information: Instances of voids and holes affecting the masonry mortar have been identified. Excepting weep holes and vents voids and holes are defects if they are visible from a normal viewing position.

Where a building element is installed in such as way that it fails to achieve the required minimum standard or level of finish at the time of the inspection, the builder needs to rectify the defect as soon as possible and m complete works to the required standard prior to handover.

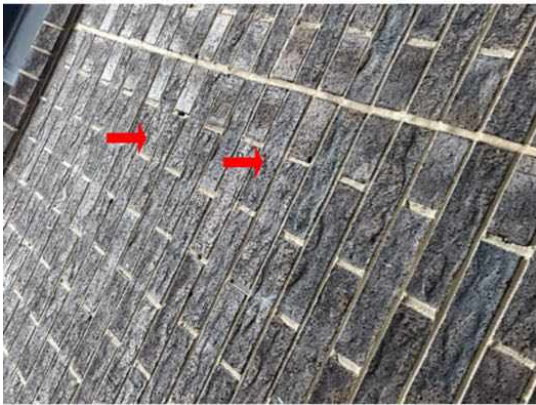
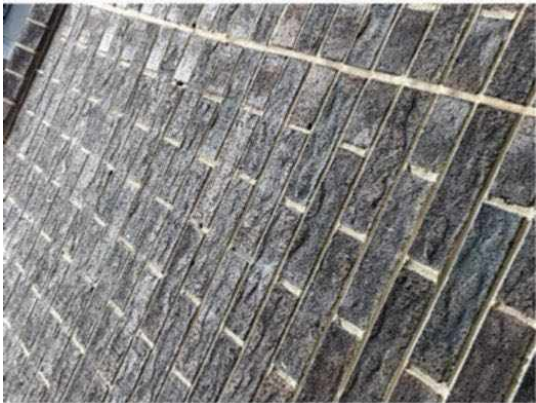
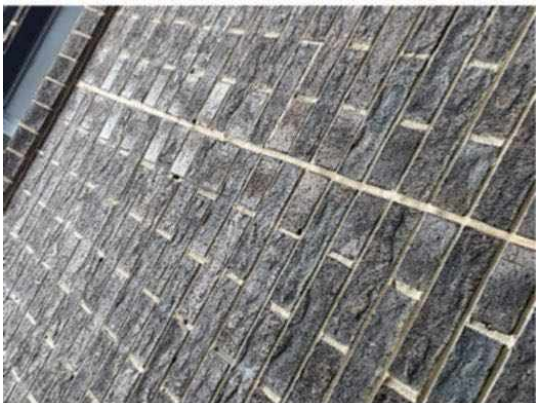
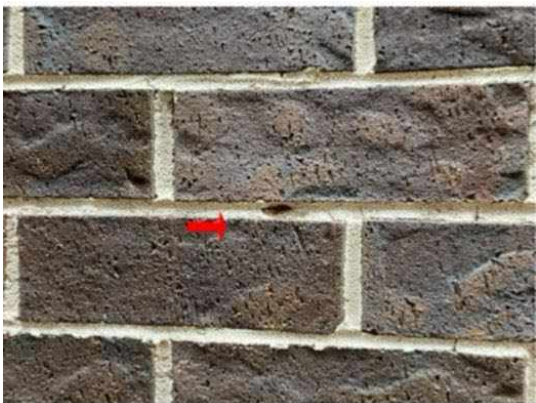
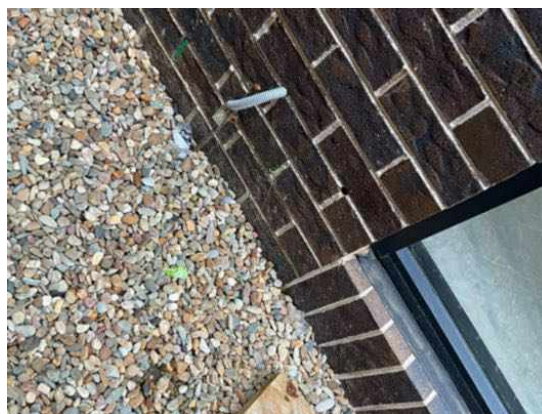
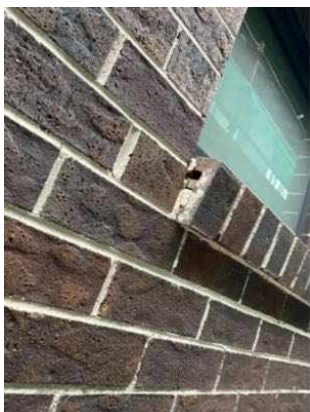
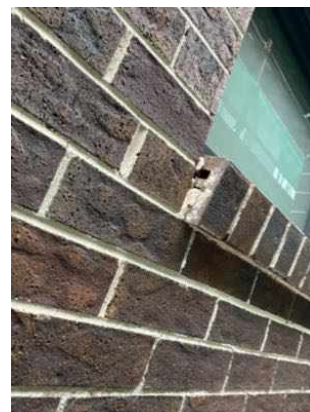
### Defects 3.07

Building:	Main Building
Location:	All Areas
Finding:	Mortar joints - Filling required
Information:	Instances of voids and holes affecting the masonry mortar have been identified. Excepting weep holes and vents voids and holes are defects if they are visible from a normal viewing position.

Where a building element is installed in such as way that it fails to achieve the required minimum standard or level of finish at the time of the inspection, the builder needs to rectify the defect as soon as possible and m complete works to the required standard prior to handover.

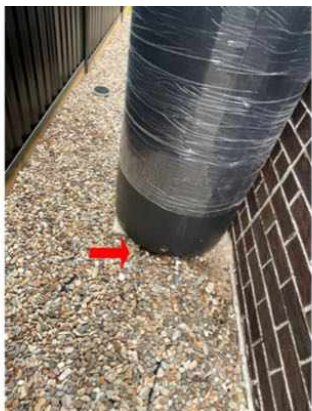
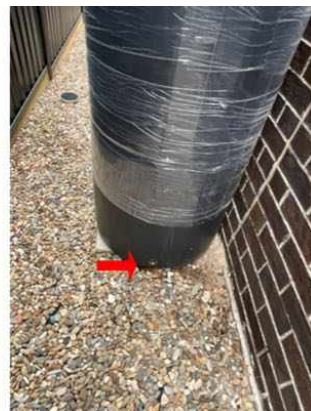
### Defects 3.08

Building:	Main Building
Location:	Exterior walls - left side
Finding:	Rain Bank Pump System Not Installed
Information:	A Rain Bank pump system was not installed at the time of inspection. No pump unit, electrical connection, inlet/outlet pipework, or integration with the roof drainage or stormwater system was observed in the inspected areas. This assessment is based on a visual, non-invasive inspection only.

If a Rain Bank pump system is intended to be provided, it is recommended that installation be carried out by a licensed plumber and suitably qualified electrician in accordance with AS 3500, manufacturer requirements, and local council provisions.

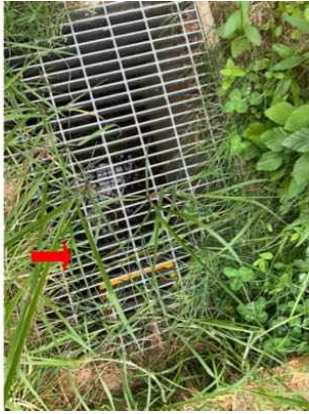
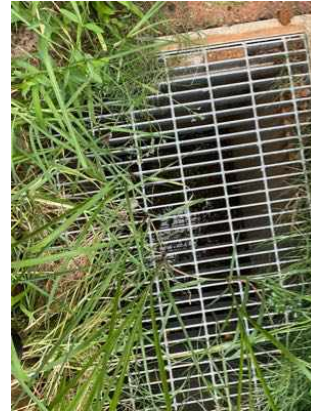
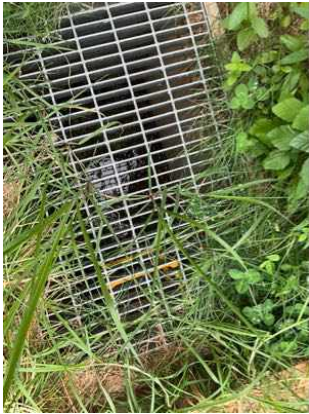
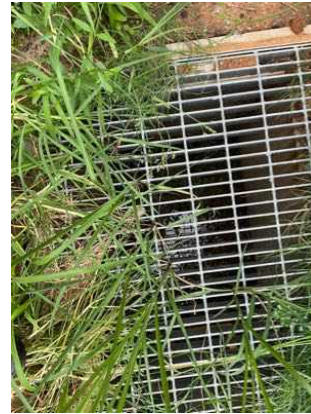
### Defects 3.09

Building: Main Building  
 Location: Yard - Back  
 Finding: Vegetation inside Drain  
 Information: Vegetation, such as roots or foliage, is obstructing the drainage system, impeding water flow and potentially leading to blockages and water damage.

The presence of vegetation in the drain poses a risk of water backup, flooding, and structural damage to the property, including foundation issues and mold growth.

A qualified plumber or drainage specialist should clear the vegetation from the drain, ensuring proper water flow and preventing potential drainage problems and associated damages. Regular maintenance may also be required to prevent future vegetation intrusion.

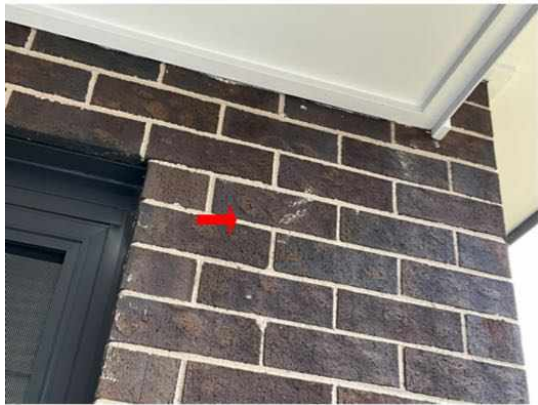
### Defects 3.10

Building:	Main Building
Location:	All Areas
Finding:	Paint - Substandard
Information:	Areas were identified where the surface finish of the painting is substandard and this is considered a defect.

Any irregularity in the surface which is visible from a normal viewing position is considered a defect. Marks may also be a result of fault by other tradespeople throughout the construction process.

Defective surface finish of paintwork is marked with an arrow to the below photos in the following locations.

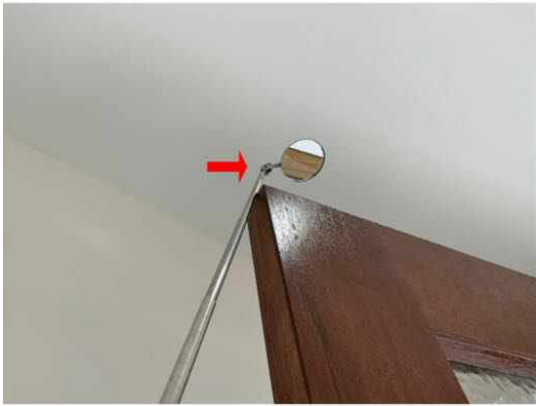
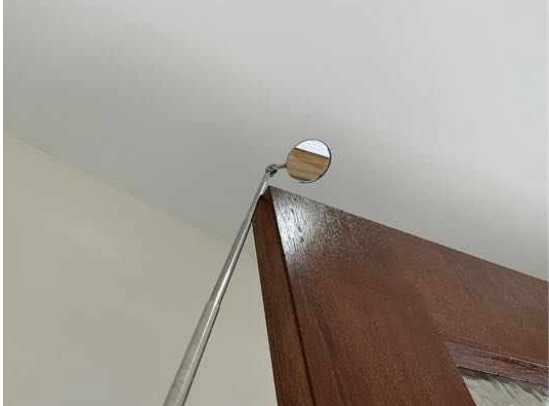
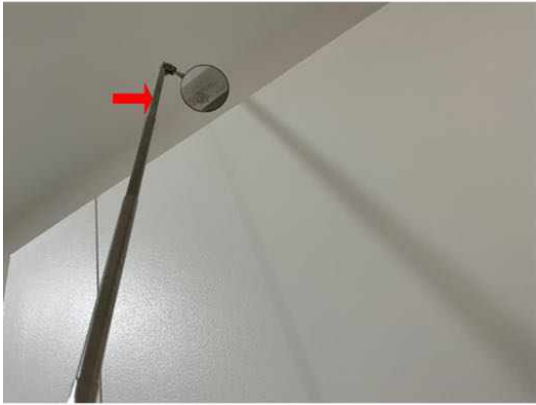
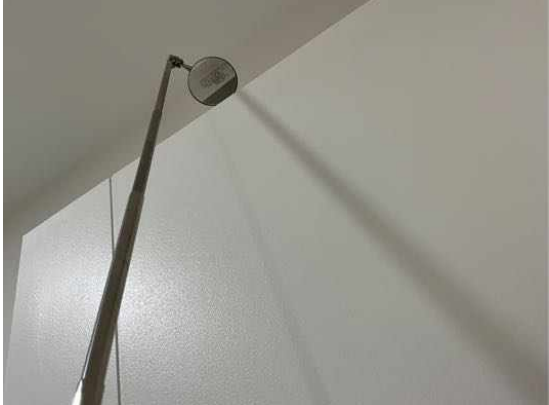
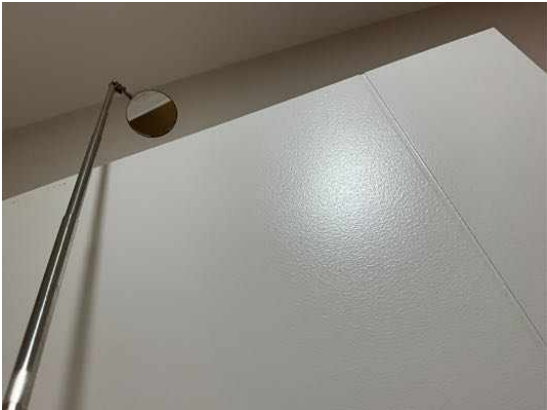
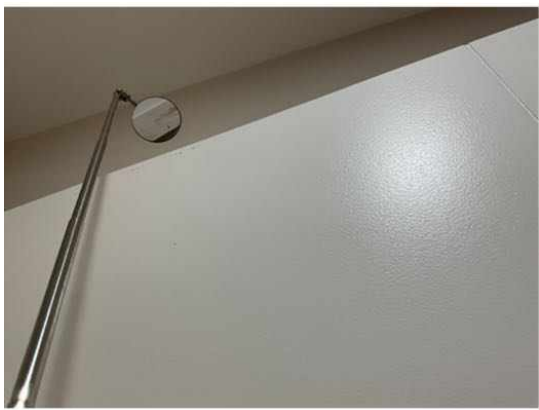
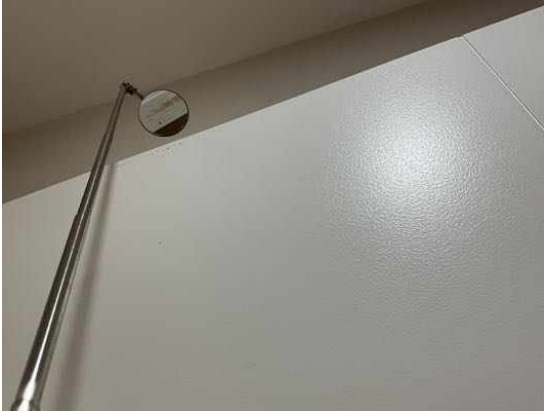
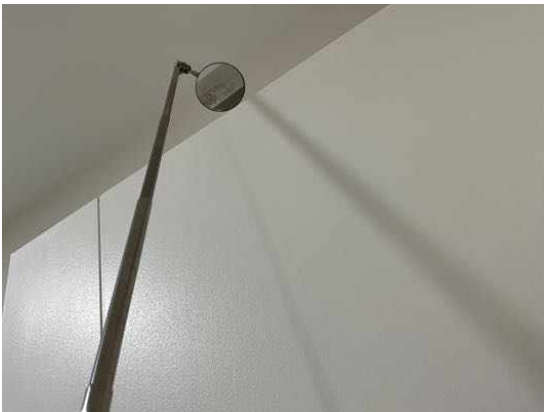
## Defects 3.11

Building:	Main Building
Location:	All Areas
Finding:	Incomplete Painting of Doors
Information:	The paintwork on the doors throughout the building is incomplete, failing to meet the requirements specified by Australian Guides and Tolerances.

- **\*\*Coverage:\*\*** Incomplete paint coverage on the doors, with visible areas left unpainted or thinly coated.
- **\*\*Edges and Corners:\*\*** Edges and corners of the doors are inadequately painted, showing bare or poorly covered areas.

- Reduced durability and protection of the door surfaces against wear and environmental factors.
- Compromised aesthetic quality and overall visual appeal of the building.
- Increased maintenance costs due to the need for early repainting or repairs.

- Ensuring complete and consistent paint coverage on all surfaces of the doors.
- Achieving a smooth and even finish without visible defects such as brush marks, drips, or streaks.

- Proper surface preparation to ensure good paint adhesion and prevent peeling or flaking.
- Thoroughly painting edges and corners to achieve a uniform appearance.

A detailed inspection should be conducted post-repainting to confirm compliance with the required standards.

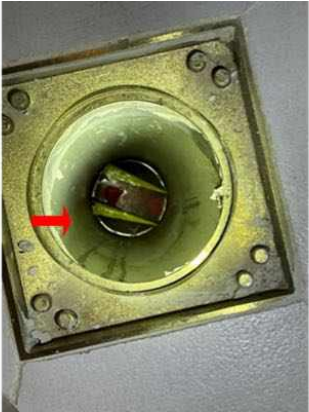
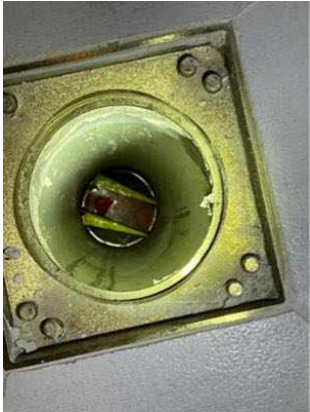
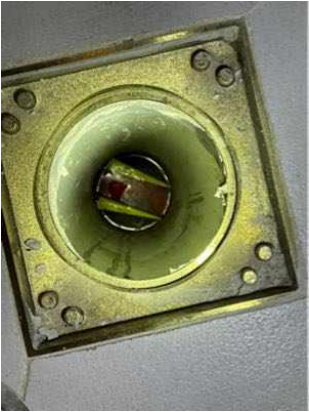
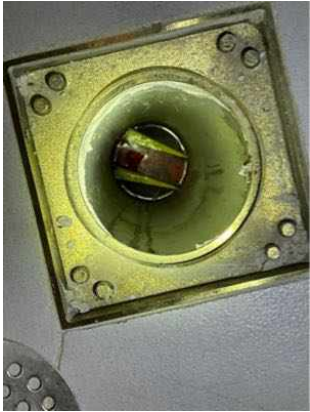
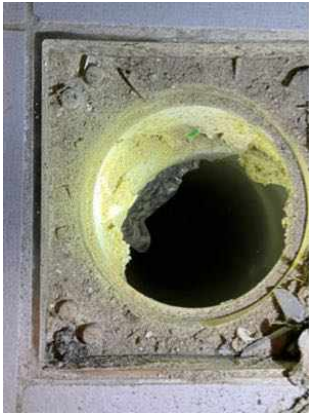
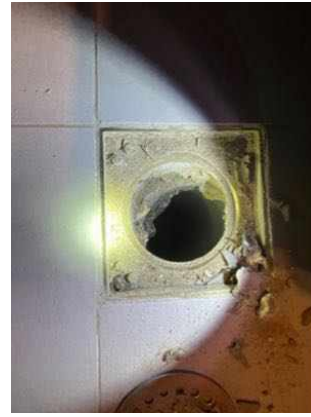
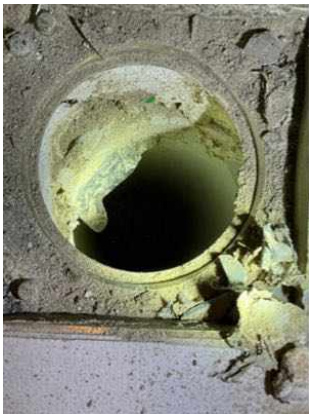
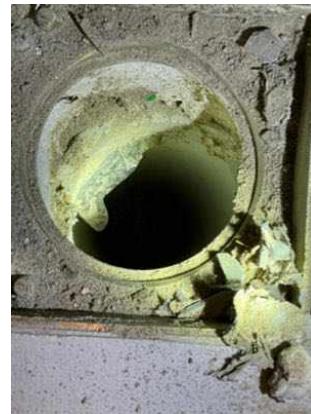
### Defects 3.12

Building:	Main Building
Location:	All Areas
Finding:	Floor waste Debris
Information:	It was noted that there is builder debris in the floor waste drainage. Debris in the plumbing system may lead to blockages in the future.

Building sites are defective if they are not clear of building debris. All floor wastes need

to be checked and cleared prior to handover.

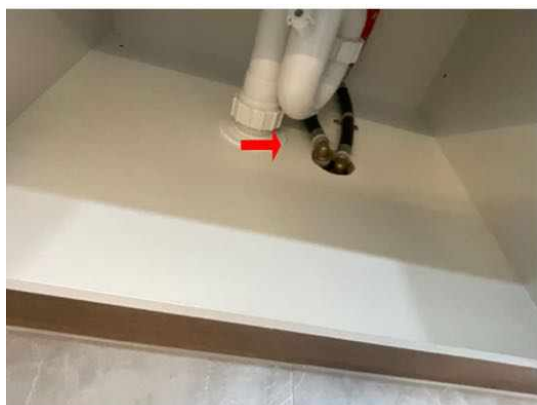
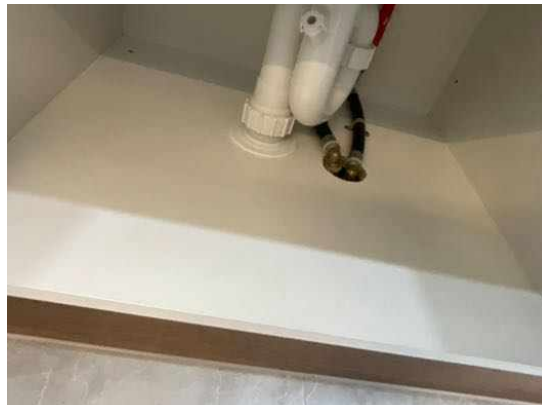
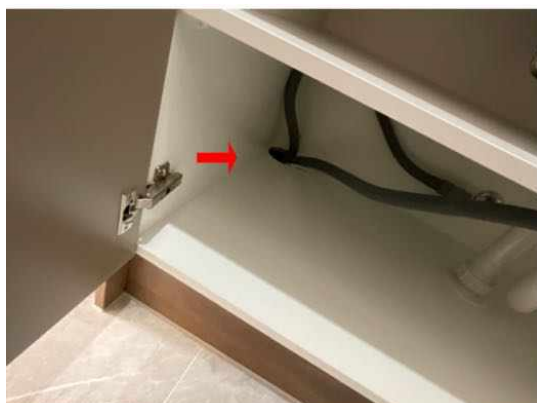
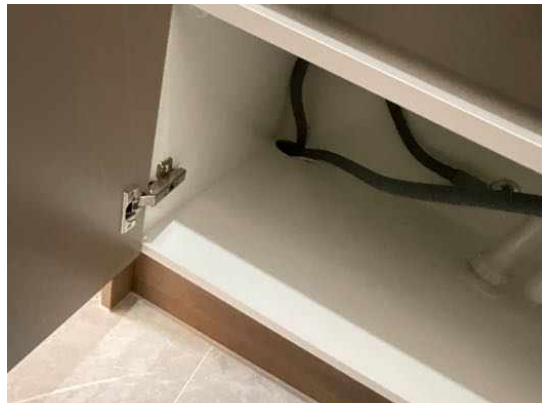
### Defects 3.13

Information: It was noted that at the time of the inspection the pipe penetrations were defective as stated in the Australian Standards and Tolerances 7.3.

Plumbing holes are defective if they are not:

- a. properly grouted as appropriate
- b. fitted through neat minimal size penetrations (in the case of cabinetwork)
- c. fitted with tight fitting cover plates or collars with penetrations kept to the smallest size practicable.

This is to be rectified prior to handover.

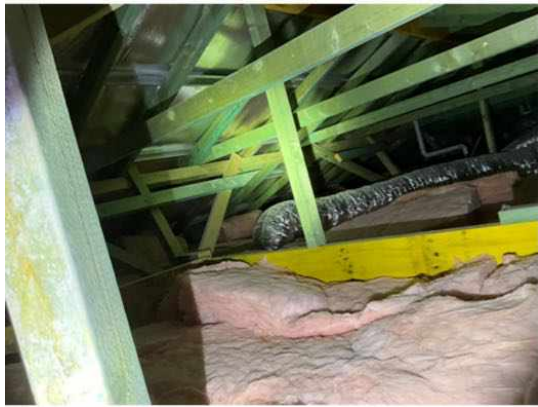
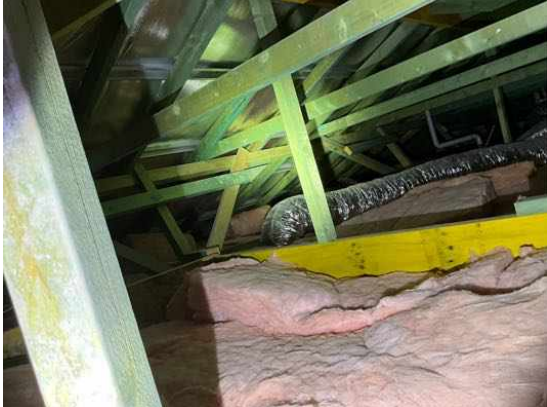
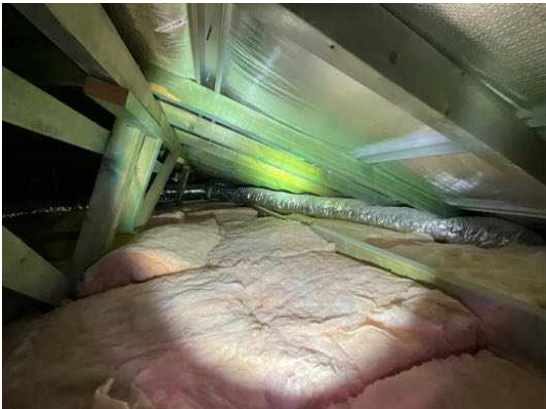
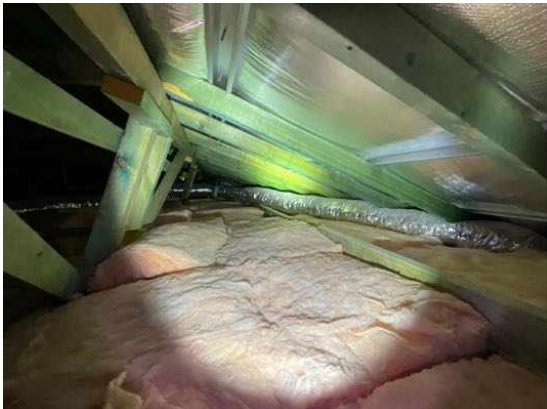
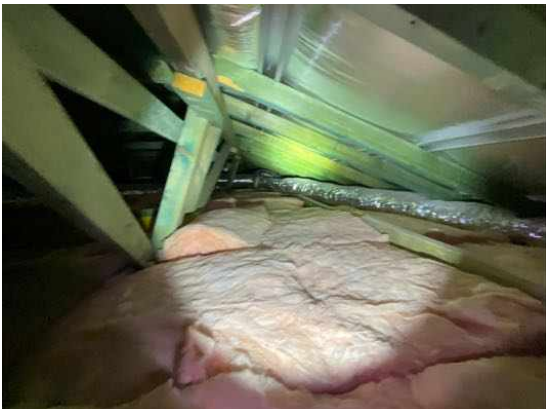
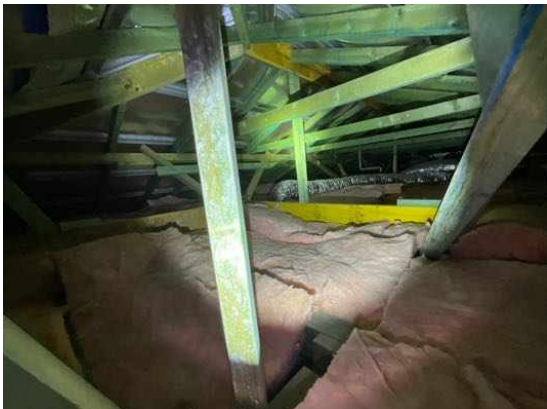
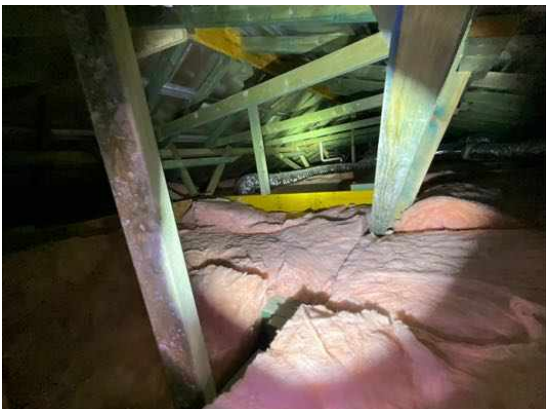
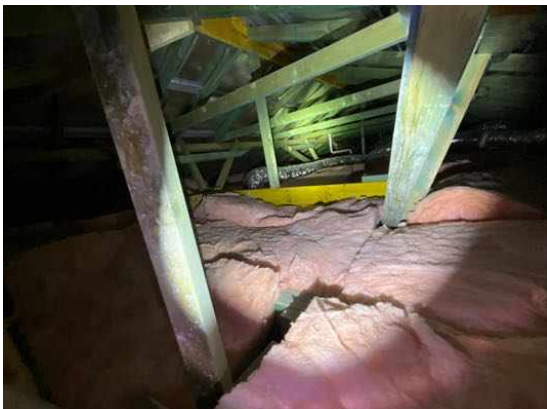
### Defects 3.14

Building:	Main Building
Location:	All Areas
Finding:	Insulation - Covering downlights
Information:	Sections of insulation in the roof void have been poorly installed or moved from their original position and are covering down light fittings. While the down lights have been fitted with appropriate protective covers, the presence of this insulation creates a potential fire hazard.

Any insulation within the vicinity of down light fixtures should be moved and re-applied to more appropriate sections of the roof void, thus ensuring the area is fire-safe. An insulation contractor should be appointed as soon as possible to perform any necessary works as required.

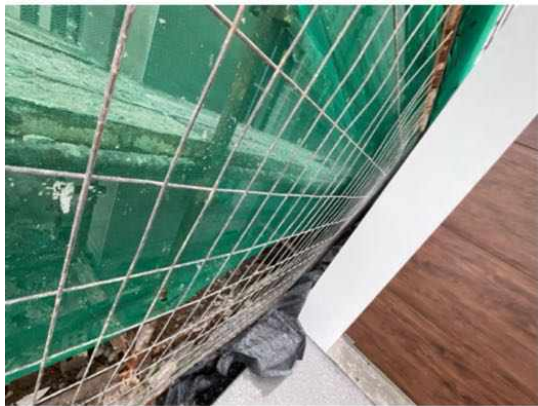
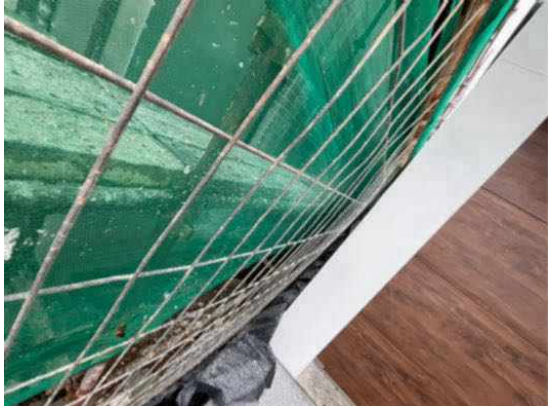
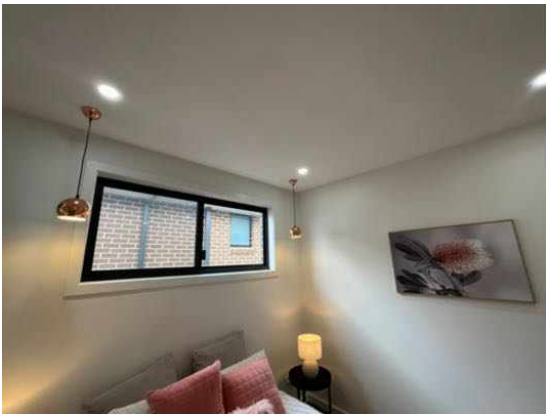
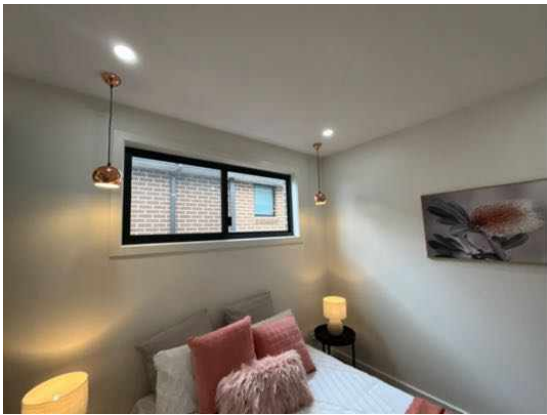
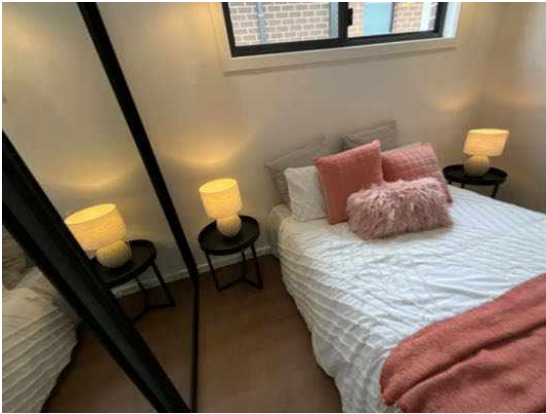
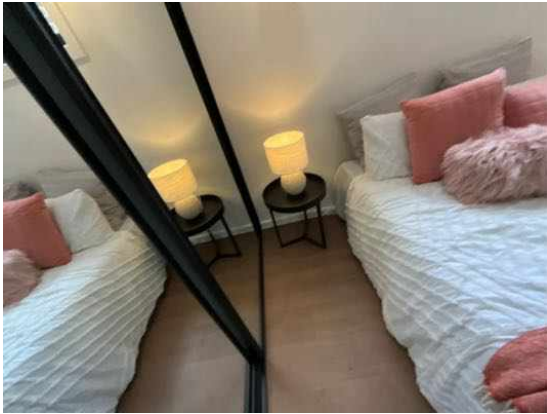
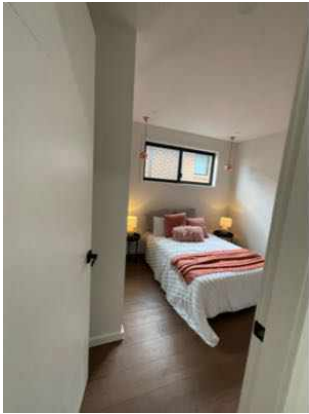
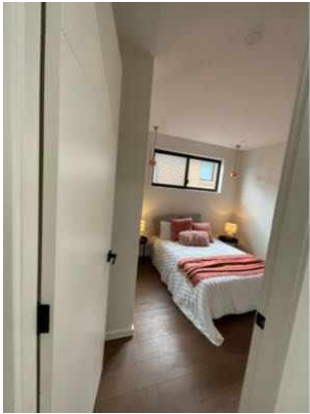
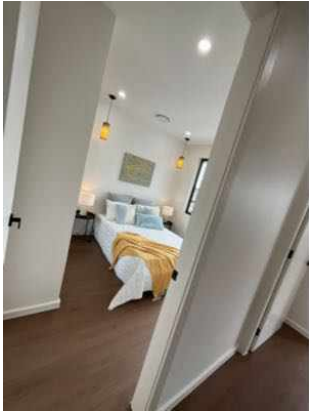
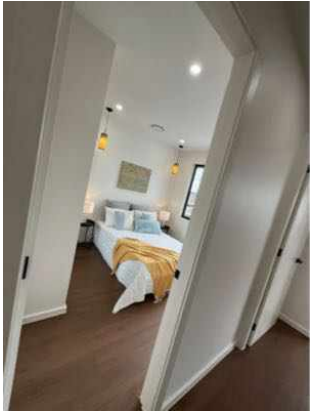
Defects 3.15

Building: Main Building  
Location: All Areas  
Finding: Additional Photos - Obstructions and Limitations  
Information: These photographs are an indication of the obstructions and limitations which impeded full inspection of the property at the time of inspection. These obstructions can hide an array of defects and should be removed to allow full inspection to be carried out. A re-inspection is recommended once the areas are made accessible.
