## Building Inspection Report

Inspection Date: Tue, 3 Feb 2026

Property Address: 14 Riberry St, Melonba NSW 2765,  
Australia

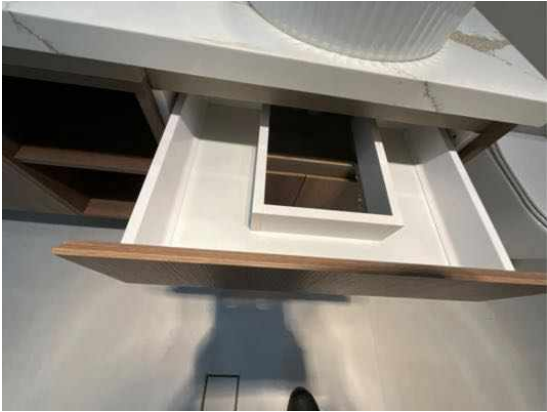
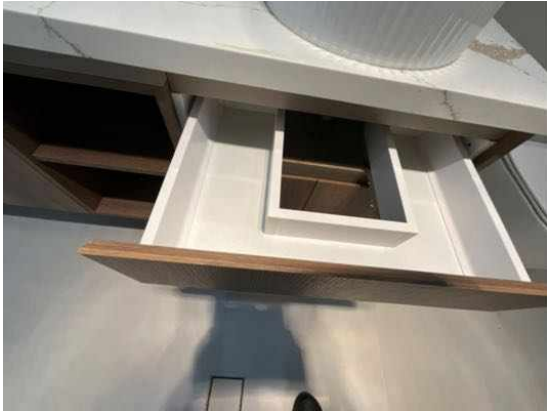
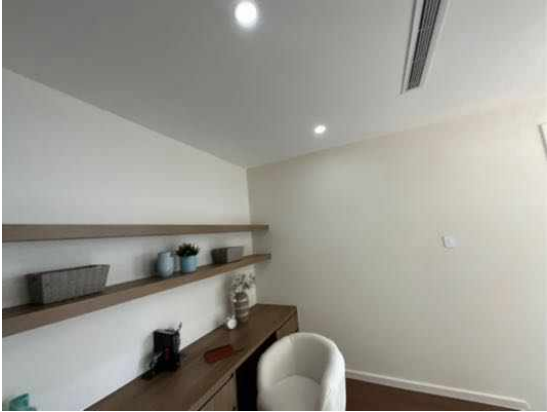
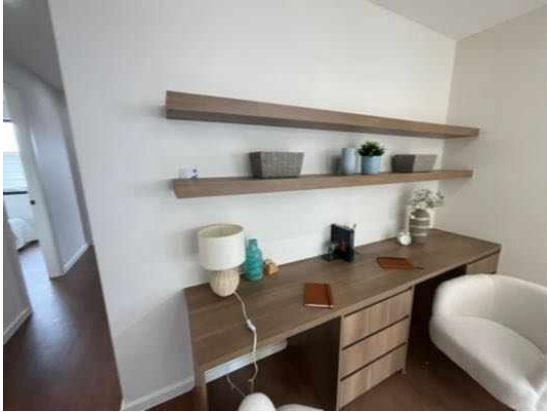
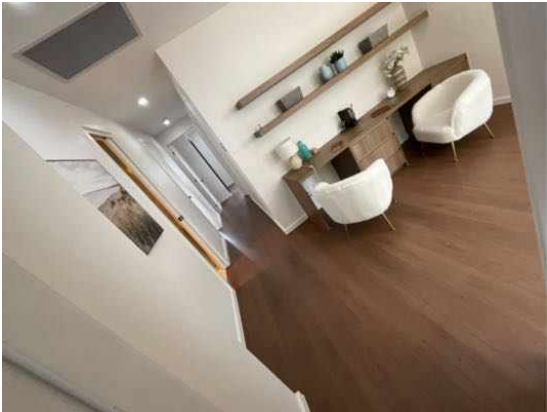
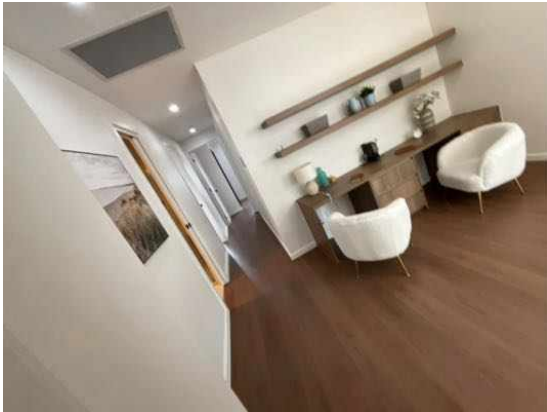
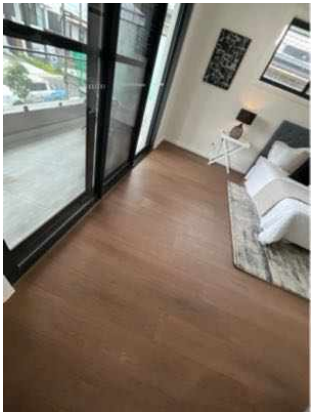
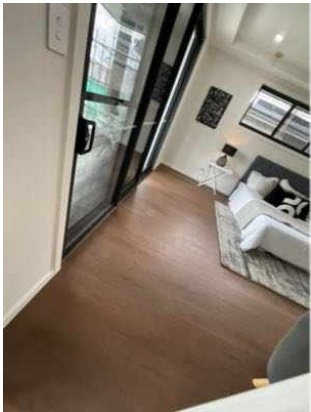
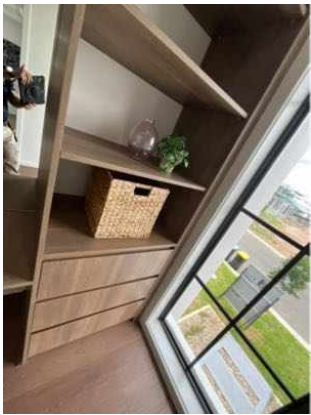
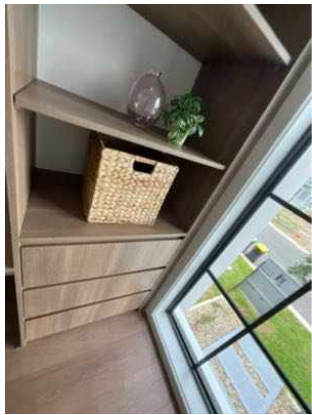
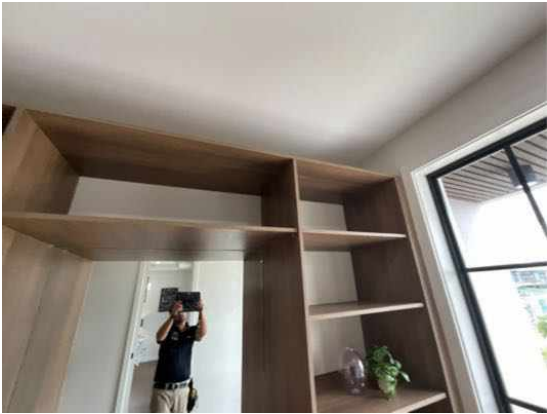
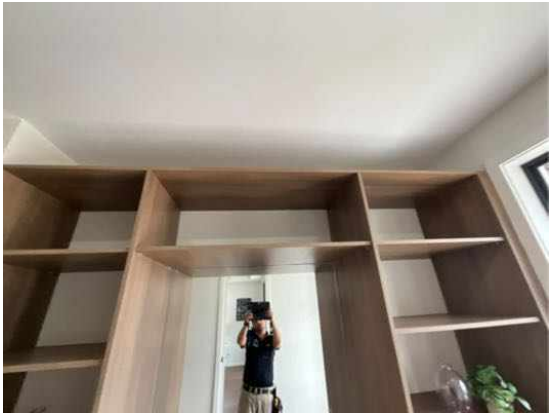
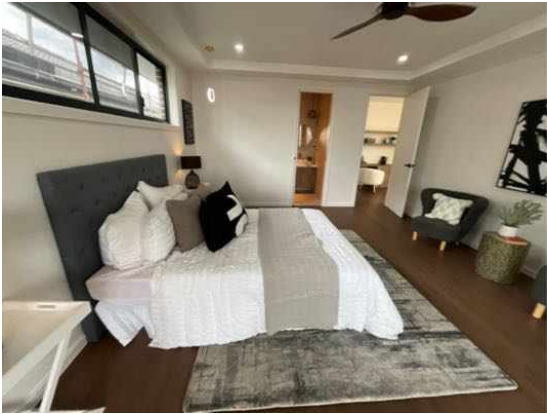
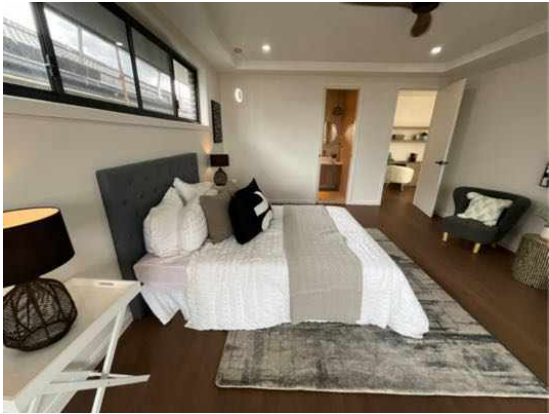
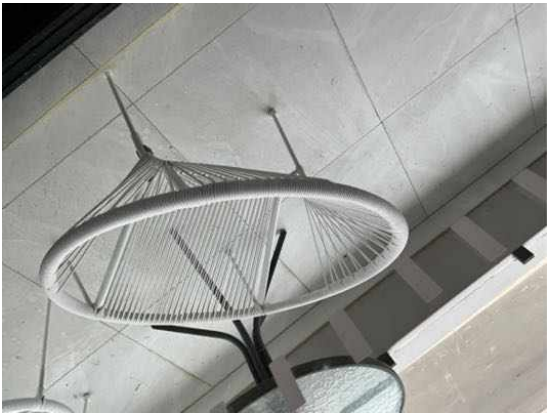
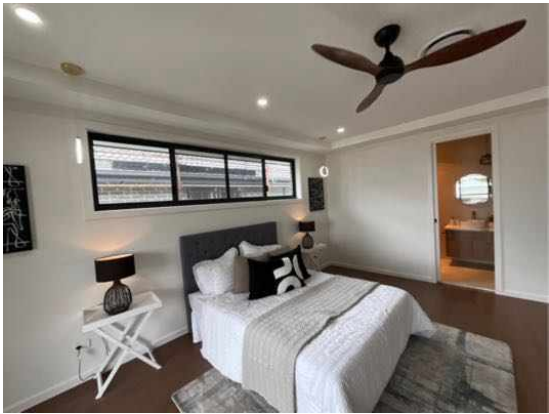
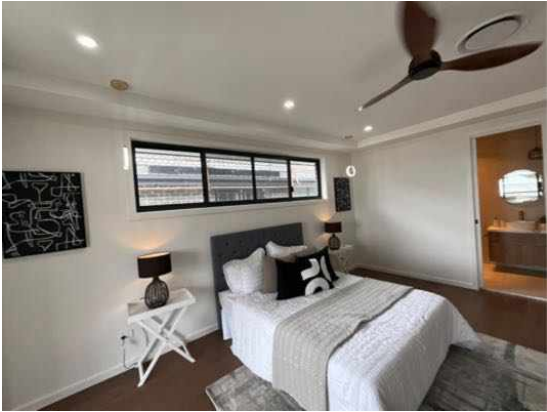
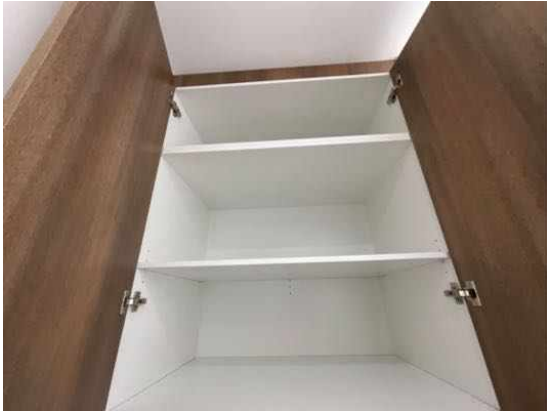
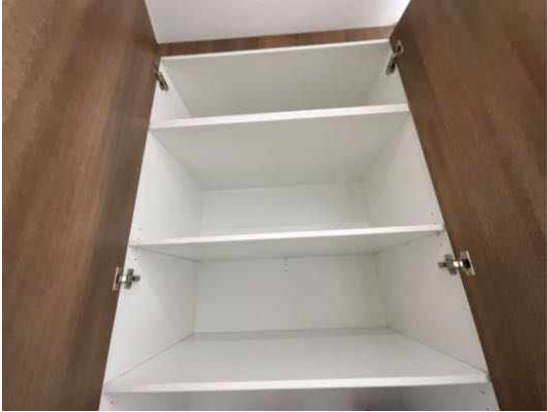
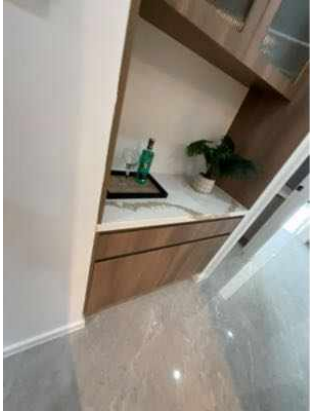
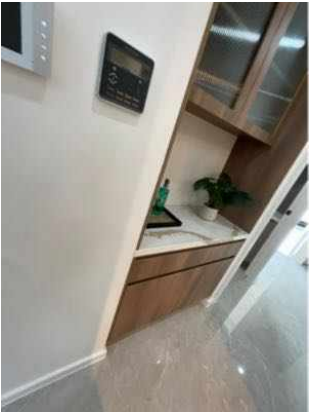
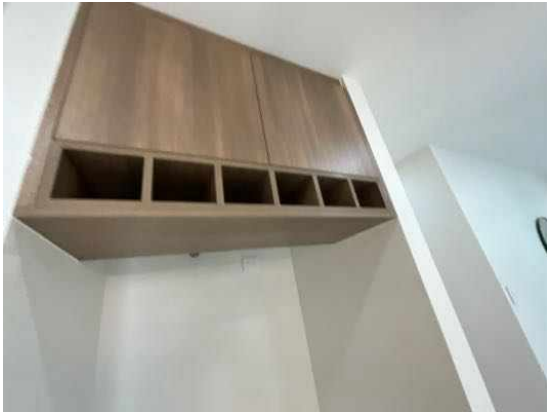
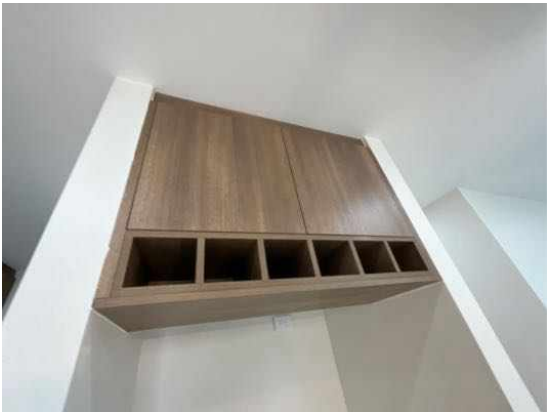
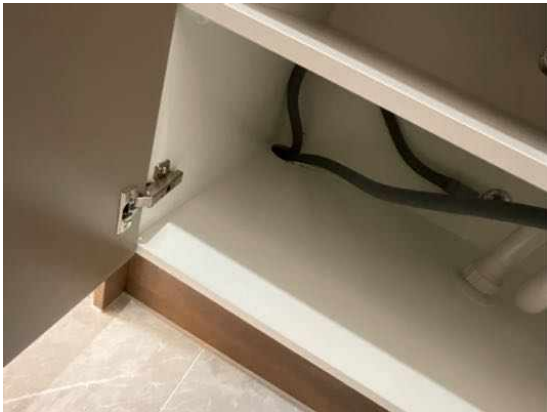
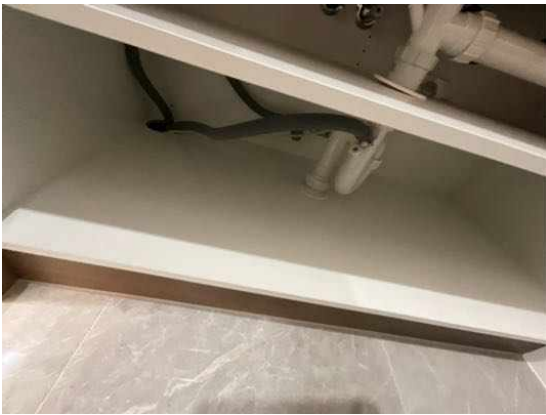
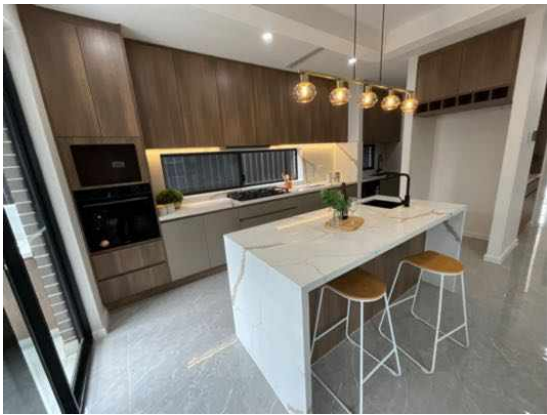
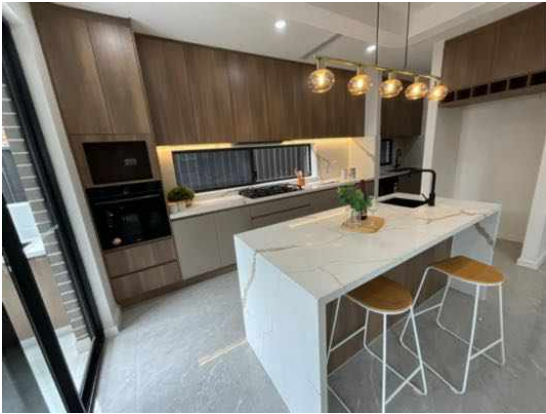
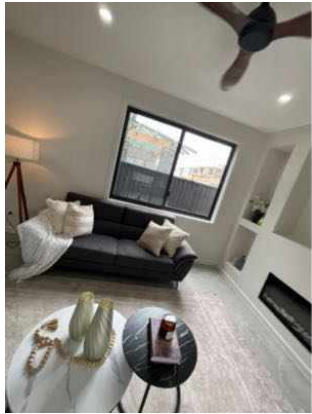
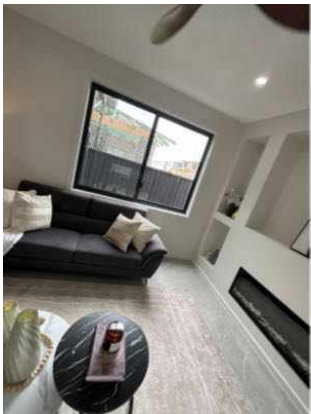
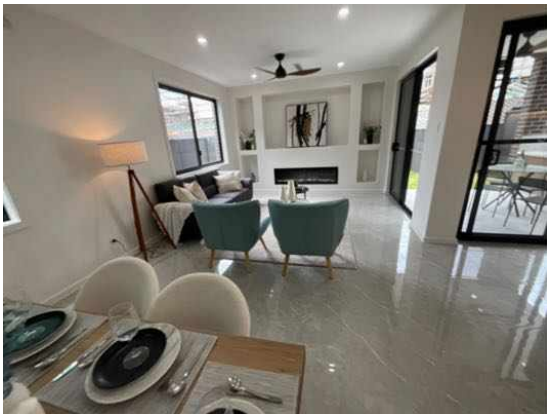
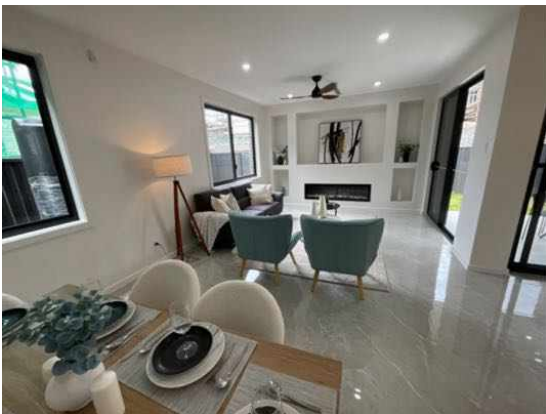
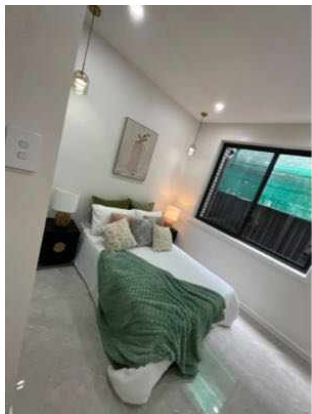
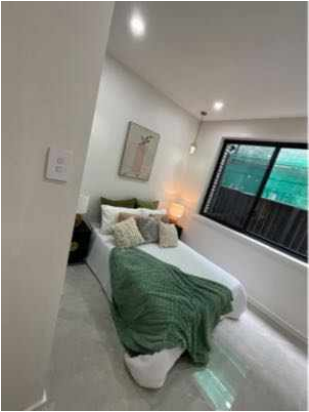
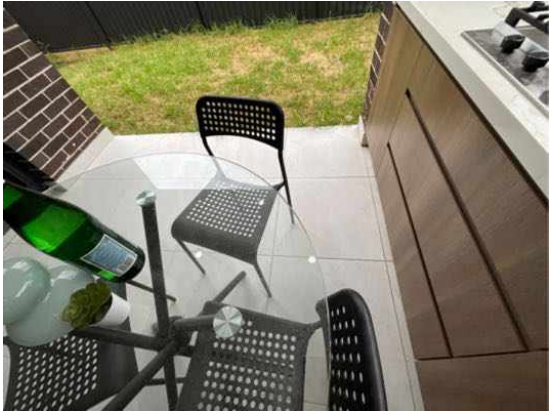
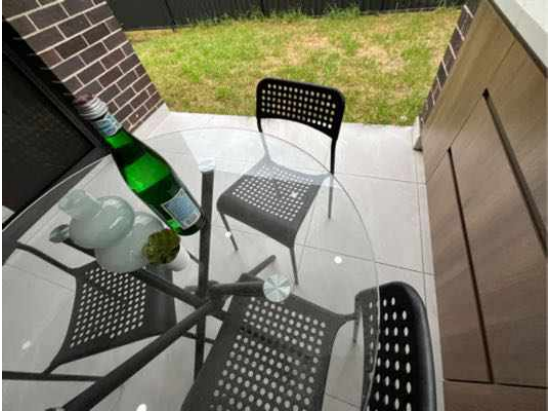
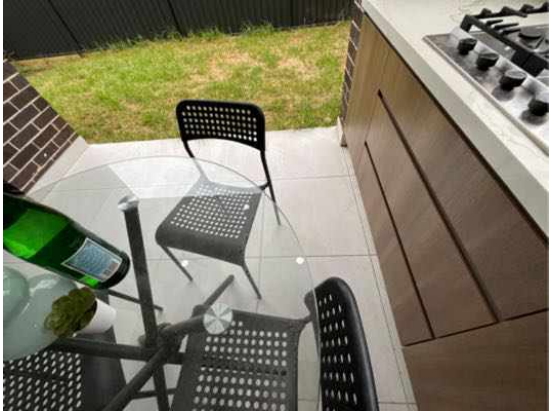
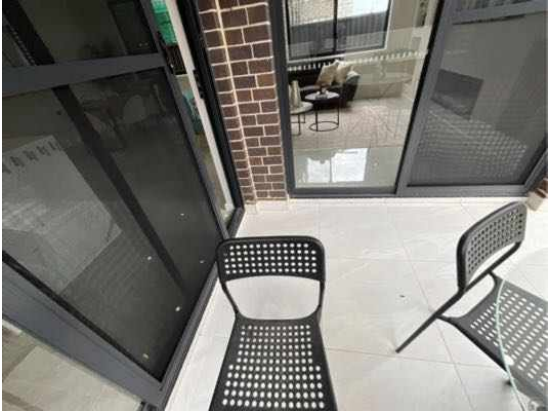
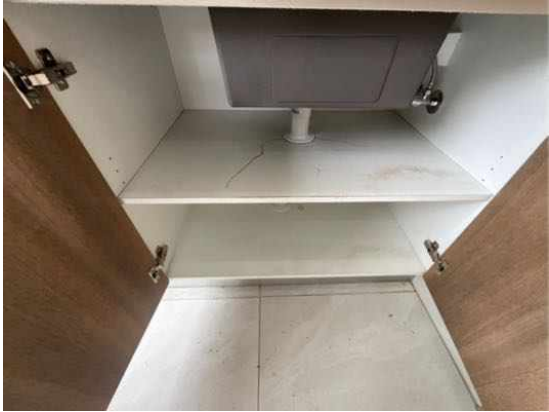
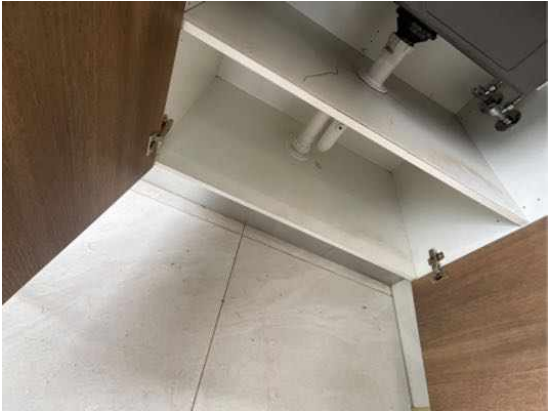
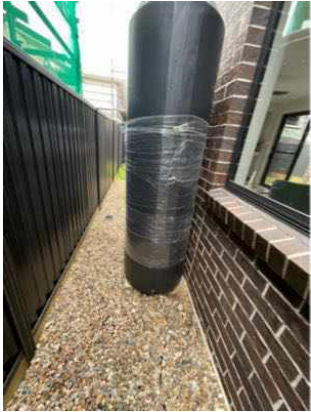
Defects 3.15

Building: Main Building  
Location: All Areas  
Finding: Additional Photos - Obstructions and Limitations  
Information: These photographs are an indication of the obstructions and limitations which impeded full inspection of the property at the time of inspection. These obstructions can hide an array of defects and should be removed to allow full inspection to be carried out. A re-inspection is recommended once the areas are made accessible.
