Building Inspection Report

Inspection Date: Fri, 30 Jan 2026

Property Address: 4 Hatcher Pl, Eumemmerring VIC 3177,
Australia

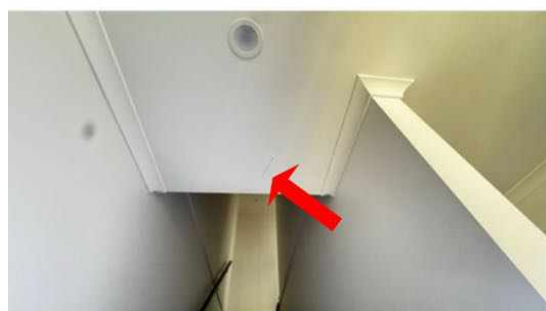
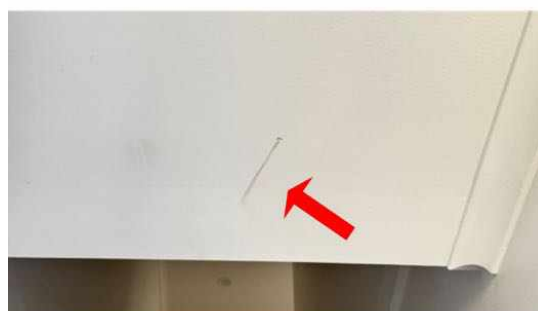
Defects 3.01

Building: Main Building
 Location: Entry > Ground Level
 Finding: Ceilings - Paint Finishes Discolouration
 Information: The ceilings were inspected for paint condition, and discolouration and uneven finishes were observed in this area. While primarily a cosmetic issue, the affected paint may indicate age-related wear, poor surface preparation, or previous repairs.

This may be due to age-related degradation of paint layers, poor application or surface preparation, or previous patching with incompatible paint.

When practical, a qualified painter should be engaged to prepare and repaint the affected areas. Addressing paint deterioration will improve the appearance of the ceilings and help protect the surfaces from further wear.

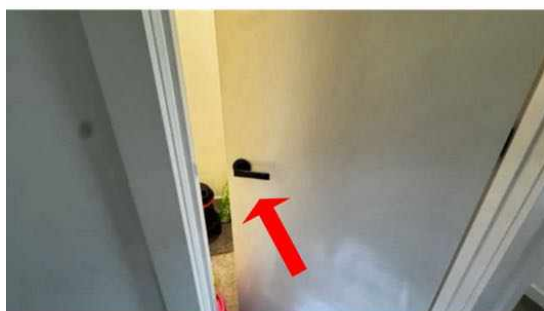
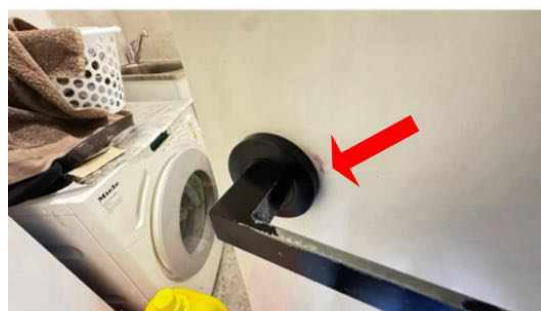
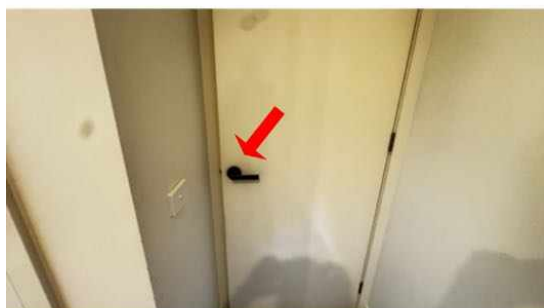
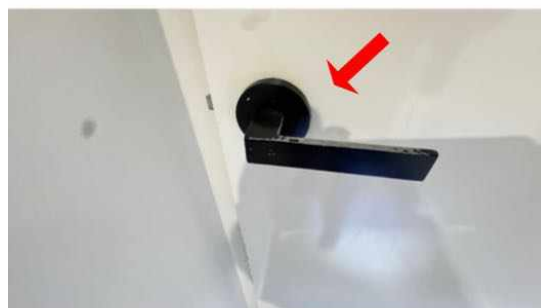
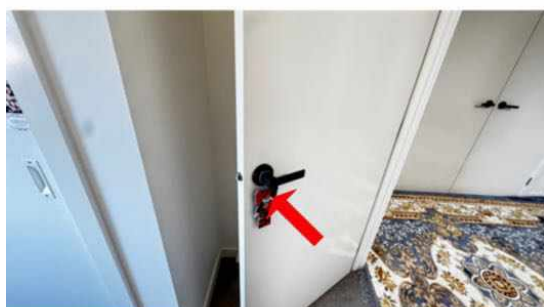
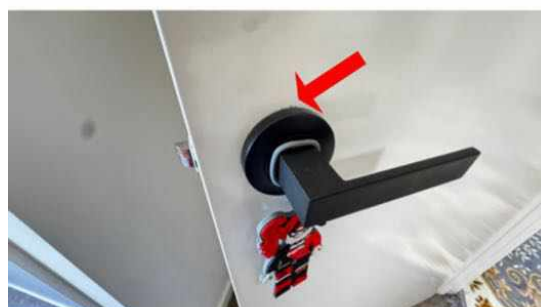
Defects 3.02

Building: Main Building
 Location: Toilet (WC), Bedroom 1 & Bedroom.2 > Ground Level
 Finding: Doors - Loose Door Handles
 Information: The inspection identified loose door handles in this area. Loose door hardware can

The issue appears to be caused by wear and tear, corrosion, improper installation, or impact damage.

A qualified carpenter or door specialist should be engaged immediately to repair, replace, or adjust the loose handles. Prompt rectification will ensure doors operate smoothly and maintain functionality.

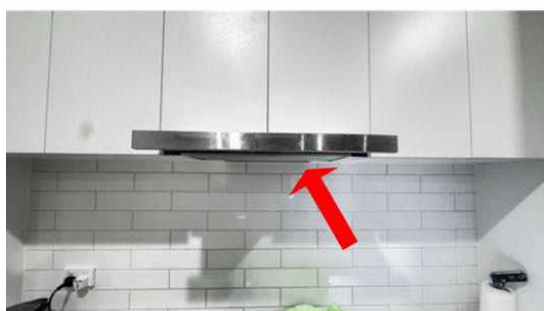
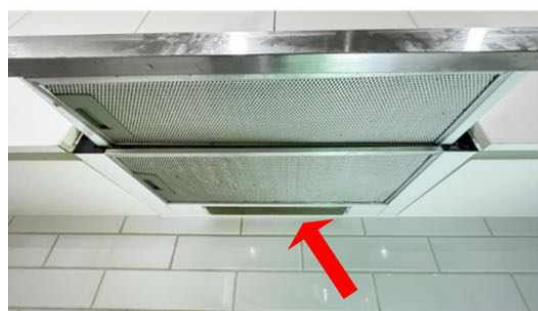
Defects 3.03

Location: Kitchen > Ground Level
Finding: Kitchen Ventilation - Light Not Operational
Information: During the inspection, the kitchen ventilation light was observed not to be operational. A non-functioning light may reduce visibility during food preparation and can indicate an electrical fault within the fitting, wiring, or switch.

The issue may be due to a failed globe, faulty light fitting, wiring defect, or switch malfunction.

It is recommended that a licensed electrician be engaged immediately to inspect the ventilation unit, identify the cause of the fault, and carry out necessary repairs to restore safe and proper operation.

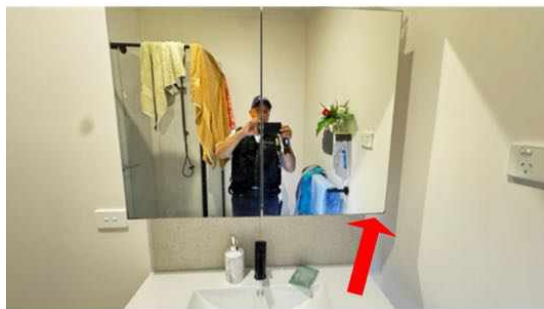
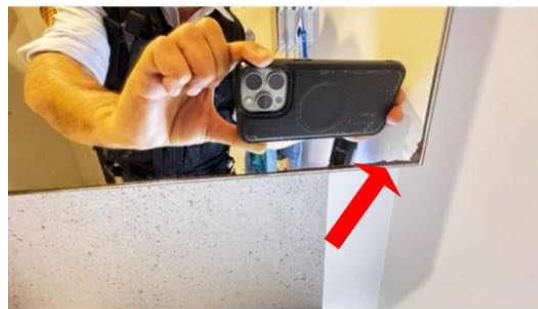
Defects 3.04

Building: Main Building
Location: Toilet (WC) > Ground Level
Finding: Bathroom Mirrors - Edge Deterioration
Information: Mirrors were observed to have edge deterioration in this area. Damaged mirrors can be a safety hazard due to sharp edges, reduce visual appeal, and affect functional use.

This may be due to age-related wear, poor installation, or exposure to moisture causing edge damage.

A qualified glazier or bathroom specialist should be engaged without delay to inspect and repair or replace the damaged mirrors. This may include replacing affected mirrors, securing the mounting, and ensuring edges are properly sealed. Prompt action will help prevent injury, restore functionality, and maintain appearance.

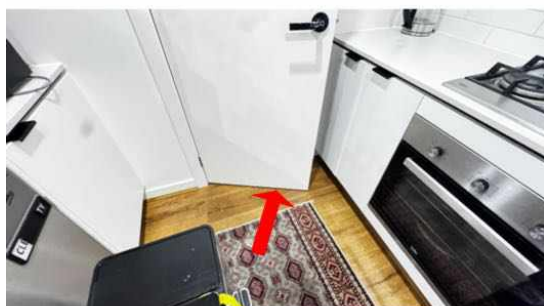
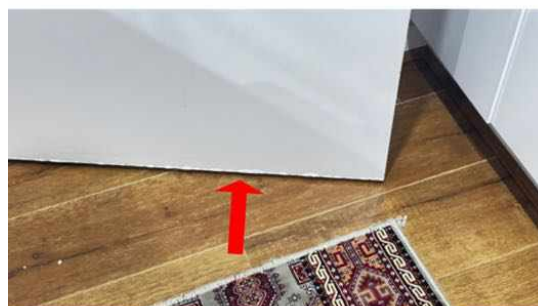
Defects 3.05

Building: Main Building
 Location: Kitchen > Ground Level
 Finding: Doors - Damaged Doors
 Information: The inspection identified doors with visible damage, including cracks, dents and splits. The damaged doors may affect operation, convenience, security, weatherproofing, and appearance.

The damage appears to be caused by age-related wear, poor maintenance such as inadequate painting or sealing, and minor structural movement affecting door alignment.

When practical, a qualified carpenter or door specialist should be engaged to repair, replace, or refinish the damaged doors. Prompt rectification will ensure safe operation, maintain security, and protect weatherproofing.

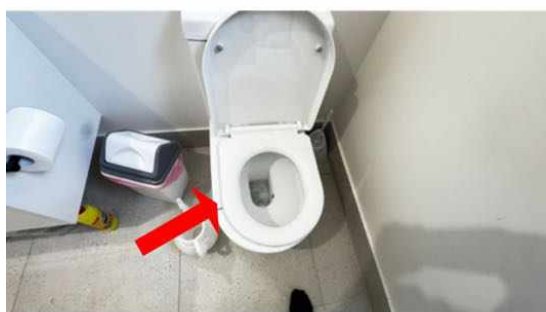
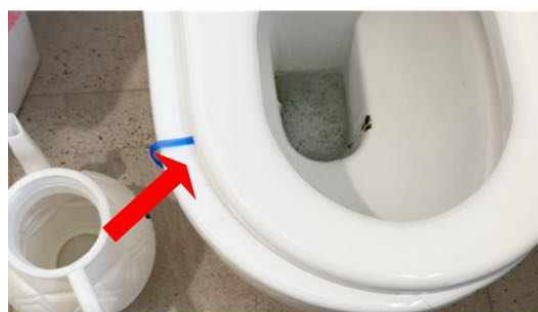
Defects 3.06

Building: Main Building
 Location: Bathroom > Level 1
 Finding: Bathroom Pan - Loose
 Information: Bathroom pans were observed to be loose. Loose pans can affect hygiene, cause

water leakage to floors or surrounding structures, and may pose a safety risk if unstable.

These conditions may be due to poor installation, age-related wear, or movement of flooring or plumbing connections over time.

When practical, a licensed plumber should be engaged to inspect and repair or secure the bathroom pans. This may include tightening fixings, repairing or replacing damaged components, and ensuring all pans are properly sealed and functional. Prompt action will help prevent water damage, maintain hygiene, and ensure safe use.

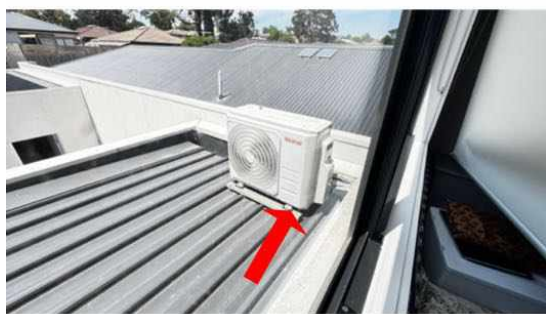
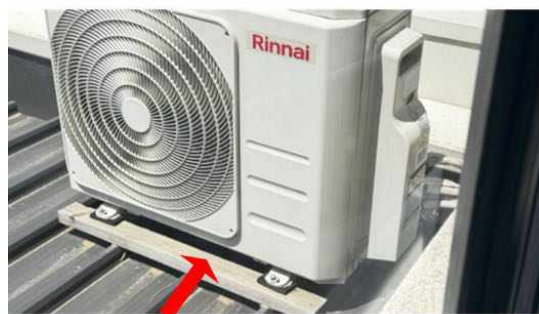
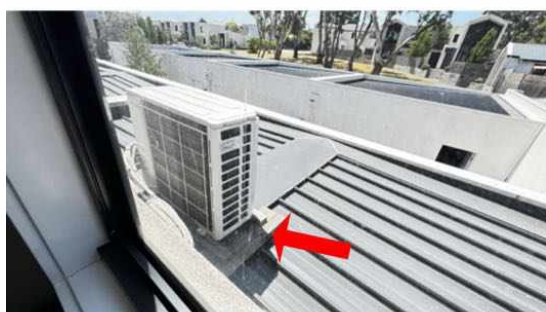
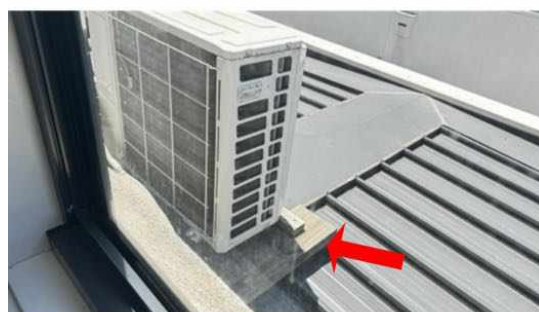
Defects 3.07

Building:	Main Building
Location:	Roof Exterior > Level 1
Finding:	AC Condensate Drain - Not Connected To Storm Water
Information:	The air conditioning condensate drain in this area was observed to be disconnected from stormwater drainage.

When condensate is not properly directed to a stormwater outlet, water can accumulate around the building or air conditioning unit, creating damp conditions that may lead to secondary defects such as timber rot, corrosion of nearby metal components, mould growth, or slippery surfaces. Prolonged pooling of water may also attract termites and contribute to long-term deterioration of surrounding building elements.

A qualified HVAC technician or licensed plumber should be engaged immediately to connect the condensate drain to a suitable stormwater outlet. Prompt rectification will ensure proper drainage, protect the building fabric, and reduce potential health and safety risks.

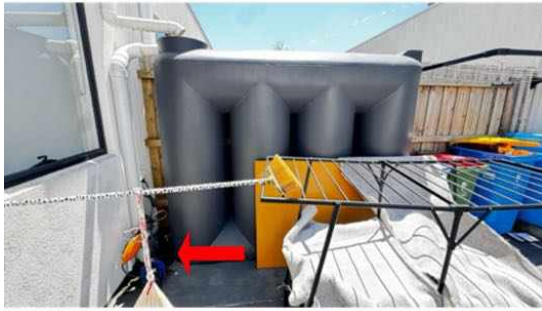
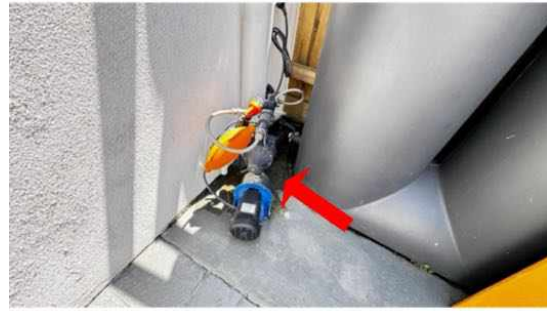
Defects 3.08

Building:	Main Building
Location:	All External Areas > Ground Level
Finding:	Rainwater Tank Pump - Fittings Leaking
Information:	The rainwater tank pump fittings are leaking and allowing water to escape from the connections. This is located at the pump and associated pipe fittings connected to the rainwater tank.

This has likely occurred due to loose, damaged, or poorly sealed fittings. Ongoing leakage may cause water pooling around the pump area and may affect the operation of the pump or surrounding surfaces.

A licensed plumber is required to repair or replace the leaking pump fittings. This should be rectified immediately to prevent further water loss and potential damage.

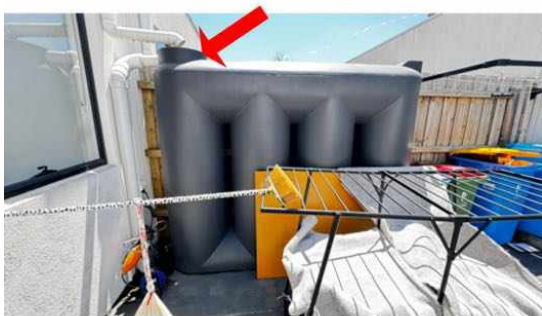
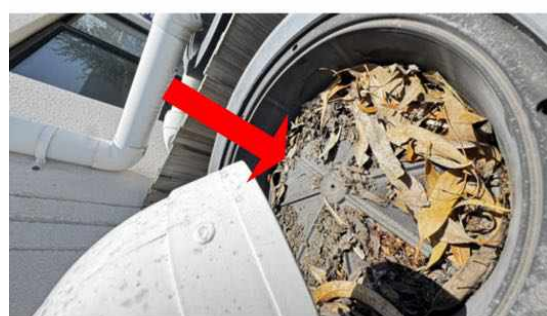
Defects 3.09

Building:	Main Building
Location:	All External Areas > Ground Level
Finding:	Rainwater Tank - Leaf Strainer Blocked
Information:	The leaf strainer on the rainwater tank is blocked with leaves and debris, restricting the flow of water into the tank. This is located at the inlet on top of the rainwater tank.

This has likely occurred due to a build-up of leaves and debris from the roof and gutters. A blocked leaf strainer may cause water to overflow, back up into gutters, or discharge uncontrolled around the tank and building.

A licensed plumber or competent hand man is required to clean and clear the leaf strainer. This should be attended to immediately to allow proper water flow and prevent overflow or damage.

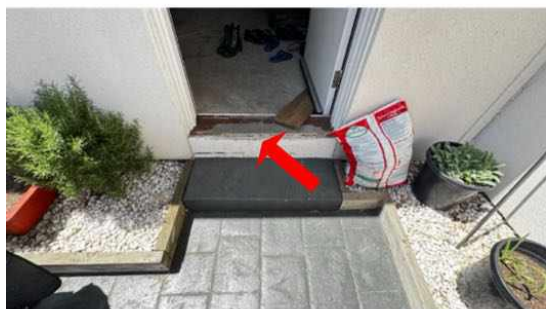
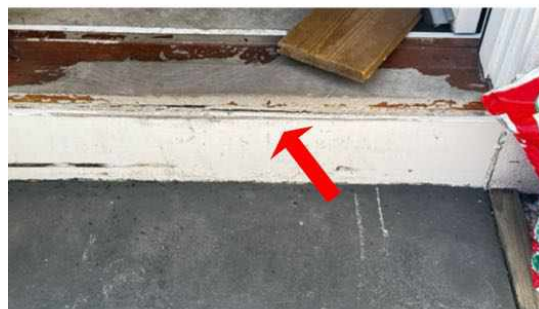
Defects 3.10

Building:	Main Building
Location:	Garage > Ground Level
Finding:	External Timber - Timber Rot
Information:	Timber elements including wall claddings, timber rails & posts, landscaping timbers, and other external timber surfaces were inspected and show signs of rot, decay and

fungal attack in these areas. Softening, discoloration, splitting, and moisture penetration indicate ongoing timber degradation.

This is likely caused by prolonged moisture exposure, inadequate protective coatings or maintenance, direct contact with soil or water, or poor detailing that traps water or limits ventilation.

If left unaddressed, the affected timber may lose structural integrity, leading to progressive decay, potential collapse of walls, decks, or landscaping features, mould growth, and reduced durability and appearance of the building exterior.

A registered builder or timber specialist should inspect the affected areas immediately to determine the extent of damage. Damaged timbers should be repaired or replaced, protective treatments applied, and drainage or detailing corrected to prevent recurrence. Ongoing monitoring and urgent remedial action are required to prevent further deterioration.

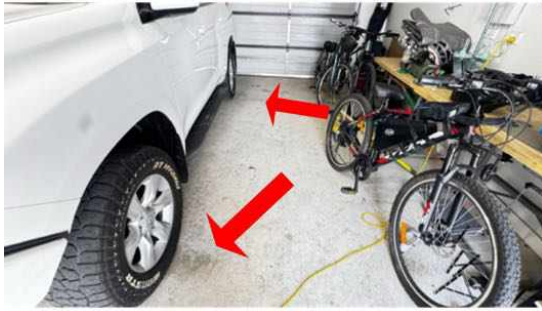
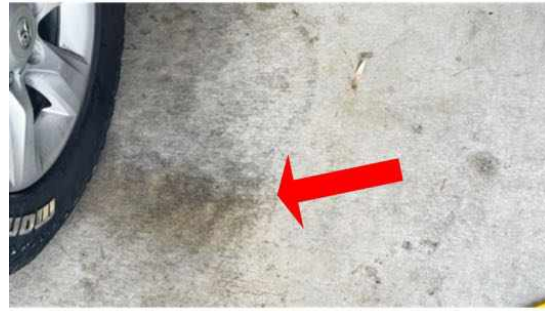
Defects 3.11

Building:	Main Building
Location:	Garage > Ground Level
Finding:	Garage - Oil Stains To Concrete Slab
Information:	The garage floor was observed to have oil stains in this area. While primarily a cosmetic issue, these stains can reduce slip resistance and may indicate leaks from vehicles or stored equipment.

The staining appears to be caused by spillage or leakage from vehicles, machinery, or general maintenance activities.

When practical, a qualified cleaning or maintenance professional should be engaged to remove the oil stains using appropriate methods. Regular cleaning and monitoring will help maintain the appearance of the floor, reduce slip hazards, and minimise potential long-term damage to the concrete surface.

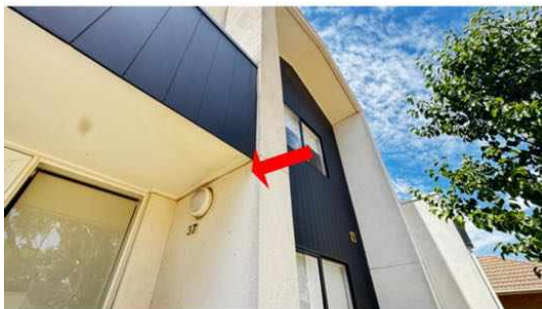
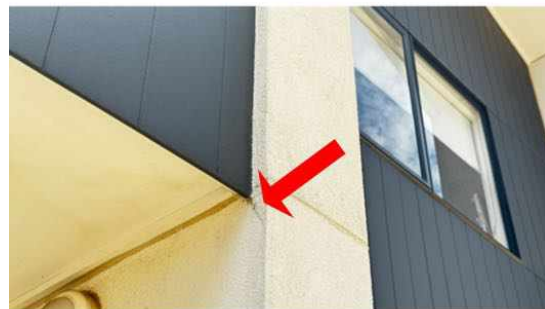
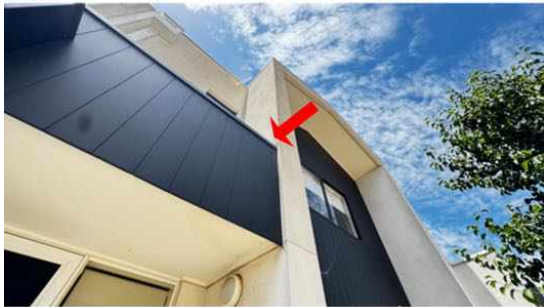
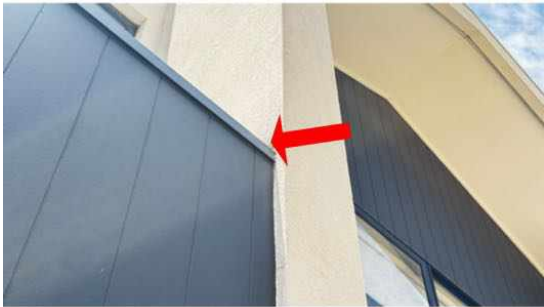
Defects 3.12

Building: Main Building
 Location: All External Areas > Front
 Finding: External Walls - Minor Cracking To Wall Claddings
 Information: Minor cracking was observed to the external walls in this area. At the time of inspection, the cracking appeared superficial and did not indicate significant structural movement; however, such cracking can allow moisture ingress if left unaddressed.

The cracking is likely due to building movement or minor settlement.

When practical, a registered builder should assess and repair the cracking, which may include sealing and repainting. The area should be monitored, and any increase in cracking or signs of movement should be further investigated immediately by a Structural Engineer.

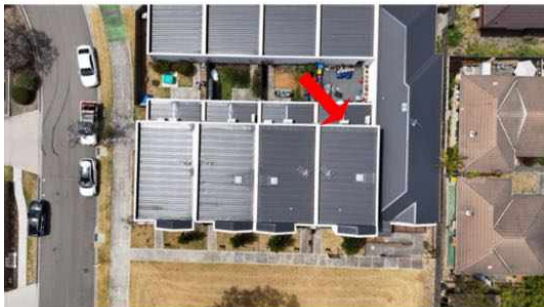
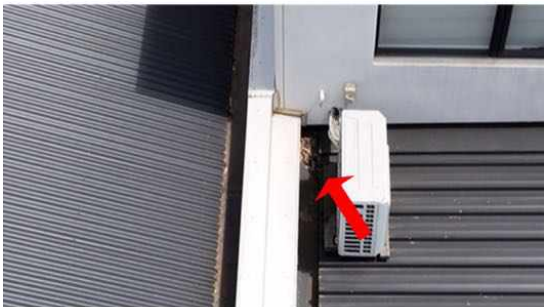
Defects 3.13

Building: Main Building
Location: Roof Exterior > Level 1
Finding: Roof Plumbing - Gutters Blocked
Information: Gutters in this area are blocked and not allowing water to flow freely. The issue is observed along the gutter runs where leaves, debris, or other obstructions have accumulated.

This has likely occurred due to lack of maintenance or build-up of debris over time. Blocked gutters may cause water to overflow, damage the roof, walls, or foundations, and increase the risk of erosion or water ingress.

A licensed roof plumber or competent handy man is required to inspect and clear the blocked gutters in this area. This should be rectified immediately to ensure water drains correctly and to prevent potential damage to the building.

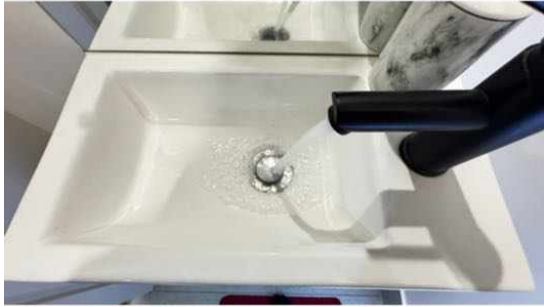
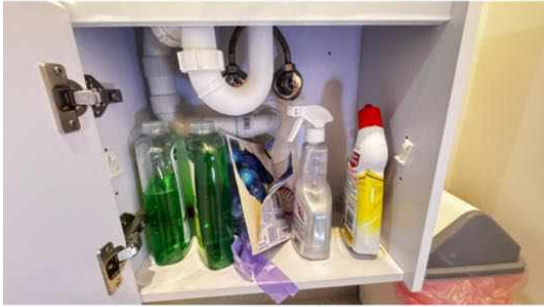
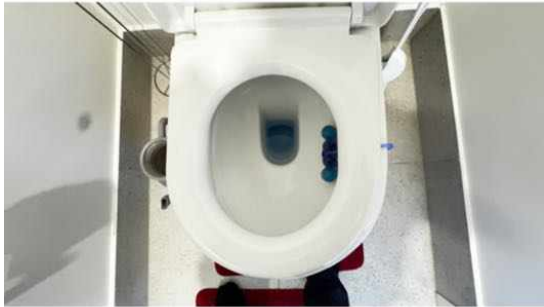
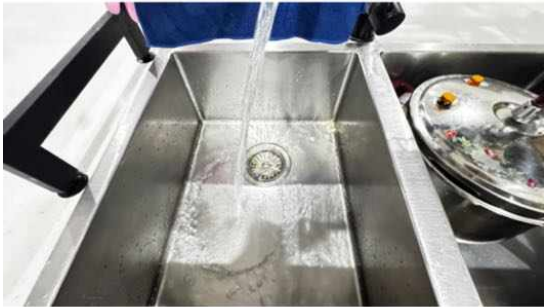
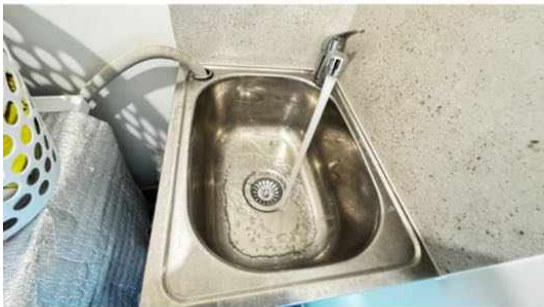
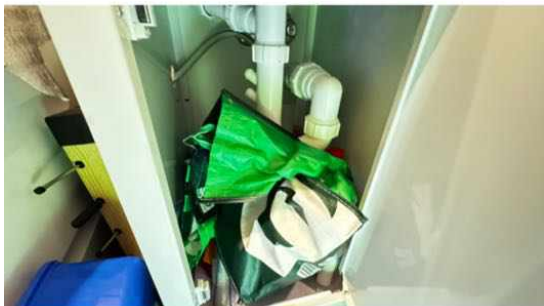
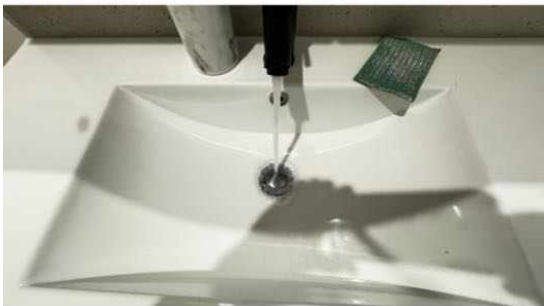
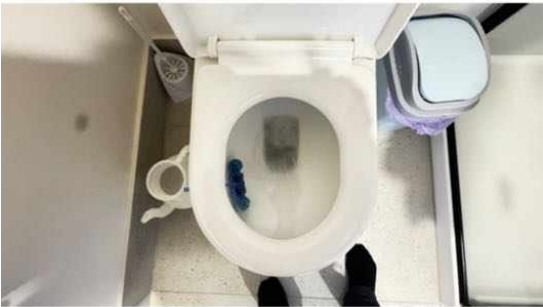
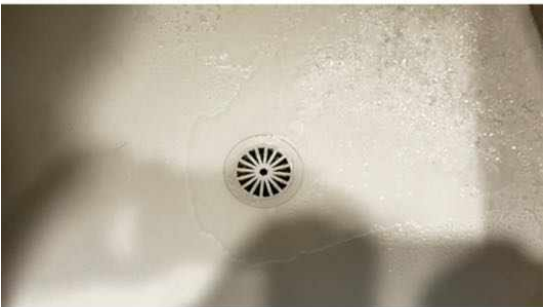
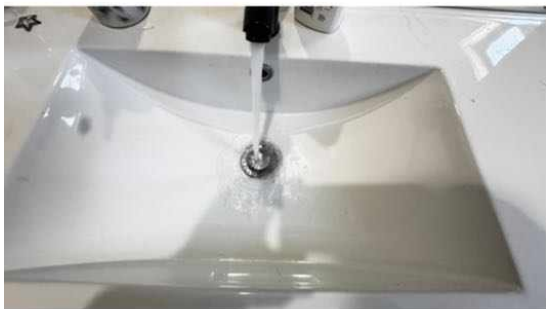
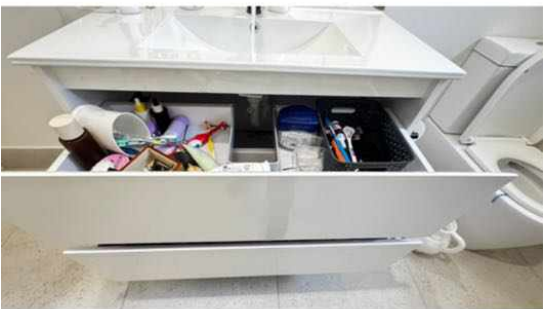
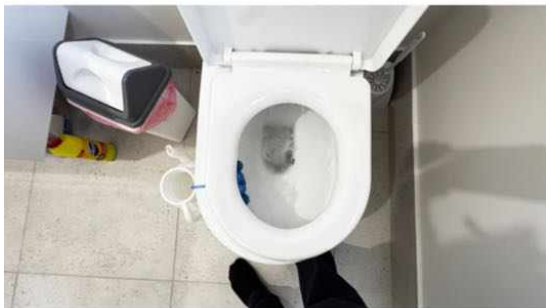
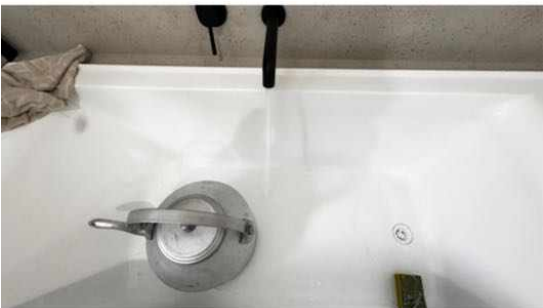
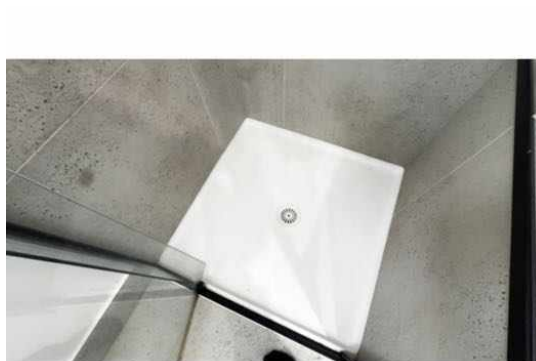
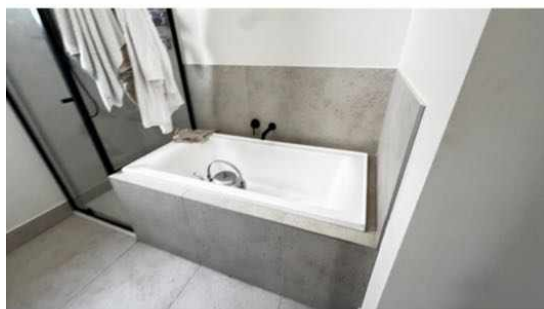
Building: Main Building
 Location: All Internal Areas
 Finding: Water Supply & Drainage - Shower, Basins, Toilets, & Plumbing Fixtures
 Information: The shower recess was tested, and no visible water penetration to surrounding areas was observed at the time of inspection, except where noted as a separate defect elsewhere in this report. Water appeared to flow freely toward the floor waste. Moisture detected to the shower walls is documented separately in the report. The shower floor waste appeared clear during inspection.

Flushing the toilet revealed no visible leaks, and the fixture appeared to operate normally unless otherwise noted as a separate defect. No water damage was observed to the vanity unit unless specifically stated elsewhere in the report. Basins, bathtubs, laundry tubs, vanities, and sinks were tested and inspected with no evidence of leaks, blockages, or drainage issues at the time of inspection unless otherwise noted. All internal taps and shower heads were tested with no leaks observed, unless documented as a separate defect.

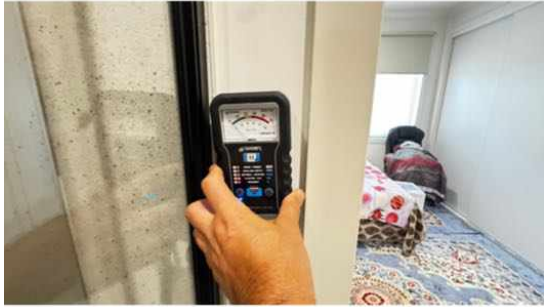
Building: Main Building
 Location: All Areas Interior & Exterior
 Finding: Moisture Levels - Advisory - No Elevated Moisture Levels Present
 Information: At the time of inspection, no elevated moisture levels were detected in these areas. Moisture readings were taken (using a Tramex Moisture Meter) and non-invasive testing methods and reflect conditions present at the time of inspection only. This item is noted for advisory purposes and should not be relied upon as a guarantee that moisture issues are not present elsewhere or may not occur in the future.

Ongoing monitoring of the property is recommended, and further investigation by a qualified tradesperson should be considered if signs of water ingress, dampness, staining, mould growth, or material deterioration become apparent.

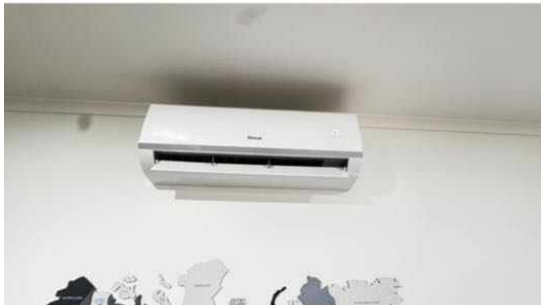
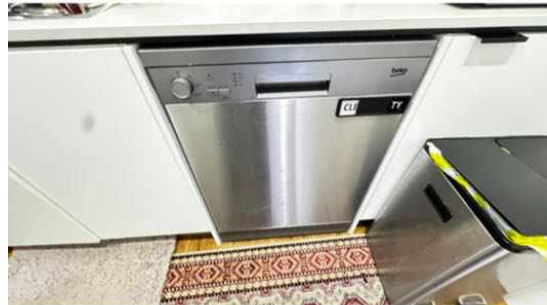
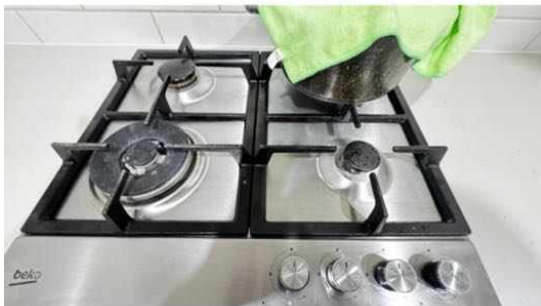
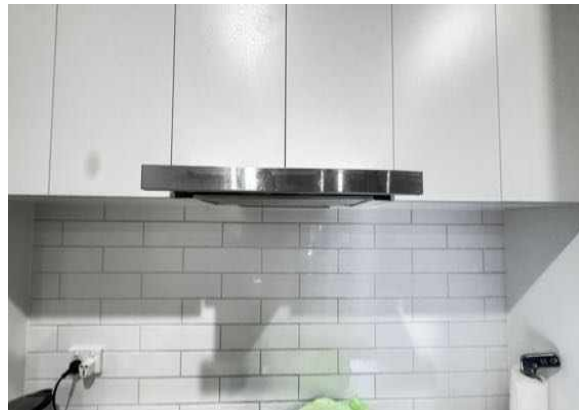
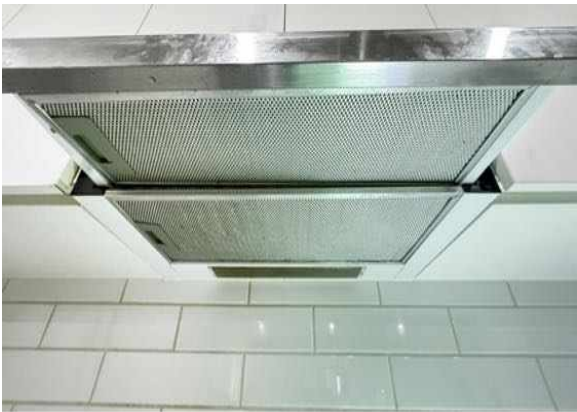
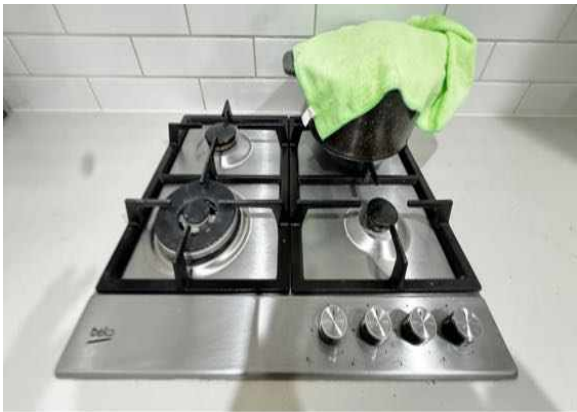
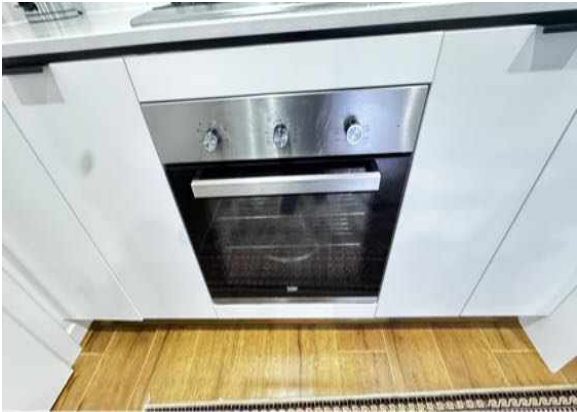
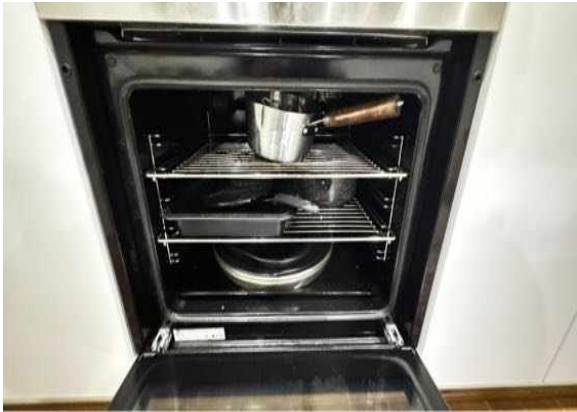
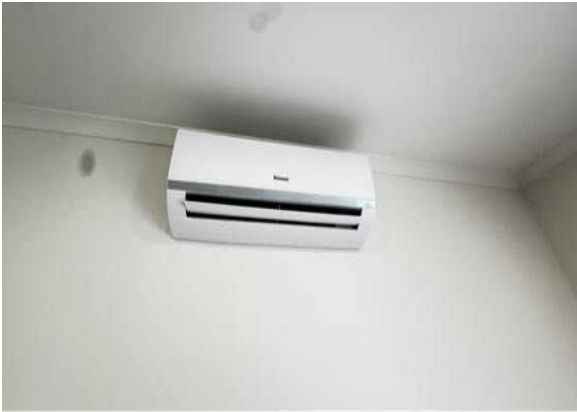
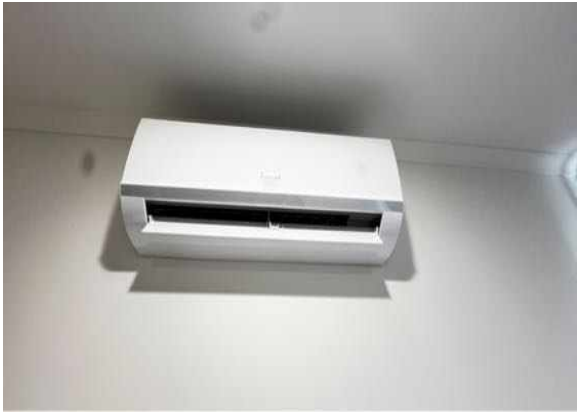
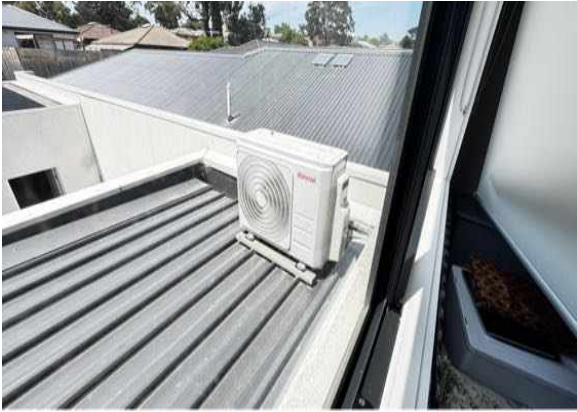
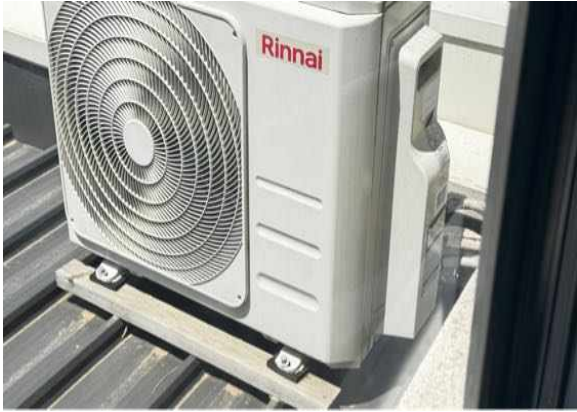
Building: Main Building
 Location: All Areas, Interior & Exterior
 Finding: Appliances, Heating & Cooling Systems, Mechanical Systems, Plumbing, Electrical, Fireplaces - Advisory
 Information: The inspection did not include testing, operation, safety, or assessment of any installed or portable appliances or mechanical systems. This includes, but is not limited to, ovens, cooktops, microwaves, rangehoods, dishwashers, ducted vacuum systems, air-conditioning units, heating systems, hot water services, ceiling fans, exhaust fans, intercoms, security systems, fireplaces, and solid fuel heaters.

Appliances may be worn, damaged, or malfunctioning. Electrical or gas appliances can pose serious safety hazards if incorrectly installed or maintained.

Service, repair, or replace equipment as necessary, particularly where service history or warranty coverage is unknown.

Inspect any water, gas, or electrical connections associated with appliances to ensure safety and compliance.

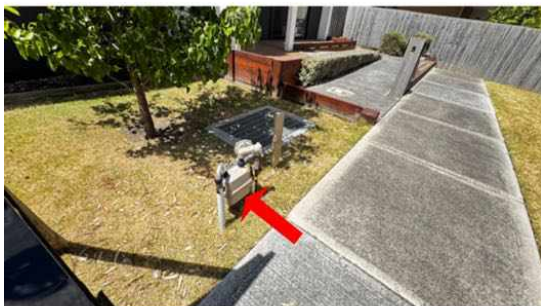
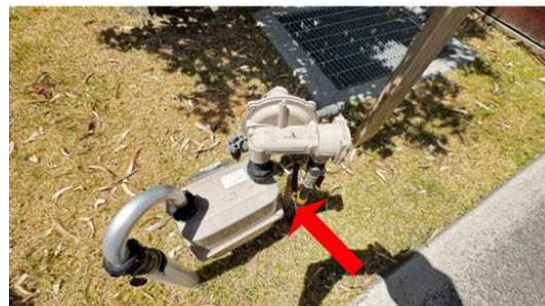
Building:	Main Building
Location:	All External Areas
Finding:	Gas Meter - Location For Your Information
Information:	The gas meter was inspected and photographed for reference and location purposes only.

Gas meters can be affected over time by age, environmental exposure, or accidental impact, which may lead to corrosion, physical damage, leakage, or non-compliance with current regulations. Regular checks are recommended to ensure ongoing safe operation.

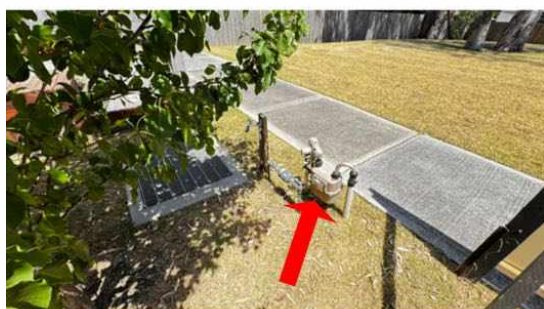
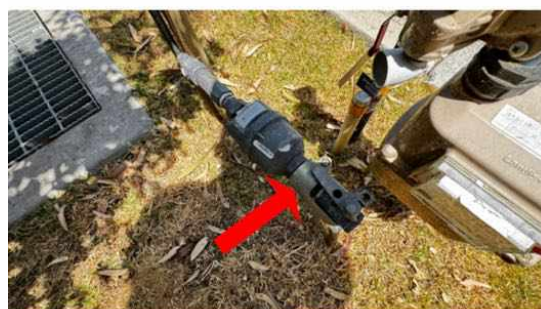
Building: Main Building
 Location: All External Areas
 Finding: Water Meter - Location For Your Information Only
 Information: The water meter was photographed at the time of the inspection. The meter is included for reference & location purposes only.

Water meters can be affected over time by age, environmental exposure, accidental impact, or poor maintenance. Potential issues could include leaks, corrosion, or malfunction that may impact water supply or cause water damage.

It is recommended that a licensed plumber carry out routine inspections and maintenance to ensure continued safe and compliant operation. Observations are for informational purposes only and do not form part of a full safety or compliance inspection.

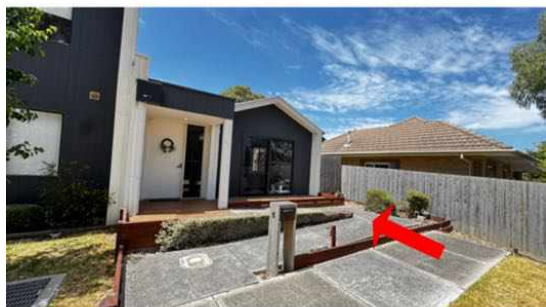
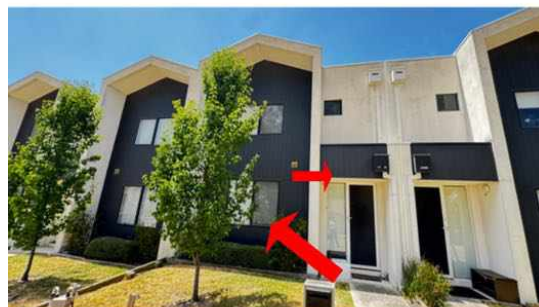
Building:
 Location:
 Finding: Neighbouring Properties - For Your Information
 Information: Neighbouring properties were visually inspected from publicly accessible areas. No detailed structural, noise, or compliance testing was performed as part of this inspection.

Recommendation: For concerns regarding noise, encroachments, or structural issues affecting neighbouring properties, it is recommended to engage relevant specialists (e.g., acoustic consultant, building surveyor, or a registered builder) and/or contact the local council.

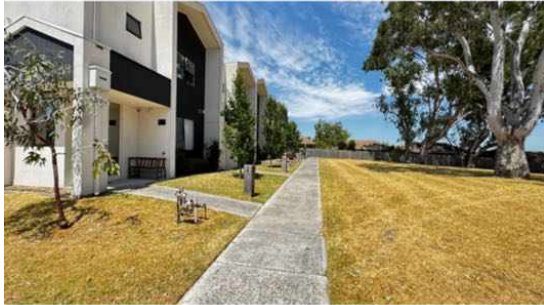
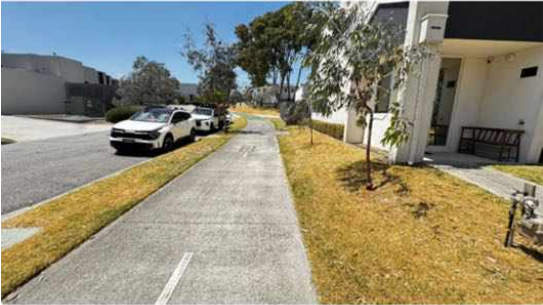
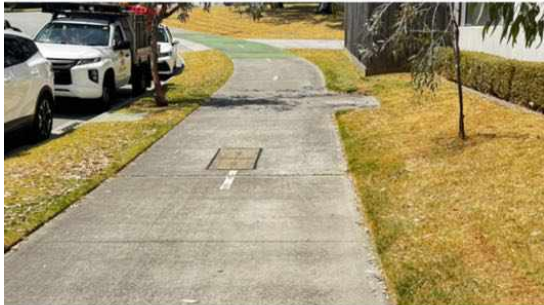
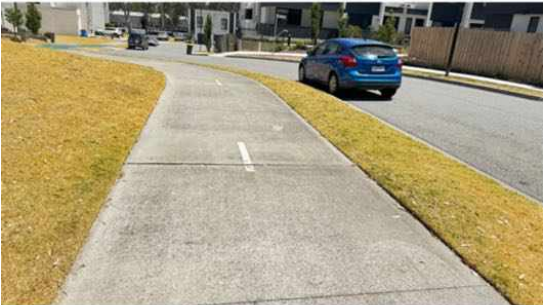
During the inspection, minor cracking, surface wear, or uneven sections were observed on footpaths or crossovers. Some accessible metal components, such as street signage or grates, showed signs of rust or deterioration. Debris accumulation and vegetation encroachment were also noted around council infrastructure. Access or visibility was limited to certain council-owned assets.

These areas should be monitored, and for detailed assessment, maintenance, or compliance verification, the relevant local council authority should be contacted immediately. Regular monitoring of adjacent council assets is recommended to ensure ongoing safety and proper maintenance.

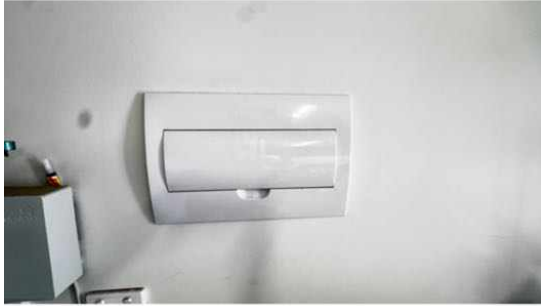
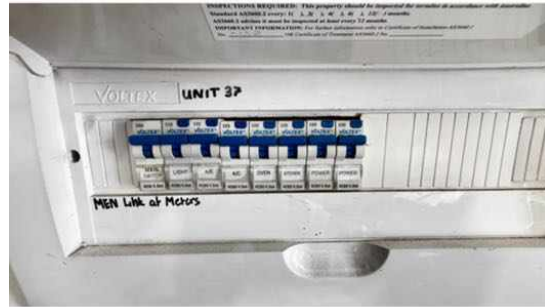
Building: Main Building
 Location:
 Finding: Timber Pests - Durable Notice Not Identified
 Information: During the inspection, no durable notice relating to a termite management system was observed on the property. A durable notice is required to identify the type of termite management system installed, the date of installation, and any ongoing maintenance or inspection requirements. The absence of this notice makes it difficult to confirm the presence, effectiveness, or maintenance status of any termite protection measures.

Without a durable notice, there is an increased risk that termite management systems may not be adequately maintained or may have expired, particularly in the case of chemical barriers that require periodic replenishment. This uncertainty increases the likelihood of undetected termite activity and potential damage to timber elements within the building.

The lack of a durable notice may be due to removal during renovations, age of the property, or the absence of a compliant termite management system at the time of construction. Regardless of the cause, this represents a gap in termite risk management and ongoing building protection.

It is recommended that a licensed pest management technician be engaged immediately to assess whether a termite management system is present and

functioning. Where a system exists, the technician should confirm its type, condition, and maintenance requirements and install a compliant durable notice in accordance with current standards.

If no termite management system is identified, it is strongly recommended that an appropriate termite protection system be installed and documented. Regular inspections and maintenance should then be undertaken to reduce the risk of future termite infestation and associated structural damage.
