Building and Timber Pest Inspection Report

Inspection Date: Fri, 6 Mar 2026

Property Address: 1A Harpur Cres, South Windsor NSW 2756,
Australia

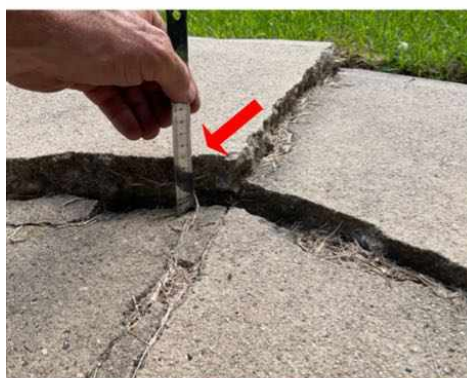
Building:	Building 1
Location:	Yard - front
Finding:	Crack in concrete slab - Category 4
Information:	Cracks of up to 48mm coded as Category 4 was identified in the slab. A Category 4 crack is described as a crack that appears as a gap in the slab, with disturbing curvature or change in level affecting the slab.

Category 4 cracking to slabs exceeds allowable Standards and Tolerances, and this is considered safety defects from trips and falls requiring urgent rectification.

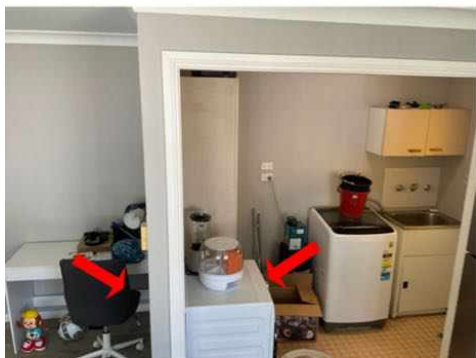
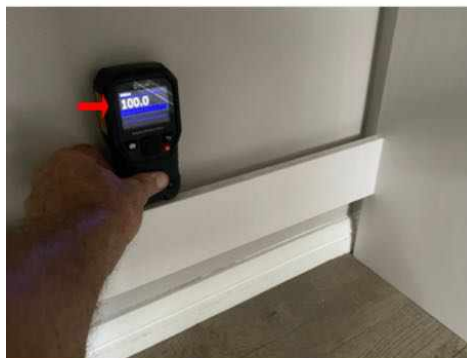
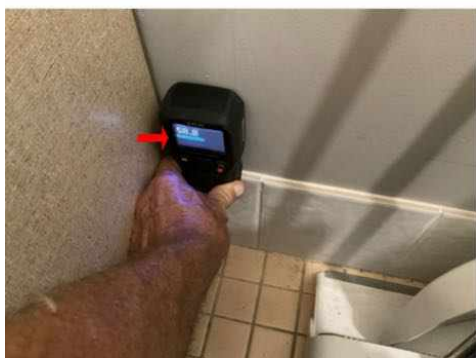
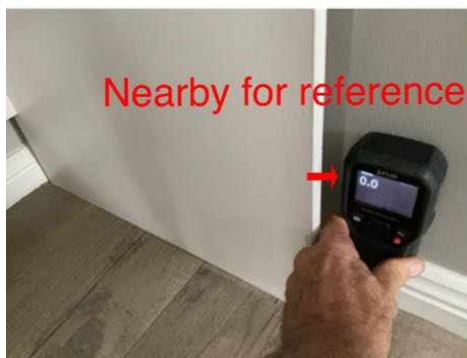
Building:	Building 1
Location:	Bathroom south east wall adjoining lounge/laundry
Finding:	Evidence of excessive moisture in the shower wall
Information:	Excessive moisture with a maximum reading of 100 was found in the shower/loungeroom wall after running the shower. A high reading was also found in the laundry/bathroom wall. This moisture can attract termites and produce conditions that promote termite attack, fungal growth and wood decay.

This defect is listed in this report as a minor defect. If it is found by an invasive inspection that this moisture has lead to severe wood rot to the wall framing, then this would then be described as a major defect in this report.

It is highly recommended that all sealant and waterproofing membranes be maintained

regularly in order to prevent excessive moisture being present in the internal property.

An invasive inspection is required to determine the reason for the moisture ingress in the wall, then quotes for repairs should be sought. This could be a failed waterproofing membrane or a leaking plumbing pipe.

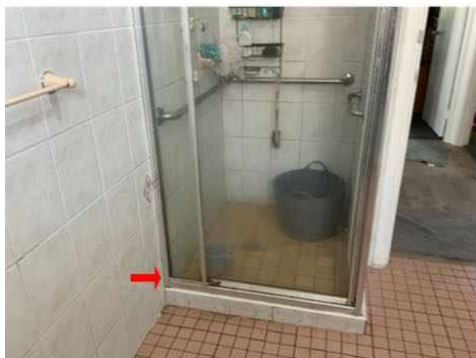
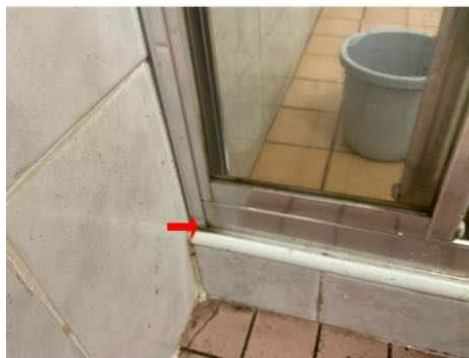
Finding 3.02

Building:	Building 1
Location:	Bathroom
Finding:	Shower screen - Leaking
Information:	Leaking was evident to the shower screening at the time of inspection. It is suspected that the leaking has occurred as a result missing sealant. Leaking from the shower , where left unattended, is likely to lead to water damage to adjoining flooring and walls. Such damage can lead to water damage and necessitate extensive remedial works being required. Active water leaks may also create an environment that is susceptible to the formation and development of mould.

Appointment of a sealant expert is required to repair or replace this missing sealant.

Such works should be performed as soon as possible to ensure that no further damage occurs.

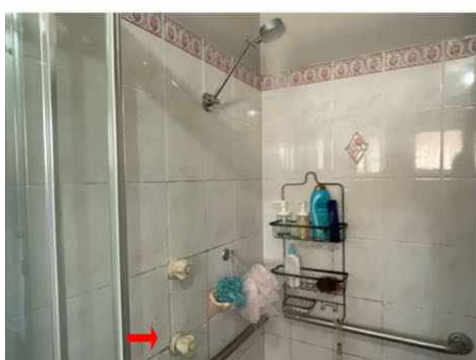
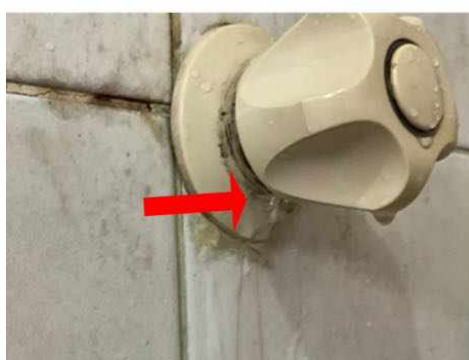
Finding 3.03

Building:	Building 1
Location:	Bathroom
Finding:	Tap - Leaking
Information:	The tap and handle was found to be leaking at the time of inspection. This is a common defect that is consistent with general ageing of the building element. However, it may be indicative of substandard plumbing workmanship.

While this defect only seems minor, if left unmanaged, it is likely to result in further defects.

It is advised that a licensed plumber be appointed to perform remedial works on the affected tap. Such works should be performed prior to the development of secondary defects to ensure adequate functionality of all associated building elements.

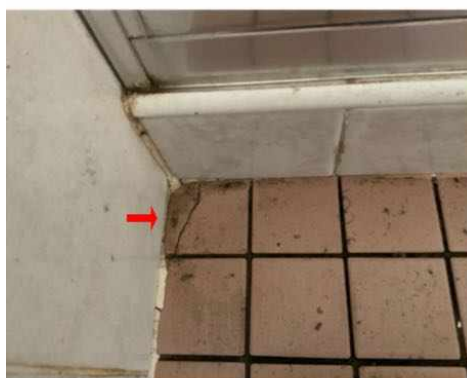
Finding 3.04

Building:	Building 1
Location:	Bathroom areas
Finding:	Tiles cracked

Information: Cracked tiles were evident in these pictured two bathroom areas at the time of inspection. It is suspected that this cracking has occurred as a result of installation damage.

Cracked tiles throughout the household detract from the overall appearance of the affected areas. In wet areas of bathrooms, it can lead to water damage of adjoining walls and floors.

Replacement of cracked tiles is recommended as soon as possible. A tiling contractor may be appointed to perform these works. Where cracks become more numerous, contact a licensed building inspector for further investigation.

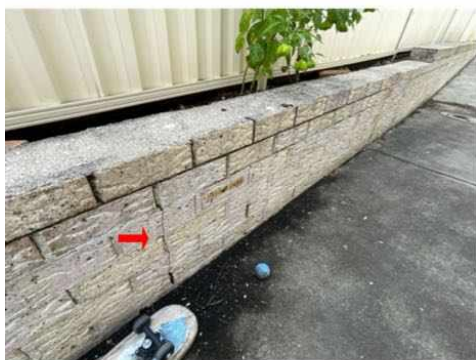
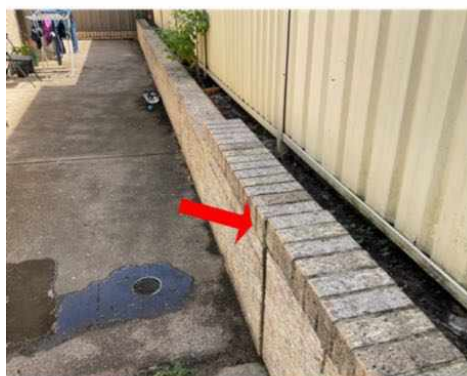
Building:	Building 1
Location:	Exterior retaining wall
Finding:	Step cracking and movement to brickwork (minor)
Information:	Step cracking and 10mm of movement was identified to the 675mm brick retaining wall in this rear area at the time of inspection. Step cracking, which is similar to other forms of cracking, has a variety of possible causes. However, the most common is the subsidence of adjacent footings.

Step cracking is a relatively common defect, and is most likely to occur adjacent to windows, doors and other openings. Mortar failure in the gaps between affected bricks indicates the stresses and tensions affecting the wall.

This wall has drainage behind it evidenced by a lower protruding drain.

Where step cracking is extensive or severe, the client is advised to consult a structural engineer. This minor step cracking can be used as a warning sign to address factors causing stress to the wall, which can include the effect of surrounding trees, water leaks, soil erosion, or even the presence of reactive soils in the surrounding area.

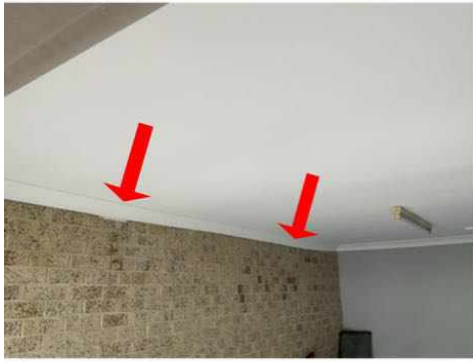
Finding 3.08

Building:	Building 1
Location:	Garage
Finding:	Ceiling - Sagging
Information:	Sections of the garage ceiling were found to be sagging at the time of inspection. Sagging to the fixed ceiling structure generally indicates that the building materials have swollen, due to contact with water, or that fixings (e.g. nails or glue) have become loose and require reattachment.

In some cases, sagging ceiling linings may also indicate that there are structural issues, causing surfaces to warp, twist or sag. Where sagging appears to be major, appointment of a structural engineer is advised to further inspect the property and identify the source and rectification works required.

Where minor sagging is evident, comparatively minor works, such as re-gluing of ceiling sheets, may be required. Such works may be performed by relevant tradespeople, such as plasterers and painters. Where excessive moisture has caused the roofing structure to swell and sag, the source of the water leak should primarily be identified prior to any remedial works being performed. No moisture was found in the roof void.

The appropriate action should be taken by the client as soon as possible to ensure that any potential further damage is limited.

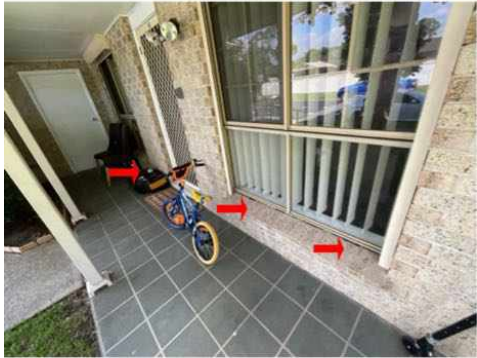
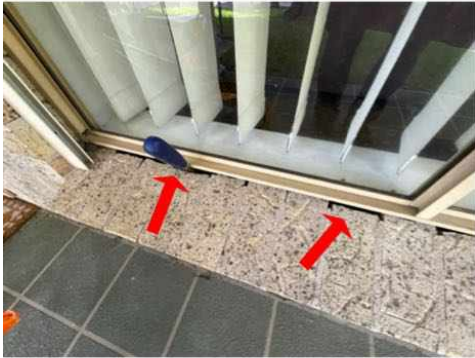
Finding 3.10

Building: Building 1
Location: Exterior walls and windows
Finding: Sealant (external) - missing
Information: It was noted on inspection that areas of external sealant was missing to small areas of the external walls and windows.

A flexible sealant, flashing or new window seals are required to protect the associated building materials from rainwater ingress.

A sealant specialist or skilled handy person should be appointed to complete these works as soon as possible

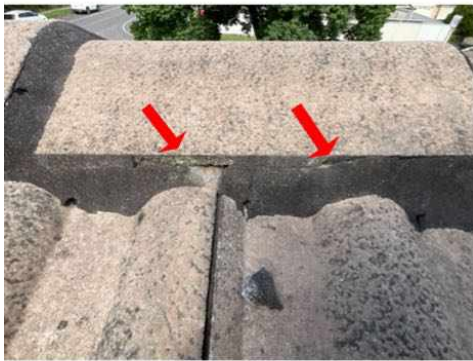
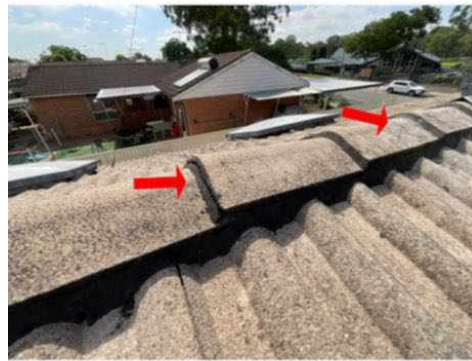
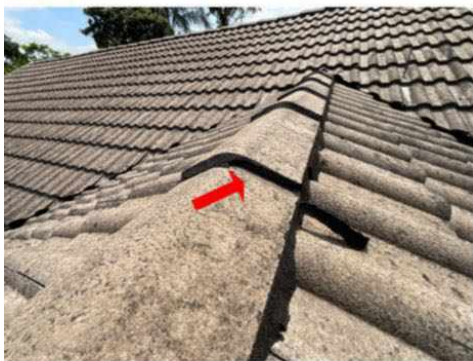
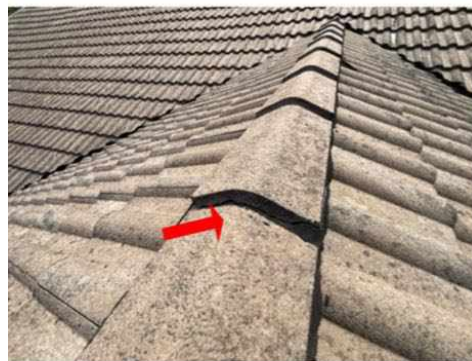
Finding 3.11

Building:	Building 1
Location:	Roof Exterior
Finding:	Roof tiles - Weathered
Information:	Upon inspection of the exterior roofing, the majority of roof tiles were considered to be in a good condition. While minor weathering of the tiles is consistent with the age of the property, maintenance works are required.

Isolated areas of mortar show minor cracking is also present. Re-pointing and re-sealing the may be considered as an interim solution by the client to help preserve and extend the life span of the tiles.

Where left unmanaged, deteriorating roof tiles are likely to lead to a number of secondary defects, including minor water leaks and weather exposure to internal roofing structures.

Consultation with a roofing contractor is highly advised to gain advice on cost of remedial works that may be required in the short to medium term. Remedial works are likely to increase the longevity of the exterior roofing structure.

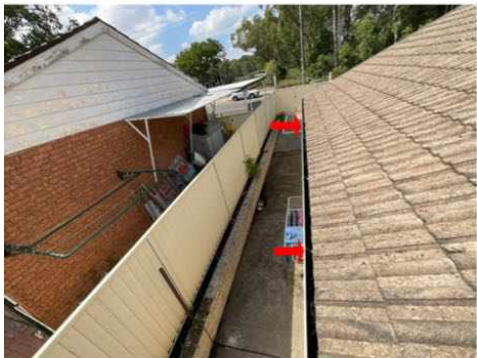
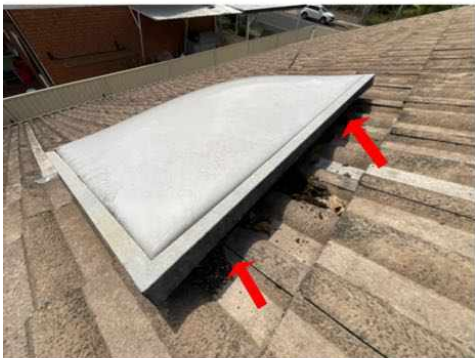
Building: Building 1
 Location: Roof exterior
 Finding: Gutters and flashing - Full and blocked
 Information: The guttering and skylight flashing on around the roof was found to be blocked at the time of the inspection. Roof plumbing structures, such as guttering and downpipes, should be free of all debris to prevent blockages. Blockages of the guttering and downpipes will lead to pooling and accumulated water overflows, which is likely to subsequently flood eaves and exterior walls.

Blocked gutters are likely to lead to high levels of moisture in the affected areas which can cause rust and decay of the gutters and downpipes and wood rot to adjoining timber areas. Blockages in gutters should therefore be removed immediately to ensure dry conditions are maintained.

It is highly advised that gutters be cleaned by the homeowner or a general handyperson as a matter of urgency. If this is not undertaken regularly, these gutters will start to sag and cause more eave damage.

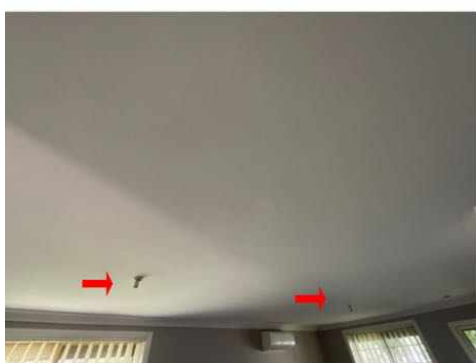
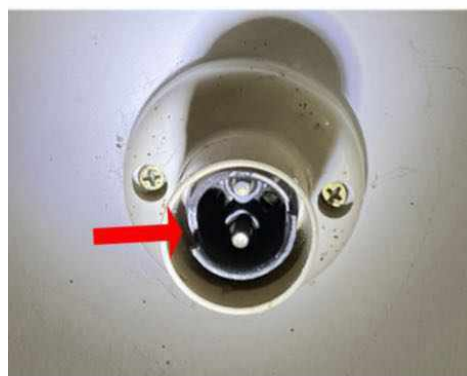
Finding 3.15

Building:	Building 1
Location:	Lounge Room
Finding:	Light fittings - Damaged
Information:	<p>The light fittings in this lounge area were found to be damaged at the time of inspection. Damage occurs generally when the building materials have aged and decayed, but may also be indicative of impact damage to the building element (accidental or deliberate). These lights need new bayonet mounts due to cracking.</p> <p>Repair and/or replacement of the damaged fitting is advised. A Licensed electrician should be appointed to repair/replace the light fitting at the client's discretion.</p>

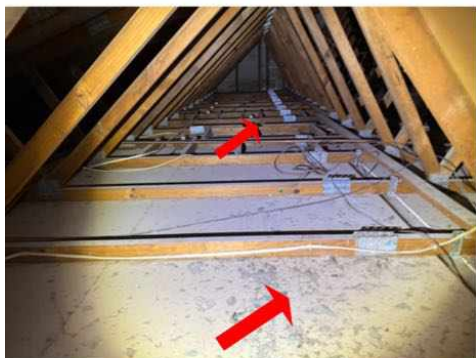
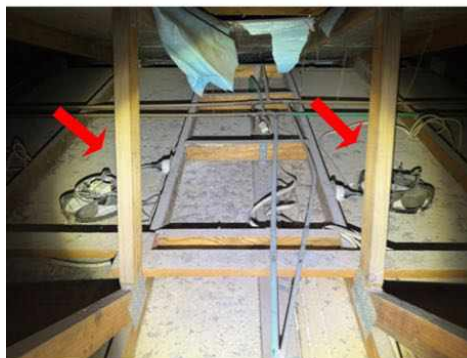
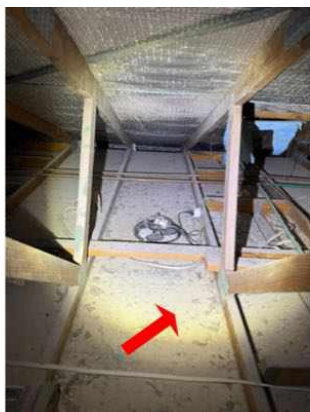
Finding 3.16

Building:	Building 1
Location:	All Roof cavity areas
Finding:	Insulation - Missing
Information:	<p>Upon inspection of the roof void it was noted that insulation is not present.</p>

Insufficient insulation will result in a comparatively higher cost to heat and cool a property as there is a lack of Insulation (or uneven coverage of insulation) which works as a barrier to heat transfer. This helps to keep out unwanted heat in summer and preserves warmth inside your home in winter. It can also help soundproof your home from unwanted airborne noise transfer.

Where insulation is absent, the area does not meet current Australian Standards. Installation of adequate insulation is required and should be conducted as soon as possible.

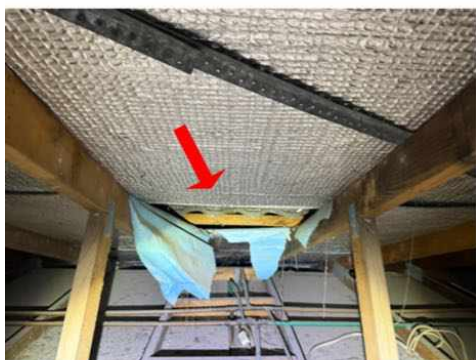
Finding 3.17

Building:	Building 1
Location:	Rear Roof cavity
Finding:	Sarking - Damaged
Information:	Sarking, a laminated aluminium foil applied to the interior of the roof covering, assists in insulating the property and acting as a vapour-barrier to the roof void and, subsequently, to the household.

Where sarking is damaged in one small area, both insulation and moisture protection of the property are inhibited. This creates a loss of energy and thus negatively impacts the energy efficiency of the property, allowing potential for moisture ingress from condensation or leaking roof tiles.

It is important to repair any holes or damaged sections of sarking to ensure that the building material is fully functional. A registered builder or qualified carpenter should be consulted to provide further advice on this defect and to perform rectification works at client discretion.

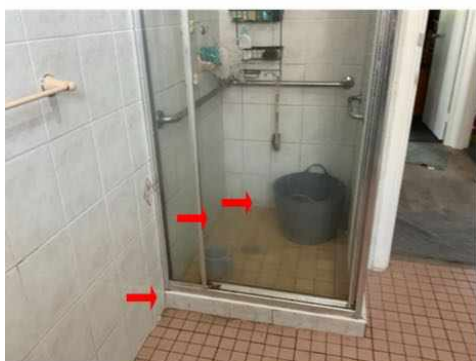
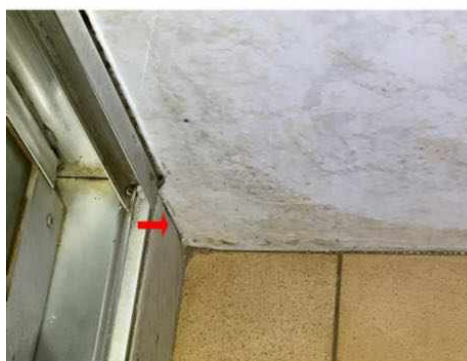
Finding 3.18

Building:	Building 1
Location:	Bathroom
Finding:	Sealant and grouting - Missing or damaged
Information:	It was noted on inspection that sealant or grout is degraded to the tiled shower alcove and or other areas of the bathroom.

Different materials and floor areas move at different rates, generally causing cracking to grout or sealant at this point. A flexible sealant is required to allow for expected expansion and contraction, while keeping the joint water tight and protective of all associated building materials.

Flexible and mould resistant materials should be applied to affected areas to prevent any subsequent water damage that is likely to occur. Regular maintenance and replacement of damage or missing or damaged sealant and grout is highly recommended to the wet areas, as this is a regular wear and tear defect. Sealant and grouting in areas that come into regular contact with water should be maintained for the long term care of your property.

A sealant specialist or tiling contractor should be appointed to complete these works after the wall leak has been rectified.

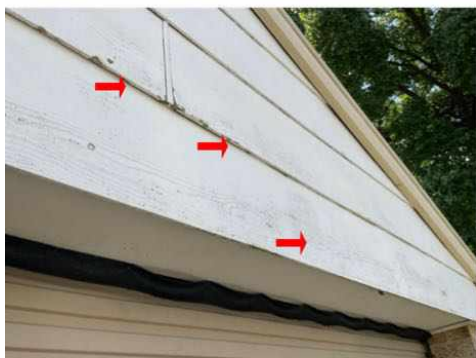
Finding 3.22

Building:	Building 1
Location:	Wall cladding
Finding:	External painting deteriorated
Information:	Some of the external cladding has been neglected and require attention to prepare and re-paint.

Whilst incomplete or missing paint finish is generally an appearance defect, it can also lead to the development of secondary building defects over time. Incomplete areas of paint finish expose the area to moisture, potentially accelerating the deterioration of underlying building materials.

Degraded paint finishes should be sanded back, filled, leveled and painted, as applicable. Where inadequate or missing paint protection has led to the deterioration of the associated building element, repair and/or replacement of this building element may be required.

A painting contractor should be appointed as soon as possible to perform necessary works to aid the appearance of the affected area and to ensure the area is protected against further deterioration. Alternatively, the homeowner following manufacturer instructions may perform these works.

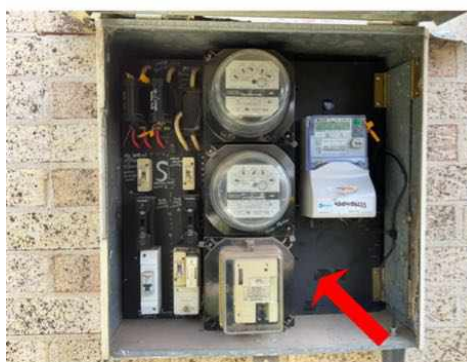
Building:	Building 1
Location:	Meter Box
Finding:	Termite Management System - no evidence of a chemical installation
Information:	The application of a post-construction chemical termite barrier is highly recommended for all properties. Such barriers are highly effective in preventing termite attack on any timber building elements throughout the property.

A durable notice should be placed in the switchboard unit to indicate current termite barriers. At the time of inspection, no durable notice was evident and it appeared as though no chemical termite management system has been installed, with no evidence to suggest preventative works taking place since the property was built.

The client may consider gaining further advice from a pest controller as to the costs and procedures involved with a 'chemical' application. It is recommended that obtaining such advice be a short-term priority.

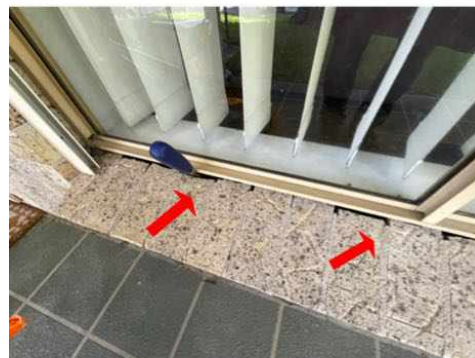
Building: Building 1
 Location: Pictured areas
 Finding: Sealant (external) - missing and attractive to termites
 Information: It was noted on inspection that areas of external sealant was missing to small areas of the external walls. A flexible sealant or flashing is required to protect the associated building materials from rainwater ingress. Any moisture ingress into the property is very attractive to termites.

A sealant specialist or skilled handy person should be appointed to complete these works as soon as possible.

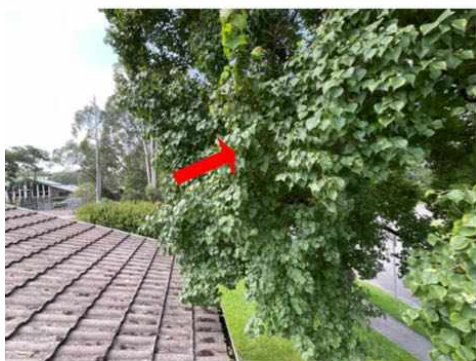
Finding 6.04

Building: Building 1
 Location: Roof - front
 Finding: Trees - Overhanging and filling gutters
 Information: Overhanging trees often result in excessive amounts of leaf debris accumulating in

Gutters are a critical part of the building's management of storm water and rain. It is therefore important that they be kept clear to prevent secondary damage to associated building elements, including exterior and interior walls, ceiling linings and any adjoining building elements. Where gutters are blocked, pooling of rainwater is likely to occur, fast-tracking rust and corrosion of the roof plumbing elements.

It is highly advised that all overhanging tree branches be removed as soon as possible to prevent any further damage. Such works should be performed by the homeowner; however, appointment of a landscape contractor or an arborist may be required.

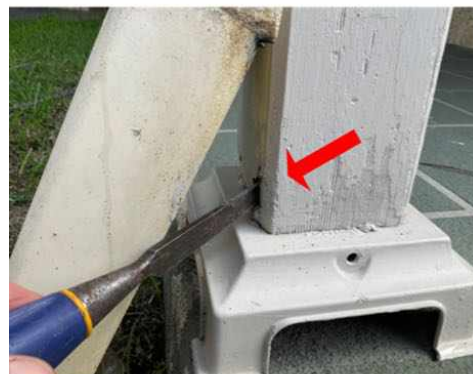
Building:	Building 1
Location:	Two posts
Finding:	Fungal decay - present (localised)
Information:	Fungal decay also known as wood decay or wood rot generally refers to the deterioration of timber elements when in contact with excessive levels of moisture for a prolonged period of time.

In this case although the affected timber element is in a decaying state the extent of any visible damage appears to be localised to a specific area and is yet to spread to other parts of the building element or affect adjoining structures. The fungal decay is therefore likely to be of a relatively superficial nature with minimal impact on the structural integrity or tensile strength of the timber element.

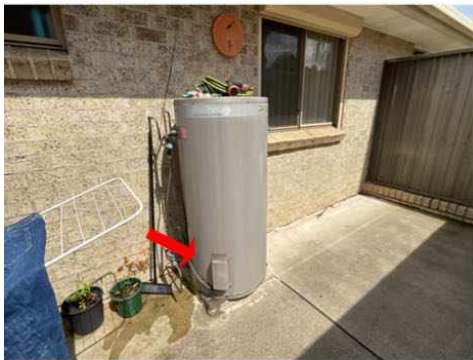
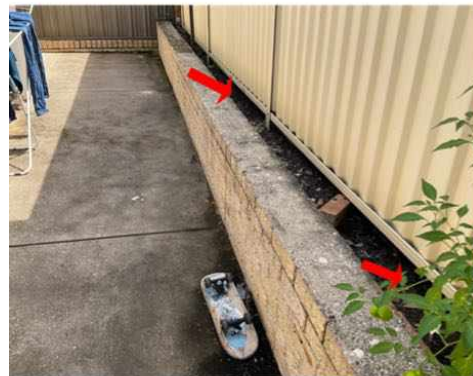
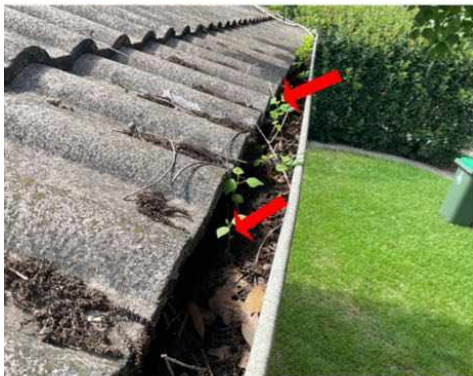
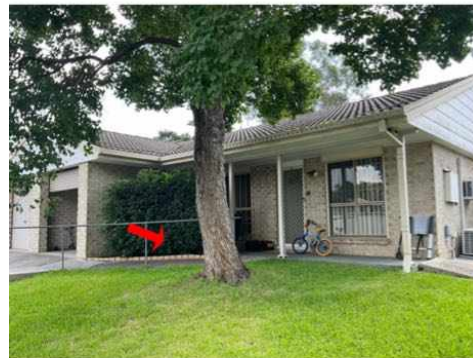
Building: Building 1
 Location: All External Areas
 Finding: Additional Photos - Obstructions and Limitations of EXTERNAL AREAS
 Information: These photographs are an indication of the obstructions and limitations which impeded full inspection of external areas at the time of inspection. These obstructions can hide an array of defects and should be removed to allow full inspection to be carried out. A re-inspection is recommended once the areas are made accessible.

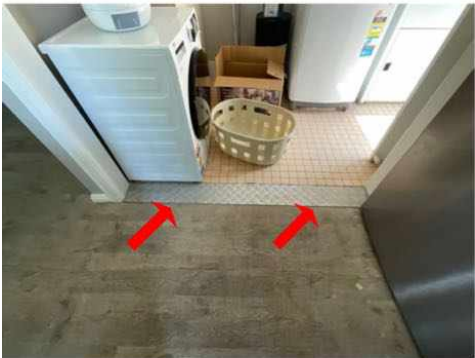
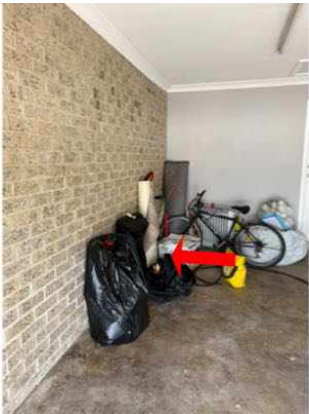
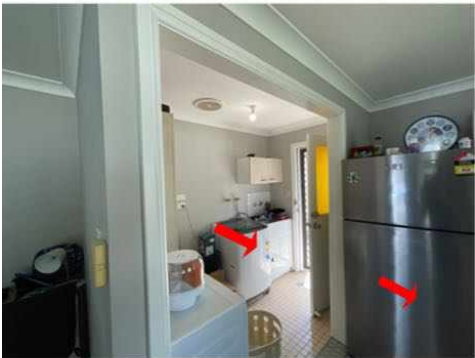
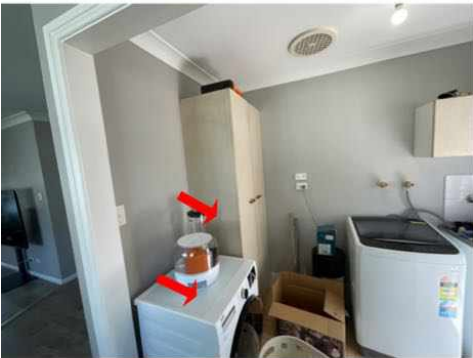
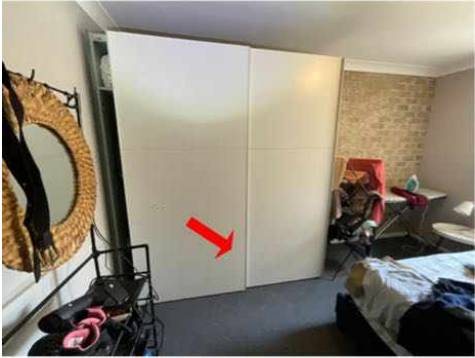
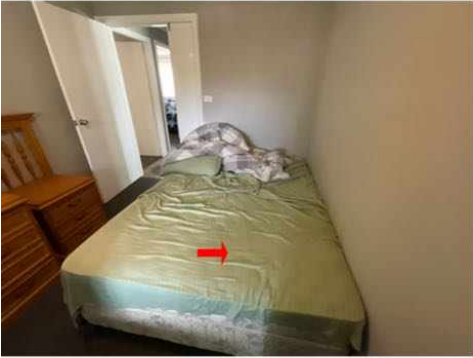
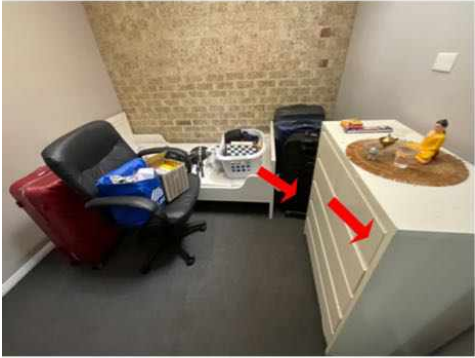
Building: Building 1
 Location: All Internal Areas
 Finding: Additional Photos - Obstructions and Limitations of INTERNAL AREAS
 Information: These photographs are an indication of the obstructions and limitations which impeded full inspection of Internal areas at the time of inspection. These obstructions can hide an array of defects and should be removed to allow full inspection to be

carried out. A re-inspection is recommended once the areas are made accessible.

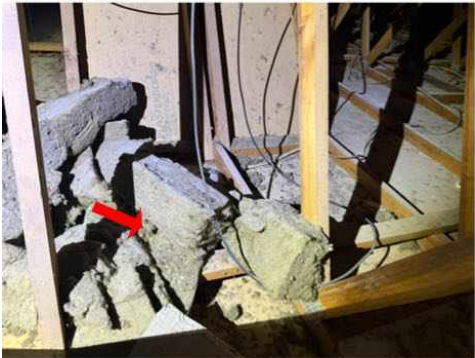
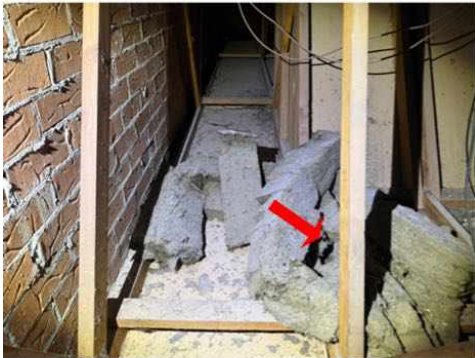
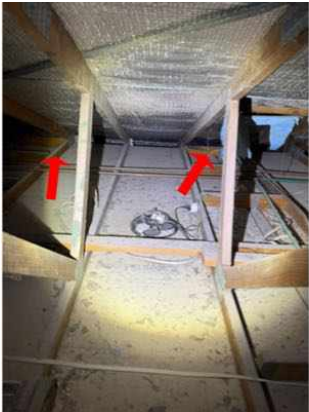
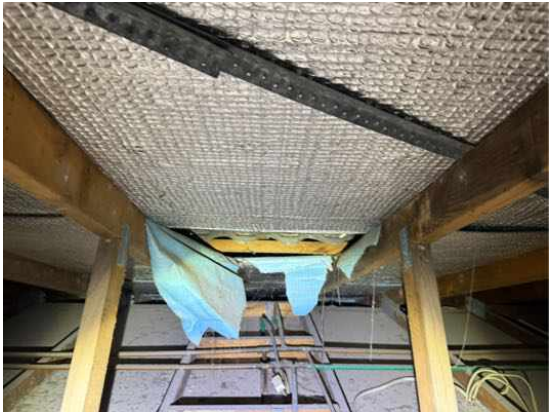
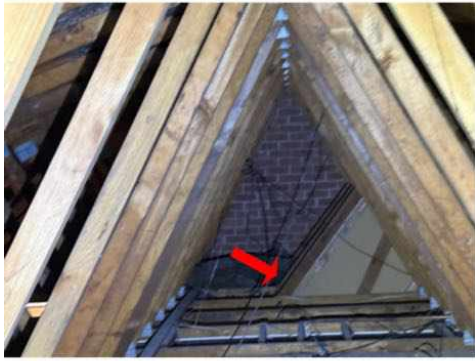
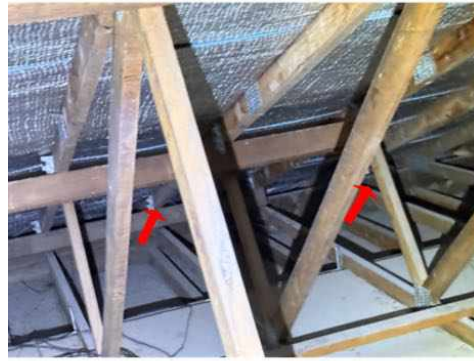
Building: Building 1
Location: All Roof cavity areas
Finding: Additional Photos - Obstructions and Limitations of the ROOF CAVITY
Information: These photographs are an indication of the obstructions and limitations which impeded full inspection of roof cavity areas at the time of inspection. These obstructions can hide an array of defects and should be removed to allow full inspection to be carried out if applicable. A re-inspection is recommended once the areas are made accessible.

The inspection was also limited to areas with an allowable crawl space of 600mm x 600mm, in particular towards the external walls where the roof line diminishes, these areas were not accessible.

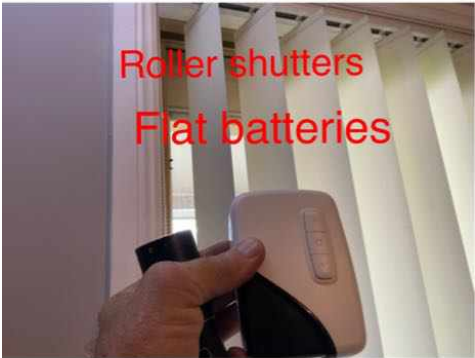
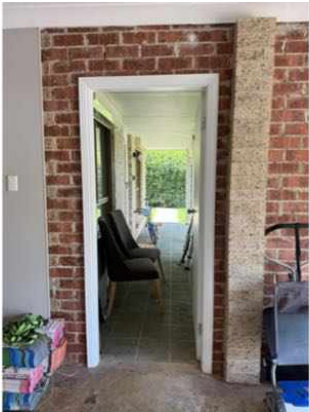
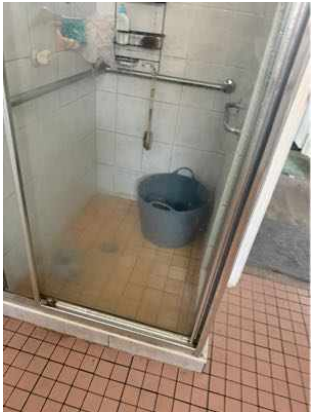
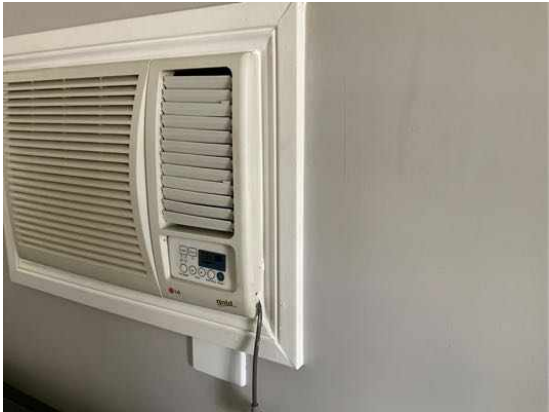
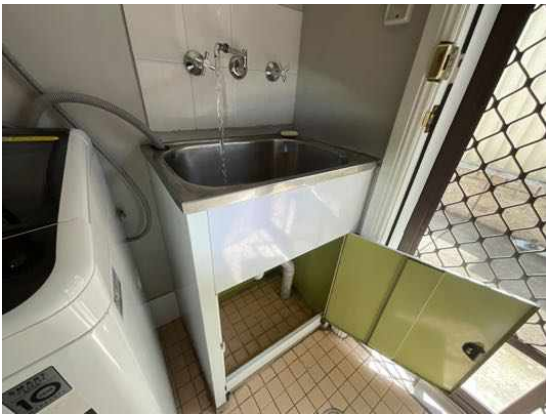
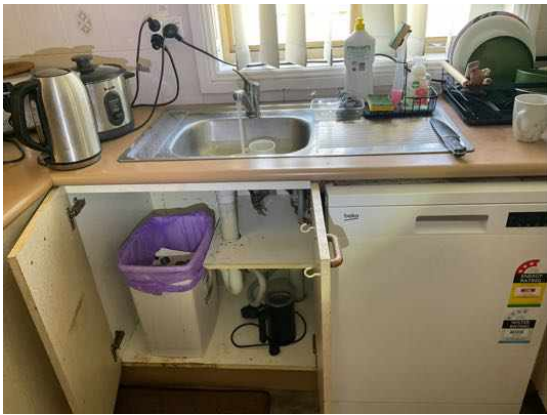
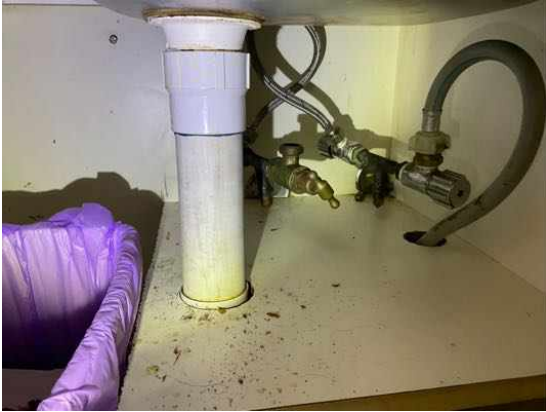
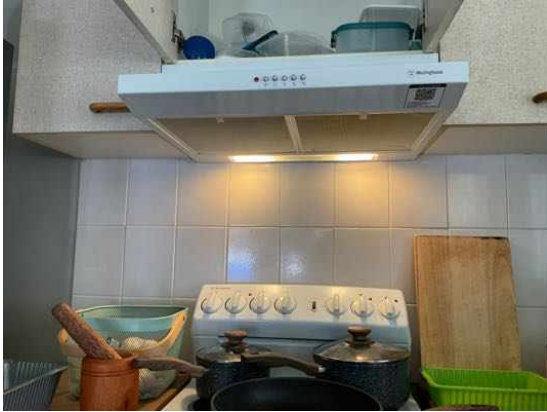
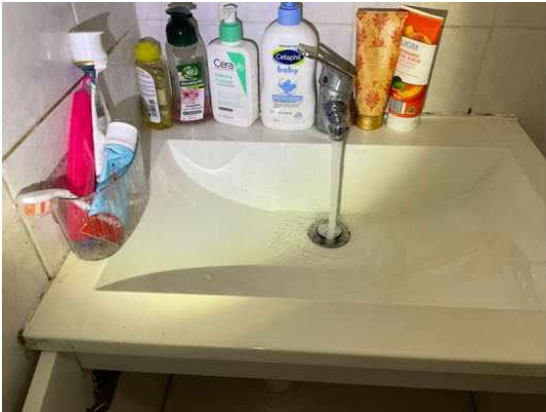
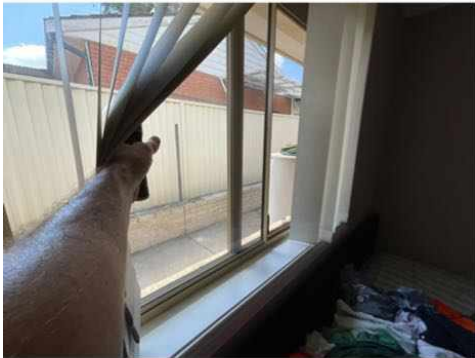
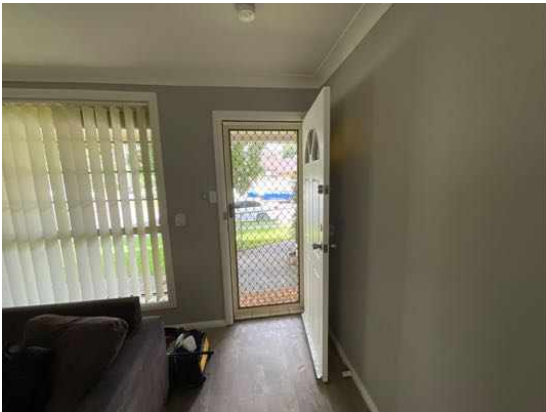
Building: Building 1
 Location: All Internal Areas
 Finding: Additional Photos
 Information: Additional photos are provided for your general reference

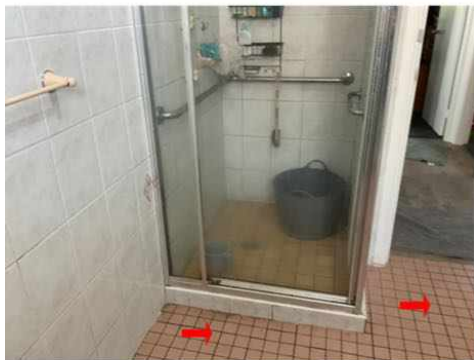
Building: Building 1
Location: Bathrooms and laundry
Finding: Waterproofing membranes - Information Only
Information: Internal Water Proofing Membranes, are crucial in preventing water ingress into the property is important to know that the Membrane System used is to Australian Standards and has been installed correctly.

With older property's where this information is unavailable all wet areas should be monitored. If any leaks, water staining, peeling or bubbling of the paint become evident to any adjacent walls or ceilings below a licensed builder or waterproofing specialist is recommended to investigate further.
