Building and Timber Pest Inspection Report VR

Inspection Date: Fri, 23 Jan 2026

Property Address: 15 Togar St, Mansfield QLD 4122, Australia

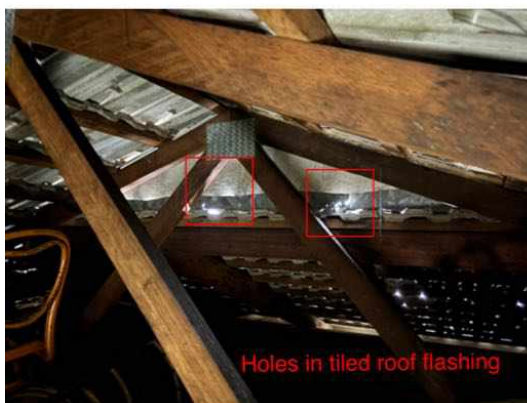
Location: Roof Exterior
Finding: Roof covering - deteriorated
Information: At the time of the inspection it was noted that the roof covering to the dwelling has deteriorated resulting in holes in the roof covering.

The front lower section of the roof covering is a metal tile. This metal tile has several holes as a result of the rust found on the metal roof. This allows moisture to penetrate the building. The lead flashings to the gables on either side of the upper tiled roof have holes in them, allowing moisture to enter the roof void.

Moisture entering the roof void will result in undetected damage occurring to the associated building materials.

A roof contractor must be engaged to assess the entire roof covering in order to provide a solution rectify these issue. This should be done as a matter of urgency.

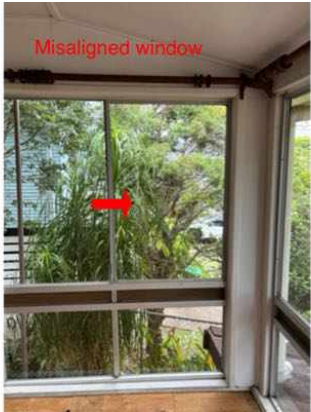
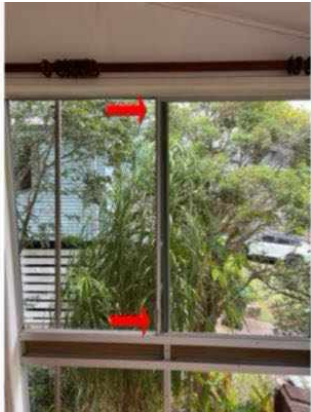
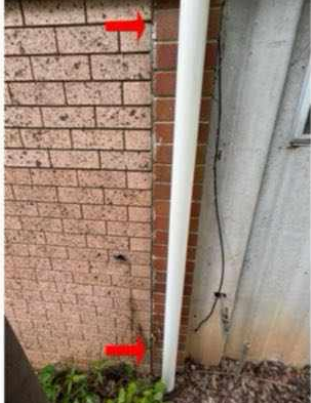
Finding 2.02

Building:	Main Building
Location:	Front right hand side of dwelling
Finding:	Front right of dwelling - suspected movement
Information:	At the time of the inspection, it was noted that the front right hand side of the dwelling has moved. This could be historic damage.

There are cracks to the wall and ceiling linings. The window on the right hand side of the sunroom is misaligned, indicating movement to the building foundations.

On the exterior in this area, there is a large gap under the timber roof beam. The expansion joint in the brickwork is wider at the top than at the bottom.

A structural engineer must be engaged to assess the dwelling and provide a solution to rectify this issue. This should be done as a matter of urgency.

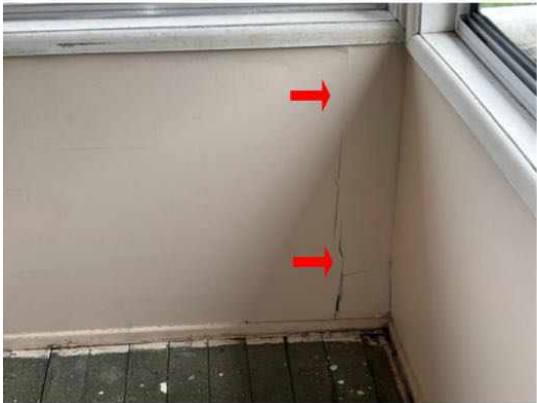
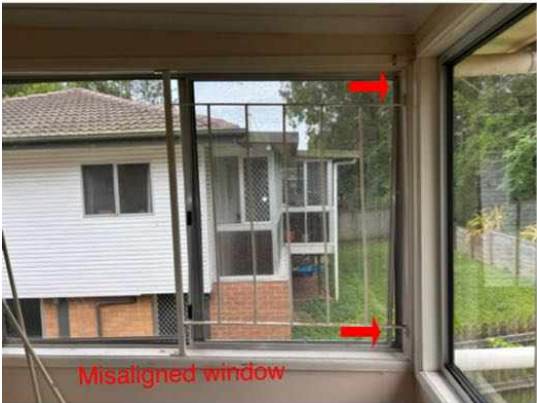
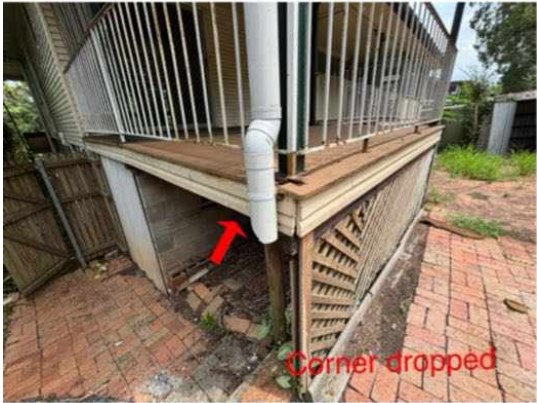
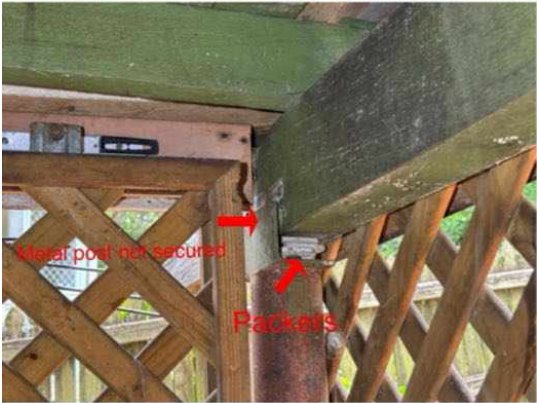
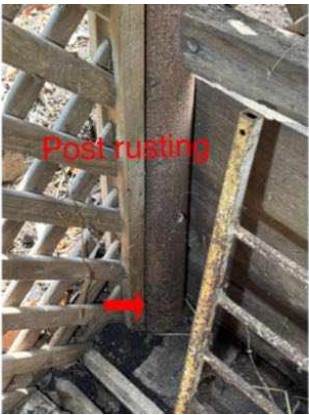
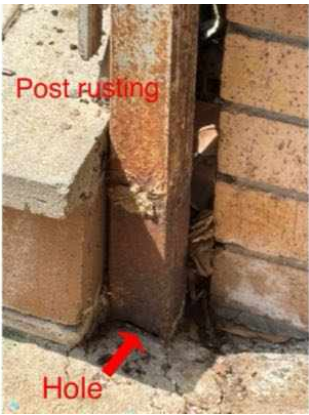
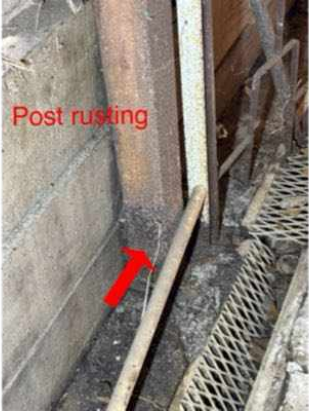
Finding 2.03

Building: Main Building
Location: Rear elevation
Finding: Rear of dwelling - suspected movement
Information: At the time of the inspection, it was noted that movement has occurred to the left and right hand side of the rear of the dwelling.

There is cracking to the wall lining in the sunroom off the bedroom. The floor in the sunroom slopes to the rear of the dwelling. The window above the crack is misaligned. On the exterior of this area, the steel posts supporting the floor framing are rusted. One has a hole in it. Two of the steel posts have packers on top of them and are not secured to the timber bearer. The packers have been used in an attempt to level or raise the floor.

The corner of the deck on the right hand side of the rear of the dwelling has dropped causing the deck to slope away from the dwelling.

A structural engineer must be engaged to assess the movement at the rear of the dwelling and provide a solution for these issues. This should be done as a matter of urgency.

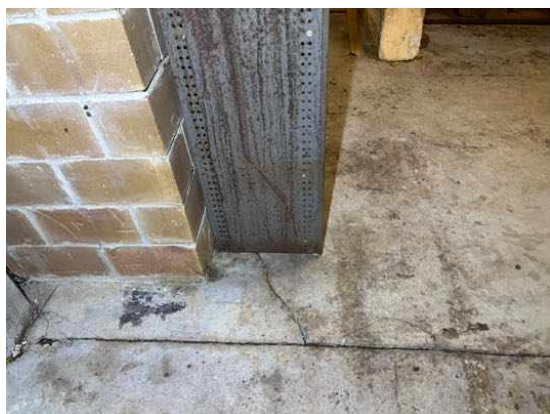
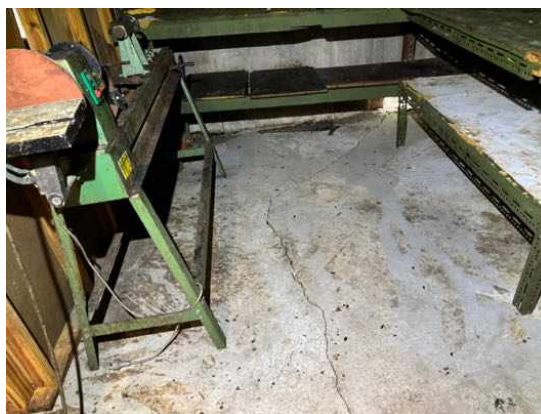
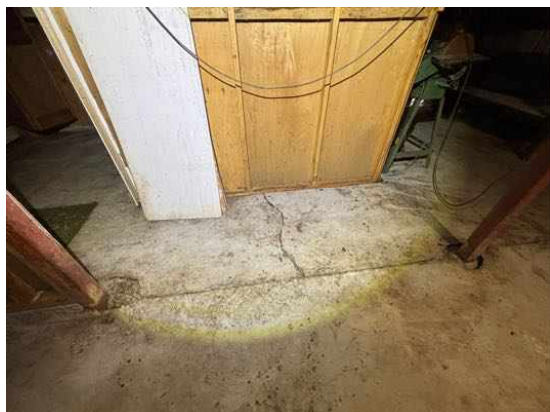
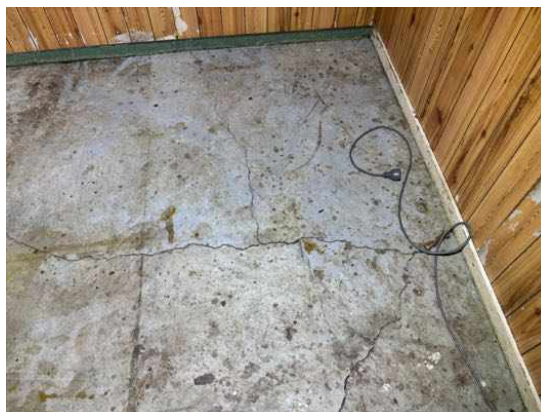
Finding 2.04

Building: Main Building
 Location: Storage area
 Finding: Storage area - concrete cracked
 Information: At the time of the inspection, it was noted that there were several cracks in the concrete floor of the storage area. Movement has occurred in the walkway near the bathroom resulting in the tiles cracking and coming loose.

A structural engineer must be engaged to assess the concrete floor and provide a solution for these issues. This should be done as a matter of urgency.

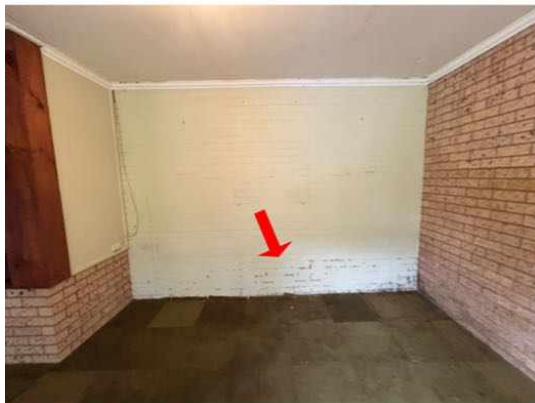
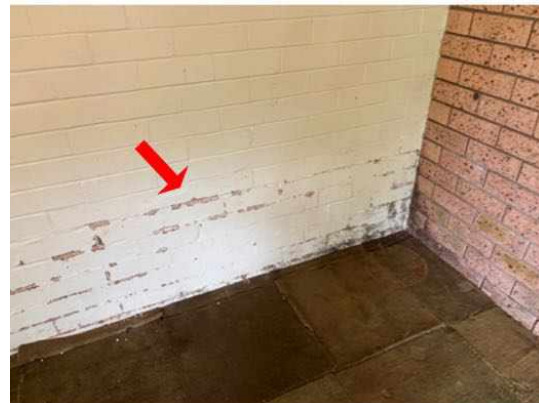
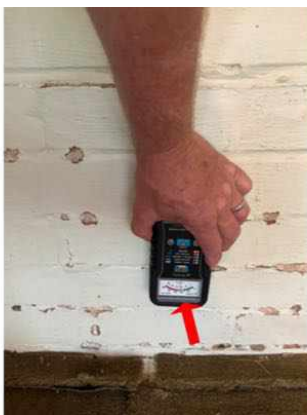
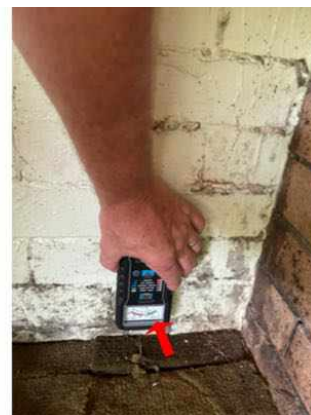
Building:	Main Building
Location:	Subfloor
Finding:	Brickwork - Efflorescence
Information:	At the time of the inspection, it was noted that there was evidence of efflorescence in the two rooms on the right hand side of the subfloor or lower level. Normal moisture readings were recorded in the front room. Elevated moisture readings were recorded on the wall in the rear room. Water staining was found on the wall lining. This indicates

that moisture is penetrating the brickwork. The ground level on the exterior is higher than the floor level on the interior. This has been noted as a minor defect as waterproofing can be carried out on the interior to prevent moisture damaging building materials on the interior of these rooms. If left unaddressed this will become a major defect.

Generally, soluble salt deposits can be removed by dry brushing with a stiff-bristled brush. Repeated dry brushing is an ideal treatment for eliminating this forming of efflorescence. A cleaning contractor or building maintenance professional, may be appointed to perform these works at the discretion of the client.

While not as affected as exterior waterproofing, the interior side of the brickwork can be waterproofed.

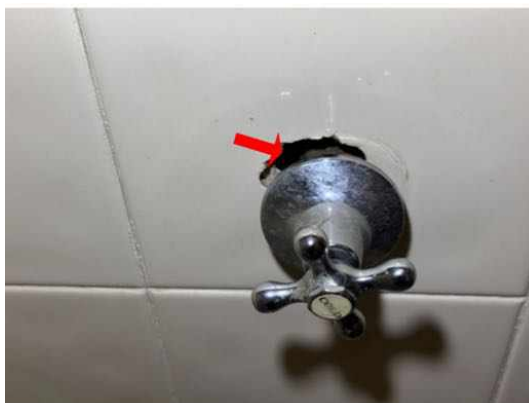
Information: At the time of the inspection, it was noted that there was no sealant to the tap/plumbing penetrations in the upper level bathroom. This allows moisture to enter the wall cavity.

Moisture in wall cavities creates a conducive environment for termite activity and can cause undetected damage to the associated building materials.

A building maintenance professional should be engaged to apply sealant to all of the

bathroom wall penetrations. This should be done as a short term priority.

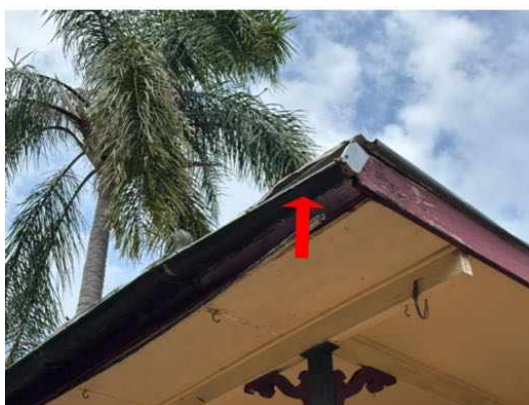
Finding 3.04

Building: Main Building
 Location: Rear elevation
 Finding: Gutters - damaged
 Information: At the time of the inspection, it was noted that the gutter on the rear of the dwelling is damaged. Gutters need to be in good working order to drain the roof properly.

If gutters are leaking, moisture may get to areas of the building that are meant to be kept dry. Damage to building elements may result of moisture ingress.

A licensed roof plumber should be appointed to inspect the gutters and advise on necessary rectification works. This should be done as a matter of urgency.

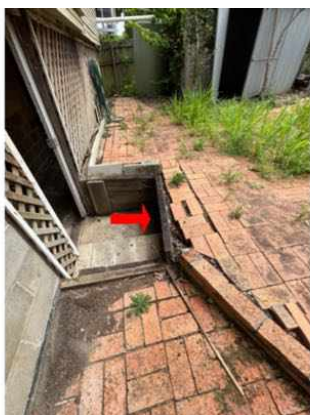
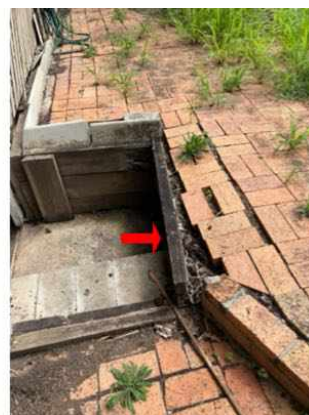
Finding 3.05

Building: Main Building
 Location: Rear elevation
 Finding: Rear elevation - timber retaining wall deterioration
 Information: At the time of the inspection, it was noted that the low timber retaining wall at the rear of the dwelling is deteriorating. This may be due to the age of the materials and

general weathering.

A retaining wall specialist could be engaged to replace the affected sections of the low timber retaining wall. This can be done at the clients discretion.

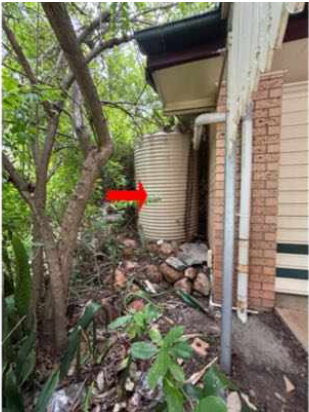
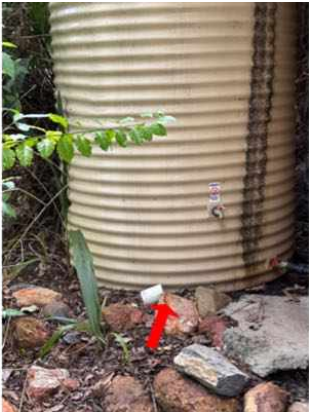
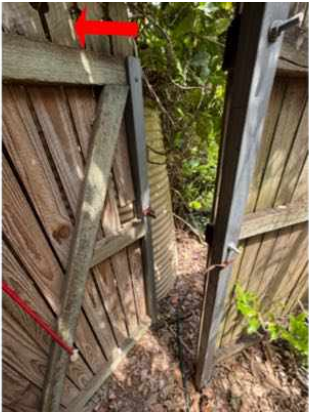
Finding 3.06

Building: Main Building
 Location: Side yard
 Finding: Side yard - water tank movement
 Information: At the time of the inspection, it was noted that the water tank on the left hand side of the dwelling has moved. This may be due to the wood rot that has affected the timber base that the water tank is sitting on. As a result of the movement, the water tank filler does not fill the tank and instead drains next to the foundations of the dwelling.

Excessive moisture next to the foundations of the dwelling creates a conducive environment for termite activity and can cause damage to the associated building materials.

If left unaddressed, further movement of this water tank can be expected.

A building maintenance professional could be engaged to replace the timber base with a more suitable base to ensure that the water tank does not move. This should be done as a short term priority.

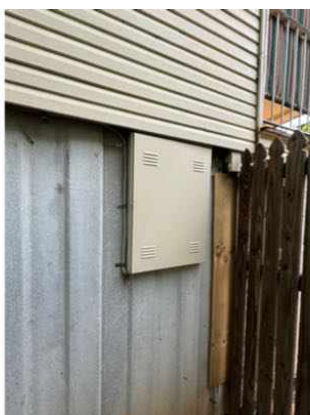
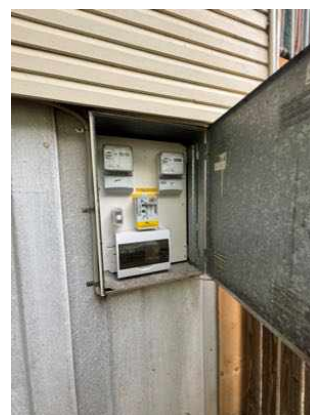
Building:	Main Building
Location:	All External Areas
Finding:	Termite Management System - no evidence of a chemical installation
Information:	At the time of the inspection, no evidence of a chemical termite management system was found. There is no durable notice in the meter box.

The client may consider gaining further advice from a pest controller as to the costs and procedures involved with this application. It is recommended that obtaining such advice be a short-term priority.

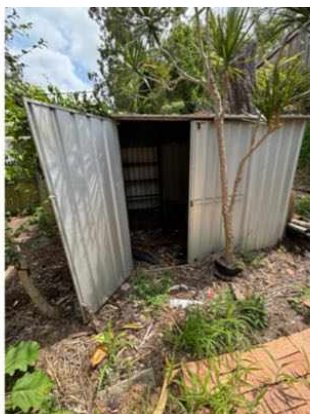
Finding 6.02

Building:	Main Building
Location:	Shed
Finding:	Shed - evidence of termite activity
Information:	At the time of the inspection, it was noted that there was evidence of termite activity in the shed at the rear of the dwelling. Termite mudding was found in the debris of the shed floor. This appears to be past activity.

A termite and timber pest technician should be engaged to treat the area to eliminate any future activity. This should be done as a matter of urgency.

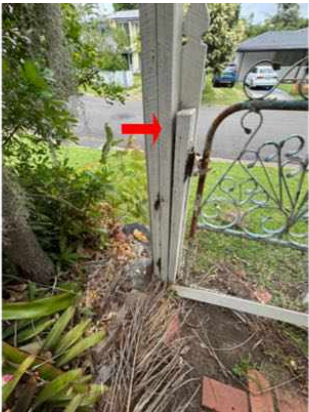
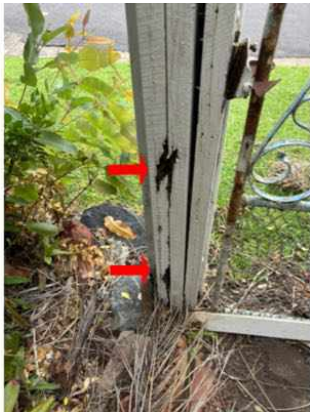
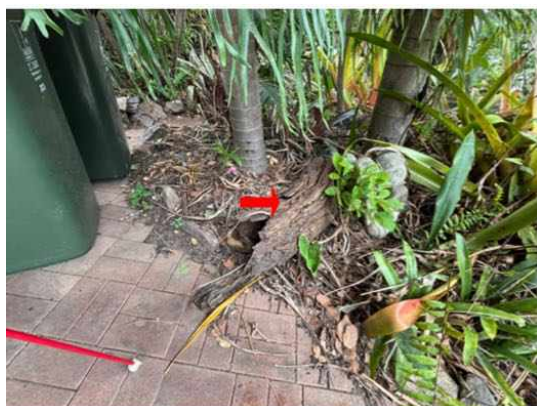
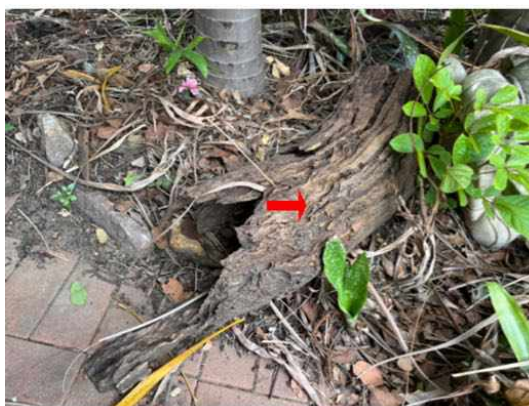
Finding 6.03

Building:	Main Building
Location:	All External Areas
Finding:	Evidence of termite damage
Information:	At the time of the inspection, it was noted that there was termite damage to old timber stumps and the front pedestrian gate structure.

It is advised that the area be visually inspected frequently to ensure that the condition of affected building materials does not worsen and to check for further termite activity.

A building contractor may be appointed to provide a further invasive inspection if further damage is evident.
