# Building and Timber Pest Inspection Report

Inspection Date: Fri, 27 Mar 2026

Property Address: 9 King St, Berowra NSW 2081, Australia

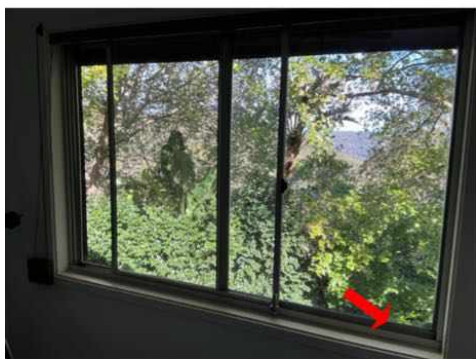
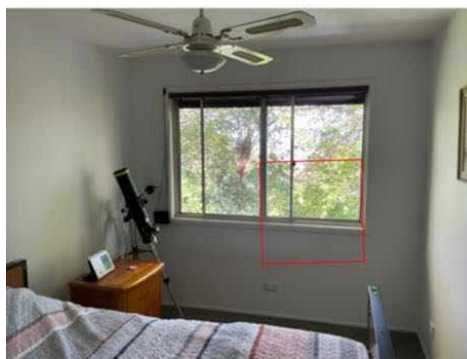
Building:	Main Building
Location:	All Areas Upstairs
Finding:	Window Restrictors - Recommended
Information:	Upstairs windows did not have window restrictors installed. Although not a requirement at the time of construction, it is advisable to install window opening restrictors on all second storey windows with sill heights below 1.7 meter and potential fall of 2 meters or more.

If you live in a strata scheme, window safety devices must be installed on all applicable windows by 13 March 2018. Residents with safety devices installed can still fully open their windows but it's recommended that devices be engaged whenever children are present, to prevent falls.

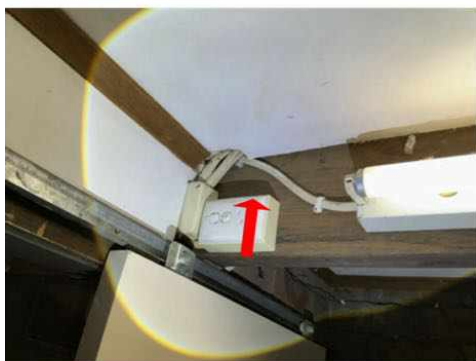
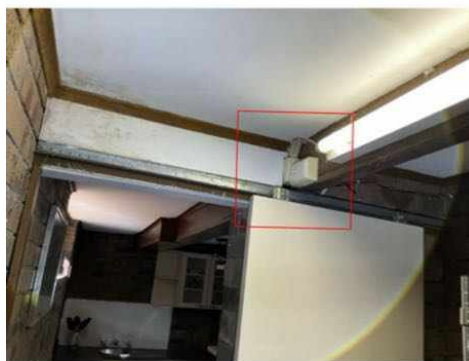
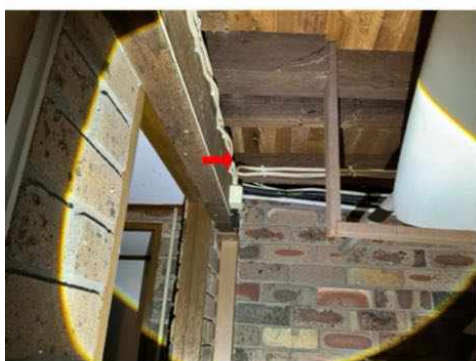
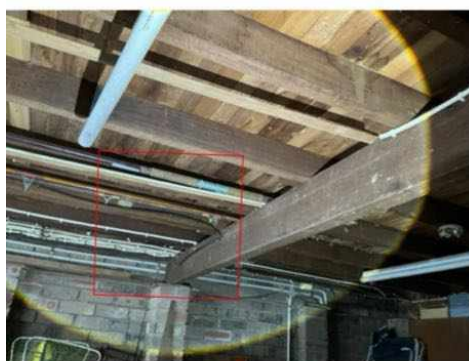
#### Finding 1.02

Building:	Main Building
Location:	Wine Cellar, Garage
Finding:	Exposed Wiring
Information:	At the time of inspection, wiring was observed to be exposed and not properly concealed. Exposed wiring presents a safety hazard, as it may be susceptible to damage, accidental contact, and potential electrical risks.

It is recommended that all wiring, whether electrical or communication/cable wiring, be properly enclosed and secured to ensure safety and compliance with acceptable standards. Where the wiring is electrical in nature, a licensed electrician should be engaged to assess and rectify the installation. For non-electrical wiring, a suitably qualified handyman may be engaged to neatly conceal and secure the wiring in a professional manner.

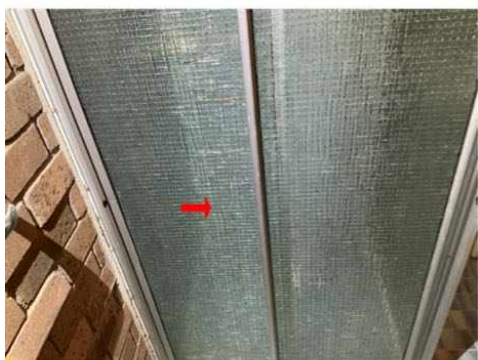
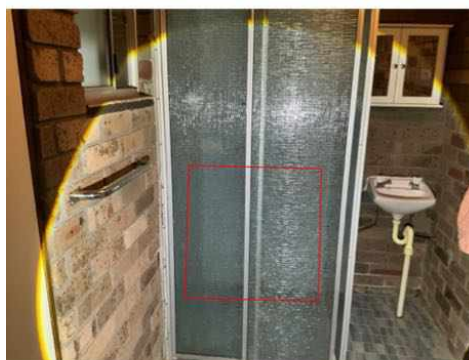
### Finding 1.03

Building:	Main Building
Location:	Downstairs Bathroom
Finding:	Shower Screen Glass - Cracked
Information:	At the time of inspection, the shower screen glass was observed to be cracked, posing a significant safety hazard.

The structural integrity of the glass is compromised, increasing the risk of breakage under minimal force or impact. This presents a serious injury risk to occupants, as shattered glass can cause cuts or other harm.

It is recommended to engage a qualified glazier as soon as possible to replace or repair the glass to ensure safety and prevent further deterioration.

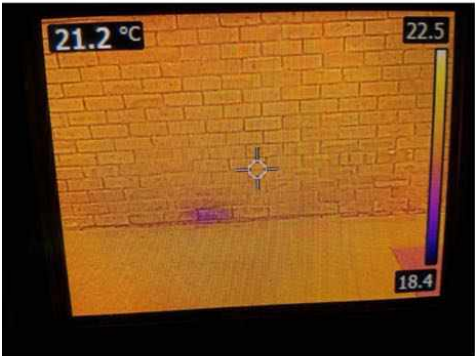
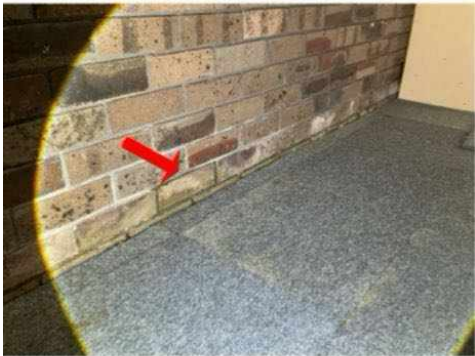
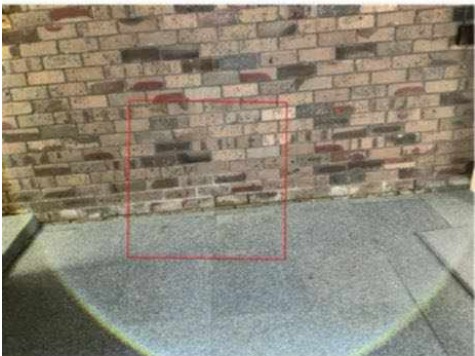
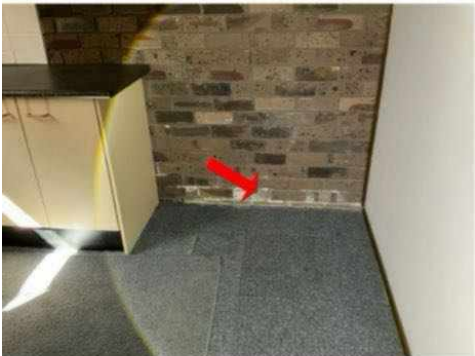
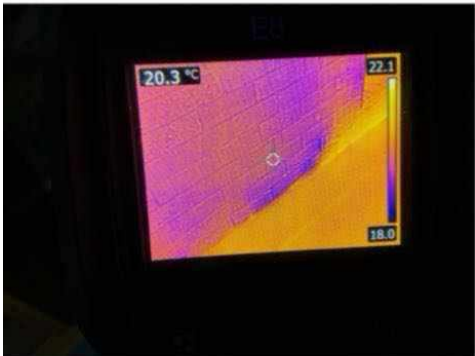
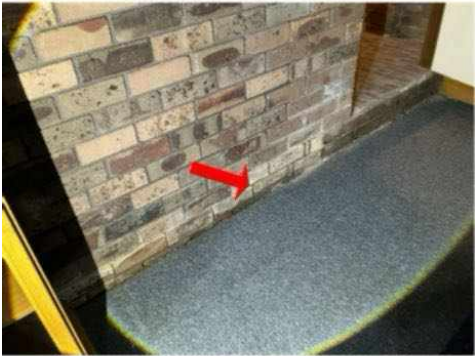
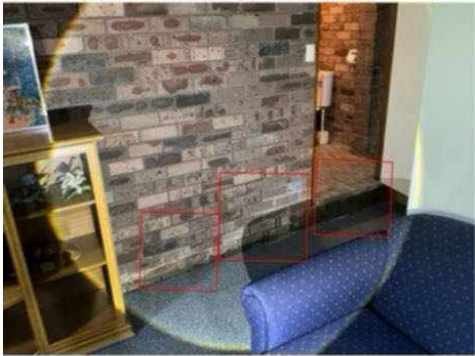
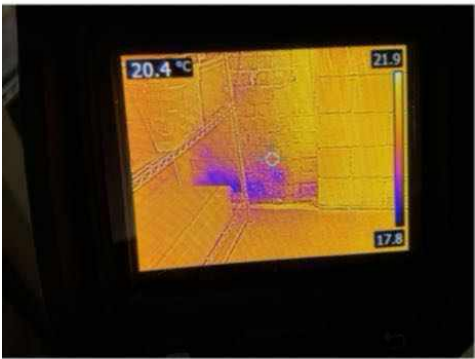
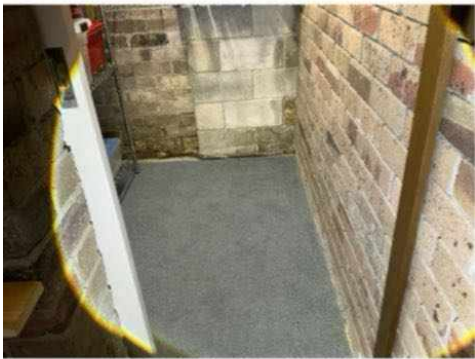
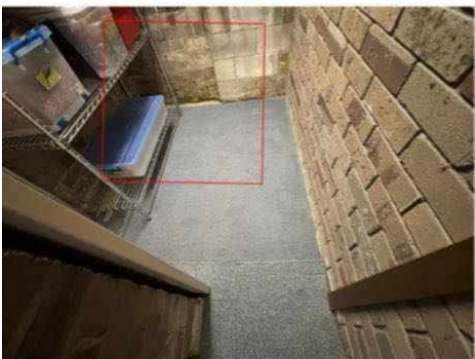
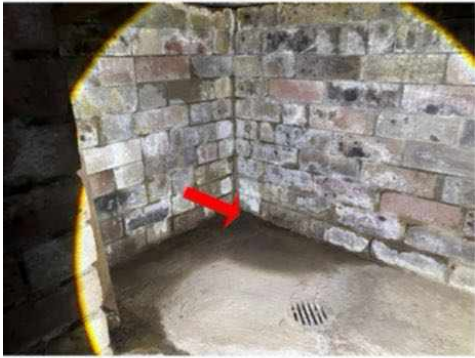
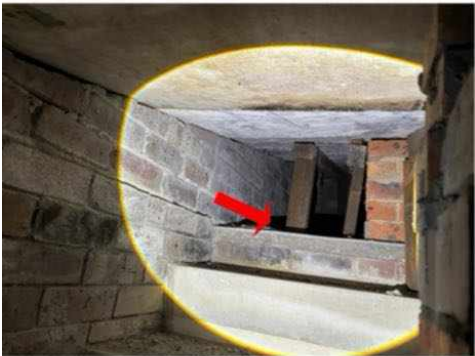
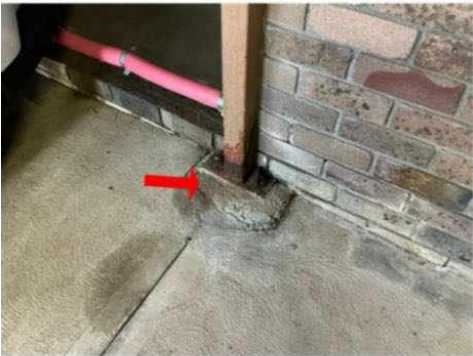
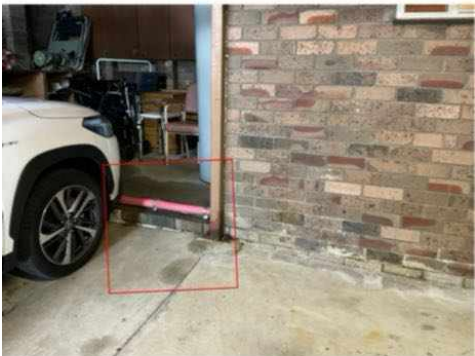
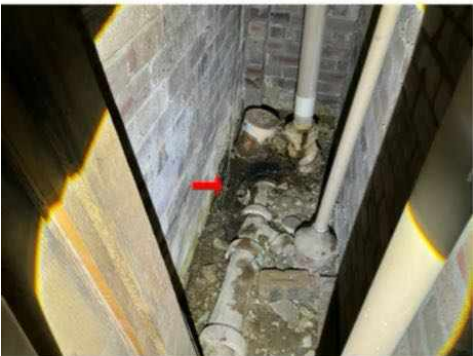
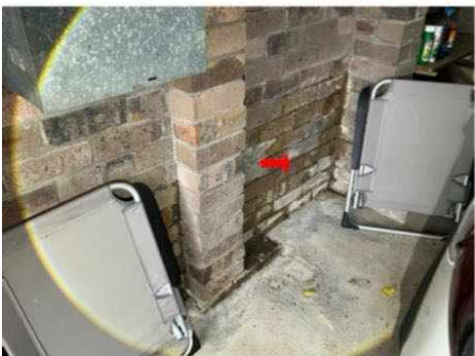
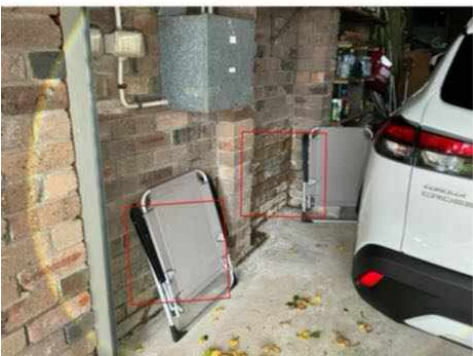
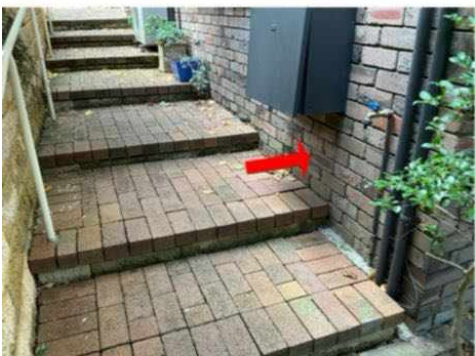
Building:	Main Building
Location:	Workshop, Downstairs Bathroom, Wine Cellar, Kitchenette, Garage
Finding:	Lateral Damp
Information:	Lateral damp was noted on this area at the time of inspection.

Lateral damp refers to moisture entering from the surrounding ground and moving sideways into the base of the wall. This often appears in walls that retain soil or are close to external ground levels. Over time, this can contribute to deterioration of internal finishes such as bubbling or peeling paint.

At this stage, no immediate rectification work is required, but the area should be monitored over the next 12 months. If any signs of bubbling paint, peeling, or further moisture staining appear along the bottom of the wall, the client is advised to engage a damp-proofing specialist to confirm whether a membrane, DPC repair, chemical injection or other moisture management works are required.

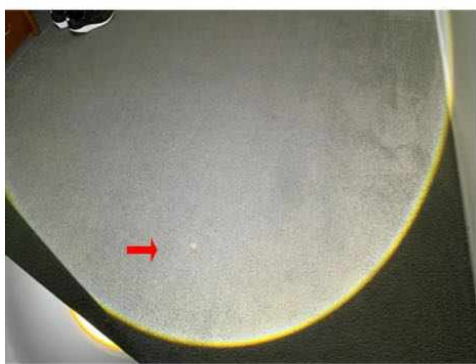
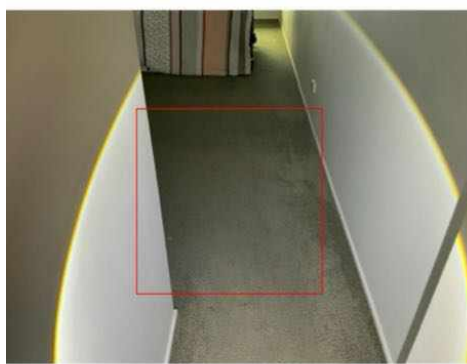
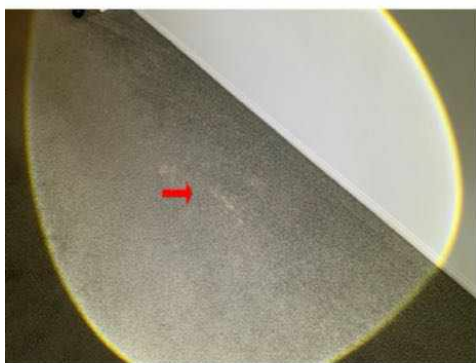
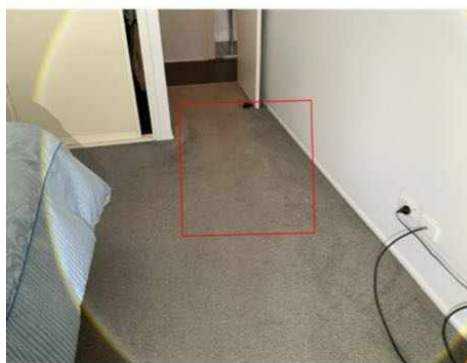
Finding 3.02

Building: Main Building  
 Location: All Areas  
 Finding: Carpet - Stained  
 Information: At the time of inspection, staining was observed on the carpet in these areas of the property.

Carpet stains can result from a range of sources, including food and drink spills, pet accidents, water intrusion, or general wear and tear from foot traffic. If left untreated, these stains may become permanent, cause unpleasant odours, and contribute to the growth of mould or bacteria, particularly in high-moisture environments.

The client is advised to engage services of a carpet cleaning company at own discretion.

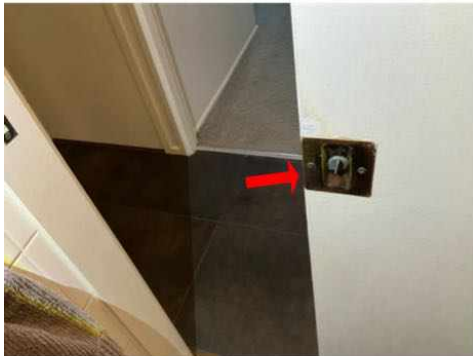
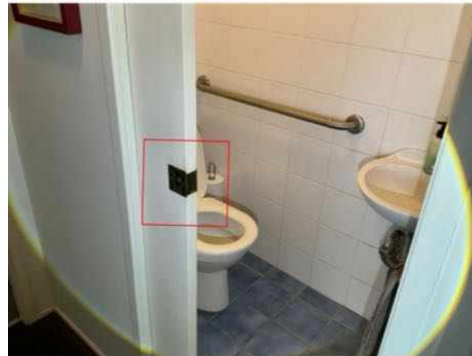
### Finding 3.03

Building: Main Building  
 Location: Toilet (WC)  
 Finding: Lock - Not working  
 Information: The lock in this area was not operational at the time of inspection. Where locks have deteriorated to a point where they are no longer usable, the security of the property is immediately compromised.

Repair or replacement of the lock is highly recommended. Consultation with a locksmith or general handyman is required to gain further advice on any added security that may be available for the area.

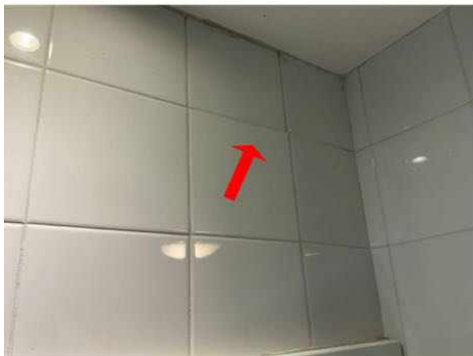
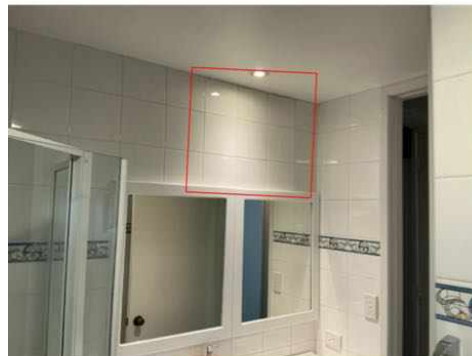
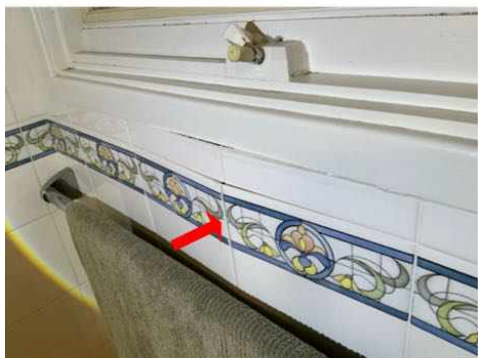
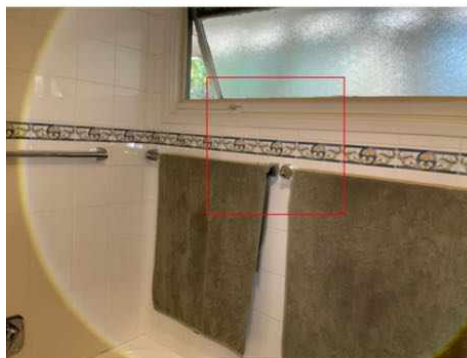
### Finding 3.04

Finding: Tiles Coming off & Deteriorating Sealant/Grout

Information: At the time of inspection, sections of tile were noted to be coming loose, with missing or deteriorated grout and sealant in the affected area. This condition may allow water to penetrate beneath the tiles, leading to potential moisture damage, mould growth, or further tile displacement. Rectification by a qualified tiler is recommended to resecure the loose tiles and reapply grout and waterproof sealant to restore the integrity of the surface.

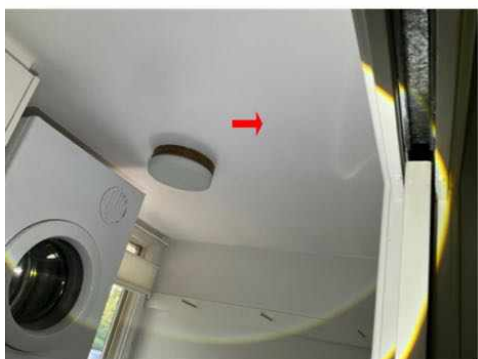
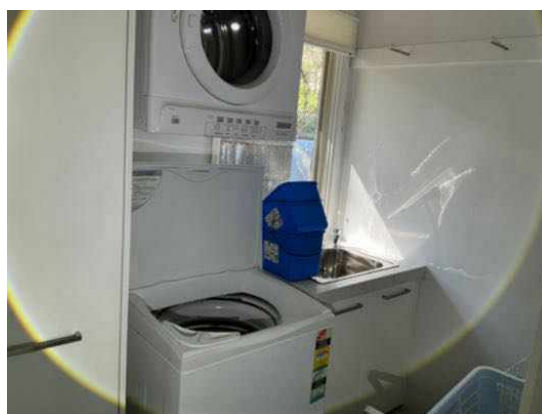
### Finding 3.05

Building:	Main Building
Location:	Laundry
Finding:	Laundry - No Exhaust Fan Installed
Information:	At the time of inspection, it was noted that the laundry area is not equipped with an exhaust fan.

The absence of mechanical ventilation in a confined space such as a laundry can lead to the accumulation of excess moisture and humidity, particularly during the use of washing machines and dryers. Over time, this can result in condensation build-up on walls and ceilings, increasing the risk of mould and mildew growth, which may cause health issues such as respiratory irritation and allergies. Additionally, persistent damp conditions can contribute to the deterioration of paint, plaster, and other building materials, potentially leading to more extensive and costly repairs.

A licensed electrician should be appointed to carry out this work to ensure the fan is installed safely and in accordance with Australian electrical standards at clients own discretion.

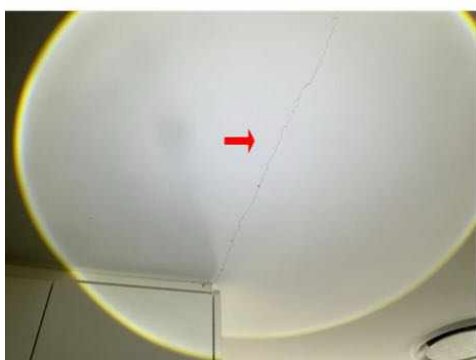
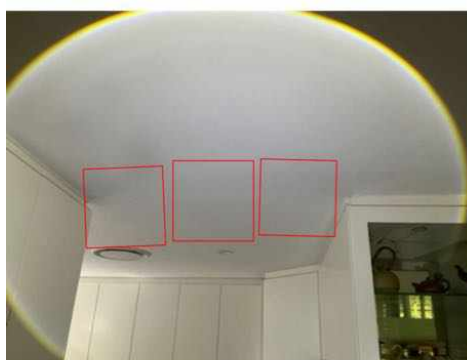
Finding: Cracking - Damage Category 1 - Fine (up to 1mm)  
 Information: Although fine cracks are quite noticeable, they are often only considered to be an appearance defect, and usually do not indicate any structural damage. Generally, the cause of a fine crack is indicative of a separation between building materials and finishes (e.g. paint, plaster, etc.) along joins.

Cracking of this nature can generally be repaired with minor sanding, filling and/or repainting. Such works should be performed by a qualified painter or a general handyman.

Monitoring of all cracking should be conducted frequently. Always contact a building inspector should cracks widen, lengthen, or become more numerous.

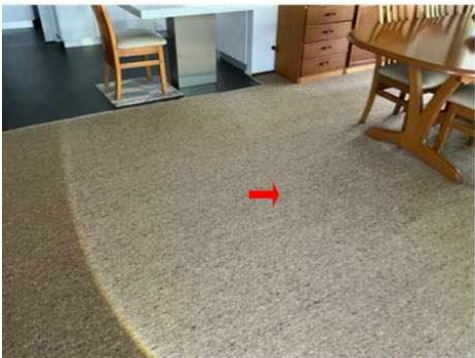
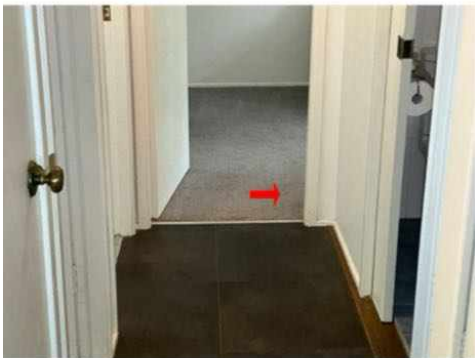
### Finding 3.07

Building: Main Building  
 Location: All Areas  
 Finding: Floors - Noisy  
 Information: The internal flooring in this area was identified as being bouncy at the time of inspection. A bouncy floor surface generally presents as a discernible change in level as they are walked across, in noisy or creaking flooring, or in consequent movement of surrounding furniture and fixtures.

Bouncy floors generally indicate that the floorboards or the subfloor structures are coming loose from the joists that they are installed on. Bouncy flooring may also be the result of gaps between flooring and stumps or joist structures, which require packing.

The client is advised to seek quotations for required repairs from a flooring specialist.

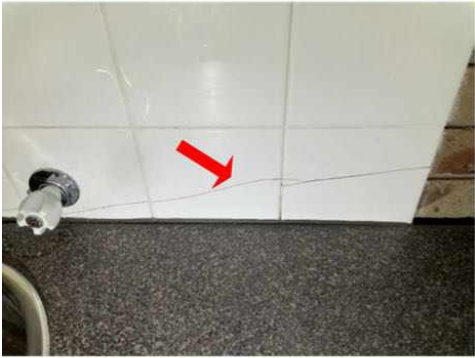
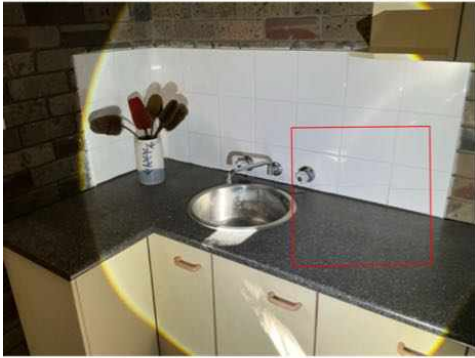
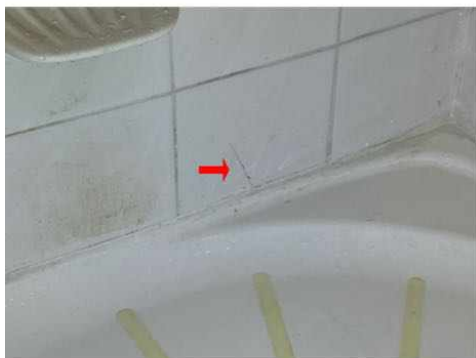
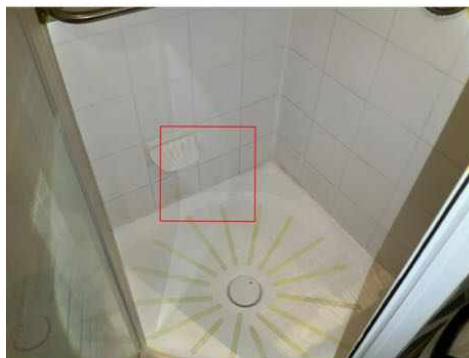
**Finding 3.08**

Building: Main Building  
Location: Bathroom Upstairs, Kitchen Downstairs  
Finding: Tiles - Cracked and/or Damaged  
Information: At the time of inspection, cracking in the tiles was evident in this area. It is suspected that this cracking has occurred as a result of minor settlement or material shrinkage.

While the cracking appears to be minor, this area may be exposed to water, allowing potential for water penetration into adjoining sections of walls or flooring. In wet areas particularly, cracked or compromised tiles can allow moisture to bypass the surface finish and place additional stress on the underlying waterproofing membrane. Over time, this may contribute to deterioration of the waterproofing system and shorten its effective service life.

While not considered a matter of urgency, replacement of cracked floor tiles is recommended at the client's discretion, particularly in wet areas to preserve the integrity and longevity of the waterproofing system. A licensed tiling contractor may be appointed to perform these works.

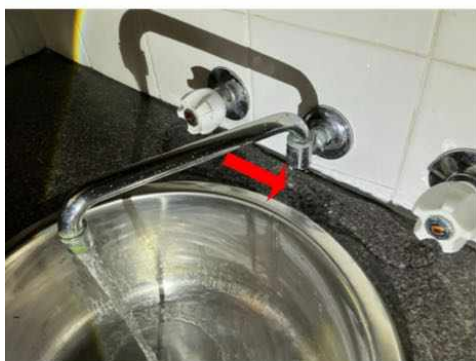
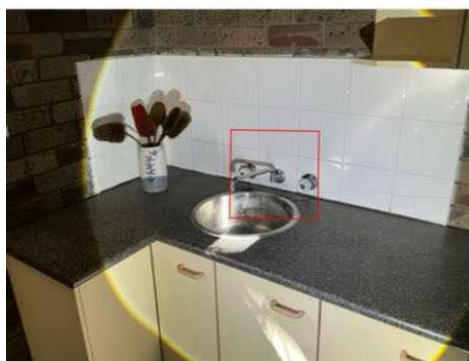
### Finding 3.09

Finding: Plumbing Fixture - Leaking

Information: A plumbing fixture was observed to be leaking at the time of inspection, likely due to factors such as worn or damaged seals, improper installation, corrosion of components, or high water pressure causing strain on the connections. Regular use or building vibrations may have also contributed to the fixture becoming loose over time. This issue requires prompt attention to prevent water wastage or potential damage. It is recommended to engage a licensed plumber to inspect the fixture, and carry out the necessary repairs or replacements to ensure proper functionality.

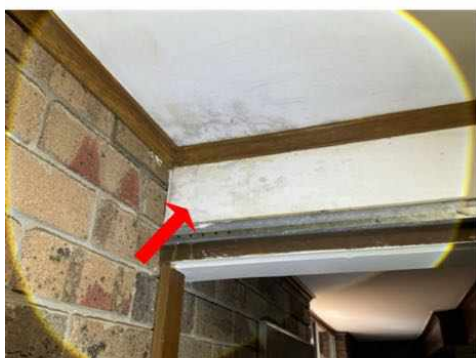
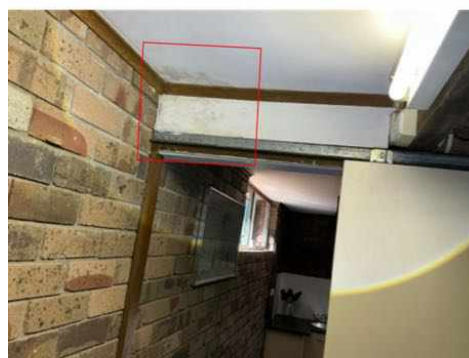
### Finding 3.10

Finding: Moisture and Mould Growth – Ceiling (Wine Cellar Room)

Information: At the time of inspection, moisture staining and visible mould growth were noted on the ceiling within the wine cellar room. This condition indicates prolonged moisture exposure to the affected area. The location of the staining corresponds with external and wet areas above, including the porch and the upstairs bathroom.

Such conditions may be associated with water ingress from above or lateral dampness affecting the structure over time. If left unaddressed, this may lead to further deterioration of building materials and potential health concerns due to mould presence.

It is recommended that the client engage a damp-proofing specialist to inspect the external areas above and surrounding the affected location and carry out appropriate rectification works to prevent further moisture ingress. Additionally, if required, a licensed plumber should be engaged to inspect and address any issues related to the bathroom plumbing or shower area above.

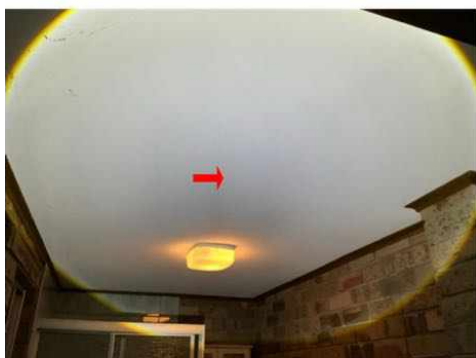
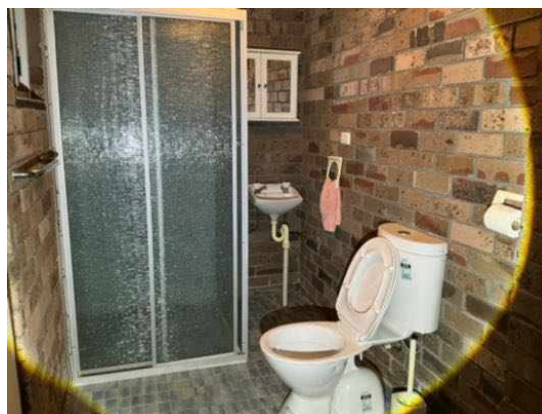
### Finding 3.11

Building:	Main Building
Location:	Downstairs Bathroom
Finding:	Exhaust Fan Missing - Bathroom
Information:	At the time of inspection, an exhaust fan was found to be missing in the bathroom.

Adequate ventilation is essential in wet areas to prevent moisture build-up, which can lead to mould growth, dampness, and potential damage to fixtures and finishes.

It is recommended that a licensed electrician be engaged to install a compliant exhaust fan to improve air circulation and maintain healthy indoor air quality.

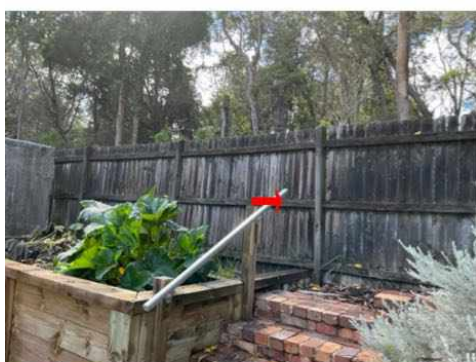
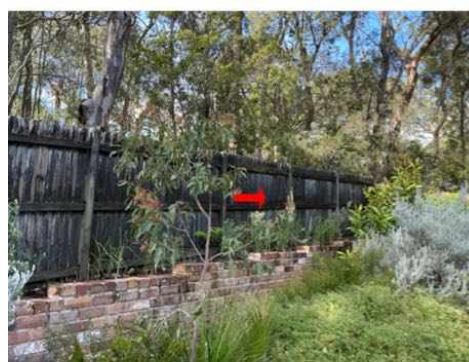
### Finding 3.12

Building:	Main Building
Location:	Fencing
Finding:	Fencing - Deteriorated
Information:	At the time of inspection, sections of the timber fencing were noted to be in a deteriorated condition, with visible signs of weathering, rot, and general ageing. This deterioration may compromise the structural integrity and intended function of the fence, including privacy, security, and containment. It is recommended that the affected sections be repaired or replaced by a qualified fencing contractor to ensure safety and maintain boundary integrity.

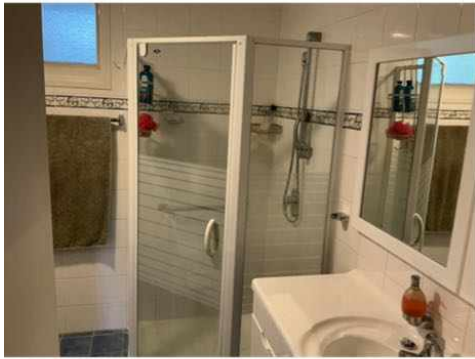
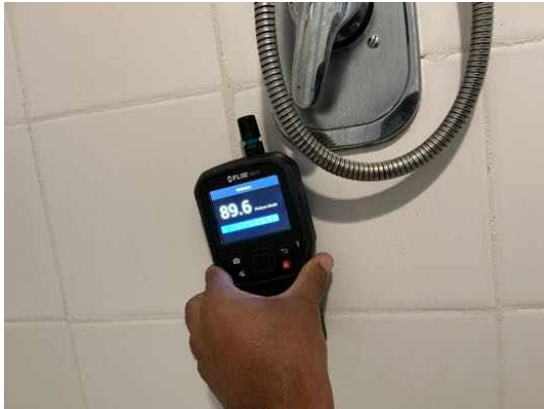
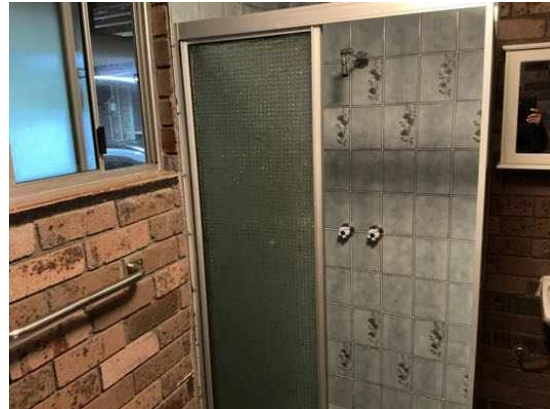
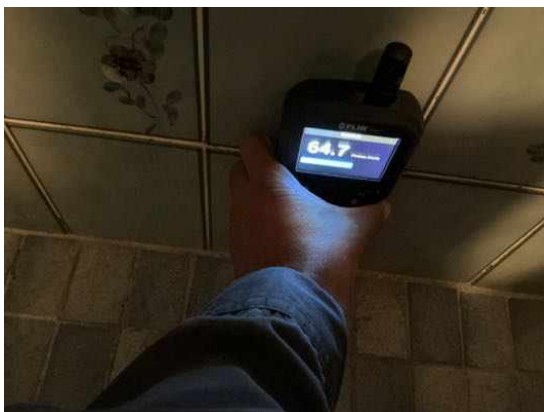
### Finding 3.13

Building:	Main Building
Location:	Both Bathrooms
Finding:	Excessive Moisture - Shower Damp
Information:	At the time of inspection, excessive moisture was noted within the shower area, which is a common issue in wet areas due to the continual exposure to water. This condition is typically caused by moisture seeping through grout lines and settling behind tiles, resulting in localised high-moisture zones. Provided there is no evidence of water staining or elevated moisture readings on the opposite side of the wall, this is considered a minor defect.

However, persistently damp conditions may act as conducive conditions for termite activity, as termites are strongly attracted to moisture-rich environments. It is recommended that the client ensures regular use of the exhaust fan and maintains adequate ventilation after shower use to promote drying and reduce long-term moisture build-up, thereby also reducing the risk of attracting termites.

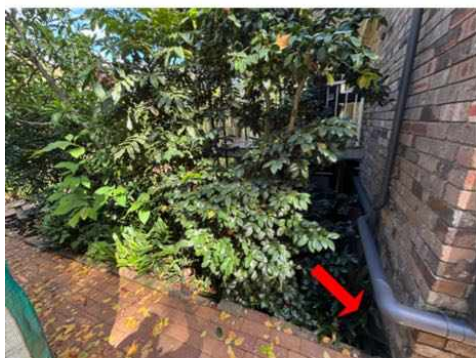
If the slab edge is not properly exposed there is a high risk of termite attack. Sometimes, in order to determine the type of slab, a suitably qualified person such as an architect or builder may be required to consult the construction plans.

Where the slab edge cannot be properly inspected, it is highly recommended that termite or timber pest inspections be carried out every 6-12 months to aid protection of the property against infestation.

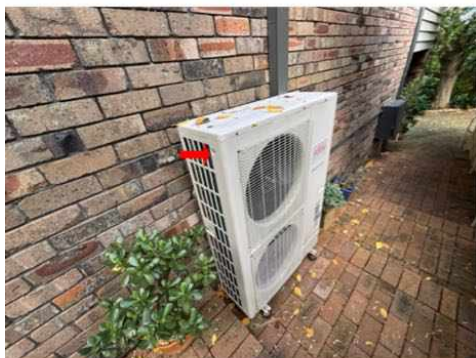
## Finding 6.02

Building:	Main Building
Location:	All Areas
Finding:	Bridging Appliances - Attachment to Buildings
Information:	Bridging occurs when items against a building provide a concealed entry point for termites into the building or by passing around a termite management system.

Where any part of an attachment to a building is not isolated and is not provided with a clear gap of not less than 25mm from the building, bridging occurs. Attachments to buildings such as hot water services, downpipes, verandahs, decks, steps, fences, service conduits and the like provide the opportunity for concealed entry.

Building attachments of this nature need to be frequently inspected for termite activity by a qualified inspector.

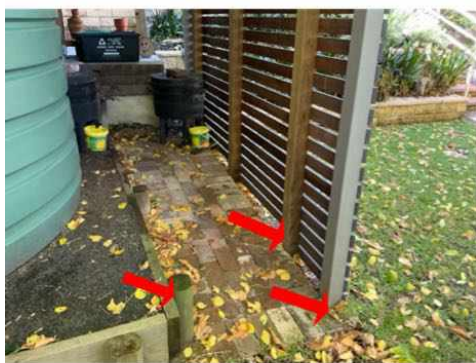
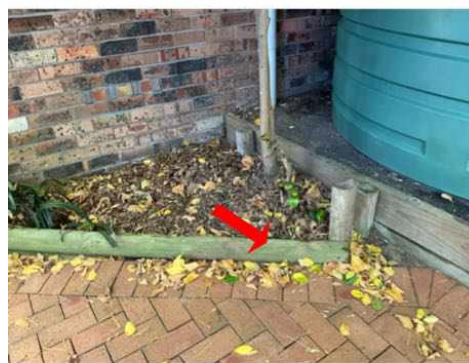
### Finding 6.03

Building:	Yard
Location:	All Areas
Finding:	Building Materials in Direct Ground Contact - Conducive to Termites
Information:	Timber elements that are in direct contact with the ground and exposed to moisture or damp conditions are highly conducive to termite activity. This susceptibility arises because timber, when in contact with soil and dampness, creates an environment that is particularly attractive to termites, encouraging infestation and potential structural compromise. Whether the timber is used as a part of the building's construction or incorporated into fencing, its presence near or on the ground can become a pathway for termites to access and damage the property.

When exposed to excessive moisture, timber begins to deteriorate, developing conditions such as wood decay and rot. These compromised areas of timber are even more appealing to termites, as they are easier to infest and consume. This is especially true for untreated or non-durable timber, which lacks the protective treatments that can deter or withstand termite attacks. Termites can use these weakened, moisture-laden elements as a bridge into other parts of the structure, creating an entry point for potential infestations that can spread and cause extensive damage if left unchecked.

For any timber in direct contact with the external ground, special attention is required. The combination of moisture, untreated wood, and direct ground contact not only accelerates the decay process but also provides subterranean termites with a straightforward means of ingress into the structure. This entry can lead to termites moving undetected into other vulnerable areas, resulting in potentially significant structural issues and costly repairs.

To mitigate the risk of termite activity, it is imperative that any such materials or timber elements be appropriately treated or removed as soon as possible. Timbers that are necessary for use should be made durable through appropriate treatments and maintained to ensure they do not create conditions conducive to termites. Additionally, the client is advised to schedule regular termite treatments to maintain an effective barrier against infestations and ensure ongoing protection.

The client is strongly advised to assess the property for any timber elements that may be in direct contact with the ground and ensure prompt action is taken to remove or treat them effectively. Regular inspections, proactive maintenance, and consistent termite treatment are essential steps in minimising the risk of termite attack and protecting the structural integrity of the property. Taking these preventive measures is crucial for maintaining a termite-free environment and avoiding potentially costly damage and future repairs.

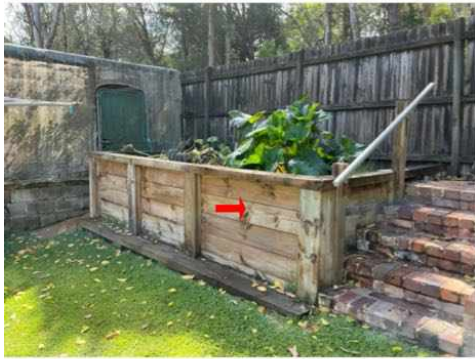
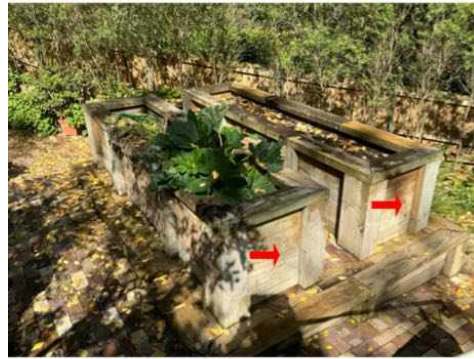
#### Finding 6.04

Building:	Yard
Location:	Yard - Back
Finding:	Garden Beds - Conditions Conducive to Termites
Information:	During the inspection, garden beds were observed in the garden area. It is important to note that these garden beds may contain untreated timber, which, when combined with the regular moisture from watering or rain, can create conditions conducive to termite activity. The constant exposure to moisture softens the timber, making it more attractive to termites and increasing the risk of termite ingress into nearby structures.

Garden beds situated close to the property, especially those containing untreated timber, can pose a significant risk by providing termites with easy access to building elements. The proximity of moisture and untreated wood creates an ideal environment for termites to thrive and potentially infiltrate the building, leading to costly damage if left unaddressed.

It is highly recommended that the client consider replacing untreated timber with treated materials, stone, or other termite-resistant alternatives. Furthermore, ensuring proper drainage around the garden beds and keeping them well-maintained will help reduce moisture buildup. Regular inspections by a pest control professional are also advised to monitor for any signs of termite activity and to take preventative measures as necessary. This will help protect the property from the risk of termite infestation and maintain the overall integrity of the structure.

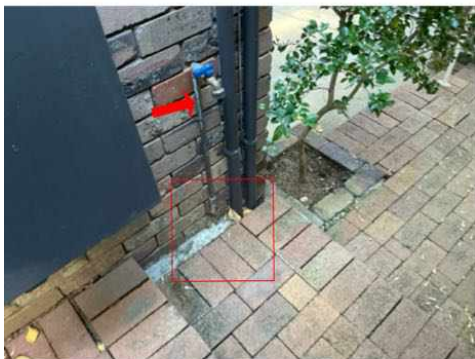
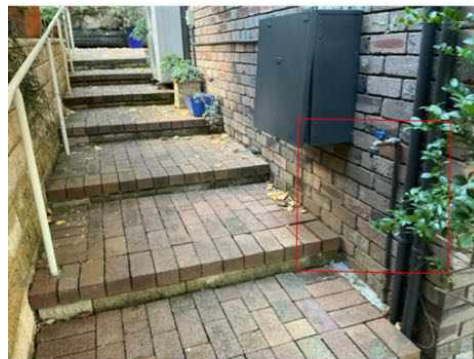
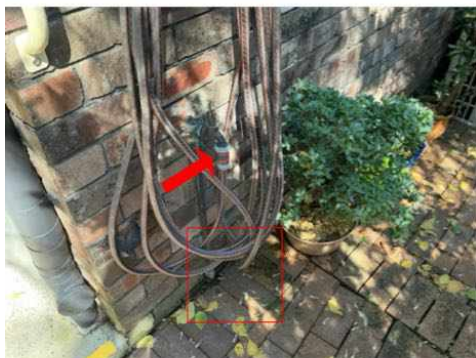
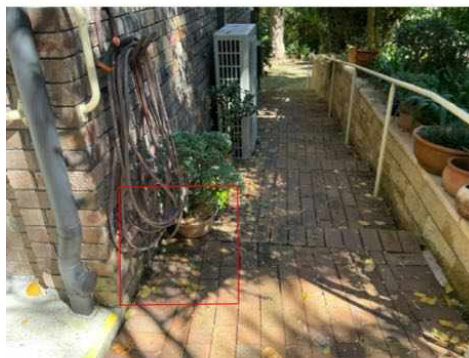
### Finding 6.05

Information: The inspection identified that the exterior tap is not connected to a stormwater drainage system, allowing water to pool around the base. This can lead to moisture-related issues such as deterioration of nearby building materials, mould growth, and increased risk of termite activity—each of which may compromise the property's structural integrity and create health or safety concerns.

To prevent these risks, it is strongly recommended that a licensed plumber be engaged to assess the area and install appropriate drainage, such as a stormwater connection or splash block, to redirect water away from the property. Ongoing maintenance and monitoring of external water sources are also advised to ensure long-term protection.

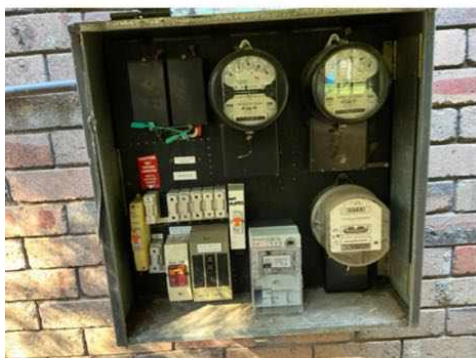
## Finding 6.06

Building:	Main Building
Location:	Meter Box
Finding:	Termite Management System - No Evidence of Installation
Information:	The application of a post-construction chemical termite barrier is strongly recommended for all properties, especially if there has been any history of live termite activity on-site. These barriers are highly effective in protecting timber building elements throughout the property by preventing termite attacks. It is also advisable to install a durable notice within the switchboard unit, indicating the presence of any termite barriers for future reference.

During the inspection, there was no indication that a termite management system had been installed, nor was there any evidence to suggest that preventative measures had previously been undertaken. The client is encouraged to seek further advice from a licensed pest controller regarding the costs and procedures involved in the application of a termite barrier. Prioritizing this step in the short term is strongly advised to ensure long-term protection.

Additionally, the client may want to consult with the vendor to determine whether regular Timber Pest inspections, as per AS4349.3 or AS 3660.2, have been conducted in the past. This will provide further insights into any past termite management practices and help inform the appropriate course of action.

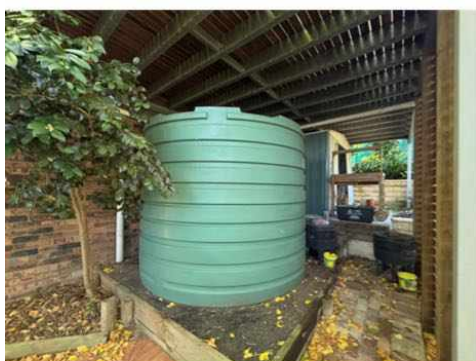
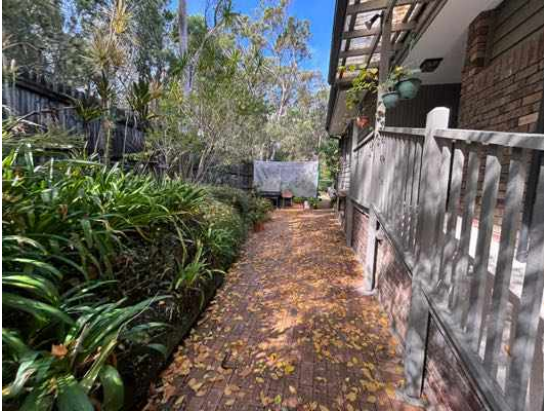
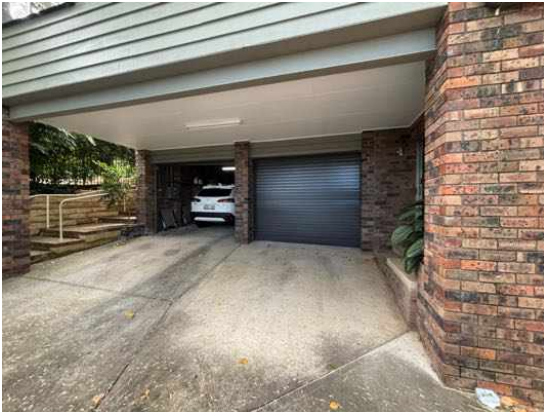
Building:	Main Building
Location:	All External Areas
Finding:	Obstructions and Limitations - External Areas
Information:	The attached photographs provide a visual representation of the obstructions and limitations that impeded a full inspection of the external areas of the property at the time of assessment. These obstructions, which may include vegetation, stored items, debris, or other physical barriers, can obscure potential defects and prevent a thorough evaluation of the property's condition. Obstructions of this nature can conceal a wide range of issues, such as structural damage, water ingress, pest infestations, or deteriorating building materials, which may not be visible during the initial inspection.

It is essential that these obstructions be cleared to allow for a comprehensive inspection of the external areas. Removing these barriers will enable a more accurate assessment of the property's condition and allow any hidden defects to be identified and addressed promptly. Failure to do so could result in undetected issues worsening over time, potentially leading to more costly repairs in the future.

Therefore, it is strongly recommended that the obstructions be removed and a re-inspection be scheduled once the affected areas are made fully accessible. This will ensure a complete evaluation of the property's exterior and provide the client with a clear understanding of any potential issues that may have been concealed during the initial inspection.

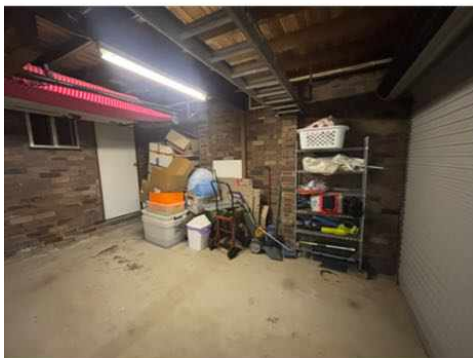
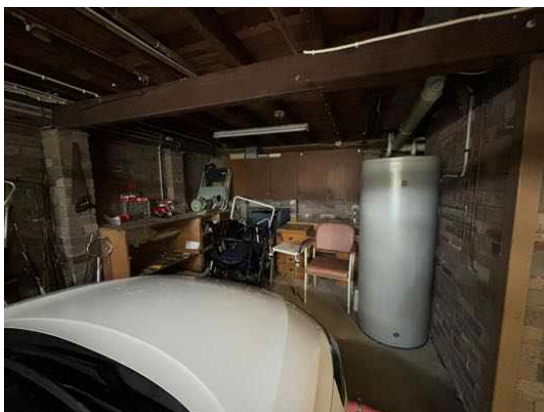
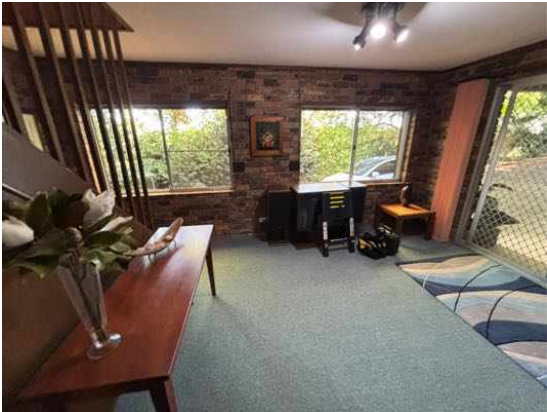
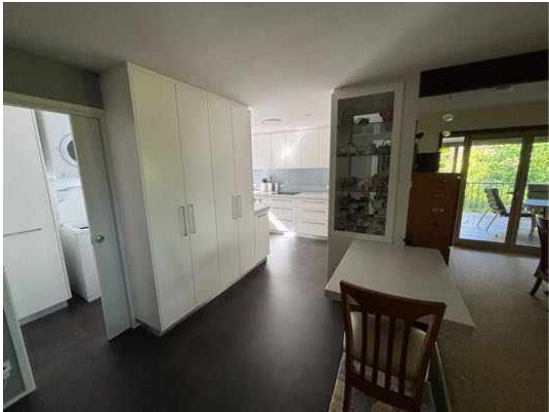
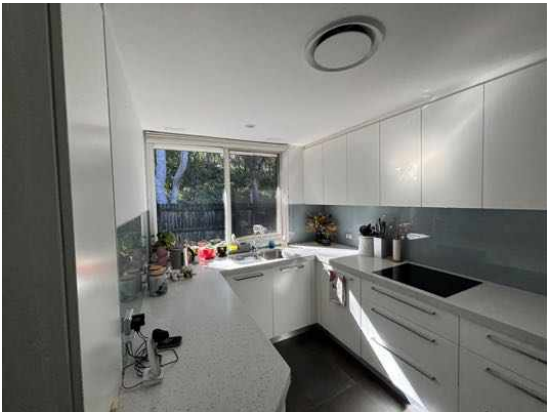
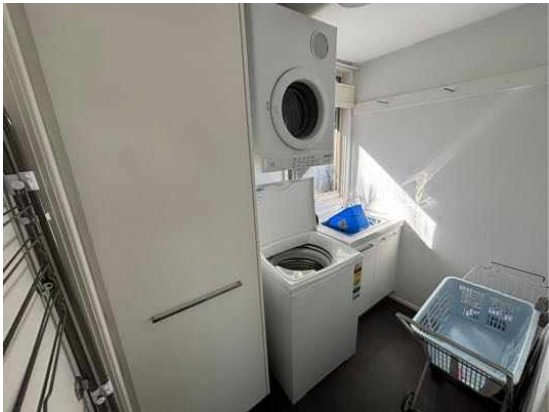
Building:	Main Building
Location:	All Internal Areas
Finding:	Obstructions and Limitations - Internal Areas
Information:	The accompanying photographs provide clear evidence of the obstructions and limitations that restricted a comprehensive inspection of the internal areas of the property at the time of assessment. These obstructions, which may include furniture, personal belongings, stored items, or structural elements such as wall coverings and built-ins, significantly hindered the ability to thoroughly evaluate these areas. It is important to note that such obstructions can potentially conceal a wide array of defects, ranging from hidden structural damage, water leaks, pest infestations, or

electrical issues, to deteriorating materials that may not be visible during the initial inspection.

The presence of these impediments means that critical areas of the property were not accessible, and therefore, any underlying defects that may affect the integrity and safety of the property could remain undetected. These hidden defects, if left unaddressed, could worsen over time and may result in costly repairs or pose potential safety hazards to the occupants.

It is highly recommended that all obstructions be cleared to facilitate a complete and thorough inspection of the internal areas. Once the obstructions have been removed and full access is available, a re-inspection should be carried out to ensure that any previously concealed issues can be properly identified and rectified. This follow-up inspection will provide a more accurate assessment of the property's internal condition and help the client make informed decisions about any necessary repairs or maintenance.

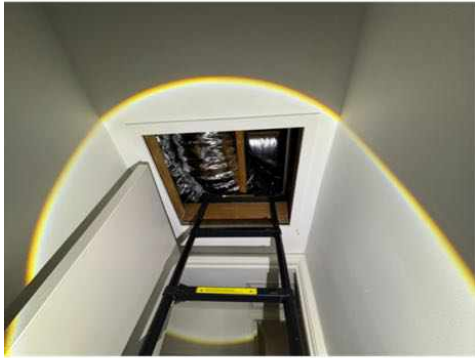
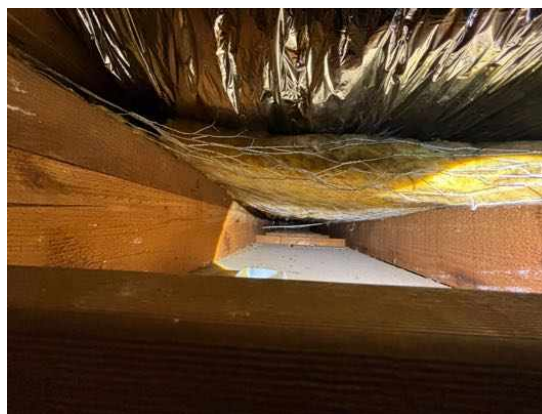
Building: Main Building  
 Location: Roof Void  
 Finding: Obstructions, Limitations, and General Roof Space Condition  
 Information: The photographs provided document both the general condition and the obstructions and limitations that were present in the roof cavity of the main building at the time of inspection. These obstructions—such as insulation materials, stored items, structural elements, or electrical wiring—restricted safe and adequate access to key areas within the roof space. As a result, a comprehensive inspection of all components could not be completed.

Obstructions of this nature may conceal a variety of potential defects, including

damaged framing, compromised insulation, evidence of moisture ingress, pest activity, or electrical hazards. While no major issues were observed in the visible areas, the presence of these limitations means that some defects may remain undetected.

It is recommended that these barriers be removed or repositioned to facilitate full and safe access to the roof space. Once clear, a follow-up inspection should be conducted to allow for a thorough assessment of all concealed areas. This will help ensure that the condition of the roof cavity is accurately evaluated and any hidden issues are appropriately identified and addressed.

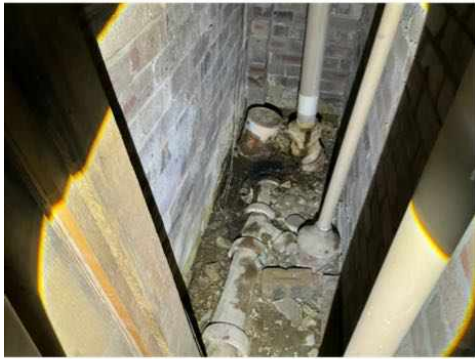
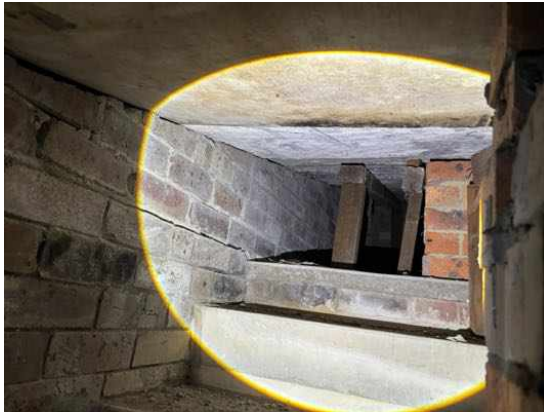
Building: Main Building  
 Location: Subfloor  
 Finding: Obstructions, Limitations, and General Subfloor Condition  
 Information: The attached photographs illustrate the obstructions and access limitations that restricted a full inspection of the subfloor area of the main property at the time of assessment. Items such as stored materials, construction debris, low-hanging services, and insulation impeded movement and visibility within key sections of the subfloor. In addition, the limited crawl height further restricted safe access to inspect critical structural components.

Restricted access and confined spaces can significantly hinder the ability to evaluate important elements such as floor joists, bearers, stumps, drainage, subfloor ventilation, and signs of moisture or pest activity. These obstructions may also conceal defects such as timber decay, water ingress, termite damage, inadequate support, or ventilation issues that are not immediately visible during a limited inspection.

While no major concerns were identified in the accessible areas, a full and unobstructed inspection is necessary to properly assess the overall condition of the subfloor. It is recommended that obstructions be removed and access improved where possible. Once adequate clearance is provided, a re-inspection should be arranged to ensure that any concealed defects can be identified and addressed accordingly. This will assist in providing a more comprehensive understanding of the subfloor's condition and reduce the risk of unforeseen issues.

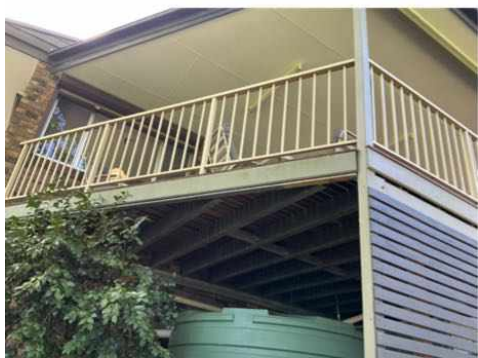
You should also arrange annual inspections of the structure by an engineer or other suitably qualified person to ensure any maintenance, that may become necessary, is identified. Care must be taken not to overload the structure.

Nothing contained in this report should be taken as an indicator that an assessment has been made, on any elevated structure, as suitable for any specific number of people or purpose. This can only be done by a qualified engineer. For the purpose of this report, the Structure includes elevated decks, verandah, pergolas, balconies, handrails, stairs and children's play areas.
