# Building and Timber Pest Inspection Report

Inspection Date: Fri, 27 Mar 2026

Property Address: 9 King St, Berowra NSW 2081, Australia

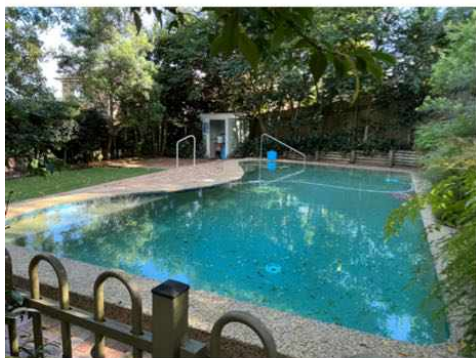
Building:	Main Building
Location:	Pool Area
Finding:	FYI - Pool Area
Information:	This inspection explicitly excludes any assessment of the pool, spa, associated pool equipment, and the surrounding areas. As a standard building inspection does not encompass these elements, it is crucial for the client to understand that no evaluation has been conducted regarding the condition, functionality, or safety compliance of the pool or its associated systems. This includes, but is not limited to, pumps, filters, heating equipment, and structural integrity of the pool or spa surrounds.

To gain a comprehensive understanding of the condition and compliance of these components, it is highly recommended that the client engages a specialist pool inspector. A pool inspection will evaluate the structural condition of the pool, ensure the functionality of all associated equipment, and assess whether the pool and its surroundings meet current safety regulations. In particular, pool safety requirements, including fencing and access controls, are subject to stringent regulatory standards, which must be verified separately by a qualified pool inspector.

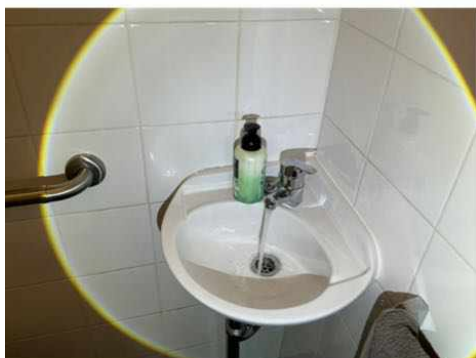
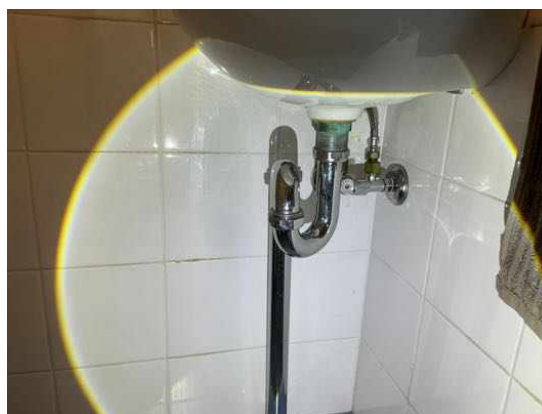
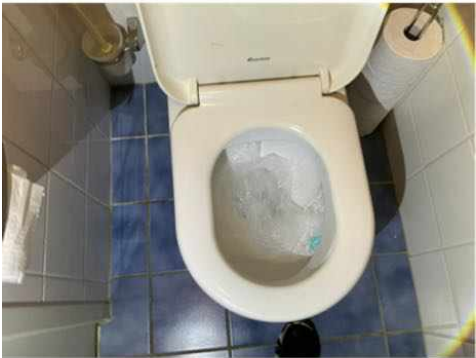
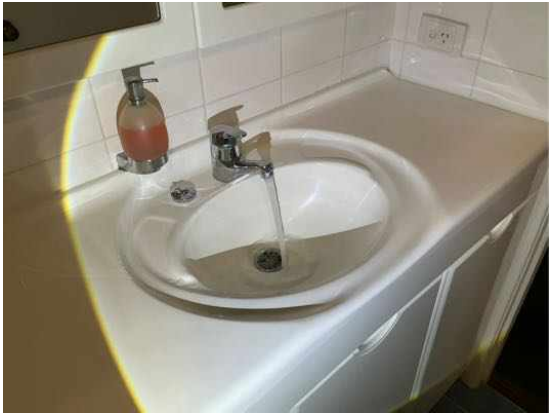
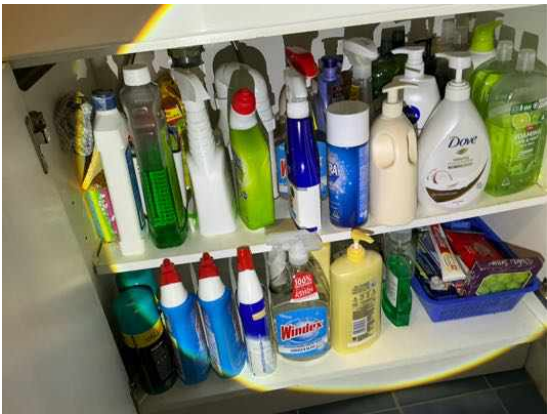
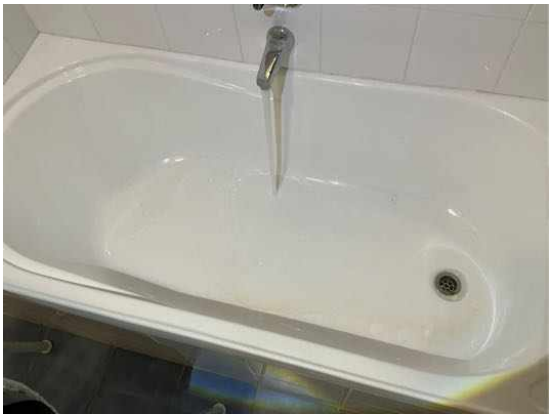
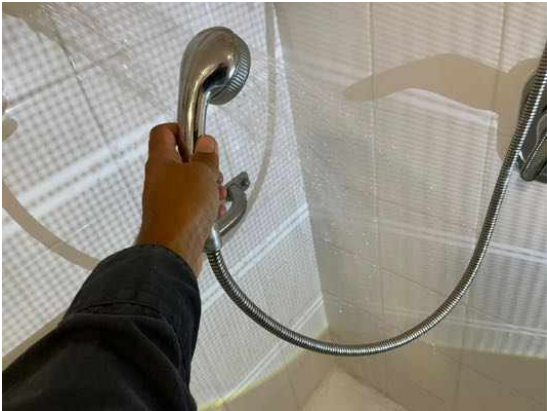
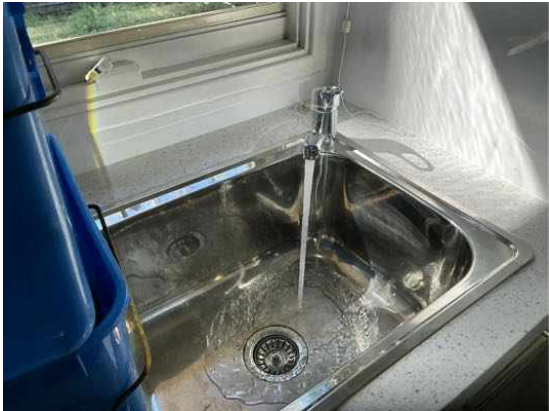
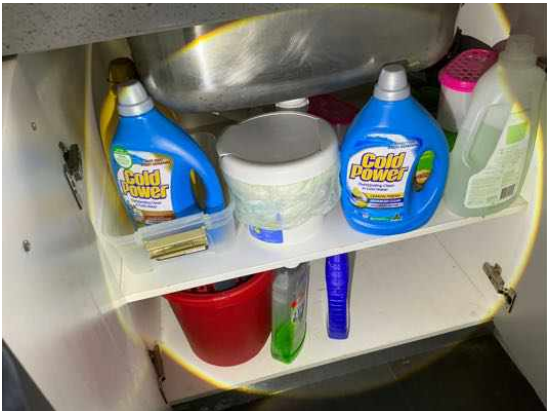
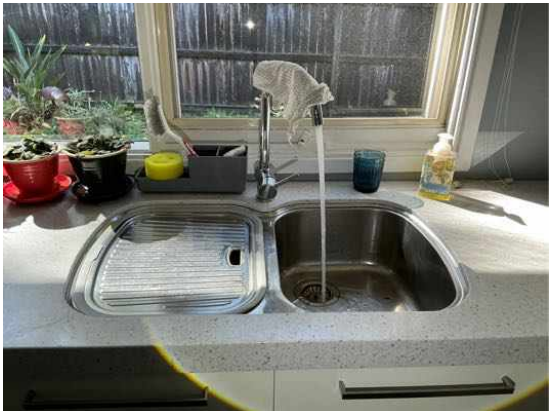
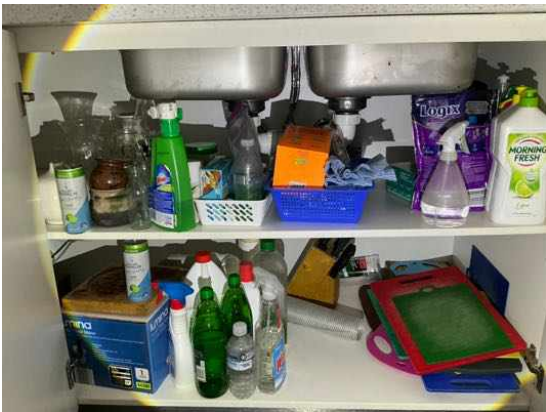
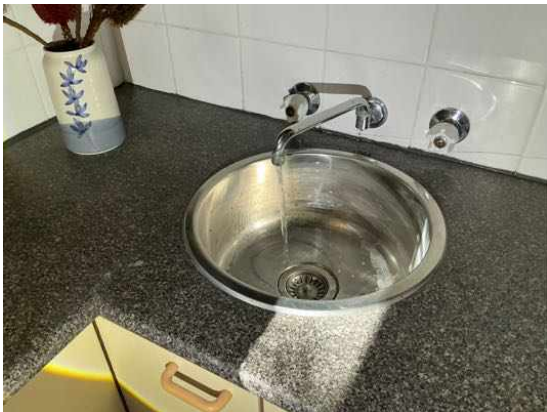
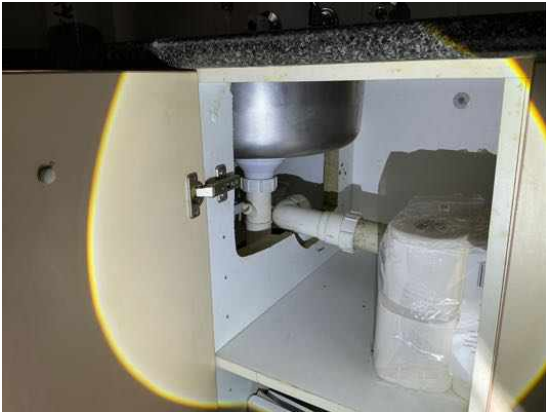
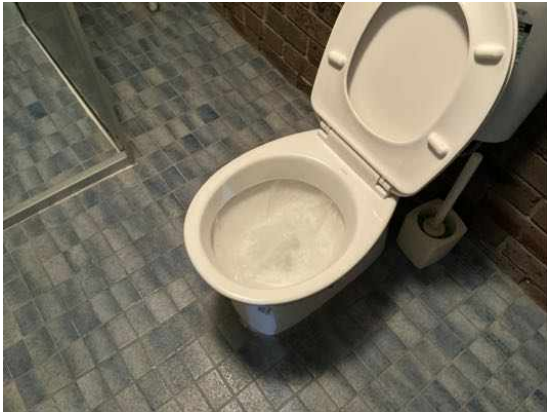
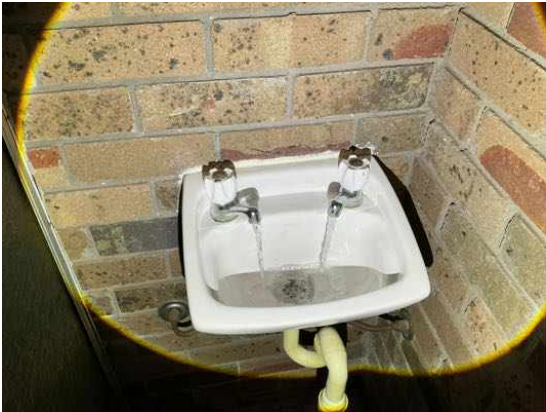
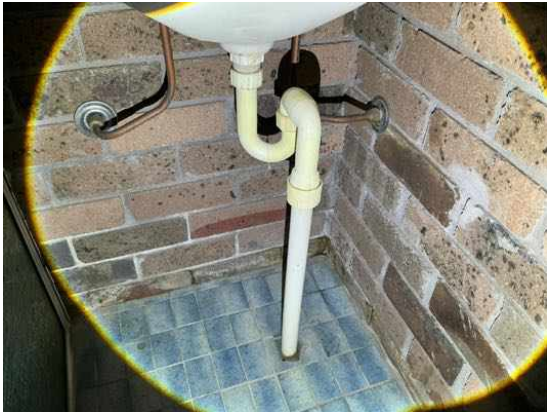
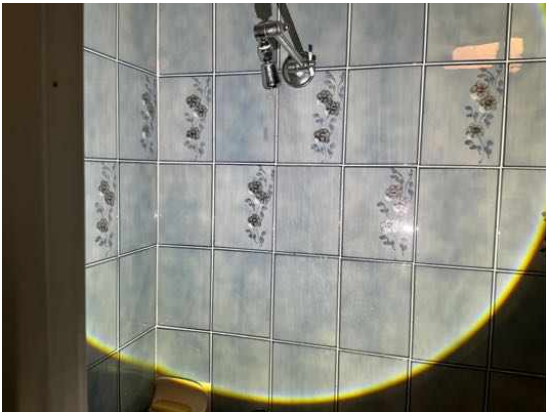
Building:	Main Building
Location:	All Areas
Finding:	FYI - Taps, Drainage & Toilets Tested and Cabinetry Obstructions
Information:	During the inspection, all accessible taps, drainage systems, and toilets were tested for water flow and drainage efficiency, and checked for any visible signs of leakage. At the time of the inspection, no issues were noted in these areas. Unless highlighted in a separate defect statement, no immediate remedial work appears necessary. Supporting images may be found in the additional photos section for reference.

It is important to note that while a visual inspection of cupboards and cabinetry beneath sinks and vanities was undertaken, stored personal items and fixtures presented obstructions that limited full visibility of the internal areas. As per standard inspection practices, inspectors are not permitted to move or disturb personal belongings during the inspection process. Therefore, only visible and accessible sections were inspected, and concealed water damage or plumbing defects may not have been detected.

Given this, a re-inspection is recommended after all obstructions have been cleared to allow for a comprehensive assessment of these areas. Regular maintenance and monitoring of plumbing and drainage systems is also advised to ensure ongoing functionality and early detection of potential issues.

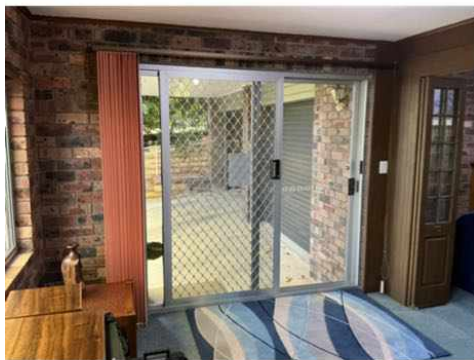
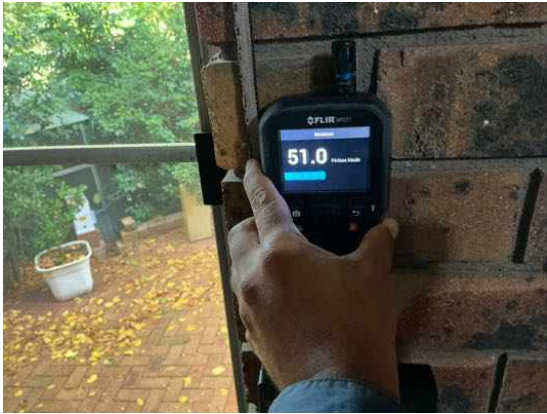
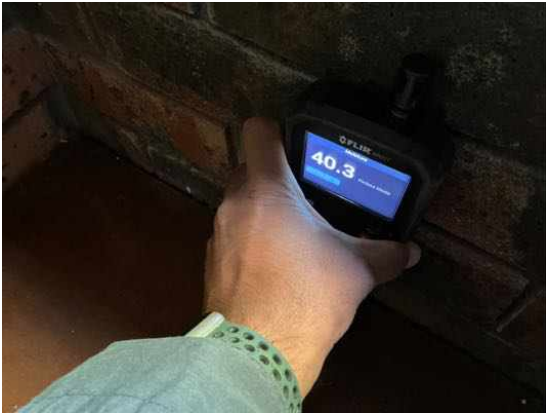
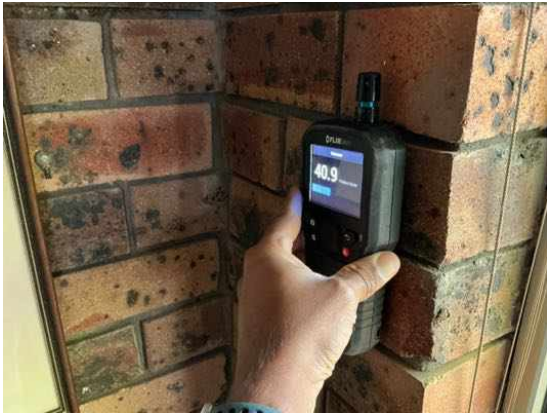
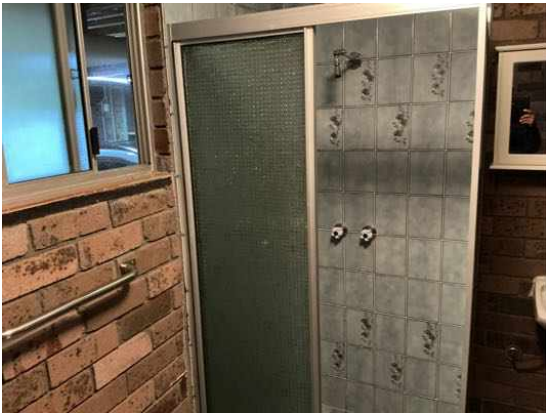
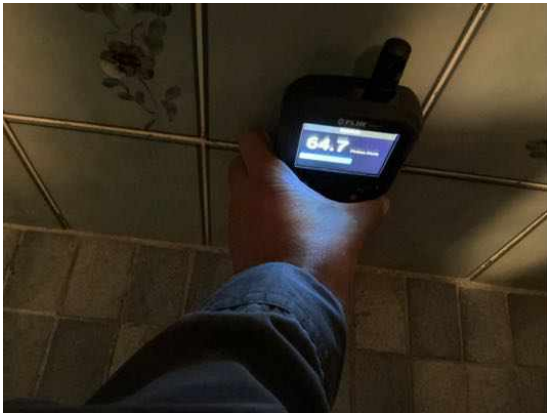
Building: Main Building  
Location: All Areas  
Finding: Additional Photos - Moisture Meter Readings  
Information: Additional moisture meter reading photos have been provided for the property to offer further clarity on areas tested during the inspection. These photos are intended to give a visual reference for the specific locations where moisture levels were measured. These readings were taken at the time of the inspection to assess any potential moisture-related issues within the property. Any defects related to moisture that were identified during the inspection have been separately mentioned in the defect statements within the report.

It is important for the client to understand that moisture levels can fluctuate over time due to various factors, including changes in weather, humidity, and environmental conditions. While the readings reflect the property's moisture levels during the inspection, they may not represent future conditions, and increased moisture could lead to issues such as dampness, mould growth, or deterioration of building materials if left unmonitored.

For further clarification or additional information regarding the moisture readings, the client is encouraged to contact the building inspector directly. Regular monitoring of moisture-prone areas is recommended to ensure any emerging concerns are addressed promptly, particularly during wetter seasons or in high-humidity conditions.

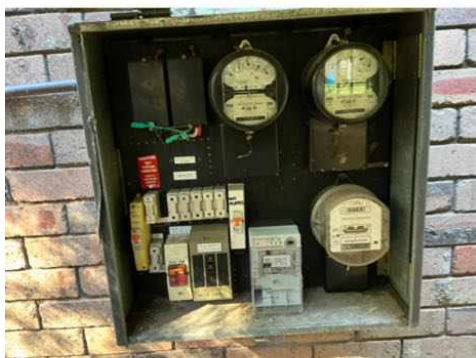
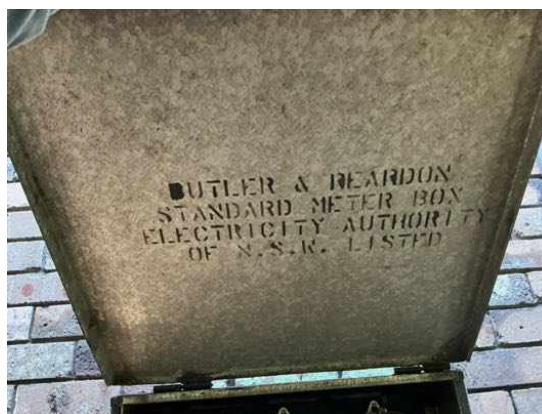
Noted Item

Building:	Main Building
Location:	Meter Box
Finding:	Termite Management Recommendation – No Evidence of Chemical Installation
Information:	At the time of inspection, there was no visible evidence of a chemical termite management system installed around the property. Chemical barriers are a key component of termite protection and are particularly important in preventing concealed termite entry into timber elements of the structure.

In accordance with standard requirements, a durable notice should be located within the electrical switchboard to detail any termite protection systems applied, including chemical treatments. No such notice was observed during the inspection.

It is recommended that the client engage a licensed pest controller to assess the suitability of installing a chemical barrier, and to provide advice on associated costs and procedures. This should be considered a short-term priority, particularly if the property has any history of termite activity or is located in a high-risk area.

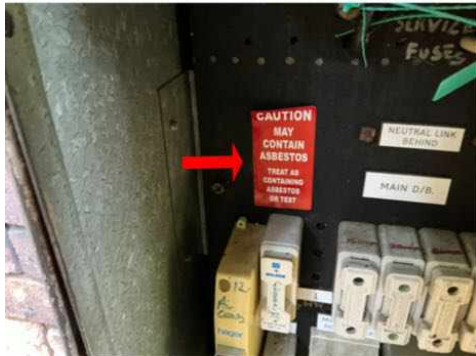
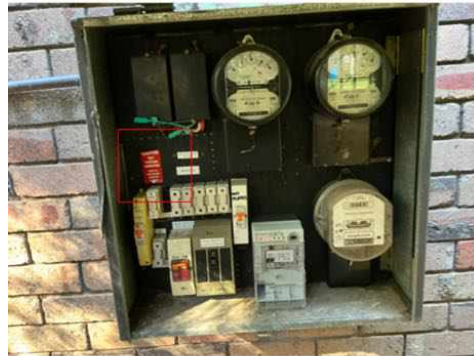
## Noted Item

Building:	Main Building
Location:	Meter Box
Finding:	Asbestos - Suspected ACM Identified on Site
Information:	Reporting on Asbestos is outside the Scope of this Report. This suspected defect is highlighted as a caution only. We suspect, based on our experience in the building industry, that there is a higher risk of the identified building element containing asbestos.

a separate Asbestos Inspection and Condition Audit, which can include the taking of samples for definitive confirmation of the presence of Asbestos.

In the interim, the client is advised to act with caution, especially when considering any damage to building materials general wear and tear renovations extensions demolition and general maintenance activities due to the suspected presence of Asbestos.
