Building and Timber Pest Inspection Report

Inspection Date: Tue, 24 Feb 2026

Property Address: 1/2 Hatton St, Ryde NSW 2112, Australia

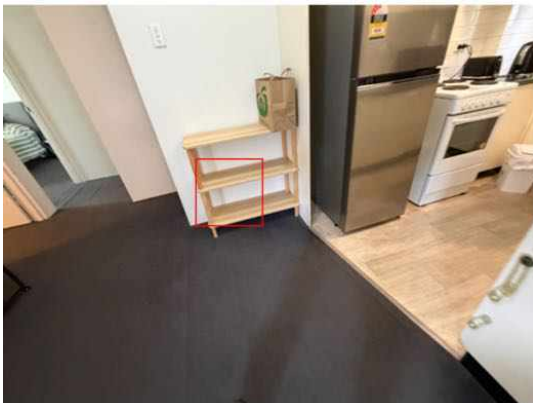
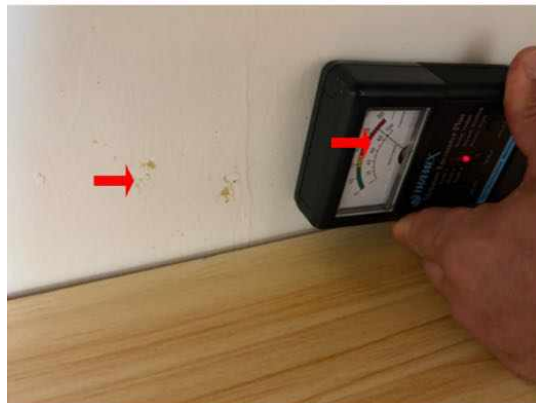
Finding: Water leak - Internal

In extreme cases, structural damage may develop due to a prolonged water leak. It is highly advised that a bathroom specialist be appointed urgently for rectifications.

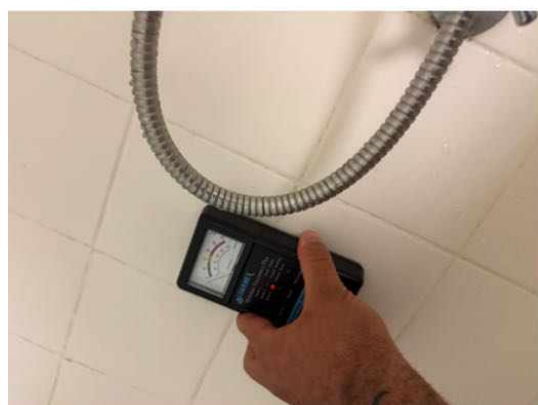
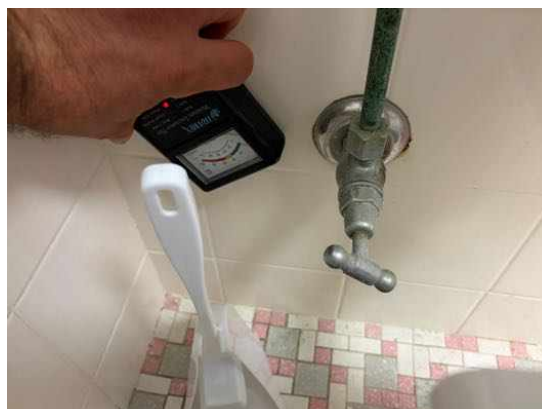
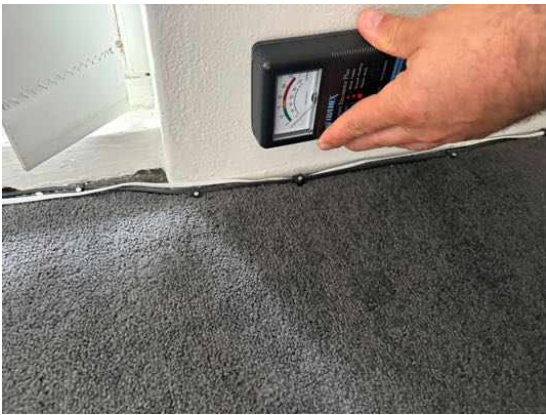
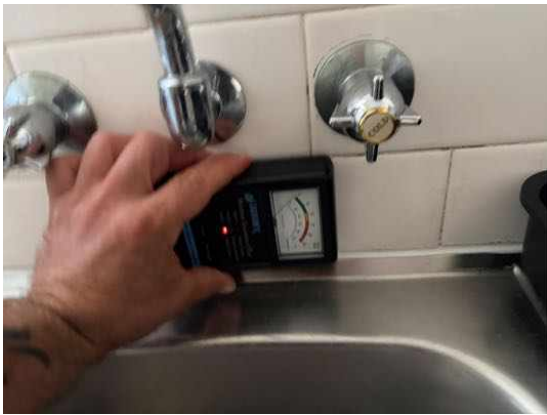
Building: Main Building
 Location: All Areas
 Finding: Moisture metre
 Information: During the inspection the property was checked for moisture using a moisture metre.
