# Building and Timber Pest Inspection Report

Inspection Date: Tue, 17 Mar 2026

Property Address: 40 Edgeware Rd, Aldgate SA 5154,  
Australia

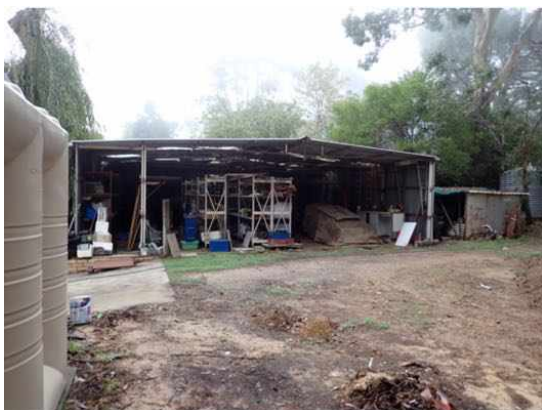
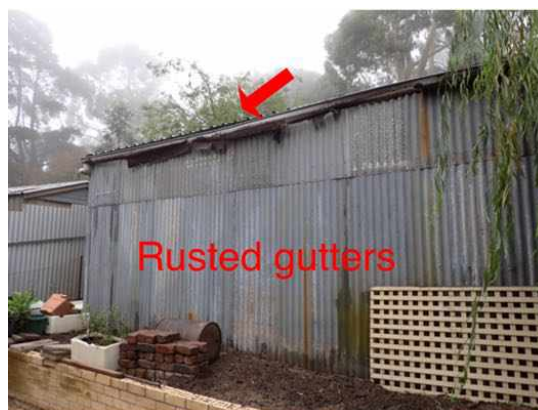
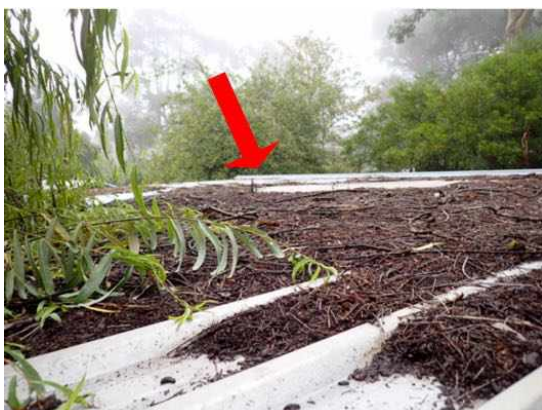
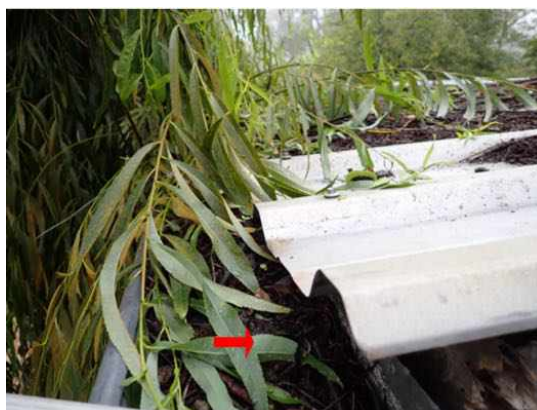
Building:	Shed
Location:	Roof Exterior
Finding:	Roof plumbing - Rusted or corroded
Information:	<p>This shed roof plumbing has areas of rust and corrosion. It is suspected that this has been caused by blockages, resulting in pooling or standing water, that have prematurely rusted elements of the roof plumbing. Rusted roof plumbing will generally develop holes and leaks that can affect other building elements with poor drainage of storm water. Poorly drained roof areas will also lead to damp conditions surrounding the base perimeter of the building which, if left unmanaged, can lead to a range of secondary building defects.</p>

Repair and/or replacement of rusted roof plumbing is highly required in order to reinstate the roof drainage system to a fully operational level. To further maintain these areas, gutters should be cleaned frequently, allowing the avoidance of any partial blockages.

A licensed plumber or specialist roof restoration company should be appointed to undertake these works. It is advised that such works be completed as soon as possible to prevent any further damage and deterioration.

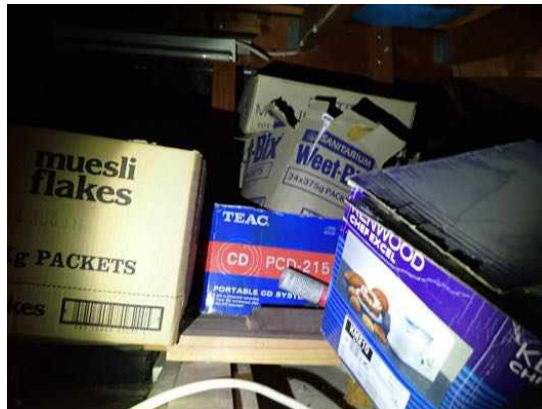
### Finding 3.02

Building:	Shed
Location:	Roof Void
Finding:	Stored Goods/Rubbish
Information:	<p>An array of debris/stored goods was found in the roof void area at the time of inspection. Debris in this area restricts ventilation and creates potential for concealed pest activity , as well as unnecessary strain on the roof structure. Debris in the roof void should be removed as soon as possible. Depending on the location and amount of debris and stored items, the homeowner may elect to undertake this task. Alternatively there are a large number of rubbish removal subcontractors that could undertake these works.</p>

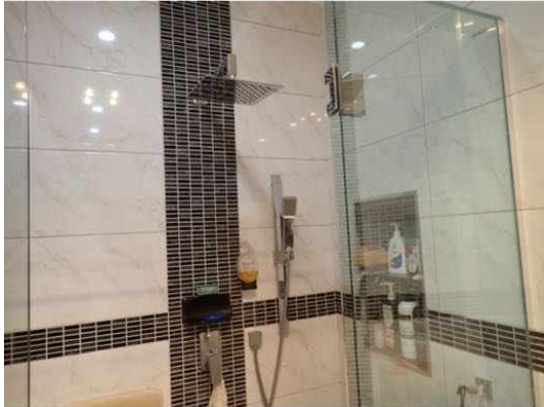
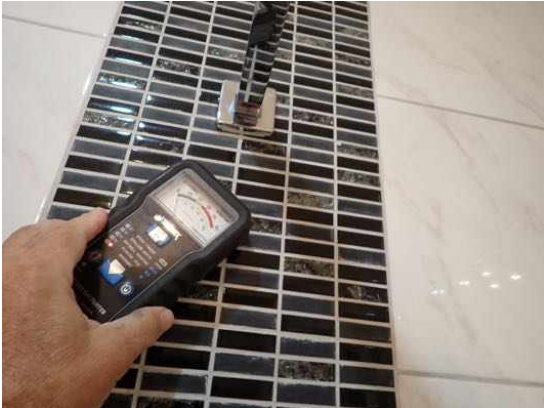
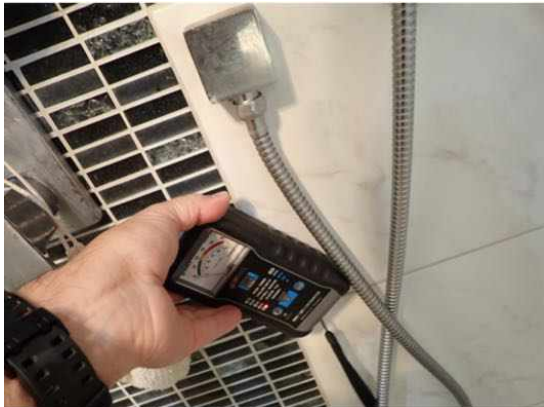
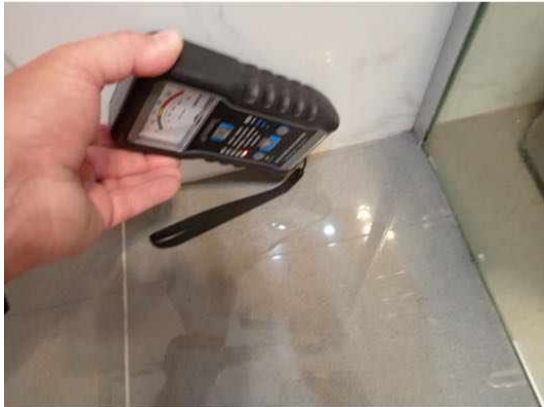
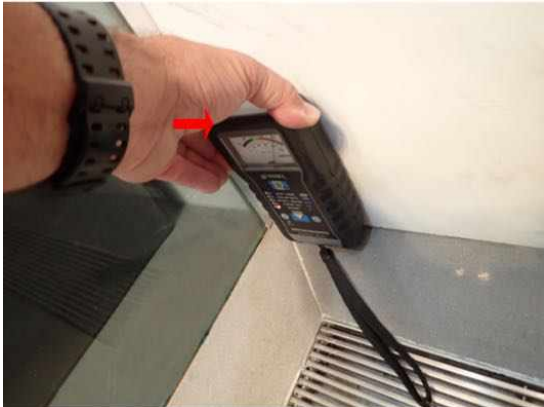
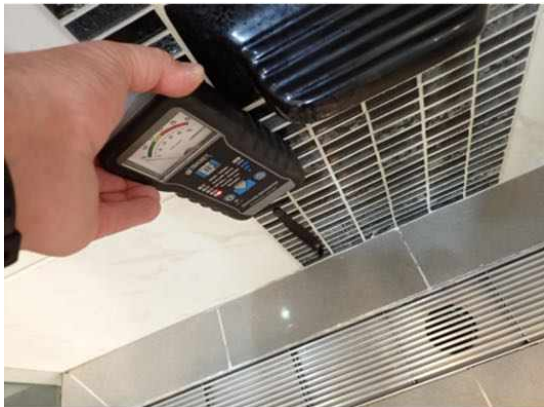
### Finding 3.03

Building: Shed  
 Location: Bathroom  
 Finding: Shower Damp - Monitor  
 Information:

Damp is evident to the lower 400mm of wall to the shower alcove. There is no high reading around the taps nor are there high readings transferring to the other side of the wall. Both sealant and grout appear in poor condition at present and will need to be renewed, as it is suspected that the high moisture readings at the shower base have been caused by moisture permeating or leaching through the grouting and perhaps gaps in the sealant.

Damp (or structural damp) refers to the presence of unwanted moisture in the structure of a building, either as the result of intrusion from outside, or condensation from within the structure. In the shower area, internal water leaks, residual moisture or other sources of excessive moisture are generally the cause of damp, which also creates an environment conducive to termite activity.

Consultation with a qualified plumber or bathroom specialist would be advised to conduct a precautionary pressure test, to identify the cause of damp and to perform remedial works to prevent further deterioration and additional costs.

Always ensure that sealant and grout is in good condition to prevent any moisture issues occurring in the future.

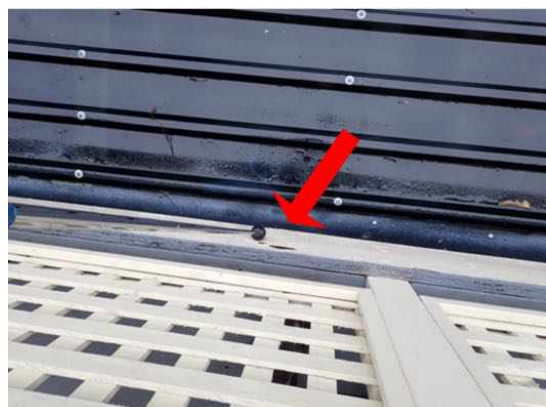
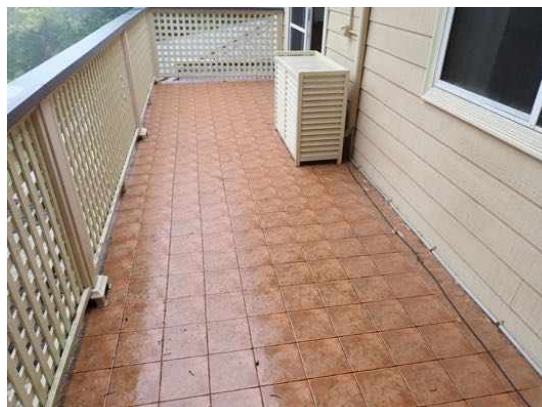
Finding 3.04

Building: Shed  
 Location: Balconies  
 Finding: External Timber Balcony or Deck - Structural Stability  
 Information: The load capacity of the external balconies could not be verified during the inspection. External timber structures are also constantly exposed to weather elements and can deteriorate in an accelerated manner, ongoing assessments are required.

It is highly recommended that a Structural Engineer further assess the external timber balcony or deck to inform the client of its load capacity. Regular maintenance inspections by competent practitioners is needed.

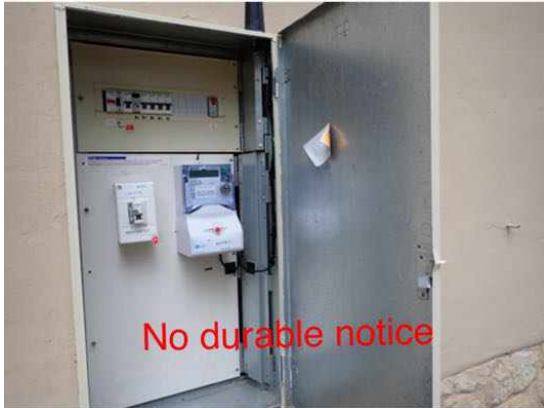
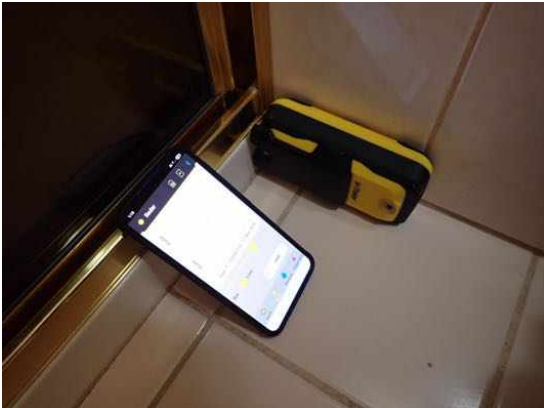
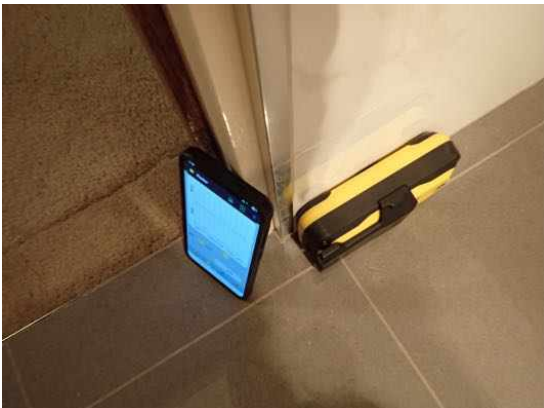
Building: Shed  
 Location: External Areas  
 Finding: Termite Damaged - Suspected Activity Identified

**Information:** Although no evidence of live termite activity was found at the time of the inspection, it is suspected that a termite colony may be present on or near the property. Visible evidence of termite workings was found in timber within the yard. Further inspection of external and internal areas is required in order to correctly identify the presence of termite activity and may include works of an intrusive nature.

It should be noted that where termite activity has occurred in close proximity to the dwelling, the risk of termite activity within the dwelling is greatly increased, particularly where inspection is restricted or obstructed due to inaccessible areas.

It is strongly recommended also that an internal invasive inspection/treatment of the dwelling be conducted as soon as possible.

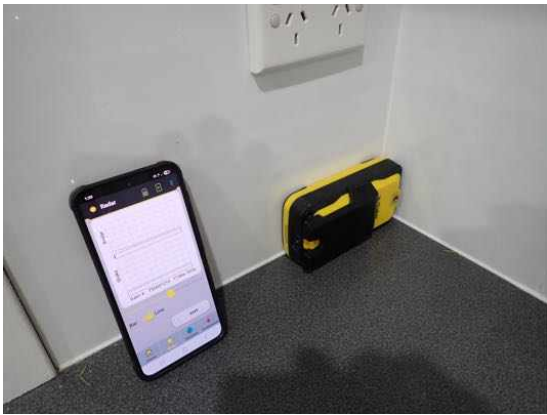
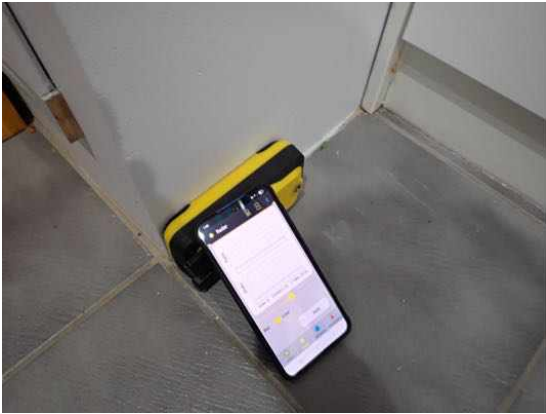
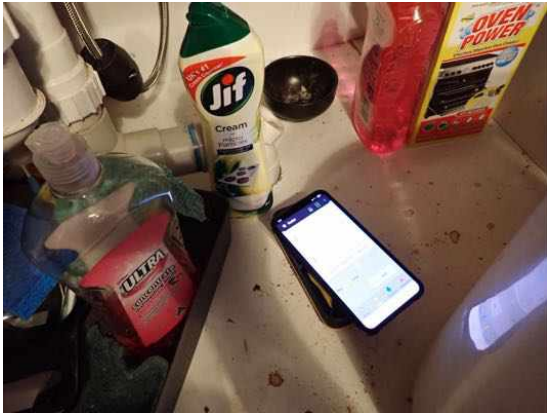
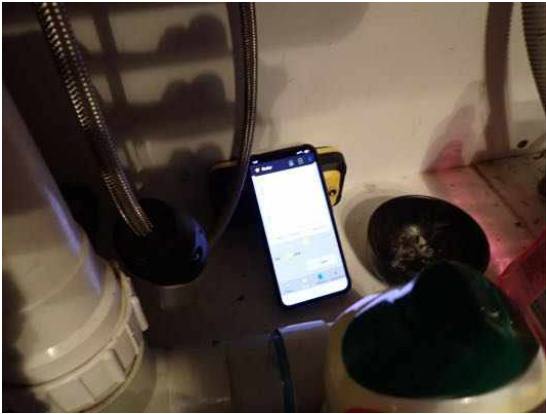
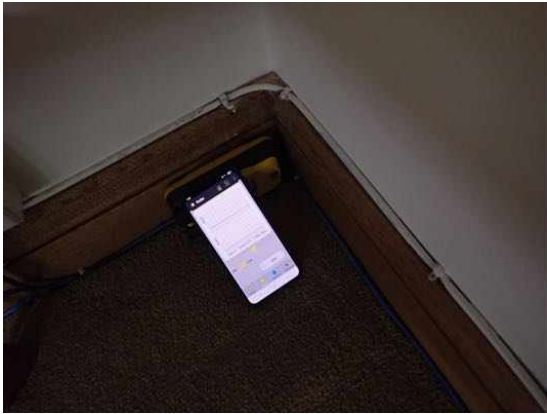
A durable notice should be placed in the switchboard unit to indicate current termite barriers. At the time of inspection, it appeared as though no current termite management system is in place, as no durable notice was present. The client should gain further advice from a pest controller as to the costs, procedures and types of termite management systems available.

The application of a post-construction chemical termite barrier is highly recommended for all properties, particularly if live termite activity has been found on the site previously. Such barriers are highly effective in preventing termite attack on any timber building elements throughout the property.

It is recommended that obtaining such advice be a priority and adopting a termite management system essential for the protection of the dwelling.

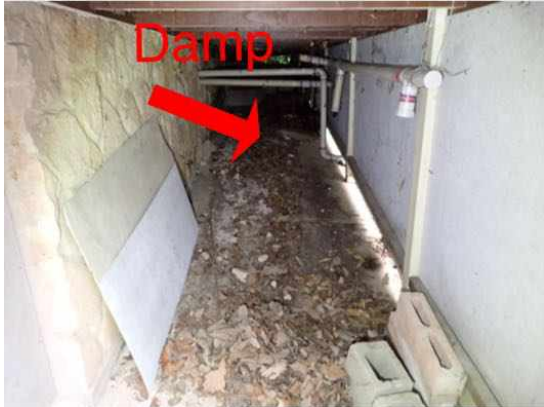
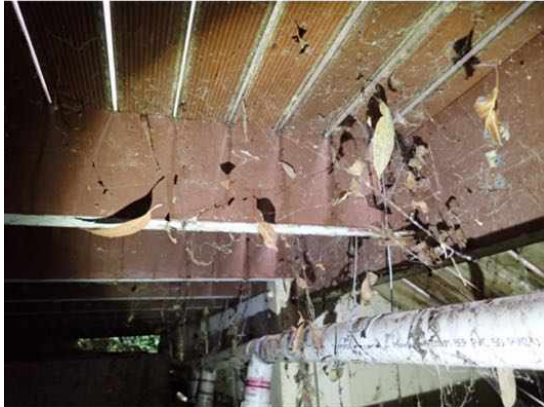
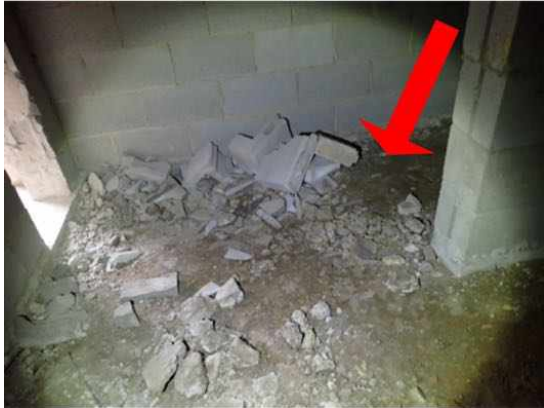
Building:	Shed
Location:	Subfloor
Finding:	Sub Floor - Damp
Information:	Dampness to localised sections of the subfloor area was identified. It is suspected that this dampness has occurred due to poor site drainage and inadequate subfloor ventilation. Dampness in this area is likely to lead to wood rot and general deterioration of structures within the subfloor space. Excessive moisture also creates an environment which is conducive to termite and pest infestation.

A licensed plumber should be appointed to ensure proper subfloor drainage. This will ensure a dry subfloor space.

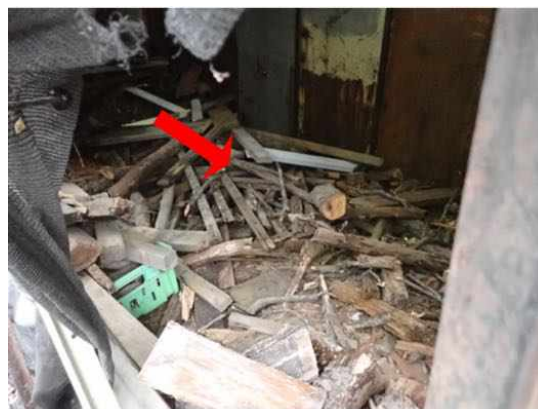
## Finding 6.04

Building:	Shed
Location:	External Areas
Finding:	Stored timbers - subfloor space or external area
Information:	The storing of timbers in the subfloor space or around the external property increases the risk of termite activity being present. As they are likely to come into contact with weather conditions or excessive moisture wood rot is likely to develop on timbers that are not treated.

It is highly recommended that any stored timbers be immediately removed from areas in which they may attract any termite / timber pest attack. Minimisation of risk / prevention of termite attack is far more adequate than dealing with the presence of termite activity.

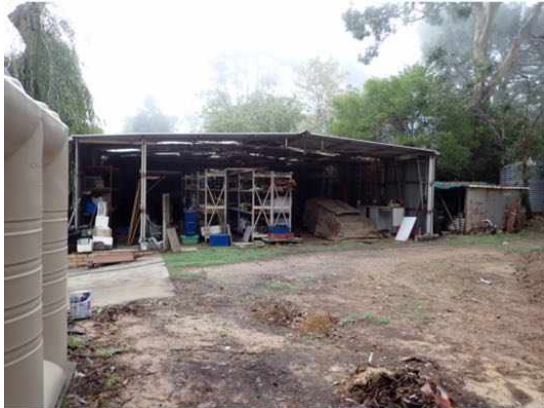
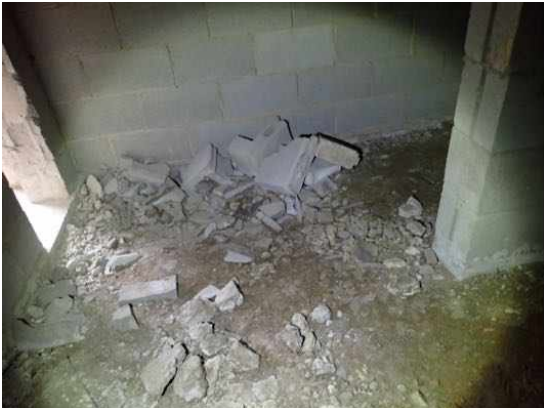
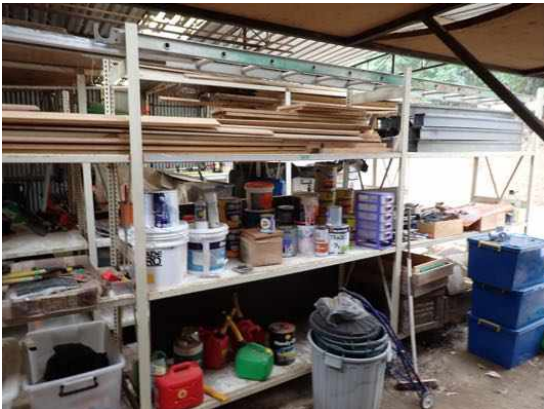
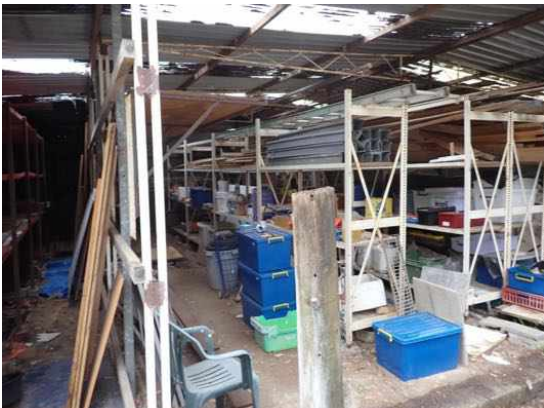
Building: Shed  
 Location: All Areas  
 Finding: Additional Photos - Obstructions and Limitations  
 Information:

These photographs are an indication of the obstructions and limitations which impeded full inspection of the property at the time of inspection. These obstructions can hide an array of defects and should be removed to allow full inspection to be carried out. A re-inspection is recommended once the areas are made accessible.

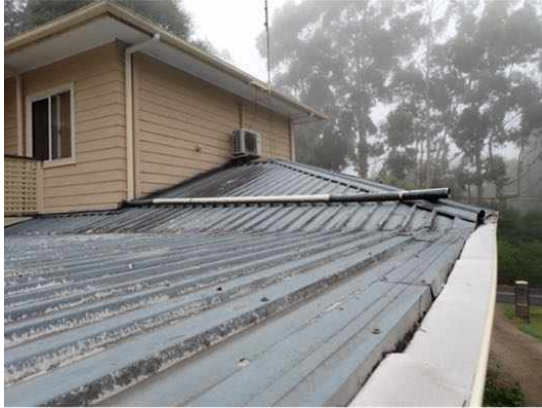
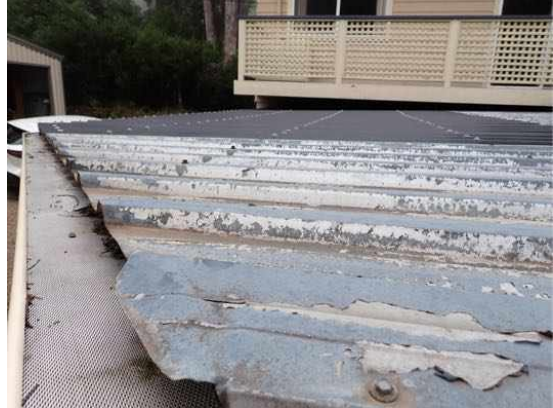
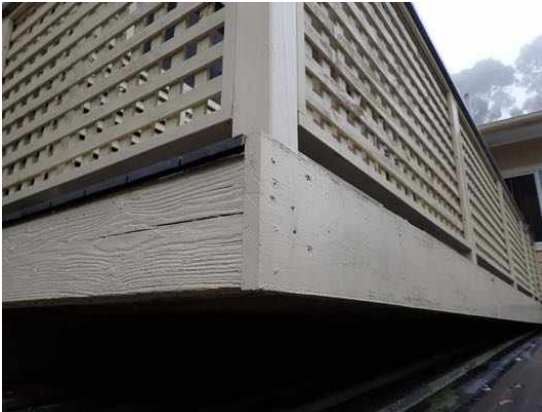
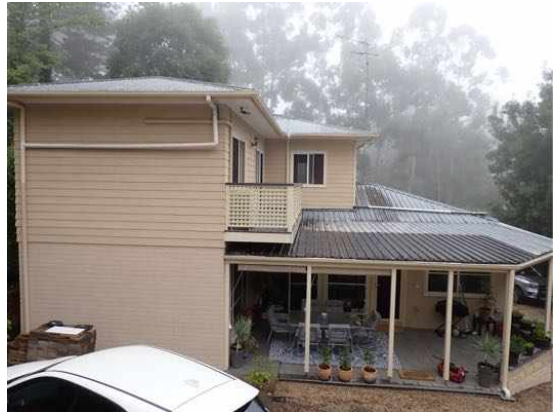
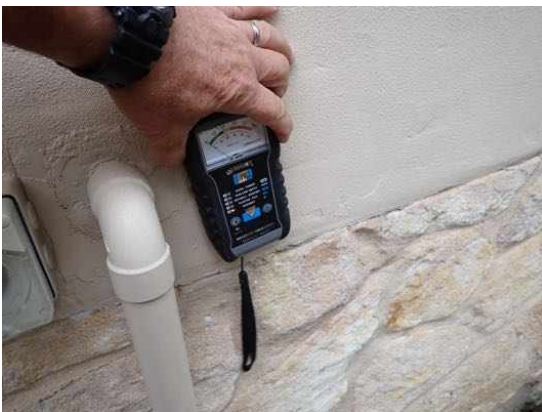
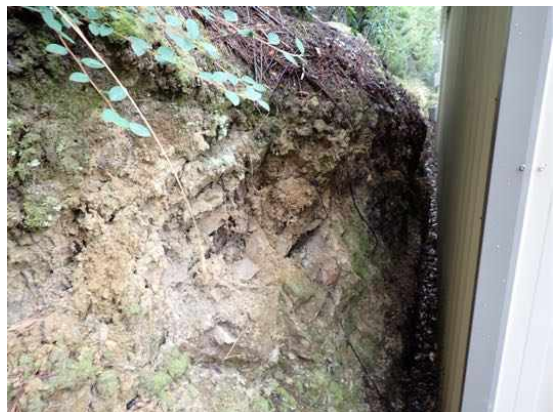
Building: Shed  
Location: All Areas  
Finding: Additional Photos  
Information: Additional photos are provided for your general reference
