Building and Timber Pest Inspection Report

Inspection Date: Thu, 5 Mar 2026

Property Address: 30 White Haven Ave, Magenta NSW 2261,
Australia

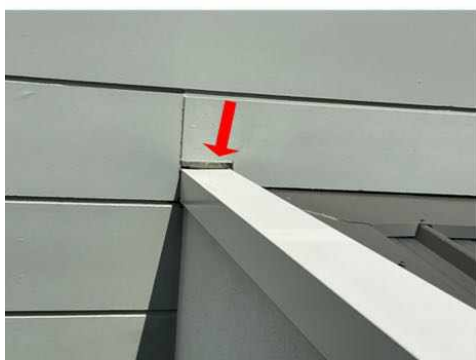
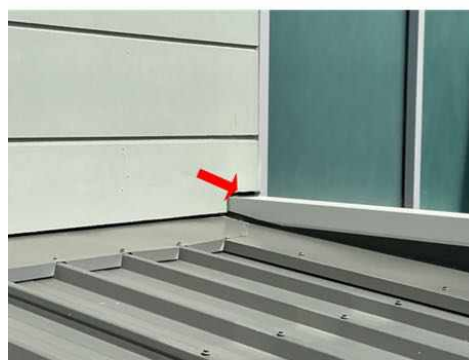
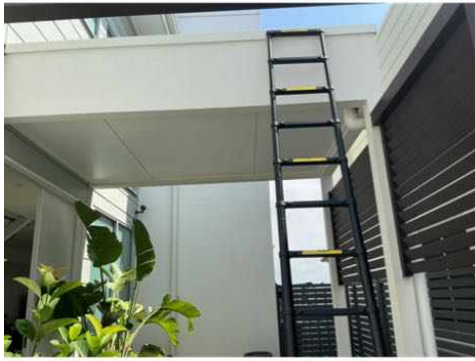
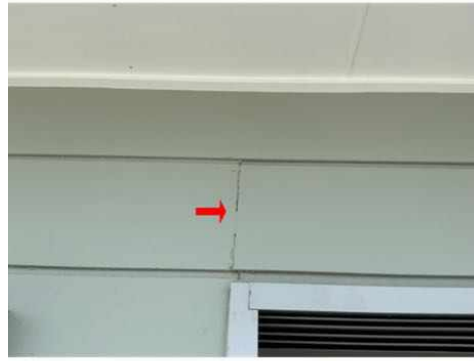
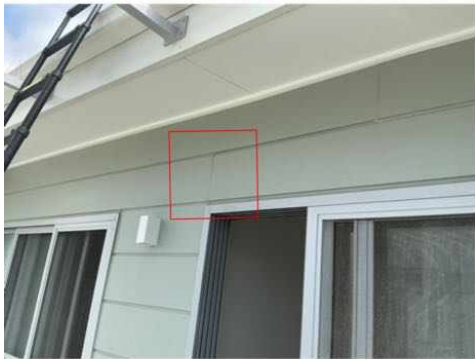
Building: Main Building
Location: Entry, Front Balcony
Finding: Cladding - Separation/Gaps
Information: Gaps were noted in the cladding at the time of inspection.

The separation of the lightweight wall cladding may be caused by a variety of factors. One common reason is thermal expansion and contraction, where the cladding material expands and contracts due to temperature fluctuations. If sufficient expansion joints or flexible fixings were not incorporated during installation, this movement can lead to cladding separation over time. Additionally, improper installation, such as incorrect use of fasteners or adhesives, can also result in the cladding pulling away from the structure.

It is recommended to engage a qualified builder or cladding specialist to thoroughly inspect the area and seal it to prevent further damage. It is advised to monitor that cladding over time because the sealant on the joints can deteriorate due to weather.

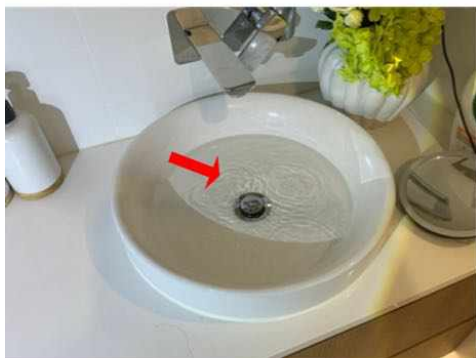
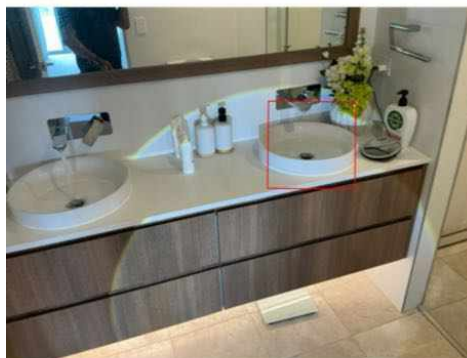
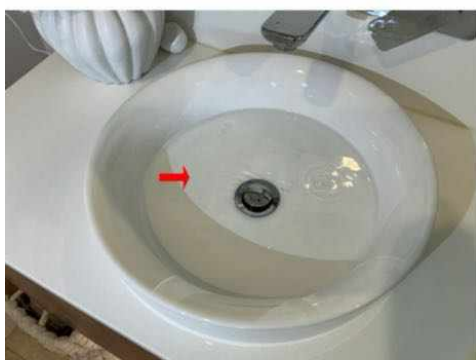
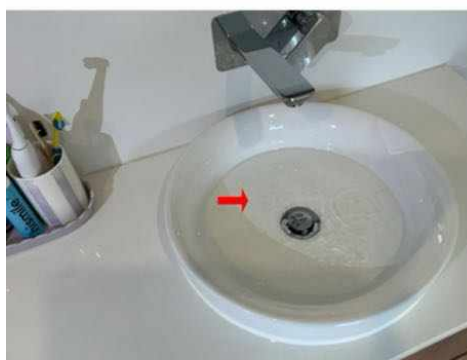
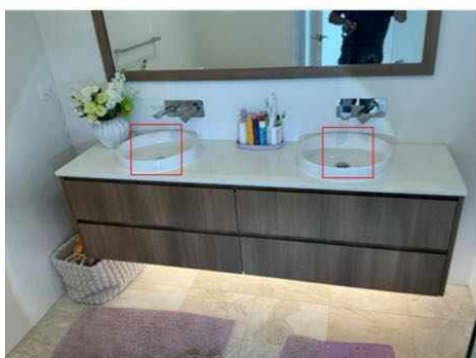
Finding 3.02

Building:	Main Building
Location:	Both Bathrooms
Finding:	Sink - Slow Draining
Information:	The sink drain appeared to be slow draining at the time of inspection.

Blockages prevent building elements from operating as intended. If left unmanaged, a lack of general maintenance may lead to the development of more significant defects, such as water damage to surrounding building materials. It is advised that the blockage be removed as soon as possible.

If blockage remains, a licensed plumber should be appointed as soon as possible to perform any remedial works where required.

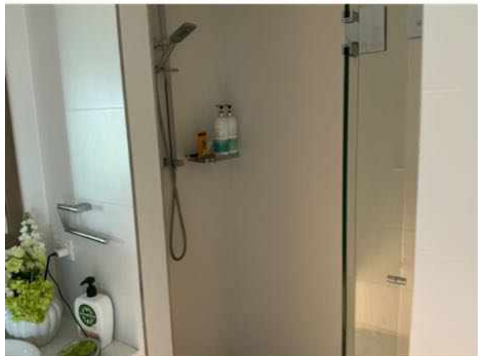
Finding 3.03

Building:	Main Building
Location:	Both Bathrooms
Finding:	Excessive Moisture - Shower Damp
Information:	At the time of inspection, excessive moisture was noted within the shower area, which is a common issue in wet areas due to the continual exposure to water. This condition is typically caused by moisture seeping through grout lines and settling behind tiles, resulting in localised high-moisture zones. Provided there is no evidence of water staining or elevated moisture readings on the opposite side of the wall, this is considered a minor defect.

However, persistently damp conditions may act as conducive conditions for termite

activity, as termites are strongly attracted to moisture-rich environments. It is recommended that the client ensures regular use of the exhaust fan and maintains adequate ventilation after shower use to promote drying and reduce long-term moisture build-up, thereby also reducing the risk of attracting termites.

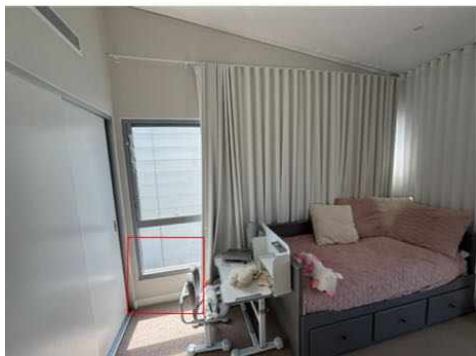
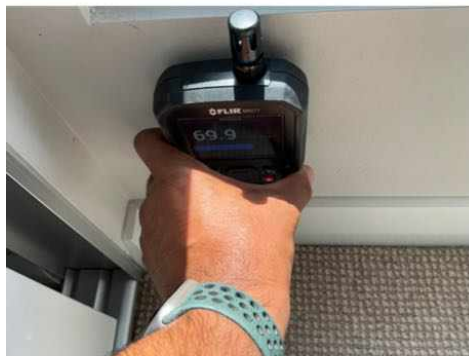
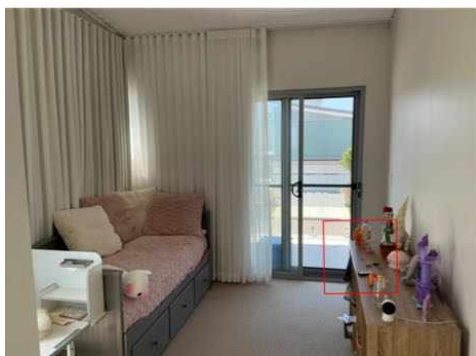
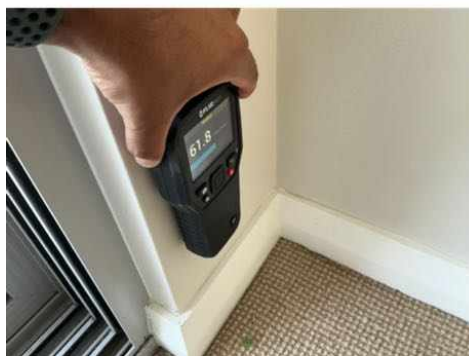
Finding 3.04

Building:	Main Building
Location:	Front Right Bedroom
Finding:	Elevated Moisture Readings to Wall Areas
Information:	At the time of inspection, slightly elevated moisture readings were detected to the wall areas below the window and adjacent to the sliding door leading to the balcony. This

may be associated with minor moisture ingress from external areas, potentially due to small gaps in the cladding or around window penetrations, as noted in a previous observation.

No immediate action is required at this stage. The client is advised to monitor the affected areas over the next 12 months. If visible signs such as bubbling paint, staining, or deterioration of the wall surface develop, a cladding specialist should be engaged to inspect the external cladding and check for any gaps around the window or adjoining sections, and seal the area as required.

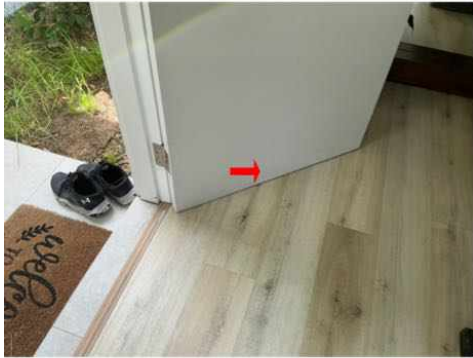
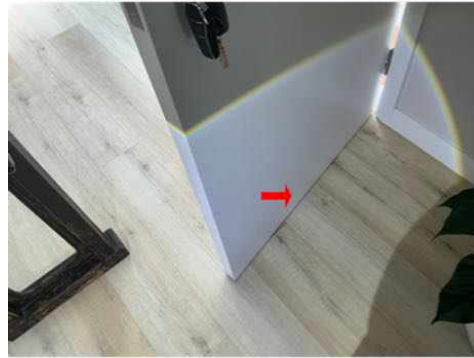
Finding 3.05

Building:	Main Building
Location:	Entry
Finding:	Door Weatherstrip - Missing
Information:	It was noted at the time of inspection, the door weatherstrip was missing.

The absence of a door weatherstrip could be due to wear and tear, improper installation, or deliberate removal. The implications include increased energy loss, reduced insulation, potential water leaks during rain, and a compromised seal, allowing drafts and noise to enter the space. Replacing the missing weatherstrip is advisable to maintain energy efficiency, weather protection, and overall comfort within the enclosed area.

A general handy man should be appointed to install the weatherstrip at owners discretion.

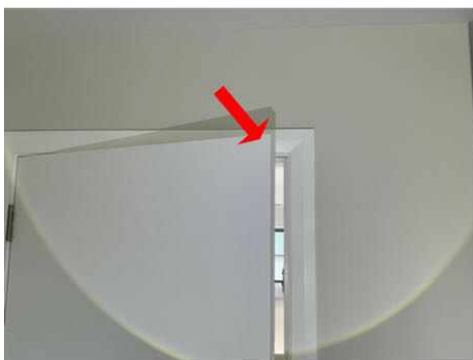
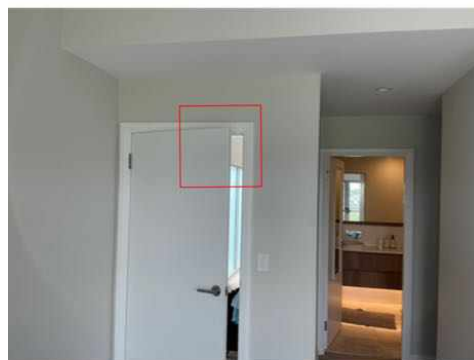
Finding 3.06

Building: Main Building
 Location: Bedroom - Master
 Finding: Door(s) - Binding/Jamming
 Information: At the time of inspection, it was noted that the door was binding or jamming in this area.

Several factors could contribute to this issue, including swelling due to moisture, which can cause wooden doors to expand and fit tightly in the frame. Misaligned or loose hinges may also result in the door sagging or becoming misaligned, making it difficult to close. Over time, wooden doors may warp due to fluctuations in temperature or humidity, leading to improper closure.

It is recommended that a qualified carpenter or handyman be engaged to carry out the necessary repairs to ensure proper door operation.

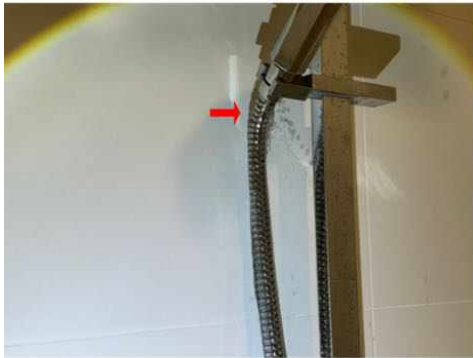
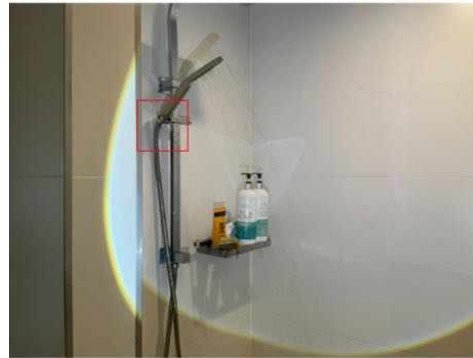
Finding 3.07

Location: Ensuite - Master
 Finding: Shower Head - Leaking
 Information: Showerhead was found to be leaking at the time of inspection. This is a common defect.

A leaking shower head could be due to issues like a worn-out washer, a loose connection, a damaged O-ring, or mineral deposits blocking the flow. Inspecting and replacing any damaged components or tightening connections might help resolve the leakage.

A qualified plumber should be engaged to rectify the situation as soon as possible.

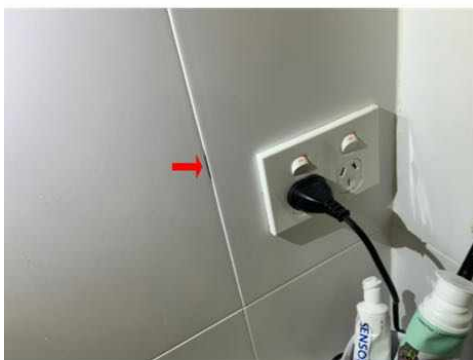
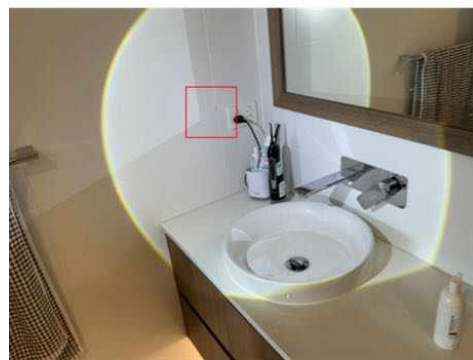
Finding 3.08

Building: Main Building
 Location: Ensuite - Master
 Finding: Sealant and Grouting - Missing/Damaged (VR)
 Information: At the time of inspection, some areas were noted to have missing or deteriorated sealant and grout. This can allow water to seep into gaps and cause minor damage over time. It is recommended that a tiling or sealant specialist reapply flexible, mould-resistant sealant to maintain a proper waterproof barrier and prevent future issues.

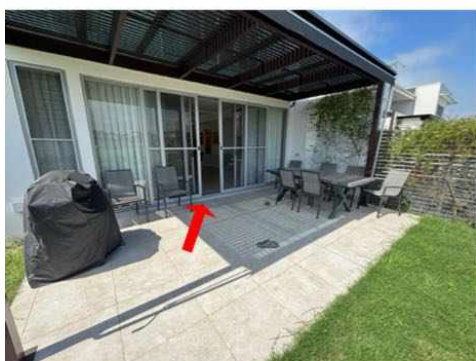
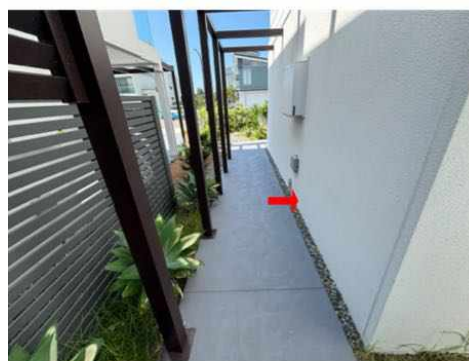
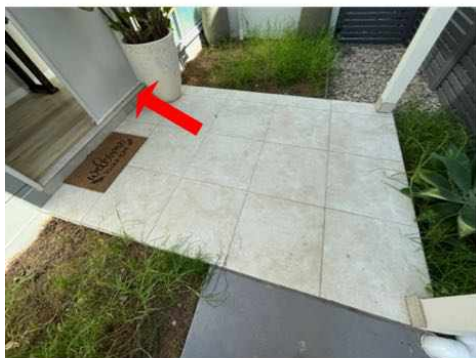
If the slab edge is not properly exposed there is a high risk of termite attack. Sometimes, in order to determine the type of slab, a suitably qualified person such as an architect or builder may be required to consult the construction plans.

Where the slab edge cannot be properly inspected, it is highly recommended that termite or timber pest inspections be carried out every 6-12 months to aid protection of the property against infestation.

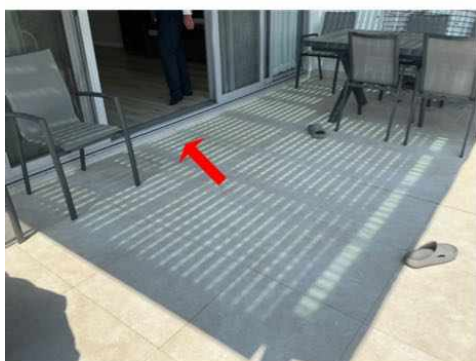
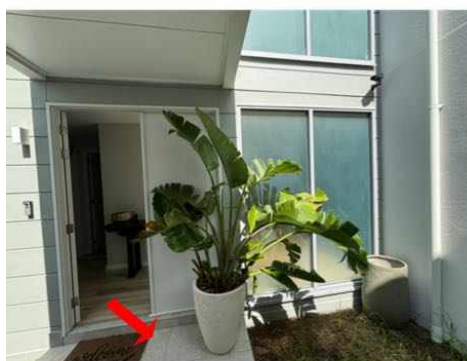
Finding 6.02

Building:	Main Building
Location:	Both Entries
Finding:	Bridging or Breaching of Termite Barriers - Adjacent Internal Flooring
Information:	Bridging is the spanning of a termite barrier or inspection zone so that subterranean termites are provided with passage over or around that barrier.

It is important for internal flooring to be raised above adjacent external ground levels. Where external ground levels are above or same level as internal flooring, water pooling and subsequent internal flooding is likely to occur which may attract termite activity to the internal area.

It is highly advised that a landscaper or relevant tradesperson be appointed to lower external grounds that are raised above or same as adjacent internal flooring. Alternatively if external grounds and internal flooring is level installation of a raised door sill may be appropriate in preventing any water pooling in the area. If the client wishes not to make any changes, then a qualified pest controller is recommended for termite treatment around the perimeter of the house and subfloor (if any) as soon as possible.

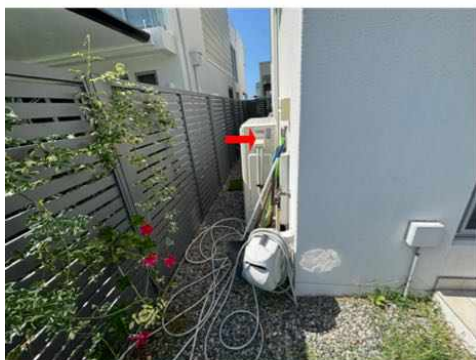
Finding 6.03

Building:	Main Building
Location:	Exterior walls - right side
Finding:	Bridging Appliances - Attachment to Buildings
Information:	Bridging occurs when items against a building provide a concealed entry point for termites into the building or by passing around a termite management system.

Where any part of an attachment to a building is not isolated and is not provided with a clear gap of not less than 25mm from the building, bridging occurs. Attachments to buildings such as hot water services, downpipes, verandahs, decks, steps, fences, service conduits and the like provide the opportunity for concealed entry.

Building attachments of this nature need to be frequently inspected for termite activity by a qualified inspector.

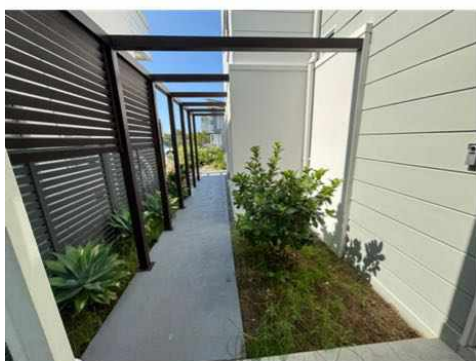
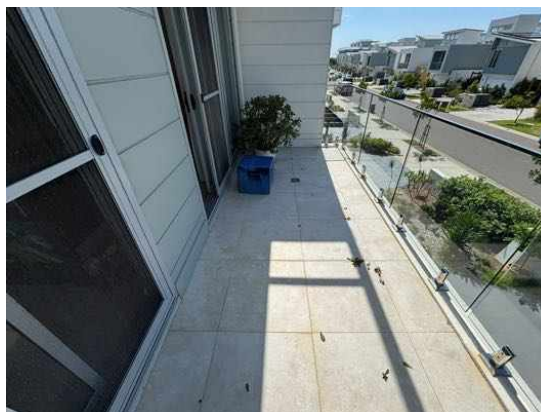
Building: Main Building
Location: All External Areas
Finding: Obstructions and Limitations - External Areas
Information: The attached photographs provide a visual representation of the obstructions and limitations that impeded a full inspection of the external areas of the property at the time of assessment. These obstructions, which may include vegetation, stored items, debris, or other physical barriers, can obscure potential defects and prevent a thorough evaluation of the property's condition. Obstructions of this nature can conceal a wide range of issues, such as structural damage, water ingress, pest infestations, or deteriorating building materials, which may not be visible during the initial inspection.

It is essential that these obstructions be cleared to allow for a comprehensive inspection of the external areas. Removing these barriers will enable a more accurate assessment of the property's condition and allow any hidden defects to be identified and addressed promptly. Failure to do so could result in undetected issues worsening over time, potentially leading to more costly repairs in the future.

Therefore, it is strongly recommended that the obstructions be removed and a re-inspection be scheduled once the affected areas are made fully accessible. This will ensure a complete evaluation of the property's exterior and provide the client with a clear understanding of any potential issues that may have been concealed during the initial inspection.

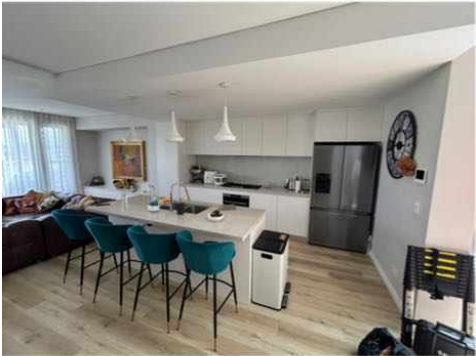
Information: The accompanying photographs provide clear evidence of the obstructions and limitations that restricted a comprehensive inspection of the internal areas of the property at the time of assessment. These obstructions, which may include furniture, personal belongings, stored items, or structural elements such as wall coverings and built-ins, significantly hindered the ability to thoroughly evaluate these areas. It is important to note that such obstructions can potentially conceal a wide array of defects, ranging from hidden structural damage, water leaks, pest infestations, or electrical issues, to deteriorating materials that may not be visible during the initial inspection.

The presence of these impediments means that critical areas of the property were not accessible, and therefore, any underlying defects that may affect the integrity and safety of the property could remain undetected. These hidden defects, if left unaddressed, could worsen over time and may result in costly repairs or pose potential safety hazards to the occupants.

In summary, the limitations encountered during the inspection highlight the importance of ensuring full access to all areas of the property to accurately assess its overall condition. A re-inspection is strongly advised once these areas are made accessible.

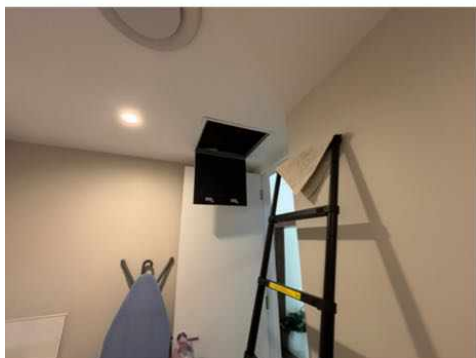
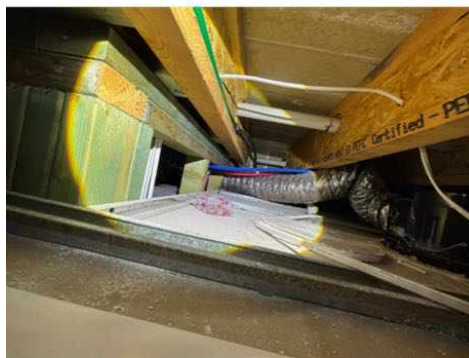
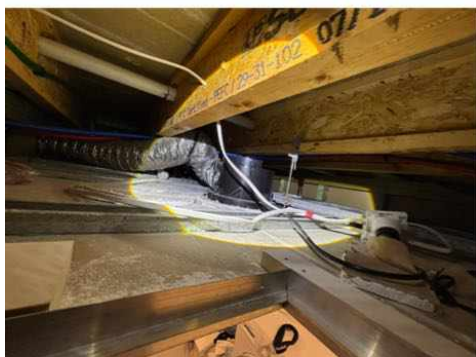
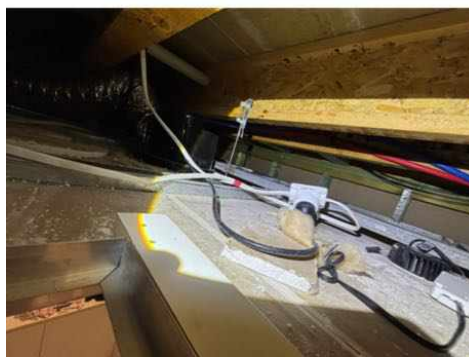
Obstructions of this nature may conceal a variety of potential defects, including damaged framing, compromised insulation, evidence of moisture ingress, pest activity, or electrical hazards. While no major issues were observed in the visible areas, the presence of these limitations means that some defects may remain undetected.

It is recommended that these barriers be removed or repositioned to facilitate full and safe access to the roof space. Once clear, a follow-up inspection should be conducted to allow for a thorough assessment of all concealed areas. This will help ensure that the condition of the roof cavity is accurately evaluated and any hidden issues are appropriately identified and addressed.

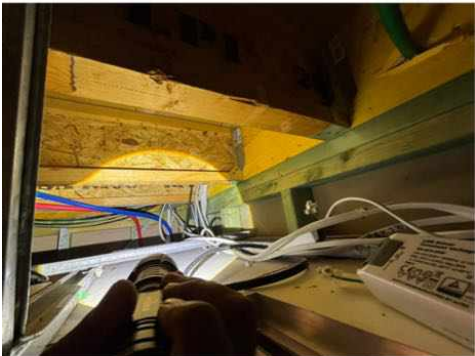
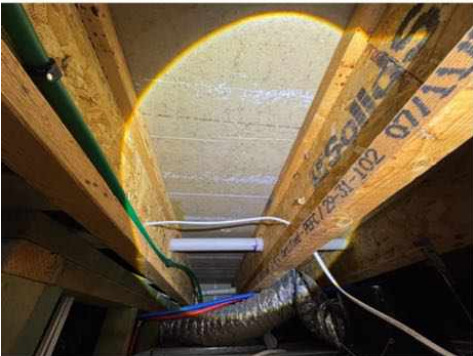
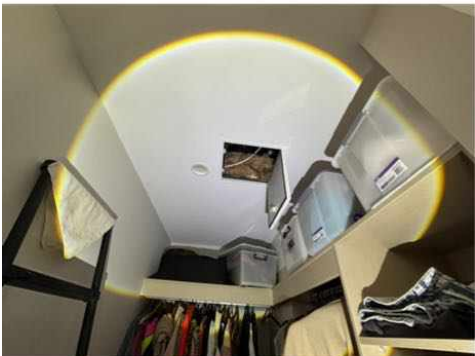
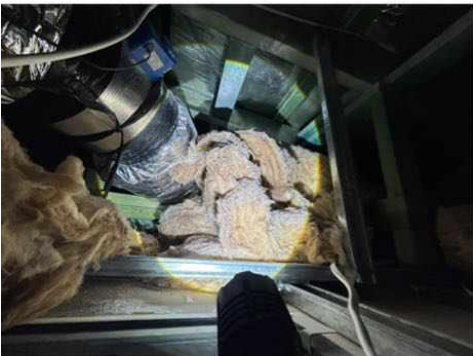
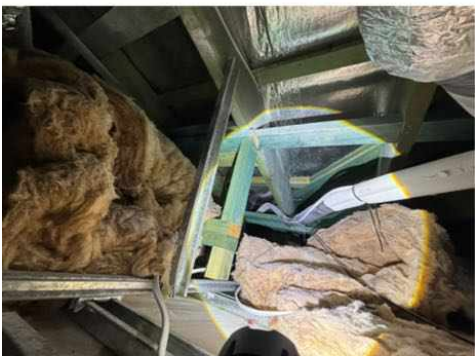
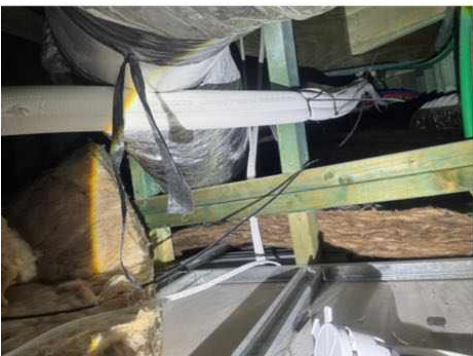
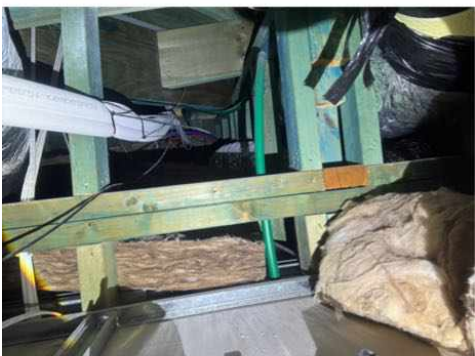
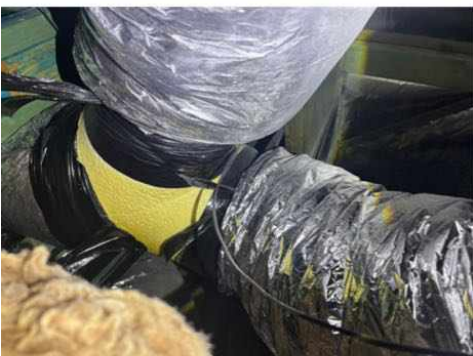
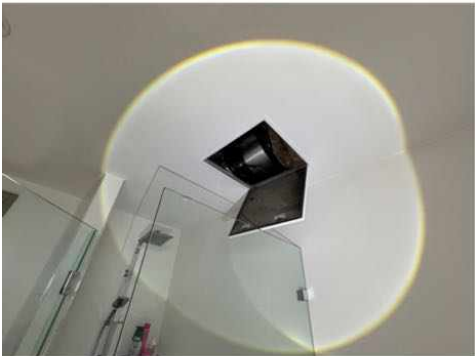
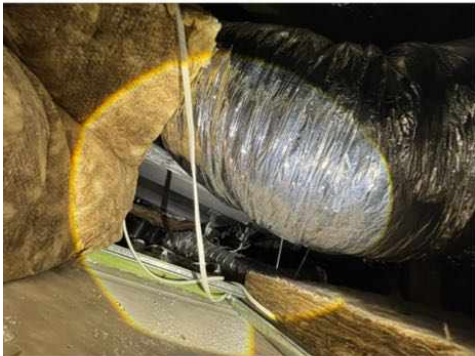
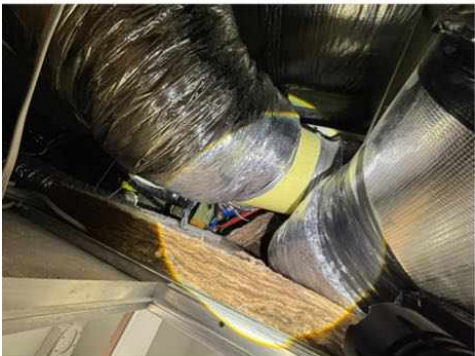
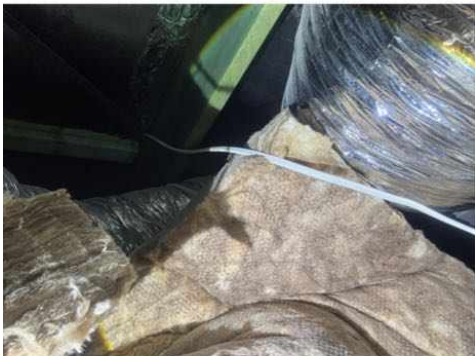
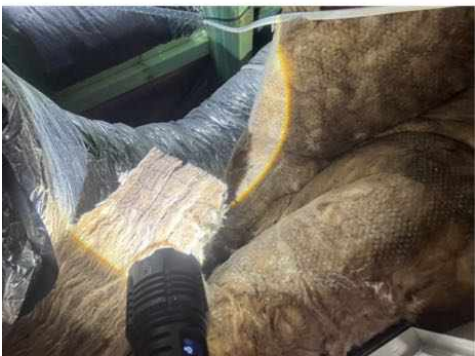
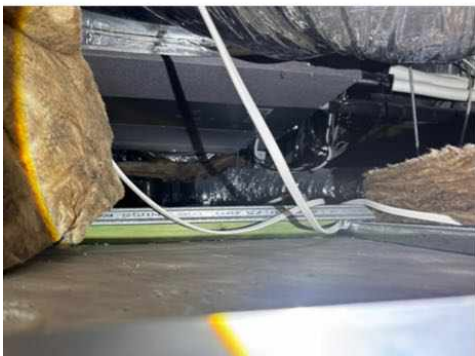
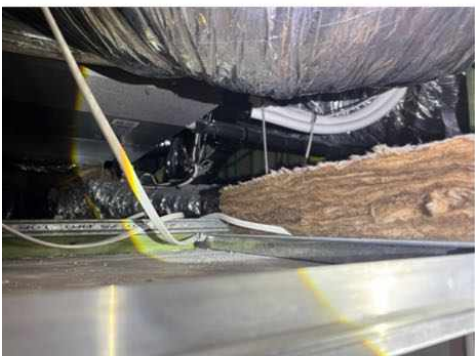
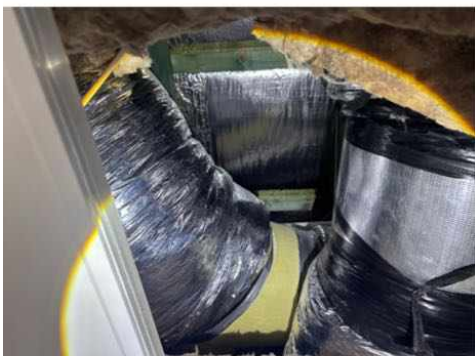
Building: Main Building
Location: Roof Void
Finding: Obstructions, Limitations, and General Roof Space Condition
Information: The photographs provided document both the general condition and the obstructions and limitations that were present in the roof cavity of the main building at the time of inspection. These obstructions—such as insulation materials, stored items, structural elements, or electrical wiring—restricted safe and adequate access to key areas within the roof space. As a result, a comprehensive inspection of all components could not be completed.

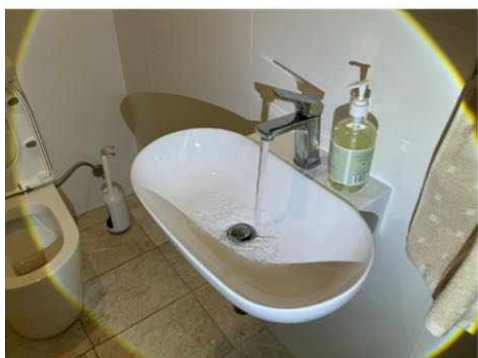
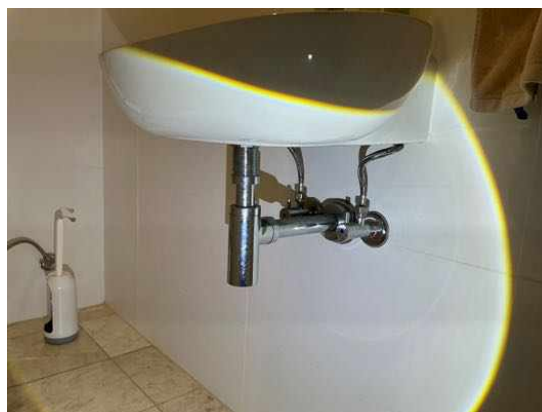
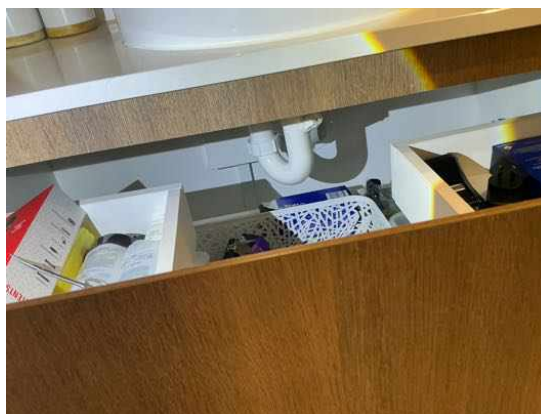
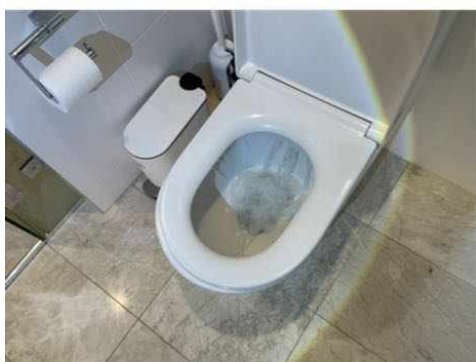
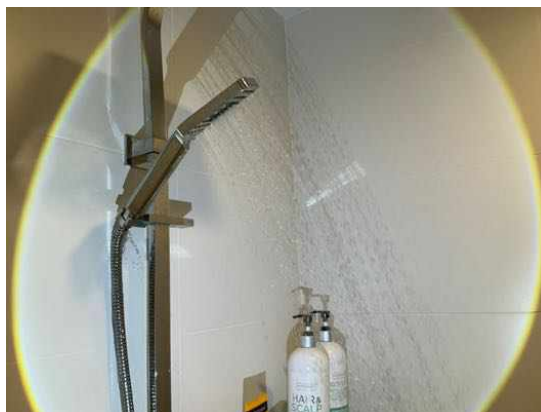
Building:	Main Building
Location:	All Areas
Finding:	FYI - Taps, Drainage & Toilets Tested and Cabinetry Obstructions
Information:	During the inspection, all accessible taps, drainage systems, and toilets were tested for water flow and drainage efficiency, and checked for any visible signs of leakage. At the time of the inspection, no issues were noted in these areas. Unless highlighted in a separate defect statement, no immediate remedial work appears necessary. Supporting images may be found in the additional photos section for reference.

It is important to note that while a visual inspection of cupboards and cabinetry beneath sinks and vanities was undertaken, stored personal items and fixtures presented obstructions that limited full visibility of the internal areas. As per standard inspection practices, inspectors are not permitted to move or disturb personal belongings during the inspection process. Therefore, only visible and accessible sections were inspected, and concealed water damage or plumbing defects may not have been detected.

Given this, a re-inspection is recommended after all obstructions have been cleared to allow for a comprehensive assessment of these areas. Regular maintenance and monitoring of plumbing and drainage systems is also advised to ensure ongoing functionality and early detection of potential issues.

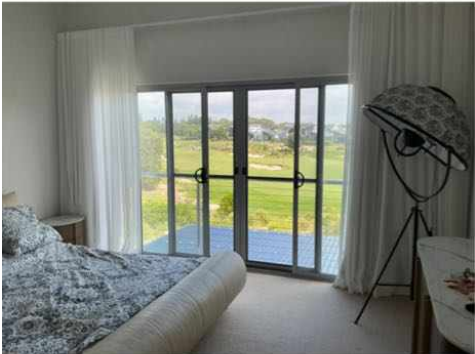
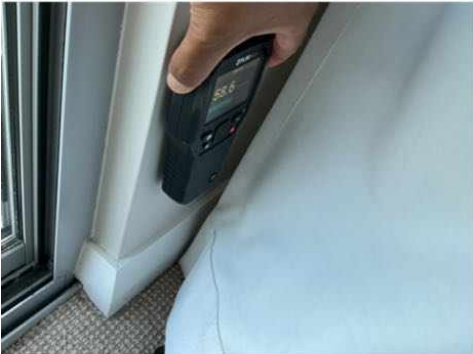
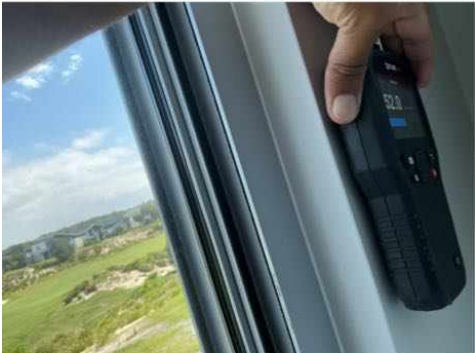
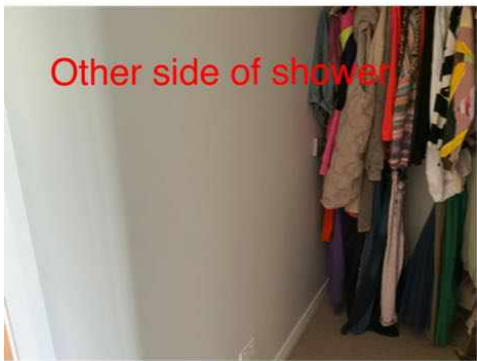
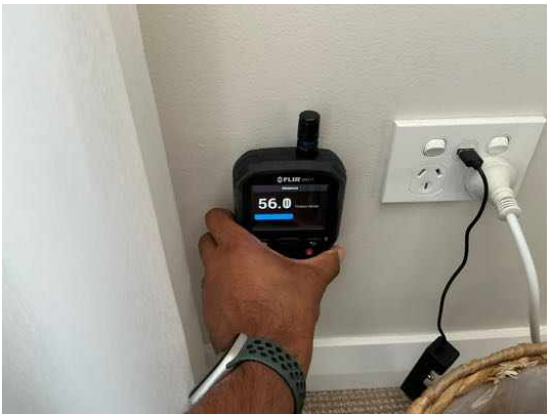
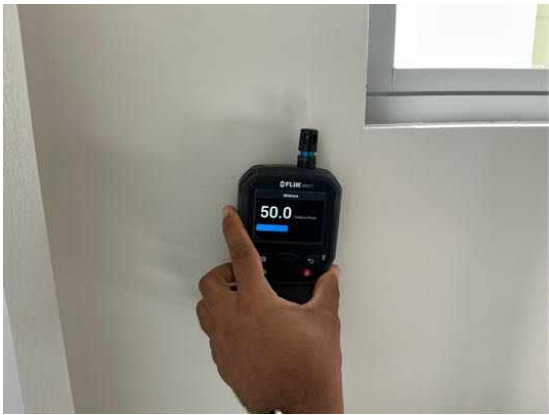
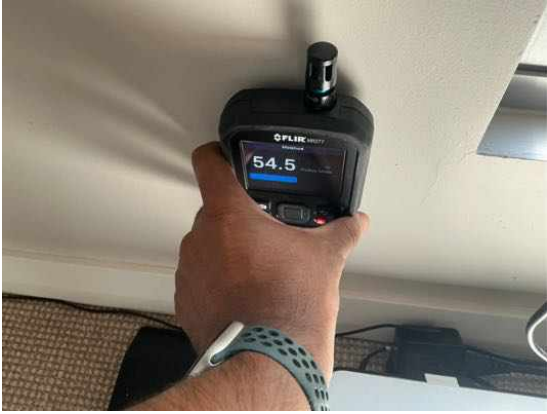
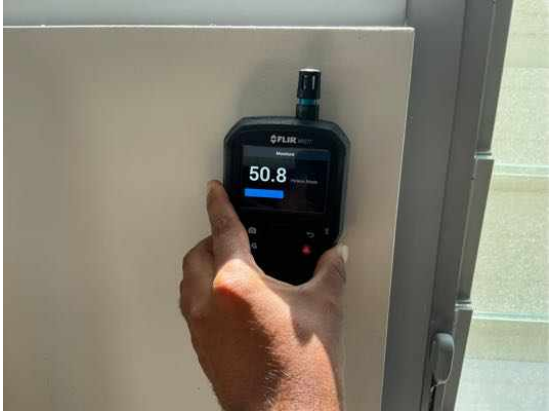
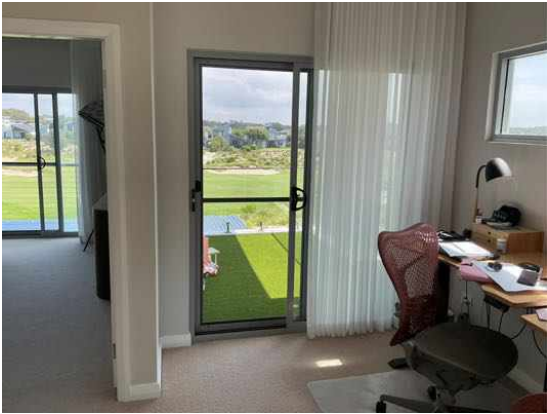
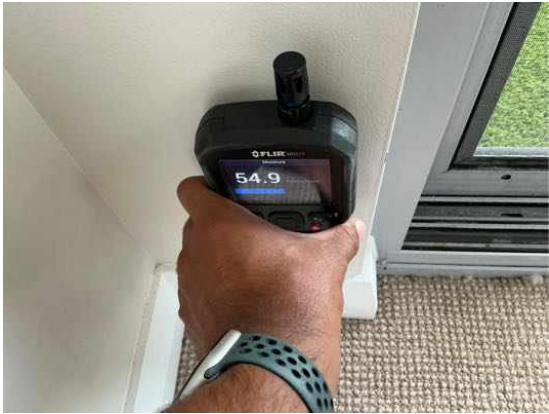
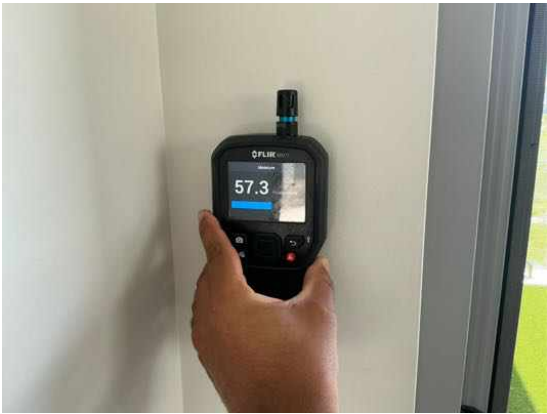
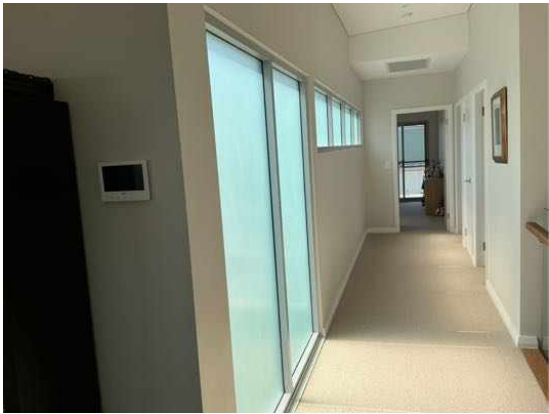
Building:	Main Building
Location:	All Areas
Finding:	Additional Photos - Moisture Meter Readings
Information:	<p>Additional moisture meter reading photos have been provided for the property to offer further clarity on areas tested during the inspection. These photos are intended to give a visual reference for the specific locations where moisture levels were measured.</p> <p>These readings were taken at the time of the inspection to assess any potential moisture-related issues within the property. Any defects related to moisture that were identified during the inspection have been separately mentioned in the defect statements within the report.</p>

It is important for the client to understand that moisture levels can fluctuate over time due to various factors, including changes in weather, humidity, and environmental conditions. While the readings reflect the property's moisture levels during the inspection, they may not represent future conditions, and increased moisture could lead to issues such as dampness, mould growth, or deterioration of building materials if left unmonitored.

For further clarification or additional information regarding the moisture readings, the client is encouraged to contact the building inspector directly. Regular monitoring of moisture-prone areas is recommended to ensure any emerging concerns are addressed promptly, particularly during wetter seasons or in high-humidity conditions.

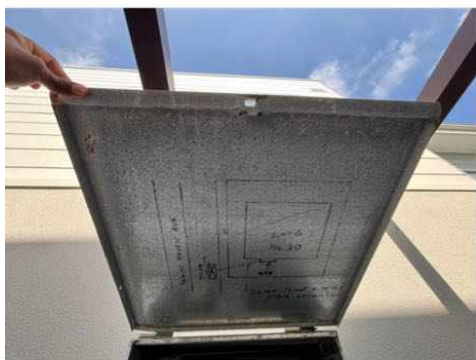
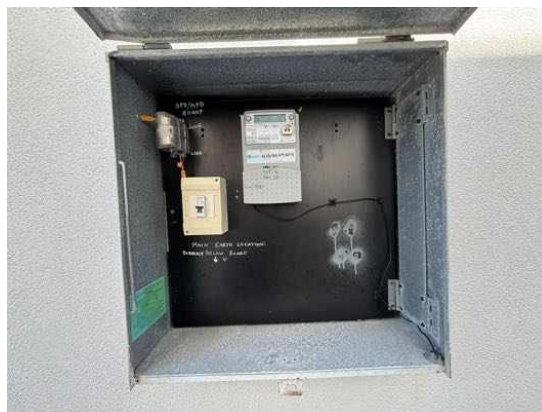
Building: Main Building
 Location: Meter Box
 Finding: Termite Management Recommendation – No Evidence of Chemical Installation
 Information: At the time of inspection, there was no visible evidence of a chemical termite management system installed around the property. Chemical barriers are a key component of termite protection and are particularly important in preventing concealed termite entry into timber elements of the structure.

In accordance with standard requirements, a durable notice should be located within the electrical switchboard to detail any termite protection systems applied, including chemical treatments. No such notice was observed during the inspection.

It is recommended that the client engage a licensed pest controller to assess the suitability of installing a chemical barrier, and to provide advice on associated costs and procedures. This should be considered a short-term priority, particularly if the property has any history of termite activity or is located in a high-risk area.

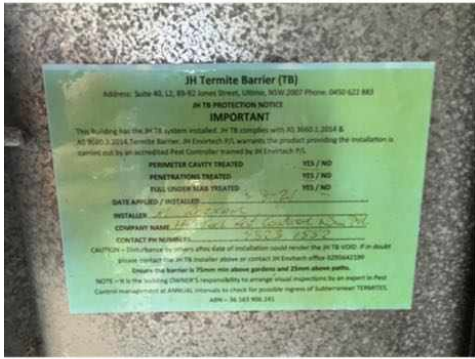
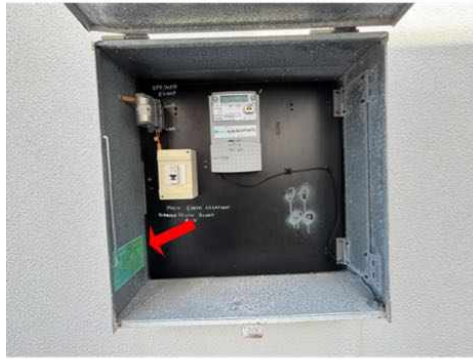
Where a Termite Management System has been identified you should refer to the type of barrier date of installation warranty conditions and any documentation provided by a builder or past owner. Consult the company who installed the barrier to confirm whether the system is still under warranty.

Most chemical termite management systems expire and require replenishment and all physical systems are primarily designed to prevent concealed entry.
