# Building and Timber Pest Inspection Report

Inspection Date: Tue, 7 Apr 2026

Property Address: 11 Chivell St, Corowa NSW 2646, Australia

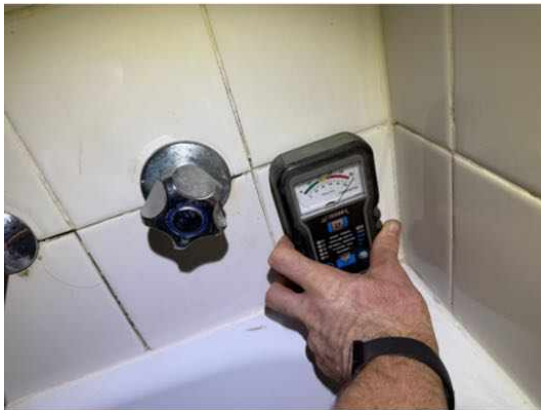
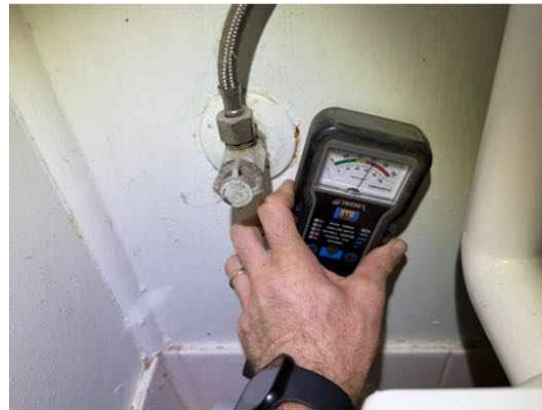
Building: Main Building  
 Location: Shower & Toilet  
 Finding: Shower & Toilet - High Moisture  
 Information: It appears that high moisture is present at but not limited to, below the toilet plumbing and the shower taps. Potential causes of leaking include but are not limited to loose or damaged plumbing fittings and fixtures, and/or deteriorated seals or waterproofing.

Areas of leaking and high moisture create an environment conducive to termite activity and therefore should not be neglected.

Recommend engaging a licensed plumber promptly, to identify the cause of the moisture & provide remedial works where necessary.

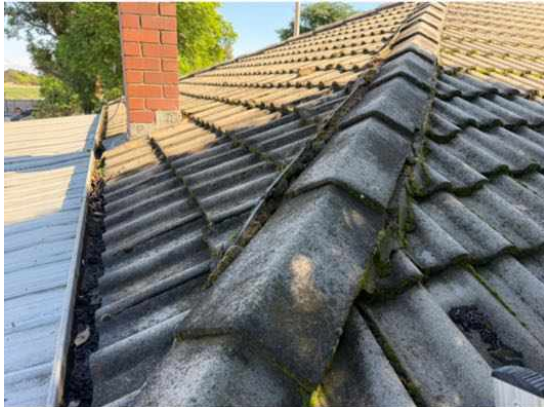
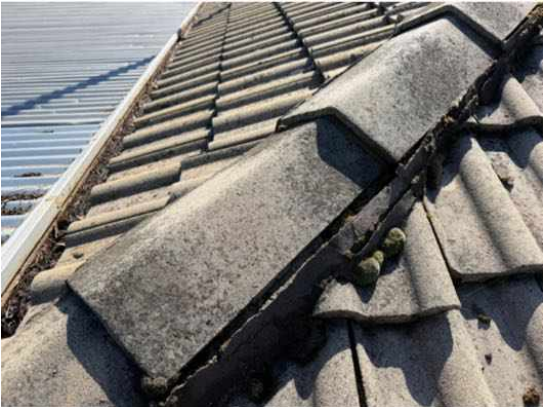
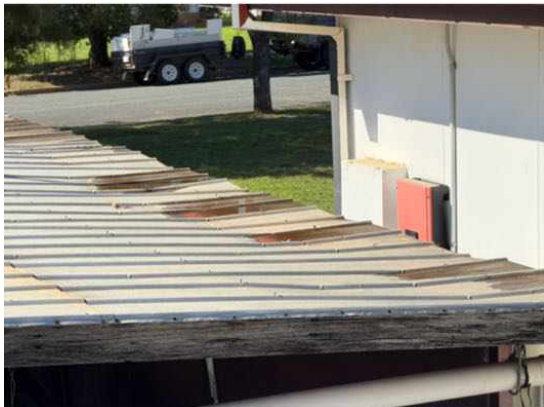
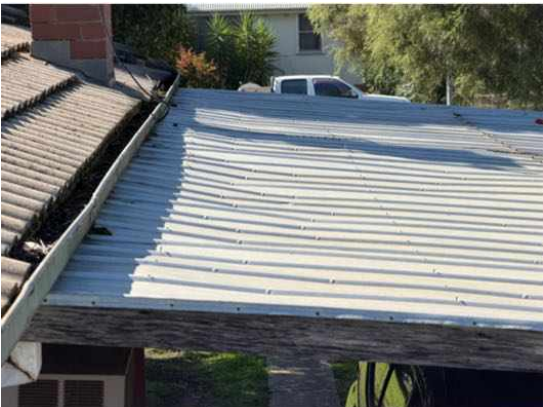
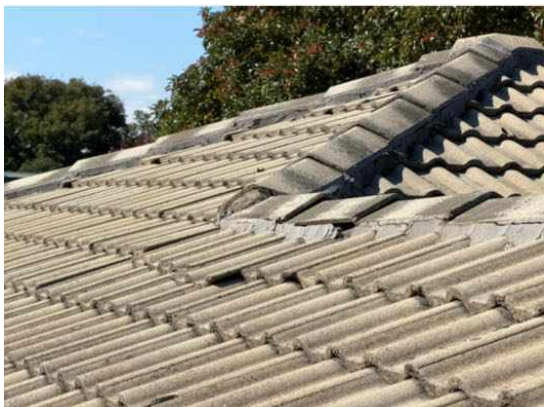
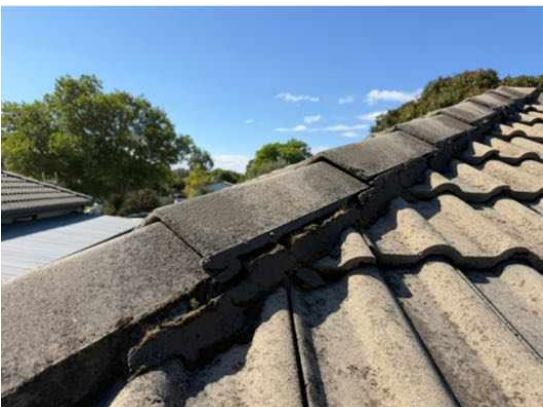
#### Finding 3.01

Building: Main Building  
 Location: Roof Exterior & Carport Roof  
 Finding: Roof Exterior - Cracking, Slippage, Rust  
 Information: Areas of chipped and slipped tiles and cracking in the tile pointing were identified to the roof exterior. The carport roof appeared to have areas of rust and loose / bent roof sheeting. While weathering of the roof exterior is consistent with the age of the

Where left unmanaged, deteriorating and damaged roof tiles are likely to lead to secondary defects, including water leaks.

Recommend consulting with a licensed roofing contractor in the short term, to provide further advice on remedial works needed.

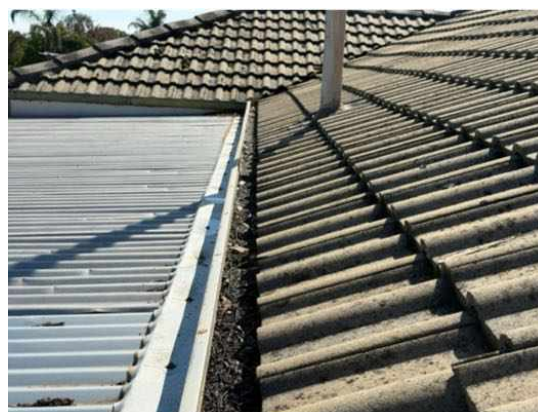
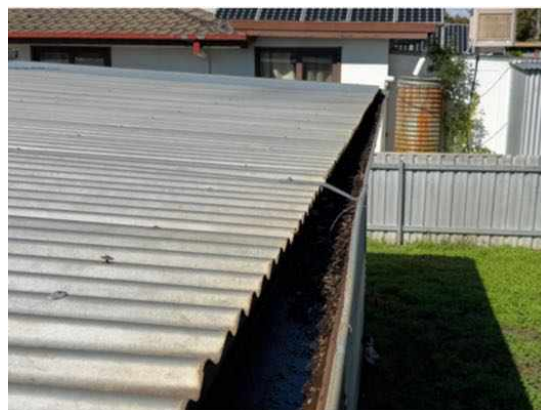
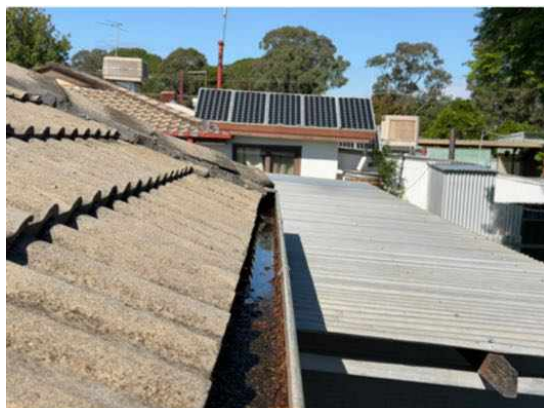
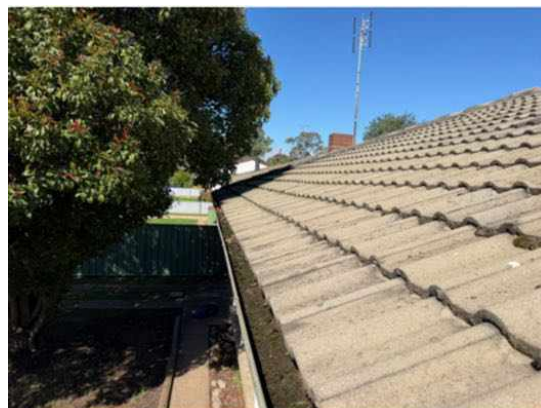
Building: Main Building  
 Location: Gutters  
 Finding: Gutters - Debris & Water pooling  
 Information: Water pooling and debris were noted in sections of the guttering at the time of inspection, likely due to sagging or blockages. Water pooling can lead to deterioration of the roof plumbing over time, if neglected.

A licensed roof plumber should be engaged in the short term, to provide further advice & maintenance works to ensure adequate roof drainage is achieved. All debris should be cleared promptly to ensure proper drainage and prevent overflows.

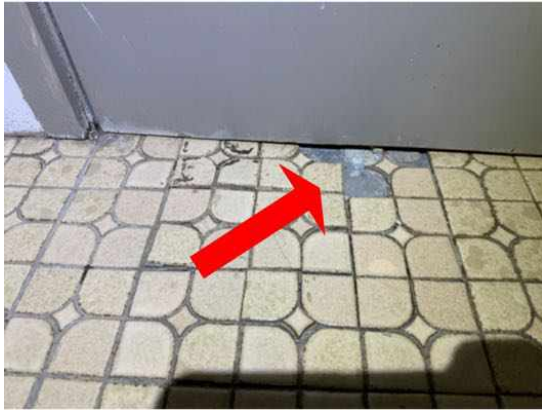
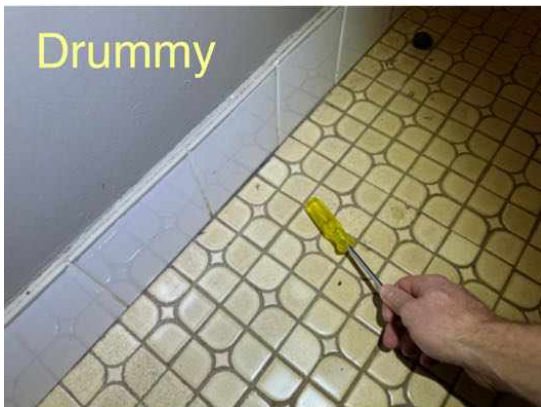
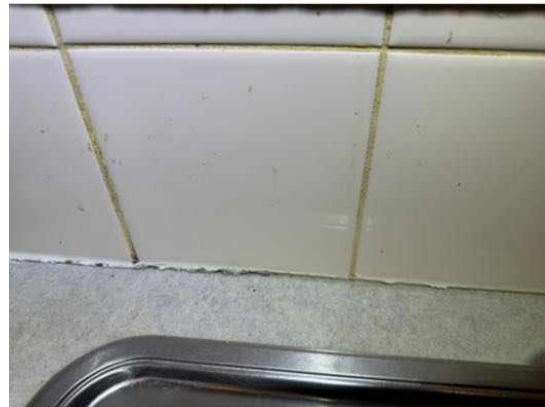
### Finding 3.04

Building:	Main Building
Location:	Tiled Areas
Finding:	Sealant / grouting - deteriorated or missing & Cracked & Drummy Tiles
Information:	It appears that the sealant and grout has deteriorated in some tiled areas, a common defect in buildings of a similar age. Areas of cracked & drummy/loose tiles were also noted, which can allow for moisture ingress behind the tiles, if neglected.

Sealant and grouting in areas that come into regular contact with water should be maintained for the long term care of your property.

Recommend engaging a licensed tiling contractor promptly, to provide maintenance works where necessary.

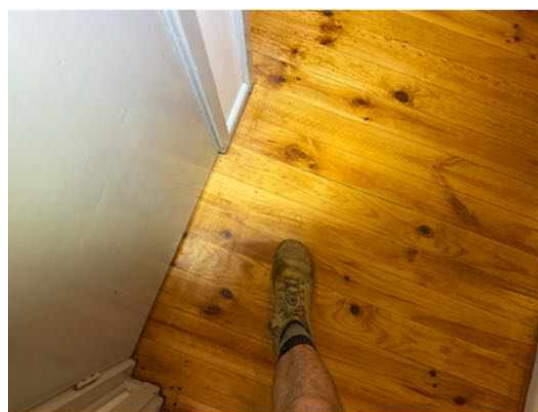
Building: Main Building  
Location: All Areas  
Finding: Flooring - Uneven  
Information: Some areas, of the flooring throughout the building appear to be slightly uneven. It is advised that the client monitor the flooring to identify any further movement. Where flooring remains relatively unchanged for an extended period of time, it is likely that this defect has been caused by expected movement of the foundations of the property.

However, where further movement and unevenness occurs, a structural engineer

should be engaged promptly for further evaluation.

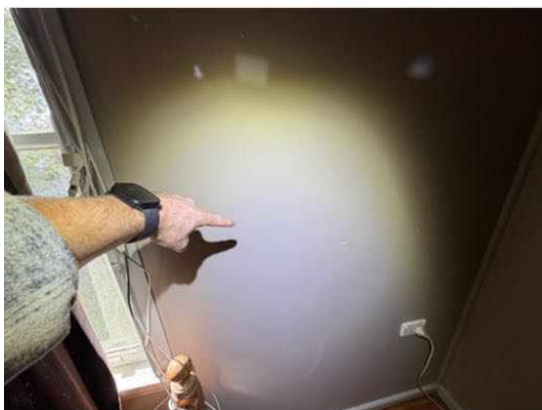
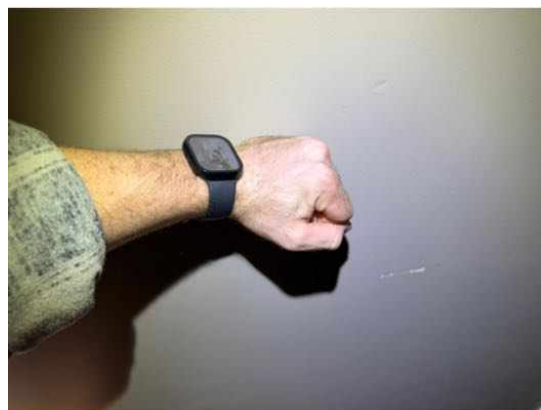
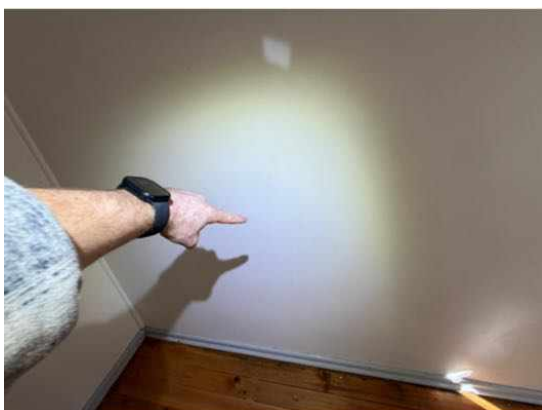
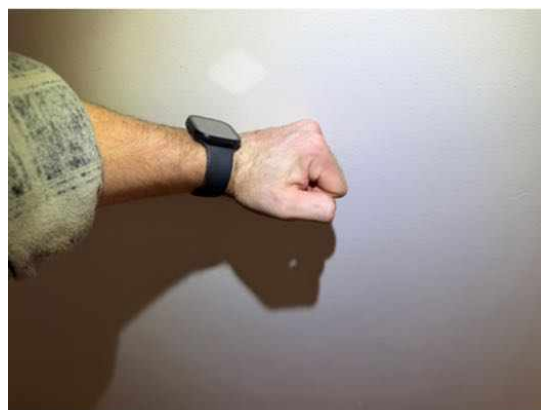
Building:	Main Building
Location:	Bedrooms
Finding:	Audible Indications of Potential Termite Damage
Information:	It appears areas of audible droppings in the wall cavities were identified at, but not limited to the front & rear bedroom walls. This may be an indicator of potential termite damage in the wall cavity. Therefore, a more invasive inspection conducted by a licensed tradesperson is recommended to confirm, and identify the extent of the damage.

Should termite damage be confirmed, a registered builder should then be engaged to replace any affected building materials.

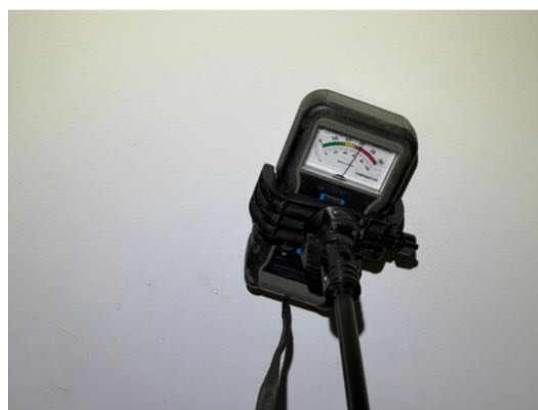
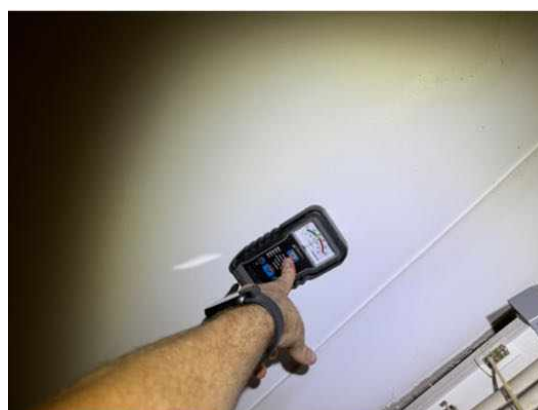
### Finding 6.03

Building: Main Building  
 Location: Bathroom, Lounge Room & Kitchen Ceilings  
 Finding: Ceiling Leaks  
 Information: High moisture was identified at, but not limited to the ceilings of the bathroom & kitchen. It appears water staining was also present to the lounge room ceiling however no high moisture was identified in this area, at the time of inspection. Potential causes of leaking include damaged plumbing fittings and fixtures, or deterioration of the roof exterior.

This creates an environment conducive to termite activity. Recommend engaging a licensed roof plumber or roofing contractor promptly to identify the cause & provide remedial works.

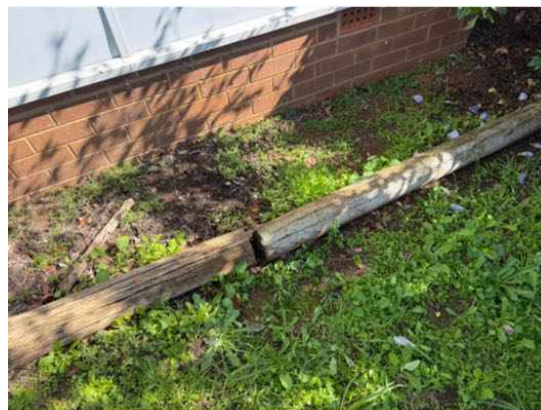
Building: Main Building  
 Location: All External Areas, Subfloor  
 Finding: Timber in direct ground contact & trees - conducive to termites  
 Information: Where timber materials are in direct contact with the ground and consequently moisture, they become conducive to termite activity. The tree stumps, timber debris in the subfloor, landscaping timbers, and trees surrounding the building create an environment conducive to termite infestation.

Where feasible, any timbers in direct contact with the ground should be removed and any trees in close proximity to the building should be removed or test drilled (inspected) at least annually to reduce the risk of termite infestation & detect any early signs of termite activity.

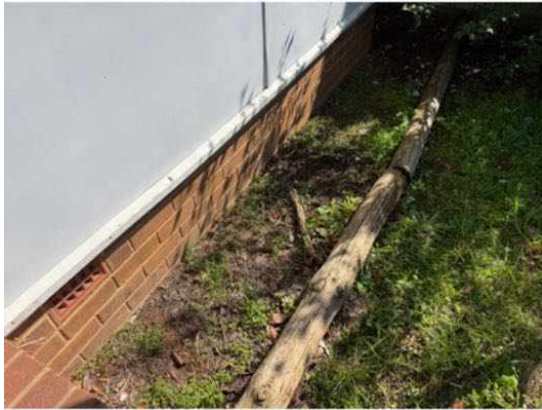
Building: Main Building  
Location: All external areas  
Finding: Potential Water pooling - against property  
Information: It appears that there are potential areas around the perimeter of the property that could be susceptible to water pooling. Where insufficient drainage of taps, hot water system & aircon overflows, and garden beds against the house are present, water pooling is likely to occur, and can create areas conducive to timber pests and potential damage to the subfloor structure overtime, if neglected.

Recommend consulting with a licensed plumber in the short term to further assess and provide remedial advice.

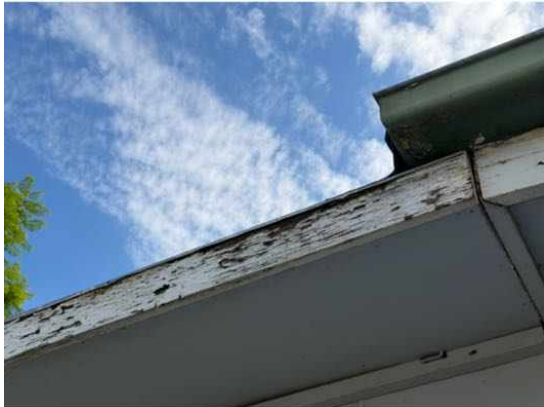
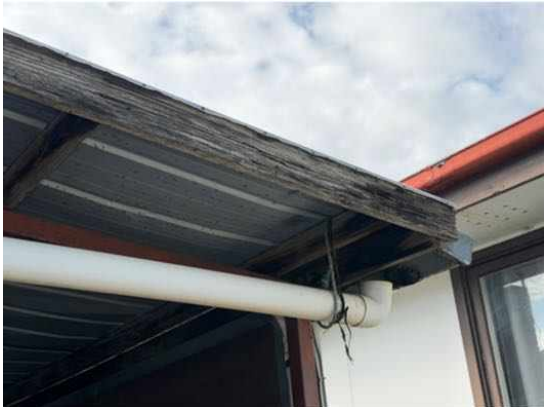
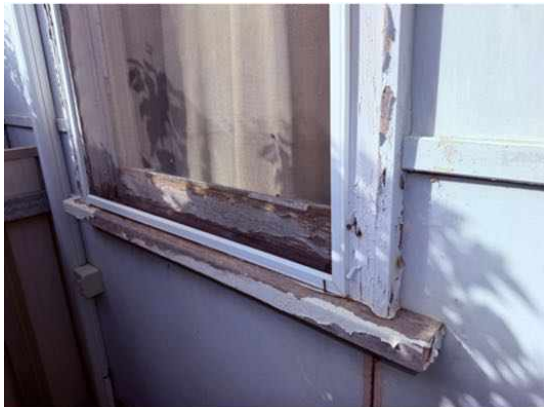
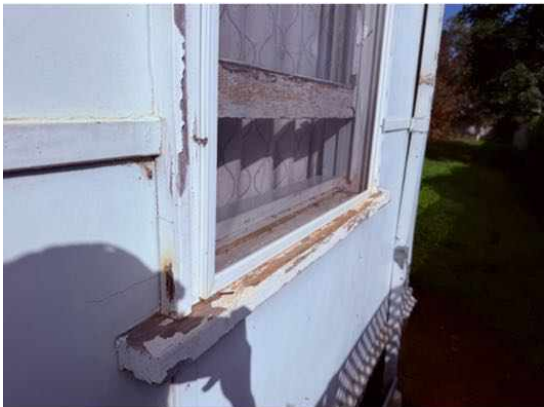
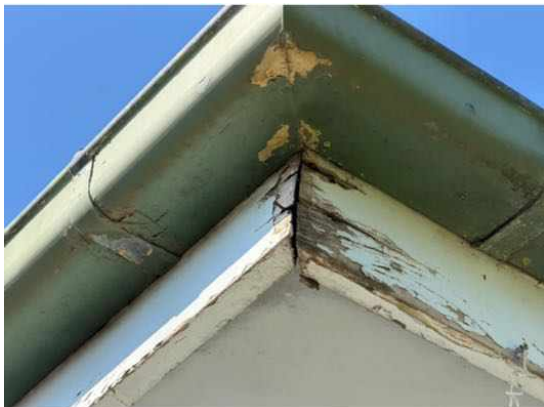
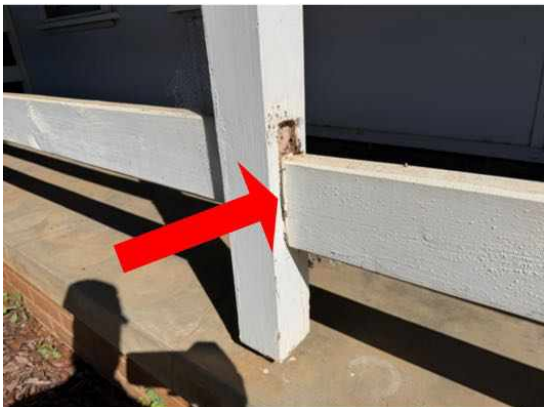
### Finding 7.01

Building:	Main Building
Location:	Fascias, window frames, carport framing
Finding:	Fungal decay & weathering
Information:	Areas of fungal decay (wood rot) were identified at but not limited to the fascias, window frames & carport framing. It appears that a rail of the front balustrade has also become loose & dropped.

For areas of fungal decay, the client can engage a licensed carpenter at their discretion to replace affected materials. For areas of general weathering, it is advised the client engage a licensed painter to apply protective sealant or coating to areas of weathered external timbers.

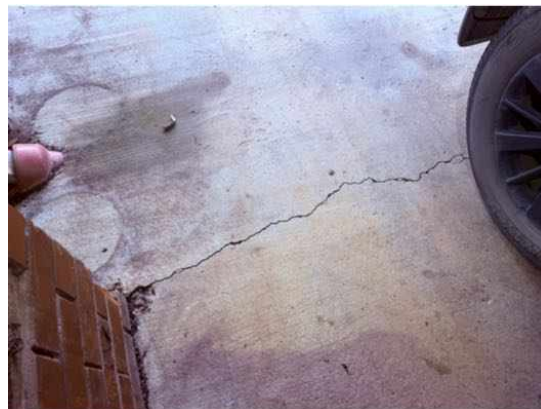
Building: Main Building  
 Location: Driveway  
 Finding: Cracking - Driveway  
 Information: It was noted there is cracking in areas of the driveway. Cracks in driveways are a common occurrence in houses of a similar age. Recommend that the client monitor the cracking. A concrete specialist can be engaged at clients discretion, to provide further advice, should cracks widen, lengthen, or become more numerous.

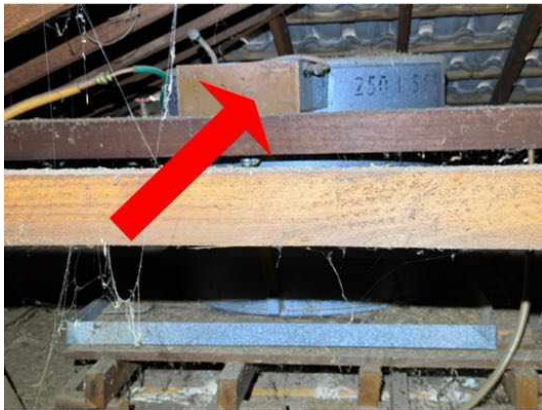
Information: A disconnected gravity-fed hot water system (HWS) remains in the roof void. Despite this plumbing system being unused, it may contain residual water. If neglected, rust of the system overtime, may lead to residual water leaking.

Recommend that the client either monitor the condition of the system or get the system drained by a licensed plumber to prevent any potential future leaks.
