Building and Timber Pest Inspection Report

Inspection Date: Wed, 21 Jan 2026

Property Address: 151 Kiara Rd, Miranda NSW 2228,
Australia

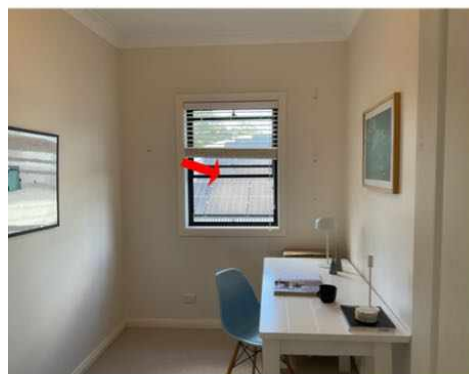
Building:	Building 1
Location:	Upstairs windows
Finding:	Window opening restrictors missing.
Information:	The Building Code of Australia rules require all openable windows (where the internal floor is more than 2m above the ground outside) in residential rooms to be fitted with a suitable screen or restrictor. Windows located 1.7m above the floor level do not require protection.

Window restrictors are required where people who are vulnerable to the risk of falling have access to windows. This means all windows above ground level which do not have another fall prevention safety measure in place, such as a balcony or balustrade should have a restrictor.

These need to be added urgently for the safety of all persons.

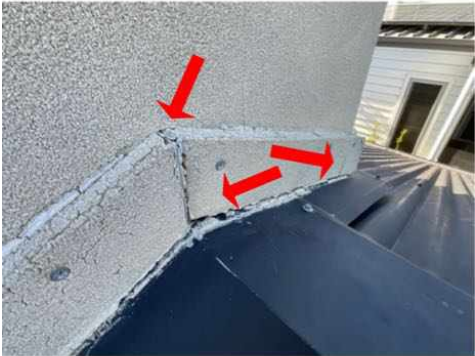
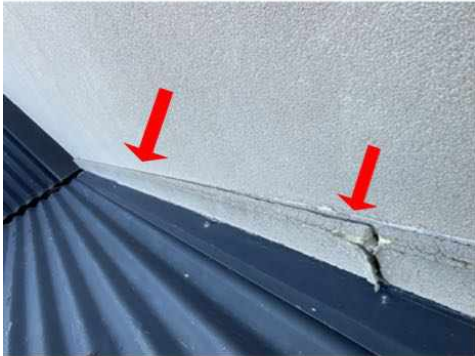
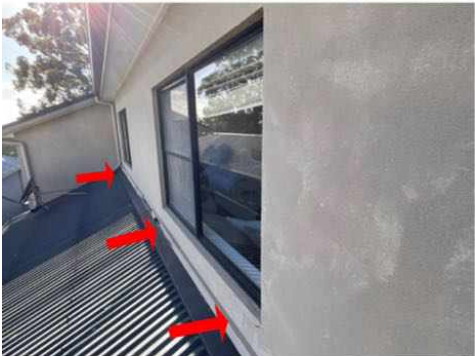
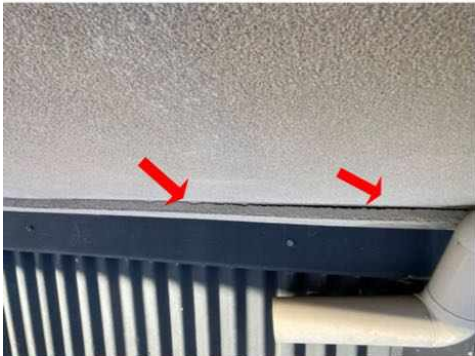
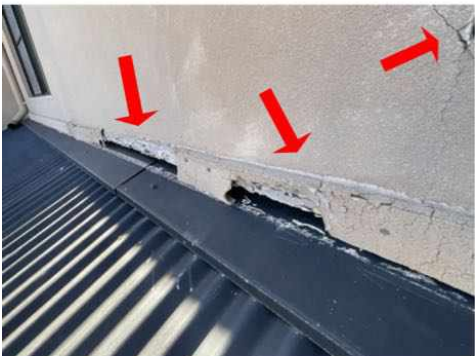
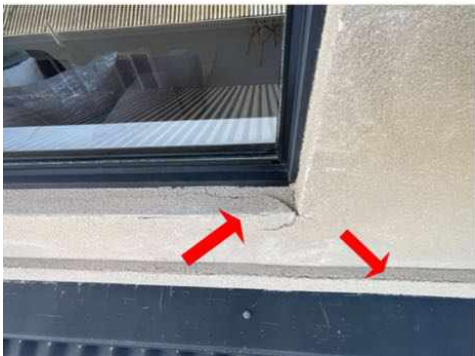
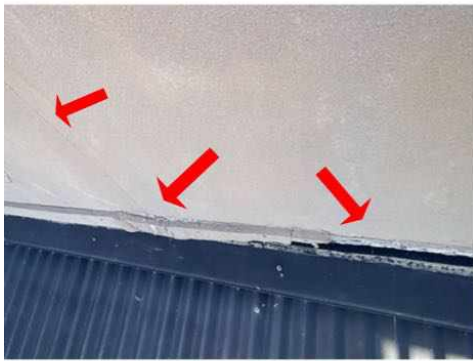
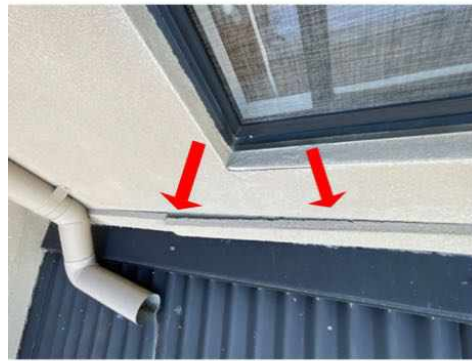
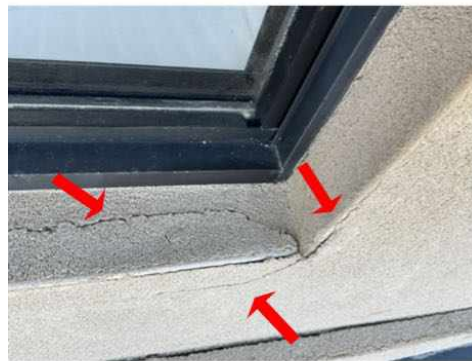
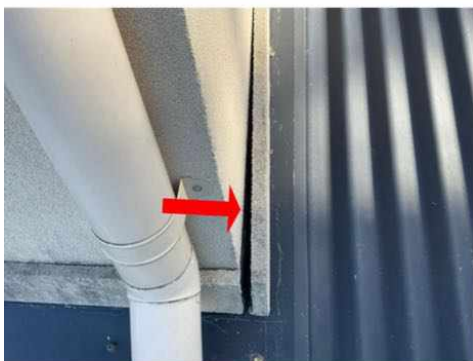
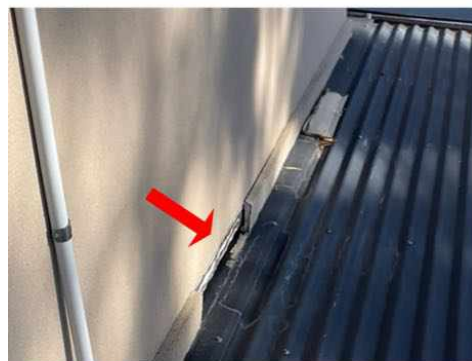
Finding 2.01

Building:	Building 1
Location:	Upper wall areas
Finding:	Cladding and Render (external) - loose and cracking
Information:	The wall cladding appears to be Hebel. Hebel needs meticulous sealing and waterproofing which has not occurred on this property.

It has been observed that numerous areas of loose cladding and cracked rendered surfaces has occurred. The degree of damage on the upper roof walls is severe and a

major defect as this can allow water ingress into the property to further damage internal areas. Some areas are falling off. The lower wall areas are described as minor defects due to most cracks being approximately 1-2 mm in width. Some are at expansion joints which show minor movement.

The upper roof damage required urgent repair/replacement and quotes for this should be sought. Due to the large number of cracks to the lower walls, it is suggested to get quotes to replace all cladding at one time.

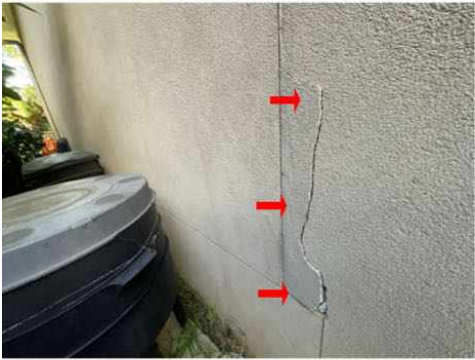
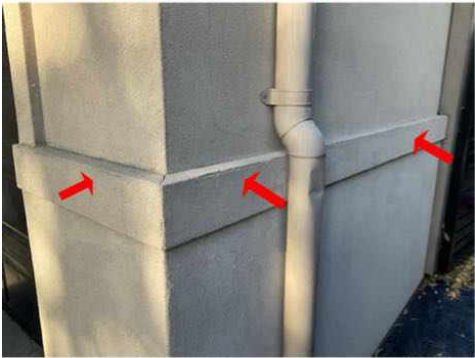
Finding 3.01

Building: Building 1
Location: Wall areas
Finding: Cladding and render (external) cracking and cladding damage on rear left (continued)
Information: See pictures of lower wall cracking which are all considered minor except photos 1 & 2.

All these require repair to keep the property watertight.

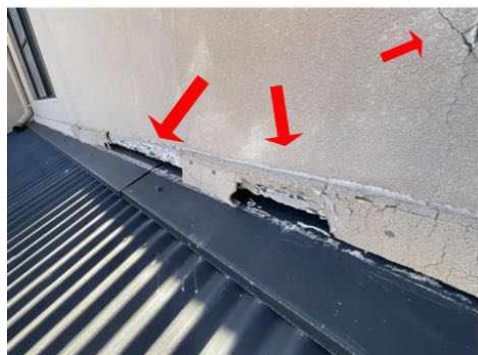
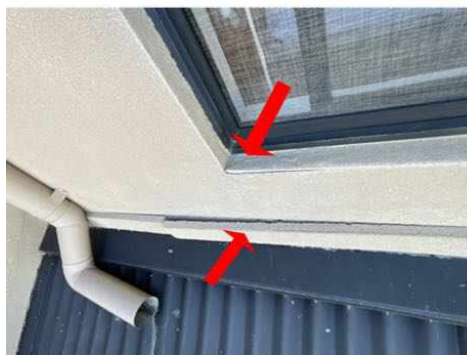
Building: Building 1
Location: Most exterior walls
Finding: Sealant (external) - missing
Information: It was noted on inspection that many areas of external sealant was missing to small areas of the external walls.

Flexible sealants should be applied to these affected areas to prevent any subsequent water damage that is likely to occur.

A registered builder or cladding expert should be appointed to complete these works as soon as possible.

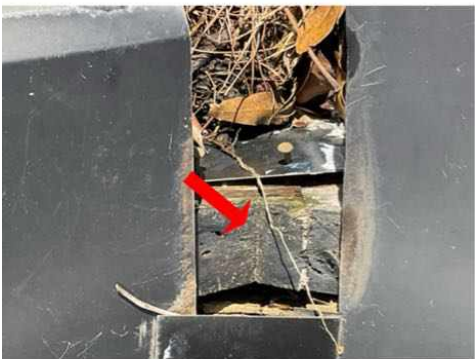
Finding 3.04

Finding: Wood rot

Information: The building shows evidence of a few small areas of wood rot. Wood rot, also known as Fungal Decay, occurs when timbers and other cellulose building materials are exposed to damp conditions on an ongoing basis. This could be the result of exposure to weathering over a prolonged period of time, or the attraction of excessive moisture from other abutting building materials.

Early intervention and regular maintenance, particularly of exterior timbers, will prolong the useful life of these building elements. Prior to any works being performed, the cause of the moisture that has created the visible wood rot should be identified and addressed in a suitable manner. Replacement of affected timbers may then be a necessary step in protecting surrounding building elements from such deterioration.

A qualified carpenter or registered builder may also be required to replace affected building materials.

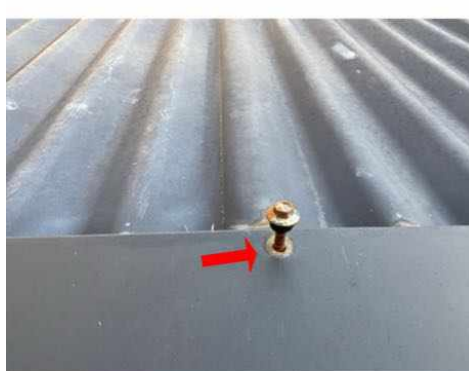
Finding 3.05

Building: Building 1
Location: Pictured small areas
Finding: Additional fixings required
Information: Evidence of insufficient fixings were evident on the right gate and front roof that need additional fixings to ensure their longevity. It is also recommended to replace all rusted roofing screws.

A carpenter or handy person would be able to add additional fixings to these areas.

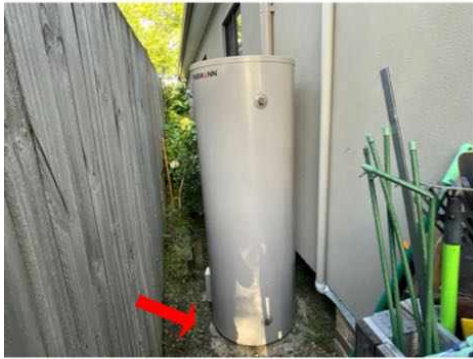
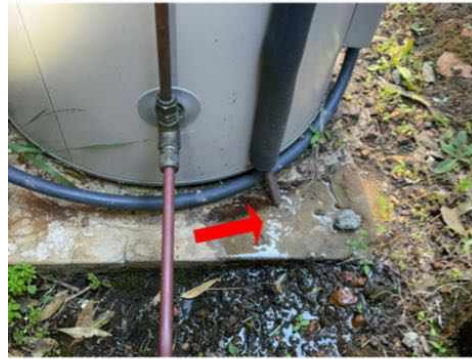
Finding 3.06

Building:	Building 1
Location:	Left Wall Area
Finding:	Site drainage - Inadequate
Information:	The site drainage in this left area was found to be inadequate at the time of inspection, creating potential for subsequent water damage to associated building elements.

The hot water system overflow run against the house walls. As the subfloor ground level is lower than the external ground, some rainwater may run to subfloor areas causing the minor mould found.

It is important that water does not lie against the base of walls; surrounding paths and ground levels should be sloped to drain water away from walls. Downpipes should not discharge stormwater onto lower walls or plinths. Stormwater should be carried away by large, regularly cleaned drains. Ground levels may need to be lowered to expose a buried DPC.

Where site drainage is inadequate, installation of an Agricultural (Aggie) Drain may be required. A qualified plumber should be appointed to further inspect the property and perform any remedial works as necessary. Secondary defects are likely to occur if left unmanaged.

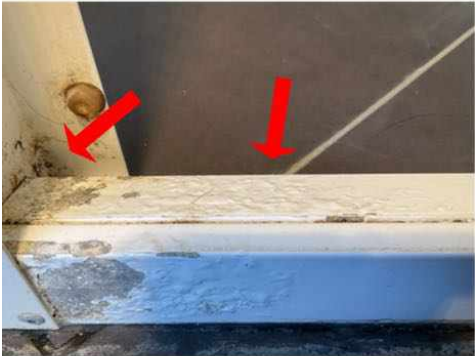
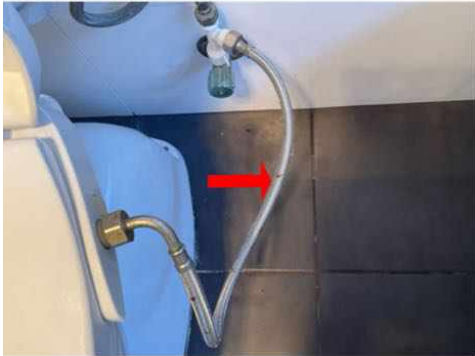
Building:	Building 1
Location:	Roof screws and bathroom areas
Finding:	Areas rusted or corroded
Information:	These roof and bathroom areas shows evidence of rusting and corrosion, which is likely to have developed as a result of excessive exposure to moisture and or inadequate coatings.

As surface rust provides no protection to the underlying iron, the deteriorating condition is likely to worsen if not addressed in the short-term future.

Where possible, the use of galvanized (treated) metals or aluminium coated metals aid in rust prevention, as does regular general maintenance. Rust formation can be controlled with coatings, such as paint, that isolate the iron from the environment.

Rusting and corrosion should be managed by ideally removing or limiting the affected surface from exposure to moisture. A skilled handy person should be appointed immediately to replace the roof screws that have been severely affected by rust or water damage.

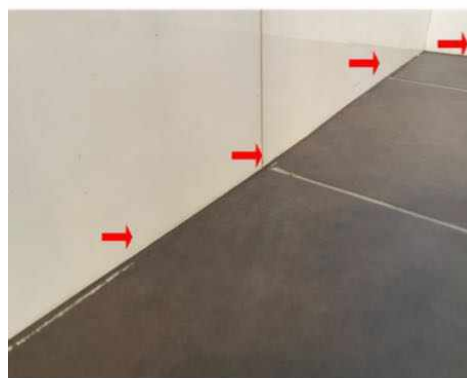
Finding 3.09

Building:	Building 1
Location:	Kitchen and bathroom
Finding:	Sealant and grouting - Missing or damaged
Information:	It was noted on inspection that sealant or grout is degraded to these pictured areas.

Different materials and floor areas move at different rates, generally causing cracking to grout or sealant at this point. A flexible sealant is required to allow for expected expansion and contraction, while keeping the joint water tight and protective of all associated building materials.

Flexible and mould resistant materials should be applied to affected areas to prevent any subsequent water damage that is likely to occur. Regular maintenance and replacement of damage or missing or damaged sealant and grout is highly recommended to the wet areas, as this is a regular wear and tear defect. Sealant and grouting in areas that come into regular contact with water should be maintained for the long term care of your property.

A sealant specialist or tiling contractor should be appointed to complete these works as soon as possible

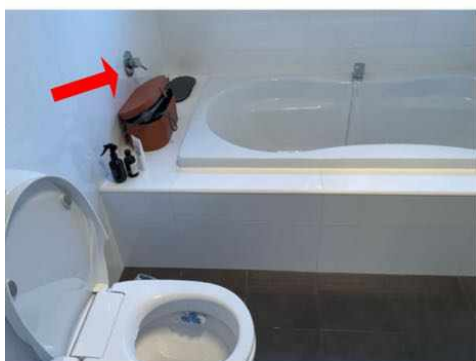
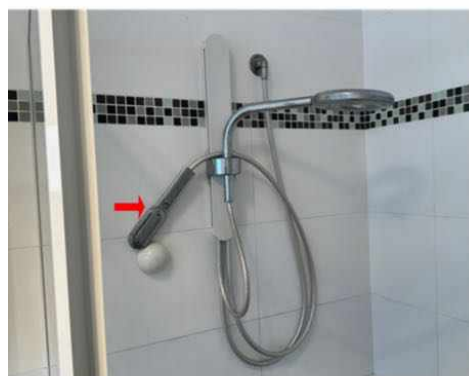
Finding 3.10

Building: Building 1
 Location: Bathroom
 Finding: Tap - Water hammer and hand shower not operating
 Information: This tap shows evidence of water hammer being present. Water hammer, a pressure surge resulting when a fluid is forced to suddenly change direction, is a common defect in plumbing fittings, particularly those that are aged and not frequently maintained. Water hammer is generally caused by factors that create high water pressure in the affected plumbing fixture, usually evidenced by a faint banging noise during operation of the affected tap.

Although water hammer is generally considered to be a minor defect, subsequent damage such as erosion of tap hardware and/or water damage to associated building elements is likely to occur if left unmanaged.

The hand shower button to operate it was not working and requires replacement, the other shower head was operating normally.

A licensed plumber should be appointed as soon as possible to replace any affected tap hardware and perform any remedial works as necessary. Please be advised that the appointment of a cabinet maker or qualified carpenter may be necessary if water damage to associated building elements has occurred.

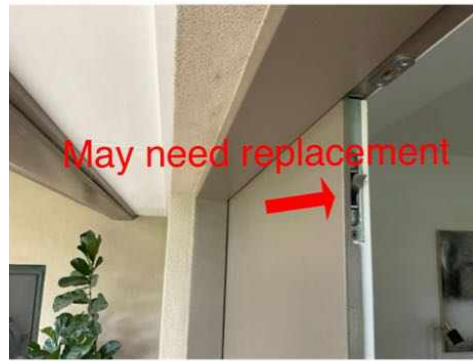
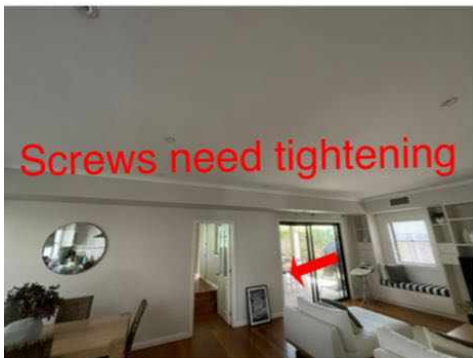
Finding 3.11

Building: Building 1
 Location: Two rear doors
 Finding: Building element - Damaged
 Information: Evidence of minor damage was identified to two door locks. They both need adjustment and one would no lock.

A carpenter would be trade responsible for rectification.

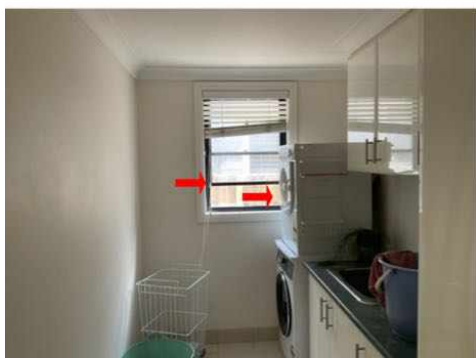
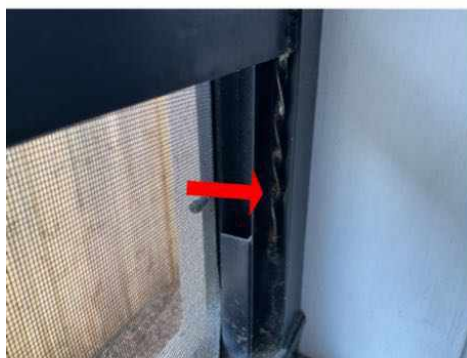
Finding 3.12

Building:	Building 1
Location:	Laundry
Finding:	Windows - Sash balances broken
Information:	Sashes are the moveable panes of windows that primarily slide vertically over each other to expose one half of the window area. Each sash is provided with springs balances and/or compression weather-stripping, which act to hold the window in place in one position.

The sash balance mechanism will need replacement to allow the window to function as intended. Such works may be completed by a qualified carpenter or registered builder.

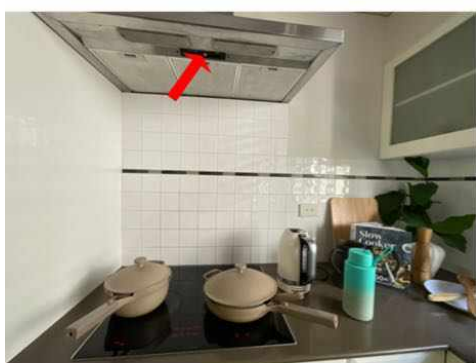
Finding 3.13

Building:	Building 1
Location:	Kitchen
Finding:	Rangehood - Light not working
Information:	While the range hood appears to be working at a satisfactory level, the light to the appliance was not working at the time of inspection.

A licensed electrician should be appointed to replace the light on the range hood to restore it to a fully operational state.

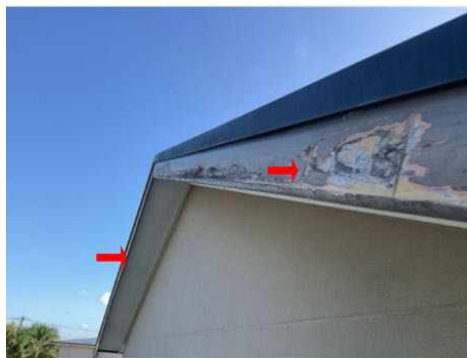
Finding 3.14

Building:	Building 1
Location:	Roof Exterior
Finding:	External painting deteriorated
Information:	Some of the small areas of external paintwork has been neglected and require attention to prepare and re-paint.

Whilst incomplete or missing paint finish is generally an appearance defect, it can also lead to the development of secondary building defects over time. Incomplete areas of paint finish expose the area to moisture, potentially accelerating the deterioration of underlying building materials.

Degraded paint finishes should be sanded back, filled, leveled and painted, as applicable. Where inadequate or missing paint protection has led to the deterioration of the associated building element, repair and/or replacement of this building element may be required.

A painting contractor should be appointed as soon as possible to perform necessary works to aid the appearance of the affected area and to ensure the area is protected against further deterioration. Alternatively, the homeowner following manufacturer instructions may perform these works.

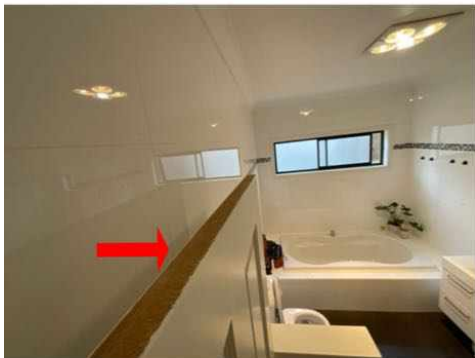
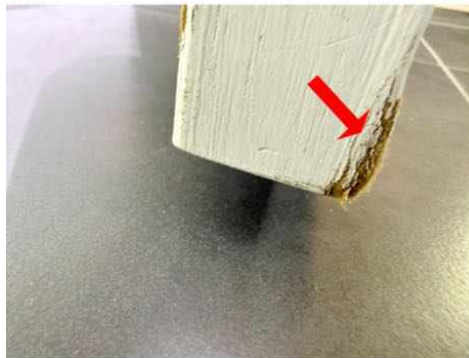
Finding 3.15

Building:	Building 1
Location:	Bathrooms
Finding:	Paint finish on doors - Incomplete
Information:	The paint finish on some doors was identified as being incomplete at the time of inspection.

NSW Guide to Standards and Tolerances 9.6 states that “door leaves are defective if they do not have all sides, top and bottom edges sealed/painted

Whilst incomplete or missing paint finish is generally an appearance defect, it can also lead to the development of secondary building defects over time. Incomplete areas of paint finish expose the area to moisture, potentially accelerating the deterioration of underlying building materials.

Incomplete paint finishes should be sanded back, filled, leveled and painted, as applicable. Where inadequate or missing paint protection has led to the deterioration of the associated building element, repair and/or replacement of this building element may be required.

A painting contractor should be appointed as soon as possible to perform necessary works to aid the appearance of the affected area and to ensure the area is protected

against further deterioration. Alternatively, the homeowner following manufacturer instructions may perform these works.

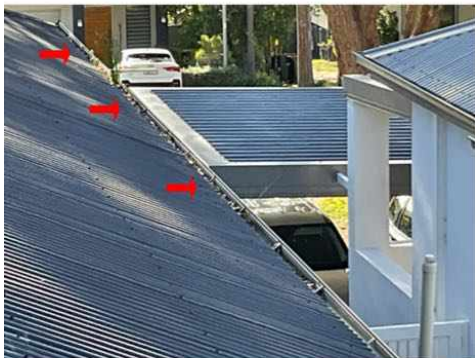
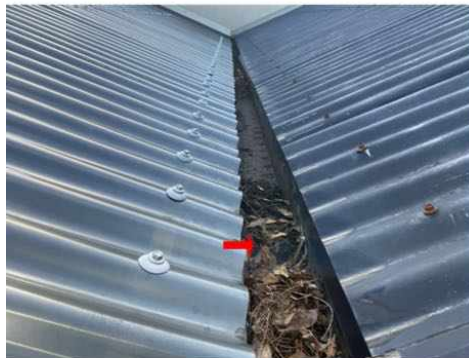
Finding 3.16

Building: Building 1
 Location: Roof exterior
 Finding: Gutters - Full and blocked
 Information: The guttering on around the roof was found to be blocked at the time of the inspection. Roof plumbing structures, such as guttering and downpipes, should be free of all debris to prevent blockages. Blockages of the guttering and downpipes will lead to pooling and accumulated water overflows, which is likely to subsequently flood eaves and exterior walls.

Blocked gutters are likely to lead to high levels of moisture in the affected areas which can cause rust and decay of the gutters and downpipes and wood rot to adjoining timber areas. Blockages in gutters should therefore be removed immediately to ensure dry conditions are maintained.

It is highly advised that gutters be cleaned by the homeowner or a general handyperson as a matter of urgency.

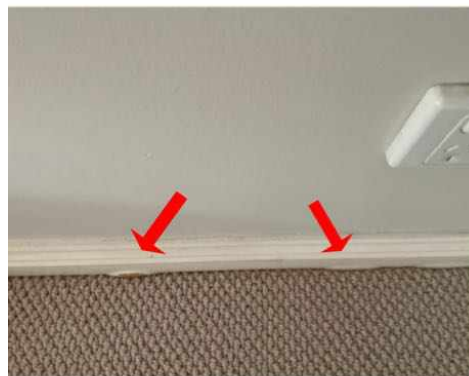
Finding 3.17

Building: Building 1
 Location: Bedroom - front
 Finding: Building element - Swollen
 Information: Swollen skirting generally indicate that the building materials have been affected by excessive moisture over a prolonged period of time, and have swollen as a result.

No reason was found for this damage and no significant moisture was found. It is thought to be old damage. Repair and/or replacement of the swollen skirting can be undertaken by a qualified carpenter.

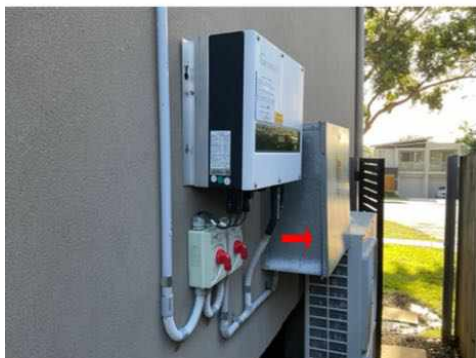
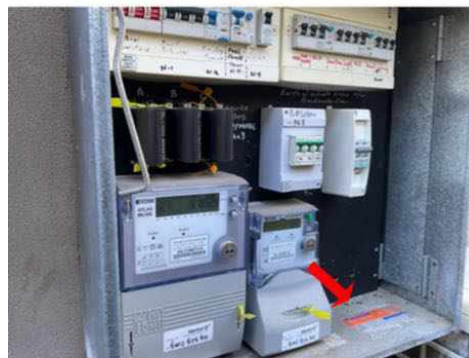
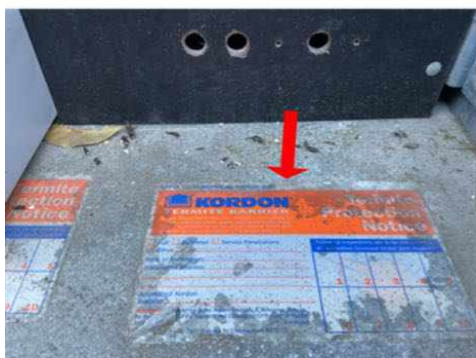
Building:	Building 1
Location:	Meter Box
Finding:	Termite Management System - no evidence of a chemical installation
Information:	The application of a post-construction chemical termite barrier is highly recommended for all properties. Such barriers are highly effective in preventing termite attack on any timber building elements throughout the property.

A durable notice should be placed in the switchboard unit to indicate current termite barriers. At the time of inspection, the durable notice was evident but could not be read and it appeared as though no chemical termite management system has been installed, with no evidence to suggest preventative works taking place since the property was built.

The client may consider gaining further advice from a pest controller as to the costs and procedures involved with a 'chemical' application. It is recommended that obtaining such advice be a short-term priority.

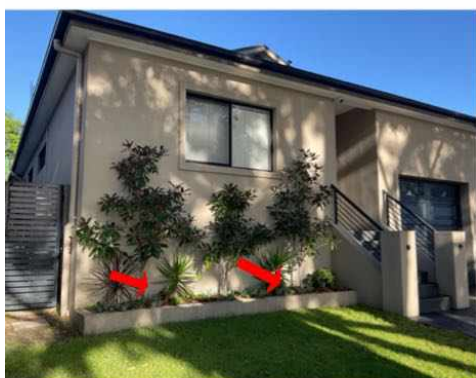
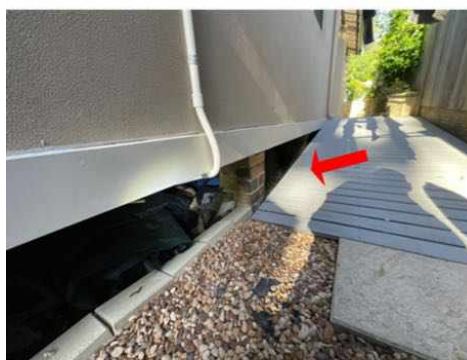
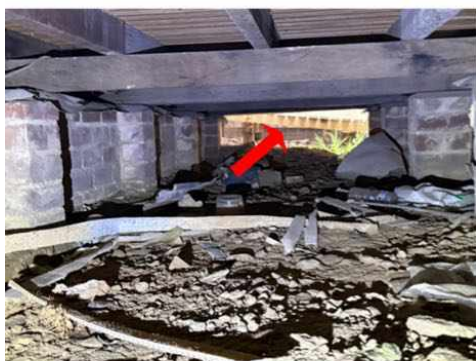
Finding 6.02

Building:	Building 1
Location:	Yard at front and right path
Finding:	Bridging - Vegetation and decking
Information:	Where vegetation and decking obstructs inspection of building elements, also known

as bridging as it provides a bridging point for the access of termites, full inspection can not be achieved. Consequently moisture or dampness may be present and the areas becomes conducive to termite activity. Plants and decks against or very close to buildings provide cover, shade and can provide an environment that is attractive to termite infestation.

The removal and replanting of plant species that do not provide "cover" or cutting back of existing vegetation and leaving a small gap between decking and the building walls will assist greatly in preventing Bridging from occurring.

The removal of any such stored building or plant materials that may be conducive to termite activity should be carried out as soon as possible and arrange re inspection to minimize the risk of termite attack.

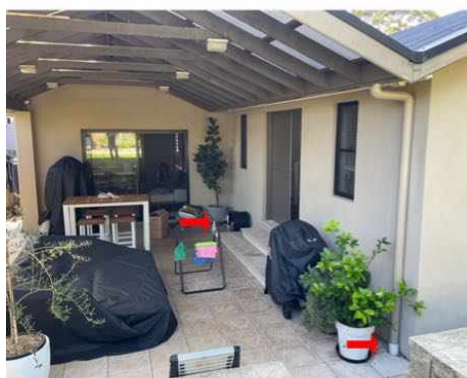
Finding 6.03

Building:	Building 1
Location:	Exterior rear walls
Finding:	Slab Edge - Exposure
Information:	An inspection zone of at least 75mm in relation to the exposed slab edge, between the bottom brick and the perimeter pavement, is required. This inspection zone should be maintained in order to force termites into the open where they can be detected more readily during regular inspections. The slab edge should not be

If the slab edge is not properly exposed there is a high risk of termite attack. Sometimes, in order to determine the type of slab, a suitably qualified person such as an architect or builder may be required to consult the construction plans.

Where the slab edge cannot be properly inspected, it is highly recommended that termite or timber pest inspections be carried out every 6-12 months to aid protection of the property against infestation.

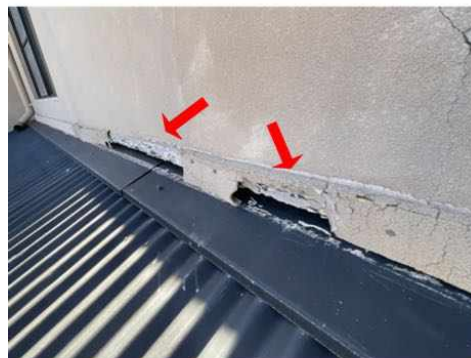
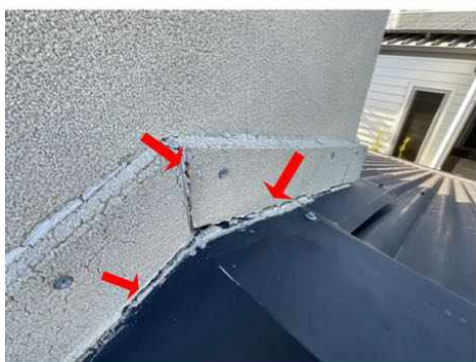
Finding 6.04

Building:	Building 1
Location:	Many wall areas
Finding:	Sealant (external) - missing and attractive to termites
Information:	It was noted on inspection that areas of external sealant was missing to small areas of the external walls. A flexible sealant or flashing is required to protect the associated building materials from rainwater ingress. Any moisture ingress into the property is very attractive to termites. Flexible sealants or flashing should be applied to these affected areas to prevent termite activity.

A sealant specialist or skilled handy person should be appointed to complete these works as soon as possible.

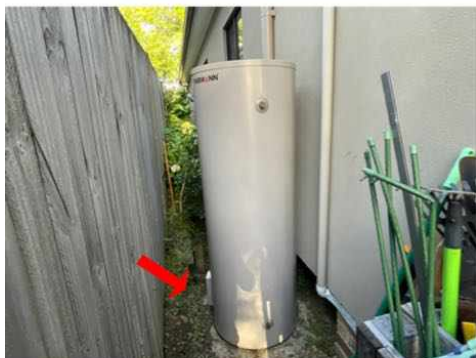
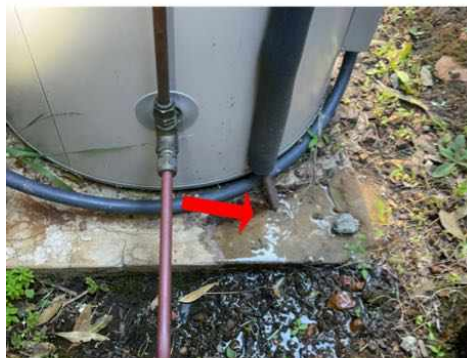
Finding 6.05

Building:	Building 1
Location:	Pictured external wall areas
Finding:	Overflows - Not plumbed for drainage
Information:	The pictured overflow pipes are not plumbed or connected to suitable drainage, which has resulted in the surrounding area becoming excessively damp.

These damp conditions can lead to secondary defects such as rot, rust or corrosion of associated building elements, the formation of fungal decay, or even the creation of potential slip hazards. When coupled with poor site drainage, pooling of water may also attract termite activity to this area. It is highly recommended that a qualified plumber be appointed to install adequate drainage to these areas. These works will ensure that the area remains dry and free of any secondary defects.

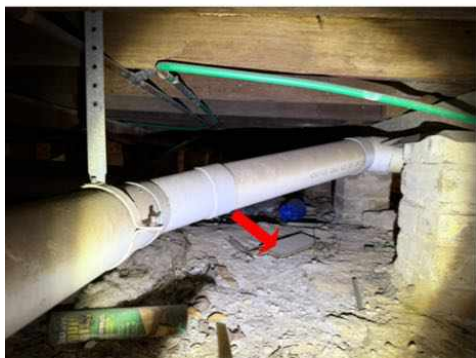
Finding 6.06

Building:	Building 1
Location:	Small subfloor areas
Finding:	Timber in contact with the ground
Information:	Any timbers in direct ground contact provide opportunity for concealed termite entry and are likely to be subject to premature rot and decay as the soil retains moisture or damp conditions against the timbers.

Removal of all waste timber that is in direct contact with ground is highly advised. This timber is promoting mould and wood rot and is very attractive to termites.

Frequent pest inspections are advised to readily identify any termite activity in these areas.

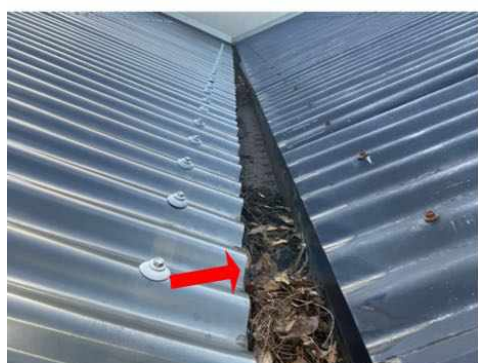
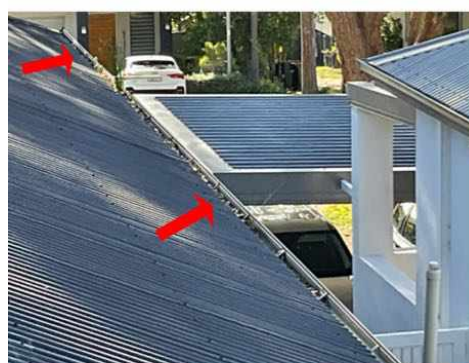
Finding 6.07

Building:	Building 1
Location:	Roof exterior
Finding:	Gutters - Full and blocked
Information:	The guttering on around the roof was found to be blocked at the time of the inspection. This is a building and pest defect so is mentioned in both reports. Roof plumbing structures, such as guttering and downpipes, should be free of all debris to

Blocked gutters are likely to lead to high levels of moisture in the affected areas. Such moisture will not only cause rust and decay of the associated building materials, but can also provide conditions that are conducive to termite and timber pest activity. Blockages in gutters should therefore be removed immediately to ensure dry conditions are maintained.

It is highly advised that gutters be cleaned by the homeowner or a general handyman as a matter of urgency.

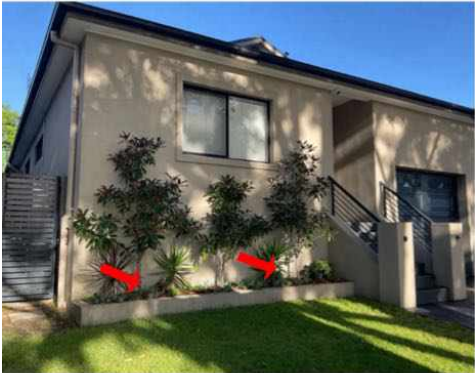
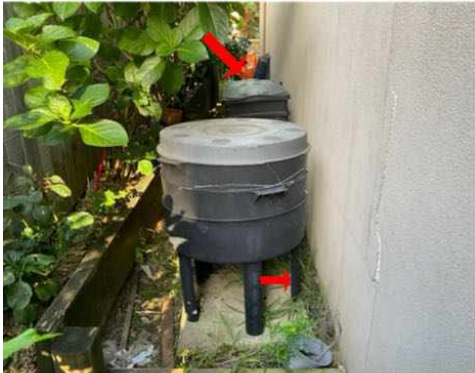
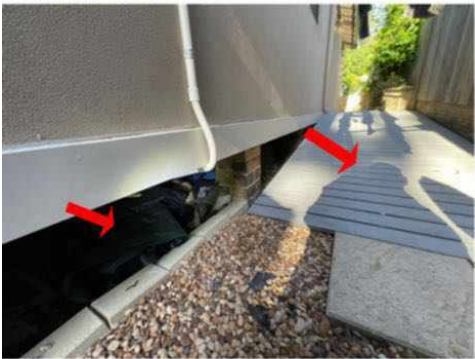
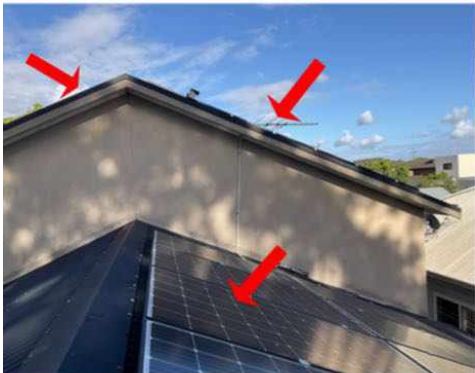
Building: Building 1
 Location: All External Areas
 Finding: Additional Photos - Obstructions and Limitations of EXTERNAL AREAS
 Information: These photographs are an indication of the obstructions and limitations which impeded full inspection of external areas at the time of inspection. These obstructions can hide an array of defects and should be removed to allow full inspection to be carried out. A re-inspection is recommended once the areas are made accessible.

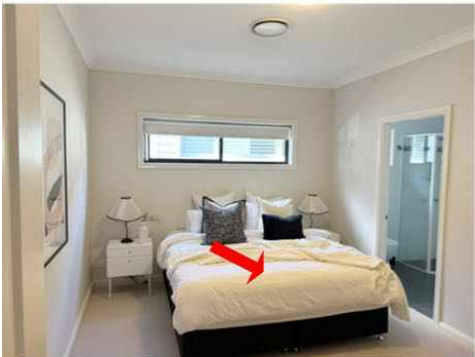
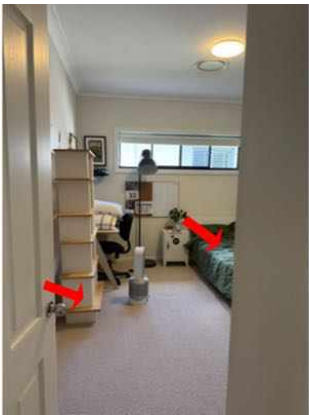
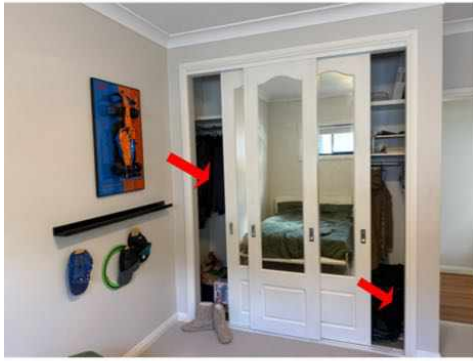
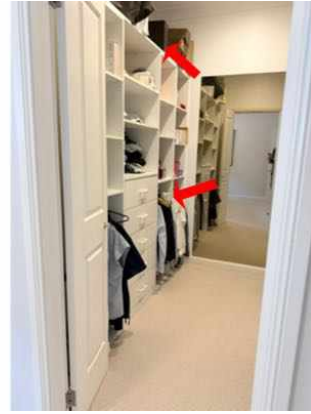
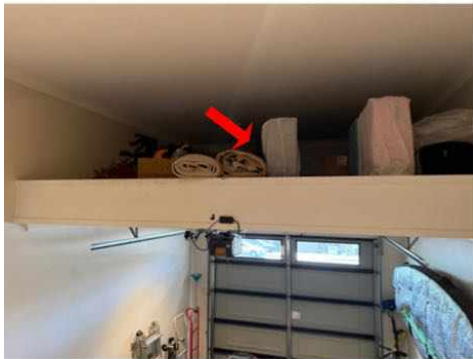
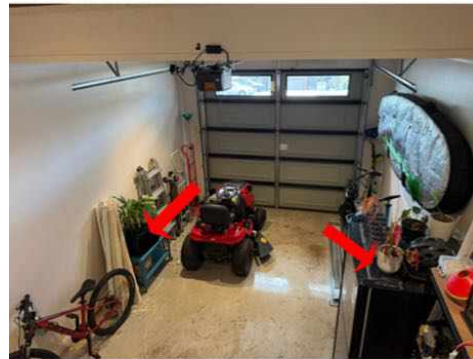
Building: Building 1
Location: All Internal Areas
Finding: Additional Photos - Obstructions and Limitations of INTERNAL AREAS
Information: These photographs are an indication of the obstructions and limitations which impeded full inspection of Internal areas at the time of inspection. These obstructions can hide an array of defects and should be removed to allow full inspection to be carried out. A re-inspection is recommended once the areas are made accessible.

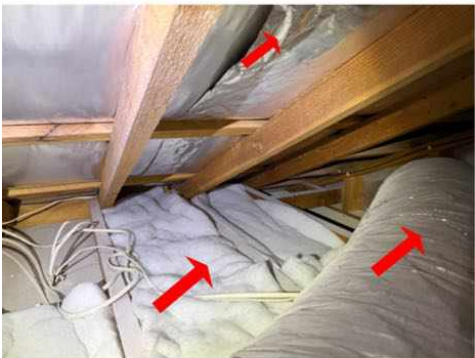
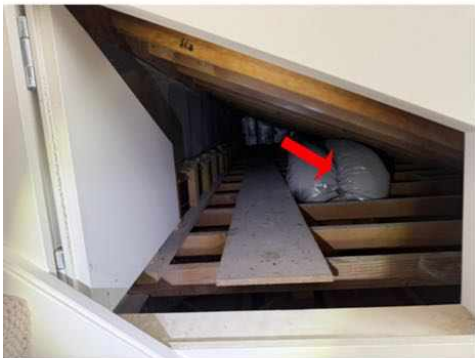
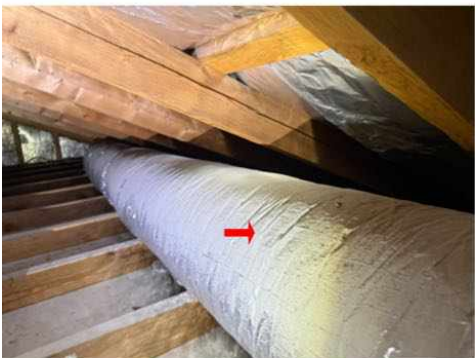
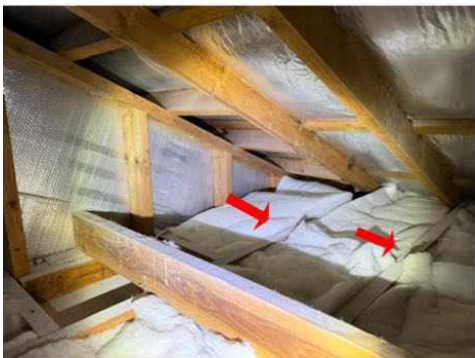
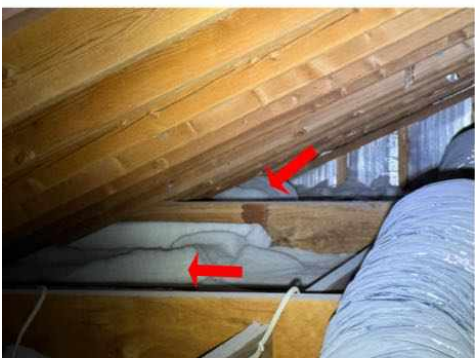
Building: Building 1
 Location: All Roof cavity areas
 Finding: Additional Photos - Obstructions and Limitations of the ROOF CAVITYS
 Information: These photographs are an indication of the obstructions and limitations which impeded full inspection of roof cavity areas at the time of inspection. These obstructions can hide an array of defects and should be removed to allow full inspection to be carried out if applicable. A re-inspection is recommended once the areas are made accessible.

The inspection was also limited to areas with an allowable crawl space of 600mm x 600mm, in particular towards the external walls where the roof line diminishes, these areas were not accessible.

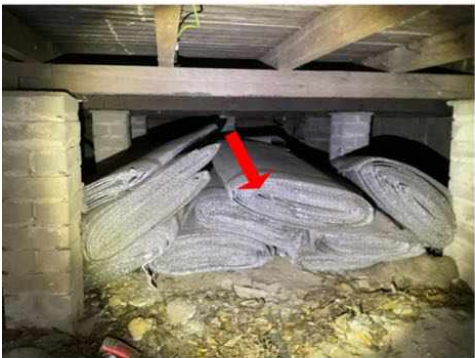
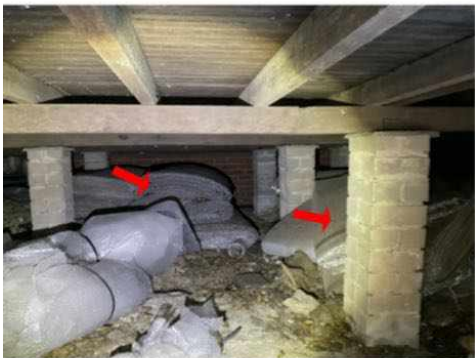
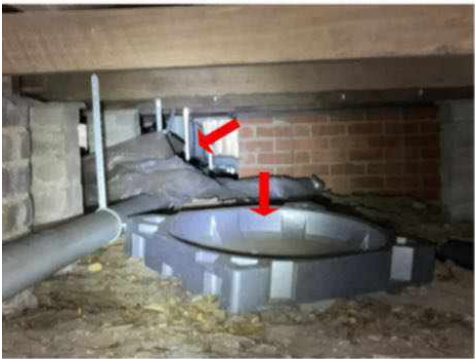
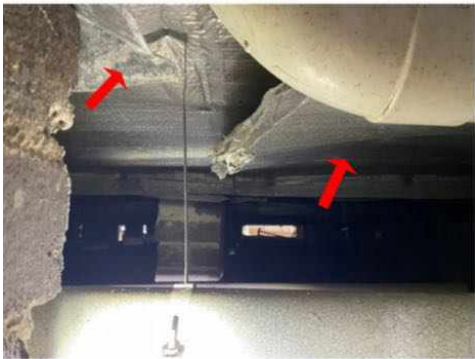
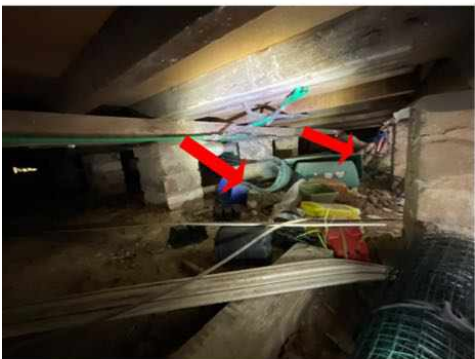
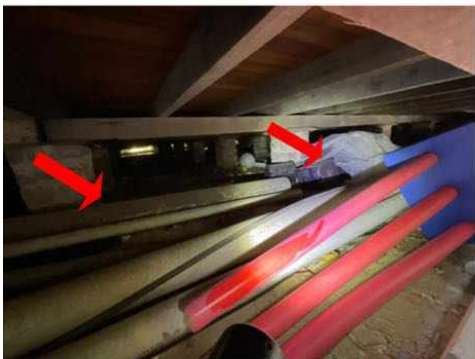
Building: Building 1
Location: All Subfloor Areas
Finding: Additional Photos - Obstructions and Limitations of SUBFLOOR AREAS
Information: These photographs are an indication of the obstructions and limitations which impeded full inspection of subfloor areas at the time of inspection. These obstructions can hide an array of defects and should be removed to allow full inspection to be carried out. A re-inspection is recommended once the areas are made accessible.

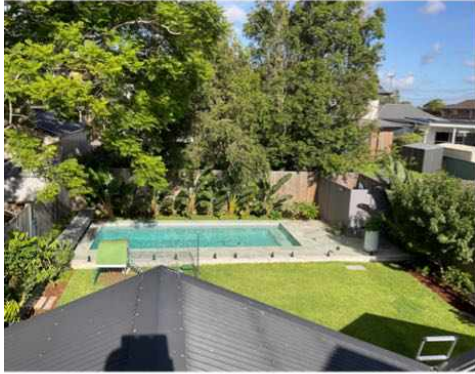
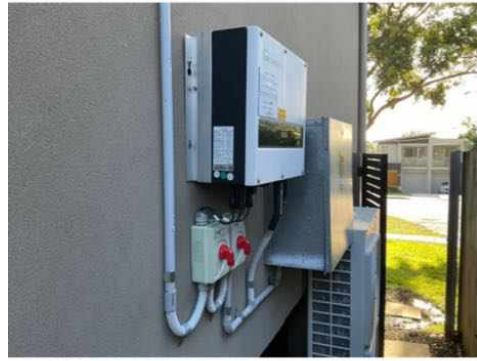
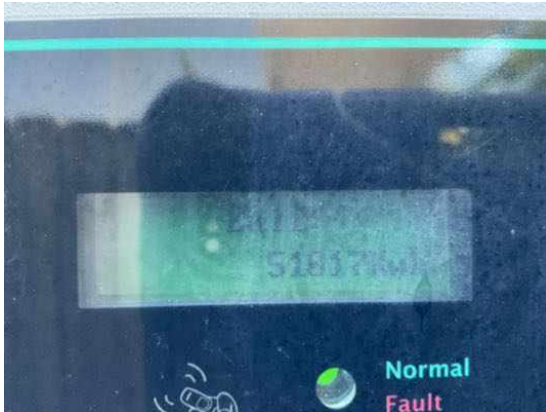
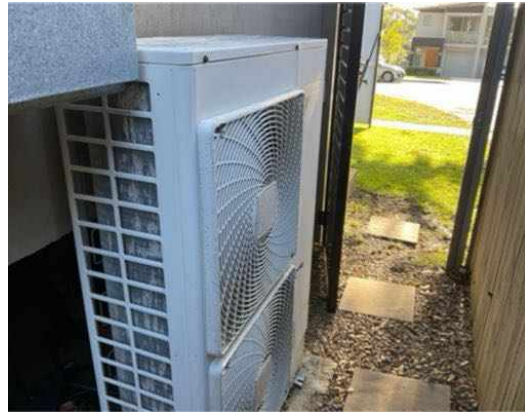
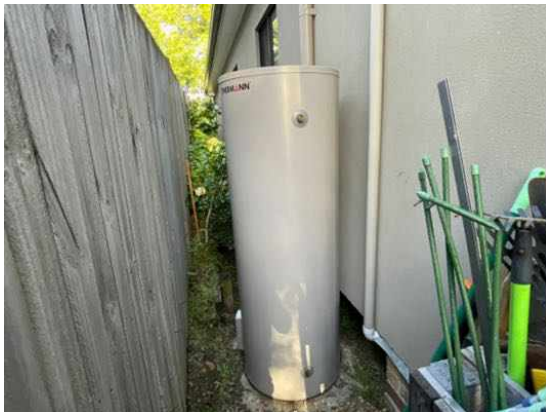
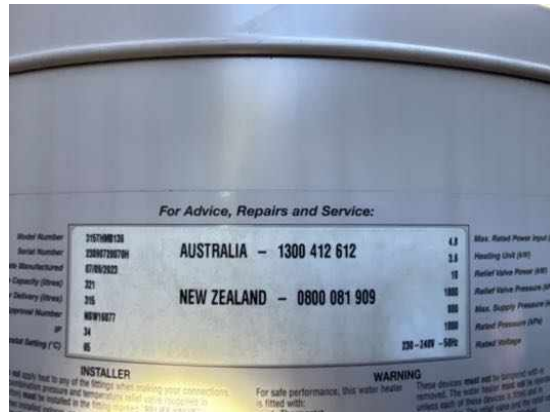
Building: Building 1
Location: All External Areas
Finding: Additional Photos
Information: Additional photos are provided for your general reference

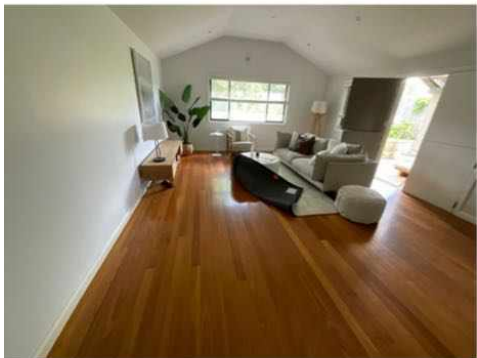
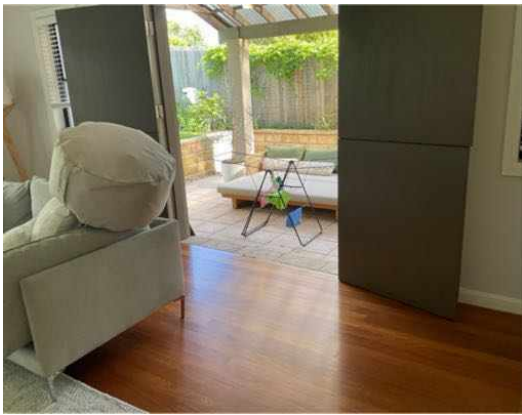
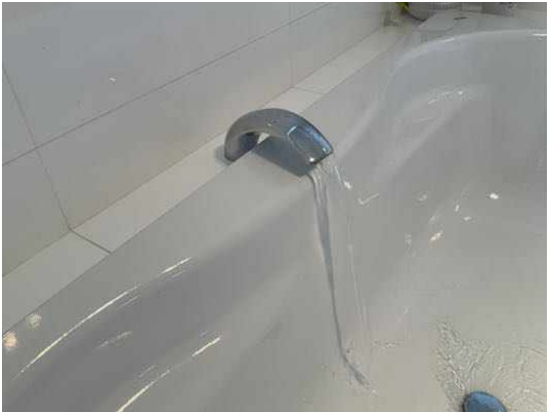
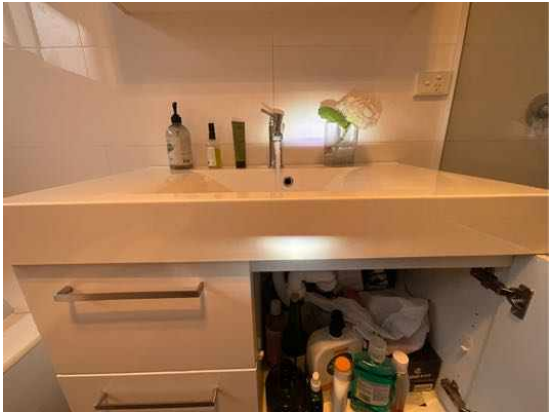
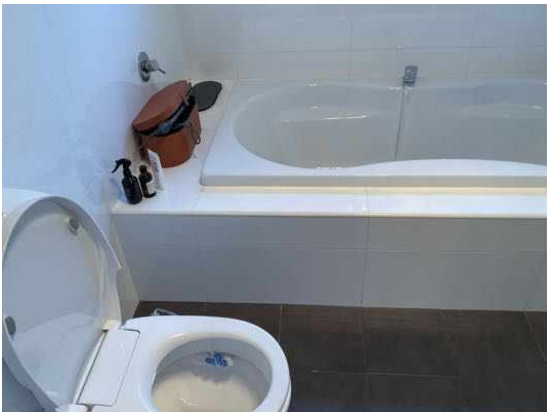
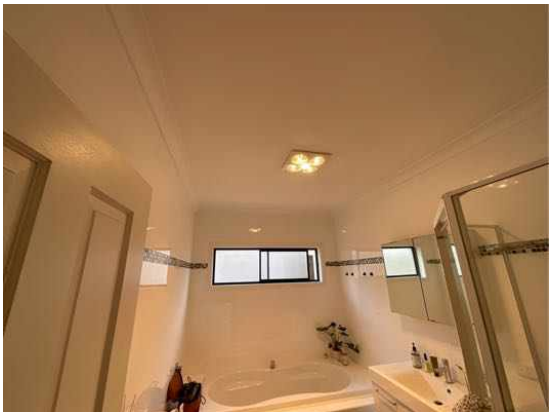
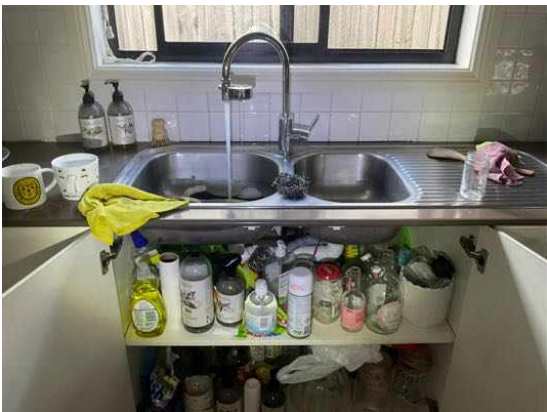
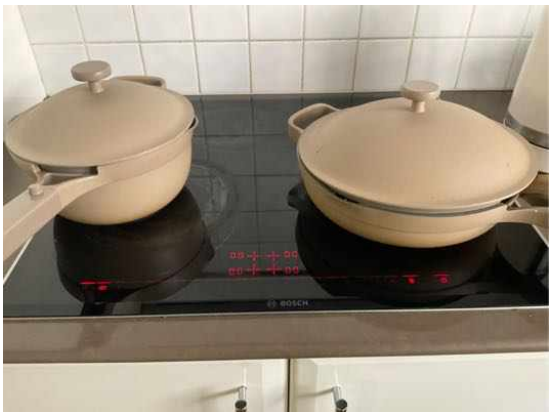
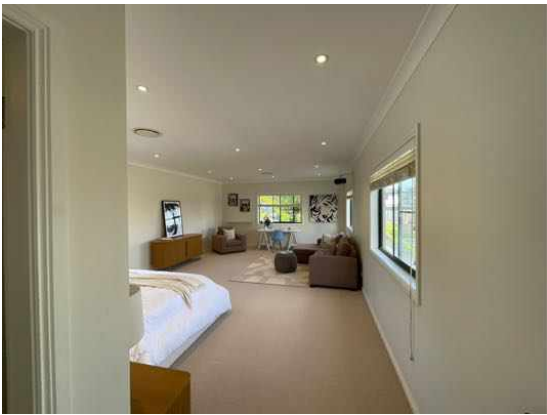
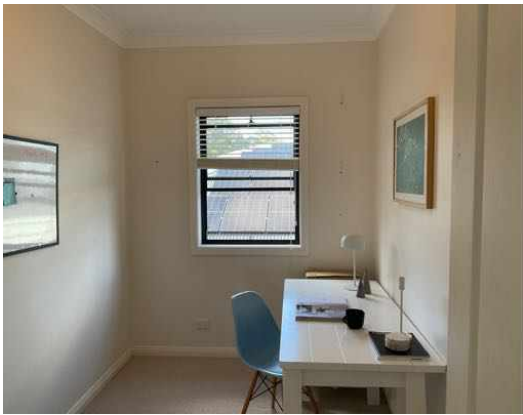
Building: Building 1
 Location: All Internal Areas
 Finding: Additional Photos
 Information: Additional photos are provided for your general reference
