Building and Timber Pest Inspection Report

Inspection Date: Wed, 21 Jan 2026

Property Address: 151 Kiara Rd, Miranda NSW 2228,
Australia

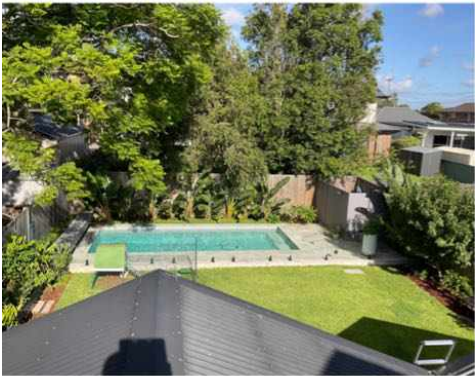
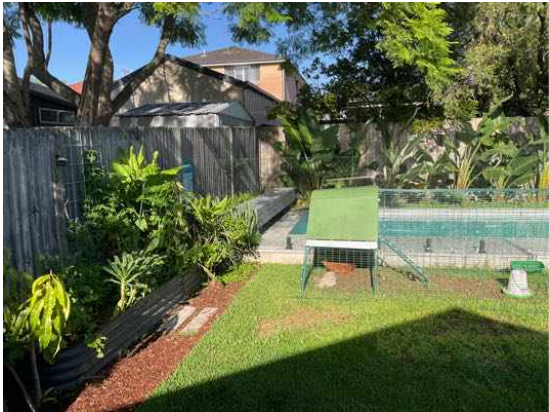
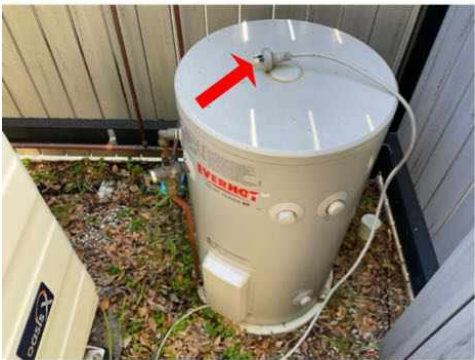
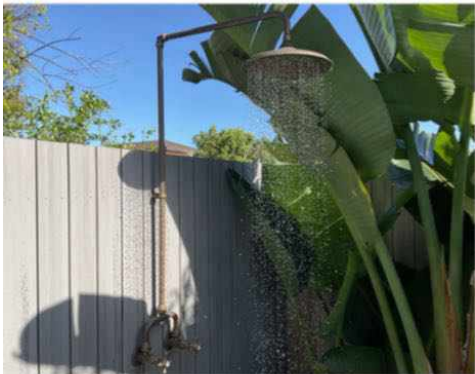
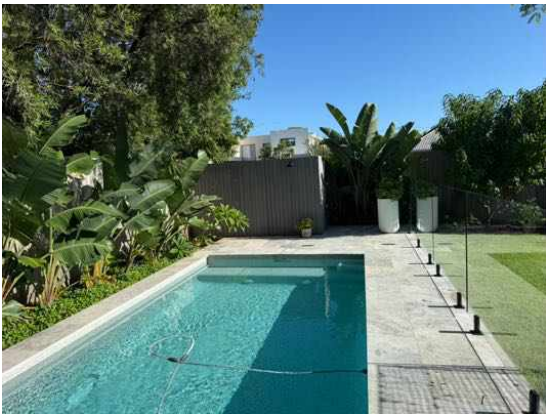
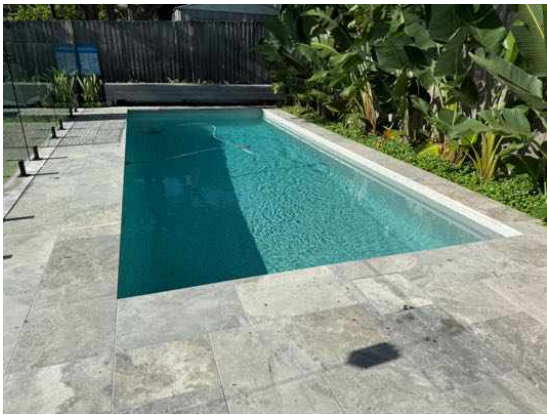
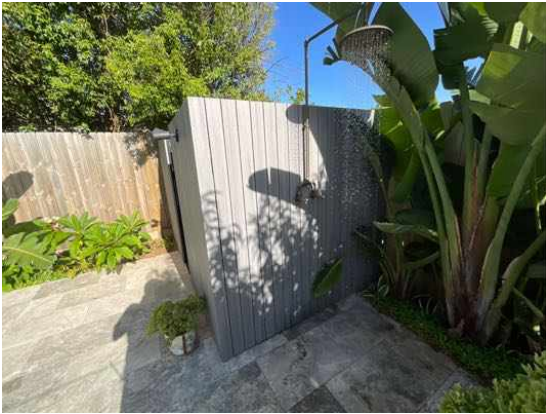
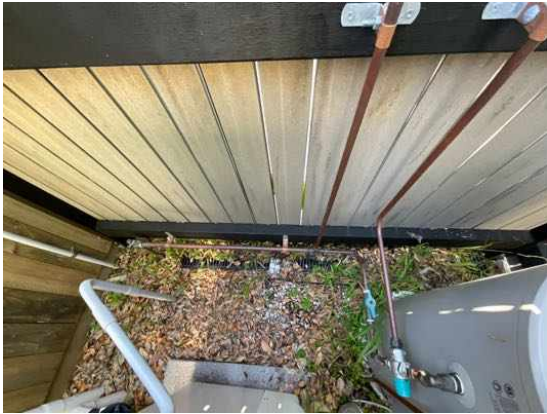
Building: Building 1
Location: Yard - Back
Finding: Additional Photos or pool areas
Information: Additional photos are provided for your general reference

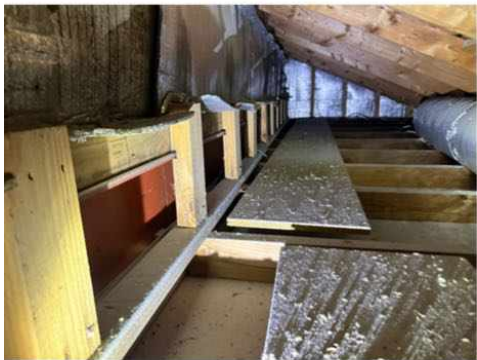
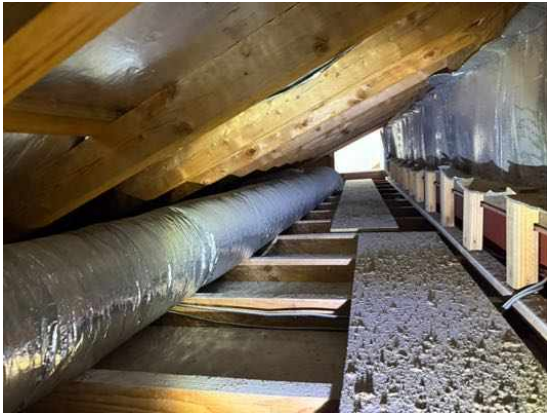
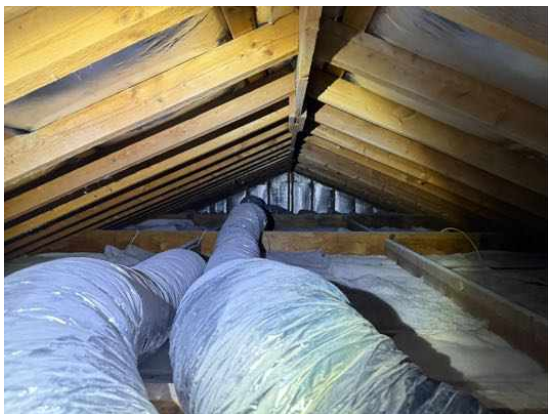
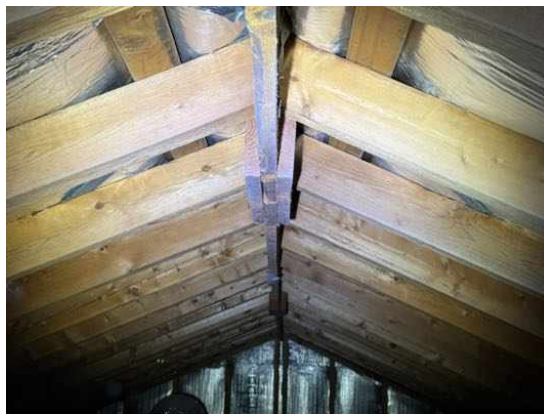
Building: Building 1
Location: All Roof cavity areas
Finding: Additional Photos
Information: Additional photos are provided for your general reference

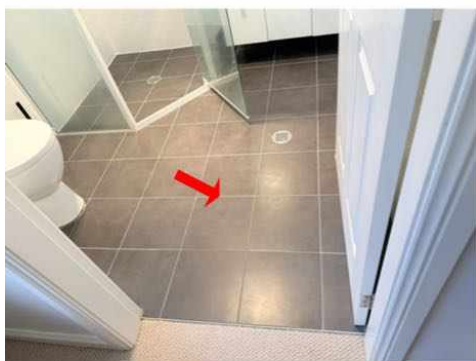
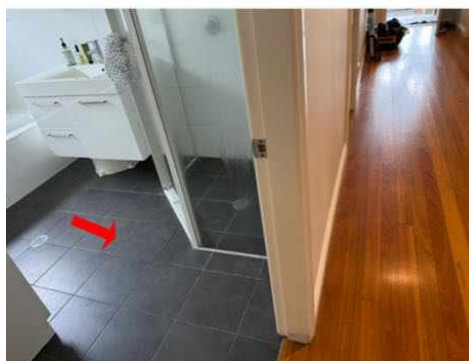
Building: Building 1
 Location: Bathrooms and laundry
 Finding: Waterproofing membranes - Information Only
 Information: Internal Water Proofing Membranes, are crucial in preventing water ingress into the property is important to know that the Membrane System used is to Australian Standards and has been installed correctly.

With older property's where this information is unavailable all wet areas should be monitored. If any leaks, water staining, peeling or bubbling of the paint become evident to any adjacent walls or ceilings below a licensed builder or waterproofing specialist is recommended to investigate further.
