Building and Timber Pest Inspection Report

Inspection Date: Tue, 7 Apr 2026

Property Address: 32 Renita St, Slacks Creek QLD 4127, Australia

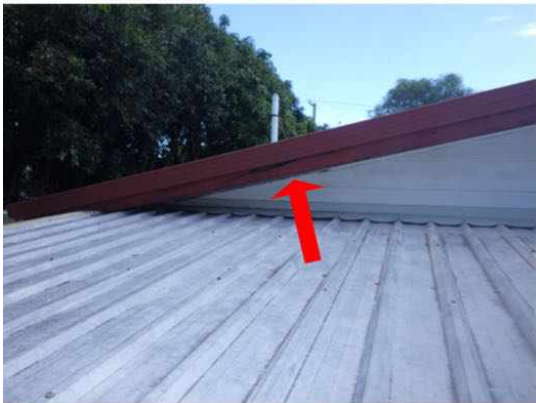
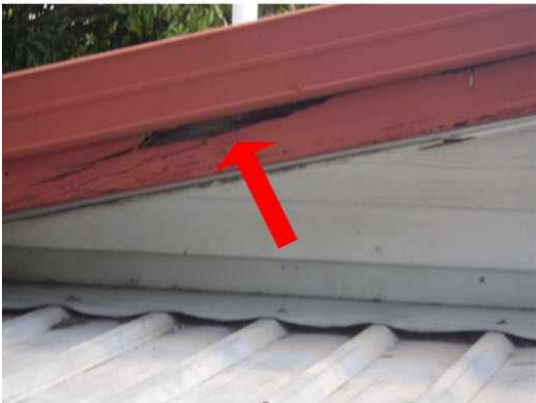
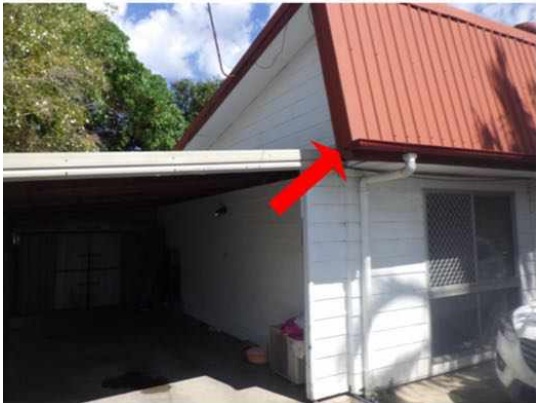
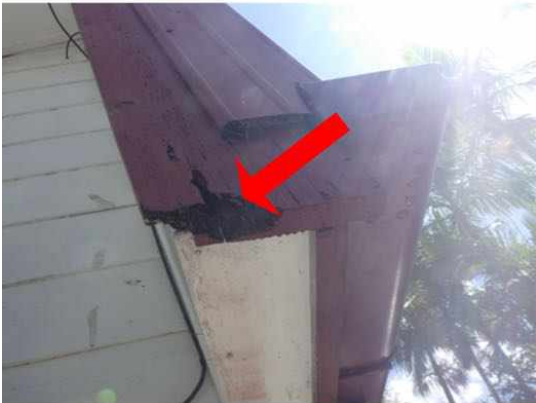
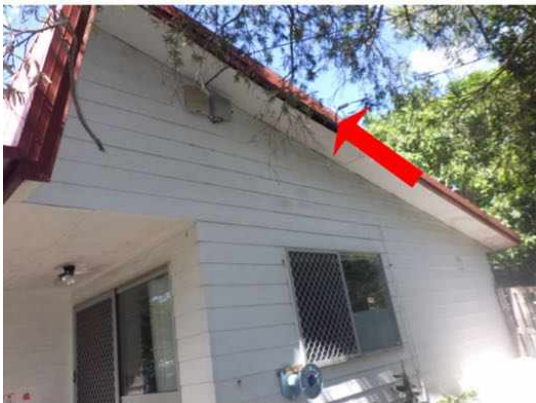
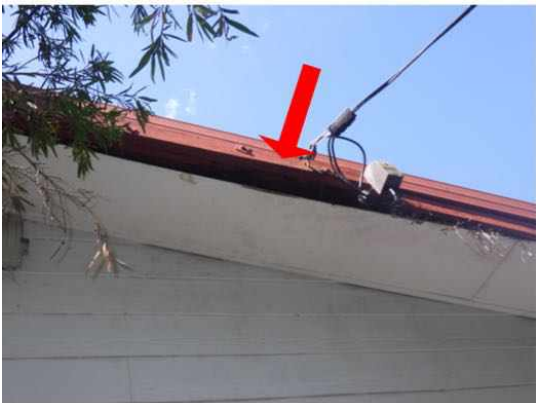
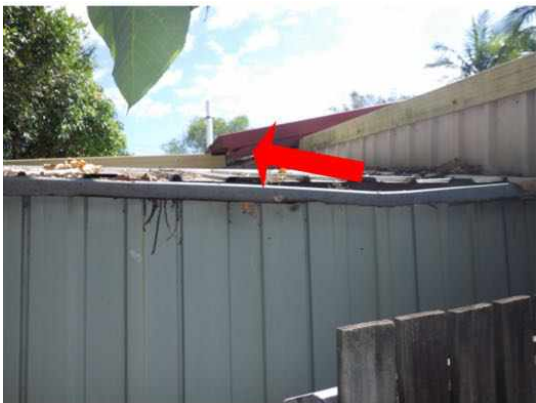
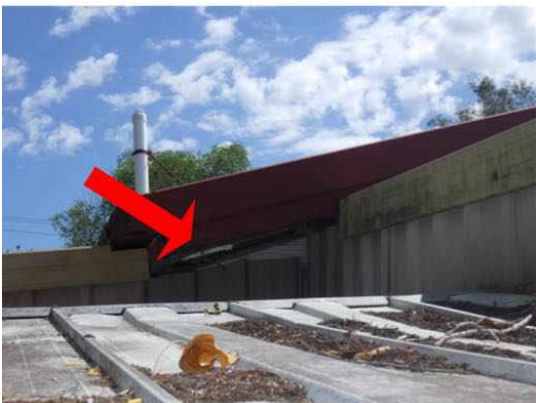
Building: Main Building
Location: Eaves > Existing
Finding: Fascias - Wood rot
Information: At the time of inspection wood rot was found to be affecting fascias and barges, evidenced by the presence of mould on the surface in some areas (as per example photos). Wood rot, also known as Fungal Decay, occurs when timbers and other cellulose building materials are exposed to damp conditions on an ongoing basis.

Frequent exposure to rain and other weather conditions make fascias and barges susceptible to accelerated deterioration.

Early intervention and regular maintenance will prolong the useful life of these building elements. Prior to any works being performed, the cause of the moisture that has created the visible wood rot should be identified and addressed in a suitable manner.

A qualified carpenter or registered builder will be required to replace affected fascia's.

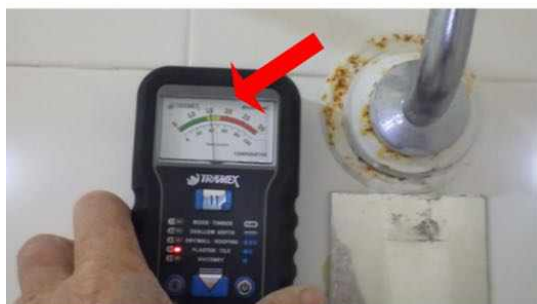
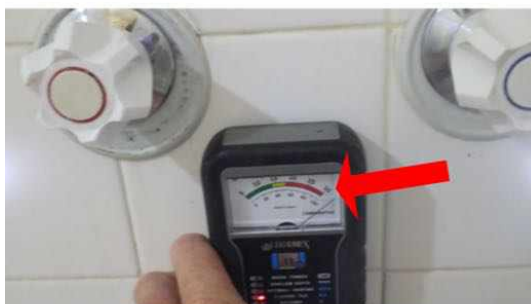
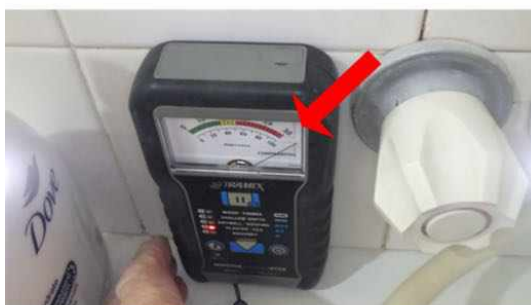
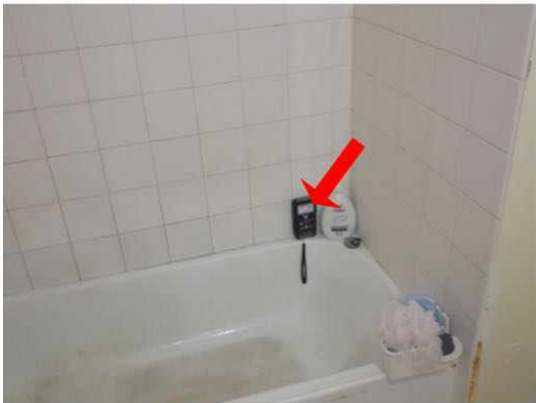
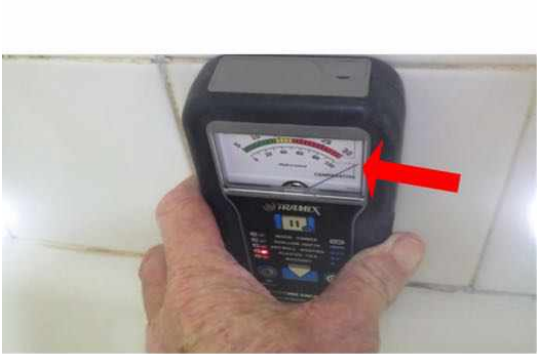
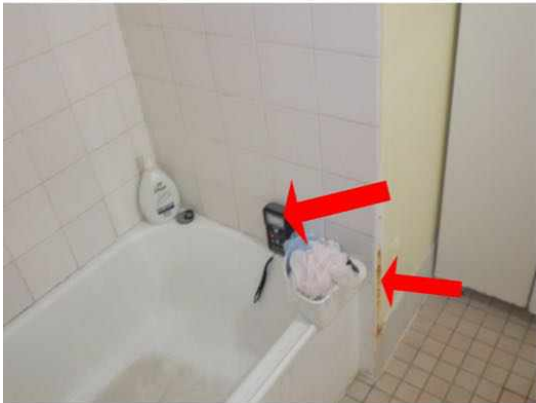
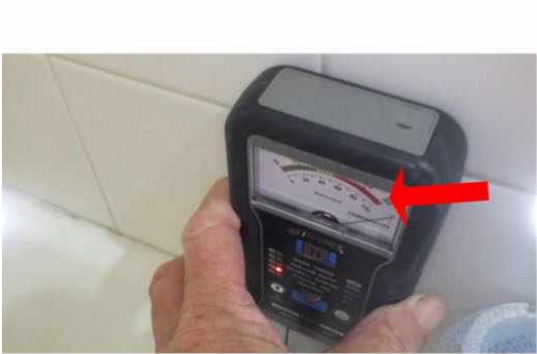
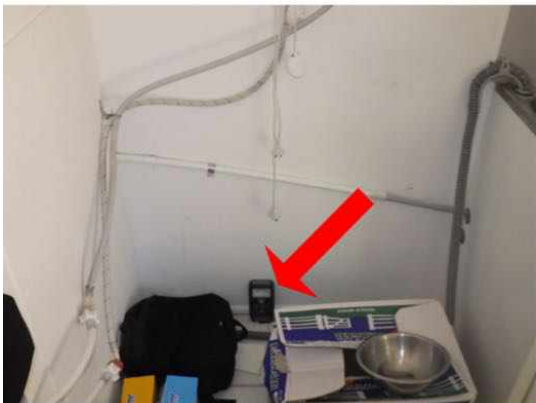
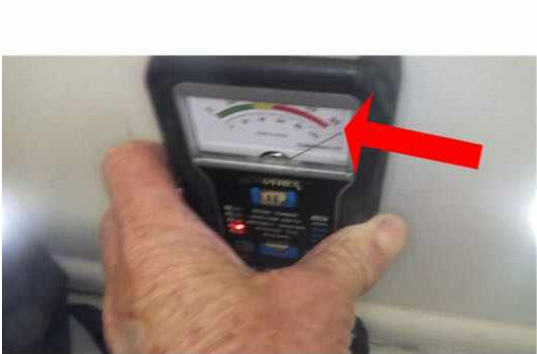
Finding 2.02

Building: Main Building
Location: Bathroom > Rear Right
Finding: Shower - Leaking
Information:

The bathroom shower area registered elevated moisture level readings to the wall areas of the shower cubicle at the time of inspection, with the elevated moisture level readings transferring to the opposite side of the walls which would indicate the shower is leaking.

It is suspected that the leaking has occurred as a result of general ageing of the building elements and deterioration of sealants and grout.

Leaking from the shower area, where left unattended, is likely to lead to water damage to adjoining flooring and walls. Such damage can lead to water damage and necessitate extensive remedial works being required. Active water leaks may also create an environment that is susceptible to the formation and development of mould and /or timber termite activity.

Appointment of a licensed builder or shower area specialist will be required to repair or replace the shower area. Such works should be performed as soon as possible to ensure that no further damage occurs.

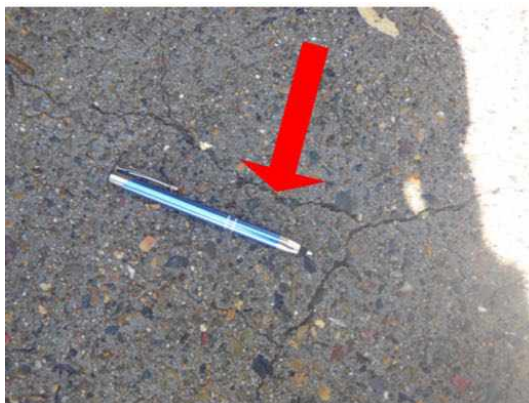
Finding 3.01

Building: Main Building
Location: Driveway > Ground Level
Finding: Cracking in concrete slab - Category 1
Information: Cracking coded as Category 1 was identified in the driveway and/or footpaths concrete slab. A Category 1 crack is described as a fine but noticeable crack, with the slab at an otherwise reasonable level.

To be considered Category 1, the approximate width of the crack is less than 1.0mm, or a less than 10mm change in offset when a 3m straight edge is placed over the defect.

Category 1 cracks should be monitored for a period of 12 months. At the end of the monitoring period, identified cracks that are rated greater than Category 2 are considered defects, and require rectification.

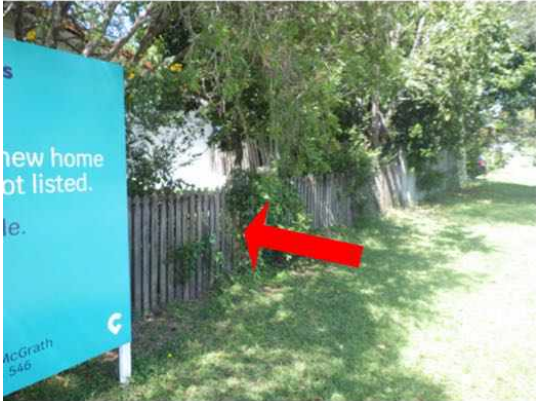
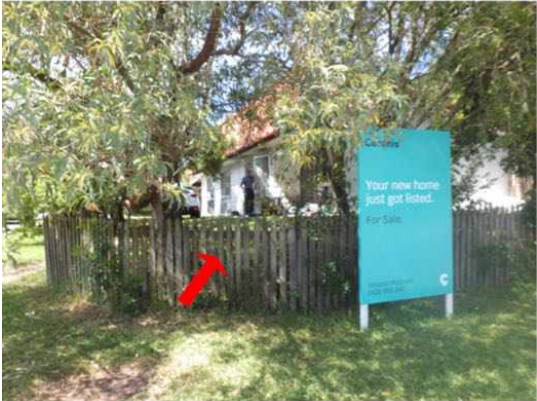
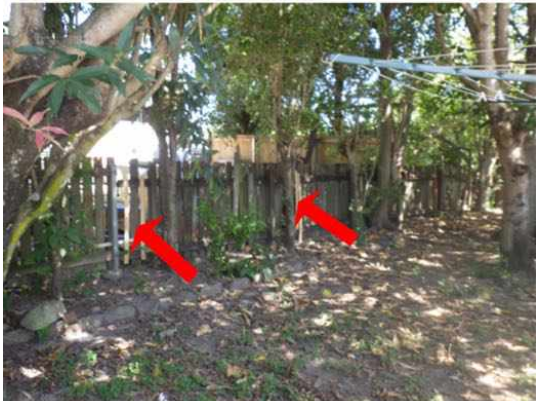
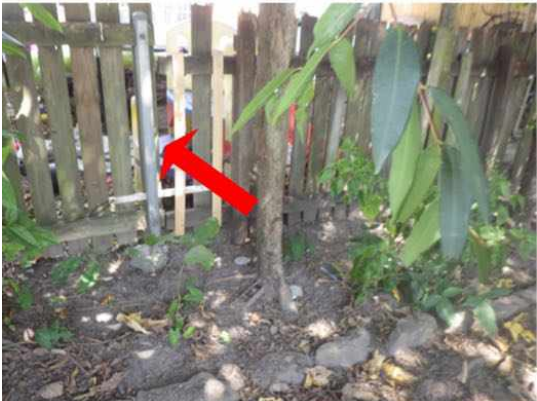
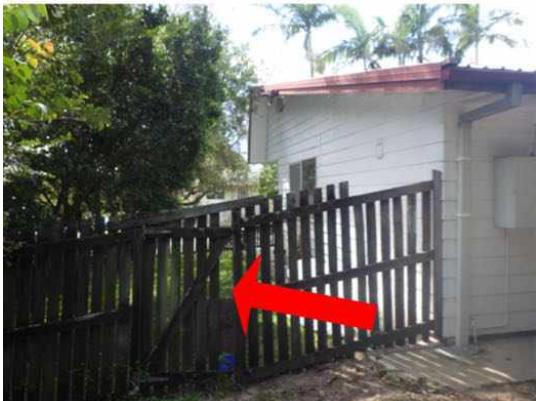
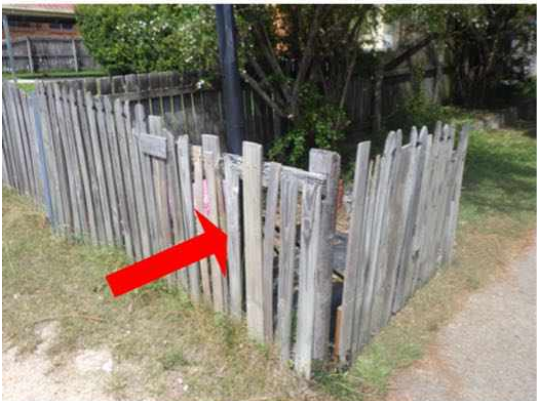
Finding 3.02

Finding: Fencing - Deteriorated

Information: It was noted at the time of inspection that sections of the fencing throughout the property have deteriorated (as per example photos). Typically fencing deteriorates due to age and or wear, rot and or rust which is generally expected for a structure of this age, due to prolonged exposure to weather conditions. Sometimes inadequate installation or maintenance can be to blame.

If left unattended, it is likely that further damage will occur. It is suspected that repair of several elements of the fencing may be required however replacement may be a consideration of the client also.

A licensed fencing contractor should be appointed to provide further advice and perform rectification works as necessary.

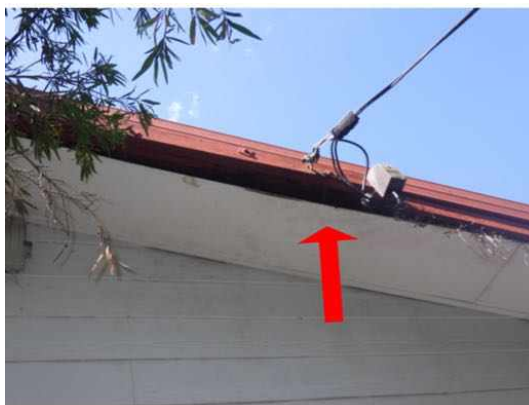
Finding 3.03

Building: Main Building
 Location: Eaves > Centre Right
 Finding: Eaves - Sagging
 Information: At the time of inspection the eaves to the right side of the property were found to have sagged. The damage may have been sustained as a result of a number of possible causes, including poor roof drainage, substandard workmanship at the time of construction or minor impact damage.

Where eaves show moderate damage, remedial works may be required.

NOTE - The eaves linings may be of an asbestos containing material.

A qualified carpenter or general handyman could be engaged to undertake repair work.

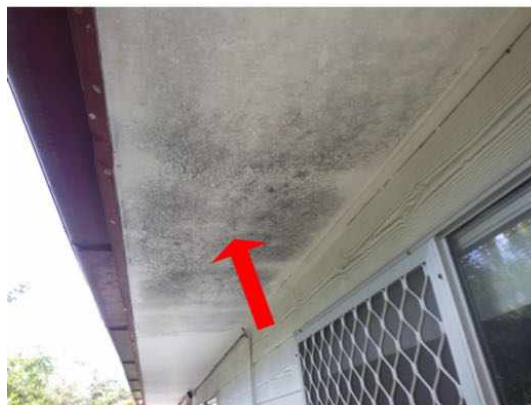
Finding 3.04

Building: Main Building
 Location: Eaves > Centre,Front
 Finding: Mould - Present in eaves.
 Information: The eaves linings to the front of the property show signs of excessive mould and mildew at the time of inspection. This defect can at times be caused by blocked or overflowing gutters in the areas associated.

Where evidence of mould growth was noted, there may be environmental, biological or health issues associated.

Generally, the client is advised to ensure that the general environment is free of moisture and humidity to aid in the prevention of mould formation and development. Any mould found during the inspection should be cleaned immediately by a cleaning contractor or the homeowner as applicable.

Please note that severely affected building elements may require replacement by a registered builder or qualified carpenter.

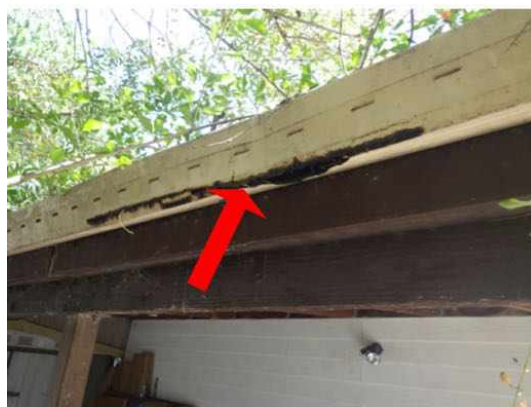
Finding 3.05

Building:	Main Building
Location:	Roof Exterior > Centre Left
Finding:	Gutter - Rusted
Information:	Upon inspection of the exterior guttering, evidence of significant rust and deterioration to the left side carport section was identified.

Metal gutters generally comprise of sections of guttering, which join and overlap. These intersections are particularly prone to lift at the edge and consequently rust at these points.

A roofing contractor could be appointed to assess the damage to the roof guttering and to perform remedial works as necessary.

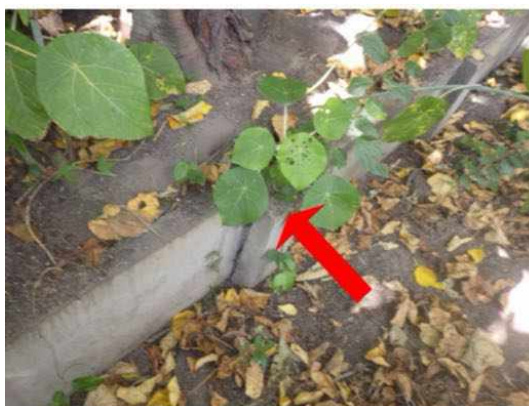
Finding 3.06

Building:	Main Building
Location:	Yard - Side > Ground Level
Finding:	Retaining wall
Information:	The concrete retaining wall to the left side of the property showed signs of movement at the time of inspection. Generally, deteriorated retaining walls are caused by poor material use or continuous exposure to weather conditions. However, deteriorated or

movement to retaining walls may also be a result of vegetation growth.

A landscaper or retaining wall installer could be appointed to repair or replace the wall, at the discretion of the client.

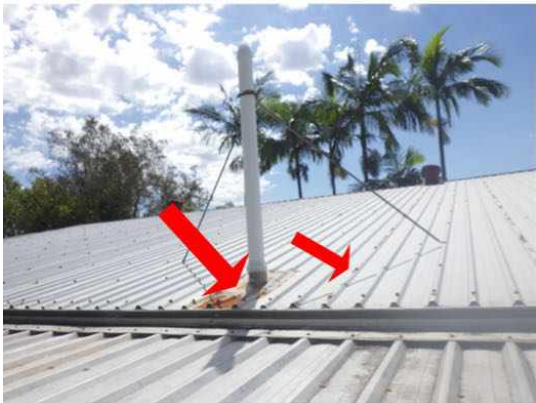
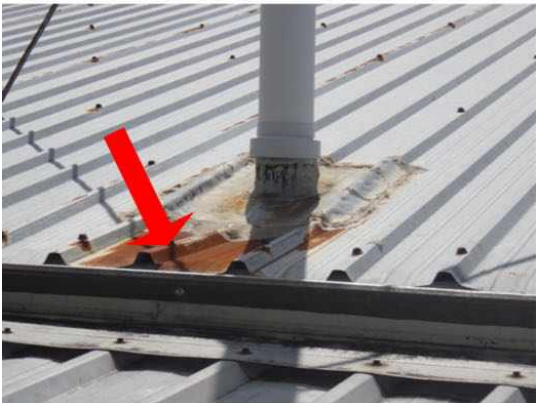
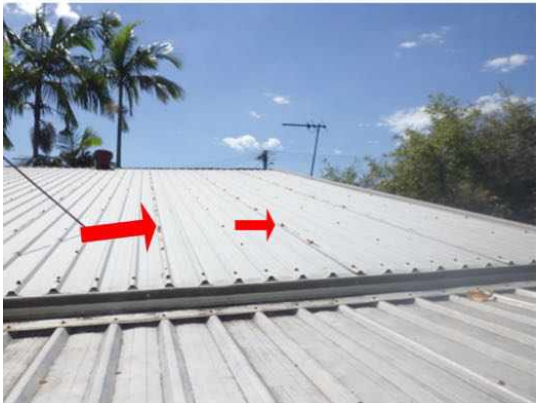
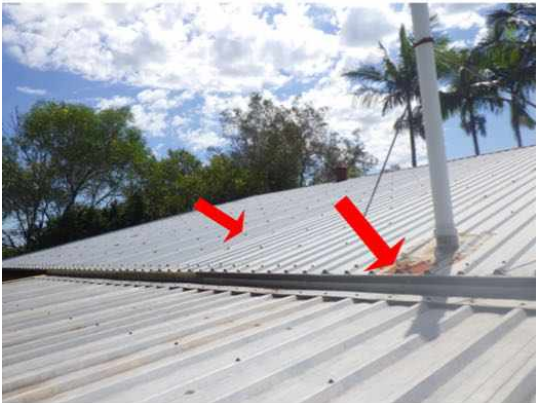
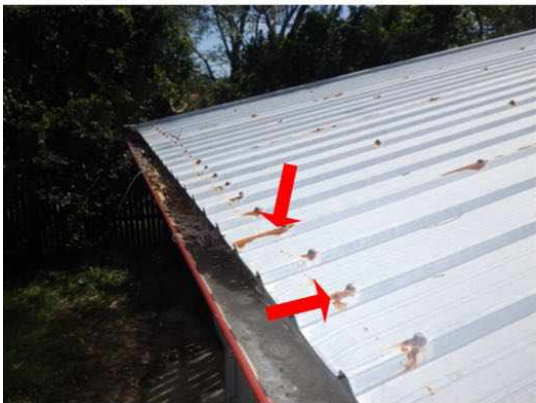
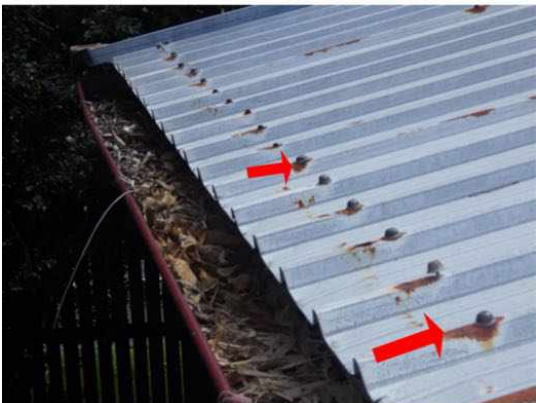
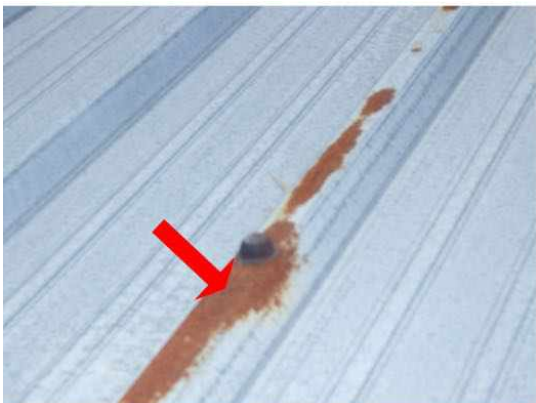
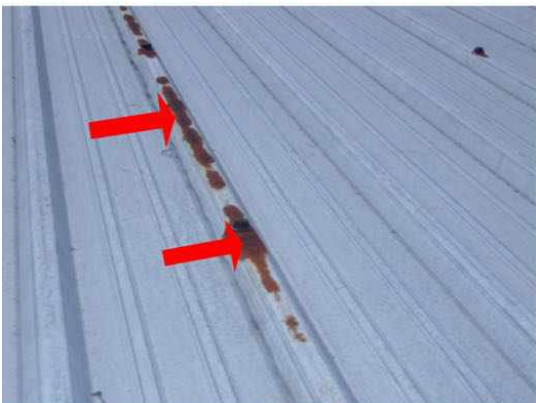
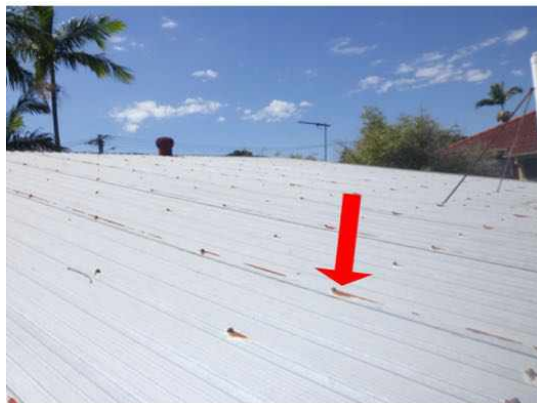
Finding 3.07

Building:	Main Building
Location:	Roof Exterior > Existing
Finding:	Roof sheets - Rusted
Information:	Upon inspection of the exterior roofing structure, evidence of rust to roof sheeting and fixings was identified. If left unmanaged, these degrading roof sheets can allow water ingress to the internal roofing structures, potentially leading to secondary damage of building elements. Accelerated deterioration of the roofing sheets and any associated building elements is also likely to occur.

A roofing contractor should be appointed immediately to assess the damage to the roofing sheets and to perform remedial works as necessary. Works may include replacement of severely affected roofing sheets or minor works such as the application of rust-retardant surface protectors.

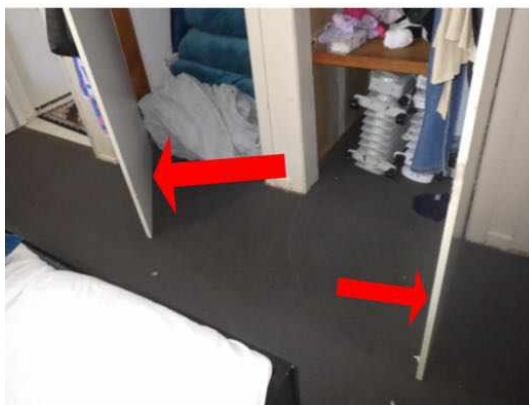
Finding 3.30

Building: Main Building
 Location: Bedroom 1 > Front
 Finding: Damaged Door
 Information: The door leading into bedroom 1 has suffered damage to the bottom edge.

Damage occurs generally when the building materials have aged and decayed, but in this instance the damage appears to be the result of exposure to moisture, possibly from the bottom and/or top edges of the door not being sealed with a suitable paint or sealant at the time of construction.

A qualified carpenter or general handyman could be appointed to repair/replace the door at the clients discretion.

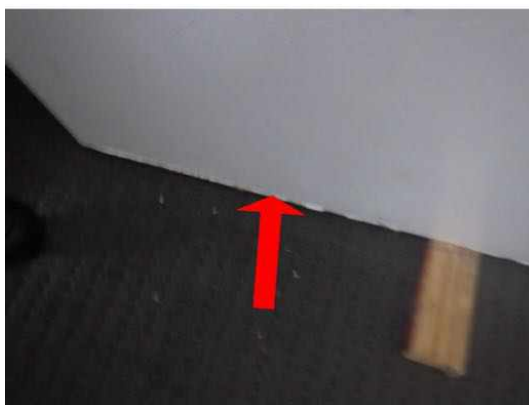
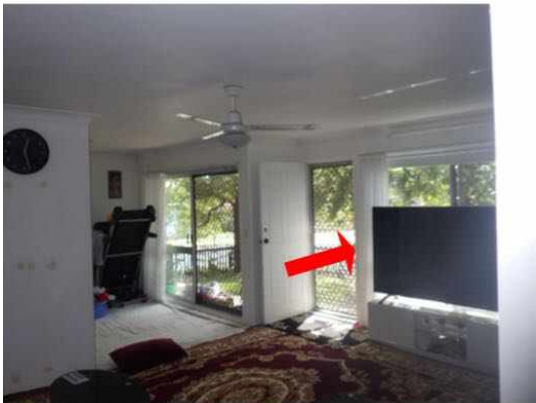
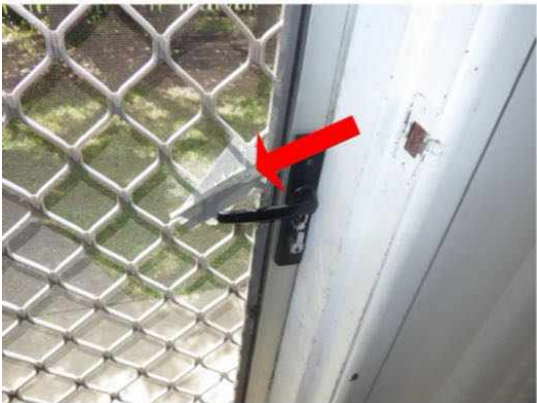
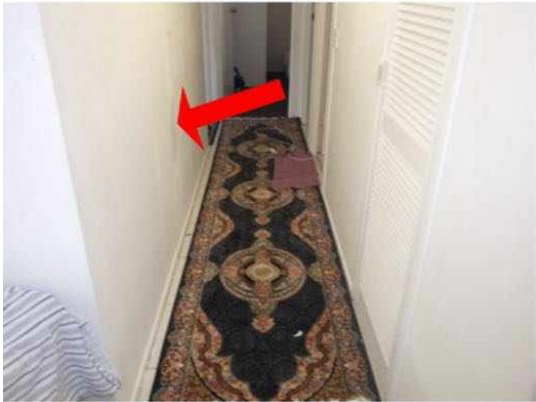
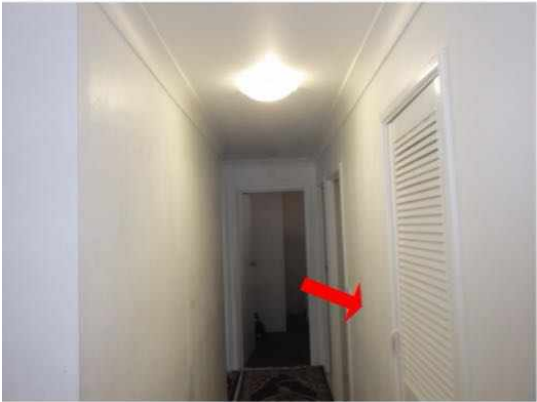
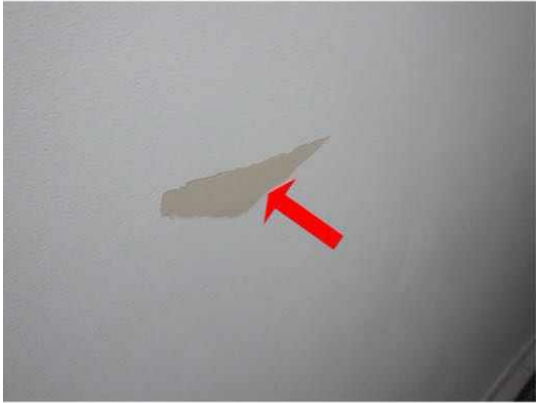
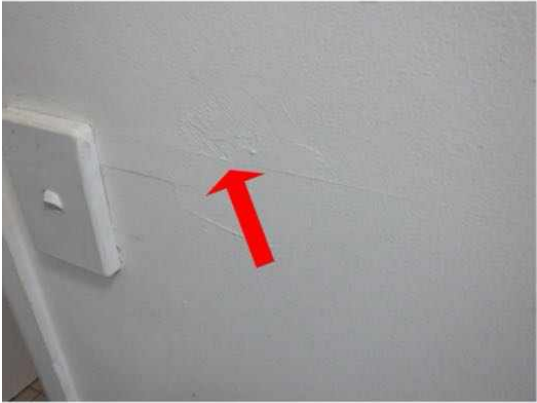
Finding 3.31

Building: Main Building
Location: Internal Areas > Existing
Finding: Wear and Tear
Information: At the time of inspection the building interior showed signs of deterioration, minor cracking and/or scuffing to floors, walls, ceilings ,cornices, fixtures and fittings (as per example photos).

The level of damage appears consistent with general deterioration and/or wear and tear.

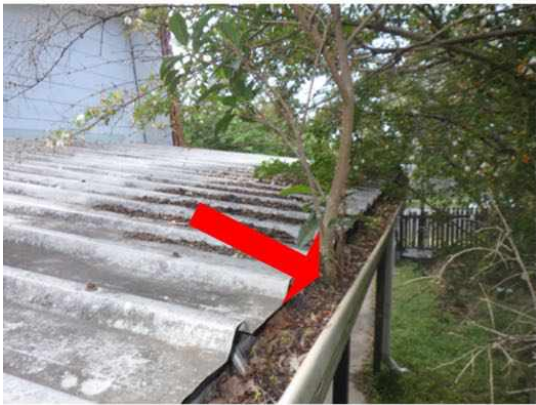
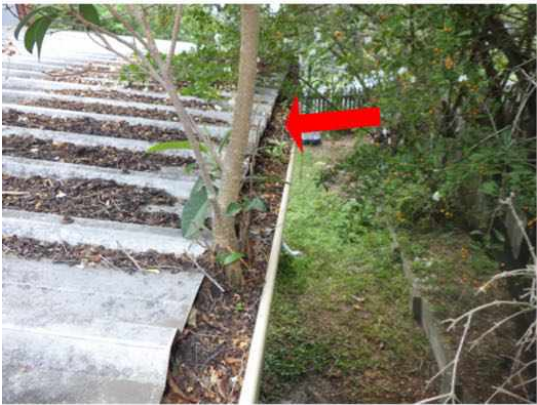
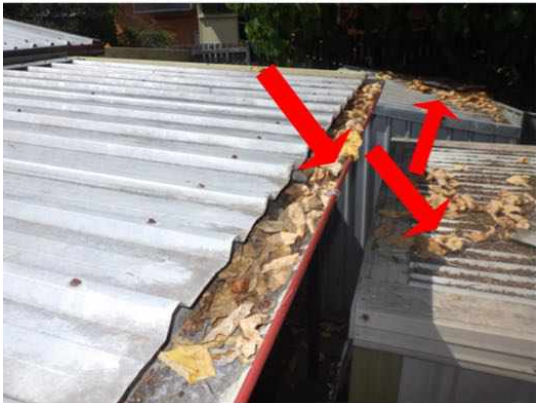
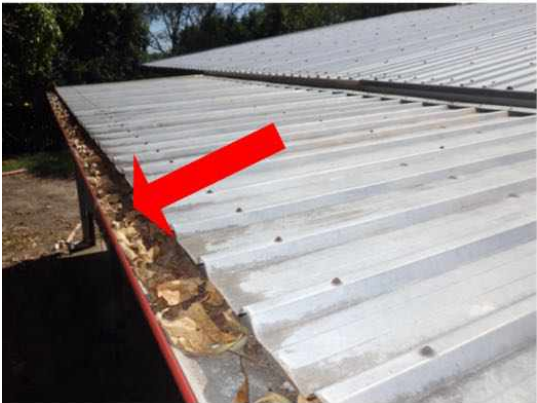
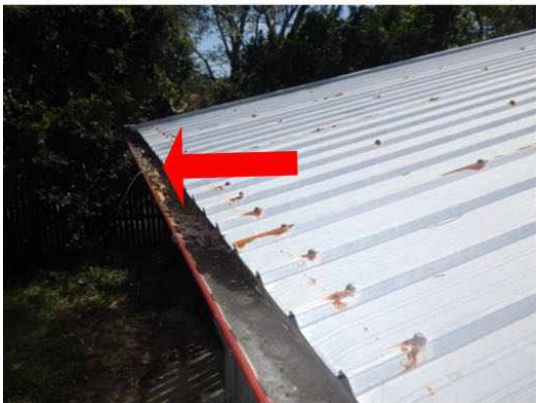
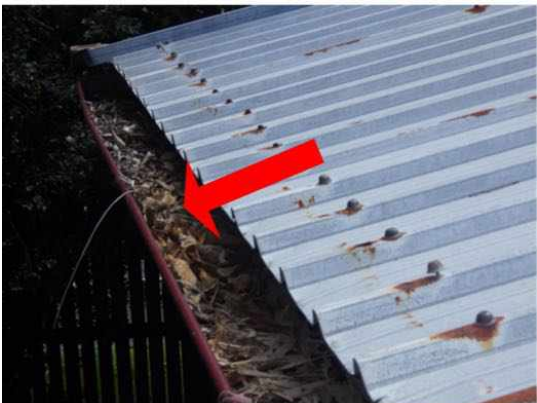
Roof plumbing structures, such as guttering and downpipes, should be free of all debris to prevent blockages. Blockages of the guttering and downpipes will lead to pooling and accumulated water overflows, which is likely to subsequently flood eaves and exterior walls.

Blocked gutters are likely to lead to high levels of moisture in the affected areas. Such moisture will not only cause rust and decay of the associated building materials, but can also provide conditions that are conducive to termite and timber pest activity. Blockages in gutters should therefore be removed immediately to ensure dry conditions are maintained.

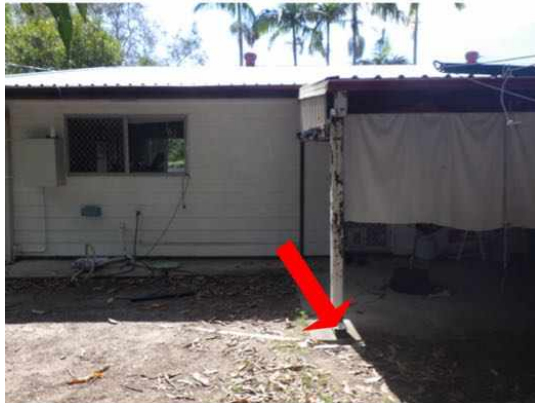
Finding 6.02

Building: Main Building
Location: Exterior walls - rear > Rear Right
Finding: Stormwater downpipe

Where roof plumbing doesn't drain as required, the area at the base perimeter can become excessively damp, potentially creating an environment that is susceptible to flooding and rust or corrosion of surrounding building elements, as well as attracting termites and other pests.

It is recommended that a licensed plumber be appointed to further inspect and to extend the down pipes to the properties stormwater line as necessary.

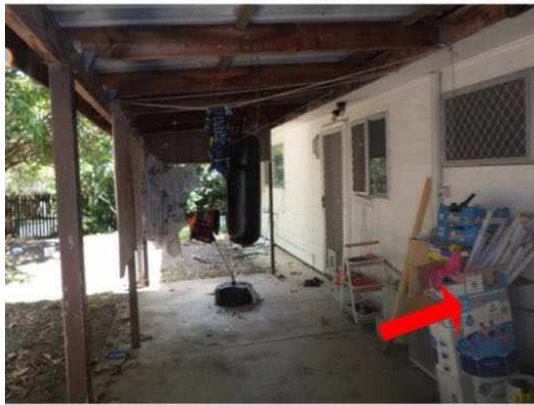
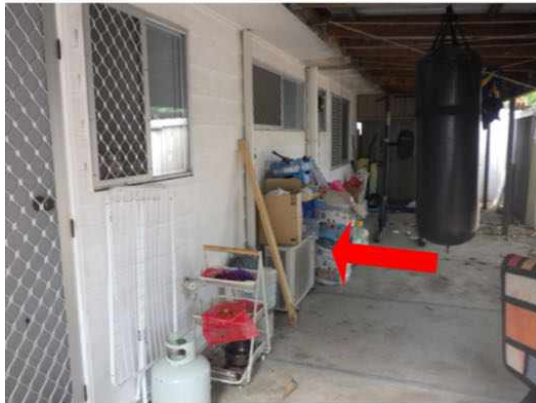
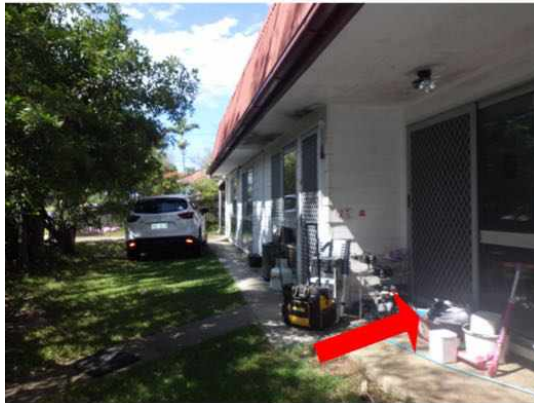
Building:	Main Building
Location:	Exterior walls > Existing
Finding:	Stored timbers - external area
Information:	At the time of inspection there was stored items and/or timbers against the exterior walls of the property.

The storing of personal items and timbers around the external property increases the risk of termite activity being present. As they are likely to come into contact with weather conditions or excessive moisture wood rot is likely to develop on timbers that are not treated.

It is highly recommended that any stored timbers and/or items be immediately removed from areas in which they may attract any termite / timber pest attack. Minimisation of risk / prevention of termite attack is far more adequate than dealing with the presence of termite activity.

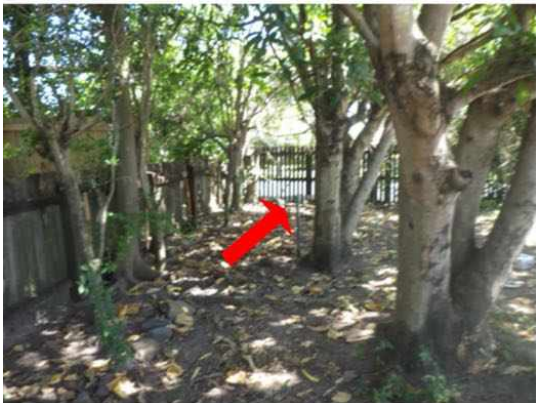
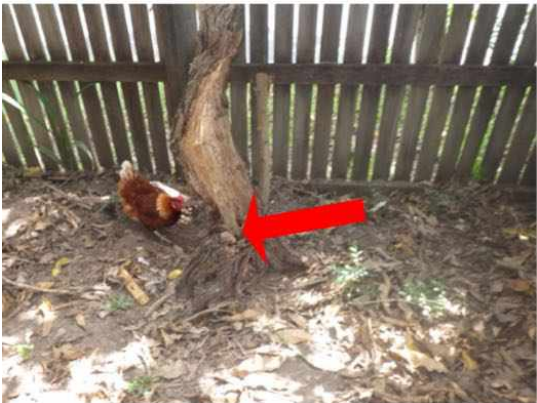
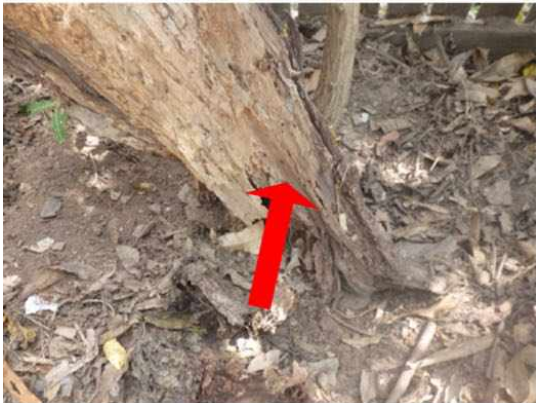
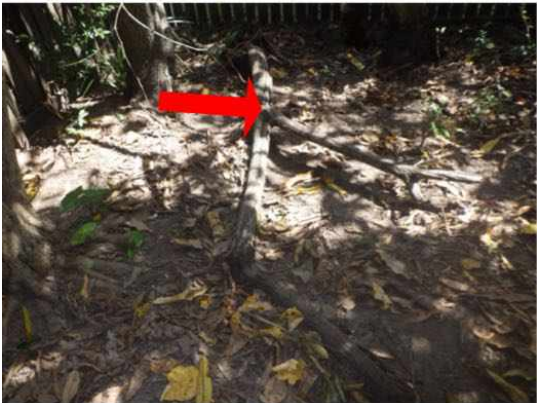
Finding 6.04

Building:	Main Building
Location:	Yard - Back > Ground Level
Finding:	In ground - Tree Stump
Information:	At the time of inspection there was tree stumps and timber on/in ground areas to the rear right side of the property.

Any timbers in direct ground contact provide opportunity for concealed termite activity and are likely to be subject to premature rot and decay as the soil retains moisture or damp conditions against the timbers.

Additionally, although there was no live activity found, it was observed there appeared to be previous timber termite damage to tree stumps.

Removal of any untreated timber or tree stumps which are in direct contact with external ground is recommended. Frequent pest inspections are highly advised to readily identify any termite activity in these areas.

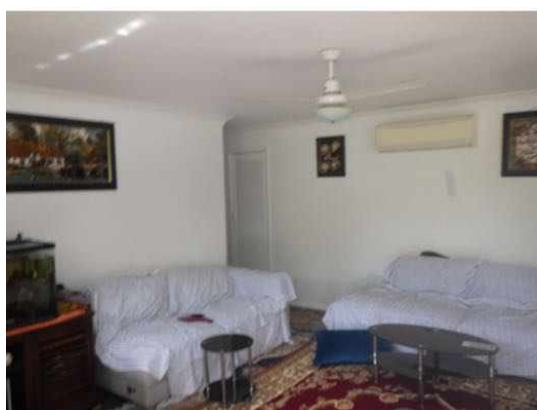
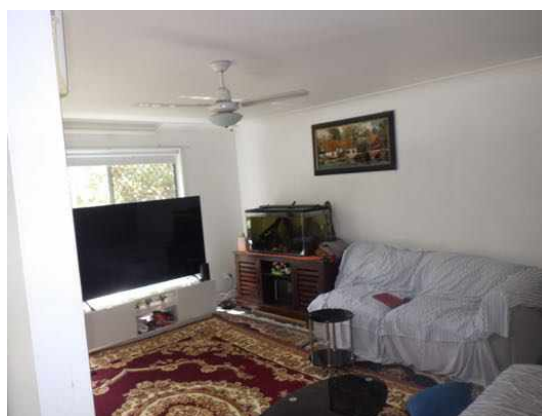
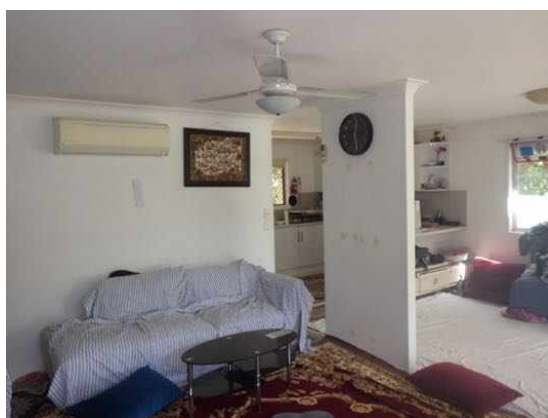
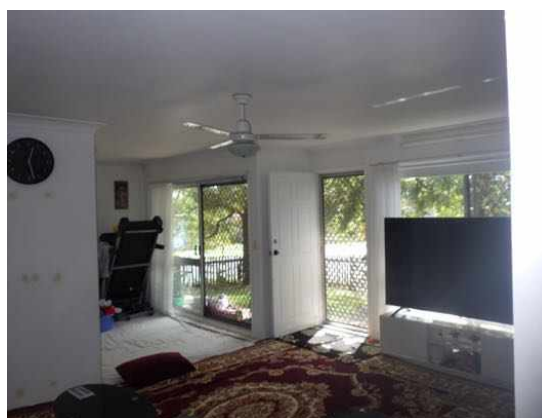
Building: Main Building
 Location: Entry/Lounge Room > Existing
 Finding: No obvious defect
 Information: No obvious defects found at the time of inspection.

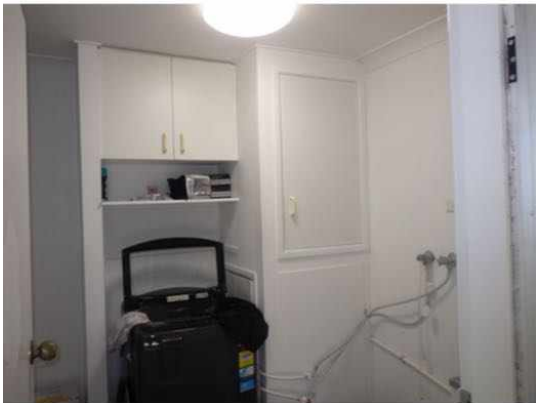
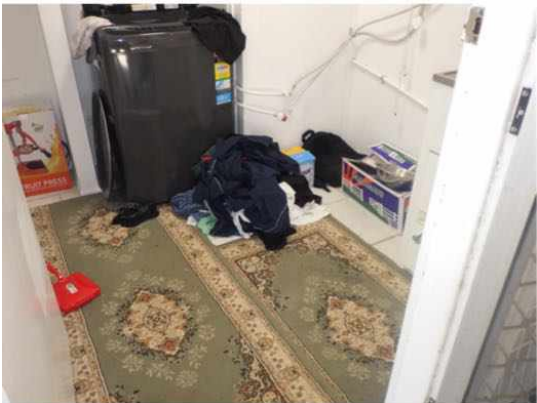
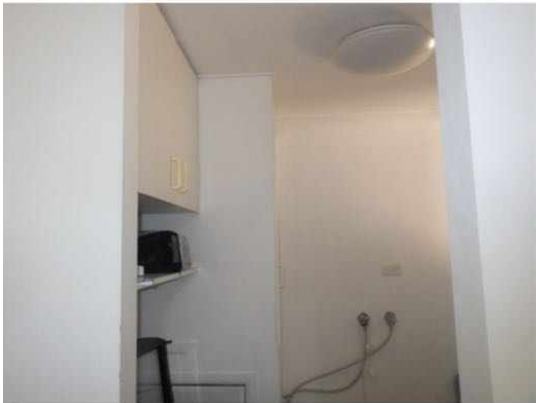
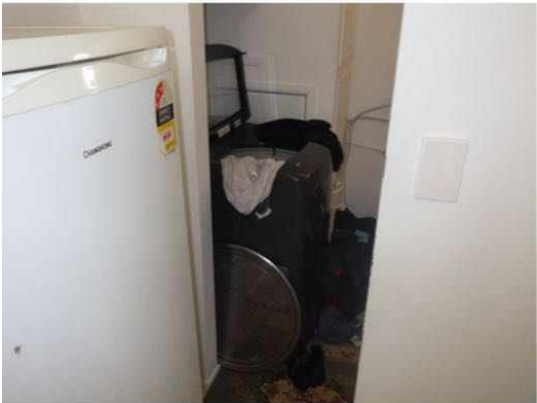
Building: Main Building
 Location: Laundry > Existing
 Finding: No obvious defect
 Information: No obvious defects found at the time of inspection.

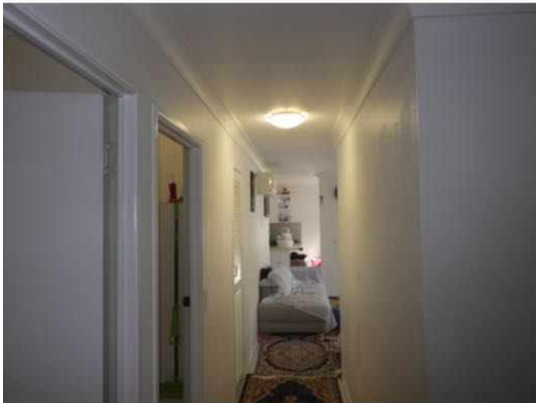
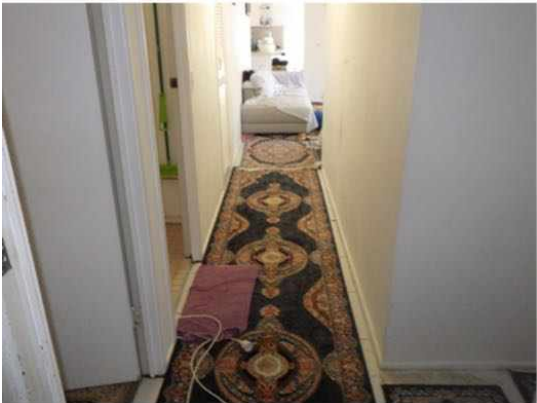
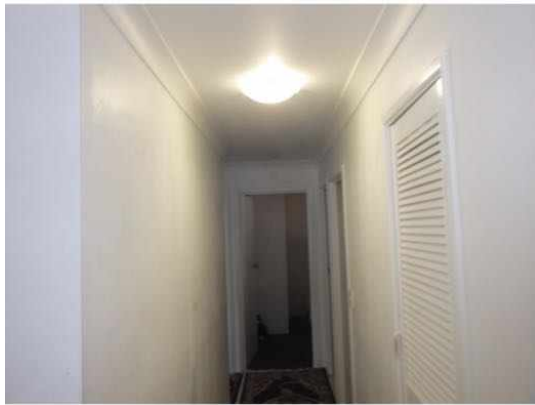
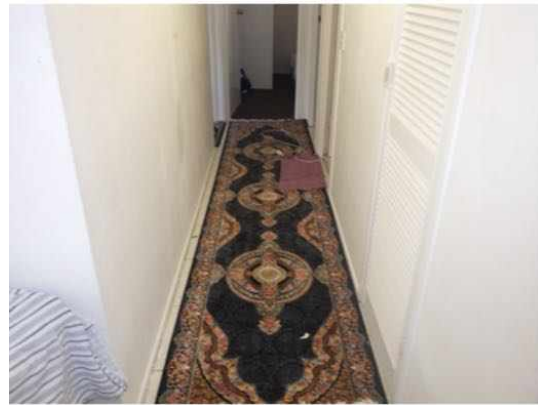
Building: Main Building
Location: Hallway > Existing
Finding: No obvious defect
Information: No obvious defects found at the time of inspection.

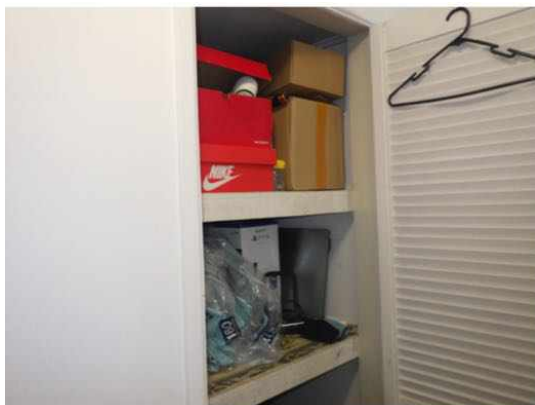
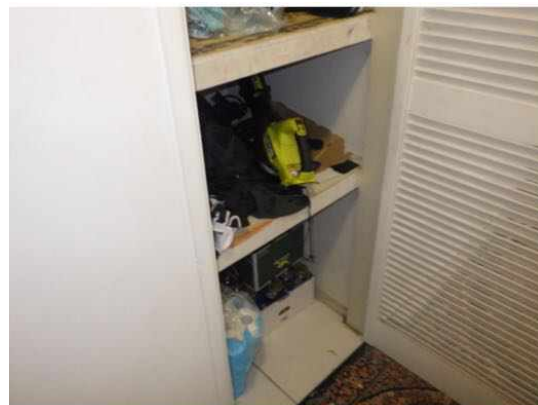
Building: Main Building
Location: Linen Cupboard > Existing
Finding: No obvious defect
Information: No obvious defects found at the time of inspection.

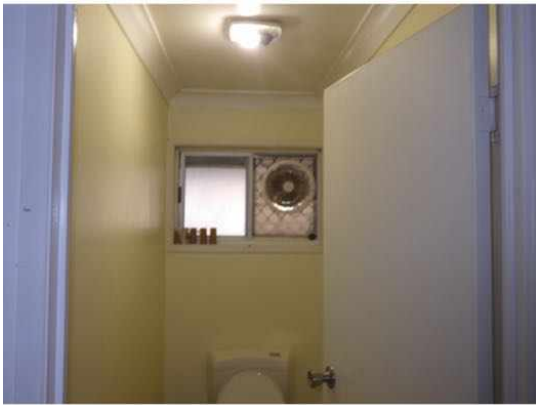
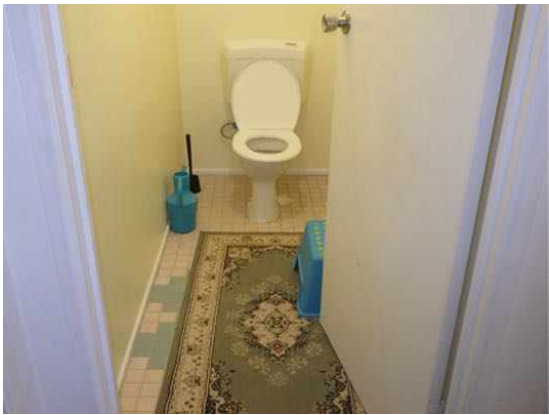
Building: Main Building
Location: Toilet (WC) > Existing
Finding: No obvious defect
Information: No obvious defects found at the time of inspection.

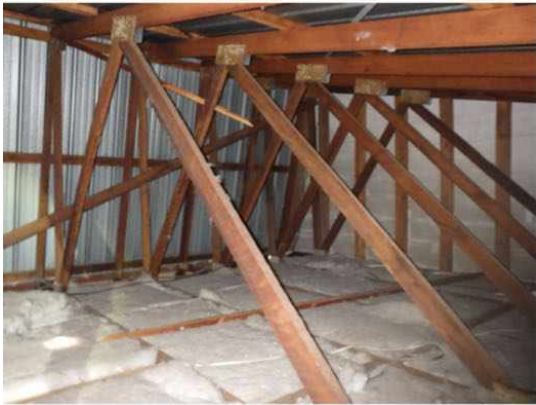
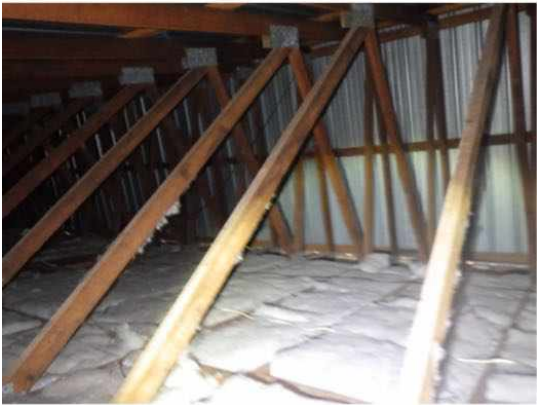
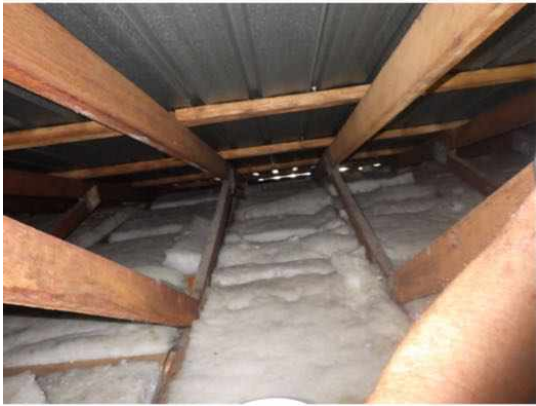
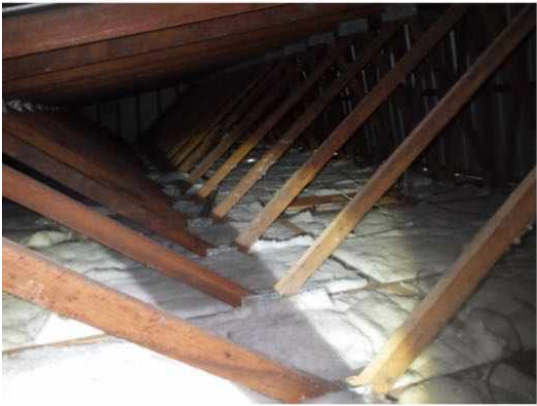
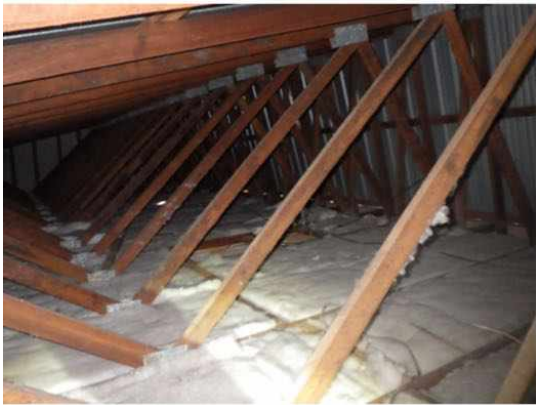
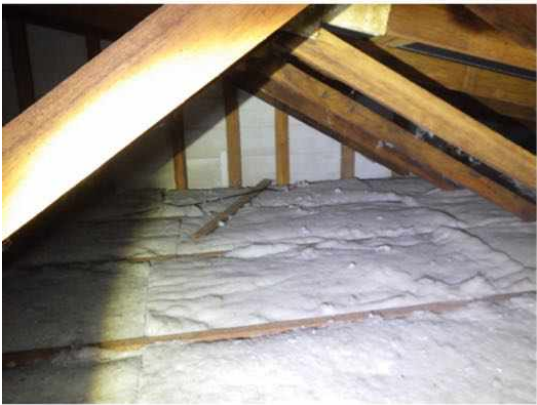
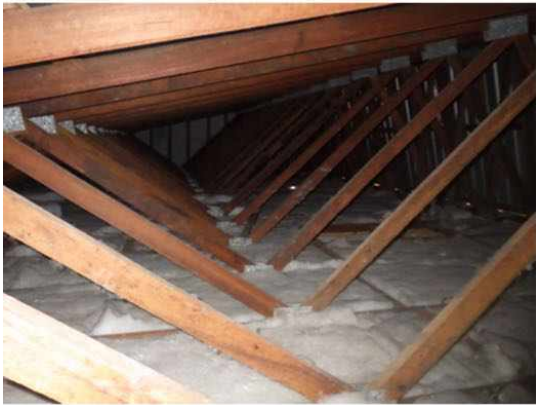
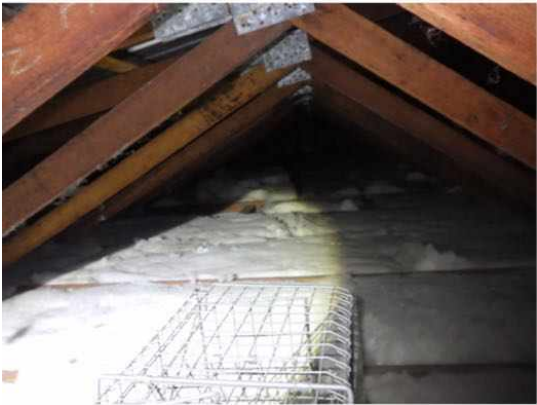
Building: Main Building
Location: Attic > Existing
Finding: Additional Photos
Information: Additional photos are provided for your general reference
