Building and Timber Pest Inspection Report

Inspection Date: Tue, 7 Apr 2026

Property Address: 32 Renita St, Slacks Creek QLD 4127, Australia

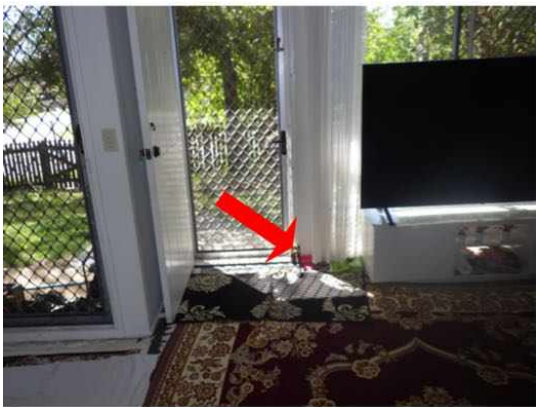
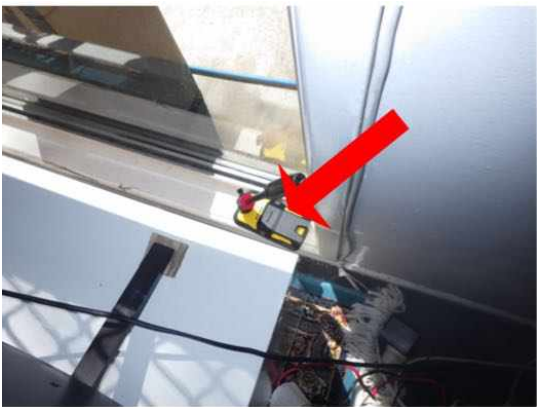
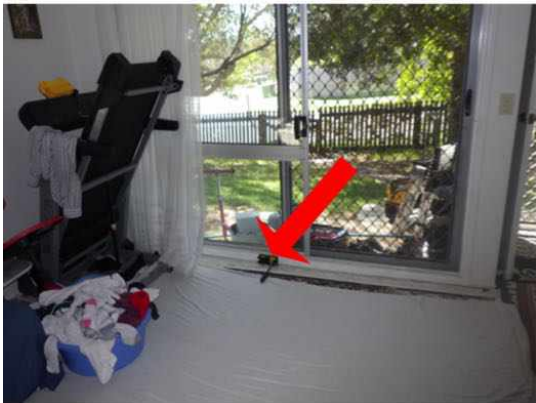
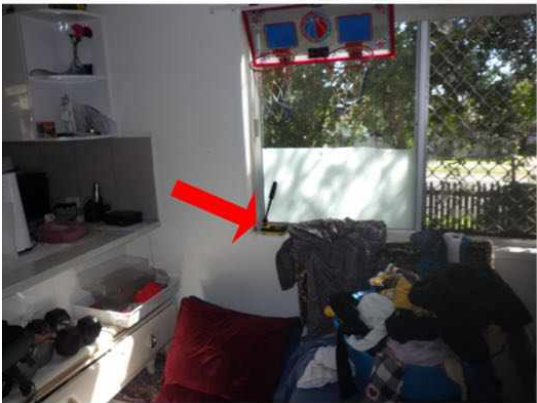
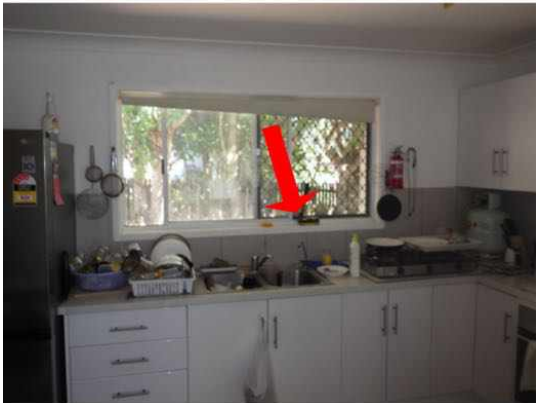
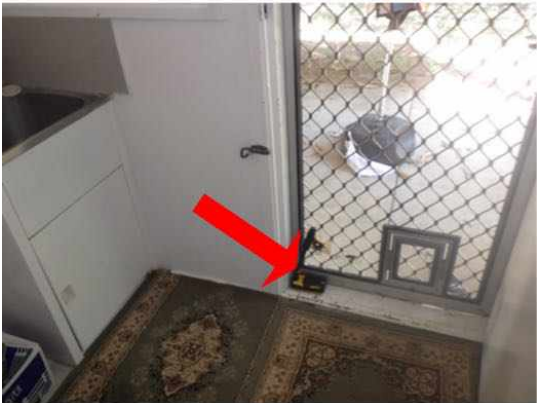
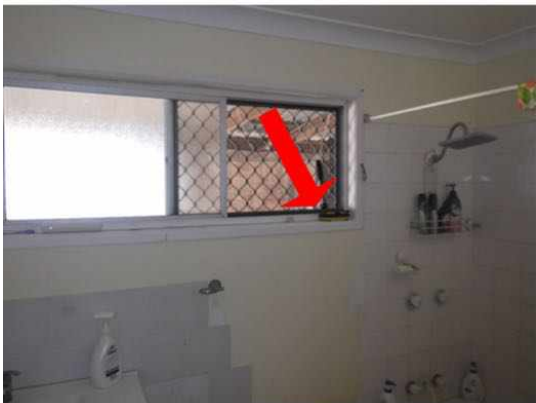
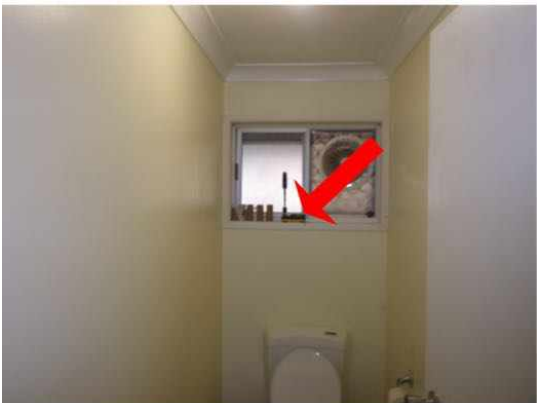
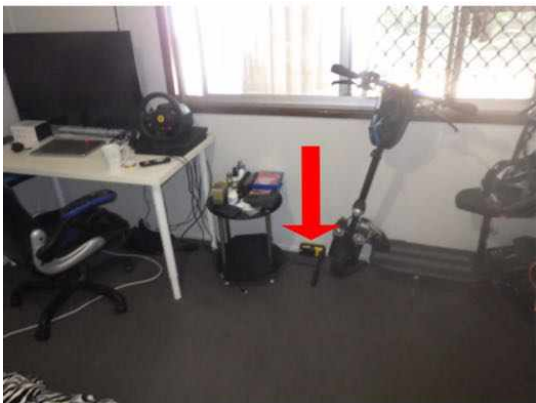
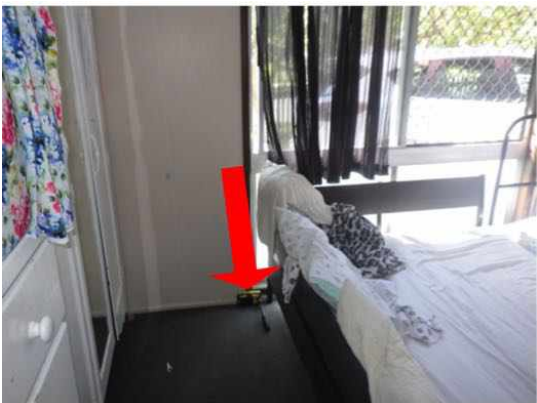
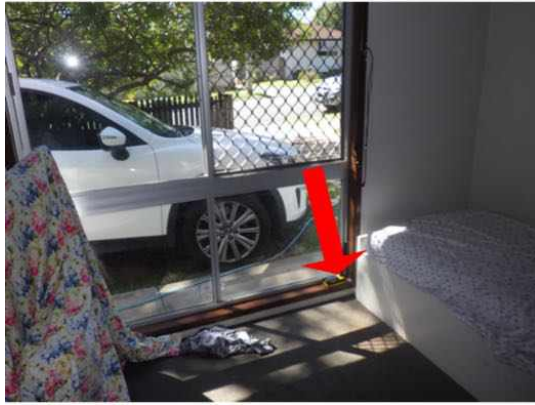
Building: Main Building
Location: Internal Areas > Existing
Finding: Termitracker
Information: The termitracker was positioned randomly to internal wall, timber skirting and window frame areas checking for signs of termite activity.

No activity was recorded at the time of inspection.

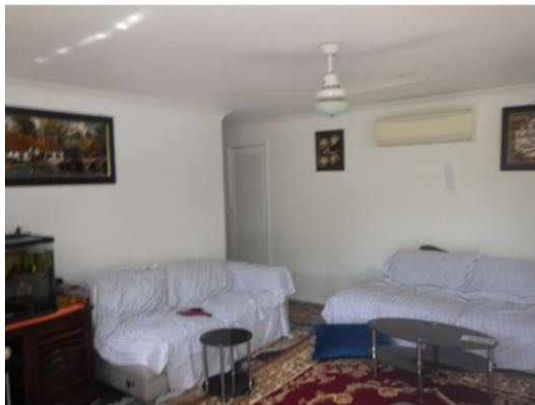
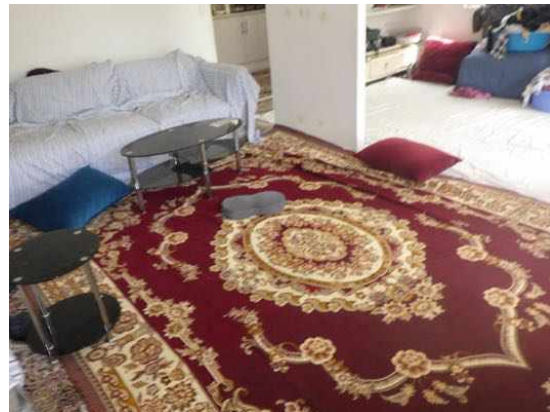
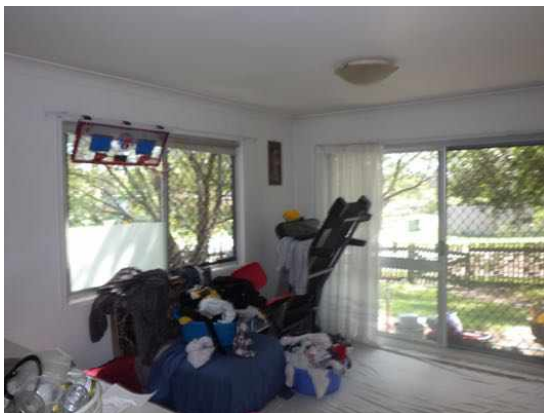
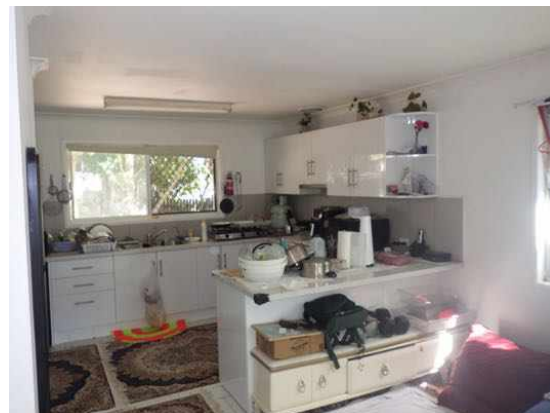
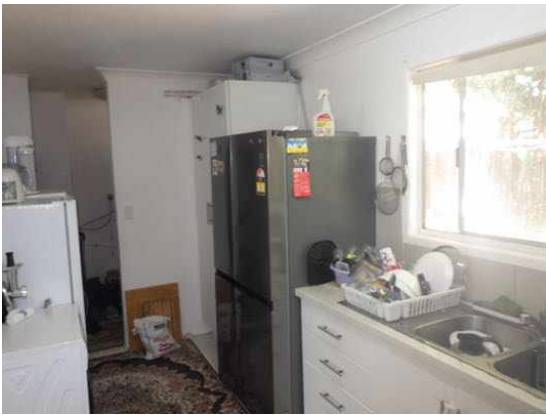
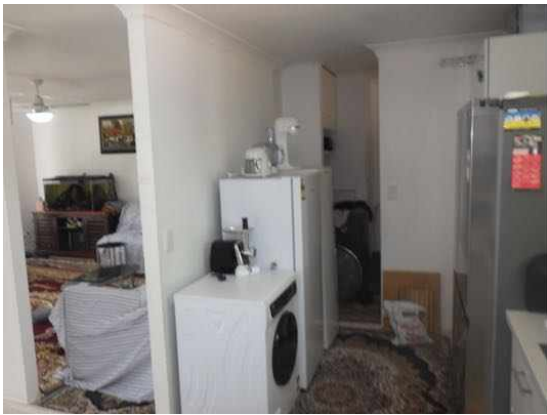
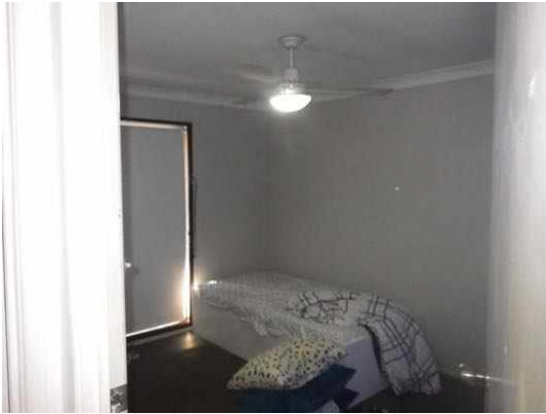
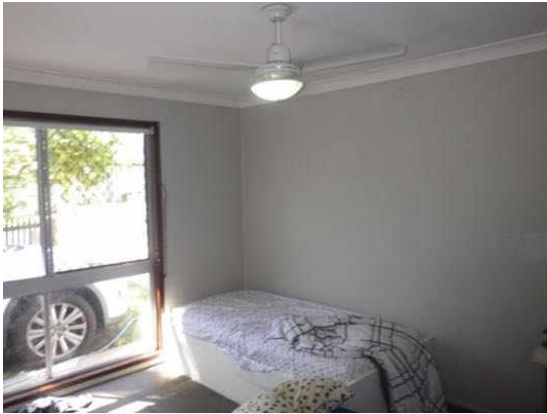
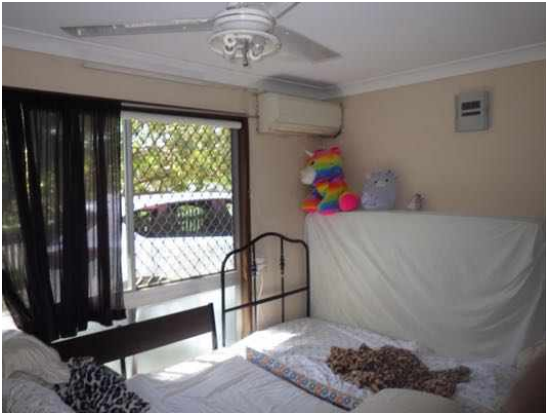
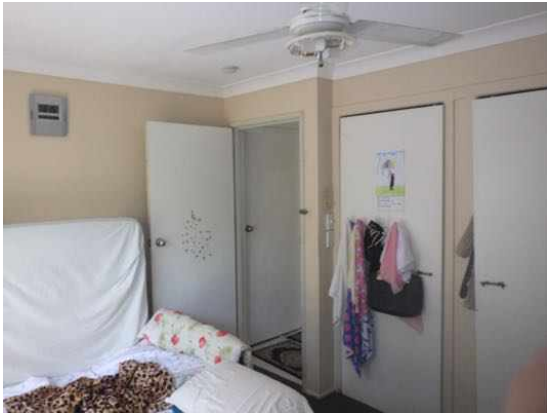
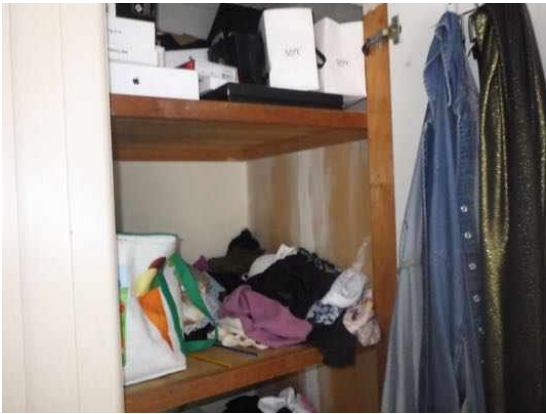
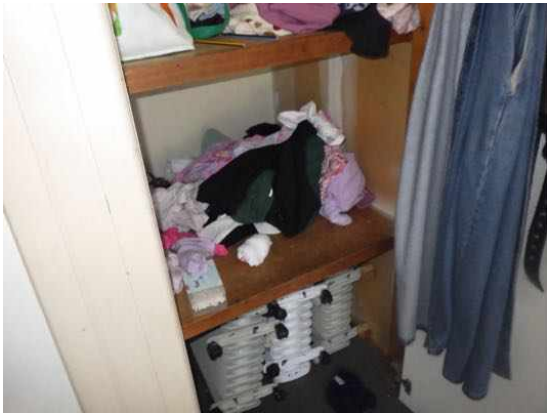
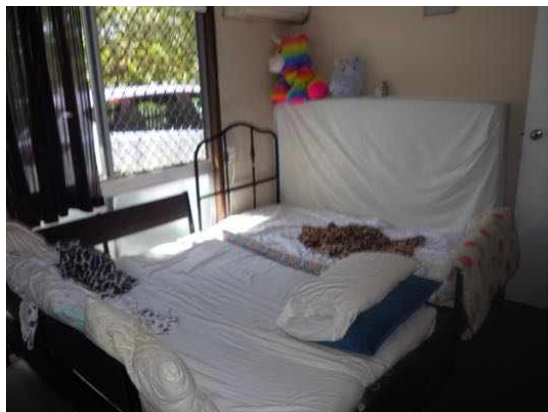
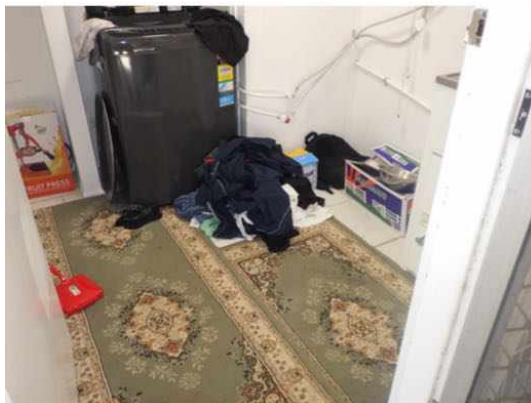
Building: Main Building
 Location: Internal Areas > Existing
 Finding: Additional Photos - Obstructions and Limitations
 Information: These photographs are an indication of the obstructions and limitations which impeded full inspection of the property at the time of inspection. These obstructions can hide an array of defects and should be removed to allow full inspection to be carried out. A re-inspection is recommended once the areas are made accessible.

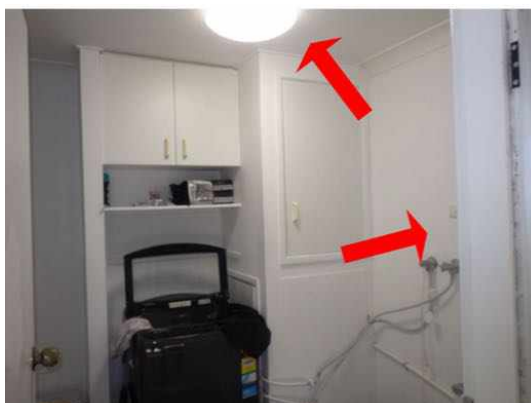
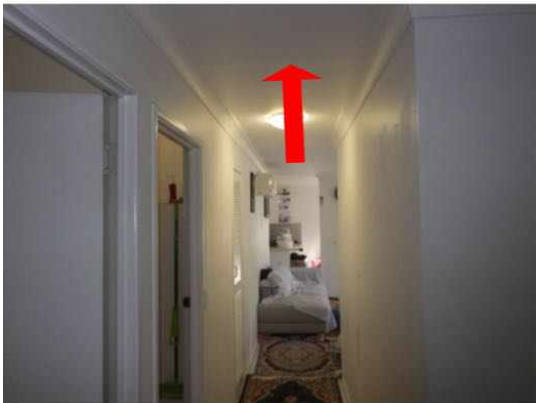
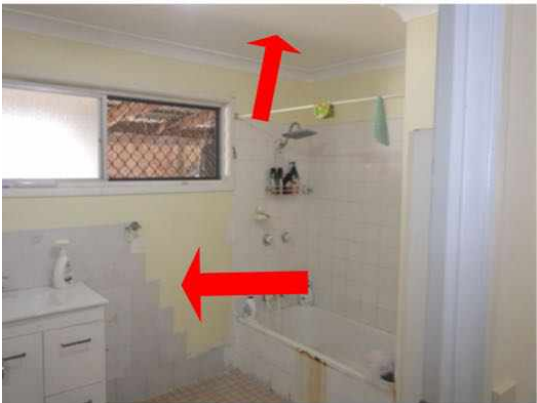
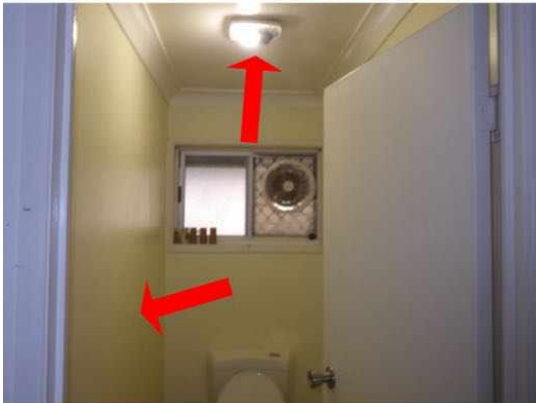
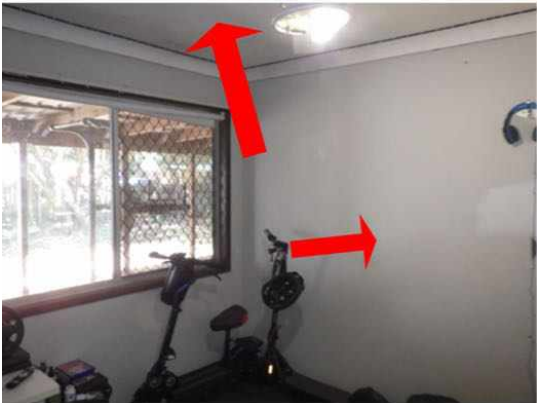
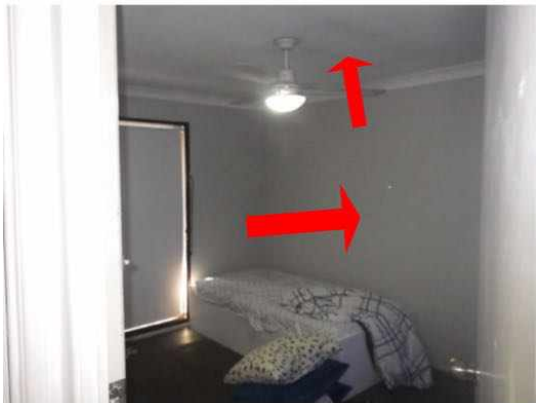
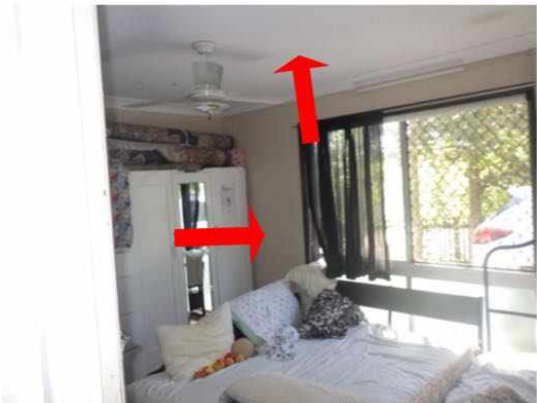
Building: Main Building
 Location: Internal Areas > Existing
 Finding: Asbestos - Suspected ACM Identified on Site
 Information: At the time of inspection it was suspected internal wall and ceiling linings may be of asbestos containing materials.

Reporting on Asbestos is outside the Scope of this Report. This suspected defect is highlighted as a caution only. We suspect, based on our experience in the building industry, that there is a higher risk of the identified building elements containing asbestos.

As Asbestos Reporting is outside the scope of this report, we advise that you consider a separate Asbestos Inspection and Condition Audit, which can include the taking of samples for definitive confirmation of the presence of Asbestos.

In the interim, the client is advised to act with caution, especially when considering any damage to building materials general wear and tear renovations extensions demolition and general maintenance activities due to the suspected presence of Asbestos.

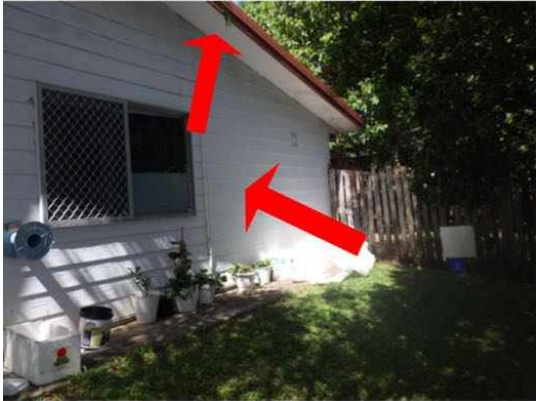
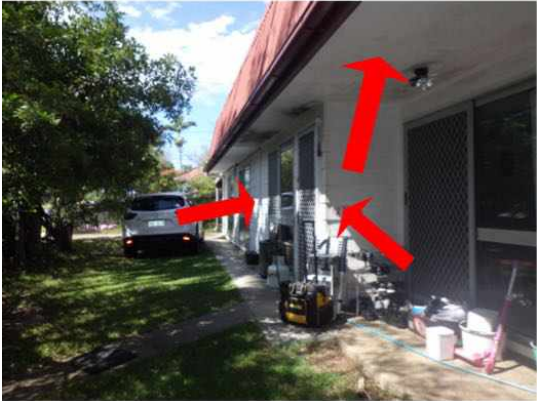
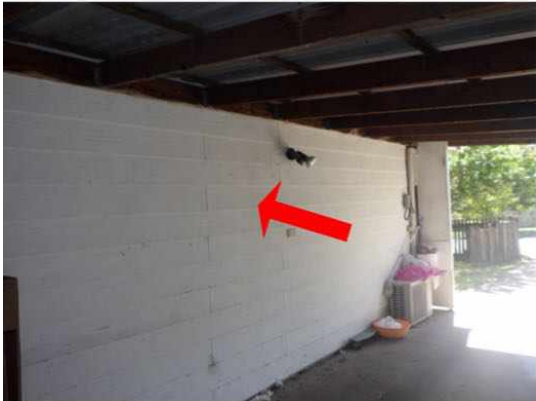
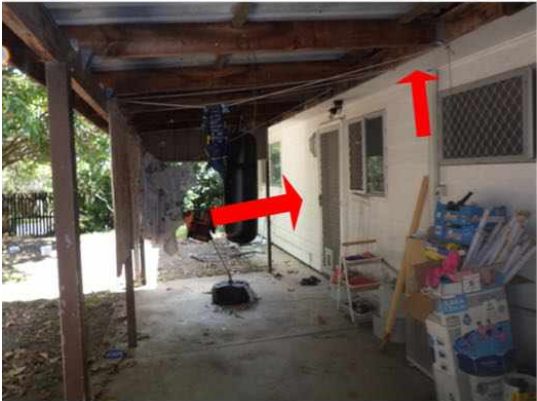
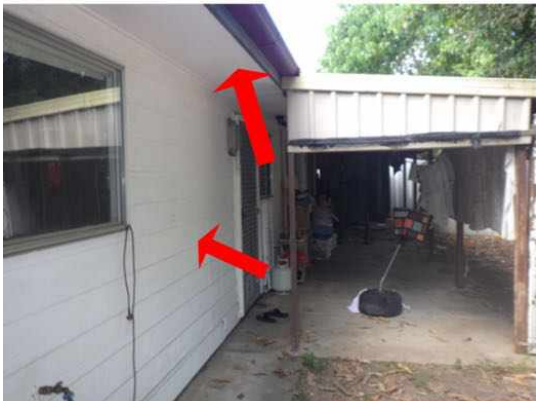
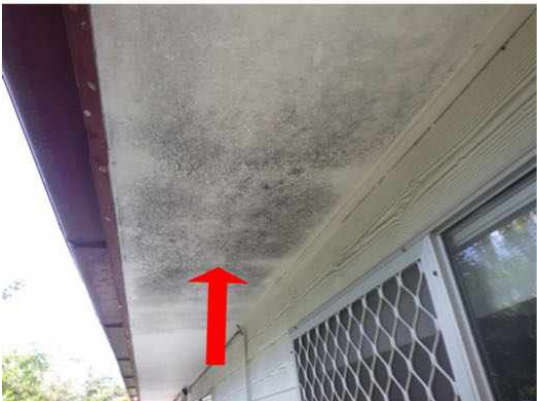
Reporting on Asbestos is outside the Scope of this Report. This suspected defect is highlighted as a caution only. We suspect, based on our experience in the building industry, that there is a higher risk of the identified building elements containing asbestos.

As Asbestos Reporting is outside the scope of this report, we advise that you consider a separate Asbestos Inspection and Condition Audit, which can include the taking of samples for definitive confirmation of the presence of Asbestos.

In the interim, the client is advised to act with caution, especially when considering any damage to building materials general wear and tear renovations extensions demolition and general maintenance activities due to the suspected presence of Asbestos.

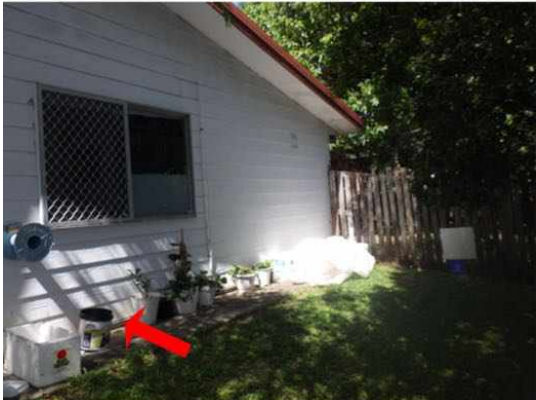
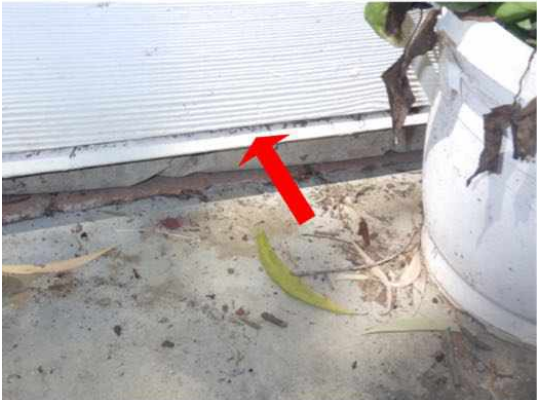
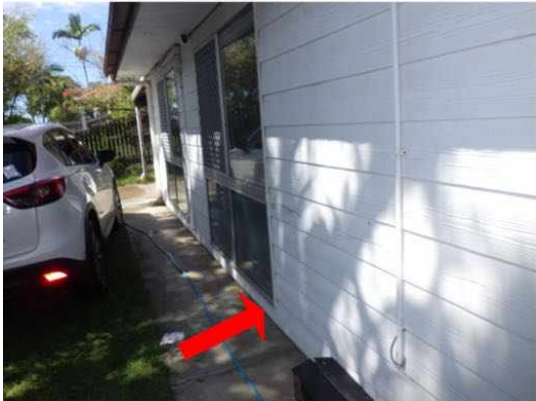
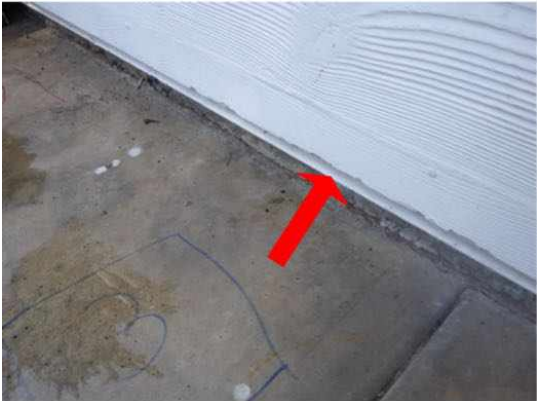
In this instance evidence of a previously installed physical barrier was observed in the form of a metal flashing to the exterior wall cladding/slab edge, along with a visual inspection zone. This system requires regular annual inspections.

No evidence of regular or annual inspections was found.

Where a Termite Management System has been identified you should refer to the type of barrier date of installation warranty conditions and any documentation provided by a builder or past owner.
