Building and Timber Pest Inspection Report

Inspection Date: Wed, 11 Feb 2026

Property Address: 25 Byron Rd, Tahmoor NSW 2573, Australia

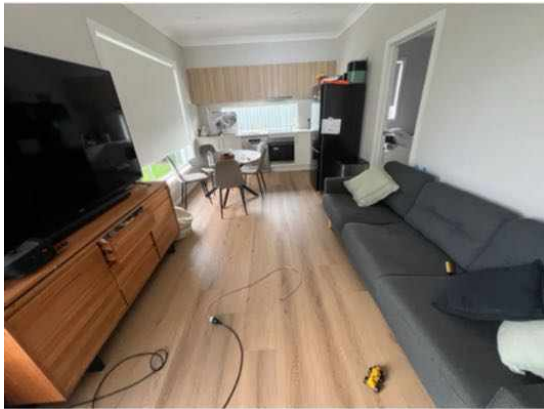
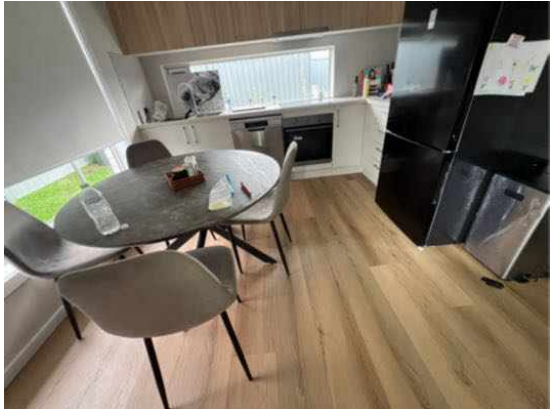
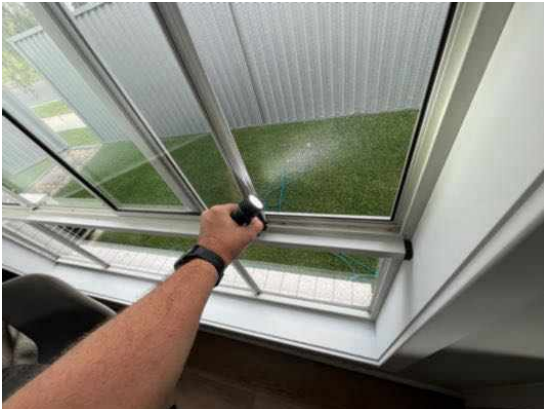
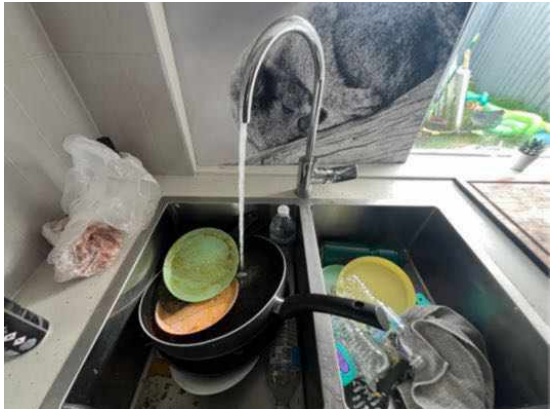
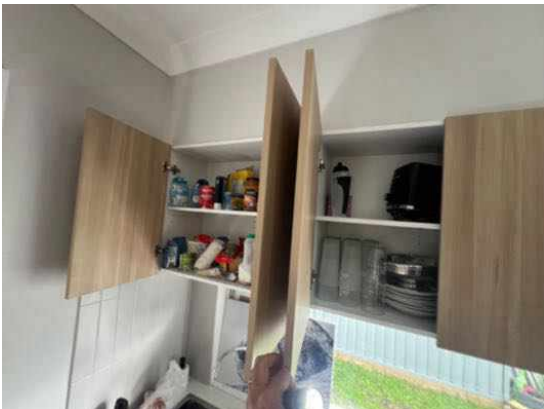
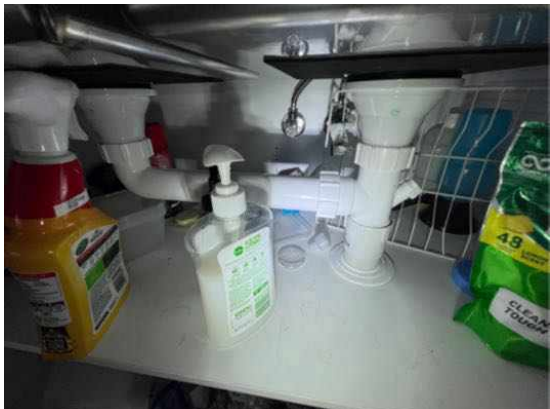
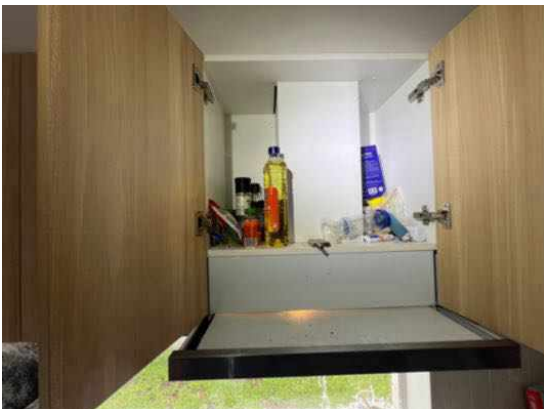
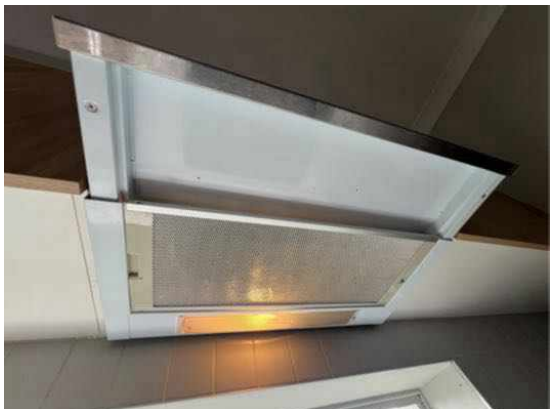
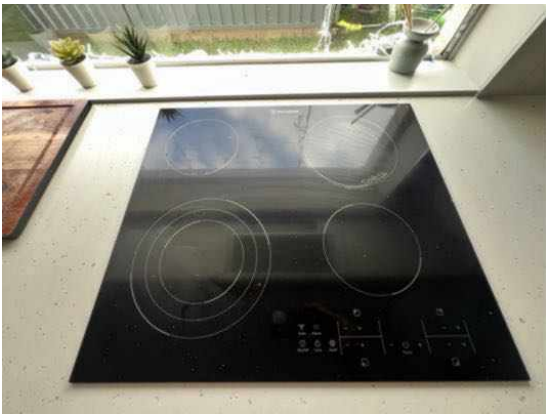
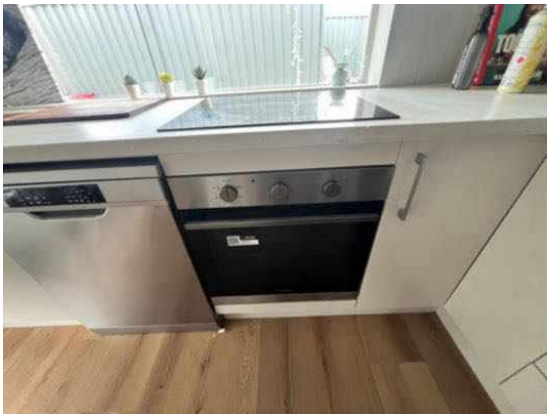
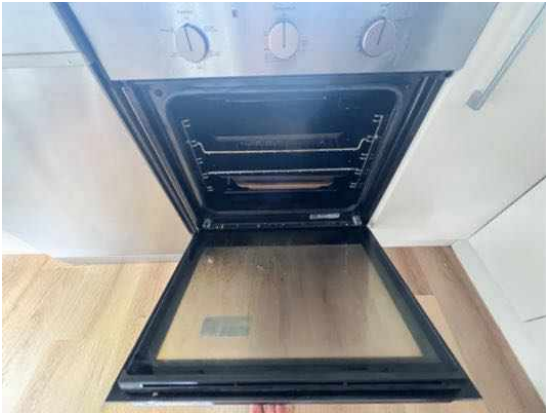
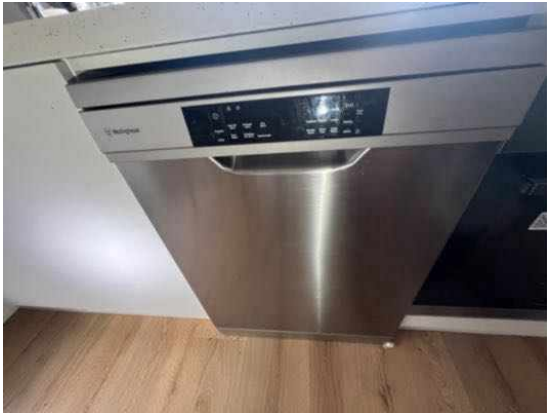
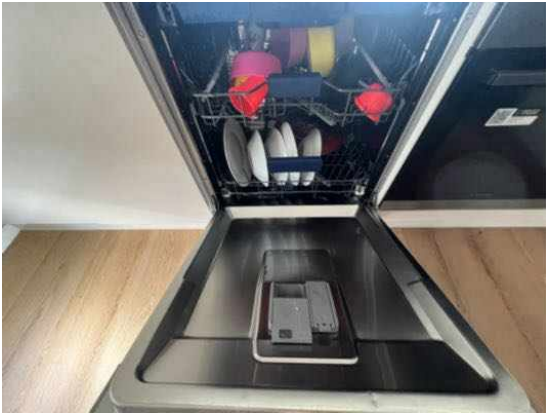
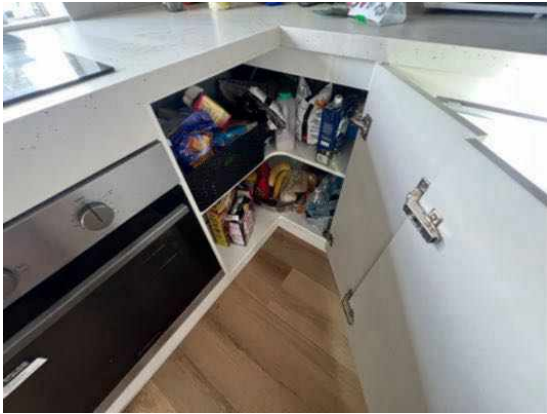
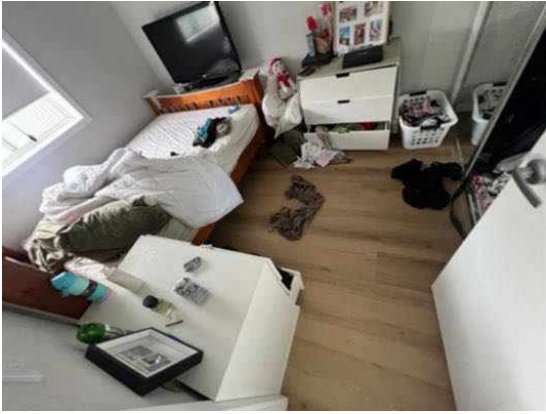
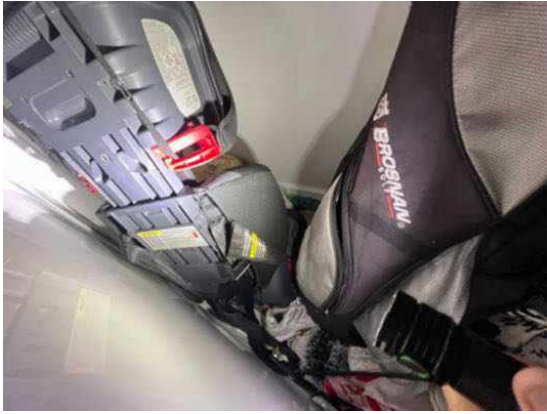
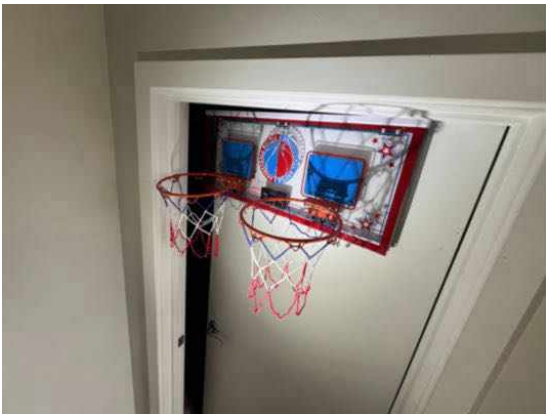
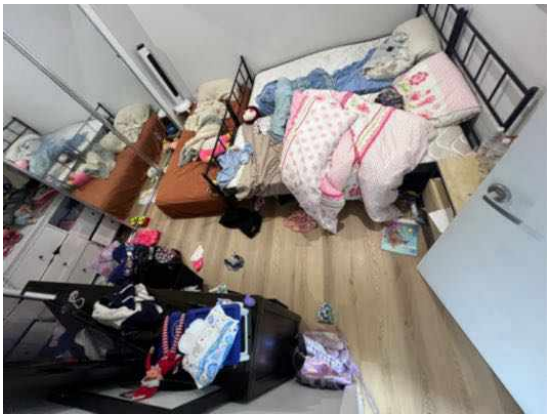
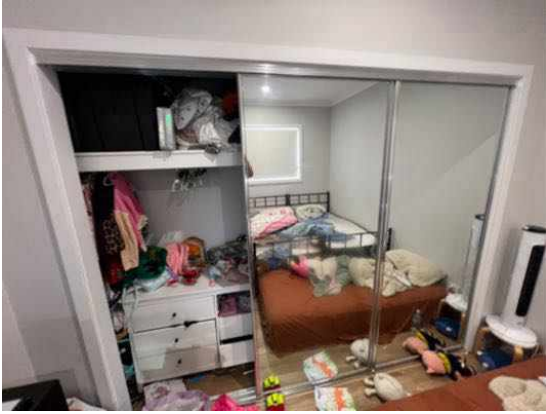
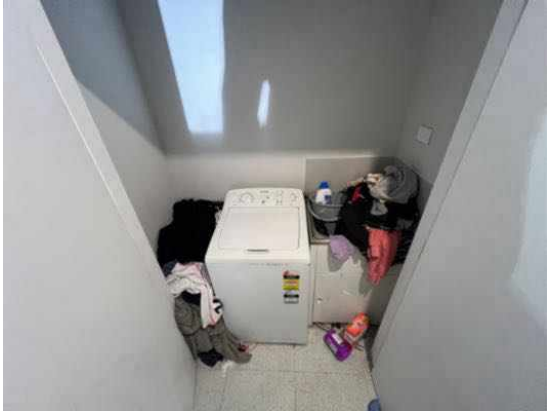
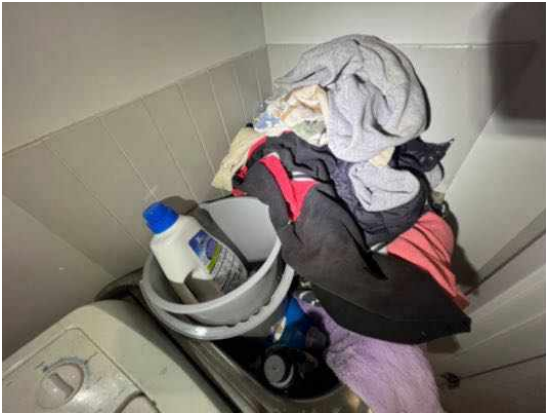
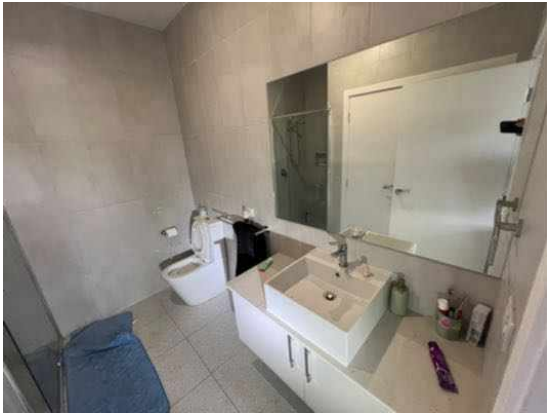
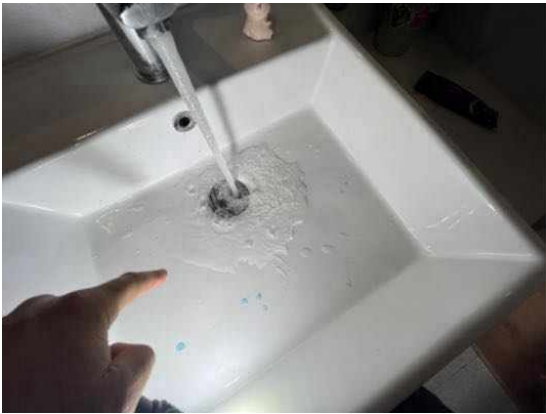
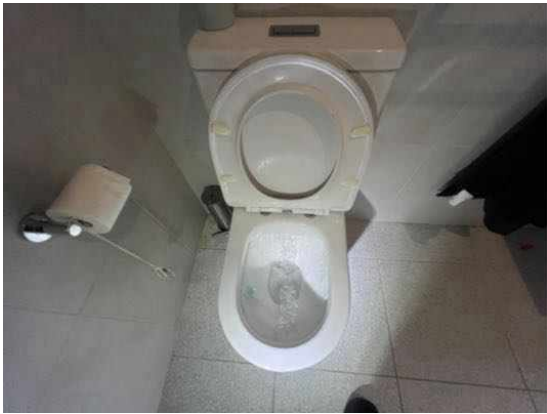
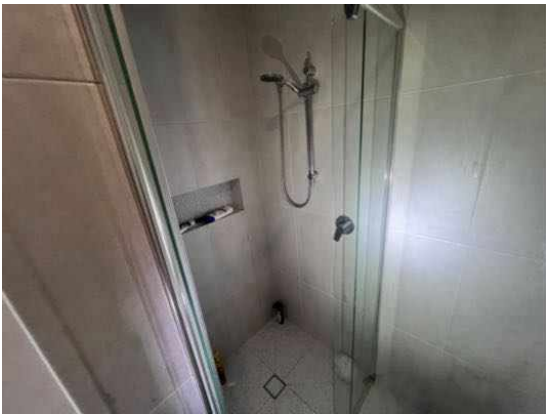
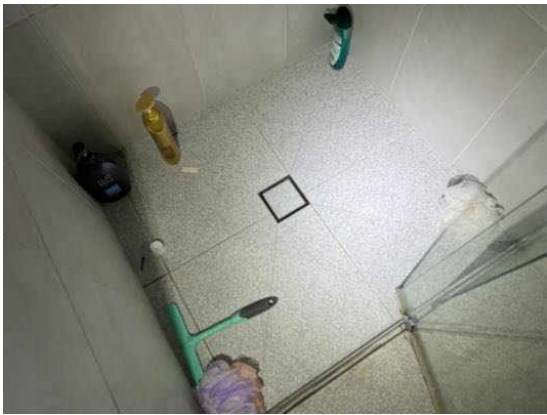
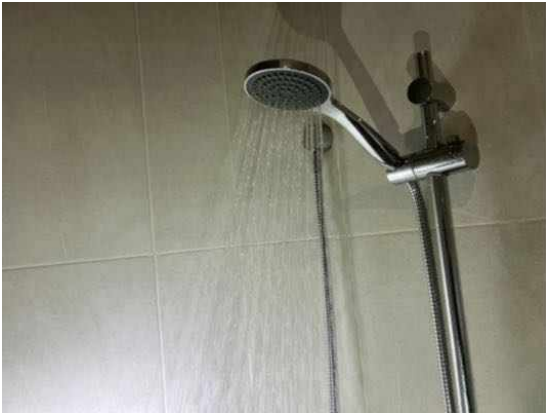
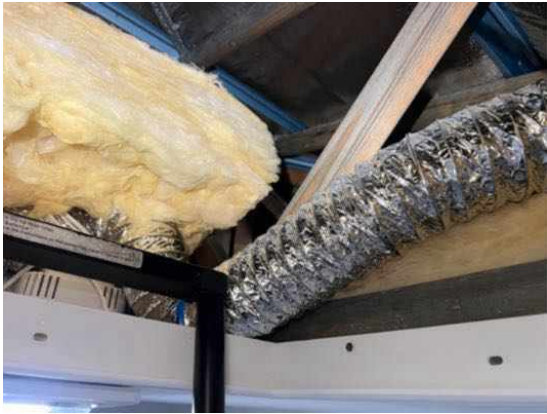
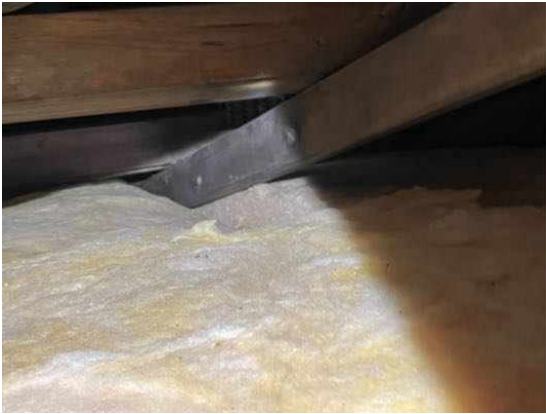
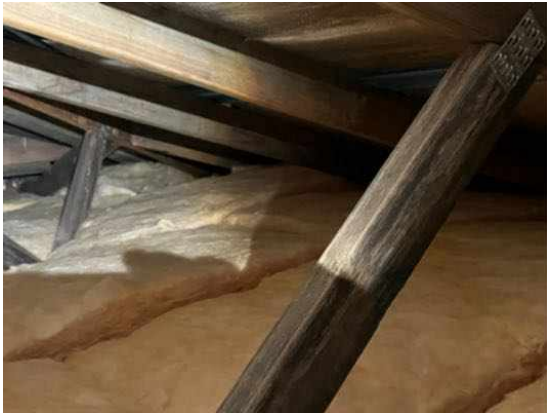
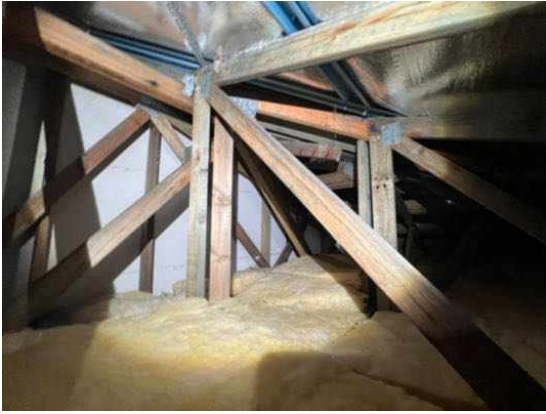
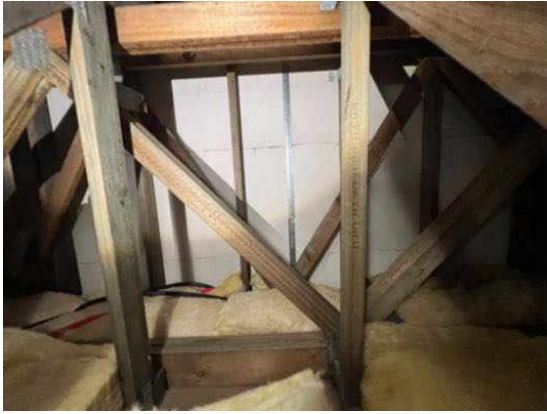
Finding: FYI - Additional Photos

Information: Additional photos are provided for your general reference and may include obstructions, testing of water & windows, moisture readings or minor maintenance items.
