Building and Timber Pest Inspection Report VR

Inspection Date: Thu, 26 Feb 2026

Property Address: 40A Lamonerie St, Toongabbie NSW 2146,
Australia

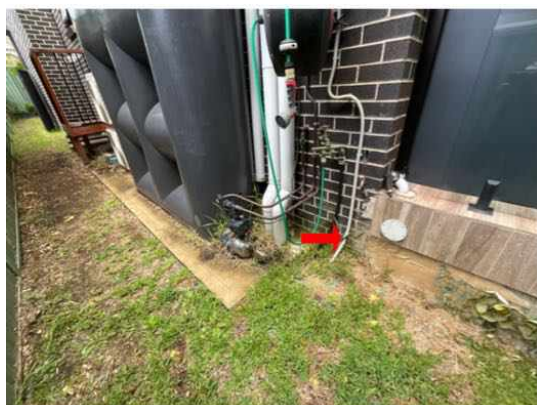
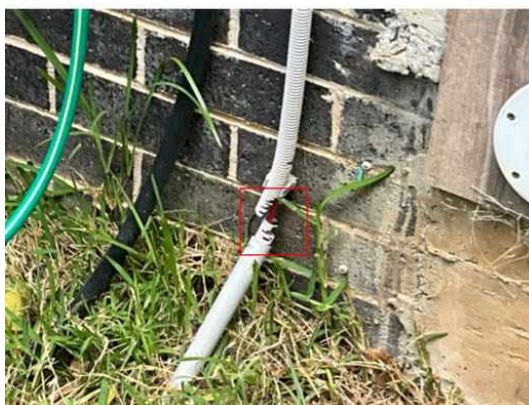
Building:	Main Building
Location:	Exterior walls - rear
Finding:	Conduit - Damaged
Information:	The conduit in this area was found to have been damaged at the time of inspection. This is a safety measure that is aimed at protecting the wires and preventing any personal injury that may result if wires are squashed or damaged.

Without a conduit providing adequate protection, external wiring is likely to become damaged and deteriorated over time, creating an electrical safety hazard. Damage to the wiring is also likely to result in the associated elements losing function.

A licensed electrician should be contacted immediately to install a conduit around the wires and provide any further advice on additional works that may be required to increase the safety of the wiring and its surrounding area.

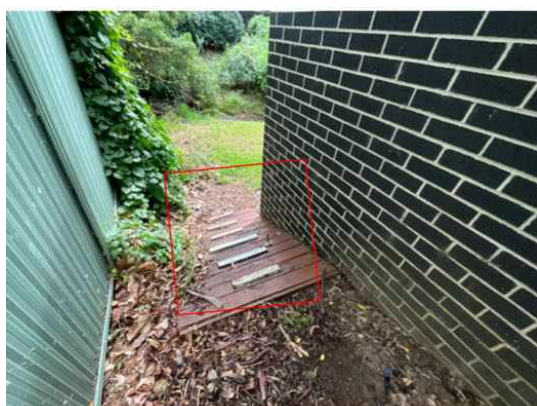
Finding 1.02

Building:	Main Building
Location:	Backyard
Finding:	Stairs - Non Compliant
Information:	The stairs in this area are non-compliant

Section 3.9.2.4 Handrails states:

- a) Handrails to a stairway or ramp must -
 - (i) be located along at least one side of the flight or ramp; and
 - ii) be located along the full length of the flight or ramp, except in the case where a handrail is associated with a balustrade, the handrail may terminate where the balustrade terminates and;
 - iii) have the top surface of the handrail not less than 865mm vertically above the nosings of the stair treads or the floor surface of the ramp; and
 - iv) have no obstruction on or above them that will tend to break a handhold.
- b) The requirements of (a) do not apply to -
 - (i) areas referred to in 3.9.1.2b or
 - (ii) a stairway or ramp providing a change in elevation of less than 1m

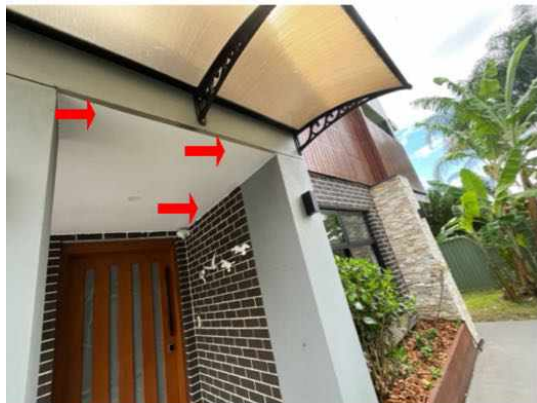
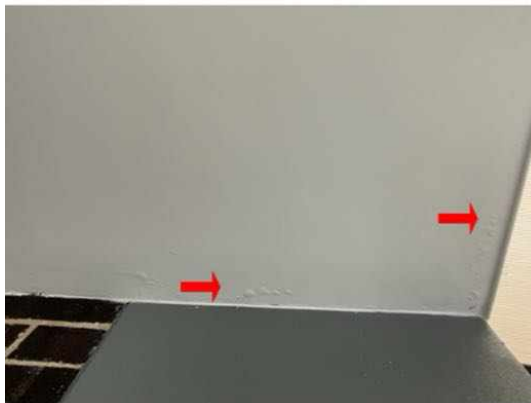
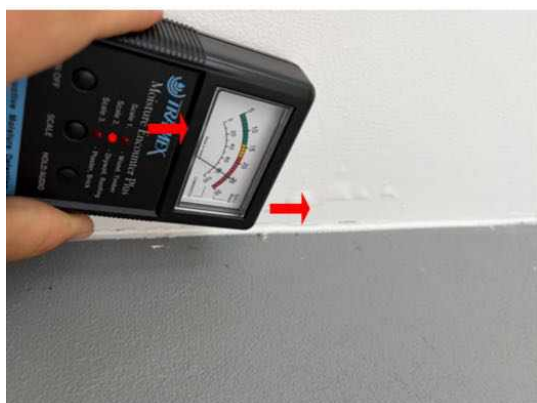
Finding 2.01

Building:	Main Building
Location:	Porch
Finding:	Water leak suspected - Internal
Information:	Internal water leak is suspected in this area at the time of inspection. Internal water leaks can be detrimental to surrounding building elements; their potential causes include damage to plumbing fittings and fixtures, through to water damage and deterioration of associated building elements.
	Rust, corrosion, decay and water damage are potential outcomes where a minor water leak is left unattended. More serious defects may also result, such as electrical

hazards, or water damage to structural building elements.

In extreme cases, structural damage may develop due to a prolonged water leak. It is highly advised that internal water leaks be addressed by a licensed roof plumber as a matter of relative urgency.

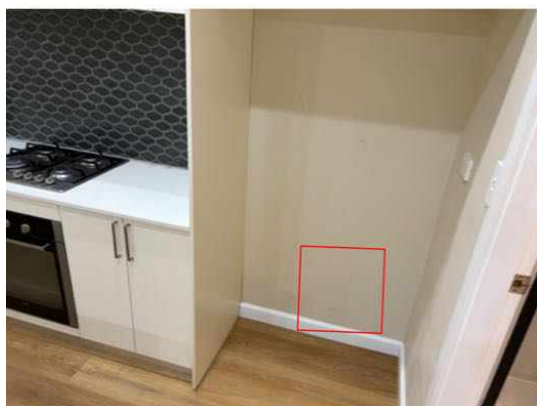
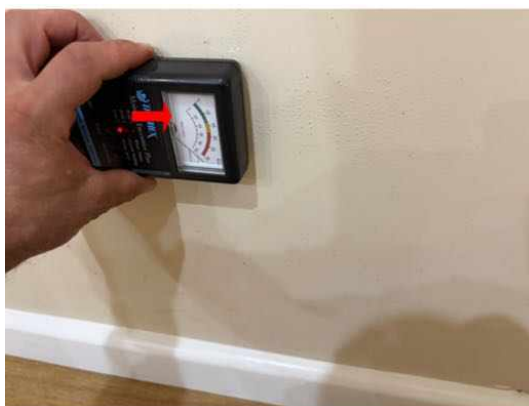
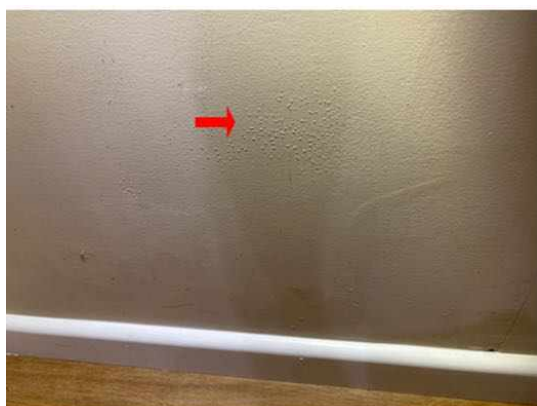
Finding 2.02

Building:	Main Building
Location:	Studio kitchen
Finding:	Evidence of excessive moisture was present at the time of inspection
Information:	Excessive moisture can attract termites and produce conditions that promote termite attack, fungal growth and wood decay. Excessive moisture is generally caused by deteriorated, inadequate or missing roof drainage, leaking plumbing pipes or fixtures, poorly plumbed HWS overflows or condenser units and poor site drainage. It is highly recommended that all plumbing and drainage fixtures and fittings be maintained regularly in order to prevent excessive moisture being present in the external / internal property.

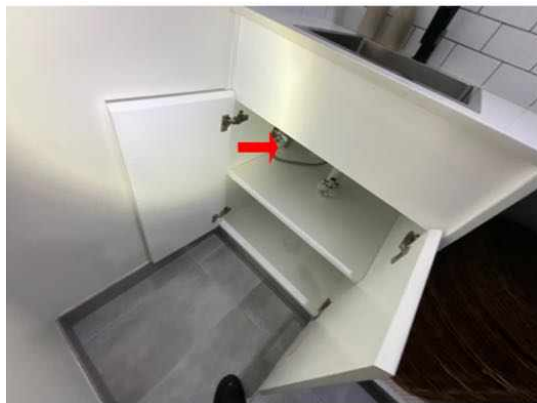
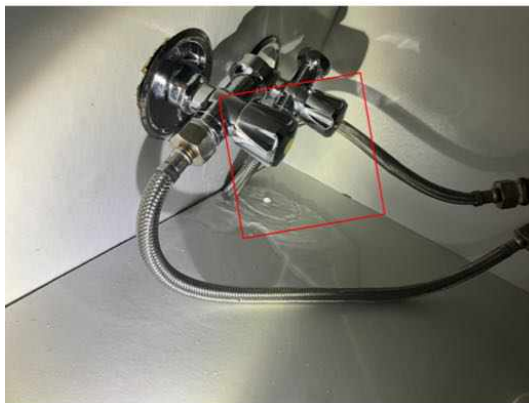
Finding 3.01

Building:	Main Building
Location:	Laundry
Finding:	Water leak - Active
Information:	Generally, water leaks occur when a particular area of the property is not weather or water tight. As the surrounding area was found to be damp at the time of inspection, the leak is considered ongoing and hence requires urgent action.

Regardless of the location, even minor leaks that are left unmanaged can lead to serious damage of associated building elements and result in the need for replacement of building materials. Mould and other hazards such as electrical hazards may also arise if the leak is left to develop.

It is highly advised that the cause of the leak be identified and resolved immediately by a licensed plumber to prevent any further damage. Depending on the extent of the damage previously sustained, repair and/or replacement of any affected building materials may be required.

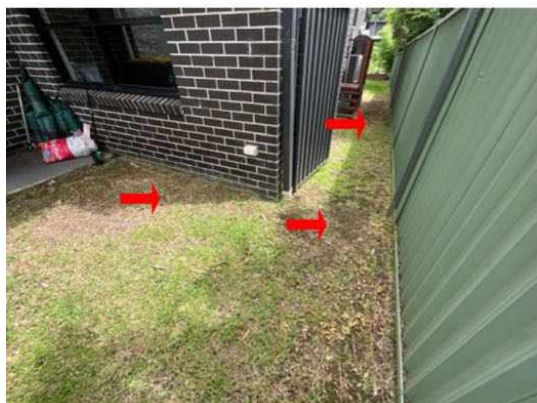
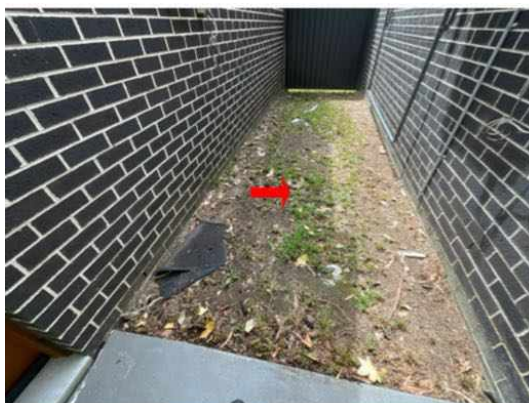
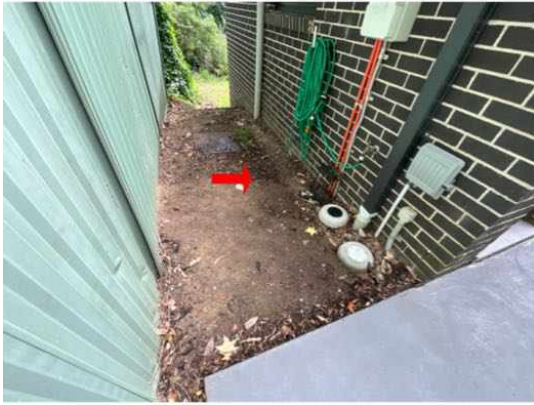
Finding 3.02

Finding: Site drainage— Inadequate

Information: The site drainage in this area was found to be inadequate at the time of inspection, creating potential for subsequent water damage to associated building elements. This is additionally conducive to termite activity.

It is important that water does not lie against the base of walls; surrounding paths and ground levels should be sloped to drain water away from walls. Downpipes should not discharge stormwater onto lower walls or plinths. Stormwater should be carried away by large, regularly cleaned drains. Ground levels may need to be lowered to expose a buried DPC.

Finding: Site drainage— Inadequate
 Information: The site drainage in this area was found to be inadequate at the time of inspection, creating potential for subsequent water damage to associated building elements. This is additionally conducive to termite activity.

Where site drainage is inadequate, installation of an Agricultural (Aggie) Drain may be required. A licensed plumber should be appointed to further inspect the property and perform any remedial works as necessary. Water damage and secondary defects are likely to occur if left unmanaged.

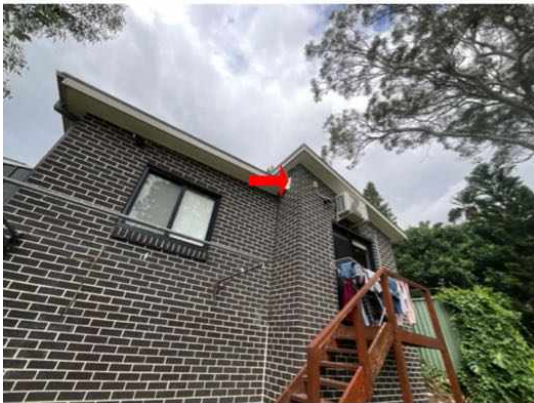
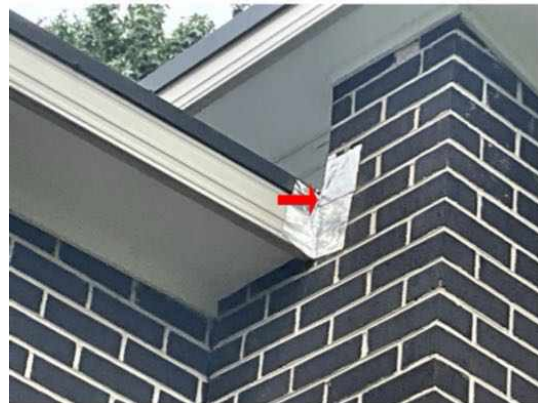
Finding 3.03

Building:	Main Building
Location:	Rear Elevation
Finding:	Unconventional handyman work
Information:	This handyman work appears to have been completed to a substandard level and does not comply with regular building practices. Where handyman work is not completed satisfactorily, accelerated deterioration of the associated building elements is likely to occur and secondary defects to surrounding structures may develop.

It is highly recommended that the substandard work be rectified by professional services. Works to improve this area are likely to increase the safety and the operation of the associated building elements.

The client should exercise care when coming into the immediate vicinity of the substandard works. Rectification works are advised as soon as possible by the appropriate trades.

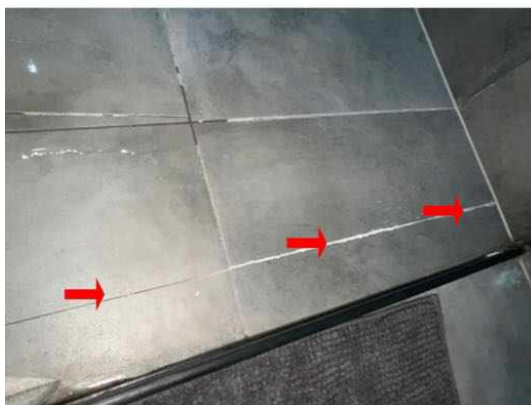
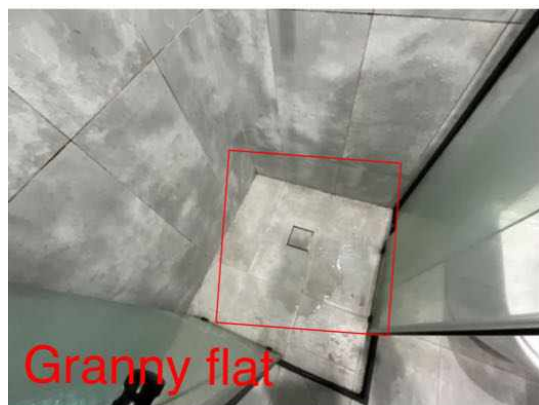
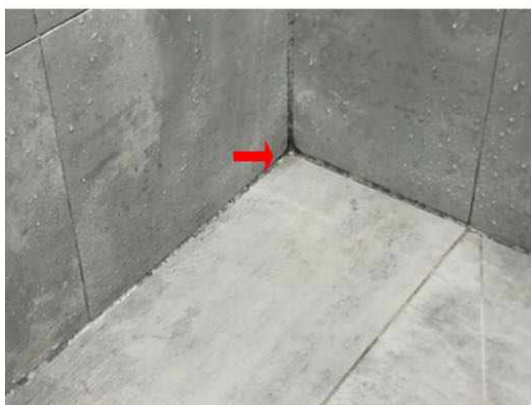
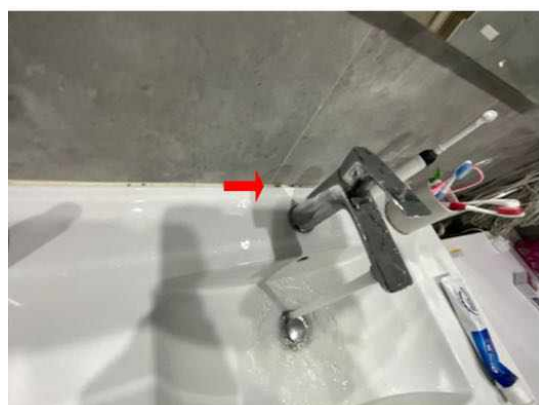
Building: Main Building
 Location: Multiple areas
 Finding: Sealant and grouting - Missing or damaged
 Information:

It was noted on inspection that sealant or grout is degraded to this area.

Different materials and floor areas move at different rates, generally causing cracking to grout or sealant at this point. A flexible sealant is required to allow for expected expansion and contraction, while keeping the joint water tight and protective of all associated building materials.

Flexible and mould resistant materials should be applied to affected areas to prevent any subsequent water damage that is likely to occur. Regular maintenance and replacement of damage or missing or damaged sealant and grout is highly recommended to the wet areas, as this is a regular wear and tear defect. Sealant and grouting in areas that come into regular contact with water should be maintained for the long term care of your property.

A sealant specialist should be appointed to complete these works as soon as possible.

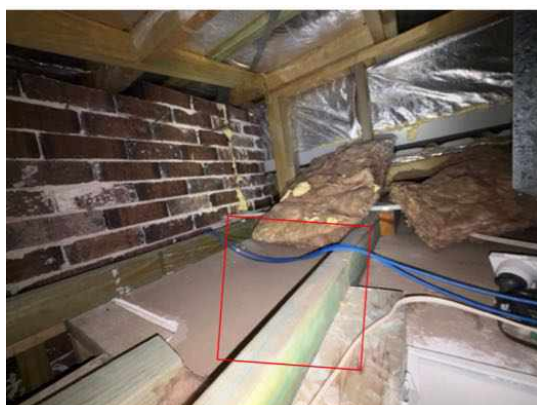
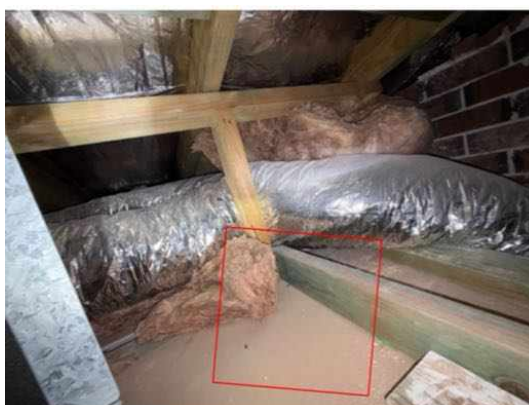
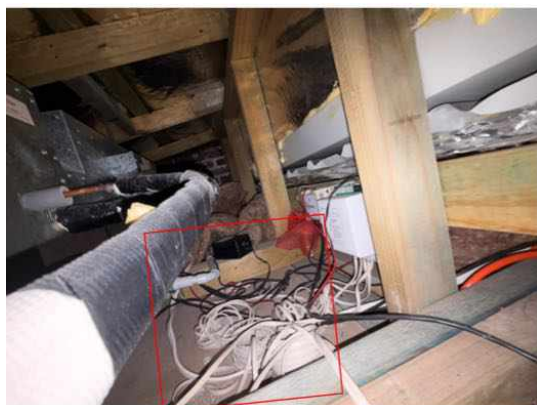
Finding 3.06

Building:	Main Building
Location:	Roof Void
Finding:	Insulation - Inadequate
Information:	Upon inspection of the roof void it was noted that there is a lack of adequate insulation.

The level of insulation in the property does not meet current Australian Standards. Installation of adequate insulation is required and should be conducted as soon as possible.

Caution should be exercised when accessing the roof void. Do not attempt to stand on the framework to the underside of the trusses and be aware there is a potential for electric shock if contact is made with exposed or faulty electrical wiring.

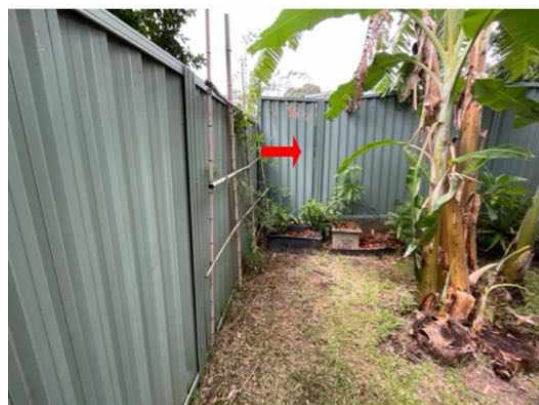
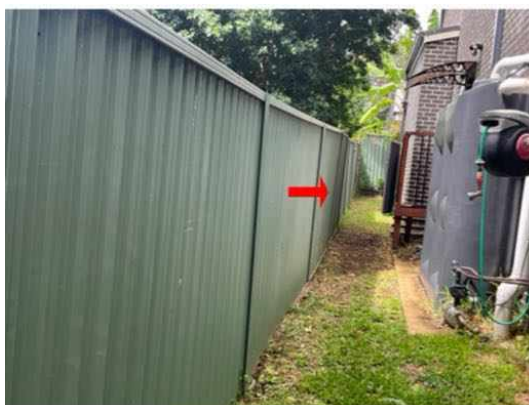
Finding 3.07

Building:	Main Building
Location:	Fencing
Finding:	Fencing - Deteriorated
Information:	It was noted at the time of inspection that sections of the fencing in this area has deteriorated. Typically fencing deteriorates due to age and or wear, rot and or rust which is generally expected for a structure of this age, due to prolonged exposure to weather conditions. Sometimes inadequate installation or maintenance can be to blame.

If left unattended, it is likely that further damage will occur. It is suspected that repair of several elements of the fencing may be required however replacement may be a consideration of the client also.

A licensed fencing contractor should be appointed to provide further advice and perform rectification works as necessary.

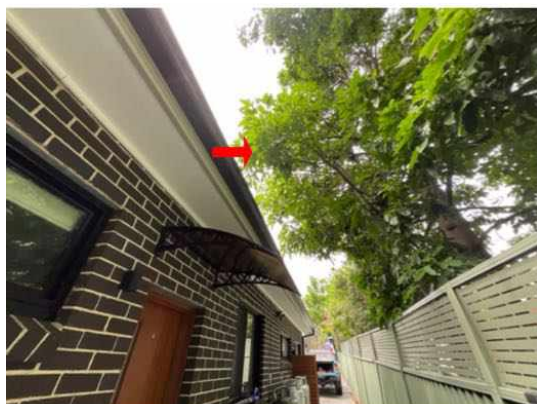
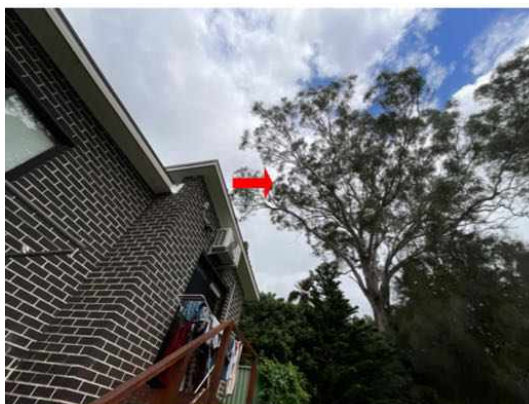
Finding 3.08

Building:	Main Building
Location:	Roof Exterior
Finding:	Trees - Overhanging and filling gutters
Information:	Overhanging trees often result in excessive amounts of leaf debris accumulating in gutters.

Gutters are a critical part of the building's management of storm water and rain. It is therefore important that they be kept clear to prevent secondary damage to associated building elements, including exterior and interior walls, ceiling linings and any adjoining building elements. Where gutters are blocked, pooling of rainwater is likely to occur, fast-tracking rust and corrosion of the roof plumbing elements.

It is highly advised that all overhanging tree branches be removed as soon as possible to prevent any further damage. Repair and/or replacement of sections of damaged guttering may also be required where the extent of the damage necessitates.

Such works should be performed by the homeowner; however, appointment of a landscape contractor or an arborist may be required. Consultation with a licensed roof plumber is required where guttering has been damaged.

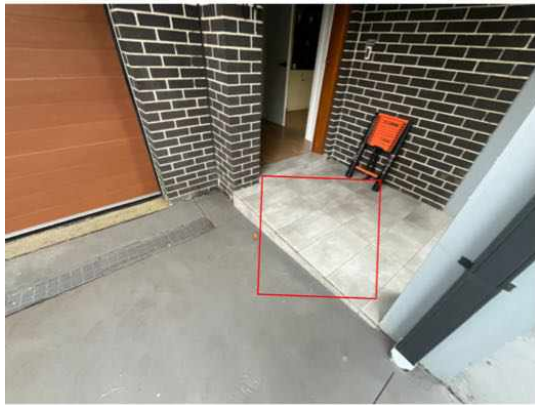
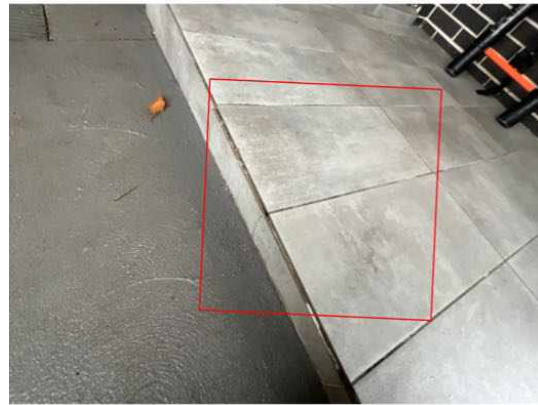
Finding 3.09

Information: Drummy tiled areas were identified at the time of inspection. The term 'drummy' refers to tiles that have become detached from their fixing, despite otherwise being in relatively good condition. Such defects are generally caused by physical or moisture damage to the area. Drummy tiled areas may also be a direct result of poor workmanship during the construction process.

Tiled areas may swell and shrink with changes in air humidity if the area has sustained moisture damage. Any exposure to moisture is capable of causing tiled areas to become drummy and/or cracked over a prolonged period of time. Drummy tiled areas generally require removal and replacement of affected tiles, with adequate sealant and grouting.

Specialist trades are available for these types of services. A licensed tiling contractor may be appointed to perform works as necessary.

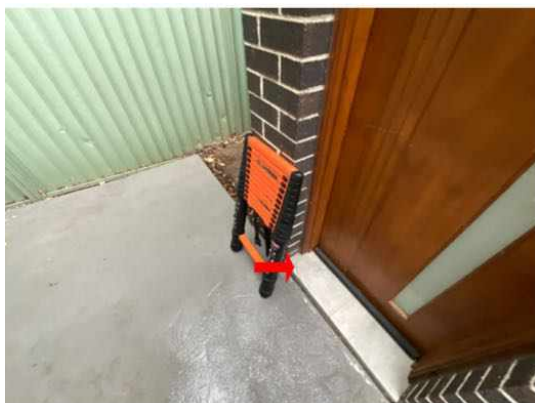
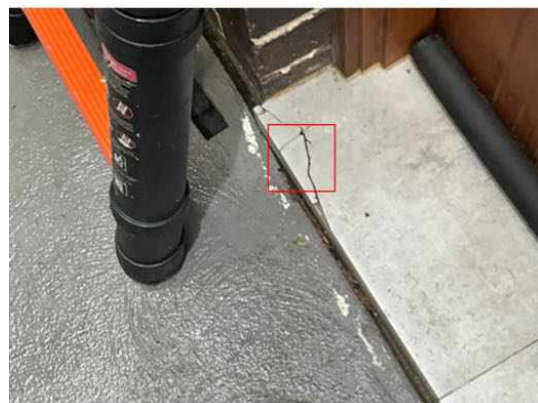
Finding 3.10

Building: Main Building
 Location: Granny flat
 Finding: Cracked floor tiles
 Information:

Cracking in the floor tiles was evident in this area at the time of inspection. It is suspected that this cracking has occurred as a result of minor settlement or shrinkage.

Cracked tiles throughout the household detract from the overall appearance of the affected areas however it is unlikely to create or lead to any secondary defects.

While not considered a matter of urgency, replacement of cracked floor tiles is recommended at the clients discretion. A licensed tiling contractor may be appointed to perform these works. Where cracks become more numerous, contact a licensed building inspector for further investigation.

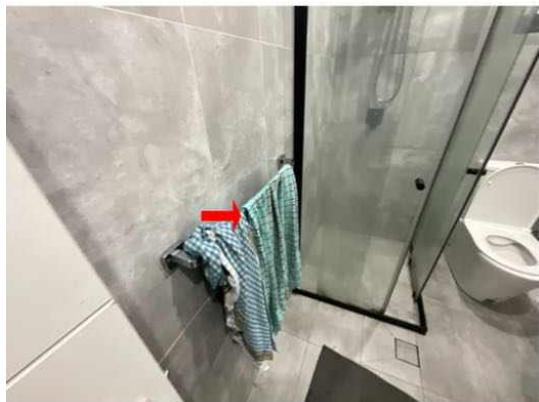
Finding 3.11

Building: Main Building
 Location: Granny flat
 Finding: Toilet roll holder / Towel rack - Loose
 Information:

The toilet roll holder and or the towel rack was found to be loose at the time of inspection. While not a major operational defect, function can deteriorate if the problem is left unmanaged.

It is advised that a registered builder performs remedial works to re-attach this element to its original fixing.

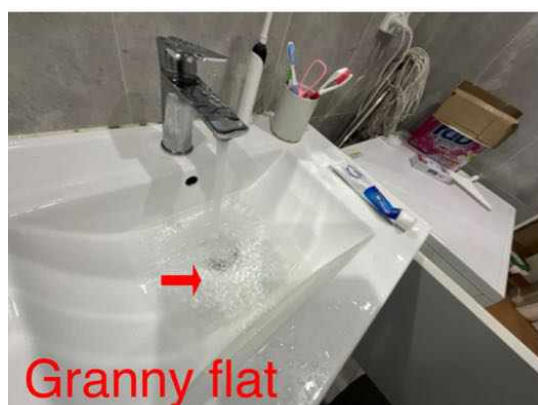
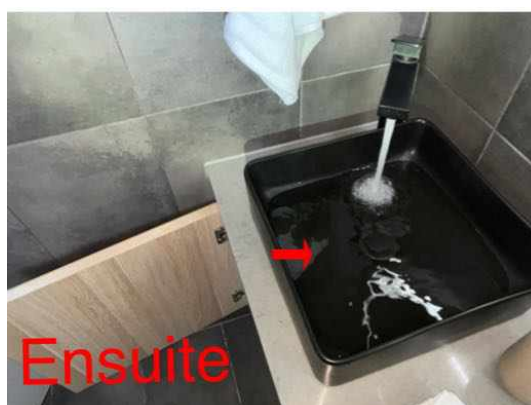
Finding 3.12

Building: Main Building
 Location: Multiple areas
 Finding: Sink/basin - slow draining
 Information:

The sink/basin drain appeared to be partially blocked at the time of inspection. Blockages here are usually caused by hair and other debris. If left unmanaged, a lack of general maintenance may lead to the development of more significant defects, such as water damage to surrounding building materials.

A licensed plumber should be appointed to remove the blockage at the client discretion.

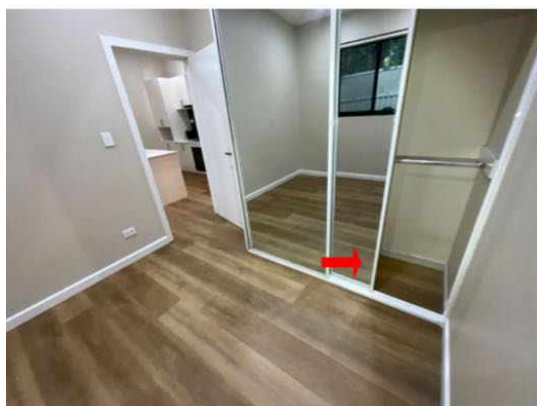
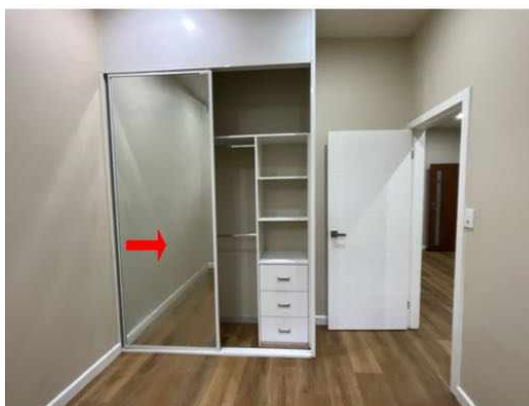
Finding 3.13

Building: Main Building
 Location: Studio
 Finding: Door - Stiff to slide
 Information:

The door in this area was jammed and difficult to slide along the associated tracks at the time of the inspection. Restricted function of the affected door may pose as a potential safety hazard if required for emergency egress from the building.

Generally, factors such as general age of the building element and a lack of maintenance are the usual causes for this type of defect.

Replacement of door hardware or tracks may be required, as well as minor repairs and cleaning. A registered builder will be required to repair the affected doors.

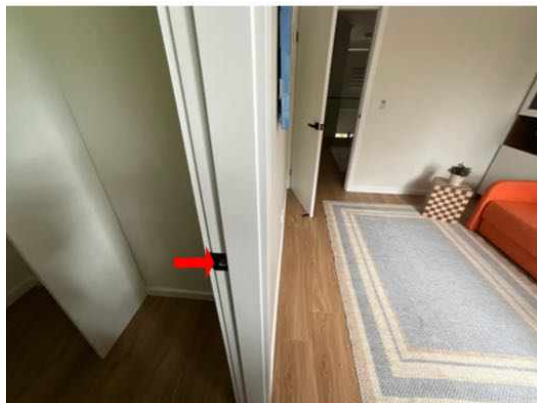
Finding 3.14

Building: Main Building
 Location: Study
 Finding: Door - Striker plate misaligned
 Information:

This is a common defect and is expected in a property of this age, whether being due to substandard installation or general deterioration of the door hardware.

Readjustment of the striker plate is recommended at client discretion. Works such as these can be completed by a general handyman or qualified carpenter.

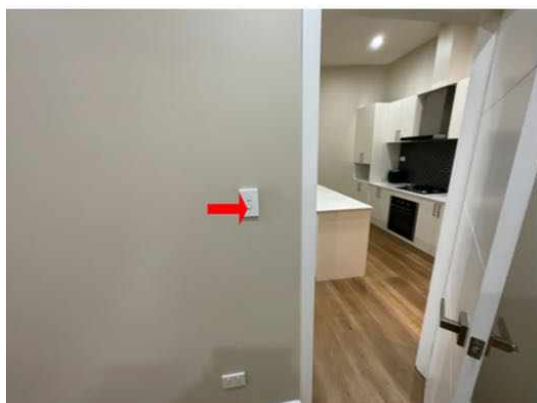
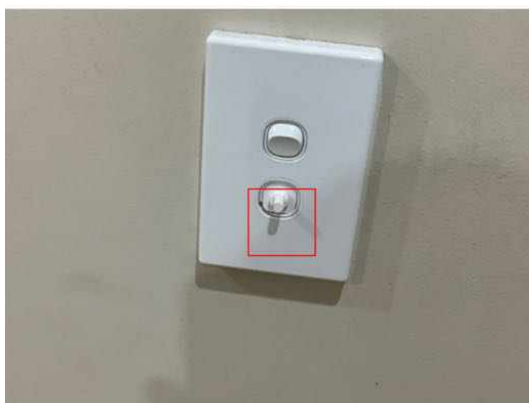
Building: Main Building
 Location: Studio
 Finding: Switches - Damaged/Faulty
 Information: The switches in this area was found to be damaged or faulty at the time of inspection. This occurs generally when the building materials have either aged and decayed or as a result of impact damage (accidental or deliberate). This damage may also have occurred during installation.

Repair and/or replacement of the switches is advised to ensure the fixture and it's associated structures are safe and fully operational. A licensed electrician should be appointed to repair/replace the light switch as soon as possible.

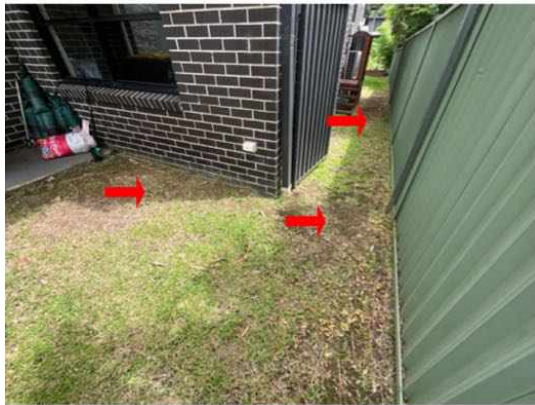
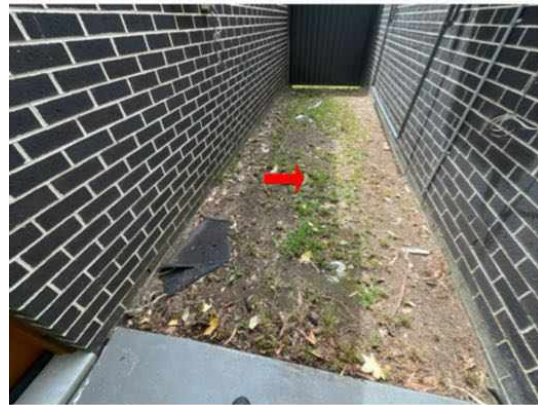
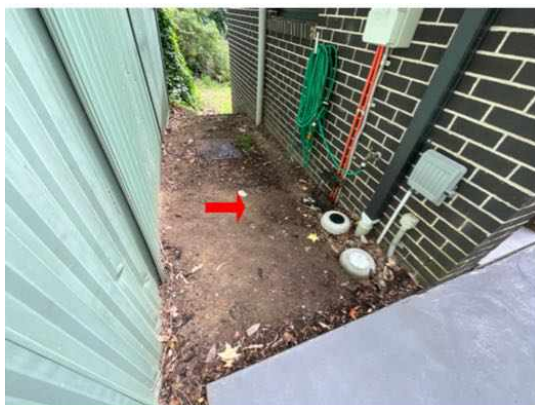
Finding 6.02

Building:	Main Building
Location:	Yard

It is important that water does not lie against the base of walls; surrounding paths and ground levels should be sloped to drain water away from walls. Downpipes should not discharge stormwater onto lower walls or plinths. Stormwater should be carried away by large, regularly cleaned drains. Ground levels may need to be lowered to expose a buried DPC.

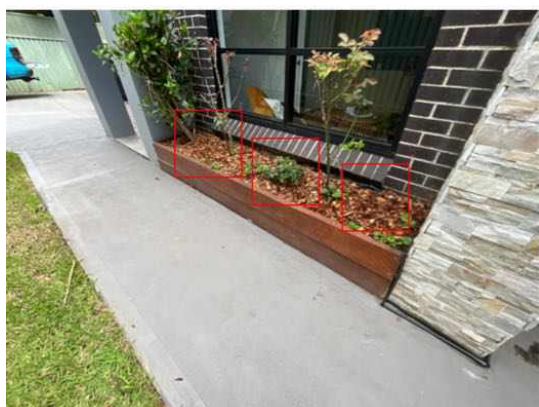
It is important for internal flooring to be raised above adjacent external ground levels. Where external ground levels are above internal flooring water pooling and subsequent internal flooding is likely to occur which may attract termite activity to the internal area.

It is highly advised that a landscaper or paver be appointed to lower external grounds that are raised above adjacent internal flooring. Alternatively if external grounds and internal flooring is level installation of a raised door sill may be appropriate in preventing any water pooling in the area.

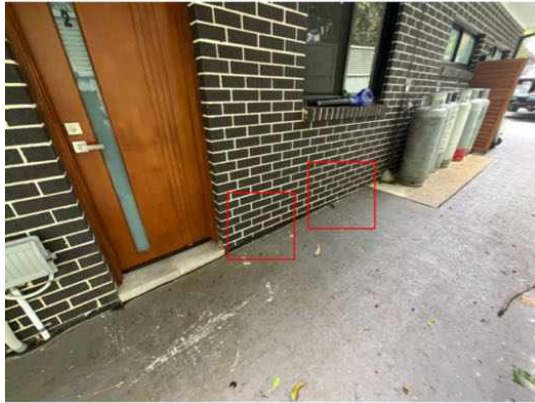
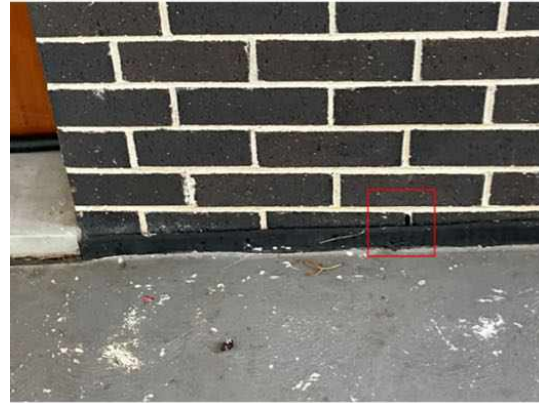
Finding 6.06

Building: Main Building
 Location: Exterior walls - right side
 Finding: Bridging or breaching of termite barriers - weep holes
 Information: Bridging is the spanning of a termite barrier or inspection zone so that subterranean termites are provided with passage over or around that barrier.

Weep holes in the exterior brickwork of the property are designed to allow condensation that may build up between the brickwork and subsequent timber framework to drain from within the wall hence preventing any deterioration of the timber building elements.

Additionally build-up of moisture is likely to occur if weep holes are covered further attracting termite activity to these areas.

It is highly recommended that weep holes are left exposed in all areas throughout the external property. Therefore if any termite activity leading into weep holes becomes easily detectable during frequent pest inspections.

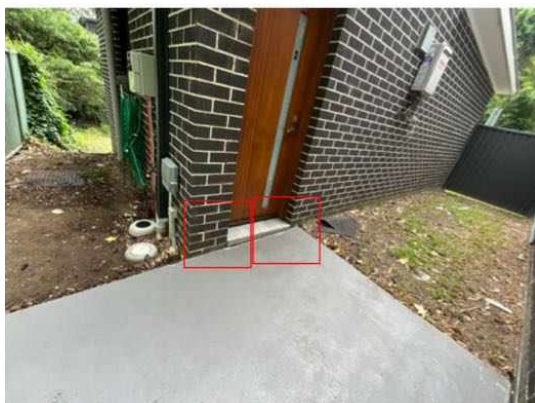
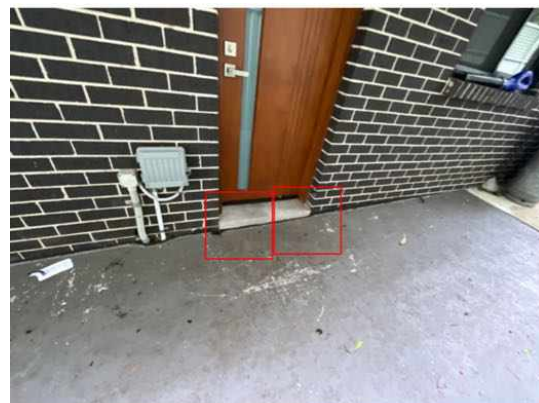
Finding 6.07

Building:	Main Building
Location:	Multiple areas
Finding:	Bridging of termite barrier
Information:	Bridging of termite barriers occurs when termites bridge (usually by building a mud tunnel) a termite barrier or inspection zone or where termites have a passage allowing them to bridge the barrier.

Generally this takes the form of finished ground levels external paving or concrete being retrospectively installed above the damp course level the adjacent internal floor level or weep and ventilation holes.

Where bridging has occurred full inspection is prevented and termites may enter a property in a concealed or undetectable manner.

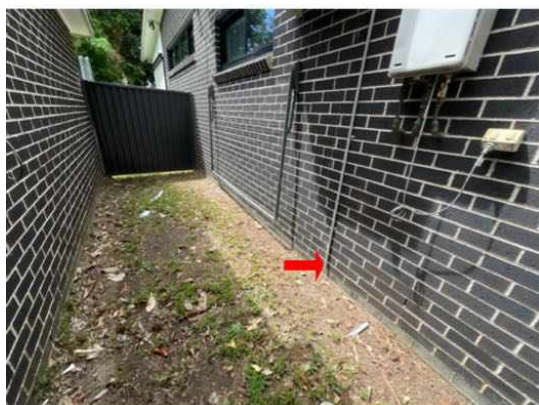
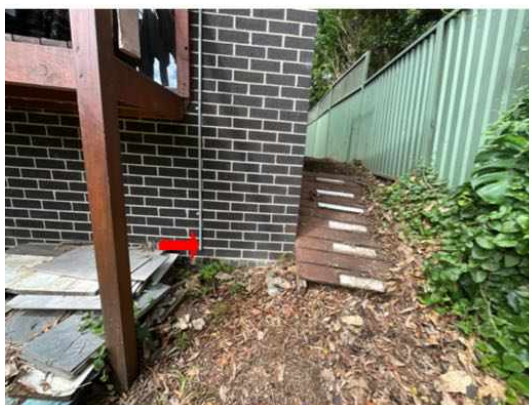
Finding 6.08

Building:	Main Building
Location:	Yard - Side
Finding:	Overflow - Not plumbed for drainage
Information:	The overflow is not plumbed or connected to suitable drainage, which can result in the surrounding area becoming excessively damp.

These damp conditions can lead to secondary defects such as rot, rust or corrosion of associated building elements, the formation of fungal decay, or even the creation of potential slip hazards. When coupled with poor site drainage, pooling of water may also attract termite activity to this area.

It is highly recommended that a licensed plumber be appointed to install adequate drainage to the overflow. These works will ensure that the area remains dry and free of any secondary defects.

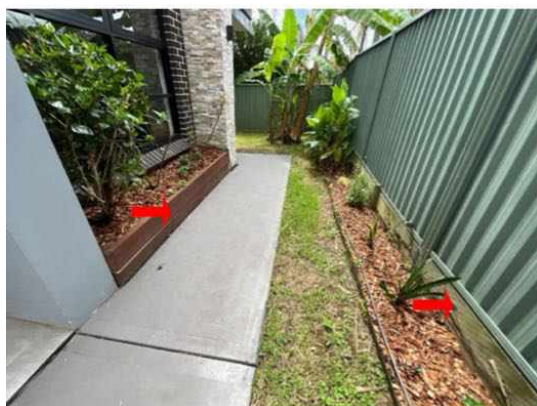
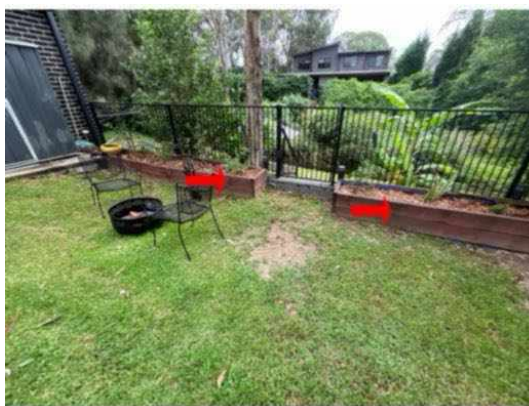
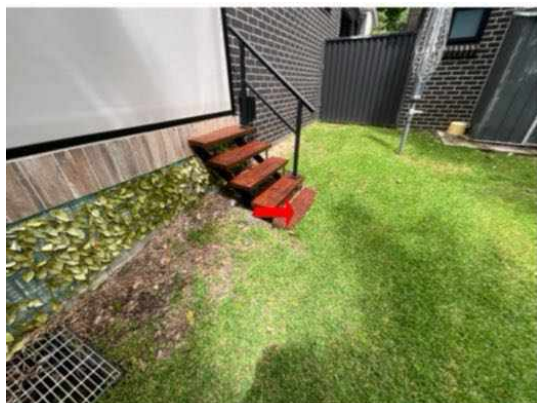
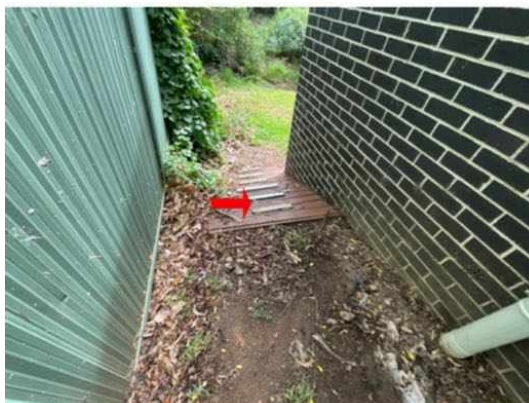
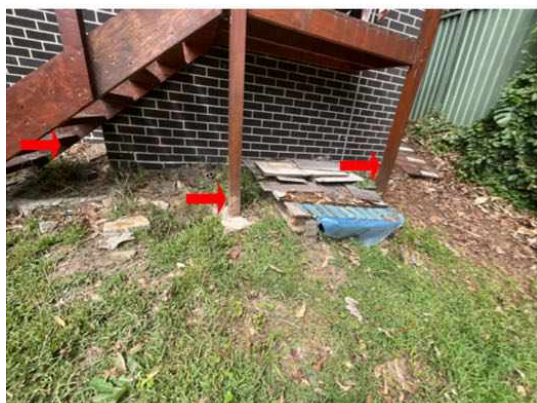
Finding 6.09

Building:	Main Building
Location:	Fencing & Landscaping
Finding:	Building materials in direct ground contact - conducive to termites
Information:	Where timber elements are in direct contact with the ground and consequently moisture or dampness they become conducive to termite activity. Whether timber is used as a building element part of a fencing structure or stored as an unused item they can provide an environment that is attractive to termite infestation.

When met with excessive moisture timber begins to decay and develop wood rot. Any timbers that are in direct contact with external grounds especially if left untreated or non-durable also provide ingress for subterranean termites into that particular element.

The removal of any such materials that may be conducive to termite activity should be removed as soon as possible to minimise the risk of termite attack.

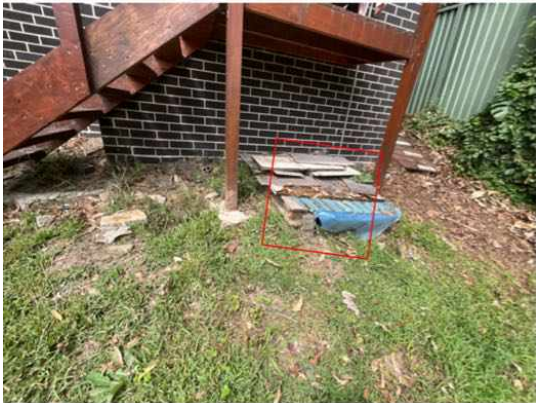
Finding 6.10

Information: The storing of timbers in the subfloor space or around the external property increases the risk of termite activity being present. As they are likely to come into contact with weather conditions or excessive moisture wood rot is likely to develop on timbers that are not treated.

It is highly recommended that any stored timbers be immediately removed from areas in which they may attract any termite / timber pest attack. Minimisation of risk / prevention of termite attack is far more adequate than dealing with the presence of

termite activity.

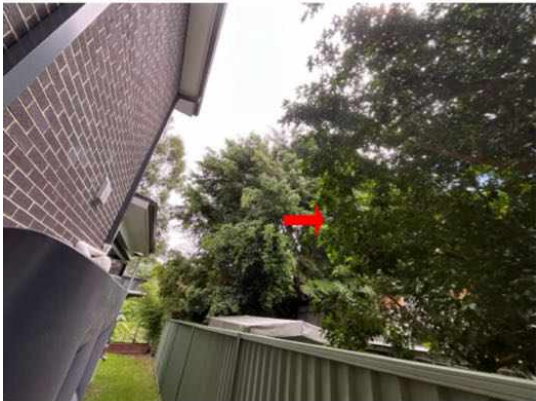
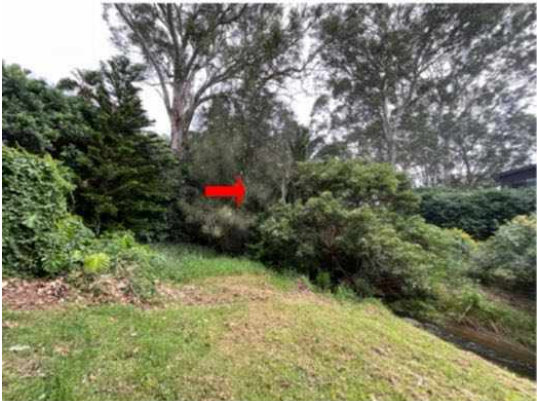
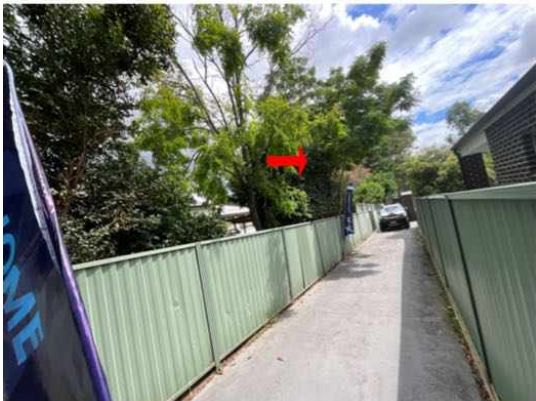
Finding 6.11

Building: Main Building
 Location:
 Finding: Surrounding bushland - Conducive
 Information: Home and or building is situated in a high risk area for termite activity, due to close proximity to surrounding bushland.

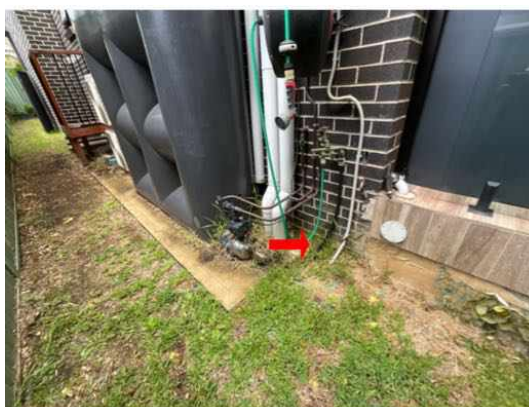
Building:	Main Building
Location:	External tap
Finding:	Tap - No drain
Information:	The external tap in this area was noted to have no drain at the time of inspection.

This keeps the surrounding surfaces damp while using the tap, which becomes conducive to termite activity.

A licensed plumber must be appointed to ensure an appropriate drain is installed.

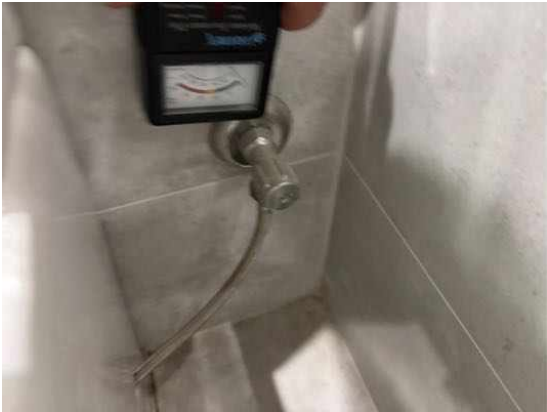
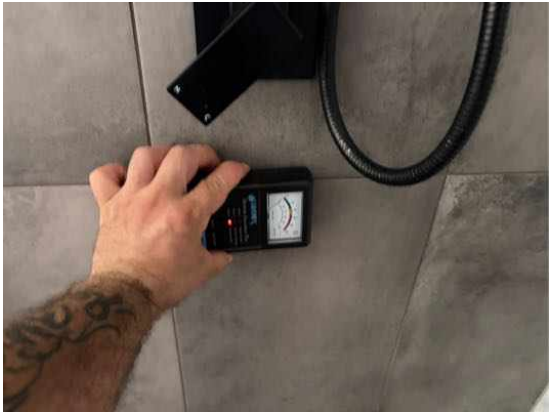
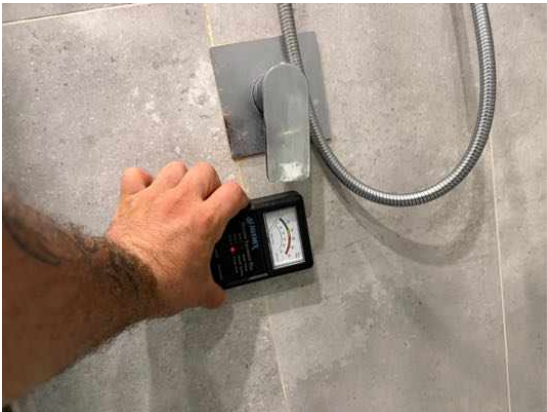
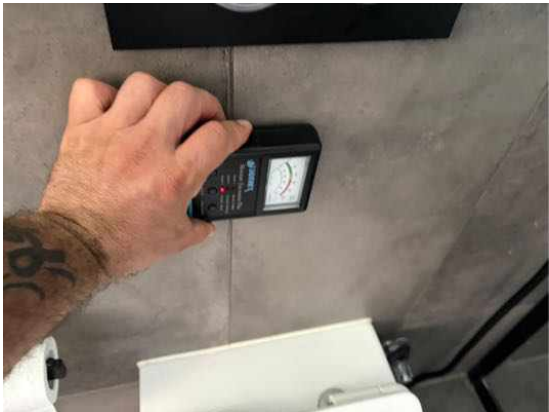
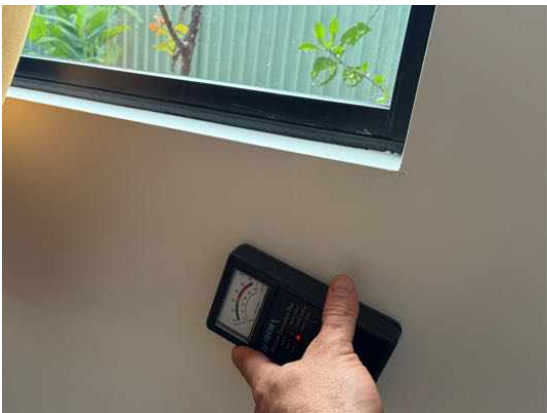
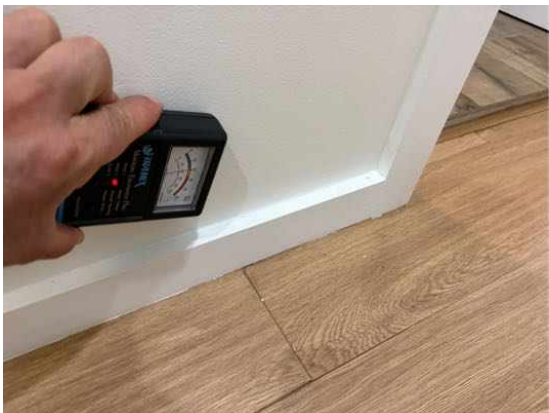
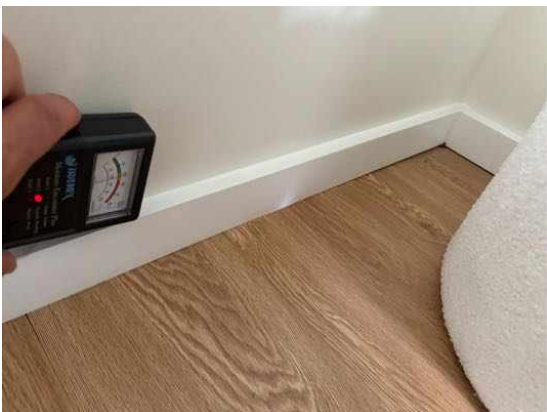
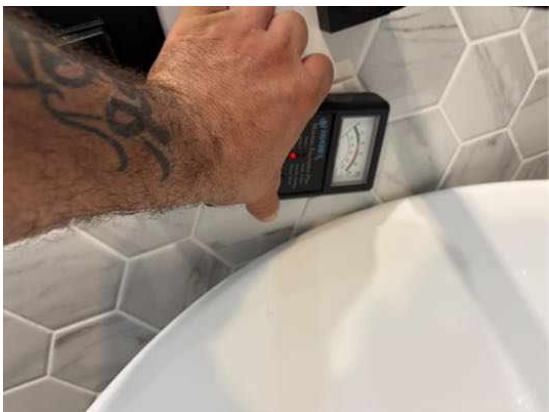
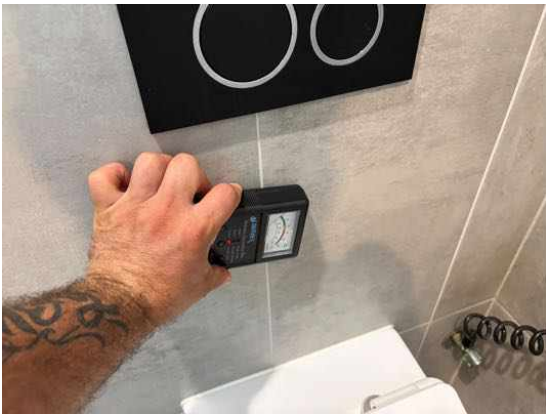
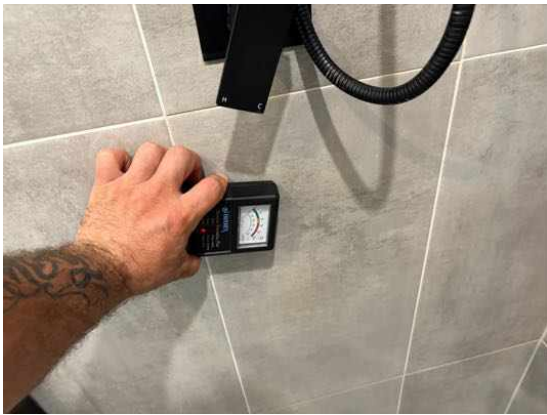
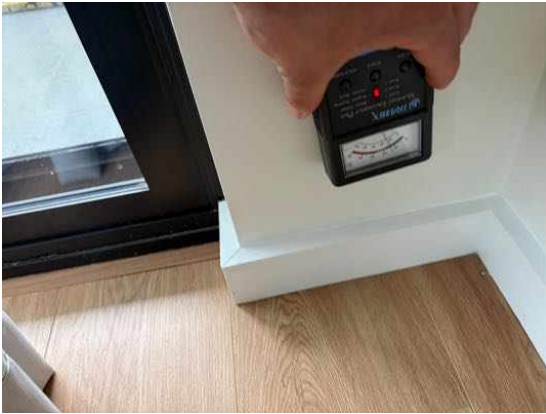
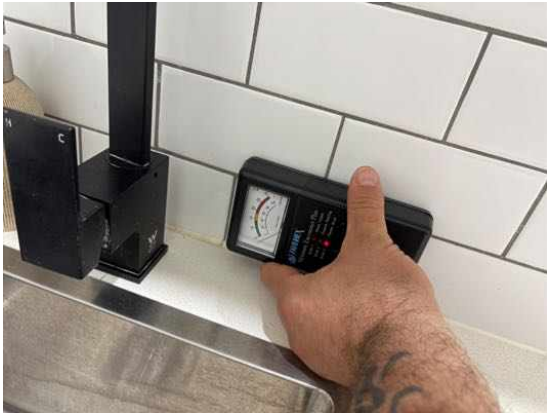
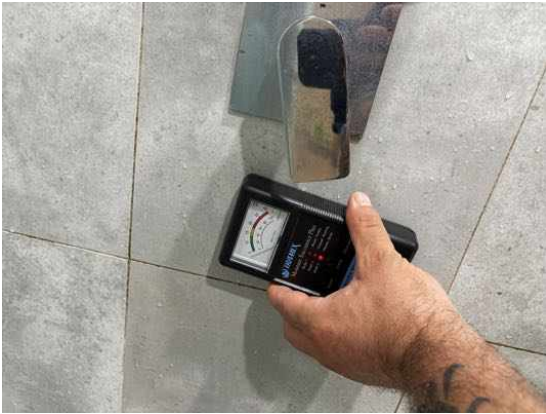
Building: Main Building
 Location: All Areas
 Finding: Moisture metre
 Information: During the inspection the property was checked for moisture using a moisture metre.

This is for information only.
