Building and Timber Pest Inspection Report VR

Inspection Date: Thu, 26 Feb 2026

Property Address: 40A Lamonerie St, Toongabbie NSW 2146,
Australia

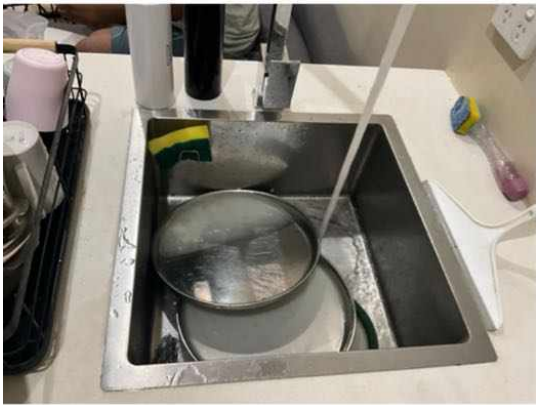
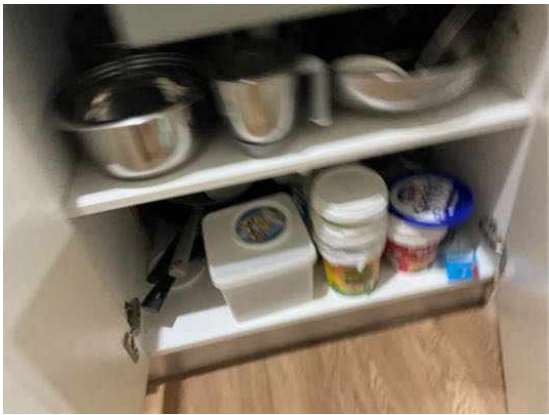
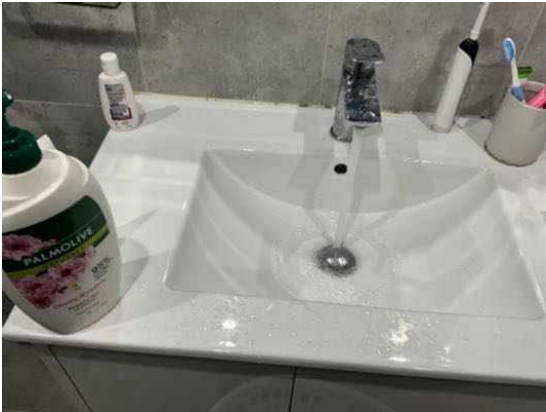
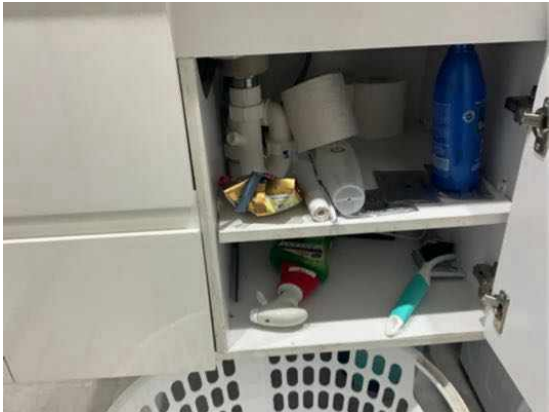
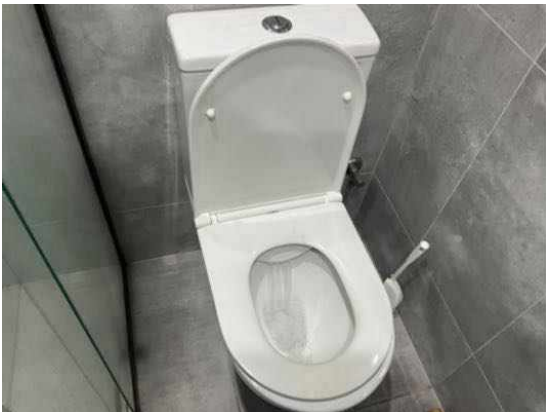
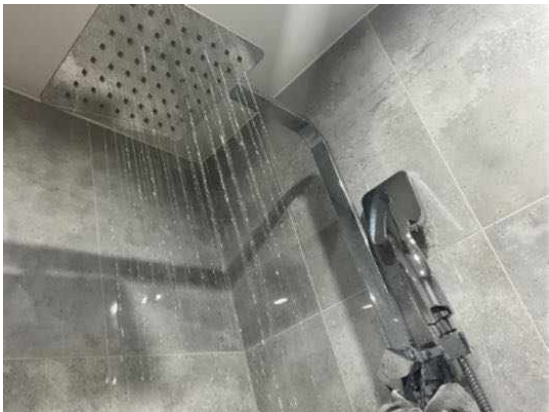
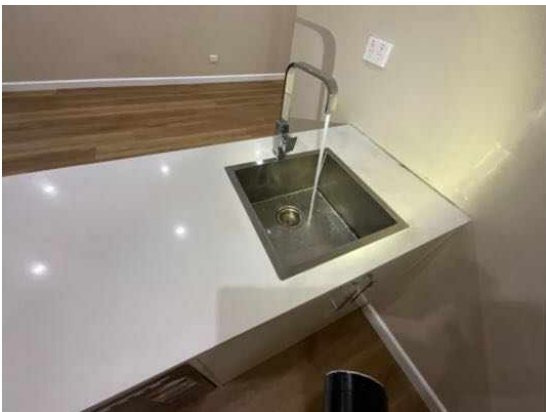
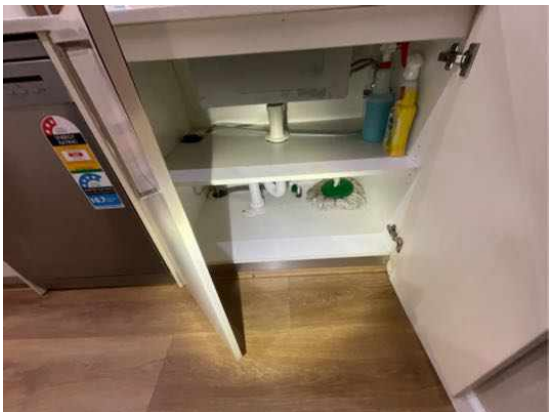
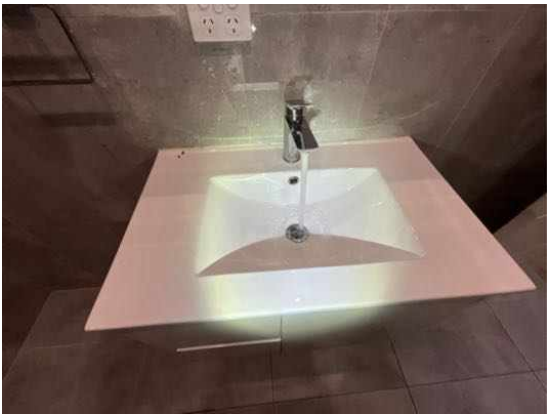
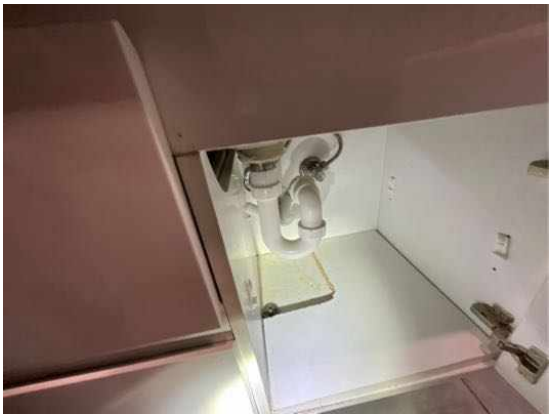
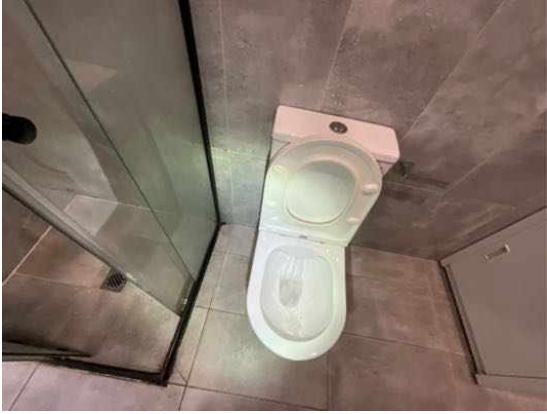
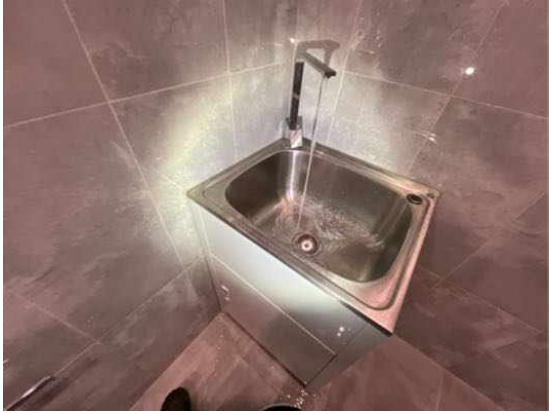
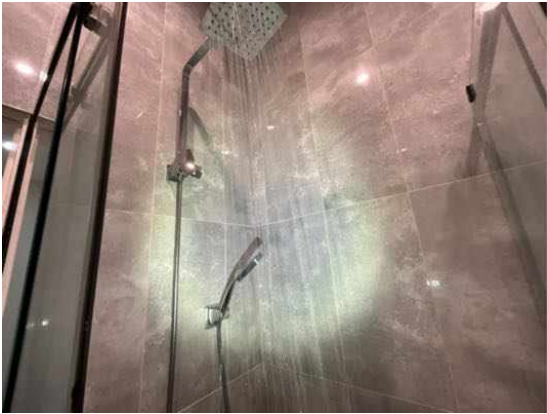
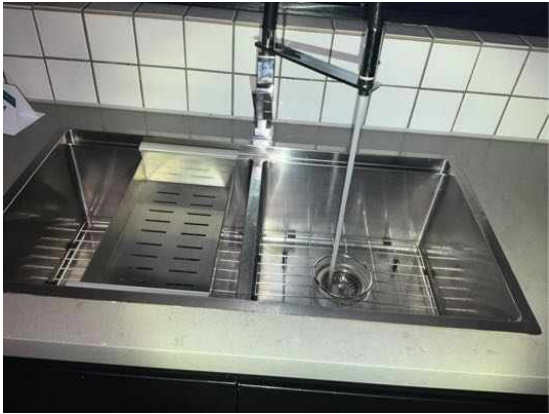
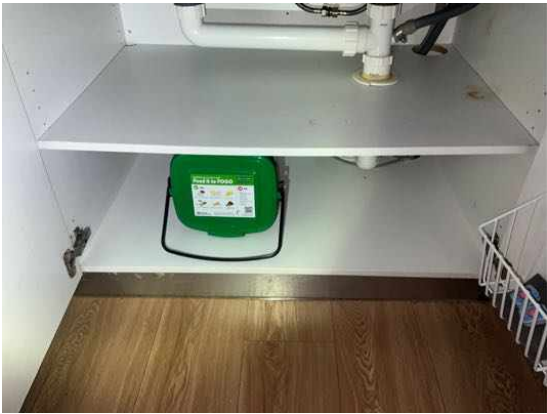
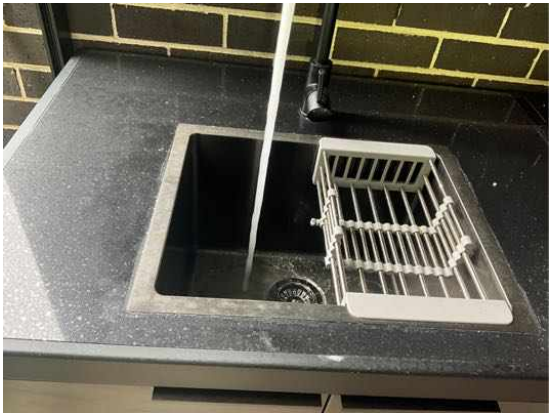
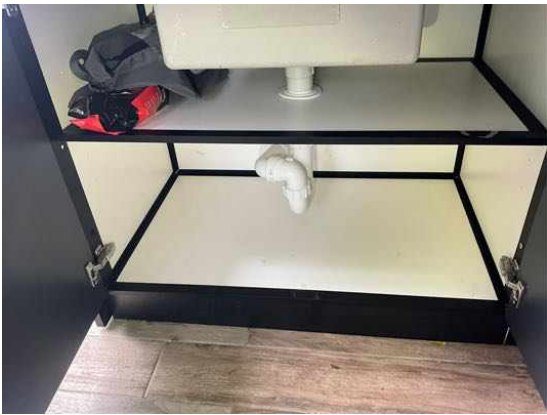
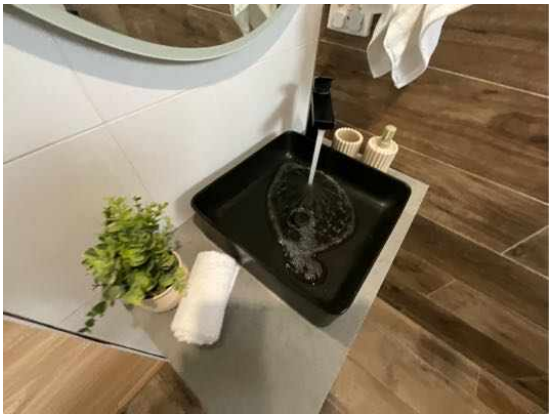
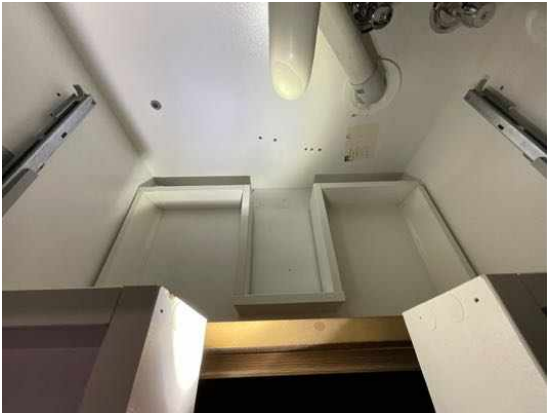
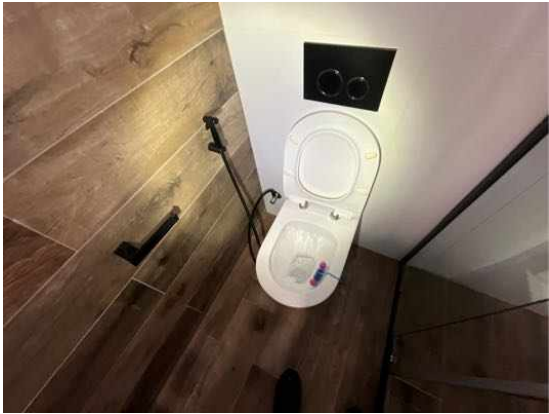
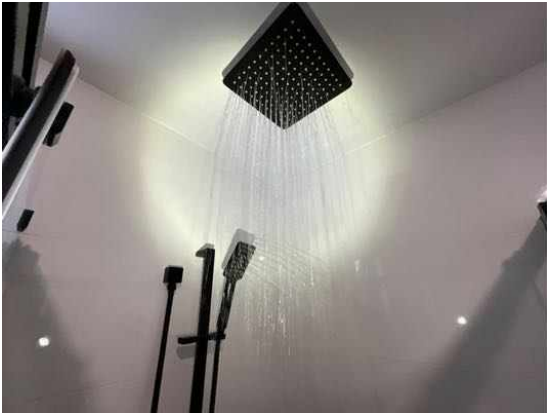
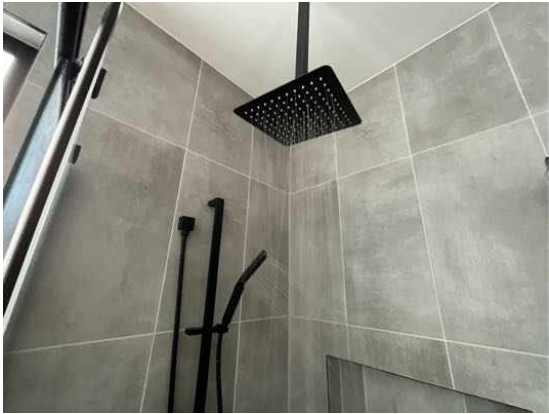
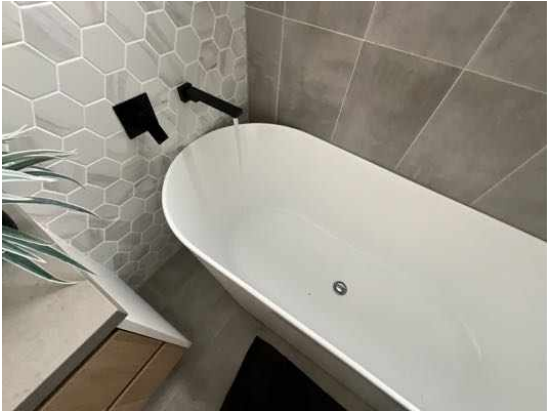
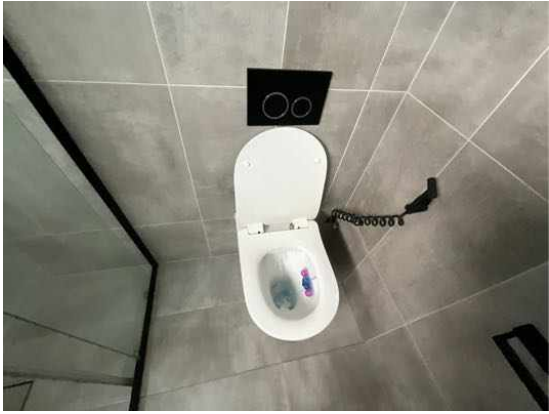
Building: Main Building
Location: All Wet Areas
Finding: Additional Photos
Information:

Additional photos are provided for your general reference.

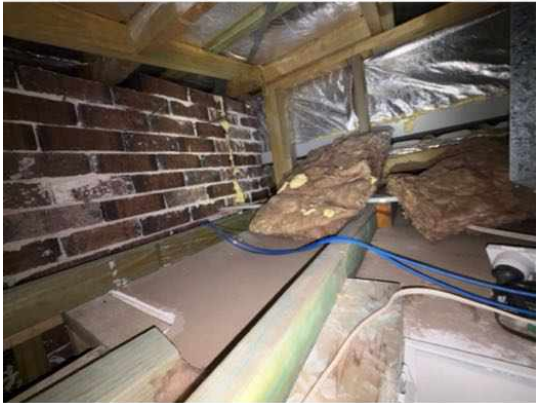
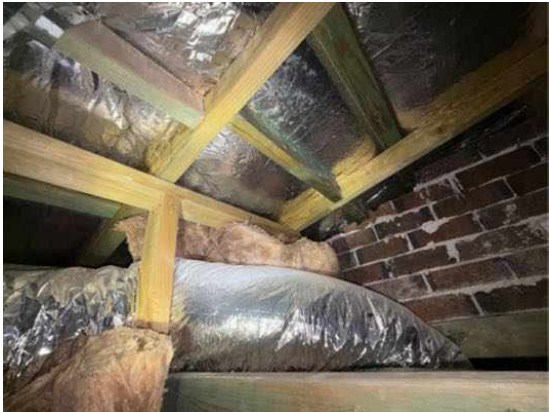
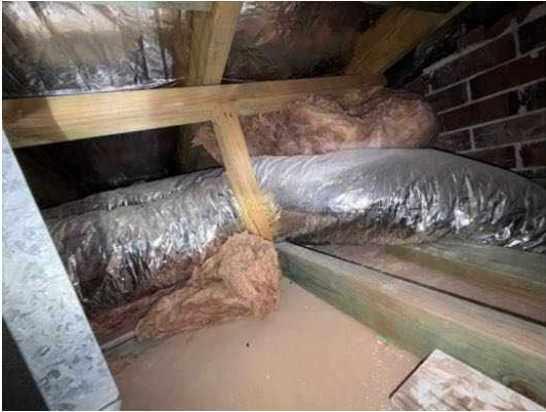
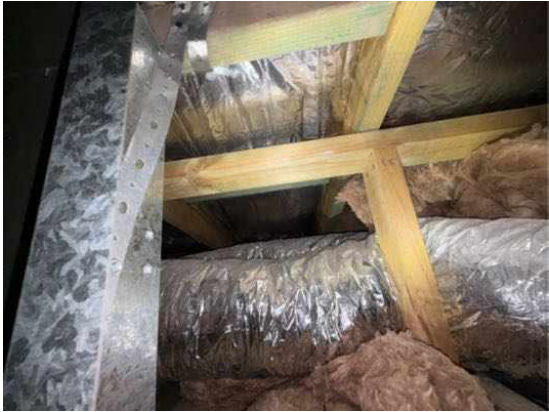
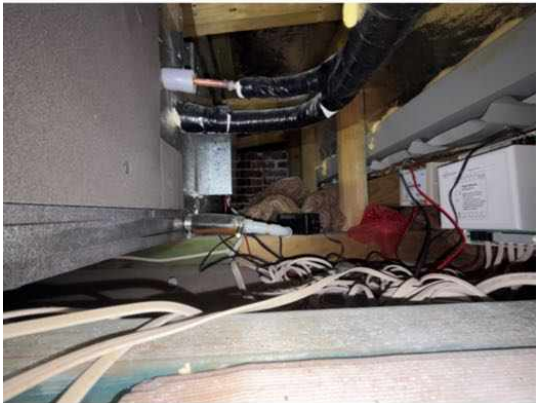
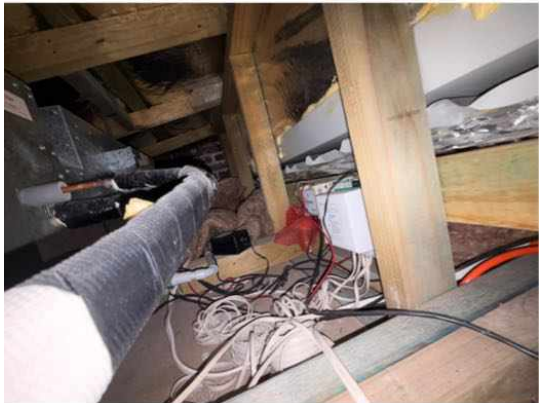
Building: Main Building
Location: Roof Void
Finding: Additional Photos
Information:

Additional photos are provided for your general reference.

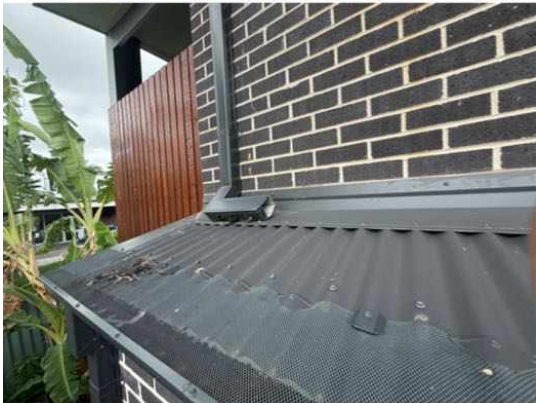
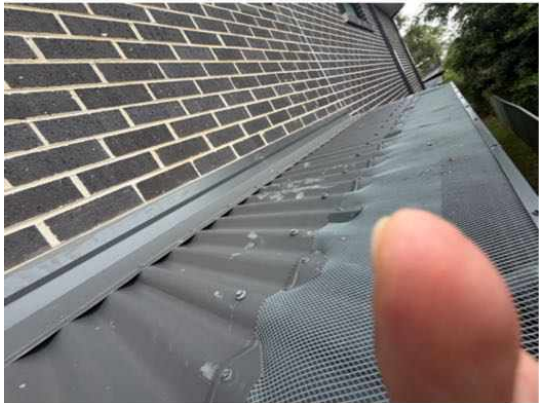
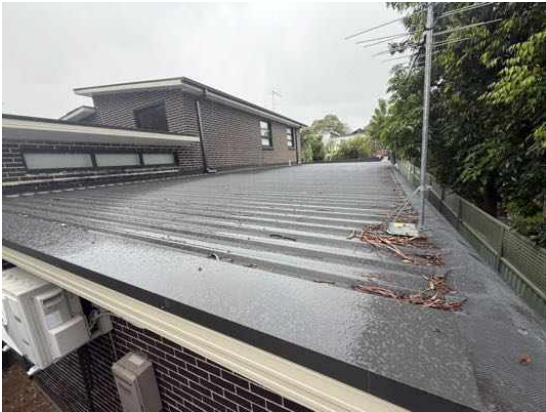
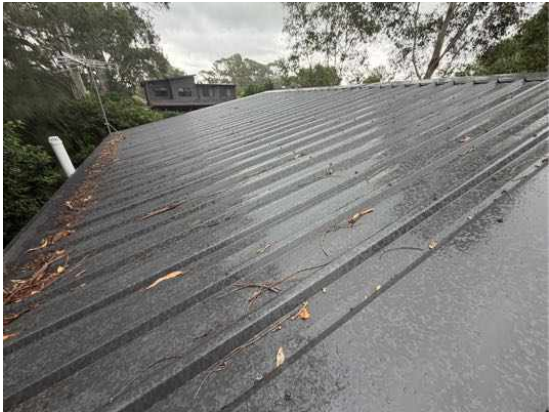
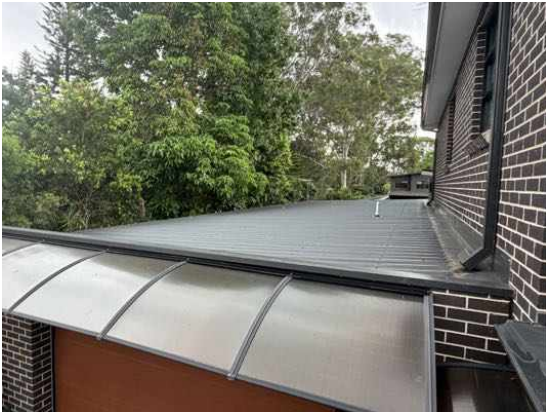
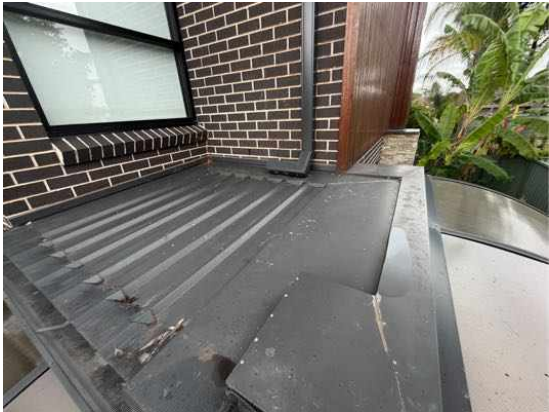
Building: Main Building
Location: Roof Exterior
Finding: Additional Photos
Information:

Additional photos are provided for your general reference.

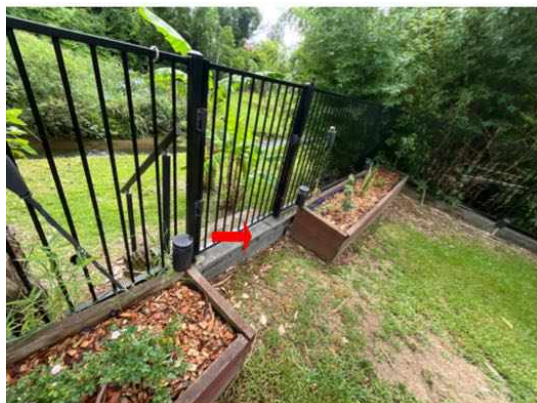
Building:	Main Building
Location:	Retaining walls
Finding:	Retaining walls
Information:	At the time of inspection the retaining walls were checked and no defects were observed other than those which May have been mentioned earlier in this report.

AS4349.1-2007 requires all retaining walls in excess of 700mm to be inspected by a licensed and practicing structural engineer.

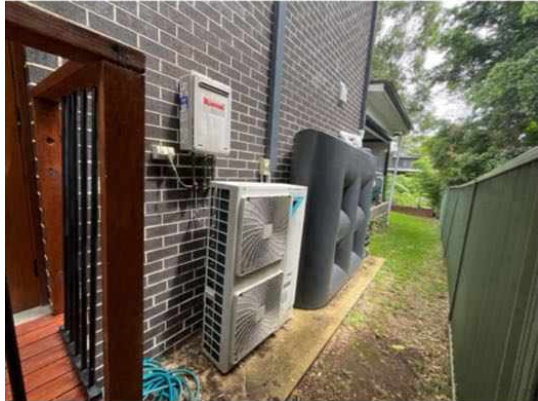
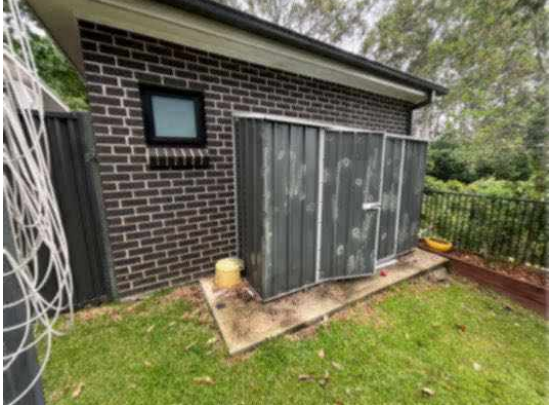
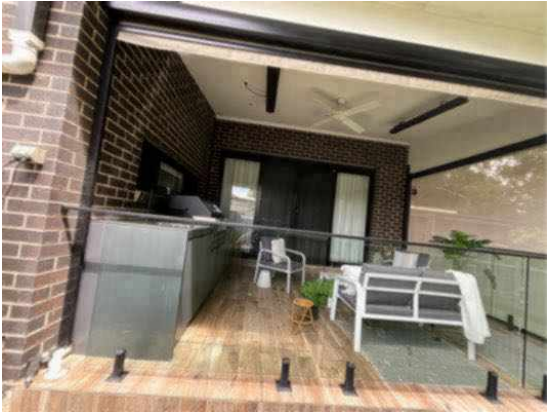
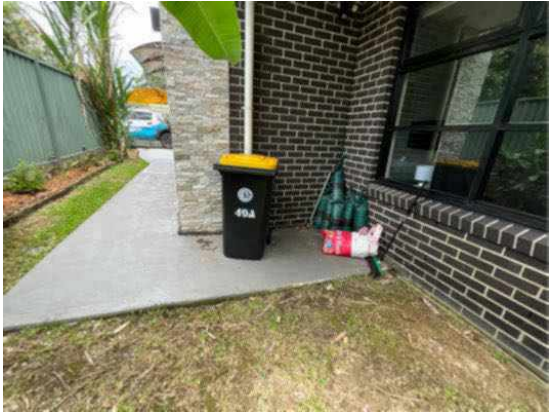
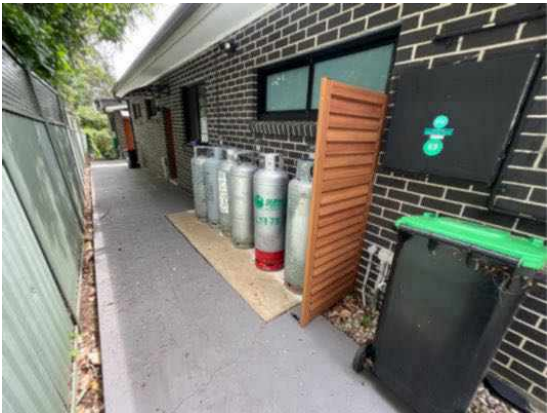
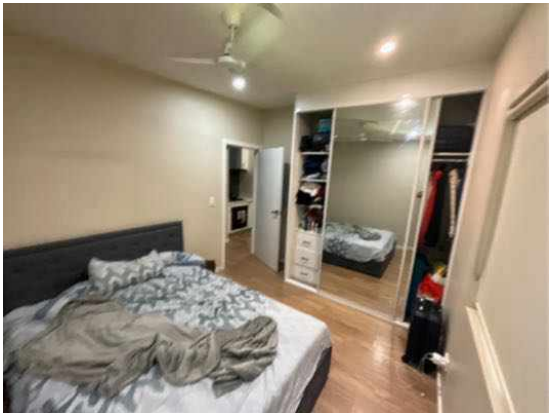
Building: Main Building
Location: All Areas
Finding: Additional Photos - Obstructions and Limitations
Information:

These photographs are an indication of the obstructions and limitations which impeded full inspection of the property at the time of inspection. These obstructions can hide an array of defects and should be removed to allow full inspection to be carried out. A re-inspection is recommended once the areas are made accessible.

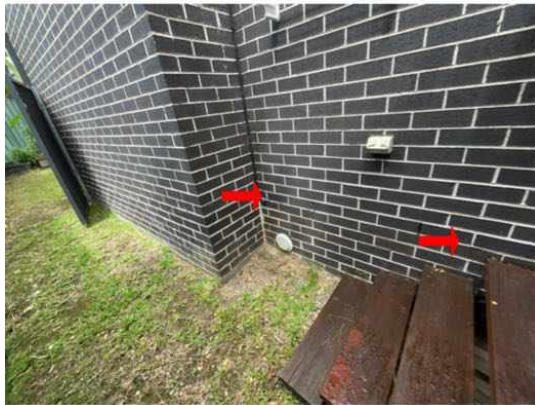
The following items were noted as - Evidence of a previous termite management program

Where a Termite Management System has been identified you should refer to the type of barrier date of installation warranty conditions and any documentation provided by a builder or past owner. Consult the company who installed the barrier to confirm whether the system is still under warranty.

Most chemical termite management systems expire and require replenishment and all physical systems are primarily designed to prevent concealed entry.
