# Building and Timber Pest Inspection Report

Inspection Date: Thu, 12 Mar 2026

Property Address: 35 Union St, Maclean NSW 2463, Australia

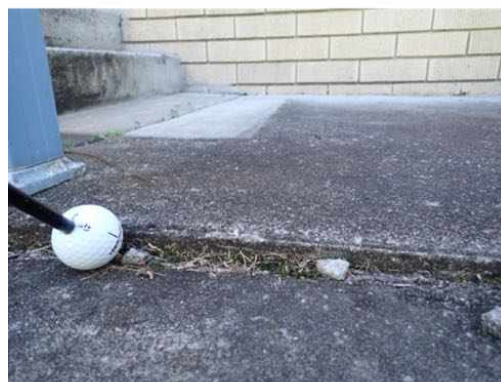
#### Finding 1.02

Building:	Main Building
Location:	Path at front of building
Finding:	Steps in Concrete Path at Front of Building
Information:	Steps were identified in the concrete path at the front of the building. Variations in the level of concrete paths can occur due to minor ground movement, settlement of the supporting ground, or ageing of the concrete over time and this is a common defect in external concrete paths. The uneven surface presents a trip hazard. Preventative measures include monitoring the area for any further movement. Repairs, if considered necessary, should be carried out by a suitably qualified concreter or suitably qualified handyman.

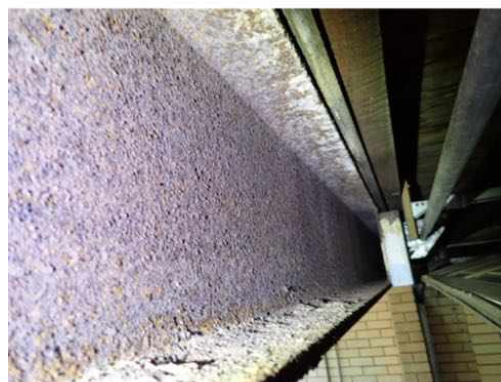
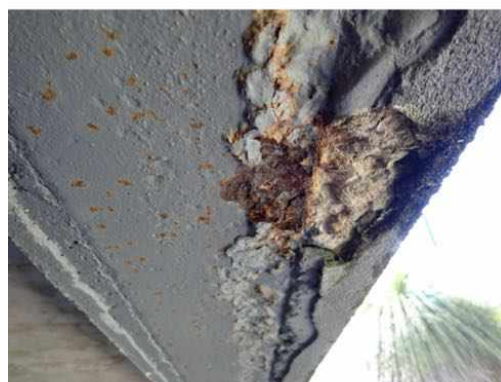
Building:	Main Building
Location:	Garage
Finding:	Surface Rust Identified to Steel Beams at Garage Door and Front Porch
Information:	Surface rust was identified to the steel beam above the garage door and to the steel beam encased in concrete at the front of the front porch. Surface corrosion to exposed steel elements is commonly caused by moisture exposure and deterioration of protective coatings over time. If left unaddressed, the rust may continue to develop and lead to further deterioration of the steel. Preventative measures include removing the rust, treating the affected areas, and applying a suitable protective coating to help prevent further corrosion. Rectification works should be carried out by a suitably qualified handyman or relevant contractor.

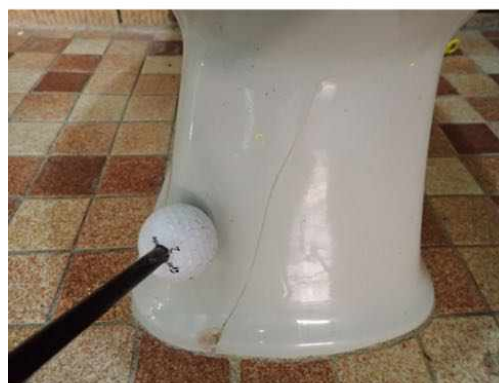
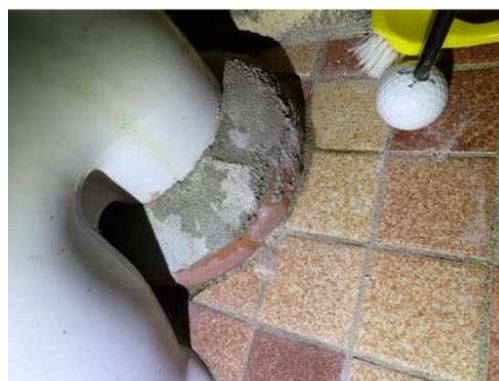
Finding 2.03

Building:	Main Building
Location:	Toilet (WC)
Finding:	Cracked Toilet Suite and Minor Leak at Sewer Connection
Information:	A crack was identified in the toilet suite, and a minor leak was observed where the toilet suite connects to the sewer plumbing. Cracks in toilet suites can allow water leakage and may worsen over time. If left unaddressed, continued leakage may cause water damage to surrounding materials and create unsanitary conditions. Preventative measures include ensuring plumbing fixtures remain in good condition and watertight. Repair or replacement of the toilet suite and sealing of the connection should be carried out by a licensed plumber.

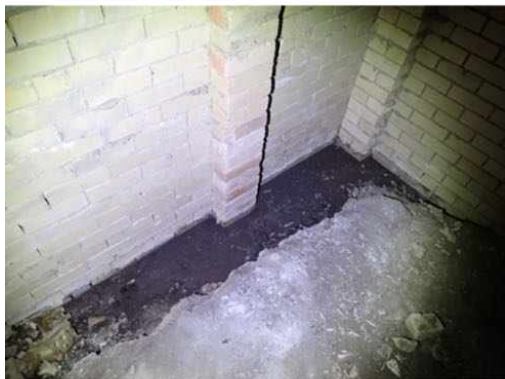
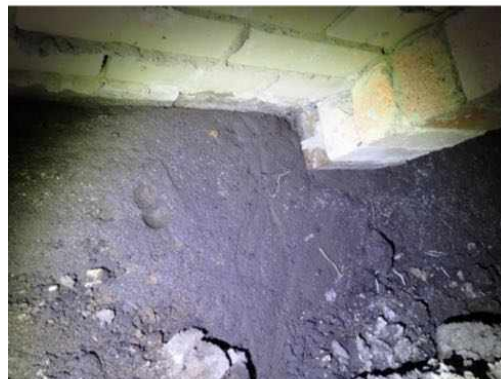
### Finding 2.04

Building:	Main Building
Location:	Subfloor
Finding:	Damp Conditions Identified in Subfloor at Base of Garage Wall
Information:	Damp Conditions Identified in Subfloor at Base of Garage Wall

Damp conditions were identified within the subfloor area at the base of the garage wall at the time of inspection. Excess moisture in subfloor areas can contribute to deterioration of surrounding building materials and may indicate drainage or water ingress issues. This is a common defect in subfloor areas where a building is built on a sloping block. Preventative measures include identifying and addressing the source of

the moisture and ensuring adequate drainage and ventilation to the subfloor area. Further investigation and rectification works should be carried out by a suitably qualified contractor as required.

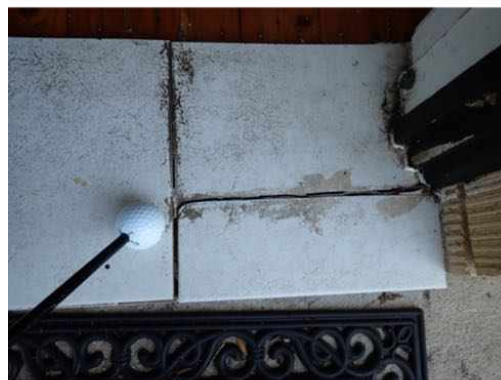
### Finding 2.05

Finding: Cracked Sill Tiles to Front Door

Information: Cracked tiles were identified to the sill at the front door. Tile cracking can occur due to minor movement of the building structure, poor installation, impact, or age-related wear to the tiled surface and underlying substrate. If left unaddressed, the cracks may worsen and allow moisture to penetrate to the underlying materials. Preventative measures include maintaining the tiled surfaces and ensuring the underlying substrate remains stable. Repairs or replacement of the affected tiles should be carried out by a qualified tiler or suitably qualified handyman.

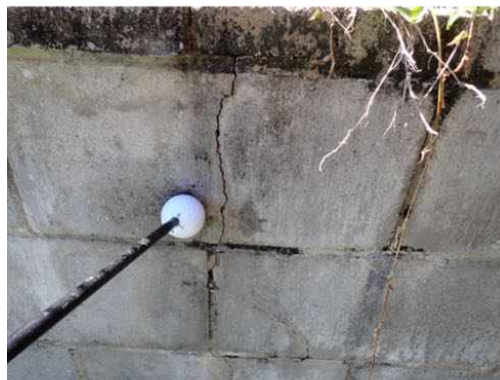
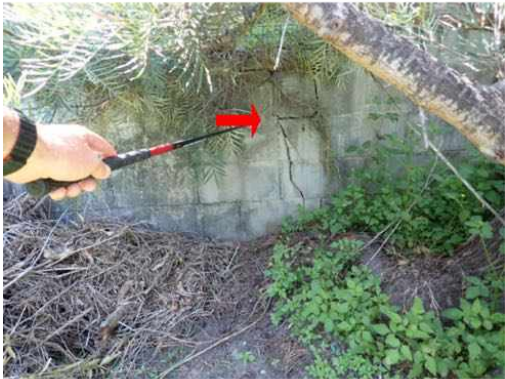
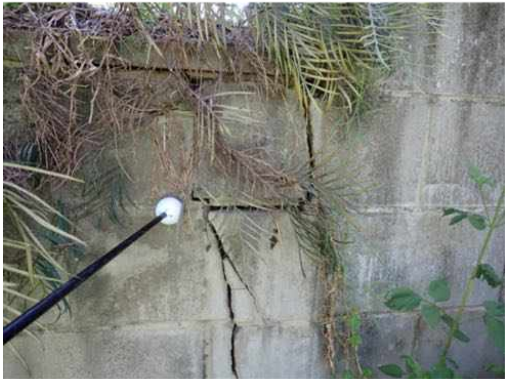
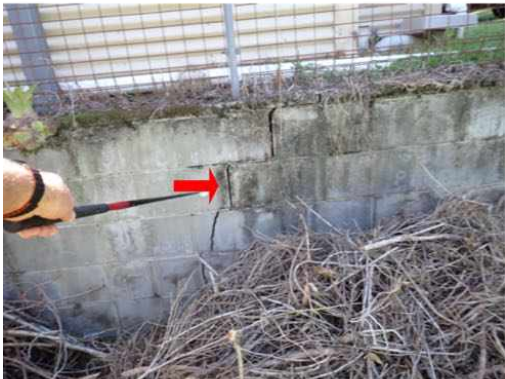
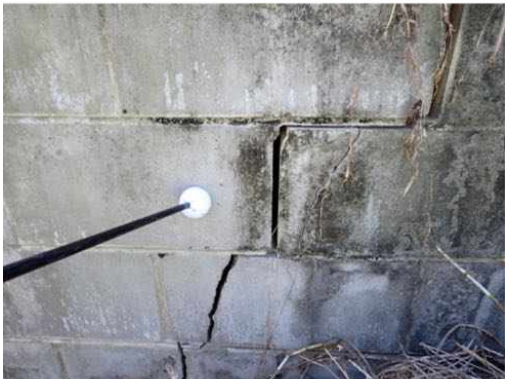
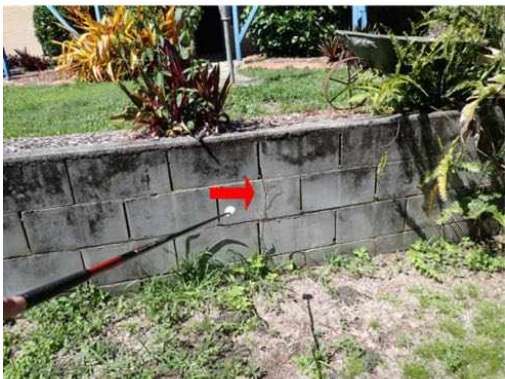
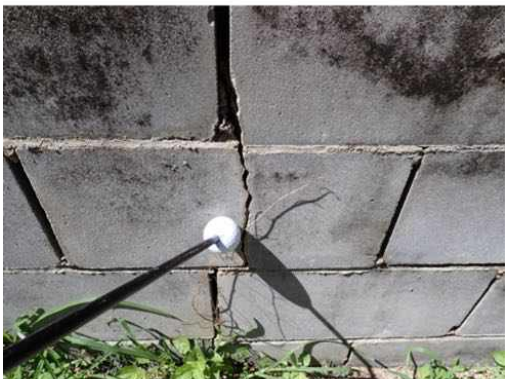
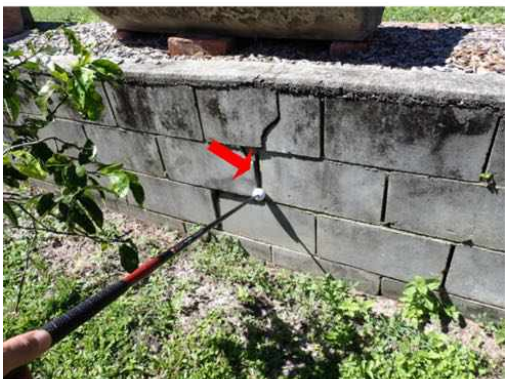
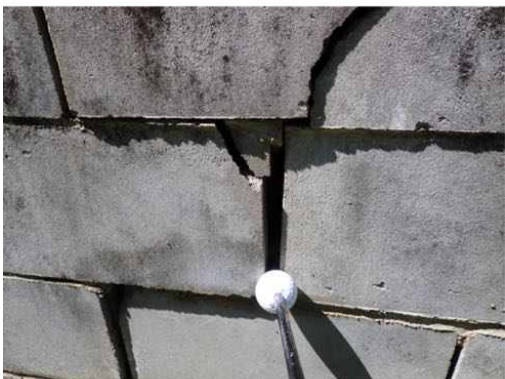
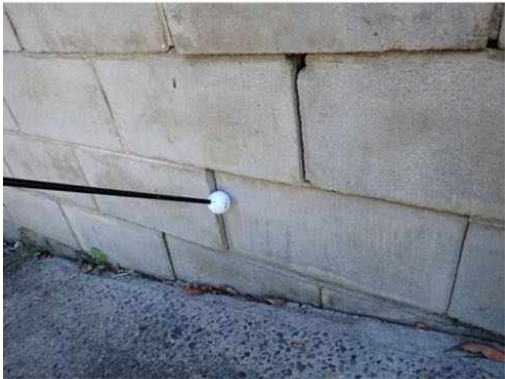
### Finding 2.06

Building:	Yard
Location:	Block work retaining walls
Finding:	Major and Minor Cracks Identified to Blockwork Retaining Walls
Information:	Major and minor cracks were identified in the blockwork retaining walls. Cracking of this nature can occur due to ground movement, soil pressure behind the wall, or settlement over time. If left unaddressed, the cracking may worsen and could affect the structural performance of the retaining walls. Preventative measures include monitoring the cracks for any signs of further movement or deterioration. Further assessment by a structural engineer is recommended to determine the extent of the issue and any required remedial works. Repairs should be carried out by a suitably qualified contractor in accordance with the engineer's recommendations.

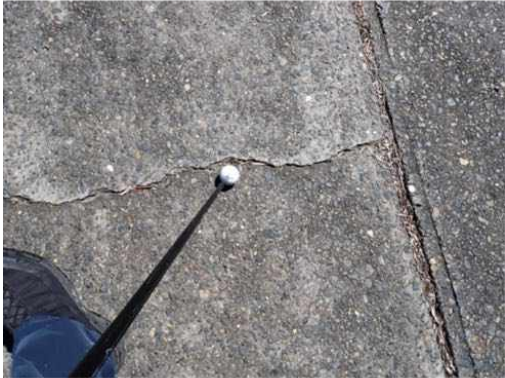
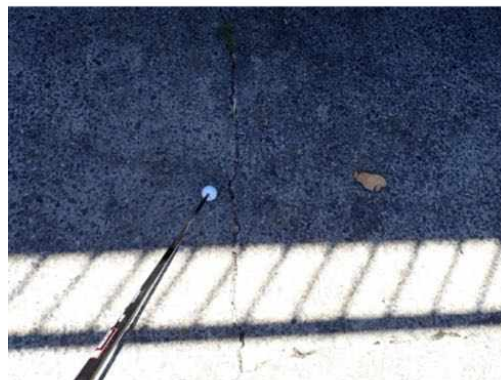
**Finding 2.07**

Building: Yard  
Location: Driveway  
Finding: Major and Minor Cracks Identified to Concrete Driveway  
Information: Major and minor cracks were identified in the concrete driveway. Cracking of this nature can occur due to ground movement, settlement of the supporting ground, or deterioration of the concrete over time. If left unaddressed, the cracks may gradually worsen and lead to further deterioration of the driveway surface. Preventative measures include monitoring the cracks for any signs of further movement. Repairs should be carried out by a suitably qualified concreter or suitably qualified handyman.

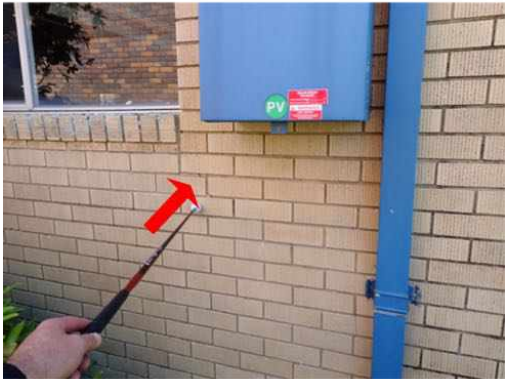
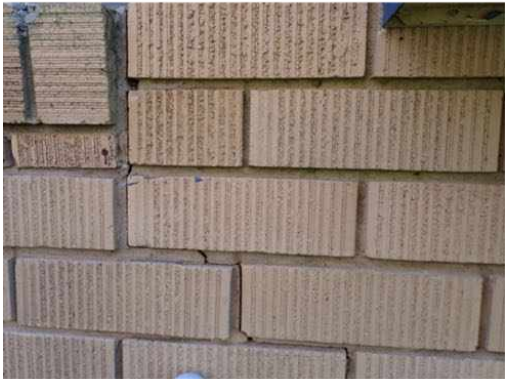
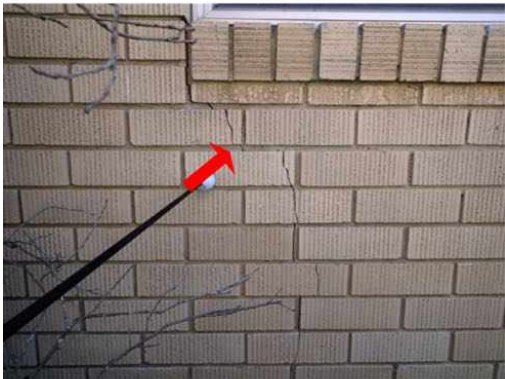
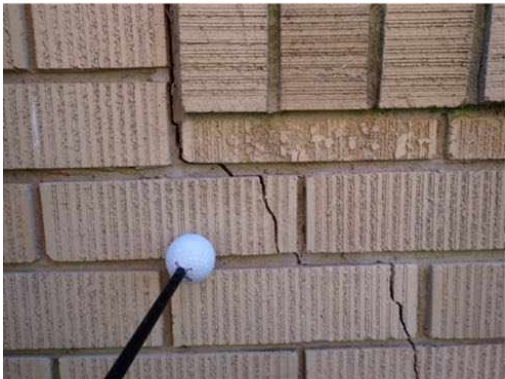
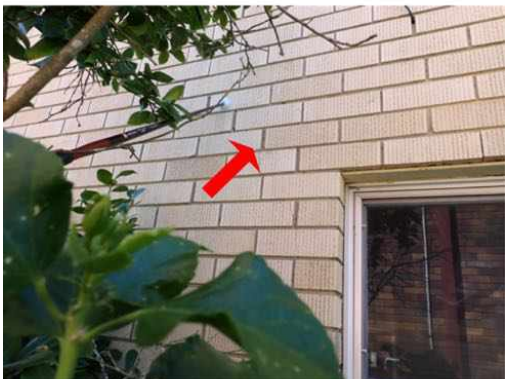
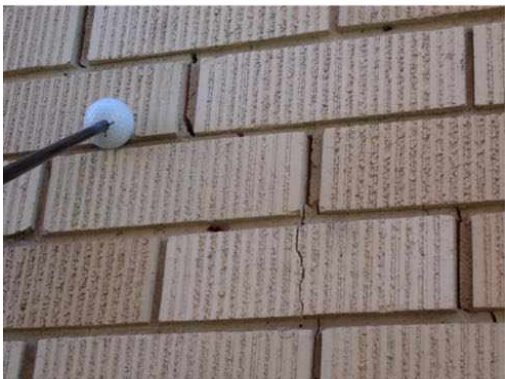
### Finding 2.08

Building:	Main Building
Location:	Garage
Finding:	Minor Cracking Was Identified in the Internal Brickwork to the Garage.
Information:	Cracking of this nature can occur due to normal building movement, minor settlement, or ageing of mortar joints and is commonly observed in brickwork. If the cracks worsen over time, further assessment may be required to determine if structural movement is occurring. Preventative measures include maintaining mortar joints and monitoring the cracks for any signs of further movement. If significant movement is observed, consultation with a structural engineer is recommended. Repairs, if considered necessary, should be carried out by a suitably qualified bricklayer or suitably qualified handyman.

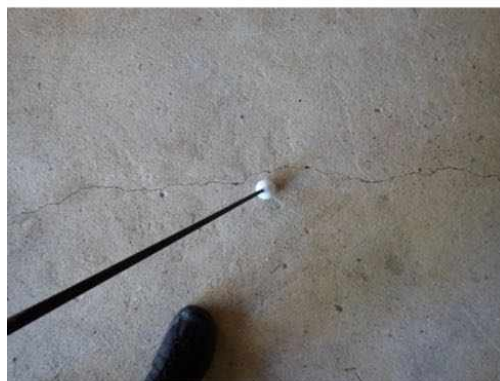
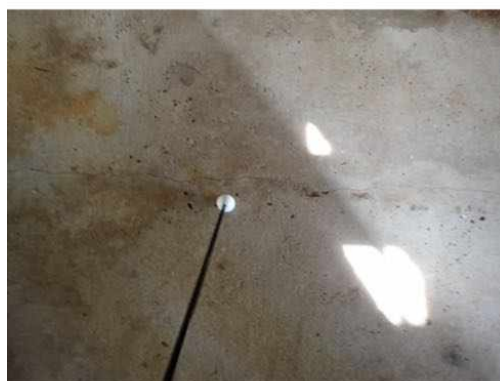
**Finding 3.01**

Building: Main Building  
Location: Garage  
Finding: Minor Cracks Identified in Garage Concrete Slab  
Information: Minor cracks were identified in the garage concrete slab. Cracking of this nature can occur in concrete due to natural shrinkage during curing, minor ground movement, or normal settlement of the supporting ground and is commonly observed in concrete slabs. Preventative measures include maintaining stable ground conditions and

monitoring the cracks for any signs of further movement or widening. If significant movement is observed, consultation with a structural engineer may be required. Repairs, if considered necessary, should be carried out by a suitably qualified concreter or suitably qualified handyman.

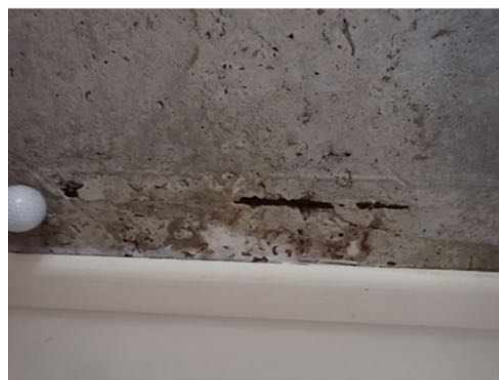
### Finding 3.02

Building:	Main Building
Location:	Laundry
Finding:	Minor Concrete Spalling Identified to Laundry Ceiling
Information:	Minor concrete spalling was identified to the laundry ceiling. Spalling occurs when small sections of concrete surface break away, often due to moisture exposure, corrosion of embedded reinforcement, or general ageing of the material. If left unaddressed, the affected area may continue to deteriorate over time. Preventative measures include identifying and addressing any sources of moisture and maintaining the surrounding structure. Repairs, if considered necessary, should be carried out by a suitably qualified concreter or suitably qualified handyman.

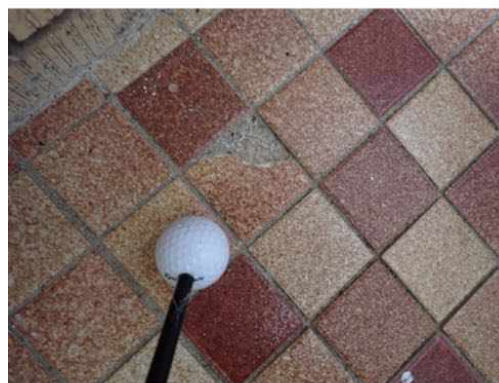
### Finding 3.03

Building:	Main Building
Location:	Toilet (WC)
Finding:	Damaged Tile to Toilet Area
Information:	A damaged tile was identified in the toilet area. Damage to tiles can occur from impact, general wear, or movement of the underlying substrate. If left unaddressed, the damage may worsen and allow moisture to penetrate through the tile surface and affect the underlying materials. Preventative measures include maintaining tiled surfaces and ensuring damaged tiles are repaired promptly. Repair or replacement of the affected tile should be carried out by a qualified tiler or suitably qualified handyman.

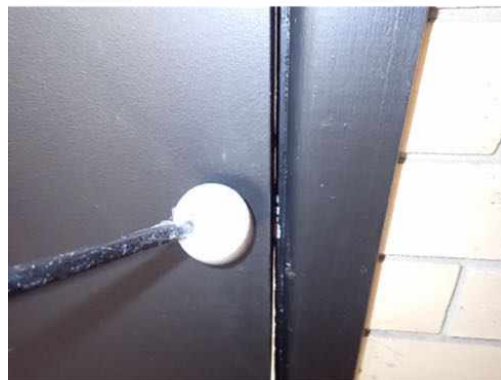
### Finding 3.04

Building:	Main Building
Location:	Garage
Finding:	Garage Entry Door Catching on Door Jamb
Information:	The garage entry door was observed catching on the door jamb during normal operation. This condition can occur due to minor building movement, door misalignment, swelling of the door, or wear to the door hardware. If left unaddressed, the issue may worsen and lead to damage to the door, door frame, or associated hardware. Preventative measures include maintaining door hardware and ensuring the

door and frame remain properly aligned. Adjustment, repair, or trimming of the door should be carried out by a qualified carpenter or suitably qualified handyman.

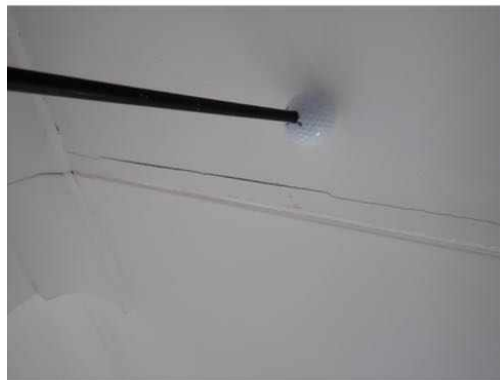
Building:	Main Building
Location:	Living room
Finding:	Minor Cracks in Living Room Ceiling Plaster
Information:	Minor cracks were identified in the ceiling plaster within the living room. Cracking of this nature can occur due to normal building movement, settlement, or ageing of the

plaster materials and is commonly observed in plaster surfaces over time. If left unaddressed, the cracks may gradually widen and affect the cosmetic appearance of the ceiling. Preventative measures include maintaining stable building conditions and monitoring the cracks for any signs of further movement. Repairs, if considered necessary, should be carried out by a qualified plasterer or suitably qualified handyman.

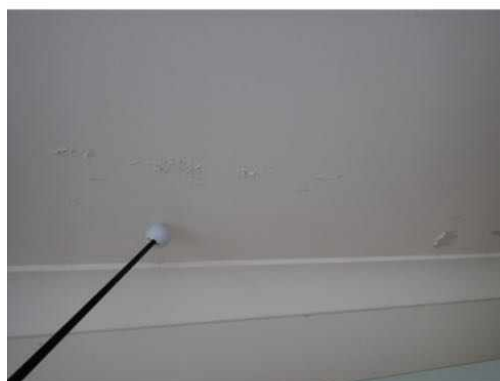
### Finding 3.07

Building: Main Building  
Location: Kitchen  
Finding: Deteriorated Paintwork to Kitchen Ceiling  
Information: Deteriorated paintwork was identified to the kitchen ceiling. Paint deterioration can occur due to age, moisture exposure, steam from cooking activities, or general wear over time. If left unaddressed, the condition may continue to deteriorate and affect the overall finish of the ceiling surface. Preventative measures include maintaining adequate ventilation within the kitchen area and ensuring ceiling surfaces are properly sealed and maintained. Repainting of the affected area should be carried out by a qualified painter or suitably qualified handyman.

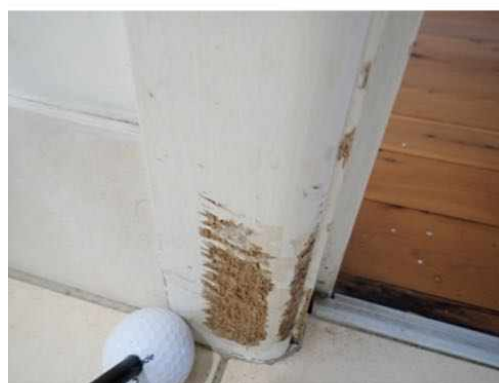
### Finding 3.08

Location:	Bathroom
Finding:	Impact-Related Damage to Bathroom Architrave
Information:	Impact-related damage was identified to the bathroom door architrave. Damage of this nature can occur from accidental impact or general wear over time. If left unaddressed, the damage may worsen and affect the condition and appearance of the timber trim. Repair or replacement of the affected architrave should be carried out by a qualified carpenter or suitably qualified handyman.

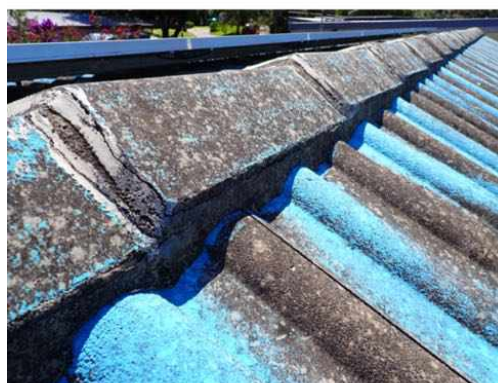
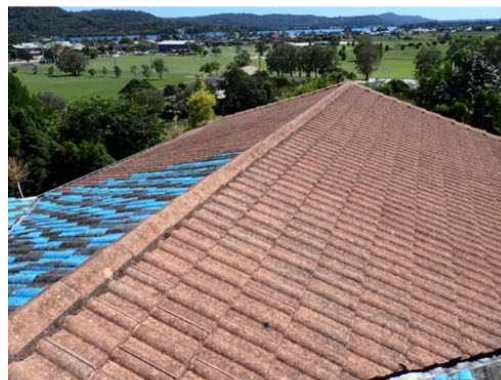
### Finding 3.11

Building:	Main Building
Location:	Roof exterior
Finding:	Roof Tiles in Fair Condition
Information:	The roof tiles were found to be in fair condition overall, with minor age-related cracking to the ridge capping pointing and general weathering of the tiles observed. These conditions are common with tiled roofs over time due to prolonged exposure to the elements. Preventative measures include routine roof inspections and maintenance to ensure tiles and ridge capping remain in serviceable condition. Repairs, if considered necessary, should be carried out by a licensed roofing contractor.

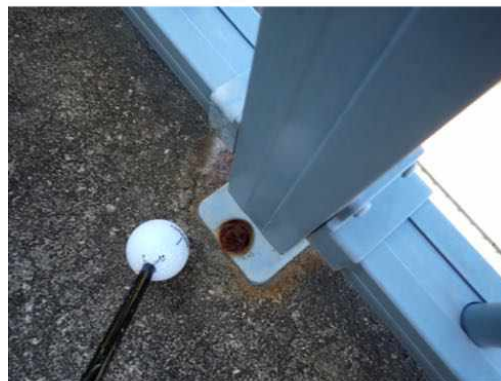
### Finding 3.12

Building:	Main Building
Location:	Front porch handrail
Finding:	Front Porch Handrail Post Fixings Rusted
Information:	Rust was identified to the fixings at the base of the front porch handrail posts. Corrosion of metal fixings can occur over time due to weather exposure and deterioration of protective coatings. If left unaddressed, the rust may continue to develop and affect the integrity of the fixings. Preventative measures include maintaining protective coatings and ensuring external metal fixings are regularly inspected and maintained. Repair or replacement of the affected fixings should be carried out by a suitably qualified handyman or relevant contractor.

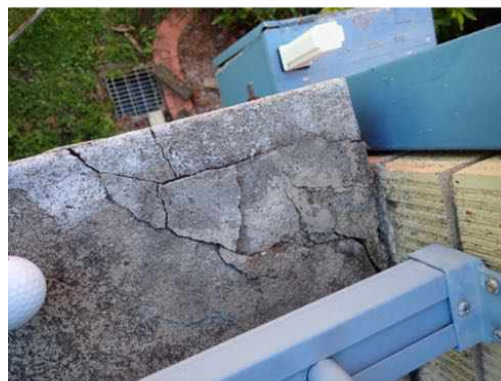
Building:	Main Building
Location:	Front porch
Finding:	Minor Cracks Identified to Front Porch Suspended Concrete Slab at Left-Hand Cornes
Information:	Minor cracks were identified to the suspended concrete slab of the front porch at the left-hand corners. Cracking of this nature can occur due to normal building movement, minor settlement, or shrinkage of the concrete over time and is commonly observed in concrete structures. If left unaddressed, the cracks may allow moisture penetration and gradual deterioration of the concrete surface. Preventative measures include

monitoring the cracks for any signs of further movement. Repairs, if considered necessary, should be carried out by a suitably qualified concreter or suitably qualified handyman, and consultation with a structural engineer may be considered if the cracks worsen over time.

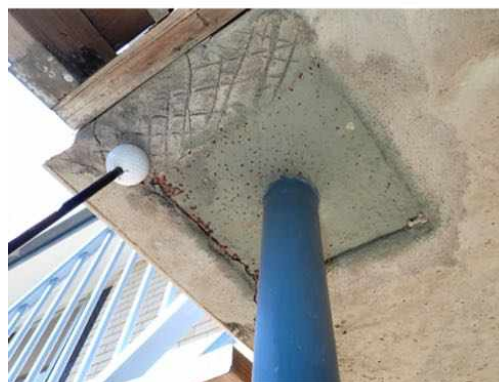
### Finding 3.14

Building:	Main Building
Location:	Rear of building
Finding:	Surface Rust Identified to Top Plates of Deck Support Steel Posts
Information:	Surface rust was identified to the top plates of the steel posts supporting the deck above. Corrosion of exposed steel elements can occur over time due to weather exposure and deterioration of protective coatings. If left unaddressed, the rust may continue to develop and lead to further deterioration of the steel components. Preventative measures include removing surface rust and applying a suitable protective coating to help prevent further corrosion. Rectification works should be carried out by a suitably qualified handyman or relevant contractor.

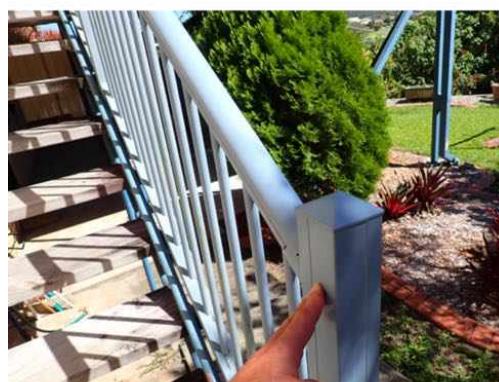
### Finding 3.15

Building:	Main Building
Location:	Rear of building
Finding:	Loose Handrail Post to Rear Staircase
Information:	The handrail post to the rear staircase was found to be loose at the time of inspection. Loose handrail posts can occur due to deterioration of fixings, or general wear over time. If left unaddressed, the condition may worsen and affect the stability of the handrail. Preventative measures include maintaining fixings and ensuring handrail components remain securely fastened. Re-fixing or repair of the handrail post should be carried out by a qualified carpenter or suitably qualified handyman.

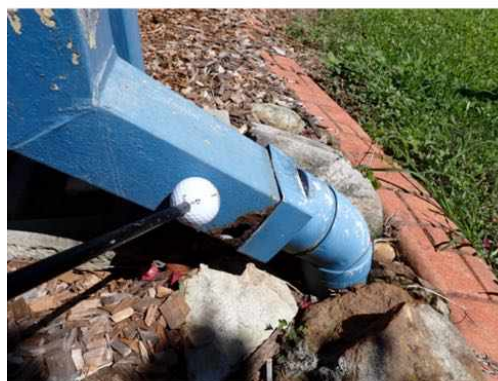
### Finding 3.16

Building:	Main Building
Location:	Rear yard
Finding:	Rust Identified to Bottom of Rear Deck Downpipe
Information:	Rust was identified to the bottom section of the rear deck downpipe. Corrosion of metal downpipes can occur over time due to prolonged exposure to moisture and weather conditions. If left unaddressed, the rust may worsen and lead to deterioration of the downpipe and potential water discharge issues. Preventative measures include maintaining protective coatings and ensuring downpipes are regularly inspected and maintained. Repair or replacement of the affected section should be carried out by a

licensed plumber or suitably qualified contractor.

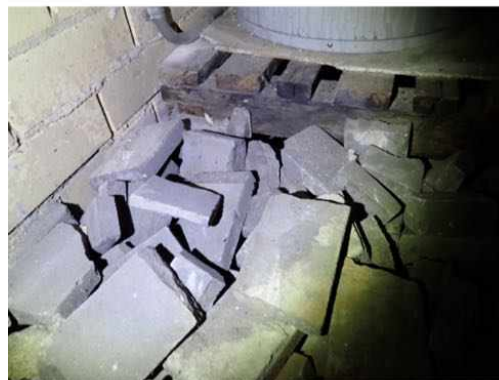
### Finding 6.01

Building:	Main Building
Location:	Subfloor
Finding:	Timber Pellet Used as Base for Hot Water Unit in Subfloor – Conducive to Termite Attack
Information:	A timber pellet was identified being used as a base for the hot water unit within the subfloor area. Timber materials in subfloor areas, particularly when in contact with or close to the ground, are considered conditions conducive to termite attack and timber decay. If left in place, the timber may attract termite activity and increase the risk of timber pest infestation within the structure. Preventative measures include removing timber materials from the subfloor area and replacing them with suitable non-timber supports. Rectification should be carried out by a suitably qualified handyman or relevant contractor.

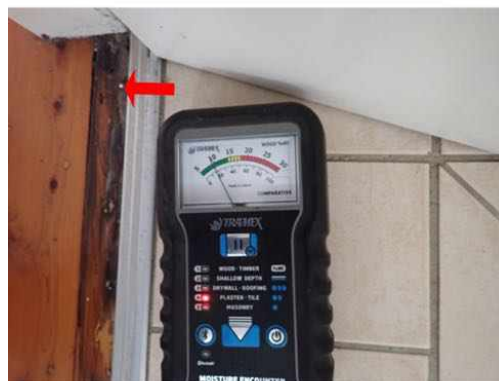
### Finding 7.01

Building:	Main Building
Location:	Bathroom
Finding:	Minor Wood Rot Identified to Flooring at Bathroom Door Entry
Information:	Minor wood rot was identified to the flooring at the door entry to the bathroom. No elevated moisture readings were identified in this area at the time of inspection. Wood rot of this nature is typically associated with past moisture exposure or long-term wear to the flooring materials. If left unaddressed, the affected timber may continue to deteriorate over time. Repairs or replacement of the affected flooring section should be carried out by a qualified carpenter or suitably qualified handyman.

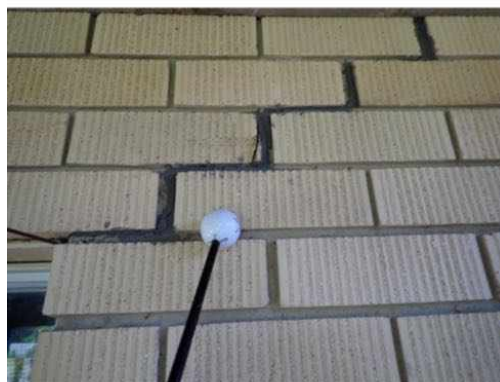
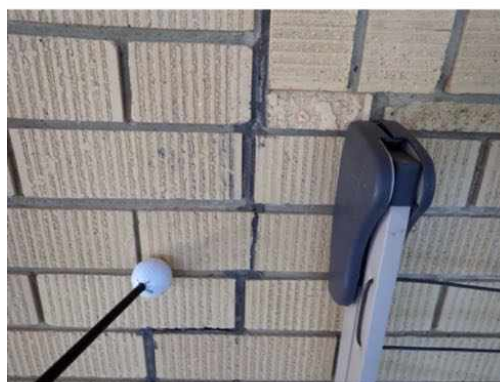
Building: Main Building  
Location: Garage  
Finding: Repaired Concrete Cracks Identified at Rear of Garage Wall  
Information: Previously repaired concrete cracks were identified at the rear of the garage wall. The real estate agent advised that a structural engineer's report has been obtained in relation to these cracks. Cracking of this nature can occur due to building movement, ground movement, or settlement. It is recommended that the structural engineer's report be obtained and reviewed to better understand the cause of the cracking and any recommended remedial works. Any further repairs, if required, should be carried out by a suitably qualified contractor in accordance with the engineer's recommendations.

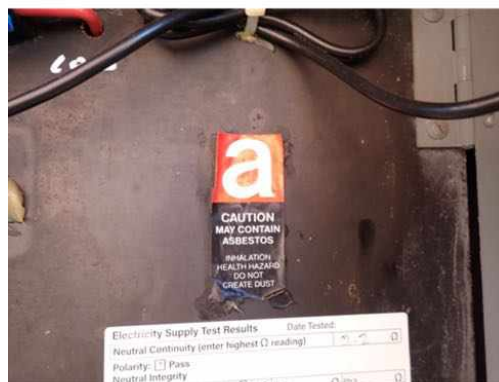
Location:	Left hand side of building
Finding:	Asbestos Warning Sign Identified Within Electrical Meter Box
Information:	An asbestos warning sign was identified within the electrical meter box. The presence of this sign indicates that asbestos-containing materials may be present within the building. Materials suspected to contain asbestos should not be disturbed as they may pose a health risk if fibres become airborne. If works are required in areas where asbestos-containing materials may be present, the materials should be treated as asbestos-containing until confirmed otherwise. Further assessment and any required removal should be carried out by a licensed asbestos contractor in accordance with relevant safety regulations.

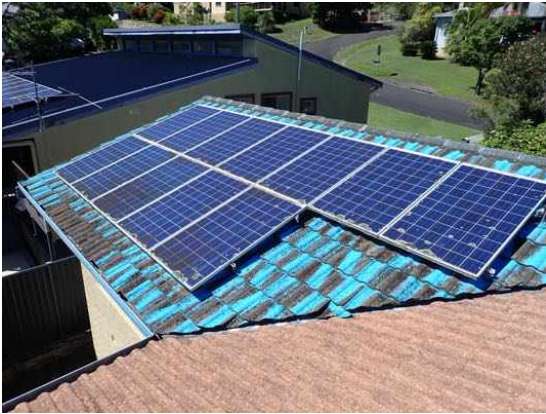
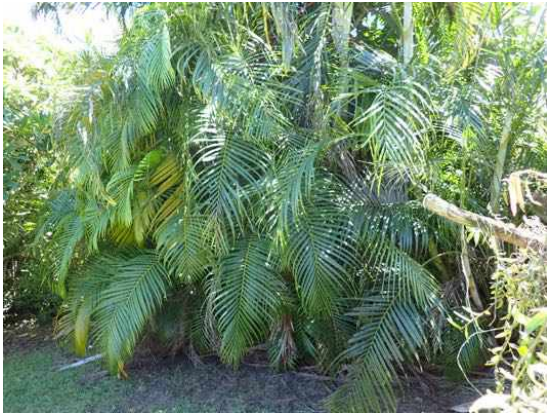
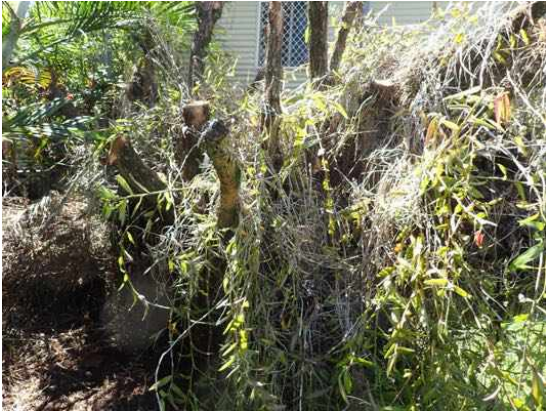
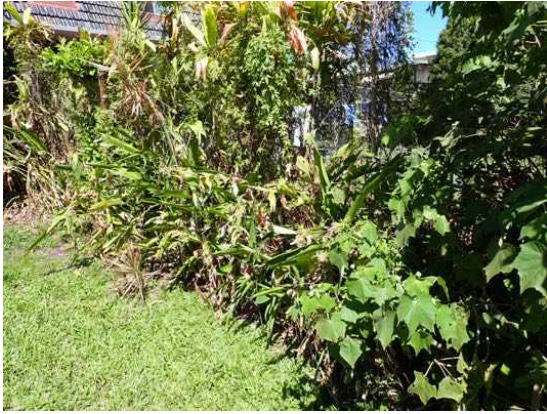
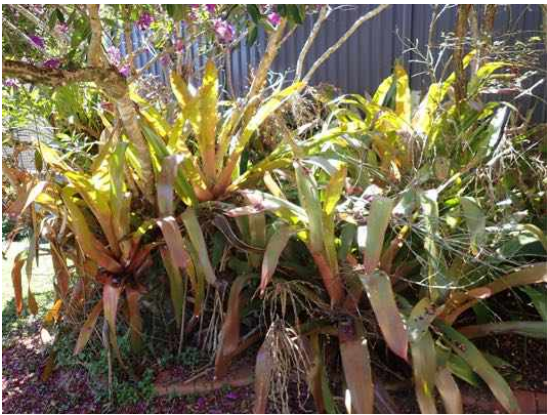
Building:	Main Building
Location:	All Areas
Finding:	Additional Photos - Obstructions and Limitations
Information:	These photographs are an indication of the obstructions and limitations which impeded full inspection of the area at the time of inspection. These obstructions can hide an array of defects and should be removed to allow full inspection to be carried out. A re-inspection is recommended once the areas are made accessible.
