Building and Timber Pest Inspection Report

Inspection Date: Fri, 6 Feb 2026

Property Address: 806/187 Kent Street, Sydney NSW 2000

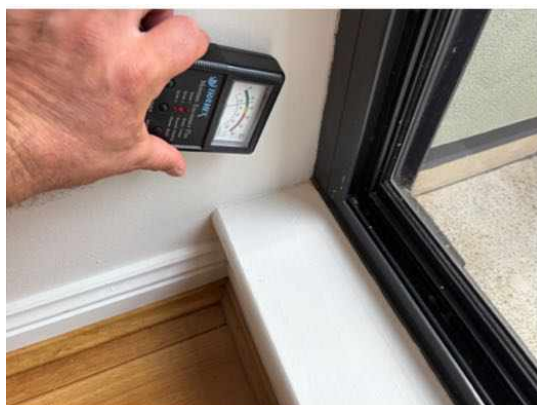
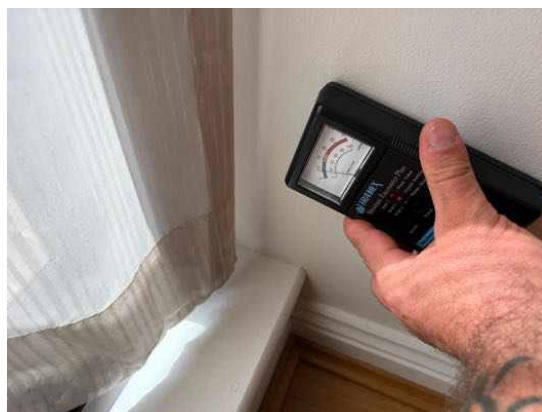
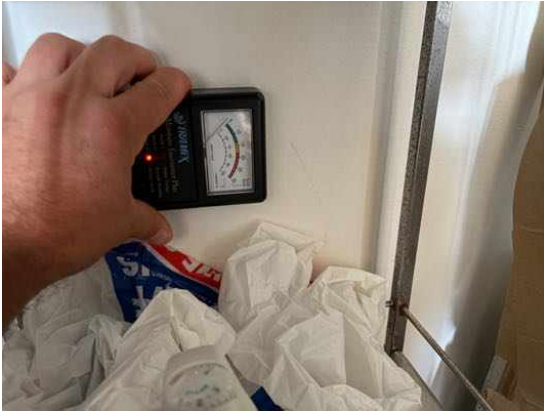
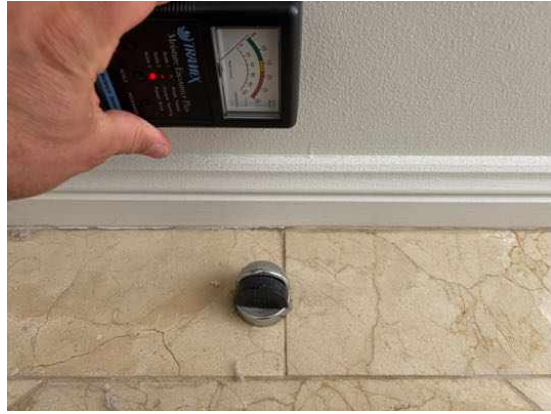
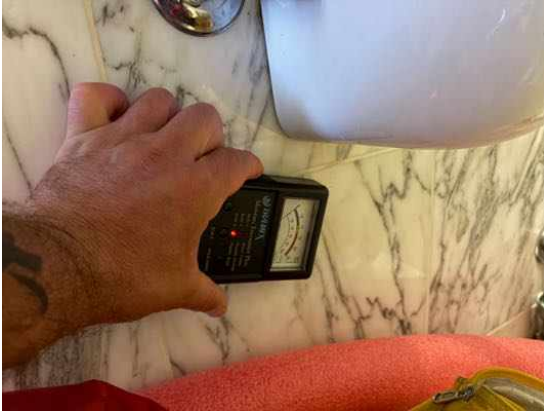
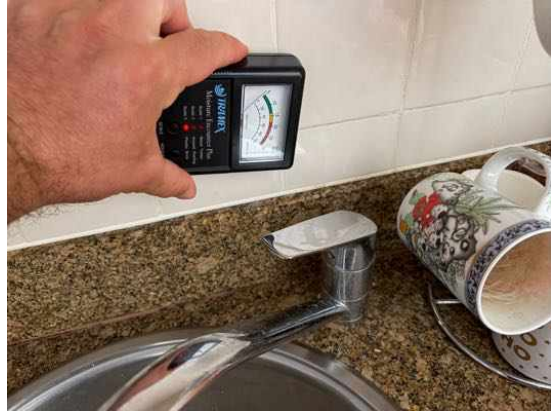
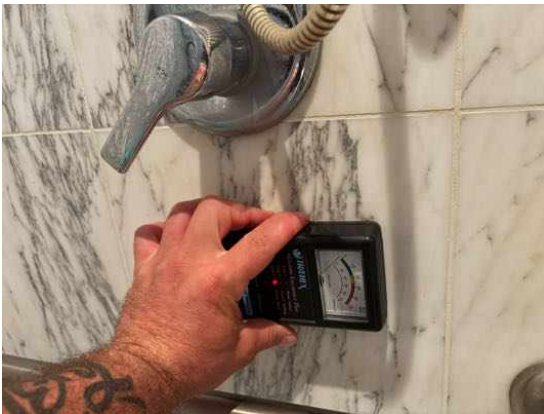
Building: Main Building
 Location: All Areas
 Finding: Moisture metre
 Information: During the inspection the property was checked for moisture using a moisture metre.

This is for information only.

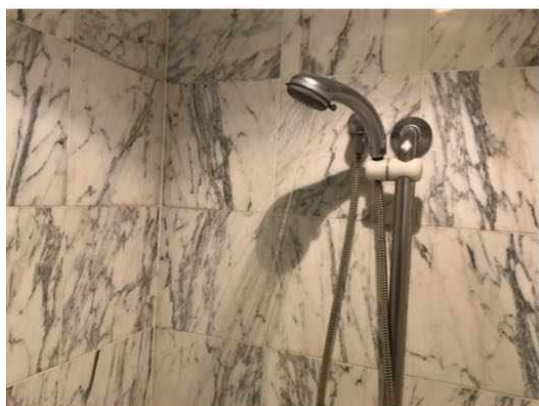
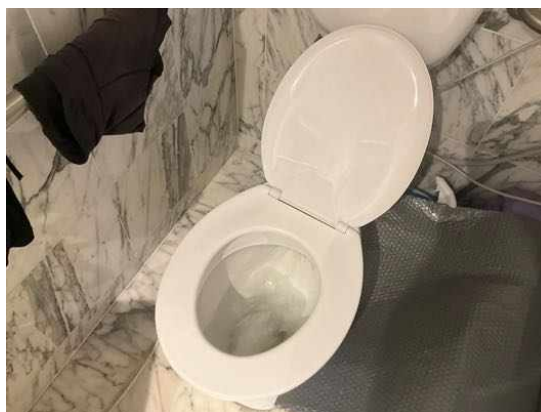
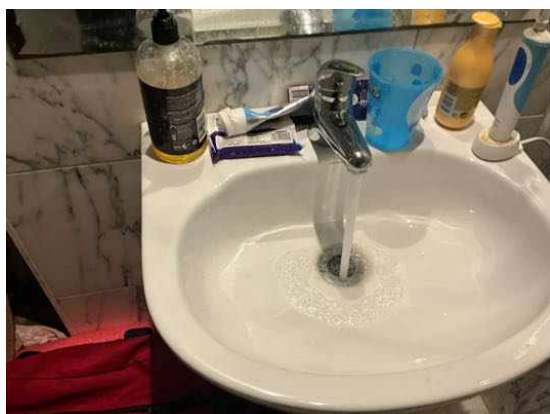
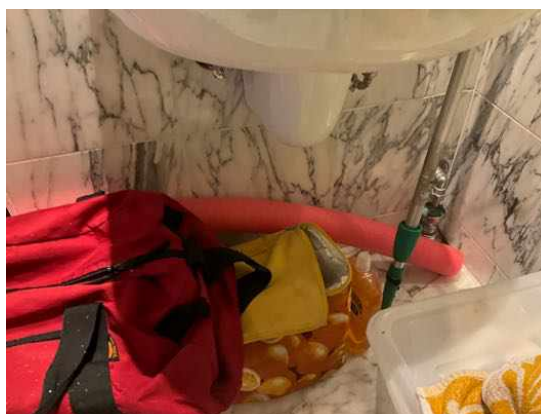
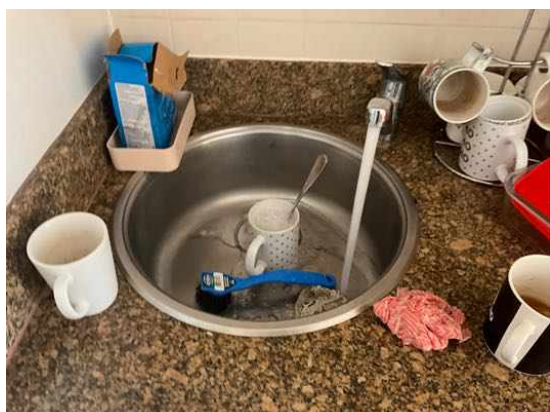
Building: Main Building
Location: All Wet Areas
Finding: Additional Photos
Information:

Additional photos are provided for your general reference.

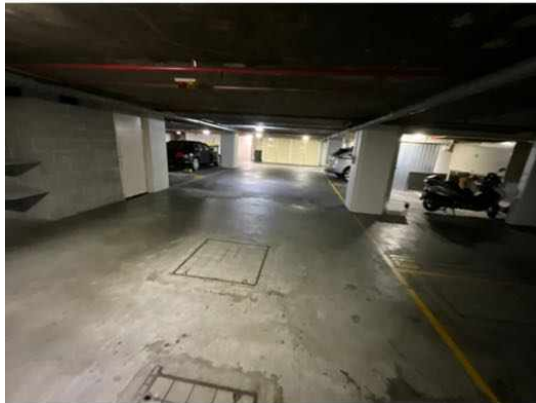
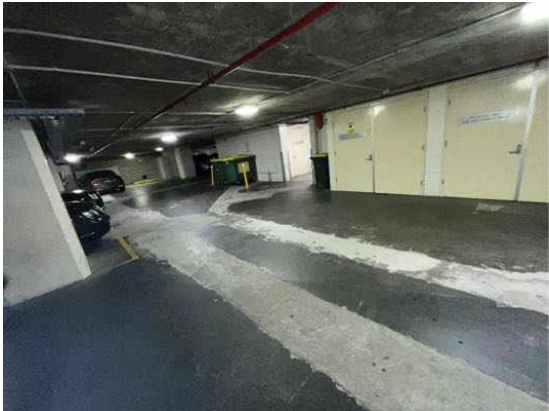
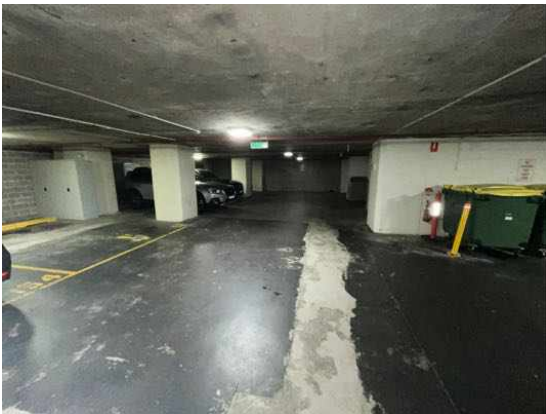
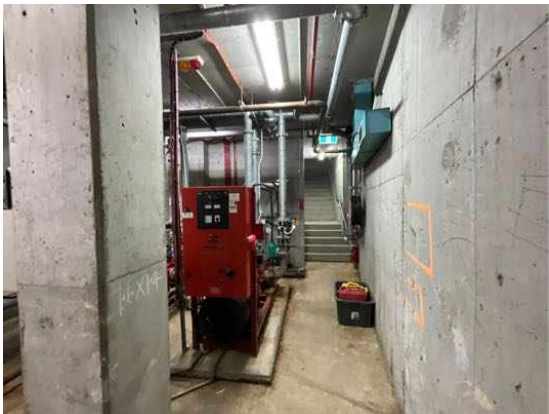
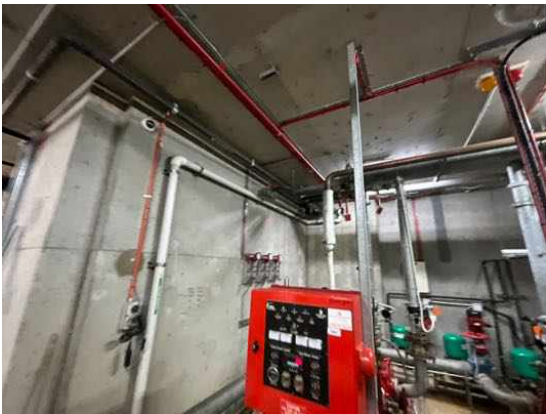
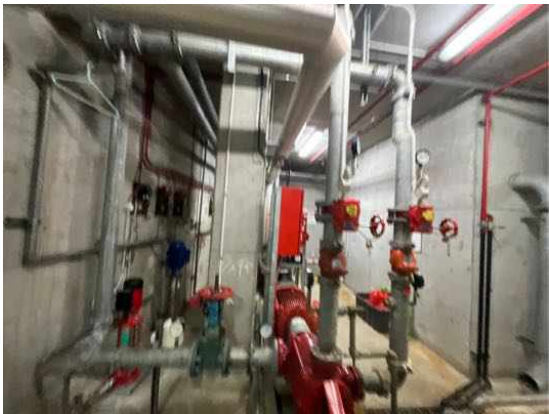
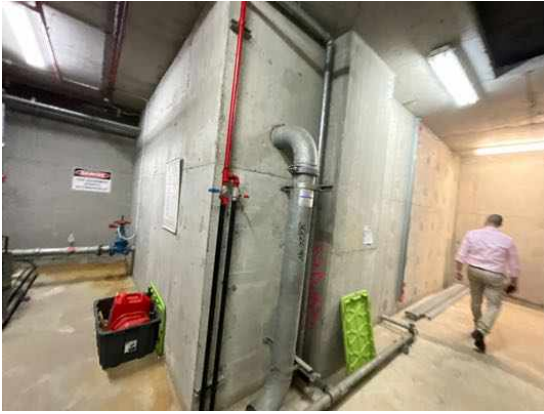
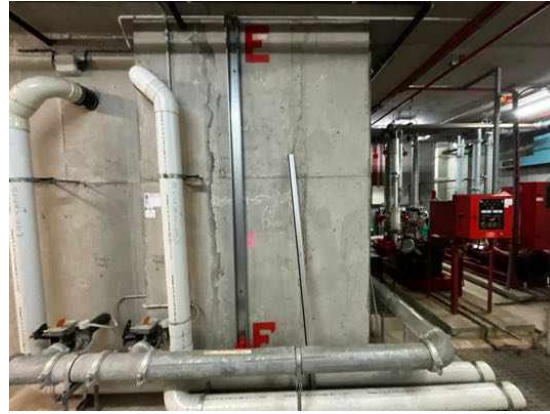
Building: Main Building
Location: Garage
Finding: Additional Photos- Garage
Information: Additional photos are provided for your general reference. Arrows may have been included to highlight areas of importance. Please discuss these photos with your building consultant for clarification.

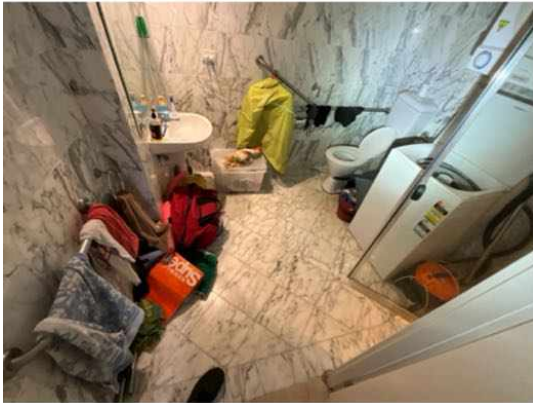
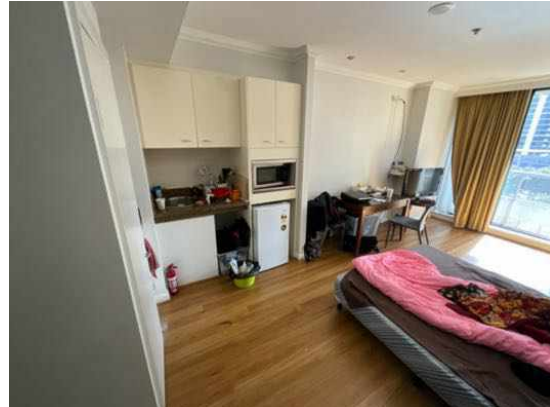
Building: Main Building
 Location: All Areas
 Finding: Additional Photos - Obstructions and Limitations
 Information:

These photographs are an indication of the obstructions and limitations which impeded full inspection of the property at the time of inspection. These obstructions can hide an array of defects and should be removed to allow full inspection to be carried out. A re-inspection is recommended once the areas are made accessible.
