# Building and Timber Pest Inspection Report

Inspection Date: Tue, 24 Feb 2026

Property Address: 19A Henderson Rd, Bexley NSW 2207,  
Australia

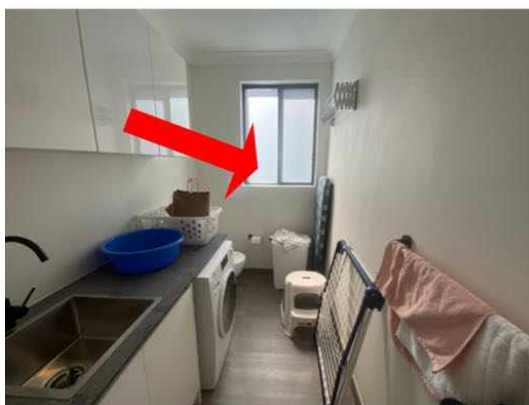
Building:	Main Building
Location:	Laundry
Finding:	Window - Cracked
Information:	Cracks were identified in the window in this area. Cracking in windows is generally the result of impact damage, and is likely to develop further when left unmanaged.

The likelihood of this windowpane further cracking and shattering is increased exponentially, providing a safety hazard in the area. The cracked window also impairs the weather tightness of the building, creating potential for minor water leaks.

A qualified glazier is required to repair the window as soon as possible. Depending on the extent of the cracking, replacement of the window may be required. Please be advised that any persons coming into contact with the cracked window should do so with due caution to avoid any personal injury that may ensue.

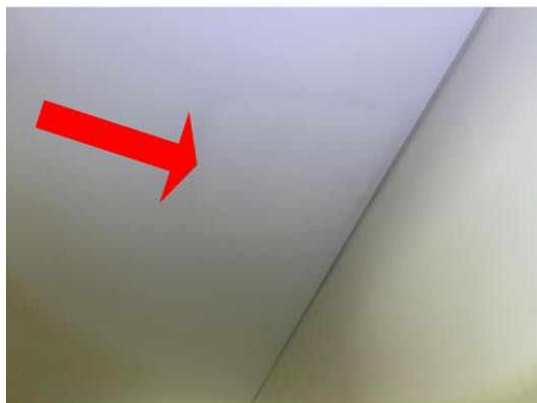
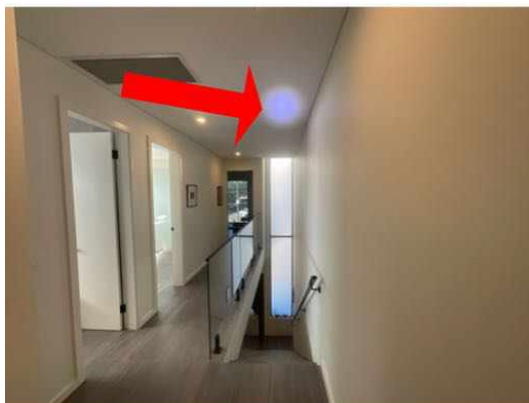
Building:	Main Building
Location:	Hall > Upstairs
Finding:	Ceiling - suspected water damage
Information:	Suspected water damage to the ceiling lining is generally an indication of excessive

moisture being present in the roof void, usually via a leak to the roof covering.

Where water damage is evident to the ceiling, the primary requirement is to identify and rectify the source of the leak. A roofing plumber should be appointed as soon as possible to identify the leak and perform rectification works as necessary, ensuring the water damage is restricted.

Once the leak is repaired, consultation with relevant tradespeople, including plasterers and painters, is advised. Rectification works may include replacement of ceiling lining or minor repainting, depending on the extent of the damage.

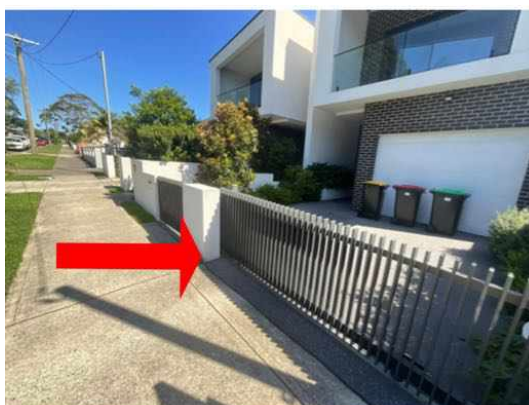
### Finding 3.02

Building:	Main Building
Location:	All External Areas
Finding:	Rendered or hard plastered surfaces - damaged
Information:	It is observed that the rendered and / or hard plastered surfaces are damaged as weather or other impacts. A qualified tradesperson should be nominated to rectify the defect for stopping the further damages

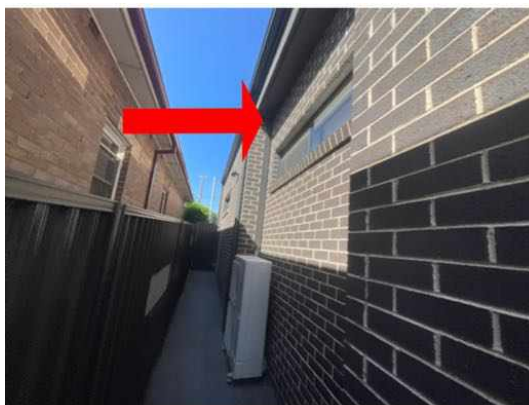
### Finding 3.03

Gaps and holes around pipework makes the area susceptible to insect and vermin ingress, as well as allowing water penetration to the cavity wall. As such, associated building elements are likely to deteriorate at an accelerated rate, and major implications are expected if holes around the pipework are left unmanaged.

All excessive holes, gaps or cracks should be adequately filled by a suitable sealant or trimmings as soon as possible to prevent any further damage. Such works may be conducted by a general handyperson or licensed plumber.

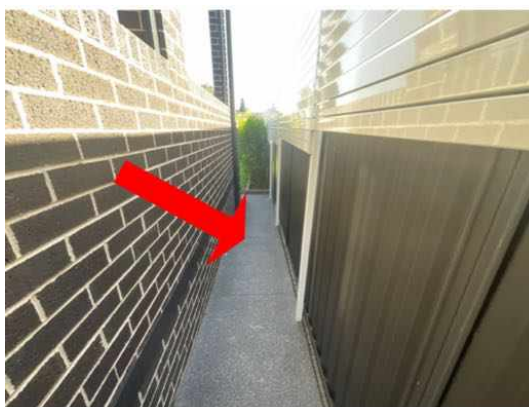
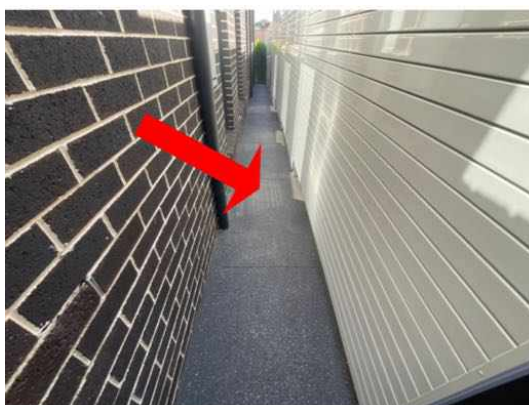
### Finding 3.04

Building:	Main Building
Location:	All External Areas
Finding:	Cracking - External Concrete Paving Damage Category 1 - Fine (less than 2mm)
Information:	Fine cracks were identified in external concrete paving. Although fine cracks are quite noticeable, they are often only considered to be an appearance defect, and usually do not indicate any structural damage. To be considered a Category 1 or fine crack, the crack is found to be less than 2mm in width.

Generally the cause of a hairline crack in existing concrete paving such as driveways and pathways is indicative of the expansion and contraction of the concrete. Such causes are generally due to environmental factors, such as moisture levels, weather conditions, root systems of nearby trees or the soil types on which they are laid.

Fine cracks may also be due to poor original installation of the concrete. Factors such as poor compaction of the sub surface and/or inadequate reinforcing of the slab may create cracking and other secondary defects.

Monitoring of all cracking should be conducted frequently. Always contact a building

inspector should cracks widen, lengthen, or become more numerous.

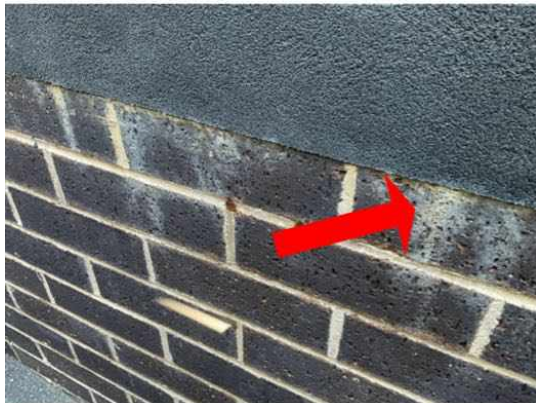
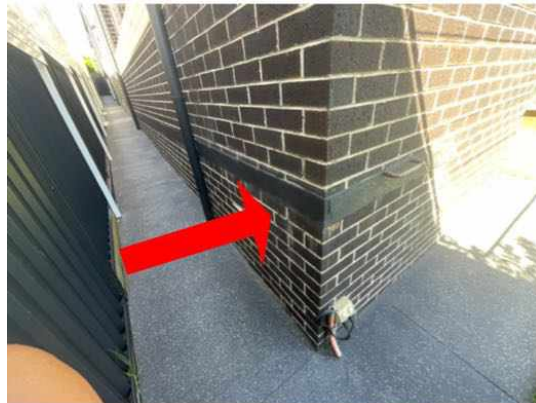
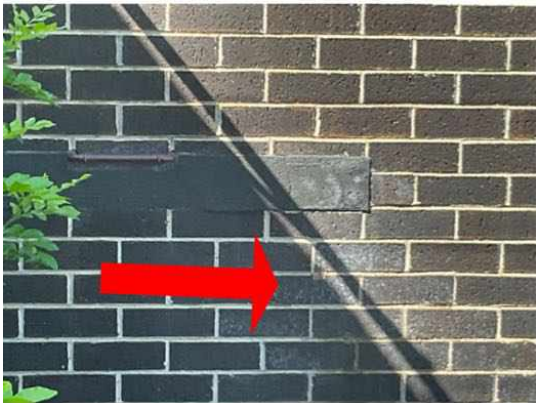
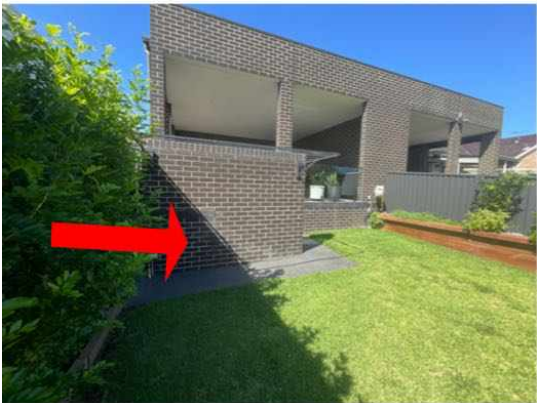
Building:	Main Building
Location:	Exterior walls - rear
Finding:	Black staining observed on external brickwork.
Information:	Dark discolouration is present on the face of several bricks, likely due to biological growth (mould or algae) caused by moisture retention. This may be attributed to inadequate drainage, lack of sunlight exposure, or poor surface runoff management.

Clean affected areas with a suitable biocide or diluted bleach solution. Inspect for and rectify any sources of water ingress or poor drainage, such as faulty flashing or leaking downpipes. Consider applying a breathable water-repellent sealant to prevent recurrence. Ongoing monitoring is recommended to ensure the issue does not persist or worsen.

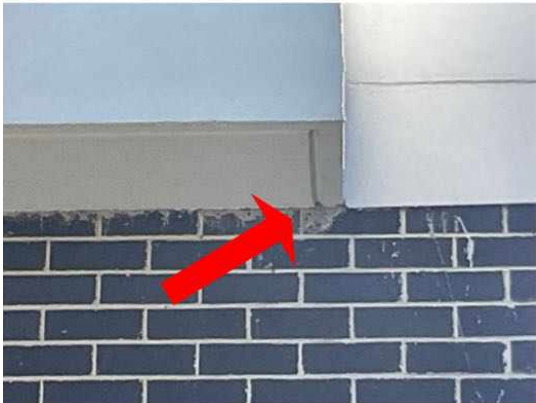
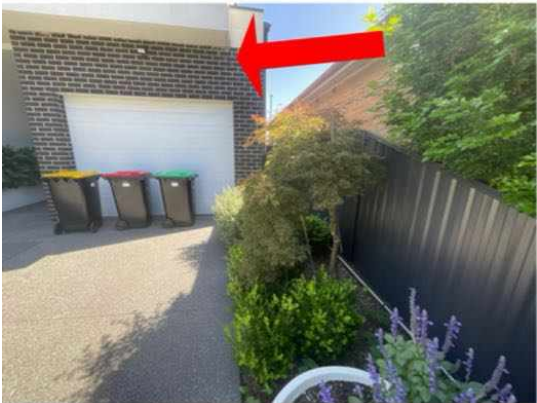
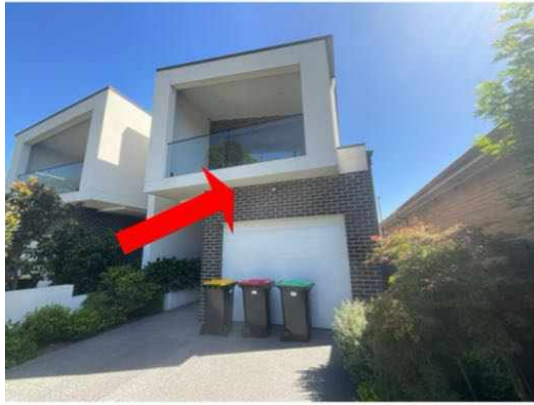
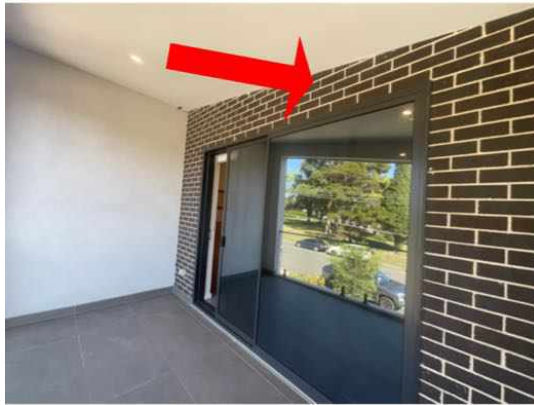
**Finding 3.07**

Building: Main Building  
Location: Exterior walls - front  
Finding: Surface - Requires cleaning  
Information: Regular cleaning and maintenance improves the longevity of all building elements. A build up of dirt and debris can reduce the useful life of building materials and may result in earlier replacement of items being required.

Excessive dirt is also likely to lead to secondary hazards, including potential health hazards, as the building elements begin to harbour bacteria and/or mould.

Remedial cleaning is recommended in order to improve the appearance of this area as well as to counteract the development of bacteria. Such works can be performed by a cleaning contractor and should be completed at the discretion of the client.

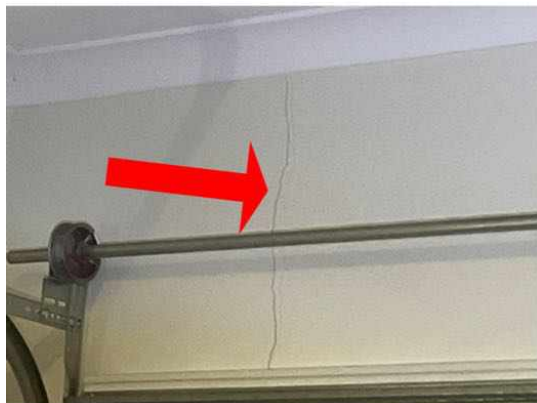
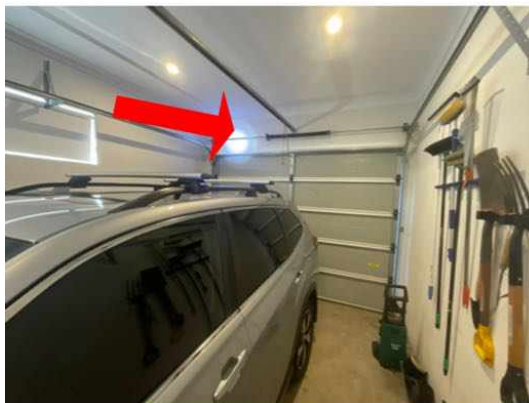
### Finding 3.08

Finding: Damage to Masonry Walls (Cracks)- Category 2

Information: It has been observed that damage to masonry walls caused by movement of slabs, footings, or other causes, has occurred. The degree of damage falls within Category 2, described as noticeable cracks which are easily filled. Such cracking may cause doors and/or windows to stick slightly, and are generally less than 5mm in width.

Damage of this category is required to be monitored for a period of 12 months, after which time a crack rated at Category 2 or above is considered a defect requiring rectification, such as minor repairs and repointing. Always contact your building inspector should cracks widen, lengthen, or grow more numerous.

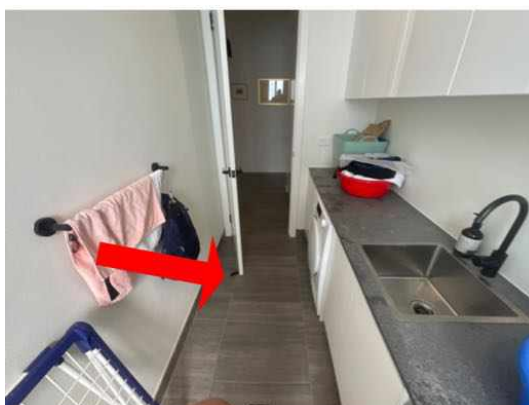
### Finding 3.09

Building:	Main Building
Location:	Laundry
Finding:	Door stop - Missing
Information:	The door stop is missing or is inadequate to stop the door handle from damaging the wall. Although some building elements may seem irrelevant or unnecessary, all building elements play a key role in the operation and function of the overall structure and its performance.

Re-installation or replacement of the door stop is advised as soon as possible to prevent any subsequent damage to the door or associated structures. A general handyman may be appointed to perform these works at client discretion.

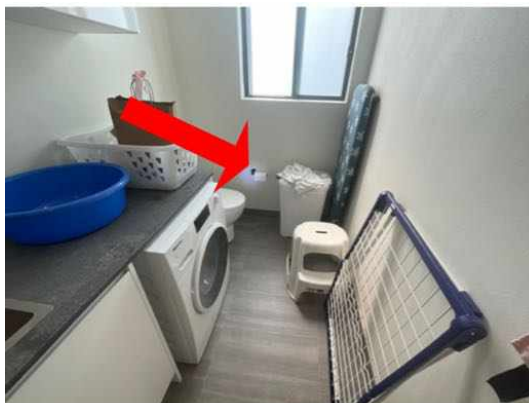
### Finding 3.10

Building:	Main Building
Location:	Laundry
Finding:	Toilet roll holder - Loose
Information:	The toilet roll holder was found to be loose at the time of inspection. While not a major operational defect, function can deteriorate if the problem is left unmanaged.

It is advised that the homeowner performs remedial works to re-attach the toilet roll

holder to its original fixing. A general handyperson may be required to perform these works.

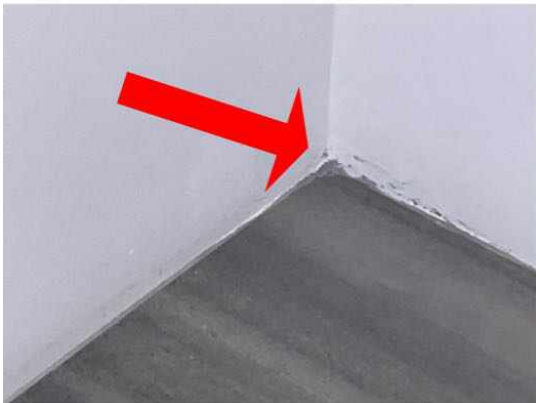
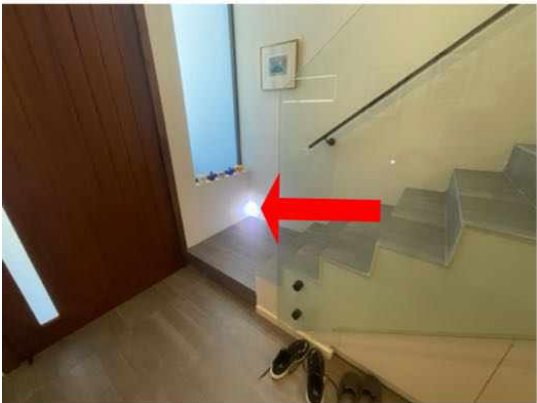
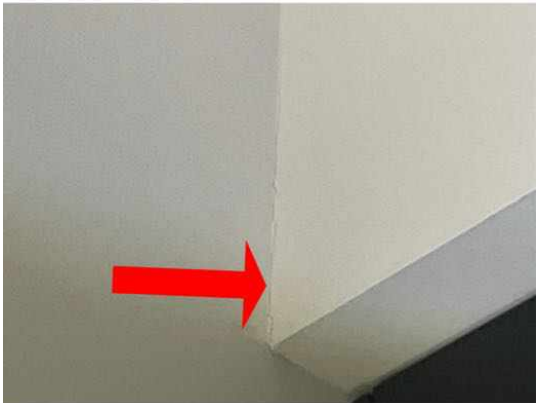
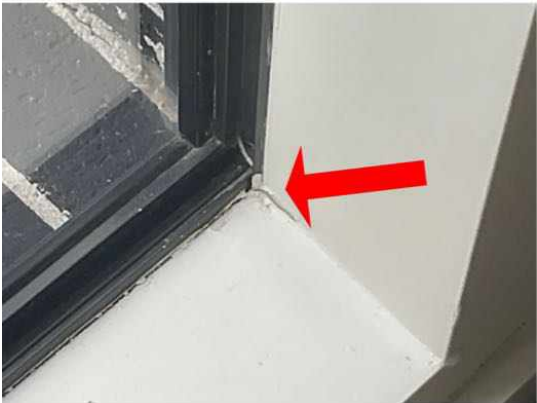
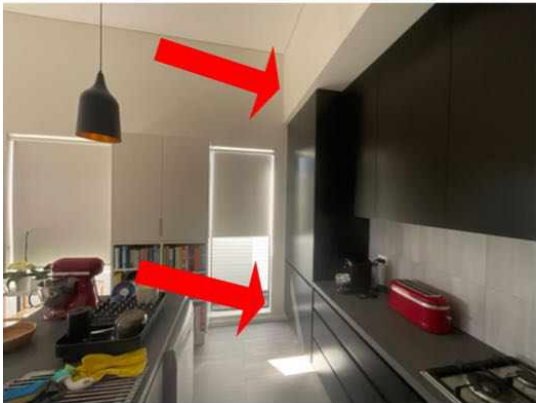
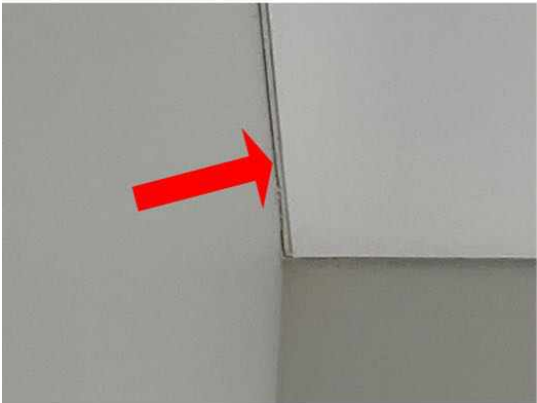
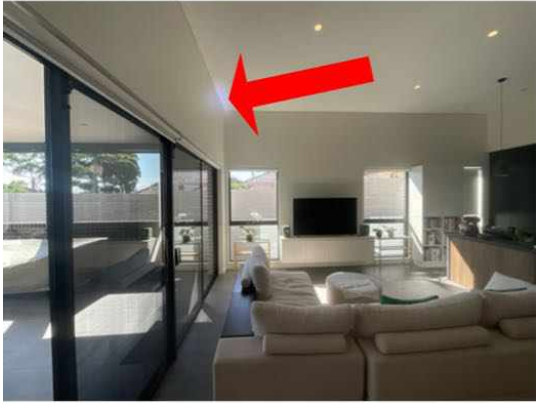
### Finding 3.11

Building:	Main Building
Location:	All Internal Areas
Finding:	Paint finish - Substandard, Wear and Tear
Information:	The paint finish in this area was found to have been completed to a substandard level or wear and tear as the normal deterioration of a property from ordinary, everyday use. Exposure to the elements, time, as well as day to day living can cause fair wear and tear.

If this applies, further areas of poor and incomplete finishes could develop over time. Furthermore, substandard, wear and tear paint finishes in areas exposed to moisture, e.g. external areas or wet areas, could lead to deterioration of underlying building materials.

Substandard, wear and tear paint finishes should be sanded back, filled, leveled and repainted, as applicable. Where inadequate paint protection has led to the deterioration of the associated building element, repair and/or replacement of this building element may be required.

A painting contractor should be appointed as soon as possible to perform necessary works to aid the appearance of the affected area and to ensure that the area is protected against further deterioration. Alternatively, the homeowner following manufacturer instructions may be able to provide this service.

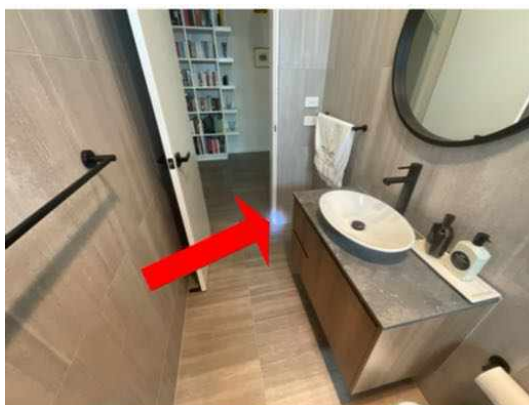
Finding 3.12

Building:	Main Building
Location:	Bathroom
Finding:	Bathroom - Damp
Information:	<p>Damp is evident to the lower 300mm of wall to the bathroom alcove. This defect is quite common, and is suspected to have been caused by moisture permeating through the grouting in this area, which shows evidence of deterioration. Leaking pipes within the adjoining wall is also a possible cause. Damp (or structural damp) refers to the presence of unwanted moisture in the structure of a building, either as the result of intrusion from outside, or condensation from within the structure. In the bathroom area, internal water leaks or other sources of excessive moisture are generally the cause of damp. Unmanaged damp in the bathroom recess is likely to facilitate the formation and development of mould and fungi growth, decaying associated building materials and compromising their structural integrity. It is important to address damp conditions, as the World Health Organisation notes that excess moisture leads - on almost all indoor materials - to growth of microbes such as moulds, fungi and bacteria, which subsequently emit spores and other matter into the indoor air. Exposure to these contaminants is associated with a wide range of respiratory and other health-related problems. Consultation with a qualified plumber or bathroom specialist is advised immediately to identify the cause of damp and to perform remedial works as required. Where excessive mould growth is present, further inspection by a specialist environmental health inspector should also be considered. Always ensure that sealant and grout is in good condition to prevent any moisture issues occurring in the future.</p>

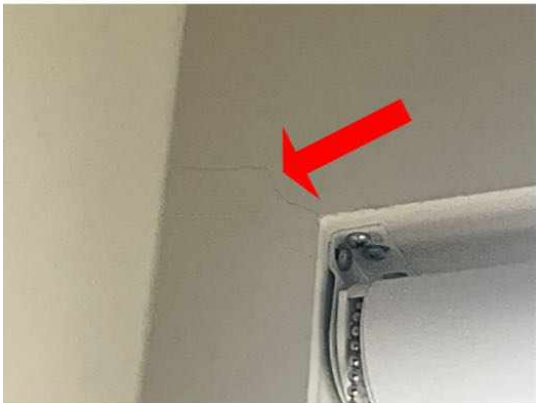
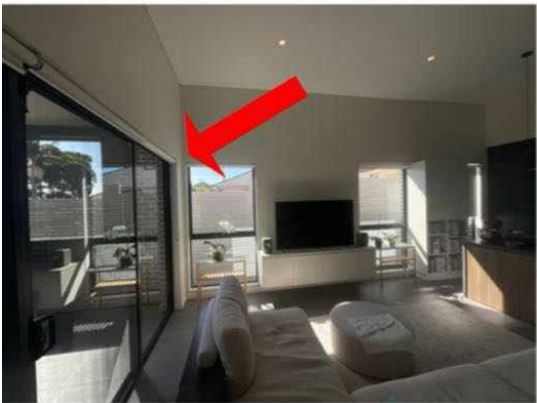
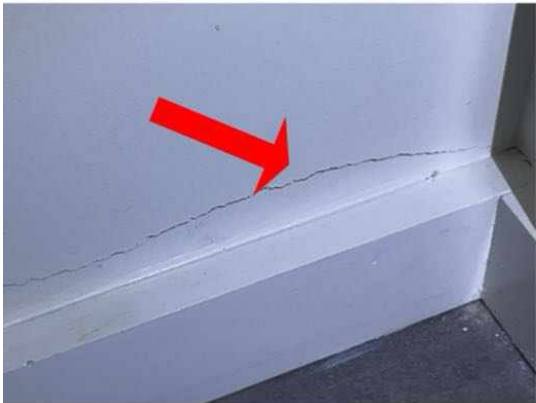
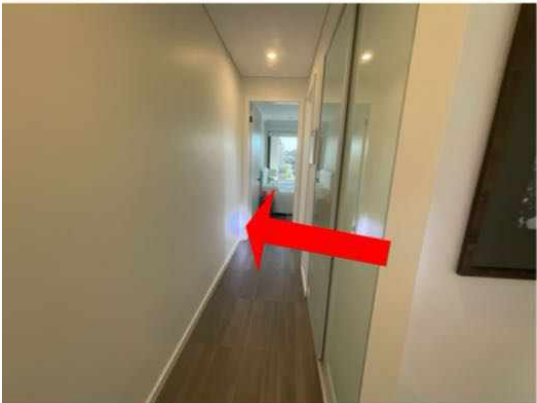
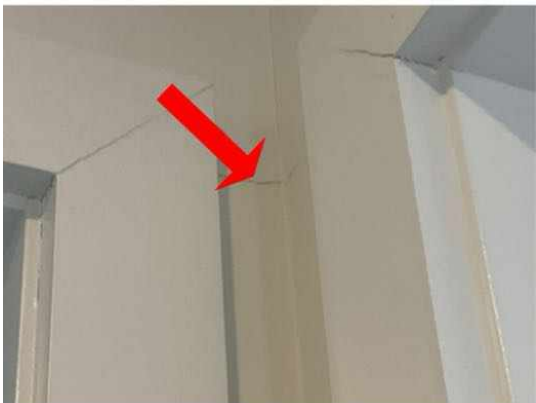
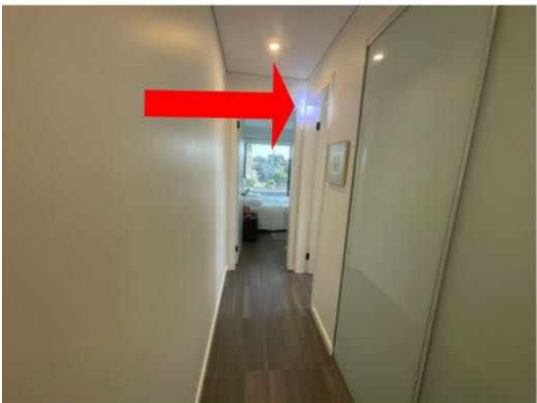
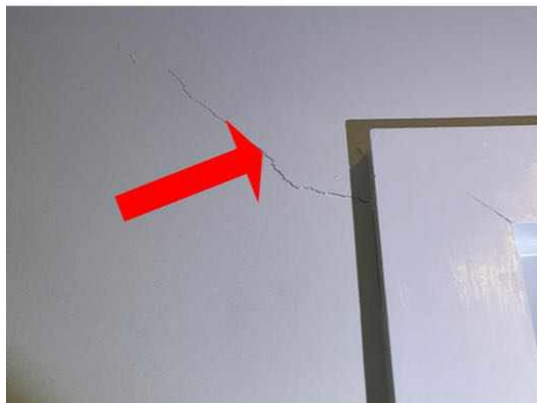
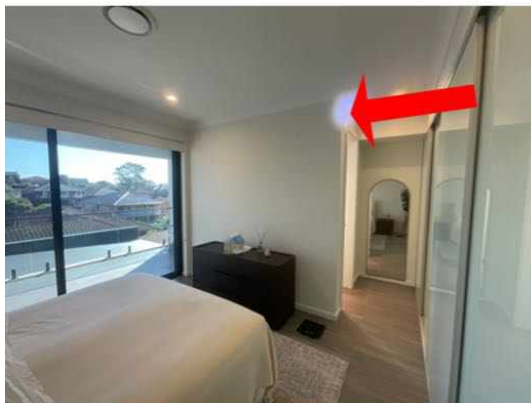
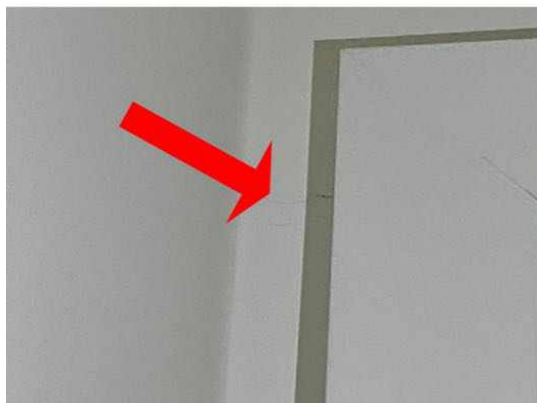
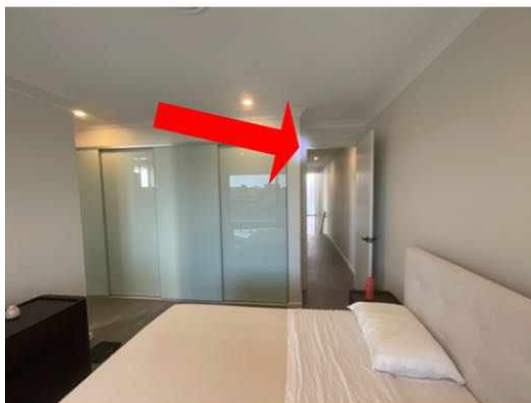
### Finding 3.13

Building:	Main Building
Location:	All Internal Areas
Finding:	Plasterboard - cracking
Information:	<p>It was identified that there are crack/s in the plasterboard hard plaster and / or other plaster elements affecting the walls ceilings and or bulkheads that is greater than 1mm in width which can be seen from a normal viewing position.</p>

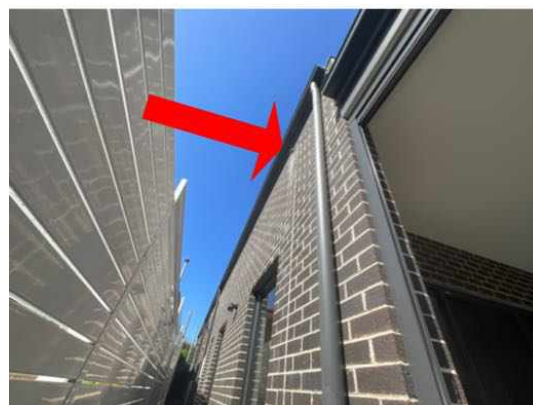
### Finding 6.02

Building:	Main Building
Location:	All Areas
Finding:	Overflow - Not plumbed for drainage
Information:	The overflow is not plumbed or connected to suitable drainage, which has resulted in the surrounding area becoming excessively damp. These damp conditions can lead to secondary defects such as rot, rust or corrosion of associated building elements, the formation of fungal decay, or even the creation of potential slip hazards. When coupled with poor site drainage, pooling of water may also attract termite activity to this area. It is highly recommended that a qualified plumber be appointed to install adequate drainage to the overflow. These works will ensure that the area remains dry and free of any secondary defects.

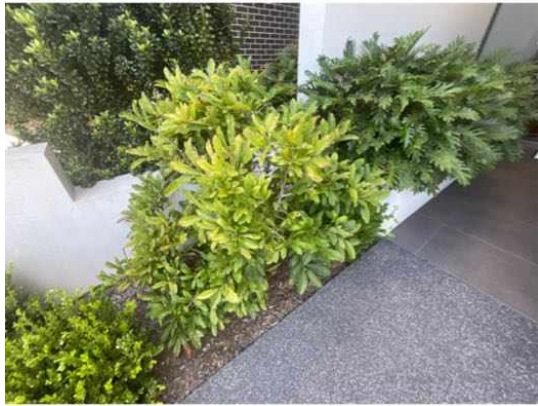
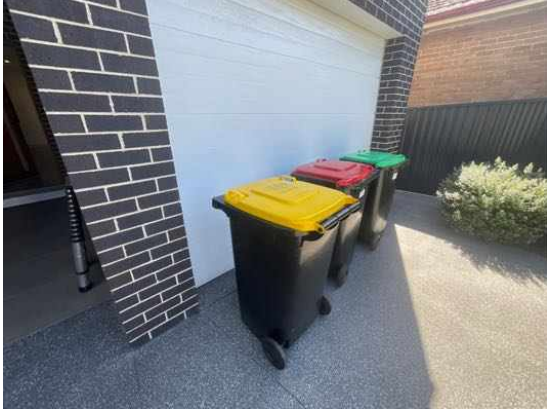
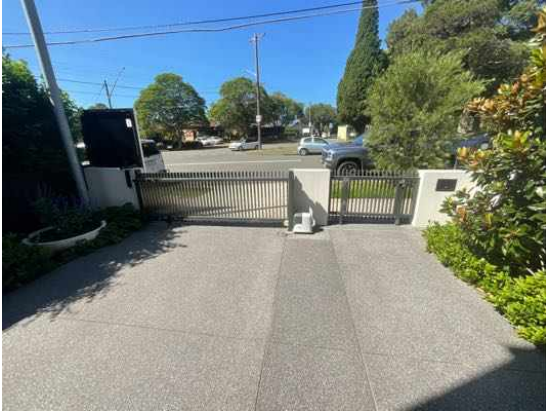
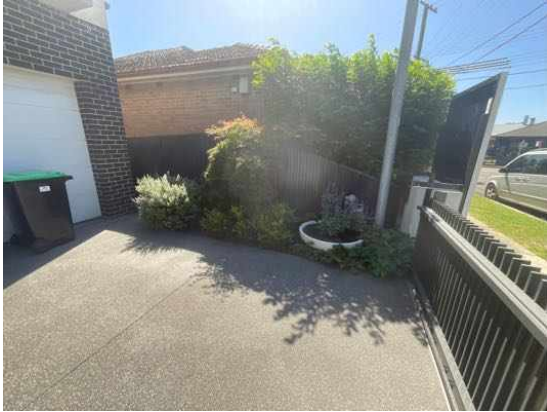
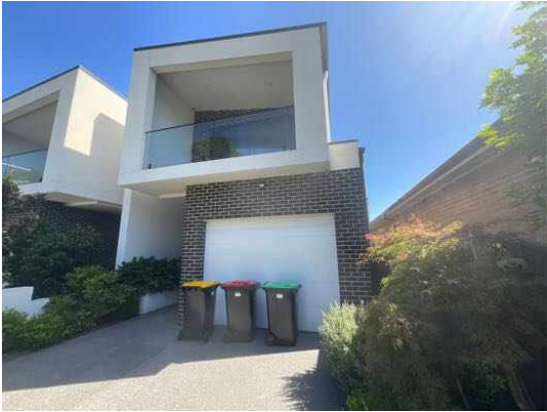
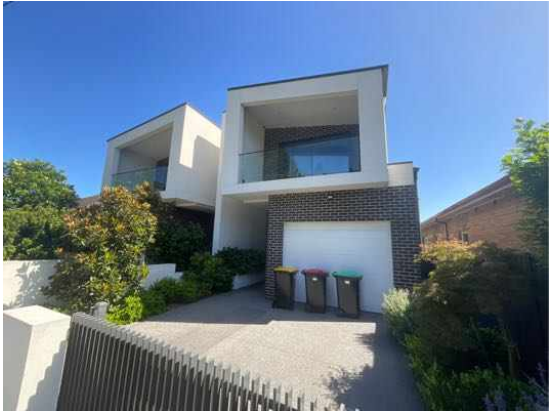
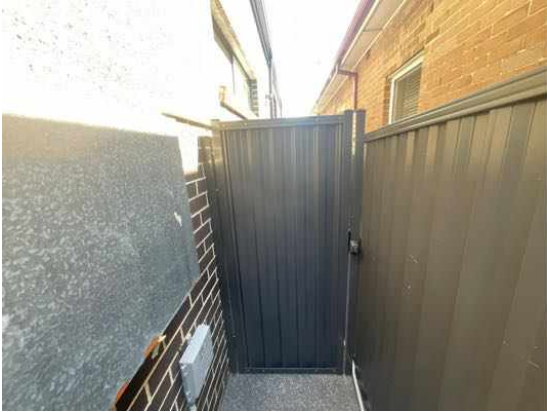
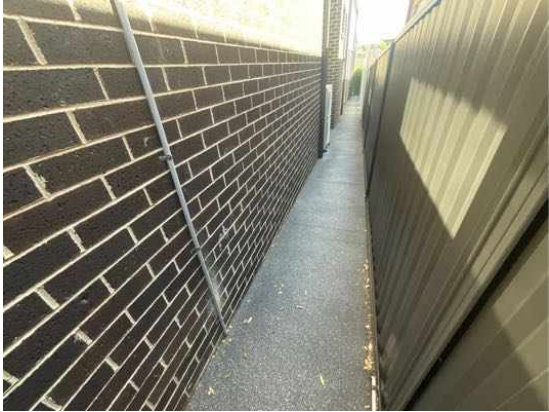
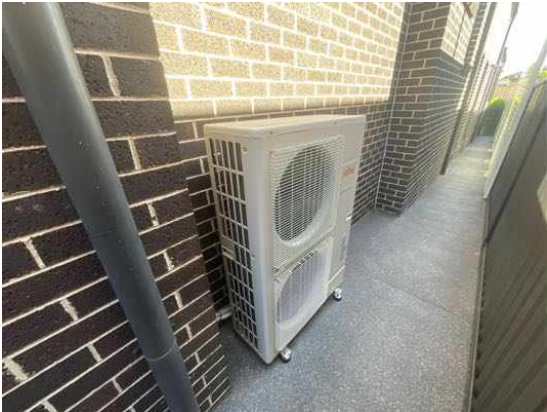
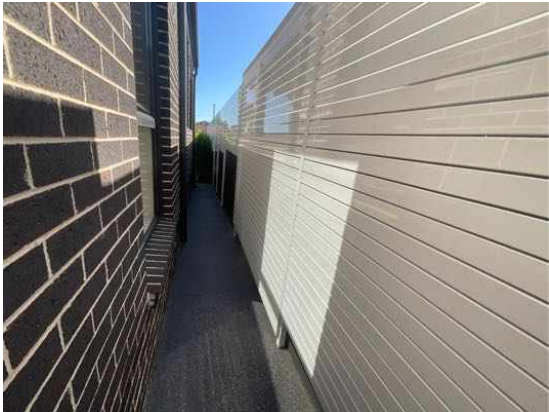
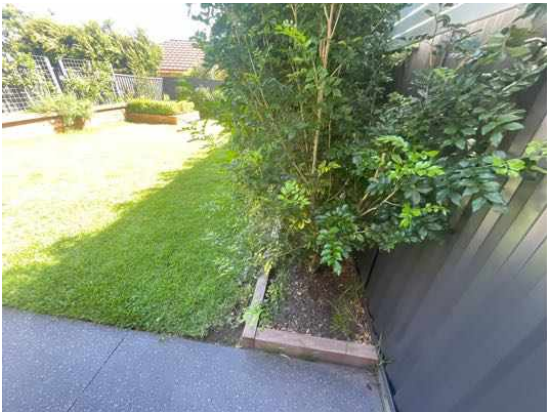
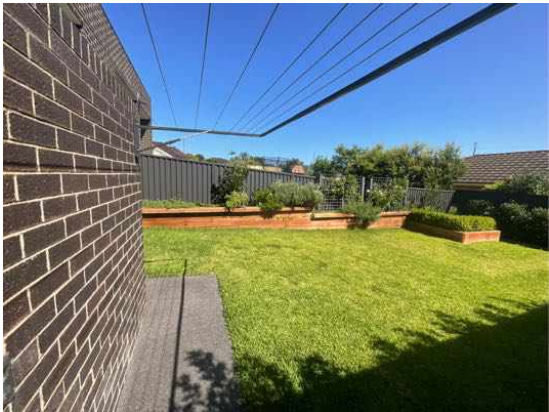
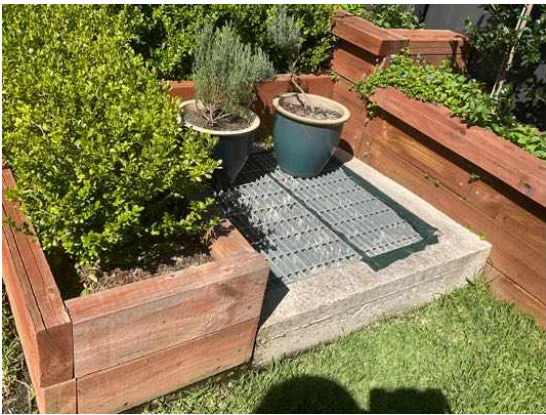
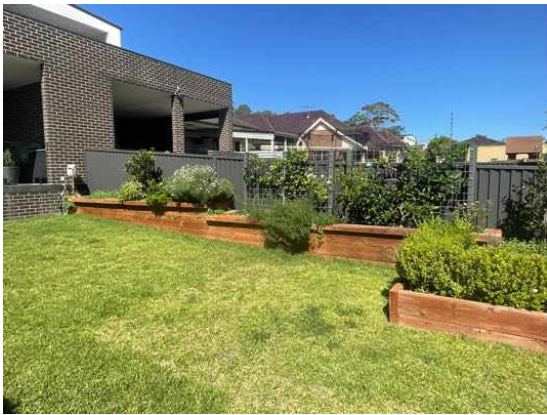
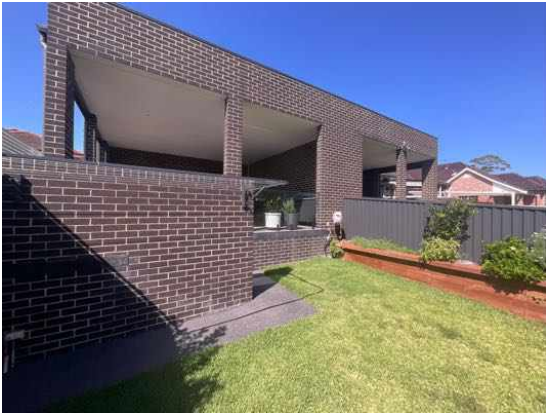
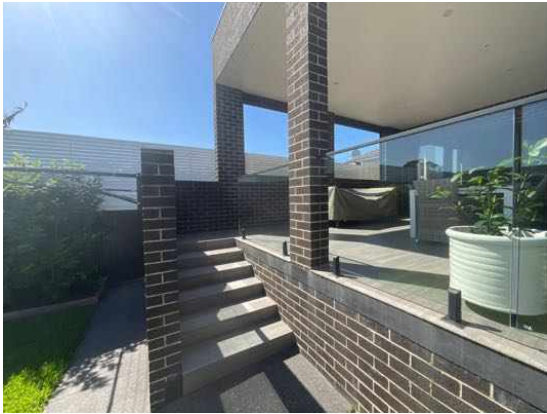
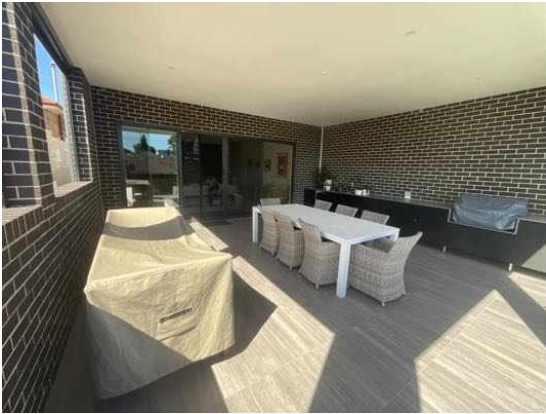
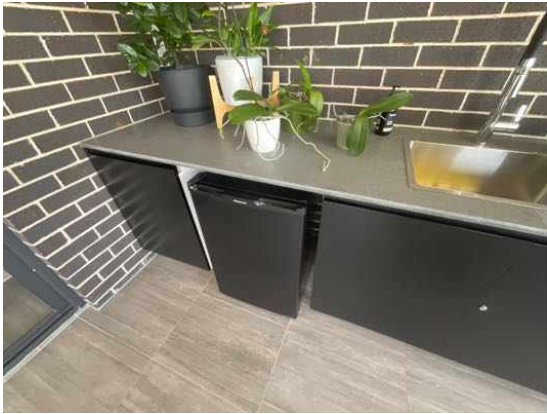
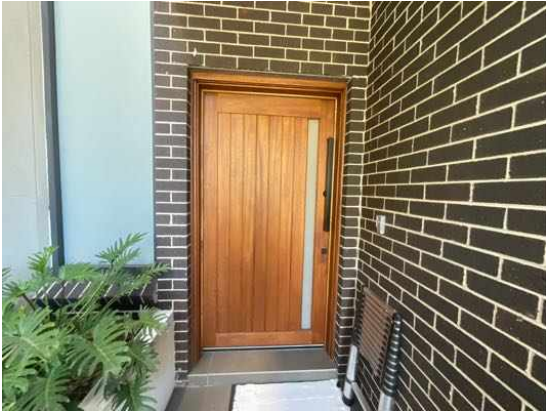
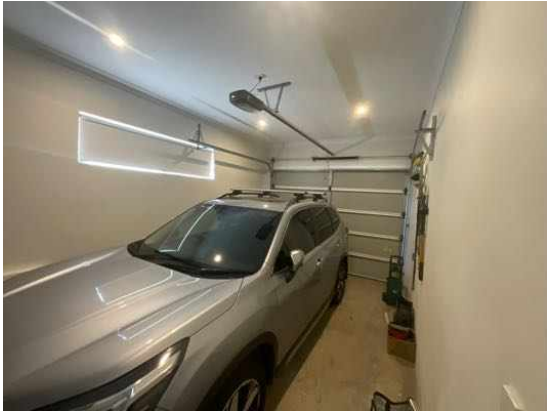
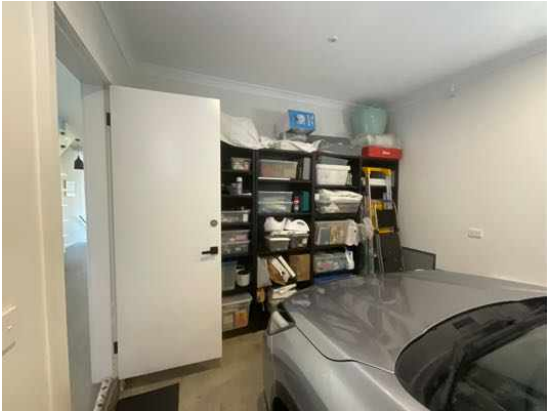
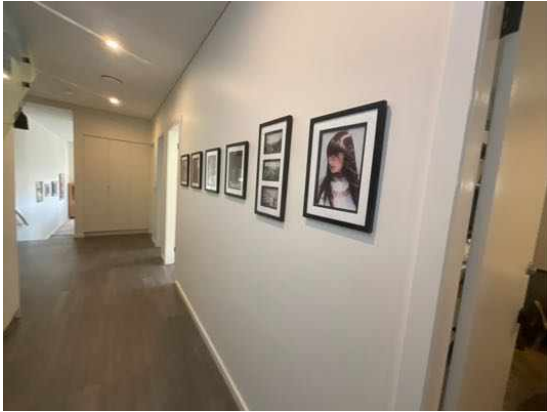
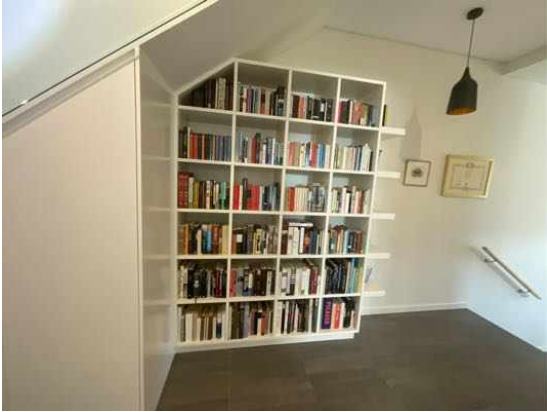
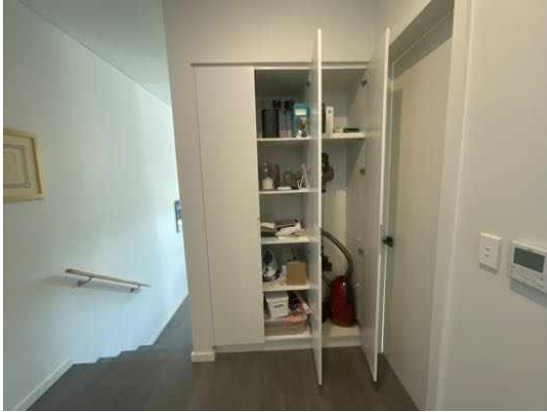
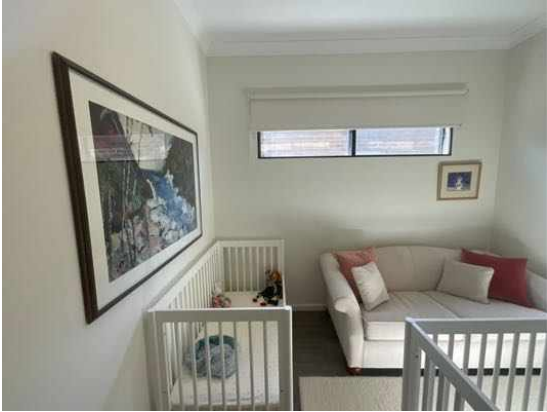
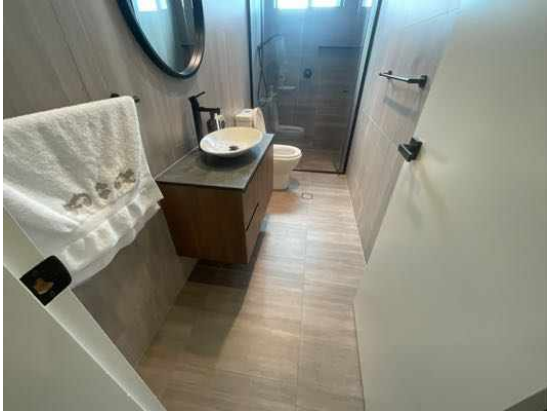
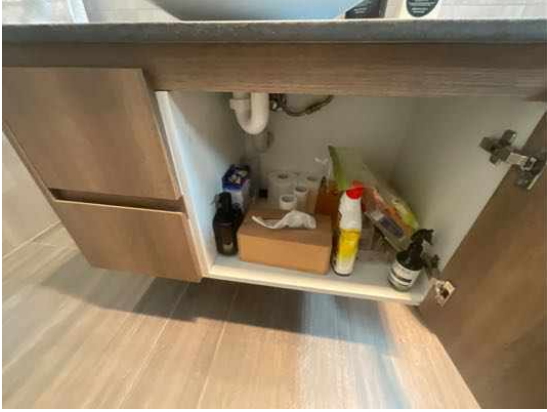
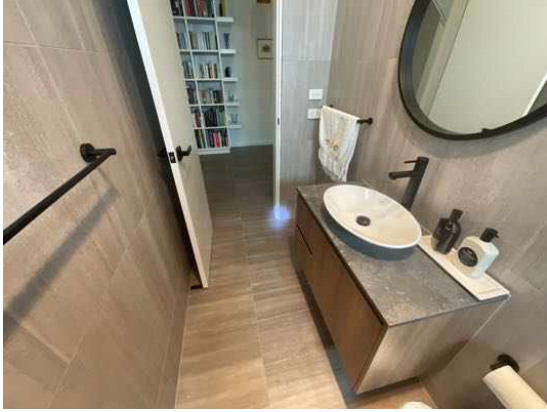
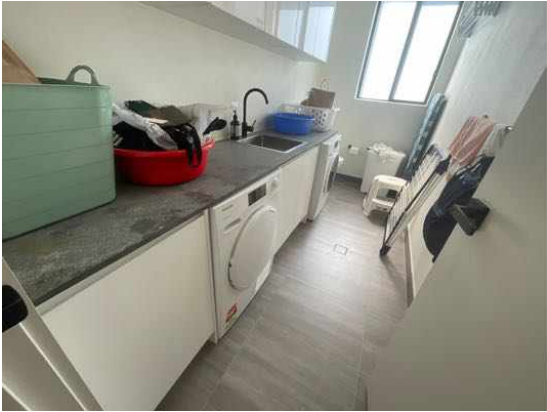
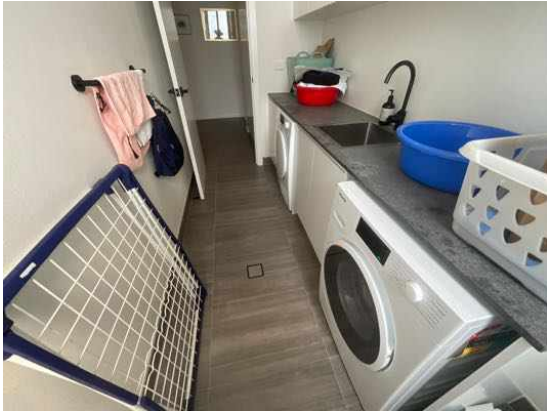
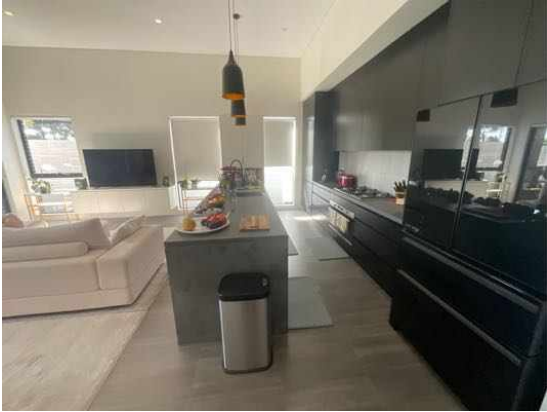
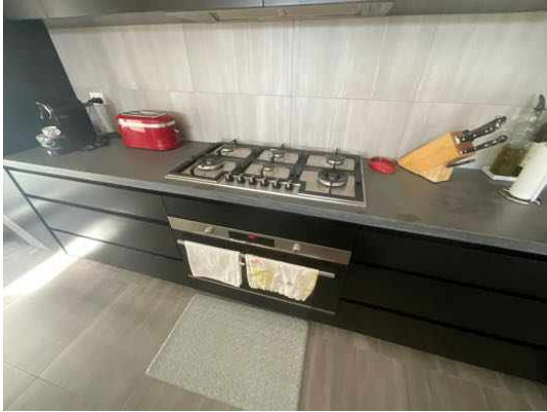
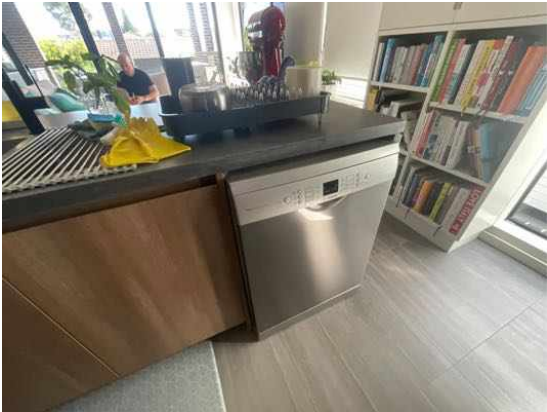
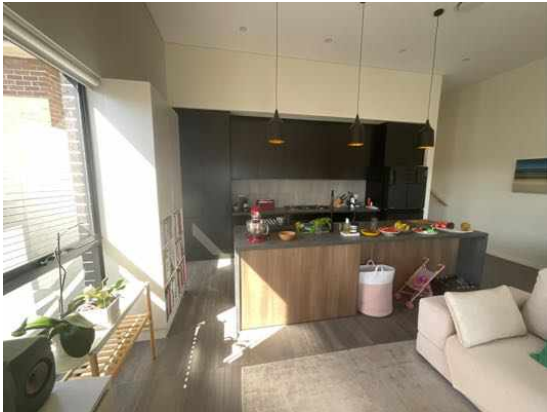
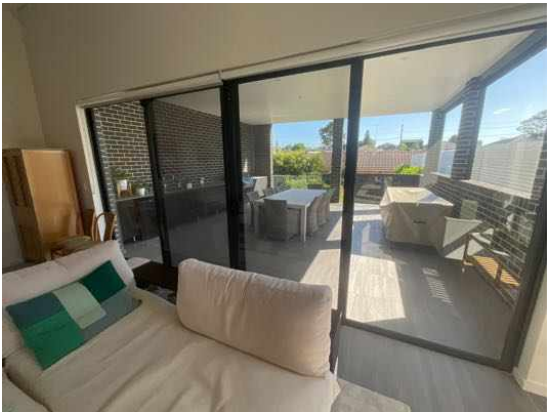
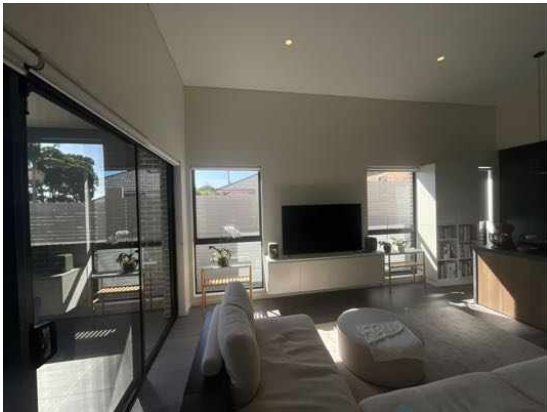
Building: Main Building  
Location: All Areas  
Finding: Additional Photos - Obstructions and Limitations  
Information: These photographs are an indication of the obstructions and limitations which impeded full inspection of the property at the time of inspection. These obstructions can hide an array of defects and should be removed to allow full inspection to be carried out. A re-inspection is recommended once the areas are made accessible.
