# Building and Timber Pest Inspection Report

Inspection Date: Tue, 24 Feb 2026

Property Address: 19A Henderson Rd, Bexley NSW 2207,  
Australia

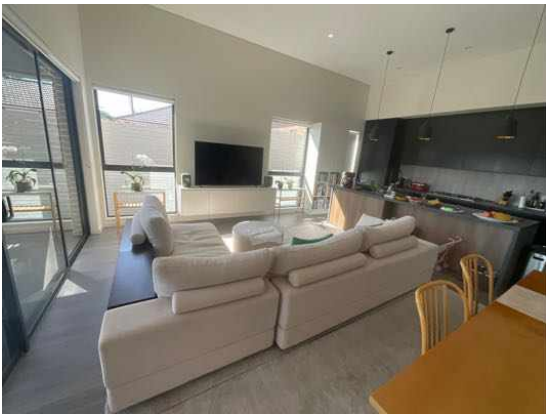
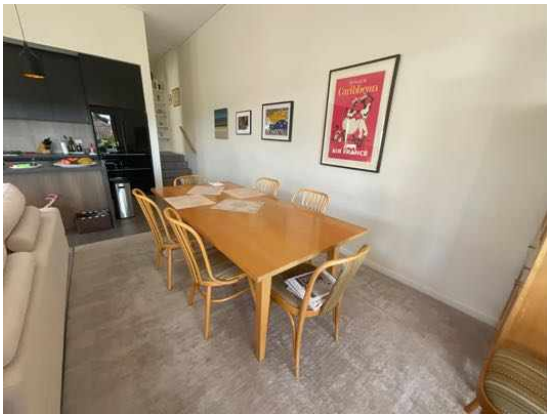
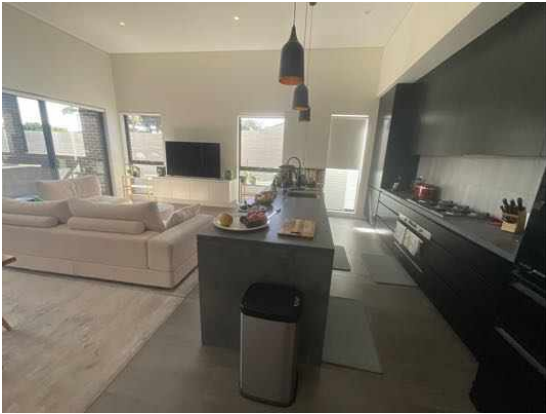
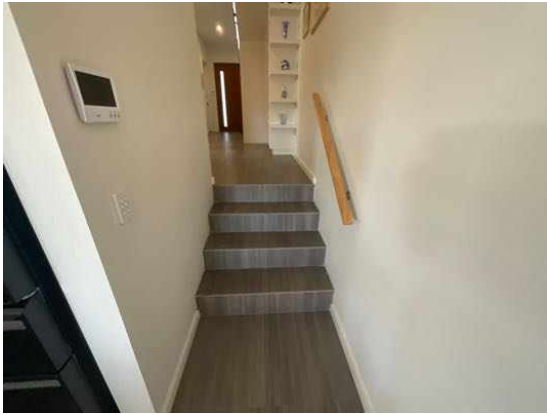
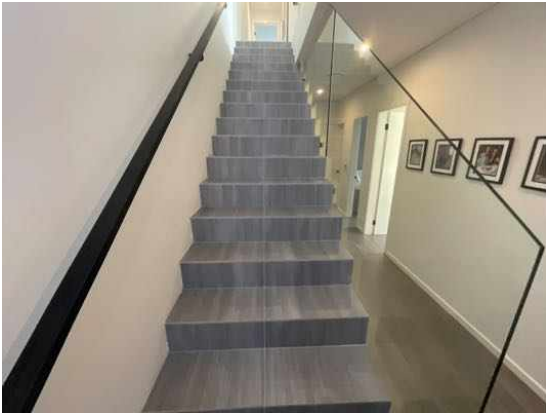
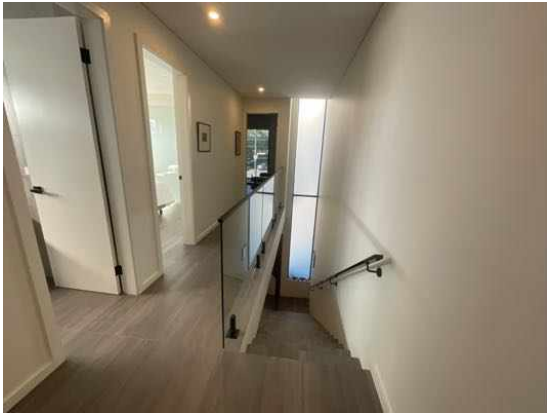
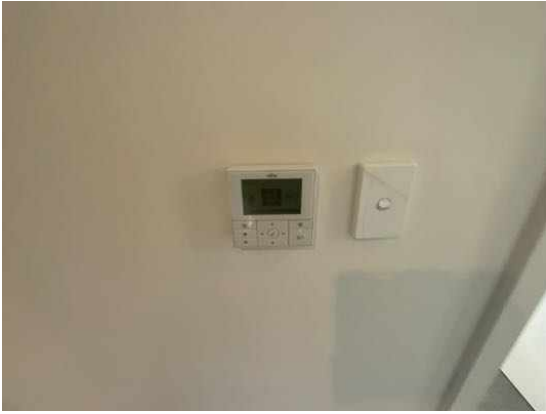
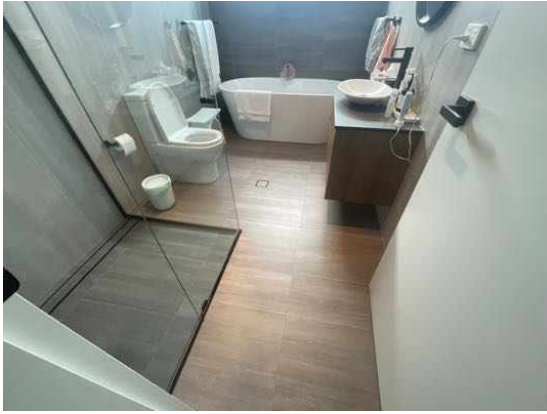
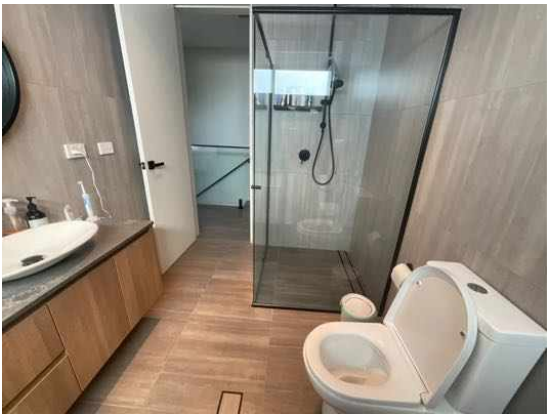
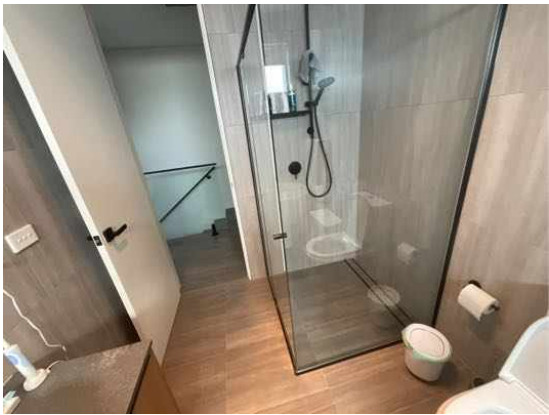
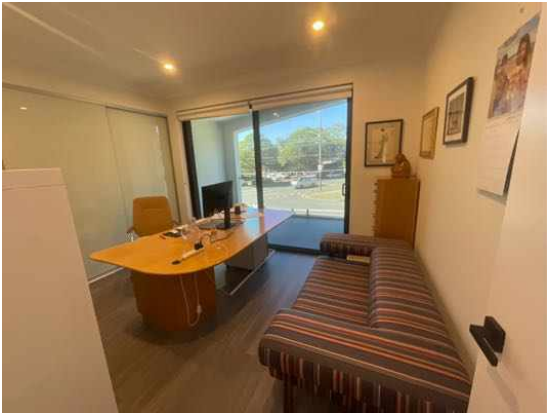
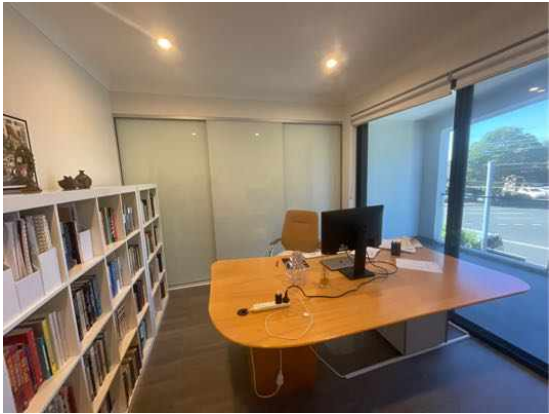
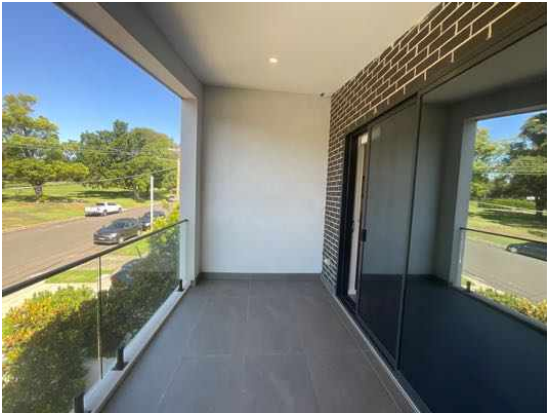
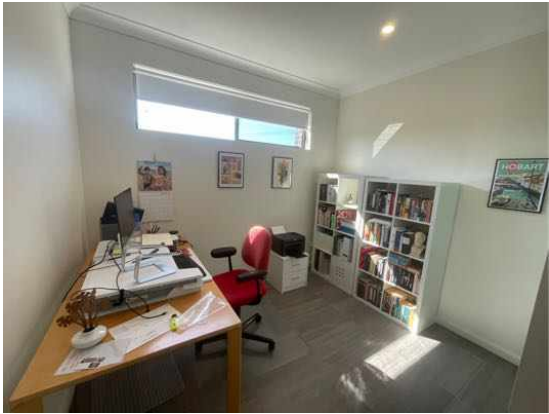
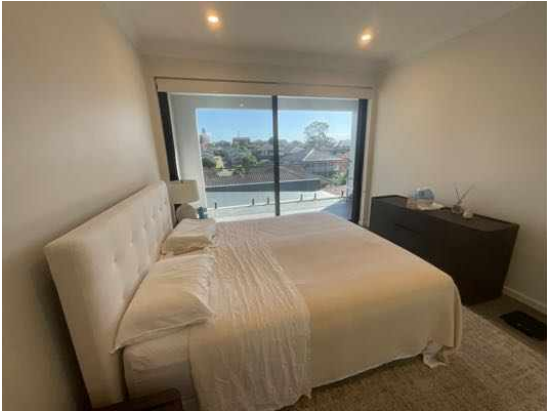
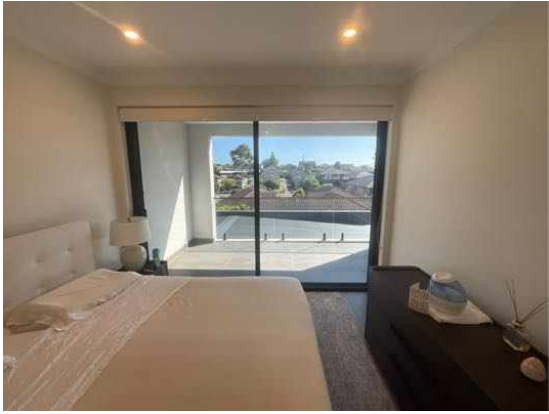
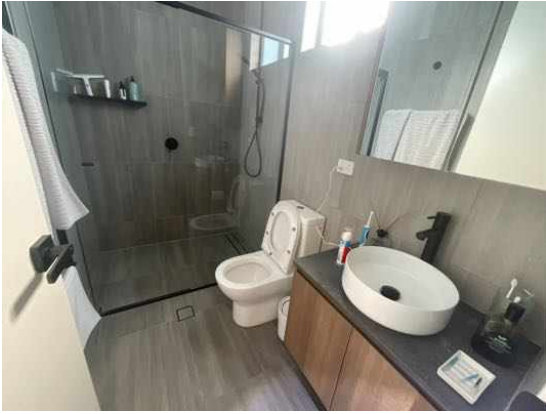
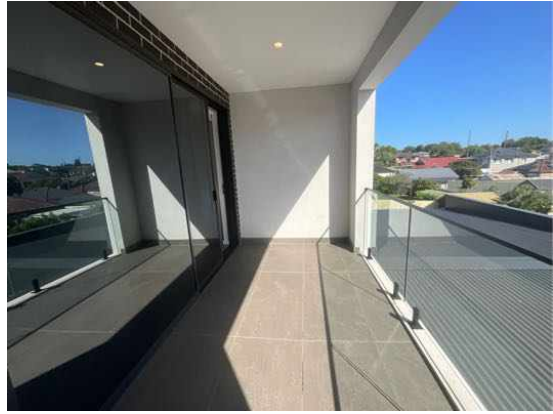
Building: Main Building  
Location: All Areas  
Finding: Additional Photos - Obstructions and Limitations  
Information: These photographs are an indication of the obstructions and limitations which impeded full inspection of the property at the time of inspection. These obstructions can hide an array of defects and should be removed to allow full inspection to be carried out. A re-inspection is recommended once the areas are made accessible.

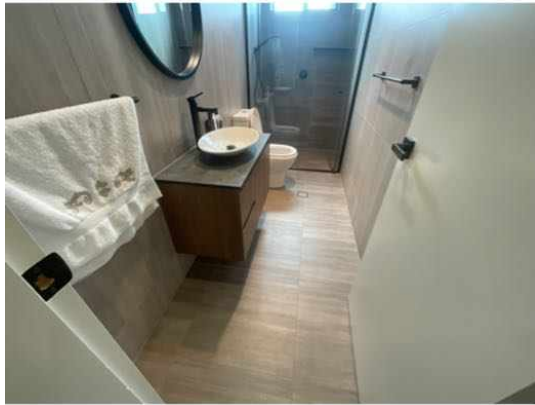
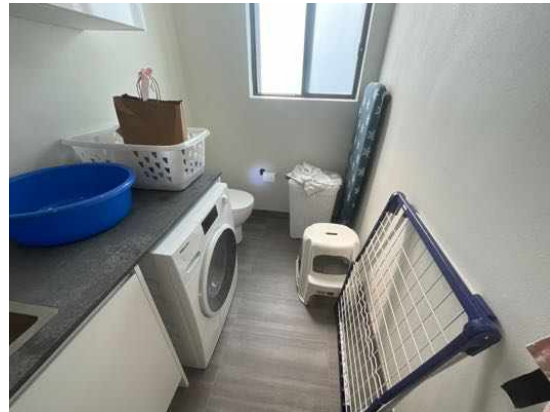
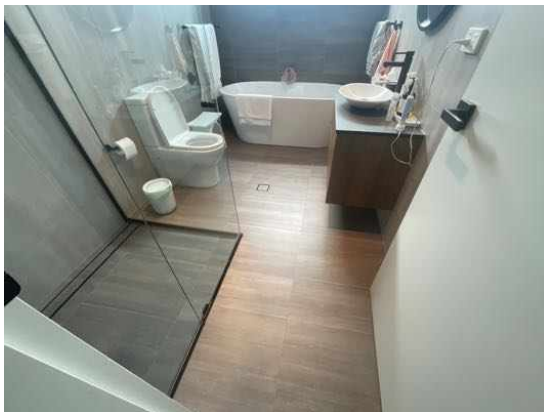
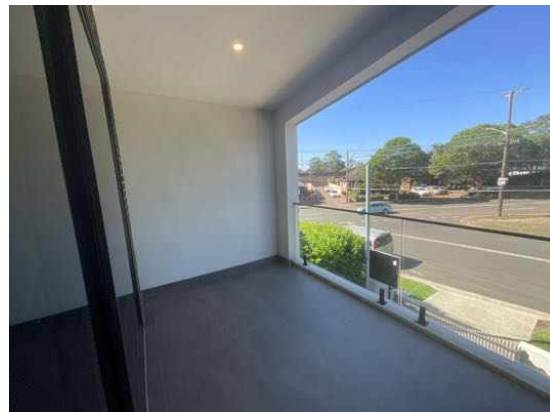
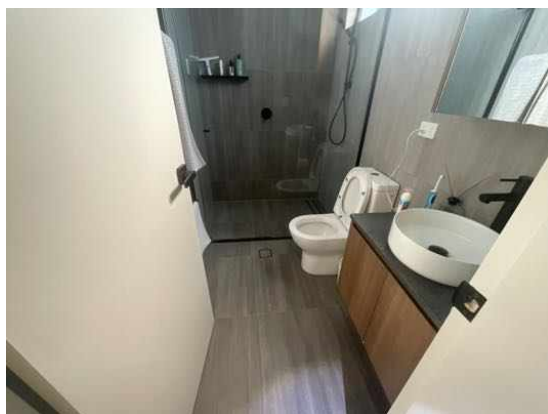
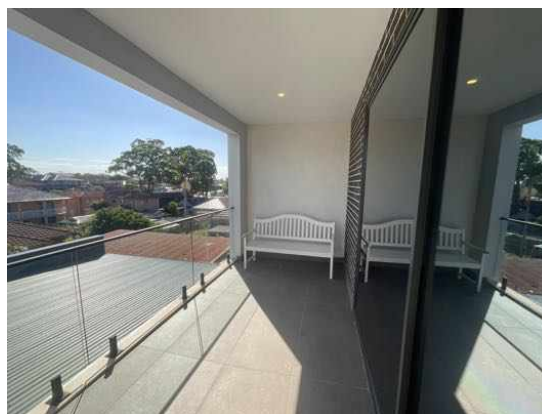
Building: Main Building  
Location: All Areas  
Finding: Water Proofing Membranes - Information Only  
Information: Internal Water Proofing Membranes, are crucial in preventing water ingress into the property is important to know that the Membrane System used is to Australian Standards and has been installed correctly. Please refer to the original Building Documents or Maintenance Schedule for the relevant information including; - Membrane used and Manufacturers Specifications. - The Installer and Installation Certification. Especially with older property's where this information is unavailable, all wet areas should be monitored. Generally new waterproofing with a certificate may only have a guarantee of 8yrs. If any leaks, water staining, peeling or bubbling of the paint become evident to any adjacent walls or ceilings below a licensed builder or waterproofing specialist is recommended to investigate further.

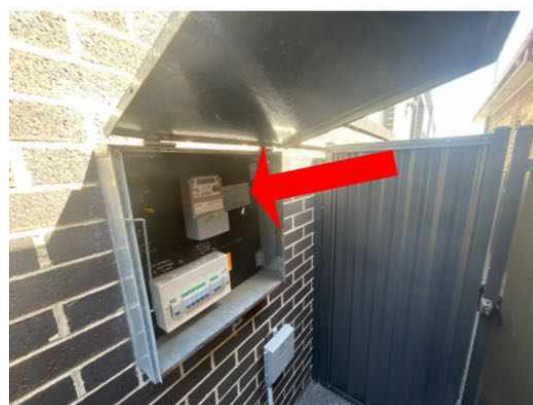
Building: Main Building  
 Location: All Areas  
 Finding: Evidence of a chemical treated zone barrier was identified  
 Information: During inspection of the property, it was noted that works to install a chemical treated zone barrier had previously been completed. A chemical treated zone barrier is likely to ensure effective protection against termites.

However, we strongly recommend annual inspections of the barrier and surrounding areas as there are several factors that can lead to deterioration of the barrier and decrease its effectiveness.

Where a Termite Management System has been identified, the client should identify to the type of barrier, date of installation, warranty conditions and any documentation provided by a builder or past owner. Consult the company who installed the barrier to confirm whether the system is still under warranty.
