Building Inspection Report

Inspection Date: Fri, 27 Feb 2026

Property Address: 8 Madeira Dr, Clyde North VIC 3978,
Australia

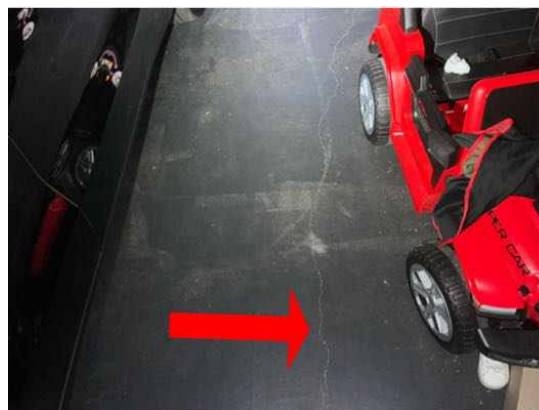
Defects 3.01

Finding: Noticeable cracks in concrete slab of the the garage floor

Information: During the inspection, multiple noticeable cracks were identified in the concrete slab of the garage floor. These cracks vary in size and location, which may indicate underlying movement or stress within the slab. While they do not currently appear to significantly impact the structural integrity, their presence suggests potential early-stage deterioration.

It is recommended that the cracks be monitored closely over the next 12 months. If any of the cracks widen or worsen during this period, it is critical to engage a structural engineer immediately to assess the situation and recommend appropriate rectification measures to prevent further damage and ensure the long-term stability of the structure.

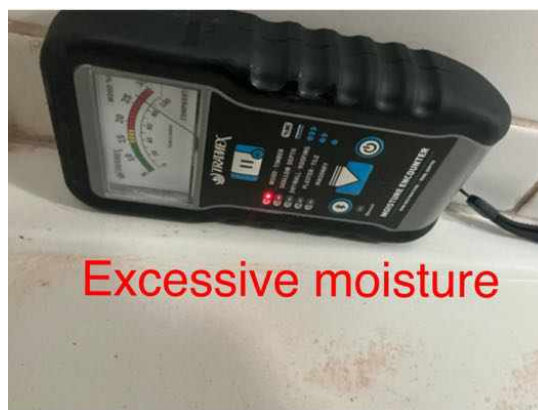
Defects 3.02

Building:	Main Building
Location:	Ensuite - Master
Finding:	Shower - Damp
Information:	Damp is evident to the lower 300mm of wall to the shower alcove. This defect is quite common, and is suspected to have been caused by moisture permeating through the grouting in this area, which shows evidence of deterioration. Leaking pipes within the adjoining wall is also a possible cause.

Unmanaged damp in the shower recess is likely to facilitate the formation and development of mould and fungi growth, decaying associated building materials and compromising their structural integrity. It is important to address damp conditions, as the World Health Organisation notes that excess moisture leads - on almost all indoor materials - to growth of microbes such as moulds, fungi and bacteria, which subsequently emit spores and other matter into the indoor air. Exposure to these contaminants is associated with a wide range of respiratory and other health-related problems.

Consultation with a qualified plumber or bathroom specialist is advised immediately to identify the cause of damp and to perform remedial works as required. Where excessive mould growth is present, further inspection by a specialist environmental health inspector should also be considered.

Always ensure that sealant and grout is in good condition to prevent any moisture issues occurring in the future.

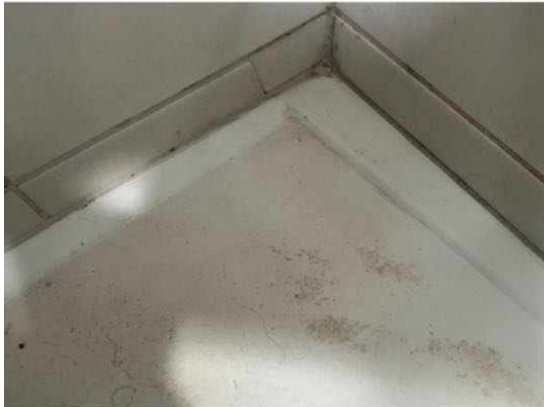
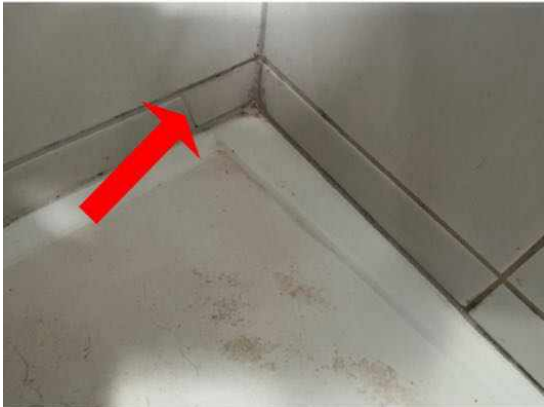
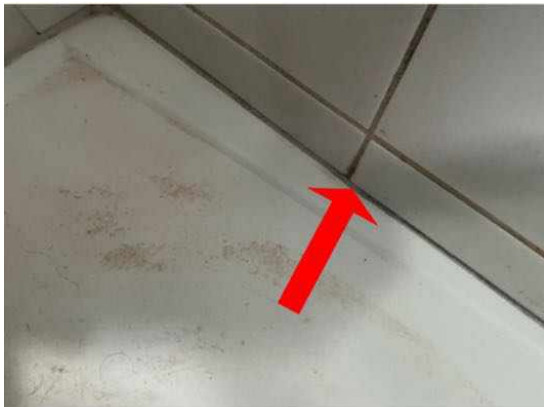
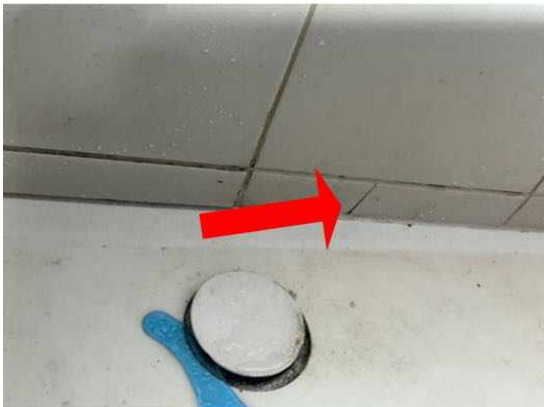
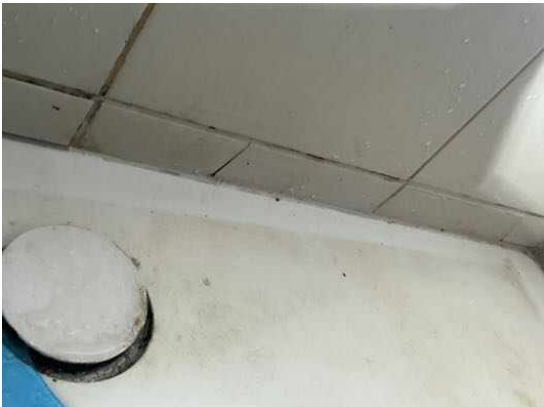
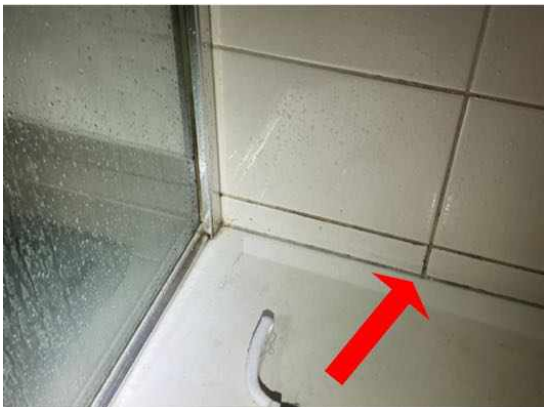
Defects 3.03

Building: Main Building
 Location: Ensuite - Master
 Finding: Sealant and grouting - Deteriorated
 Information:

It was noted at the time of inspection that sealant and/or grout is degraded to the tiled shower alcove and other areas of the bathroom. Different materials and floor areas move at different rates, generally causing cracking to grout or sealant at junctions and perimeters. A flexible sealant is required at movement joints to allow for expected expansion and contraction while maintaining a watertight seal and protecting associated building materials.

There appears to be excessive mould present to sections of the sealant and grout, which will likely require complete removal and replacement. In addition, a number of cracked tiles were observed within the shower area. It appears these cracked tiles have been filled or patched with grout rather than being properly replaced. Grouting over cracked tiles is not considered an appropriate repair method, as it does not restore the structural integrity or waterproof performance of the tiled surface. These cracked tiles should be removed and replaced without delay to prevent potential water ingress and further deterioration of the substrate or waterproof membrane.

Flexible, mould-resistant sealant materials should be applied to all affected movement joints following proper preparation of the surfaces. All deteriorated grout should be removed and replaced as required. Regular inspection, maintenance and timely replacement of damaged or missing sealant and grout is strongly recommended in wet areas, as this is considered a common wear-and-tear item. A qualified tiling contractor or sealant specialist should be engaged to undertake these rectification works as soon as practicable to minimise the risk of water damage.

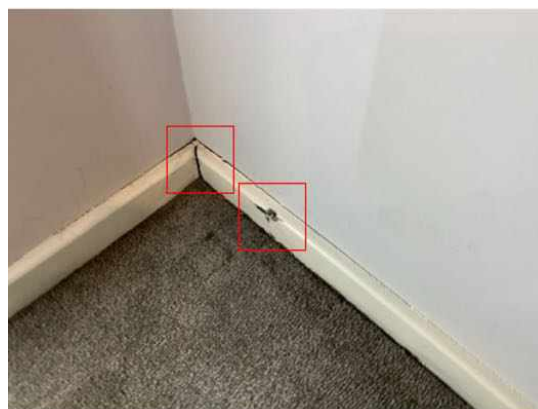
Defects 3.04

Building: Main Building
Location: Bedroom - Master
Finding: Possible Moisture Damage and Concealed Mould – Master Bedroom Wall Adjacent to Ensuite Shower

At the time of inspection, the lower section of the wall and skirting board within the master bedroom, directly adjacent to and behind the ensuite shower, exhibited staining and visual irregularities consistent with possible past moisture ingress. The base of the skirting board showed markings suggestive of potential mould growth. It appears that water may have previously penetrated from the adjoining shower area into the wall assembly. Non-invasive moisture testing conducted at the time of inspection did not record elevated moisture levels; however, this does not exclude the possibility of prior moisture exposure that has since dried.

As this was a visual, non-invasive inspection, no destructive testing or removal of finishes was undertaken. Concealed areas such as behind the skirting boards, within the wall cavity, behind plasterboard linings, insulation, or beneath the adjacent carpeted flooring could not be accessed. Accordingly, the presence of concealed mould growth, timber decay, or deterioration of the waterproofing membrane cannot be confirmed or ruled out. Visual indicators suggest that further investigation is warranted.

It is strongly recommended that a registered builder conduct an invasive inspection of the affected wall section, including removal of the skirting board and selective opening of the wall lining to inspect framing, insulation, and waterproofing integrity. If mould is identified, remediation should be undertaken by a qualified mould remediation specialist. Prompt investigation and rectification are advised to prevent potential ongoing structural deterioration or internal environmental issues.

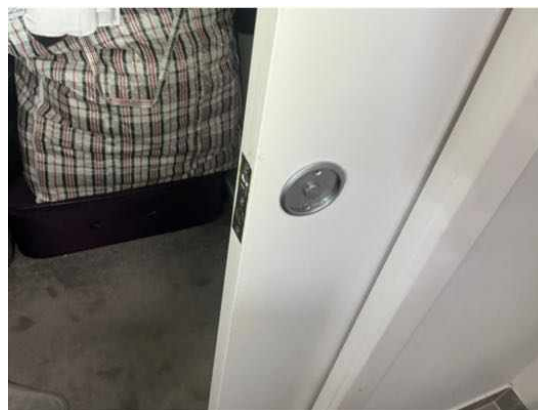
Defects 3.05

At the time of inspection, the sliding door separating the master bedroom and master ensuite was observed to be restricted in operation and did not open fully. The door travelled only approximately halfway along its track before stopping. This condition may be due to track misalignment, obstruction, hardware wear, roller failure, or frame distortion.

Restricted operation may result in inconvenience, reduced functionality of the room layout, and potential ongoing wear to door hardware if force is applied during use. Continued use in its current condition may lead to further deterioration of the track, rollers, or door frame components.

It is recommended that a qualified carpenter undertake adjustment, repair, or replacement of the sliding door hardware and track components as required to restore full and proper operation. Rectification should be carried out in a timely manner to prevent further damage to associated components.

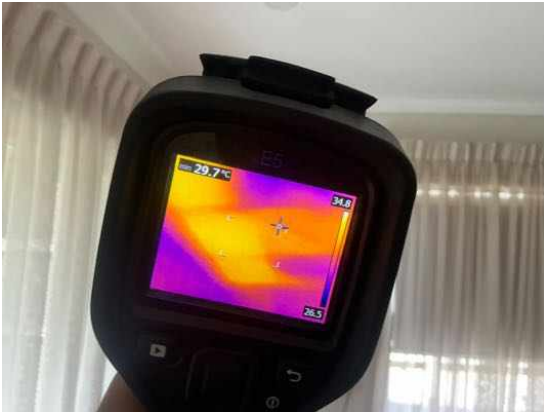
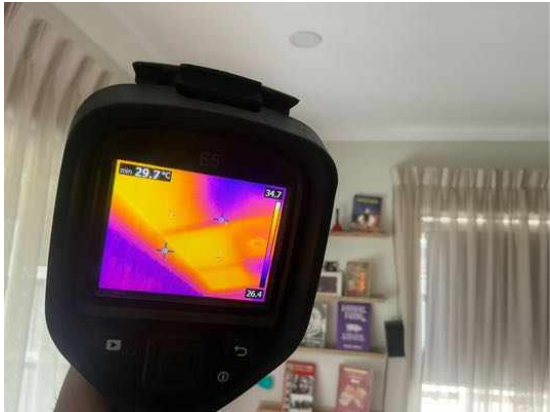
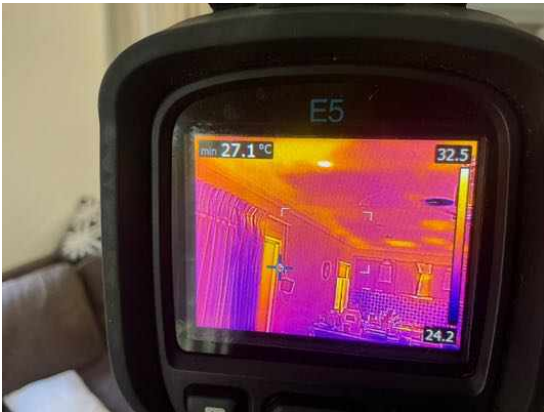
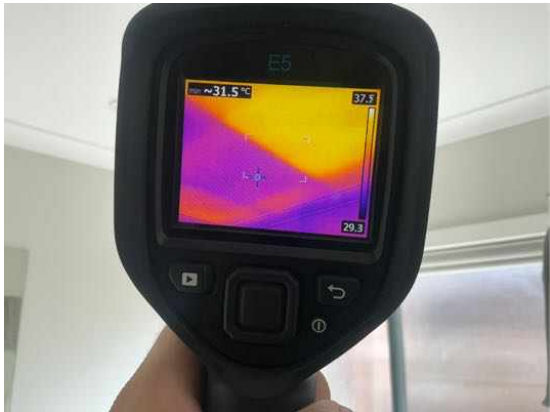
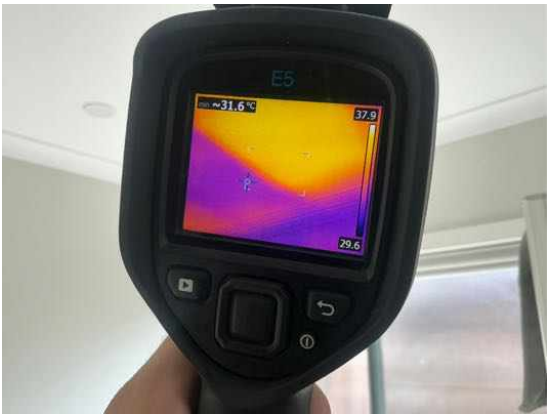
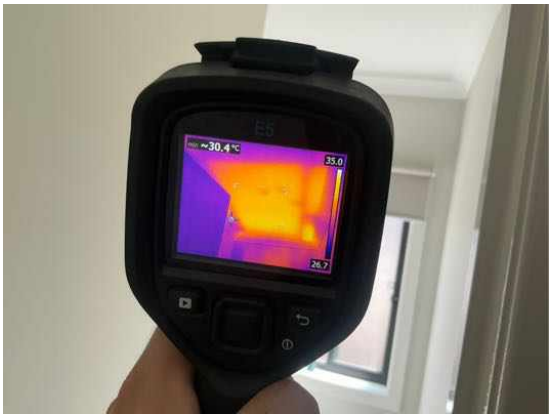
Defects 3.07

Building: Main Building
 Location: All Internal Areas
 Finding: Inconsistent Thermal Performance to Ceiling Areas – Suspected Insulation Deficiencies
 Information: Thermal imaging conducted to internal ceiling areas at the time of inspection identified inconsistent heat patterns, which are indicative of variations in thermal performance across the roof space. These patterns are commonly associated with areas of missing, displaced, or insufficient insulation above the ceiling linings.

Inadequate or uneven insulation coverage can reduce the energy efficiency of the dwelling, contribute to heat loss in cooler periods and heat gain in warmer conditions, and may result in reduced occupant comfort and increased heating and cooling costs. Due to the non-invasive nature of the inspection, the exact extent and condition of insulation could not be confirmed visually in all affected areas.

It is recommended that a qualified insulation contractor inspect the roof space, assess insulation coverage and condition, and top up or reinstate insulation where required to achieve consistent thermal performance throughout the property.

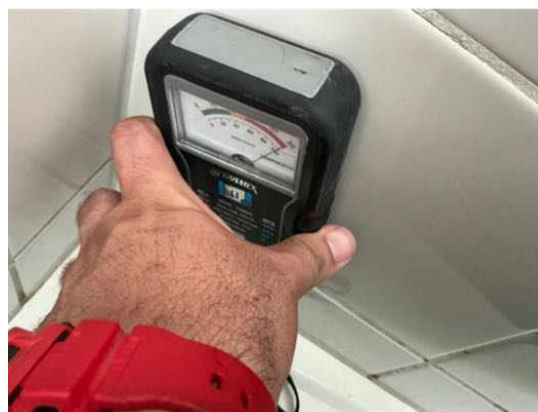
Defects 3.08

Information: Damp is evident to the lower 300mm of wall to the shower alcove. This defect is quite common, and is suspected to have been caused by moisture permeating through the grouting in this area, which shows evidence of deterioration. Leaking pipes within the adjoining wall is also a possible cause.

Unmanaged damp in the shower recess is likely to facilitate the formation and development of mould and fungi growth, decaying associated building materials and compromising their structural integrity. It is important to address damp conditions, as the World Health Organisation notes that excess moisture leads - on almost all indoor materials - to growth of microbes such as moulds, fungi and bacteria, which subsequently emit spores and other matter into the indoor air. Exposure to these contaminants is associated with a wide range of respiratory and other health-related problems.

Consultation with a qualified plumber or bathroom specialist is advised immediately to identify the cause of damp and to perform remedial works as required. Where excessive mould growth is present, further inspection by a specialist environmental health inspector should also be considered.

Always ensure that sealant and grout is in good condition to prevent any moisture issues occurring in the future.

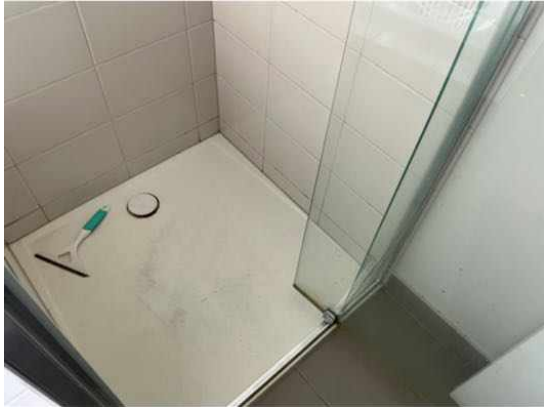
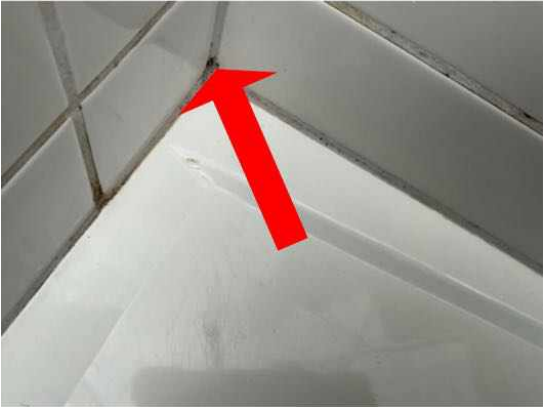
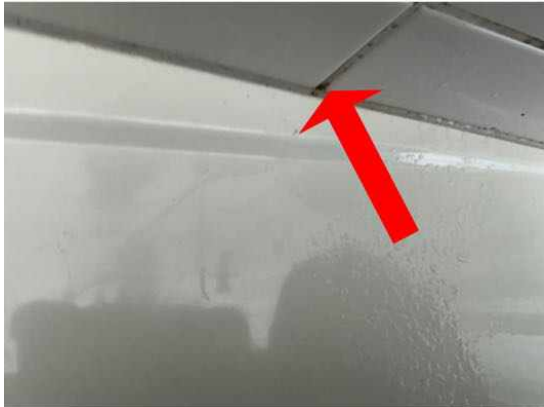
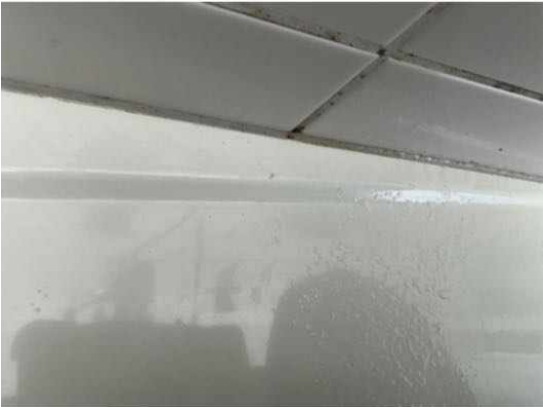
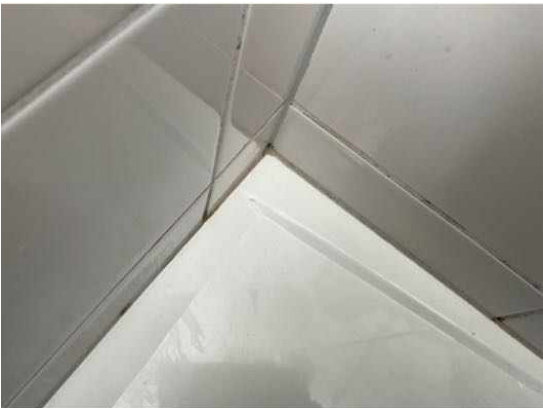
Defects 3.09

Building:	Main Building
Location:	Bathroom 2
Finding:	Sealant and grouting - Deteriorated
Information:	It was noted on inspection that sealant or grout is degraded to the tiled shower alcove and or other areas of the bathroom.

Different materials and floor areas move at different rates, generally causing cracking to grout or sealant at this point. A flexible sealant is required to allow for expected expansion and contraction, while keeping the joint water tight and protective of all associated building materials.

There appears to be minor mould to the sealant and grout which will likely require scraping out and replacement.

Flexible and mould resistant materials should be applied to affected areas to prevent any subsequent water damage that is likely to occur. Regular maintenance and replacement of damage or missing or damaged sealant and grout is highly recommended to the wet areas, as this is a regular wear and tear defect. Sealant and grouting in areas that come into regular contact with water should be maintained for the long term care of your property.

A sealant specialist or tiling contractor should be appointed to complete these works as soon as possible

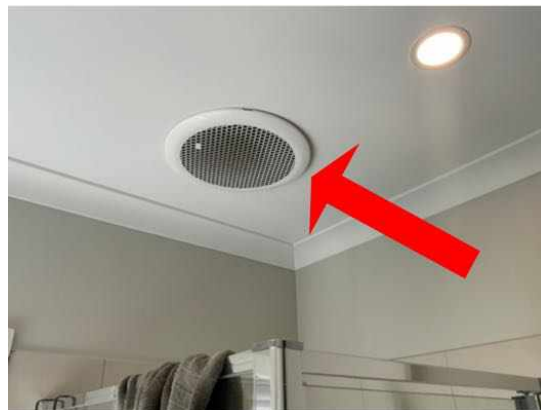
Defects 3.11

This issue may reduce the efficiency of the exhaust fan, leading to inadequate ventilation in the en-suite, which could contribute to moisture buildup and potential issues such as mold or mildew growth. A noisy fan is also generally less effective at expelling humid air, which could affect the overall air quality and comfort of the space.

It is recommended that a qualified technician inspect and service the exhaust fan to determine the cause of the noise. If necessary, the fan should be repaired or replaced to restore proper ventilation and ensure the en-suite remains well-ventilated and free of excess moisture.

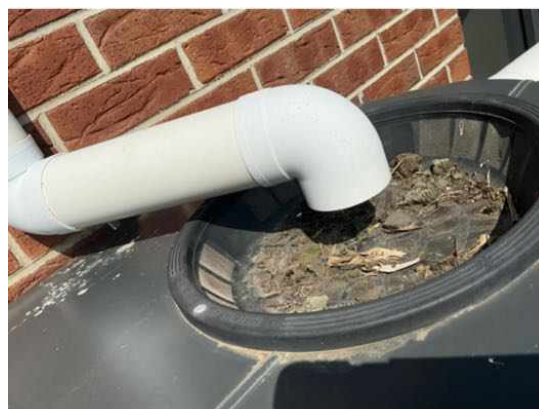
Defects 3.15

Building:	Main Building
Location:	Watertank
Finding:	Partially Blocked water tank inlet
Information:	The water tank inlet is currently partially blocked by an accumulation of grass, weeds, and rubbish. This obstruction hinders the proper flow of water into the tank, which can lead to reduced water capacity, contamination, and potential damage to the tank system. Immediate removal of the debris and regular maintenance are required to restore the water tank's functionality and prevent further issues.

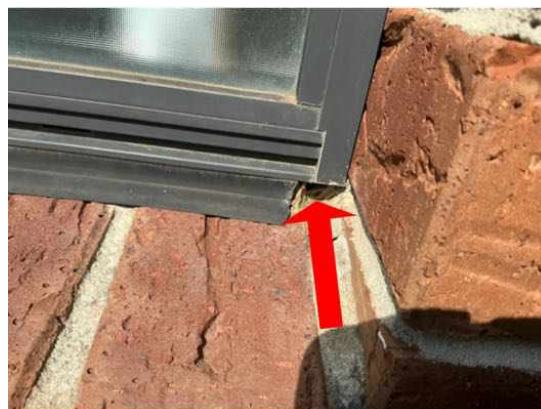
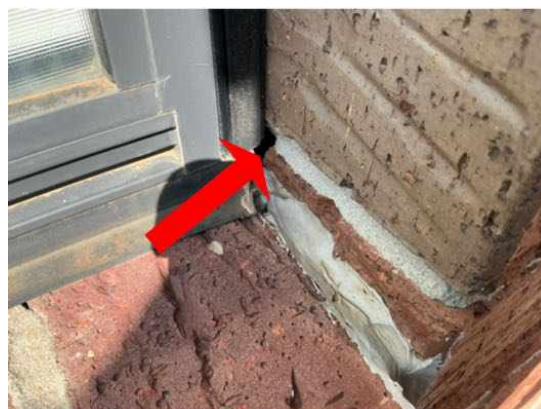
may also contribute to internal dampness and premature deterioration of surrounding building elements.

A qualified handyman or registered builder should apply a consistent, waterproof, flexible exterior-grade sealant around all affected windows to ensure adequate weatherproofing and protection against moisture and pest entry.

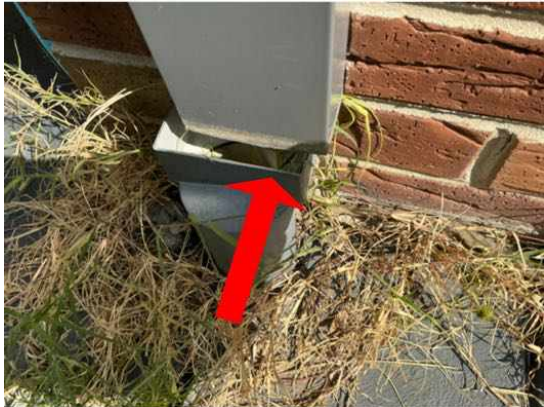
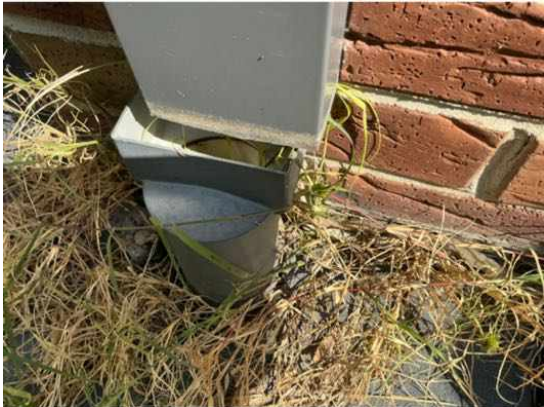
Defects 3.17

Building: Main Building
 Location: All External Areas
 Finding: Disconnected Downpipes – Stormwater System
 Information:

At the time of inspection, downpipes around the perimeter of the dwelling were observed to be detached from their respective stormwater drainage connections. The disconnections appear likely to have occurred due to ground movement or settlement affecting the underground pipework.

Disconnected downpipes may discharge roof water directly adjacent to the foundation, which can contribute to soil saturation, differential movement, and potential structural issues over time. Uncontrolled surface discharge may also cause localised erosion and moisture-related deterioration of adjacent building elements.

It is recommended that a licensed plumber reconnect the affected downpipes to the

stormwater drainage system and inspect the underground connections for movement or damage. Rectification should be undertaken as soon as practicable to ensure proper drainage of roof water away from the dwelling.

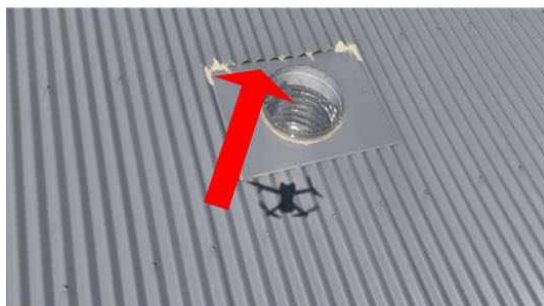
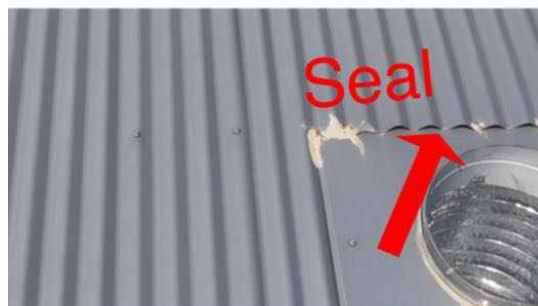
Defects 3.19

Building: Main Building
 Location: Roof Exterior
 Finding: Inadequate Sealant – Skylight Flashing (Roof Exterior)
 Information:

At the time of inspection of the external roof surface, the sealant application around the skylight flashing was observed to be inadequate and inconsistent in areas. Sections appear to have insufficient coverage, which may compromise the weatherproofing integrity of the flashing junction.

Inadequate sealing around roof penetrations such as skylights may increase the risk of water ingress, particularly during heavy or wind-driven rain events. Over time, moisture entry at flashing junctions may lead to deterioration of roof framing, ceiling linings, insulation, and associated building elements.

As an advisory measure, it is recommended that a qualified roofing contractor inspect the skylight flashing in detail and properly reseal all perimeter junctions using appropriate external-grade roofing sealant. Preventative rectification is advised to minimise the risk of future moisture penetration.

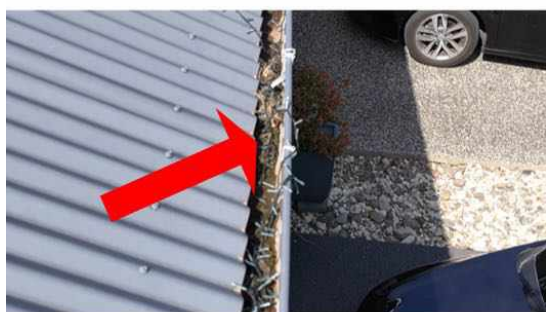
Defects 3.21

Blocked gutters are likely to lead to high levels of moisture in the affected areas. Such moisture will not only cause rust and decay of the associated building materials, but can also provide conditions that are conducive to termite and timber pest activity. Blockages in gutters should therefore be removed immediately to ensure dry conditions are maintained.

Consult a Licensed Plumber for further specific advice on remedial works that may be required. In the interim, it is highly advised that blocked gutters be removed by the homeowner or a general handyperson as a matter of urgency.

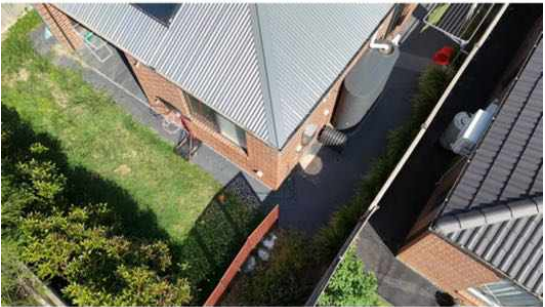
Building: Main Building
 Location: All External Areas
 Finding: Obstructions and Limitations - Exterior
 Information: These photographs are an indication of the obstructions and limitations which impeded the inspection of the external areas of the property at the time of inspection. These obstructions can hide an array of defects and should be removed to allow full inspection to be carried out. A re-inspection is recommended once the areas are made accessible.
