Building and Timber Pest Inspection Report

Inspection Date: Tue, 24 Feb 2026

Property Address: 20 Pettitt St, Riverstone NSW 2765,
Australia

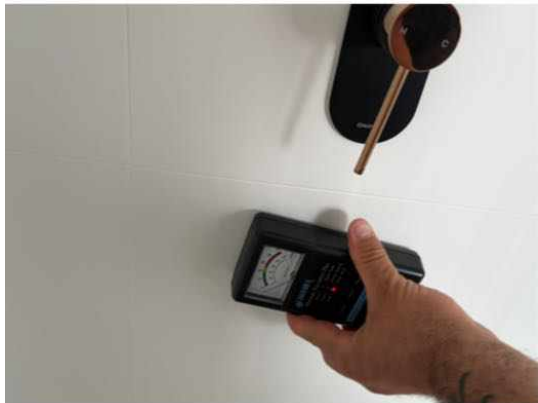
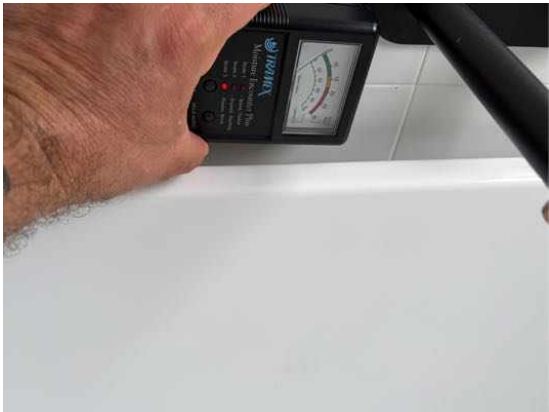
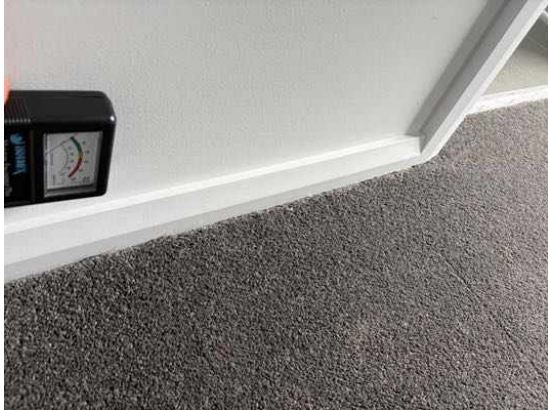
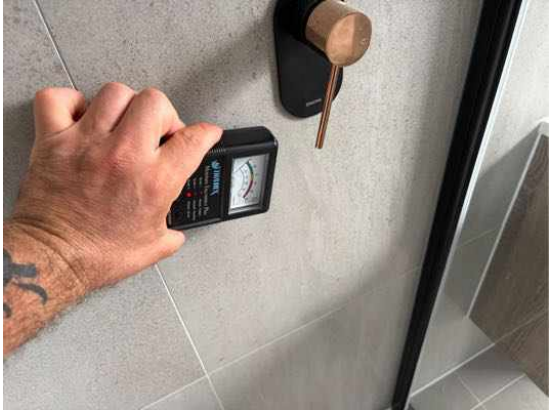
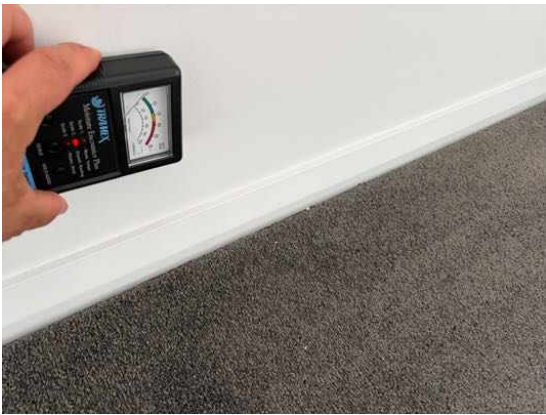
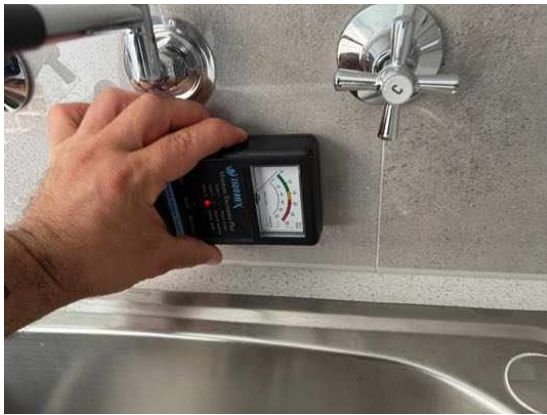
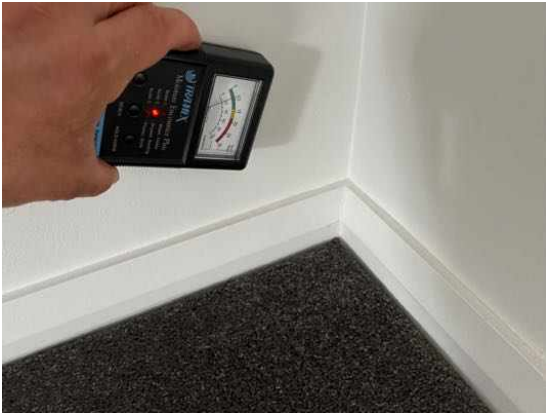
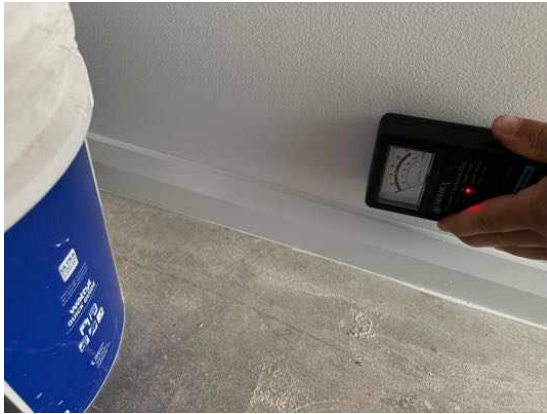
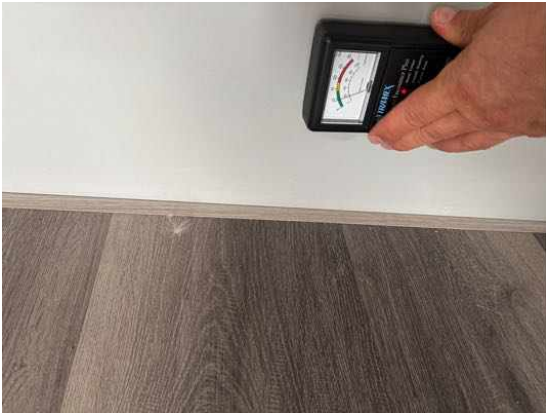
Building: Main Building
Location: All Areas
Finding: Moisture metre
Information: During the inspection the property was checked for moisture using a moisture metre.

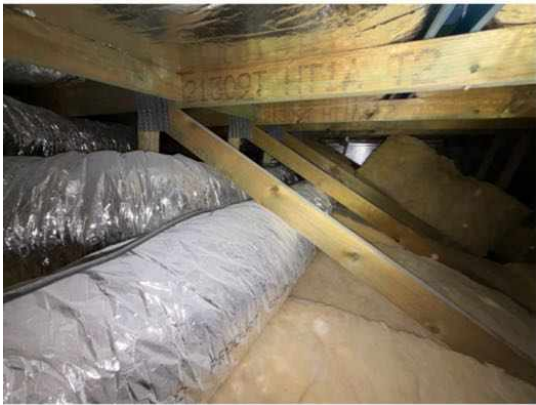
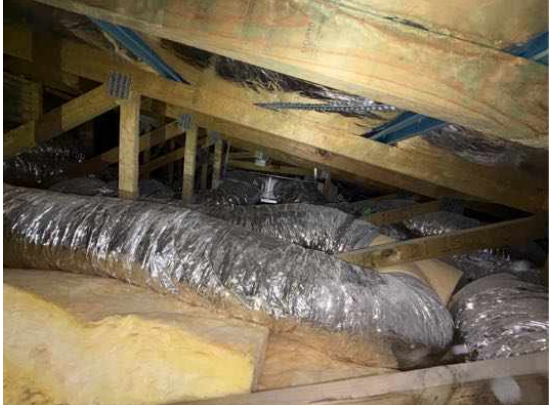
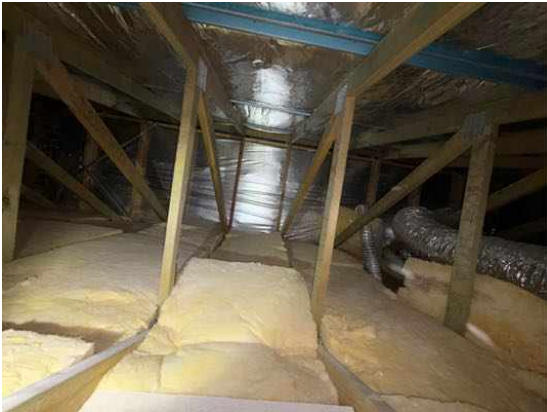
Building: Main Building
Location: Roof Void
Finding: Additional Photos
Information:

Additional photos are provided for your general reference.

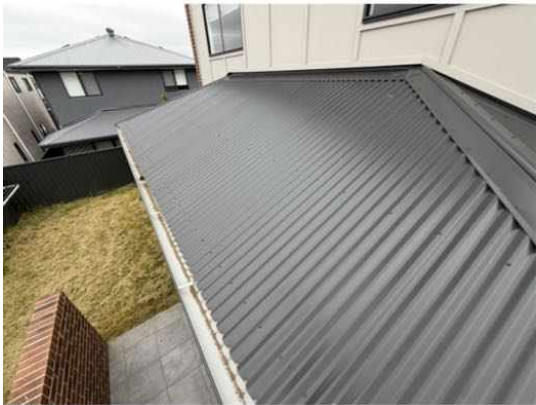
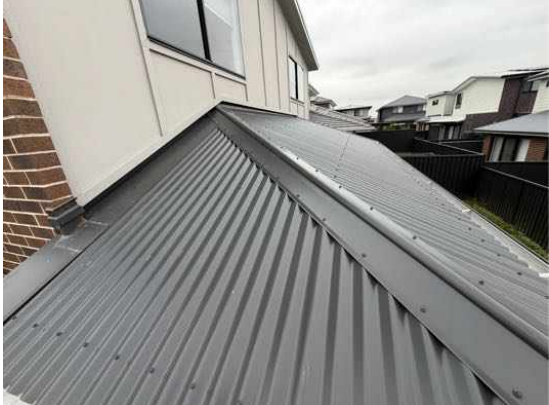
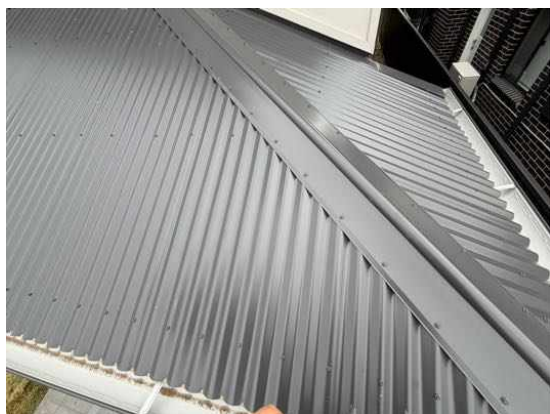
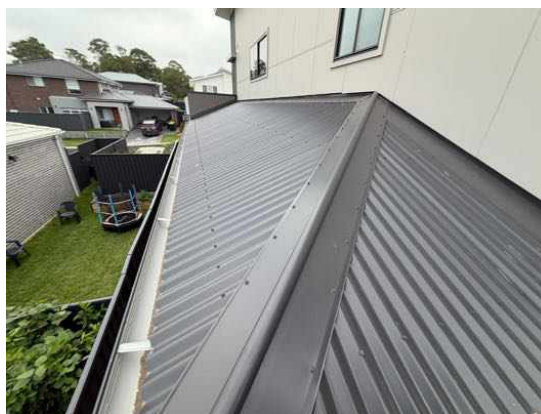
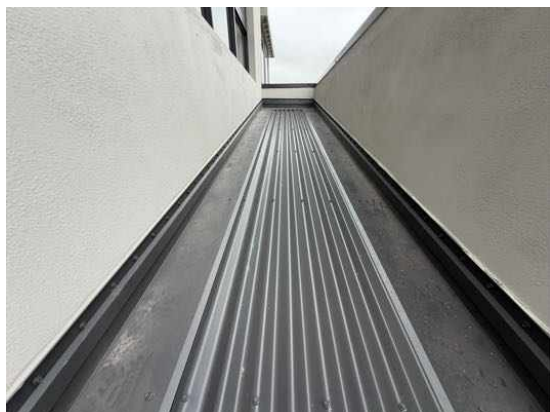
Building: Main Building
Location: Roof Exterior
Finding: Additional Photos
Information:

Additional photos are provided for your general reference.

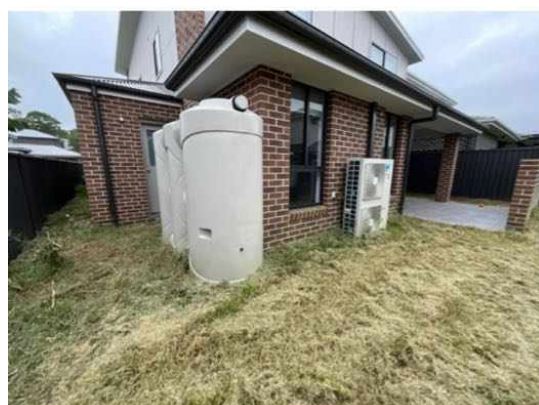
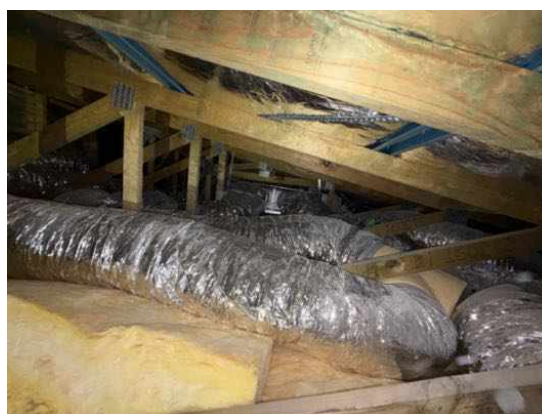
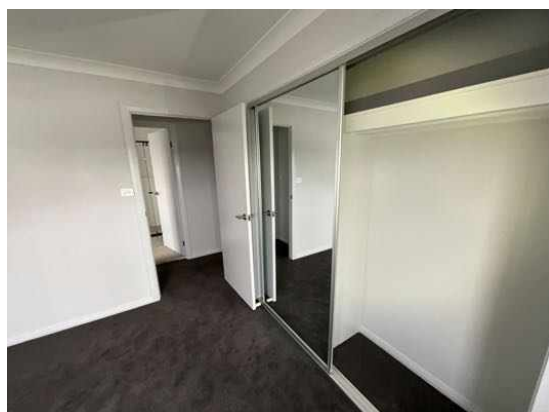
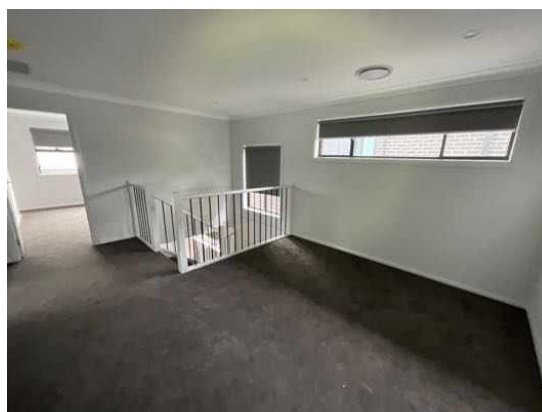
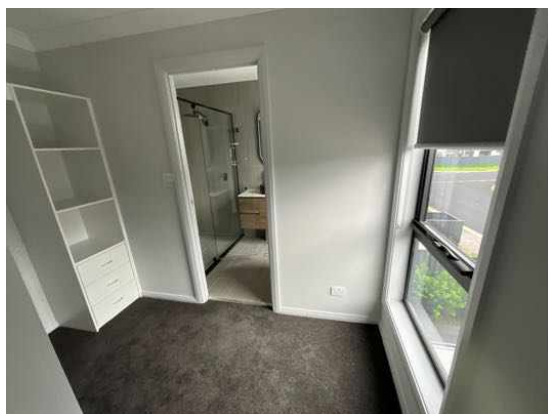
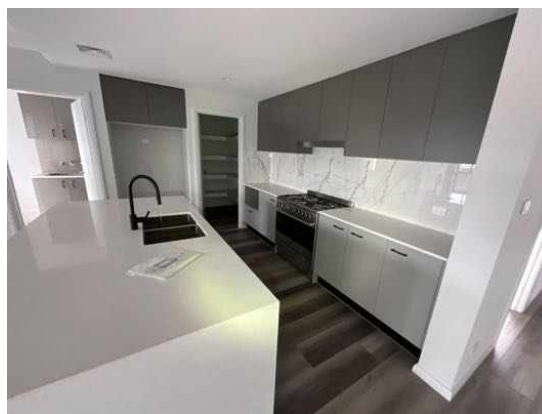
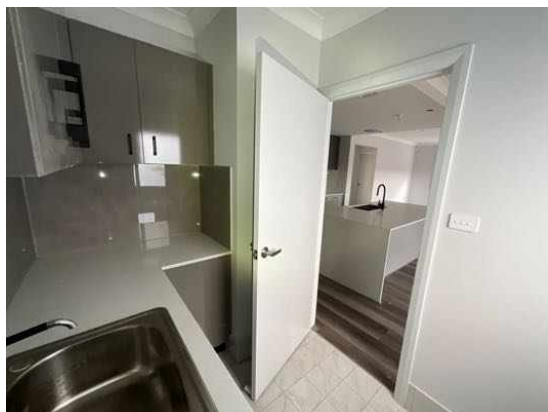
Building: Main Building
Location: All Areas
Finding: Additional Photos - Obstructions and Limitations
Information:

These photographs are an indication of the obstructions and limitations which impeded full inspection of the property at the time of inspection. These obstructions can hide an array of defects and should be removed to allow full inspection to be carried out. A re-inspection is recommended once the areas are made accessible.

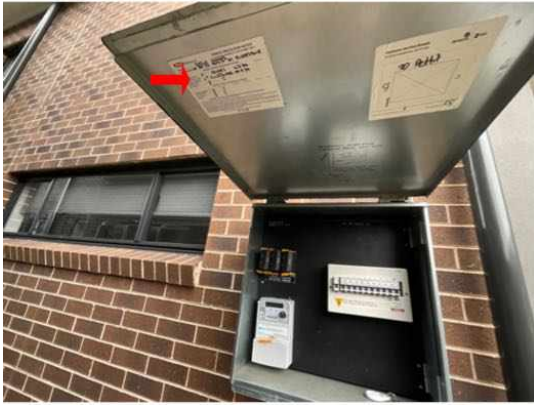
Where a Termite Management System has been identified you should refer to the type of barrier date of installation warranty conditions and any documentation provided by a builder or past owner. Consult the company who installed the barrier to confirm whether the system is still under warranty.

Flick Anticimex **TERMITE PROTECTION NOTICE**
In accordance with BCA 3.1.3 & AS 3660.1: 2014

BUILDER EAGLE HOMES
PROPERTY ADDRESS LOT 55, 20 PETTIT ST, RIVERSTONE
