## Building Inspection Report

Inspection Date: Tue, 24 Mar 2026

Property Address: 62 Calibre Circuit, Clyde North VIC 3978,  
Australia

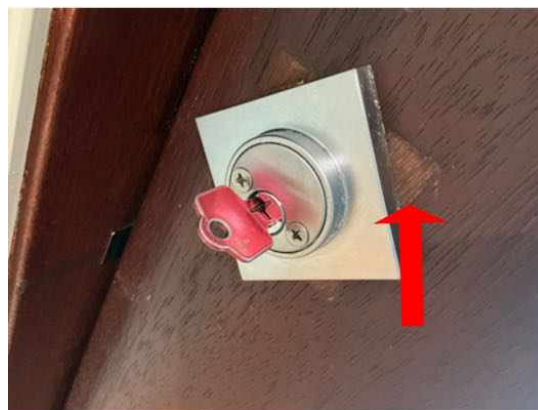
If left unaddressed, this condition may compromise the security of the property and may lead to further loosening or failure of the locking mechanism, potentially preventing proper locking of the entry door.

It is recommended that a qualified locksmith inspect the entry door lock assembly and securely fix or re-install the lock components. Replacement of the lock or associated hardware may be required if the existing unit is found to be defective or worn.

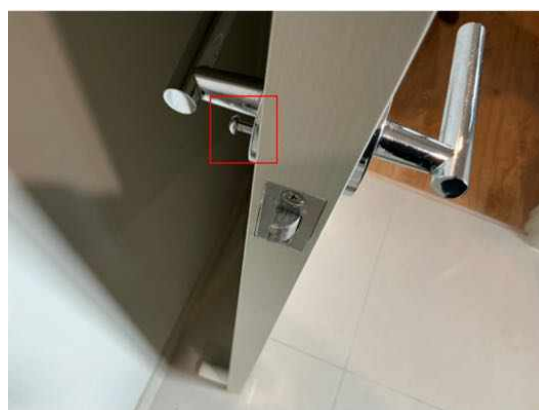
If left unaddressed, the door may fail to latch or lock securely, leading to reduced privacy and potential ongoing wear to the lock and door components due to improper engagement.

It is recommended that a qualified carpenter or handyman realign the door, latch, and striker plate to ensure proper engagement and smooth operation of the locking mechanism.

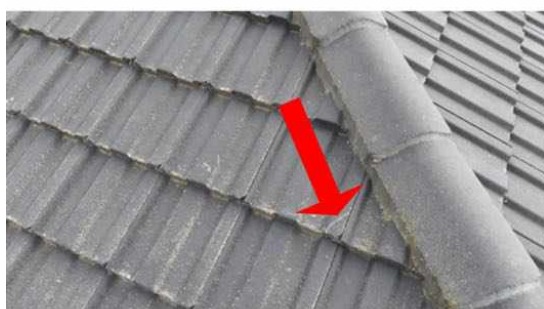
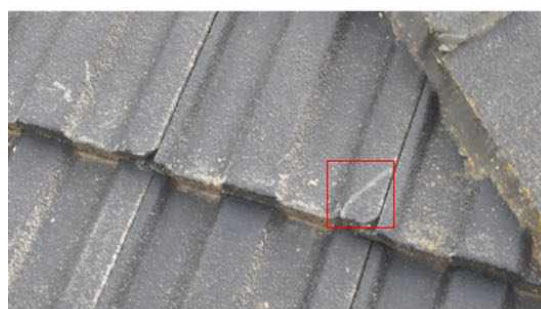
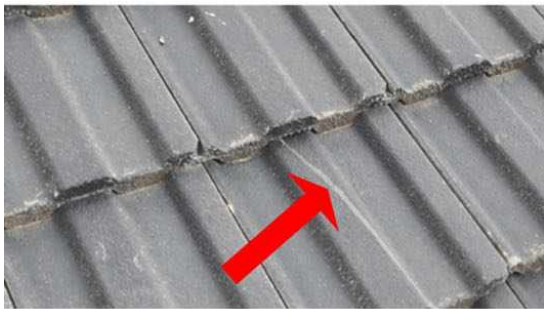
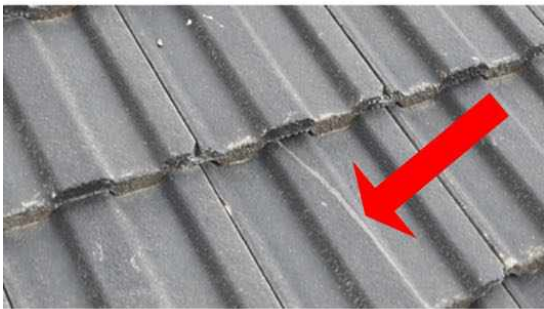
If left to further deteriorate, broken and brittle roof tiles are likely to lead to water penetration via the roof into the ceiling space, causing secondary damage to ceiling linings, insulation and roof structures. Broken roof tiles are also likely to detract from the effectiveness of the roof drainage system, creating potential for secondary damage to the exterior roof covering and roof plumbing.

Replacement of broken tiles is required and should be performed by a roofing contractor as soon as possible.
