Building and Timber Pest Inspection Report

Inspection Date: Tue, 24 Feb 2026

Property Address: 165 Quarry Rd, Ryde NSW 2112, Australia

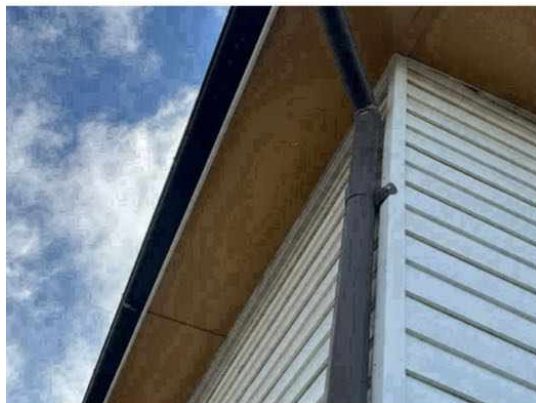
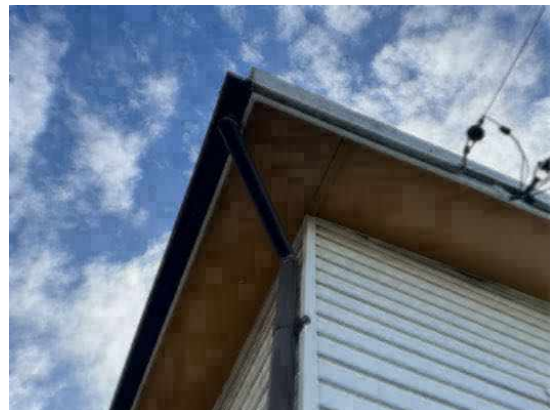
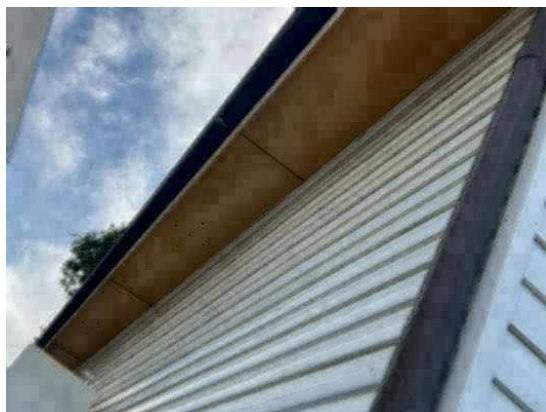
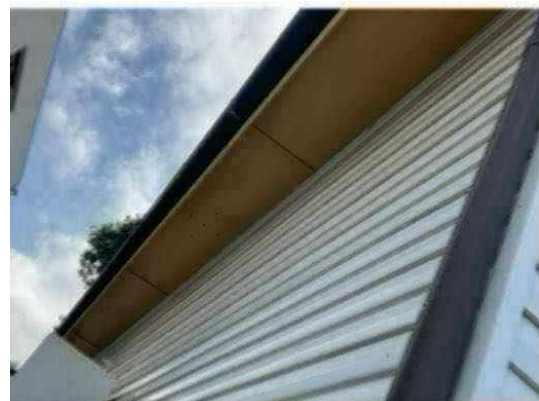
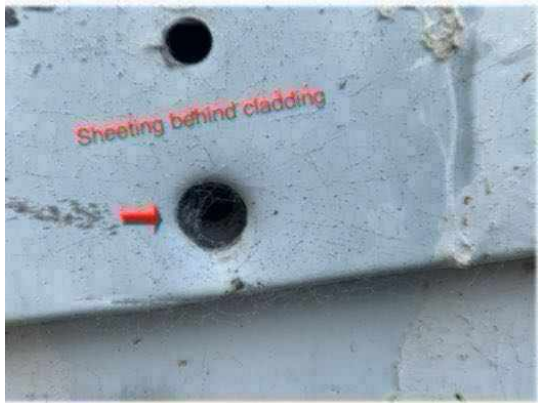
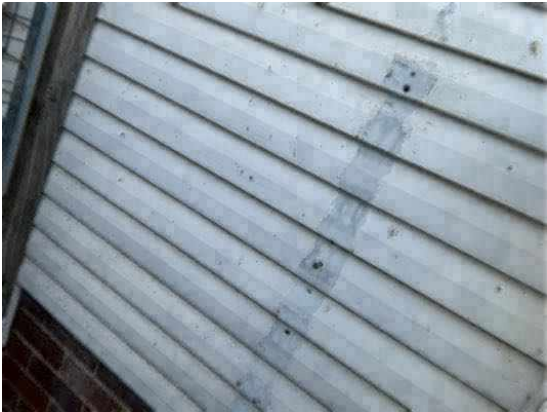
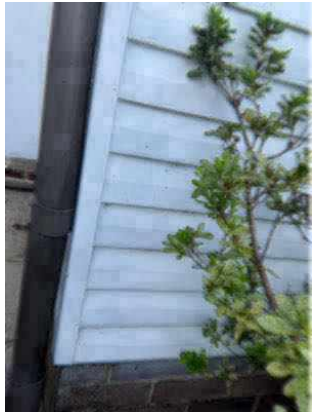
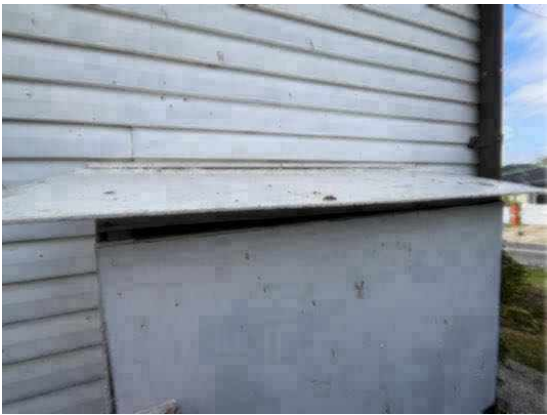
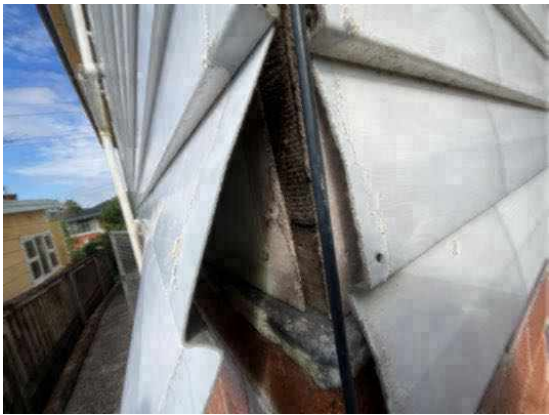
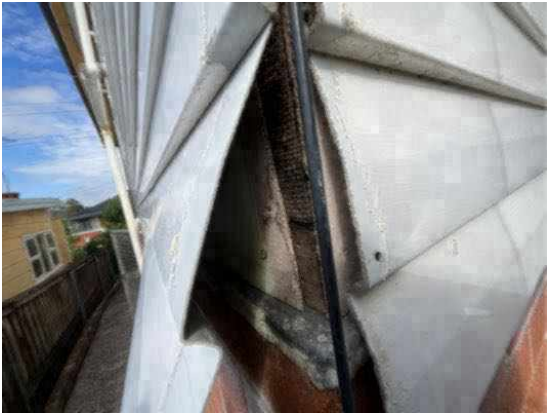
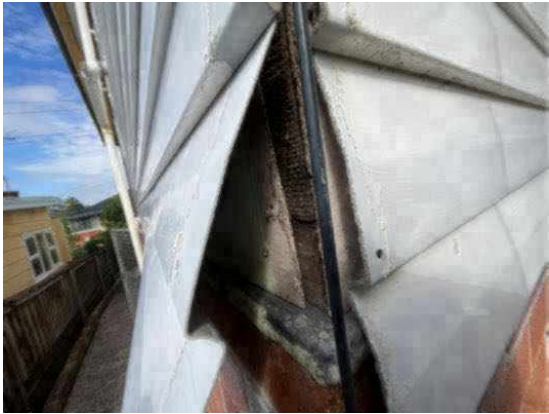
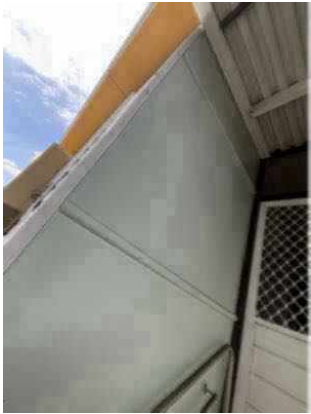
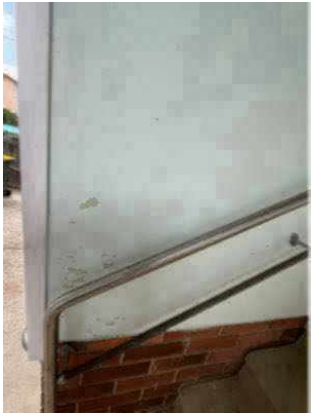
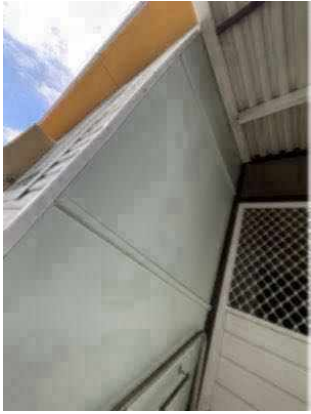
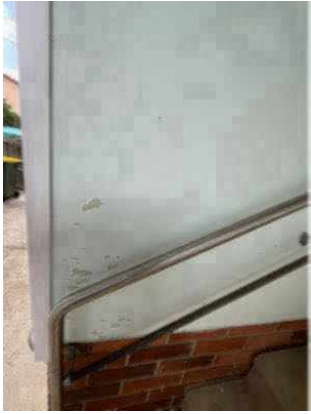
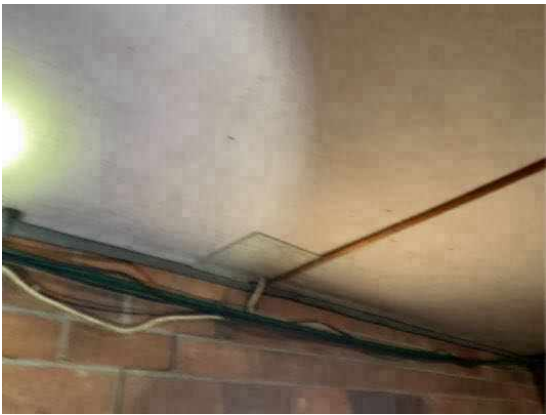
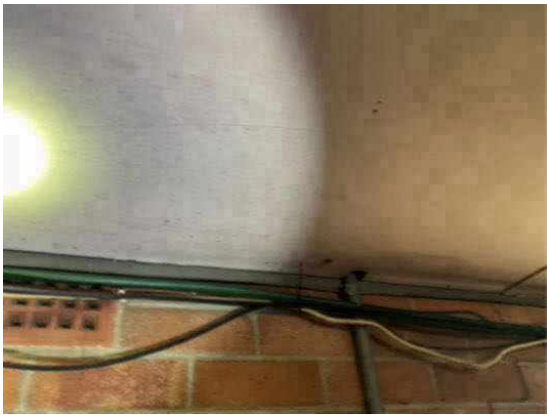
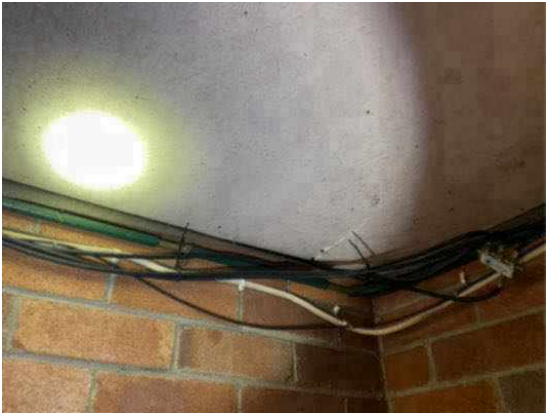
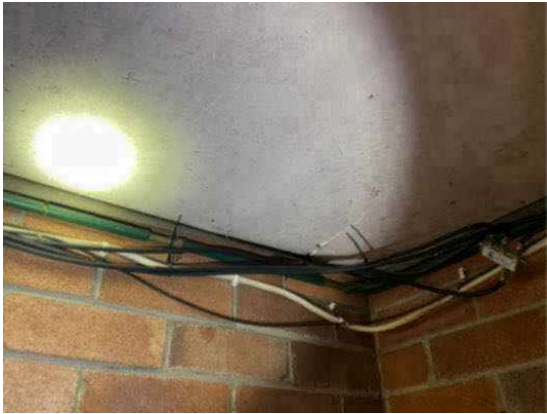
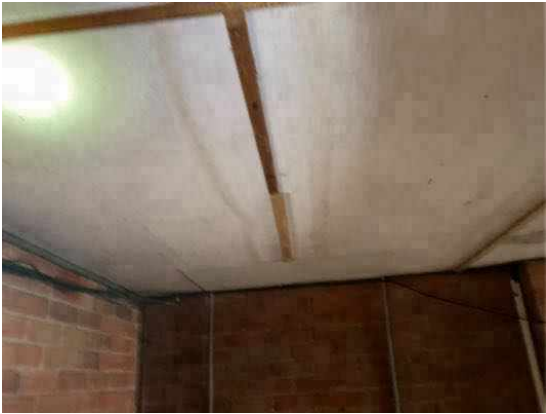
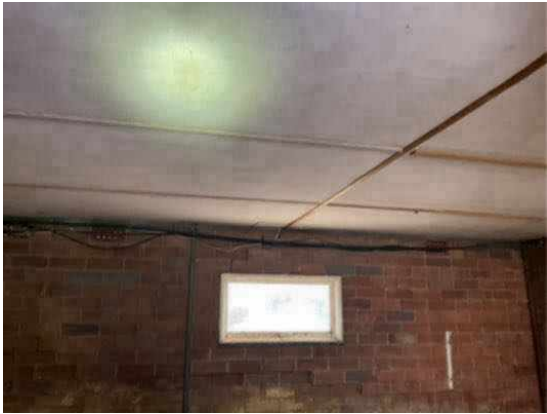
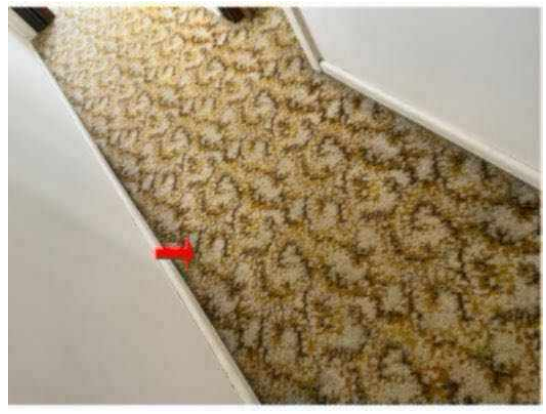
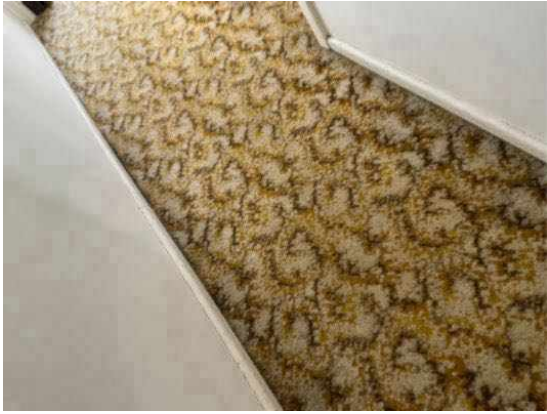
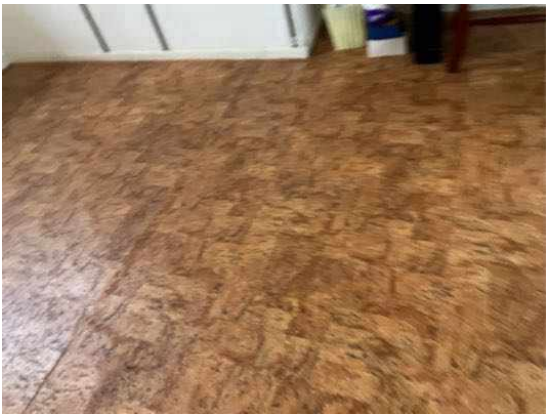
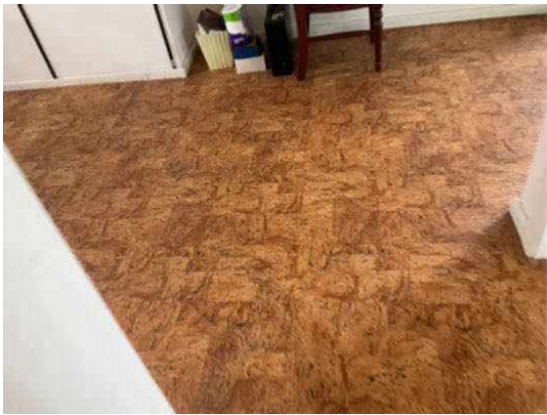
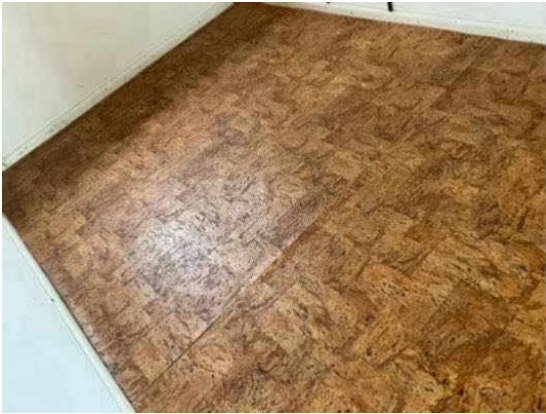
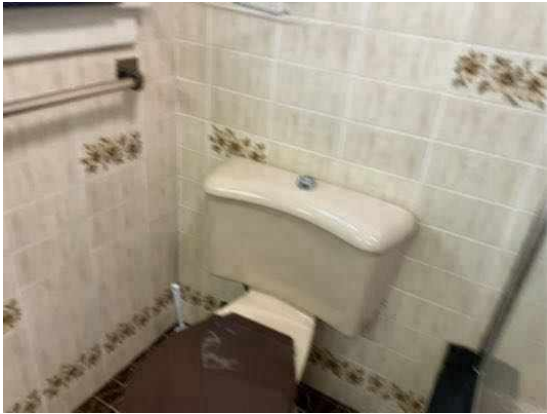
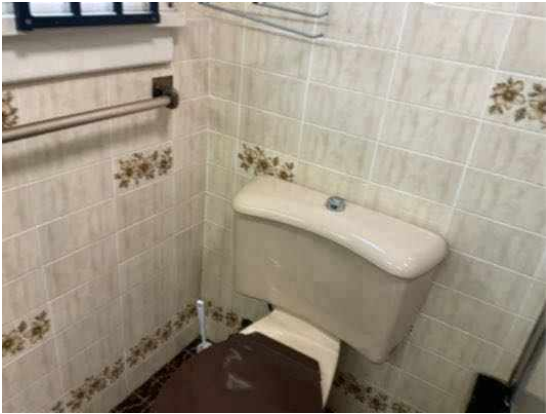
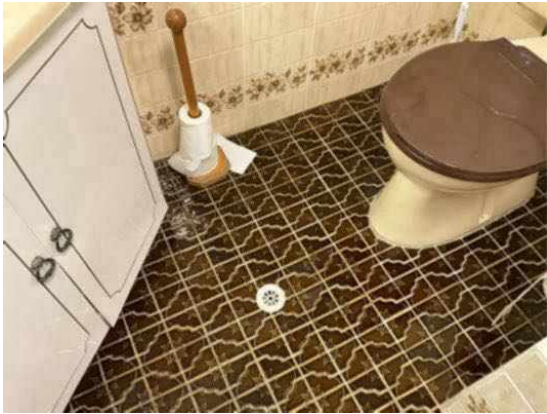
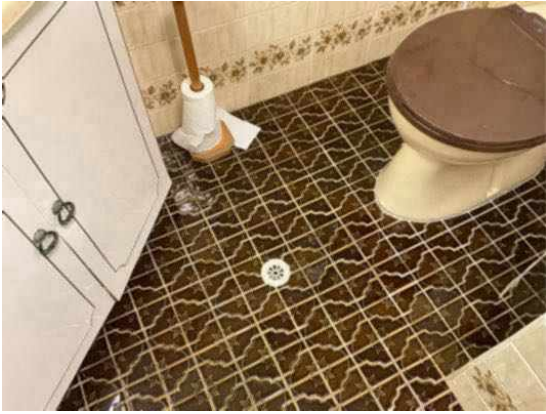
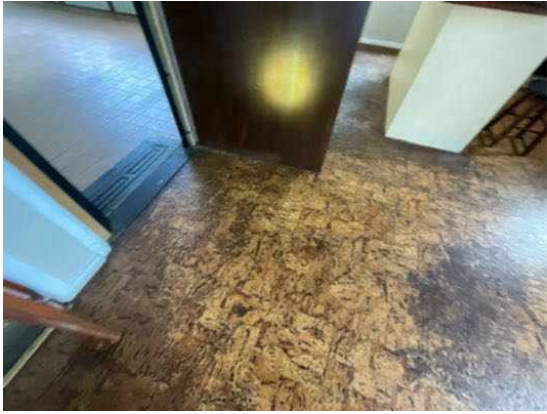
Building:	Main Building
Location:	All Areas
Finding:	Asbestos - Suspected ACM Identified on Site
Information:	Reporting on Asbestos is outside the Scope of this Report. This suspected defect is highlighted as a caution only. We suspect, based on our experience in the building industry, that there is a higher risk of the identified building element containing asbestos.

As Asbestos Reporting is outside the scope of this report, we advise that you consider a separate Asbestos Inspection and Condition Audit, which can include the taking of samples for definitive confirmation of the presence of Asbestos.

In the interim, the client is advised to act with caution, especially when considering any damage to building materials general wear and tear renovations extensions demolition and general maintenance activities due to the suspected presence of Asbestos.

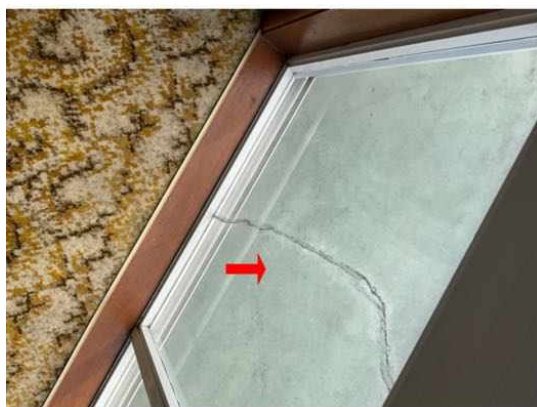
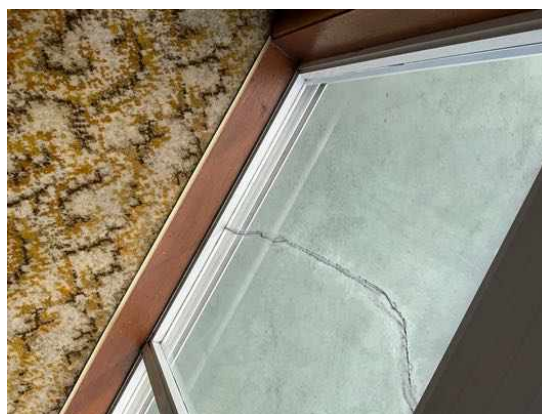
Finding 1.02

Building: Main Building
 Location: Bedroom
 Finding: Broken Glass
 Information: The glass panel is broken, exhibiting cracks and sharp edges.

Risk: The broken glass poses a safety hazard, increasing the risk of injuries due to cuts or lacerations to individuals in the vicinity. Additionally, it compromises the structural integrity of the surface, potentially leading to further damage or accidents.

A qualified glass repair technician or contractor should be contacted to assess the damage and perform the necessary repairs or replacement of the broken glass panel.

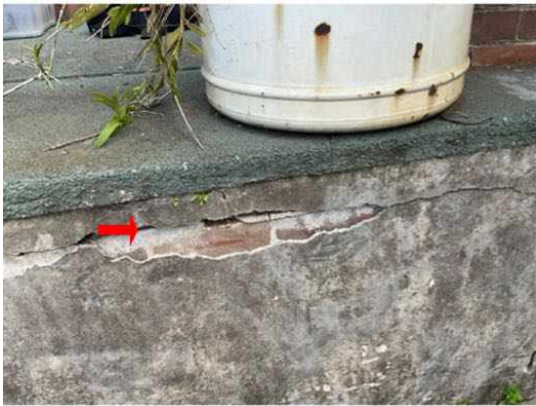
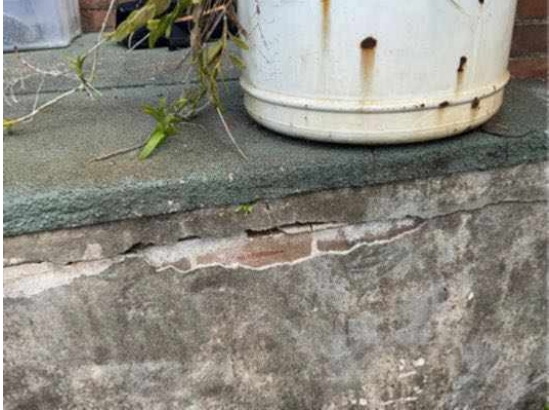
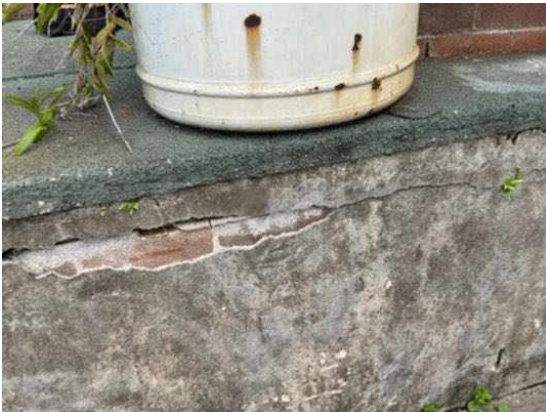
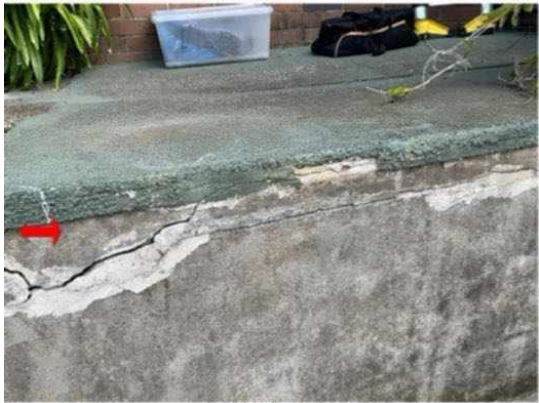
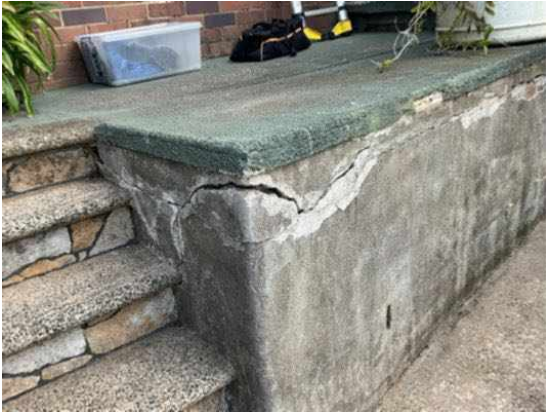
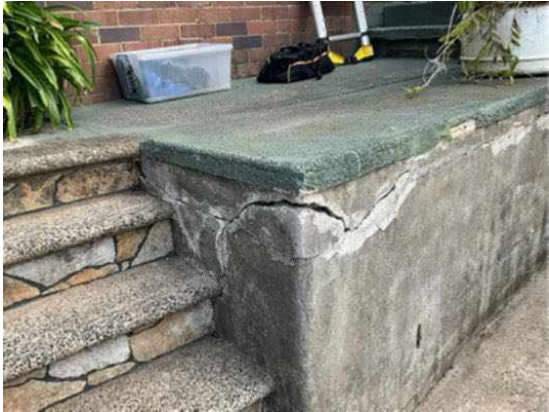
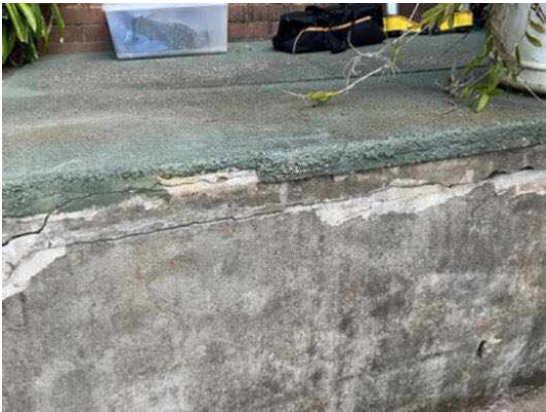
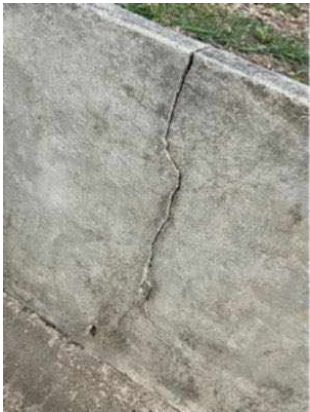
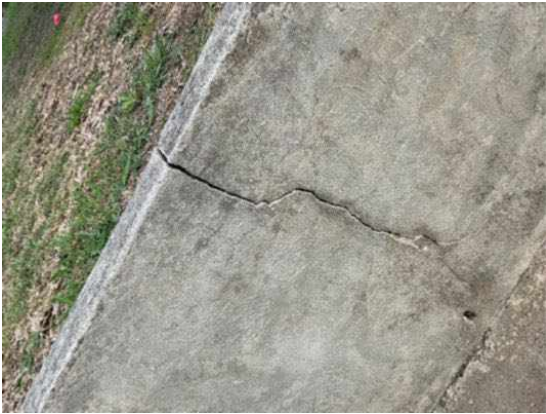
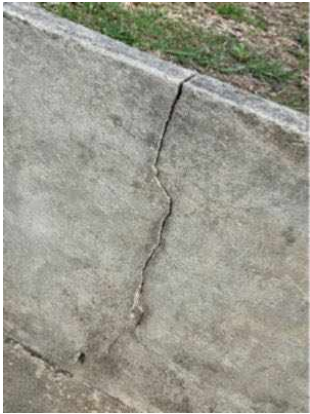
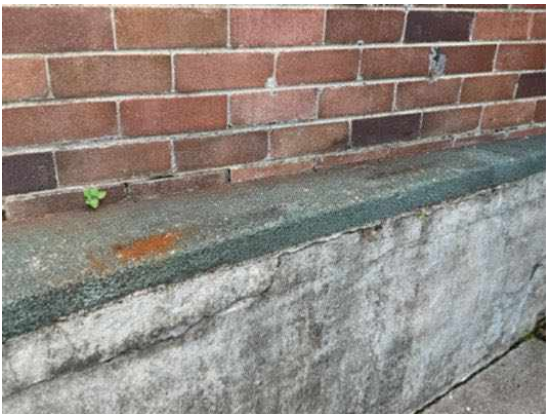
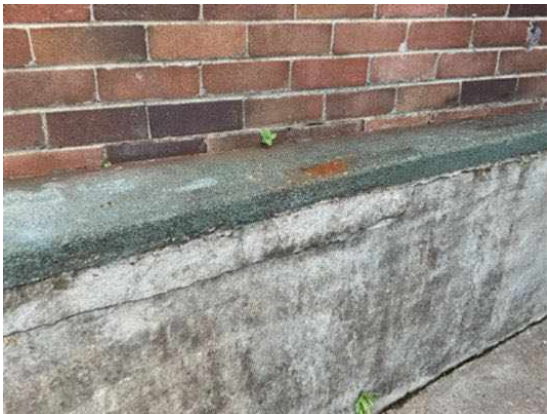
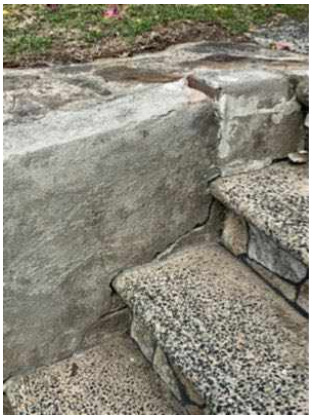
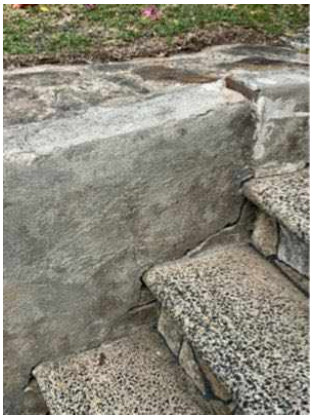
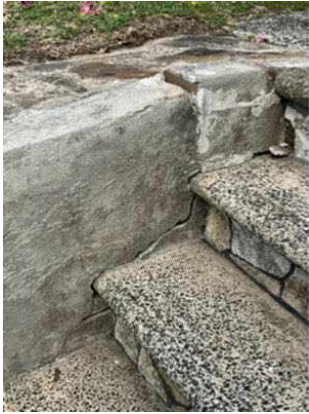
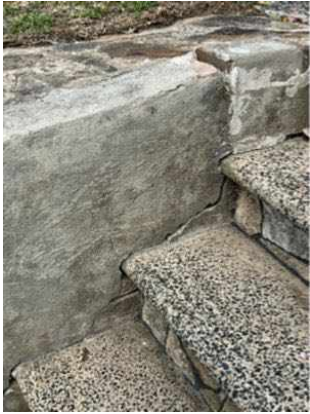
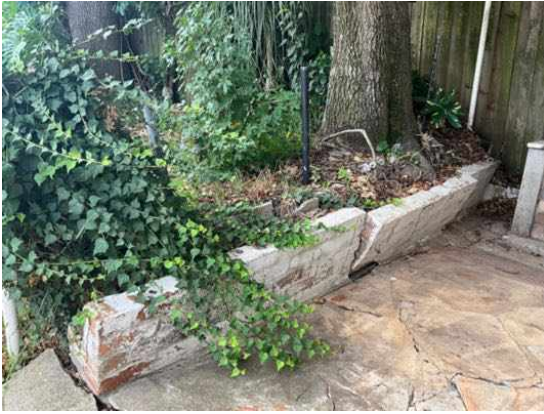
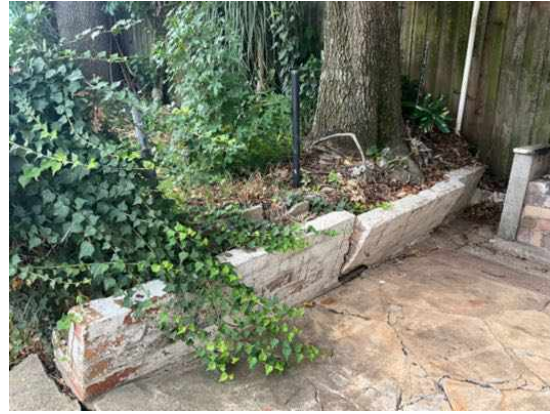
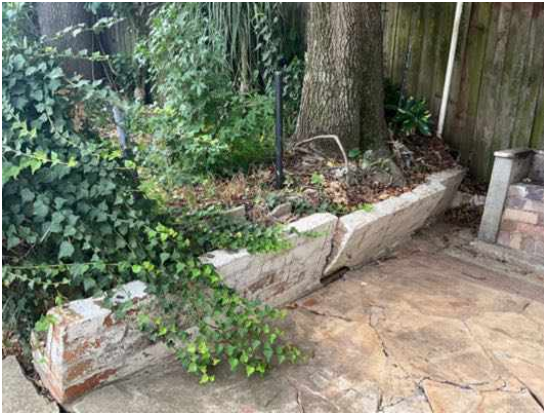
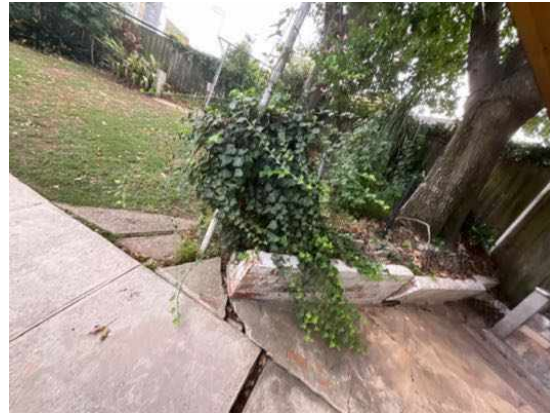
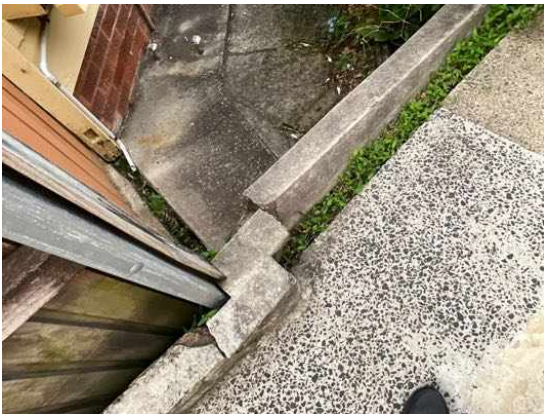
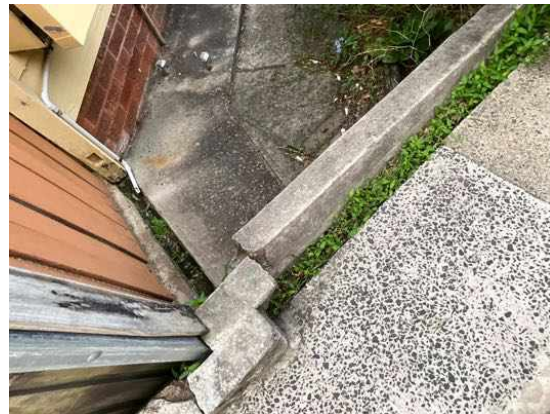
Finding 2.01

Building: Main Building
 Location: All Areas
 Finding: Retaining wall Brickwork - Cracking [Repair required]
 Information: An approximate 10mm crack has been observed in the brick retaining wall, raising concerns about its stability and long-term durability. Immediate attention and repair are required to address this structural issue."

To fix this, you should consider consulting with a professional mason or a construction contractor experienced in brickwork and retaining walls. They can assess the extent of the damage and provide the necessary repairs or recommendations for the best course of action.

A qualified bricklayer should be contacted immediately to estimate and perform repair and restoration works. Consultation with a structural engineer may be required where structural instability is found to be the underlying cause of the cracking.

Always contact a building inspector should cracks widen, lengthen, or become more

numerous.

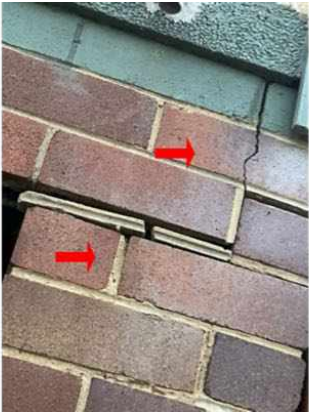
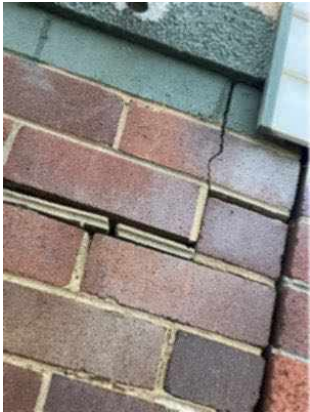
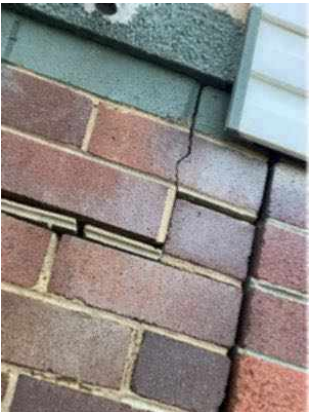
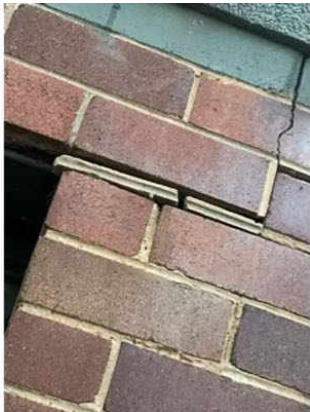
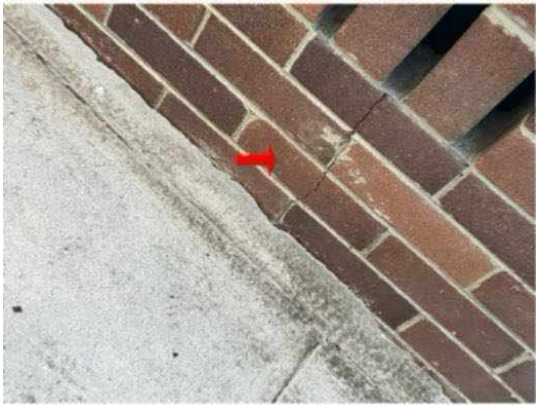
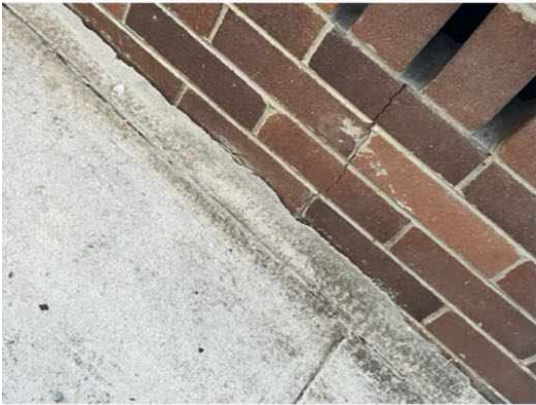
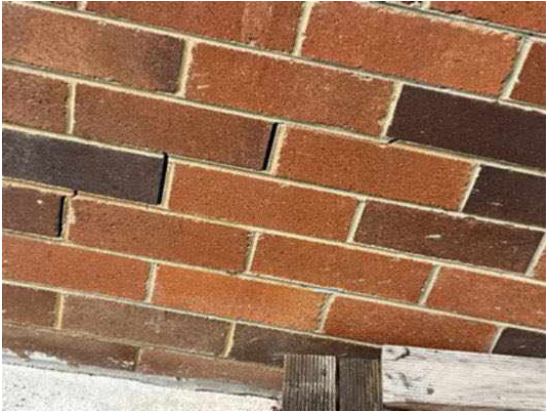
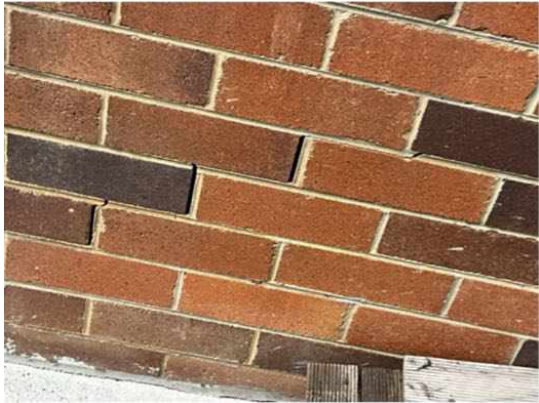
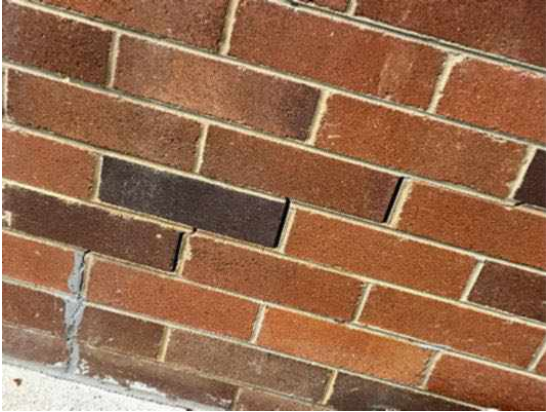
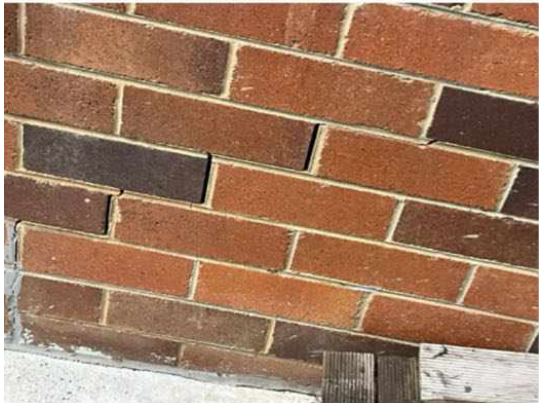
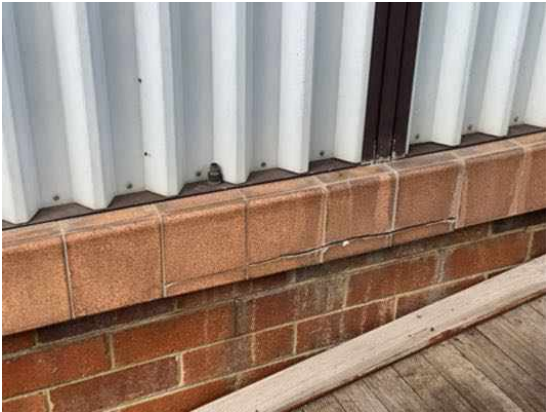
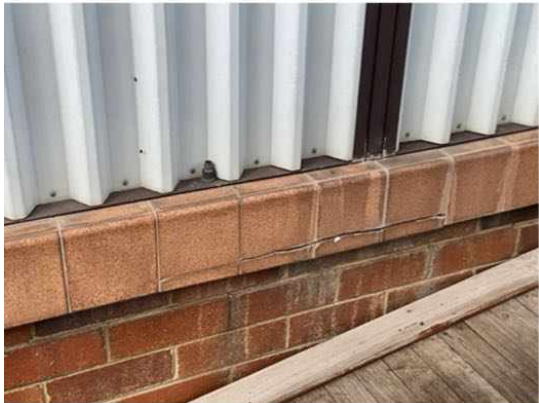
Finding: Brickwork - Cracking [Repair required]

Information: Major cracking was identified to the brickwork in this area. Cracks of this type are likely to have been caused by minor expected movement of building elements, but may also have a structural cause that is more significant.

A crack of this size may be repaired by extensive filling. Additionally, further remedial works to associated building elements, such as eave sheeting or external door frames, is likely to be required.

A qualified bricklayer should be contacted immediately to estimate and perform repair and restoration works. Consultation with a structural engineer may be required where structural instability is found to be the underlying cause of the cracking.

Always contact a building inspector should cracks widen, lengthen, or become more numerous.

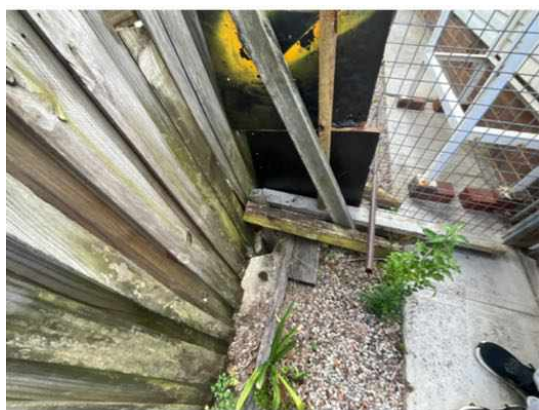
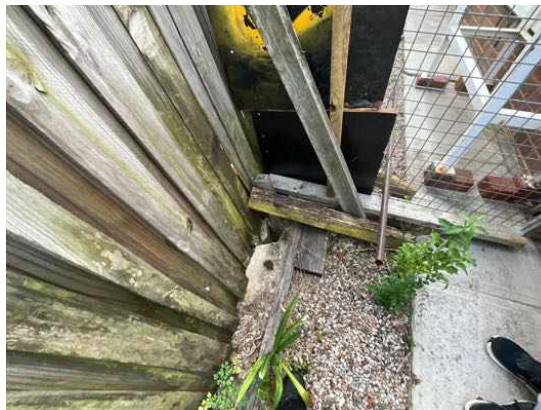
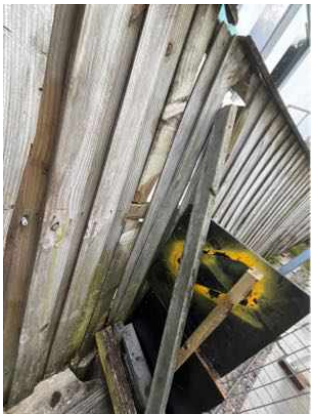
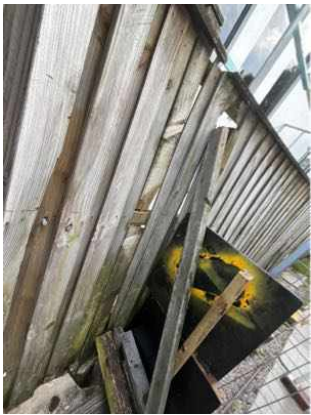
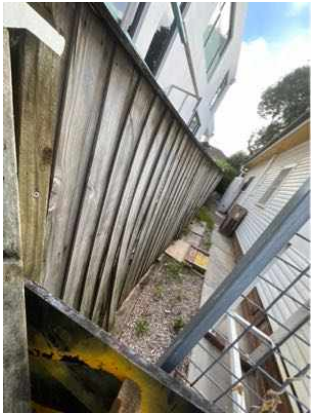
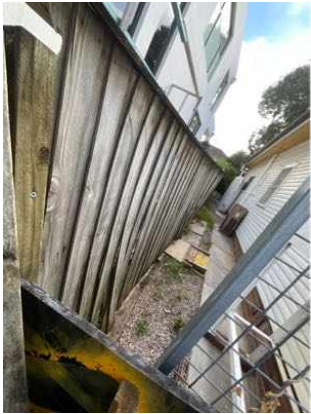
Finding 2.03

Building: Main Building
Location: All Areas
Finding: Detoriated fence
Information:

The fence along the property boundary has deteriorated significantly, showing signs of rot, rust, and structural weakness. Several sections are leaning or have become detached, compromising the integrity of the fence and its ability to perform its intended function.

The deteriorated fence poses multiple risks:

1. **Safety Hazard:** The unstable fence may collapse, posing a risk of injury to residents, visitors, and passersby.
2. **Security Concern:** The compromised fence may allow unauthorized access to the property, increasing the risk of theft, vandalism, or trespassing.
3. **Property Damage:** Falling sections of the fence could damage nearby structures, plants, or other property features.

- **Licensed Fencing Contractor:** A professional fencing contractor should be hired to assess the extent of the damage and either repair or replace the deteriorated sections.
- **Handyman Services:** For minor repairs, a qualified handyman could be engaged to reinforce or repair specific sections of the fence.
- **Landscaper (if the fence is part of a larger garden feature):** If the fence is integrated into the landscape design, a landscaper with experience in fencing could be involved in the repair or replacement process.

It's important to ensure that whoever is hired is experienced and qualified to ensure the fence is restored to a safe and functional condition, compliant with local regulations.

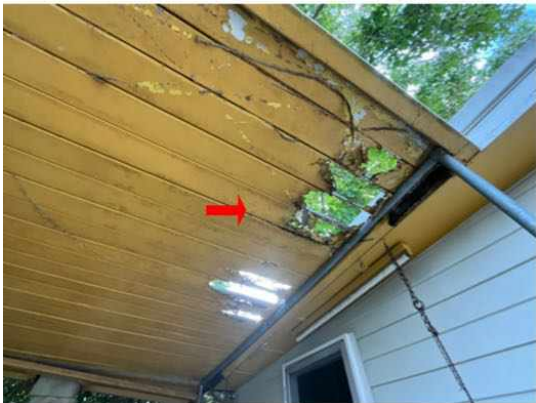
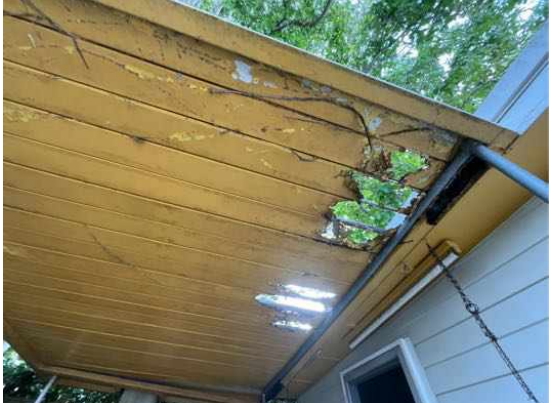
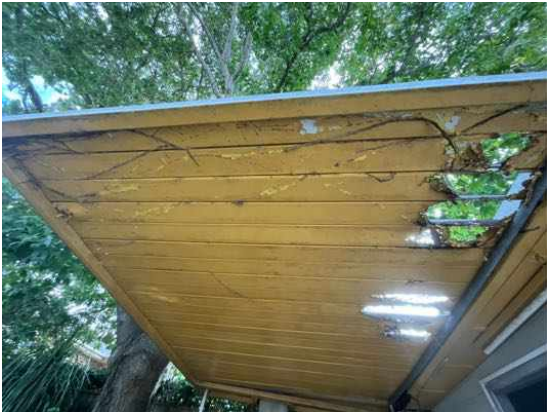
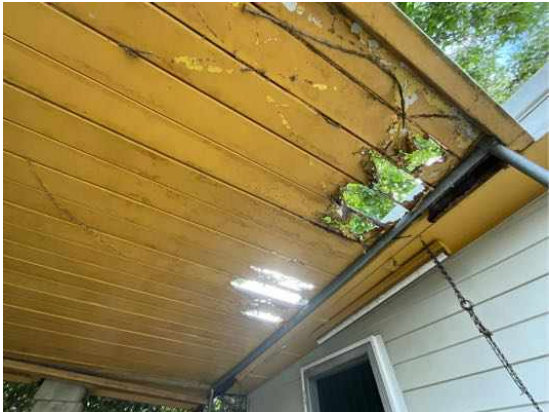
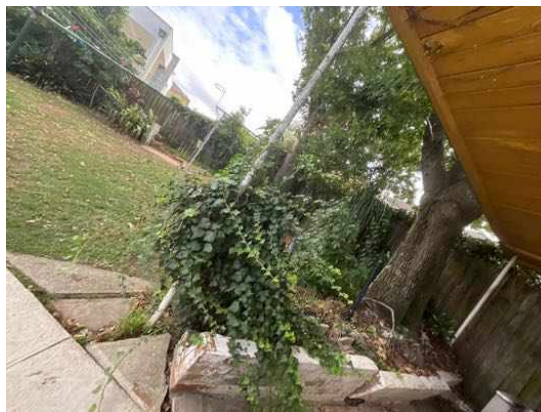
Finding 2.04

Building: Main Building
Location: Carport
Finding: carport shed - rusting
Information: The carport shed exhibits visible rusting on its structure, compromising its structural integrity and aesthetic appeal.”

Risk: Rust on the carport shed poses a risk of accelerated corrosion, potentially leading to weakened components and structural failure, which could result in safety hazards and reduced durability.

Resolution: Seek assistance from a qualified metalworker or a professional specializing in structural repairs. They can assess the extent of rust damage, perform necessary repairs, and apply protective coatings to prevent further deterioration. Regular maintenance is essential to prolong the lifespan of the carport shed.

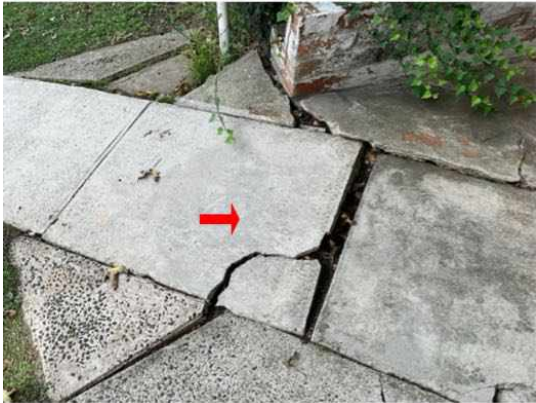
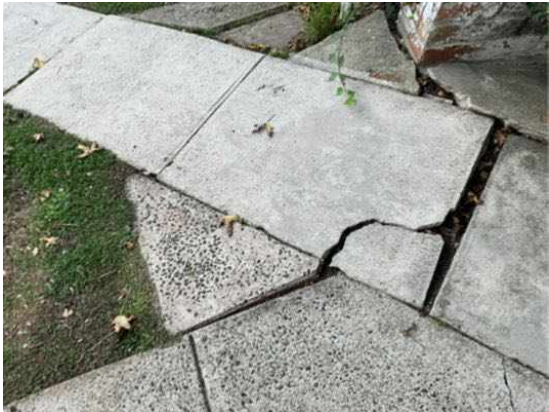
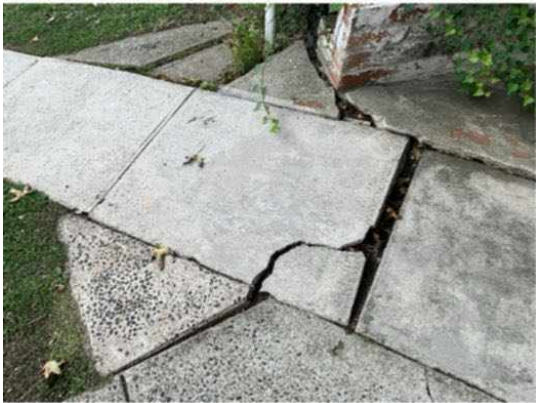
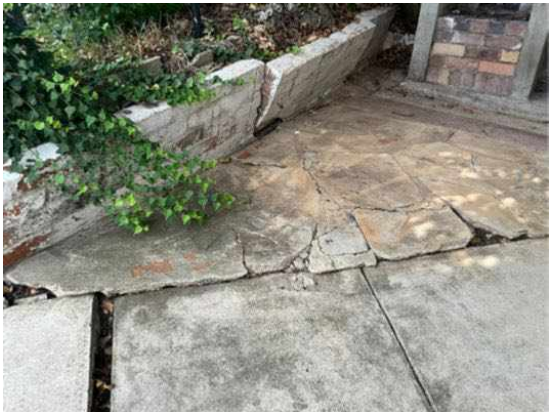
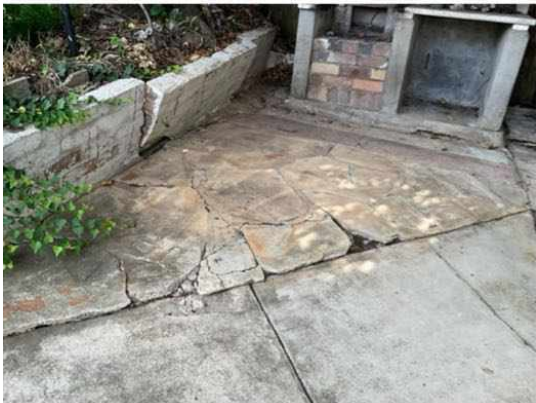
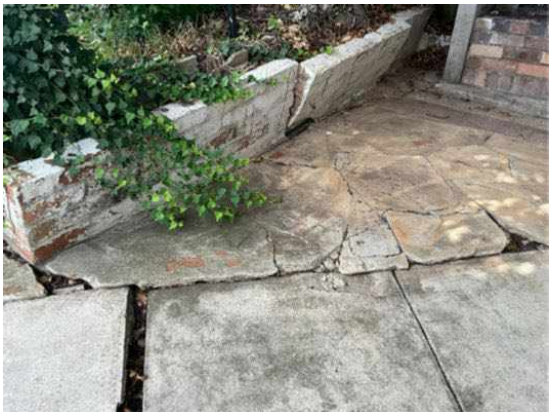
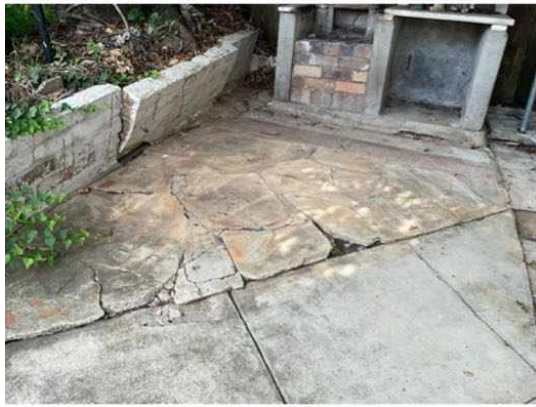
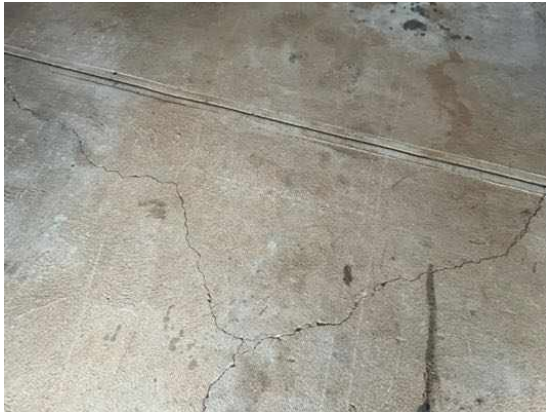
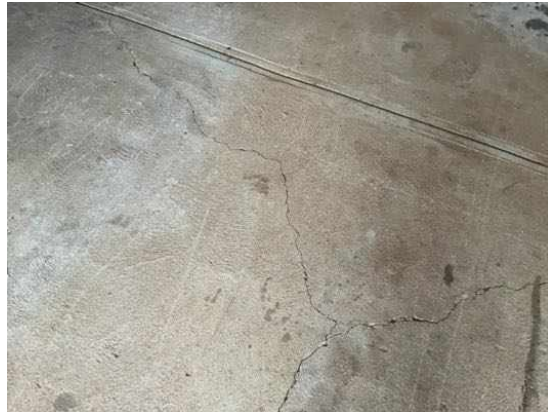
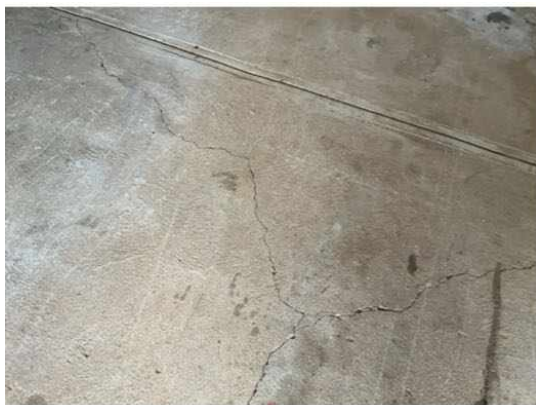
Finding 2.05

Building:	Main Building
Location:	All Areas
Finding:	Noticeable Cracking in Concrete Slab
Information:	Noticeable cracking has been observed in the concrete slab, failing to meet the required construction and quality standards.

- .
- Cracks are visible on the surface and may extend through the depth of the slab.
- Evidence of improper curing or inadequate reinforcement leading to cracking.

The presence of noticeable cracks in the concrete slab can result in:

- Compromised structural integrity of the slab, potentially leading to failure under load.
- Water ingress through cracks, causing corrosion of reinforcement and further weakening the structure.
- Potential trip hazards and aesthetic issues, reducing the overall value and safety of the property.
- Increased maintenance and repair costs due to ongoing deterioration.

- A structural engineer should be engaged to assess the extent of the cracking and recommend appropriate repair methods.
- A licensed contractor or concrete repair specialist should carry out the recommended repairs under the guidance of the structural engineer.

A detailed inspection should be conducted post-repair to confirm compliance with the required standards and to ensure that the structural integrity of the concrete slab has been restored.

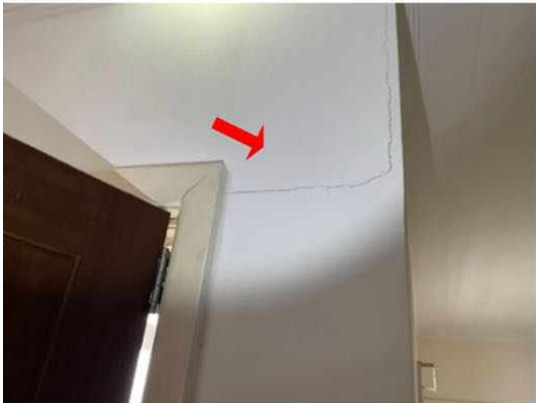
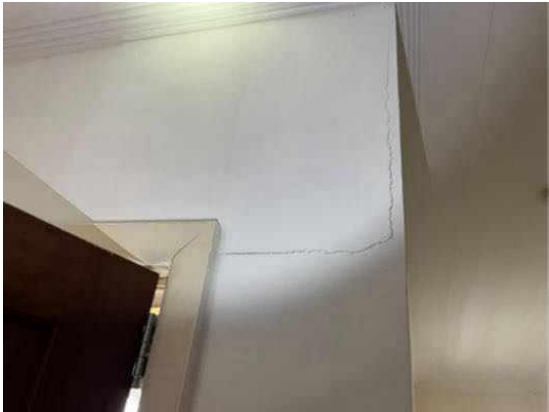
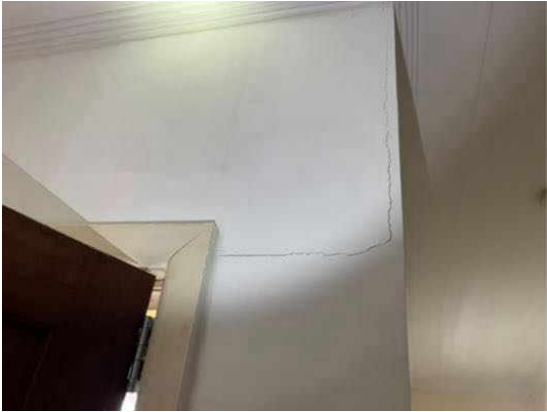
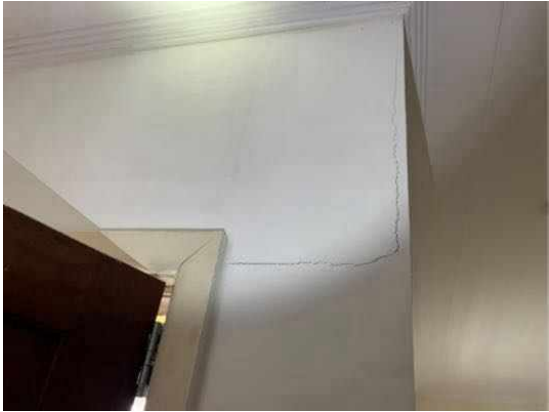
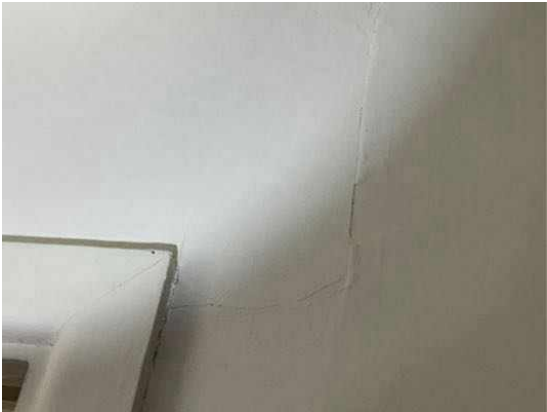
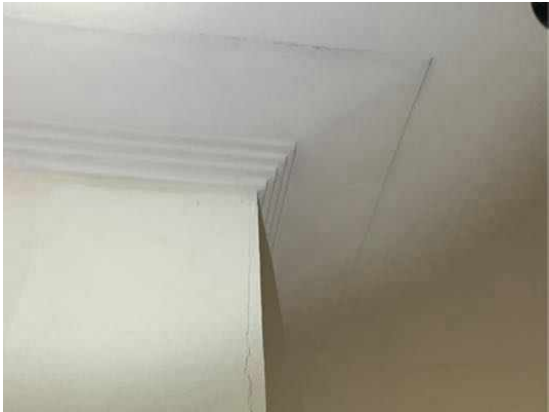
Finding 2.06

Building: Main Building
Location: All Areas
Finding: Gyprock - Crack (Fine) - walls and ceiling
Information: cracks have appeared in the gyprock of the ceiling and walls, suggesting potential issues with settling or structural movement.

These cracks in the gyprock pose a risk of further widening, compromising the aesthetic appeal of the space, and potentially indicating underlying structural problems.

A skilled plasterer or a contractor specializing in drywall repairs should assess the

extent of the cracks and address them promptly. Identifying and fixing the root cause of the issue, whether related to settling or structural concerns, is essential to prevent further damage and maintain the integrity of the ceiling.

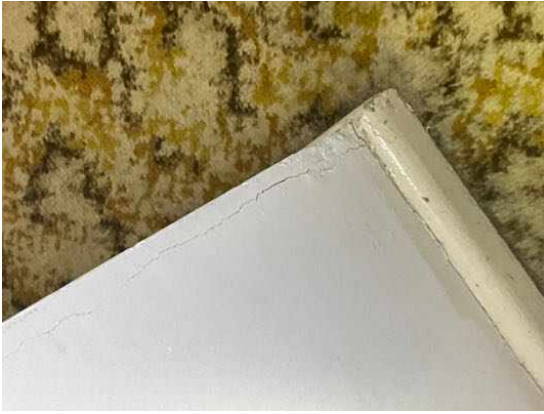
Finding 2.07

Building:	Main Building
Location:	Ensuite
Finding:	Suspected- Water damage
Information:	The area has sustained suspected water damage resulting in potential structural issues. This damage compromises both the aesthetic and functional aspects.

1 ****Plumber:**** If the water damage is due to plumbing issues, a plumber can fix leaks and ensure there are no further water-related problems.

2 ****General Contractor:**** If the damage is extensive and affects the surrounding area, a general contractor can coordinate the repair work, including any related structural or cosmetic repairs.
