Building and Timber Pest Inspection Report

Inspection Date: Tue, 24 Feb 2026

Property Address: 165 Quarry Rd, Ryde NSW 2112, Australia

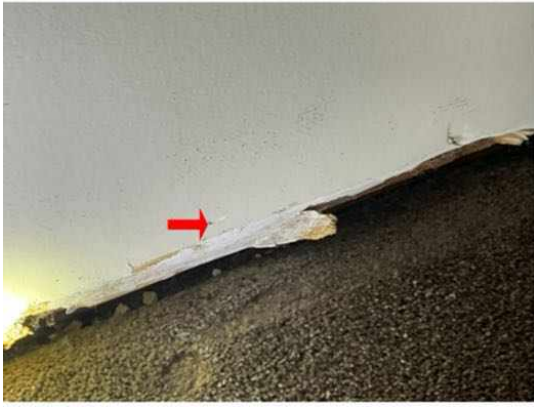
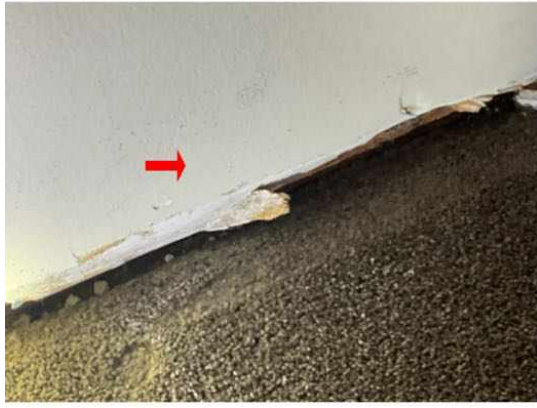
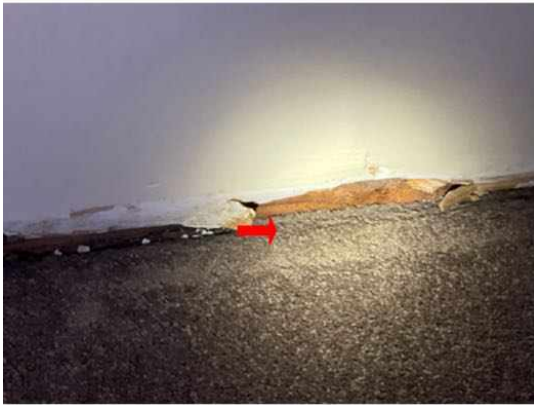
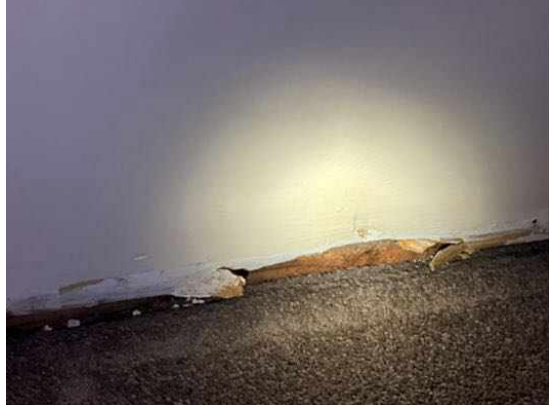
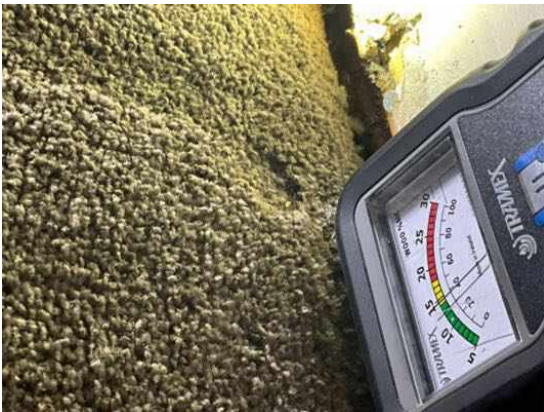
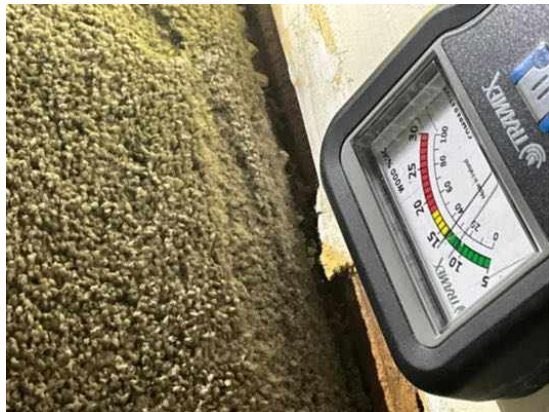
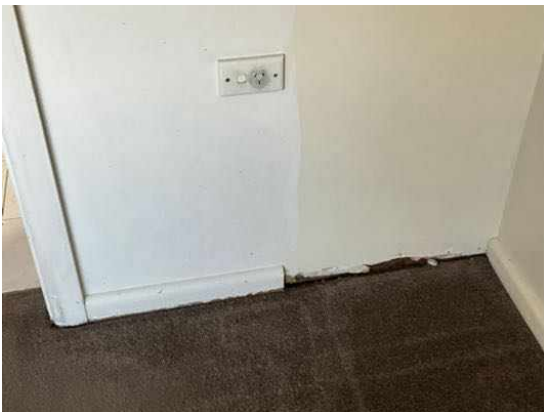
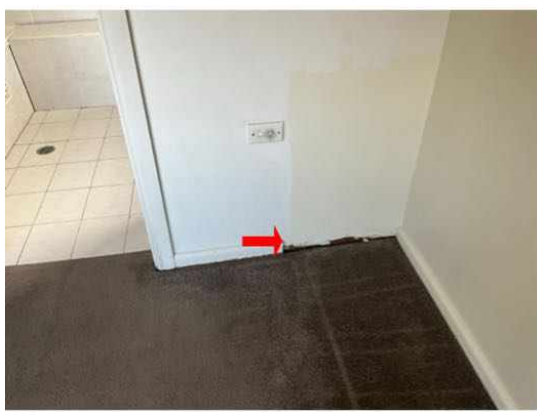
Building:	Main Building
Location:	Ensuite
Finding:	Suspected- Water damage
Information:	The area has sustained suspected water damage resulting in potential structural issues. This damage compromises both the aesthetic and functional aspects.

1 ****Plumber:**** If the water damage is due to plumbing issues, a plumber can fix leaks and ensure there are no further water-related problems.

2 ****General Contractor:**** If the damage is extensive and affects the surrounding area, a general contractor can coordinate the repair work, including any related structural or cosmetic repairs.

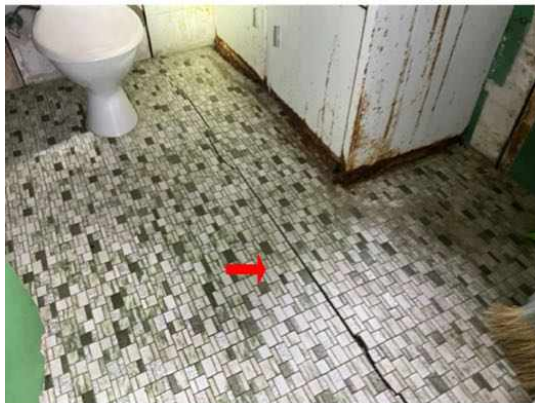
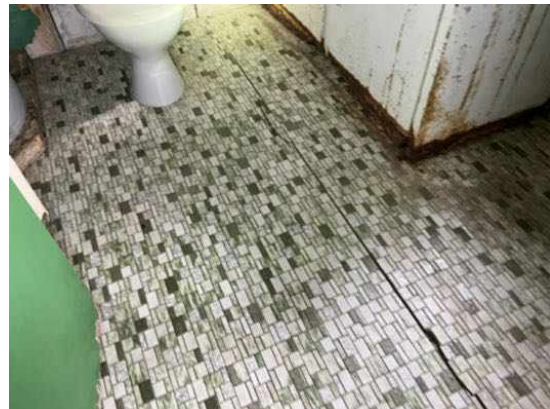
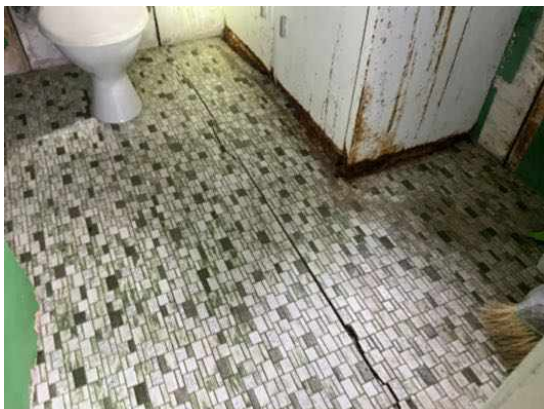
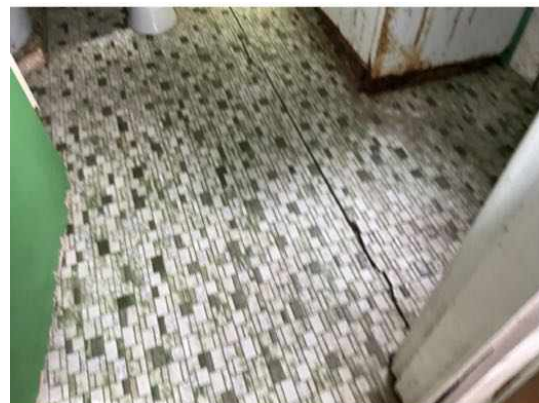
Finding 2.08

Building: Main Building
Location: Laundry
Finding: Subsidence - Structure
Information: It appears that the structure has been affected by movement of the foundations, often referred to as sinking or subsidence. Whilst a degree of movement is expected over time, especially as environmental conditions change and buildings 'settle' after construction, this degree of subfloor movement requires attention.

General subsidence is usually initiated by changes in soil moisture content. The most critical factor is identifying the specific causes, and identifying if this is a recurring or ongoing problem, or one that has been resolved by previous works in the past.

Subsidence can have complex and varying causes, which will influence the required remedial works. It is advised to begin by consulting a structural engineer to determine the required scope of works. This generally includes some form of underpinning, as well as addressing the underlying cause. Consultation with a geotechnical engineer may also be necessary where changes to soil moisture content is apparent.

A Registered Builder specialising in carry out works as advised by an Engineer.

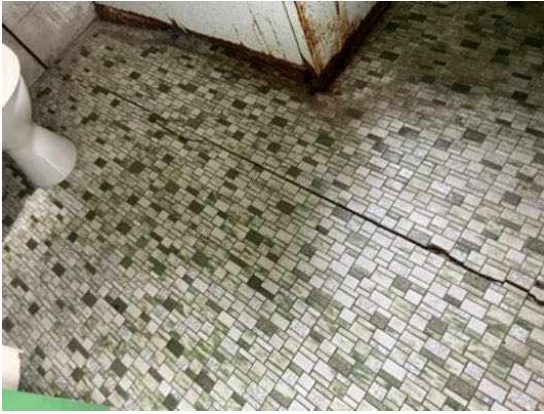
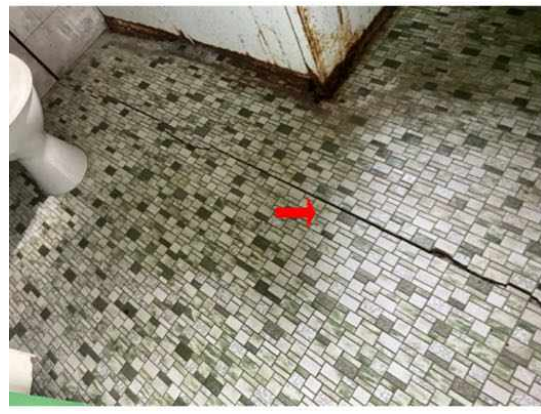
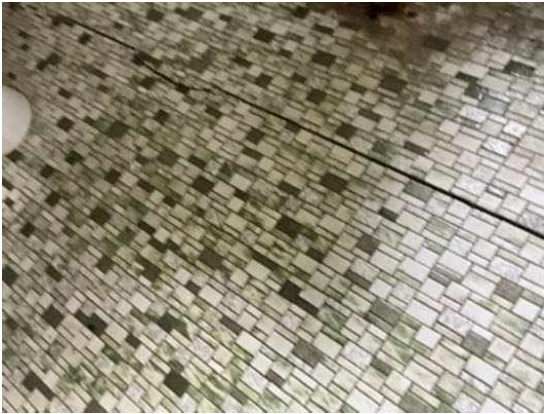
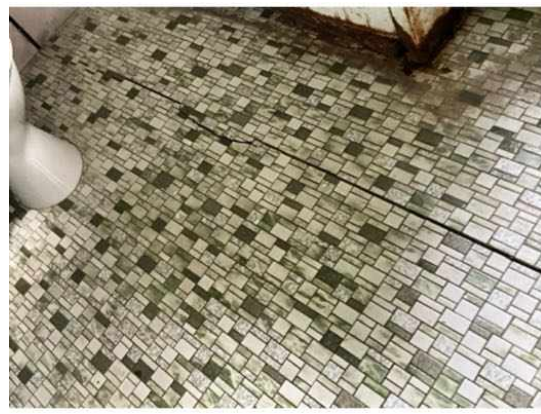
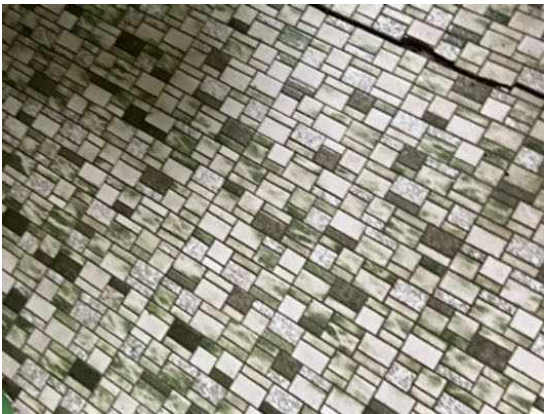
Finding 2.09

Building:	Main Building
Location:	Subfloor
Finding:	Subfloor Piers - Unstable or deteriorated
Information:	Piers to the subfloor structure are unstable, indicating that their structural integrity has been affected. The cause of this instability is likely to be movement by which piers deteriorate at a rapid rate.

The piers are suspected to be failing in their structural purpose, which is likely to lead to a range of major and minor defects. Further (potentially major) damage to the piers and structure may be imminent if left unattended.

Appointment of a Registered Builder specialising in re-stumping is required immediately to assess the condition of the stumps and provide advice on remedial works. This defect should not be left unmanaged.

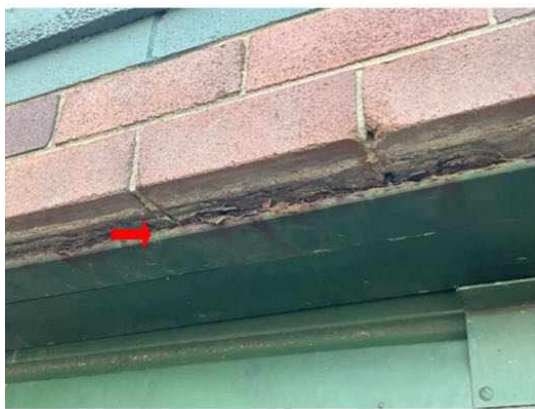
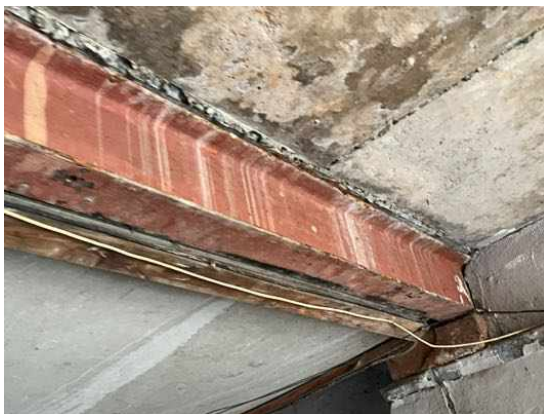
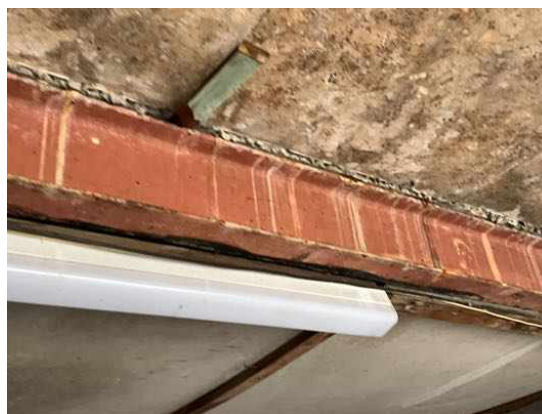
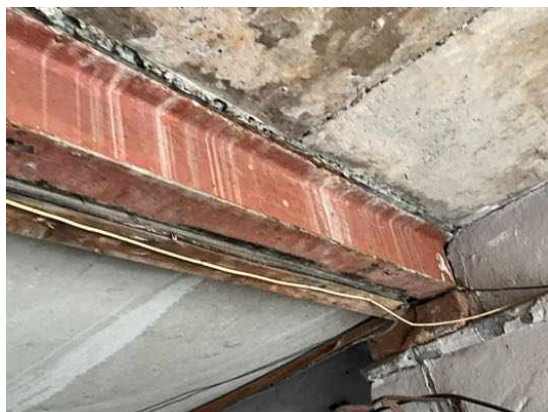
Building: Main Building
Location: All Areas
Finding: Building element - Rusted or corroded

Information: This building element shows evidence of rusting and corrosion, which is likely to have developed as a result of excessive exposure to moisture and or inadequate coatings.

As surface rust provides no protection to the underlying iron, the deteriorating condition is likely to worsen if not addressed in the short-term future.

Where possible, the use of galvanized (treated) metals or aluminium coated metals aid in rust prevention, as does regular general maintenance. Rust formation can be controlled with coatings, such as paint, that isolate the iron from the environment.

Rusting and corrosion should be managed by ideally removing or limiting the affected surface from exposure to moisture. A registered builder may be appointed to replace any building elements that have been severely affected by rust or water damage.

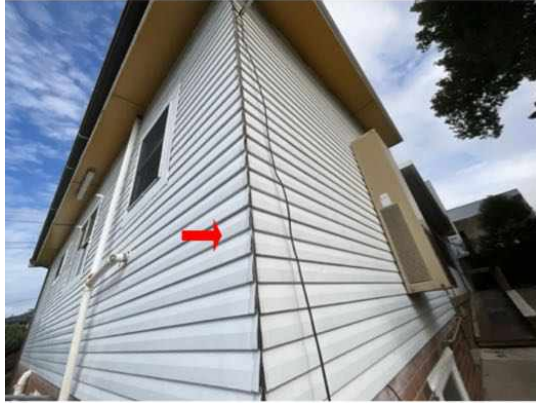
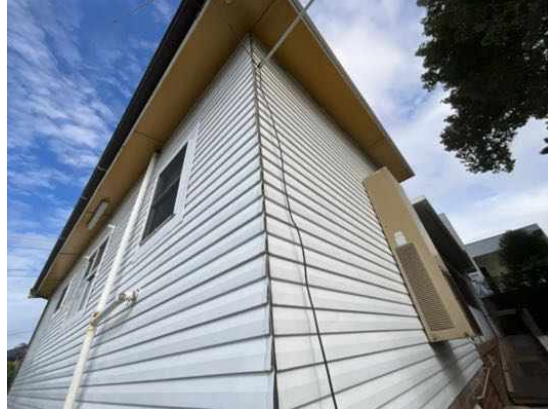
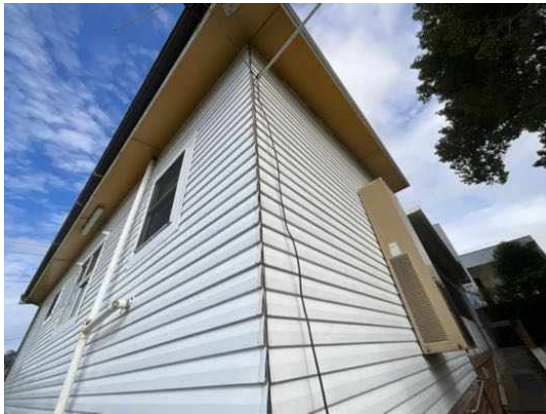
Finding 3.02

Building:	Main Building
Location:	All Areas
Finding:	Damaged Cladding
Information:	The cladding is damaged, displaying cracks, peeling, and disintegration, compromising its structural integrity and aesthetic appeal.

1. Structural instability: The damaged cladding can weaken the structure, leading to potential collapse or safety hazards.
2. Water ingress: Gaps in the cladding allow water to penetrate, leading to moisture damage, mold growth, and potential deterioration of the underlying structure.
3. Aesthetic degradation: Damaged cladding diminishes the visual appeal of the building, affecting its market value and reputation.

A qualified construction contractor specializing in cladding repair and replacement can fix the damaged cladding. Additionally, an architect or structural engineer may be required to assess the extent of the damage and recommend appropriate repair methods.

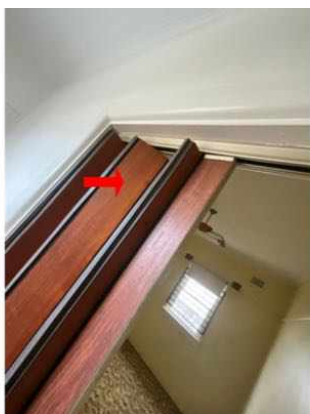
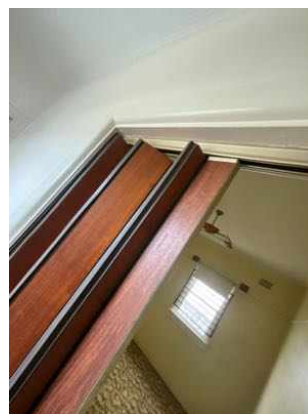
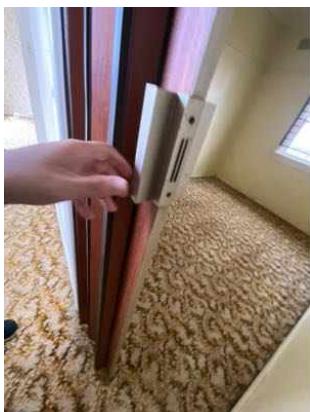
Finding 3.03

Building:	Main Building
Location:	All Areas
Finding:	Door - Binding/jamming
Information:	Binding and/or jamming of this door is evident during standard operation. This defect inhibits the functionality of the affected door as well as creating potential for secondary defects to associated building elements.

A door that binds to flooring or to the associated door frame may have several causes, ranging from minor defects, such as poor installation of the door or deteriorated hinges, through to major structural issues. For minor causes, a qualified carpenter or general handyperson should be appointed to perform minor rectification works at client discretion.

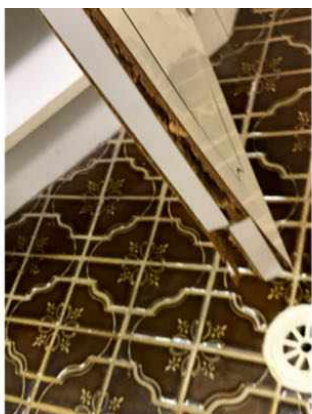
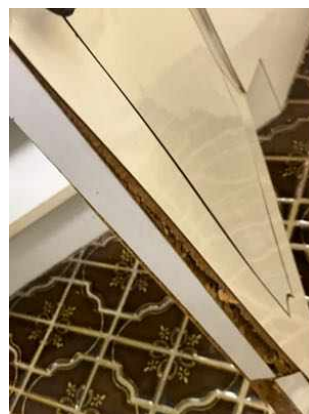
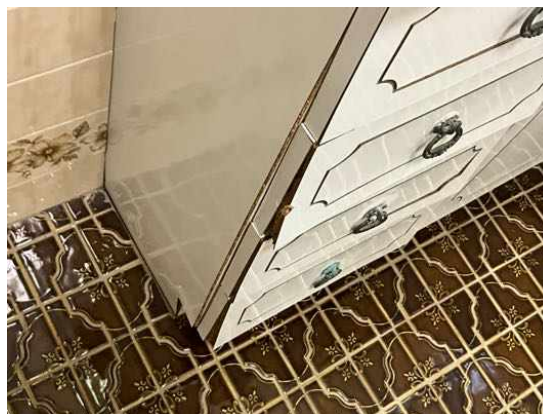
Finding 3.04

Building:	Main Building
Location:	Bathroom
Finding:	Water damage / Vanity
Information:	"The vanity in the shower area has sustained water damage, resulting in swelling and discoloration of the wood, as well as potential structural issues. This damage compromises both the aesthetic and functional aspects of the vanity."

1. **Carpenter or Woodworker:** They can assess and repair the damage to the vanity, potentially replacing any irreparable parts.
2. **Plumber:** If the water damage is due to plumbing issues, a plumber can fix leaks and ensure there are no further water-related problems.
3. **General Contractor:** If the damage is extensive and affects the surrounding area, a general contractor can coordinate the repair work, including both the vanity and any related structural or cosmetic repairs.

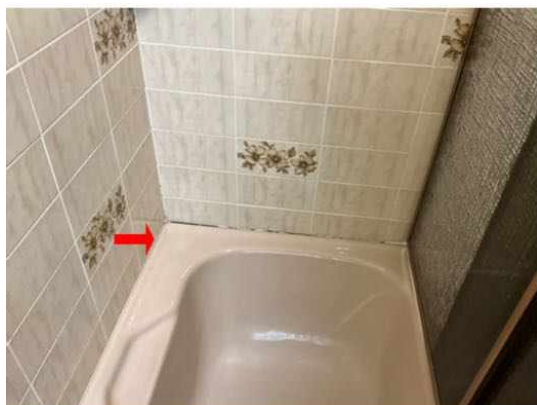
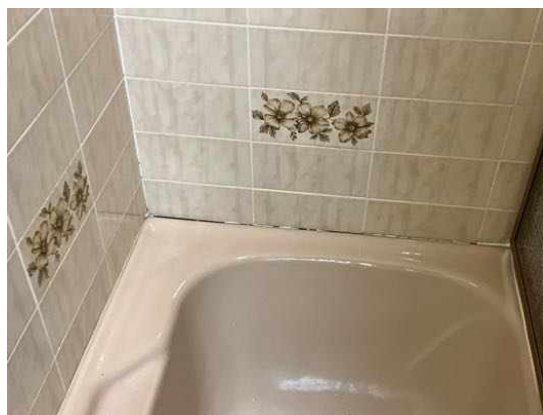
Finding 3.05

Building:	Main Building
Location:	Bathroom
Finding:	Sealant and grouting - Missing or damaged
Information:	It was noted on inspection that sealant or grout is degraded to the tiled shower alcove and or other areas of the bathroom.

Different materials and floor areas move at different rates, generally causing cracking to grout or sealant at this point. A flexible sealant is required to allow for expected expansion and contraction, while keeping the joint water tight and protective of all associated building materials.

There appears to be excessive mould to the sealant and grout which will likely require scraping out and replacement.

Flexible and mould resistant materials should be applied to affected areas to prevent any subsequent water damage that is likely to occur. Regular maintenance and replacement of damage or missing or damaged sealant and grout is highly recommended to the wet areas, as this is a regular wear and tear defect. Sealant and grouting in areas that come into regular contact with water should be maintained for the long term care of your property.

A sealant specialist or tiling contractor should be appointed to complete these works

as soon as possible

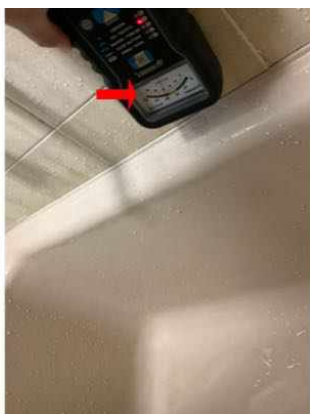
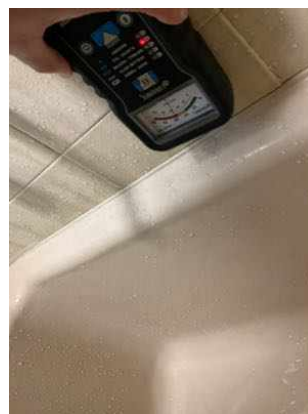
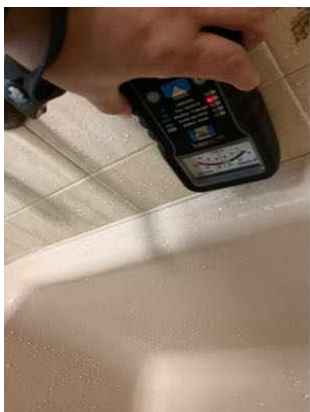
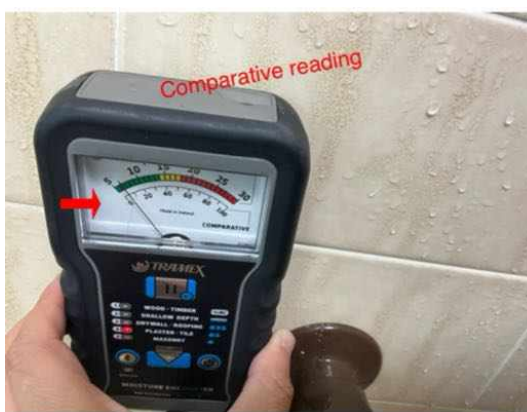
Finding 3.06

Building:	Main Building
Location:	Bathroom
Finding:	Evidence of excessive moisture was present at the time of inspection
Information:	Excessive moisture is present behind the bathroom tiles, indicating a potential water leakage issue within the wall.

The prolonged presence of moisture can lead to mold growth, deteriorate the structure, and create an environment conducive to health hazards. Additionally, it may compromise the adhesive holding the tiles, leading to their detachment.

A licensed plumber or a qualified contractor specializing in water damage remediation should investigate the source of the moisture, fix any leaks, and address the damage. Additionally, replacing affected tiles and ensuring proper waterproofing are crucial to preventing future issues.

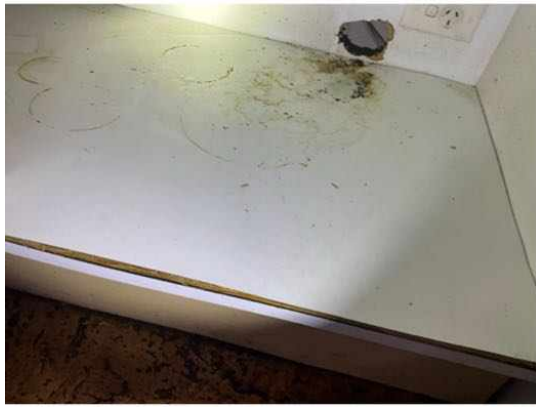
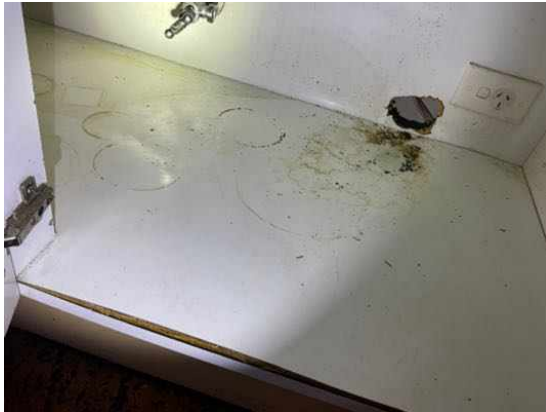
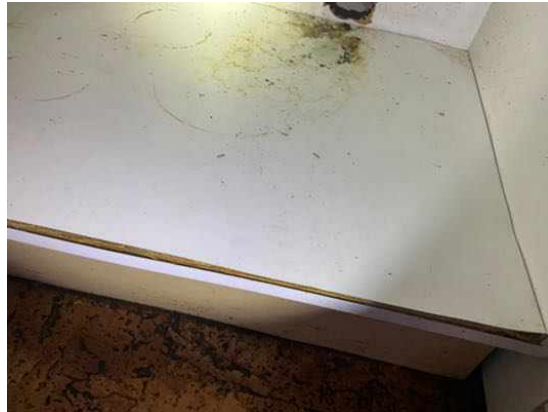
Finding 3.07

Building:	Main Building
Location:	Kitchen
Finding:	Water damage / Vanity
Information:	"The vanity in the shower area has sustained water damage, resulting in swelling and discoloration of the wood, as well as potential structural issues. This damage compromises both the aesthetic and functional aspects of the vanity."

1. **Carpenter or Woodworker:** They can assess and repair the damage to the vanity, potentially replacing any irreparable parts.
2. **Plumber:** If the water damage is due to plumbing issues, a plumber can fix leaks and ensure there are no further water-related problems.
3. **General Contractor:** If the damage is extensive and affects the surrounding area, a general contractor can coordinate the repair work, including both the vanity and any related structural or cosmetic repairs.

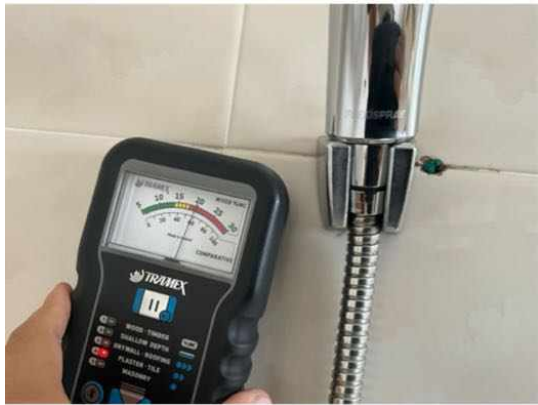
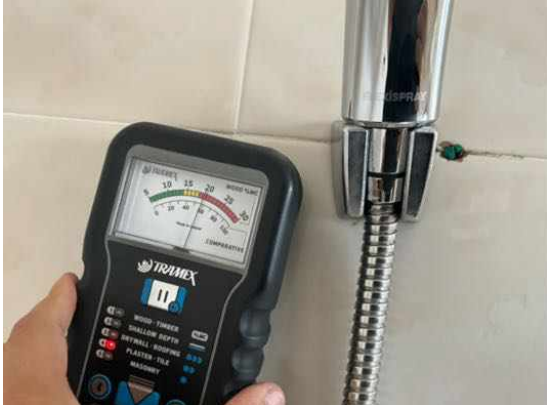
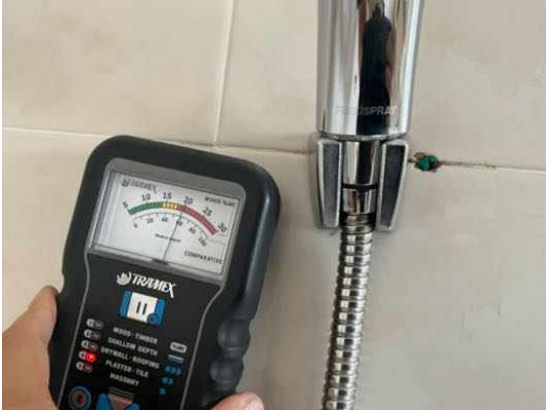
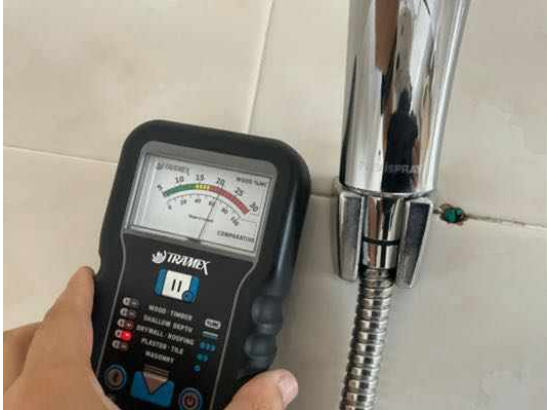
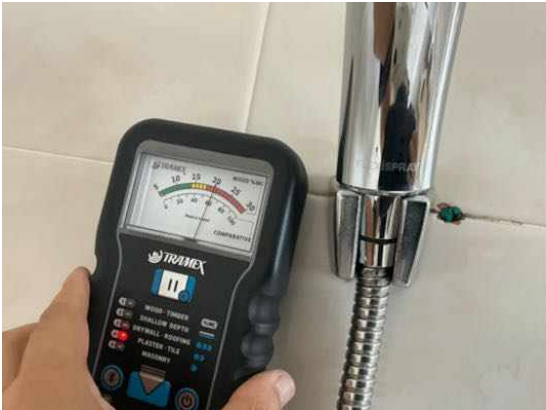
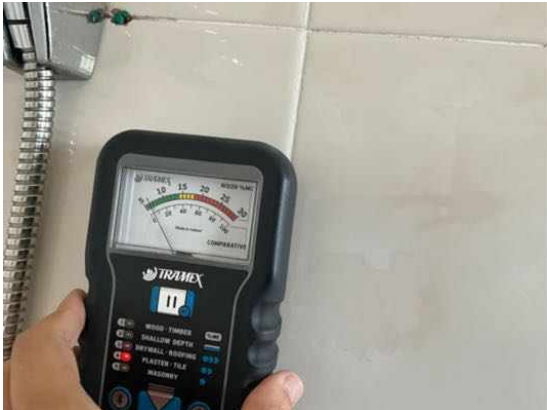
Building:	Main Building
Location:	Ensuite
Finding:	Evidence of excessive moisture was present at the time of inspection
Information:	Excessive moisture is present behind the bathroom tiles, indicating a potential water leakage issue within the wall.

The prolonged presence of moisture can lead to mold growth, deteriorate the structure, and create an environment conducive to health hazards. Additionally, it may compromise the adhesive holding the tiles, leading to their detachment.

A licensed plumber or a qualified contractor specializing in water damage remediation should investigate the source of the moisture, fix any leaks, and address the damage. Additionally, replacing affected tiles and ensuring proper waterproofing are crucial to preventing future issues.

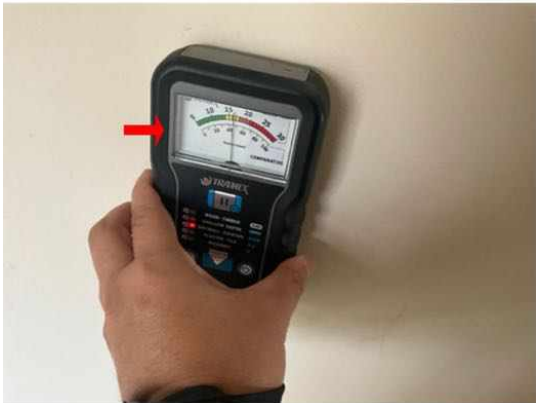
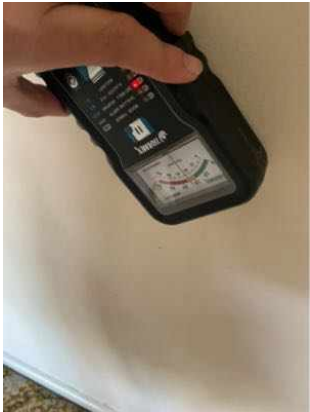
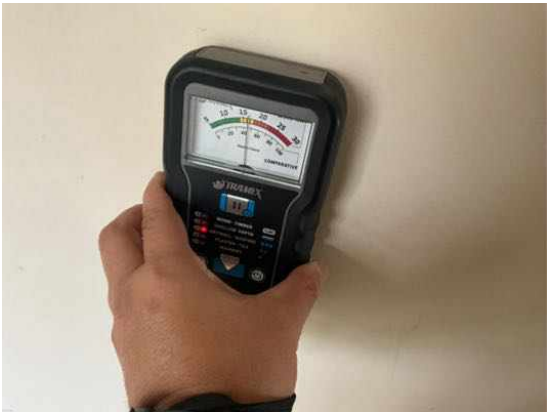
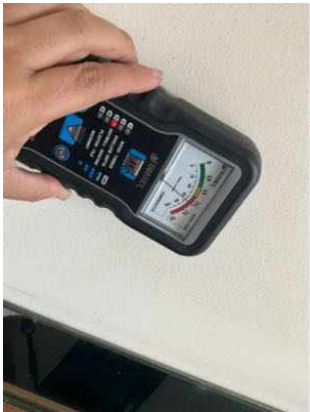
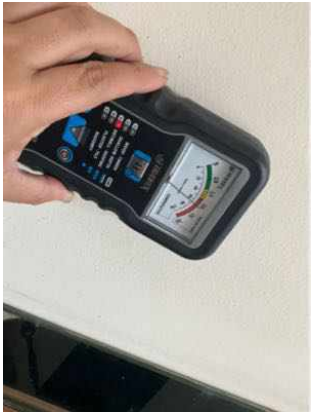
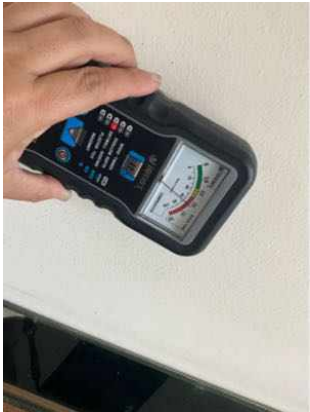
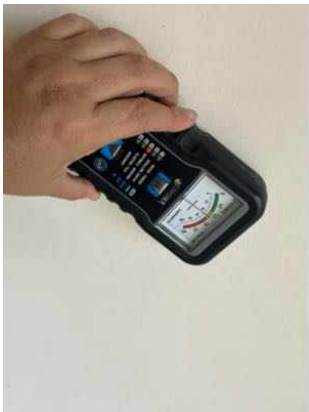
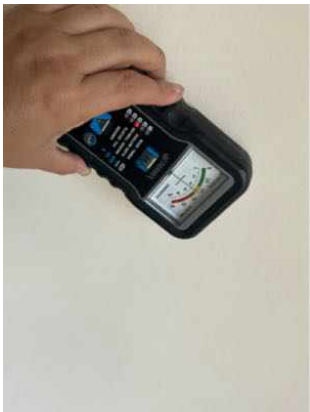
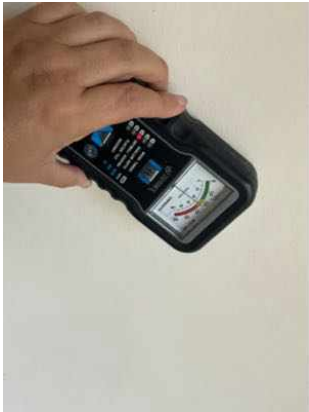
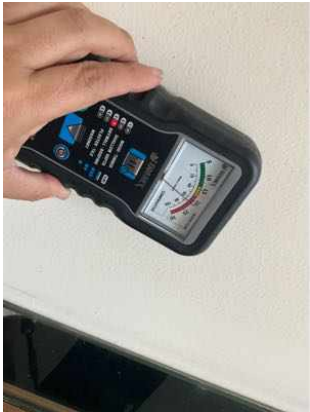
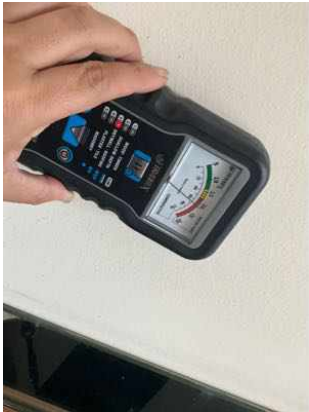
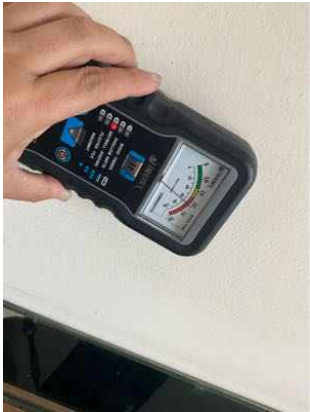
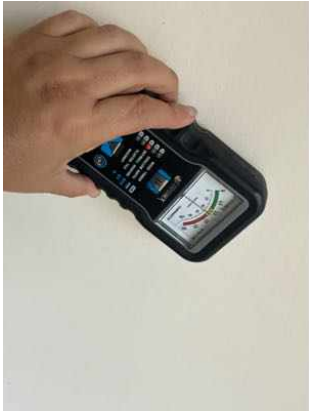
Finding 3.09

Building: Main Building
Location: All Areas
Finding: Evidence of excessive moisture - Drywall
Information: Excessive moisture is present at the time of , indicating a potential water leakage issue within the wall.

The prolonged presence of moisture can lead to mold growth, deteriorate the structure, and create an environment conducive to health hazards. Additionally, it may compromise the adhesive holding the tiles, leading to their detachment.

A licensed plumber or a qualified contractor specializing in water damage remediation

should investigate the source of the moisture, fix any leaks, and address the damage. Additionally, replacing affected tiles and ensuring proper waterproofing are crucial to preventing future issues.

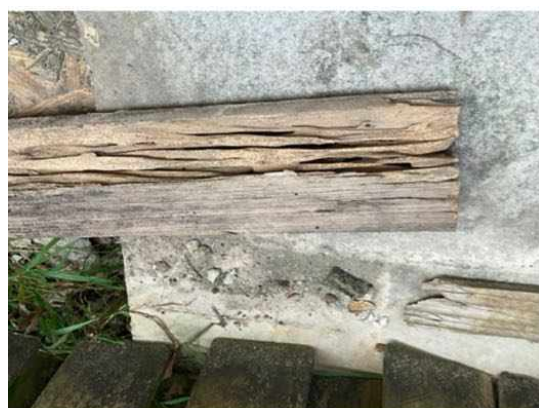
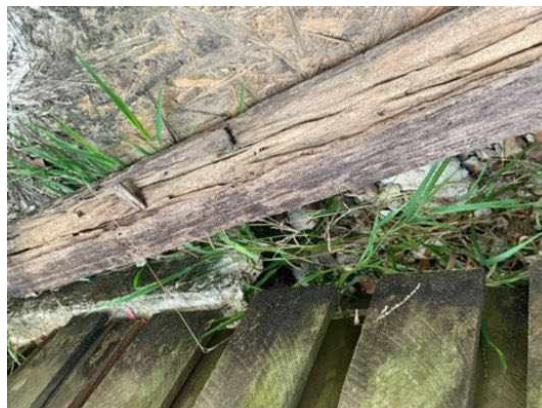
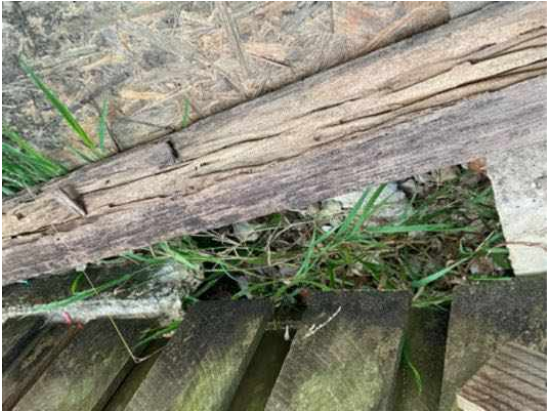
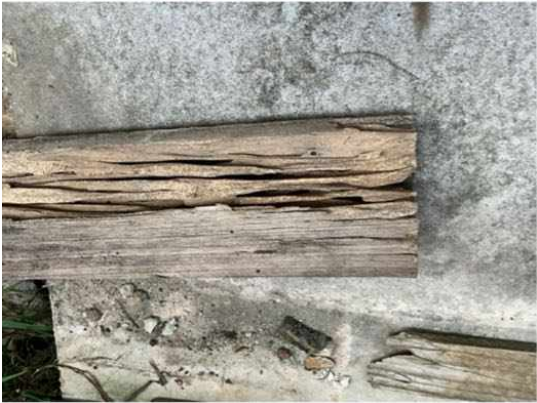
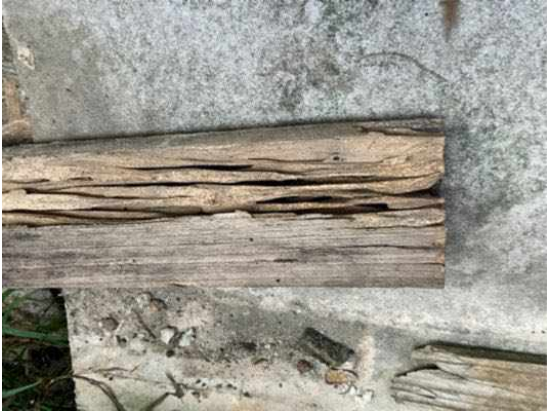
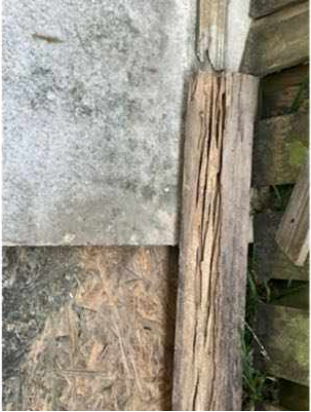
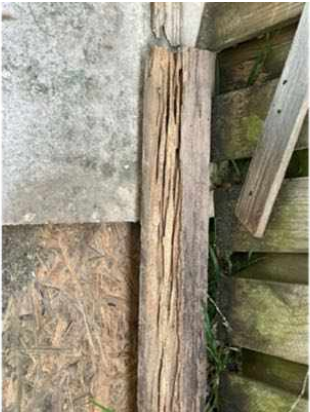
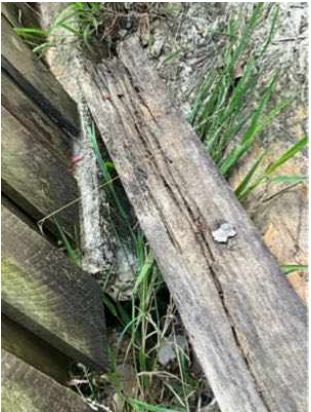
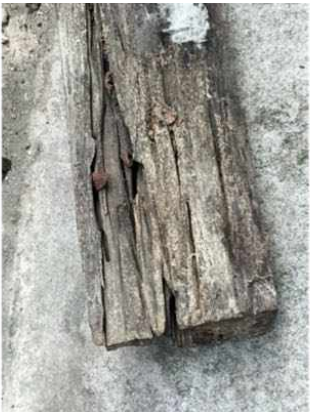
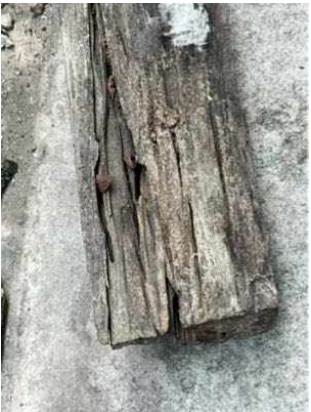
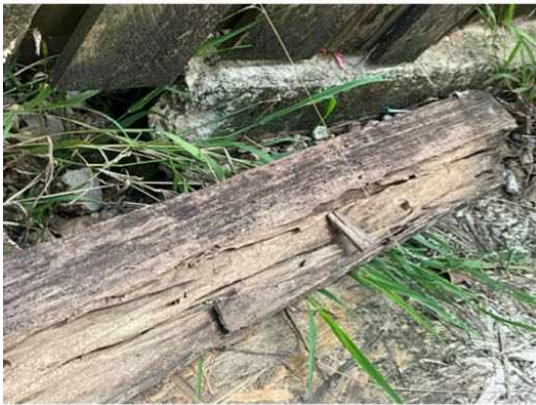
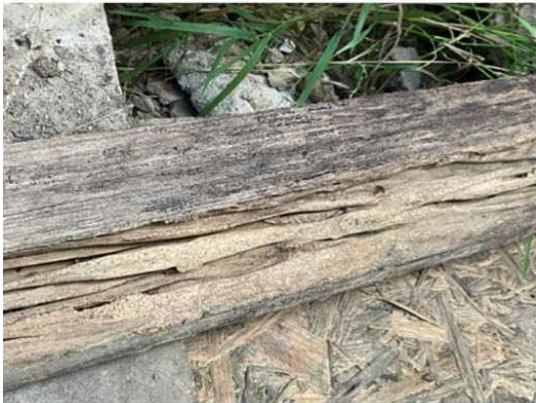
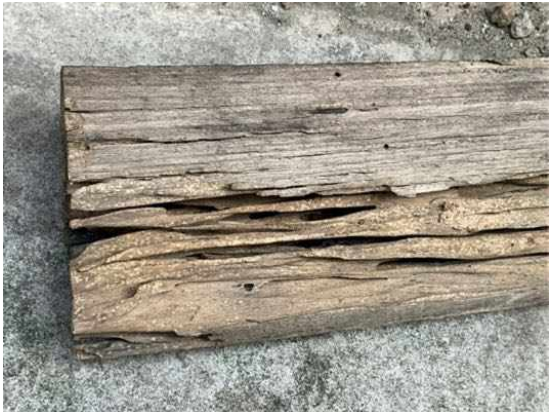
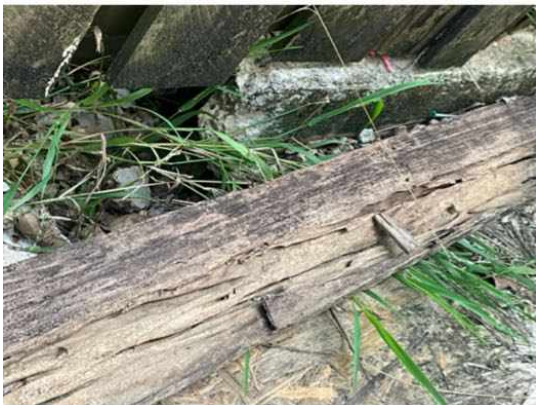
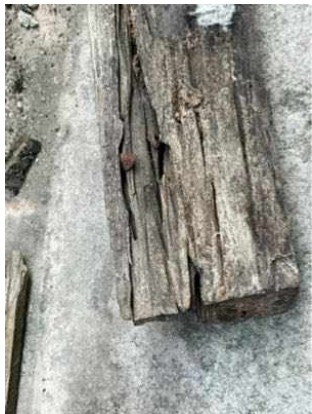
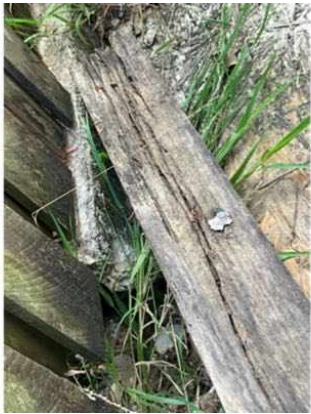
Building: Main Building
Location: Yard - Side
Finding: Timber Pest Damage
Information: Termite damage and timber decay were observed. The affected timbers show hollowing, delamination, and mud-like residue consistent with termite activity, where in contact with soil, and vegetation is overgrown, providing potential termite access points.

The damage has compromised the structural integrity and may indicate active or previous termite infestation. If left untreated, termite activity could spread to nearby structures, leading to significant hidden timber damage and costly repairs.

Replace all affected timber members using H3/H4 treated pine or non-timber alternatives,

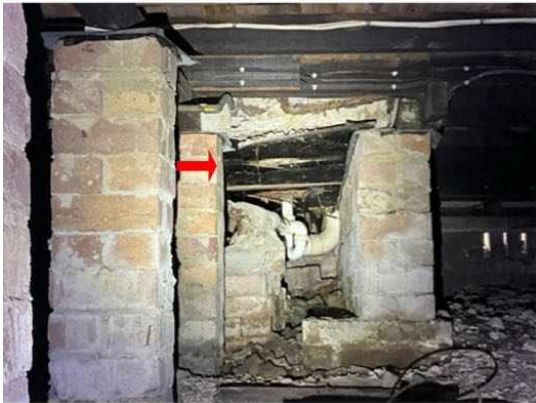
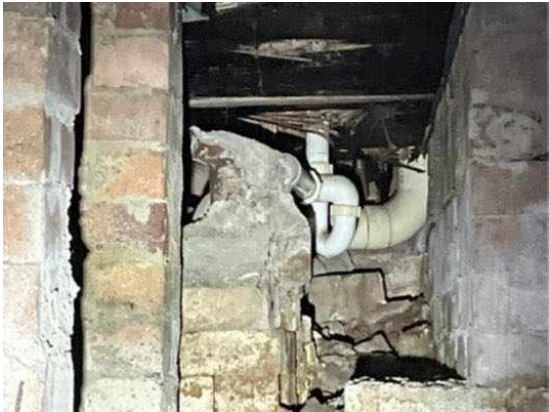
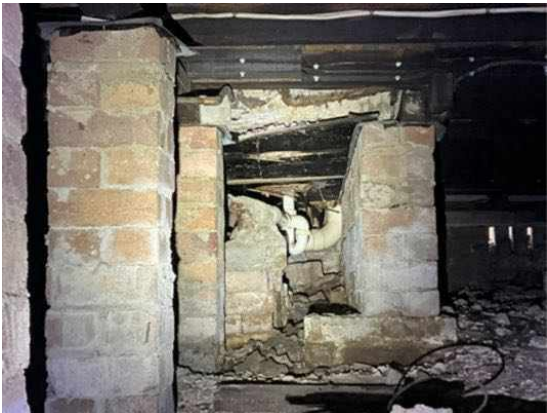
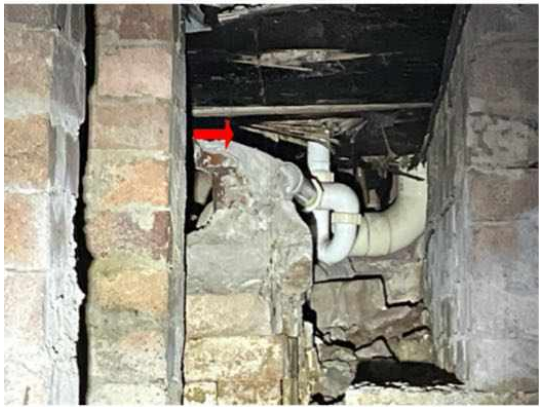
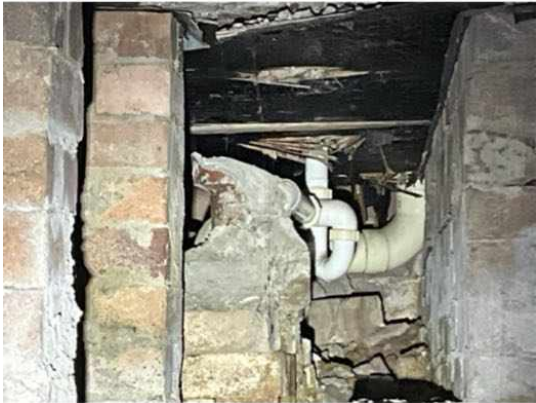
Finding 5.02

Building: Main Building
Location: Subfloor
Finding: Suspected - Timber pest damage
Information: Despite no live termite or timber pest activity being indicated, suspected previous timber pest damage was found to have affected this area. This damage is considered to be inactive at the time of inspection.

It is advised that the area be visually inspected frequently to ensure that the condition of affected building materials does not worsen.

A licensed pest controller must be appointed to provide a further invasive inspection.

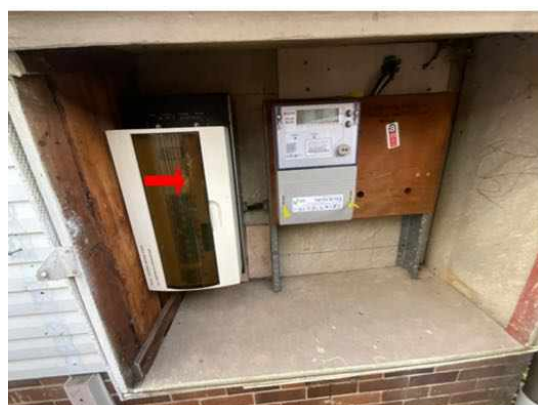
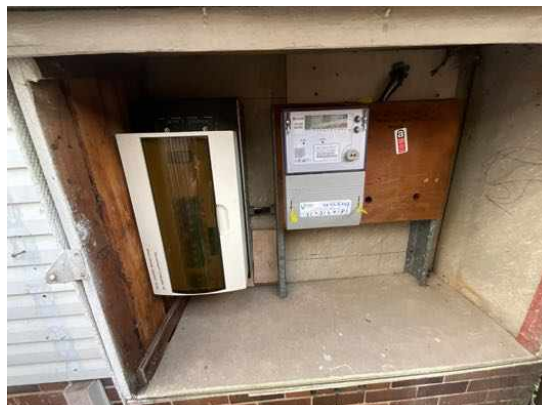
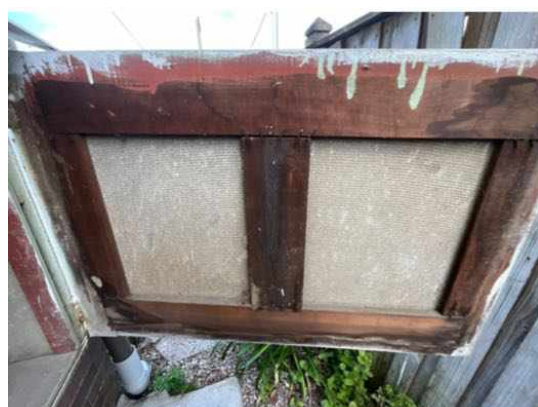
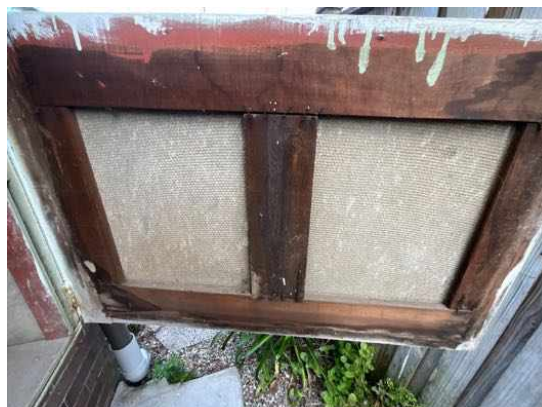
Building:	Main Building
Location:	Exterior walls - left side
Finding:	No Evidence of Termite Management System - Durable notice / Legible Sticker
Information:	The application of a pre & post-construction chemical termite barrier is highly recommended for all properties. Such barriers are highly effective in preventing termite attack on any timber building elements throughout the property.

A durable notice was not placed in the switchboard unit to indicate current termite barriers is legible at the time of inspection.

Client must seek further information from the vendor or real estate agent if the conditions of termite management systems were maintained.
