Building and Timber Pest Inspection Report

Inspection Date: Tue, 24 Feb 2026

Property Address: 165 Quarry Rd, Ryde NSW 2112, Australia

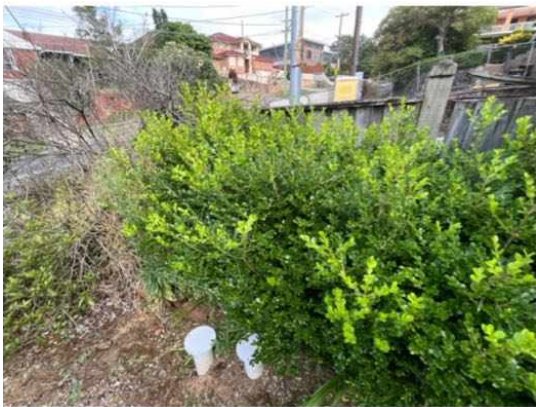
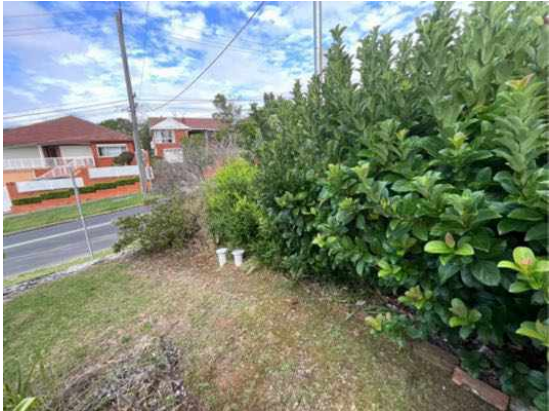
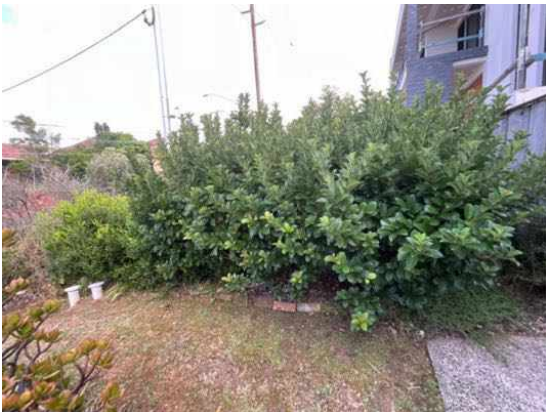
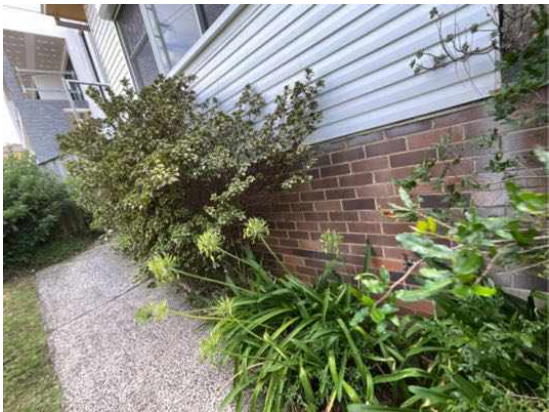
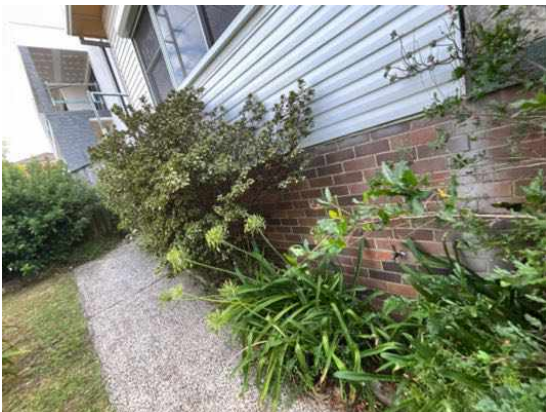
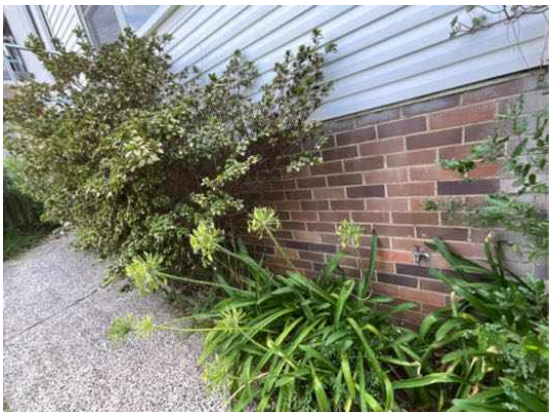
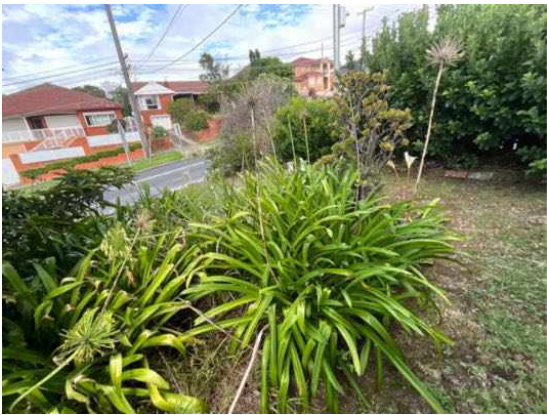
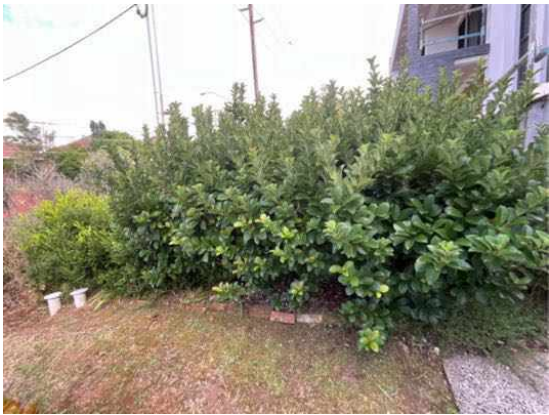
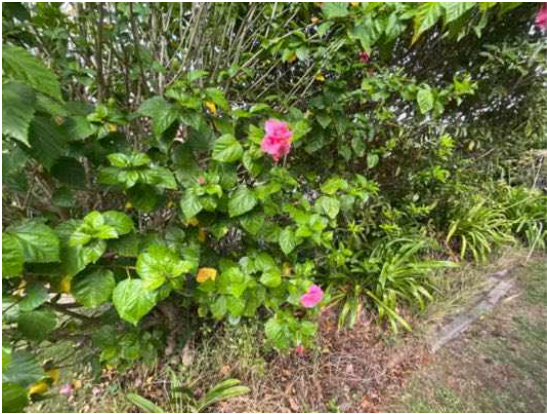
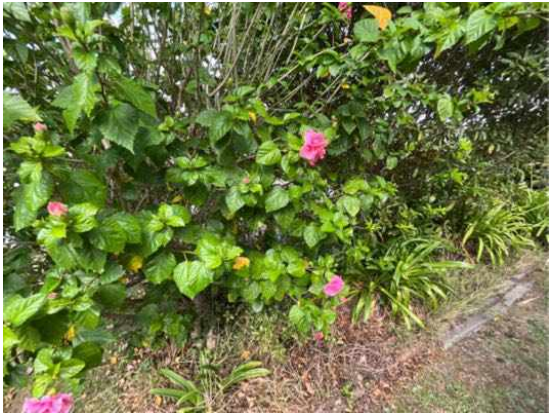
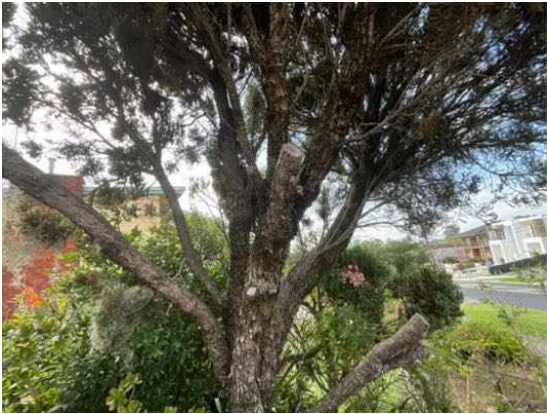
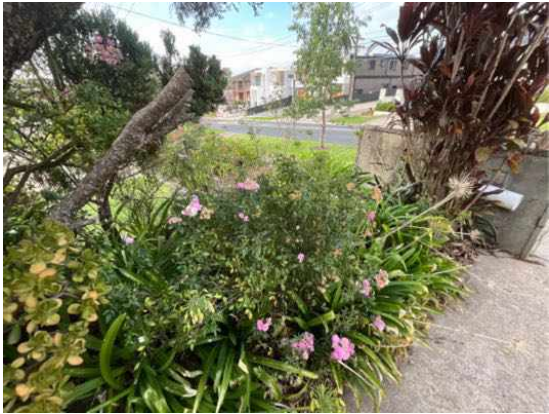
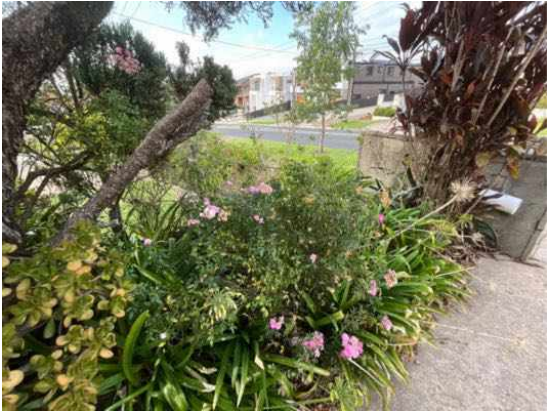
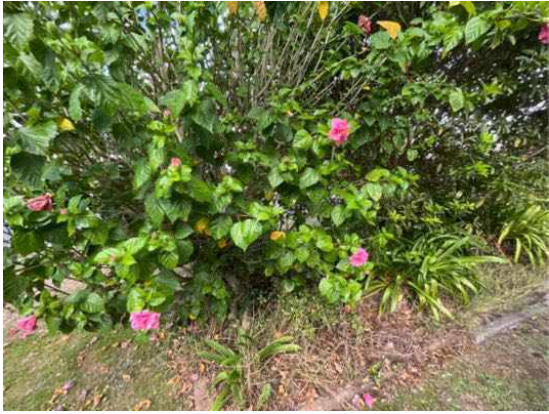
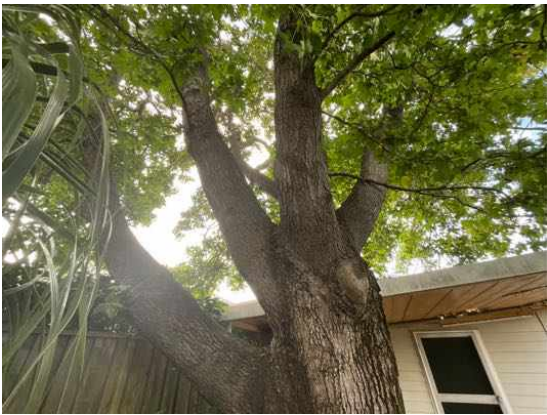
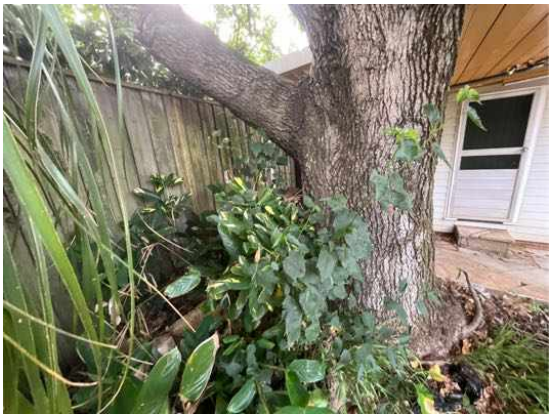
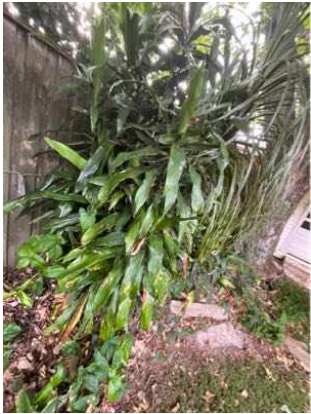
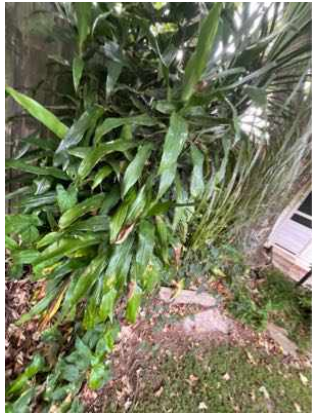
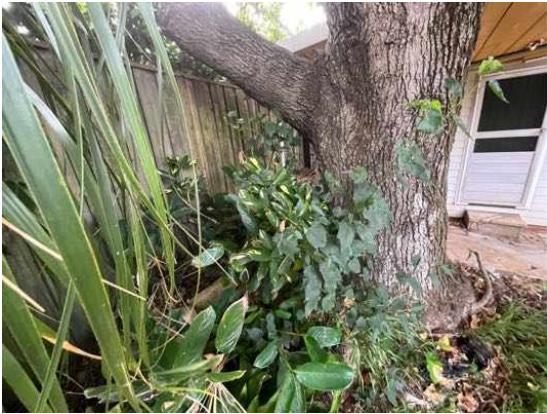
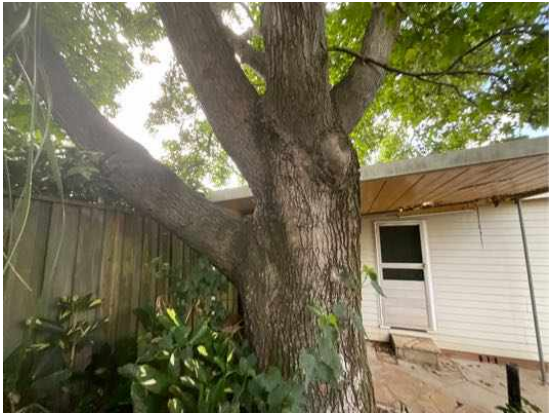
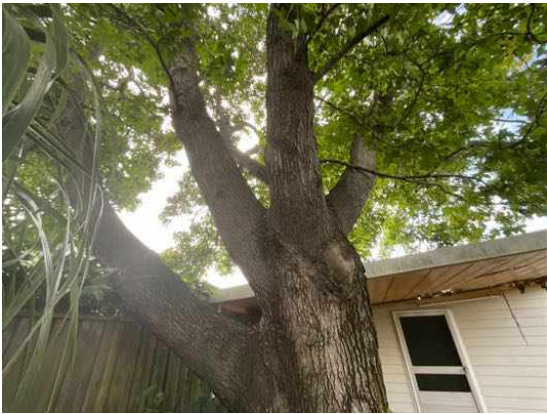
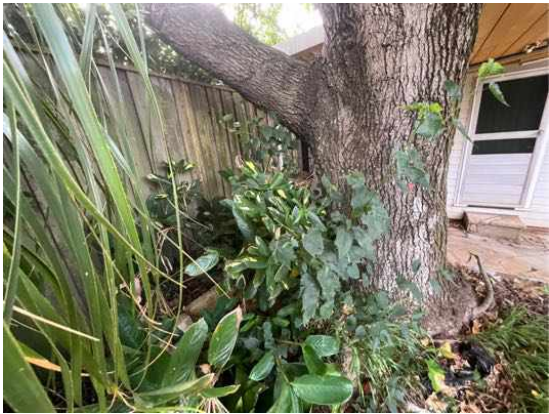
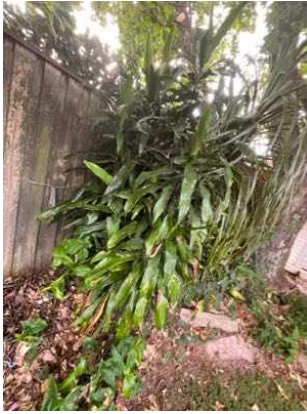
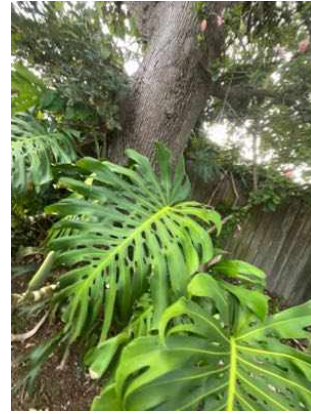
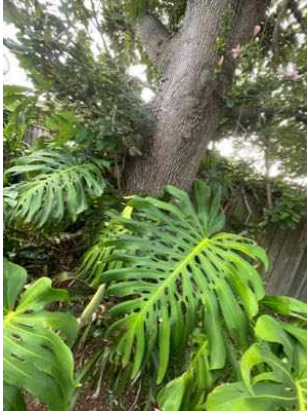
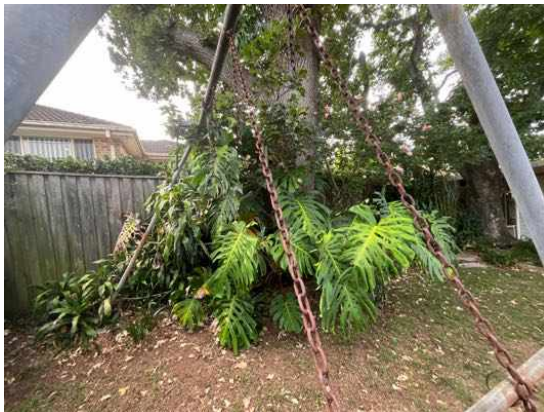
Finding 6.02

Building:	Main Building
Location:	All Areas
Finding:	Dense vegetation around a property can increase the risk of termite infestation
Information:	The presence of dense vegetation around a property can increase the risk of termite

infestation, as it provides a conducive environment for them. To address this, consider maintaining a clear space between the vegetation and your home. If you suspect a termite issue, it's advisable to consult with a licensed pest control professional for inspection and treatment.

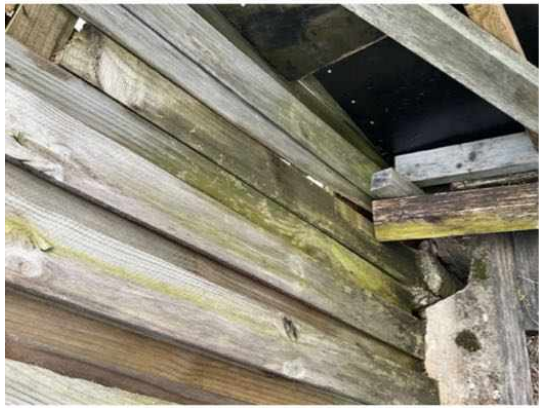
Finding 6.03

Building:	Main Building
Location:	All Areas
Finding:	Timber on ground / conducive conditions to termite damage
Information:	Timber on the ground is indeed conducive to termite damage. Termites are known to thrive in moist environments, and wood in contact with soil or moisture is more susceptible to infestation.

To prevent this, it's important to keep timber elevated and away from direct ground contact. Regular inspections and proper termite control measures are also essential to protect your wooden structures from termite damage.

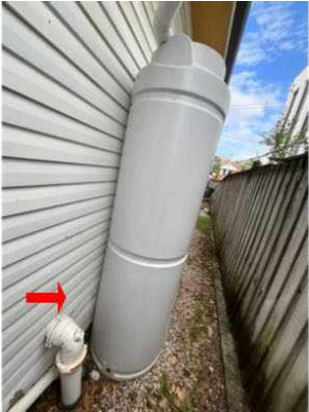
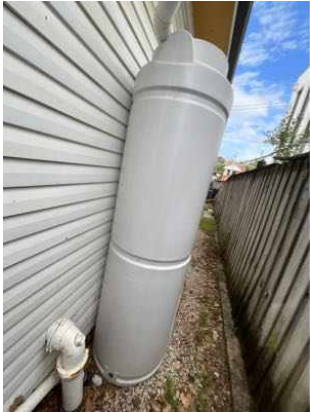
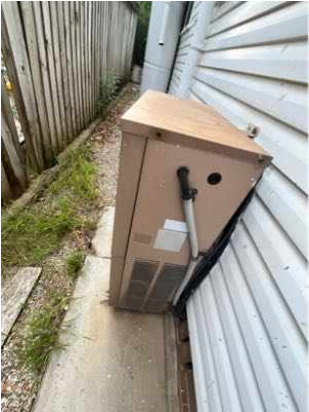
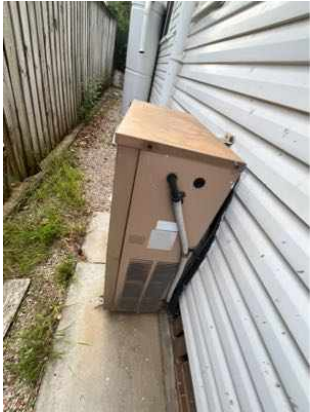
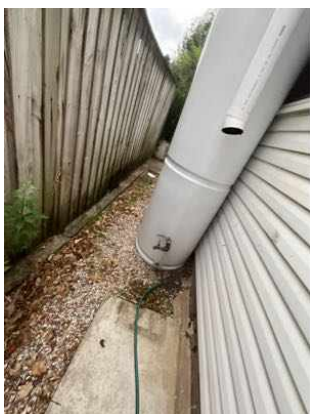
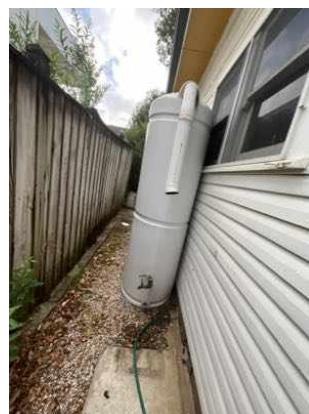
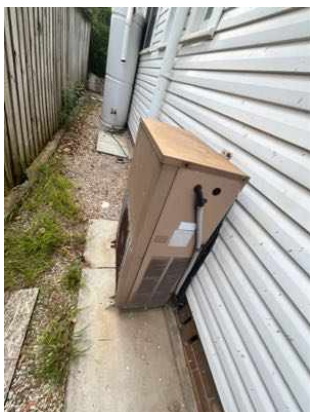
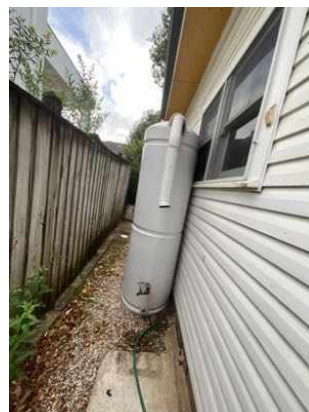
Finding 6.04

Building: Main Building
Location: All Areas
Finding: Bridging or Obstruction Conducive environment for Termites
Information: Bridging of termite barriers occurs when termites bridge (usually by building a mud tunnel) a termite barrier or inspection inspection zone or where termites have a passage, allowing them to bridge the barrier.

Where bridging has occurred full inspection is prevented and termites may enter a property in a concealed or undetected manner.

Recommended moving obstructions away from the external walls for further and future inspections.

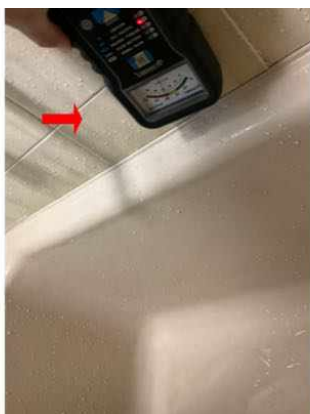
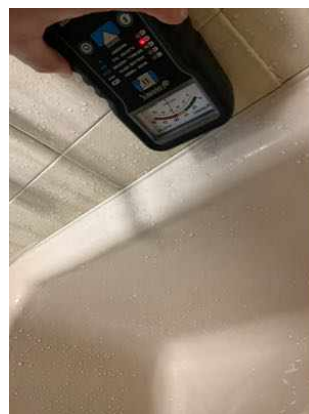
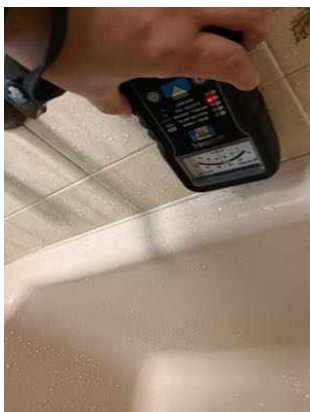
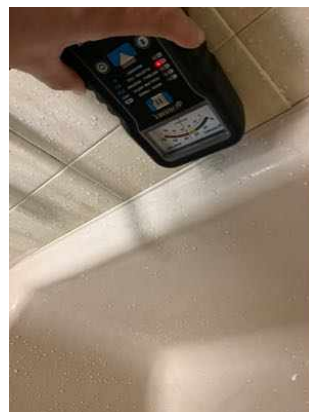
Building:	Main Building
Location:	Bathroom
Finding:	Excessive moisture - Conducive to Timber pest
Information:	Excessive moisture can attract termites and produce conditions that promote fungal growth and wood decay.

Excessive moisture is generally caused by deteriorated inadequate or missing roof drainage leaking plumbing pipes or fixtures poorly plumbed HWS overflows or condenser units and poor site drainage.

If mould growth has been found there may be environmental biological or health issues involved. In these cases an appropriately qualified inspector should also be contacted.

Prior to any remedial works being performed a qualified plumber should be appointed to further inspect the property and to identify the cause of the excessive moisture. Works to remove affected building elements may then be necessary and should be performed by an appropriate tradesperson.

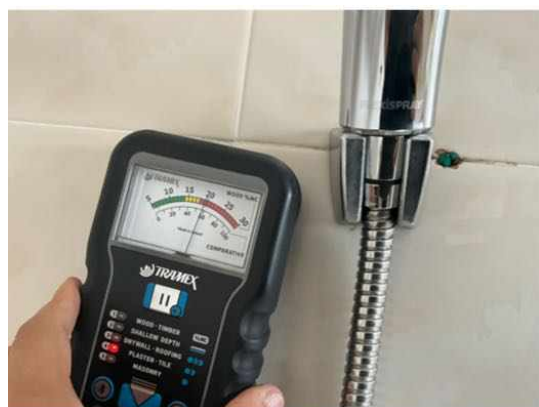
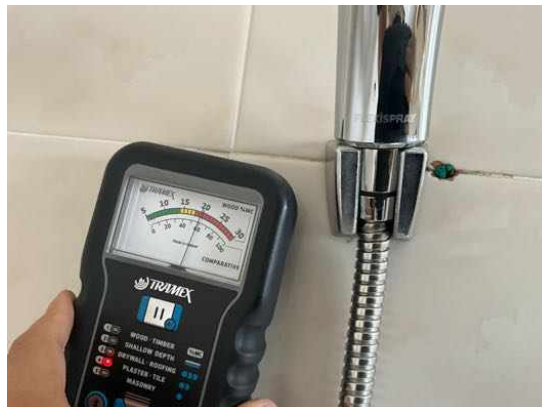
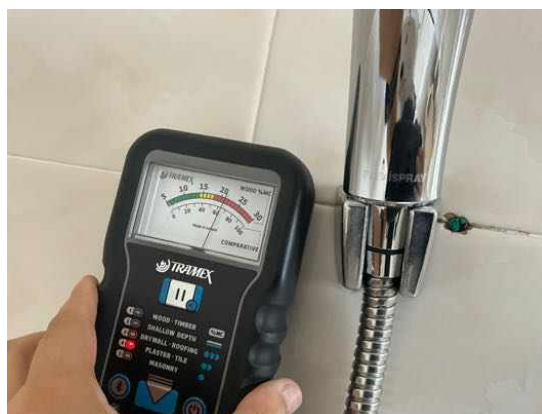
Finding 6.06

Building:	Main Building
Location:	Ensuite
Finding:	Excessive moisture conducive condition near Air-conditioner
Information:	<p>Excessive moisture near an air conditioner can indeed create conducive conditions for termites. Termites are attracted to damp and decaying wood, which can be found in areas with high moisture levels. To fix this issue:</p> <ol style="list-style-type: none"> 1. Fix Leaks: Check for any leaks or condensation around your air conditioning unit. Repair any damaged pipes, drains, or insulation that may be causing moisture buildup. 2. Proper Drainage: Ensure that your air conditioner has proper drainage. Make sure the condensate drain line is clear and directed away from your home's foundation. 3. Ventilation: Improve ventilation around the unit. Ensure that the area is well-ventilated to reduce humidity levels. 4. Regular Maintenance: Schedule regular maintenance for your air conditioning system. This can help prevent leaks and ensure

it's working efficiently, reducing the chance of moisture.

5. Please consult a HVAC Technician: HVAC (Heating, Ventilation, and Air Conditioning) technicians are trained to diagnose and

repair a wide range of air conditioning problems. They can handle issues with the cooling system, refrigerant, electrical components, and more.

6. Consult an appropriate and Qualified Professional: For severe moisture issues or persistent termite problems, consult with a

pest control professional who can provide targeted solutions.

By addressing these issues, you can reduce the moisture levels around your air conditioner and minimize the attractiveness of the area to termites.

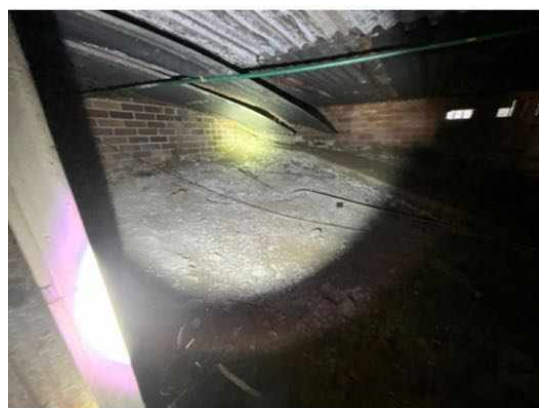
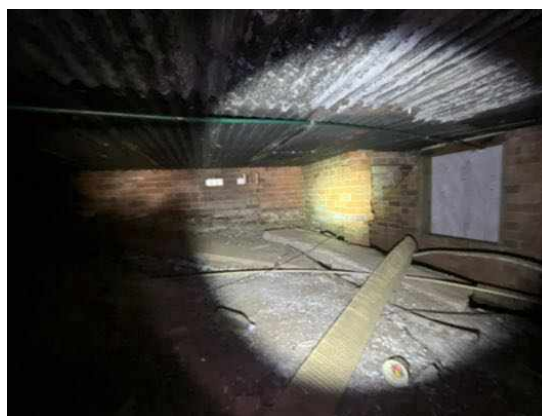
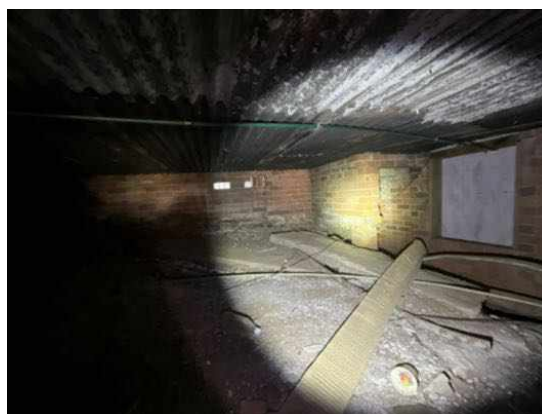
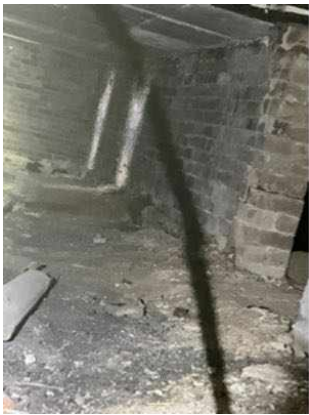
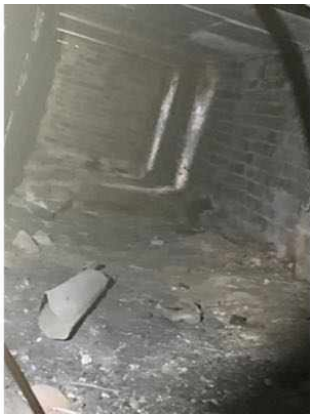
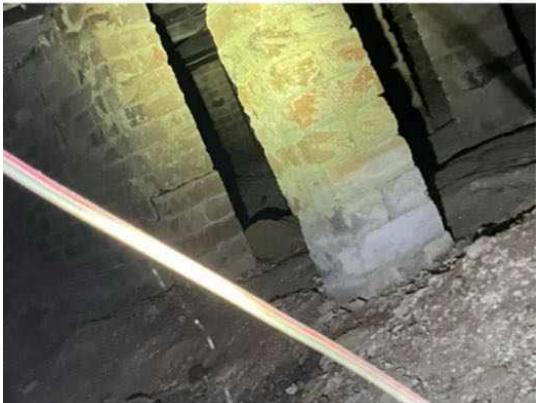
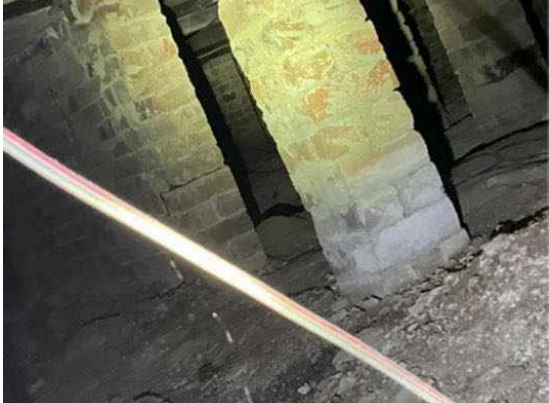
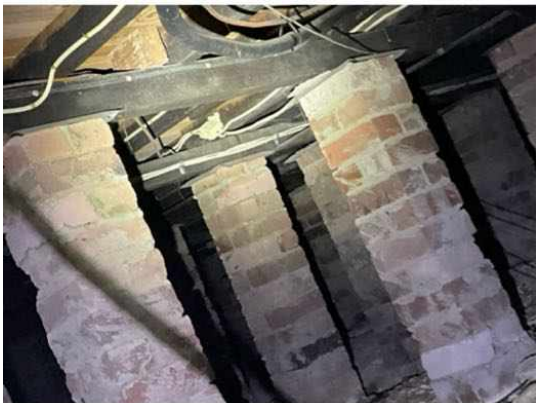
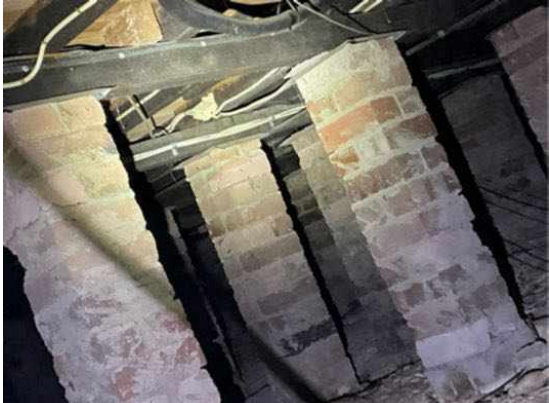
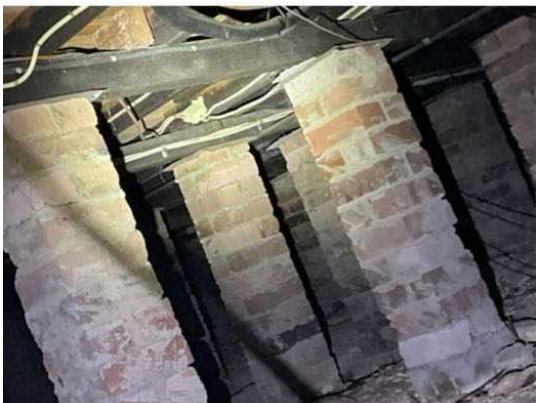
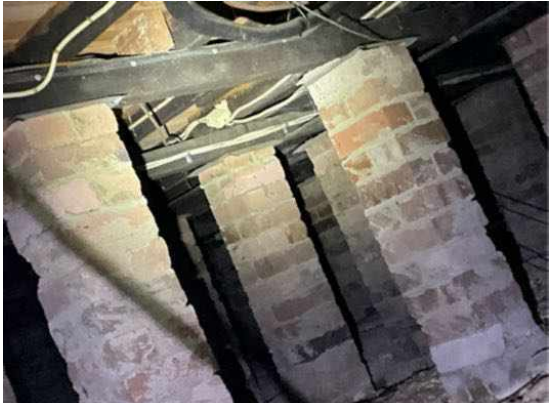
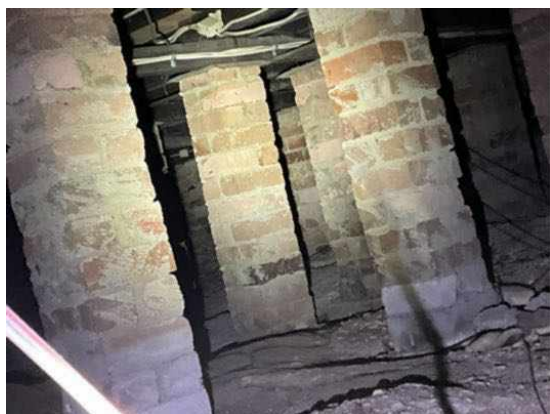
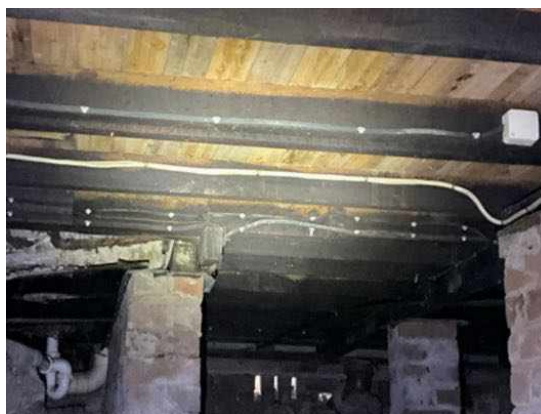
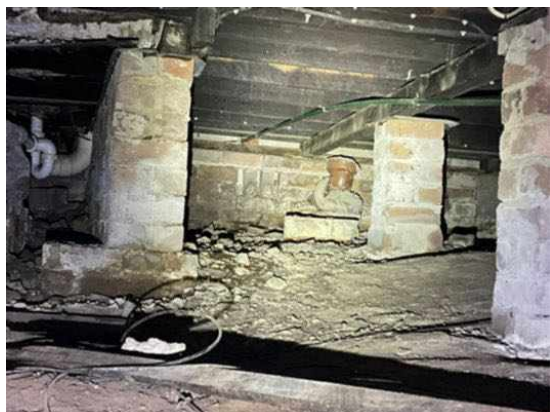
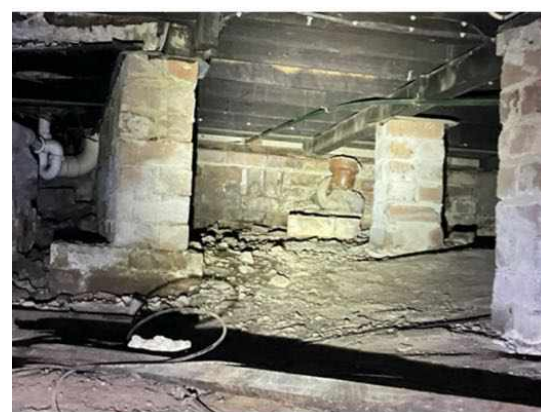
Finding 6.07

Building:	Main Building
Location:	Subfloor
Finding:	Subfloor - poor ventilation, inadequate site drainage, water stains
Information:	The subfloor lacks adequate ventilation, suffers from inadequate site drainage, exhibits water stains, creating conducive conditions for timber pests such as termites.

Risk: The combination of poor ventilation, inadequate drainage, water stains significantly increases the risk of timber pest infestations. Termites are attracted to moist environments and can thrive in subfloors with high humidity levels and water damage. The lack of proper ventilation and drainage exacerbates moisture retention, providing an ideal habitat for timber pests to establish colonies and cause extensive damage to the subfloor structure. Additionally, water stains indicate previous or ongoing moisture issues, which further attract timber pests and contribute to the deterioration of timber materials.

A licensed pest control professional specializing in timber pest management should be consulted to assess the extent of the infestation and develop a comprehensive treatment plan. They can implement strategies to eliminate existing timber pests, such as termites and prevent future infestations by addressing underlying moisture issues. Additionally, a qualified plumber or builder may be needed to improve subfloor ventilation, enhance site drainage, repair water-damaged areas. Regular inspections and maintenance are essential to ensure ongoing protection against timber pests and maintain the structural integrity of the subfloor.

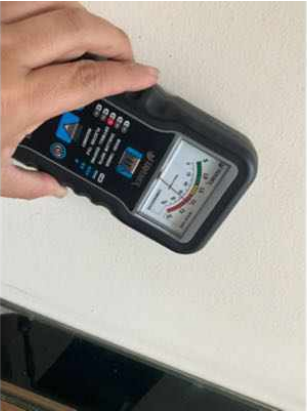
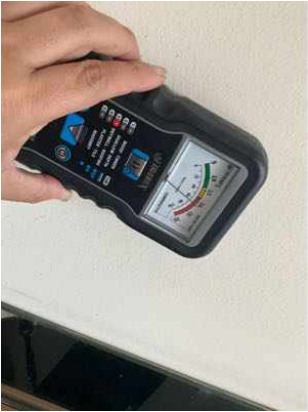
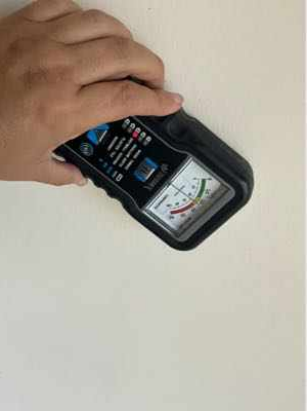
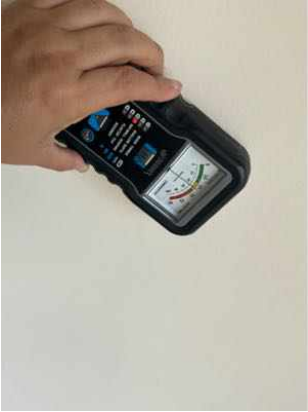
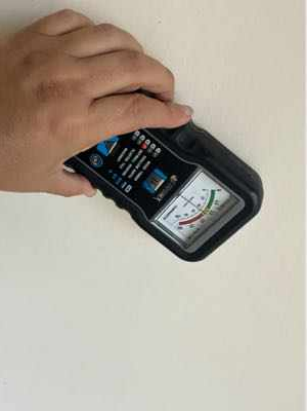
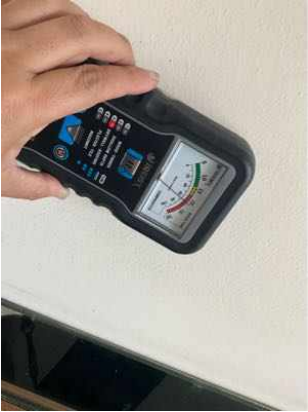
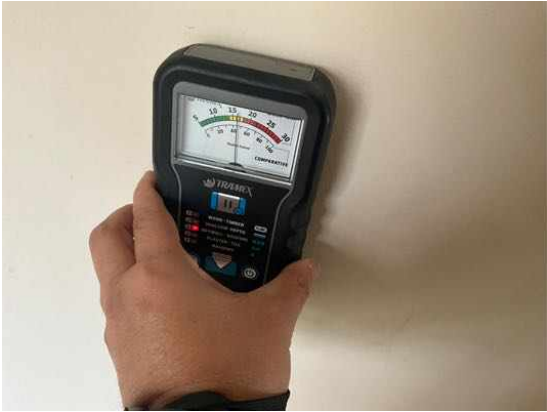
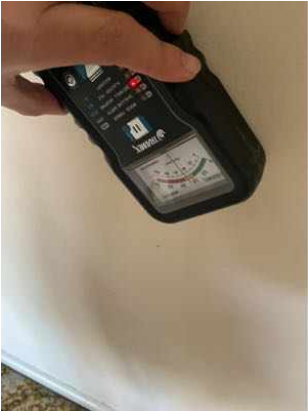
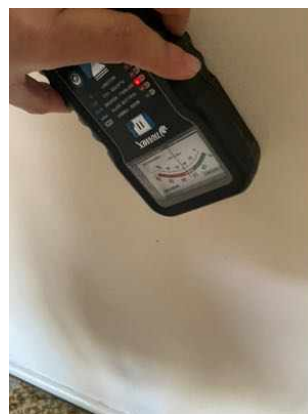
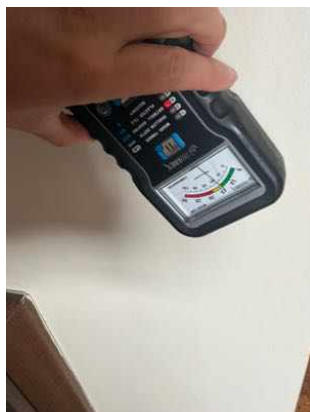
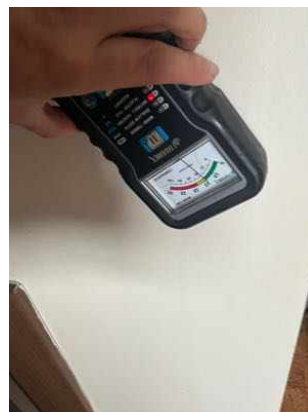
Finding 6.08

Building:	Main Building
Location:	All Areas
Finding:	Excessive moisture - Conducive to Timber pest
Information:	Excessive moisture can attract termites and produce conditions that promote fungal growth and wood decay.

Excessive moisture is generally caused by deteriorated inadequate or missing roof drainage leaking plumbing pipes or fixtures poorly plumbed HWS overflows or condenser units and poor site drainage.

If mould growth has been found there may be environmental biological or health issues involved. In these cases an appropriately qualified inspector should also be contacted.

Prior to any remedial works being performed a qualified plumber should be appointed to further inspect the property and to identify the cause of the excessive moisture. Works to remove affected building elements may then be necessary and should be performed by an appropriate tradesperson.

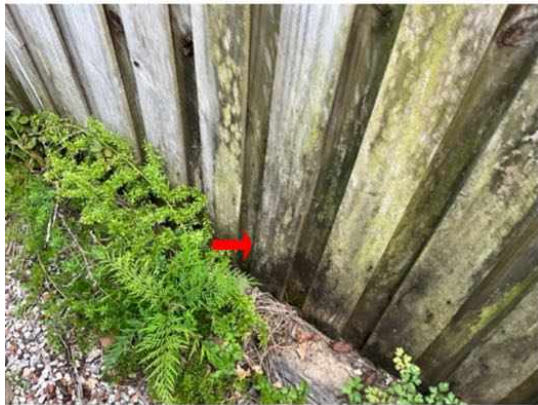
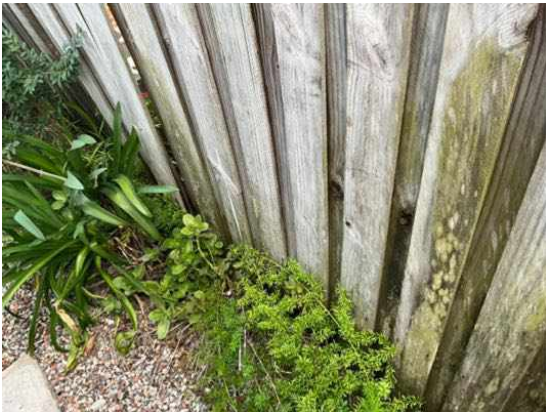
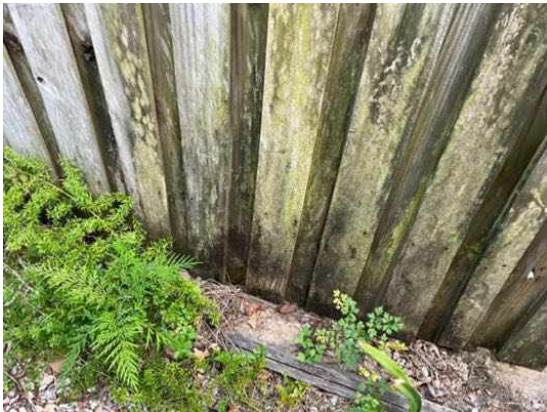
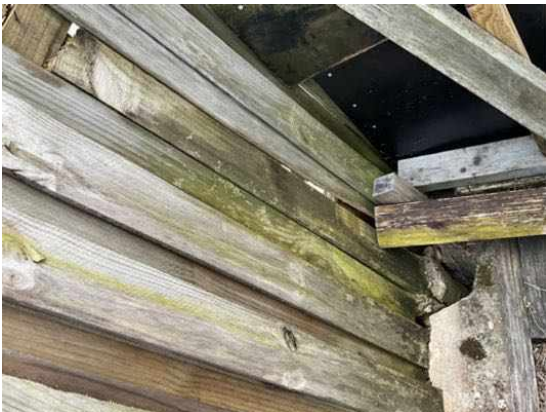
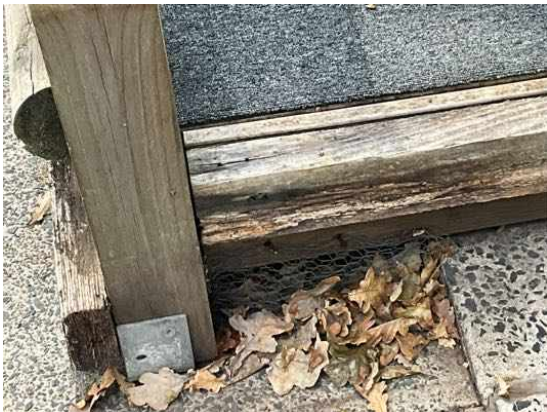
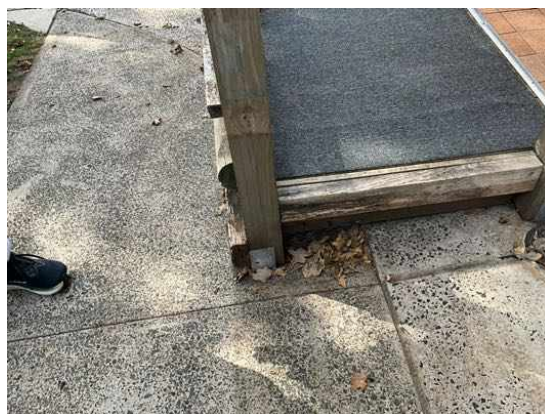
Finding 7.01

Building:	Main Building
Location:	All Areas
Finding:	Wood rot
Information:	This building element shows evidence of wood rot. Wood rot, also known as Fungal Decay, occurs when timbers and other cellulose building materials are exposed to damp conditions on an ongoing basis. This could be the result of exposure to weathering over a prolonged period of time, or the attraction of excessive moisture from other abutting building materials. Contributing factors also include poor air ventilation in the area.

Wood rot is often associated with general damp problems and is evidenced by a 'musty' smell or mould and mildew occurring on surfaces. If left unmanaged, damp conditions can lead to further health problems and the decay of timbers will continue.

Early intervention and regular maintenance, particularly of exterior timbers, will prolong the useful life of these building elements. Prior to any works being performed, the cause of the moisture that has created the visible wood rot should be identified and addressed in a suitable manner. Replacement of affected timbers may then be a necessary step in protecting surrounding building elements from such deterioration.

A qualified plumber may be appointed to assess the cause of excessive moisture and to provide advice on any remedial works as required. A qualified carpenter or registered builder may also be required to replace affected building materials.
