Building and Timber Pest Inspection Report

Inspection Date: Tue, 24 Feb 2026

Property Address: 165 Quarry Rd, Ryde NSW 2112, Australia

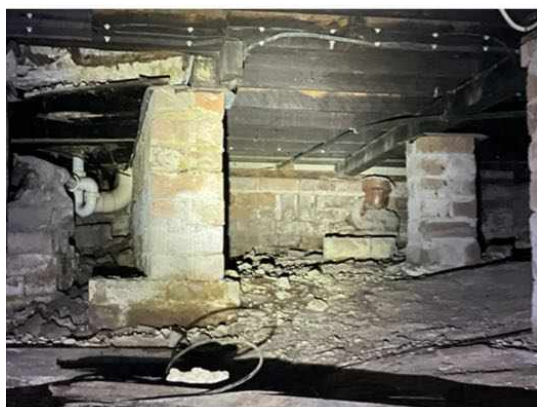
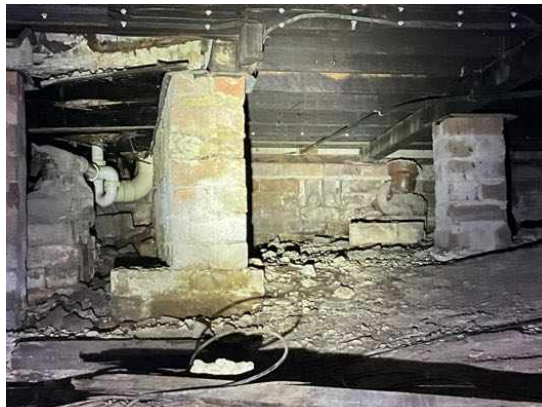
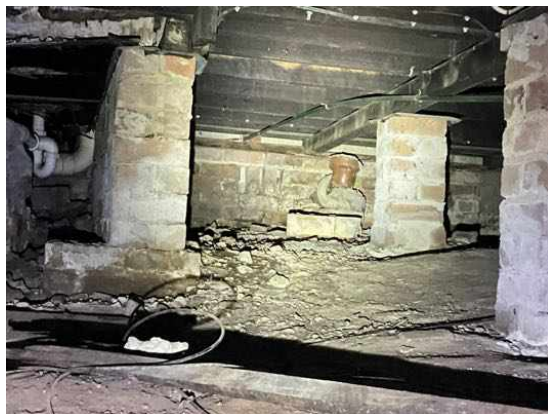
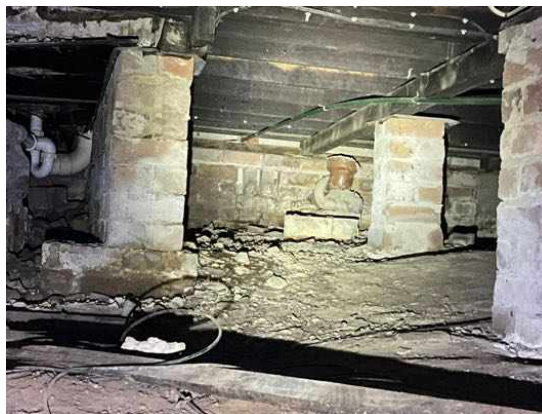
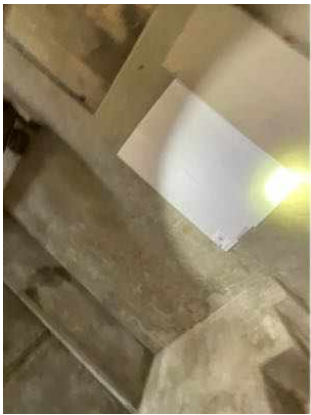
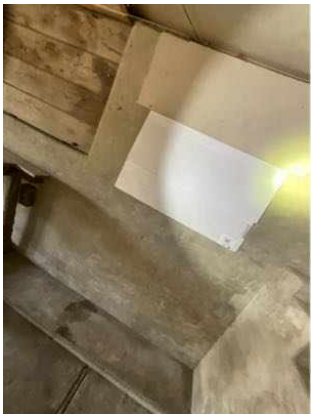
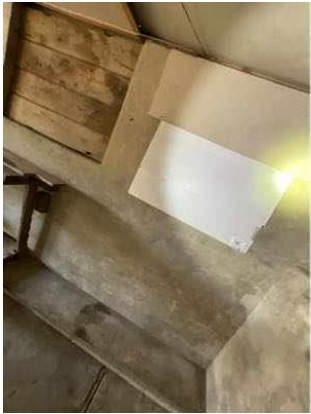
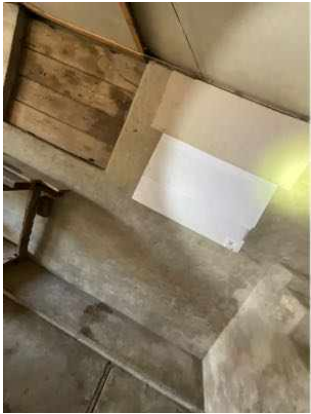
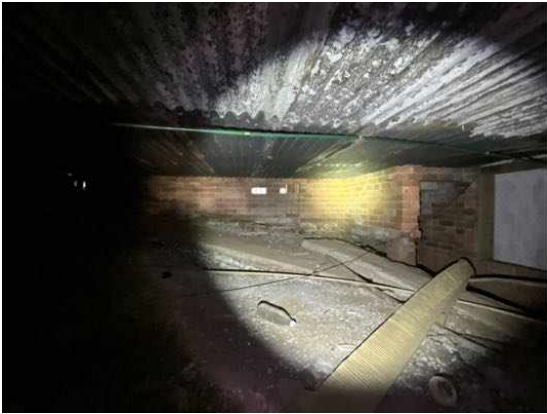
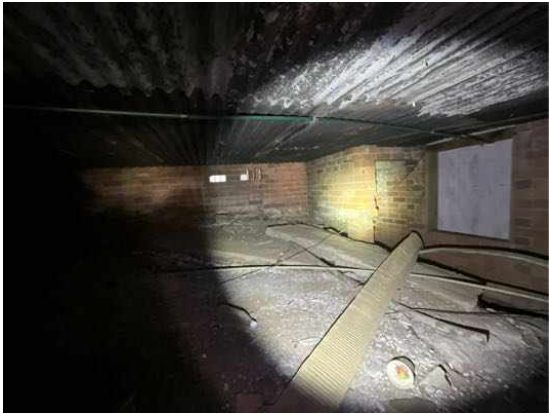
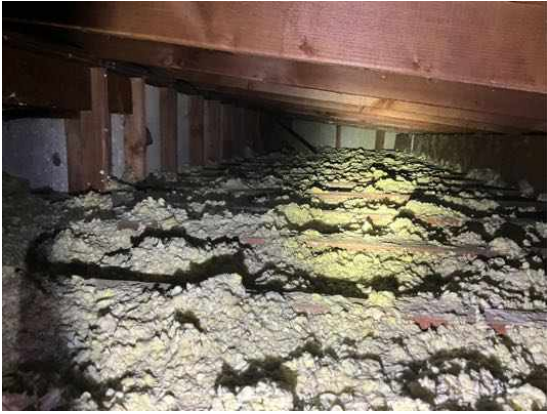
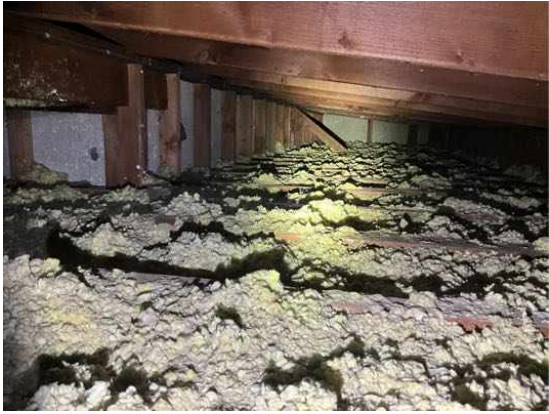
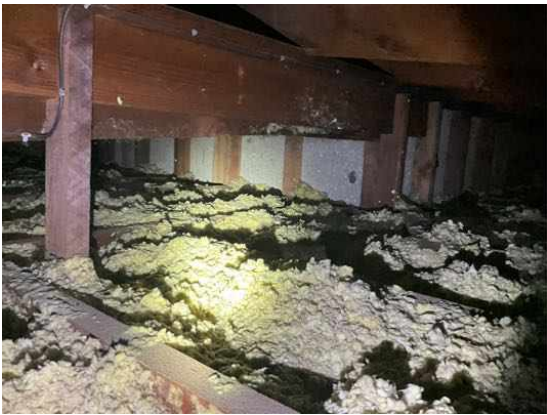
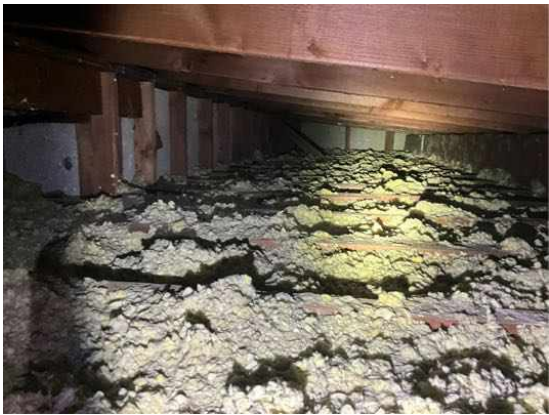
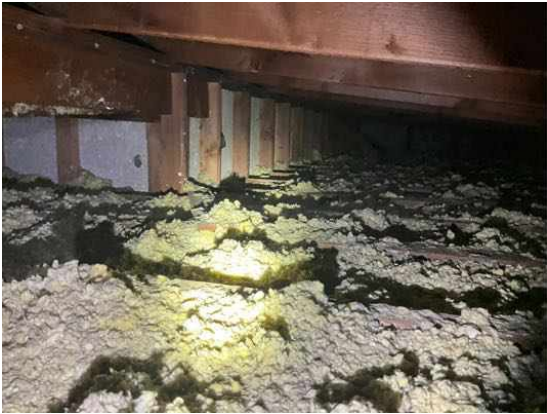
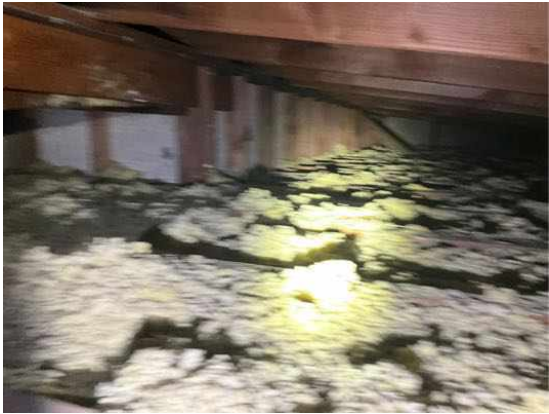
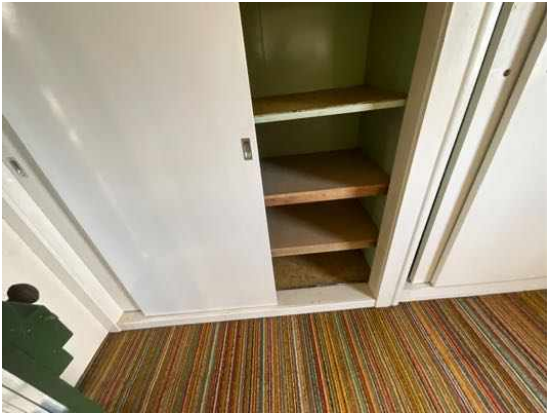
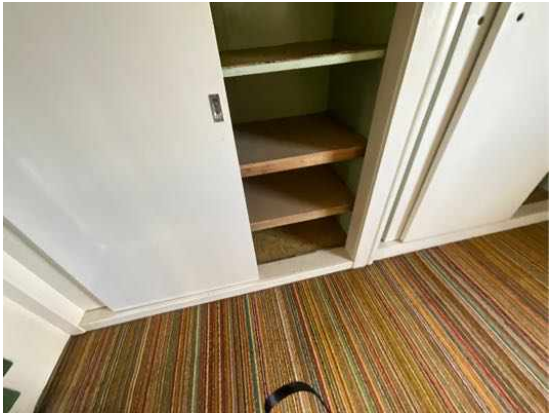
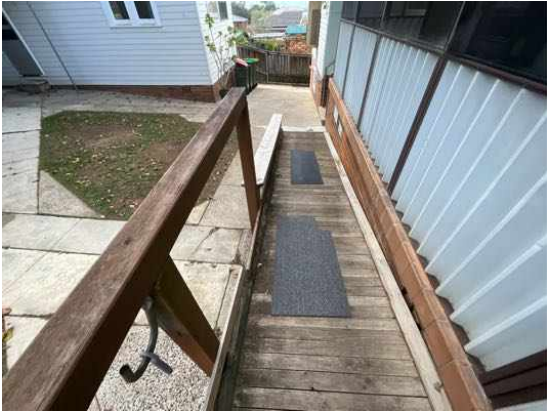
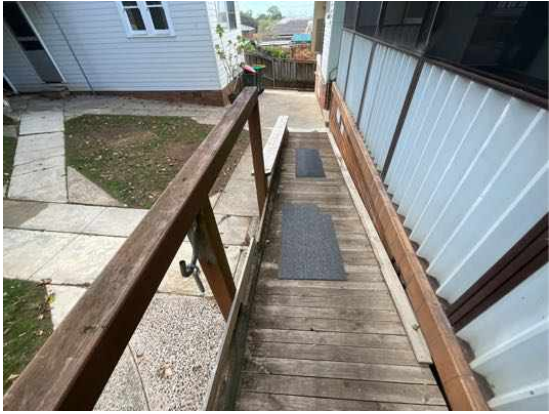
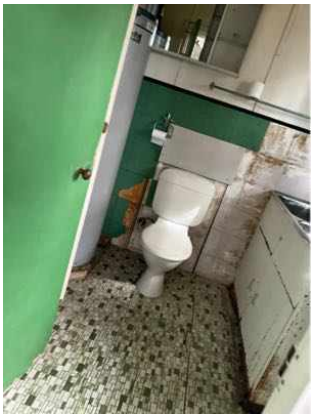
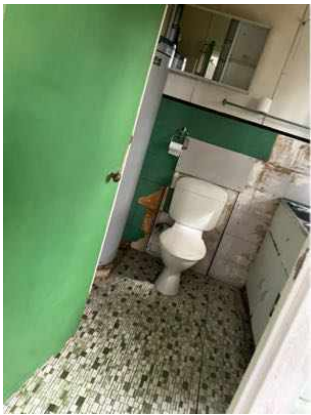
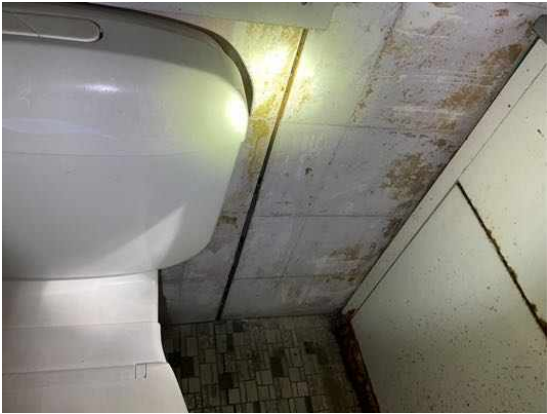
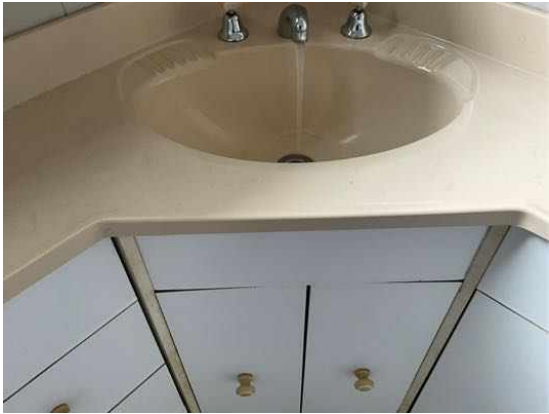
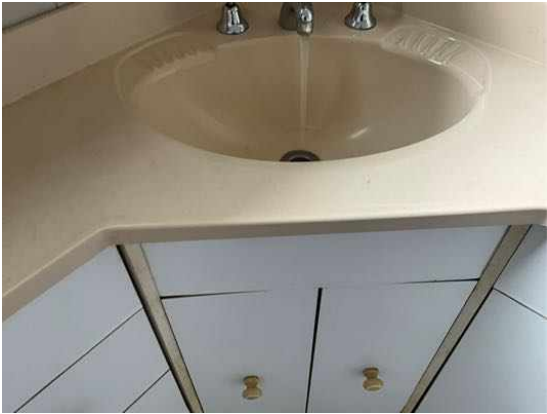
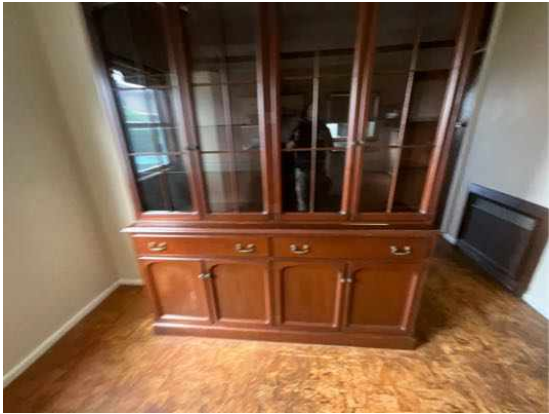
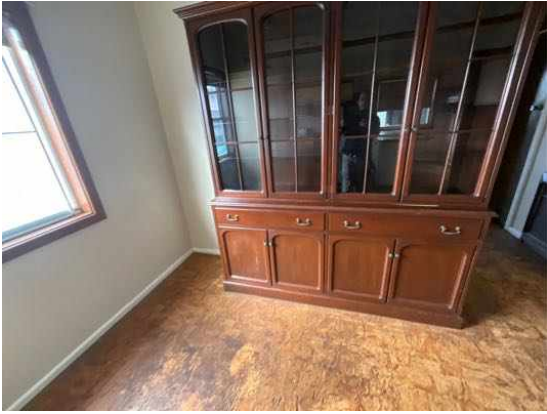
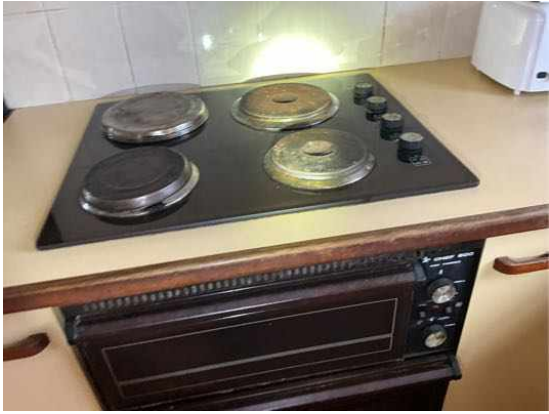
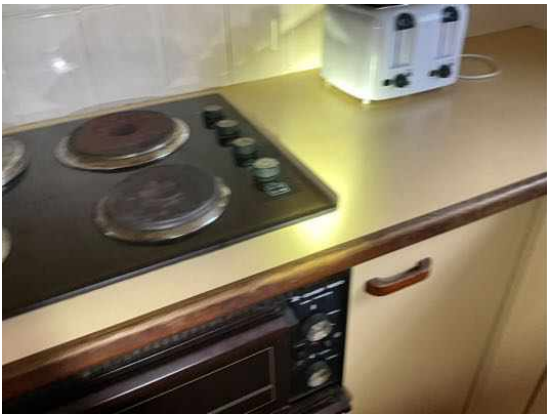
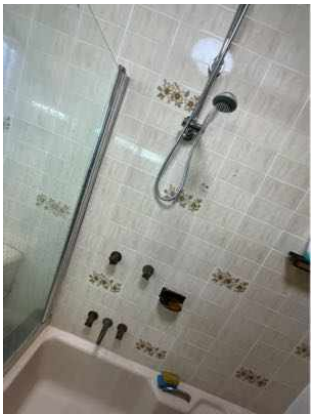
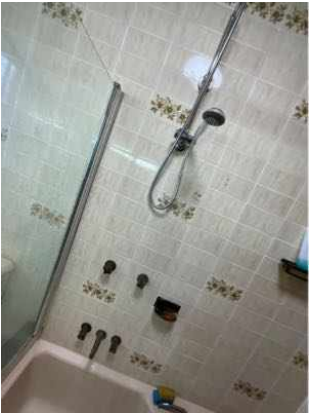
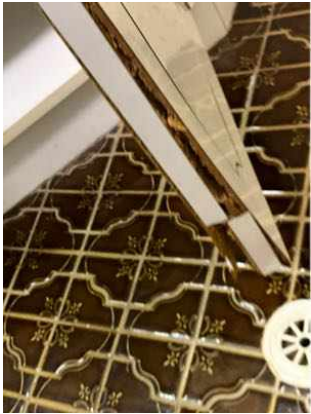
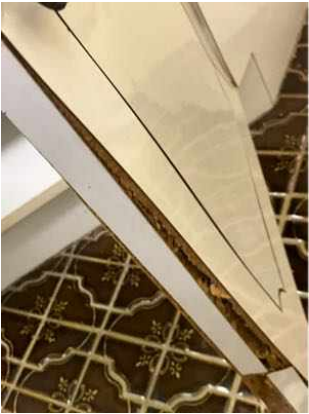
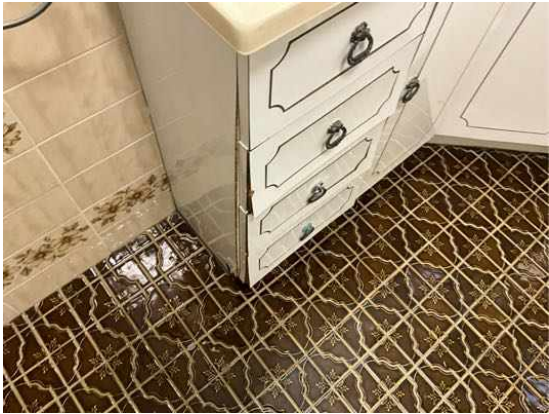
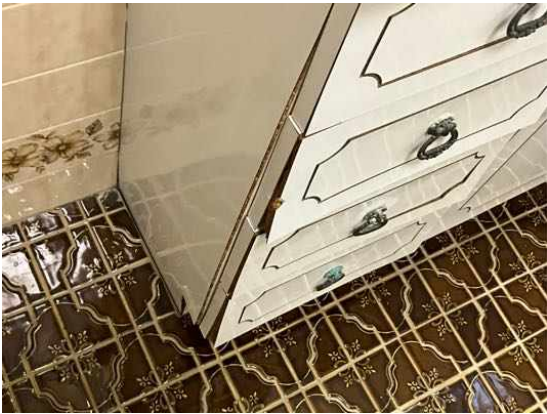
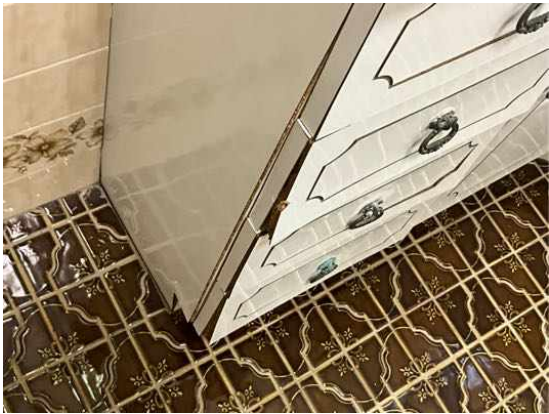
Finding: Additional Photos - Obstructions and Limitations

Information: These photographs are an indication of the obstructions and limitations which impeded full inspection of the property at the time of inspection. These obstructions can hide an array of defects and should be removed to allow full inspection to be carried out. A re-inspection is recommended once the areas are made accessible.

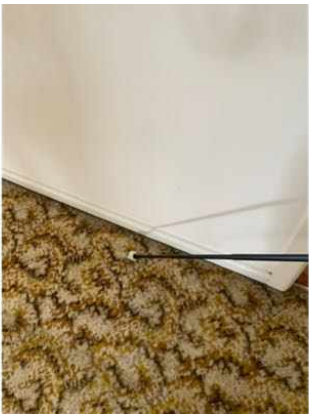
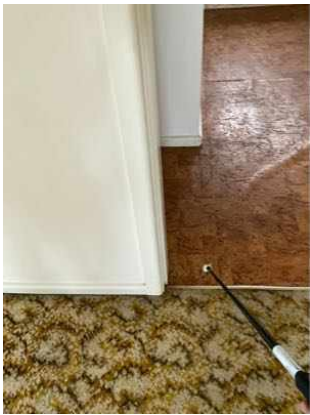
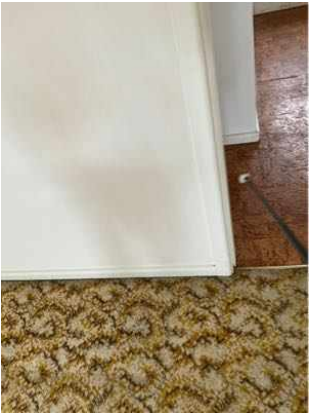
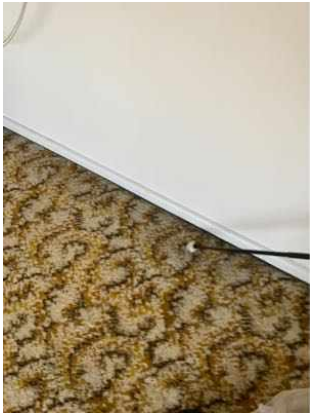
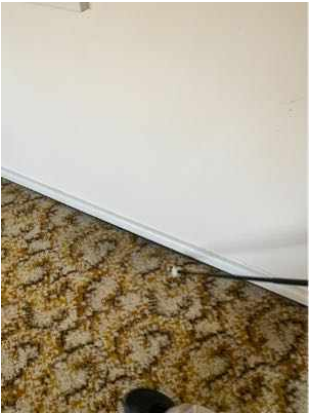
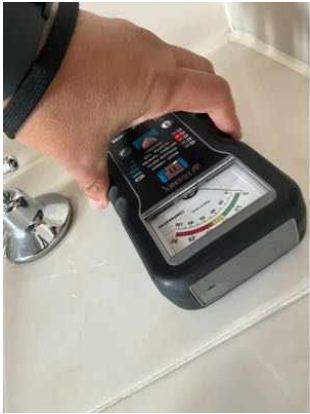
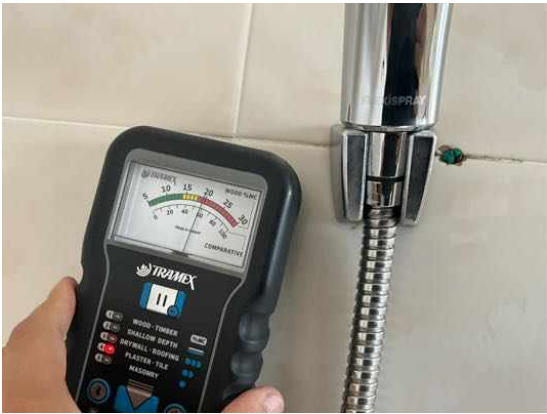
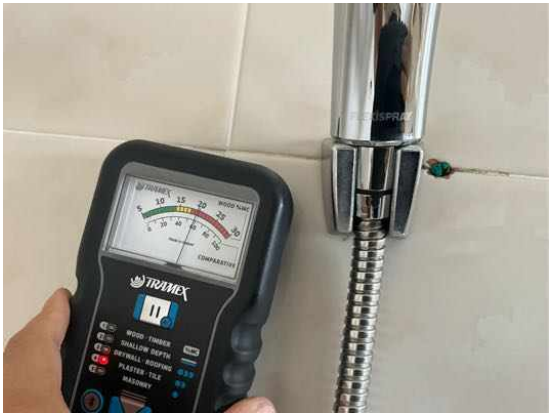
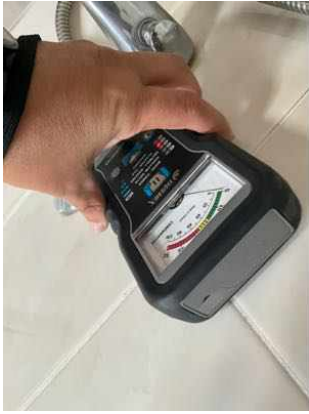
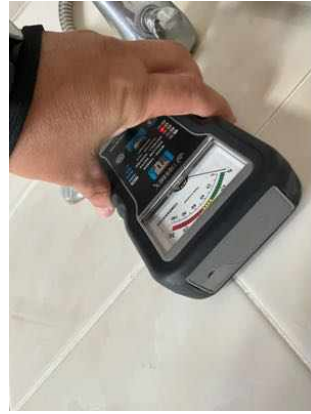
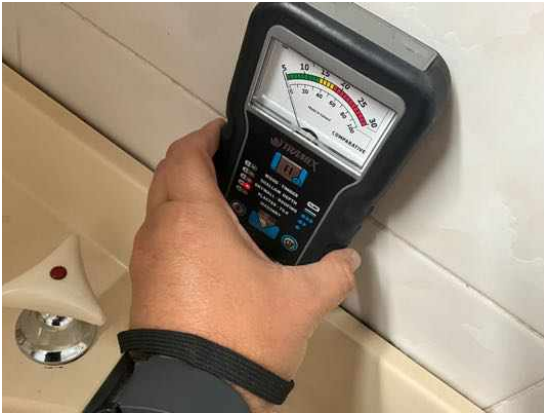
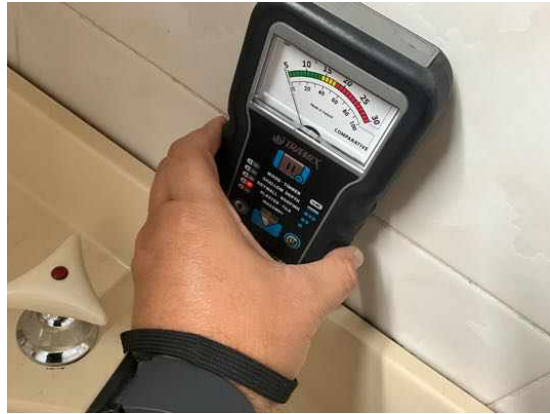
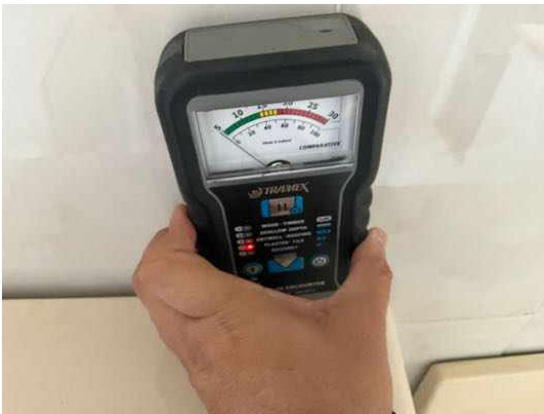
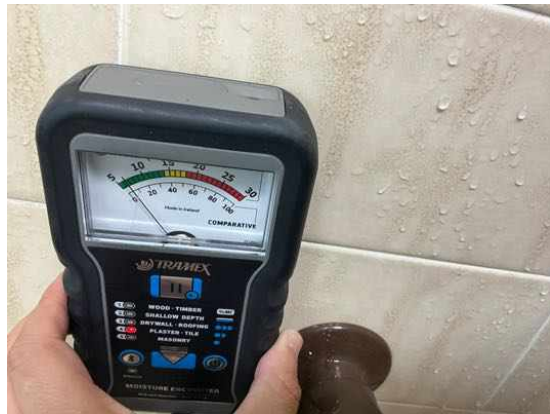
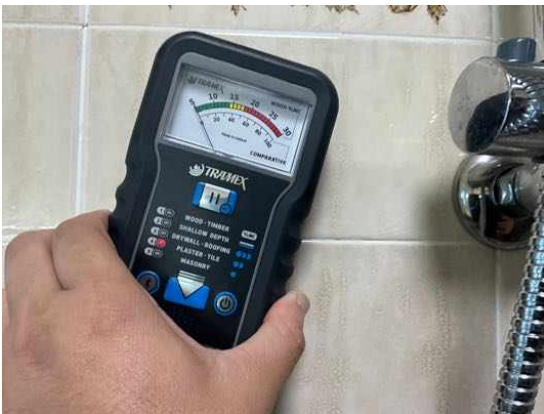
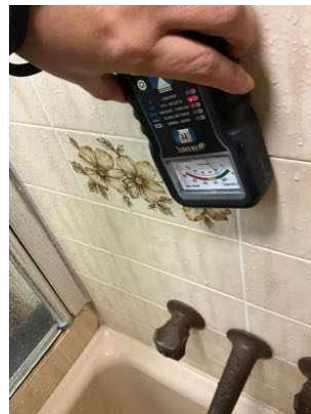
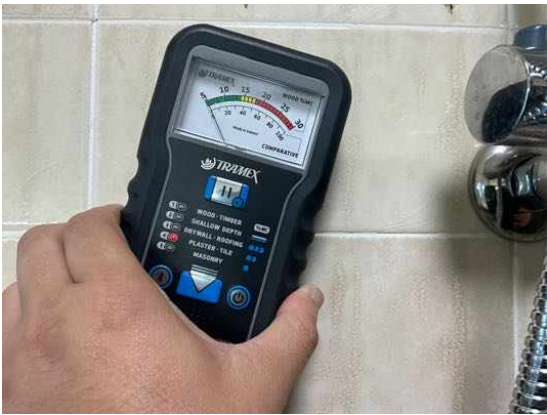
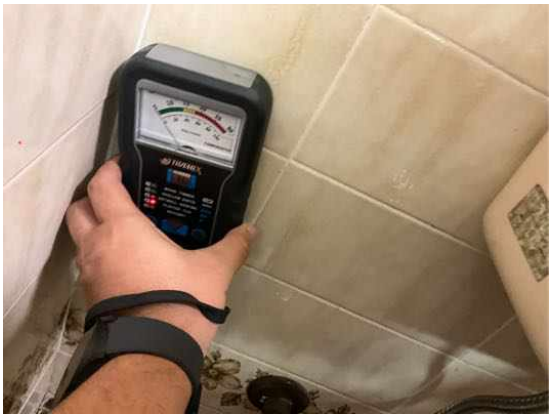
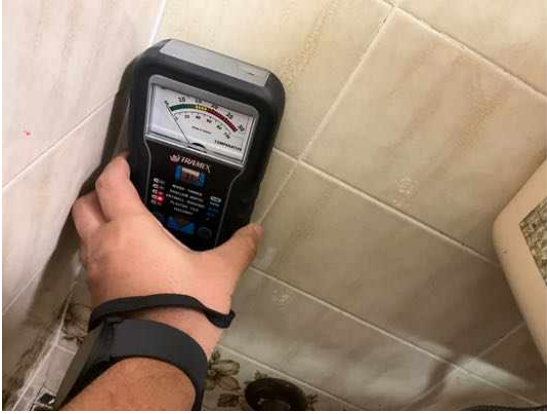
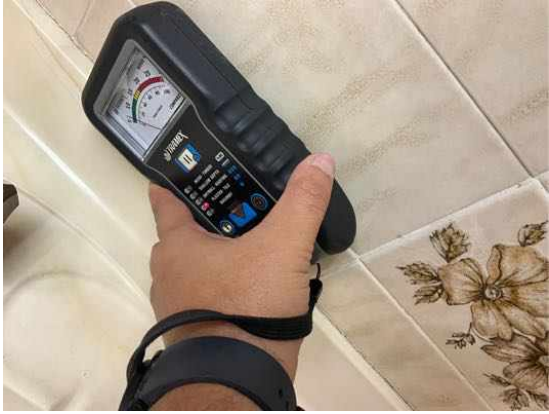
Building: Main Building
Location: All Areas
Finding: Additional Photos
Information: Additional photos are provided for your general reference
