Building and Timber Pest Inspection Report

Inspection Date: Mon, 16 Feb 2026

Property Address: 22 Meaklim St, Shepparton VIC 3630,
Australia

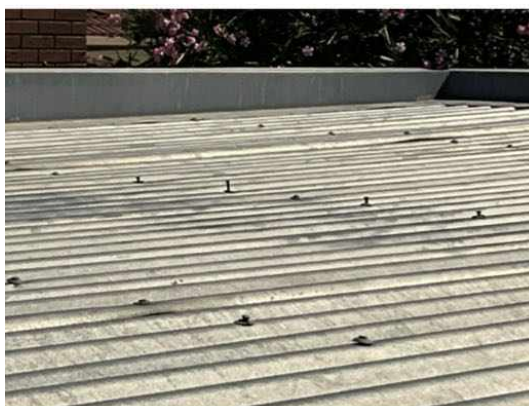
Building:	Building 1
Location:	Shed
Finding:	Roof sheets - Loose
Information:	Upon inspection of the exterior roof covering, it was noted that numerous roof sheets have become loose from their original fixings. It is suspected that this defect has developed as a result of a lack of adequate maintenance, but may also have been caused by inappropriate fixings being used in the construction process.

Loose roof sheeting detracts from the weather tightness of the roof covering, making the internal roofing structure susceptible to water penetration and subsequent damage. If left unaddressed, it is likely that secondary damage to associated building elements will develop, potentially necessitating remedial works to these structures.

A roofing restoration contractor should be appointed to advise on rectification options and on the cost of repair. It is advised that remedial works be performed as soon as possible to prevent any further damage.

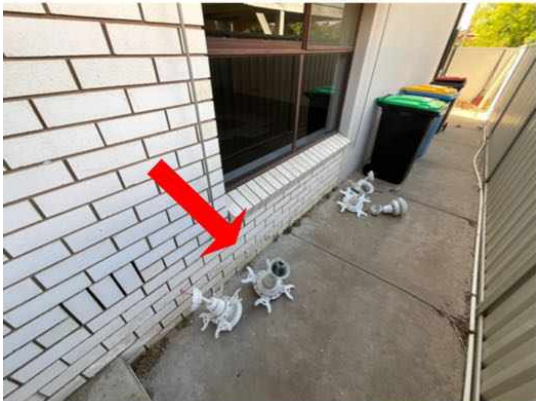
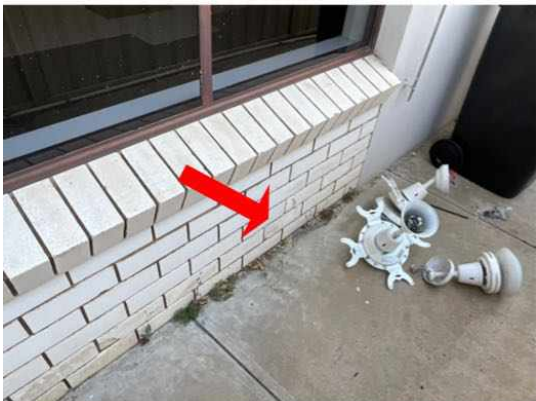
Finding 3.02

Building:	Building 1
Location:	Yard - Side
Finding:	Brickwork - Deterioration
Information:	Deterioration was evident to sections of the brickwork in this area at the time of inspection. Commonly referred to as brick corrosion or erosion, the bricks are aged and likely to have been affected by a variety of factors, including weather exposure, damage, salt-based deterioration, and more.

Overtime, these factors can affect the bricks, causing them to become brittle and appear corroded or eroded. The mortar in the brickwork may also become powdery, further detracting from the structural integrity of the brickwork. If left unmanaged,

potential implications include further deterioration of the building materials, the development of secondary defects, and potential development of structural instability of the wall.

A bricklayer should be contacted for any advice on remedial works.
